# Ultra-High Performance Concrete in Ohio

## Student Study

*Prepared for:*  
The Ohio Department of Transportation,  
Office of Statewide Planning & Research

*Final Report*

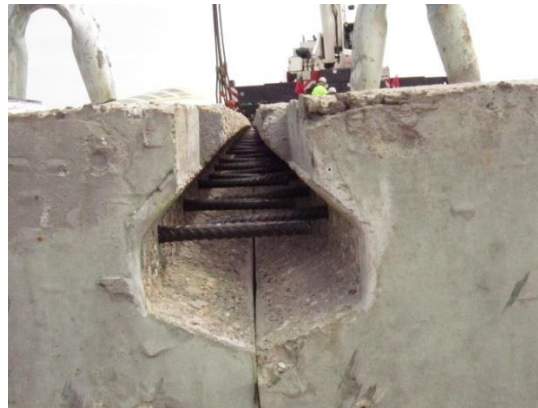
**Figure 2: Sollars Road Longitudinal Joint (a) Detail (b) Field Installation**

The Sollars Road Bridge was constructed in the summer of 2014 in Fayette County. It was the first bridge in the U.S. to utilize UHPC and dowel bars in the longitudinal joints of an adjacent prestressed concrete box beam bridge. No transverse dowel bars were used, and beam diaphragms only existed at the ends. Figure 2(a) shows details of the longitudinal joint used in the bridge. The dowel bar system had two parts, where the first part was embedded in the beam 18 in. and contained a female threaded end. The part that was embedded in the shear key had a length of 4.75 in. and had a male threaded end allowing it to be screwed into the part embedded in the beam. Figure 2(b) shows the joint during bridge construction.

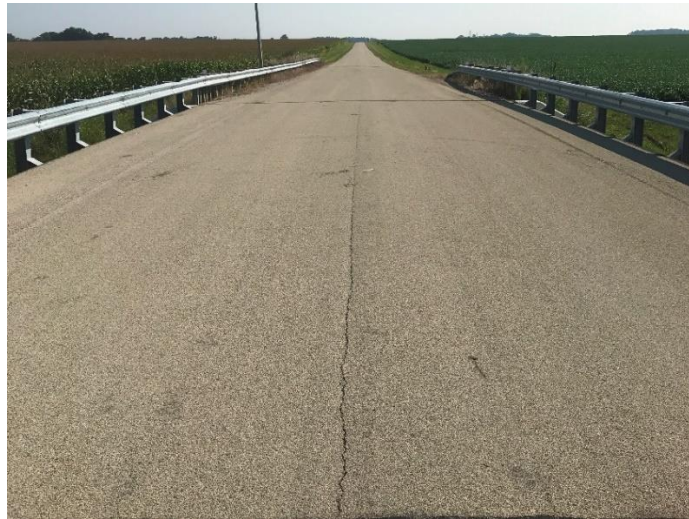
**Figure 3: Sollars Road Bridge Asphalt Crack**

bridge. All instrumentation was still usable and in working order. The longitudinal crack in the pavement was along the centerline of the pavement and along the pavement seam between lanes. Since the bridge consisted of seven adjacent box beams with the lanes centered on the bridge, it was determined this longitudinal crack was not reflective as it existed over the center of the middle beam and was caused by the paving operations. Figure 3 shows the longitudinal crack in the asphalt overlay. In addition, no leakage between beams has been observed.

The bridge was heavily instrumented and monitored during construction, loading, and for approximately one year after being open to traffic. The County Engineer noted a longitudinal crack in the asphalt pavement in the late summer of 2017. The research team visited the site in August of 2017 to determine if original instrumentation was still usable and to visually inspect the

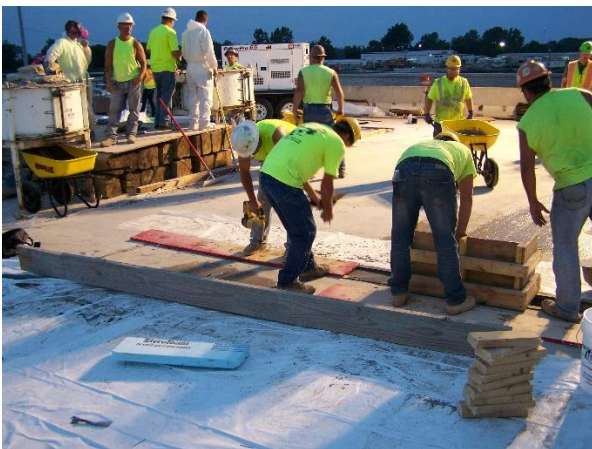
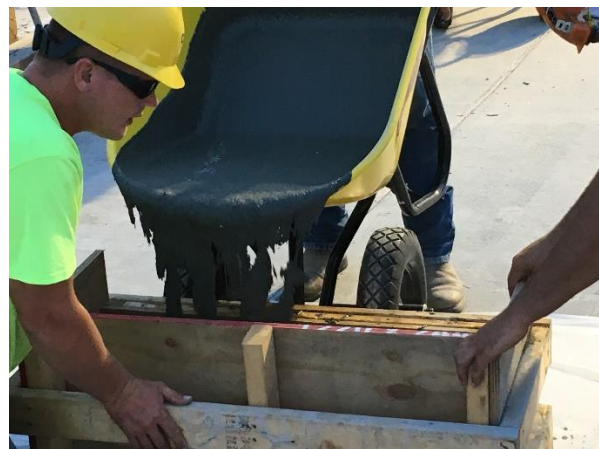
**Figure 5: LIC 310 UHPC Placement**

The UHPC was mixed and placed in the joint the evening of August 3, 2017. Figure 5(a) shows the overall process. The UHPC was moved from the mixers to the joints by wheelbarrows and placed into a wood chimney as shown in Figure 5(b). This allowed the UHPC to flow into the joint and form a hydraulic head to fill the joint. The UHPC was placed approximately  $\frac{1}{4}$  in. higher than the surrounding road surface and then later ground flush. This is due to the initial shrinkage of UHPC during setting and to assure no low spots exist from the possibility of trapped air. The joint was also sealed on top with plywood to allow the UHPC to flow above the joint.

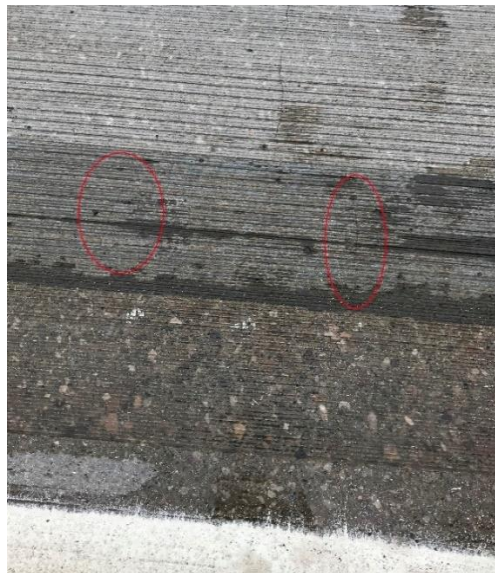
**Figure 6: UHPC Cracking**

During inspection in April of 2018, small hairline cracking was noticed in the deck and the UHPC closure pour (see Figure 6). This cracking was not observed during inspections in the Fall of 2017.

The UHPC used for the closure pour in the location of a wheel path is performing well, even though micro-cracking has been observed. Strains from truck loading were minimal and measured tensile strains during various temperature changes did not exceed 150 microstrain. Therefore, the measured strains would not cause cracking.

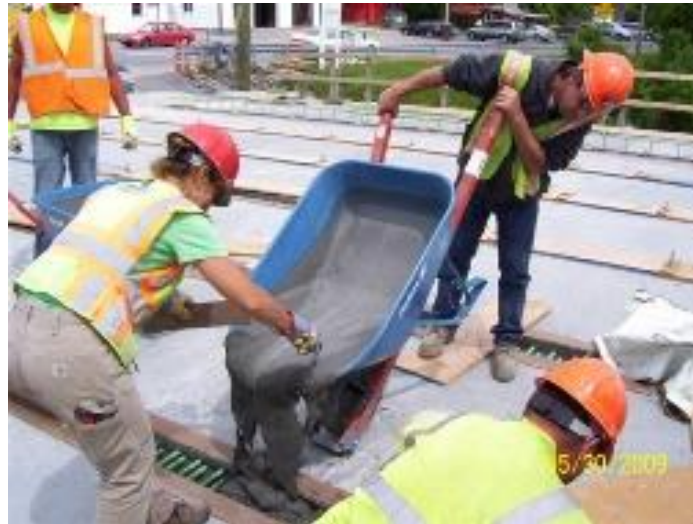
**Figure A1: UHPC Placement (Graybeal, 2010a)**

UHPC is flowable when thoroughly mixed and requires sealing of joints to eliminate leakage. Figure A1 (Graybeal, 2010a) shows a procedure of placing UHPC directly into the joint. Another procedure for UHPC placement involves covering the top of the joints and then using “chimneys” placed along the joints that allow the flow of the UHPC along the joint. The usage of the chimneys is shown in Figure A2 (Steinberg, et. al., 2015a). The flow of the UHPC in joints

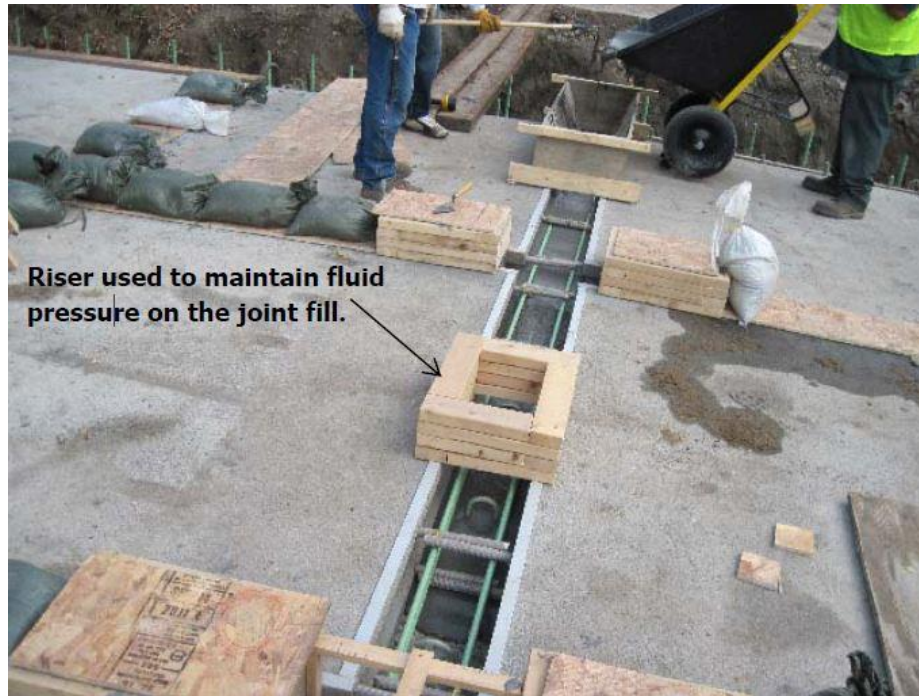
**Figure A9: Waffle Deck Panels with UHPC Joints (Heimann, 2013)**

with UHPC as shown in Figure A9 (Heimann, 2013). In addition, a fair amount of analytical work has been performed on the UHPC waffle deck panel systems (Garcia, 2007; Aaleti, et al., 2013).

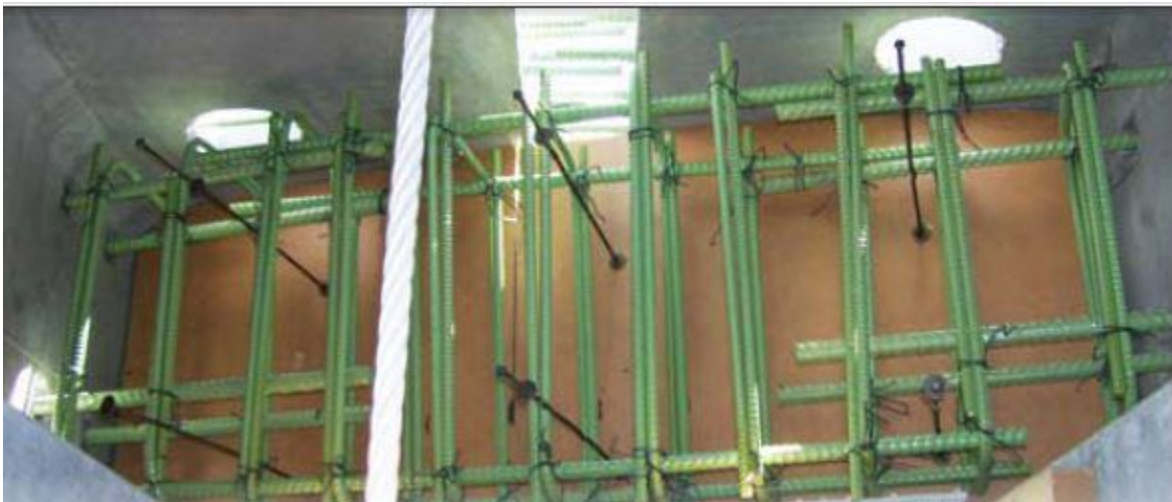
**Figure A10: Lyons, NY DBT Bridge from below before UHPC Placement (Shutt, 2009)**

projected from the beam flanges and were staggered as shown above the diaphragm reinforcement in Figure A10 (Shutt, 2009). The bars extended 4 in. or 6 in. from the edge of the girders which were only 6 in. thick at the flange edge. Kunin and White (2009) instrumented the beams of the bridge in Lyons, NY. The beams were modified *Prestressed Concrete Committee for Economic Fabrication* (PCEF) bulb tee girders by increasing the top flange thickness in order to eliminate the need for a separate concrete deck slab. The bridge had a span of 85 ft and was 42.75 ft wide with a 15-degree skew. Camber adjustment was performed prior to UHPC placement to provide a flat bridge deck as shown in Figure A11 (Royce, 2011). Once the UHPC obtained a strength of 14 ksi, the camber adjustment equipment was removed. It was determined the camber adjustment created a maximum locked-in compressive stress of approximately 400 psi and a maximum locked-in tensile stress of approximately 230 psi (Kunin and White, 2009). Load transfer across the joints and load distribution appeared to be performing well based on field load tests.

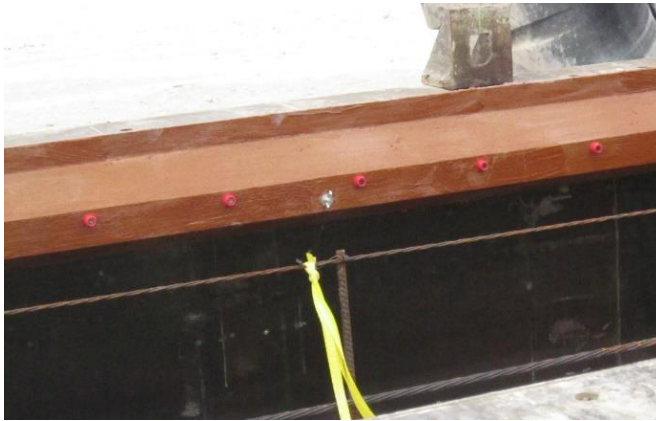
**Figure B1: Shear Key Form**

The box beams for the Sollars Road Bridge were fabricated in Kalamazoo, Michigan in May 2014 in a precast and prestressed concrete manufacturing facility. The typical box beam form was used, except the shear key shape was modified using wood. The wood form for the new shear keys can be seen in Figure B1. The form was coated with a retarder and the embedded ends of the dowel bar assemblies (with the female threaded ends) were placed on the red plastic tabs. Figure B2 shows the final installation. Figure B3 shows the shear key upon removal of the box beam from the forms and after power washing. The end result was a rough shear key surface with exposed aggregate that enhanced the bond between the beams and UHPC.

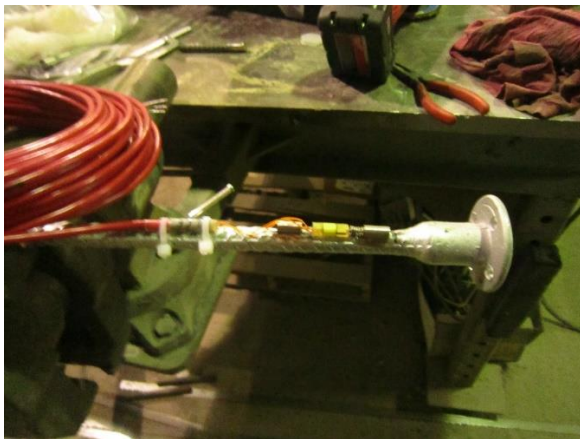
**Figure B6: Instrumented Dowel Bar**

The embedded ends of the dowel bars in each beam were instrumented using vibrating wire strain gages (see Figure B6), with one at the quarter span and one at mid-span. The gages were installed at a distance of 51 mm (2 in) from the threaded end. Beams 1, 2, and 3 had the instrumented dowel bars on right side of the cross section. Beam 3 was also instrumented with four thermocouples throughout the depth to measure the temperature along the depth of the beam (see Figure B7).

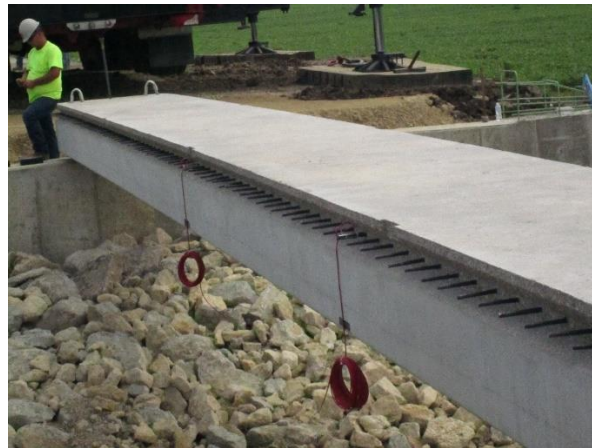
**Figure B8: Installed Instrumented Dowel Bars**

On Saturday July 12, 2014, the box beams were transported to the site. Six vibrating wire strain gages were installed 38 mm (1.5 in) from threaded end on six dowel bar inserts. Instrumented dowel bars were installed to the left side of Beams 2, 3 and 4. Two instrumented dowel bars were used in each beam, one at the quarter span and one at mid-span (see Figure B8). For reference, the beams were numbered 1 to 7, from left to right, while facing the forward abutment.

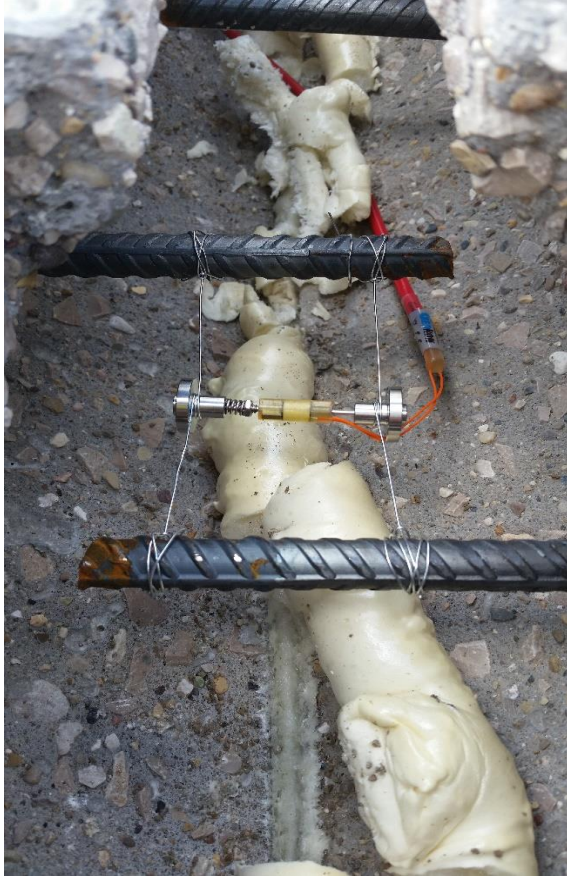
**Figure B9: Transverse Shear Key Gage**

On July 16, 2014, the three shear keys between Beams 1 - 4 were instrument with vibrating wire strain gages. Each shear key was instrumented with one transverse gage at the quarter span and one transverse strain gage at mid-span (see Figure B9). Shear keys 1 and 3 were instrumented with one gage at the quarter span and one gage at mid-span in the longitudinal direction (see Figure B10). After installation, the excess expandable filler material between beams was removed and the joints were covered with plywood, except for larger openings at the quarter points along the shear key.

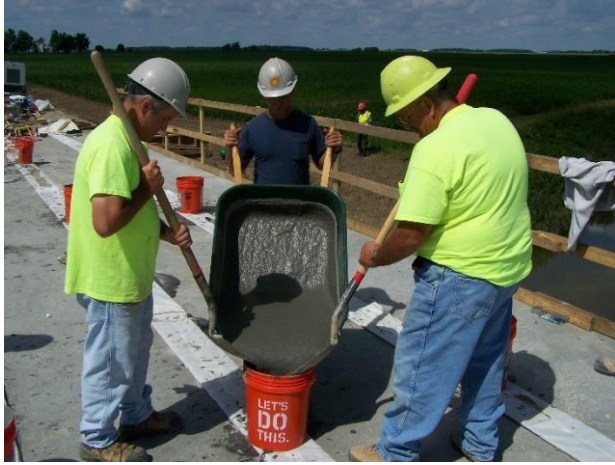
**Figure B11: UHPC Placement**

On July 17, the shear key joints were cast using ultra-high performance concrete (UHPC). Two mixers were used to properly mix the UHPC. The UHPC was moved to the joints in wheelbarrows and placed into chimneys made of plastic buckets located at the larger joint openings (see Figure B11). The UHPC flowed into the joints, and the filling of the joints was assured by the hydraulic head of the UHPC in the chimneys. Instrumentation was connected to data acquisition systems in order to monitor the bridge as the UHPC cured. On July 22, the plywood forms were removed from the joints. No cracks were observed from inspection of the shear keys. On July 24, a waterproofing membrane was installed on the top of the bridge. The bridge was paved with an asphalt wearing surface on August 5. The following day, frames were set up underneath the bridge at the quarter span and mid-span (see Figure B12). On August 7, a total of 16 strain gages, seven LVDT's, and three thermocouples were installed to monitor the bridge.

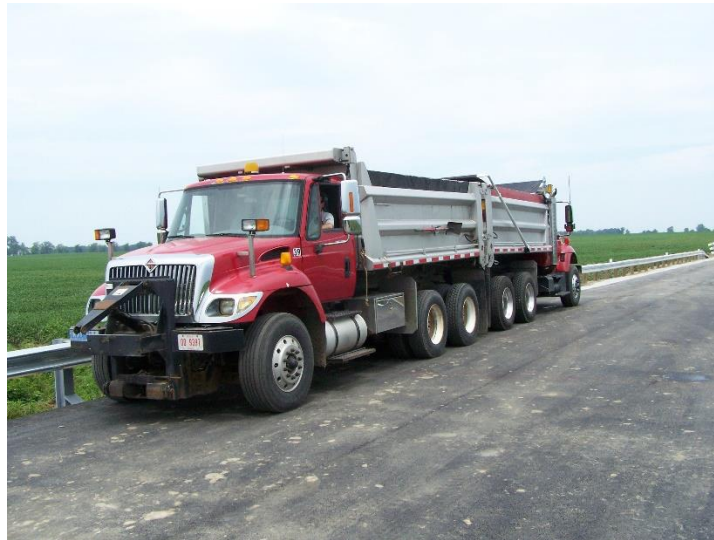
**Figure B13: Truck Loading**

1. A single 56.1 kip truck load placed in the left lane
2. A single 53.4 kip truck load placed in the right lane
3. Two trucks placed side-by-side with a 109.6 kip total load
4. Two trucks placed back to back in the left lane for a 109.6 kip total load (see Figure B13).

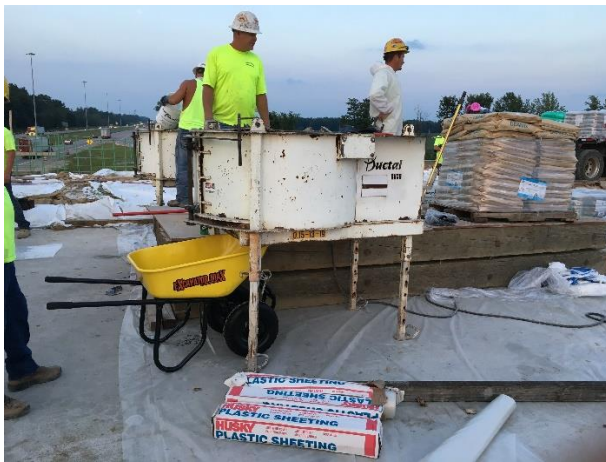
**Figure C1: Preparing to Mix UHPC**

The UHPC was mixed and placed in the joint the evening into the night of August 3, 2017. This was done in order to work with the UHPC at lower ambient temperatures to assure set time did not occur too rapidly. The contractor had ice available in case temperatures of the UHPC mix exceeded manufacturer recommendations. Crews added the components into the mixers rented from the supplier. The mixers are high shear mixers to assure proper mixing of the UHPC components. The mix components include a dry bagged Ductal premix material (see right side Figure C1), fibers (see Figure C2), a water reducing admixture, and water. Once properly mixed, the UHPC is flowable as shown in Figure C3. The closure pour joint had an exposed aggregate finish to improve bond between the previously cast decks and the UHPC (see Figure C4). This finish was created by the contractor using a retarder on the forms for the deck and power washing the joint after form removal. Prior to placement of the UHPC the joint was sprayed with a water mist to assure a moist joint surface (see Figure C5). The UHPC was transported from the mixers to the joint by wheelbarrows and placed into a wood chimney. This allowed the UHPC to flow

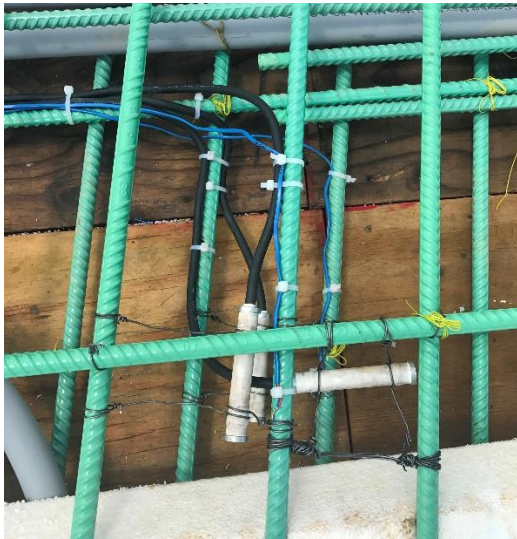
**Figure C7: Deck Gages**

At L1, three strain gages were installed on June 21, 2017 in the driving portion of the deck before concrete placement. One gage was installed near the top in the transverse and longitudinal directions and one gage was installed near the bottom in the transverse direction as shown in Figure C7. On July 28, 2017 instrumentation was installed in the UHPC joint. At L1 and L2 locations, strain gages were installed to the top and bottom transverse bars in the UHPC joint as shown in Figure C8. Also strain gages were installed to exist within the UHPC in the top and bottom transverse and longitudinal directions as shown in Figure C9. In addition, thermal couples were installed at numerous locations to measure temperature within the deck and joint as well as ambient temperature.

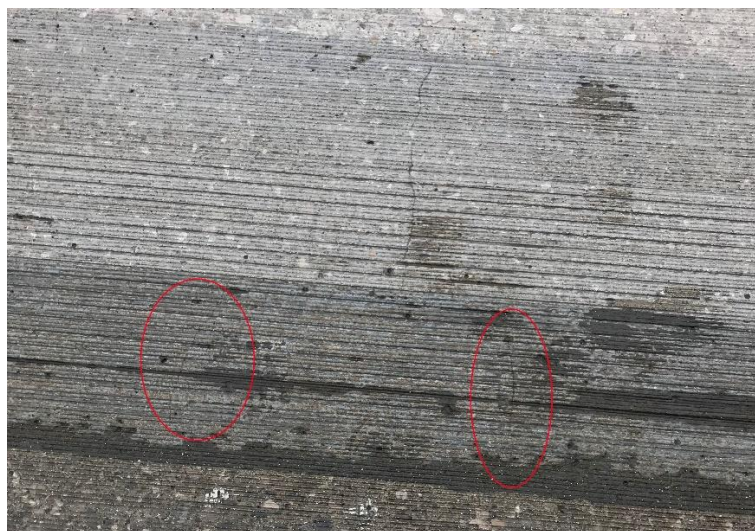
**Figure C15: Cracks in UHPC and Deck**

Since the cracking was not observed until after the first winter, it is suspected the cracking was the result of restraint from thermal contraction. The cracking was not a concern due to the size of the cracks and because it was sealed by ODOT after observation. Cracks in the deck adjacent to the UHPC appear to be wider as shown in Figure C15. The larger deck crack is above and in between the two smaller circled UHPC cracks in Figure C15. This would tend to imply that fibers were still properly mixed and well distributed within the UHPC. The cracking is not likely due to initial shrinkage/settlement since it was not noticed until spring after the placement of the UHPC and that cracks are also observed in the deck concrete adjacent to the UHPC. The depth of the cracks have likely not penetrated to any significant depth and do not compromise the durability of the UHPC.
