GATE SKIRTS RESEARCH AT A HIGHWAY-RAIL GRADE CROSSING IN RAMSEY, NJ

SUMMARY

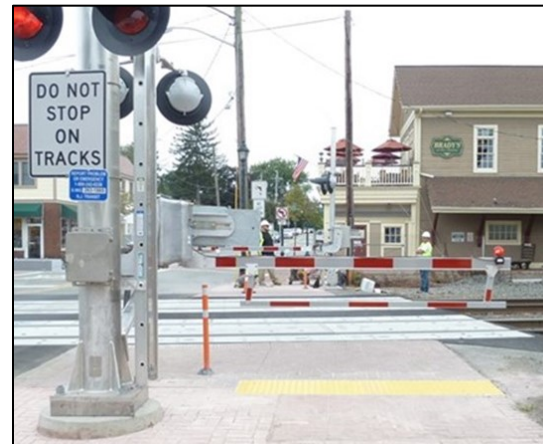
Figure 1. Gate Skirts Installed at E. Main St. Crossing in Ramsey, NJ

The gate skirts were installed in September 2017. Fencing along the right-of-way (ROW) leading up to the pedestrian gate on the northeast corner of the crossing was installed in March 2018 to reduce the number of grade crossing violations originating in that corner of the crossing. This is shown in [Figure 3](#).

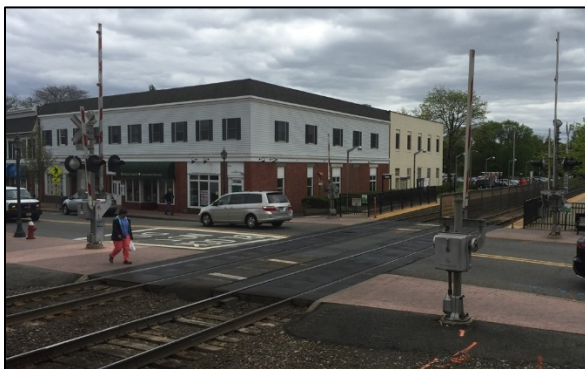
NJ DOT selected the highway-rail grade crossing at E. Main St. (Crossing ID 263186S) in Ramsey, New Jersey. The crossing, as shown in [Figure 2](#), experiences about 110 activations per day, mostly for NJT service on the Main and Bergen County Lines and about 4–5 freight movements. The Ramsey station is adjacent to the crossing.

Figure 2. E. Main St. Crossing in Ramsey, NJ

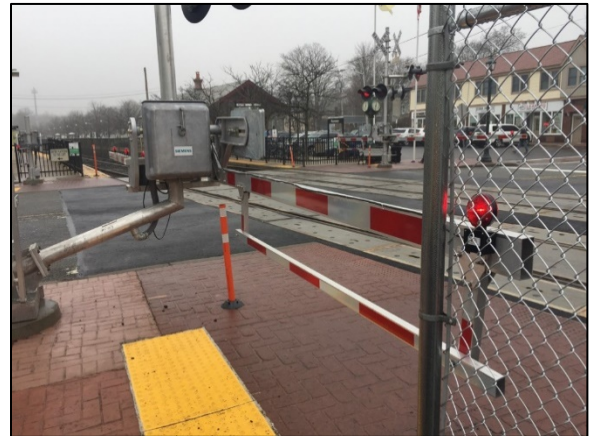
The conditions present at the crossing before and after the installation of the gate skirts and fencing were documented. The clearances between the gates and ground ranged from 37½ to 43 inches between all four original pedestrian gates. After the installation of the gate skirts, the

clearances between the lower gates and ground ranged from 26 to 28½ inches. Delineator posts were added to the 34–42-inch horizontal gaps remaining between the lower gates and gate posts. Sidewalk tactile pads were also added to all four approaches to the crossing. These additional improvements are shown in [Figure 3](#).

Figure 3. Gate Skirts and Fencing at Northeast Quadrant of E. Main St. Crossing in Ramsey, NJ

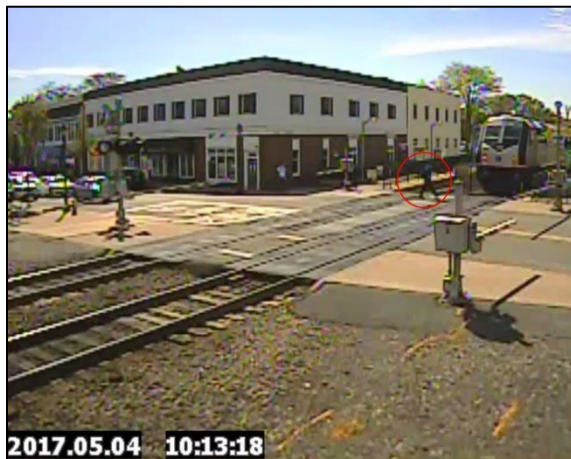
For the pre-installation period, pedestrian movements at the crossing were analyzed for 7 consecutive days from 5/4/17 to 5/10/17. This was about 3 months before the pedestrian gates were upgraded to gate skirts. There were a total of 438 grade crossing activations with pedestrians present. A total of 27 pedestrians committed a Type I violation and 63 pedestrians and cyclists committed a Type II violation. A Type II violation example is shown in Figure 4.

Figure 4. Baseline Type II Violation Example

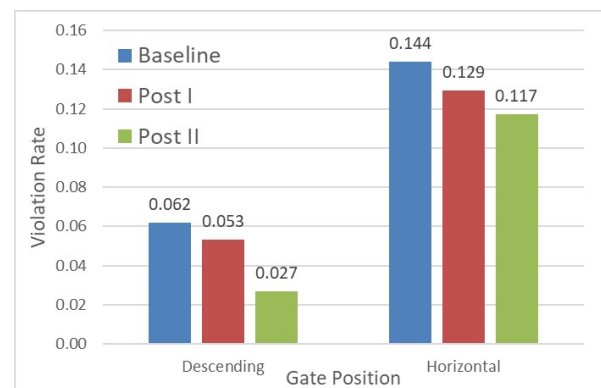
Researchers compared crossing violation rates (violations per crossing activation) between the three periods. Type I violations decreased by approximately 56 percent between the baseline and Post II periods, from 0.062 to 0.027 violations per crossing activation, as shown in Figure 5. Type II violations decreased by approximately 19 percent.

Figure 5. Violation Rates (number of violations per crossing activation) during Study Period
