Unmanned Aircraft Systems (UAS) Impact on Operational Efficiency and Connectivity

Final Report

December 2019

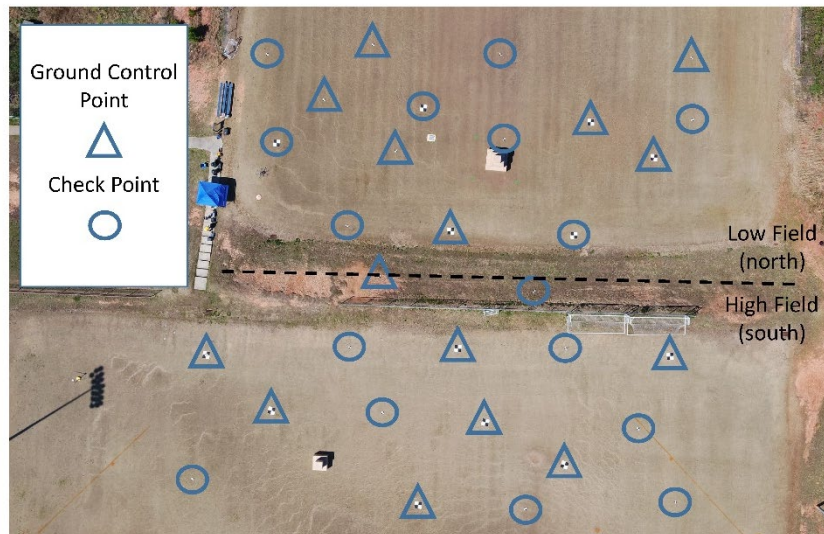
Figure 3.1: Test field with ground control points and checkpoints.

The central goal of this study is to address the question of how accurate drone-based surveys are given real-world conditions and commercially available equipment. To address this question a structured experiment was created using a 14,000m² (3.5 acres) site. The test site was made up of two large fields adjacent to one another. The field to the north was approximately 2.1m (7 feet) lower than the south field. Thirty-one, 30.5cm (1.000 feet) x 30.5cm (1.000 feet), black and white aerial targets were distributed evenly across both fields. The aerial targets were located by a licensed professional land surveyor using a robotic total station. Sixteen of the aerial targets were used as GCPs and the other 15 were used as checkpoints. Figure 3.1 shows the two fields and distribution of GCPs and checkpoints.

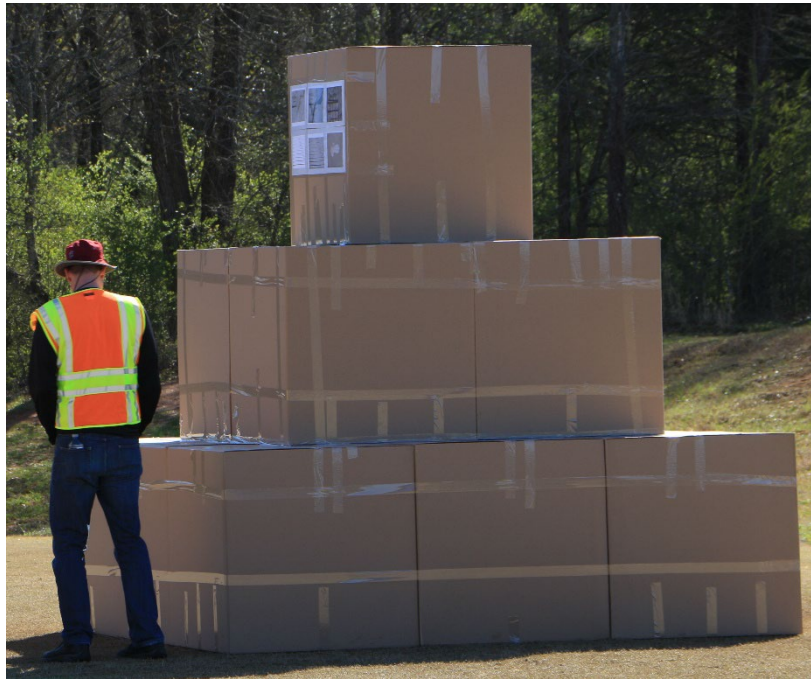
Figure 4.1: Cardboard pyramid stockpile simulation.

For the first phase of testing, a two-acre test field was secured. The test field was an open field with grass cut short and no trees or other obstructions. In the test field, 17 aerial targets were evenly distributed. The aerial targets were 12"x12" with a black and white checkerboard pattern making it easy to locate the center from drone imagery. The targets were then located by the surveyor using a GeoMax Zoom 80 2" reflectorless robotic total station. In the center of the field, a cardboard pyramid was erected. The pyramid was constructed with 3 feet x 3 feet x 3 feet cardboard boxes (1 cubic yard each). The base was made of nine boxes, the middle tier had four boxes, and the top tier had one box. Figure 1 is a picture using a standing adult for size reference. The total volume of the pyramid was 378 cubic feet (14 cubic yards).

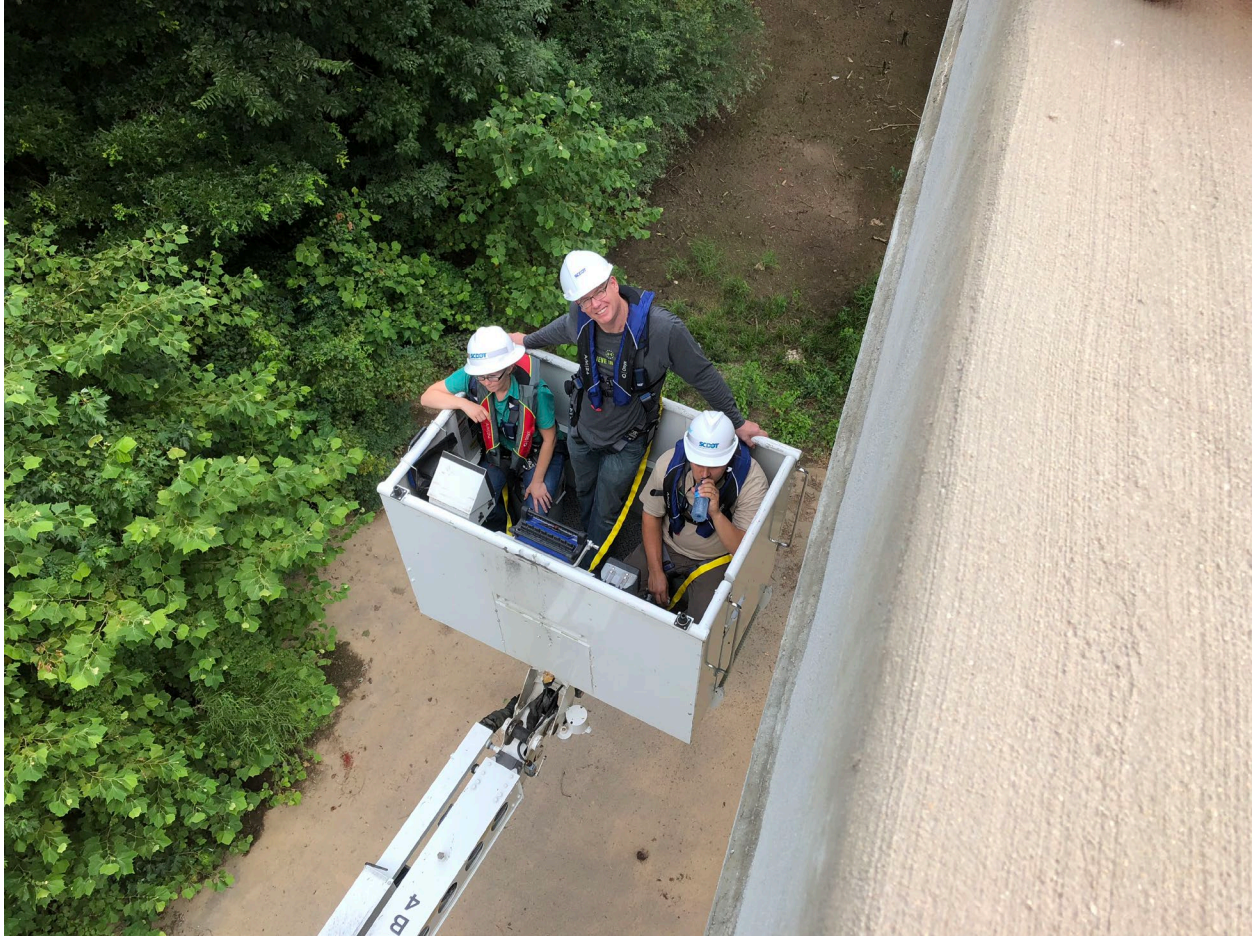
Figure 5.1: Traditional inspection with UBIT.

The first step in the investigation was for the researchers to shadow an inspection team as they assessed bridges in their district. South Carolina is divided into seven districts each with at least one bridge inspection team. The bridge inspection team from district seven supported this study. The team consisted of three certified BIEs and in some cases a summer intern (figure 1). The local SCDOT counties provided traffic control when needed. The researchers shadowed the BIEs primarily to have a better understanding of the type of deficiencies that were common and the methods for how those deficiencies were found. Another important objective was to observe bridges that could serve as the test bridge in the study's experiments. The BIEs from district 7 were informed about the goals of the project and were consulted about which bridges they thought could be good candidates. The researchers coordinated their shadowing schedule so they could observe these bridges.

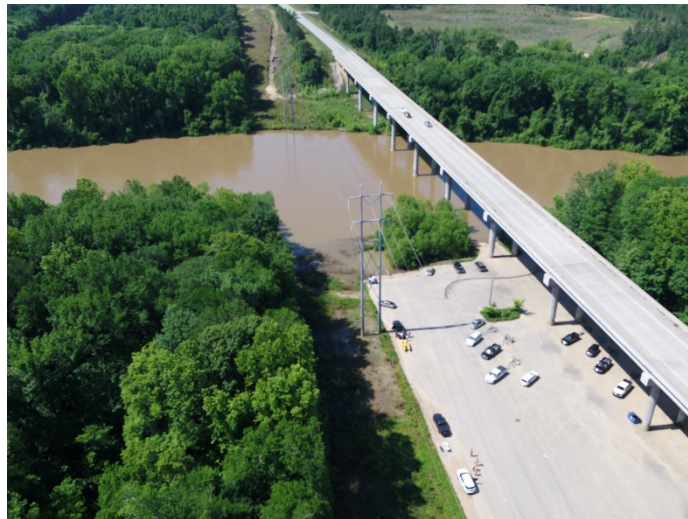
Figure 5.2: Bates bridge #1.

Desirable characteristics of the test bridge were that it be of significant enough scale to benefit from a drone inspection and that there were not significant obstructions making drone flight dangerous. A total of 12 bridges were identified by the BIEs as potential candidates and observed by the researchers as they were assessed using traditional methods. The structure varied from concrete, steel, and timber pile caps. Their length and number of lanes of traffic also varied. Some of the bridges were over rivers while others had streets, rail or a dry stream bed under them. Ultimately, the Bates Bridge was selected (see figure 5.2 and 5.3). The Bates Bridge is a two-lane bridge over the Congaree River located southwest of Columbia. It is approximately 0.3 miles long and has a concrete structure. Three factors made this bridge the most desirable of the bridges evaluated for the experiments. First, a UBIT truck is required for the traditional inspection and as this bridge has two lanes of travel (one lane of travel each way), there was significant traffic disruption during the inspection. Second, the Bates Bridge had very little vegetation surrounding it making flying the drone much more manageable. The third reason this bridge was selected was that a large parking lot was located under the northeast side of the bridge. This parking lot served a boat dock located under the bridge. The parking lot made an excellent staging area to conduct the experiments.

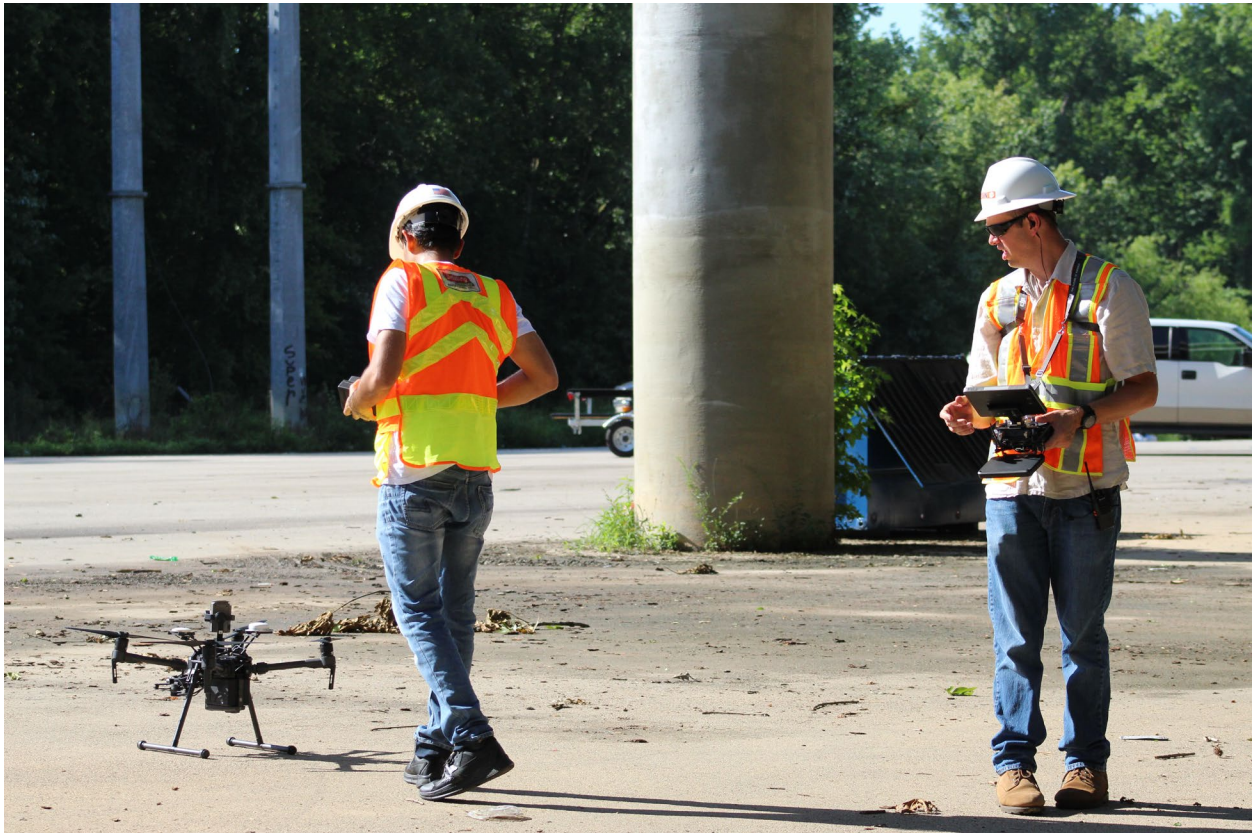
Figure 5.4: Bates bridge mock inspection.

After the test bridge was selected, a “mock” inspection was performed without the BIEs (figure 5.4). The purpose of the mock inspection was not just to evaluate the drone’s capability but to make sure all logistical issues were accounted for prior to having the BIEs on site. The researchers captured many images from above and below the bridge deck so 3D reconstruction models could be created later. The BIEs also flew the drone under the bridge to observe aspects of the bridge they believed the BIEs would want to observe. This was done to get an understanding of how the drone would respond as the GPS signal was repeatedly lost and then reacquired. The bridge location also had high-voltage power transmission lines nearby and it was important to test how those impacted flight controls

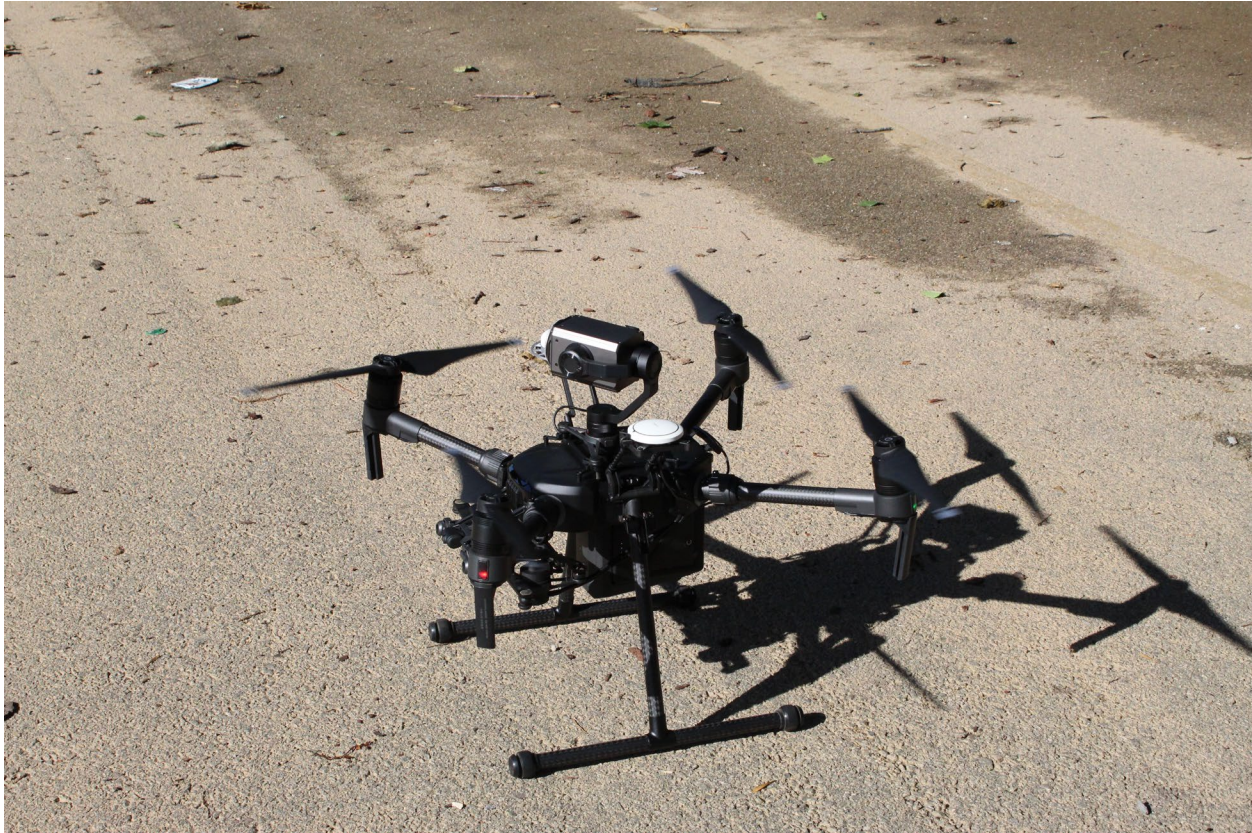
Figure 5.5: DJI M210 RTK UAS used in inspection.

The research team had originally planned to use a Sense Fly Albris quadcopter drone as it had been successfully tested with other bridged inspections (Lovelace, 2015; Wells and Lovelace, 2017). However, this aircraft was discontinued by the manufacturer before the project was awarded. The aircraft that was selected to replace it was DJI’s M210 RTK (version 1) (figure 5.5). The M210 RTK is a general-purpose quadcopter in DJI’s enterprise line. It can support several different sensors including the Zenmuse Z30 camera (Z30). The Z30 sensor was used for this experiment because it has a 30 times optical zoom. This allowed for detailed observations without having to fly the drone in close proximity to the bridge structure. This model also features a real-time kinematic (RTK) positioning ground control station (figure 5.6). The RTK unit was

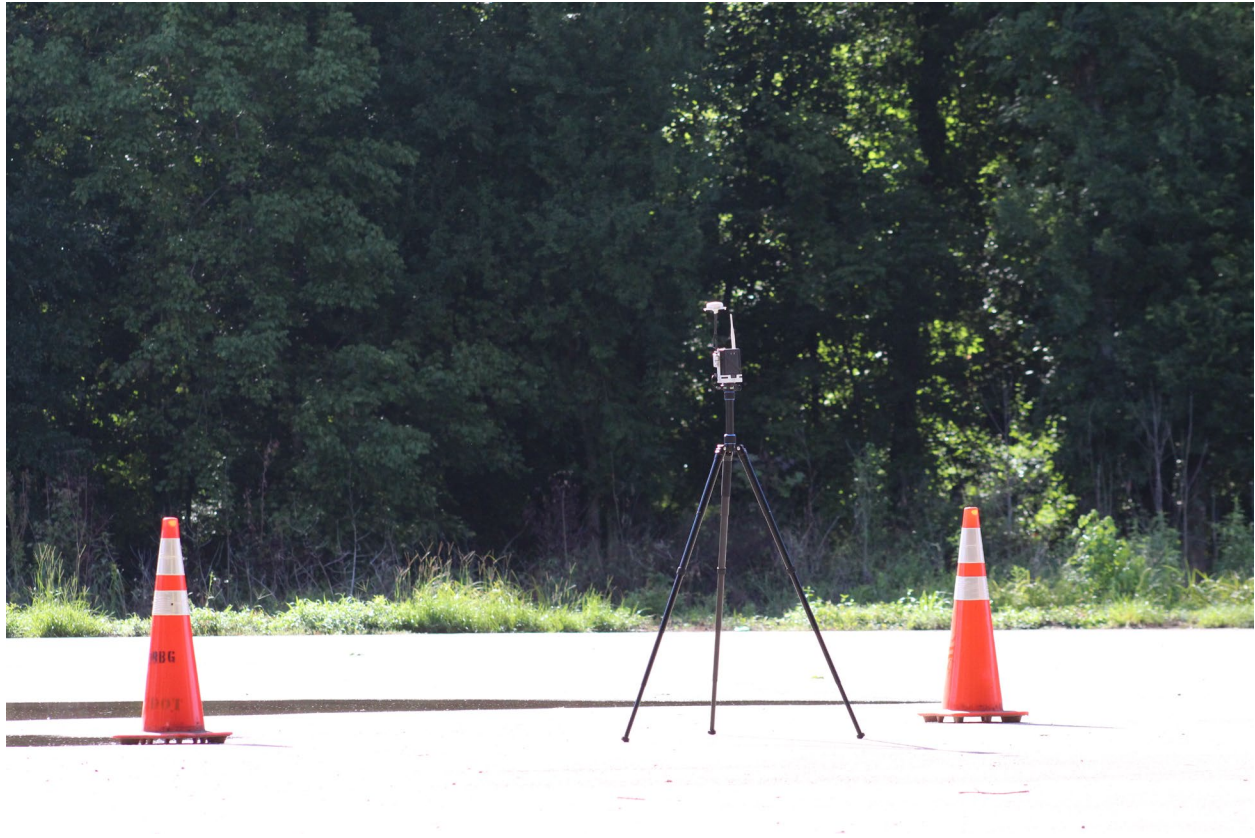
Figure 5.6: RTK ground station.

located on a tripod away from the bridge. The RTK unit located itself via satellite and then help position the M210 RTK drone when it flew in a GPS denied environment. TB50 and TB55 are two different battery types supported by the M210. (The second generation of the M210 is only supported by TB55 batteries.) TB50 is the smaller of the two and will sustain flight times of approximately 17 minutes when the Z30 is mounted. The TB50 was selected because, unlike the TB55, the manufacture sells a battery charging hub that can charge eight batteries at a time (figure 5.7). The research team found that a supply of 16 TB50 batteries was sufficient to continually charge batteries at the same rate they were depleted. Like most bridge sites, power was not available so a generator was procured. The charging station at full capacity drew 1,000W so a 2,000W generator was used to also support various other electronics like laptops, controller battery chargers, tablets and cell phones. This aircraft allows for the camera to be controlled by a second person with another controller. For this experiment, two Cendence controllers with 7.85-inch CrystalSky monitors were used (figure 5.8). The pilot controlled the aircraft while the BIE controlled the camera. The controller and monitor are both powered with a WB37 battery. The researchers found that four batteries in use, while another four were charging (eight total), were sufficient to keep the two controllers continually operational. Additional equipment and materials used included a 12'x12' tent, table, walkie-talkies, hard hats, safety vests, air horns, sunscreen, insect repellent, water/snacks, first aid kit, and safety cones (figure 5.9 and 5.10).

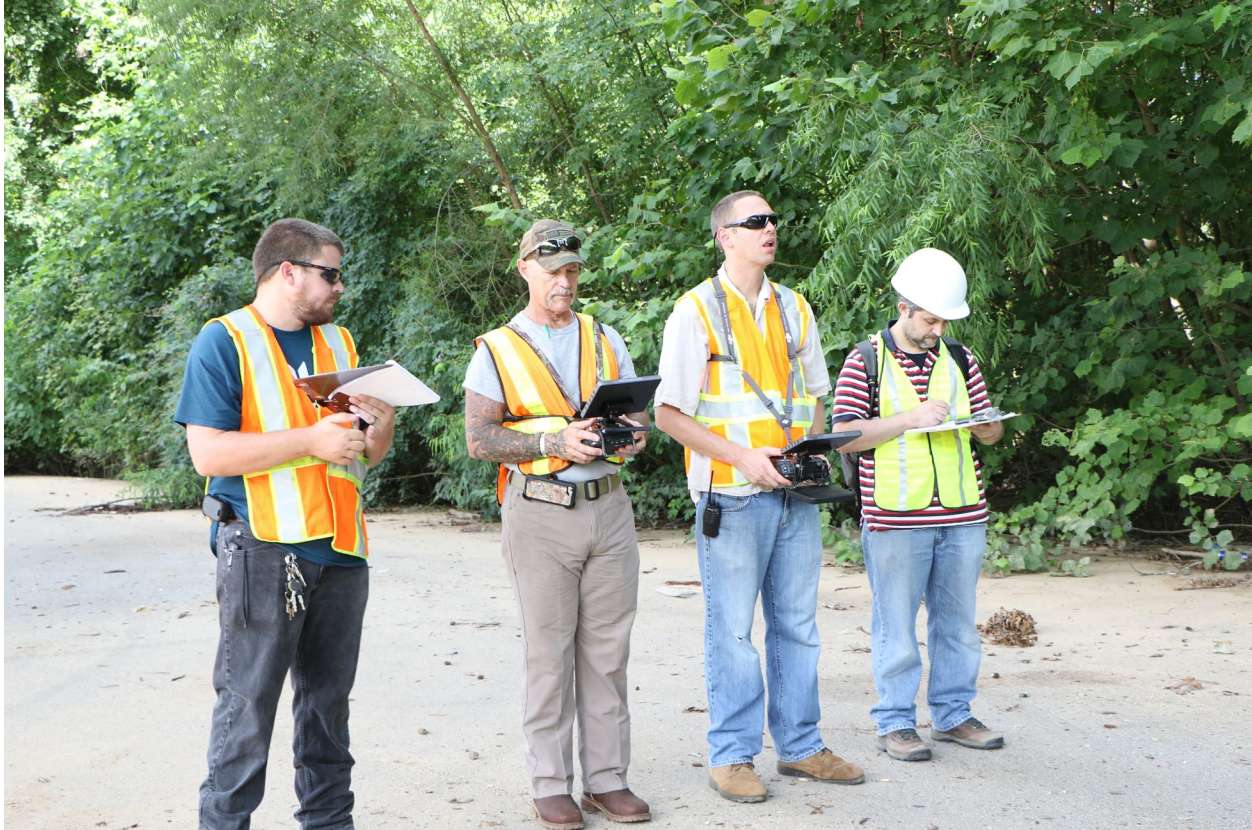
Figure 5.18: Flight crew #3.

The second experiment was similar; however, a different BIE controlled the camera (figure 5.18). The inspection report was also not provided to the BIE. The BIE was told that he was tasked with inspecting this bridge using only the drone. As with the first experiment, the PI piloted the aircraft while a third person took notes.

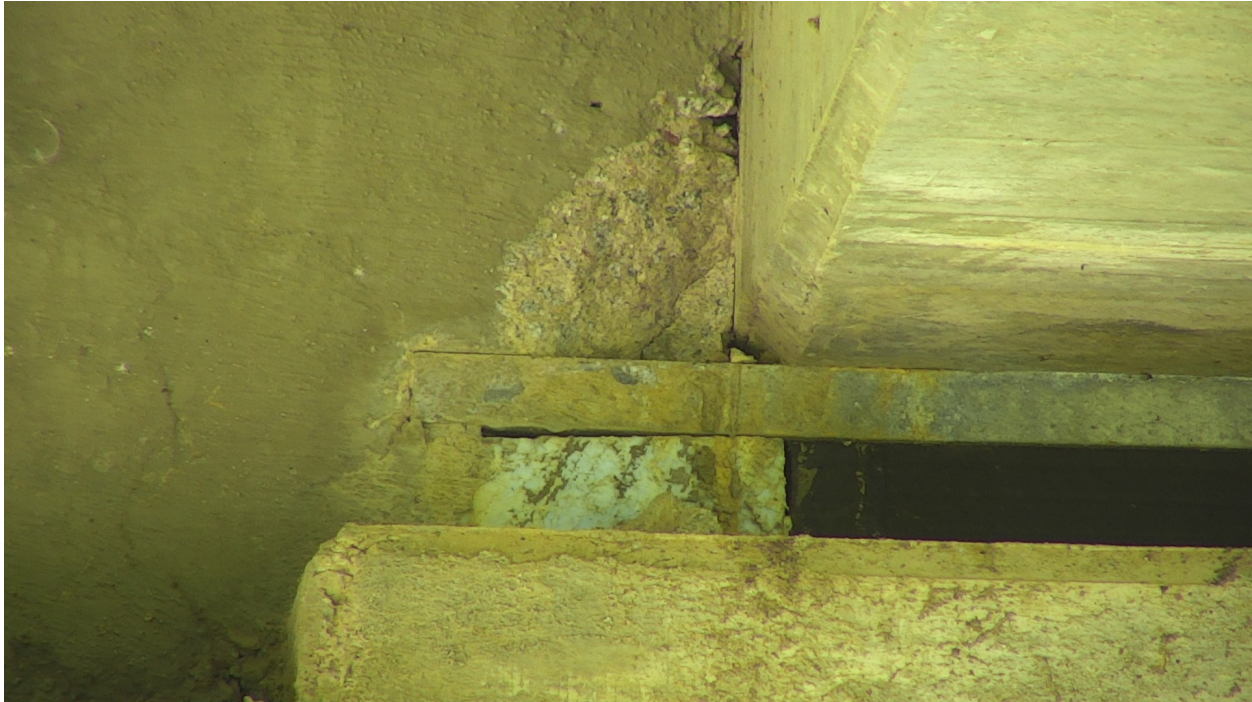
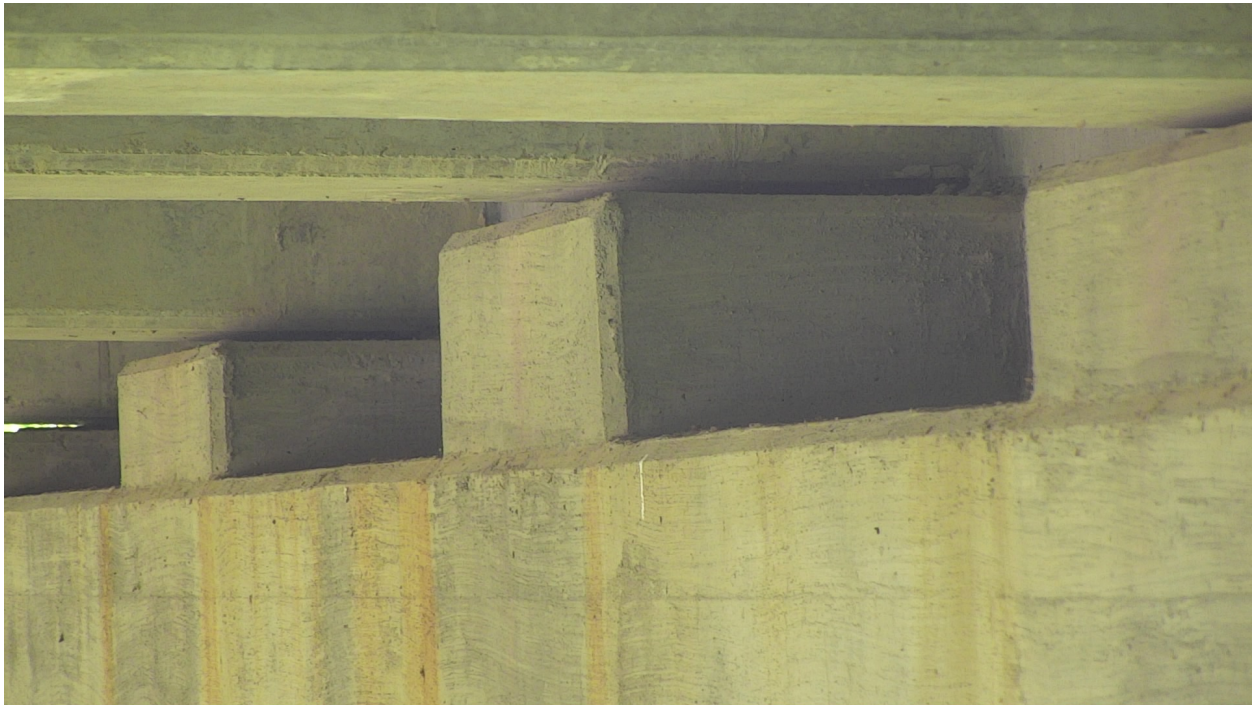
Figure 5.20: Bearing unable to see sufficiently #1.

During the first flight, 9:00 am-9:15 am, inspection on the 10th span was carried out. Camera zoom was investigated. The most critically, bearings were checked. They were confirmed as too thin to see in detail and replied as “no” (figure 5.20 and 5.21). During this flight, zoom in, out, orientation with respect to beams, and the glare was figured out. At this stage, a significant amount of time was spent seeing the specific location of the previous crack noted. Both with checklist and drone piloting were coordinated successfully. Initially, it was asked if the pilot would be able to move up and down without being uncomfortable with the proximity of the structure. As the pilot’s and aircraft’s performance were improved, the BIE was later able to guide the pilot to specific spots with accurate distances. Moreover, a method was developed to scan through different sides of the bridge efficiently. This included mainly quickly finding good angles, zoom in and out, and to avoid sun glare. Note that the orientation initially was asked to pilot and a communication procedure with the pilot was demanded which later evolved to comfortable with orientation even if the aircraft was not seen. Except for one or two instances, the camera was very responsive,

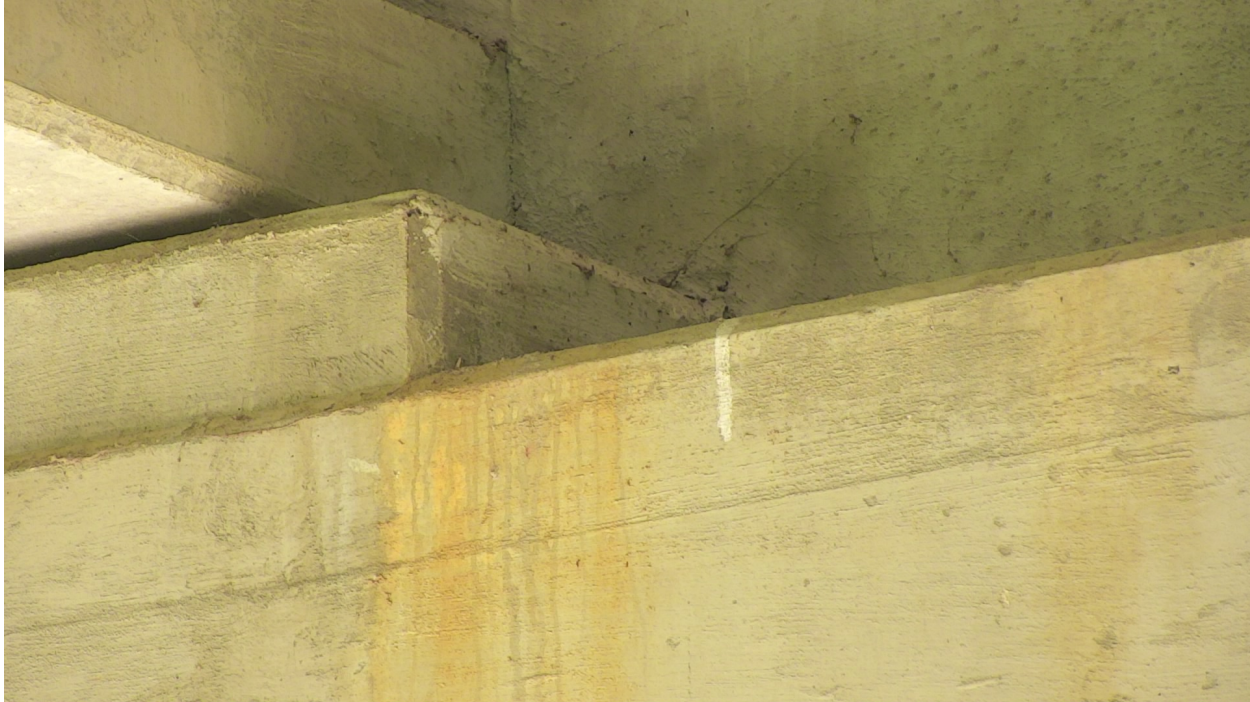
Figure 5.22: Hairline cracking observed with the drone.

pictures were clear at all zoom levels. The aircraft was also very responsive to directions to the BIE. It was also noted “yes” for being able to see almost all horizontal, vertical hairline and map cracks even in inch scale.

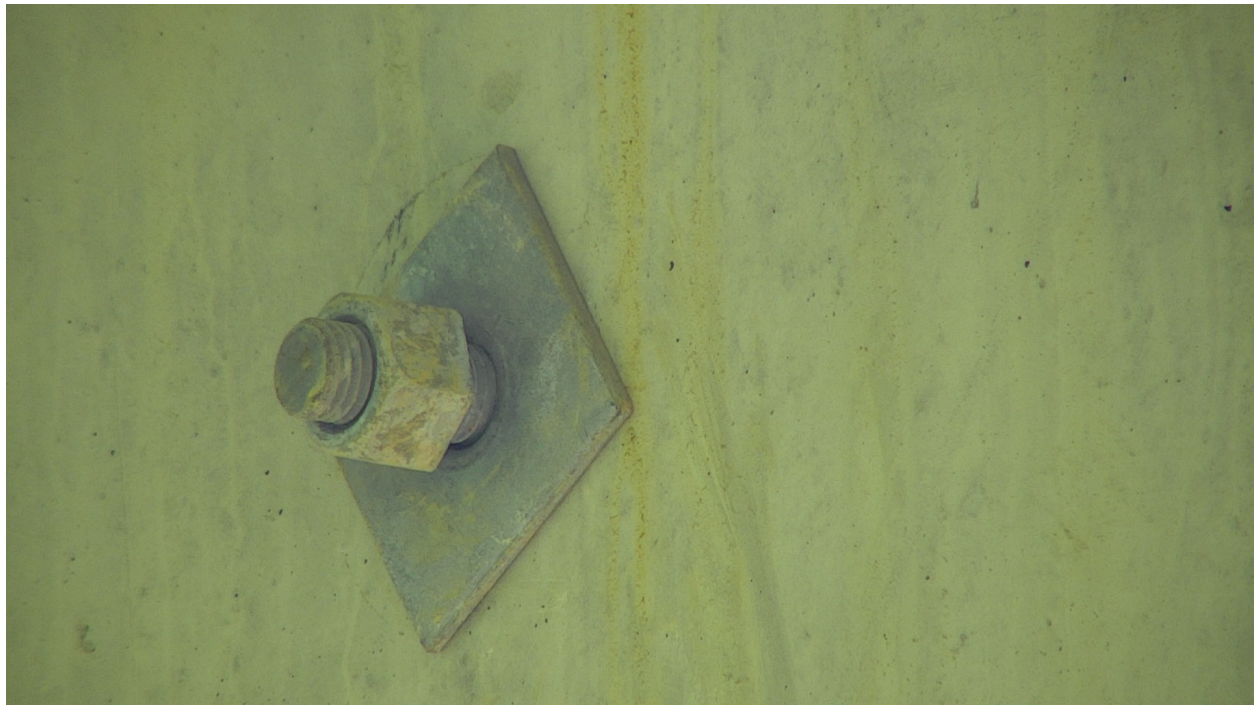
Figure 5.24: Anchor bolt not tightened down.

On 6th flight 9:30 am-9:40 am, the BIE started to check the north side of 12th bent caps. Hairline cracks of 4 to 6-inch on different beams. Loosed bolts and rust bleeding were detected.

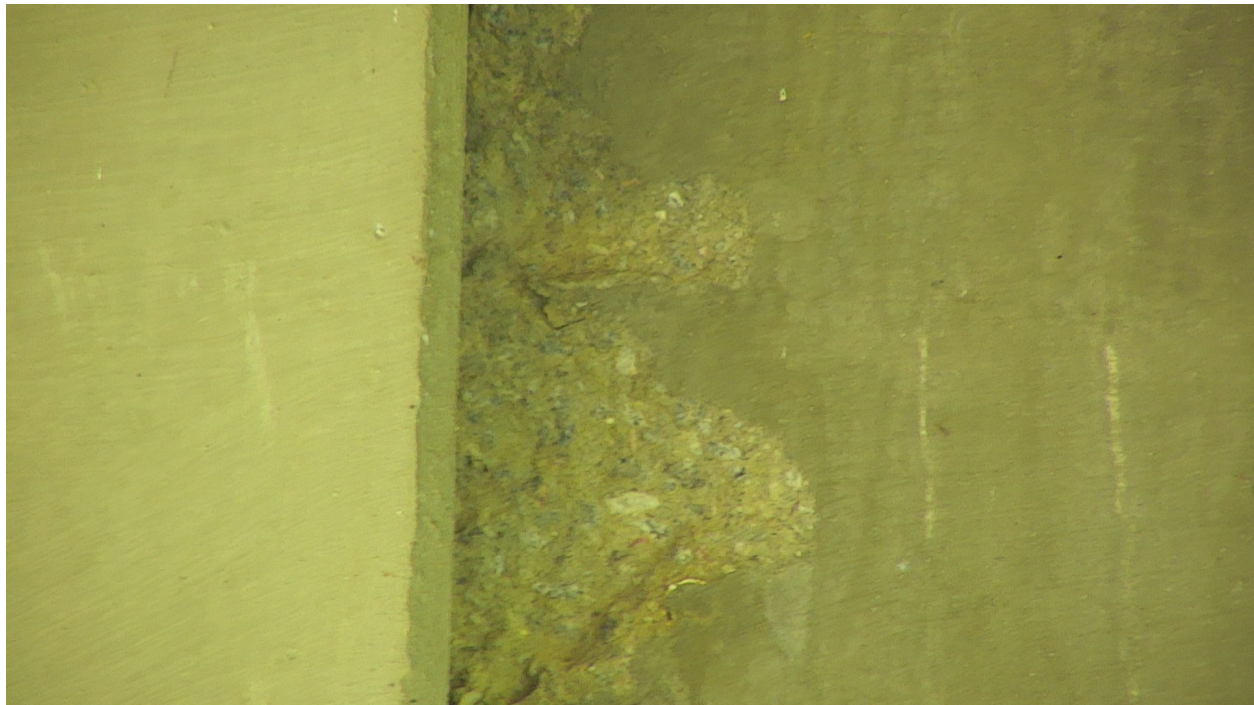
Figure 5.25: Minor spalling observed with a drone.

In 10th flight 10:32 am-10:43 am, the BIE thoroughly scanned 13th bent's north side. A very small glitch on the connection was observed. Line of spalling, shrinkage cracking at the end of a beam, and minor shift on the side bearing pad was observed (figure 5.25).

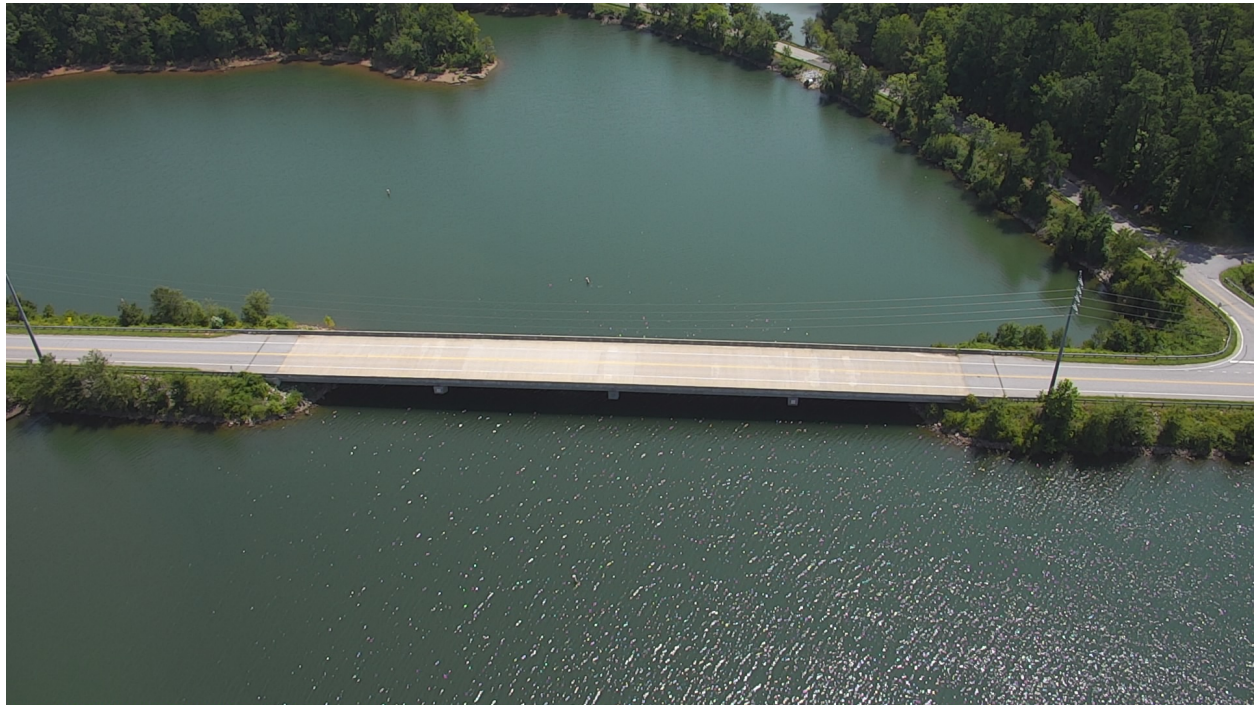
Figure 5.29: Remote test bridge #1.

located at their home office approximately 30 miles away (figure 5.28). The flight crew live-streamed the video using two different apps; Flighthub and Kittyhawk. The flight crew and BIE communicated by phone or through the app. The test bridge used in the previous experiment had insufficient cellular service to live stream the video so a similar bridge in an area with better coverage was selected (figure 5.29 and 5.30). The construction type of the bridge was the same and it also had two lanes of travel.

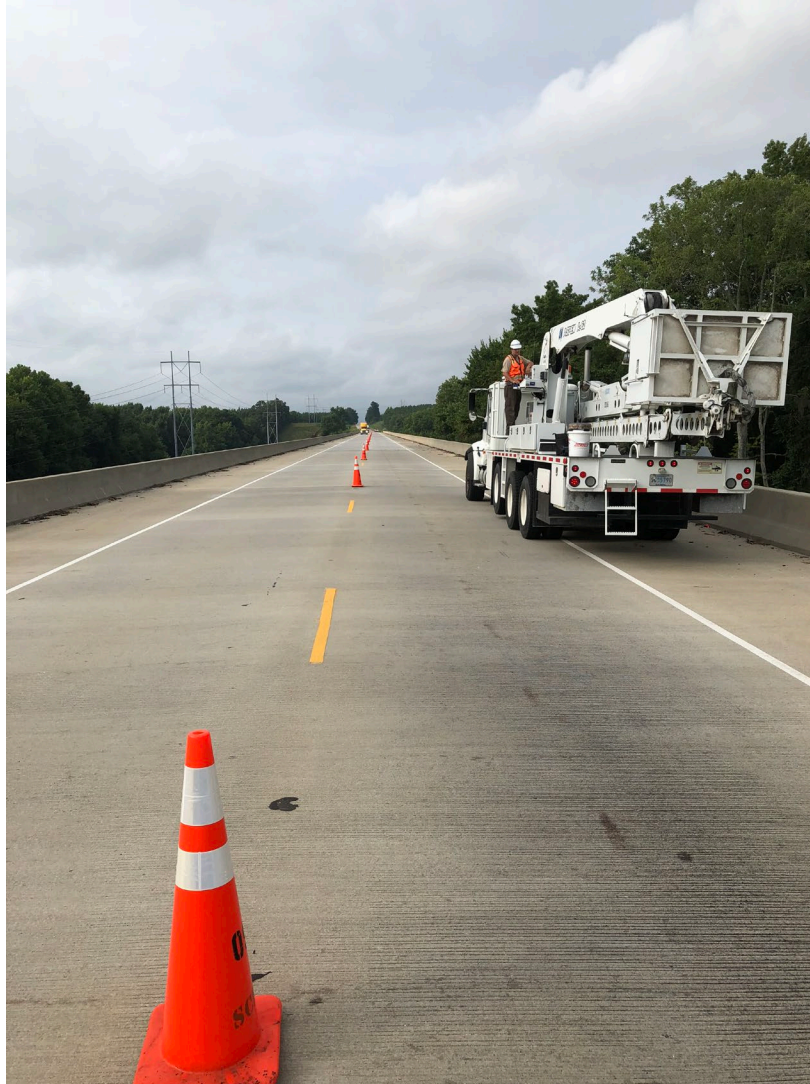
Figure 5.31: Lane closure of Bates Bridge.

The researchers participated in the traditional inspection of the Bates Bridge and documented the resources needed to complete it. The BIE team for the SCDOT in District 7 was made of three inspection engineers. The Bates Bridge has two lanes (one in each direction). One of the lanes was required to be shut down in order to stage the UBIT (figure 5.31). This necessitated the use of six traffic control workers to safely coordinate alternating flows of traffic on a single lane. Traffic control also required two illuminated signs, six stationary signs, and approximately 75 cones. A crash attenuator trailer was staged behind the UBIT. Additionally, because the bridge was located over a waterway, a boat and operator were deployed for emergency water evaluations. The inspection started at approximately 8:00 am and finished at 5:00 pm for an 8-hour workday. A summary of the approximate costs is provided in table 5.1. The unit costs used were from published state DOT average costs databases and when not available RS Means by Gordian. The estimated cost to conduct this inspection using traditional methods was \$5,242.
