U.S. Department of
Transportation

Federal Railroad
Administration

Broken Rim Detection Using Proximity Sensors

1. AGENCY USE ONLY (Leave blank)		2. REPORT DATE November 2020		3. REPORT TYPE AND DATES COVERED Technical Report February–April 2014	
4. TITLE AND SUBTITLE Broken Rim Detection Using Proximity Sensors				5. FUNDING NUMBERS DTFR53-11-D-00008 Task Order 328

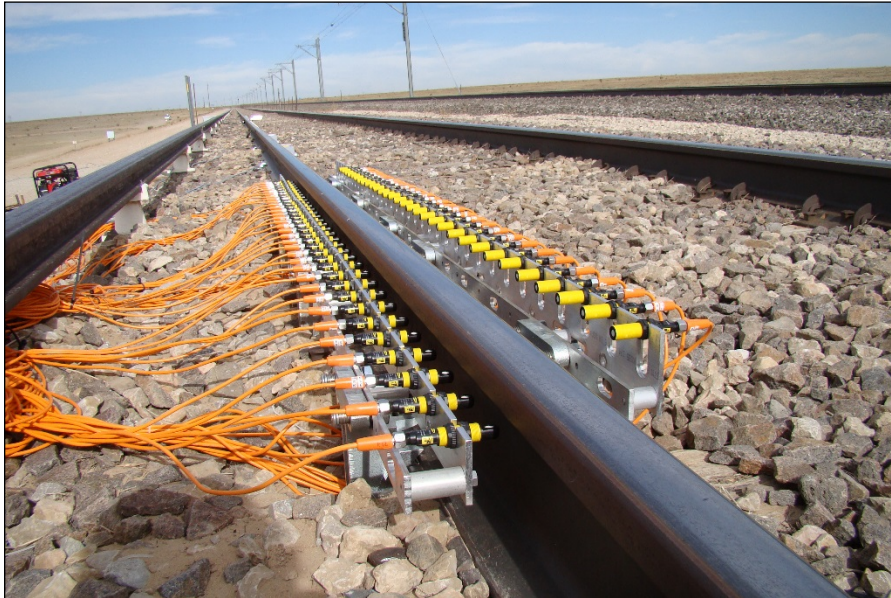
Figure 1. Broken Rim Detector Proof of Concept Prototype with Ultrasonic Sensors

TTCI and DII performed a proof of concept test on the broken rim detector technology in 2012. This prototype test was with a broken rim detector model that used ultrasonic proximity sensors. The early prototype sensed both rim and flange continuity. [Figure 1](#) shows a photograph of the early ultrasonic sensor-based device.

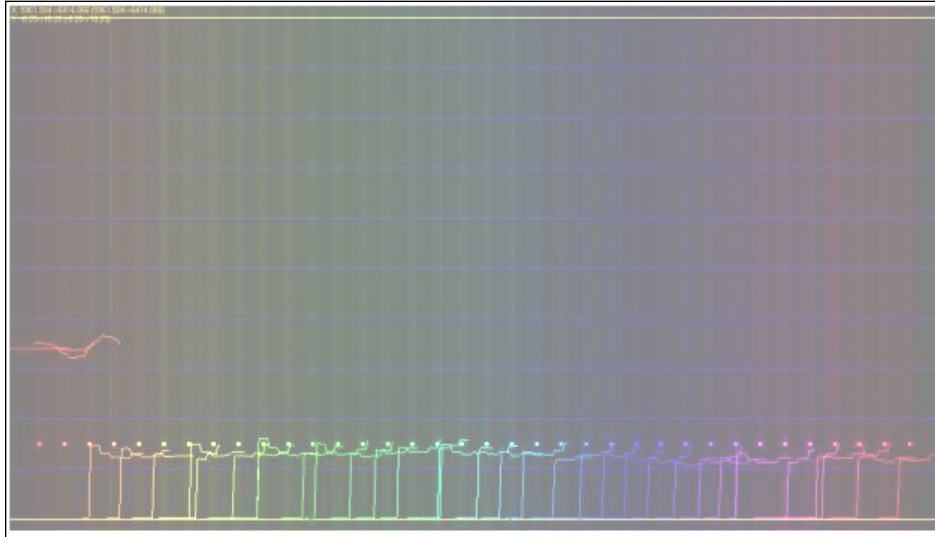
Figure 2. 33-Channel Ultrasonic Sensor Output for a Good Wheel Rim

The ultrasonic sensors are directional proximity sensors that emit a pulse of ultrasonic energy and then time the return echo to determine the distance of the target from the sensor. The system consisted of 33 sensors spaced 3.5 inches (9 cm) apart. Each sensor inspected a 7.9-inch (20 cm) sector of the passing wheel. The prototype pictured has sensors for detecting both the flange and the rim. The rim sensors face inward toward face of the rim. [Figure 2](#) shows a typical signal from the rim sensors on a good wheel. All 33 channels are displayed.

Observe that the signals are uniform for a good wheel. The magnitude and duration of the signal from every sensor is the same.

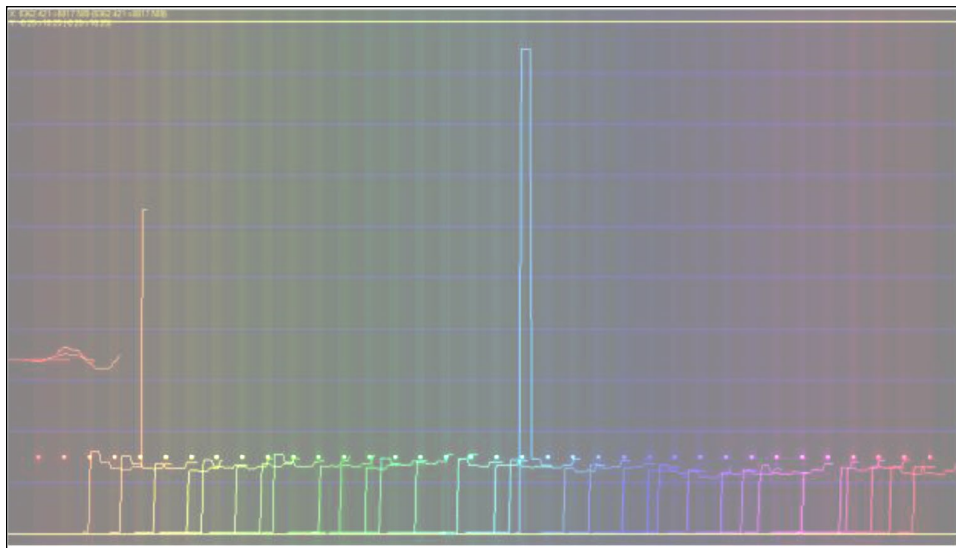
Figure 3. Narrow Spikes Occur at Small Surface Defects

Anomalies in the signal can arise from several sources. Lateral position of the wheel on the track (hunting) will change the magnitude of the signal, but changes from sensor to sensor are gradual as the entire wheel is moving laterally. Hunting shows as a low frequency sinusoid across all the sensors. There are also sources of higher frequency noise. [Figure 3](#) shows narrow spikes occurring at some of the sensors, which indicated small surface defects.

These narrow spikes are likely the result of a missing reflection from small surface defects such as shelling or rolled edge. [Figure 4](#) shows the test wheel associated with the signals in [Figure 3](#).

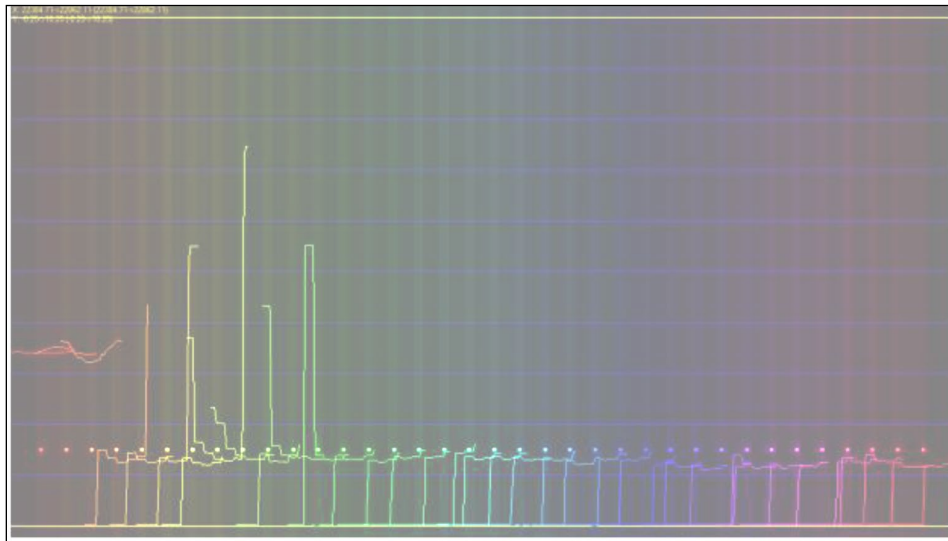
Figure 5. Ultrasonic Indication from a Shattered Rim

When a wheel with a shattered rim passes the system, the indication is much more pronounced. [Figure 5](#) shows the result of a 35 mph pass of a shattered rim wheel. [Figure 6](#) shows the wheel itself.

The DII broken rim detector with ultrasonic probes identifies three criteria in the signal that signify a shattered rim. First is that a group of consecutive sensors has unusual readings. In this case, it is seven sensors. Next, the magnitudes of the signals are on the order of two times the nominal value. The sensors get the reflection earlier and from a greater distance than nominal. This is because the sensors “see” the void as it approaches on the rotating wheel, sensing the missing material while it is still some distance from the sensor.

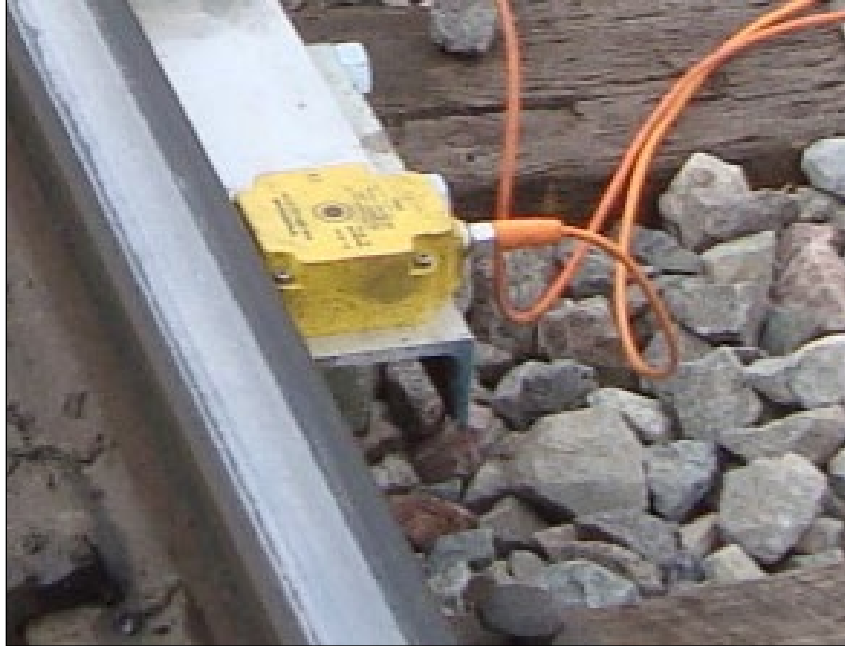
Figure 7. Magnetic Wheel Sensor

To be a commercially viable product, the technology requires a more robust sensor and a more compact design. Magnetic wheel sensors provide a robust and reliable alternative. [Figure 7](#) shows a photo of a magnetic wheel sensor that DII used on other systems.

While reliability of the magnetic sensors is well established, they do operate differently than the ultrasonic probes. First, they are arranged to be facing upward just outboard of the field side of the railhead. They sense the portion of the rim overhanging the railhead. The wheel rim produces an electrical signal when it passes over the sensor surface. The signal amplitude is proportional to the wheel speed, mass, and distance to the sensor. Compared to the ultrasonic sensors, the magnetic sensors have the advantages of analog real-time output, which is not limited by speed and the sensors do not react to airborne dust and debris including rain and snow. They can operate in any weather condition.

produces is proportional to distance, size, and speed of the passing target. When placed up along the field side of the railhead, as shown in [Figure 7](#), it will sense the portion of the wheel tread overhanging the railhead. If the wheel rim is closer to the sensor, the signal will be higher. A missing part of the rim will change the signal form. The following investigation explores the nature of this signal.

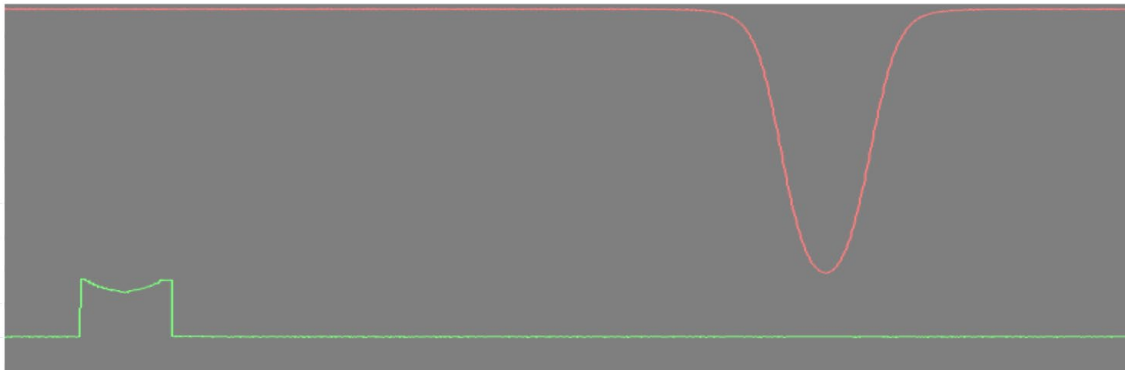
Figure 8. Comparison of Signals from the Ultrasonic Sensor (green) and Magnetic Sensors (red)

However, the signal form from the sensors is different. [Figure 8](#) shows a comparison of the typical signal from the ultrasonic sensor compared to the signal from the magnetic sensor.

The signals between the sensor types are different, because the physical sensing is fundamentally different. The magnetic sensor detects ferromagnetic materials that distort its field. The signal it

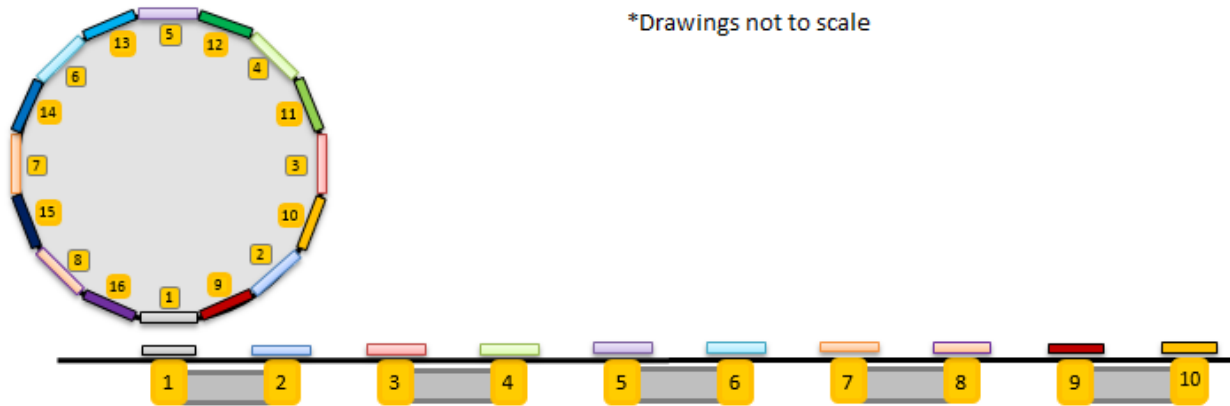
Figure 9. Staggered Sensor Spacing to inspect Entire Wheel over Two Revolutions

Each magnetic sensor covers 2 inches of the rim surface. An array of 64 sensors per rail is required to inspect a complete wheel circumference. The magnetic sensors are substantially wider than the ultrasonic sensors and they require a gap between them to prevent their fields from overlapping and causing cross talk. Because of this, they cannot be placed close enough together to sense the wheel in only one revolution. Therefore, their position must be staggered so that each sensor will sense a different segment of the rim over two revolutions. [Figure 9](#) shows the concept of the sensor layout.

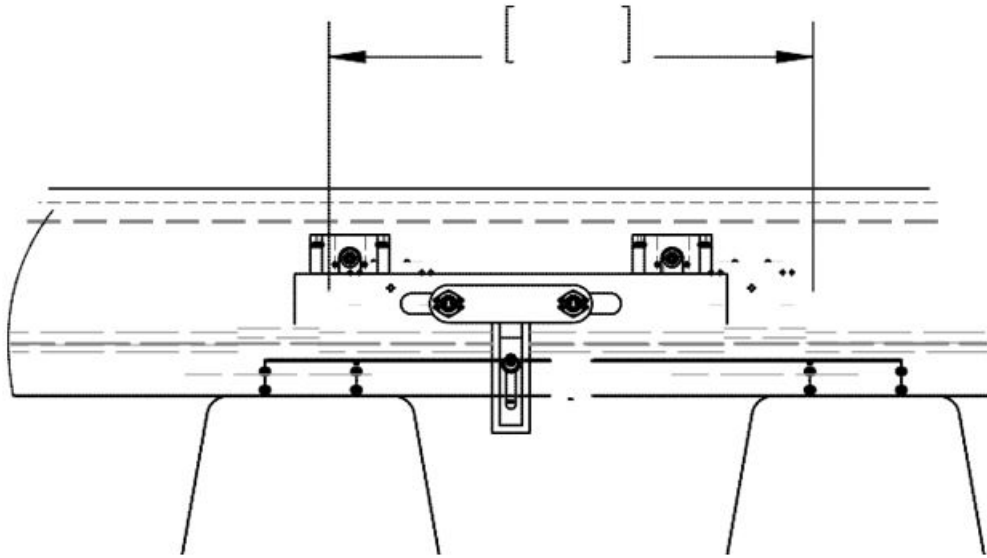
Figure 10. Sensor Mounting Clamp and Bracket Assembly

Sensors are mounted in pairs that must be precisely positioned and well aligned across the track. Lateral and vertical positioning will affect the magnitude of the signal, and longitudinal alignment across the track will affect the timing of the peak signal at each location. Each pair of sensors shares a bracket which mounts to the rail between the ties. The clamp is a commercially available piece of equipment that passes under the rail and attaches to the flange. Slotted brackets were designed to attach to the clamp. Brackets are slotted to accommodate uneven tie spacing. The range of adjustment must be sufficient to precisely stagger and align the sensors. [Figure 10](#) shows a detail of the sensor mounting bracket assembly.

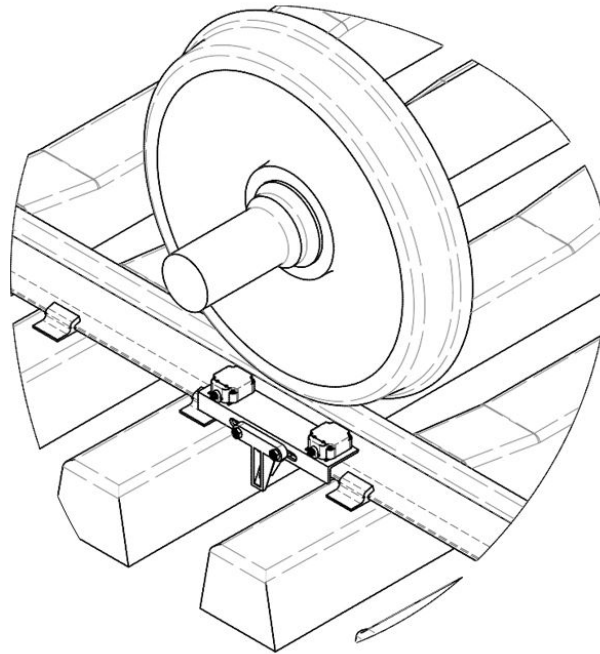
Figure 11. Perspective View of the Sensors and Mounting Bracket Relative to the Wheel

Figure 11 shows a perspective sketch of the magnetic sensors relative to the wheel.

The rim of the wheel overhangs the rail and passes within the detection range of the sensors. The sensors precisely measure the distance to the rim. Figure 12 shows the worst-case clearance to the sensor for a worn wheel profile.

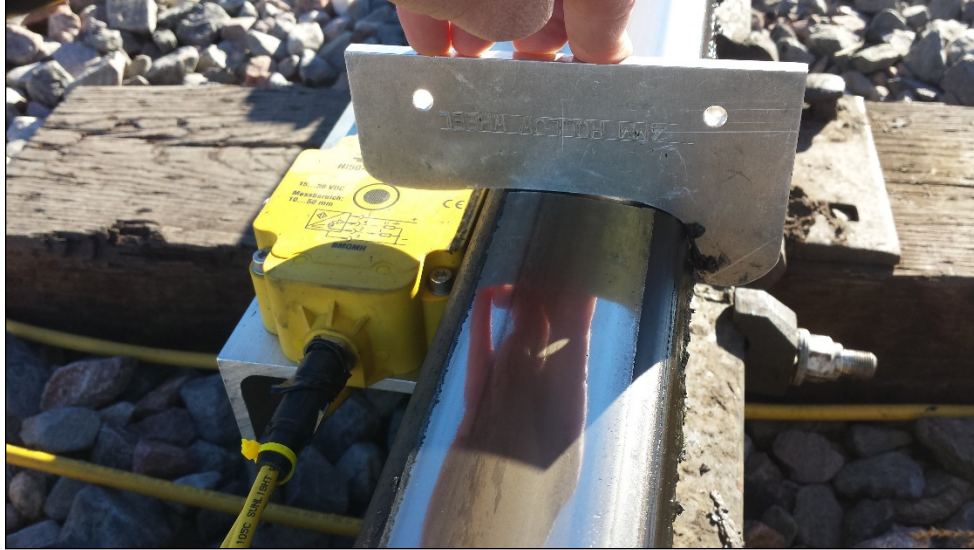
Figure 12. Clearance to Sensor with Worn Wheel Profile

The photo in [Figure 12](#) shows the wheel in flange contact with the rail. This condition puts the rim of the worn wheel as close to the sensor as possible. A new wheel in the same position would be higher by approximately 0.50 inches.

Comparatively, the wheel on the other side for an axle in this position would be almost out of the range of the sensor. This wheel would produce a very low magnitude signal. This could happen if the axle is hunting. Hunting could be controlled by placing a guardrail at the location of the detector, but this will not correct the problem. While the hunting can be controlled, the variation due to wheel wear cannot be corrected.

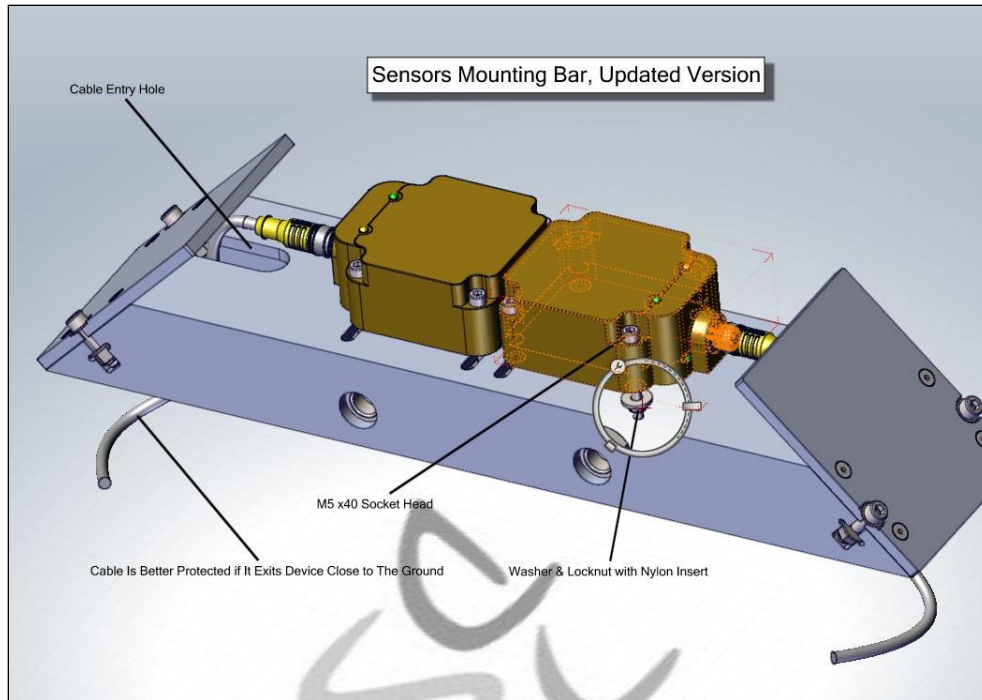
Figure 13. Service-ready Sensor Mounting Bracket with Shields

For a revenue service application, shielding and cable protection are required to protect sensitive components. [Figure 13](#) shows an alternative mounting with shields to protect sensors and cables. Several of this style mounting were tested as part of the prototype system.

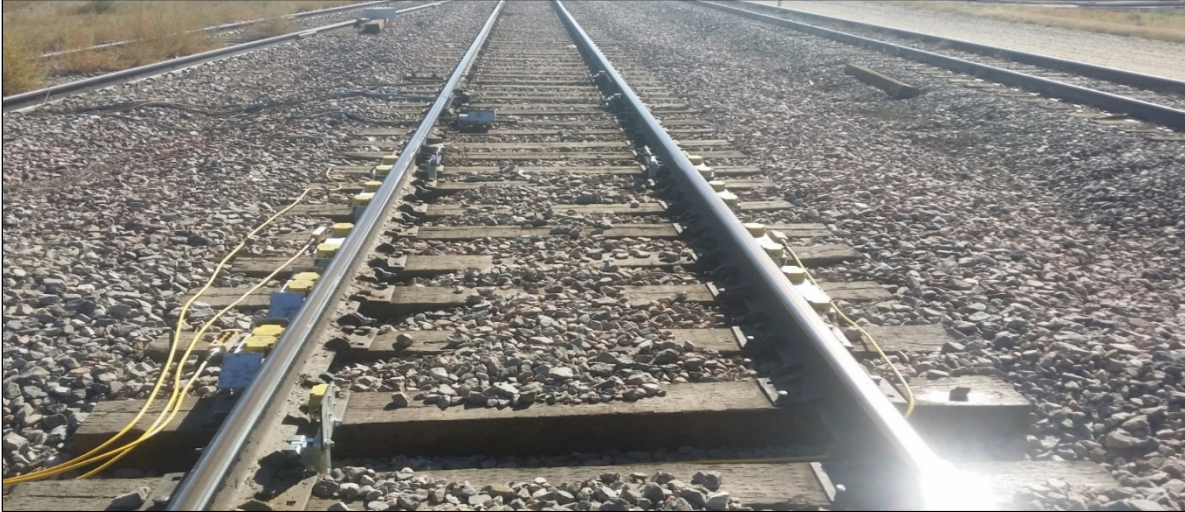
Figure 14. Broken Rim Detector System Installed at the TTC

TTCI purchased the broken rim detector hardware on behalf of FRA and installed it at the Facility for Accelerated Service Testing (FAST) on the High Tonnage Loop (HTL) at the TTC. [Figure 14](#) shows the prototype system. This system can sense wheels on both rails, but is only half as long as would be required to sense an entire wheel. This system provides enough to determine the feasibility of the concept.

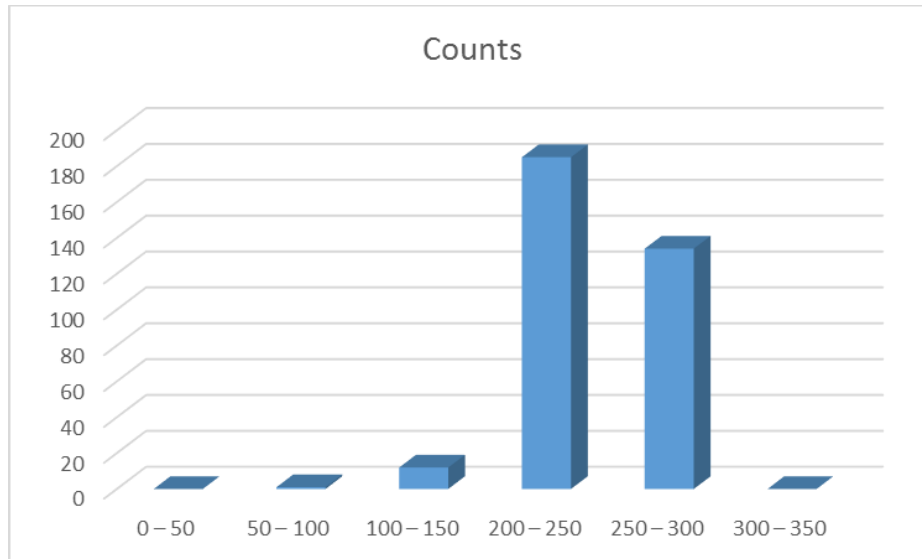
Figure 15. Graph of Magnetic Sensor Amplitude Events for a Single Pass of the Train at FAST

[Table 2](#) gives the distribution results from this event, and [Figure 15](#) shows the results graphically.

From this analysis, DII determined that the sensors have suitable reliability, but that there is substantial variability in the average reading even for known good wheels. DII surmised that the readings must be normalized so that the average event per wheel is consistent for known good wheels. The deviation from sensor to sensor must be consistent for known good wheels if a deviation due to a wheel defect is to be detected. If the signals cannot be adequately normalized, then the system will not be able to detect anomalies due to missing material. [Section 5.2](#) describes an adaptive routine to normalize the signals.

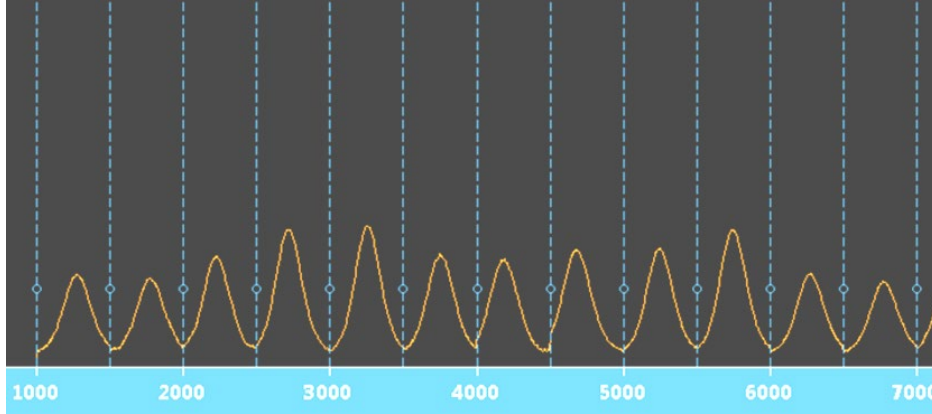
Figure 16. Amplitude Readings from a Single Wheel Passing a Magnetic Sensor on One Rail

[Figure 16](#) shows the signal from each of 12 sensors as a single wheel passes them sequentially.

The relative magnitudes of the 12 signal amplitudes are similar for every wheel that passes. Sensors 1, 2, 7, 11, and 12 are consistently smaller. This means the sensors at these locations are installed lower or further away than the others. Figure 17 shows this on a three-dimensional bar chart. In this figure, there are 8 wheels passing 12 sensors.

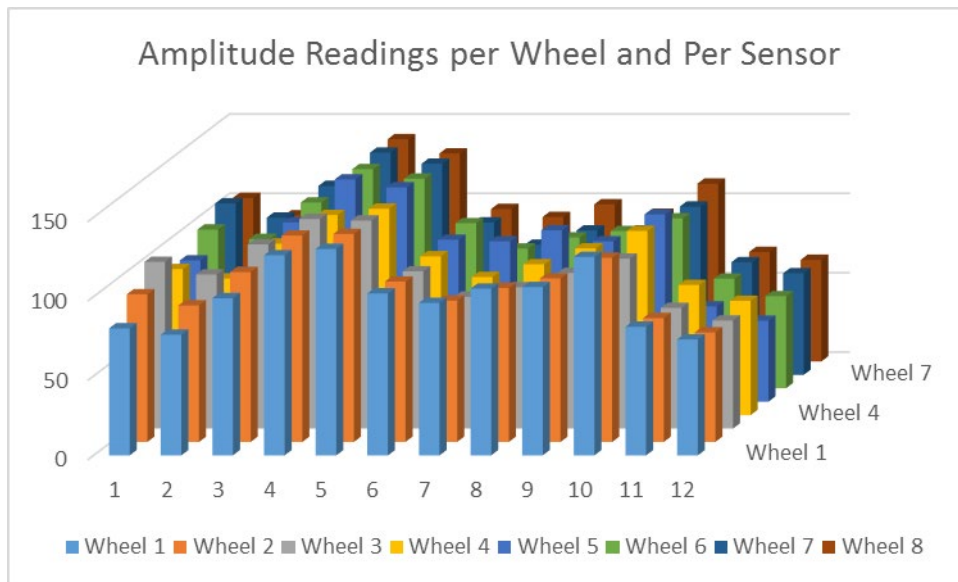
Figure 17. Amplitude Readings Showing the Stronger Dependency on Sensor Location than on Wheel

The bars from front to back (i.e., relating to a given sensor) are more uniform than the bars from right to left (i.e., relating to a given wheel). This is favorable, because it means that the readings can be normalized on a per sensor basis. Readings that are normalized on a per sensor basis will emphasize the variation due to wheels only, which is what is required. Since the signal deviation from wheel to wheel is relatively consistent, this deviation can be used from mean as the calibration coefficient to eliminate the differences due to sensor positioning. The deviation is applied on a per axle basis. This is reasonable because the sum of readings across paired sensors is consistent for any pair of sensors. As the wheelset hunts move laterally, the left signal generally decreases in proportion to the increase in signal on the right side, so the sum of the

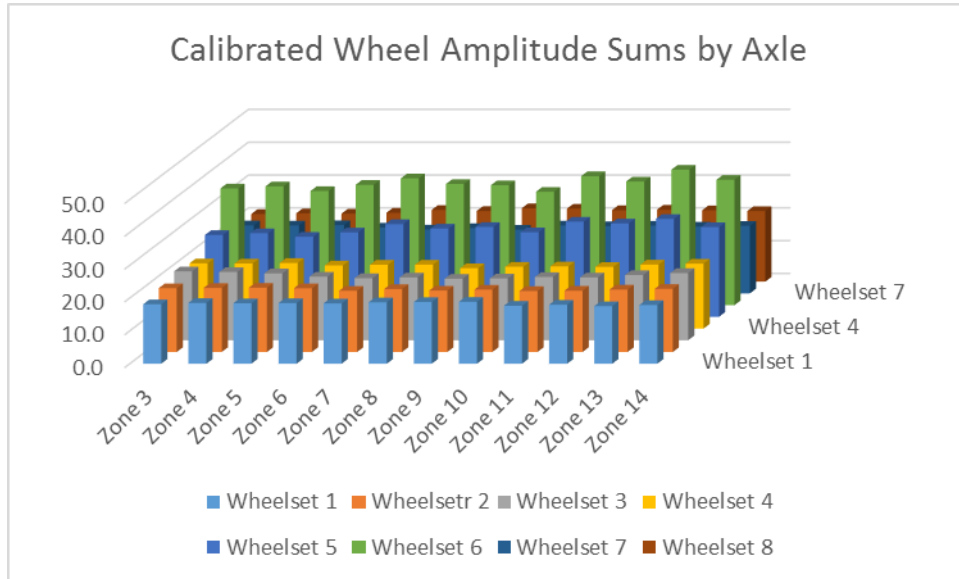
Figure 18. Normalized Amplitude Readings, Normalized Using Average Wheel Deviation per Axle

amplitudes on both wheels of an axle remains consistent. Once this calibration coefficient is applied to the data, the amplitudes per wheel are apparent, as shown in [Figure 18](#).

For this 37-mph test, the average deviation per axle is 5 percent. When converted to a distance value, this corresponds to 0.06 inches (1.5 mm) deviation. This 0.06 inch (1.5 mm) represents the average difference in position of the rim segments over the sensors at this speed.

One would expect the normalized amplitudes to be consistent from sensor to sensor for an axle with two good wheels. This is the case for the first four wheelsets, which are the locomotive wheels. The following four wheelsets are from the test car and show greater average deviation. For axles 5 and 6, the deviation is about four times higher than on the other wheels. [Section 6](#) explains the significance of these two wheels.

TTCI installed this wheelset on a test car and operated it on the broken rim detector. This wheel was located at axle 5 on the train during the testing shown in [Figure 18](#). The deviation between sensors for wheel 5 after correction suggests that the notched wheel can be detected. However, observe that the deviation for wheel 6 after correction is greater than the deviation for wheel 5. Wheel 6 has a continuous rim and should show lower deviation than wheel 5. Some underlying factor is more significant than the notch. TTCI and DII determined that this factor is hollow worn tread on wheel 6. The kinematics of the hollow tread create a nonlinearity in the rim elevation as the wheel displaces laterally. This nonlinearity in wheel position relative to the sensor is purely a function of wheel and rail geometry and cannot be corrected by the sensor deviation factor. The result is that the detector cannot be calibrated to detect wheels with broken tread before alarming on wheels with hollow worn tread.

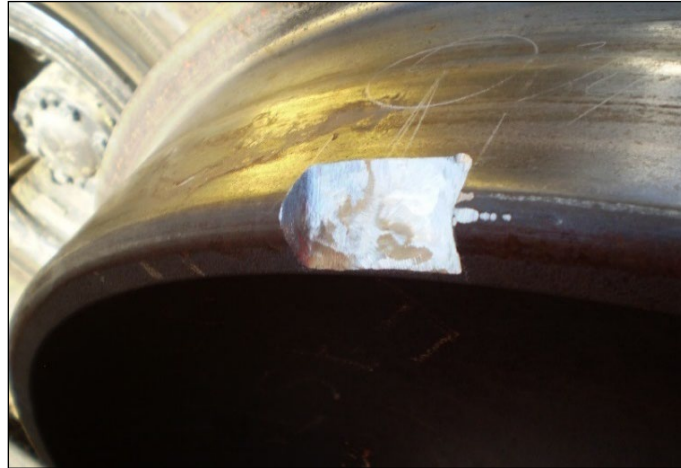
Figure 19. 0.75-inch Deep Rim Notch on the Test Wheel

TTCI produced a test wheel according to DII specification. The test wheel has three evenly spaced notches around the rim. Each one has a different depth. One is 0.25 inches (6.4 mm) deep, one is 0.50 inches (12.7 mm) deep, and one is 0.75 inch (19 mm) deep. All are 2 inches (50.8 mm) wide. [Figure 19](#) shows the 0.75 inch (19 mm) deep notch. The mating wheel on the axle has no notches.

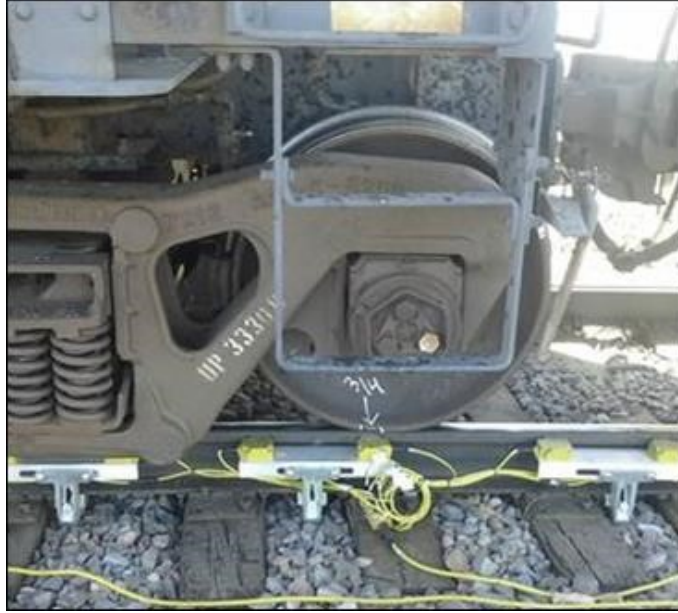
Figure 20. Test Wheel Notch Aligned on One of the Magnetic Sensors

[Figure 20](#) shows the test wheel with the 0.75-inch (19 mm) slot perfectly aligned over one of the sensors.

Unless the wheel was centered completely on the sensor, the reading was the same as if there were no slot. This ultimately becomes the limiting factor in using magnetic sensors for detecting missing material. Testing revealed that unless the void from missing material is larger than the sensing area of the magnetic sensor, then the sensor will detect the existing material and ignore the void. For in-service defects, the sensors must be much smaller than the ones selected for this testing. Smaller sensors could be used, but they would have to be mounted closer to the wheel, which creates clearance issues. This, along with the greater number of sensors required to sense the entire wheel makes such a system impractical.
