U.S. Department
of Transportation
**Federal Highway
Administration**

Guardrail Testing Program III

Final Report

Publication No. FHWA-FLP-96-012
July 1996

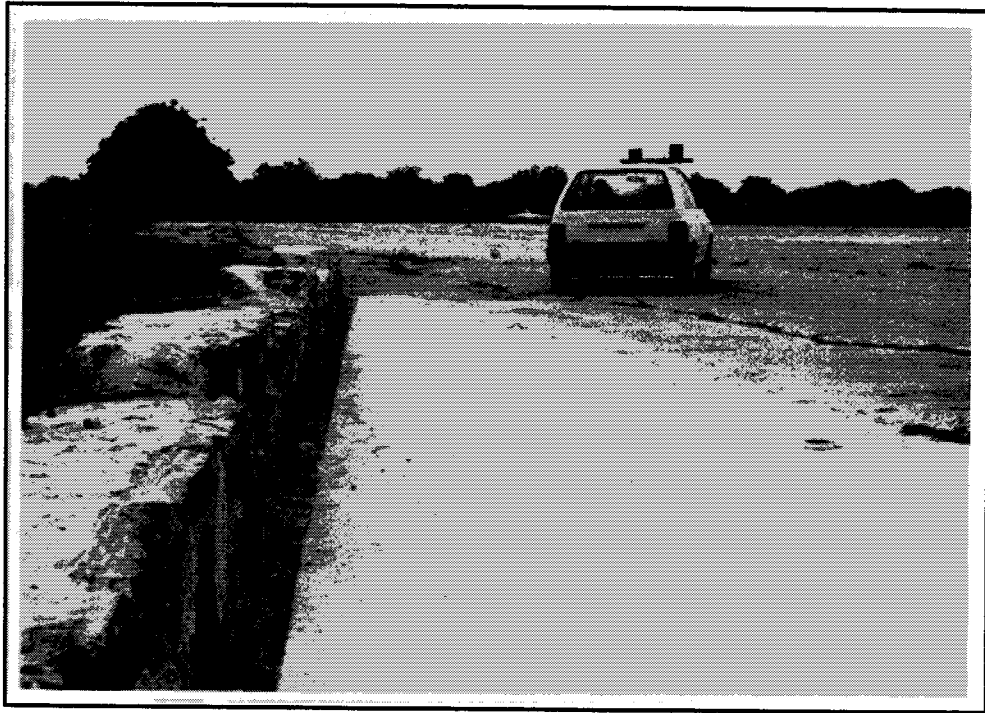
Figure 16. (Continued) After Test Photographs - Test RW-2

Damage to the barrier consisted of scuffing of the rock wall.

The test vehicle sustained damage to the left side of the front bumper, which was deformed rearward.

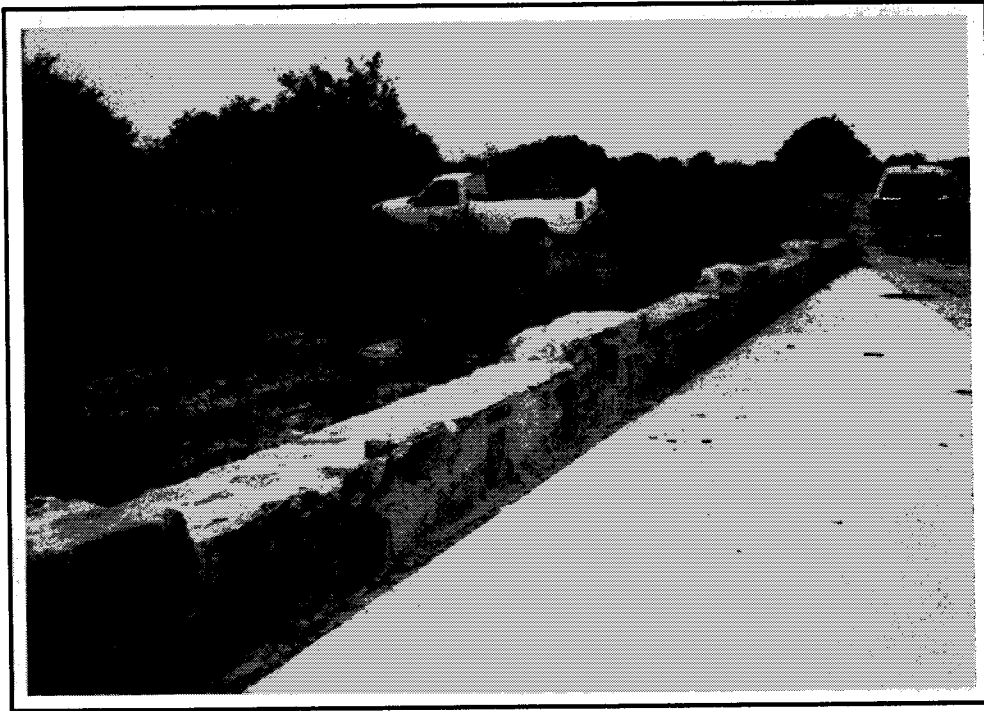
Figure 22. After Test Photographs - Test RW-3

Damage to the barrier consisted of minor scuffing of the rock wall.

The test vehicle sustained damage to all four tires, the drive shaft, and the frame.

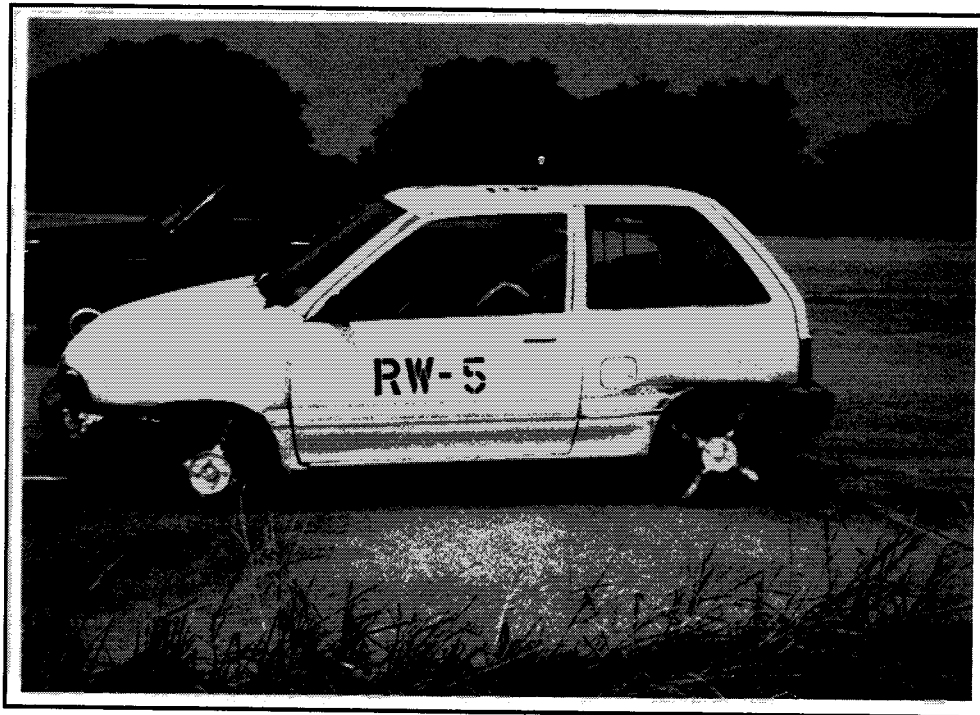
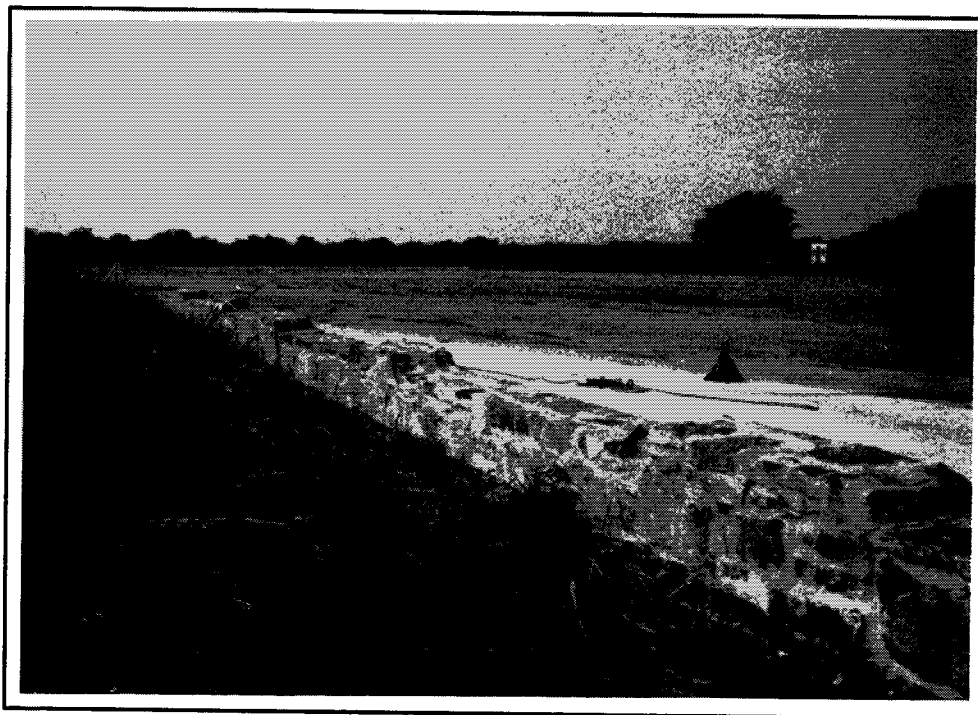
Figure 34. (Continued) After Test Photographs - Test RW-5

Damage to the barrier consisted of minor scuffing of the rock wall.

The test vehicle sustained damage to the left front fender, door, and headlight/grill area. The left side of the front bumper was deformed rearward.

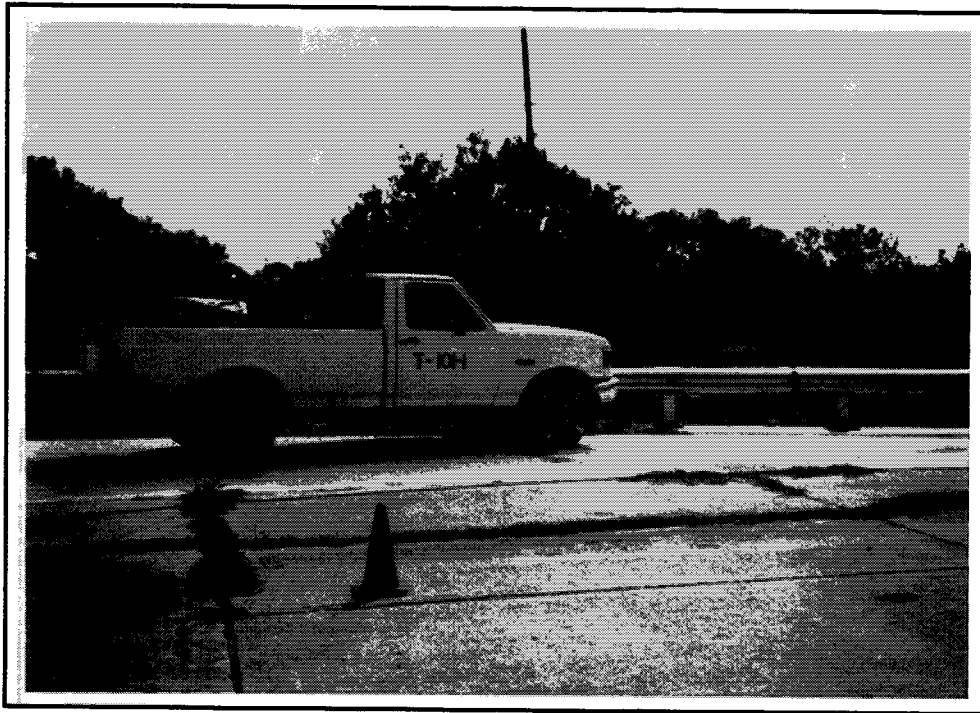
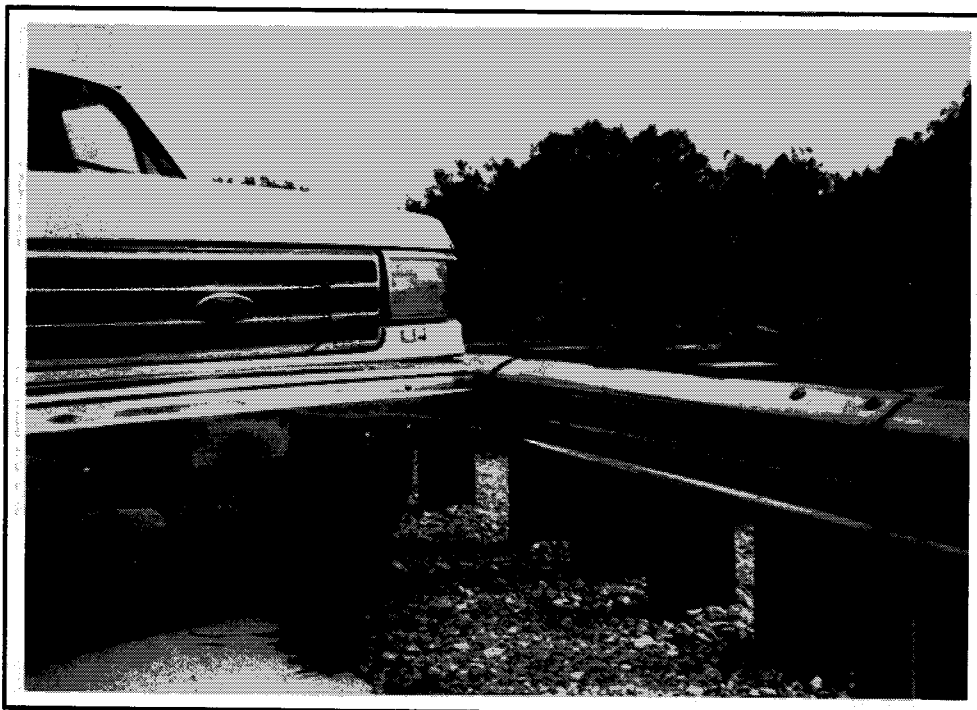
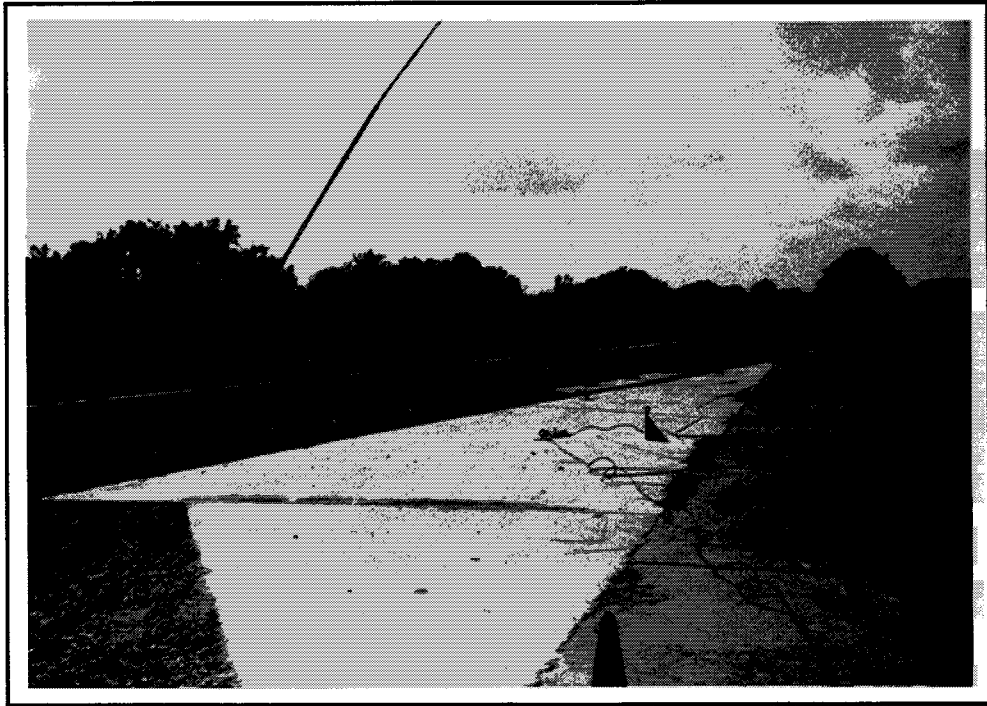
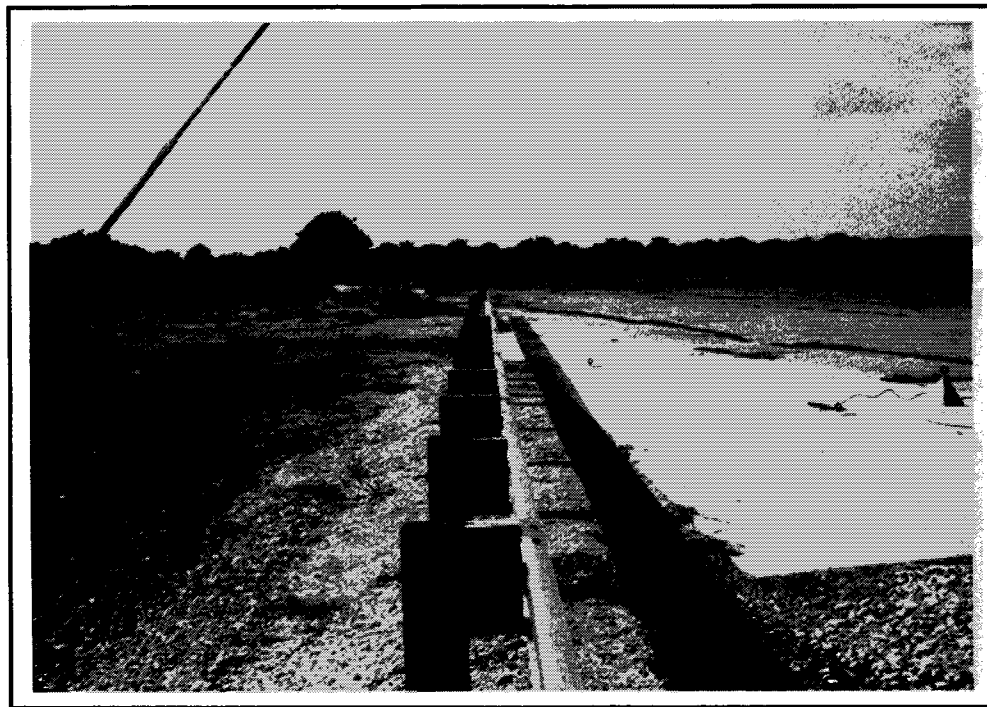
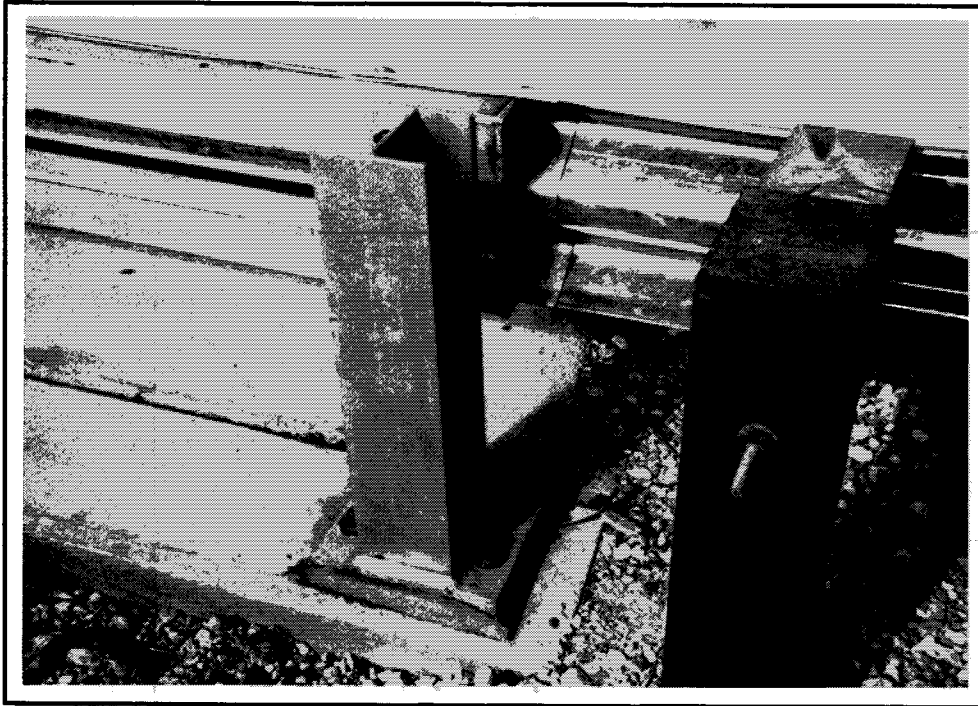
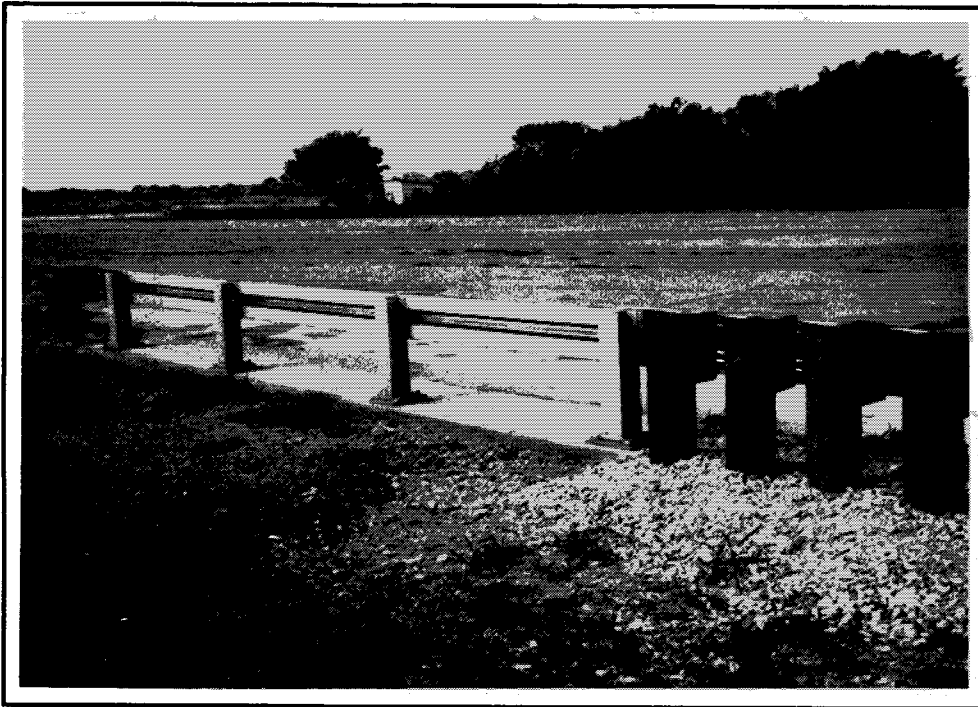
Figure 3. Before Test Photographs

The vehicle used in this test was a 1989 Ford F250 pickup. Gross test weight, including the dummy and instrumentation, was 2,039 kg. The barrier installation and test vehicle before the test are shown in Figure 3. An uninstrumented dummy was seated in the driver's seat of the test vehicle. The shoulder-and-lap seatbelt was in place around the dummy.

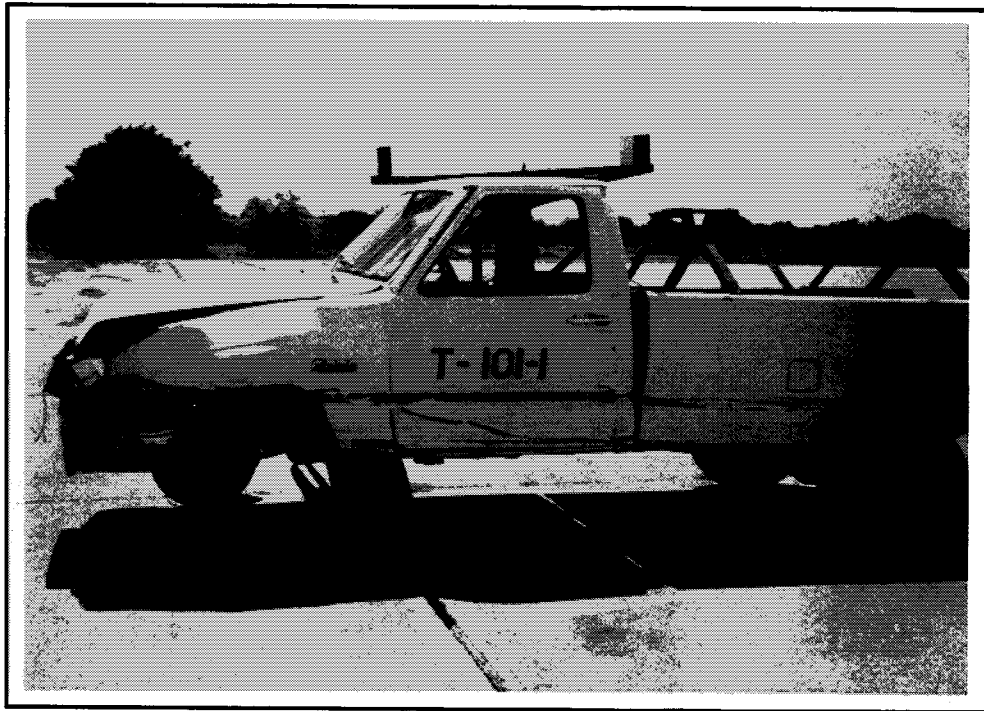
Figure 9. (Continued) After Test Photographs

Damage to the barrier consisted of the concrete spalling at the first bridge rail

post. One blackout split, and two sections of W-beam were damaged.

The test vehicle sustained damage to the left front fender, door, and headlight/grill area. The left side of the front bumper was deformed rearward. The vehicle frame was bent.

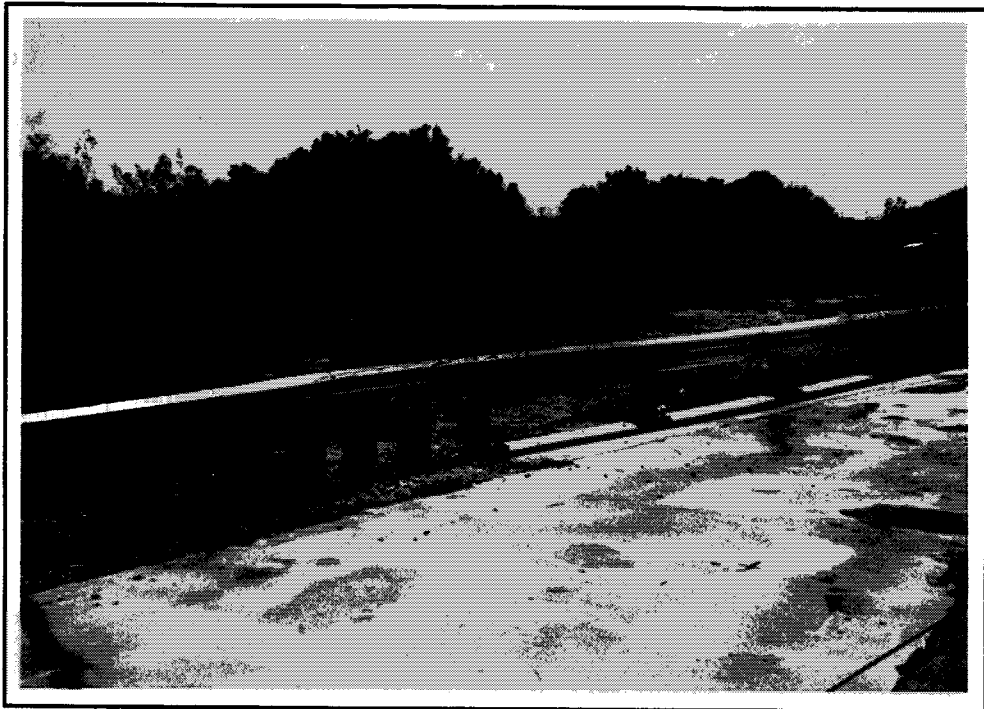
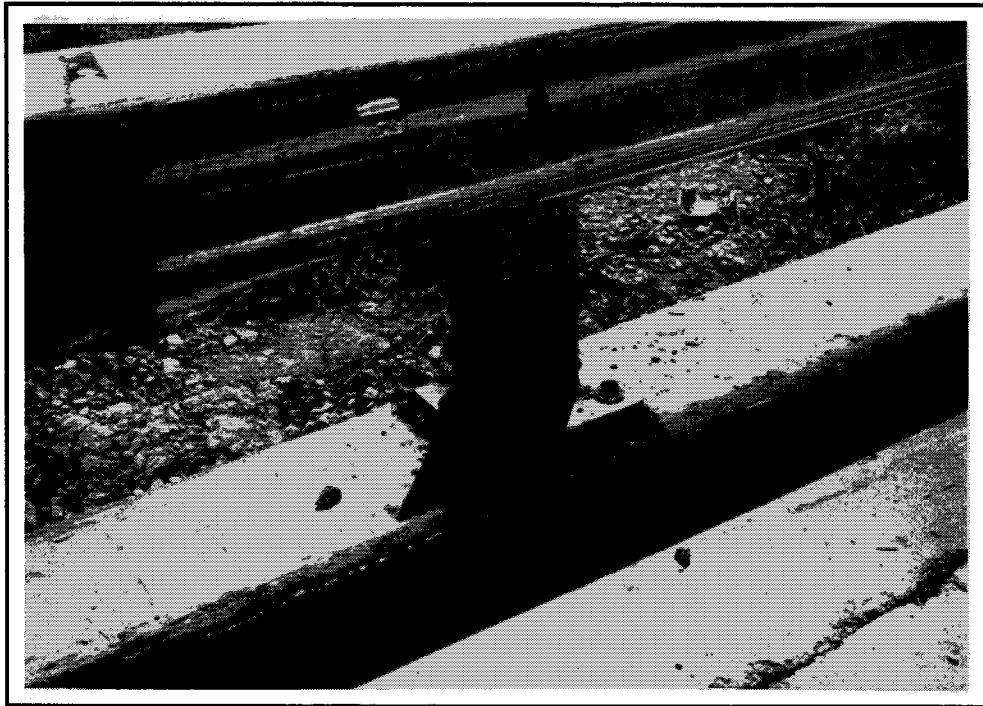
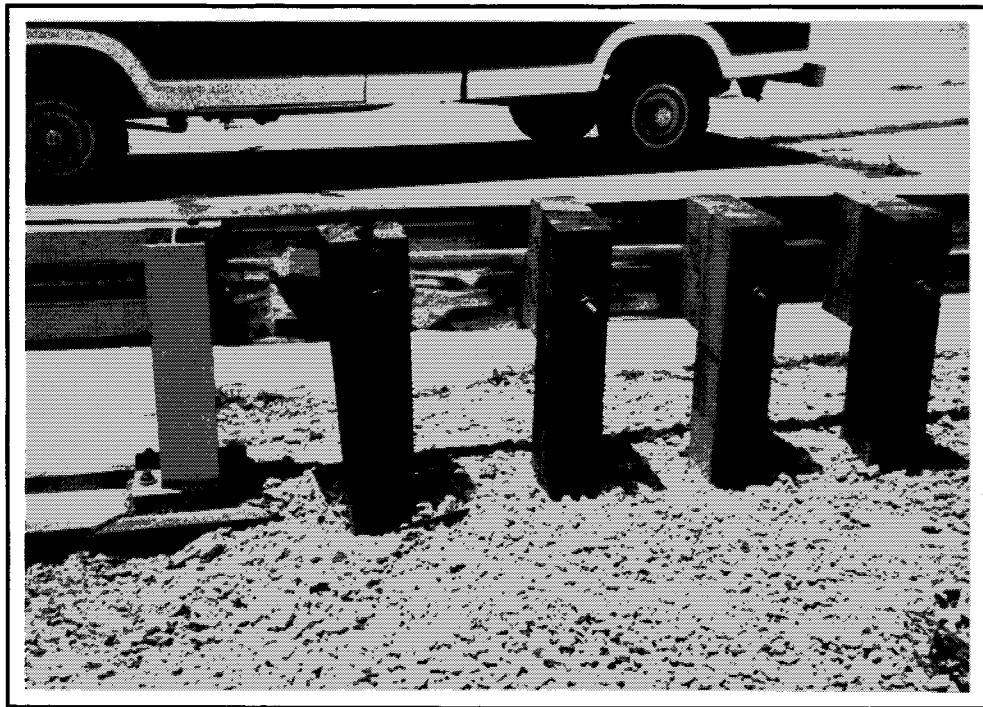
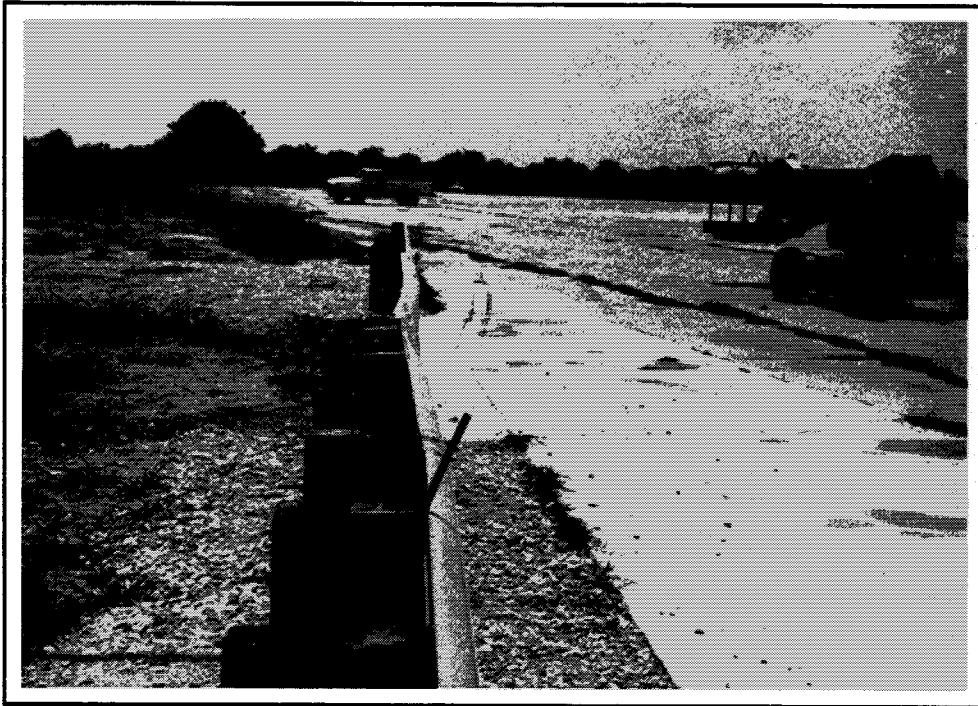
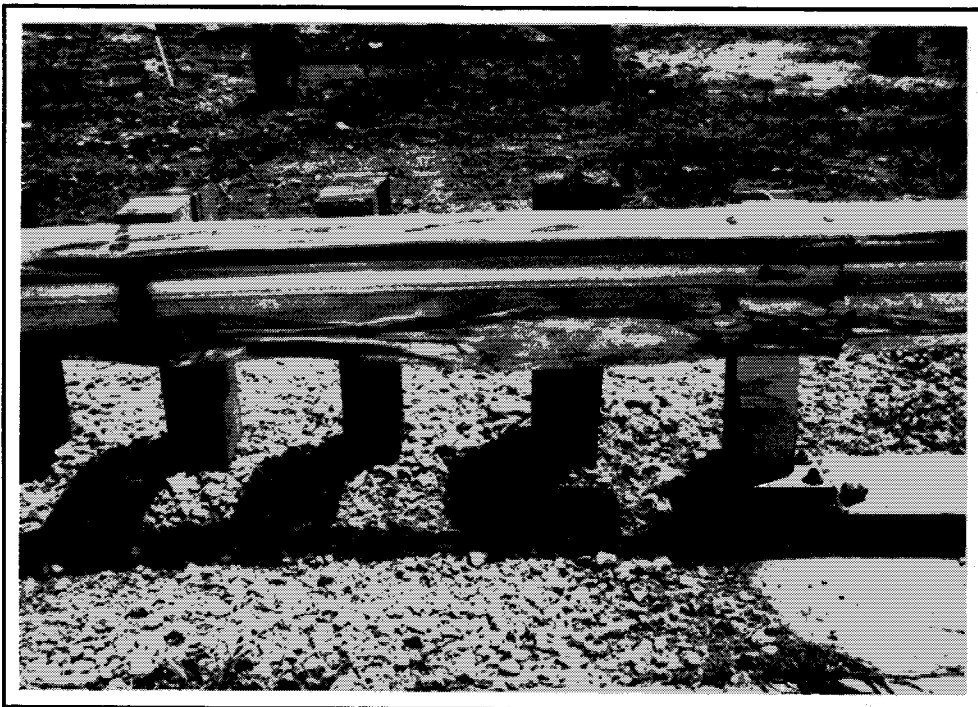
Figure 9. After Test Photographs

Actual impact conditions were 100.1 km/h and a 25-degree impact angle. Ambient temperature at test time was 35 degrees C. As shown in Figure 5, the vehicle impacted the barrier 1 m upstream of the bridge rail. The vehicle was smoothly redirected and rolled to a stop 50 m past the end of the installation. Figure 6 shows the redirection sequence of the vehicle during impact. Maximum 50-ms average accelerations of -5.78 g's longitudinal and -4.62 g's lateral were measured from onboard transducer data. Test conditions and results are summarized in Figure 7. Figure 8 contains plots of the transducer data. Barrier and vehicle damage are shown in Figure 9.

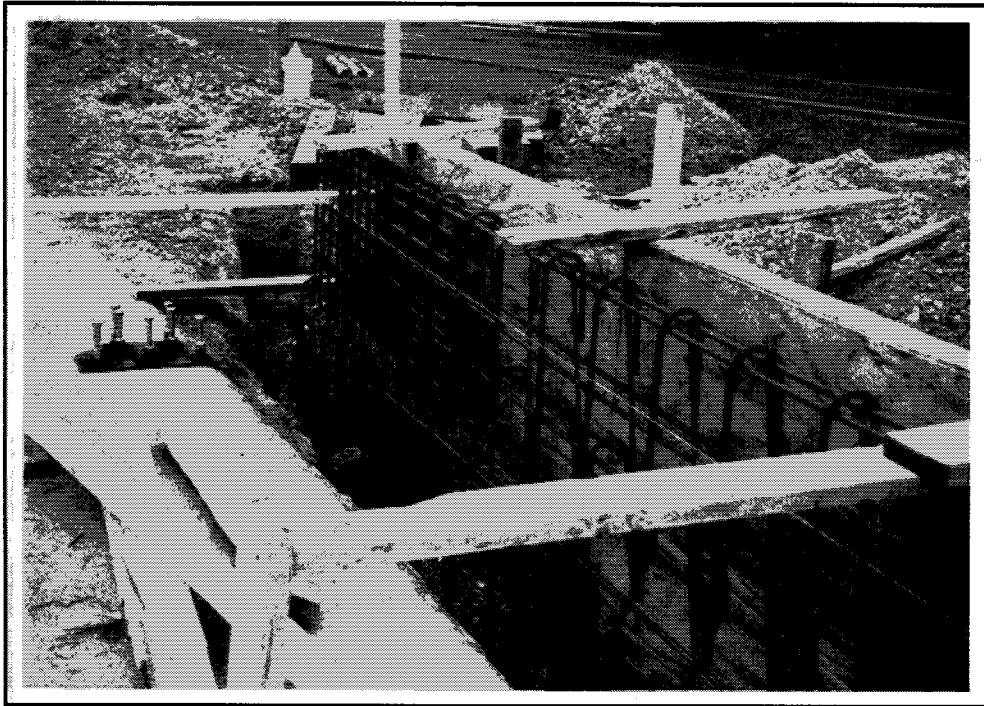
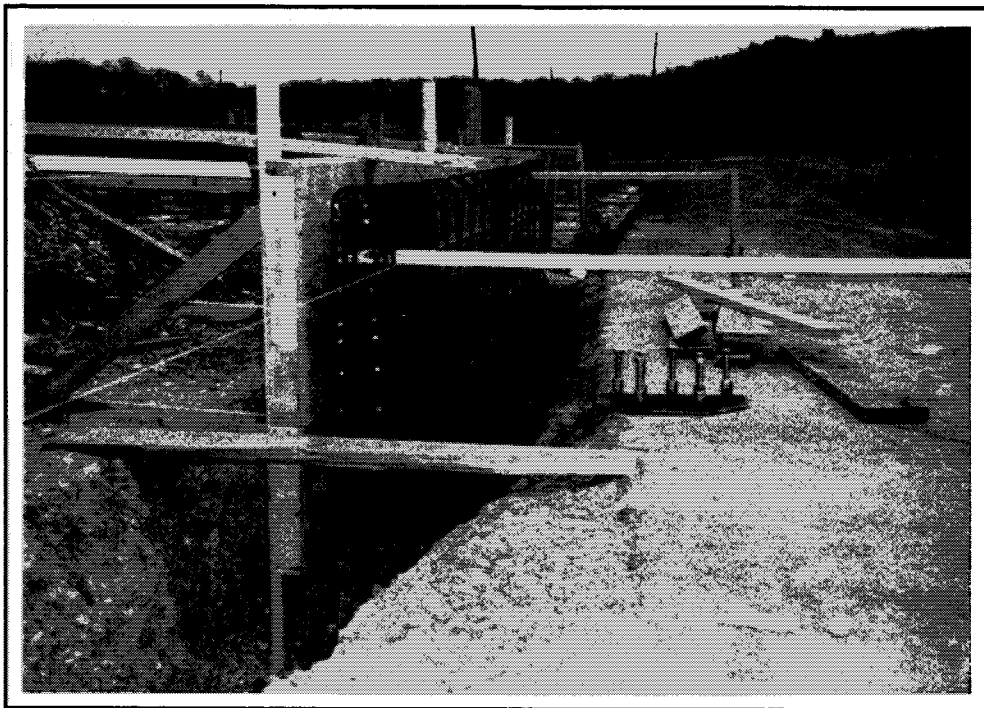
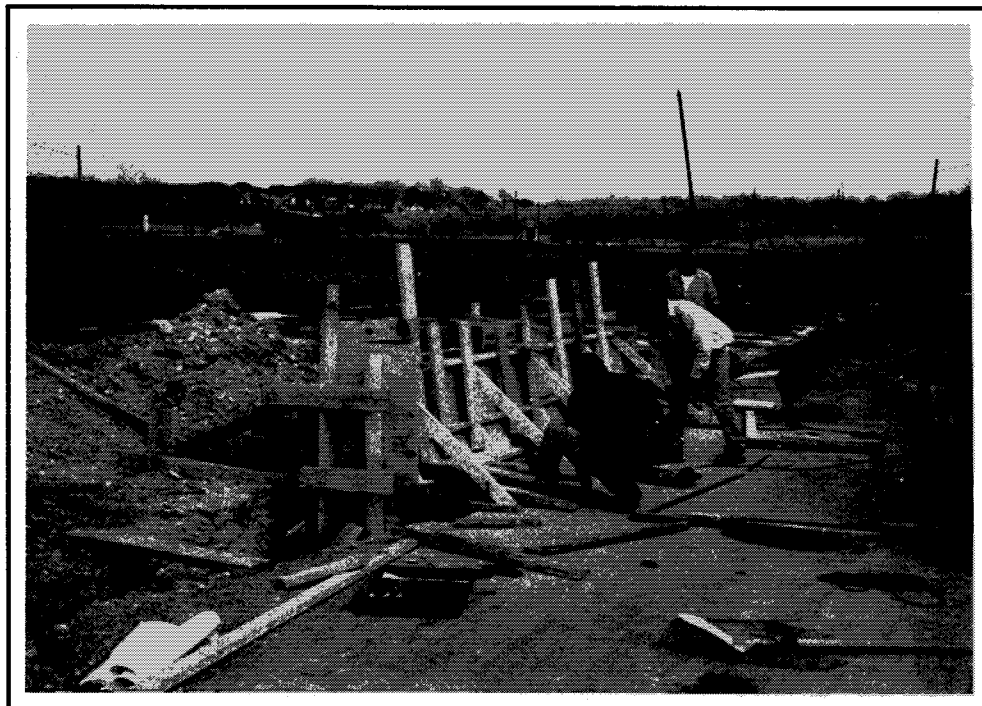
Figure 1. (Continued) Test Installation Construction Details

The thrie beam on wood post transition to a New Jersey shaped parapet shown in Figure 1 was constructed in accordance with specifications contained in "Standard Specifications for Construction of Roads and Bridges on Federal Highway Projects, FP-92."⁵ Construction of this transition system consisted of the steps listed below. Graphs of the concrete strength are shown in Figure 2. This installation consisted of 4.6 m of parapet and 15.2 m of guardrail. The parapet was tapered from the safety shape to a rectangle at the upstream end. The guardrail installation included a 1.9-m straight breakaway cable terminal (BCT) at the upstream end, 7.6 m of G4-2W guardrail system, 1.9 m for a W-beam to thrie beam transition, and 3.8 m of nested thrie beam guardrail system with reduced post

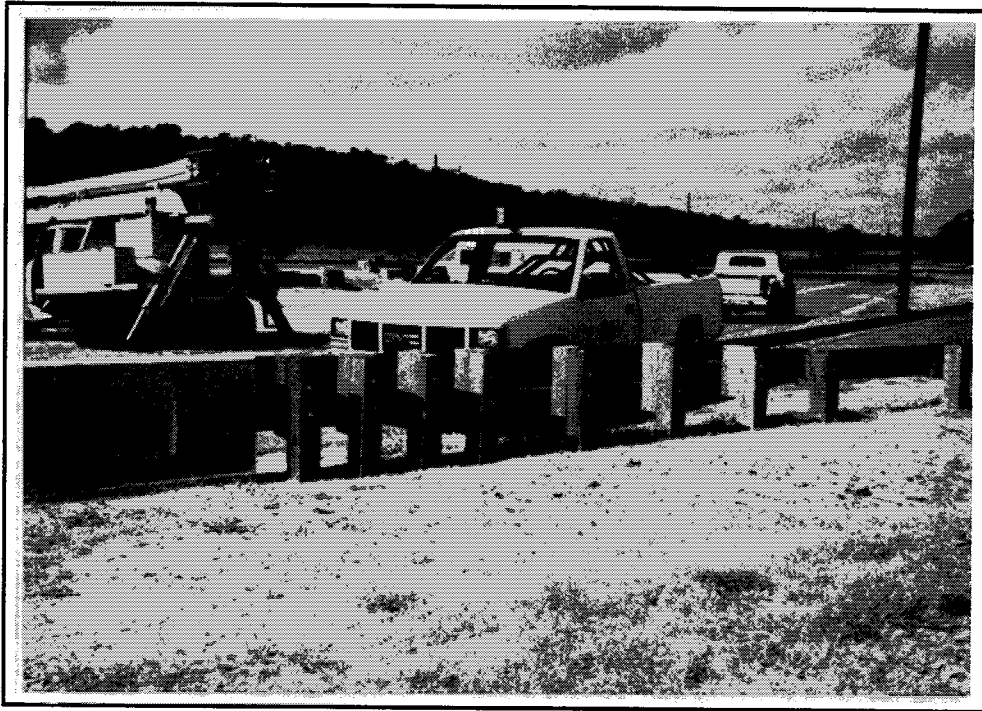
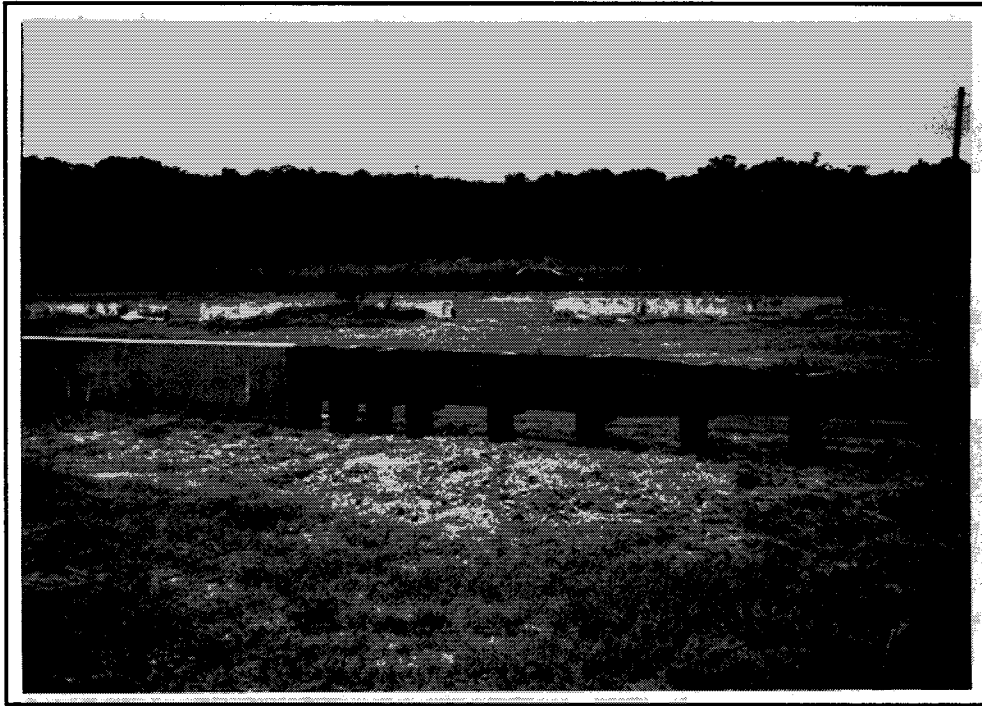
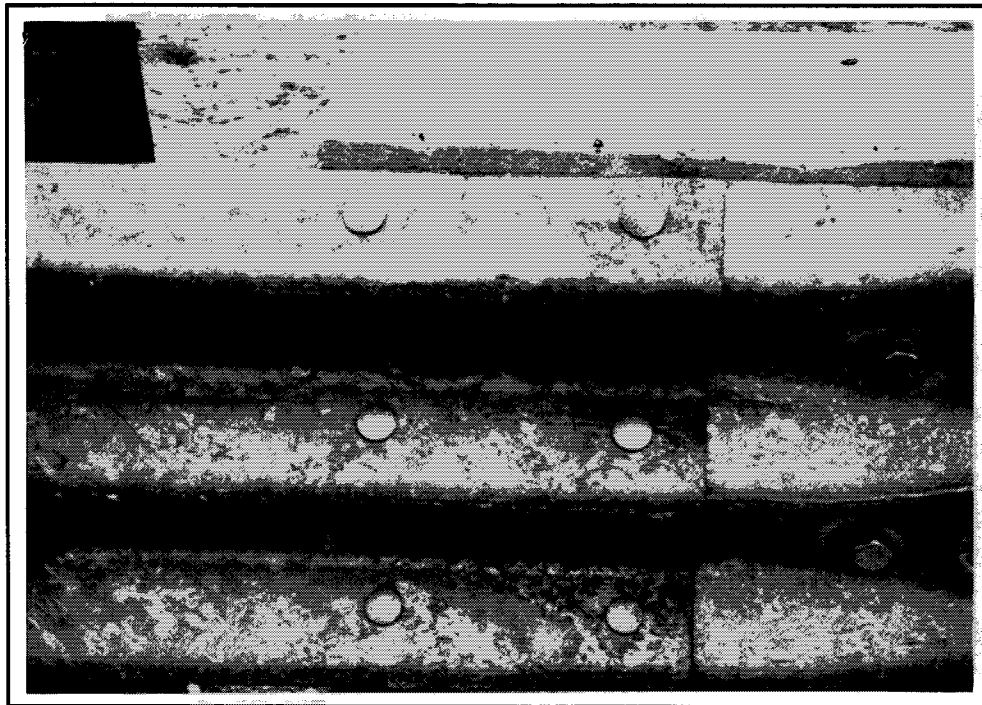
Figure 3. Before Test Photographs

including the dummy and instrumentation, was 2,039 kg. The barrier installation and test vehicle before the test are shown in Figure 3. An uninstrumented dummy was seated in the driver's seat of the test vehicle. The shoulder-and-lap seatbelt was in place around the dummy.

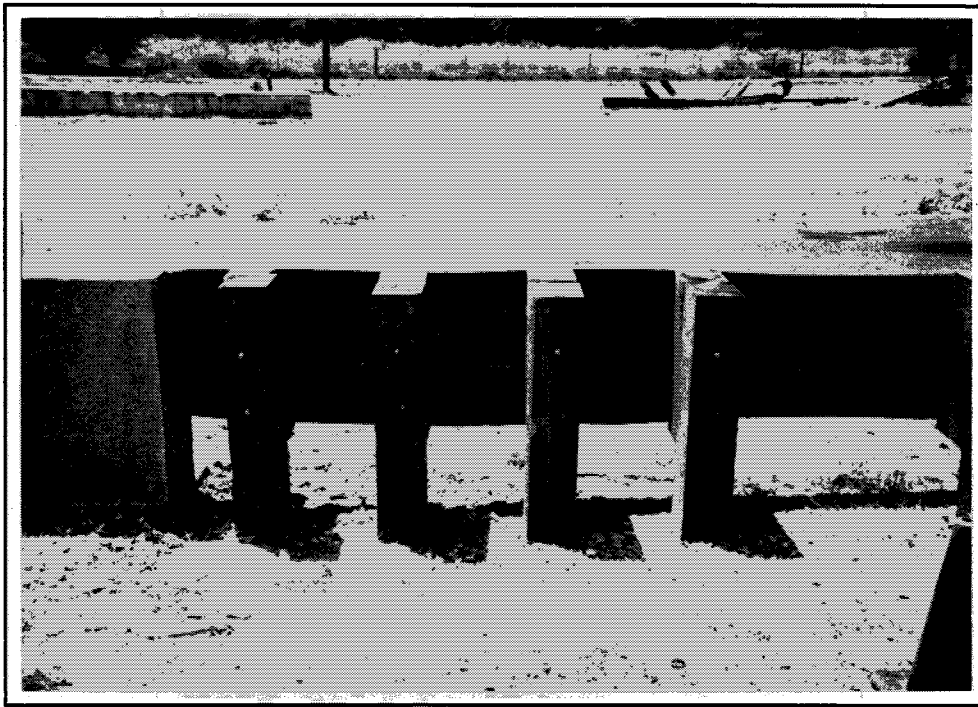
Figure 5. Test Layout

Actual impact conditions were 100.1 km/h and a 25-degree impact angle. Ambient temperature at test time was 35 degrees C. As shown in Figure 5, the vehicle impacted the barrier 1 m upstream of the New Jersey parapet. The vehicle was redirected and rolled on its side. Figure 6 shows the redirection sequence of the vehicle during impact. Maximum 50-ms average accelerations of -12.08 g's longitudinal and 11.22 g's lateral were measured from onboard transducer data. Test conditions and results are summarized in Figure 7. Figure 8 contains
