GEORGIA DOT RESEARCH PROJECT 17-32

Final Report

**VALIDATING CHANGE OF SIGN AND PAVEMENT
CONDITIONS AND EVALUATING SIGN
RETROREFLECTIVITY CONDITION ASSESSMENT ON
GEORGIA'S INTERSTATE HIGHWAYS USING 3D
SENSING TECHNOLOGY**

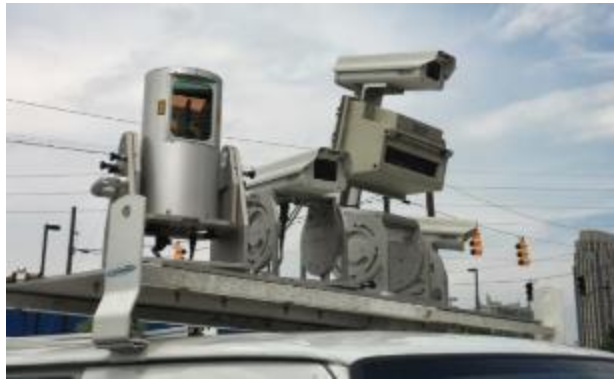
Figure 2-1. Photo. Mobile imaging sub-system on GTSV.

GPS, an inertial measurement unit (IMU), and a distance measurement instrument (DMI) to acquire the precise GPS coordinates. The camera system is synchronized with the LiDAR sensor to provide corresponding color images. **Figure 2-1** illustrates the mobile imaging sub-system on the GTSV.

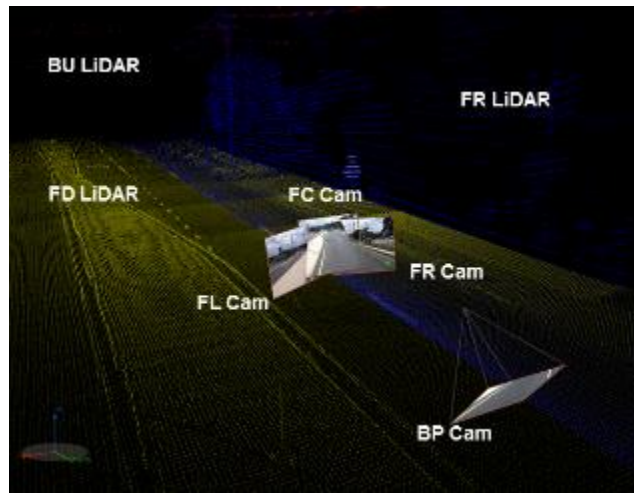
Figure 2-2. Photo. Illustration of the collected sensing data using the mobile imaging sub-system.

can be integrated with the 3D LiDAR point cloud in the same location-referencing coordinates. The data collection interval of 5 meters is used for collecting the video log images; this was recommended in the previous study for optimizing the data storage with sufficient overlap in the video log image sequence (Ai & Tsai, 2015). **Figure 2-2** shows an illustration of the collected sensing data using the mobile imaging sub-system.

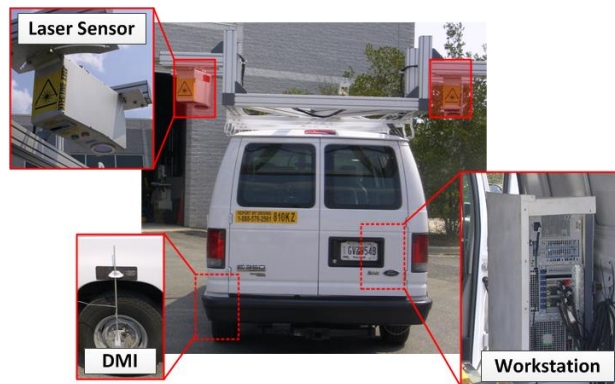
Figure 2-3. Photo. Components of 3D Line Laser System Integrated on the GTSV.

results using a high-performance workstation. As shown in **Figure 2-3**~~Error! Reference source not found.~~, the two laser sensors are installed on each side of the roof at the back of the GTSV. The current sensor delivers a resolution of 5 mm in the longitudinal direction and 1 mm in the transversal direction, with a resolution of 0.5 mm in the vertical direction. The field of view of the two sensors covers a full-lane width, i.e. 4 m. The research team configured both sensors at approximately 15 degrees clockwise to the transverse direction to avoid overlooking transverse cracks in the pavement. During data collection, each laser sensor uses a high-powered laser line projector with a customized filter to generate a fine infrared laser line illuminating a strip of the pavement. The corresponding spatial high-intensity camera captures the deformed laser line on the pavement. From the captured image, range measurements are extracted (Tsai & Wang, 2013). ~~Error! Reference source not found.~~ illustrates the collected data using the 3D line laser sub-system.

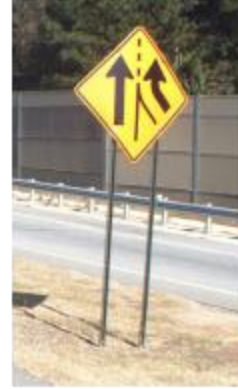
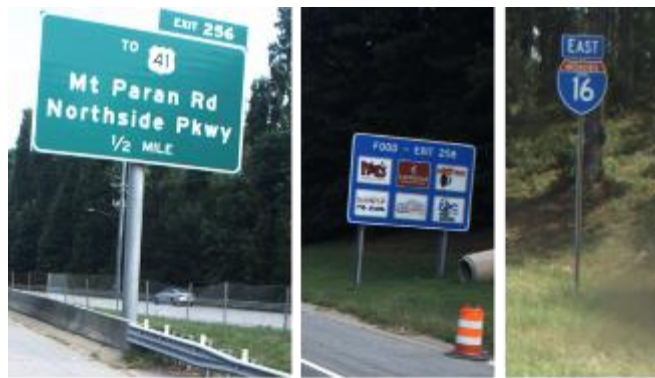
Figure 3-1. Photos. Examples of sign classification.

Sign Classification: Traffic sign classification is defined as the traffic sign classes that can distinguish different traffic sign functionalities, which has led to different designs, e.g. RX-X as regulatory signs, WX-X as warning signs, etc. (note: X is a number.). There are more than 670 types of traffic signs defined in the MUTCD, and they belong to three functional classifications (McGee, 2010): regulatory, warning, and guide. These 670 sign types are used in this project. **Figure 3-1** shows an example of the different sign classifications used in this project.

A. Subfigure of regulatory sign

B. Subfigure of warning sign

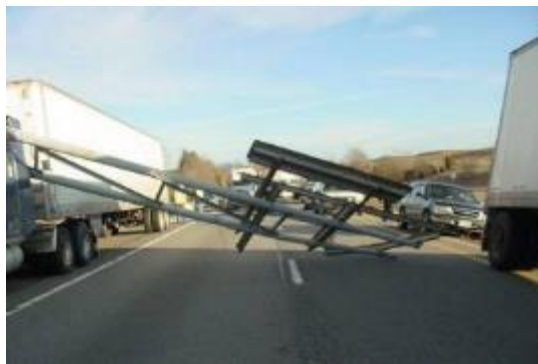
Figure 3-3. Photo. Example of overhead sign failure (FHWA, 2013).

Although overhead signs only contribute a small portion of the entire sign population, the damage of these signs and/or their corresponding support, e.g. panel failure, support structure failure, etc., may potentially lead to serious hazards to road users. **Figure 3-3** shows an example of such hazardous situations.

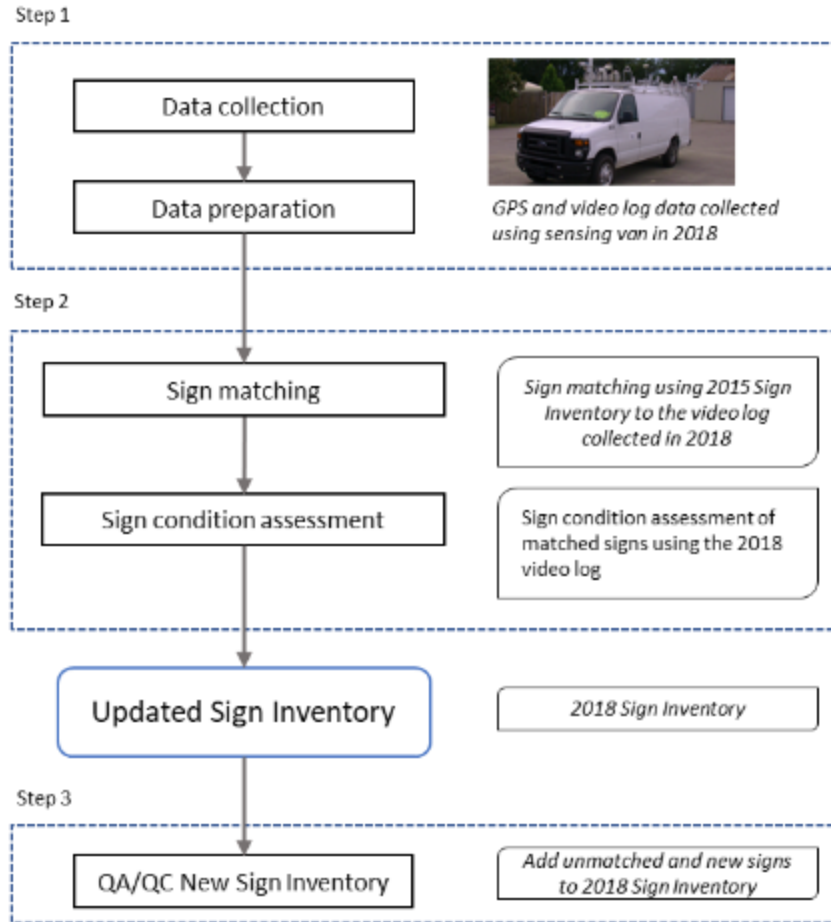
Figure 3-5. Flowchart. Procedure to create an updated sign inventory using the previously collected data.

This section discusses the procedure adopted to create an updated sign inventory for Georgia's interstate highways based on the previously created sign inventory in 2015. The three key steps involved in this procedure include 1) collecting and preparing the interstate video log images and their GPS locations, 2) matching signs in the 2015 sign inventory to the 2018 video log to validate its existence and assessing the sign condition (good, surface failure, post failure, or obstruction), and 3) performing QA/QC operation to capture the unmatched signs from the 2015 sign inventory and to capture the newly installed signs since 2015. **Figure 3-5** shows the flowchart of the proposed procedure, which consists of the 3 key steps.

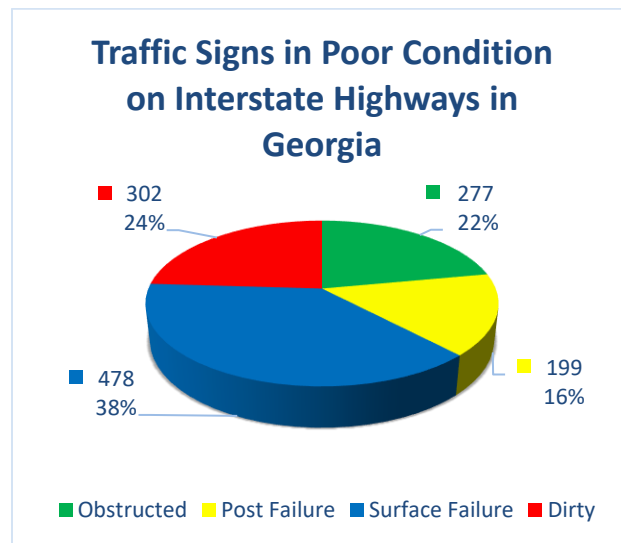
Figure 3-7. Chart. Traffic signs with poor conditions on interstate highways in Georgia.

Among all the identified signs, 6% of the signs (i.e. 1,256 signs) are in different categories of poor condition as defined in the GDOT’s Foreman’s Academy (2008). Among all the signs in different poor condition categories, surface failure (478 signs, 38.1%) and dirty signs (302 signs, 24.0%) are the two primary categories of poor conditions. The rest of the signs are in poor condition due to having a failed post (199 signs, 15.8%) and being obstructed (277 signs, 22.1%). Overall, the number of traffic signs in poor condition is only a small portion of the total number of traffic signs, indicating overall, well-maintained sign condition by GDOT. **Figure 3-7** and **Figure 3-8** show the distribution of the traffic signs in poor condition on the interstates. **Table 3-2** shows the detailed statistics for each interstate highway in Georgia that are in poor condition.

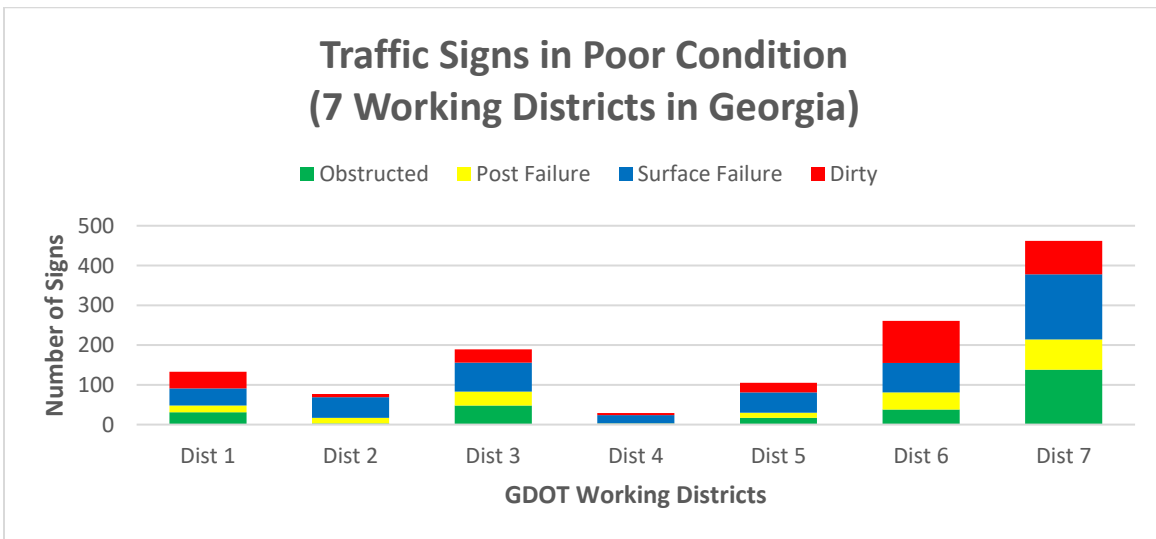
Figure 3-13. Chart. Distribution of traffic signs in poor condition in the 7 working districts.

The distribution of the traffic signs in poor condition in the seven working districts is shown in **Figure 3-13**. It can be observed that District 7 has more traffic signs in poor conditions (i.e., 462 signs, approximately 8% of the total signs in District 7) than the ones in other districts. While surface failure is the major reason in all working districts for traffic signs in poor condition, it should be noticed that traffic signs with dirty surfaces occur more frequently in District 6, and obstruction and post failure occur more frequently in District 7. These observations may provide some insight into guiding an improved maintenance effort, such as traffic sign cleaning in District 6, and repair the sign posts and vegetation trimming in District 7.

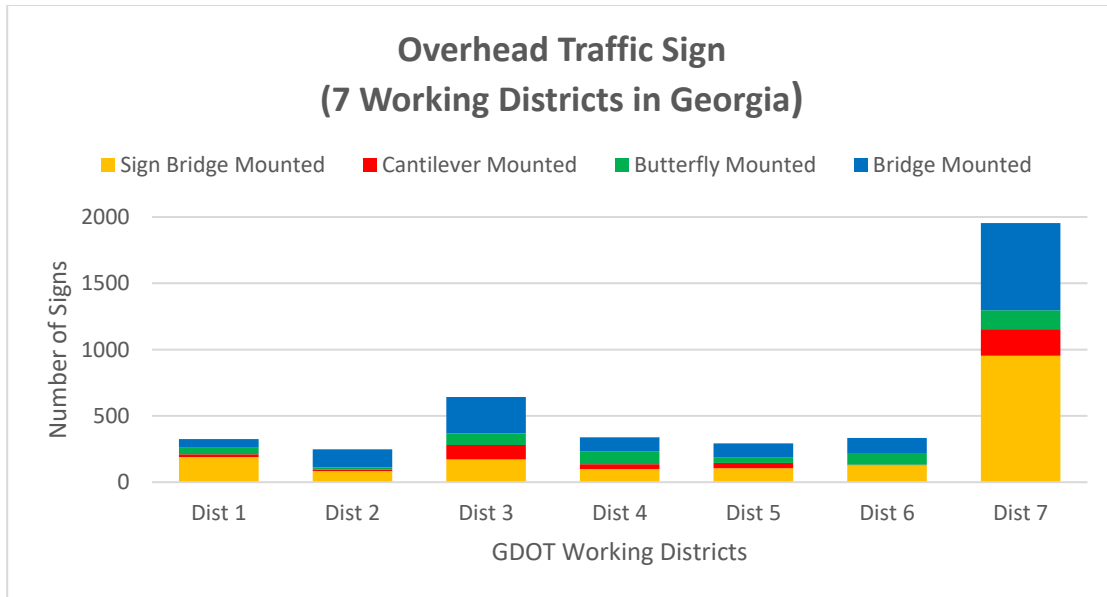
Figure 3-14. Chart. Distribution of the overhead traffic signs in the 7 working districts.

It can be observed that District 7 has a significantly larger number of overhead traffic signs (i.e., 1,954 signs, around 33% of the total signs in District 7) than other districts because of the frequent overpasses and intersections in the urban region. The large number and percentage of overhead signs in District 7 may require more maintenance efforts and activities than in other districts. Table 3-6 shows the detailed statistics of the overhead traffic sign distribution and the percentage of overhead signs in each district.

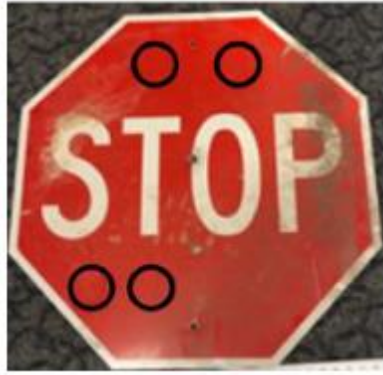
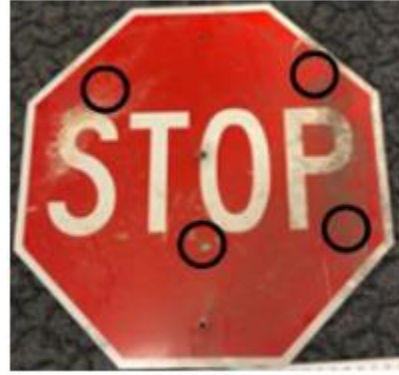
Figure 4-1. Photos. Variation of retro-reflectivity assessment results for a non-uniform sign condition.

The second method uses a retroreflectometer, which is a handheld device that is held directly against the surface of a sign at 4 different points on each color of the sign to measure the retroreflectivity value (ASTM, 2016). A numerical retroreflectivity value is given that can then be compared to the minimum levels outlined in the MUTCD (2009) to classify the sign as passing or failing. The method is quantitative and consistent, thereby overcoming the subjectivity of the visual assessment method. However, the primary issue with this method is that it is very slow, tedious (labor-intensive) and dangerous to workers making the measurement in the field. Inspectors must leave their vehicle for every measurement, which is time-consuming (approximately 5 minutes for each sign) and dangerous (while traffic is still flowing). Another concern is that this 4-sampling method does not work well when the sign condition is non-uniform. For example, **Figure 4-1** (a) and **Figure 4-1** (b) show two sets of 4-point readings, measured on the same sign (a STOP sign with dirt on right side and scratches on left top corner). **Figure 4-1** (a) shows the sampling location at which the sign is assessed as “Pass” and **Figure 4-1** (b) shows a sampling location at which the sign is assessed as “Fail” simply because four different points are selected. Thus, for signs with a non-uniform condition, the results of this assessment may fail to account for localized damage and deterioration.

A. Subfigure of pass sample

B. Subfigure of fail sample

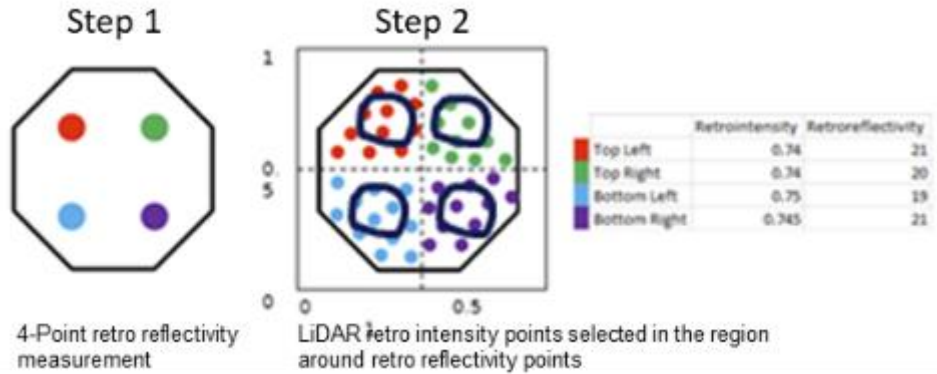
Figure 4-3. Illustration. Locations for retro-reflectivity.

sign. In the second step, the LIDAR retro-intensity points of the signs are projected to a 2D plane, and the retro-intensity points around (roughly 10 cm) the four retro-reflectivity measurement locations are selected. For retro-intensity measurements made in each location, the median retro-intensity value is computed.

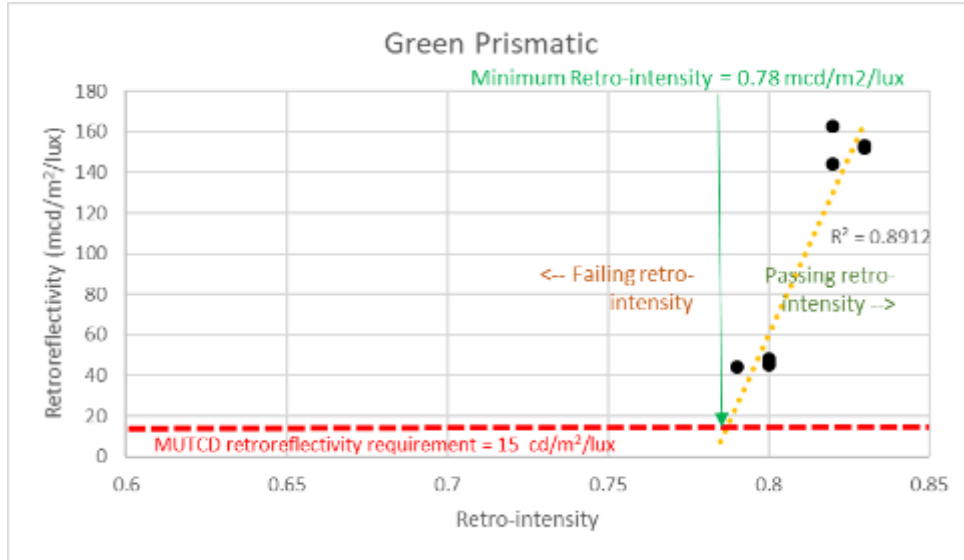
Figure 4-4. Graph. Correlation between retro-reflectivity and retro-intensity and determination of MR for green prismatic sheeting type signs.

4-4, Figure 4-5, and Figure 4-6 show the MR determination for green, yellow, and white prismatic signs as 0.78, 0.76, and 0.76, respectively.

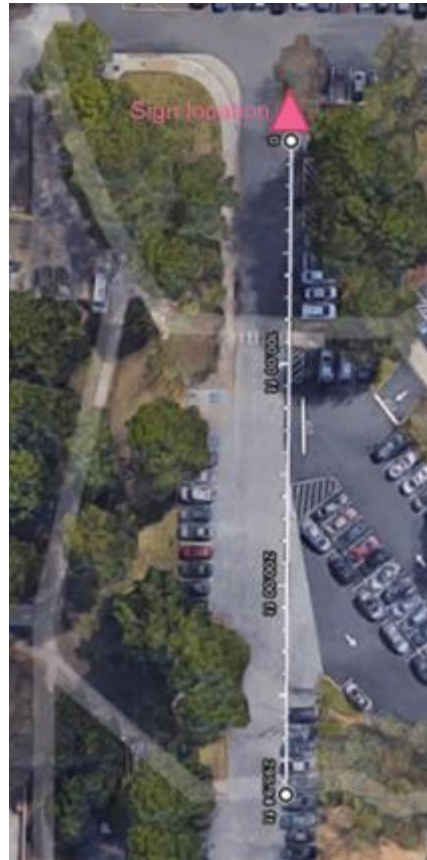
Figure 4-7. Photo. The experimental setup created in Georgia Tech campus parking lot for GDOT inspector to assess the collected signs.

approximately 300 feet to replicate the real-world, night-time sign inspection method. The aerial view of the experiment set-up is shown in **Figure 4-7**. A tripod was set up at approximately 300 feet to hold the signs for the inspector to assess. After each assessment, the signs were replaced. The inspector assessed the signs and assigned “acceptable” or “unacceptable”. Signs that that did not sufficiently reflect the headlight illumination or were dirty were put into the “unacceptable” category. Others were labeled as “acceptable” even when they were broken or had graffiti but still had high retro reflectivity.

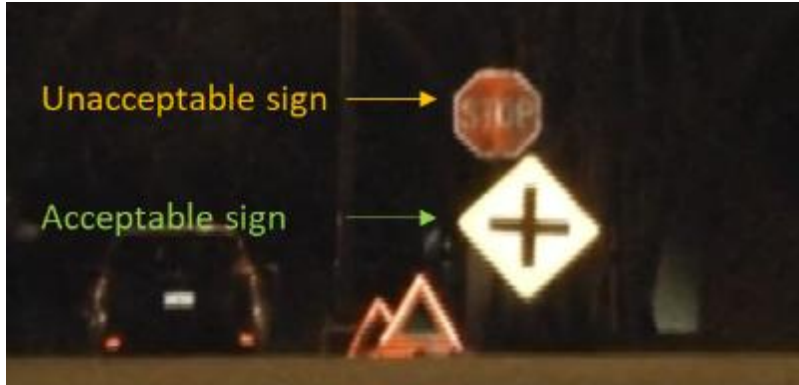
Figure 4-8. Photo. An example of poor (unacceptable) and good (acceptable) sign.

Figure 4-8 shows an example of a traffic sign (STOP) at the Georgia Tech campus and a test sign placed underneath it; these were assessed as unacceptable or acceptable by the GDOT inspector.

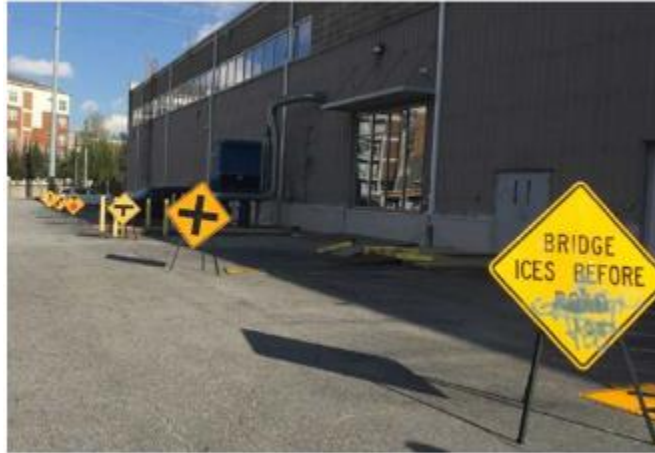
Figure 4-9. Photo. Experimental setup for sign LIDAR data collection at Georgia Tech campus.

placed on tripods to hold them upright. The experimental set-up for the LIDAR data collection at the Georgia Tech campus for the yellow prismatic signs is shown in **Figure 4-9**. The signs were spaced approximately 10 meters apart and were placed at a 90-degree angle to travel direction to mimic the on-road condition. Four to 6 signs were set up in each round. The LIDAR data was collected from approximately, 10 m to the signs.

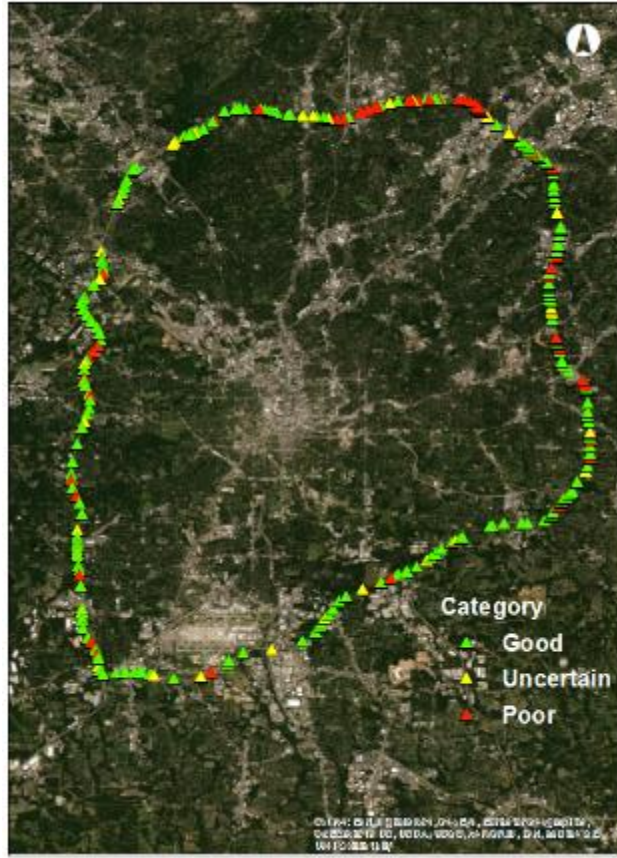
Figure 4-11. Map. Signs in good, uncertain, and poor retro-reflectivity condition on GA Interstate-285.

This section presents a case study to demonstrate the use of the proposed method using the traffic signs on the Interstate-285. The LIDAR data was acquired using right side LIDAR of the GTSV on August 8, 2018; therefore, 3D data was collected only from signs on the right side of the road. After data processing and screening, 338 signs were extracted and used for this case study. The proposed sign retroreflectivity condition assessment method was used to classify the 338 signs. Since the color for each sign was unknown, a lower MR value (0.75) was used in the proposed method for this demonstration. Sixty-seven signs were classified as “poor,” 47 signs were classified as “uncertain” and the remaining 224 signs were classified as “good.” **Figure 4-11** shows the map of the signs with different retro-reflectivity condition.

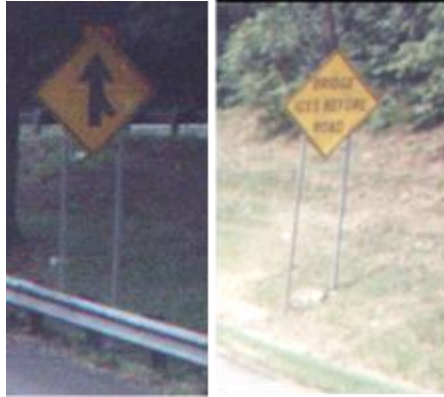
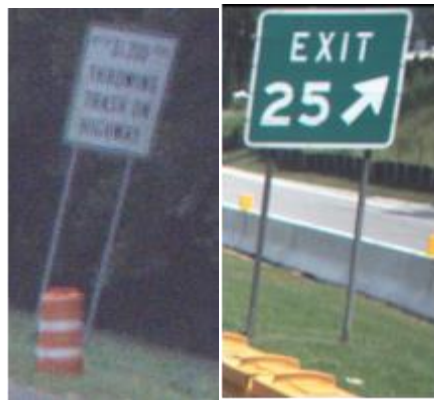
Figure 4-12 shows an example of some of the signs that were classified as poor. The typical concerns observed with the poor signs are that they are old, faded, or dirty (as seen in **Figure 4-12** (a), **Figure 4-12** (b), and **Figure 4-12** (c)). **Figure 4-12** (d) shows a sign that is clean and not faded; however, the sheeting type used does not appear to be prismatic sheeting type. This explains the poor classification of the sign, since the retro-reflectivity of this sheeting type falls under the “poor” category criteria set by the proposed method.

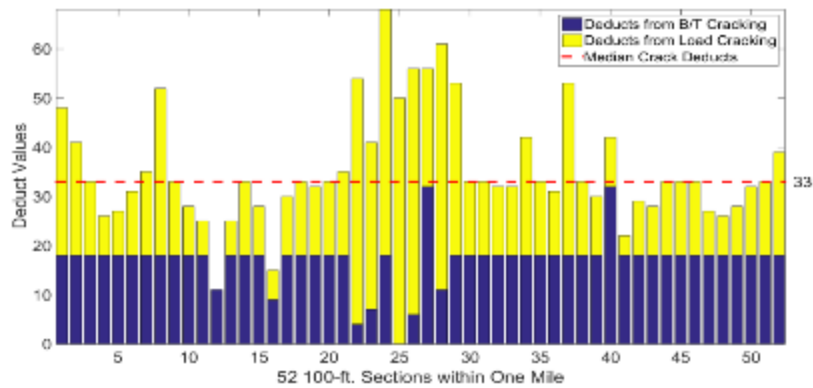
Figure 5-3. Chart. Fifty-two 100-foot sections reported within a 1-mile segment.

illustrates the fifty-two 100-foot sections reported within a 1-mile segment. In order to mimic the selection criteria performed by GDOT for a representative section, the deduct value for each individual section is computed, whereas a 60th percentile of the deduct distribution is used for selecting the “representative” section to represent the 1-mile segment. Therefore, the severity level and extent values for the selected “representative” section are used to represent the entire 1-mile segment. The percentile is calibrated by comparing the results from the automatic crack extraction, and the results are manually reviewed by field engineers from GDOT. It is observed that the 60th percentile can best capture the field engineers’ judgment in selecting the “representative” section. It should be noted that although a 60th percentile is used to generate the COPACES ratings in this study, the derived results using the automatic distress extraction have the capability to generate a full-coverage, continuous crack severity level and extent values without the need to aggregate them into a “representative” 100-foot section artificially.

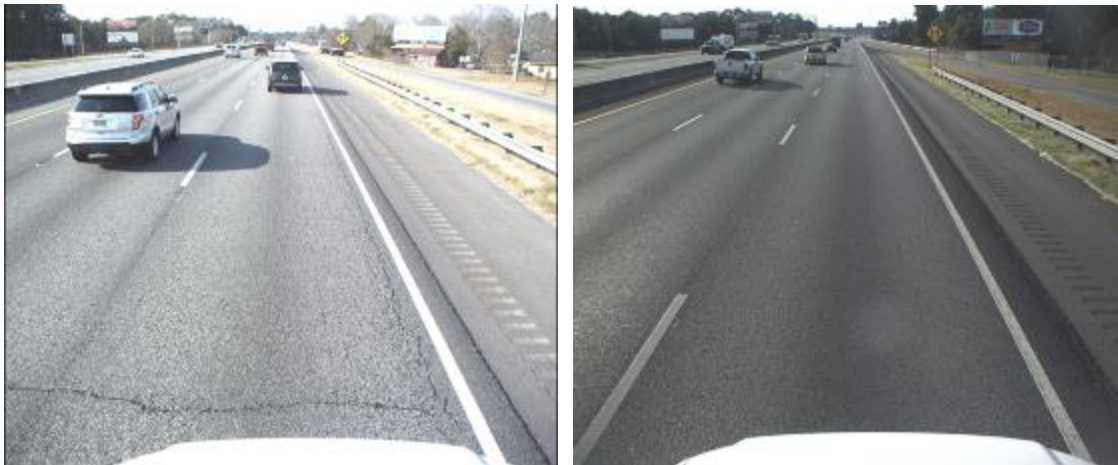
Figure 5-8. Photos. Comparison of spot 1 northbound resurfacing between 2015 and 2018.

Three spots where a noted increase of rating between 2015 and 2018 were highlighted in **Figure 5-7 (B)** for further analysis. **Figure 5-8** shows the comparison of images collected using GTSV for ‘Spot 1’ located on I-75 south-bound where complete resurfacing has been performed over the project length and road width. **Figure 5-9** shows the 2018 images of ‘Spot 2’ located on I-95 NB and SB where partial resurfacing has been performed for selected segments. **Figure 5-10** shows an image comparison of ‘Spot 3’ located on I-75 NB near Macon where partial resurfacing has been conducted on the truck lane only.

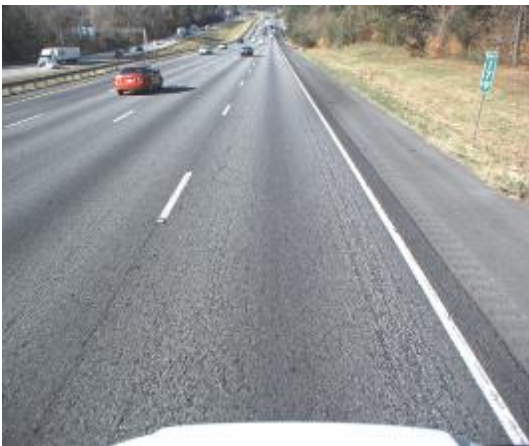
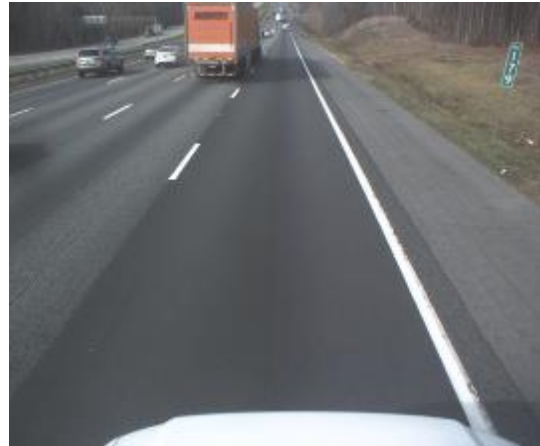
Figure 5-10. Photos. Comparison of spot 3 northbound truck lane resurfacing between 2015 and 2018.

A. Subfigure of 2015

B. Subfigure of 2018

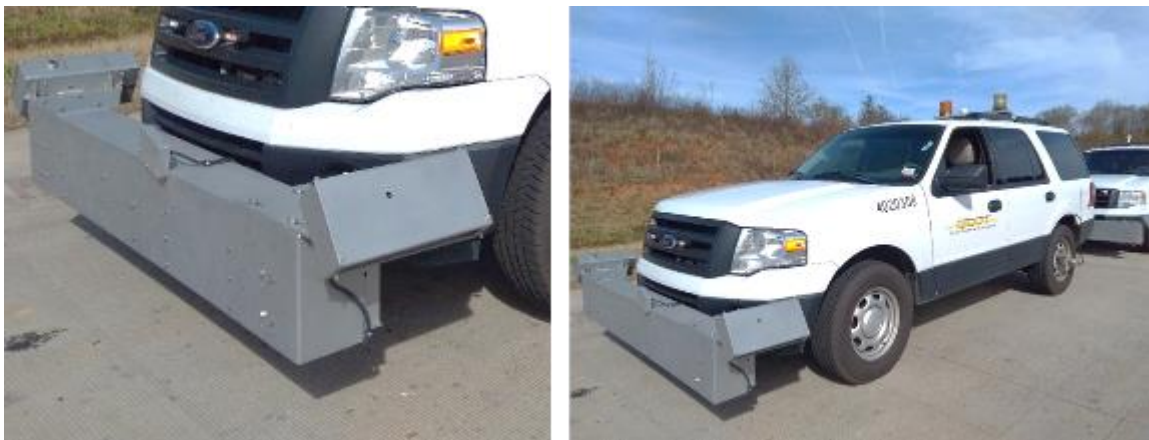
Figure 7-1. Photo. GDOT Profiler.

Validation of the method for IRI measurement was completed by comparison with IRI values obtained using AASHTO R56 (AASHTO, 2014) and certified GDOT Profilers (**Figure 7-1**) on the GDOT test sections. The GDOT Profilers comprised a system of 7 laser scanners affixed to the front bumper of a vehicle, which captured a thin longitudinal profile of the pavement surface used to estimate the IRI.

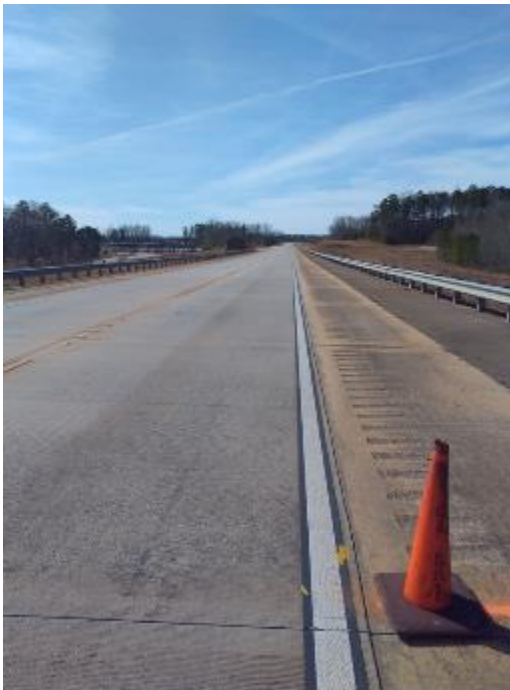
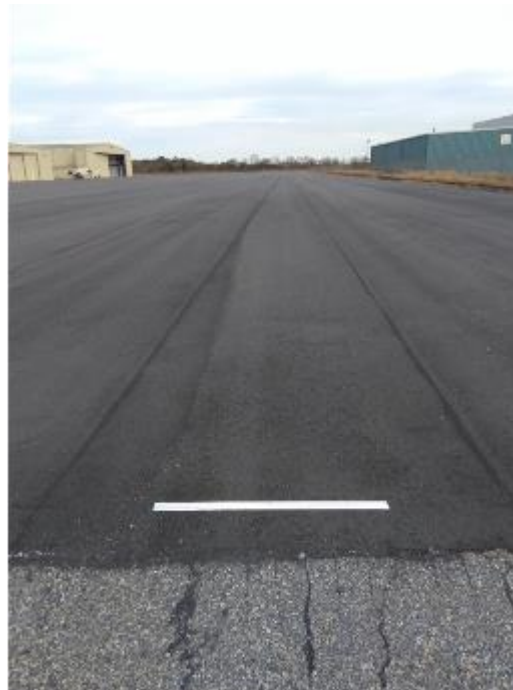
Figure 7-2. Photos. Test sections for IRI validation.

On February 14, 2019, pavement condition data was collected using both the GDOT profiler and the GTSV on two test sections (one asphalt and one concrete). The asphalt test section was located inside Middle Georgia Regional Airport near Macon, Georgia, (**Figure 7-2 (b)**) and the concrete test section was located on U.S. Route 41 near Barnesville, Georgia (**Figure 7-2(a)**). The test sections were 0.1 mile (528 feet) long, with 500-foot buffers on each side. The test sections were marked with reflective tape, as

shown in figure **Figure 7-2** (b), which would be easily visible in both the GDOT profiler's longitudinal profiles as well as the range images from the GTSV's laser scanner. The end points of the buffers were marked with traffic cones (**Figure 7-2** (a)). Each test section was covered in multiple runs by both the GDOT Profiler and the GTSV.

A. Subfigure of concrete test section

B. Subfigure of asphalt test section

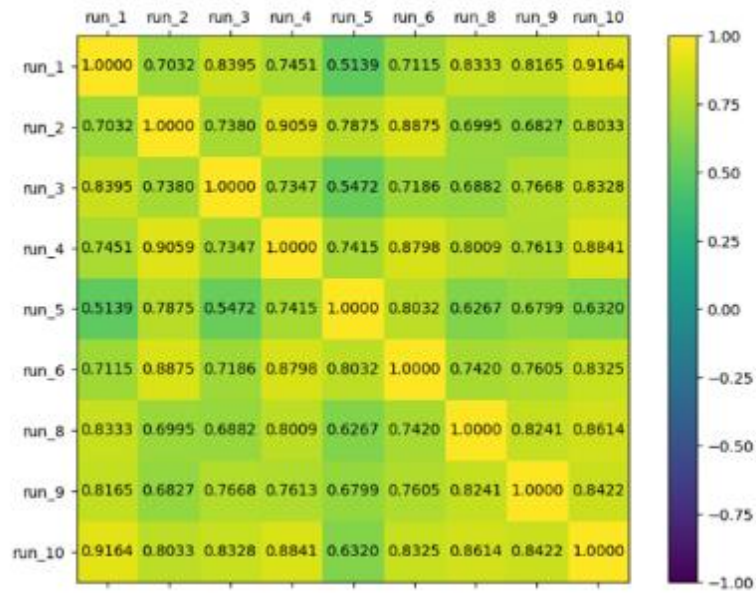
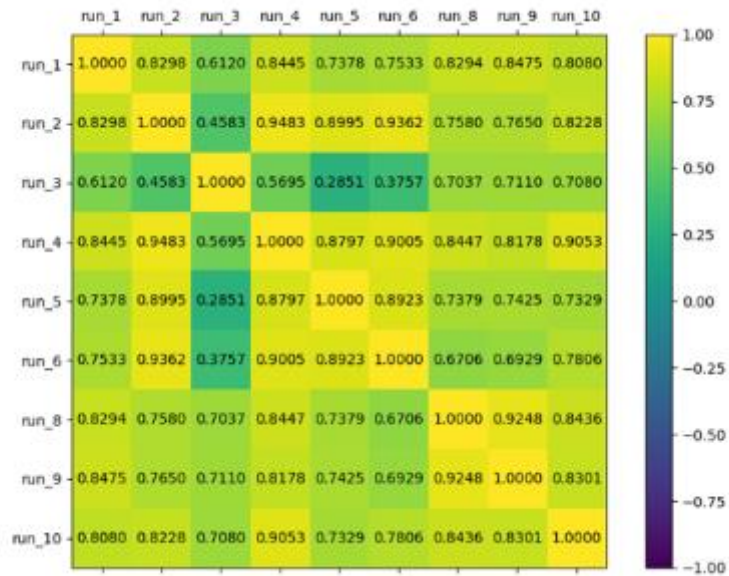
Figure 7-4. Graphs. Correlation between IRI estimated from different GTSV runs.

A. Subfigure of left wheel path

B. Subfigure of right wheel path

given in **Figure 7-3**. Run 7 was omitted as the vehicle path was askew during that run. Qualitatively, the repeatability of the estimated IRI can be observed especially in the features at Segments 13-23 in the left wheel path and Segments 13-22 in the right wheel path. Quantitatively, the Pearson correlation between each series of IRI values derived from each run was calculated. As shown in **Figure 7-4**, there is generally a high correlation between any two runs, with an average correlation of 0.7912 for the left wheel path and 0.7876 for the right wheel path.
