GENERALIZED PROCESSING OF FBG/FRP STRAIN DATA FOR STRUCTURAL HEALTH MONITORING

UNIVERSITY OF HAWAII COLLEGE OF ENGINEERING

Research Report UHM/CEE/12-01 May 2012

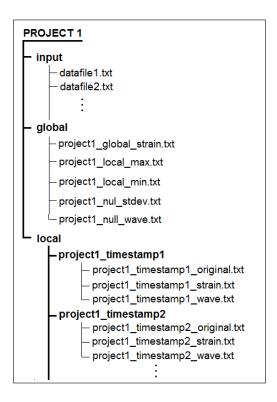
Figure 4.1. File tree which results from the data management and post-processing procedures.

Once the data management and post-processing is established, the database's file tree should look similar to Figure 4.1.

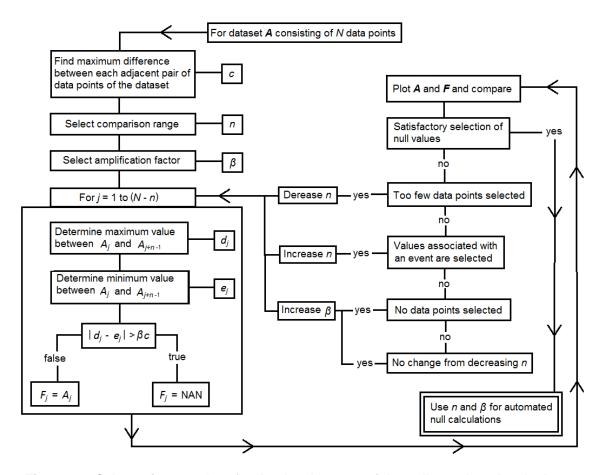
Figure 4.2. Schematic procedure for the development of the null wavelength calculator.

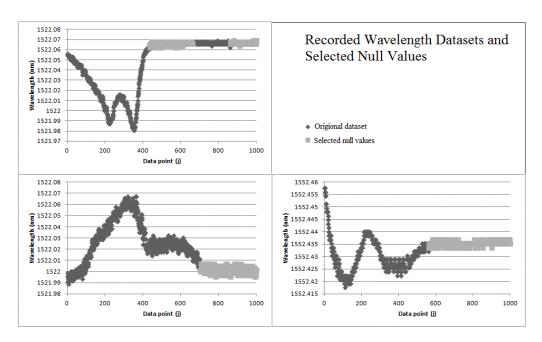
Figure 4.3. Three graphical examples of the selected data points (light gray) from the original datasets (dark gray) for calculating the null wavelengths.

Finally, plot the modified dataset **F** over the original dataset **A** to examine the values that have been selected to determine the null. If too few data points have been selected, reduce n and repeat. If some of the values associated with an event are selected, increase n and repeat. If no data points are selected, or decreasing n does not significantly change the number of selected data points, increase the noise amplification factor β . Figure 4.2 shows the schematic procedure for the development of the automated null wavelength calculator. Eventually (4.4) will be able to select data values that are not associated with an event. Figure 4.3 shows three example plots showing the selected values (light gray) of the dataset (dark gray) for the successful implementation of the automated null wavelength selection.

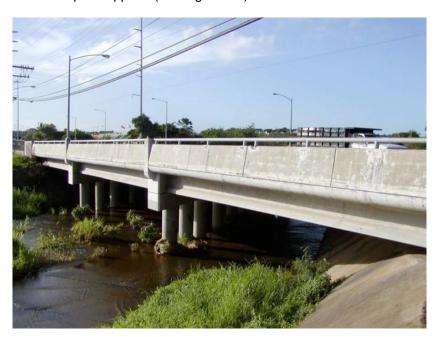
Figure 5.1. Downstream elevation of the Salt Lake Boulevard Bridge.

The Salt Lake Boulevard Bridge (SLBB) is a three-span, continuous, prestressed concrete girder bridge, spanning a total length of 150 ft. Originally built in 1968, and then widened in 1988, the SLBB is now 100 ft in width and supports six lanes of traffic and a median. The primary structural system consists of AASHTO Type-II beams and two sets of pier capped concrete piles for mid-span supports (see Figure 5.1).

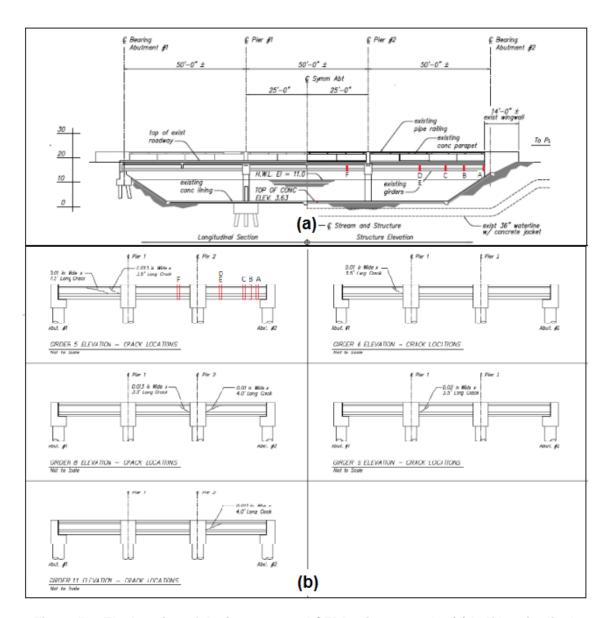
Figure 5.2. The location of the instrumented CFRP stirrups on the (a) half longitudinal section and elevation drawing, as well as in the (b) girder crack location drawings. Note that the cracks shown in (b) were prior to construction and additional cracks were observed.

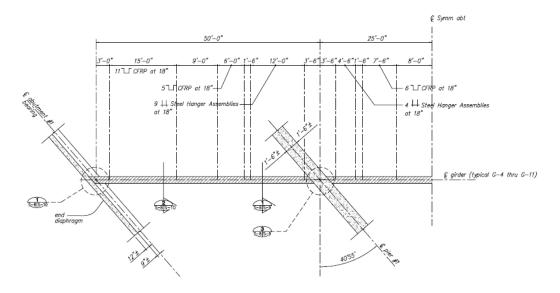
Figure 5.3. Schematic of the CFRP and SHR distribution on a typical girder.

The rehabilitation of the deficient girders consisted of traditional steel rod hangers (SRHs) and wet-layup Carbon Fiber Reinforced Polymer (CFRP). The layout of the two schemes started with the application of the first 11 CFRPs, beginning 3 ft in from the centerline of the abutment and girder and extending 15 ft. After the first set of CFRPs, no strengthening was applied for a 9 ft gap across the mid span. Then an additional 6 ft of CFRPs were applied. The first set of SRHs started 1.5 ft from the second set of CFRPs and consisted of 9 SRHs which ended 3.5 ft from the centerline of the first pier. On the adjacent side of the pier, 4 SRHs were placed over a span of 4.5 ft which started 3.5 ft from the pier's centerline, followed with a 1.5 ft gap and then an additional 6 CFRPs. Finally, an 8 ft gap of no strengthening brought the layout to the centerline of the bridge, and the scheme was symmetrically repeated. Each set of both the CFRPs and SHRs were placed 18 inches apart on center. Figure 5.3 shows the schematic for the CFRP and SHR distribution over a typical girder.

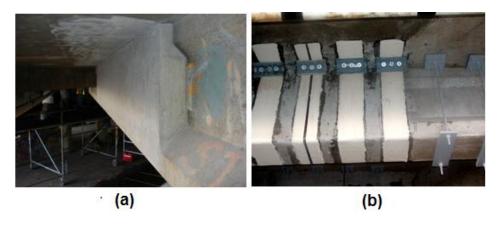
Figure 5.4. (a) Concrete infill of the AASHTO Type-II girders for the CFRP application, and (b) the completed CFRP stirrups.

Before the application of CFRP laminates, the webs of the girders where the CFRP's were to be applied were filled with concrete to create a smooth rectangular surface (see Figure 5.4a). The CFRPs were 12 inches in width and had a minimum design ultimate tensile strain of 0.0126. After the concrete infill cured, the CFRPs were applied, painted, and anchored with steel angles and three epoxy set anchor bolts. The final installation can be seen in Figure 5.4b. The construction finished in late 2008.

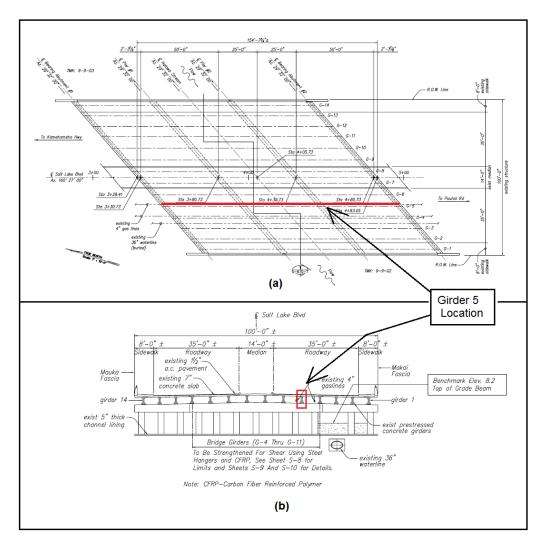
Figure 5.5. The location of the girder instrumented with FBG sensors in (a) the plan view and (b) the cross section of the construction drawings.

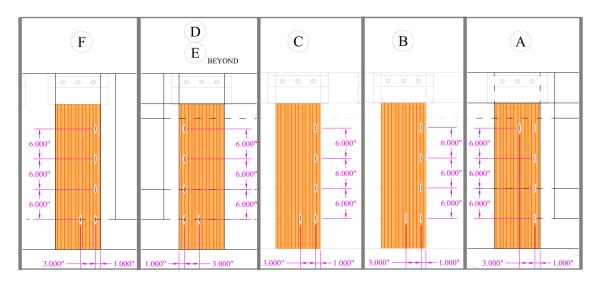
Figure 5.6. The FBG sensor layouts for each of the stirrups instrumented.

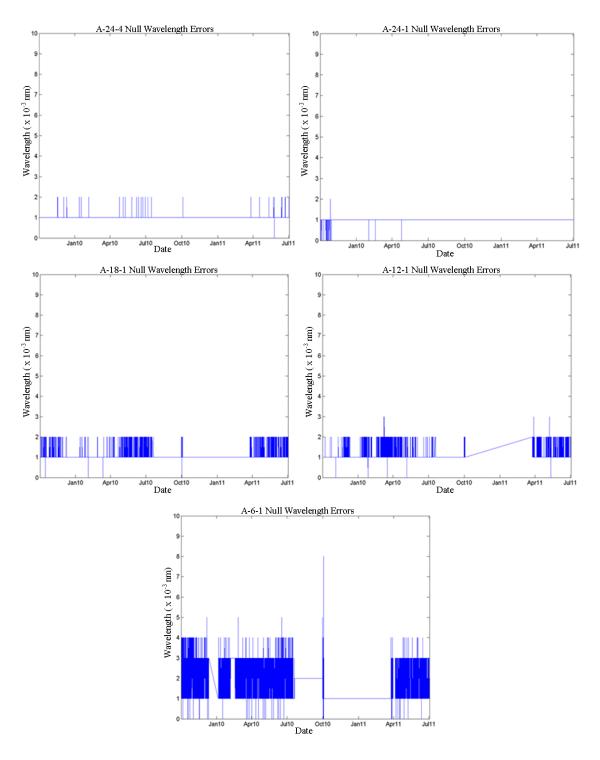
Figure 5.7. Null wavelength errors versus the dates they were recorded for sensors on stirrup A.

Through the correction of the datasets with no null wavelength calculated from the initial post-processing and the assessment of abnormally high null wavelength values, the anomalies were corrected. Comparing the null wavelength errors against the precision of the sensors demonstrated that the null wavelength errors lie within a justifiable range. Checking for a decrease in maxima values demonstrated that the FBG sensors have not debonded. Therefore, it can be concluded that the FBG system on stirrup A was in good working order over the range of recorded data.

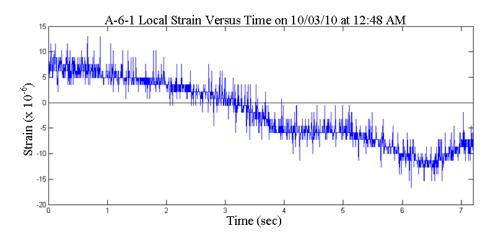
Figure 5.8. Local strain versus time for sensor A-6-1 for the file associated with the 0.008 nm null wavelength error.

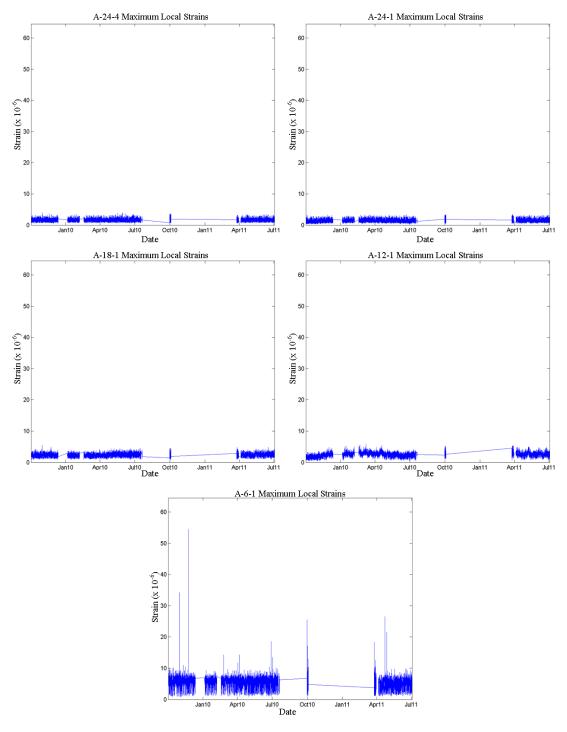
Figure 5.9. Maximum local strains versus the dates they were recorded for sensors at stirrup A.

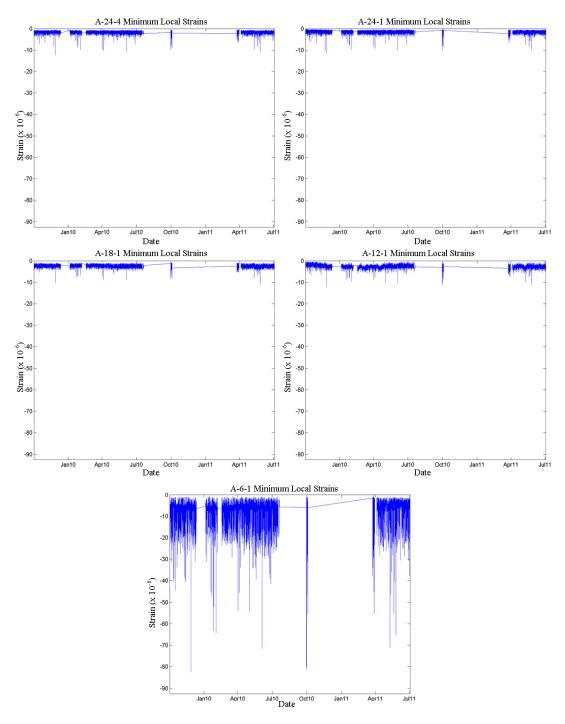
Figure 5.10. Minimum local strains versus the dates they were recorded for sensors at stirrup A.

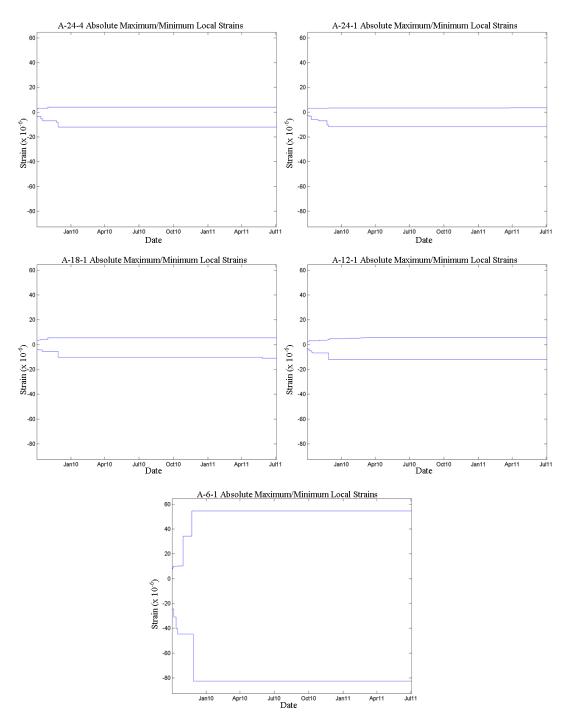
Figure 5.11. Absolute local maxima envelope versus recording date for sensors on stirrup A.

With the design-specified required minimum ultimate tensile strain of 0.0126, the first threshold value, T1, became 6,300 microstrain. Table 5.5 lists the maximum global strain ε_{GM} , the maximum local strain ε_{LM} , the absolute strain, ε_{abs} , obtained using method 1 (see 4.2.4.4.1), as well as the normalized percentage of the absolute strain against T1 for each sensor on stirrup A. From Table 5.5 it can be seen that the maximum absolute strain for all of the sensors on stirrup A only reaches 1.38% of T1. Therefore, the induced tensile strains on stirrup A are nowhere near the onset of tension rupture.

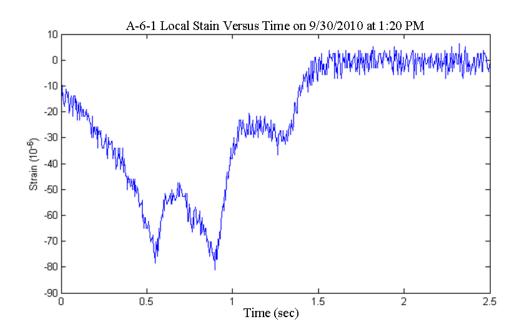
Figure 5.12. Plot of local strain versus time for sensor A-6-1 strain data recorded on September 30th, 2010 at 1:20 PM.

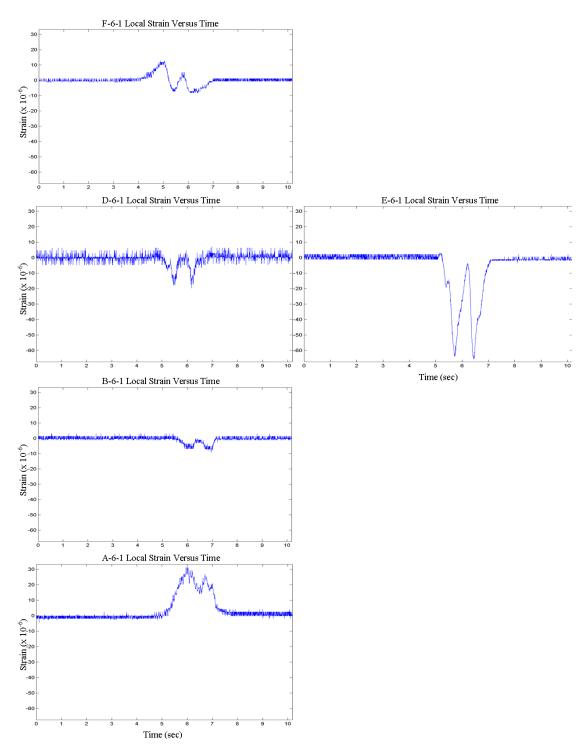
Figure 5.14. Local strain responses for the 6-1 sensors due to the semi loading in the left lane.

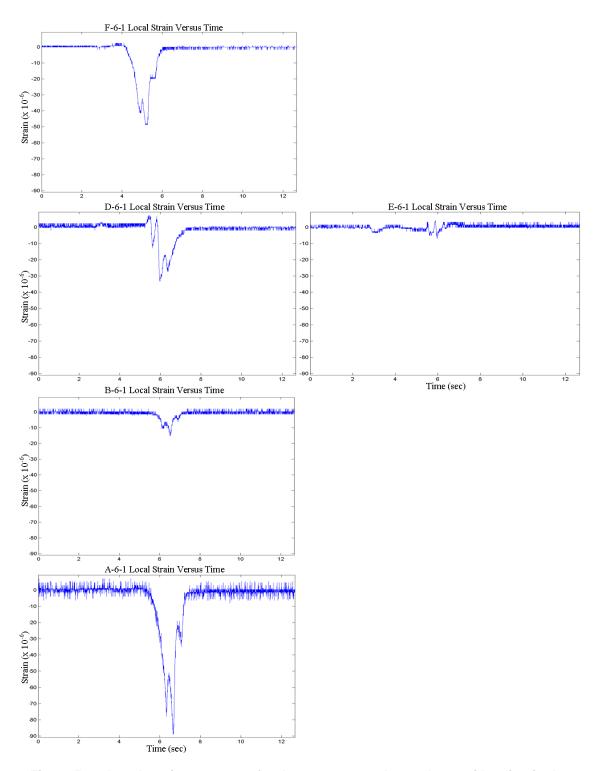
Figure 5.17. Local strain responses for the 6-1 sensors due to the semi loading in the middle lane.

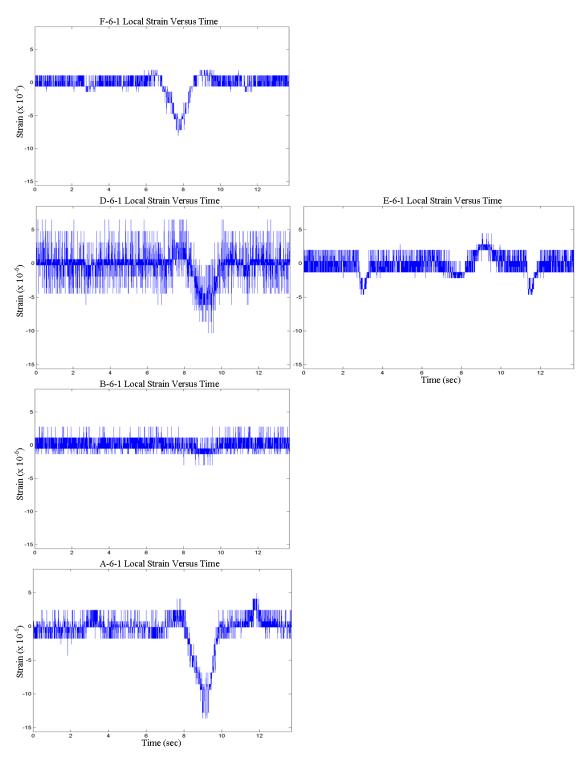
Figure 5.20. Local strain responses for the 6-1 sensors due to the bus loading in the right lane.

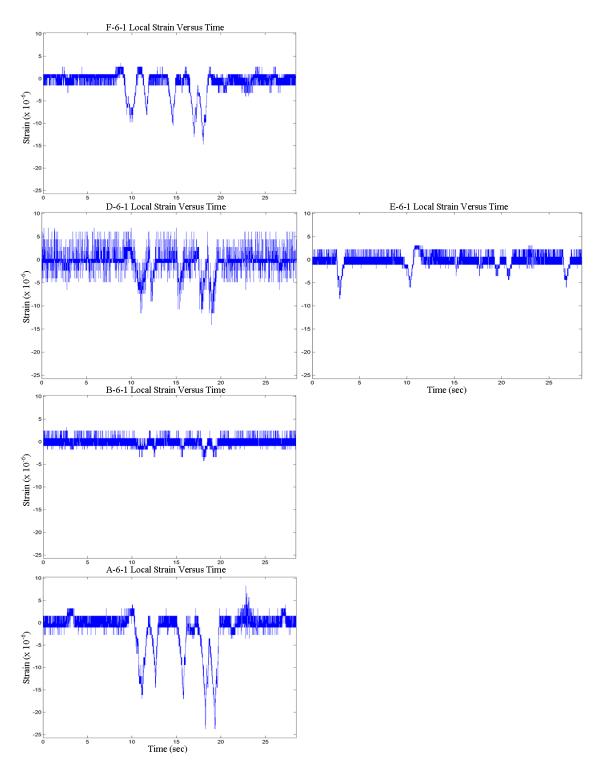
Figure 5.21. Local strain responses for the 6-1 sensors due to multiple loading.

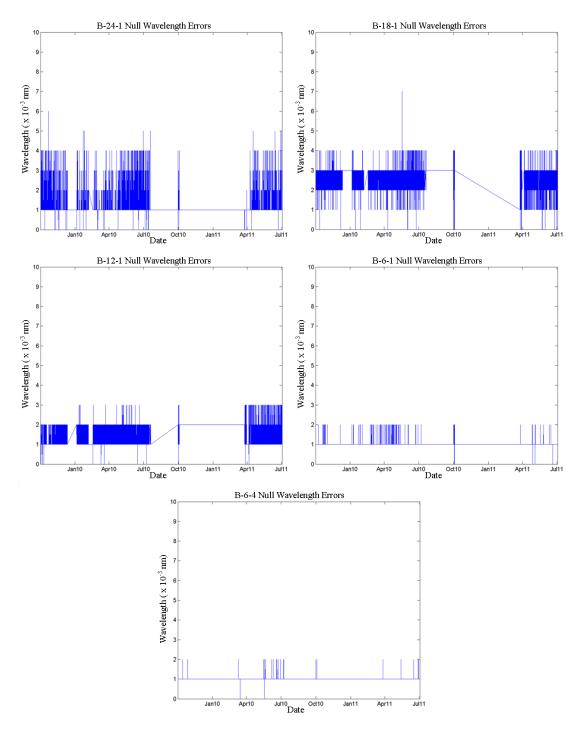
Figure B. 1. Null wavelength error versus the dates they were recorded for sensors on stirrup B.

It can also be seen from Figure B.1 that the null wavelength errors for sensors B-6-1 and B-6-4 never exceeded the recording precision of the sensors (0.002 nm). Sensor B-12-1's errors only exceeded the sensors precision by 0.001 nm. For sensors B-18-1 and B-24-1 the upper bound of the null wavelength error was typically 0.004 nm.

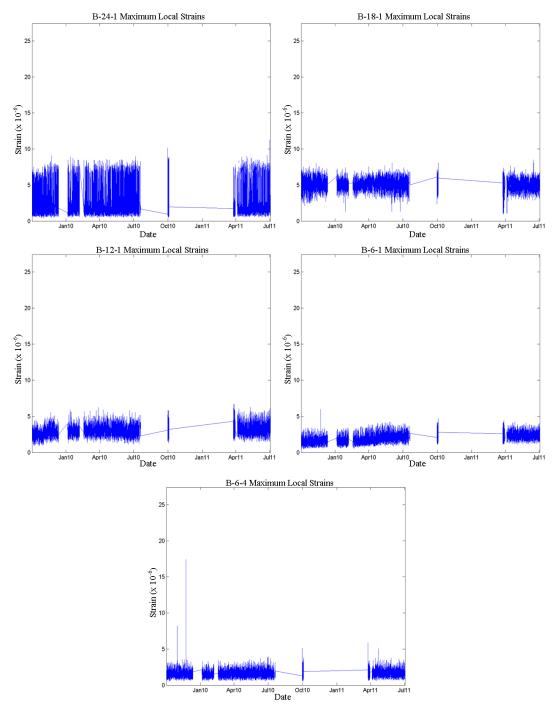
Figure B. 2. Maximum local strains versus the dates they were recorded for sensors at stirrup B.

Figure B.2 and Figure B.3 show the plots of the local maximum and minimum strains plotted against the date they were recorded for the sensors on stirrup B. Through examining these plots it can be seen that the maxima remained relatively constant for all of the sensors. Therefore, FBG debonding has not occurred for any of the sensors on stirrup B.

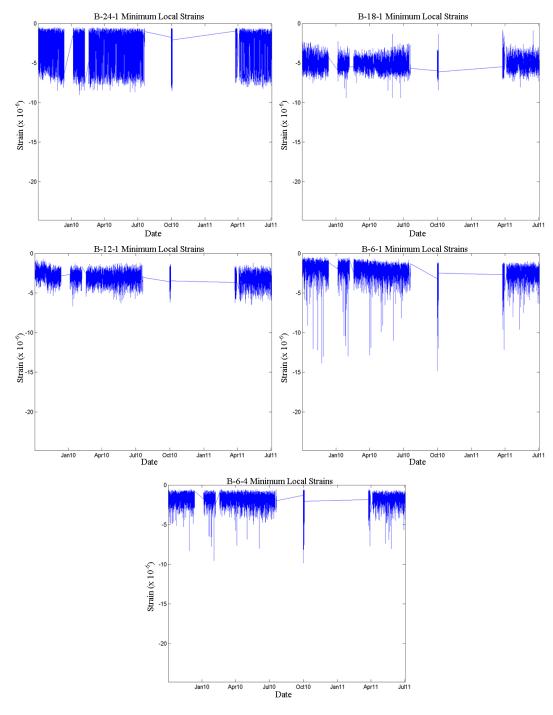
Figure B. 3. Minimum local strains versus the dates they were recorded for sensors at stirrup B.

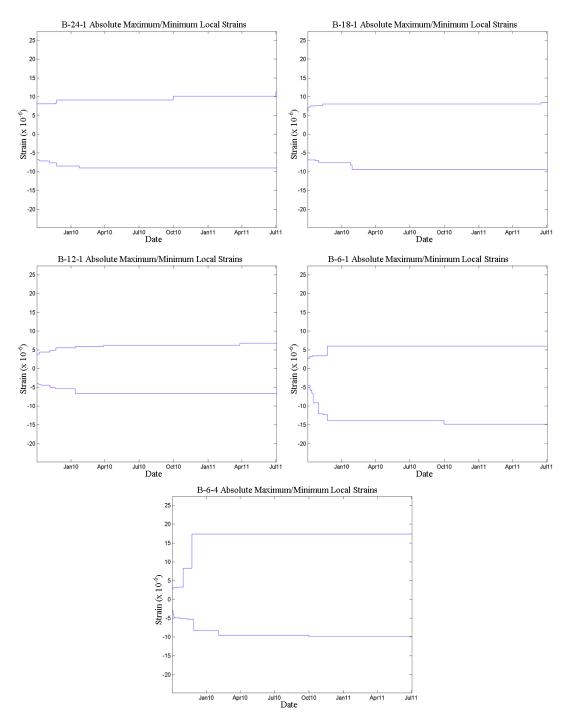
Figure B. 4. Absolute local maxima envelope versus recording date for sensors on stirrup B.

With the design-specified required minimum ultimate tensile strain of 0.0126, the first threshold value, T1, became 6,300 microstrain. Table B.2 lists the maximum global strain ε_{GM} , the maximum local strain ε_{LM} , the absolute strain, ε_{abs} , obtained using method 1 (see 4.2.4.4.1), as well as the normalized percentage of the absolute strain against T1 for each sensor on stirrup B. From Table B.2 it can be seen that the maximum absolute strain for all of the sensors on stirrup B only reaches 1.11% of T1. Therefore, the induced tensile strains on stirrup B were nowhere near the onset of tension rupture.

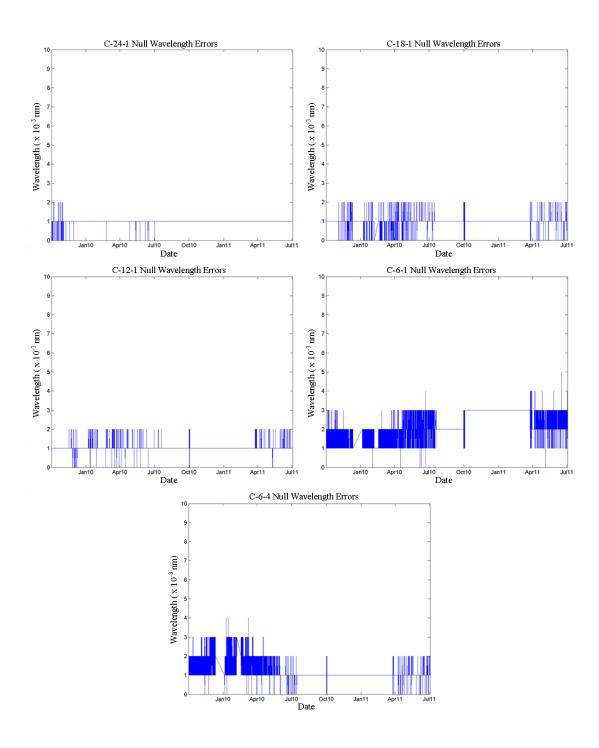
Figure C. 1. Null wavelength error versus the dates they were recorded for sensors on stirrup C.

Through the correction of the datasets with no null wavelength calculated from the initial post-processing and the assessment of abnormally high null wavelength values, the anomalies were corrected. Comparing the null wavelength errors against the precision of the sensors demonstrated that the null wavelength errors lie within a justifiable range. Checking for a decrease in maxima values demonstrated that the FBG sensors have not debonded. Therefore, it can be concluded that the FBG system on stirrup C was in good working order over the range of recorded data.

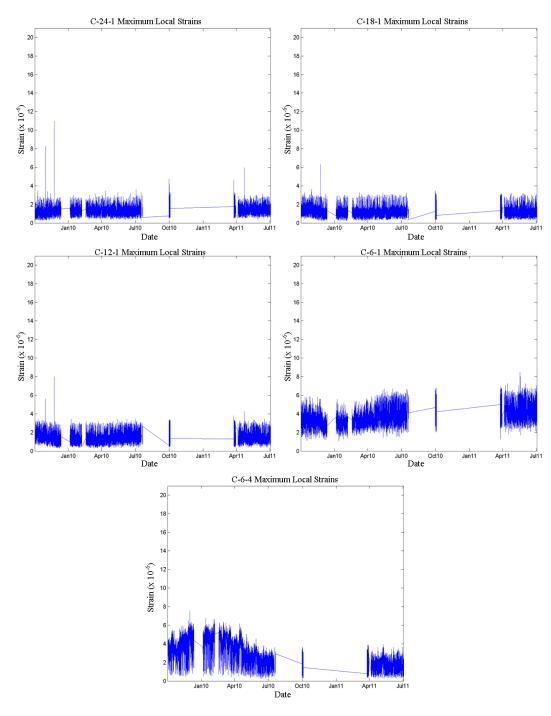
Figure C. 2. Maximum local strains versus the dates they were recorded for sensors at stirrup C.

Figure C.2 and Figure C.3 show the plots of the local maximum and minimum strains plotted against the date they were recorded for the sensors on stirrup C. Through examining these plots it can be seen that maxima remained relatively constant or increased over time for all of the sensors. Therefore, FBG debonding has not occurred for any of the sensors on stirrup C.

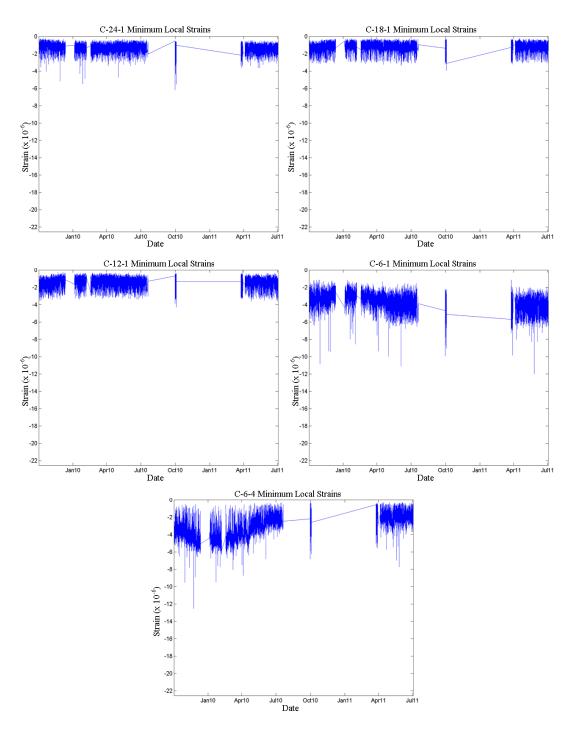
Figure C. 3. Minimum local strains versus the dates they were recorded for sensors at stirrup C.

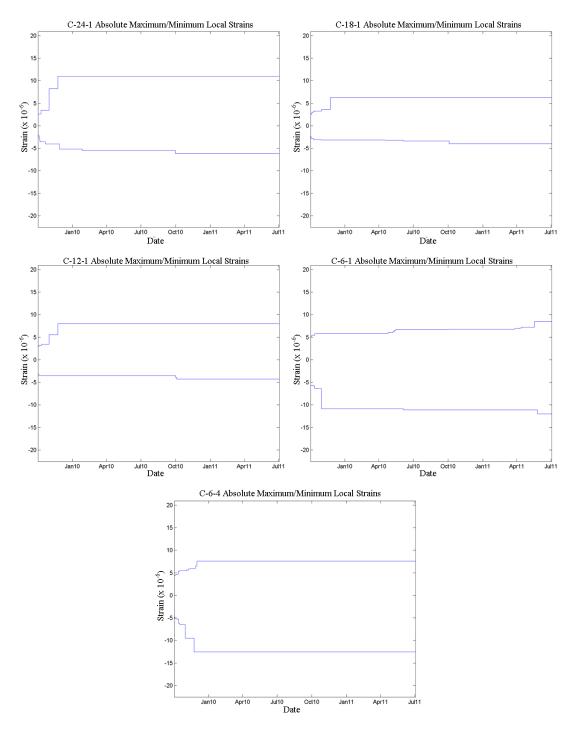
Figure C. 4. Absolute local maxima envelope versus recording date for sensors on stirrup C.

With the design-specified required minimum ultimate tensile strain of 0.0126, the first threshold value, T1, became 6,300 microstrain. Table C.2 lists the maximum global strain ε_{GM} , the maximum local strain ε_{LM} , the absolute strain, ε_{abs} , obtained using method 1 (see 4.2.4.4.1), as well as the normalized percentage of the absolute strain against T1 for each sensor on stirrup C. From Table C.2 it can be seen that the maximum absolute strain for all of the sensors on stirrup C only reaches 2.10% of T1. Therefore, the induced tensile strains on stirrup C were nowhere near the onset of tension rupture.

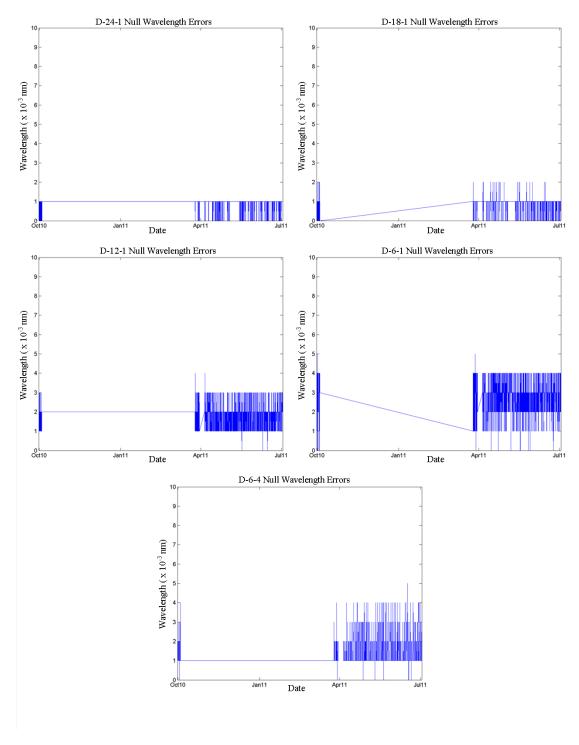
Figure D. 1. Null wavelength error versus the dates they were recorded for sensors on stirrup D.

Through the correction of the datasets with no null wavelength calculated from the initial post-processing and the assessment of abnormally high null wavelength values, the anomalies were corrected. Comparing the null wavelength errors against the precision of the sensors demonstrated that the null wavelength errors lie within a justifiable range. Checking for a decrease in maxima values demonstrated that the FBG sensors have not debonded. Therefore, it can be concluded that the FBG system on stirrup D was in good working order over the range of recorded data.

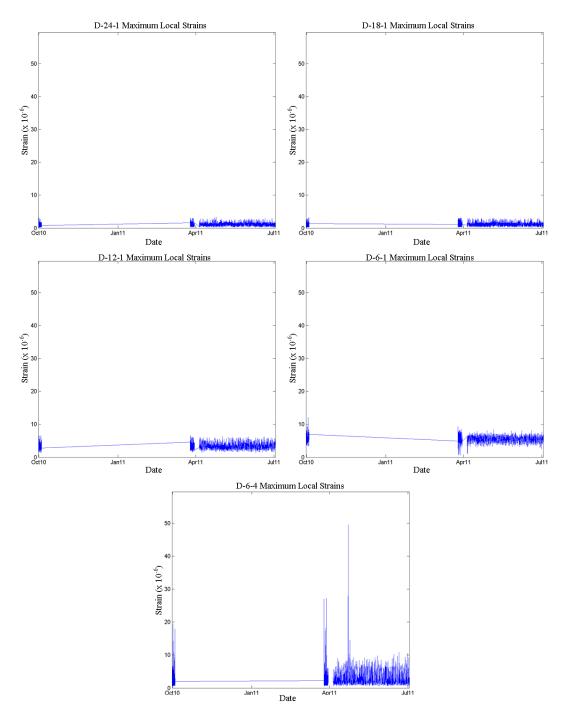
Figure D. 2. Maximum local strains versus the dates they were recorded for sensors at stirrup D.

Figure D.2 and Figure D.3 show the plots of the local maximum and minimum strains plotted against the date they were recorded for the sensors on stirrup D respectively. Through examining these plots it can be seen that maxima remained relatively constant or increased over time for all of the sensors. Therefore, FBG debonding has not occurred for any of the sensors on stirrup D.

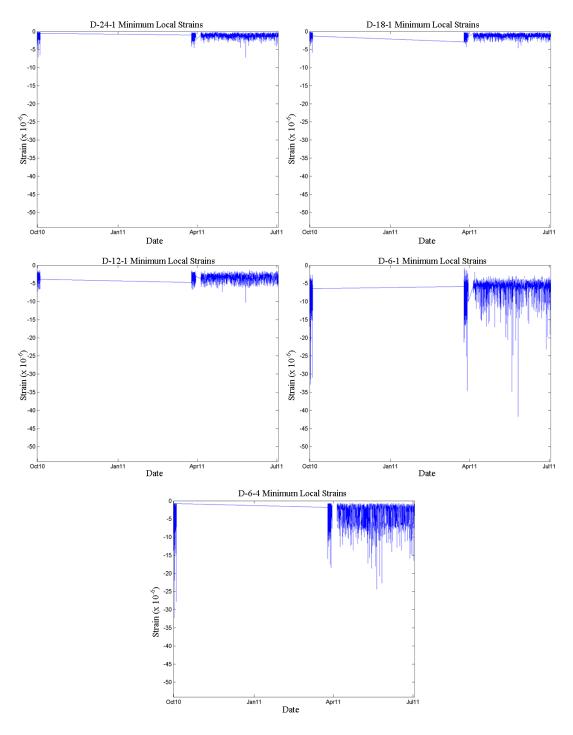
Figure D. 3. Minimum local strains versus the dates they were recorded for sensors at stirrup D.

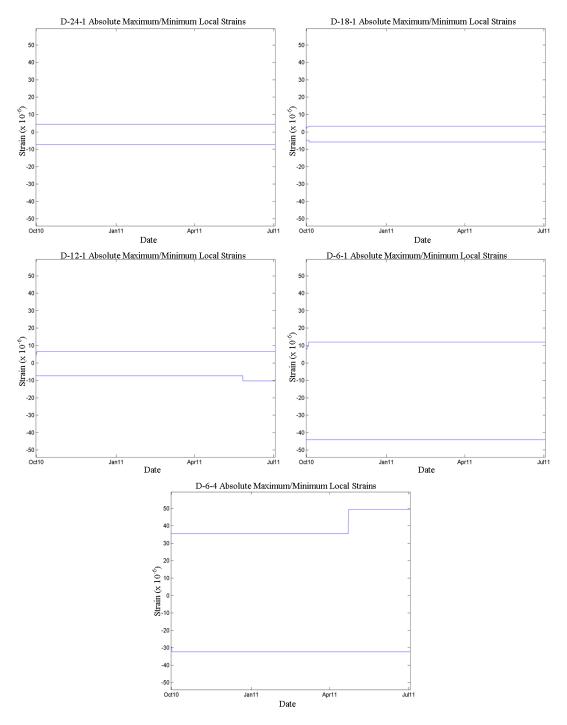
Figure D. 4. Absolute local maxima envelope versus recording date for sensors on stirrup D.

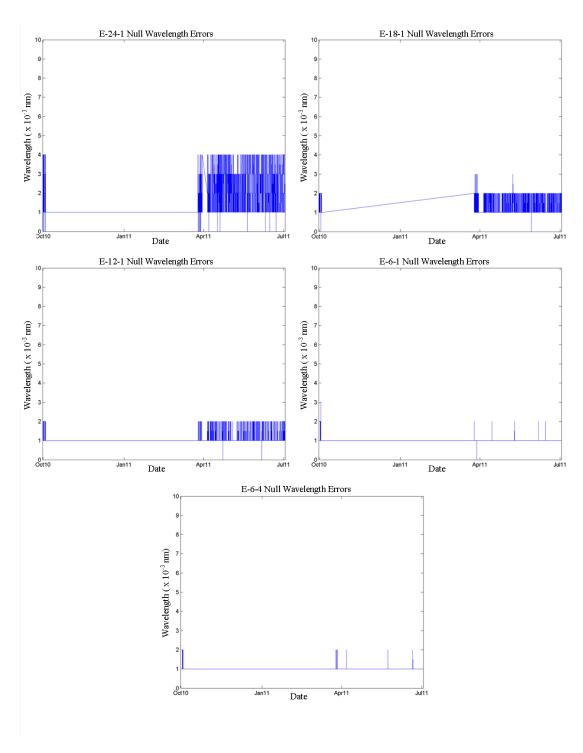
Figure E. 1. Null wavelength error versus the dates they were recorded for sensors on stirrup E.

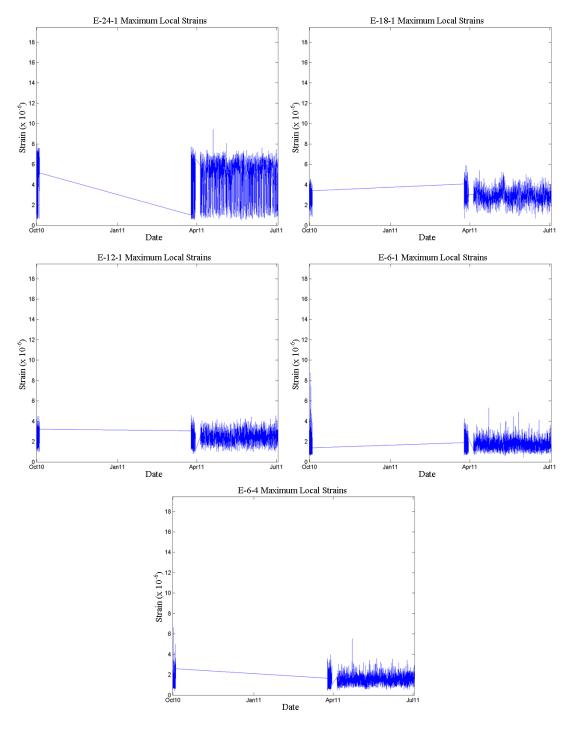
Figure E. 2. Maximum local strains versus the dates they were recorded for sensors at stirrup E.

Figure E.2 and Figure E.3 show the plots of the local maximum and minimum strains plotted against the date they were recorded for the sensors on stirrup E. Through examining these plots it can be seen that maxima remained relatively constant or increased over time for all of the sensors. Therefore, FBG debonding has not occurred for any of the sensors on stirrup E.

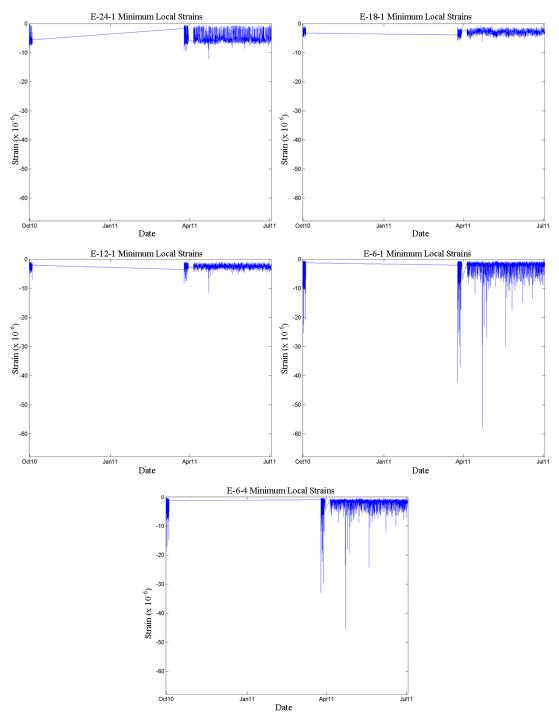
Figure E. 3. Minimum local strains versus the dates they were recorded for sensors at stirrup E.

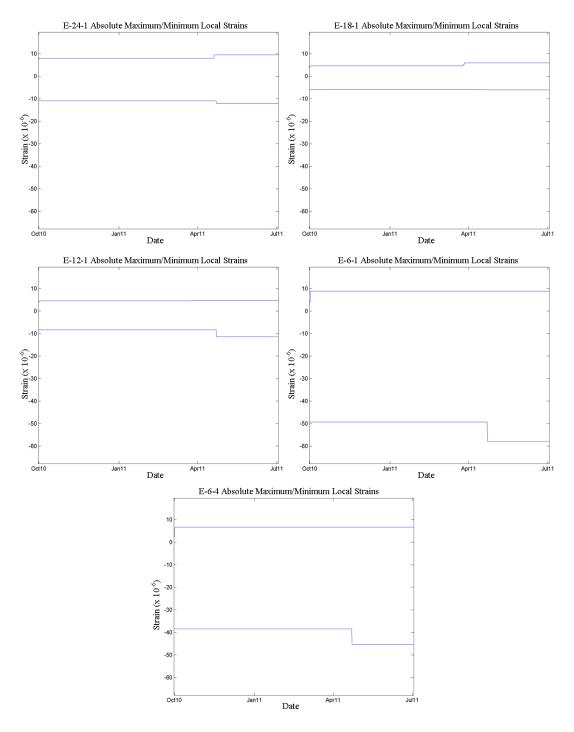
Figure E. 4. Absolute local maxima envelope versus recording date for sensors on stirrup E.

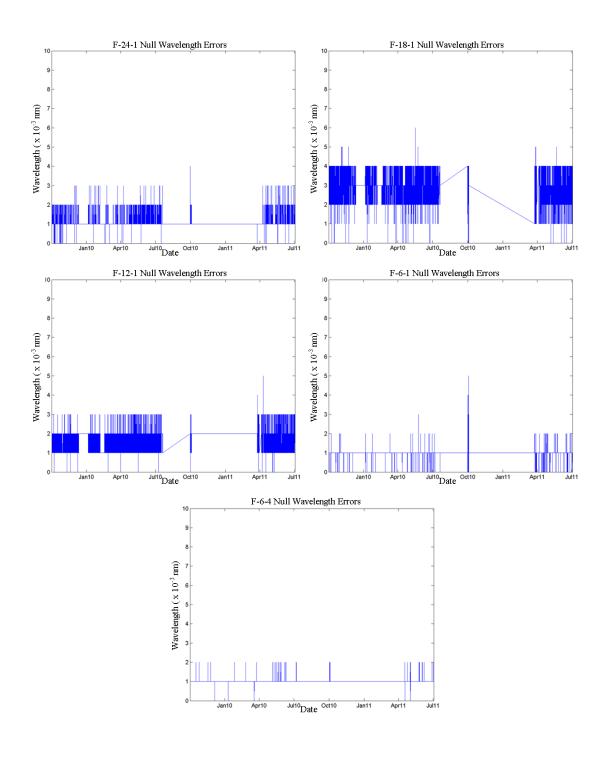
Figure F. 1. Null wavelength error versus the dates they were recorded for sensors on stirrup F.

It can also be seen from Figure F.1 that the null wavelength errors for sensor F-6-4 never exceeded the recording precision of the sensors (0.002 nm). Sensor F-6-1's errors only exceed the sensors precision on a few occasions. For sensors F-24-1 and F-12-1, the upper bound of the null wavelength error was typically 0.003 nm. The typical upper bound for sensor F-18-1 was 0.004 nm, although it did rise to 0.005 nm occasionally as well as once to 0.006 nm.

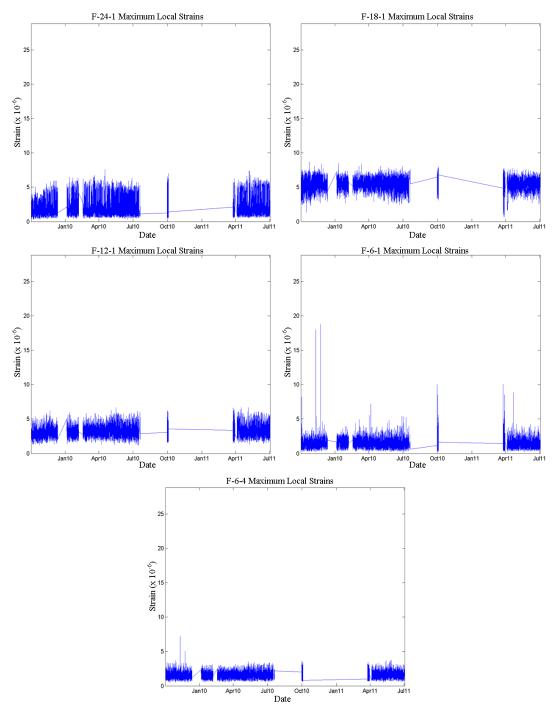
Figure F. 2. Maximum local strains versus the dates they were recorded for sensors at stirrup F.

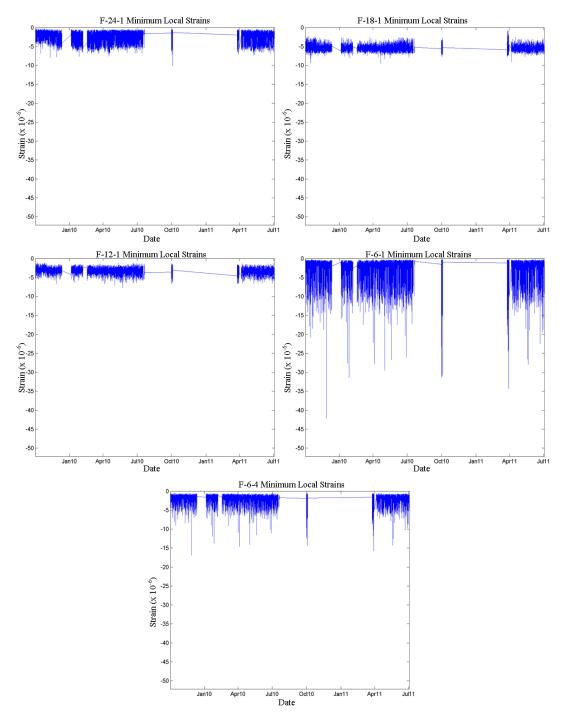
Figure F. 3. Minimum local strains versus the dates they were recorded for sensors at stirrup F.

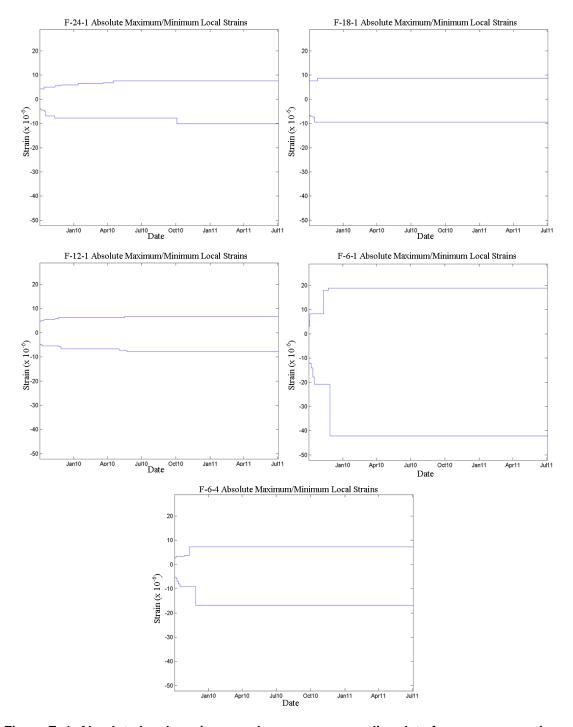
Figure F. 4. Absolute local maxima envelope versus recording date for sensors on stirrup F.

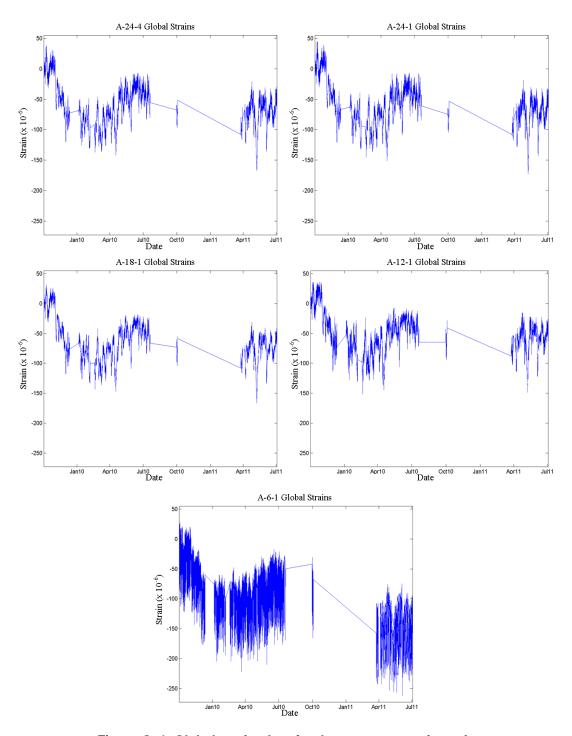
Figure G. 1. Global strain plots for the sensors on stirrup A.

The global strains of all of the sensors are presented in Appendix G. Although the diurnal and annual temperature effects can be seen in the cyclic variations, it has been observed that the global behavior was slightly erratic with no predictable trend. All of the sensors on stirrup A, minus sensor A-6-1, showed a consistent cyclic behavior with a slight compressive drift. Sensor A-6-1's cyclic behavior and drift were both doubled compared to the other sensors on stirrup A. For stirrup B, the cyclic behaviors were consistent, but the drift varies from compressive to tensile. The same can be seen for stirrup C. The sensors at D and E appeared to be relatively consistent with no apparent drift, but these sensors were not operational for the first year and as such the initial behavior is unknown. Finally, the drift and cyclic behaviors of the sensors on stirrup F varied in amplitude as well as in the drift.

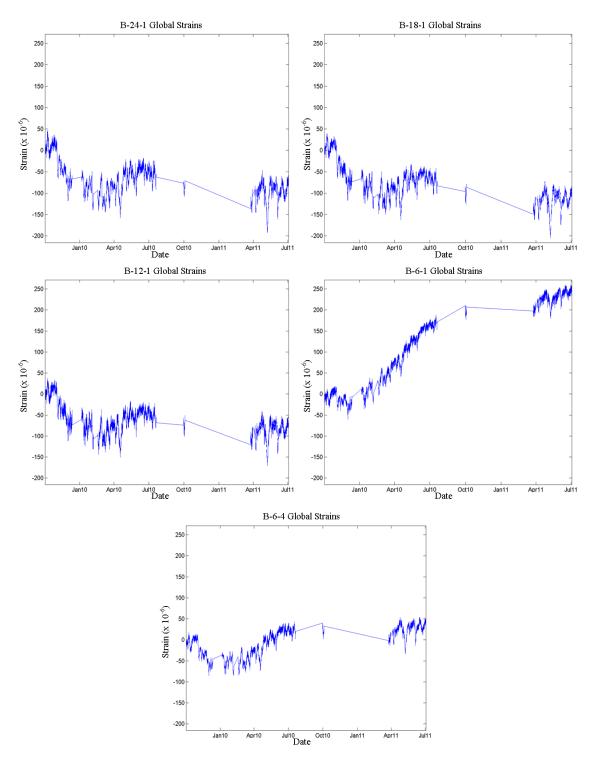
Figure G. 2. Global strain plots for the sensors on stirrup B.

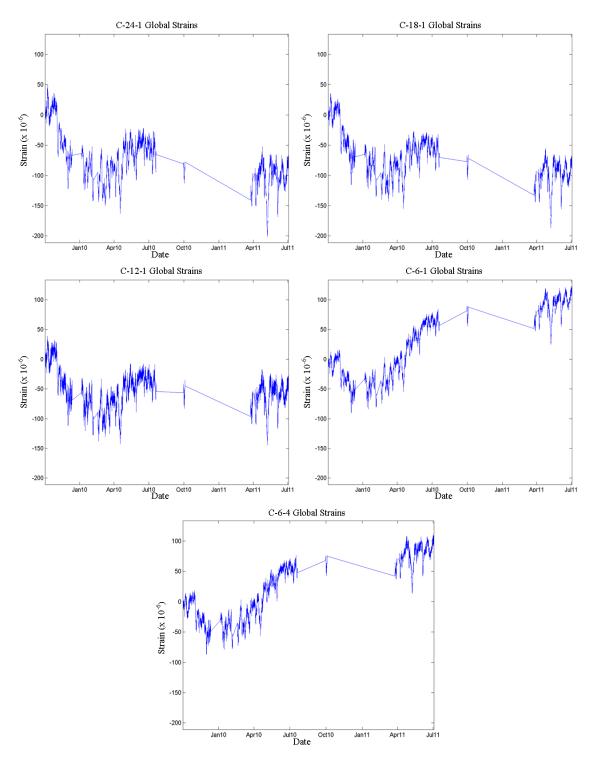
Figure G. 3. Global strain plots for the sensors on stirrup C.

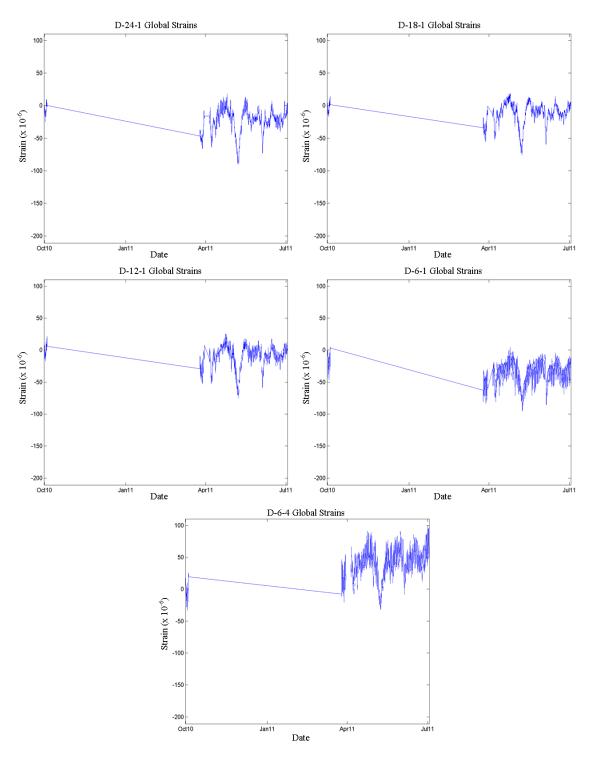
Figure G. 4. Global strain plots for the sensors on stirrup D.

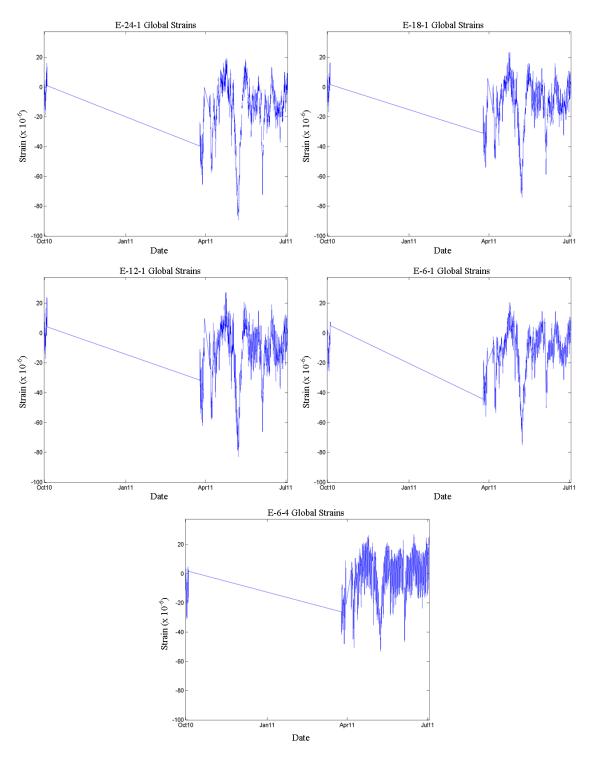
Figure G. 5. Global strain plots for the sensors on stirrup E.

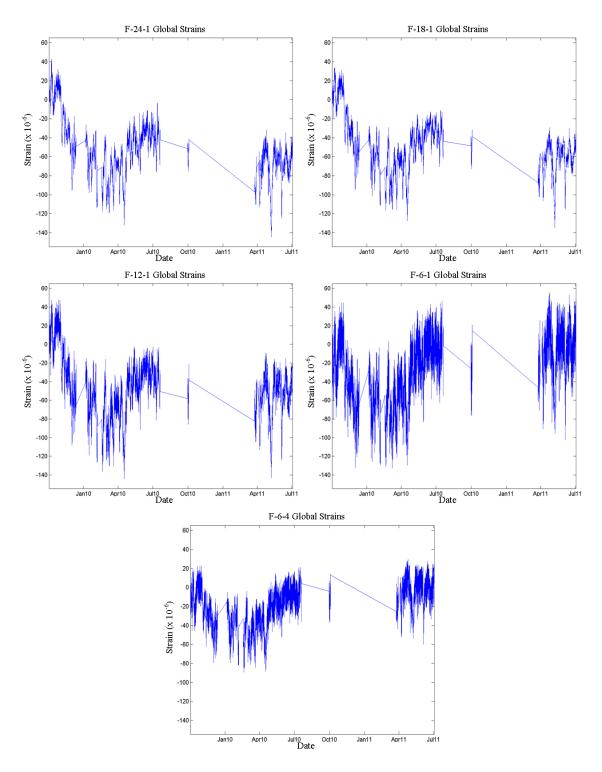
Figure G. 6. Global strain plots for the sensors on stirrup F.
