Case Studies Using Quality Control for Performance and Pay for Performance Specifications: Field Observations

Research Report No. FHWA-ICT-20-006

Evaluation of Data Trends and Variability in the Quality for Performance (QCP) and Pay for Performance (PFP) Programs

Illinois Center for Transportation

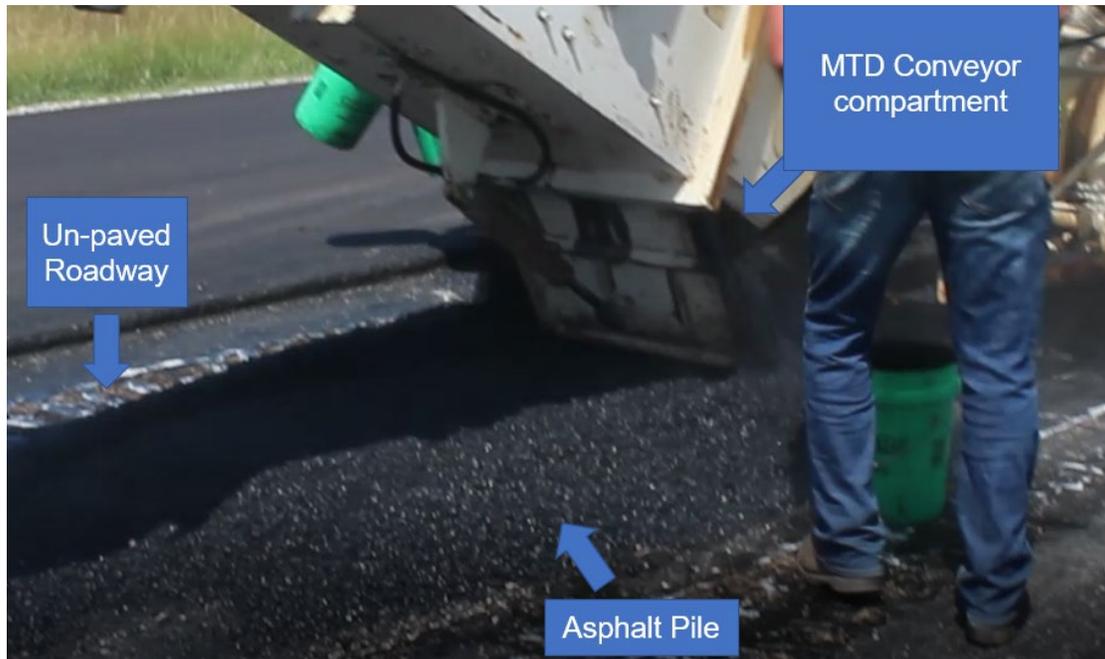
Figure 51. Photo. Field mix sampling from MTD compartment.
