**SOUTHERN PLAINS**  
TRANSPORTATION CENTER

## **Evaluation of Surface Treatments to Mitigate ASR**

**SPTC14.1-20-F**

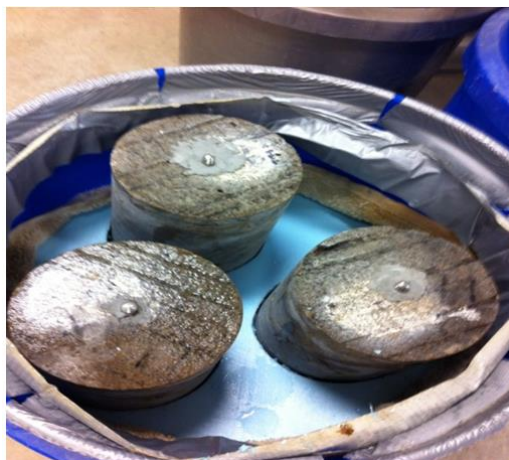
Figure 3.2. Bucket with Cores over Water

Normally, three-five gallon buckets would be used to store the nine cores in a water bath, but due to a lack of Styrofoam, three-6 in by 12 in cylinder molds were used for the 1N NaOH solution cores. The first-five gallon bucket was fitted with two wooden blocks with 1 in height at the bottom, so that 1 in. of water at the bottom could be easily measured and maintained. Above the wooden blocks, a piece of Styrofoam was cut to fit into the bucket and rest on top of the wooden blocks. Three small holes were cut just big enough in the Styrofoam for the gage studs to fit in. The cores would rest on the Styrofoam, while the gage studs would not carry any of the weight of the cores being in the holes. Four inches from the top of the bucket another Styrofoam piece was place with three holes cut into it symmetrically about the center. These holes were made just bigger than four inches to accommodate the cores. The sides of the bucket were lined with a towel. The towel was taped to the top of the bucket, while the bottom of the towel sat above the bottom piece of Styrofoam. Figure 3.2 shows the cores in the first bucket. A lid fitting over the bucket and towel was used to create a watertight seal.

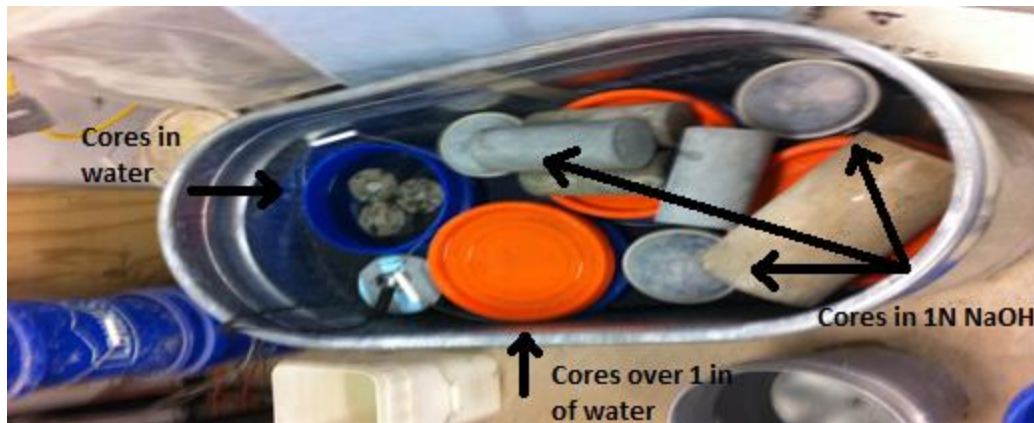
Figure 3.3. Water Bath

A water bath was prepared using a 100 gal watering trough. The water temperature was measured and controlled using an electric thermometer connected to a heater. The water bath was maintained at 100°F. All the buckets and cylinder molds were kept in the water bath throughout the testing. The buckets were not submerged in the water bath, but the water came up to just under the lid for the buckets, which is shown in Figure 3.3. The two extra buckets in Figure 3 were for another project not discussed in this paper.

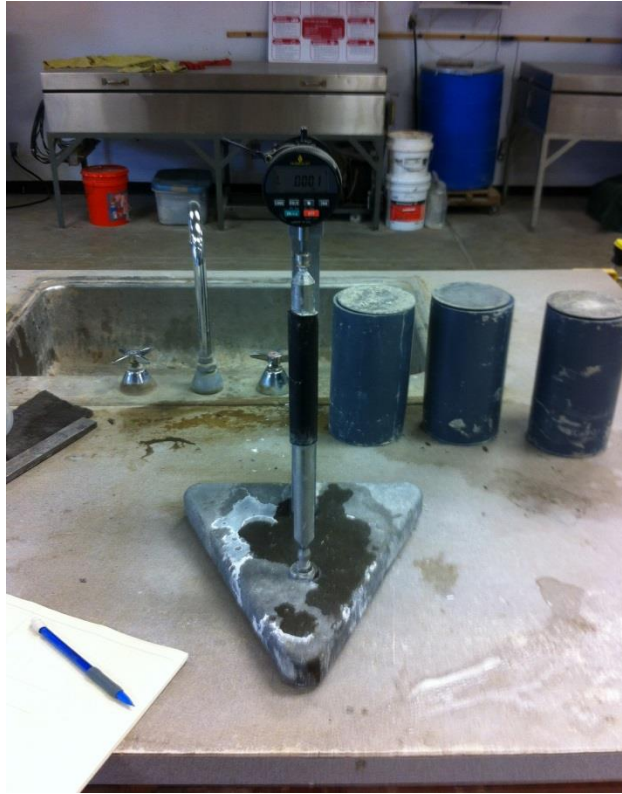
Figure 3.4. Length Change Comparator

The initial length for each core was recorded using a length change comparator which is shown in Figure 3.4. The cores were then placed into their respective buckets and placed into the water bath. Subsequent readings were taken every week for one year. Before each reading, the buckets were removed from the water bath and placed into an environmental chamber at 73°F. The buckets were allowed to cool for at least 16 hr. Each core was then removed from the buckets and measured twice using the length change comparator. The cores were measured the same way every time to ensure equivalent readings. After the lengths had been recorded, the cores were placed back in the bucket but the cylinders were flipped, so that one end of the core did not always take the weight of the core. The buckets were then returned to the water bath. At six months, the 1N NaOH solution in the cylinders was replaced.

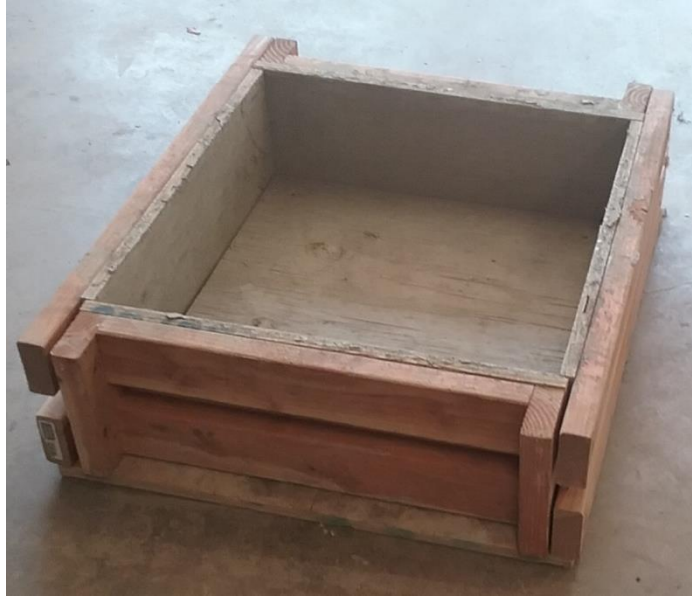
Figure 3.5. Formwork

The concrete was mixed and placed into two forms that were two feet by two feet by eight inches deep as shown in Figure 3.5. The bottom of the forms was made of plywood with four holes, so that gage studs could be placed into the concrete. As the concrete was placed into the forms, it was rodded and consolidated. After the concrete was placed, the surface was finished with a trowel.
