Implementation of New Guidelines for Tightening Large Anchor Rods of Support Structures for Signs and Luminaires

Bridge Engineering Center
Iowa State University

May 2020

Research Project
Final Report 2020-14

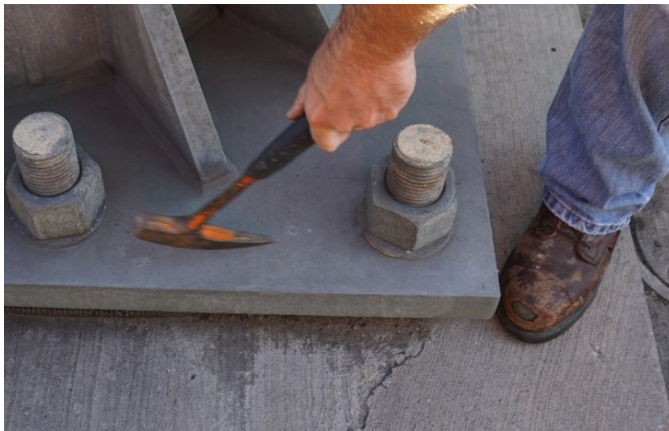
Before any maintenance on the structure, the connection is checked for inadequate clamping force by striking two opposite edges of the top and leveling washer with a pick (Figure 3.1.1).

Figure 3.1.1 Checking for clamping force in connection

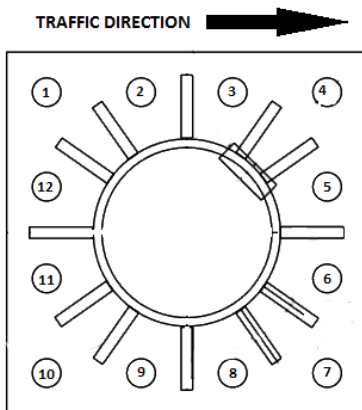
The notation for referring to anchor rod numbers is based on traffic direction. Facing traffic perpendicularly, numbering starts at the top left anchor rod and goes around clockwise. Figure 3.1.2 illustrates an example for a 12-rod structure.

Figure 3.1.2 Example of anchor rod numbering notation on a 12-rod baseplate

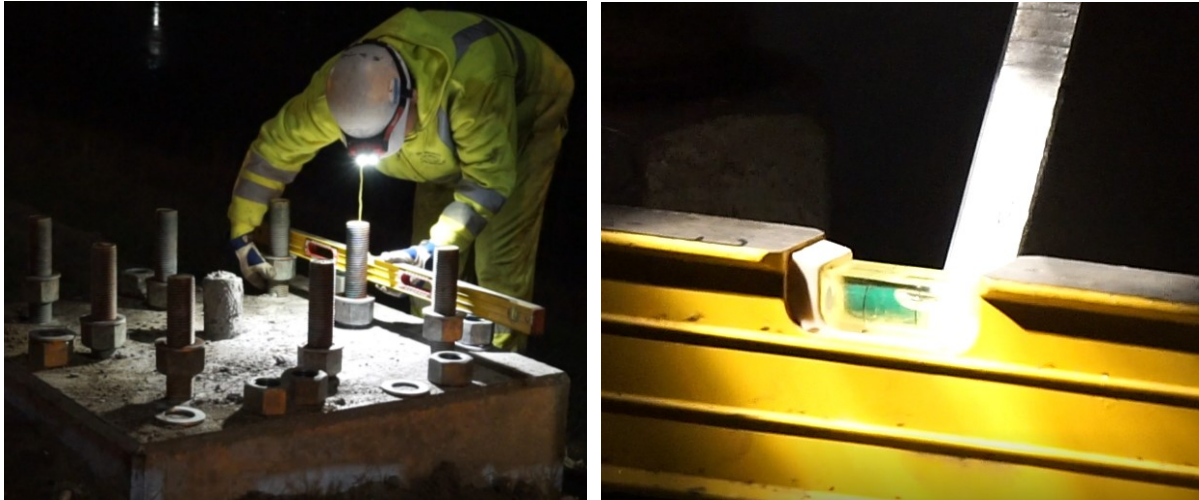
Grade 55 anchor rods were used in both installations. Both of the structures were installed by Global Specialty Contractors of Eagan, Minnesota. Both structures were installed at night due to traffic control requirements. Before the installation of the posts, the leveling nuts were leveled as illustrated in Figure 3.2.2.

Figure 3.2.2 Leveling nuts on sign truss structure (left) and final installation of COSS out of plumb (right)

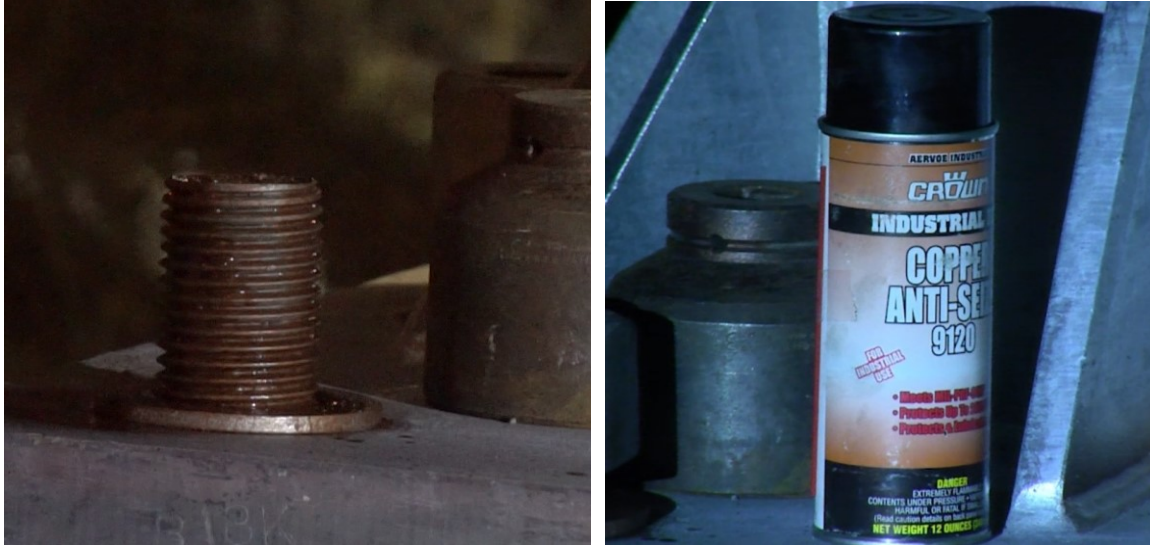
After leveling, the installation and placement of the sign structure, anchor rods, washers, and nuts could be lubricated. In the contractor's previous experience, only the anchor rods were lubricated, which would result in significantly greater friction while tightening. A copper anti-seize spray was used as the lubricant for the installation. While this was not the MnDOT-specified lubricant, spray copper anti-seize has a nut factor approximately the same as the approved lubricant, so it is possible that the pre-tension force that developed in the anchor rods was still sufficient to prevent loosening. Figure 3.2.3 (left) and (right) shows the lubricated anchor rod connection and the lubricant used, respectively.

Figure 3.2.3 Lubricated anchor rod connection (left) and lubricant utilized (right)

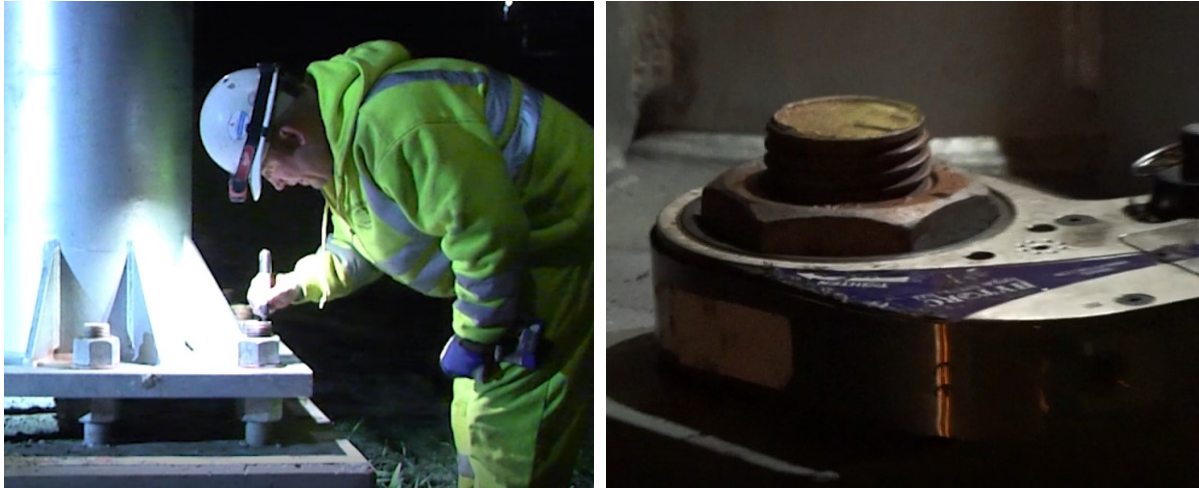
After snug-tightening, the contractor marked each rod and nut as reference for the turn-of-nut tightening (Figure 3.2.5 left).

Figure 3.2.5 Marking each rod and nut as reference for the turn-of-nut tightening (left) and tightening using a hydraulic wrench (right)

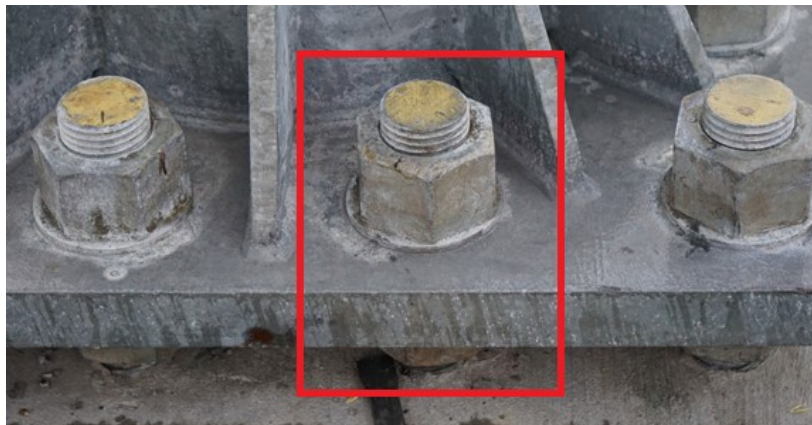
During July 2019, both of the OH sign structures observed in October of 2018 were inspected to ensure that no nuts had come loose with the new procedures. The full-span truss sign I-94-689 was found to have no loose nuts after checking both the top and leveling nuts. On the COSS OH 280-023, all of the nuts were tight, but, after inspection of the leveling nuts, it was found that nut 8 was slightly angled with the rod itself out of plumb (Figure 3.2.6), likely causing the issue.

Figure 3.2.6 Out-of-plumb anchor rod on COSS OH 280-023

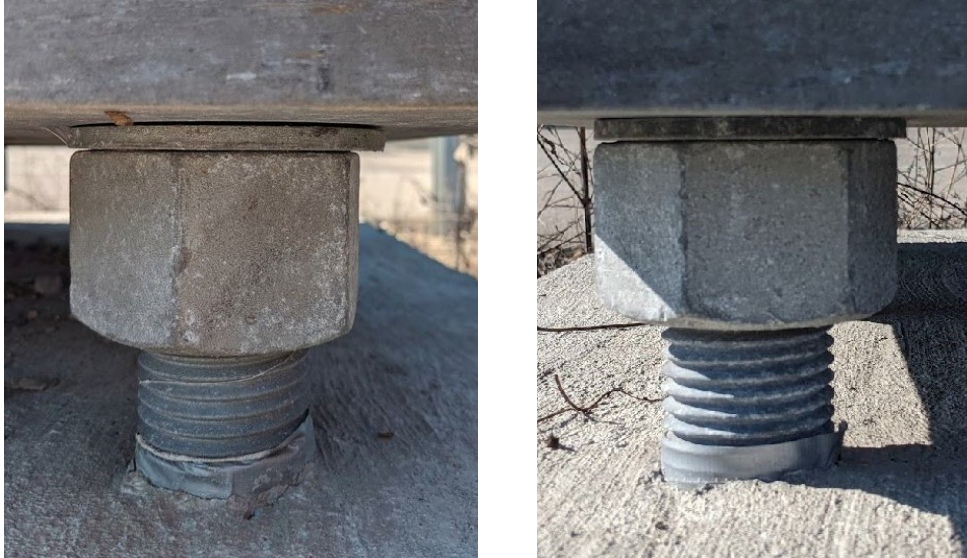
between it and the baseplate when compared to Figure 3.2.7 (right), which is rod #8 on the same structure. Note that the space between the washer and the nut is due to the geometry of the nut.

Figure 3.2.7 Gap between baseplate and washer #5 out of plumb (left) and bolt #8 plumb for reference (right)

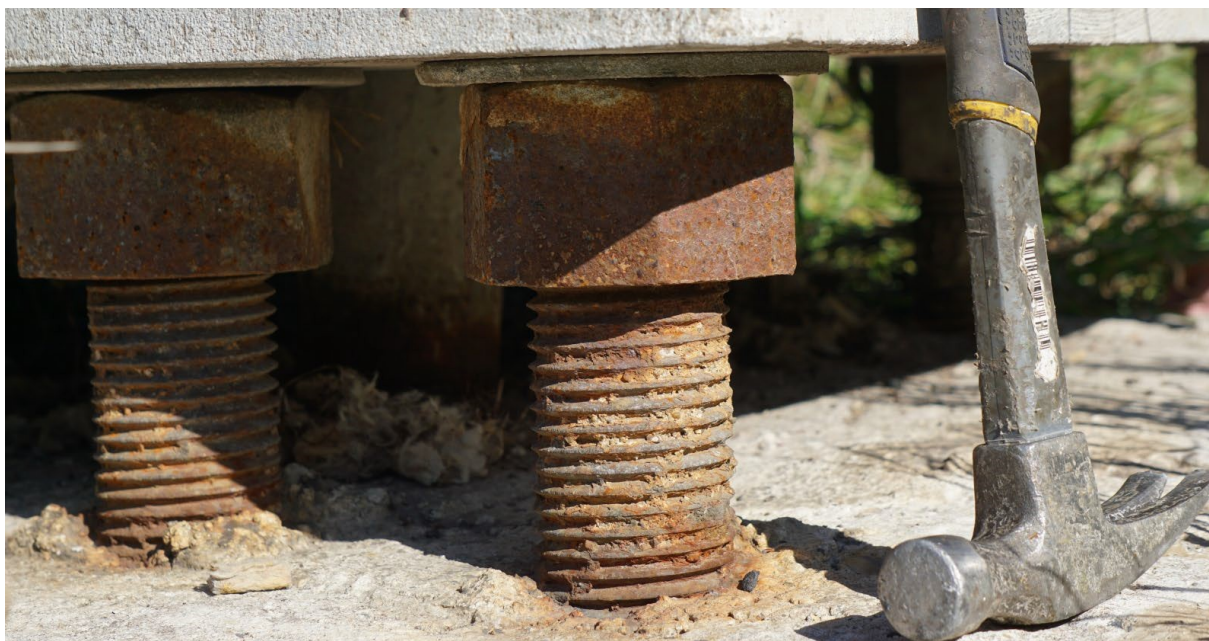
Conditions were also noted during inspections of the existing signs. For most, the installations were fairly new and in good condition. The I-494-153 sign truss structure was in slightly worse condition than the other observed structures and is an older design as indicated by the 8x2 rod layout pattern. Figure 3.2.9 shows the standoff distance issues that were found during inspection.

Figure 3.2.9 Large standoff distance on I-494-153 structure

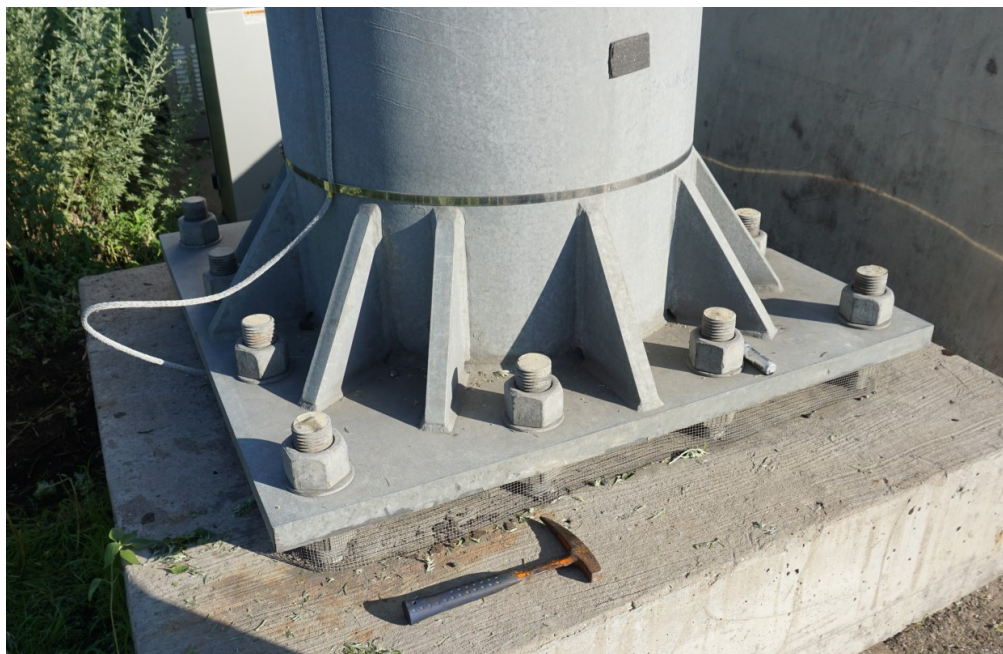
Figure 3.2.10 I-94-601 Base

I-94-601 (INCREASING SIDE) – FIGURE 3.2.10

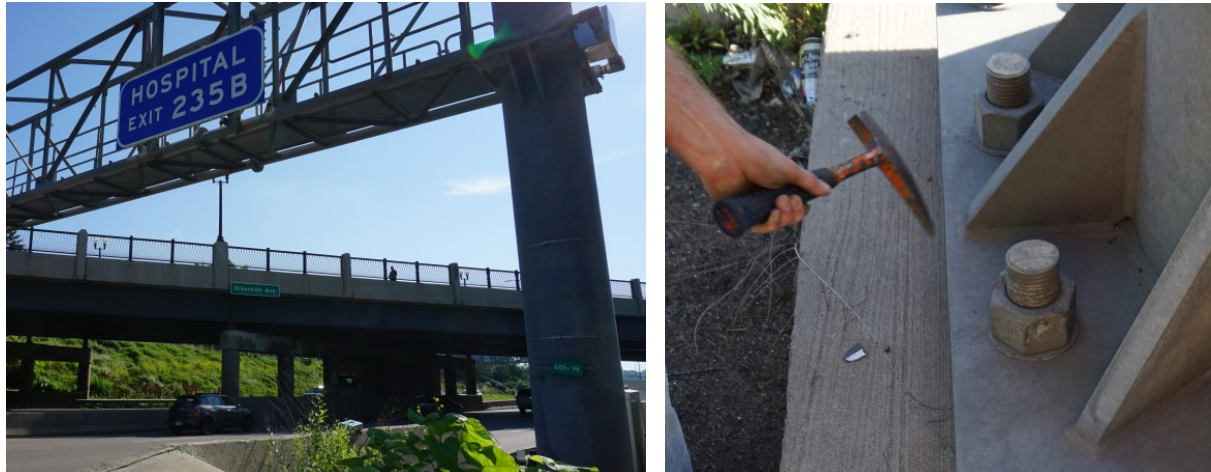
Inspection and maintenance for this structure took longer than the first, due to the new procedure being used. While striking the washers, concerns were voiced by MnDOT maintenance personnel about whether a washer was pushed up against the rod, so it would likely be beneficial to strike opposite sides of the washer when checking for looseness, as demonstrated in Figure 3.2.11 (right).

Figure 3.2.11 Full truss OH sign I-94-602 (left) and inspecting rod pre-tension force (right)

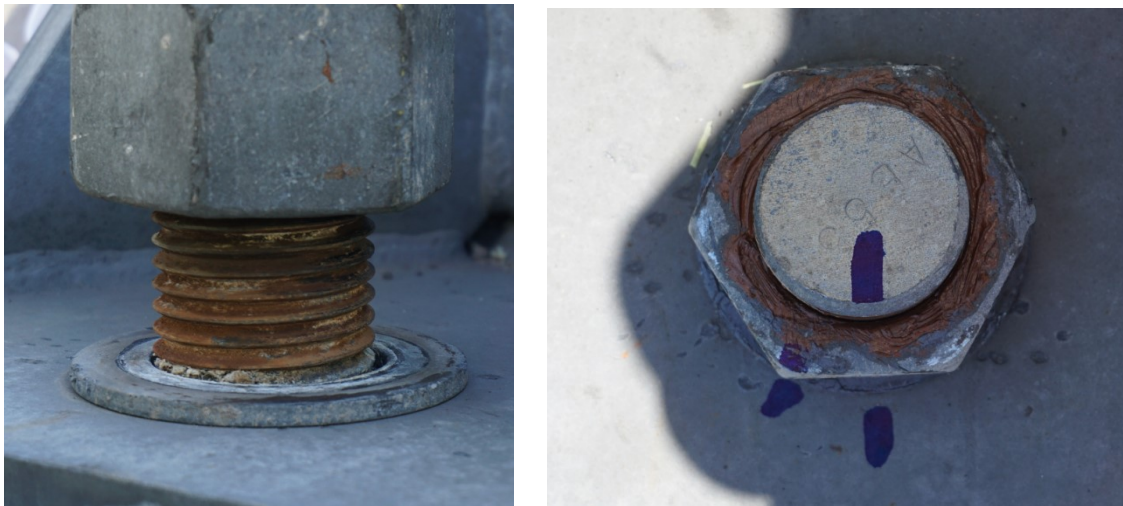
Only one rod, #3, was found to be loose, but the procedure was still followed to take all of the nuts off and lubricate to reset the installation. Much like the previous structure, rod threads were fairly corroded on the inside of the nut (Figure 3.2.13 left).

Figure 3.2.13 General condition of anchor rods (left) and sample turn-of-nut verification (right)

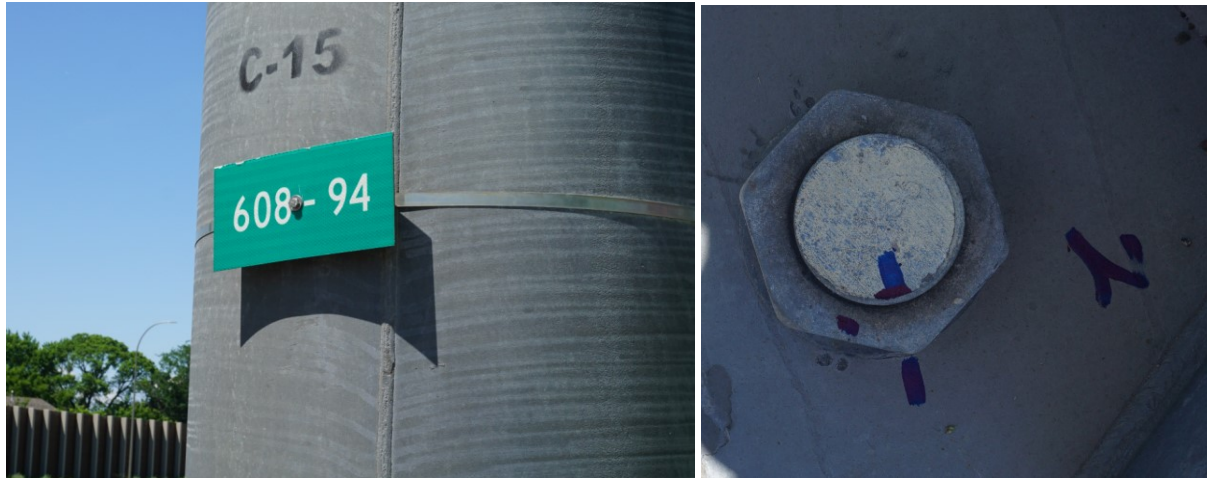
On this structure none of the washers moved when struck, so it served as another control variable where all of the nuts were brought to 110% T_v in a star pattern. In Figure 3.2.14 (left), the post has a tag marking the designation and a C-15 marking painted on.

Figure 3.2.14 I-94-608 Post (left) and 1/12 turn on nut #8 (#2 in star pattern) (right)

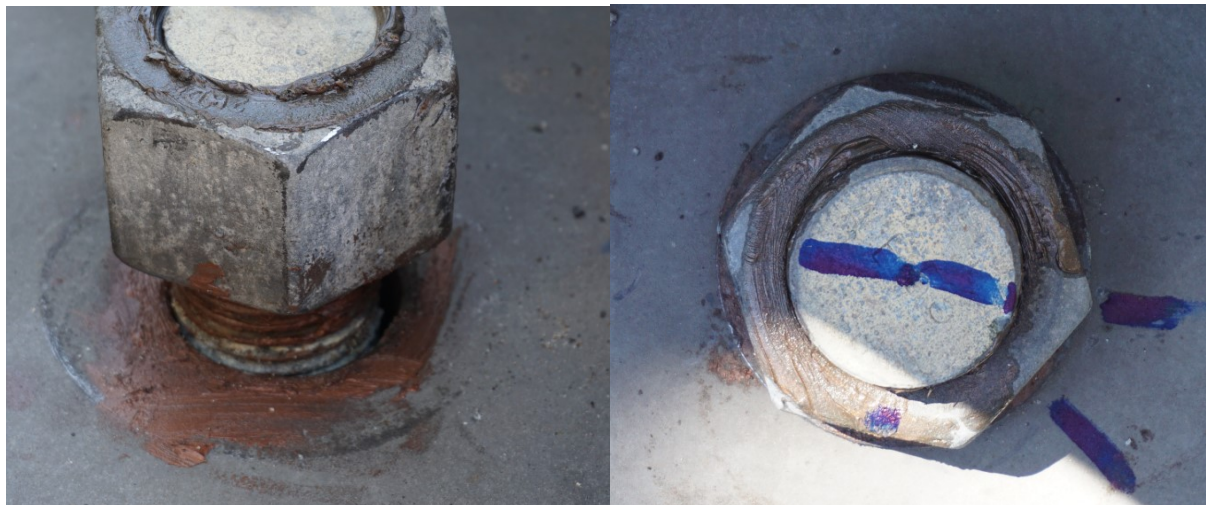
On this structure, nuts 7, 11, and 12 were found to be loose and rod 8 was missing a top washer (Figure 3.2.15 left).

Figure 3.2.15 Missing washer on rod 8 (left) and excessive turn of nut on rod 11 (right)

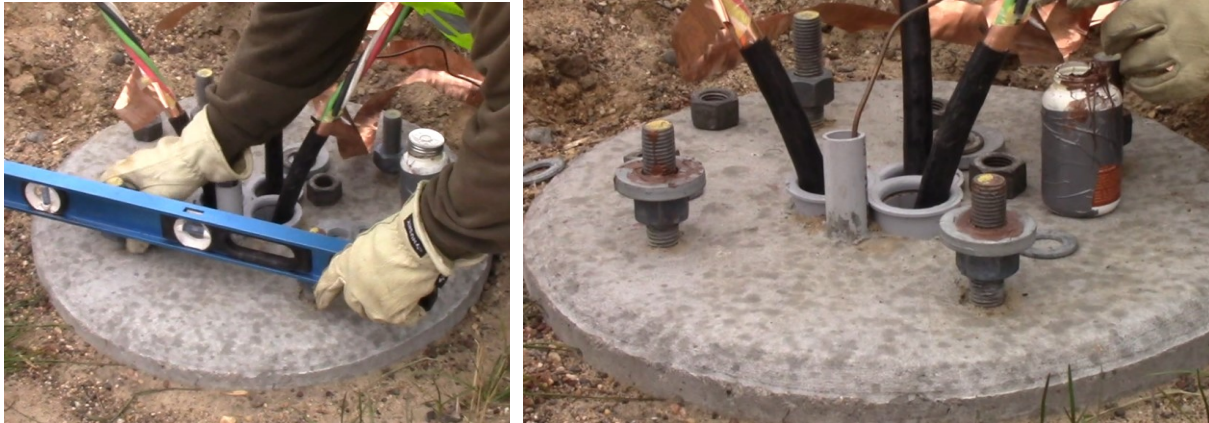
The contractor used a level to level the leveling nuts (Figure 3.3.2 left).

Figure 3.3.2 Leveling process (left) and improper lubrication of leveling nuts (right)

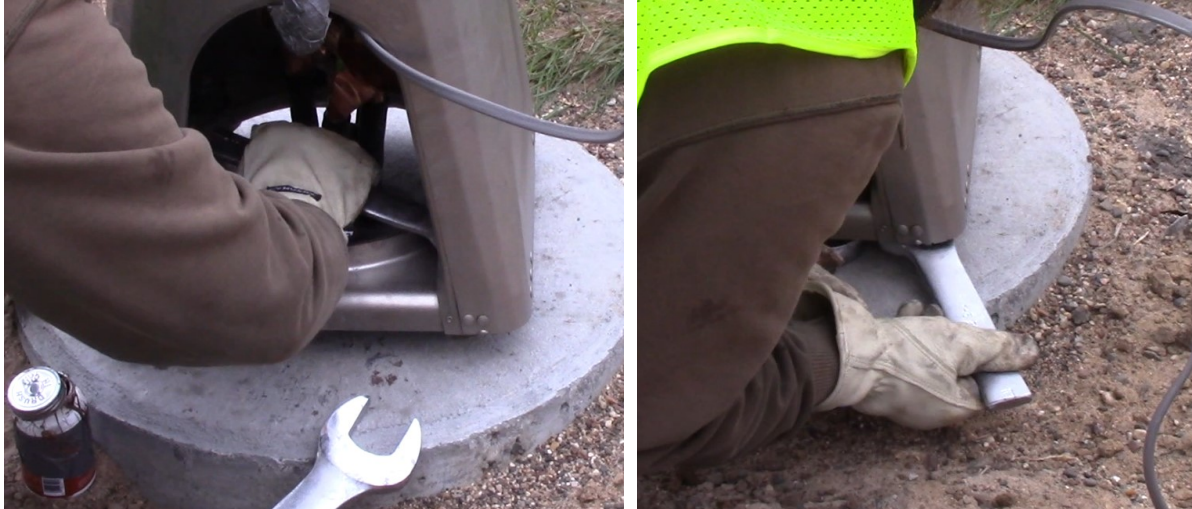
Next, two cycles of snug tightening were completed in a star pattern sequence. The top nuts were tightened to the snug-tight condition first, followed by the snug-tight condition of the leveling nuts. The contractor had the option of using either a 12" long offset wrench made by the pole manufacturer, a 12" long open-end and closed-end wrench, or a torque wrench set to 50 ft-lbs. For the first cycle, the contractor utilized the manufacturer's 12" long offset wrench to bring the leveling and top nuts to a snug-tight condition, as shown in Figure 3.3.3.

Figure 3.3.3 Snugging top nuts (left) and snugging leveling nuts (right)

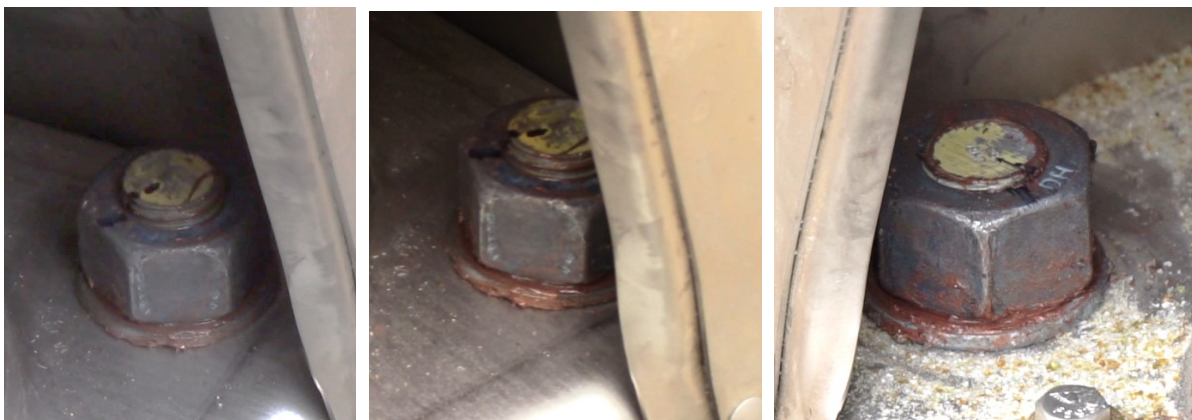
Figure 3.3.4 (left to right) shows examples of one nut before, at a second step, and after the contractor completed turn-of-nut pre-tensioning, respectively.

Figure 3.3.4 Nut turns at initial, second step, and final values (left to right)

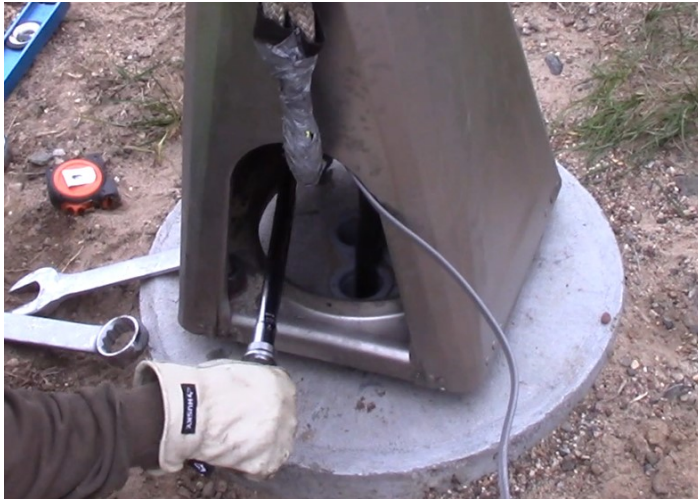
The last step, shown in Figure 3.3.5, required the contractor to use a torque wrench set to 200 ft-lbs.

Figure 3.3.5 Applying verification torque

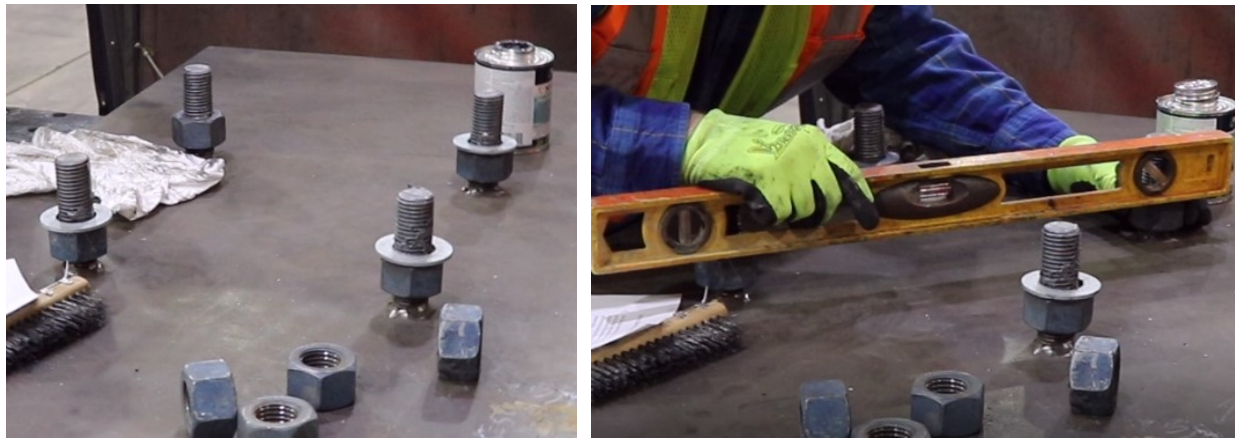
The Grade 55 anchor rods were welded onto a steel plate for demonstration purposes. The initial installation was done correctly, without lubrication on the top of the leveling nut washers, as shown in Figure 3.3.6 (left).

Figure 3.3.6 Correctly installed leveling nuts and washers (left) and leveling installation (right)

Figure 3.3.6 (right) illustrates correct leveling procedures performed on the installation. After leveling, the base was placed, and all required surfaces were lubricated with the specified grease, as shown in Figure 3.3.7 (left).

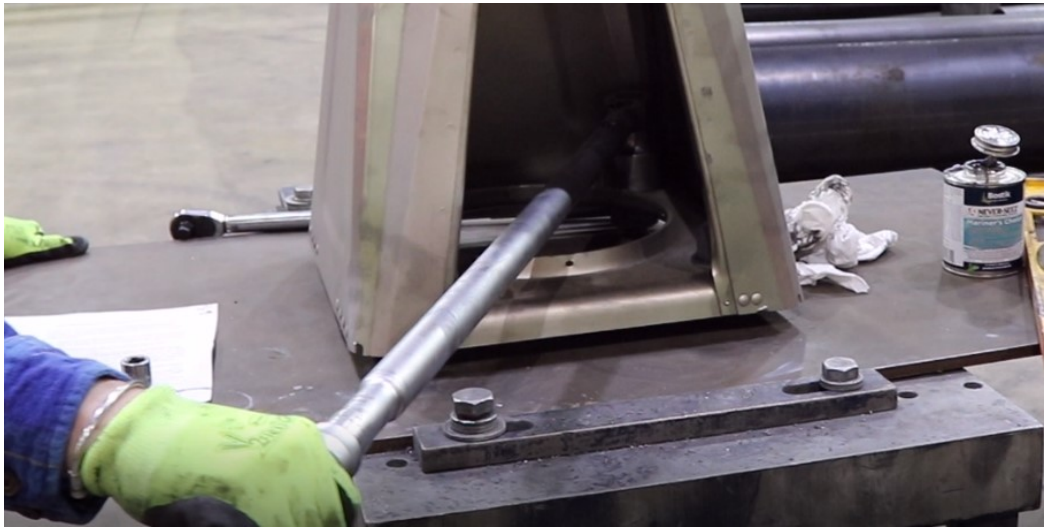
Finally, the anchor rods were immediately stressed to the full 400 ft-lbs in one step with a calibrated torque wrench (Figure 3.3.8).

Figure 3.3.8 Final verification torque on the structure installation

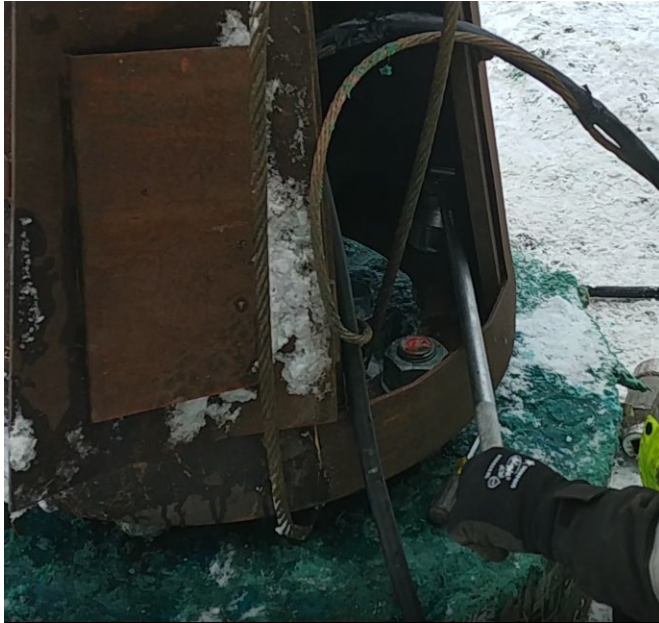
On the single observed HMLT installation, the tower anchor rods were pre-tensioned to snug tight with a calibrated manual wrench. It was intended that the HMLT anchor rods would be fully pre-tensioned at a later date using a hydraulic torque wrench. The manual wrench worked fairly well in the updated base, especially with the raised winch detail. As shown in Figure 3.3.10, clearance was limited when torquing the nuts closest to the door and required a fairly fine-toothed socket wrench to tighten.

Figure 3.3.10 Manual wrench installation tightening of HMLT anchor rods

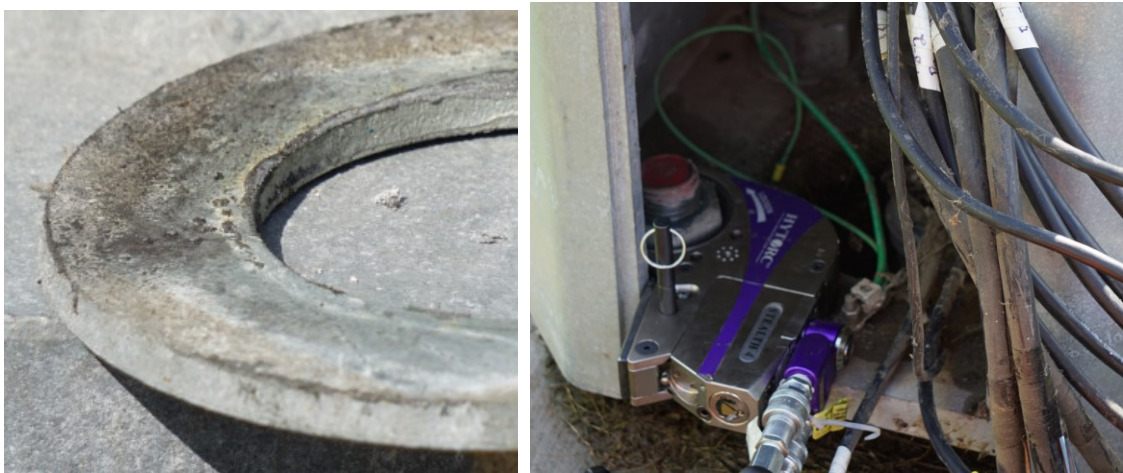
Figure 3.3.13 Galvanizing dimples on washer (left) and moved grounding wire (right)

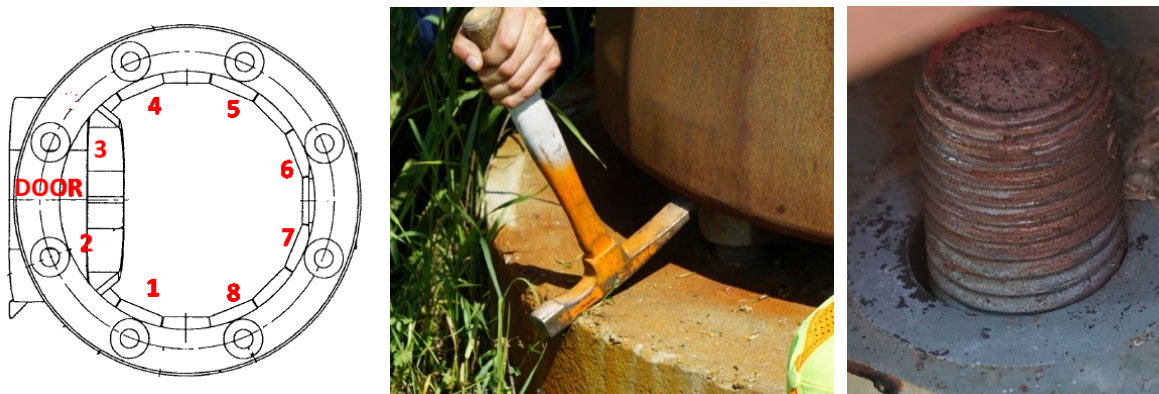
Figure 3.3.16 Rod numbering (left), checking washers for looseness (center), and prior copper anti seize lubrication on rod (right)

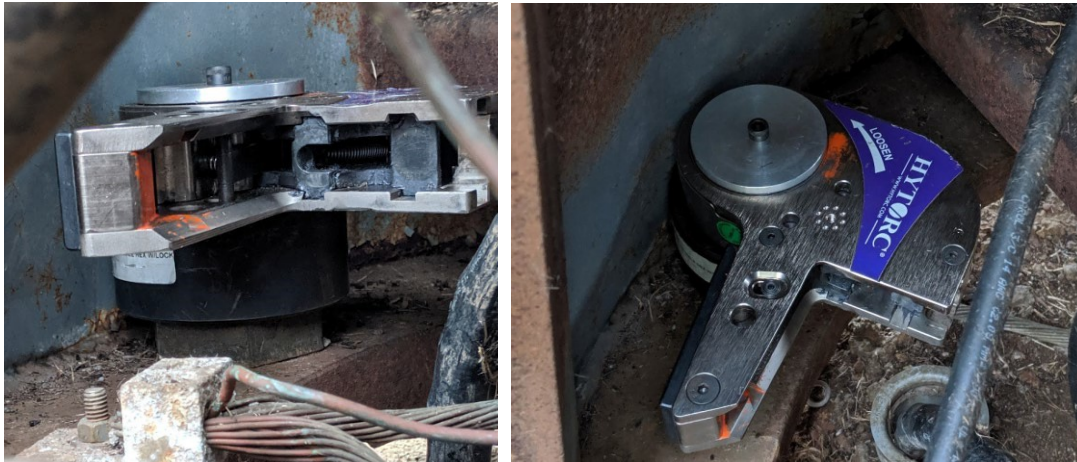
Figure 3.3.17 HYTORC Stealth 4 hydraulic wrench with stack socket

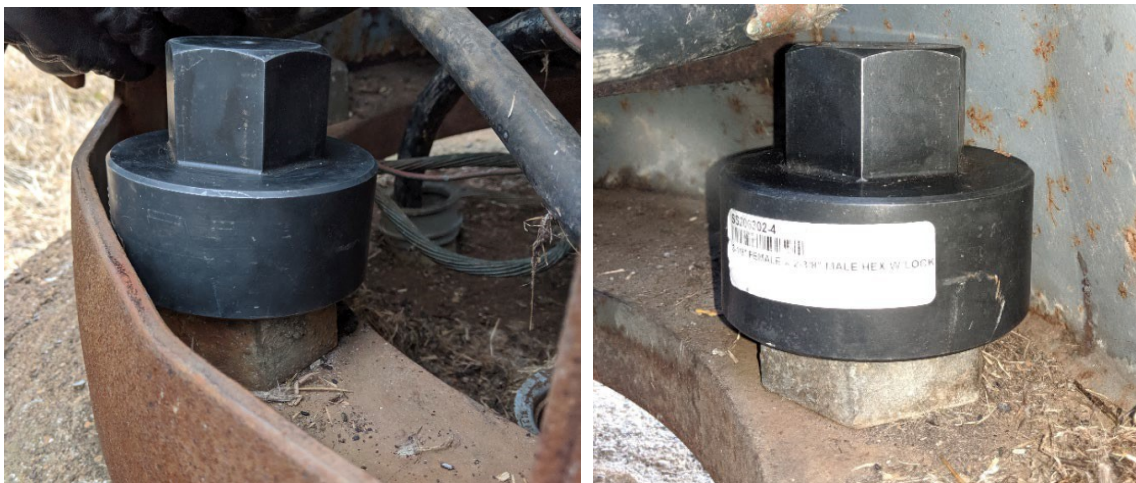
Figure 3.3.18 Wedging on door frame (left) and socket raised into wall by nut protrusion (right)

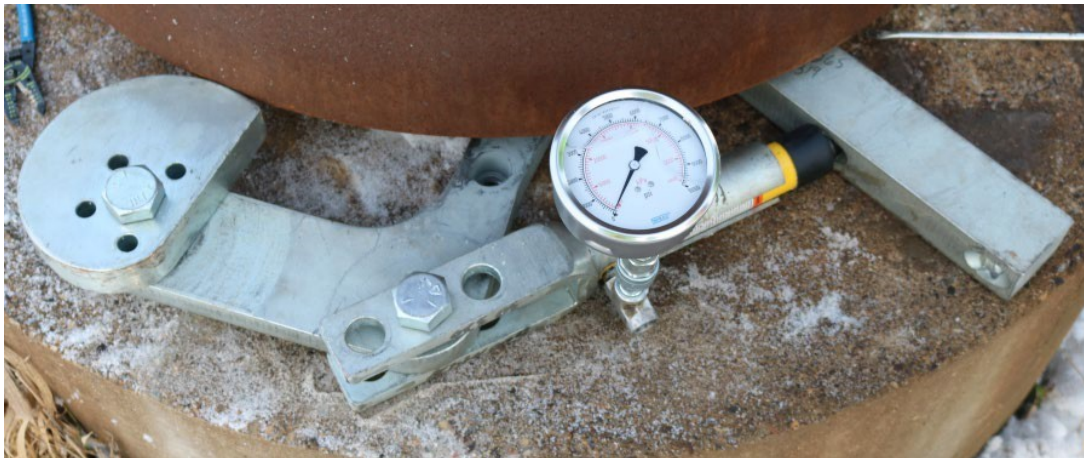
Figure 3.3.24 Millerbernd wrench operation at closest setting

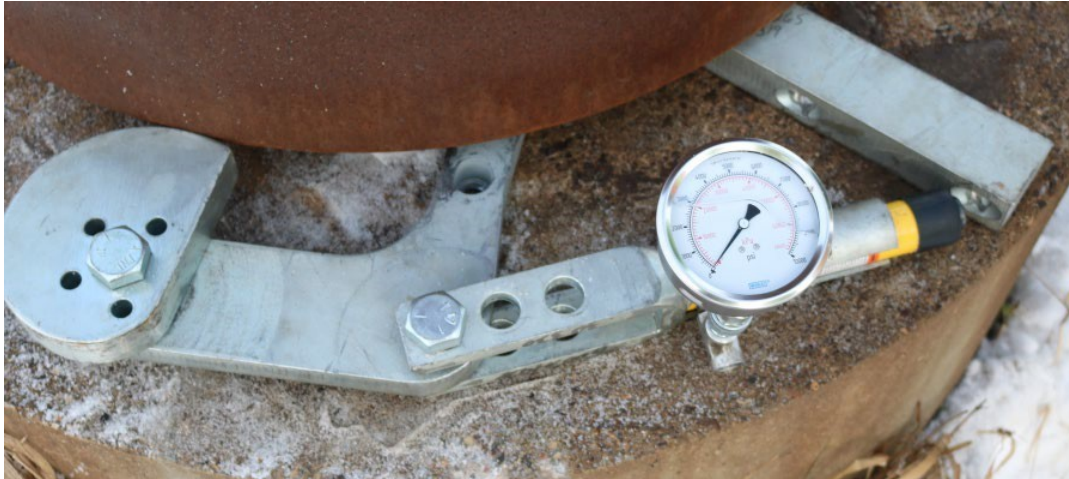
Figure 3.3.25 Millerbernd wrench operation at farthest setting

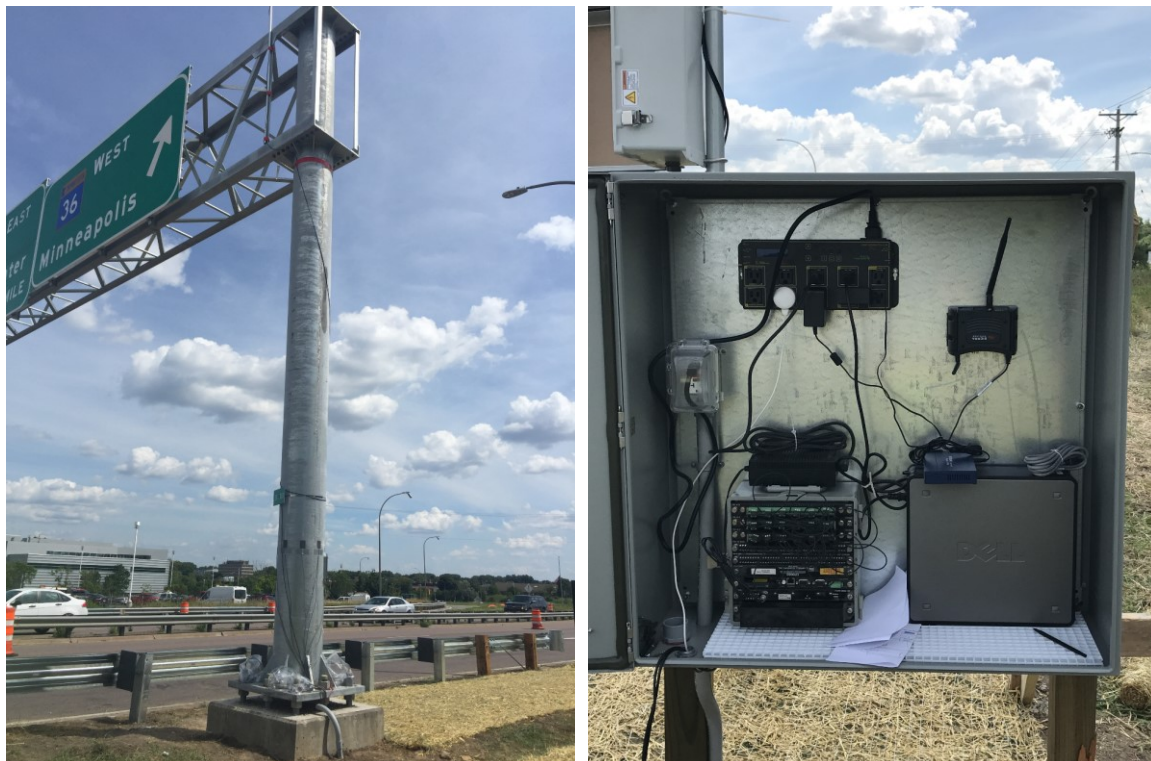
Figure 4.1.1 Instrumented sign post (left) and data logger cabinet (right)

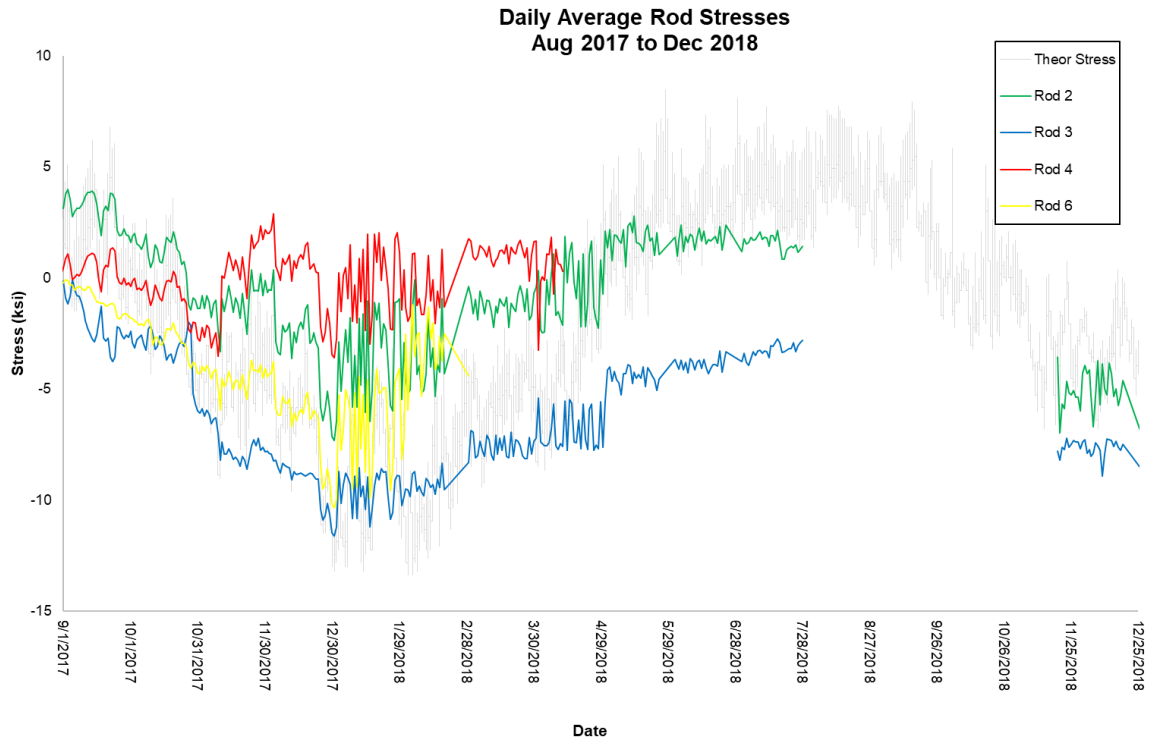
Figure 4.2.1 Long-term anchor rod stresses 8/2017–12/2018

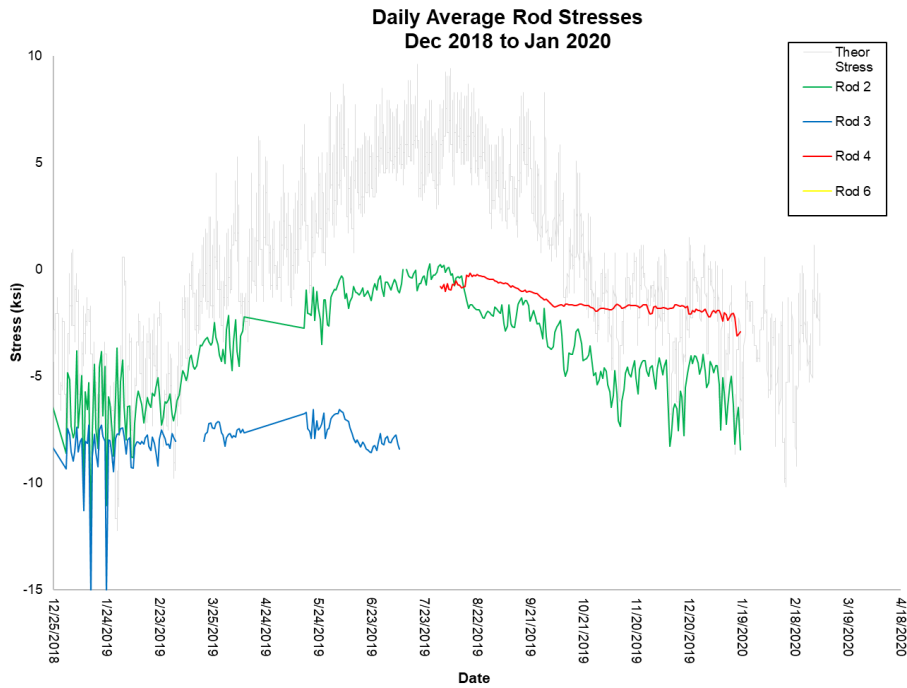
Figure 4.2.2 Long-term anchor rod stresses 12/2018–1/2020

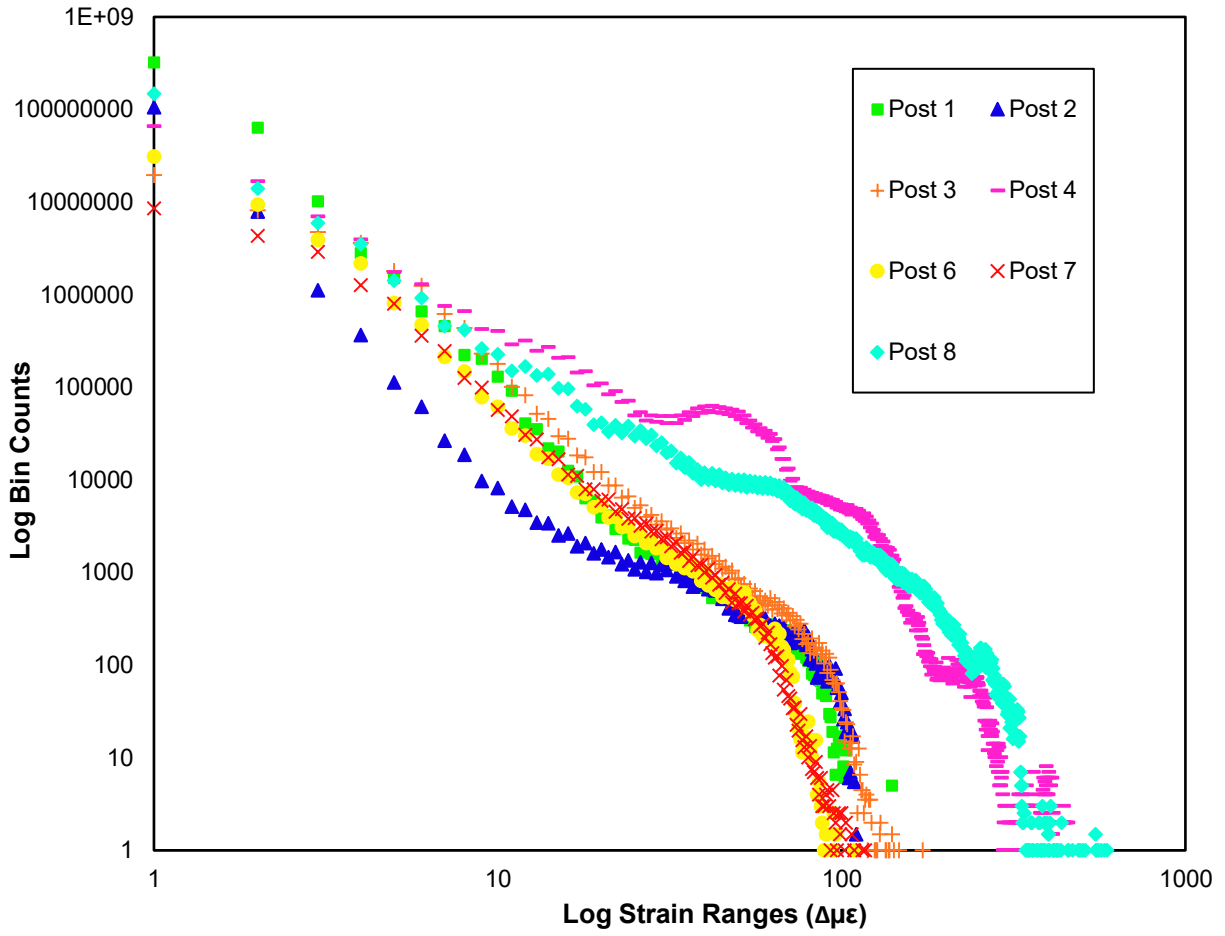
Figure 4.2.3 Field N-S curve for post stresses

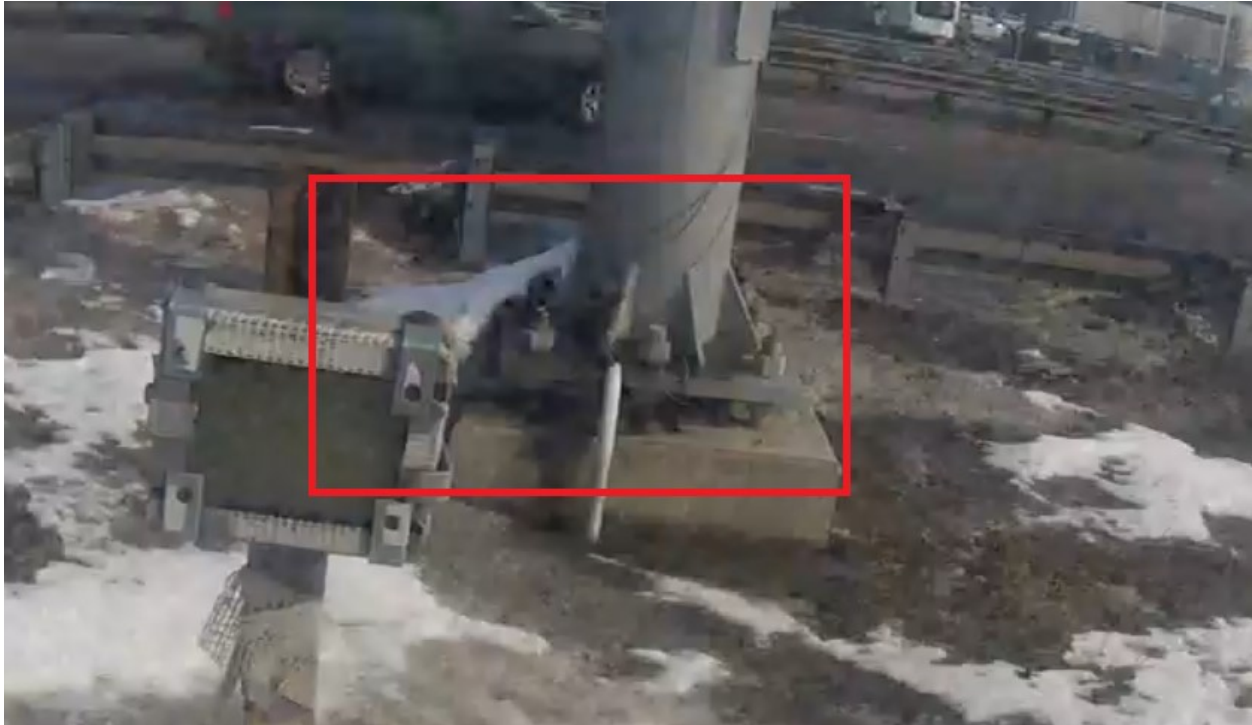
Figure 4.2.5 Snow and ice piled on anchor rod gauges
