# Permeable Pavement for Road Salt Reduction

St. Anthony Falls Laboratory  
University of Minnesota

**JUNE 2020**

Research Project  
Final Report 2020-15

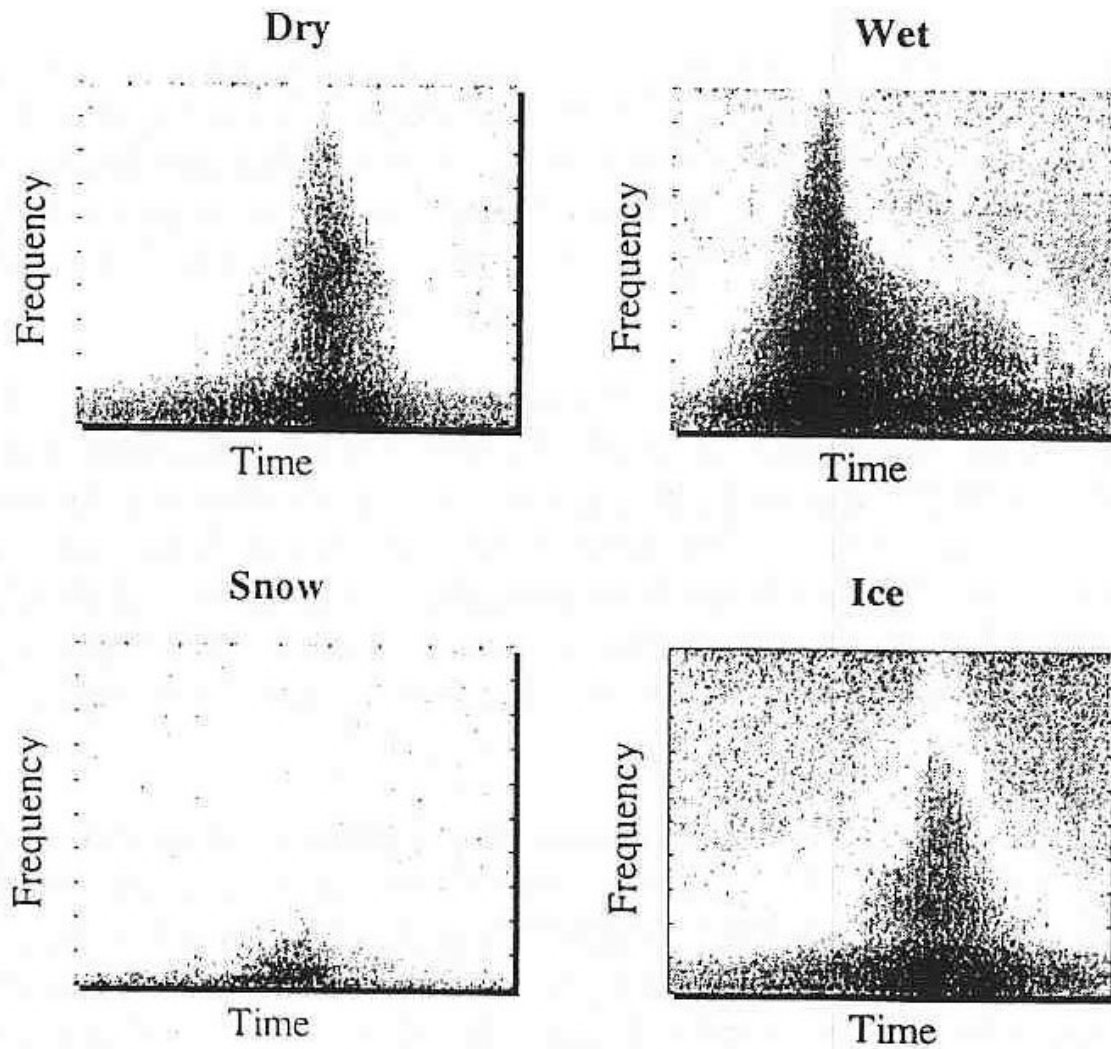
**Figure 1.1 Spectrograms of typical signals for four road classes. (from McFall 2000).**

Within a discussion of Artificial Neural Network (ANN) technologies, McFall (2000) showed that simple analysis of sound data could be used to distinguish dry, wet, snow, and ice-covered pavements. He used a Sony portable DAT recorder with an AKG C414 B-ULS microphone (max frequency = 20 kHz). The results from his analysis are shown in Figure 1.1.

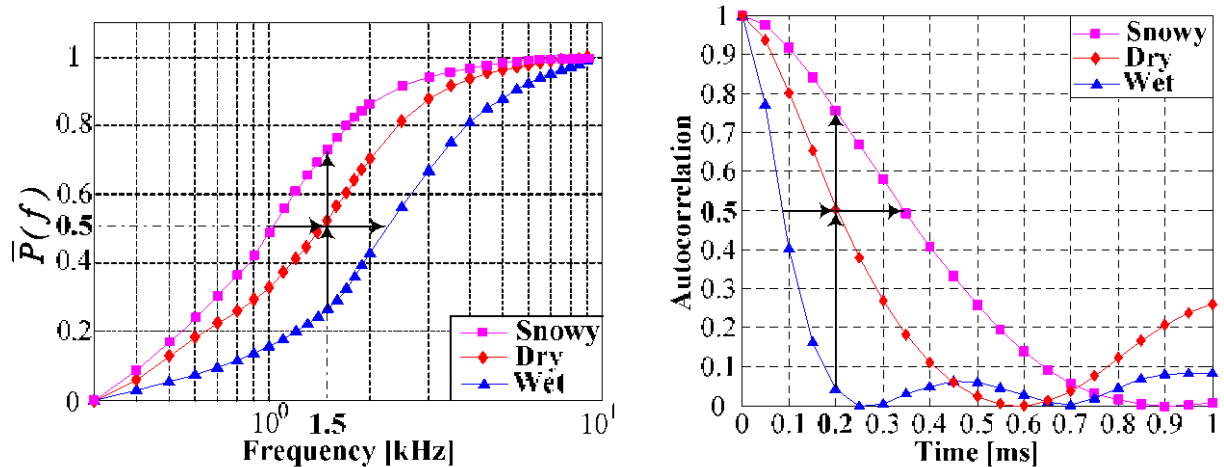
**Figure 1.2 Typical cumulative curves of the power spectrum of tire noises for five minutes (left) and Autocorrelation curves for five minutes (right). (from Kongrattanasert et al., 2010)**

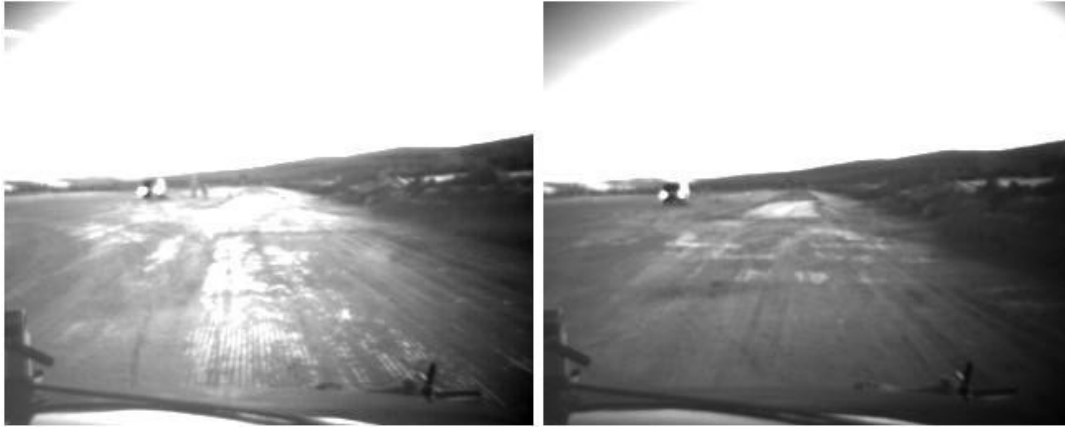
**Figure 1.4** The captured test samples. Left-hand image is captured with a horizontal polarization filter and the right-side image with a vertically polarized component. (from Kutila et al. 2008)

Kuttila et al. (2008) tested dual cameras with vertical and horizontal polarization and surface graininess to distinguish snow, ice, and dry asphalt. They used a Xenics XEVA-USB 320 camera with a 900–1700 nm range and a Peltier-cooled InGaAs array detector with 320 x 256 pixels. An example of images captured with this setup and polarizing filters is shown in Figure 1.4.

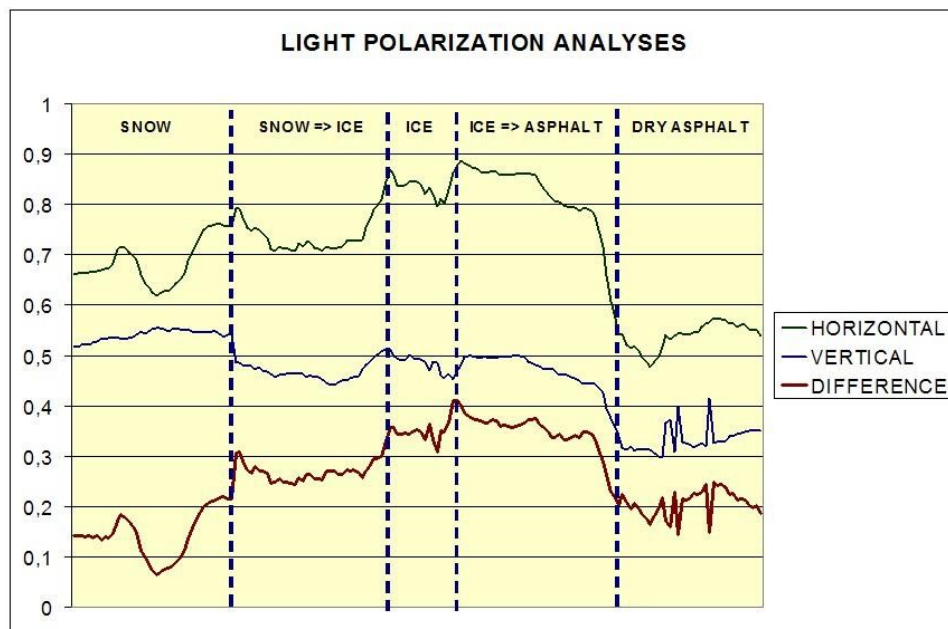
**Figure 1.5** Light polarization analysis in an asphalt road. Vertical axis is the intensity in the region-of-interest scaled to range [0... 1]. The average differences between the tested road conditions are: SNOW = 0.14; ICE = 0.35; ASPHALT = 0.21. (from Kutila et al. 2008)

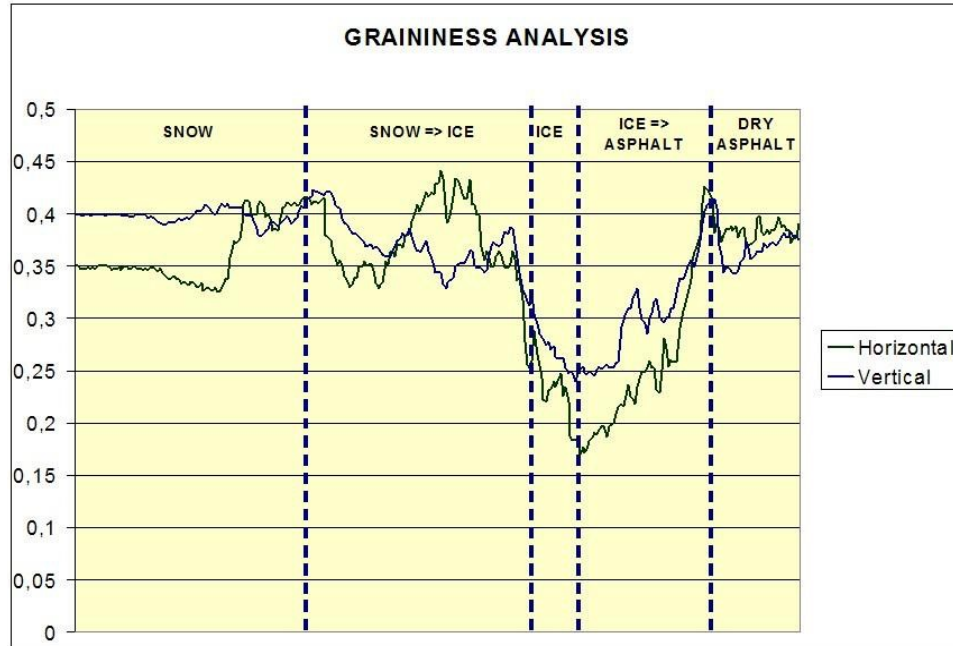
**Figure 1.6 Graininess measures against different road surfaces. The horizontal and vertical diagrams refer to the direction of the used polarization filter. The average graininess values for different conditions are: SNOW = 0.378; ICE = 0.254; ASPHALT = 0.376. (from Kutila et al. 2008)**

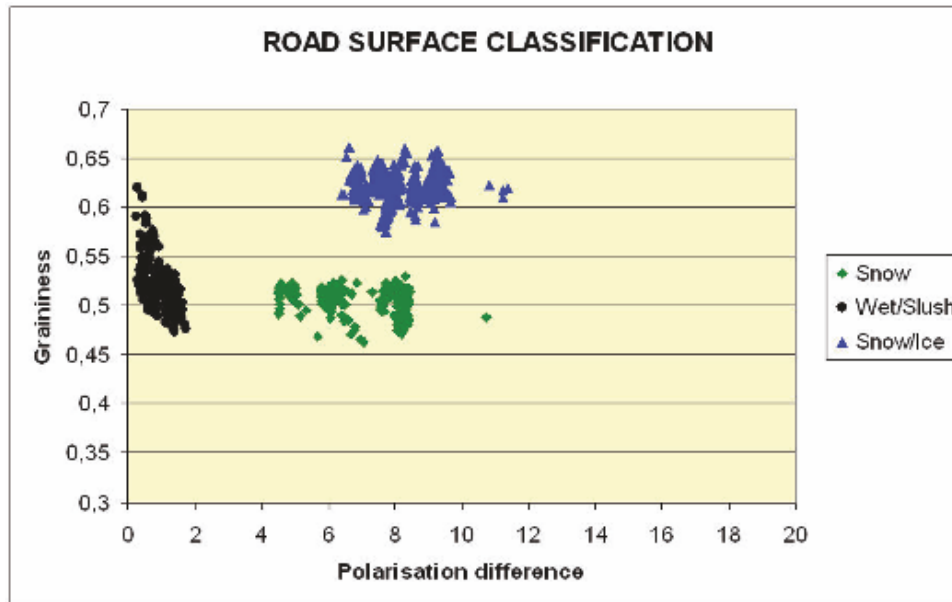
**Figure 1.7 Detection of snowy, wet, or icy road surface conditions in winter conditions using dual polarized cameras and graininess measurements. (from Kutila et al. 2009)**

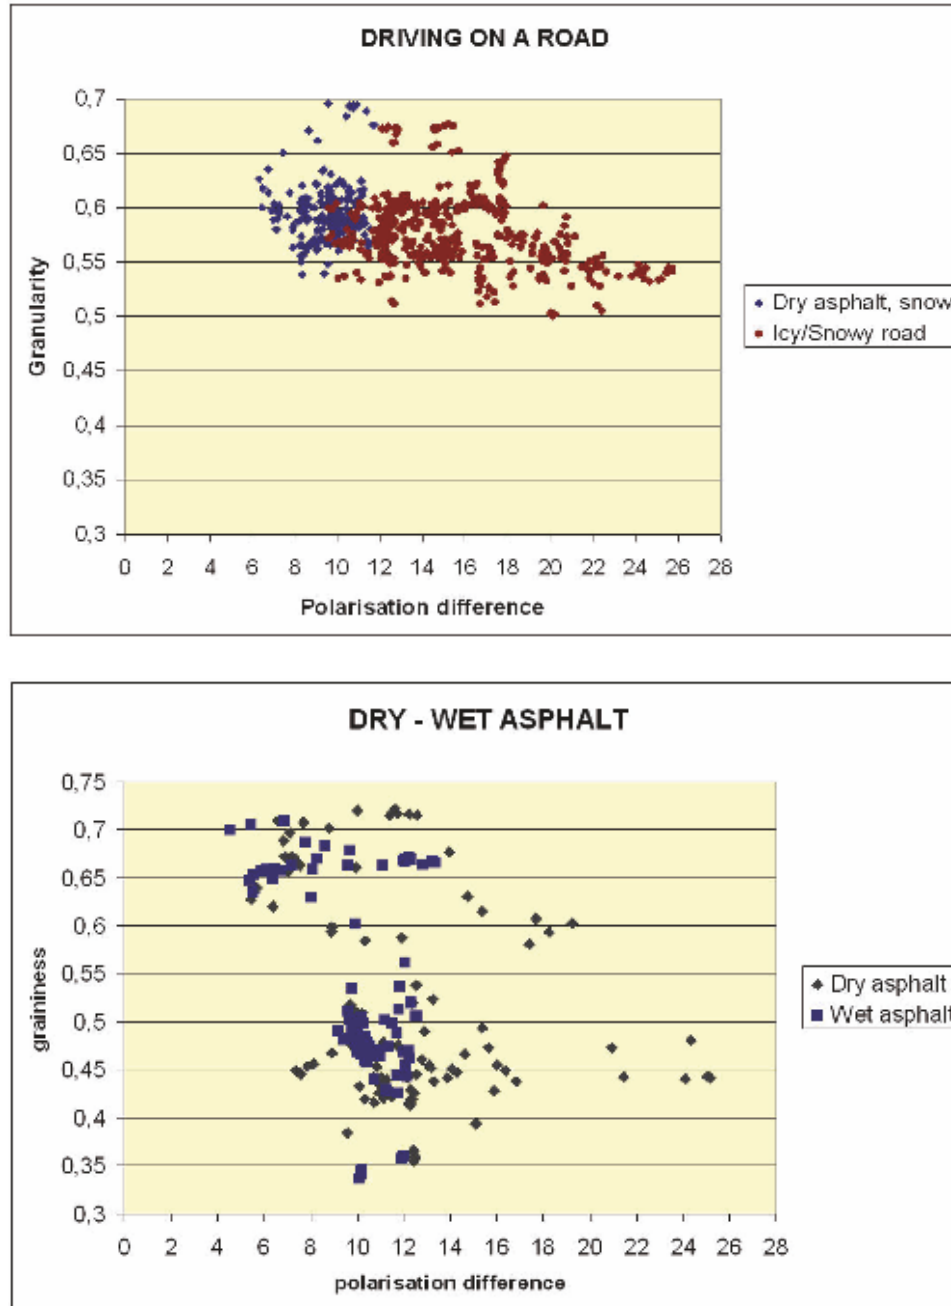
**Figure 1.8 Detection of snowy, wet, icy, and dry road surface conditions in winter conditions (top) and summer conditions (bottom). (from Kutila et al. 2009)**

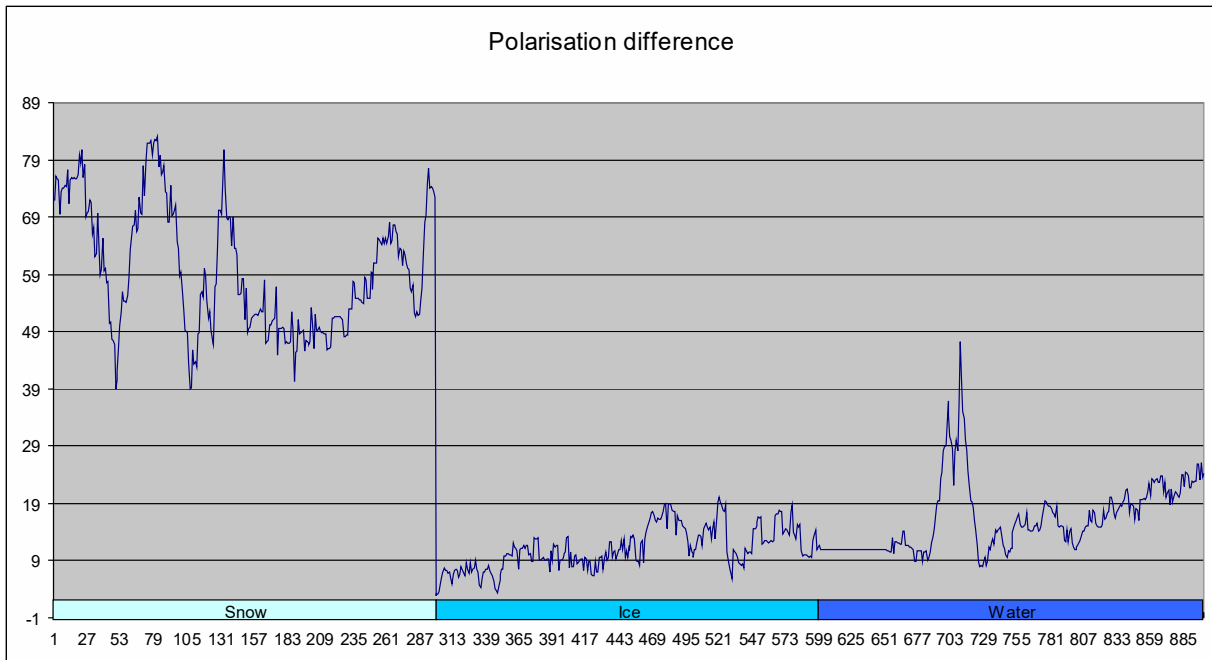
**Figure 1.9 Polarization (polarisation) difference = difference between vertically filtered and horizontal filtered images. (from Jokela et al., 2009).**

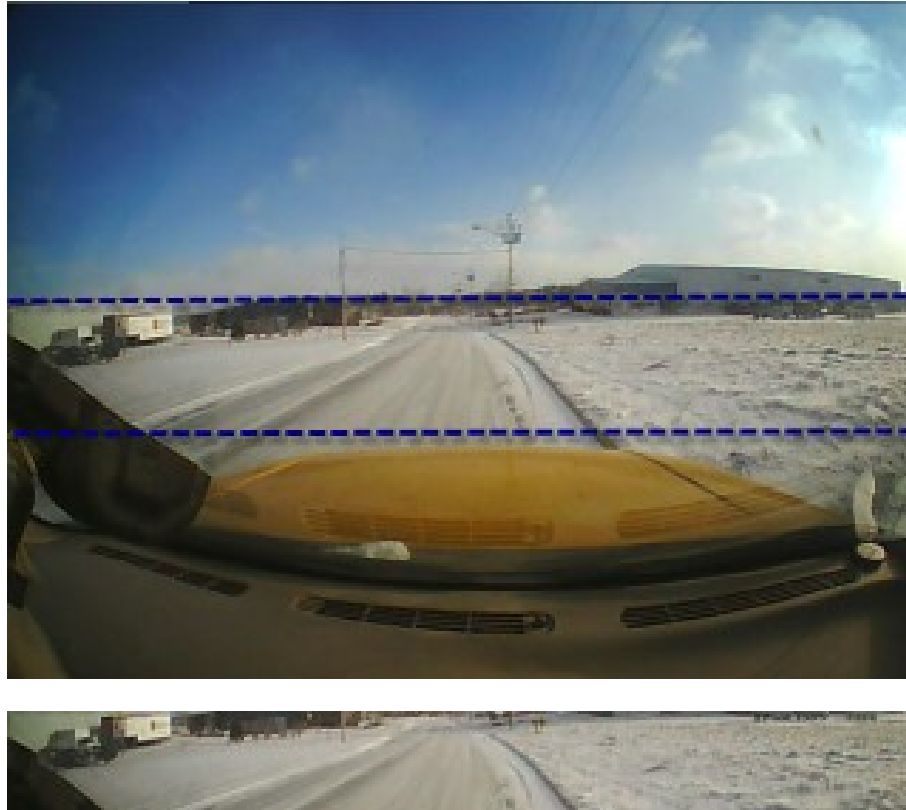
**Figure 1.11 Actual image (top) and cropped image with horizon and vehicle cropped (bottom). (from Omer and Fu, 2010)**

Omer and Fu (2010) evaluated a vehicle mounted camera system that could be installed in public vehicles such as buses and police cars, with GPS tagged images. This system would collect images as the vehicles travel their normal routes, and images would be uploaded to a central server for analysis when network connections are available. An example of the type of image captured, and how the image was cropped to only show relevant data, is shown in Figure 1.11.

Omer and Fu (2010) found that this system was accurate for snow covered vs. bare pavement when using color as the classifying image feature. For bare tracks with covered center conditions, they used grey-scale images and calculated horizontal and vertical gradients to determine the presence of straight lines. The authors describe some challenges with the initial training of the image processing system, but overall achieved 80%+ success for bare, snow-covered, and snow with bare track conditions, as shown in Table 1.2. They expect performance would improve with better quality cameras, more data for training, and better camera positioning specifically for this task.

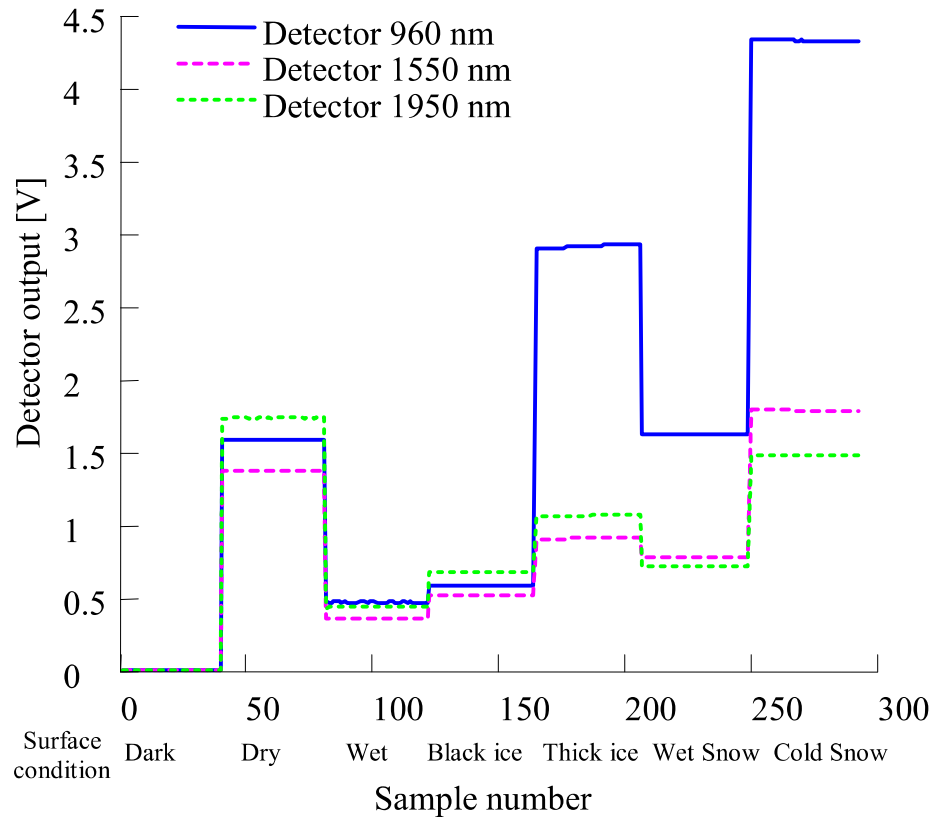
**Figure 1.14 Responses from the three detectors when exposed to different surface conditions. The surface was illuminated with a halogen lamp and the reflection was measured. The first samples are measured without illumination (Dark), and the others were measured when surface was illuminated. (from Jonsson 2011)**

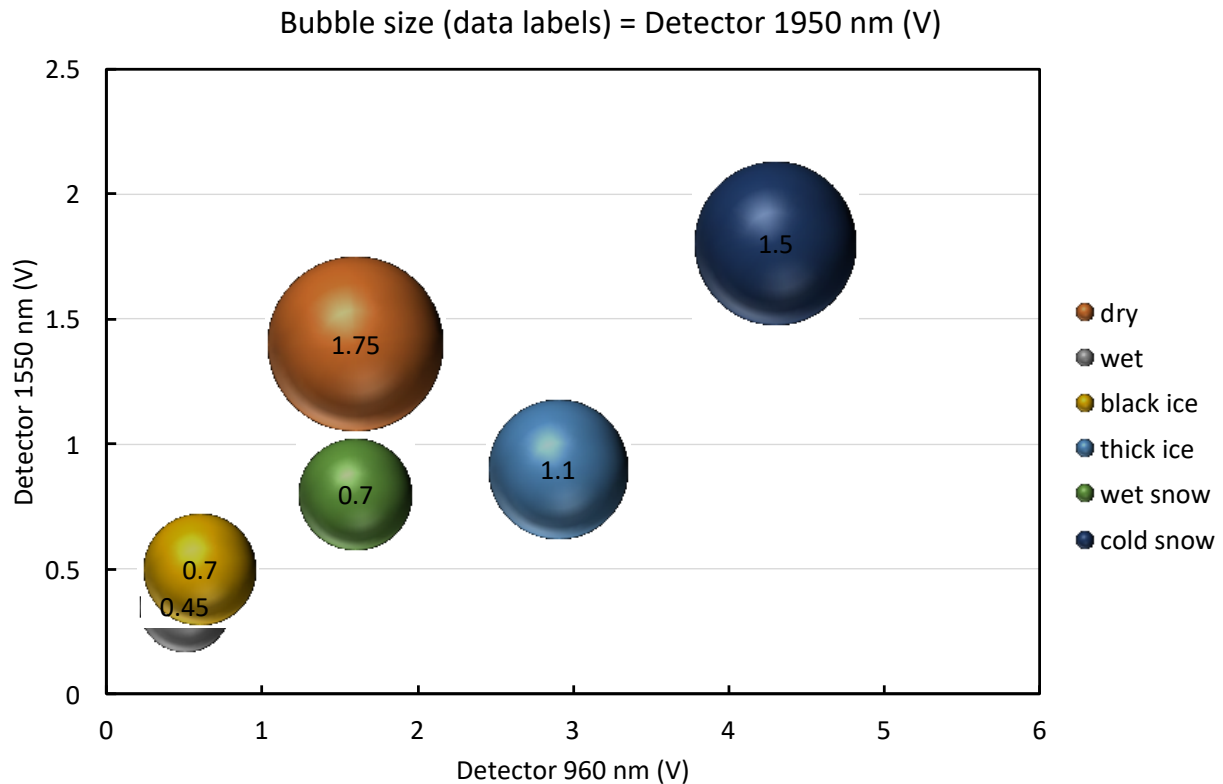
**Figure 1.15 A 3D plot of the detector readings. (adapted from Jonsson 2011)**

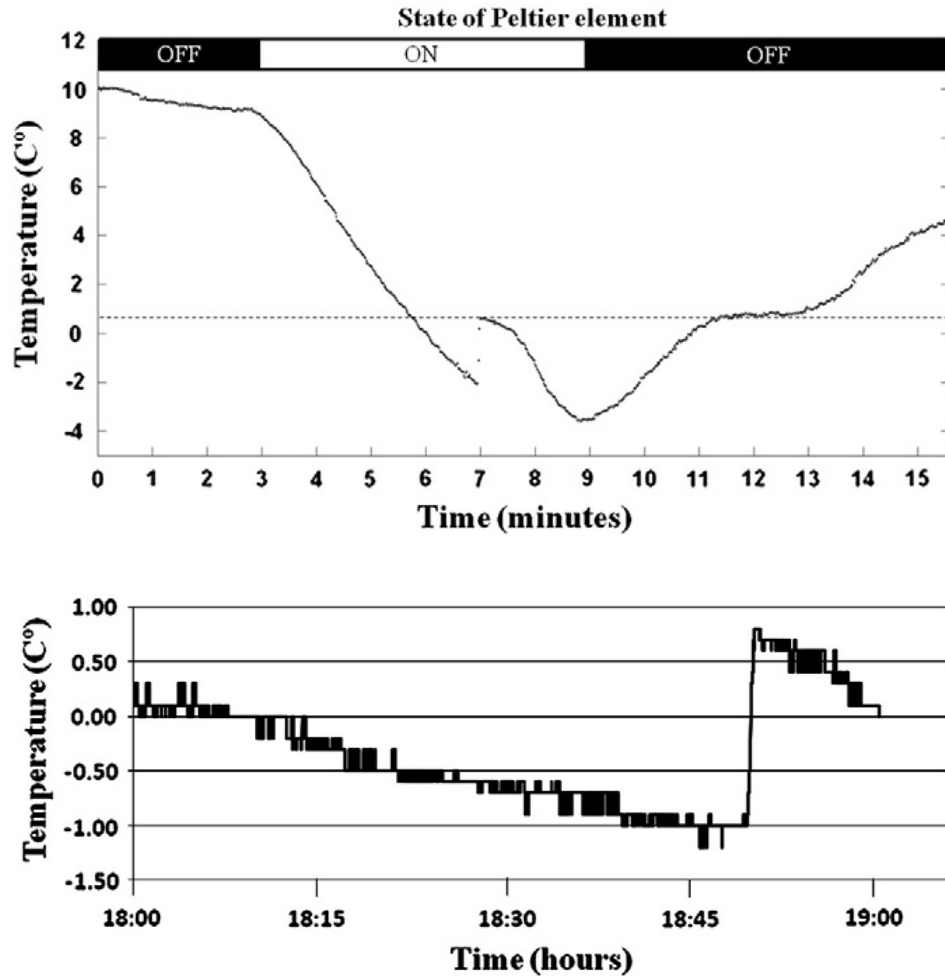
Figure 1.16 (Top) Temperature signal as ice formed on the asphalt in the laboratory climate chamber. Freezing occurred at 7 minutes and melting occurred between 11 and 13 minutes. (Bottom) The temperature signal as ice formed on the asphalt at the field site on 26 February. (from Riehm et al., 2012)

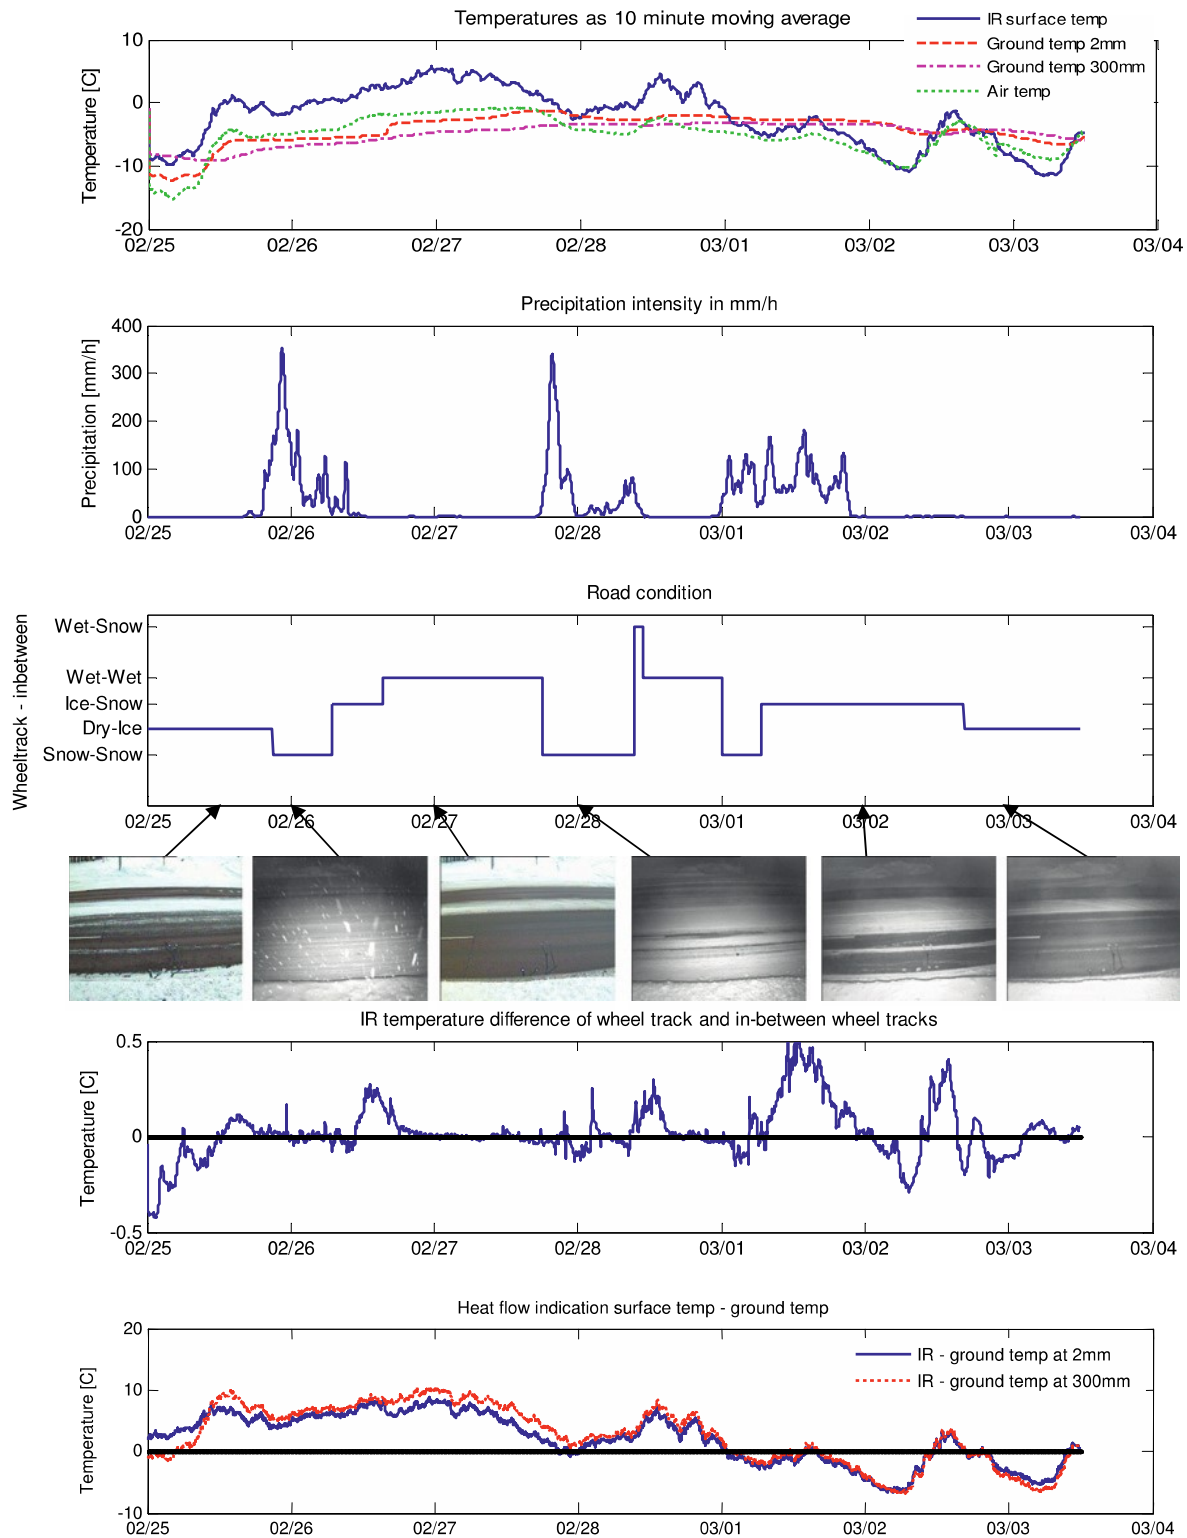
Figure 1.18 Data from a period with snow precipitation when the road surface was covered with snow or wet fluid. (from Jonsson and Riehm 2012)

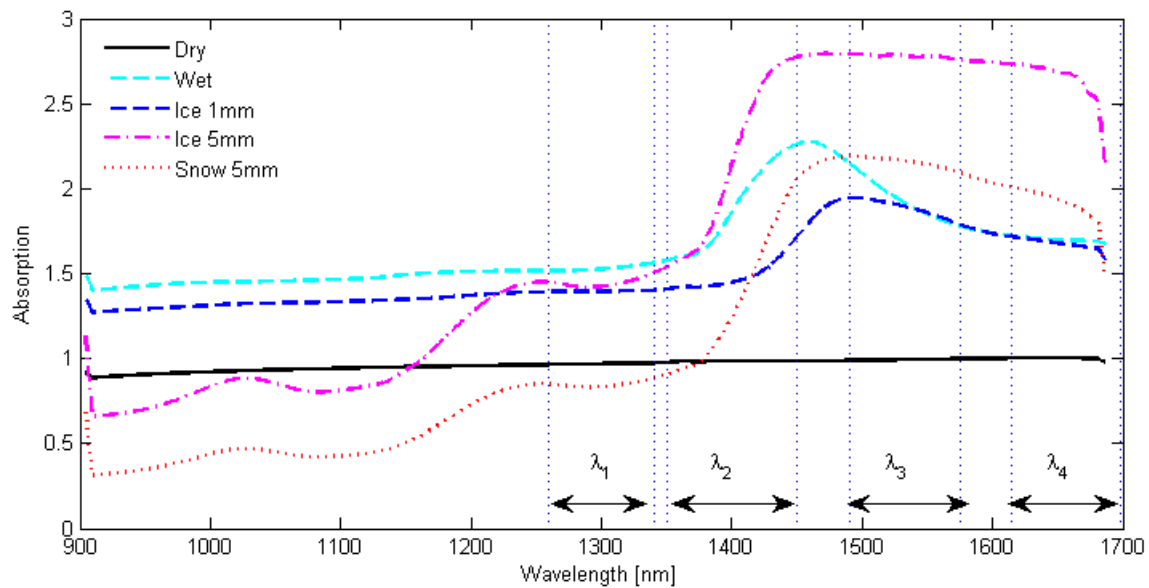
**Figure 1.19 Spectral curves obtained in the laboratory for a dry, wet, icy and snowy surface retrieved from a standard range spectrometer. (from Jonsson et al. 2015)**

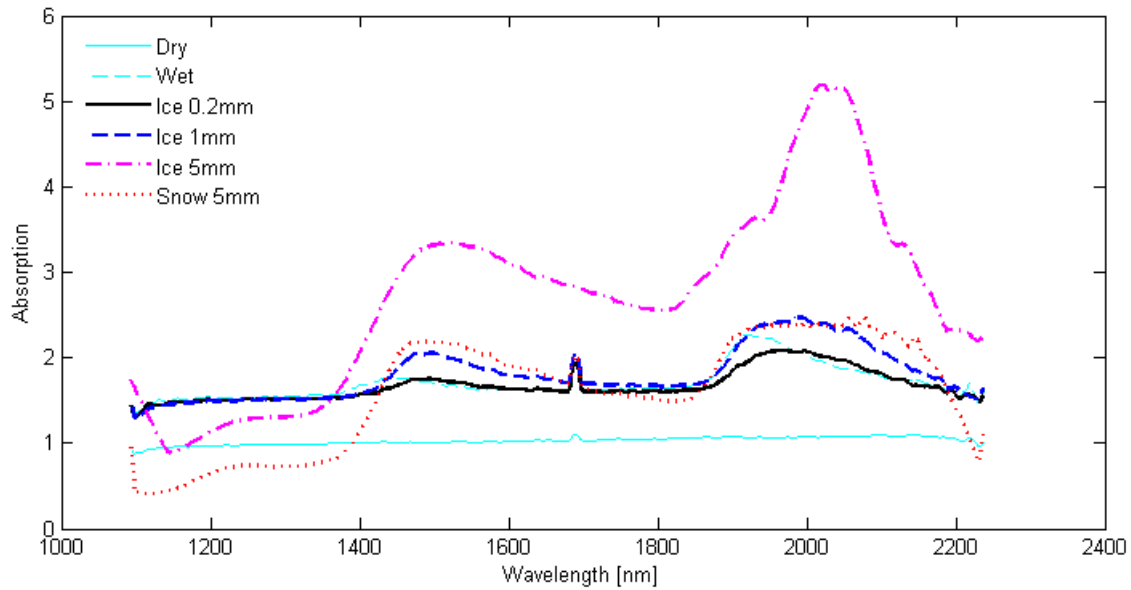
**Figure 1.20 Spectral curves obtained in the laboratory for a dry, wet, icy and snowy surface retrieved from an extended range spectrometer. (from Jonsson et al. 2015)**

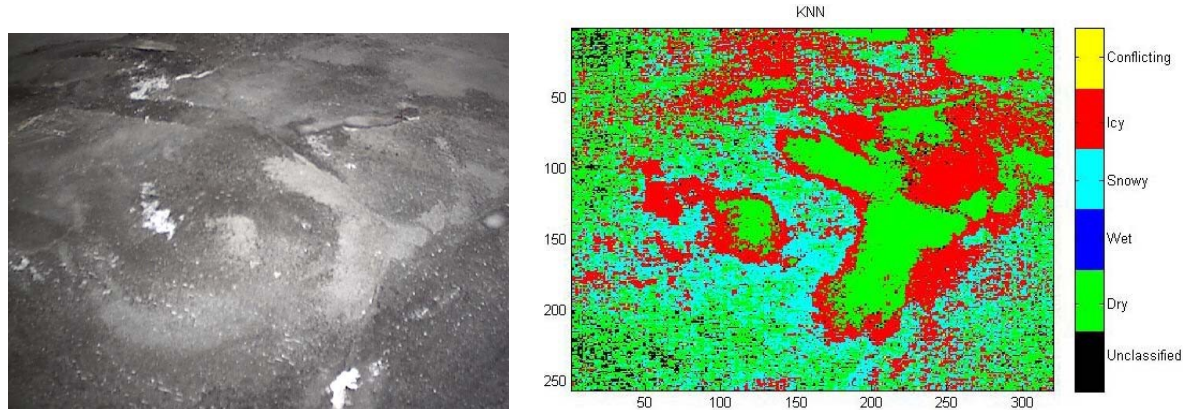
**Figure 1.21** A standard color image (left) and classification of the road condition (right). The road was dry and covered with icy patches and some snow spots. The surface and air temperature were approximately  $-10^{\circ}\text{C}$ . (from Jonsson et al. 2015)

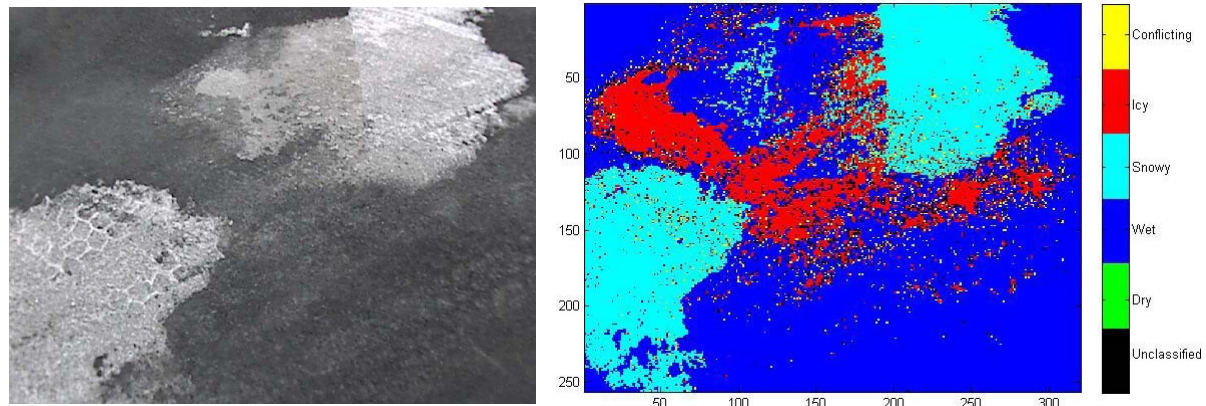
**Figure 1.22** A standard color image (left) and classification of the road condition (right). The road was wet with snow covered regions. The surface temperature was approximately  $0^{\circ}\text{C}$  and the air temperature was  $+2^{\circ}\text{C}$ . (from Jonsson et al. 2015)

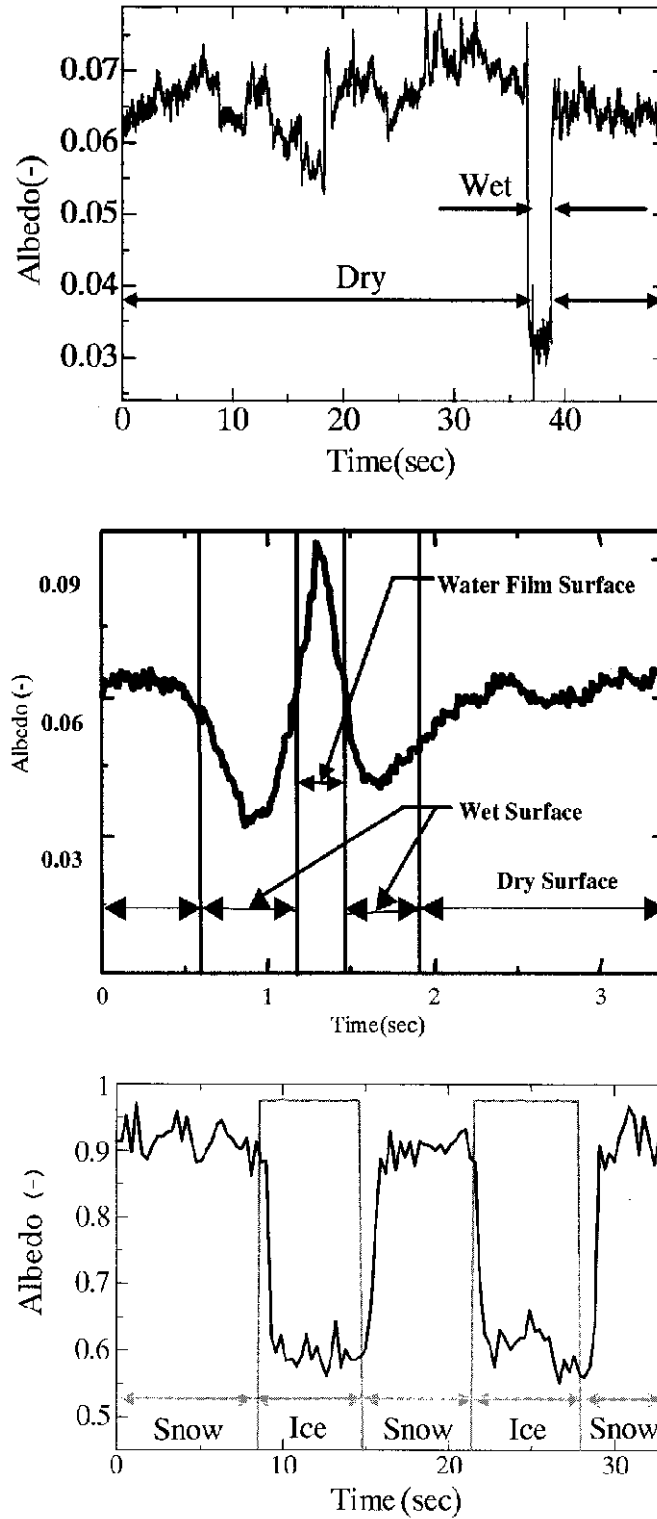
Figure 1.24 Albedo measurements on dry and wet conditions (top); dry, wet, and water film conditions (middle); and snow and ice conditions (bottom). (from Ogura et al., 2002)

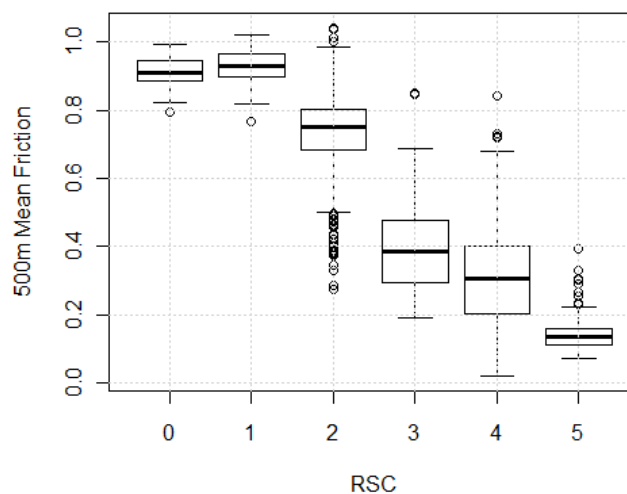
**Figure 1.25 Distribution of Mean Friction.** Note: RSC = Road Surface Condition; 0 = bare dry, 1 = bare wet, 2 = thin snow cover, 3 = slushy snow cover, 4 = partially snow cover, and 5 = mostly snow cover. (from Feng et al., 2010)

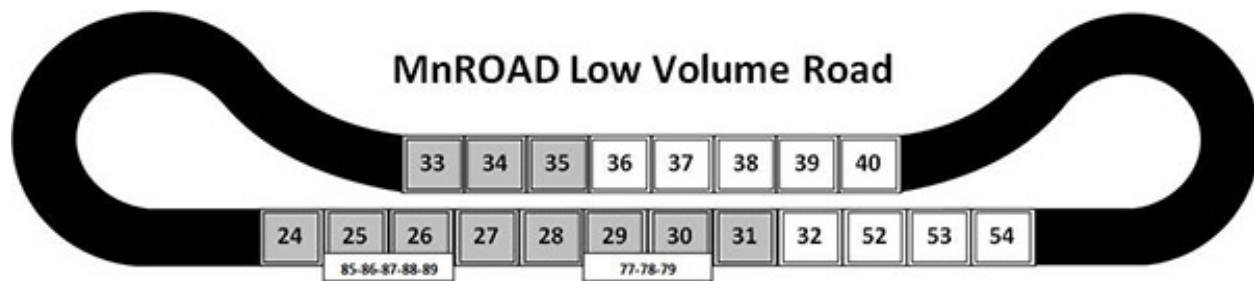
**Figure 2.2 MNRoad Research Facility Test Sections.** Data was collected on section 32 (impermeable concrete, Mn/DOT Special Mix - GGBFS, Specification 3102) and sub-sections 85 (porous concrete, Mn/DOT Specification 2301), 86 (porous asphalt, Mn/DOT Specification 2360), 87 (impermeable asphalt, Mn/DOT Specification SPWEB340B). Note that sub-sections 85-87 are located within sections 25 and 26. Sunlight conditions are similar for all sections.

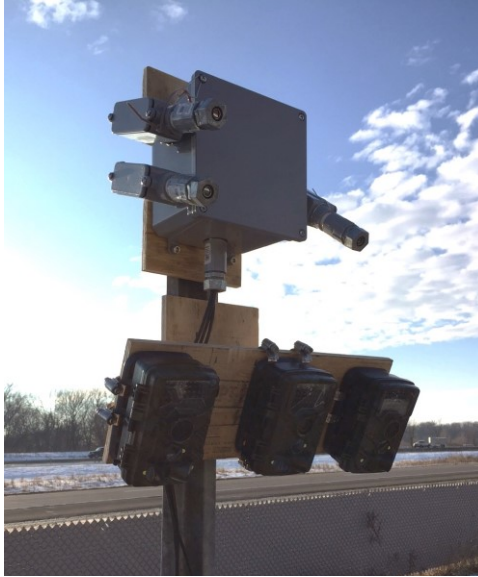
**Figure 2.3 Monitoring setup at the permeable asphalt test section: gray box at top is the enclosure and mount for the 3 infrared sensors; 3 trail cameras (two with polarized lenses) are mounted below the enclosure.**

Three thermal sensors (infrared thermistors, Micro-Epsilon Model CS) were installed in an enclosure at MNRoad to continuously measure pavement surface temperatures at three locations in one cross section (permeable asphalt, section 86). Temperature measurements represent approximately a circular portion of the roadway with approximately 30-cm diameter. Temperatures were taken at 10-second intervals and stored in 5-minute averages by a Campbell Scientific CR-1000 data logger, with roughly 25,000 sets of measurements recorded from Jan 19 – April 20, 2017. Two enclosures were used for the IR thermistors: the first enclosure (“Box 1”) was installed on Jan 19, 2017, with an RM Young shielded air temperature sensor was added to the site on Feb 10. Box 1 was uninstalled March 16 and replaced with a second set of three IR sensors in another enclosure (“Box 2”). All equipment, including Box 2, was removed on April 20. During the data collection period (Jan 19 – Apr 20), only a few snowfall events were observed, the largest of which occurred on Jan 25, Feb 7, and Mar 12. The setup for one cross section is shown with 3 trail cameras in Figure 2.3.

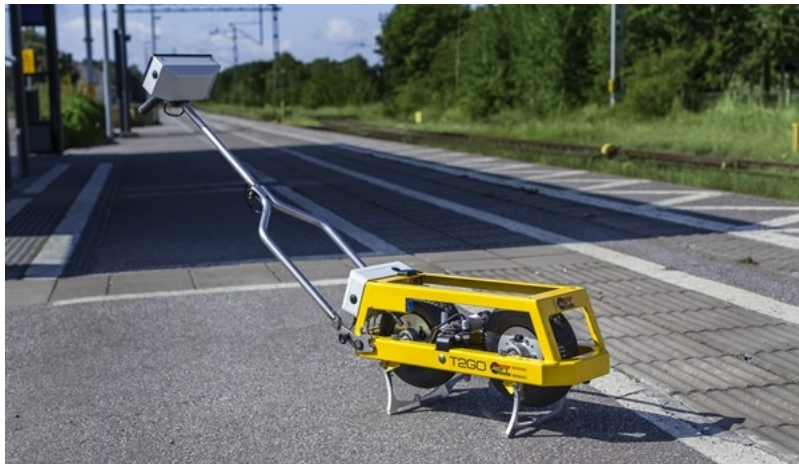
Figure 2.5 Sarsys-ASFT T2Go portable friction tester (<https://www.sarsys-asft.com/t2go>).

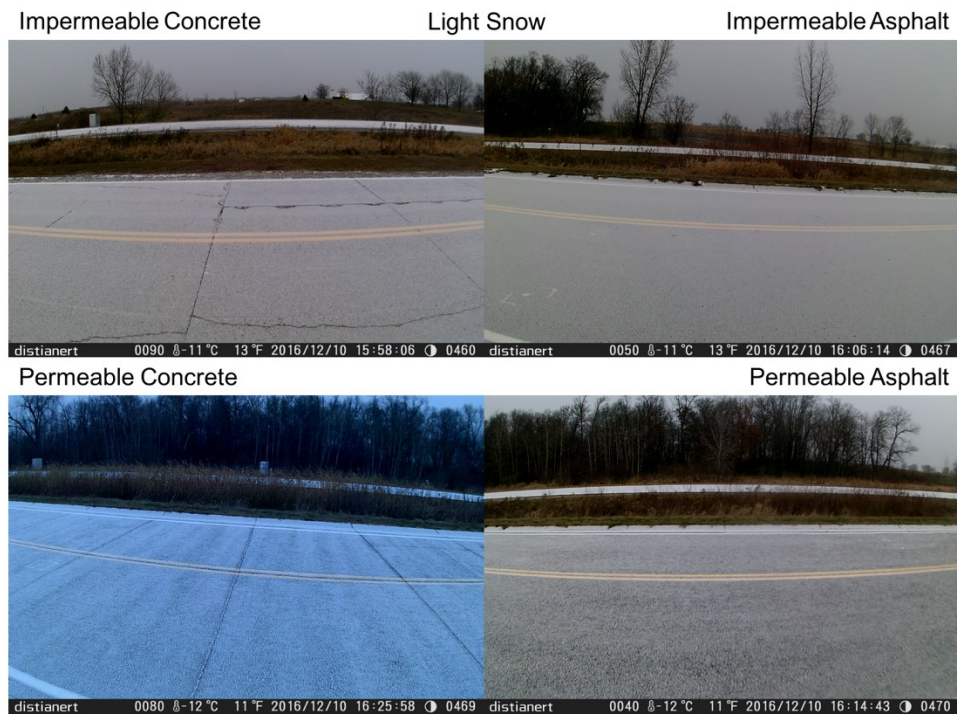
Figure 3.3 Permeable and Impermeable pavements at MNRoad during light snow conditions.

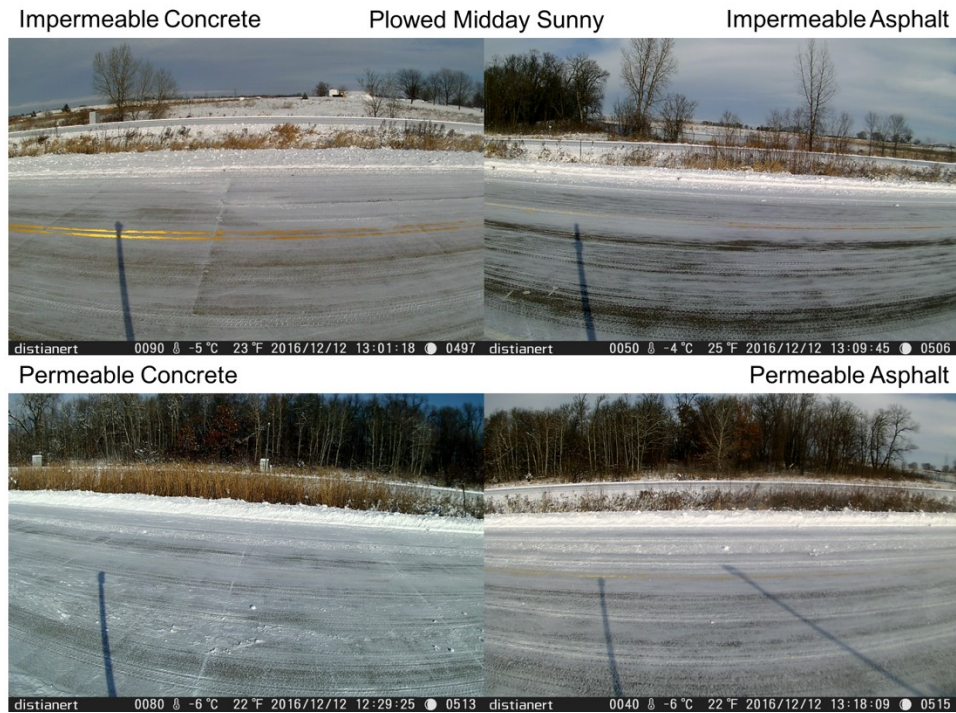
Figure 3.4 Permeable and Impermeable pavements at MNRoad after a snow storm and subsequent plowing.

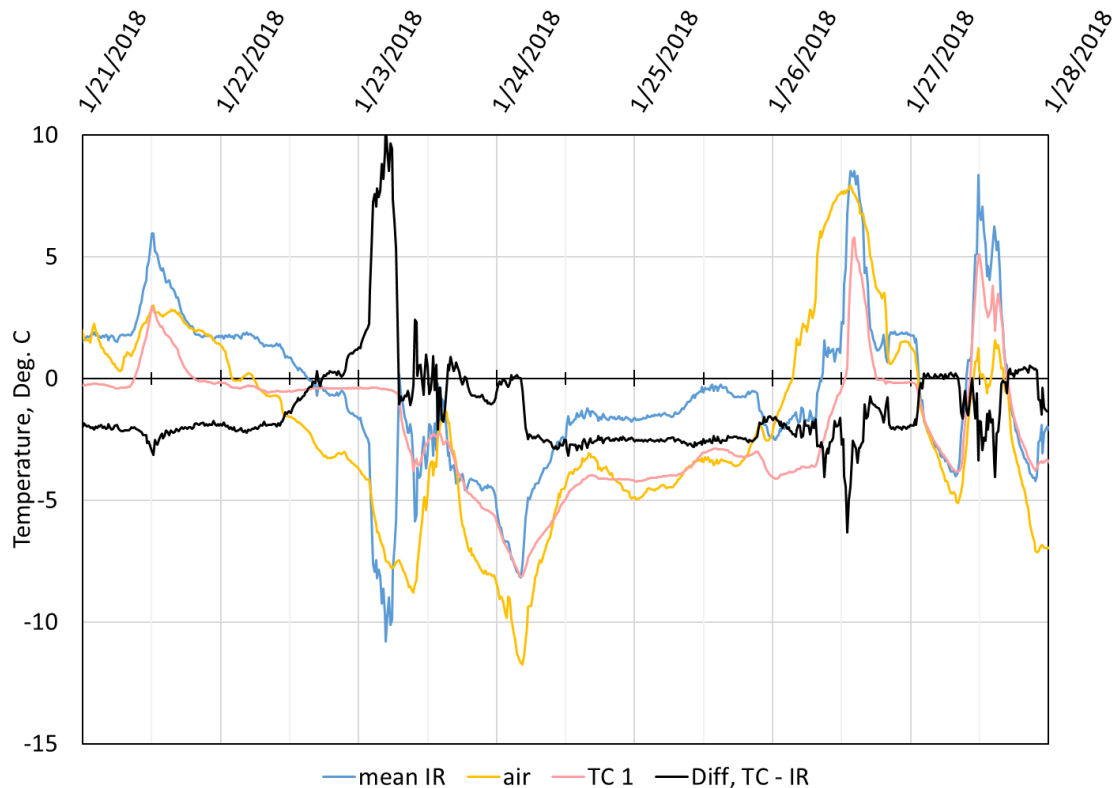
**Figure 3.11 Infrared (“Mean IR”), air, and sub-surface thermocouple temperature (“TC 1”) data recorded at the Abbott/41<sup>st</sup> permeable asphalt site during a ~12-inch snowstorm from late evening on Jan 22 through early morning Jan 23, 2018. Data from the three infrared temperature sensors are shown averaged together into a single time series (blue line) to simplify presentation. The sub-surface temperature (“TC 1”) is located at a depth of roughly one-half inch below the pavement surface. The black line is the difference between the sub-surface temperature and mean surface IR temperature.**

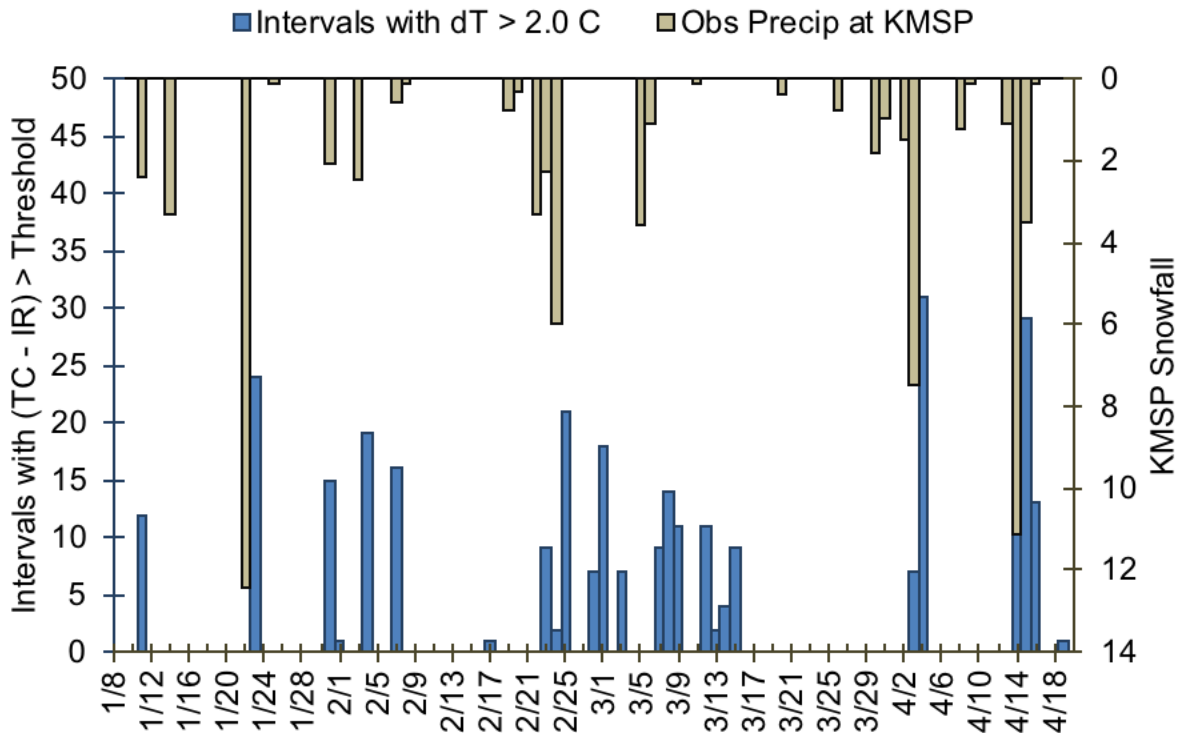
Figure 3.13 Number of measurement intervals per day with a pavement – infrared temperature difference of 2.0 °C or greater during January – April, 2018 at the Abbott/41<sup>st</sup> site, potentially indicating snow or ice on the road surface. Snowfall observed at the Minneapolis-St. Paul Airport shown for reference.

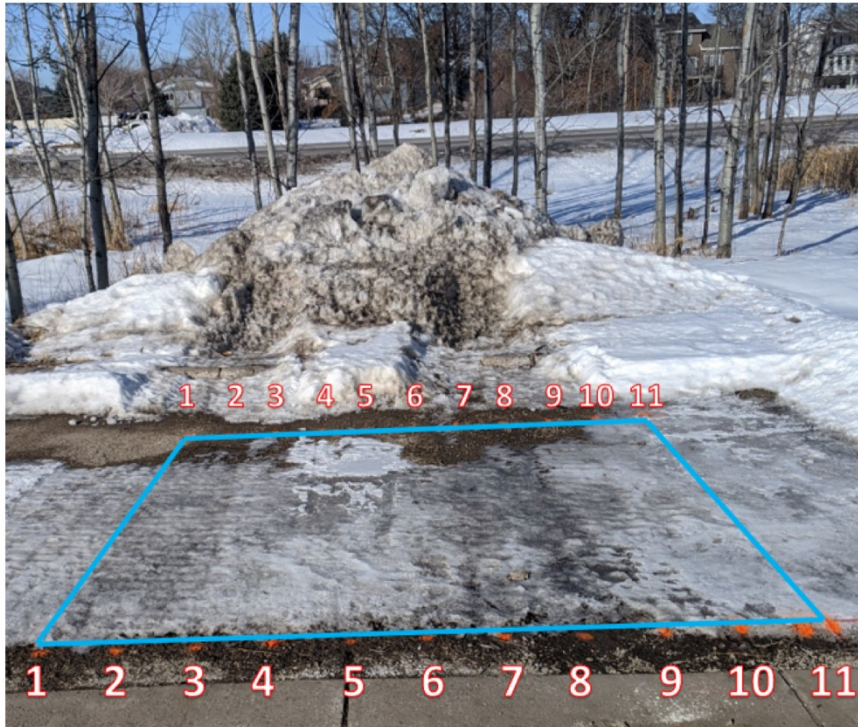
Figure 3.16 Surface friction, surface temperature, air temperature, and photo of testing space for Permeable Pavement at Blaine Fire Department.

When comparing the friction, the impermeable section has more friction (average  $\mu = 1.18$ ) and warmer surface temperature (average  $T = 7.43^{\circ}\text{C}$ ) compared to the permeable pavement (average  $\mu = 0.39$ , average  $T = -0.29^{\circ}\text{C}$ ). The photos illustrate that the permeable section has snow and ice cover while the impermeable section does not. This accounts for the temperature difference because the snow and ice on the pavement surface are typically at or below the air temperature ( $-1 < T_{\text{air}} < 1^{\circ}\text{C}$ ) while bare pavement during sunny days are typically warmer than air temperature due to absorption of solar radiation. The presence of snow and ice on the surface also explains the difference in surface friction. The amount and roughness of the snow and ice on the permeable pavement surface was such that the friction (average  $\mu = 0.39$ ) exceed the manufacturer recommendations for caution ( $\mu < 0.35$ ).
