# Permeable Pavement for Road Salt Reduction

St. Anthony Falls Laboratory  
University of Minnesota

**JUNE 2020**

Research Project  
Final Report 2020-15

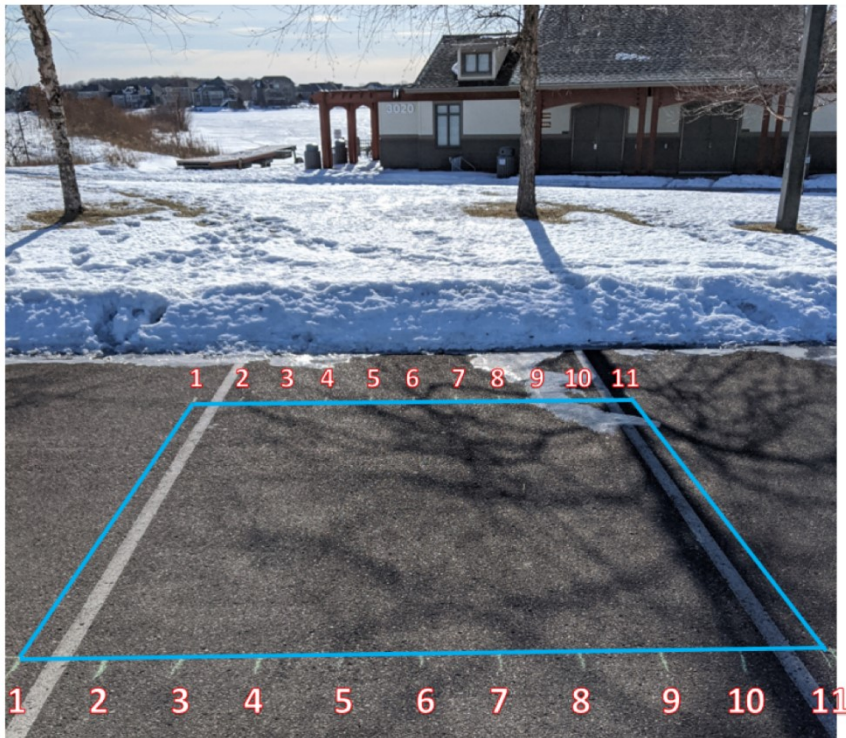
Figure 3.17 Surface friction, surface temperature, air temperature, and photo of testing space for Impermeable Pavement at Blaine Lakeside Commons Park.

When comparing the friction, the impermeable section has similar friction (average  $\mu = 1.17$ ) and surface temperature (average  $T = -1.12^{\circ}\text{C}$ ) compared to the permeable pavement (average  $\mu = 1.18$ , average  $T = -1.54^{\circ}\text{C}$ ). The photos illustrate that the permeable and impermeable sections have bare pavement throughout, except for a small portion in the top right section of the impermeable asphalt section. The ice in this section is evident from the friction data in Figure 3.17, as shown by transects 9, 10, and 11 which all decrease in friction at distances of 2 - 3 meters. Transects 9 and 10 decrease to nearly  $\mu = 0.2$ , which is below the manufacturer recommendation for unsafe pedestrian travel ( $\mu < 0.25$ ).

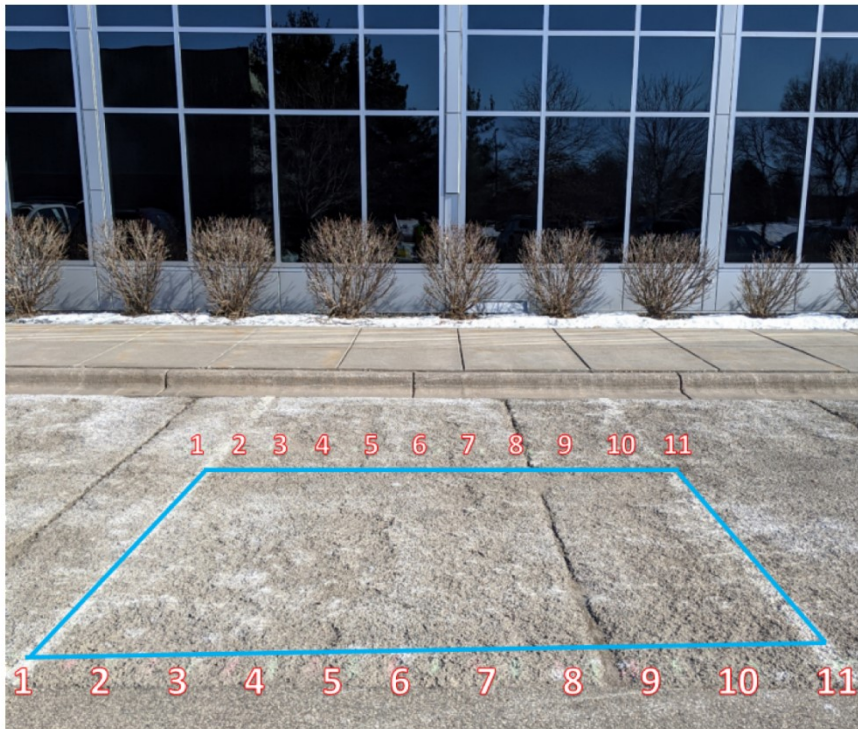
Figure 3.20 Surface friction, surface temperature, air temperature, and photo of testing space for Permeable Pavement at Blaine Public Works Facility.

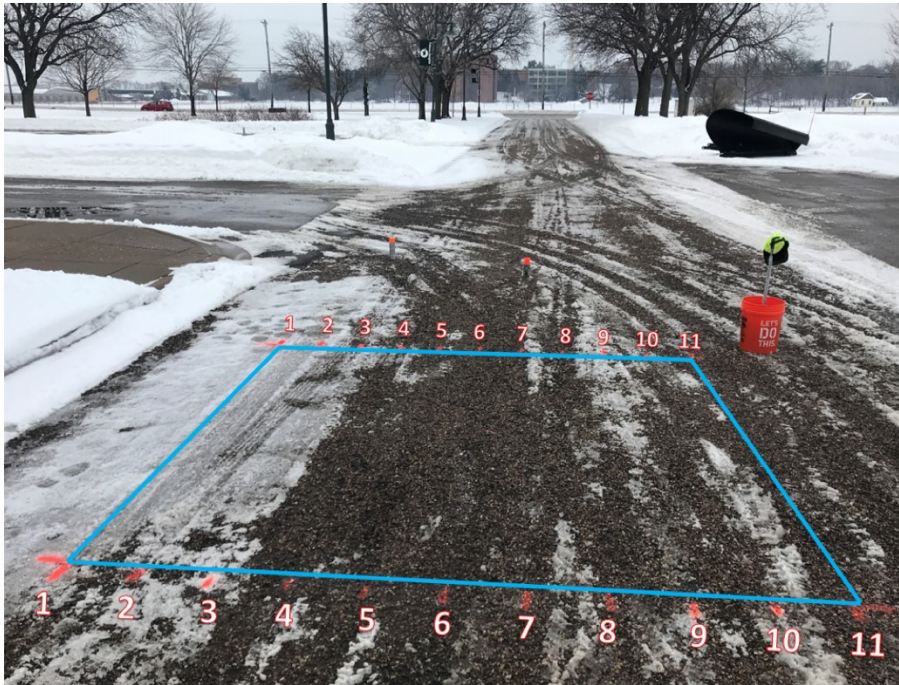
Figure 3.22 Surface friction, surface temperature, air temperature, and photo of testing space for Permeable Pavement at Falcon Heights City Hall.

When comparing the friction, the impermeable section has more friction (average  $\mu = 0.70$ ) and cooler surface temperature (average  $T = -0.12^{\circ}\text{C}$ ) compared to the permeable pavement (average  $\mu = 0.55$ , average  $T = 0.44^{\circ}\text{C}$ ). The photos illustrate that both the permeable and impermeable sections have some snow and ice on the surface, though the permeable has visibly more snow and ice. The ice in both sections is evident from the friction data in Figures 3.21 and 3.22, as shown by several transects that decrease in friction to values of approximately  $\mu = 0.2$ . Friction values below ( $\mu < 0.25$ ) are categorized as unsafe for pedestrian travel according to the manufacturer recommendations. Surface temperatures in both the permeable and impermeable are approximately equal to each other and the ambient air temperature during testing. This suggests that solar radiation was not important for this site at this time. As shown in the photos, pavements are both asphalt of approximately the same color and the measurements were collected on an overcast, cloudy day and thus solar radiation was likely minimal.

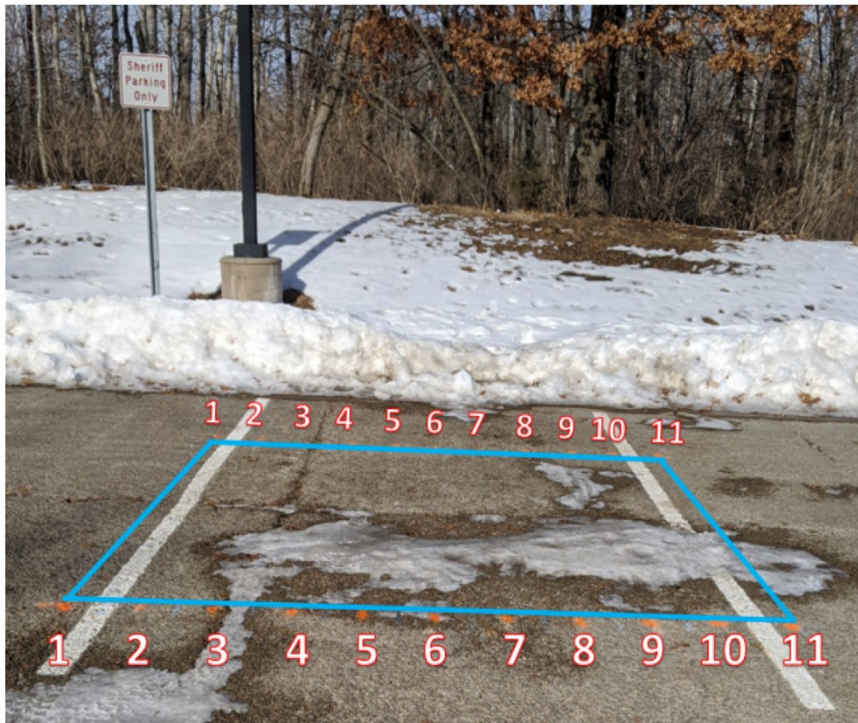
Figure 3.30 Surface friction, surface temperature, air temperature, and photo of testing space for Permeable Pavement at Mahtomedi Public Works Facility.

When comparing the friction, the impermeable section has more friction (average  $\mu = 0.94$ ) and cooler surface temperature (average  $T = 1.46^{\circ}\text{C}$ ) compared to the permeable pavement (average  $\mu = 0.75$ , average  $T = 3.23^{\circ}\text{C}$ ). The photos illustrate that both the permeable and impermeable sections have some snow and ice on the surface, though the permeable has visibly more snow and ice. The ice in both sections is evident from the friction data in Figures 3.29 and 3.30, as shown by several transects that decrease in friction to values of approximately  $\mu = 0.2$ . Friction values below ( $\mu < 0.25$ ) are categorized as unsafe for pedestrian travel according to the manufacturer recommendations. The difference in temperature (impermeable average  $T = 1.46^{\circ}\text{C}$  vs. permeable average  $T = 3.23^{\circ}\text{C}$ ) can be explained by the difference in shading. The permeable asphalt is in full sunlight compared to impermeable asphalt which has partial shade from trees. Thus, the impermeable likely absorbs less solar radiation due to shading. This is supported by the observation that the permeable asphalt is warmer than the ambient air temperature whereas the impermeable asphalt is roughly equivalent to the ambient air temperature.

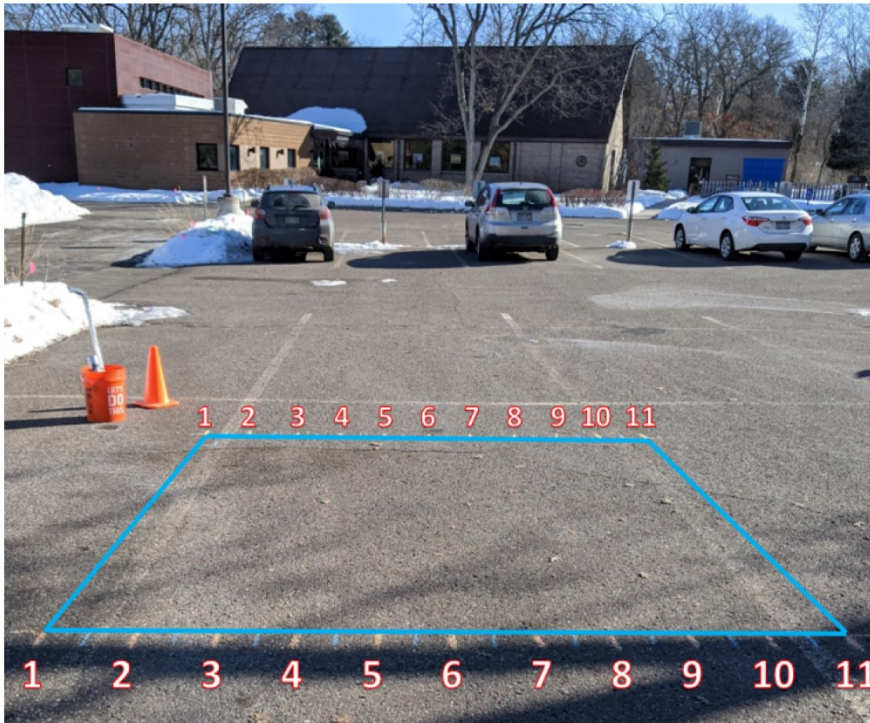
Figure 3.31 Surface friction, surface temperature, air temperature, and photo of testing space for Impermeable Pavement at Mahtomedi Universalist Church.

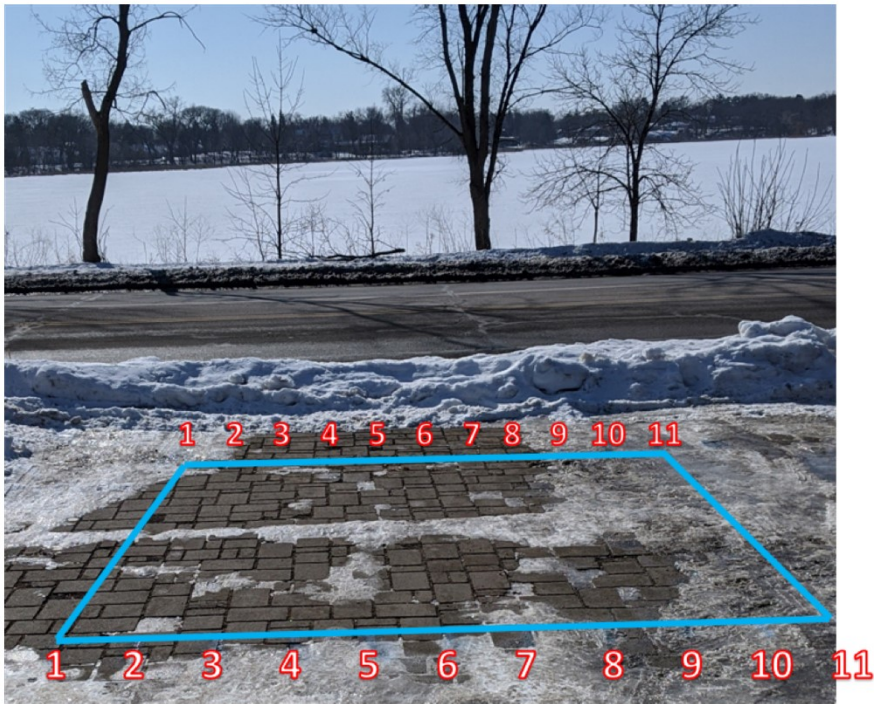
Figure 3.36 Surface friction, surface temperature, air temperature, and photo of testing space for Permeable Pavement at Minneapolis Pearl Park.

When comparing the friction, the impermeable section has similar friction (average  $\mu = 0.48$ ) and warmer surface temperature (average  $T = 1.31^{\circ}\text{C}$ ) compared to the permeable pavement (average  $\mu = 0.45$ , average  $T = -1.12^{\circ}\text{C}$ ). The photos illustrate that both the permeable and impermeable sections have some snow and ice on the surface, though the permeable has visibly more snow and ice. The ice in both sections is evident from the friction data in Figures 3.35 and 3.36, as shown by most of the transects exhibiting friction values between 0.2 and 0.8. Friction values below ( $\mu < 0.25$ ) are categorized as unsafe for pedestrian travel according to the manufacturer recommendations. The difference in temperature (impermeable average  $T = 1.31^{\circ}\text{C}$  vs. permeable average  $T = -1.12^{\circ}\text{C}$ ) can be explained by the difference in pavement color. The permeable paver blocks are lighter in color compared to impermeable asphalt, and thus likely absorbs less solar radiation. This is supported by the observation that the permeable block pavers are similar in temperature as the ambient air temperature (NWS temp) whereas the impermeable asphalt is warmer than the ambient air temperature.

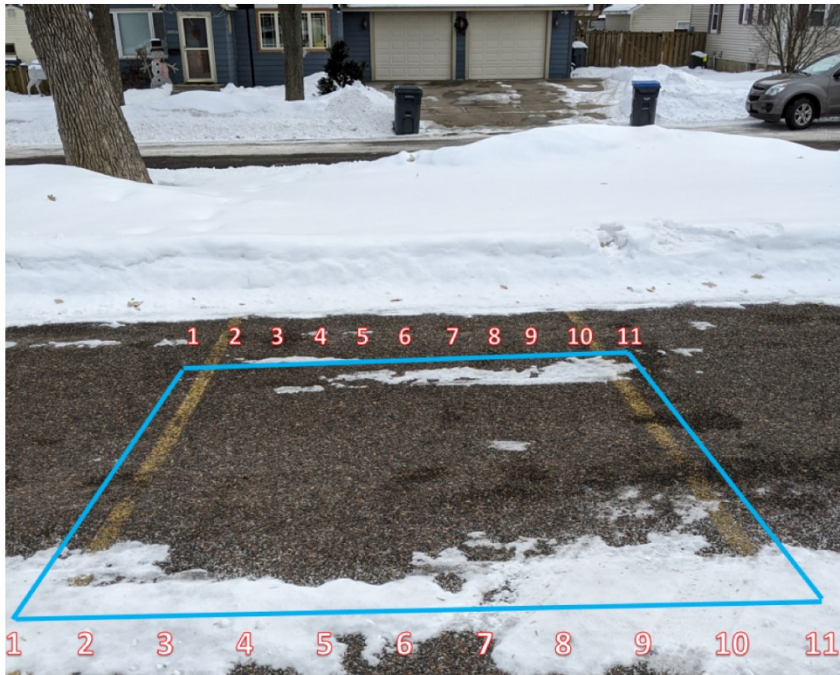
Figure 3.38 Surface friction, surface temperature, air temperature, and photo of testing space for Permeable Pavement Church of St. Peter in North St. Paul, MN . (Note: Photo was taken 6 days after friction and temperature measurements and may not accurately illustrate the pavement conditions when measured. Transect locations are accurate.)

When comparing the friction, the impermeable section has similar friction (average  $\mu = 1.18$ ) and similar surface temperature (average  $T = 5.67^{\circ}\text{C}$ ) compared to the permeable pavement (average  $\mu = 1.15$ , average  $T = 5.55^{\circ}\text{C}$ ). For the purposes of this report, friction values of  $\mu \geq 1$  are considered to have the same level of friction. The photos illustrate that the impermeable section has bare pavement and the permeable pavement has a small portion covered with snow. The snow on the permeable section is evident from the friction data in Figure 3.38, as shown by some transects at distances less than 0.5m with friction values of 0.4 - 0.6. Overall, though, the impermeable and permeable asphalt have similar friction and surface temperature.

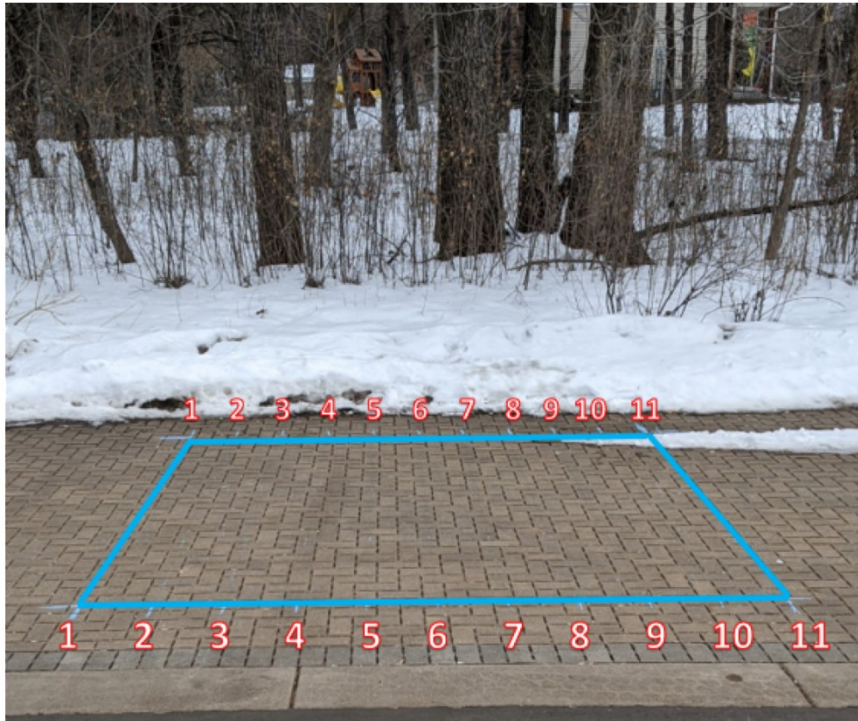
Figure 3.40 Surface friction, surface temperature, air temperature, and photo of testing space for Permeable Pavement at North St. Paul Preservation Park.

When comparing the friction, the impermeable section has more friction (average  $\mu = 0.84$ ) and cooler surface temperature (average  $T = 8.90^{\circ}\text{C}$ ) compared to the permeable pavement (average  $\mu = 1.24$ , average  $T = 6.27^{\circ}\text{C}$ ). The photos illustrate that both the permeable and impermeable sections have some snow and ice on the surface. The ice in both sections is evident from the friction data in Figures 3.39 and 4.40, as shown by some transects decreasing in friction to values of 0.4 (impermeable) and 0.2 (permeable) at distances of 2.5 - 3m. Friction values below ( $\mu < 0.25$ ) are categorized as unsafe for pedestrian travel according to the manufacturer recommendations. The difference in temperature (impermeable average  $T = 8.90^{\circ}\text{C}$  vs. permeable average  $T = 6.27^{\circ}\text{C}$ ) can be explained by the difference in pavement color. The permeable paver blocks are lighter in color compared to impermeable asphalt, and thus likely absorbs less solar radiation. This is supported by the observation that the permeable block pavers are similar in temperature as the ambient air temperature (T2Go temp) whereas the impermeable asphalt is warmer than the ambient air temperature.

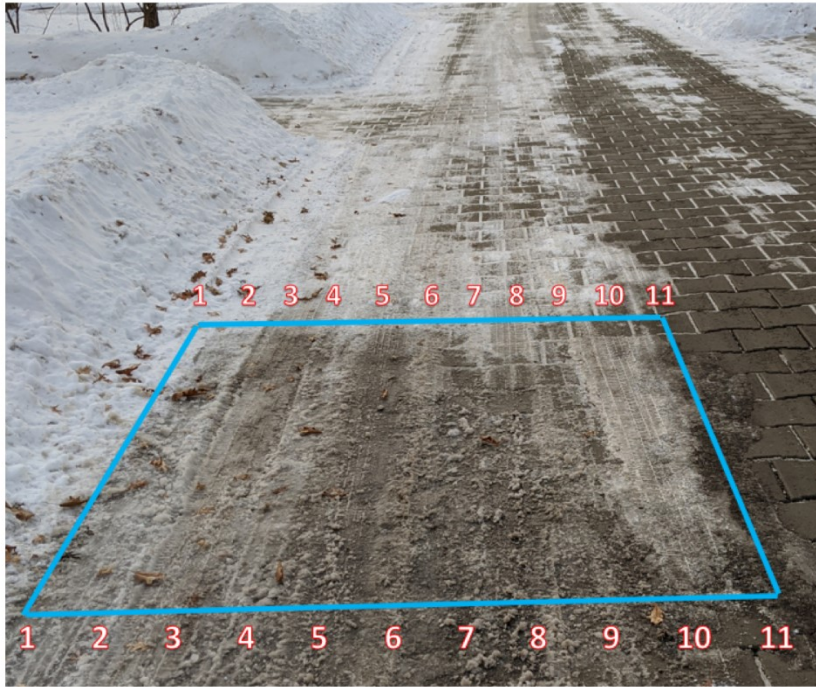
Figure 3.47 Surface friction, surface temperature, air temperature, and photo of testing space for Permeable Pavement at Janice Street in Shoreview, MN. (Note: Photo was taken 8 days after friction and temperature measurements and may not accurately illustrate the pavement conditions when measured. Transect locations are approximate.)

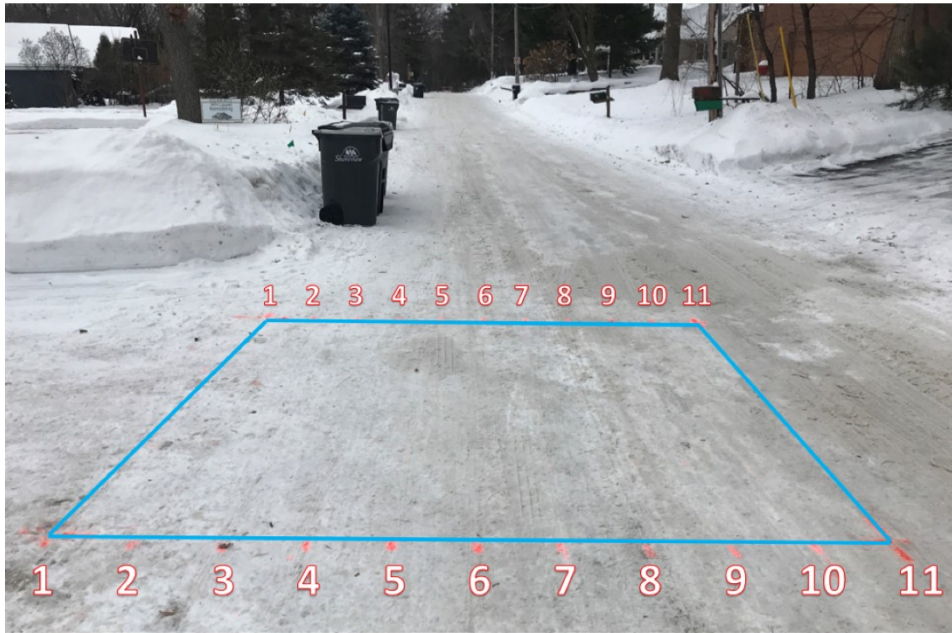
Figure 3.49 Surface friction, surface temperature, air temperature, and photo of testing space for Permeable Pavement at Oakridge Avenue in Shoreview, MN.

When comparing the friction, the impermeable section has less friction (average  $\mu = 0.30$ ) and warmer surface temperature (average  $T = -1.21^{\circ}\text{C}$ ) compared to the permeable pavement (average  $\mu = 0.35$ , average  $T = -2.79^{\circ}\text{C}$ ). The photos illustrate that the impermeable section has snow and ice cover for most transects and the permeable pavement is completely covered with snow. The snow and ice on the impermeable section is evident from the friction data in Figure 3.48, as shown by transects 3 - 11 with friction values of 0.1 to 0.4 throughout the distance. By contrast, the permeable pavement has snow cover for all transects, but friction values of 0.35 to 0.4 for nearly all transects and distance (Figure 3.48). The packed snow on the permeable pavement appears to have more friction than the ice on the impermeable pavement. Both pavements, however, are categorized as unsafe ( $\mu < 0.25$ ) or cautious ( $\mu < 0.35$ ) according to the manufacturer recommendations.

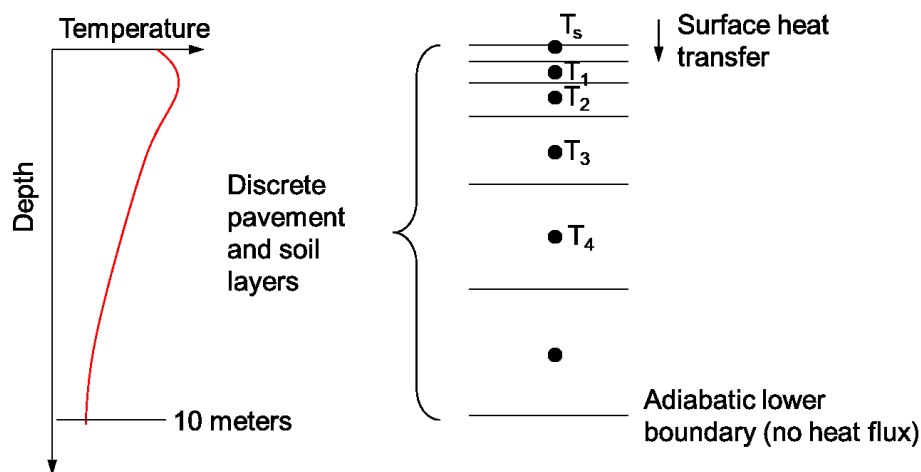
Figure 4.1 Schematic of the one-dimensional pavement temperature models.

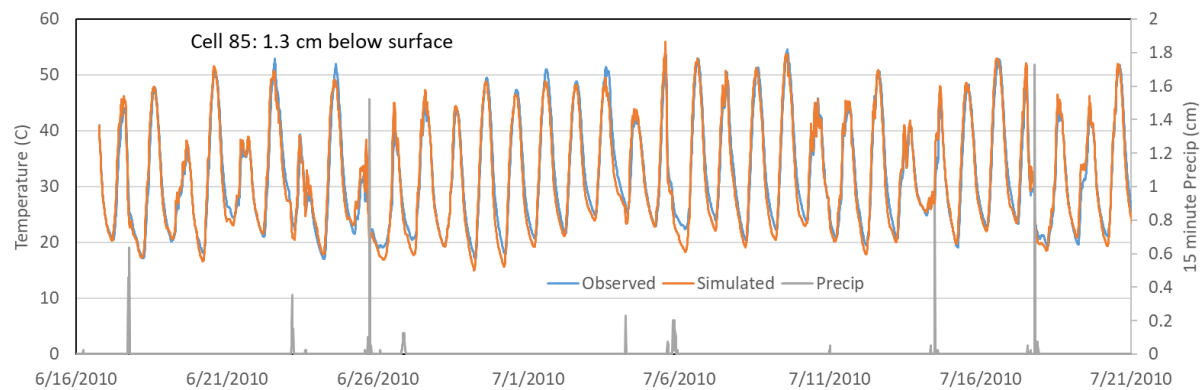
**Figure 4.3 Time series of observed and simulated pavement temperature for MnROAD cell 85 (permeable concrete), 1.3 cm below the surface.**

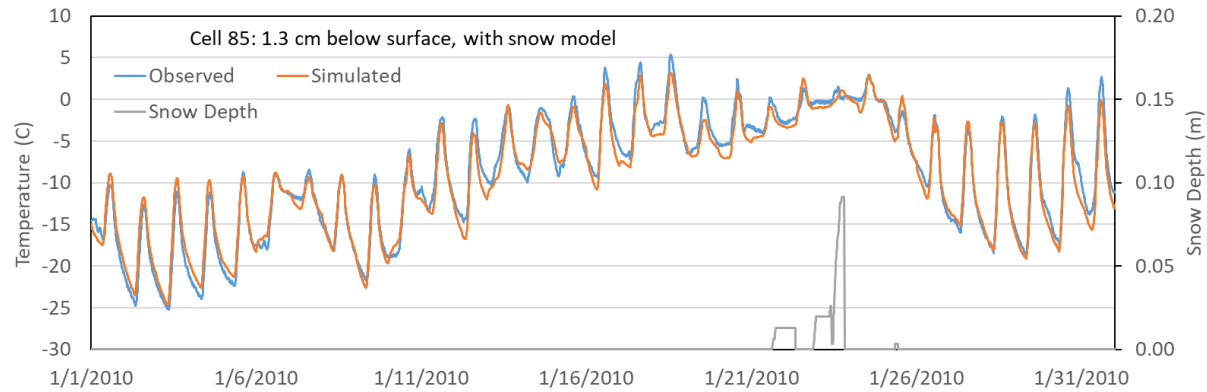
**Figure 4.4 Time series of observed and simulated pavement temperature for MnROAD cell 85 (permeable concrete), 1.3 cm below the surface, in January 2010.**
