FINAL REPORT

Assessment of the Performance of Vehicular Traffic Signal Assemblies during Hurricane Force Winds

Contract No.: BDV29 977-27

Wall of Wind Research Facility

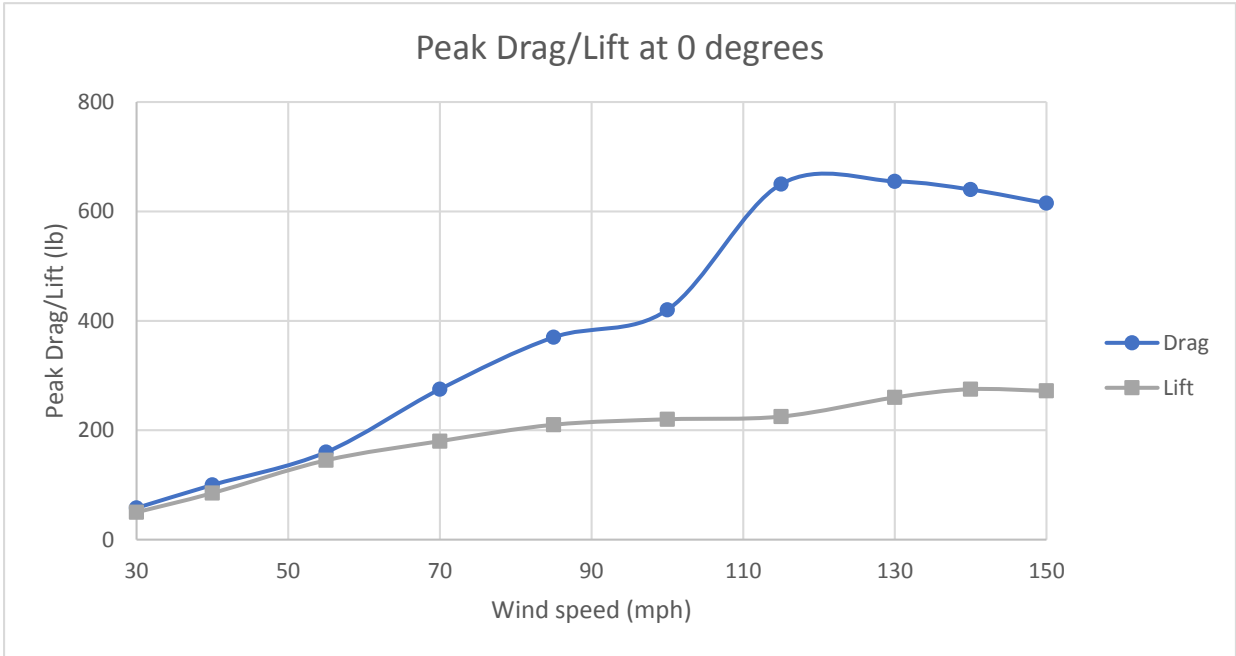
Figure 23: Drag (F_y) and lift (F_x) forces on the traffic signals at 0 degrees: a) Mean; b) Peak

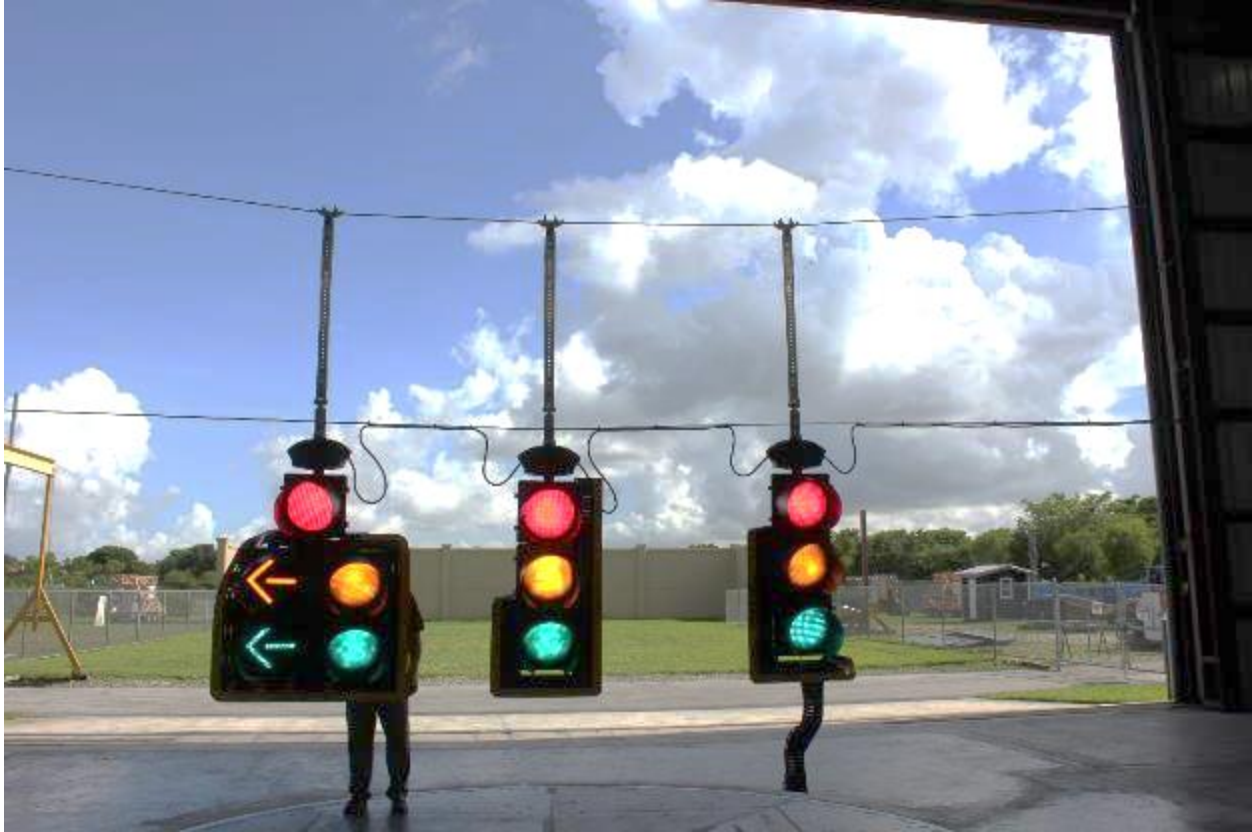
Figure 26: Signal Assembly after full wind speed test

At 70 mph, a galloping movement was first observed which continued throughout the test and back plates from all signals showed some bending. Continuing with the test at 85 mph, top back plates from 5-section signal blew away and it was noted that galloping movement was intensified. More intense galloping movement was seen to occur at 100 mph. At this point the 3-section signal back plates detached. At 115 mph, the 5-section signal showed minor rotation at the connection between the red (top) signal and the bracket that connects to the lower 4 signals. When reaching 140 mph galloping movement lessened. The 5-section and 3-section signal back plates continued to detach from the signal housing and eventually flew away. Figure 26 and Figure 27 show the signal assembly after full wind speed test and a summary of the observed damages is as follows:

- Damage to signal hanger: No permanent visual damage observed.
- Damage to disconnect hanger (box): No permanent visual damage observed.
- Damage to signal housing assembly: Other than damage to the back plates, no other permanent visual damage was observed. Some minor rotation of the 5-section signal at the connection between the red (top) signal and the bracket that connects to the lower 4 signals.

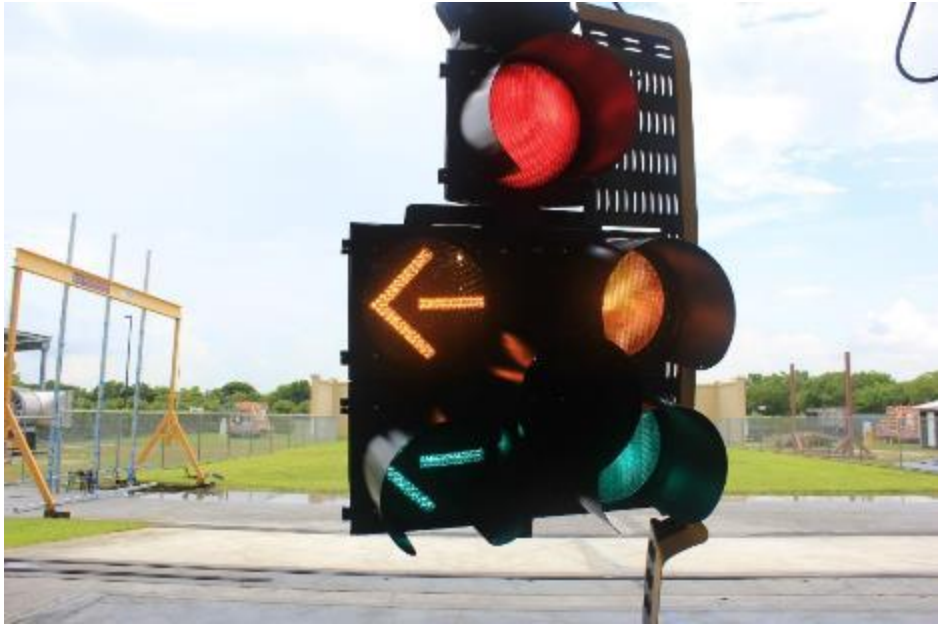
Figure 40: The 5-section signal with damaged back plates and visors

The 5-section signal that shows more damage is shown in Figure 40. Figure 41 shows the traffic signals after the completion of 130 mph wind speed test. The disconnect boxes for the 3-section traffic signals displayed no visible damage at the end of 150 mph wind speed test as shown in Figure 42 and Figure 43 respectively. A summary of the observed damage is as follows:

- Damage to signal hanger: High degree of flexure in the tri-stud hangers creating a slight permanent bend on all 3 tri-stud adjustable hangers.
- Damage to disconnect hanger (box): No permanent visual damage observed. 5-section signal rotated from disconnect-to-adjustable hanger connection.
- Damage to signal housing assembly: Damage to visors and back plate of the 5-section signal. No other permanent visual damage observed.

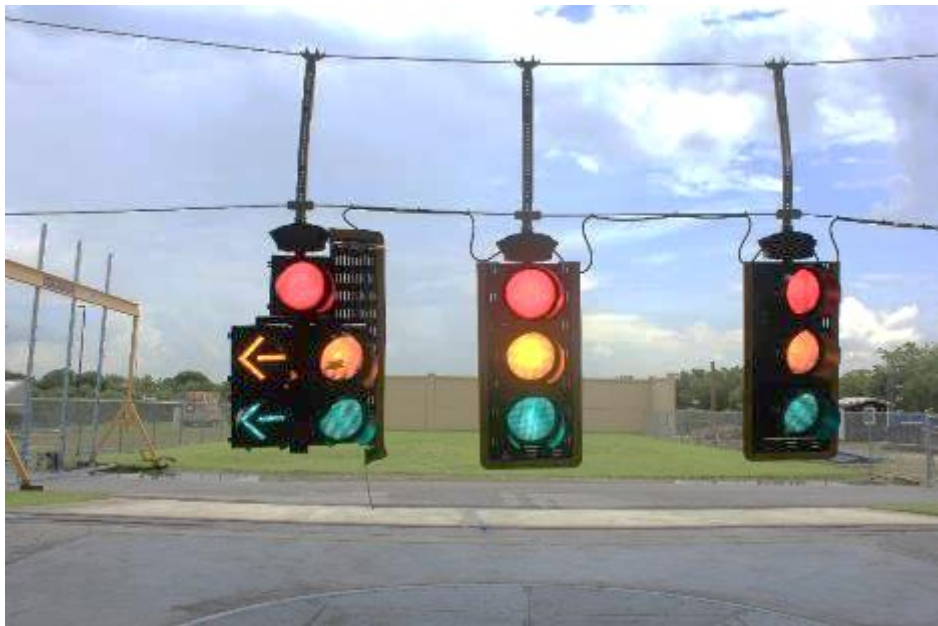
Figure 41: Traffic signals after completion of 130 mph test

There was no visible evidence of damage to any section of the signal assembly up to 70 mph, where slight flexure of the tri-stud adjustable hangers and back plates was seen. Visors were intact. Progressing to 100 mph, there was no visible signs of damage to the traffic signals and visors other than bending of back plates from 5-section signal. At 115 mph, there was higher degree of flexure observed on the tri-stud adjustable hanger assemblies, especially on the 5-section assembly. At 130 mph a slight permanent bend occurred, again mainly on the 5-section assembly, while the left side of back plates became detached. At 150 mph, visors from center 3-section signal and 5-section signal began detaching and 5-section signal rotated from disconnect-to adjustable hanger connection. Most damage occurred on the 5-section signal with severe damage in back plates, visors and disconnect box. All 3 tri-stud adjustable hangers were bent. Throughout the test, there was no visible galloping movement.

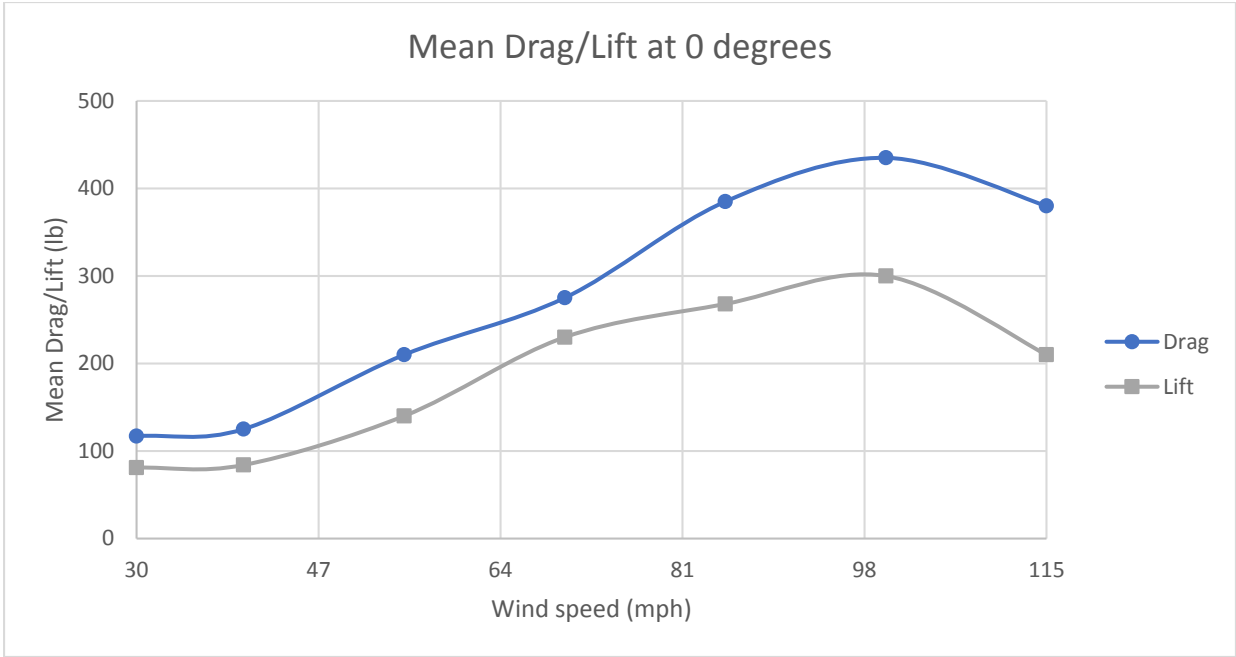
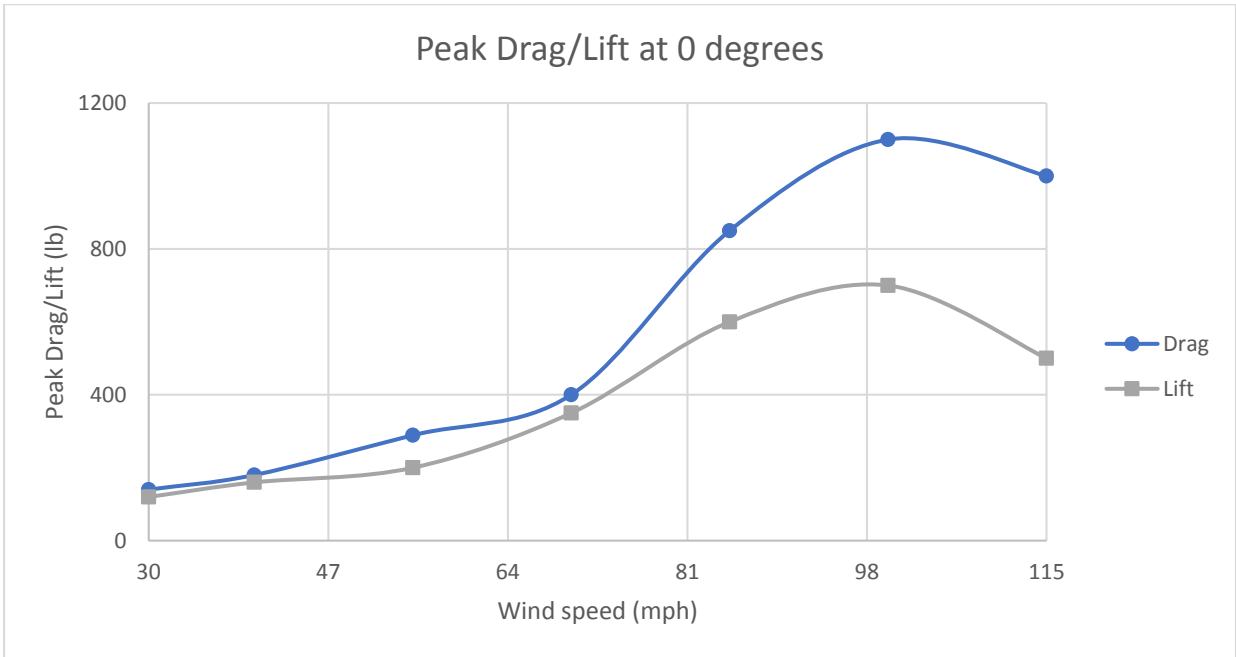
Figure 53: Drag (F_y) and lift (F_x) forces on the traffic signals at 0 degrees: a) Mean; b) Peak

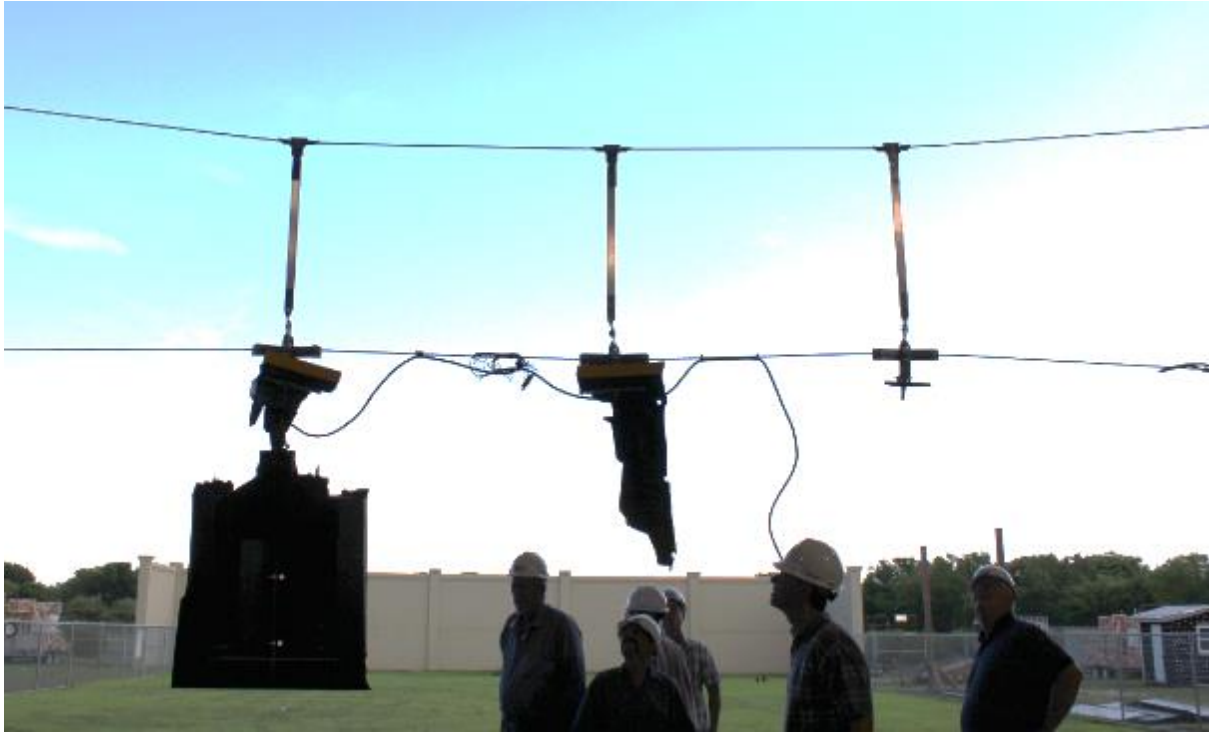
Figure 56: Signal assembly after 115 mph

- Damage to signal hanger: No permanent visual damage observed.
- Damage to disconnect hanger (box): Major damage. Housing completely destroyed. Note: In this assembly, the disconnect hanger (box) is integral to the signal housing (i.e., not a separate component).
- Damage to signal housing assembly: Major damage. Housing completely destroyed on 5 section and center 3 section. East 3 section broke off and flew away.

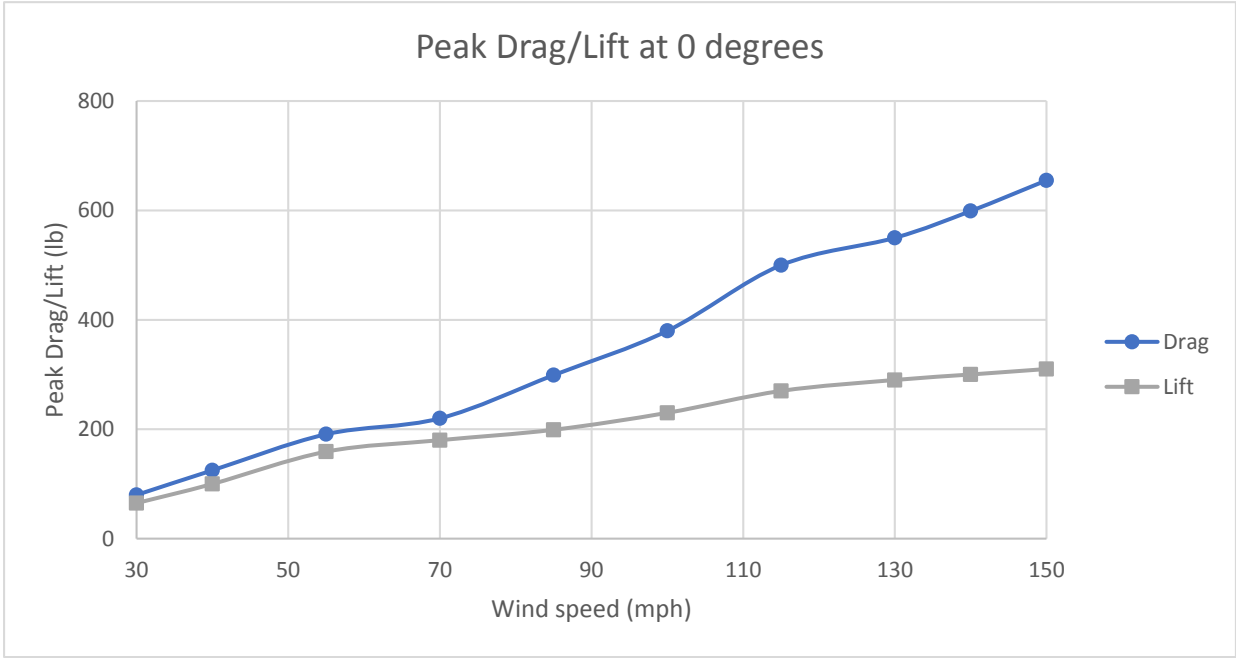
Figure 68: Drag (F_y) and lift (F_x) forces on the traffic signals at 0 degrees: a) Mean; b) Peak

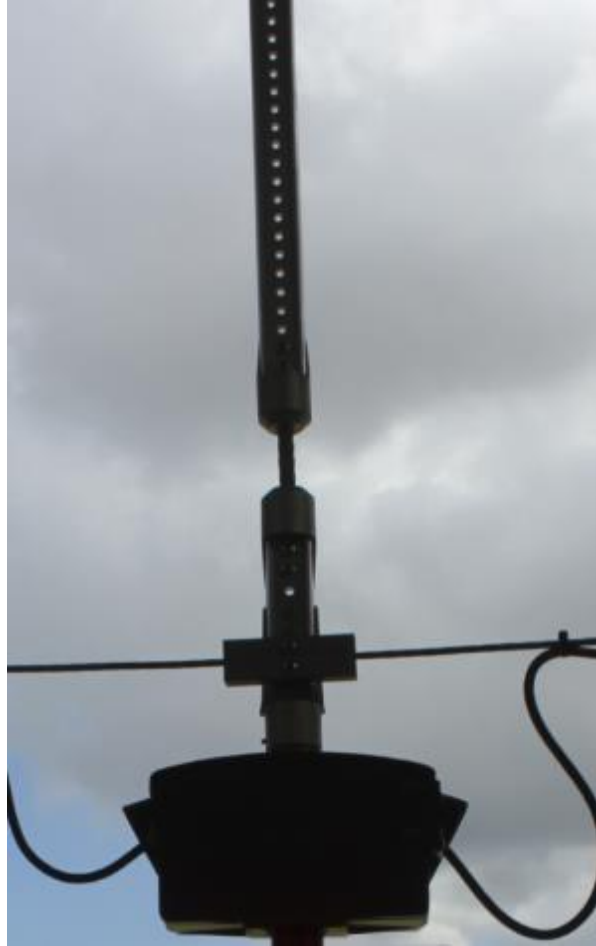
Figure 71: Pelco adjustable hanger assembly with cable dampener after full range test

- Damage to signal hanger: Flexible bending of the cable portion. Very slight permanent visual bend observed.
- Damage to disconnect hanger (box): No permanent visual damage observed.
- Damage to signal housing assembly: Damage to one visor and back plate. No other permanent visual damage observed.

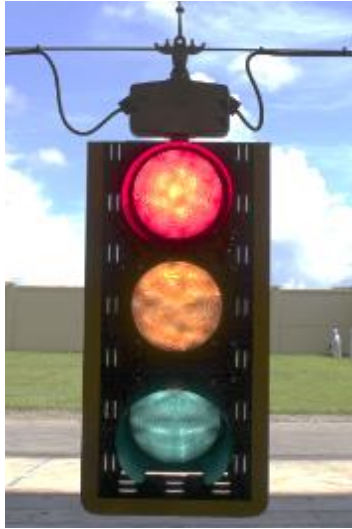
Figure 87: Damaged visor from 3-section signal (center visor missing)

- Damage to signal hanger: No permanent visual damage observed.
- Damage to disconnect hanger (box): No permanent visual damage observed.
- Damage to signal housing assembly: Major damage to visors and back plates. No other permanent visual damage observed.

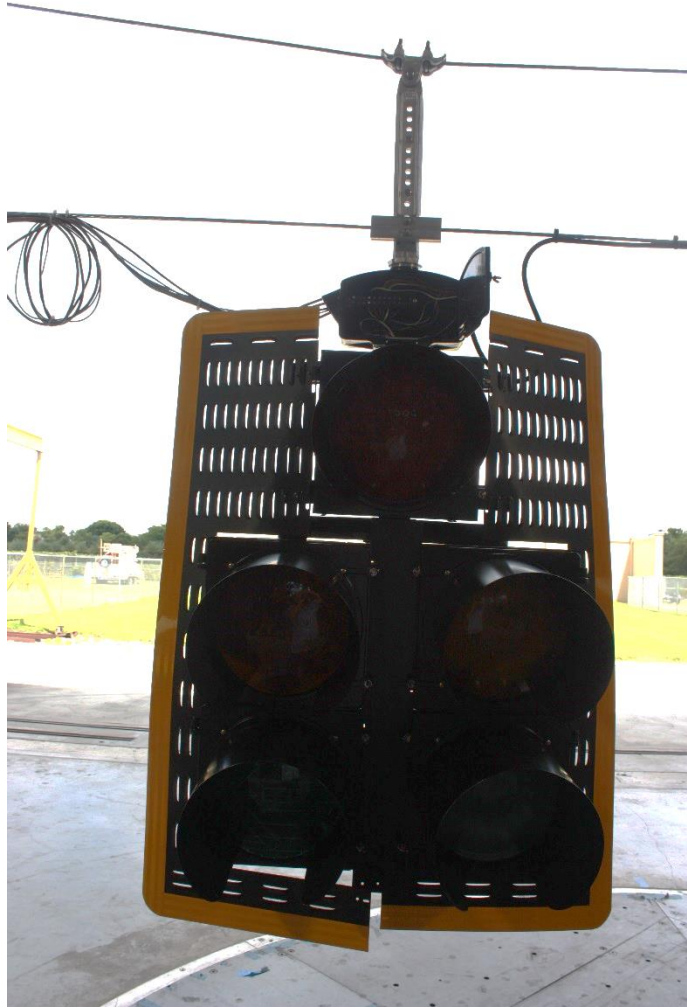
Figure 102: 5-Section signal with damaged back plates

Aerodynamic instability was first noticed at 70 mph and continued through all the duration of the test. The galloping movement was noticed to increase in intensity with higher wind speeds. The only damage observed throughout the entire test was bending of the 5-section signal back plates, as shown in Figure 102. Other than that, the traffic assembly remained fully functional with no failure of any of its components besides excessive inclinations due to the aerodynamic instability.

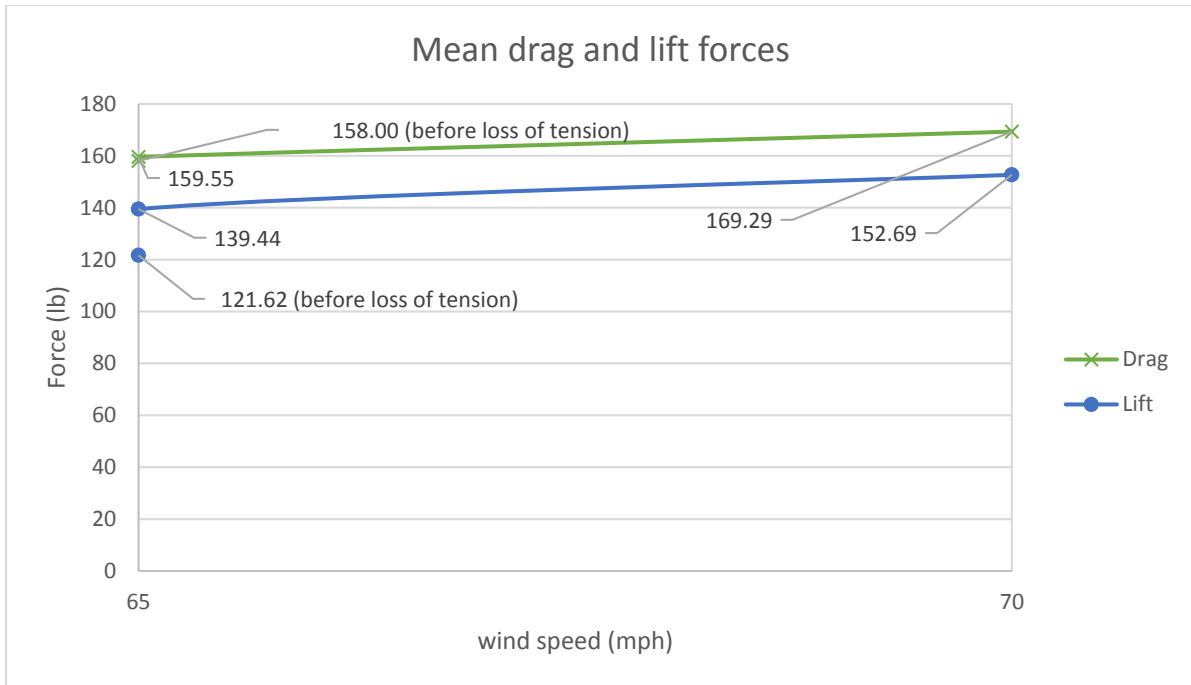
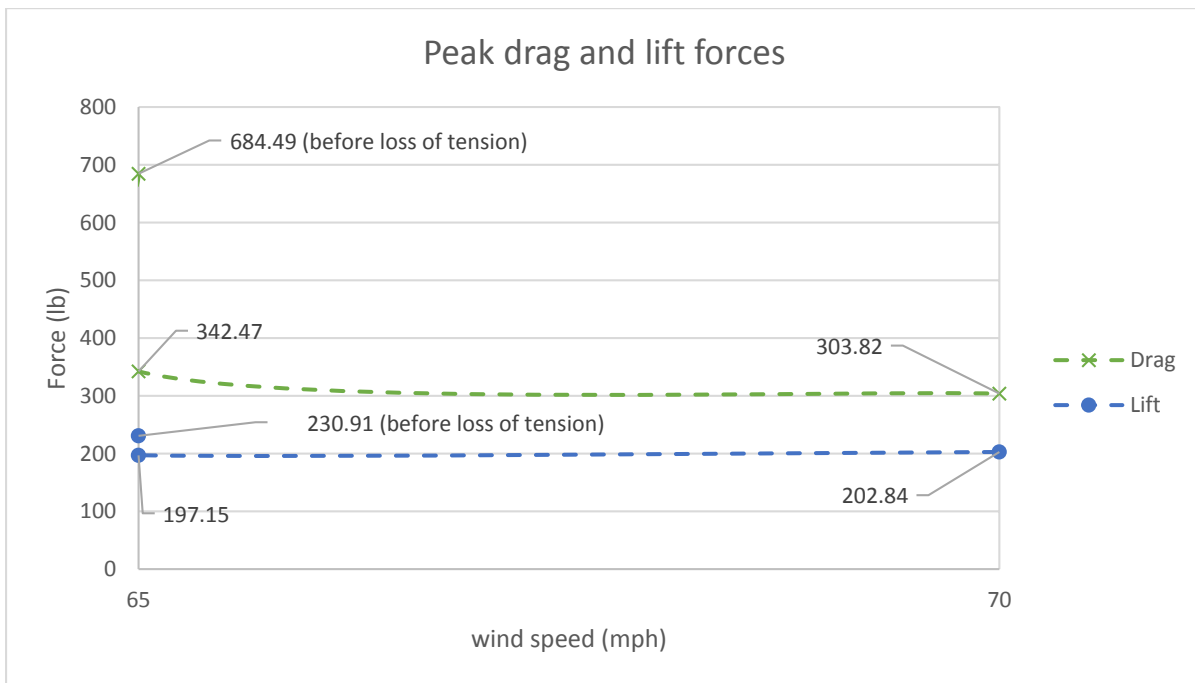
Figure 114: Drag (F_y) and lift (F_x) forces on the traffic signals at 0 degrees: a) Mean; b) Peak

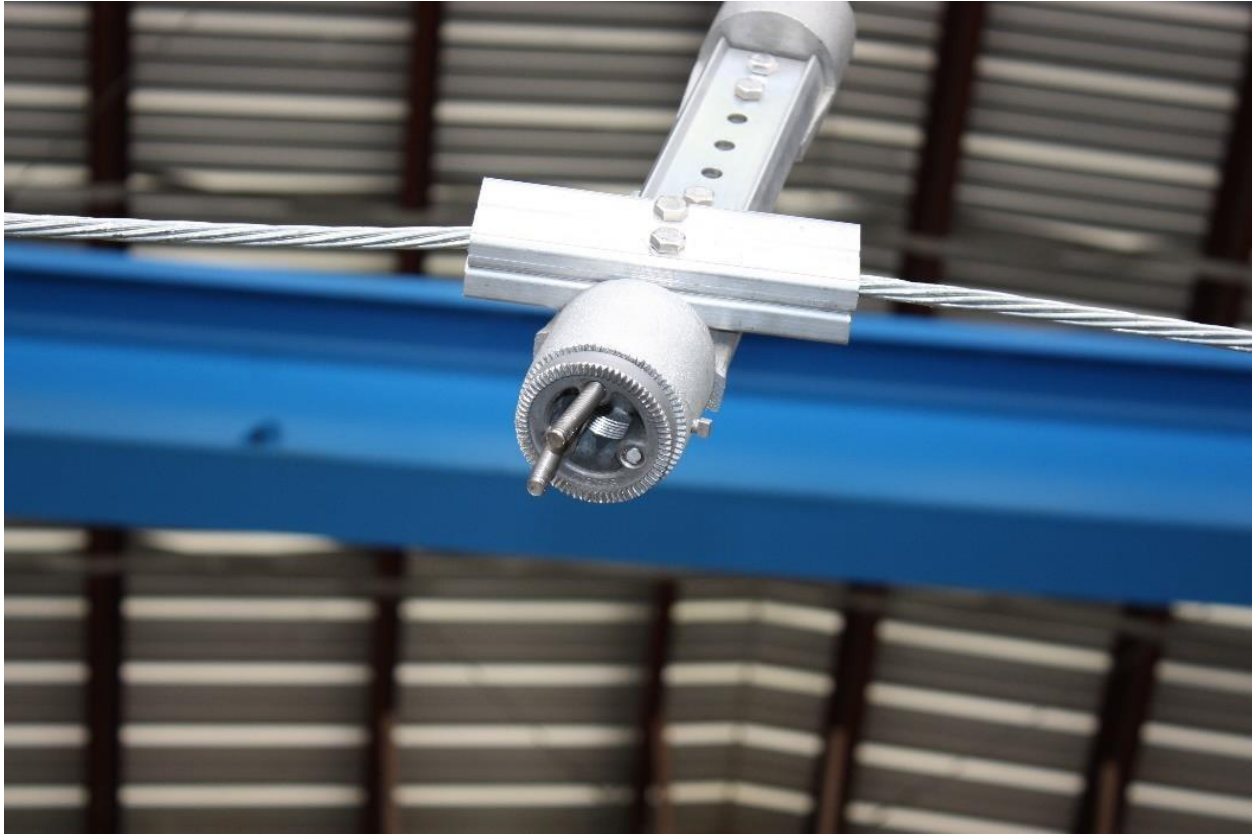
Figure 131: Adjustable hanger to disconnect box connection failure (5-section assembly)

After the test, it was found that the 5-section signal disconnect box had become detached due to a failure at the adjustable hanger to disconnect-box connection point and that the serrated teeth of the disconnect box were damaged, as shown in Figure 131 and Figure 132.

disconnect-box to signal-housing point. The failure mode with this connection point was when the serrated edge would shear, allowing the connection to turn. A resilient connection at these points should be considered to enhance the survivability of the signal under wind induced loads. Moreover, it was determined that Florida DOT specified aluminum alloy 535 should be continued due to its outstanding performance during testing and maximum overlap at tri-stud adjustable-hanger and extension-bar connection points should be used (top and bottom portions/connections).

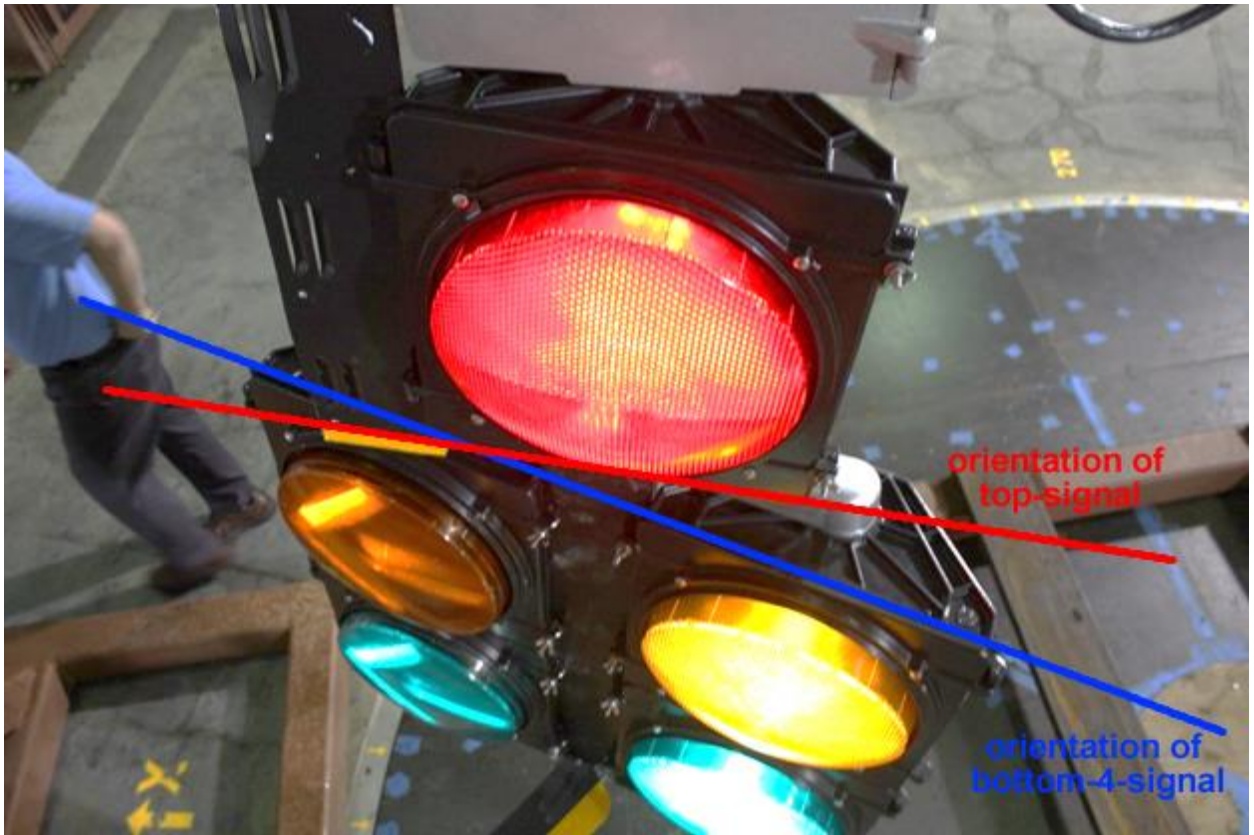
Figure 148: 5-section signal rotation from top-signal to bottom-4-signal connection

Reaching 150 mph visors from the 3-sections and 5-section signals detached and were blown away. At 80 degrees, the 5-section signal showed erratic movement causing the 5-section signal to rotate from the top-signal to 4-bottom-signals connection, as shown in Figure 148. After the test was finished, it was found that the hold down bar of the 5-section signal disconnect box broke, as shown in Figure 149, and a support bracket from the gusseted tube to tri-stud hanger support broke, as shown in Figure 150.

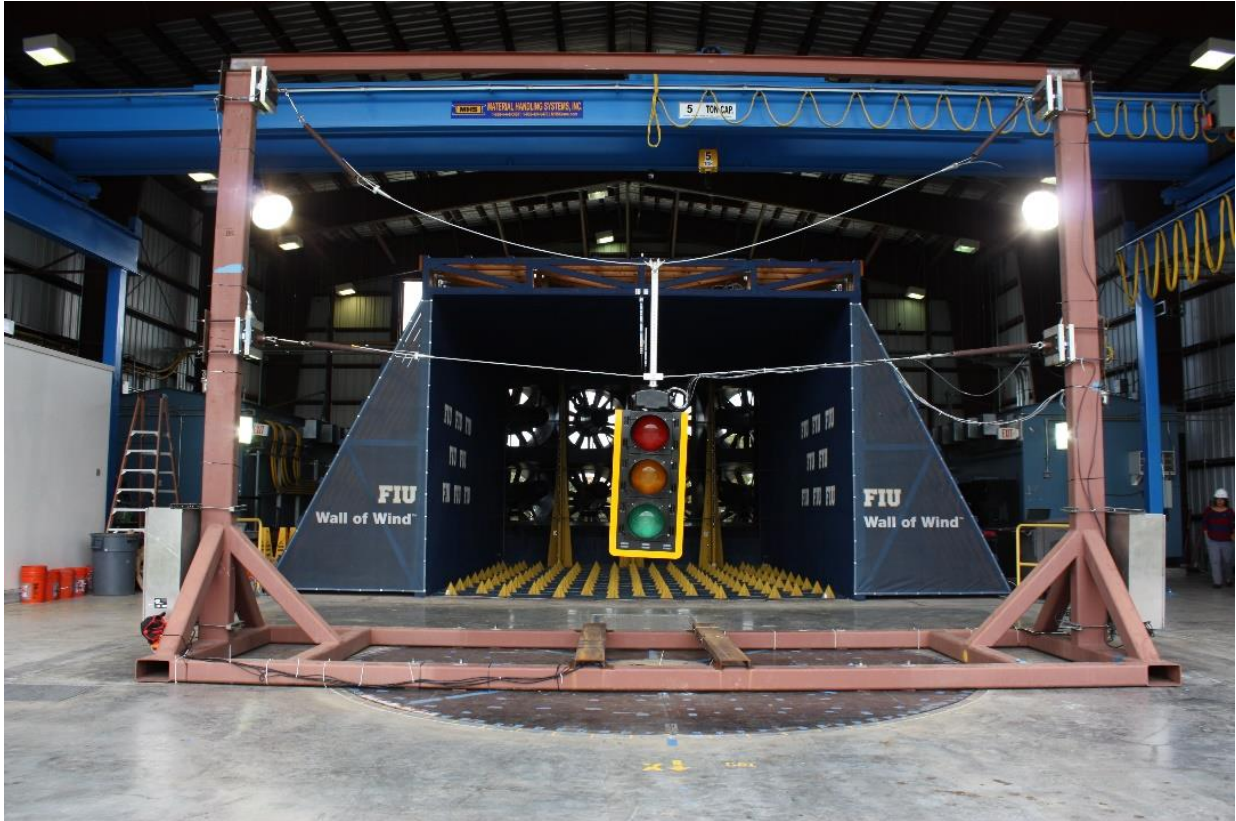
Figure 163: Signal assembly after test

After the test was finished, there was no damage to backplates, visors, hanger nor any signal housing component. A picture of the assembly after the test is shown in Figure 163 and a close up of the hanger connection is shown in Figure 164.
