Federal Highway Administration
Every Day Counts
Innovation Initiative

Safety Edge_{SM}
Demonstration Project
Turner, Maine

Field Report
June 15, 2011

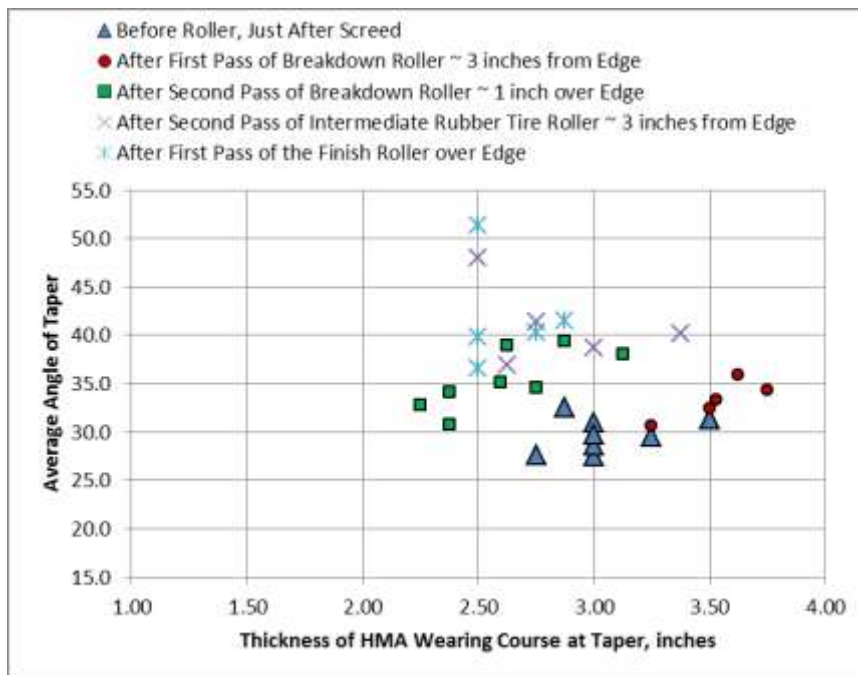
The change in the slopes of the Safety Edge_{SM} and thickness at the Safety Edge_{SM} was also evaluated as a function of the passes of the individual rollers for the section pavement using the TransTech Shoulder Wedge Maker (Refer to Figure 9).

Immediately behind the screed, and prior to the rolling of the HMA mat, the average slope was 30°. After the first pass of the breakdown roller, the average slope increased to 33°. There was a corresponding increase in average thickness (by about 0.5 inches) at the edge since the first pass of the breakdown roller was approximately 3 inches from the edge, resulting in some HMA wearing course material being shoved up near the edges. Following the second pass of the breakdown roller the average slope increased to 35°. The HMA thickness near the Safety Edge_{SM} was now reduced to an average value of 2.6 inches (from 3.5 inches) due to the fact that the second pass of the breakdown roller was 1 to 2 inches over the edge.

After two passes of the intermediate rubber tire roller (which did not go over the edge in either of the two passes but was approximately 3 inches from the edge), the average slope of the Safety Edge_{SM} increase to 41°. There was a slight increase in thickness of the HMA mat near the Safety Edge_{SM} from 2.6 inches to 2.9 inches. Following the first pass of the finish roller (over the edge) the HMA mat thickness was reduced to an average value of 2.6 inches. The average slope of the Safety Edge_{SM} was 42°.

Figure 9. Effect of rolling on the angle of taper and the thickness of HMA wearing course at the taper.
