**Safety Edge<sub>SM</sub>**  
**Demonstration Project**  
**Brogden Road in**  
**Johnston County,**  
**North Carolina**

Field Report  
June 1, 2011

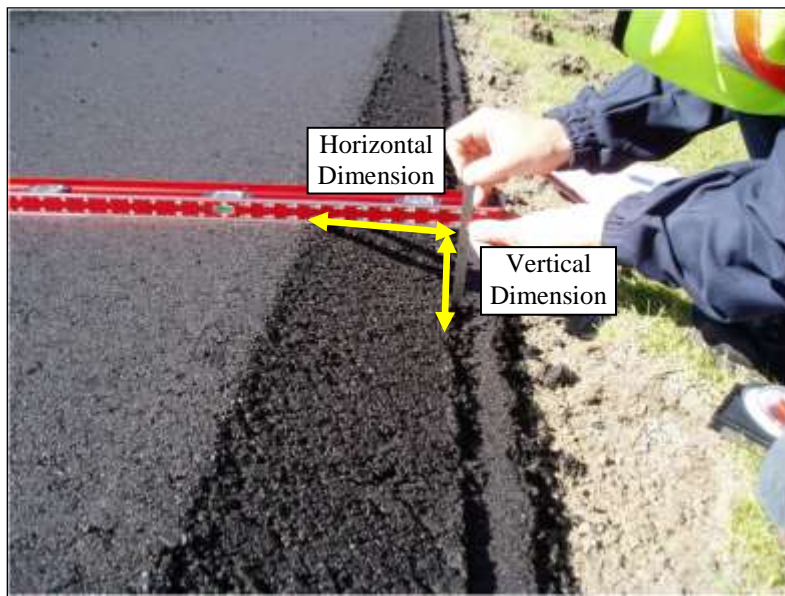
Figure 2. Slope measurement technique.

Slope measurements were recorded on test sections #1 and #2 at 25-foot intervals using a straight-edge and ruler to measure the horizontal and vertical dimensions of the edge (see Figure 2). The following summarizes the average slope measurements:

<u>Pavement Section</u>	<u>Slope</u>
Test Section #1, Troxler Device	28°
Test Section #2, NCDOT Device	26°
Section #3, Control	NA

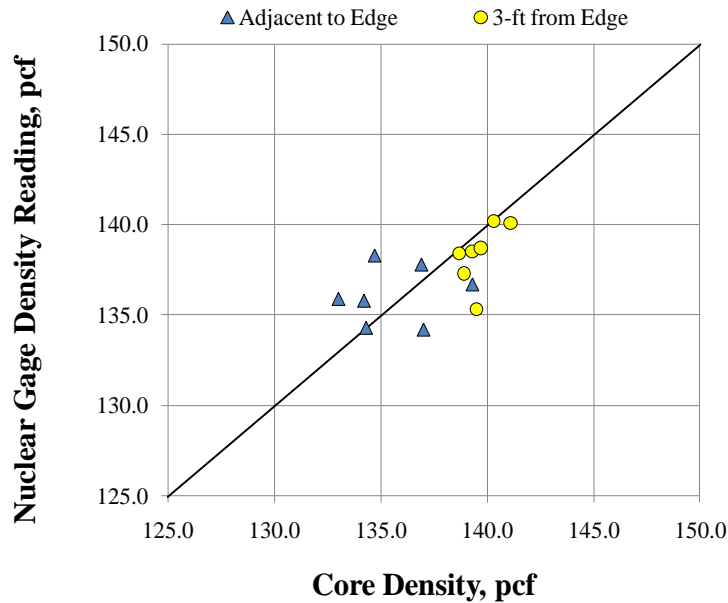
Figure 4. Comparison of the nuclear densities and core densities.

Density tests were conducted using a nuclear density gauge in backscatter mode for 60-second test durations. The tests were conducted at 50-foot intervals at 3-feet from the edge and adjacent to the edge. Table A-3 in Appendix A presents the results of the nuclear density testing along with the laboratory density results from these locations. Figure 4 compares the nuclear density readings to the densities measured on the cores. As shown, there is close correlation between the nuclear gage and core densities.

Adjustment factors were determined from correlating the nuclear density readings and the core laboratory density results shown in Table A-3 in Appendix A. The factors were close to unity and were used to adjust the nuclear density gauge readings to be consistent with the densities that were measured in the laboratory. The adjusted or corrected densities using the correction factors are listed in Table A-4 in Appendix A and are summarized as follows:

<u>Location</u>	<u>Adjustment Factor</u>
Adjacent to the edge	0.996
3 feet from the edge	1.009

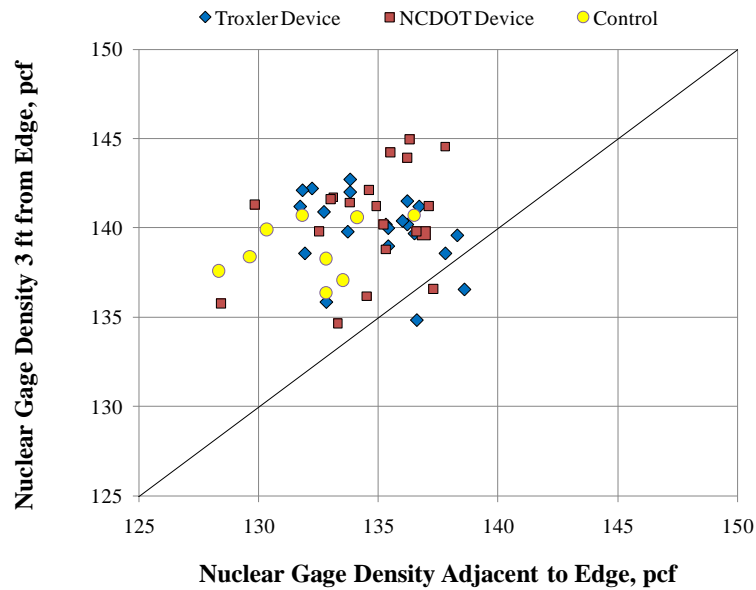
Figure 5. Comparison of the nuclear densities adjacent to the edge and 3 feet from the edge.

The control section had a lower average density value (132.2 pcf) adjacent to the edge compared to section #1 (134.9 pcf) or section #2 (134.8 pcf), suggesting the confining effect of the edge devices helped to increase densification near the edge. The rolling pattern was the same for all three sections and is discussed later in this report.

Figure 5 compares the nuclear densities taken adjacent to the edge and 3 feet from the edge. Generally, the densities were higher 3 feet from the edge in all sections.

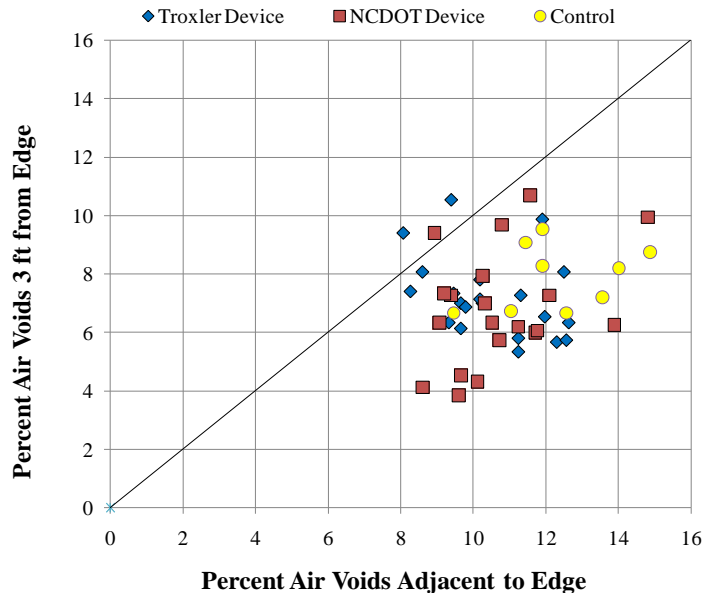
Figure 6. Comparison of the air voids adjacent to the edge and 3 feet from the edge.

Figure 6 compares the air voids (as calculated from the density test results and the maximum theoretical mix density). As shown, the percentages of air voids in the mix usually were higher adjacent to the edge.

Average air voids are summarized in Table 1. This table shows higher air voids in the control section near the edge, underscoring the favorable impact of edge devices on

increasing the quality of the mat near the edge. It is theorized that the confining pressure the edge devices exert on the edge adds to the compaction at the edge.

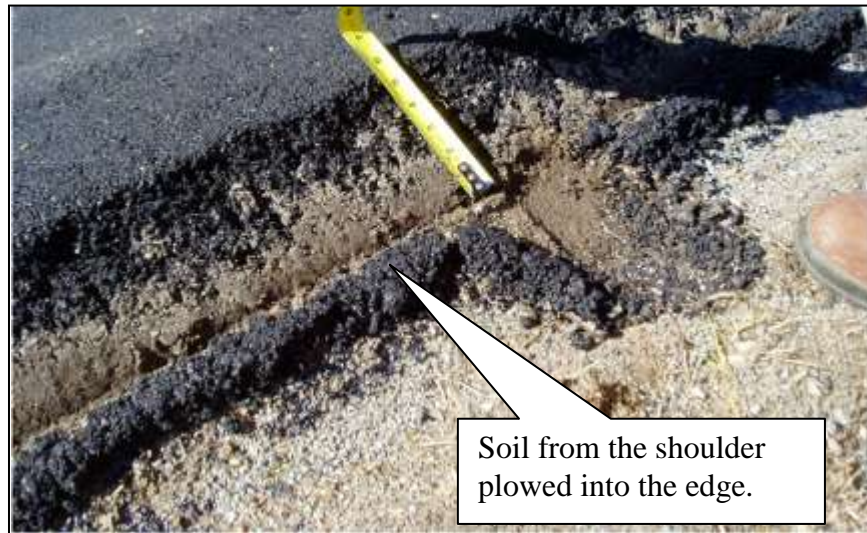
Figure 9. Example of the Safety Edge<sub>SM</sub> device plowing up soil into the Safety Edge<sub>SM</sub>.

The contractor clipped the shoulder which is standard practice for this scope of project. The conventional shoulder clipping operation was used, which did not take into account the extra width needed for the Safety Edge<sub>SM</sub>. Figure 8 shows there was enough room at this particular location, but that was not always the case. At some isolated locations the shoulder was not clipped wide enough. Although equipment was used to prepare the shoulders, labor was needed occasionally to rake or shovel clumps of soil from the shoulder ahead of the paver. Figure 9 shows an isolated instance in which the Troxler SafeTSlope Edge Smoother was running on soft soil, resulting in the device plowing soil into the Safety Edge<sub>SM</sub>.

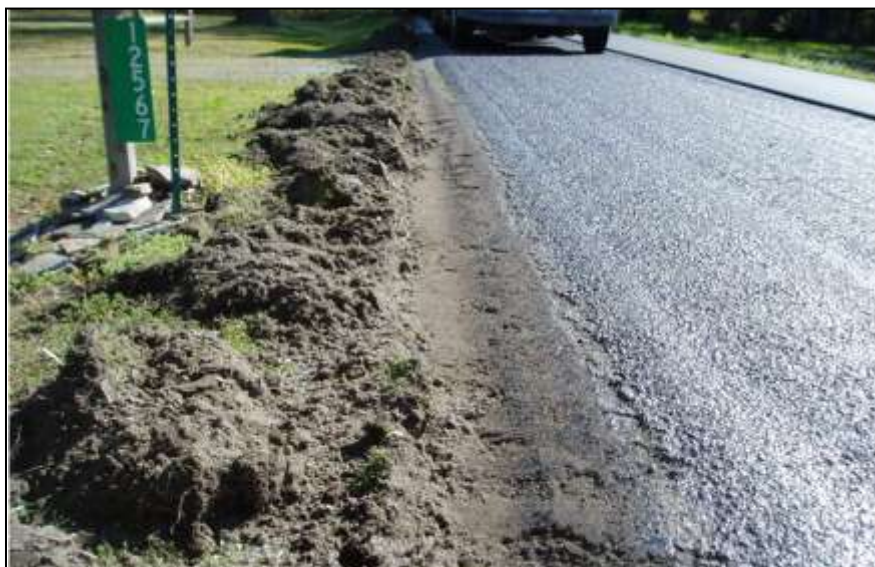
Figure 10. Soil/vegetation piled up from edge preparation work.

At some locations the clipping removed a large amount of buildup from the edge of the road. Figure 10 shows mounds of soil/vegetation piled up from the edge preparation work.

Given the extent of shoulder clipping and preparations needed for the Safety Edge<sub>SM</sub>, it is expected that more asphalt material would be placed than with conventional overlays. However, this will depend heavily on the existing site conditions. On this project, a reliable account of the extra tonnage of WMA was not available, and the contractor stated that all projects overrun the estimated amount of material regardless of a conventional edge or Safety Edge<sub>SM</sub>.

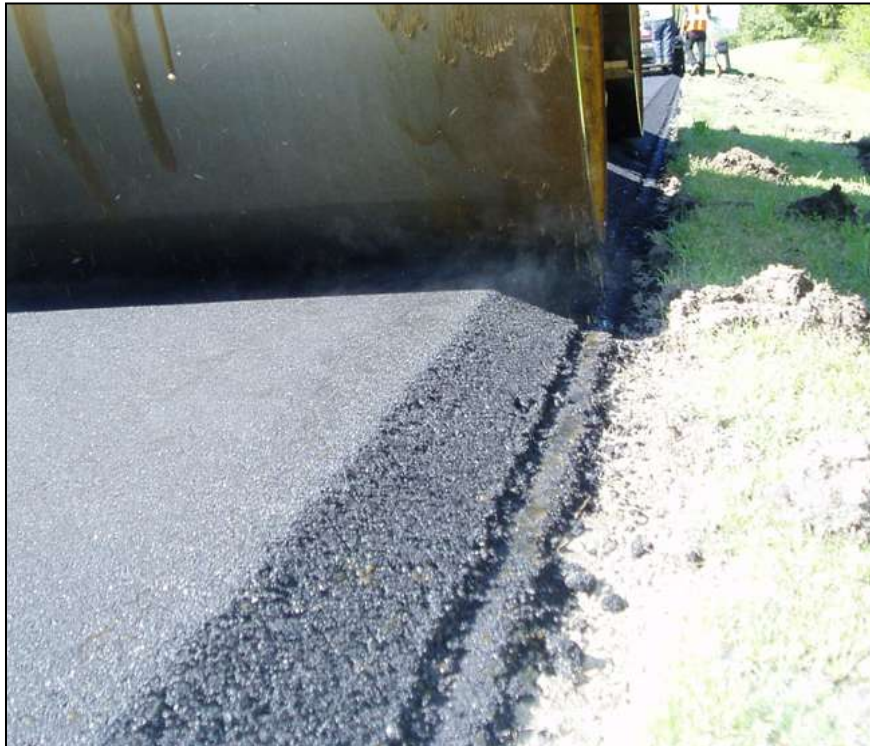
Figure 13. Slope face produced by the Troxler device.

The texture of the slope face produced by the Troxler device was smooth and uniform. Figure 13 shows the uniform constancy of the slope face.

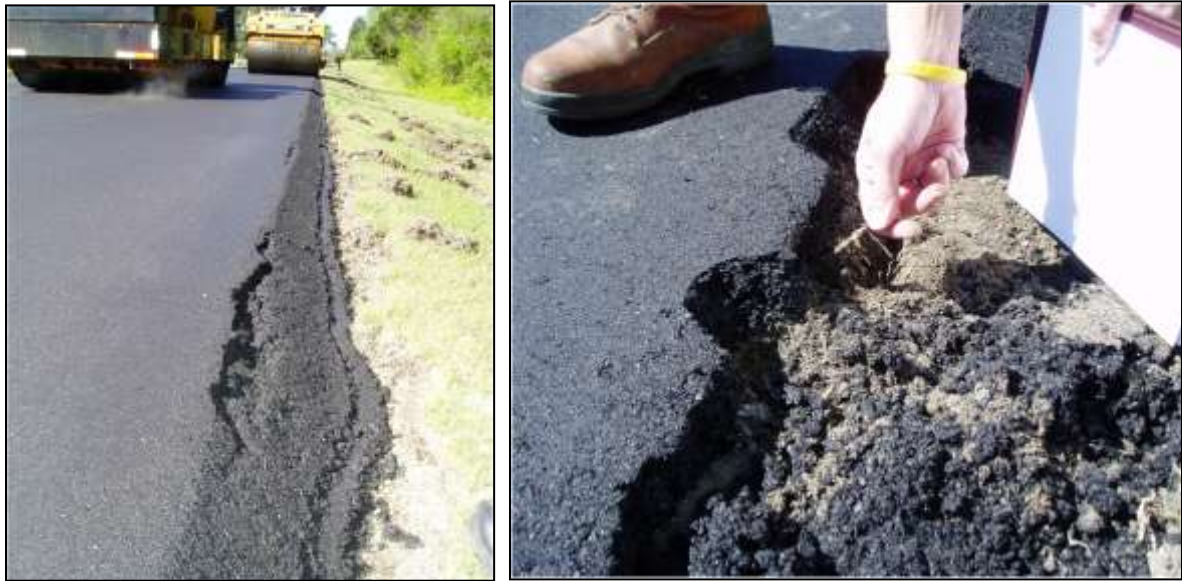
Figure 14. Isolated longitudinal edge cracking (left) and investigation revealed soil/vegetation under the pavement edge (right).

At a few isolated locations, longitudinal cracks quickly developed near the breakpoint of the slope face after the breakdown roller finished making passes (Figure 14). The asphalt mix was removed with hand tools to reveal that the reason for the cracking was the pavement edge was placed over soil/vegetation and not on top of the existing pavement. This resulted in paving on top of differential structural support which resulted in the longitudinal crack. The longitudinal crack would happen regardless of the presence of the Safety Edge<sub>SM</sub>.

- Preparing the edge of the existing pavement for this project was important to create room and remove vegetation for the Safety Edge<sub>SM</sub>.
- The edge of pavement separated from the mat at an isolated location where the edge of pavement was placed over soft soil/vegetation. This would have occurred

- regardless of the use of the Safety Edge<sub>SM</sub>; nevertheless, this underscores the importance of preparing the edge of the pavement.
- The contractor was able to attach and operate both devices successfully.

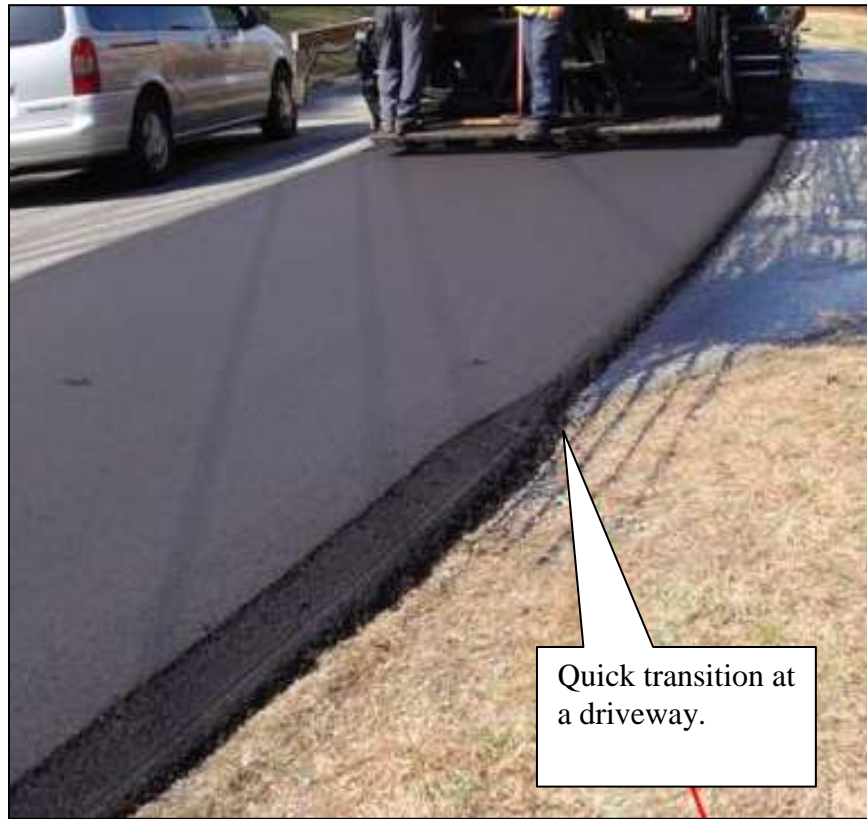
Figure 22. Transition at a driveway.

The second prototype was used successfully on the fifth route under the contract prior to Brogden Road. The contractor used an electric drill with a 15/16 inch bit to raise and lower the device at driveways in a matter of seconds. Figure 22 shows an example of the short transition length created by the ability to raise the shoe quickly for an approaching driveway. The shoe did not have to be removed; however, the cotter pin holding the shoe up had a tendency to come loose as the device was being raised and lowered.
