**Federal Highway  
Administration**

# HYDRAULIC STABILITY OF ARTICULATED CONCRETE BLOCK REVETMENT SYSTEMS DURING OVERTOPPING FLOW

Publication No. FHWA-RD-89-199  
November 1989

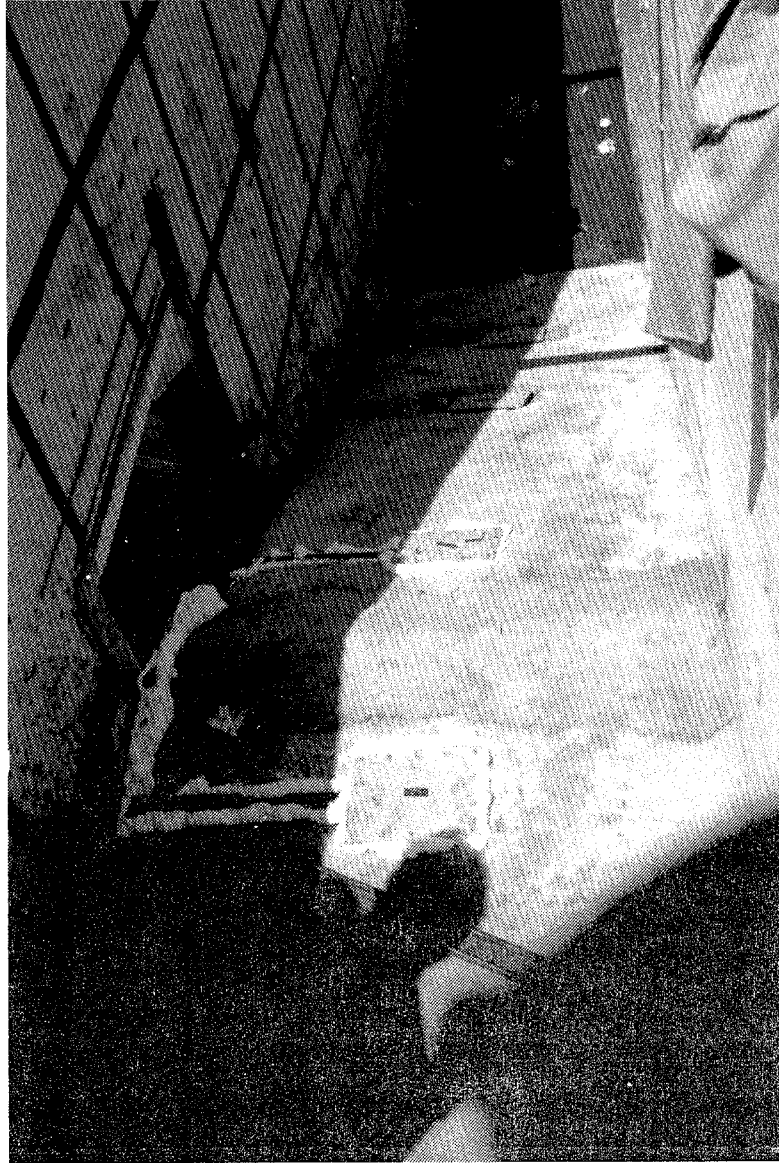
Figure 10. Completed rigid embankment with instrumentation canisters installed.

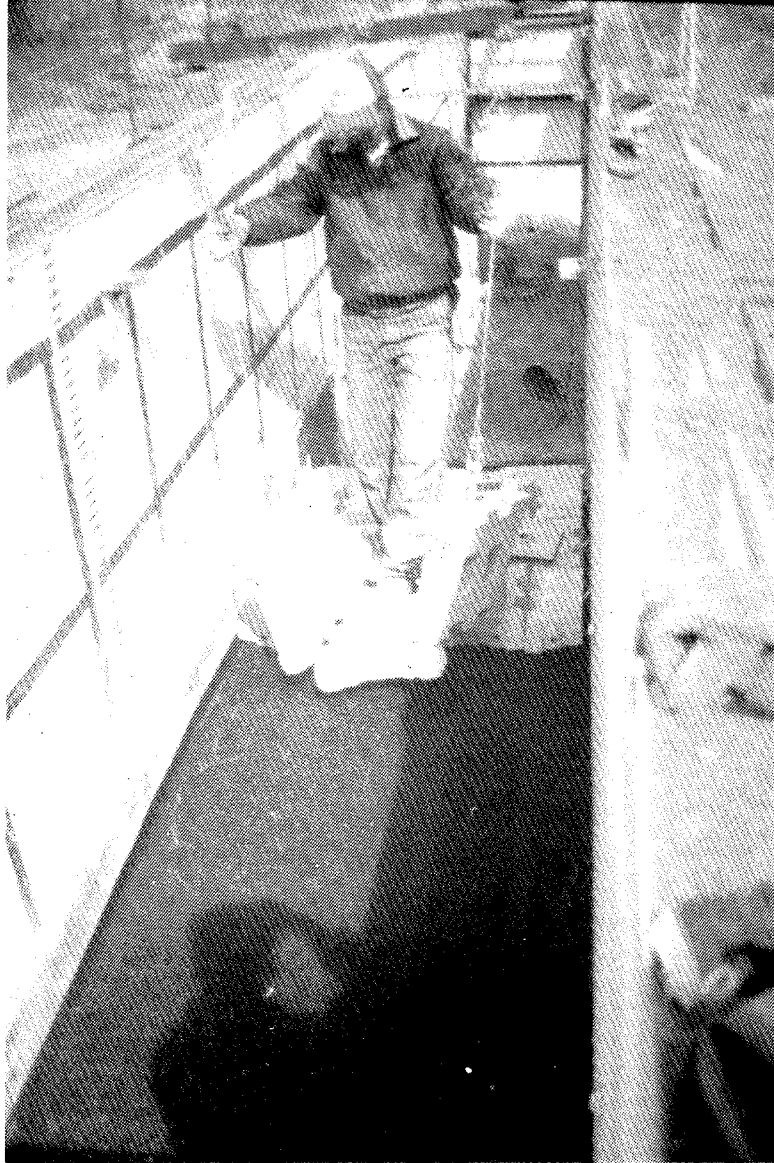
Figure 11. Installation of the Armorflex Class 30 protection system on the rigid embankment.

Two 8-hour tests were performed on the Armorflex Class 30 block system. Test AR-1 subjected the system to 2 hours with a 1-ft (0.30 m) overtopping depth, 2 hours with a 2-ft (0.61 m) overtopping and lastly 4 hours with a 4-ft (1.22 m) overtopping. All 8 hours of this test were conducted under freefall conditions.

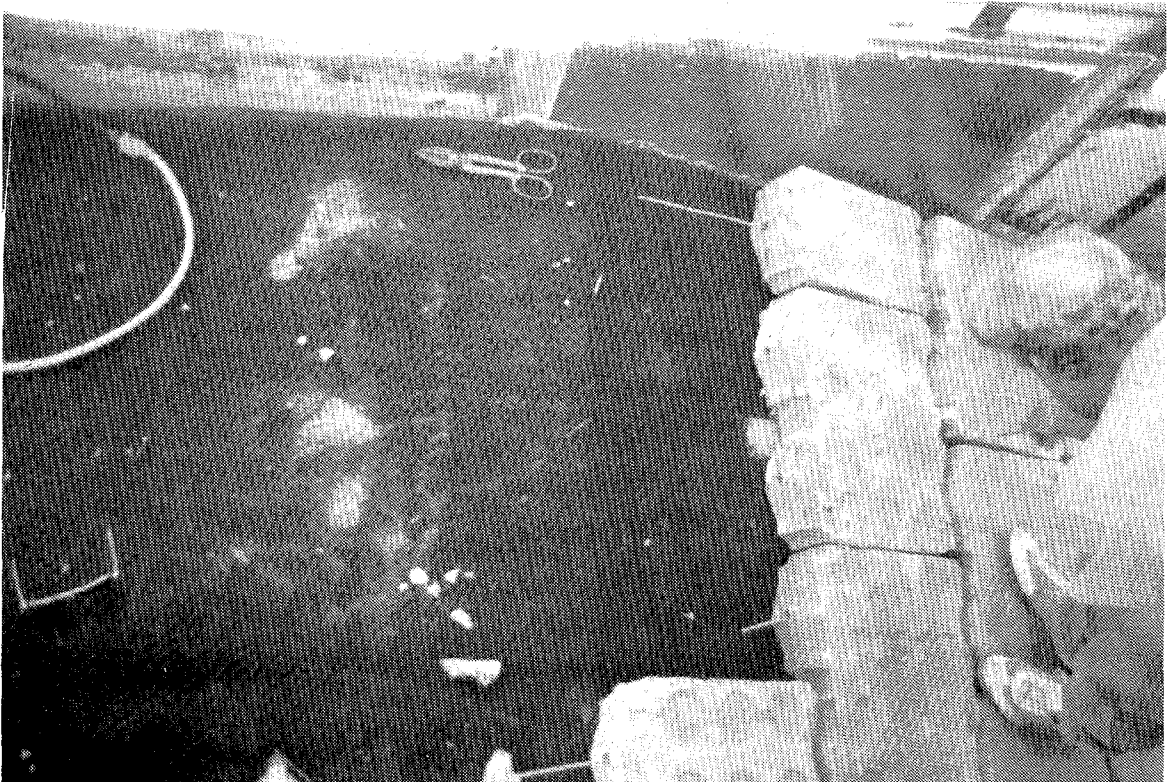
Figure 14. Installation of the Dycel 100 protection system on the rigid embankment.

The Dycel 100 concrete block mattress was subjected to four separate hydraulic conditions. Test BR-1 was an 8-hour test and consisted of 4 hours with a 1-ft (0.30 m) overtopping depth and 4 hours with a 2-ft (0.61 m) overtopping depth, both of which were conducted under freefall conditions. Test

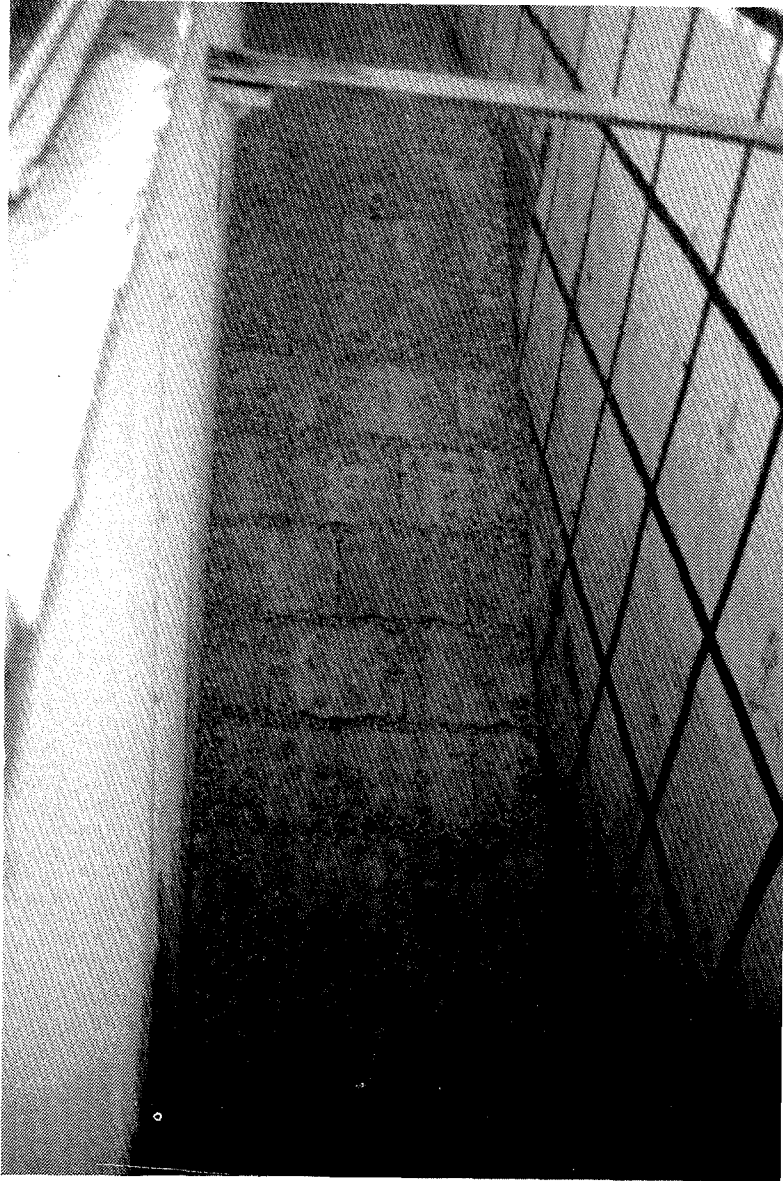
Figure 15. The completed Dycel 100 protection system on the rigid embankment.

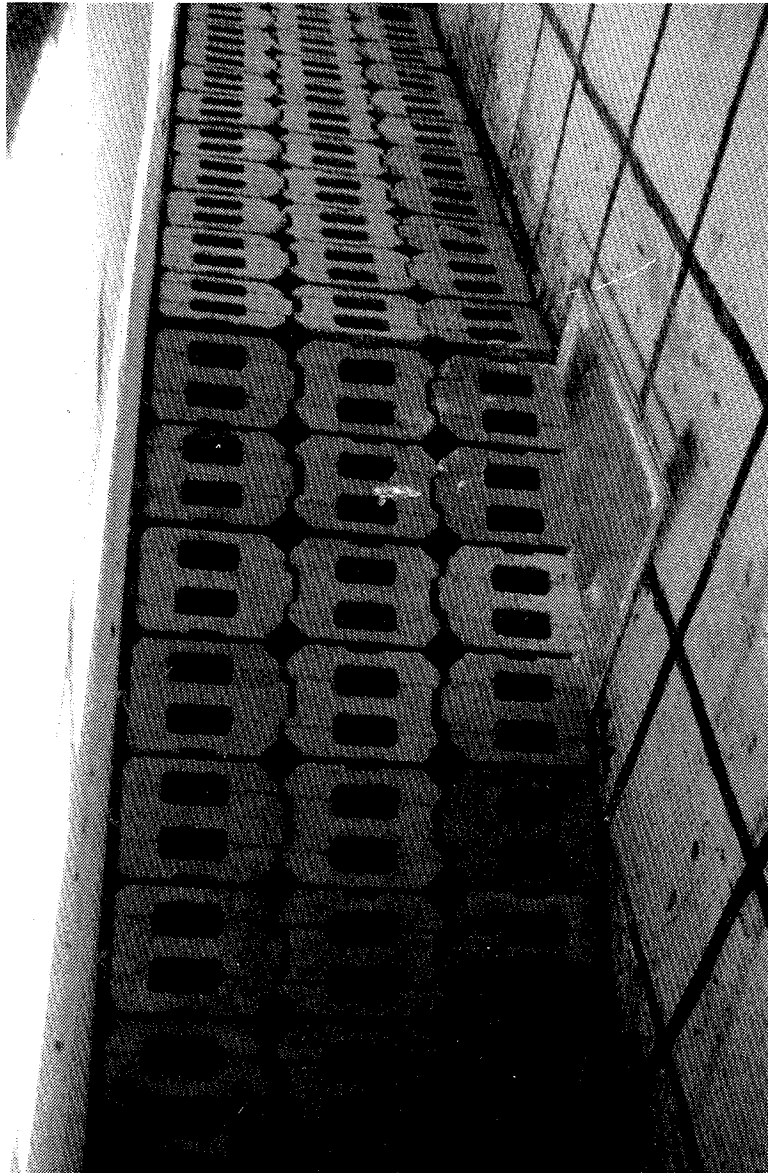
Figure 16. The completed Petraflex-Vick protection system on the rigid embankment (without rock infill).

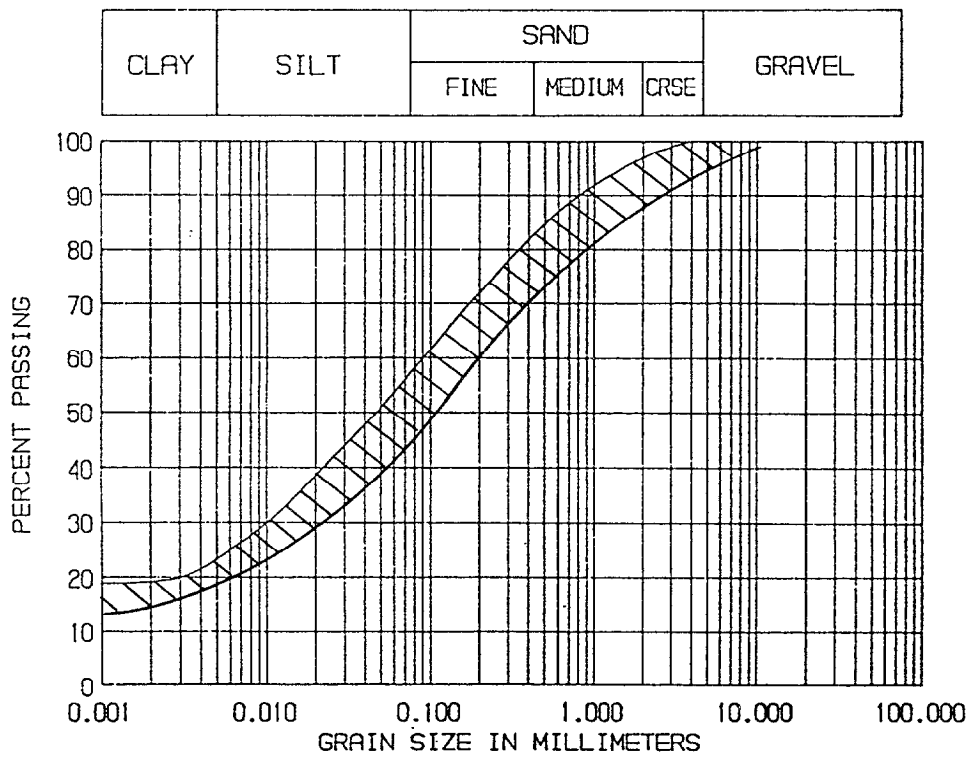
Figure 21. Grain-size distribution range for the type I soil.

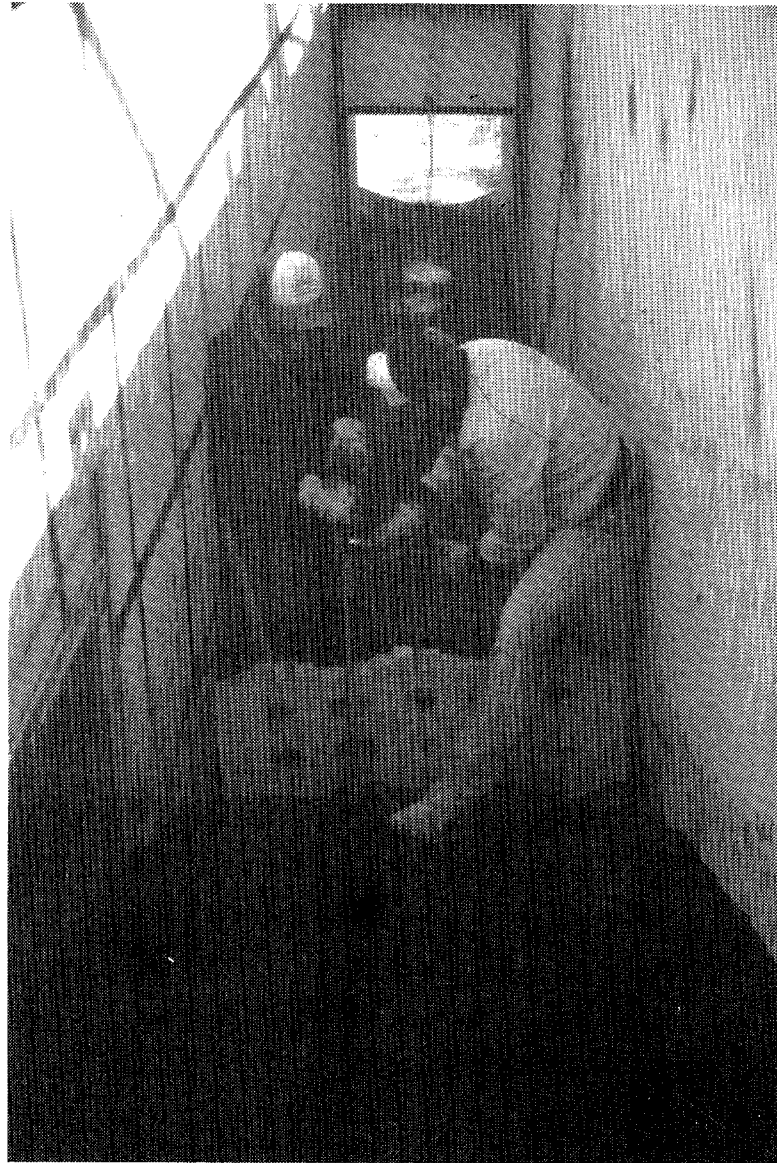
Figure 23. Installation of helix slope anchors for the Armorflex Class 30 system on the erodible embankment.

1. Two pairs of helix anchors were installed through the revetment system, one pair at station 38 and the other pair at station 42. Steel plates were mounted over the threaded stems, and secured with nuts and washers. Installation of the soil anchors is shown in figure 23.
2. Two lengths of 1/2-in (1.3 cm) rebar were placed between the block system and the flume walls between stations 20 and 48. This modification was implemented because a 3/4-in (1.9 cm) void remained between the block system and each flume wall after placement was completed. The rebar was installed in order to prevent soil scour and loss at the walls by holding the underlying geotextile and drainage fabrics in place. The gap above the rebar was then filled with angular crushed rock having a median diameter of 3/8 in (1 cm).

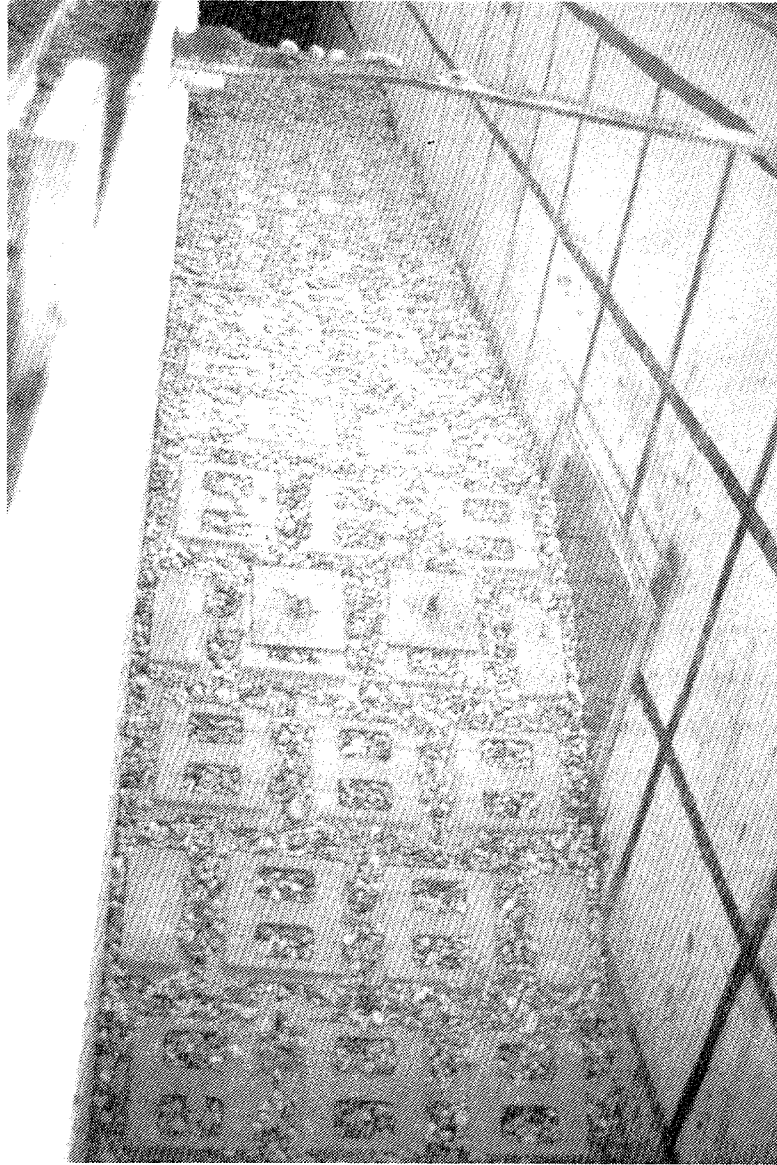
Figure 24. The completed Armorflex Class 30 protection system on the erodible embankment (with helix slope anchors).

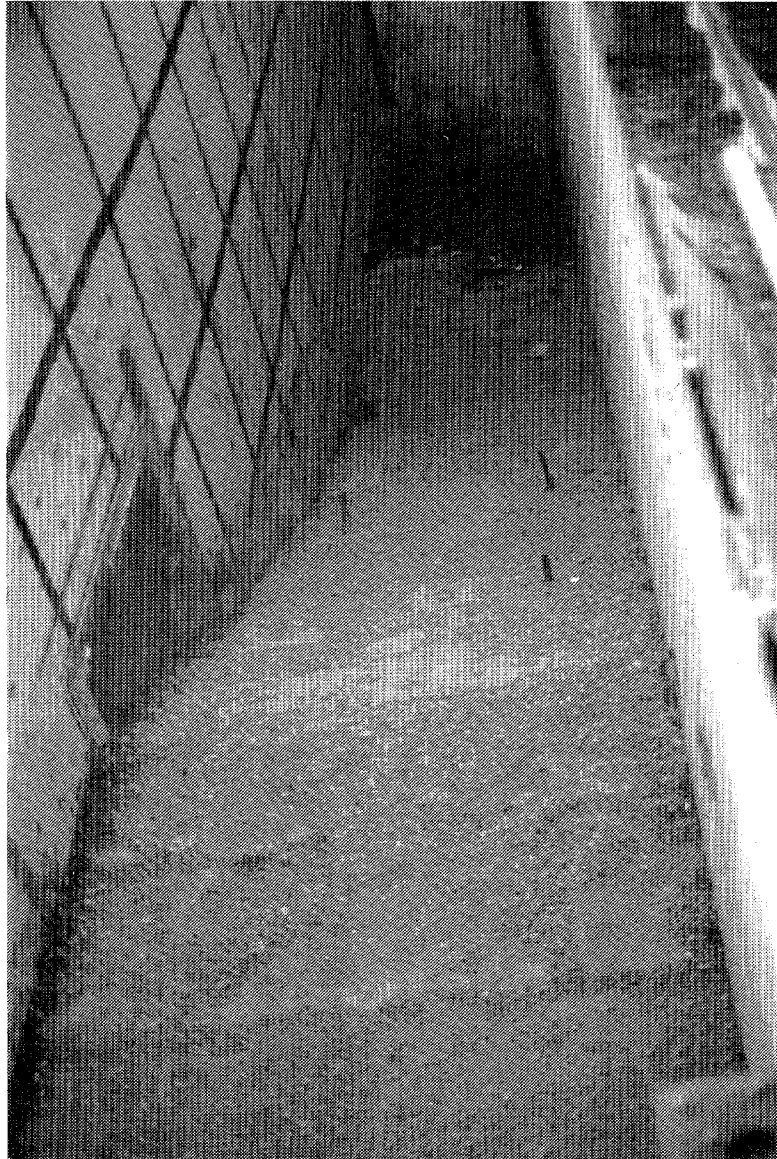
Figure 25. The completed Dycel 100 protection system on the erodible embankment (with helix slope anchors).

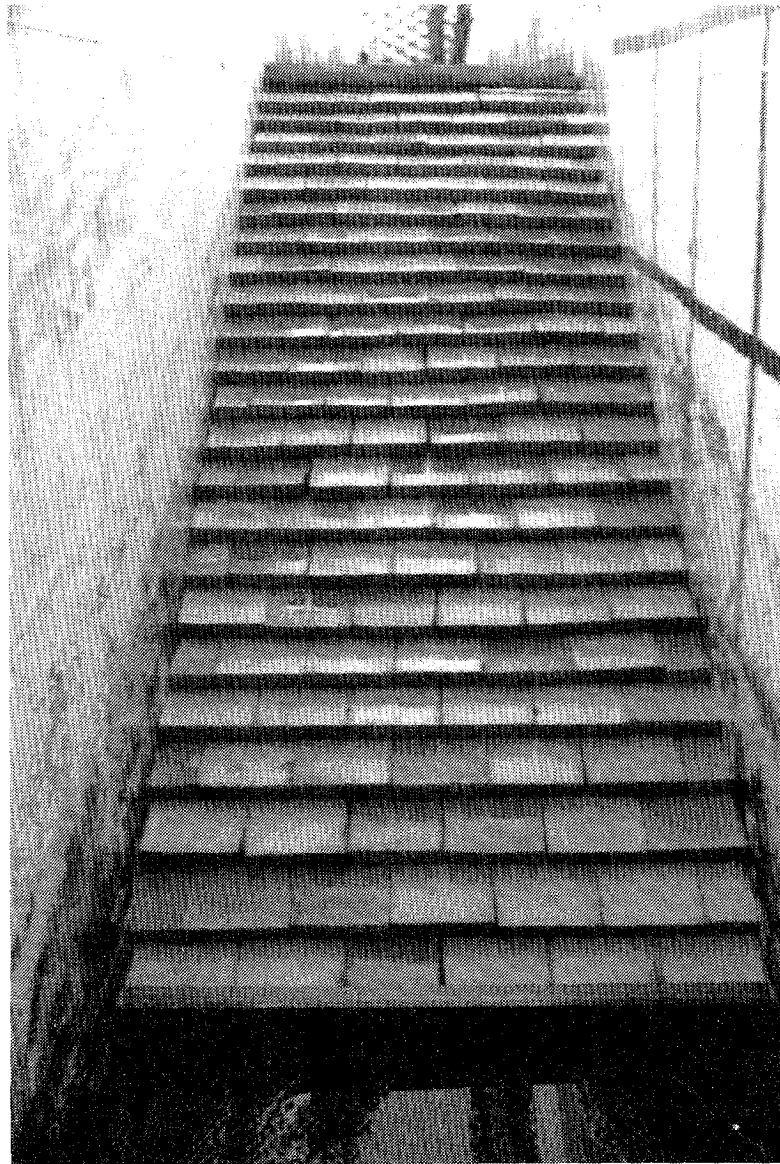
Figure 29. The wedge block protection system after testing on the rigid embankment.

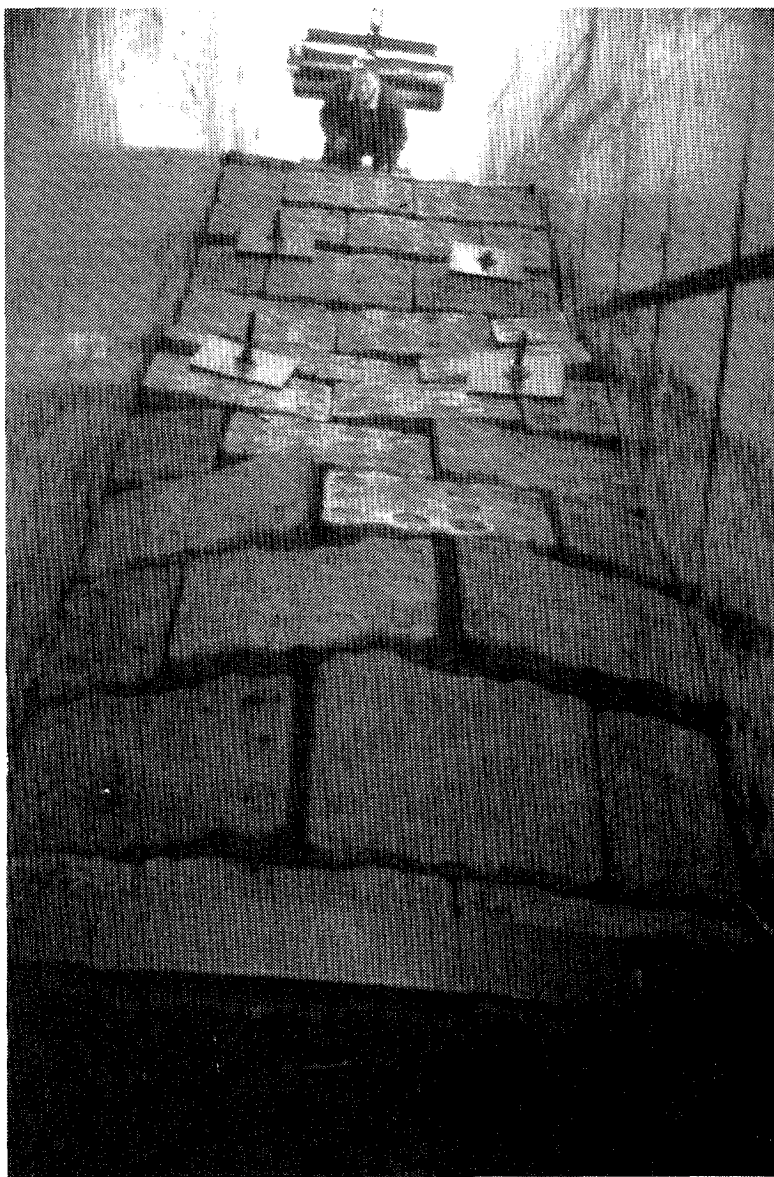
Figure 32. Failure of the Dycel 100 system after testing on the erodible embankment, looking upstream.

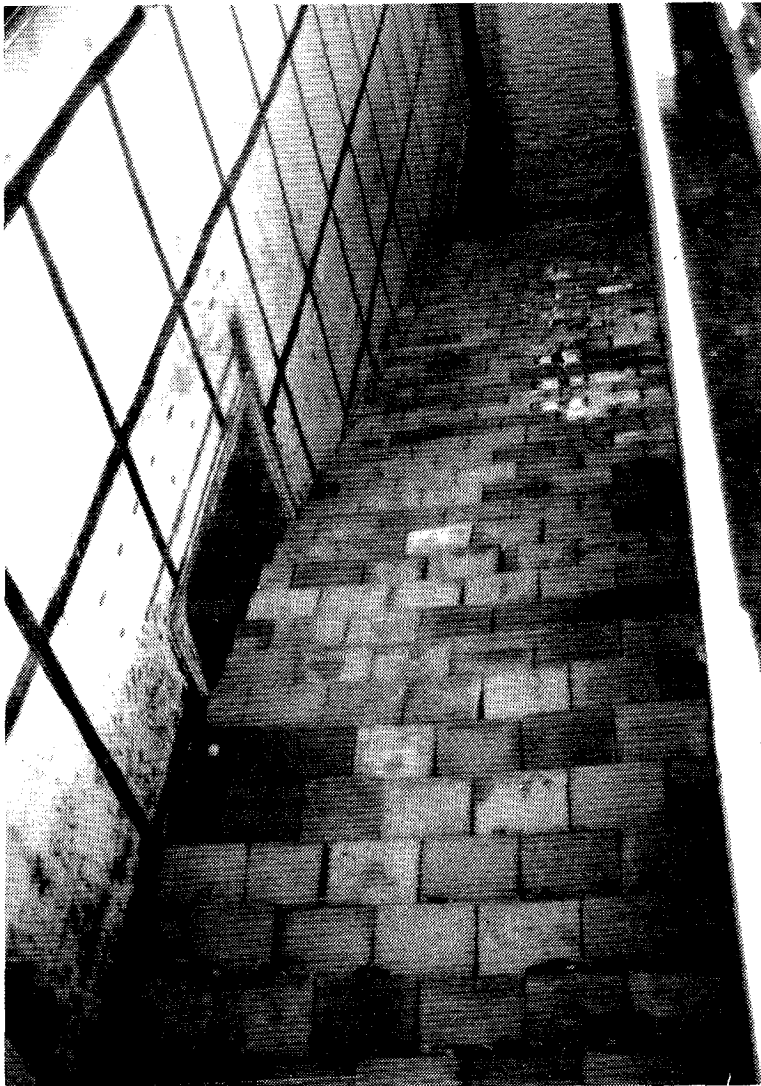
a. Looking downstream after Test ER-2. Note loose gravel remaining in the lee of the blocks

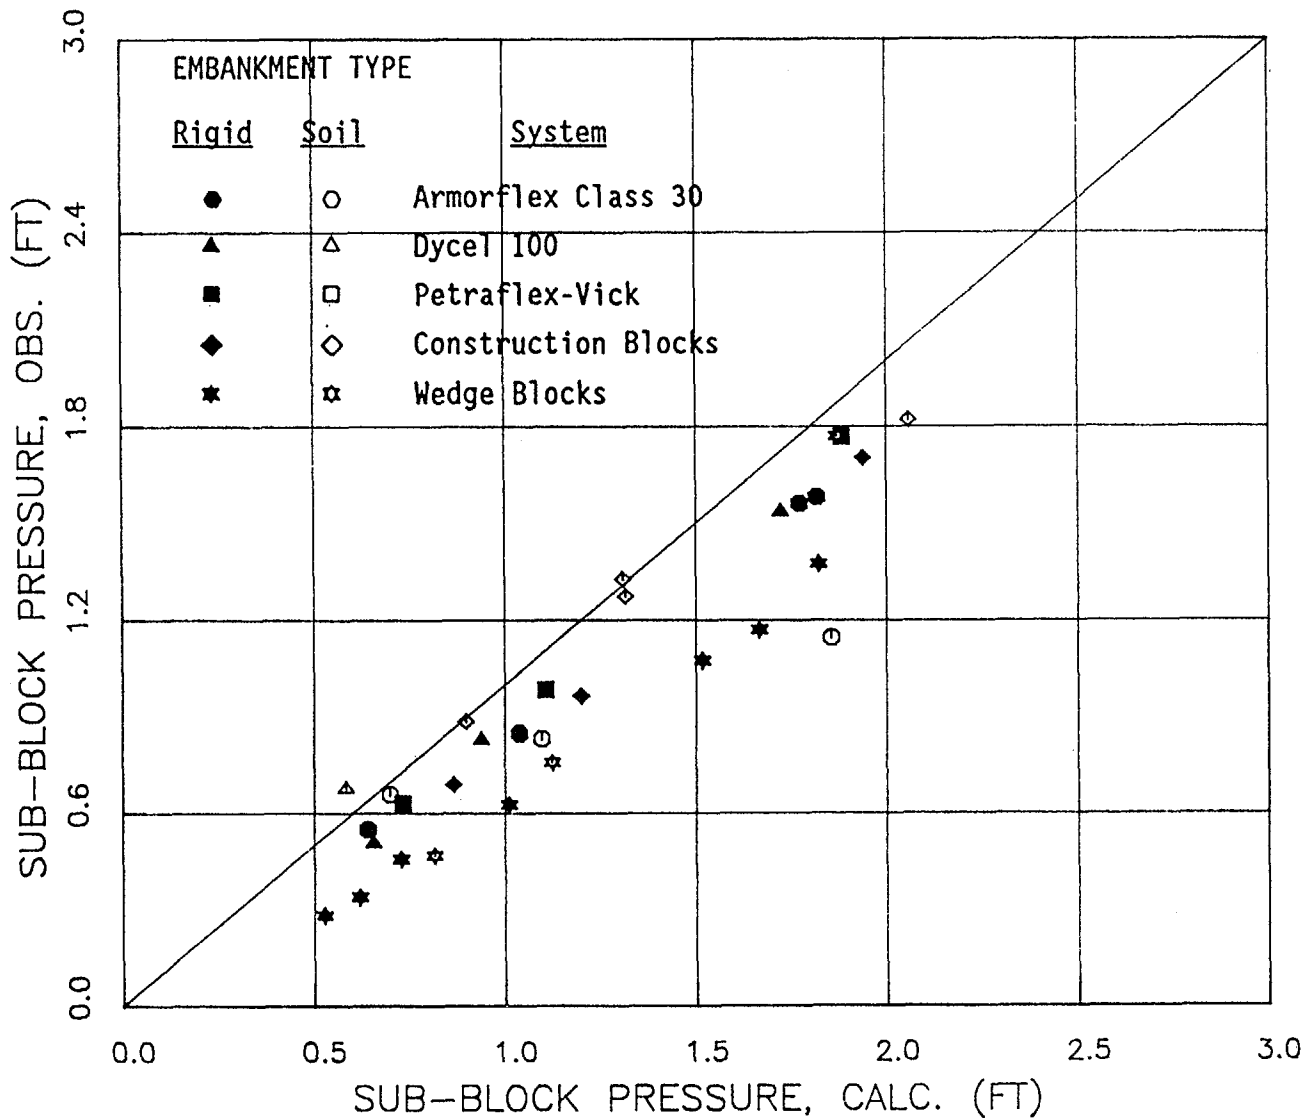
Figure 63. Mean observed sub-block pressure versus calculated sub-block pressure, in feet of water, at station 41.5.

In figures 61 through 64, points plotting above the 45° line of agreement indicate observations of subblock pressure greater than that expected from hydrostatic forces alone. In general, this was observed primarily for the construction block and Armorflex systems. In the case of the construction blocks, their large cellular dimension (approximately twice that of other systems) may contribute to the transformation of kinetic head to stagnation pressure within the cell. This pressure can then be transmitted to the subblock environment where the pressure transducers were located. In the case of the Armorflex system, it is possible that local stagnation pressures may be transmitted to the subblock environment through the joints, as opposed to through the cells. This condition is brought about through the shouldered profile of the Armorflex block and its stagger pattern of installation, which creates a somewhat lower groove or channel between blocks which then terminates in the raised shoulder of the next downstream block (see figure 31).
