Report No. FHWA/RD-80/160

# METHODS FOR ASSESSMENT OF STREAM-RELATED HAZARDS TO HIGHWAYS AND BRIDGES

March 1981  
Final Report

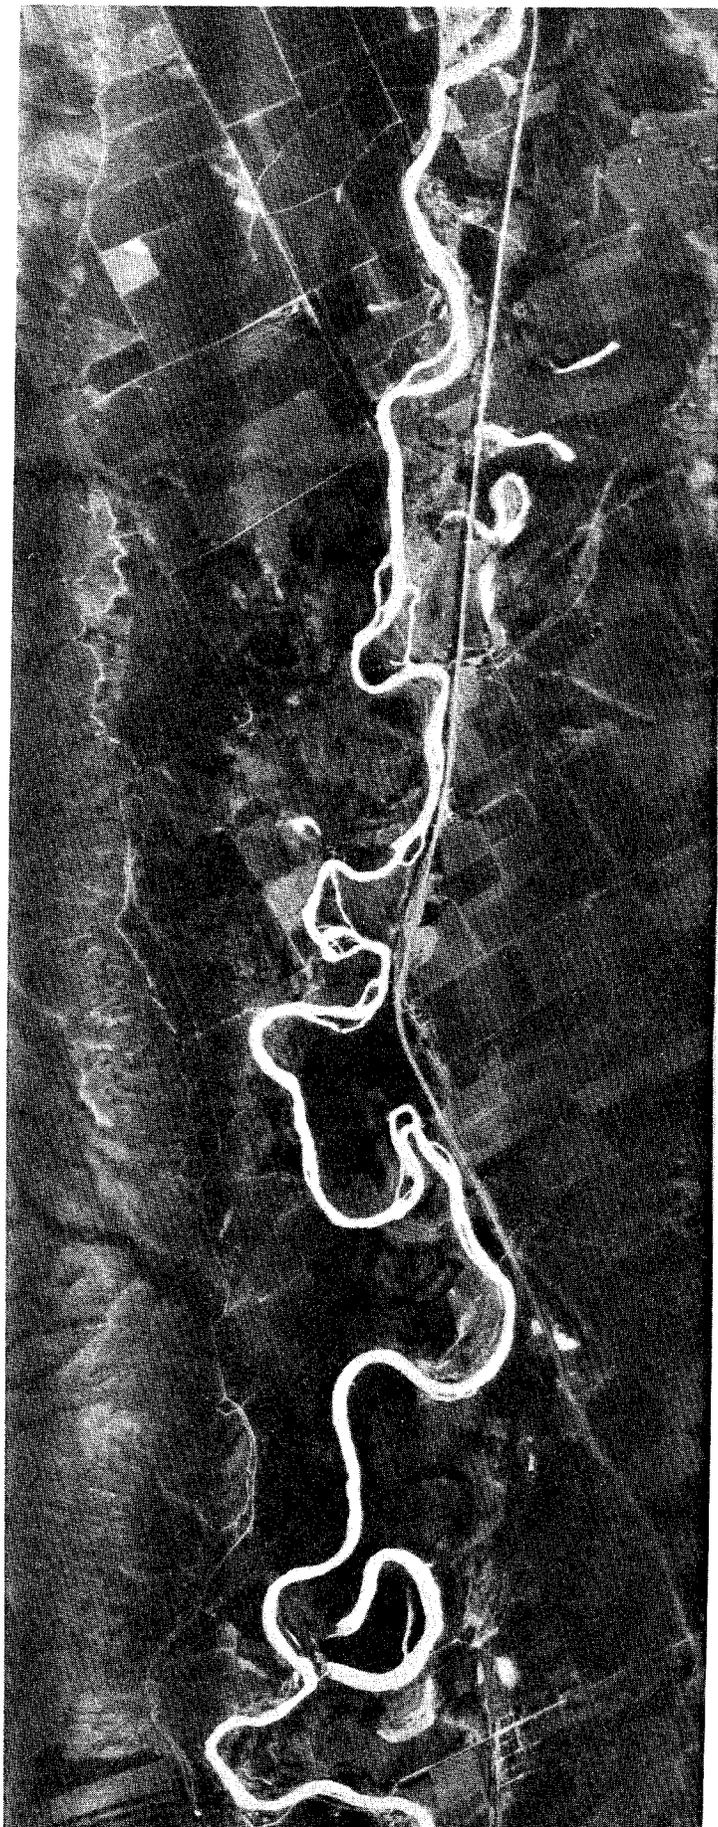
Figure 1. Meandering reach of Clark's Fork of the Yellowstone River (courtesy J. F. Ruff). Note recently formed oxbow lake which is the result of meander cutoff.

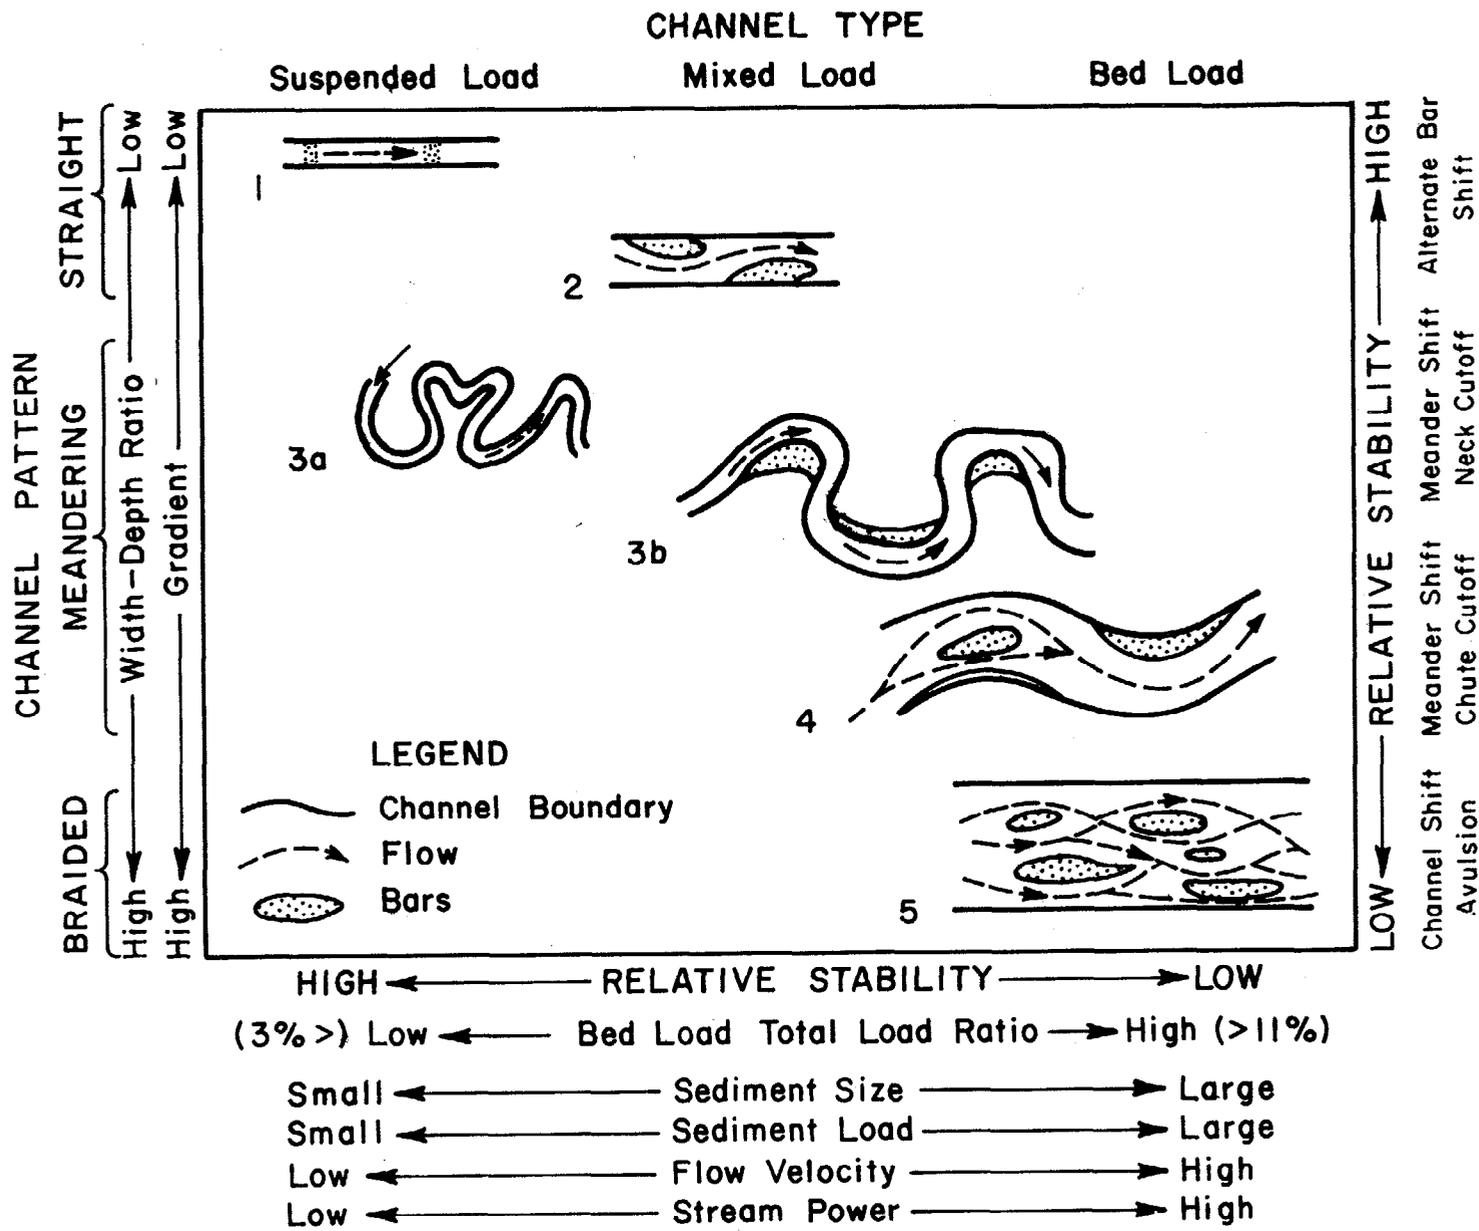
Figure 4. Channel classification showing relative stability and types of hazards encountered with each pattern.

The shift of a meander (Figs. 4, 5e) into a bridge site creates major problems as the flow alignment is drastically altered, and bank erosion may become very serious (see discussion of Example 2 in Chapter 9). The rate of a meander shift will vary greatly depending on where in the continuum of meandering patterns the river fits. For example, Brice (1975) identifies seven meandering patterns (Fig. 3). His meandering Patterns a and g are analogous to Pattern 3a (Fig. 4). His Patterns c and d are analogous to Pattern 3b (Fig. 4). His Pattern f is analogous to Pattern 4 (Fig. 4). Brice's sequence of patterns from a to f represents the range of meander patterns with decreasing stability from Pattern a to f.

Inspection of aerial photographs and comparison with the patterns of Figs. 3 and 4 provide the transportation engineer with a means of evaluating the relative stability of river channels. The discussion in this chapter has centered on pattern stability alone, and major hazards such as aggradation and degradation, which occur in bedrock-controlled, semi-controlled and alluvial channels, have not been considered. These and other hazards are discussed in Chapter 3.

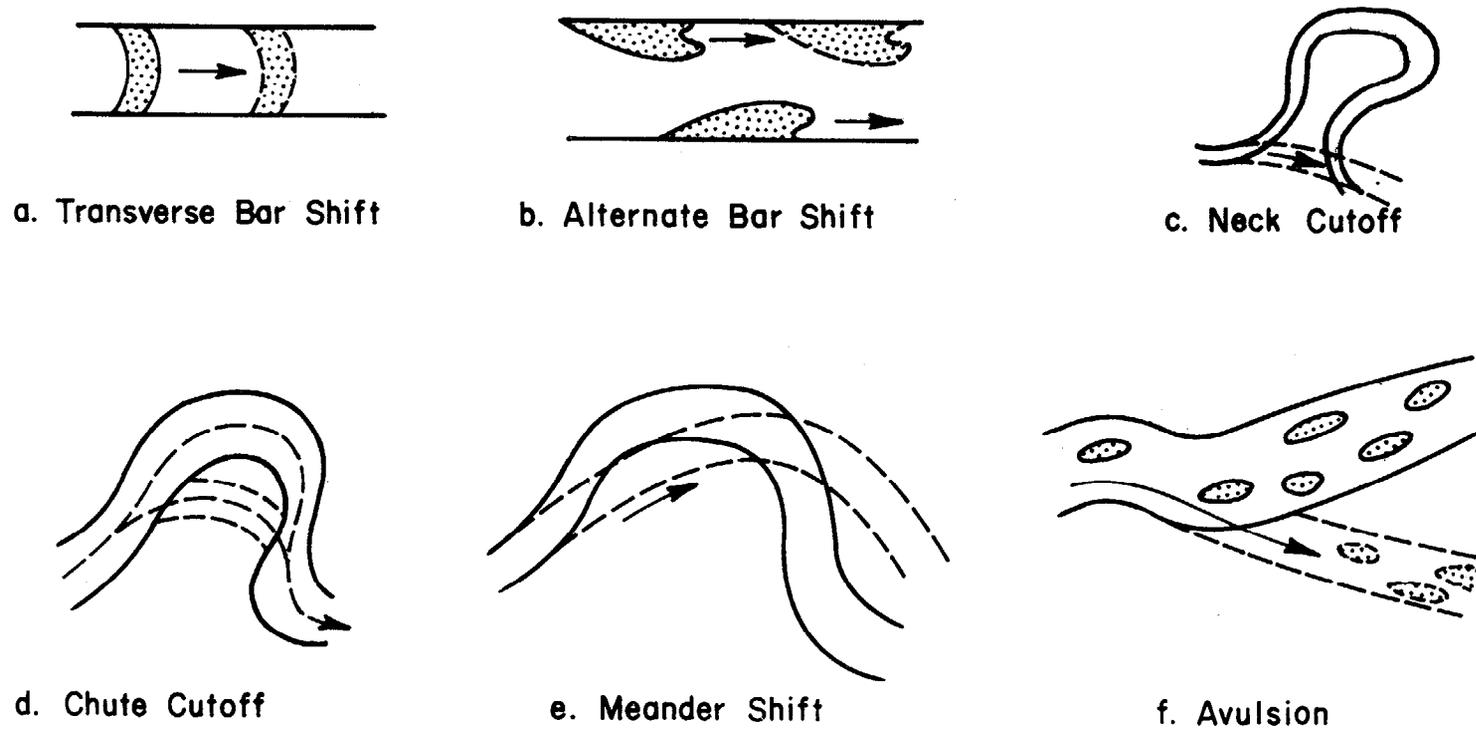
(Solid lines indicate current status and dashed lines indicate future potential changes.)

the channel will not be characterized by serious bank erosion or channel shift. Bars may migrate through the channel (Fig. 5a), but this should not create undue instability. Pattern 1 channels are rare, but stable. However, it must be determined that the straight channel is naturally straight. If the straight channel has been artificially straightened, and therefore steepened, it can be very unstable, as it attempts to return to its original gradient by degradation, development of a more sinuous course, or both.

Pattern 2. The mixed-load straight channel has a sinuous thalweg. It is relatively stable, but carries a small load of coarse sediment, which may move through the channel as alternate bars (Fig. 5b). As these bars shift through the channel, banks are alternately attacked and protected by the alternate bars (Fig. 5b). Hence, at any one location the thalweg will shift with time. At a bridge this means that apparent deposition or fill at one side of the channel will be replaced by scour as an alternate bar migrates under the bridge (Fig. 4). Also, at any time one side of the channel may be filling while the other is scouring.

Other problems associated with this type of river behavior are degradation and scour that occur upstream of meander cutoffs (Fig. 5c) and the deposition that occurs downstream of the cutoff. Depending on a bridge location, a cutoff can cause filling below the bridge or scouring.

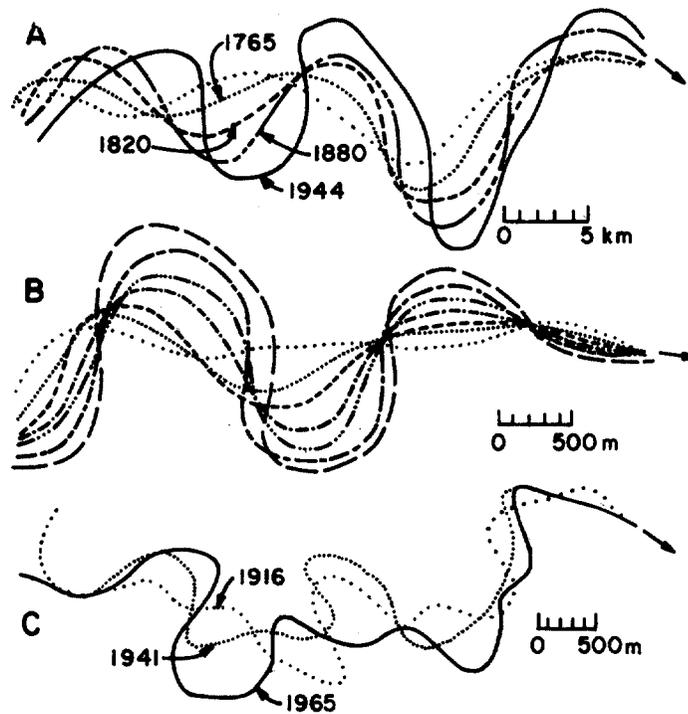
Figure 7. Evolution of simple meanders. A, Mississippi River between New Madrid, Missouri, and Dyersburg, Tennessee (Dyersburg 1:250,000); centerlines prior to 1944 interpreted from chronological sequence of alluvial deposits as illustrated by Fisk (1944, Pl. 22, Sheet 3). B, White River near Petersburg, Indiana (Iona 7½'); centerline of 1937 (heaviest line) from aerial photograph and prior centerlines interpreted from meander scrolls. C, Elkhorn River, Scribner, Nebraska (Scribner 7½' and Uehling 7½'). (From Brice, 1974.)

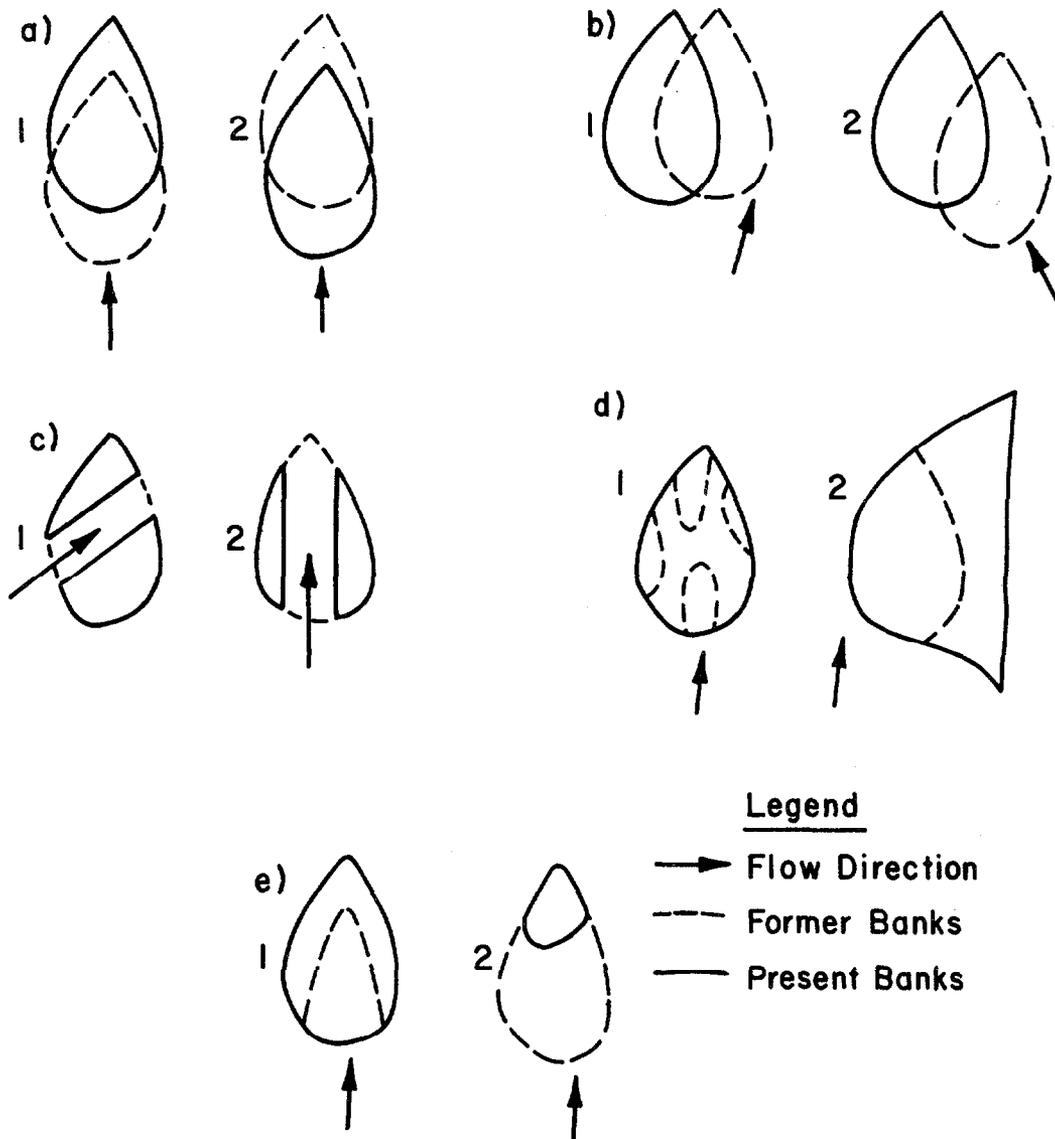
Figure 8. Island change according to Popov (1962). Arrows show direction of flow. Solid lines are original locations of islands; dashed lines show changes. (a) Island shifts up or downstream. (b) Island shifts laterally. (c) Island divided by channel. (d) Small islands coalesce and island joins flood plain. (e) Islands increase or diminish in size.

ways islands change (Fig. 8). A sixth and seventh could be added; that is, the formation of an island and the complete destruction of an island, but Fig. 8 does convey the important concept that bars and islands may be ephemeral and dynamic features of a channel.

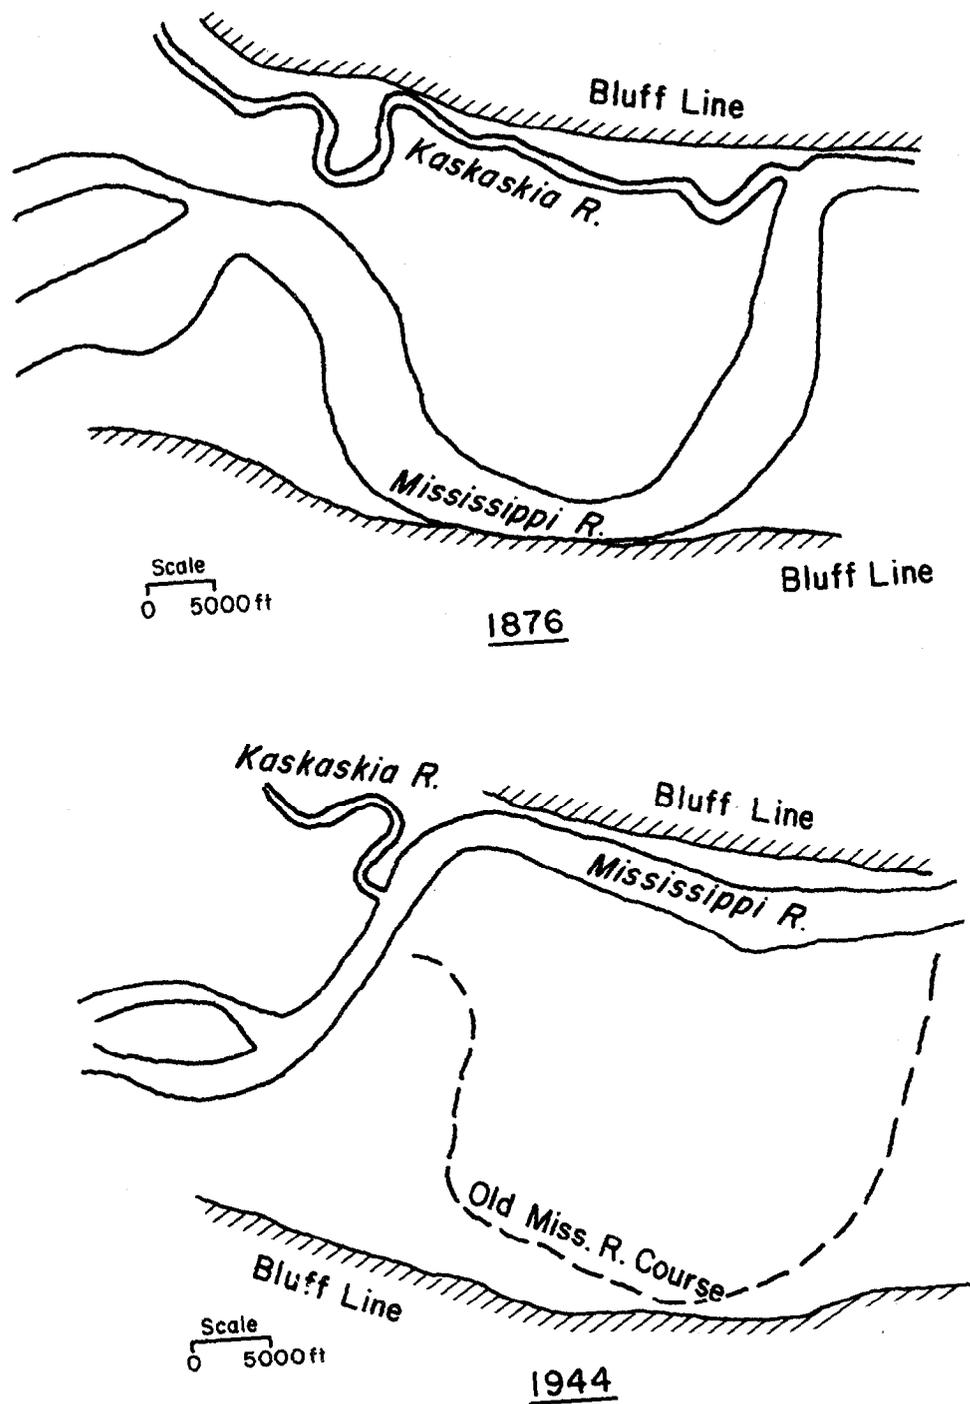
Figure 9. Patterns of Mississippi and Kaskaskia Rivers in 1876 and 1944 showing avulsion of Mississippi River (after Tiefenbrun, 1963).

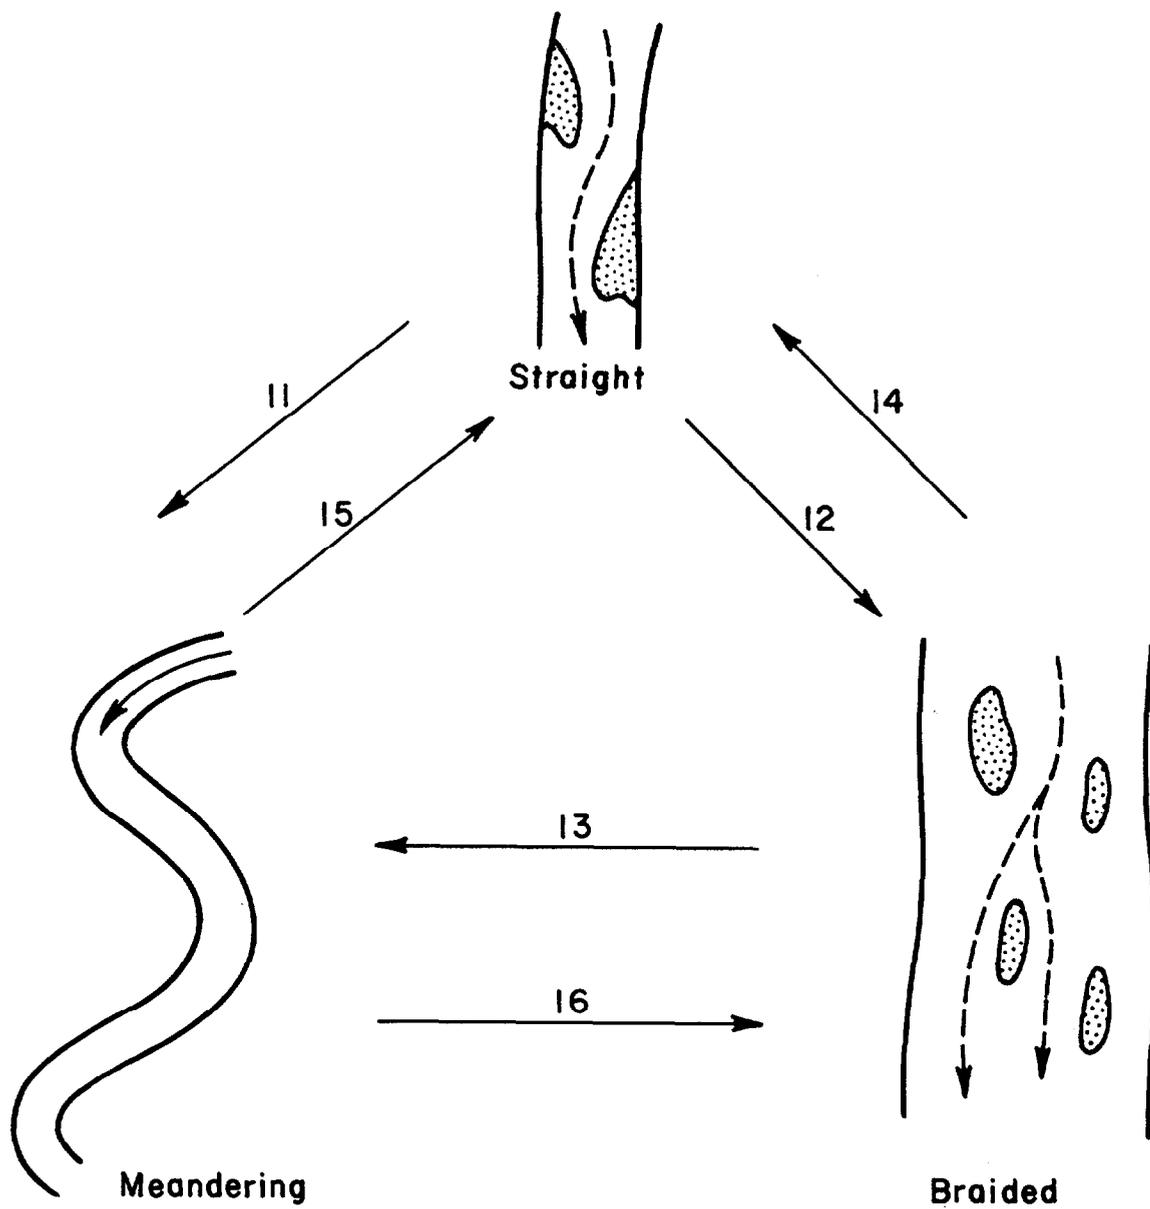
Figure 10. Types of river metamorphosis. Numbers refer to hazards listed in Table 1.

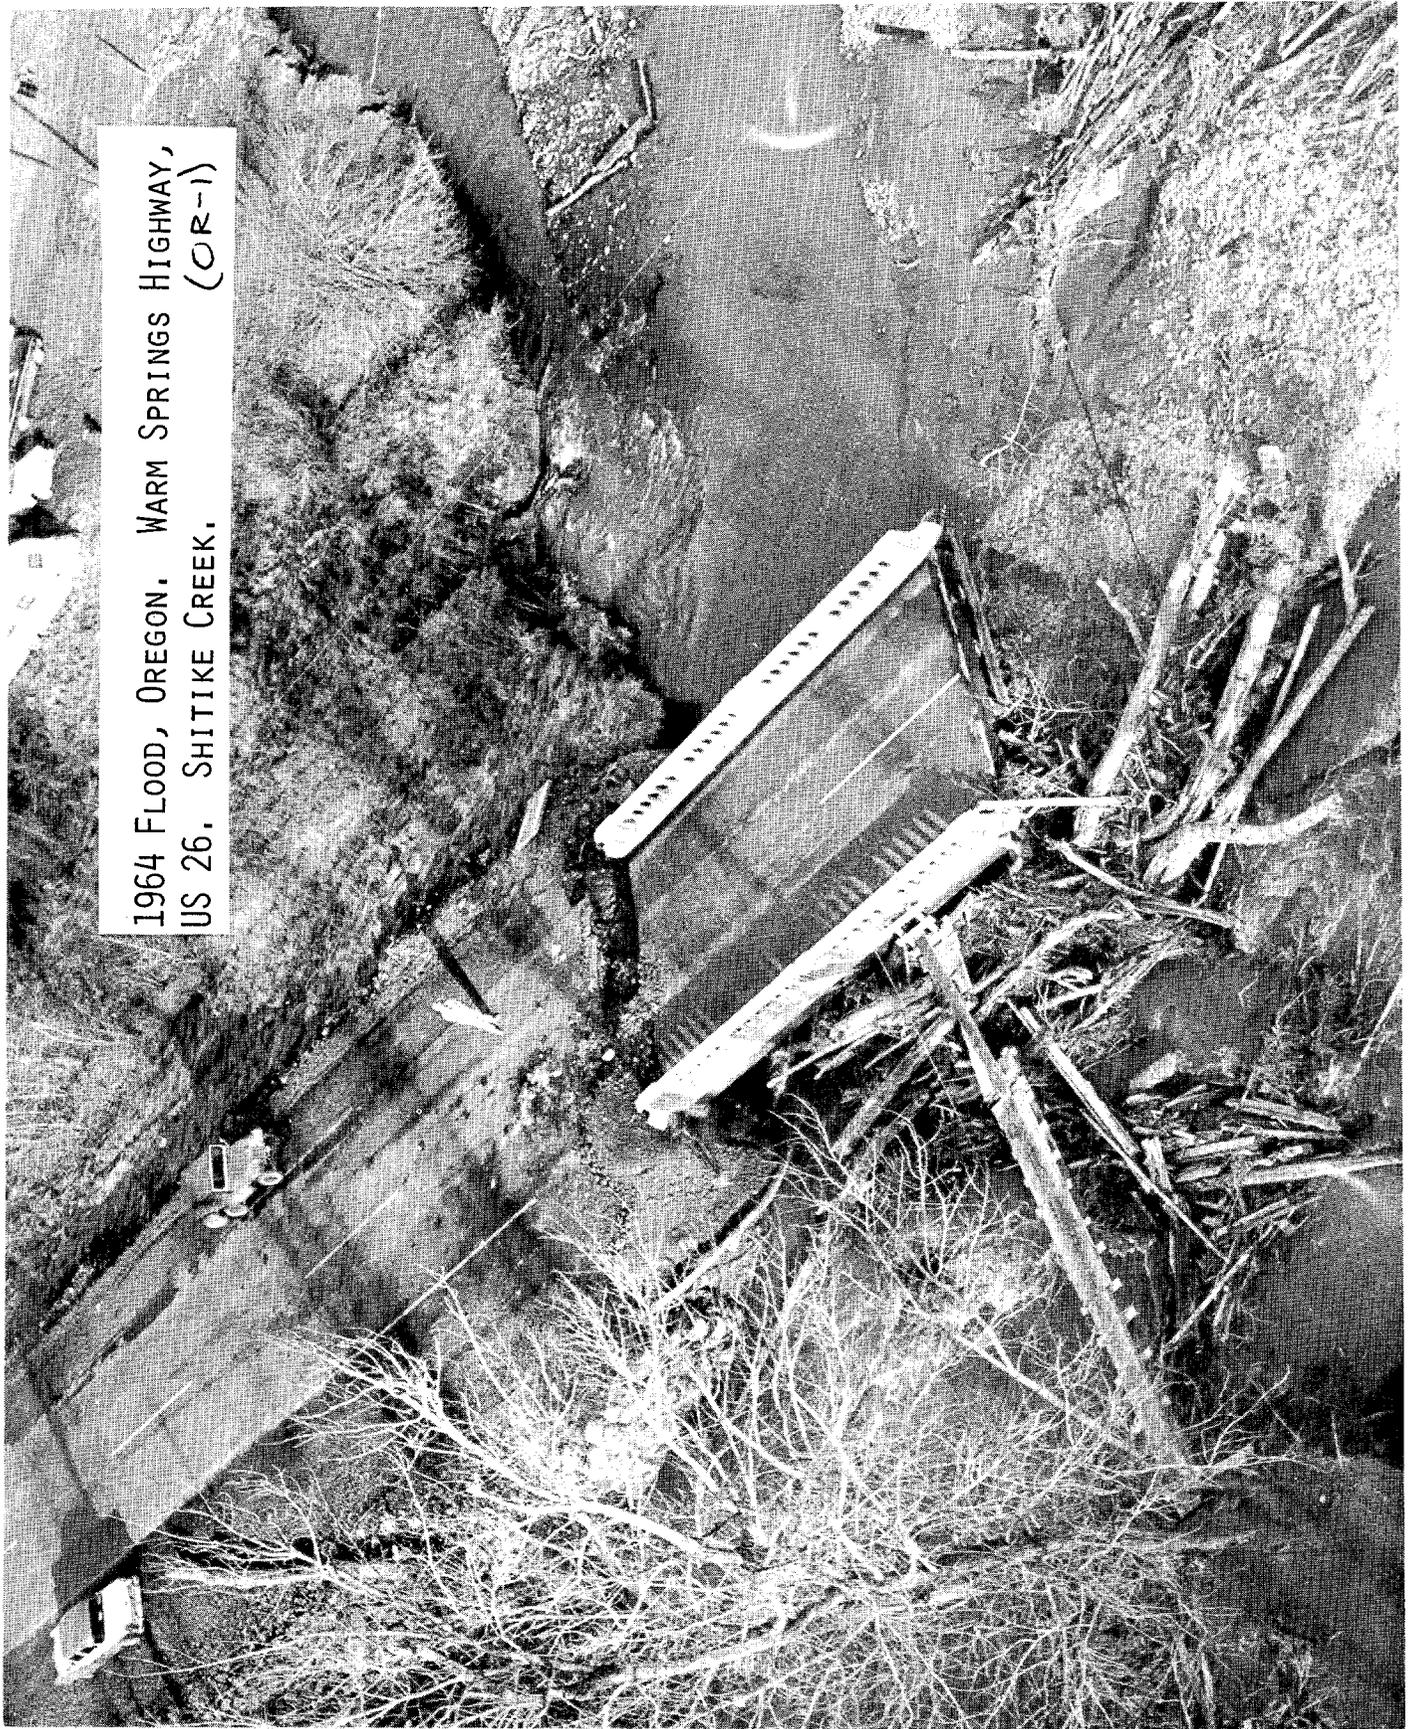
Figure 11. Debris accumulation at US 26 Bridge, Shitike Creek, Oregon, following 1964 flood.

The collection of debris at a bridge during floods can have the same effect as an ice jam (Fig. 11). Debris and ice can have indirect effects by promoting deposition on bars and islands or by causing bank erosion and scour as flow directions are altered and turbulence is increased by the obstruction.

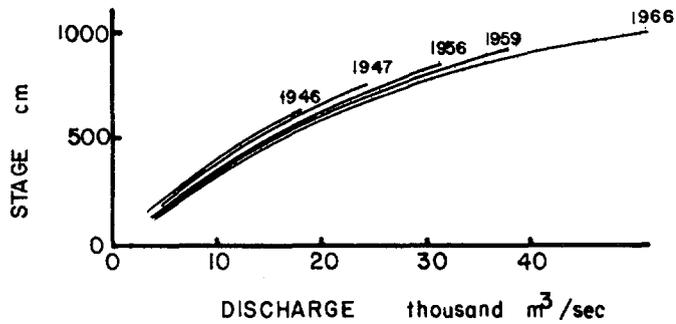
Figure 12. Relation between stage (H) and discharge (Q) of the Lena River, gaging station Tabaga (1946-1966). (From Borsuk and Chalov, 1973.)

4. Gaging station records for a given discharge will show if there is a change in the water surface elevation through time. For example, Borsuk and Chalove (1973) reported on the downcutting of the Lena River in the Soviet Union. They were able to establish that for a given discharge there has been a decrease in the gage height between 1946 and 1966 (Fig. 12). This progressive lowering of the water surface at a given discharge is clear evidence that the Lena River was degrading

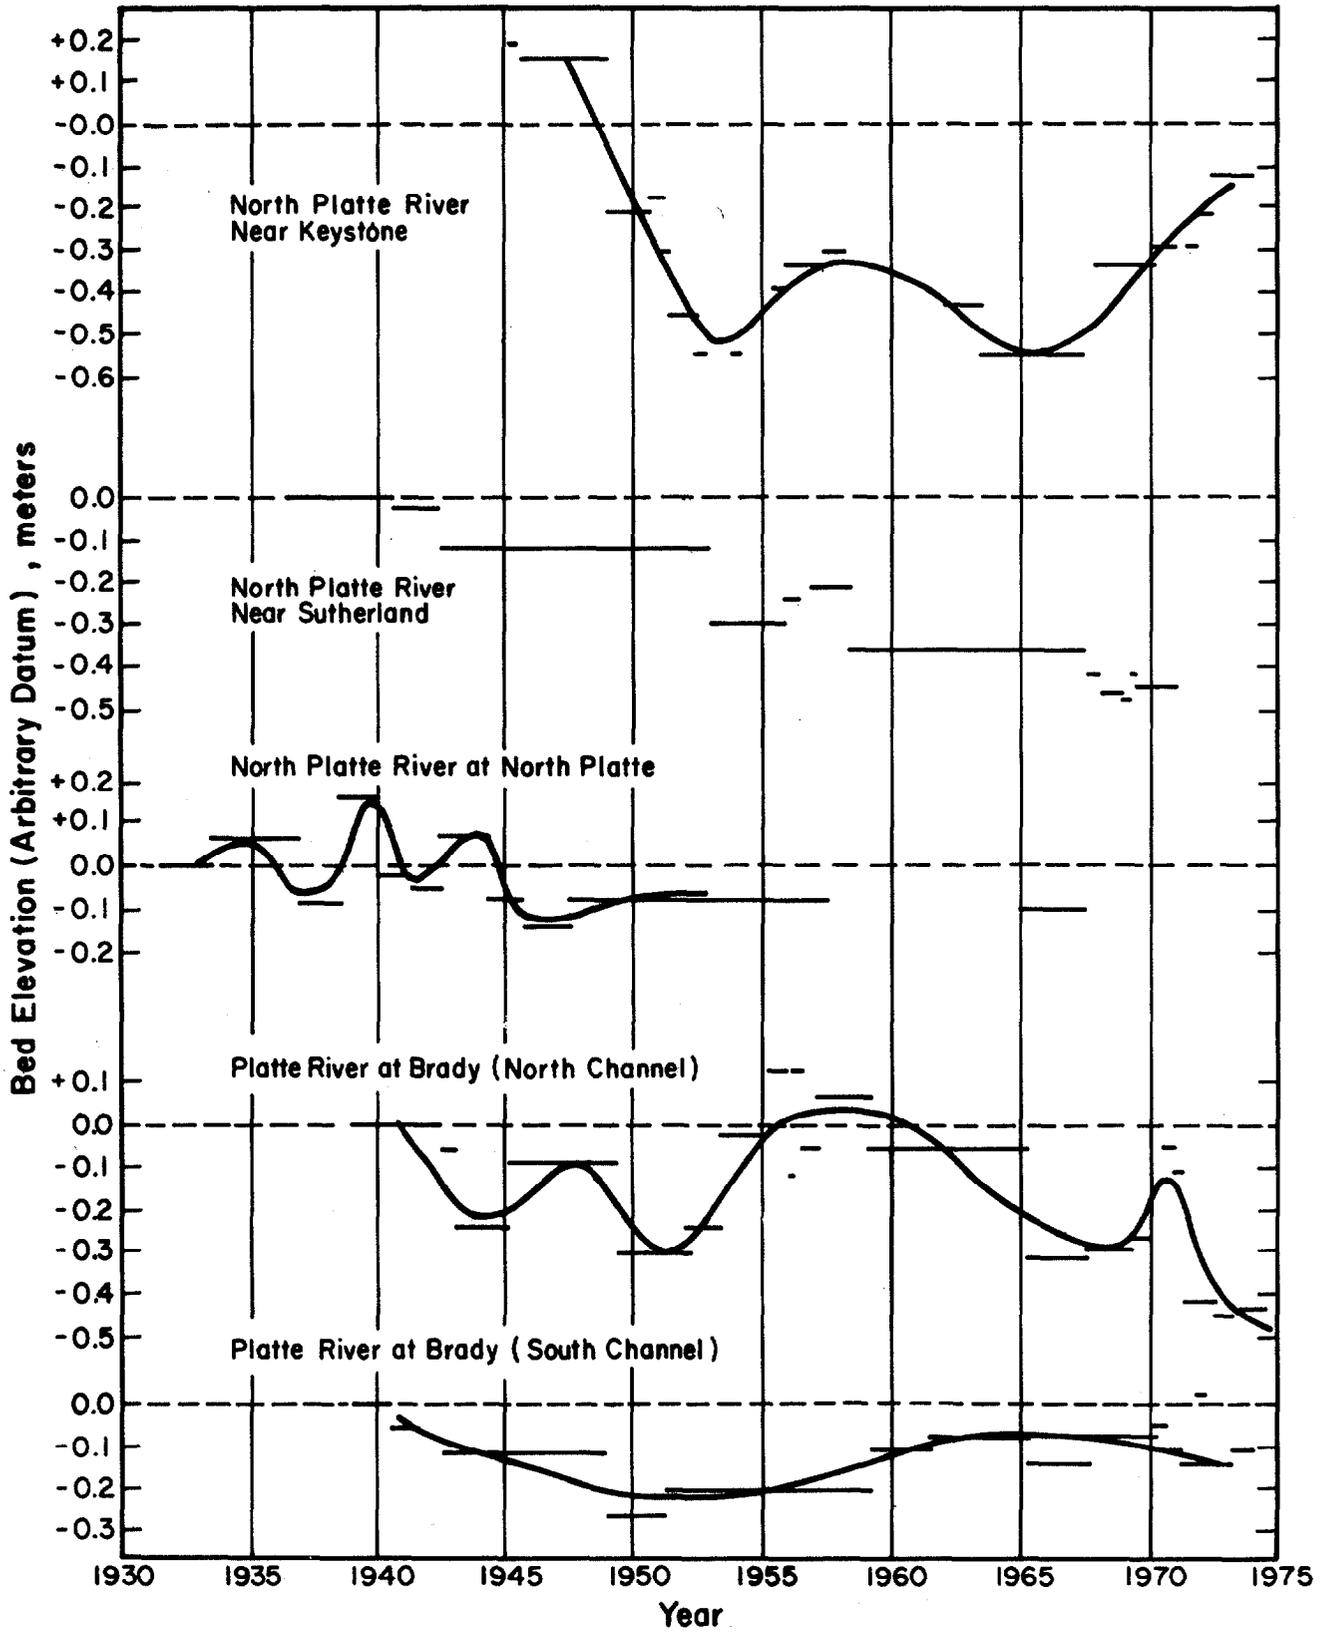
Figure 13. Changes in bed elevation - Platte River (from Williams, 1978).

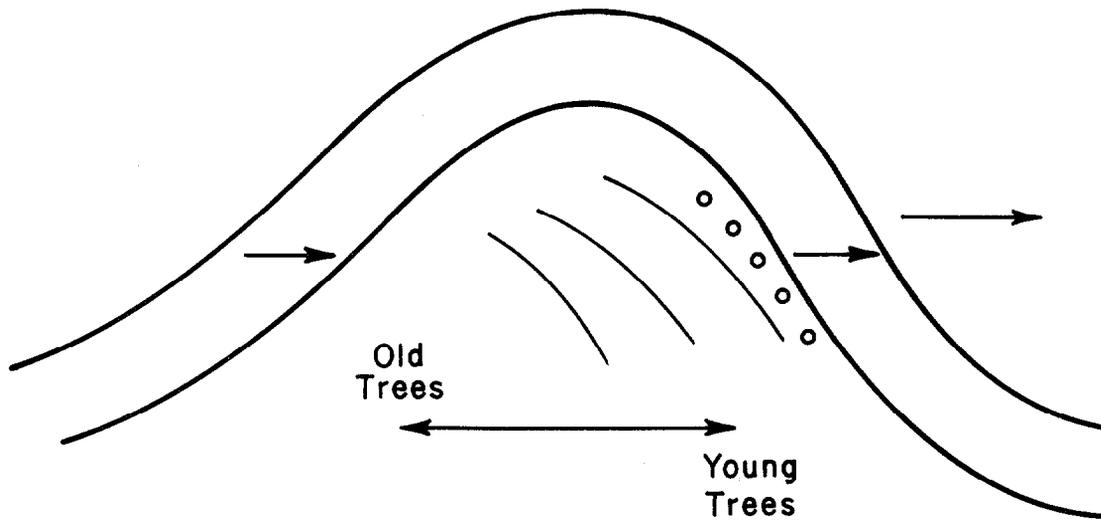
Figure 14. Distribution of trees on shifting meander.  
Meander shift is from left to right.

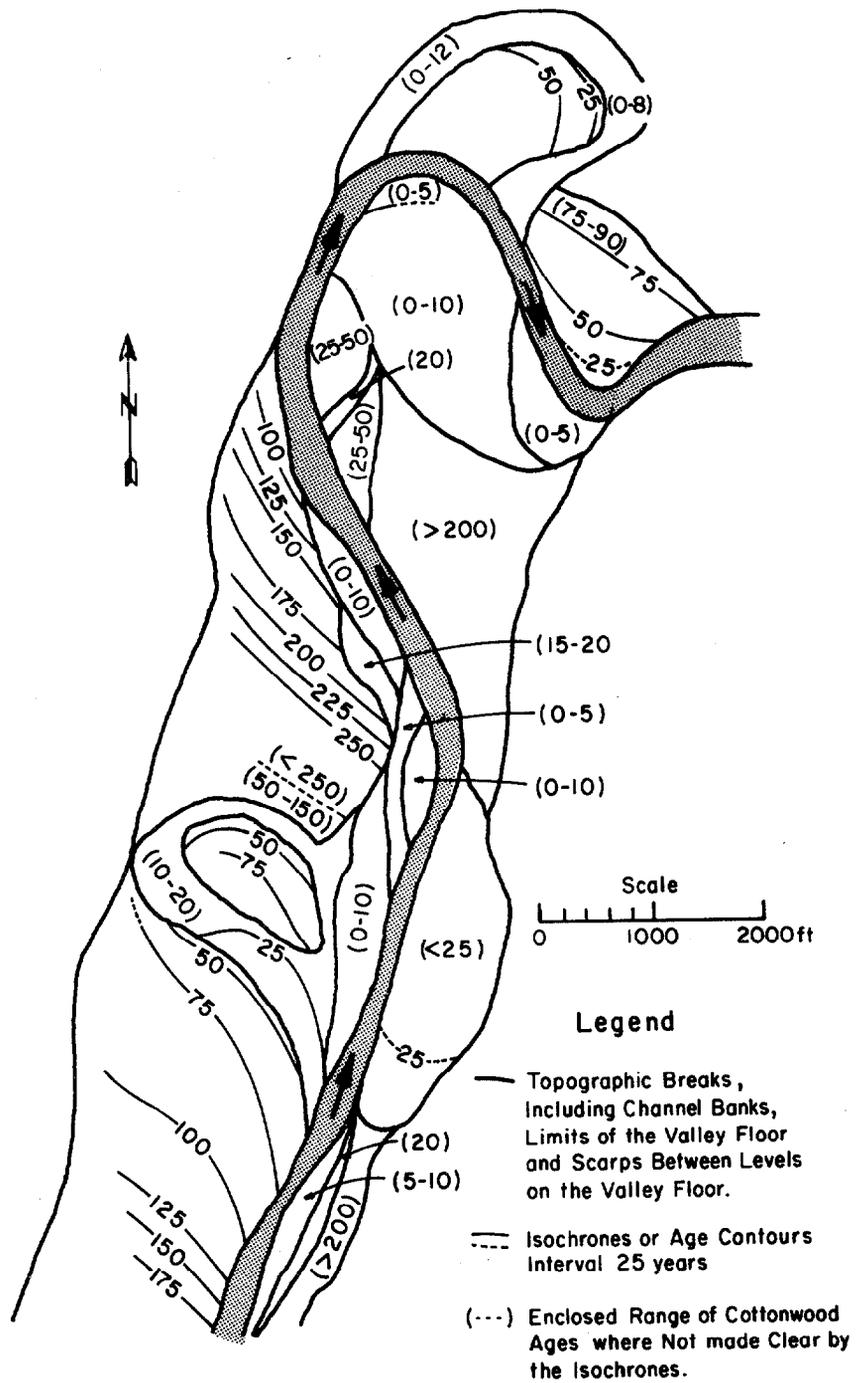
Figure 15. Distribution of tree ages on valley floor of Little Missouri River near Watford City, N.D. Contours are isochrones of tree age (from Everitt, 1968).

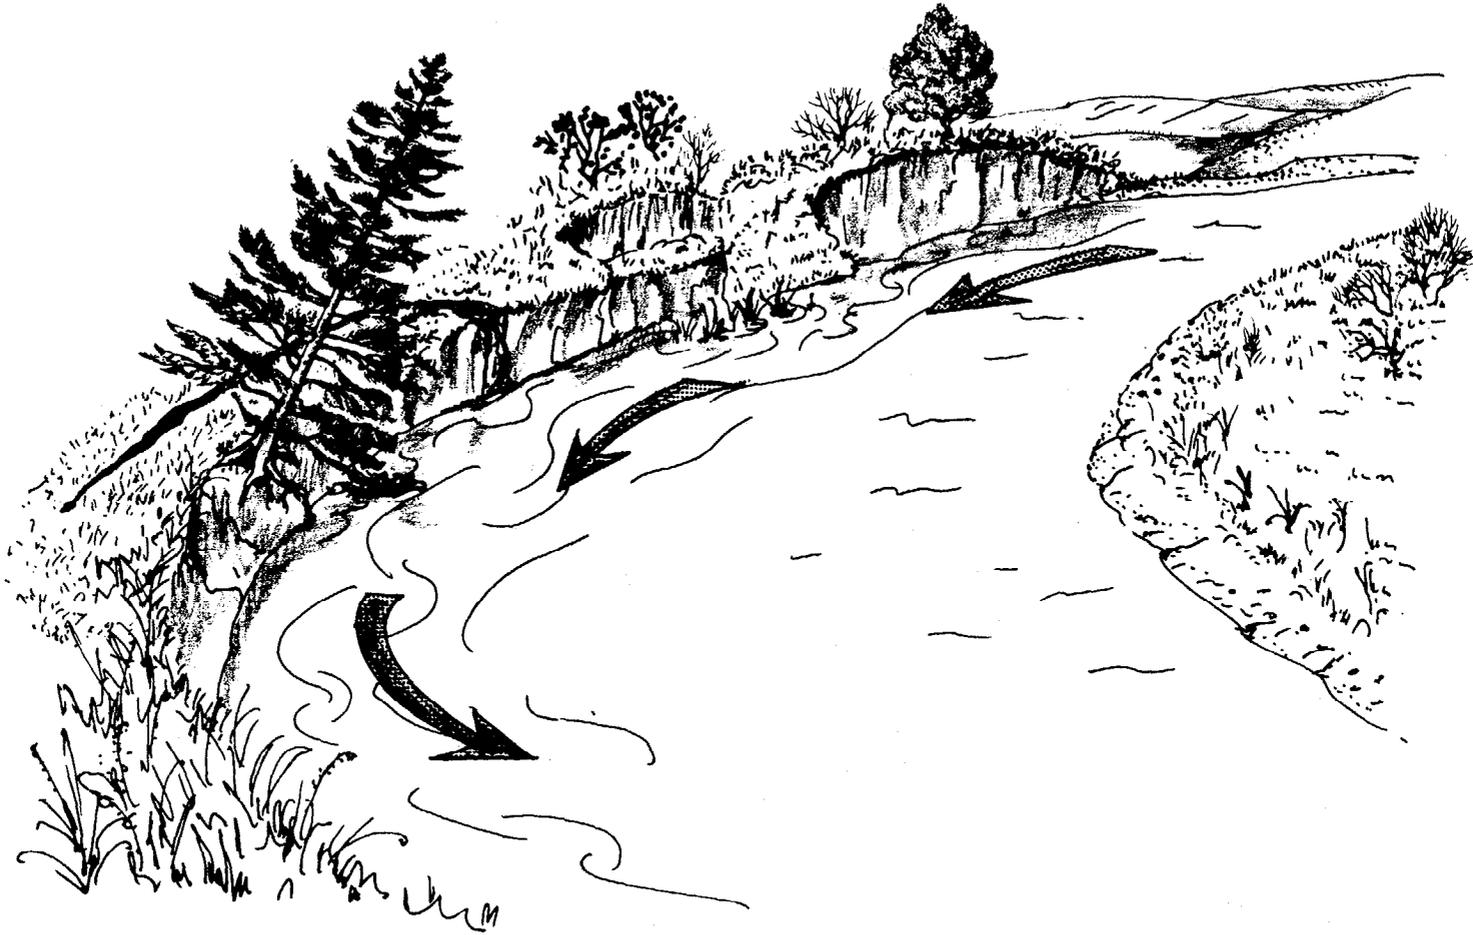
Figure 16. Active bank erosion exhibits fresh cut scarps, bankline cracks, slump blocks, and falling vegetation.

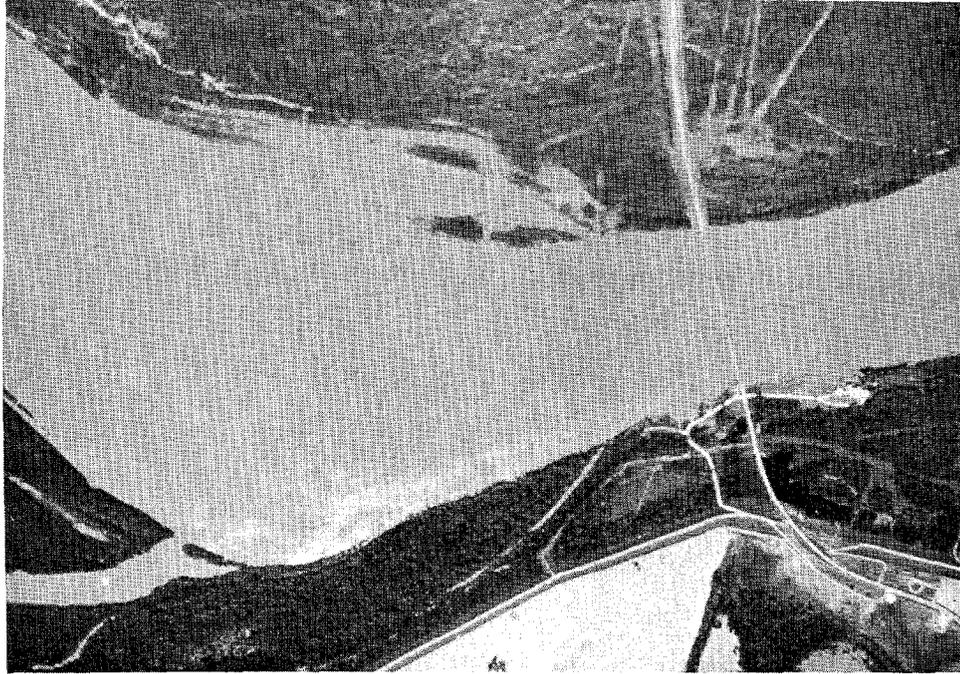
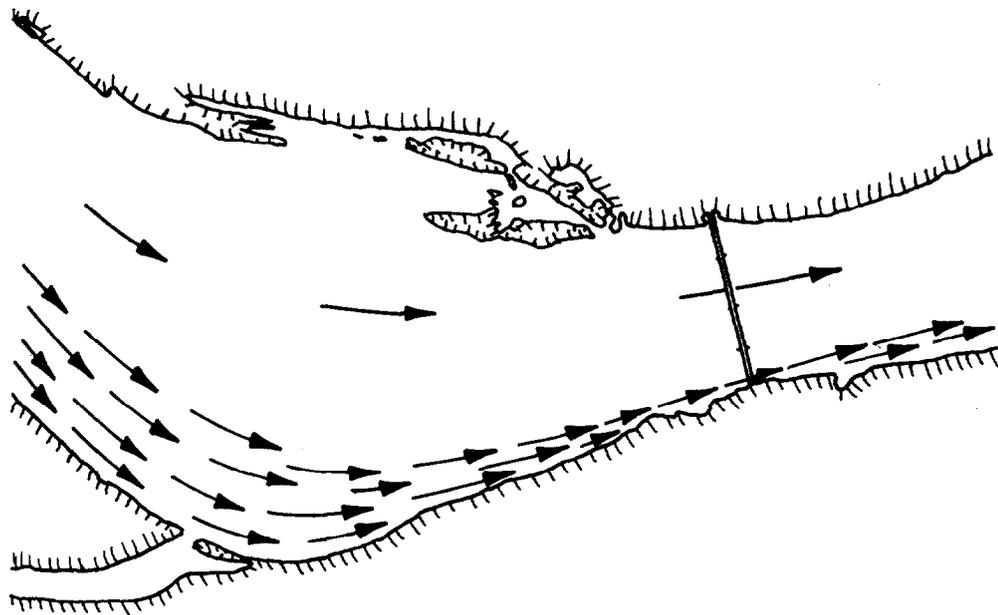
Figure 17. Color infrared photography enhances flow concentration pattern near bankline to indicate potential zone of severe bank erosion.

Color infrared aerial photography is particularly useful for noting most of the bank erosion indicators listed above. The majority of suspended material

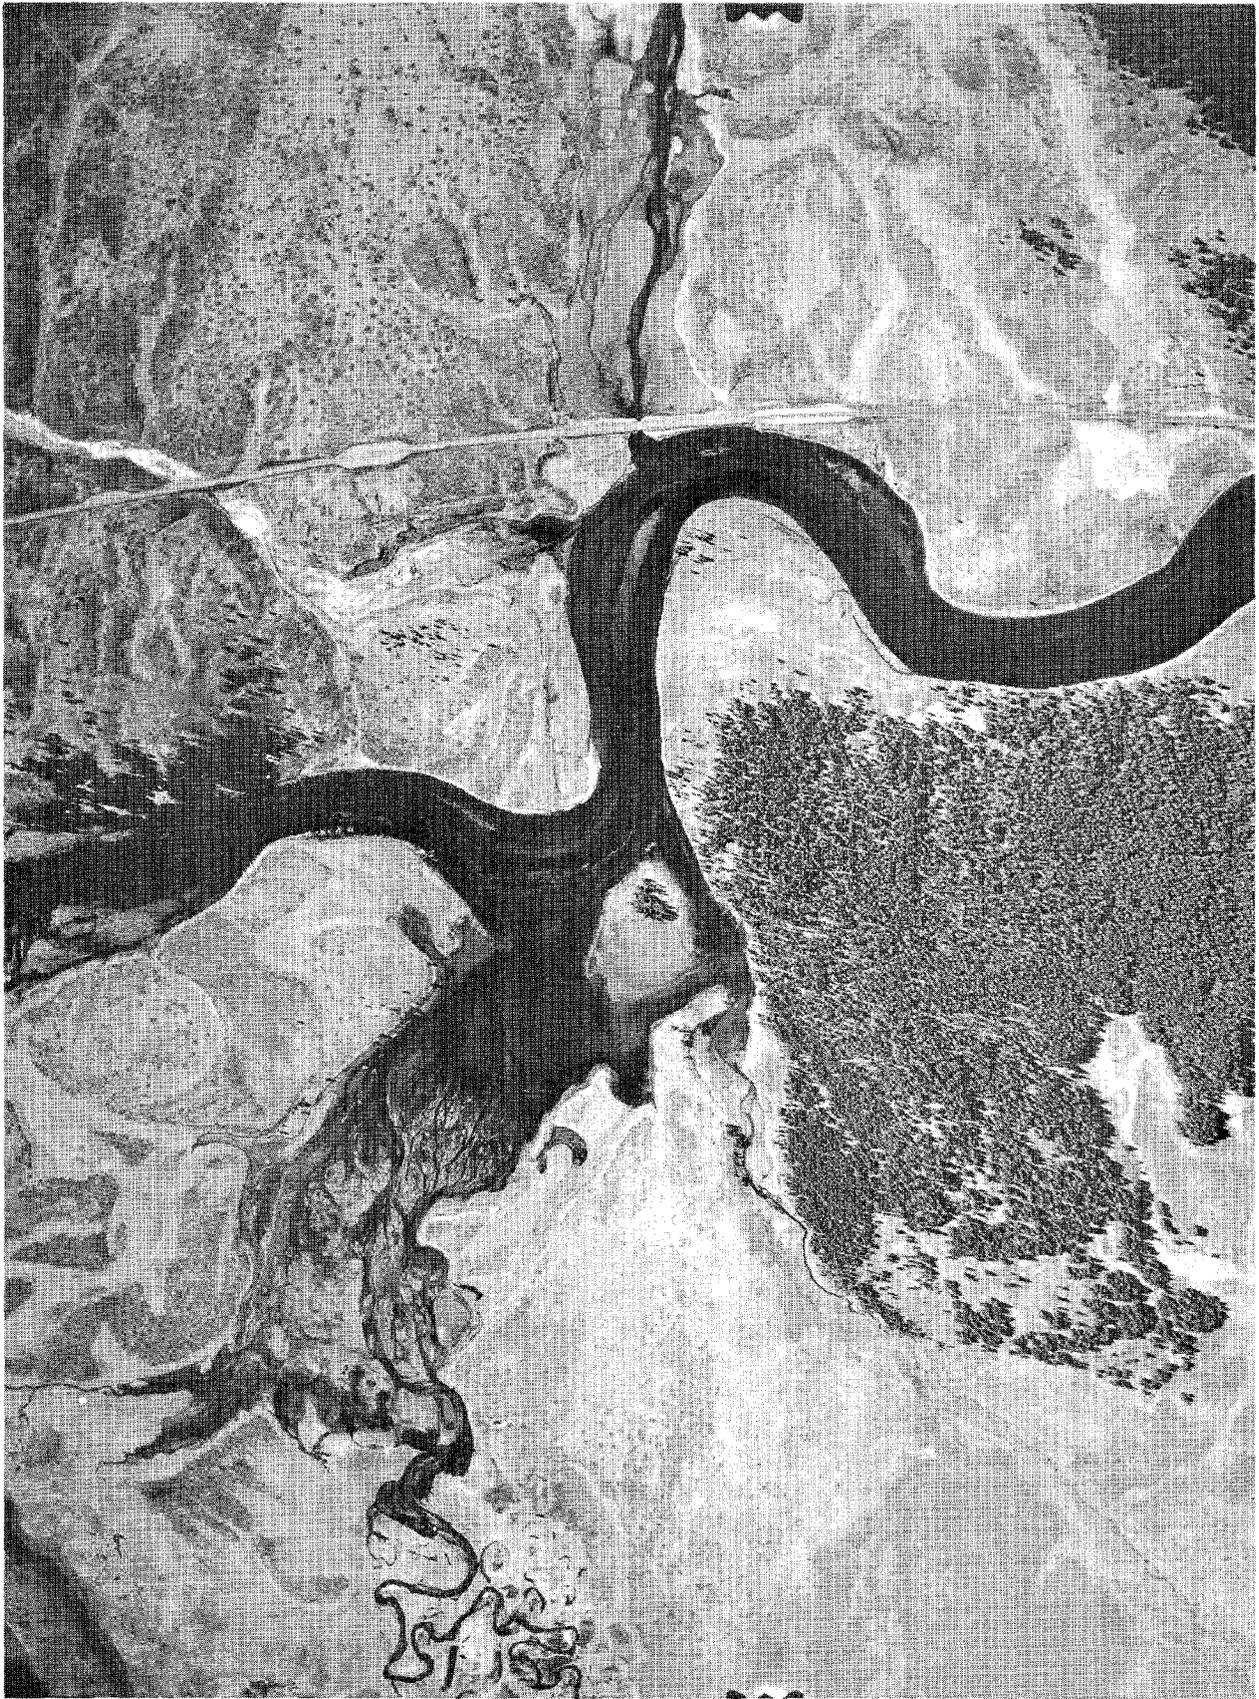
Figure 18. Deposition upstream of culverts at highway crossings and at confluences with large streams, (color infrared photograph - Yellowstone River, Yellowstone Park).

Although the main channel frequently may not show evidence of aggradation, the smaller tributaries joining the channel will also be aggrading as a result of a rising base level. If such a consistent pattern of tributary aggradation and backfilling can be detected, it is evidence of main channel aggradation.

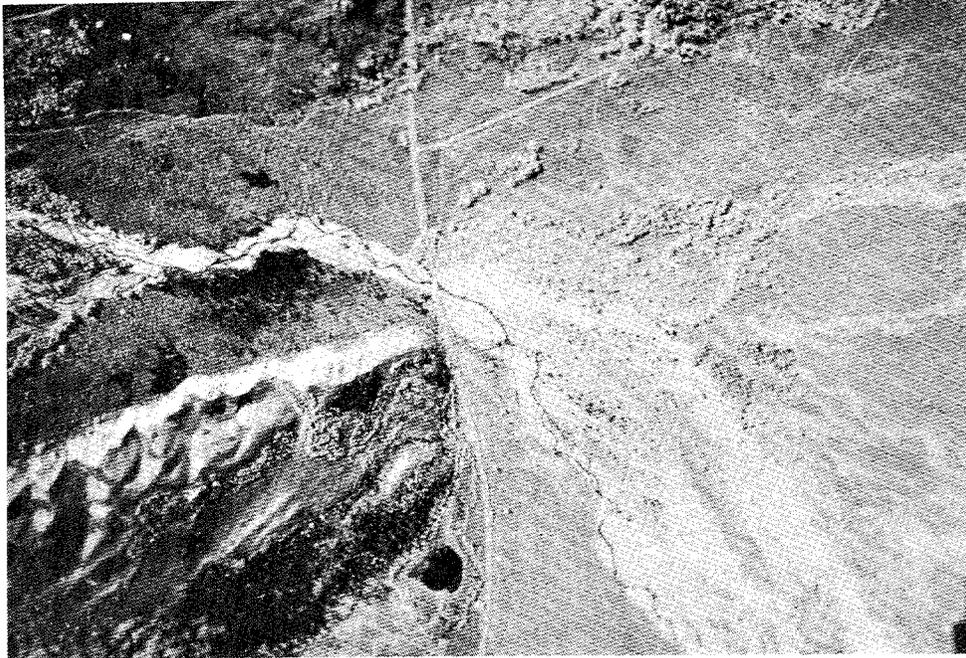
Figure 21. Bridge crossing at the head of a fan.
