Report No. FHWA/RD-80/160

# METHODS FOR ASSESSMENT OF STREAM-RELATED HAZARDS TO HIGHWAYS AND BRIDGES

March 1981  
Final Report

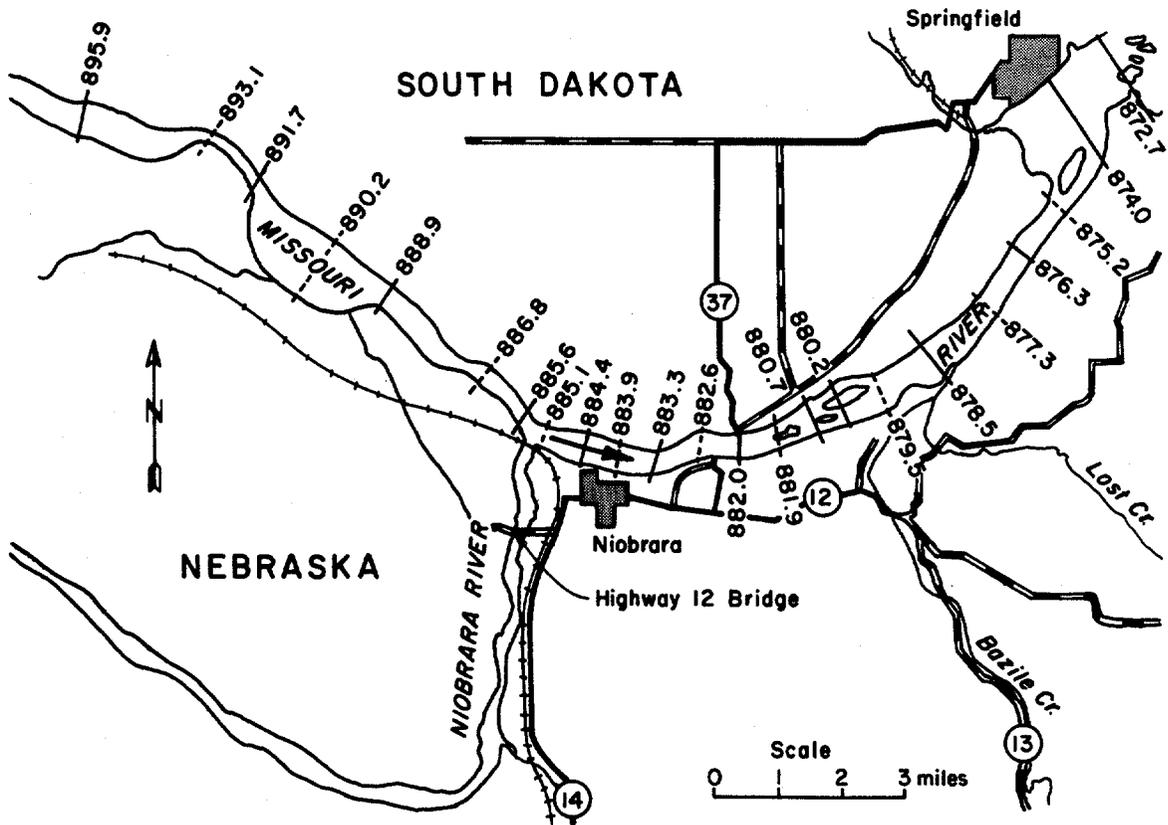
Figure 22. Confluence of Missouri and Niobrara Rivers (after Livesey, 1976).

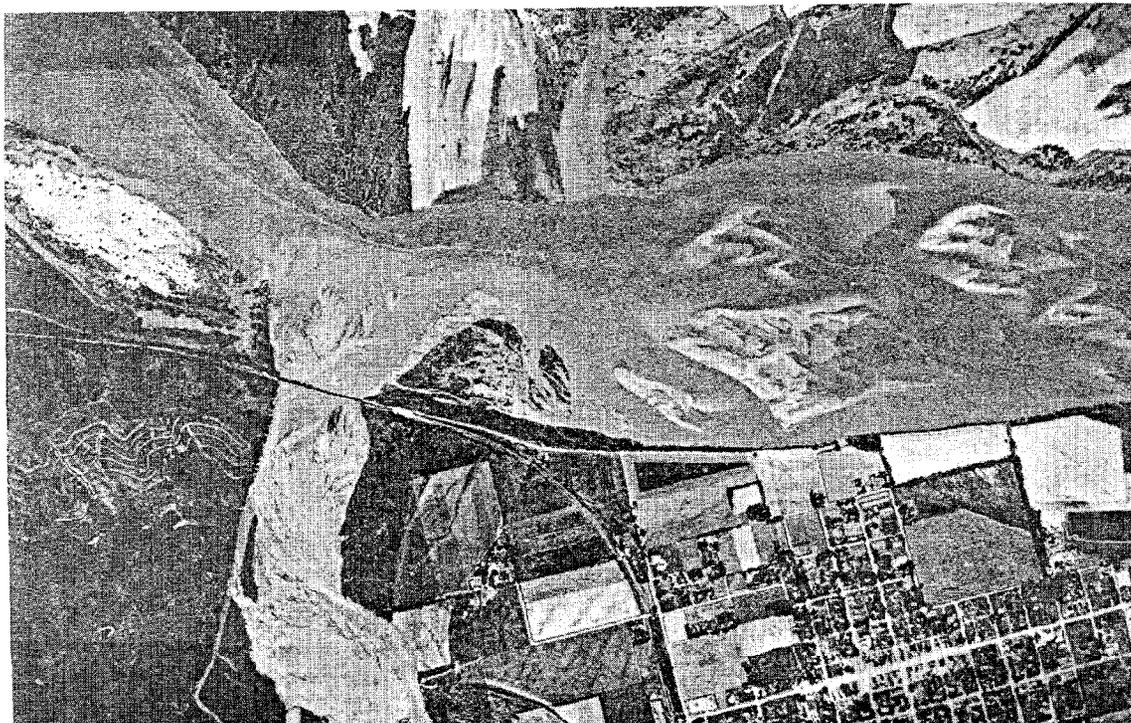
Figure 23. Aerial photograph of junction of Niobrara and Missouri Rivers (June, 1961). The bridge shown is a railroad bridge. Highway 12 Bridge is off the photograph to the south. (After Livesey, 1976.)

Aerial photographs and maps show the Niobrara at the bridge to be a very wide braided channel. The braided pattern is typical of the Niobrara upstream,

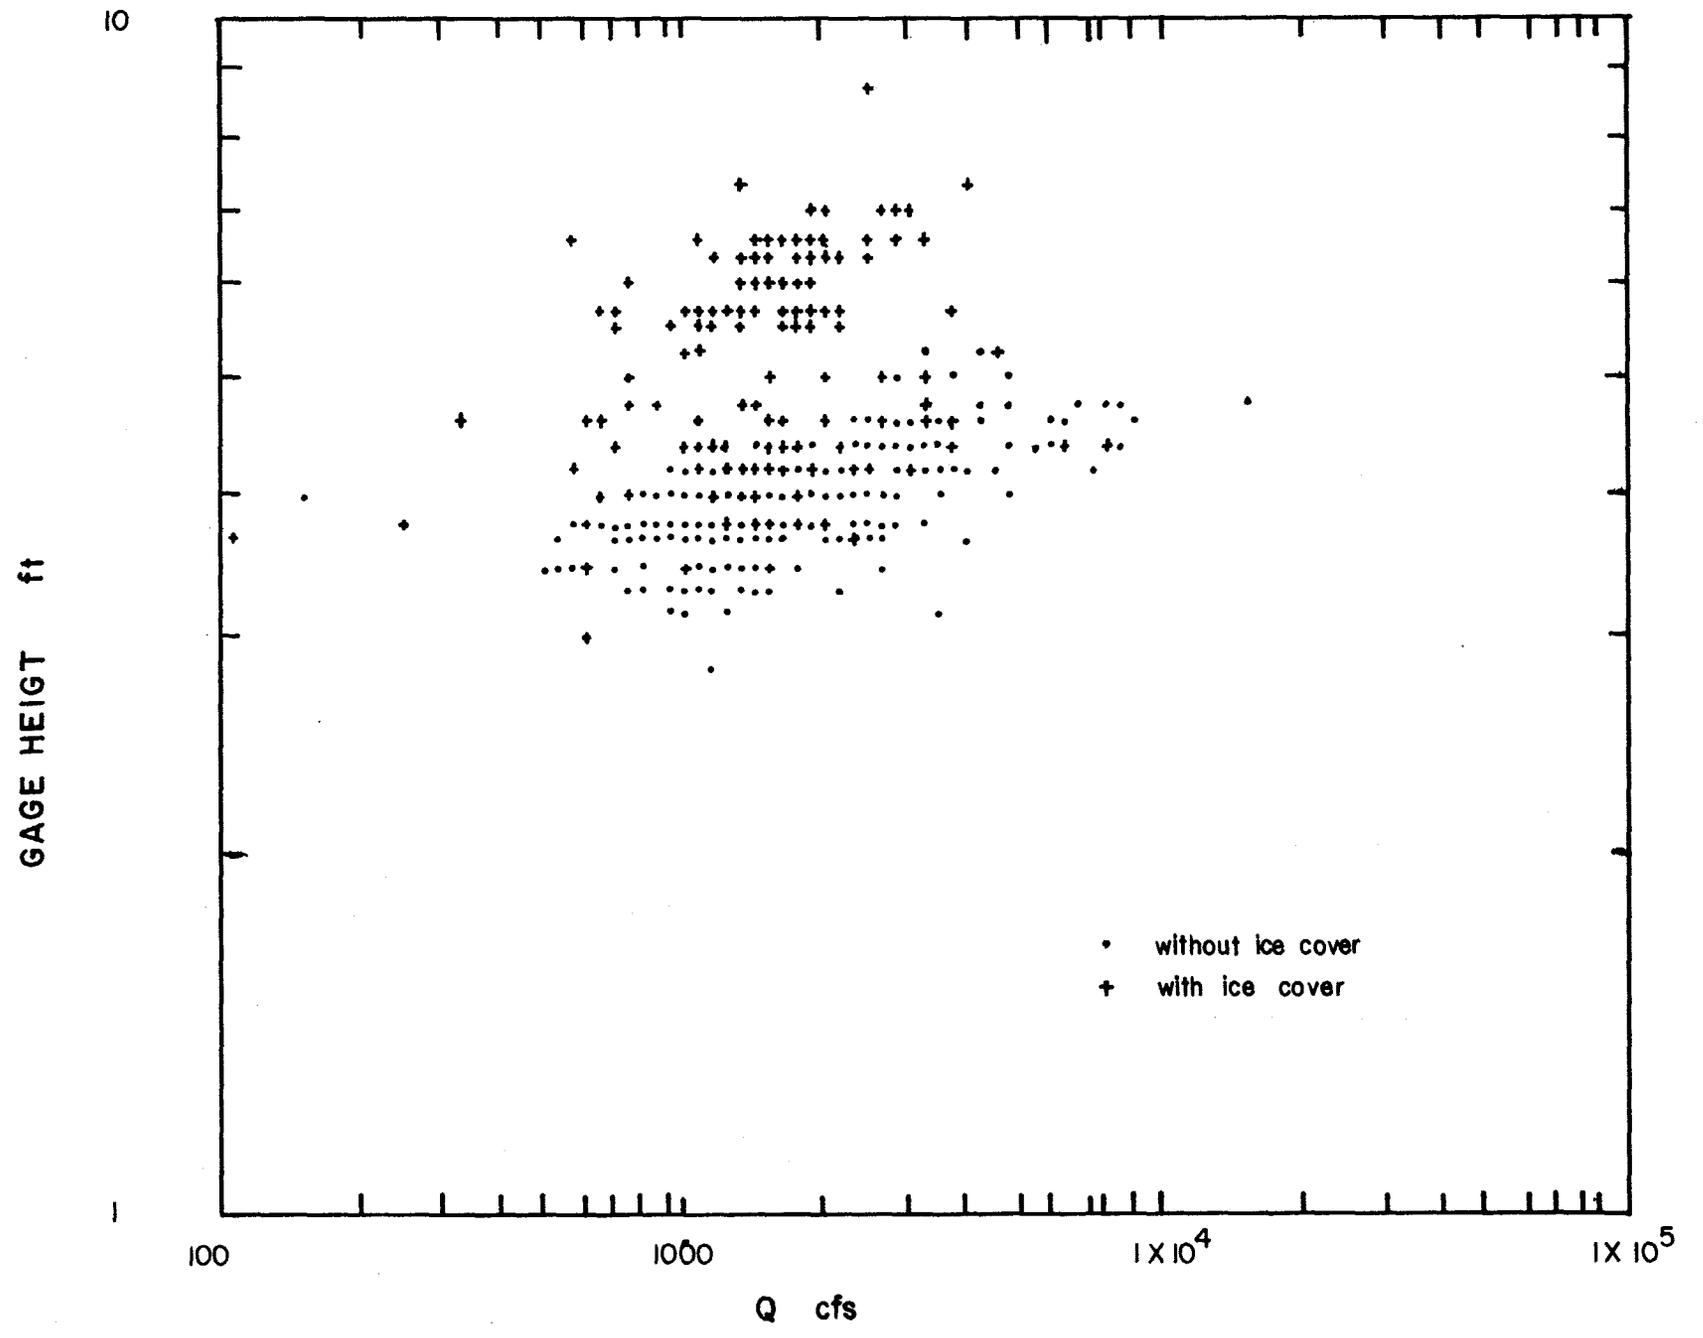
Figure 26. Stage-discharge relations at Verdell gaging station, Niobrara River.

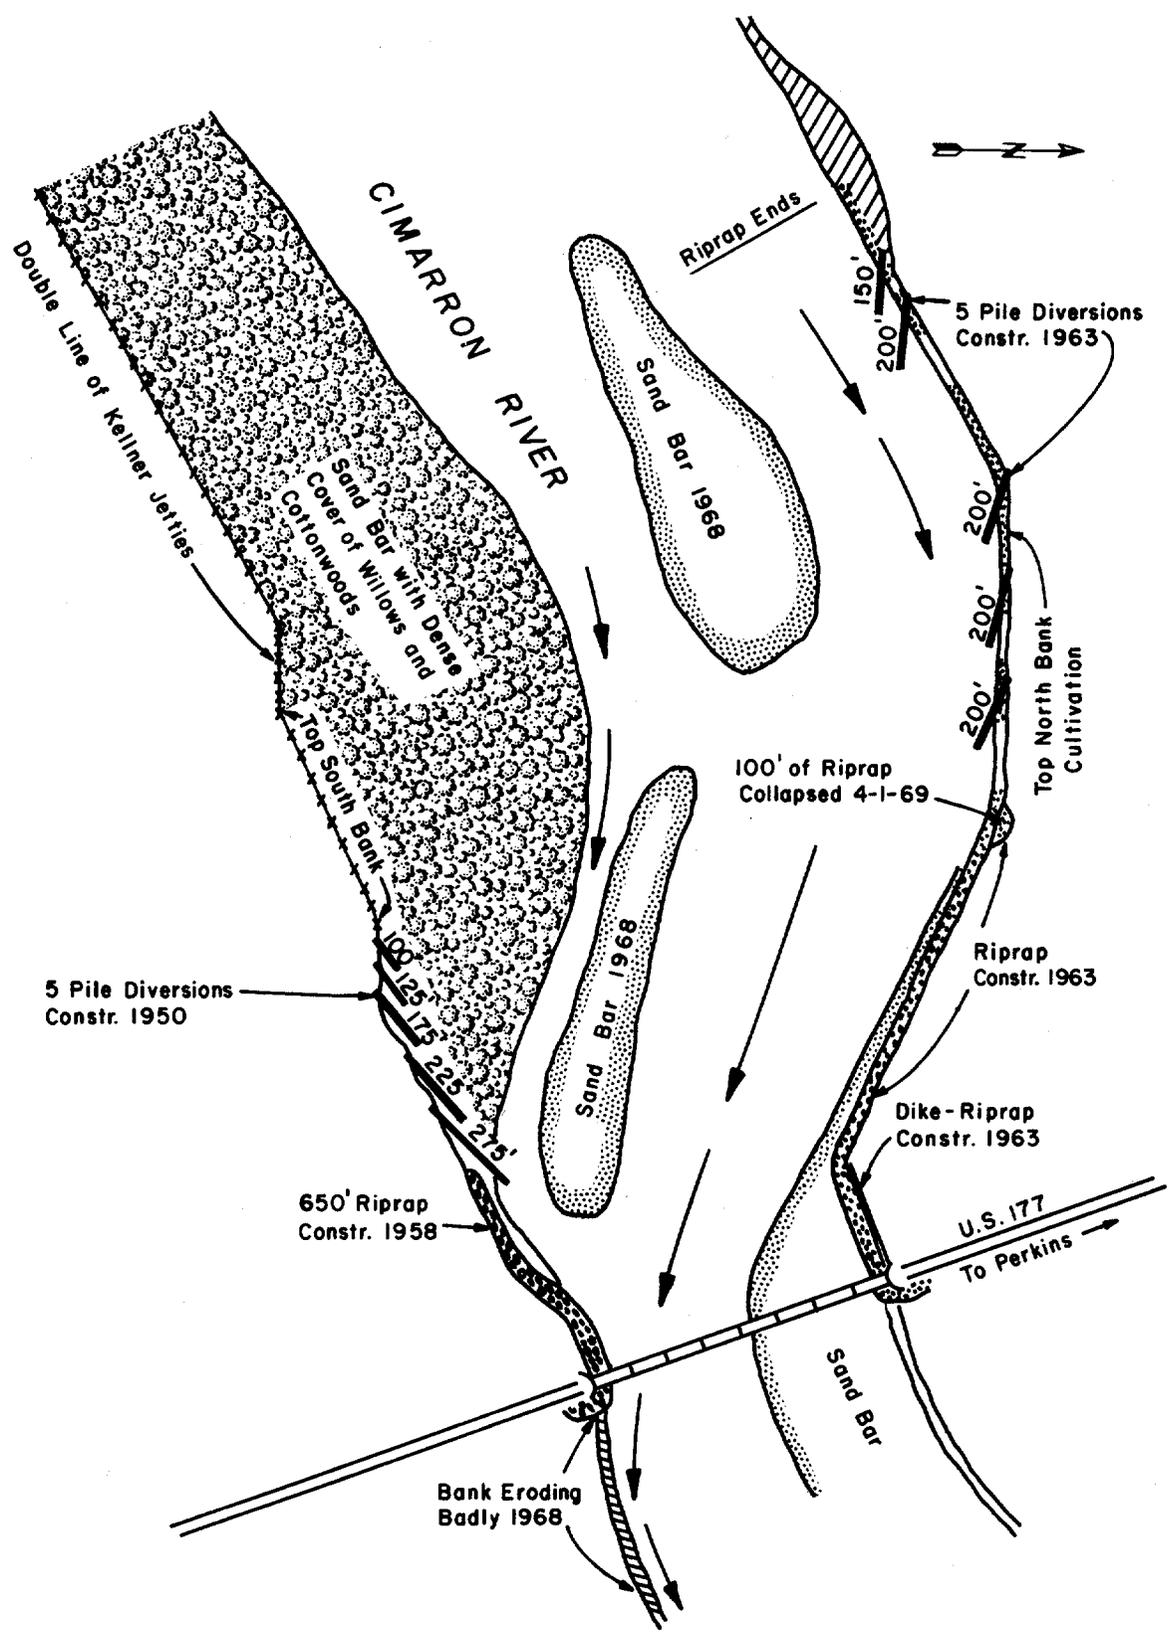
Figure 27. Map of Cimarron River at US 177 crossing (from Keeley, 1971).

The aerial photographs show that the channel was straight and braided at the site at the time of bridge construction, but there was a large meander about

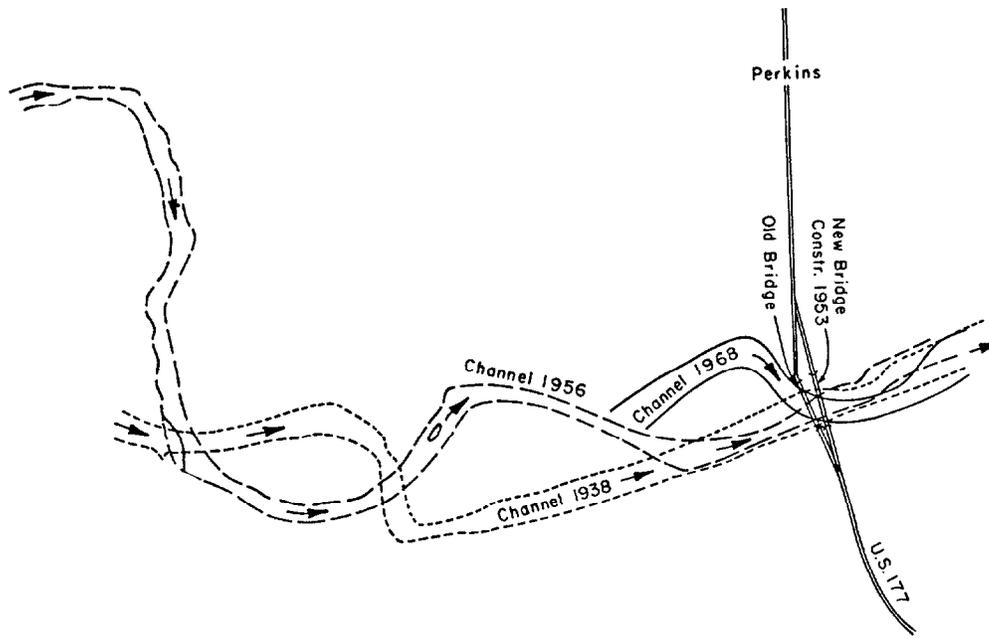
Figure 28. Meander shift as shown by 1938, 1956 and 1968 aerial photographs (after Keeley, 1971).

The shift of the maximum erosion from the south to the north side of the bridge between 1959 and 1962 (Keeley, 1971) was the result of the movement of the bend into the area of the bridge (Figure 28). Therefore, the obvious problem of bank erosion and channel scour was actually the result of meander shift.

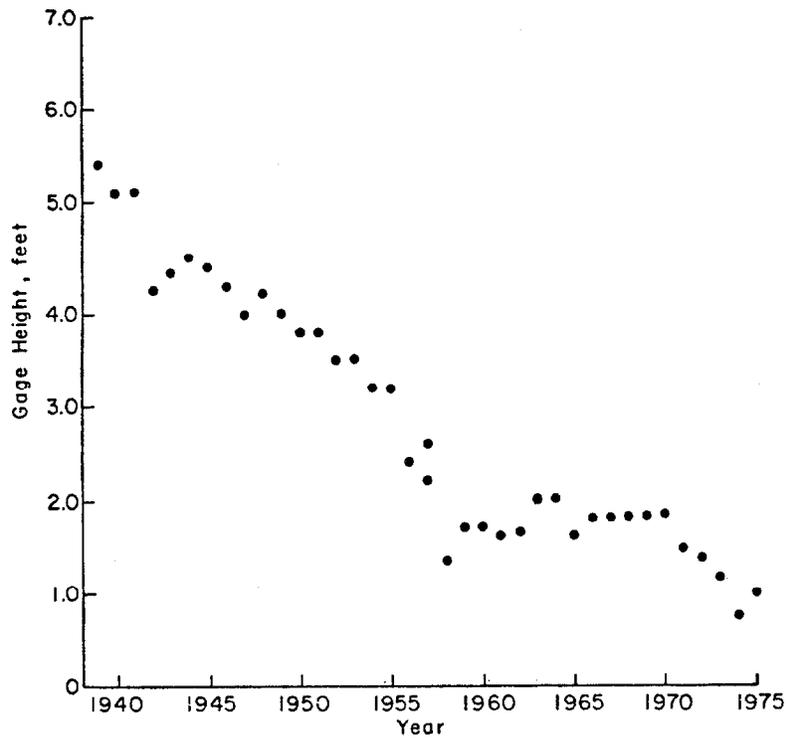
Figure 29. Change of gage height at discharge of 100 cfs, Cimarron River at Perkins, Oklahoma.

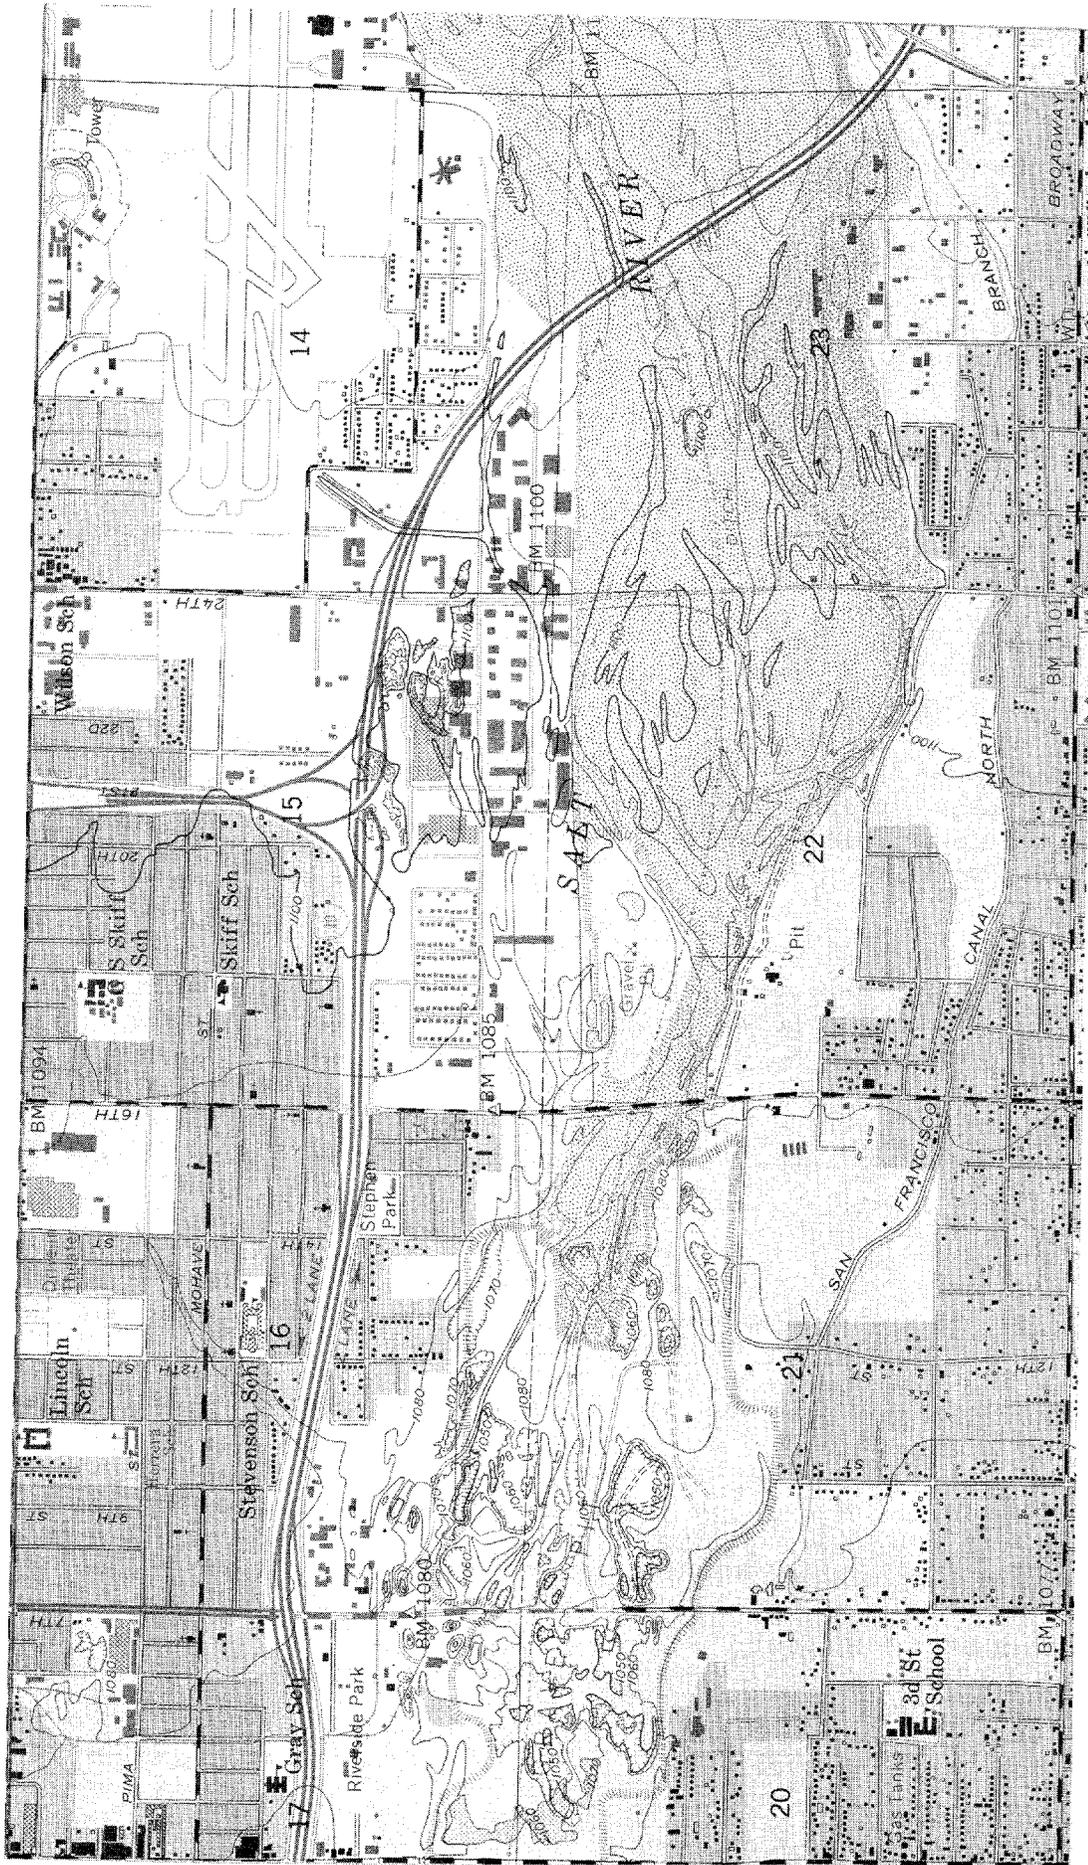
Figure 31. Salt River at Phoenix, from U.S. Geological Survey Phoenix 7½' quadrangle (1952, revised 1967 and 1973). Note extensive gravel mining and channel narrowing and channel narrowing to left (west) below I-10 Bridge.

Study of aerial photographs shows that during the large 1968 flood, another thalweg developed as the existing low-water channel was filled with sediment. At least 15 ft of aggradation occurred above the bridge during the 1978 and 1979 floods, and this filled the 20-ft deep low-water channel with sediment. Flood water flowed into the gravel pit (Figure 32) and head cut erosion resulting from the lowering of base level caused development of the new channel, which was centered on Pier 11. Scour and undermining of Pier 11 resulted, with serious damage to that span of the bridge.

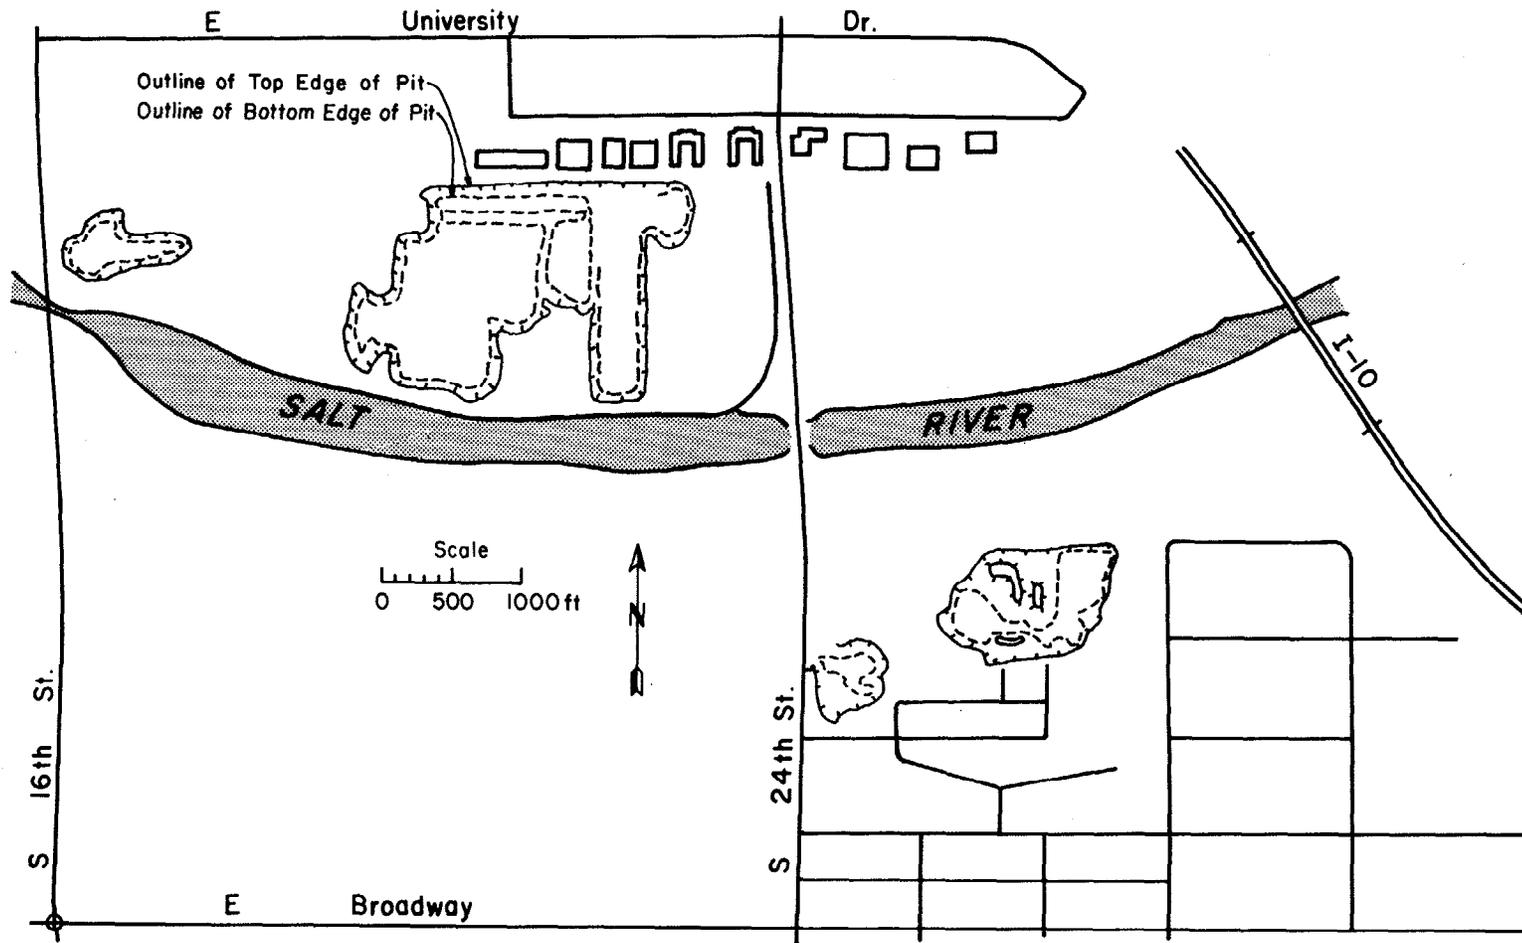
Figure 32. Map showing location of I-10 Bridge, Phoenix, Arizona, and downstream gravel pits (after Arizona Department of Transportation, 1979).

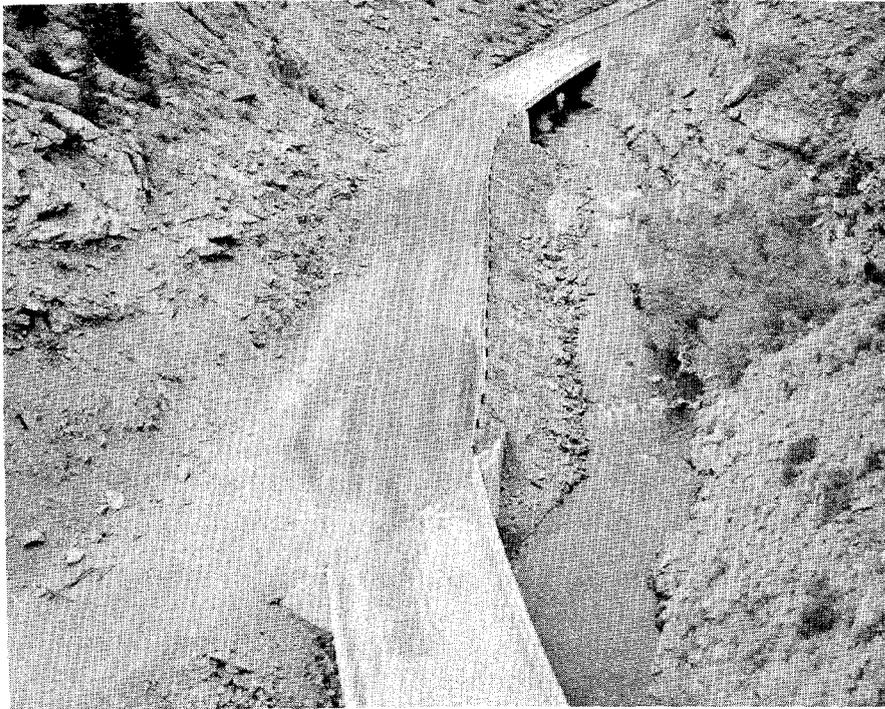
Figure 1. Bridge and Highway Embankment Showing Distress Due to Slope Movement.

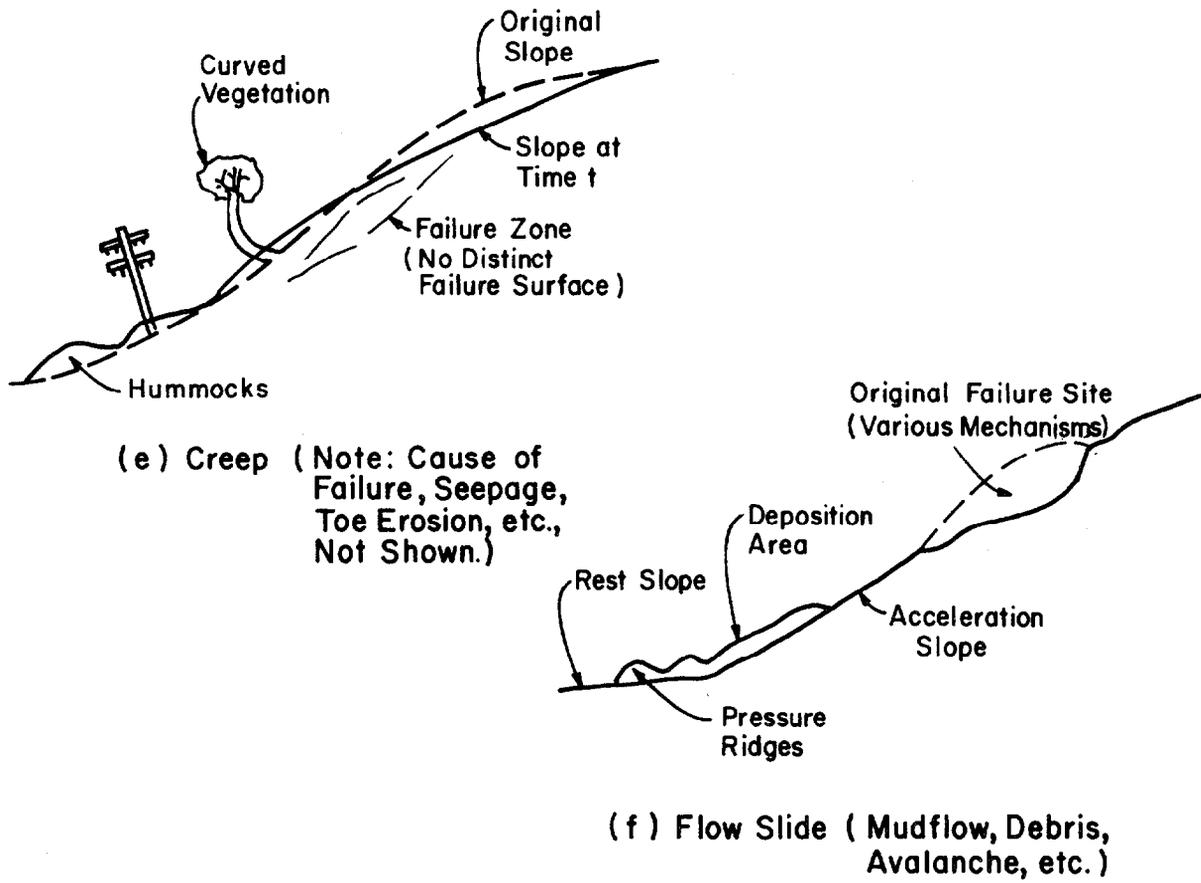
Figure 2 (continued)

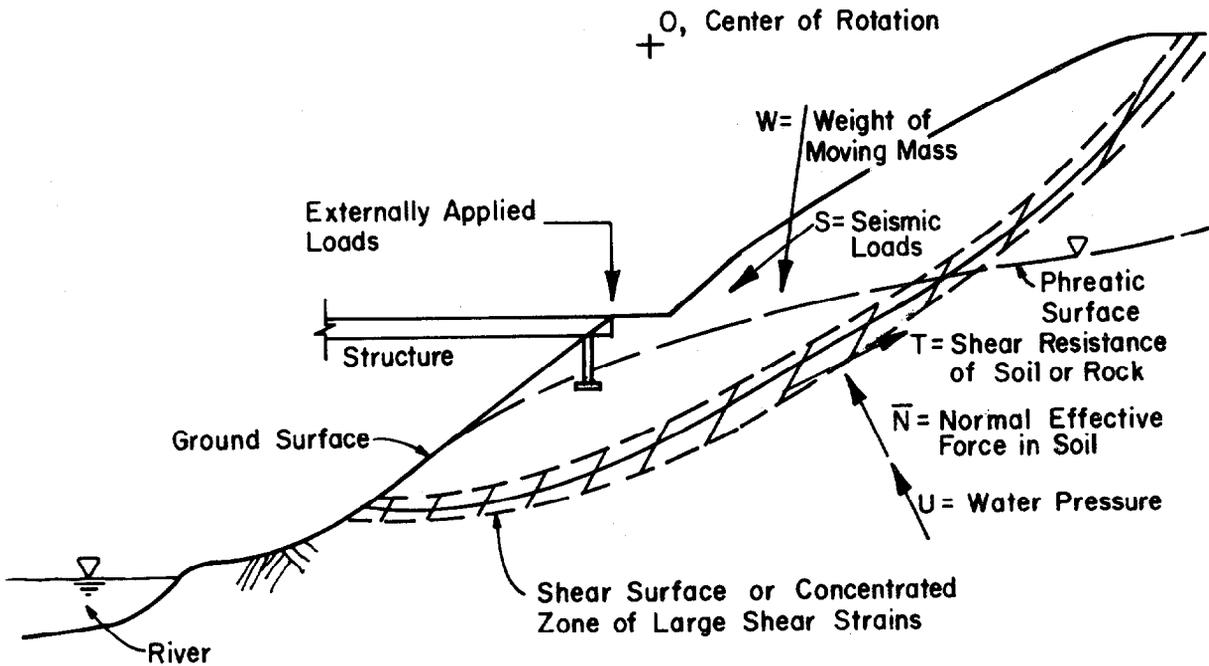
Figure 3. Forces Acting on Slope Failure.

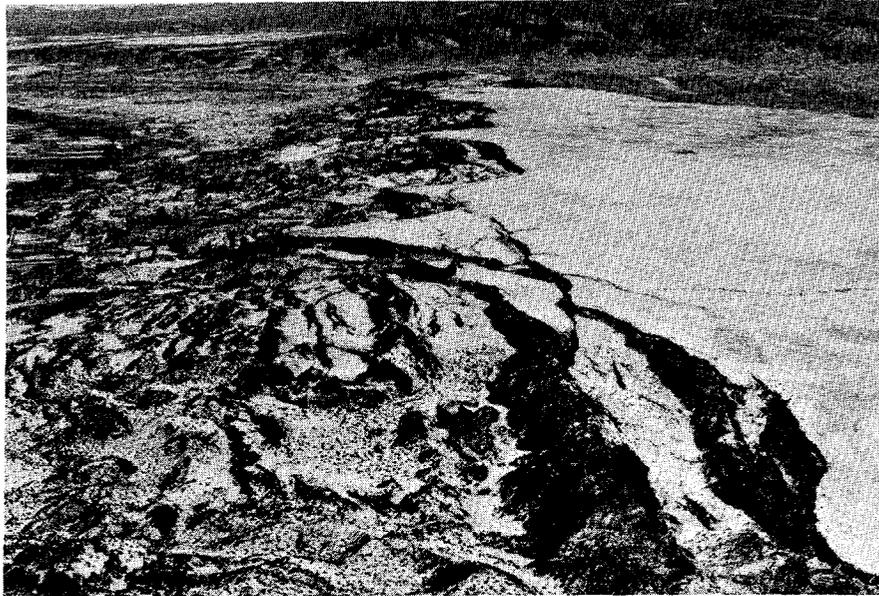
Figure 4. Headward Progression of Slope Failure Along Rio Grande as Evidenced by Series of Escarpments (photo by Donald O. Doehring, Colorado State University).

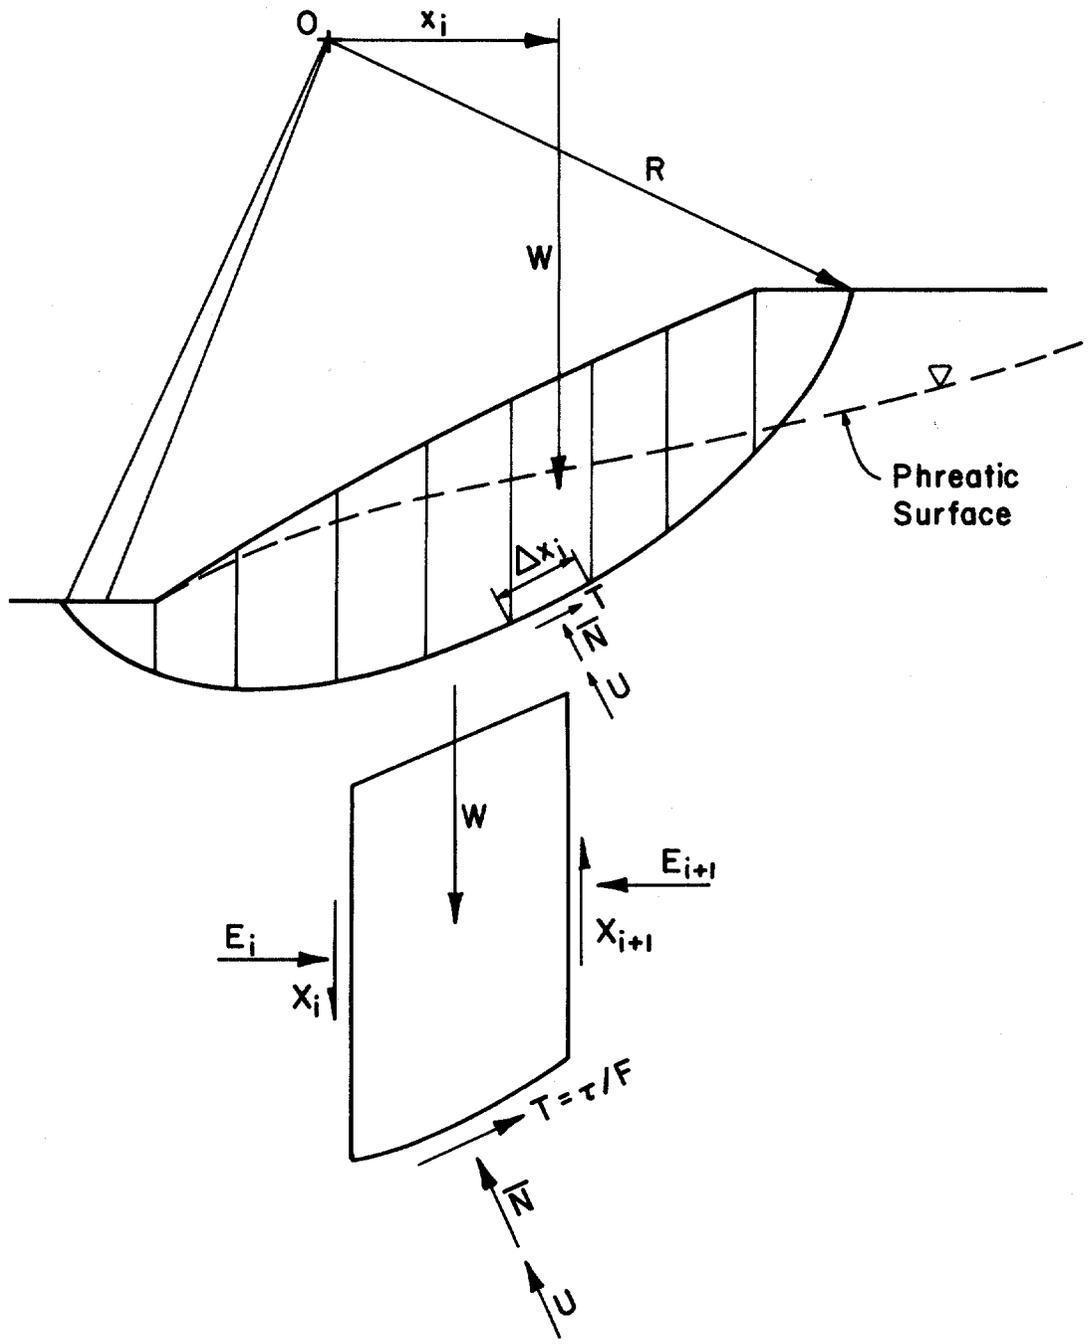
Figure 5. Slope Above Cylindrical Shear Surface Divided into Slices for Purposes of Analysis.

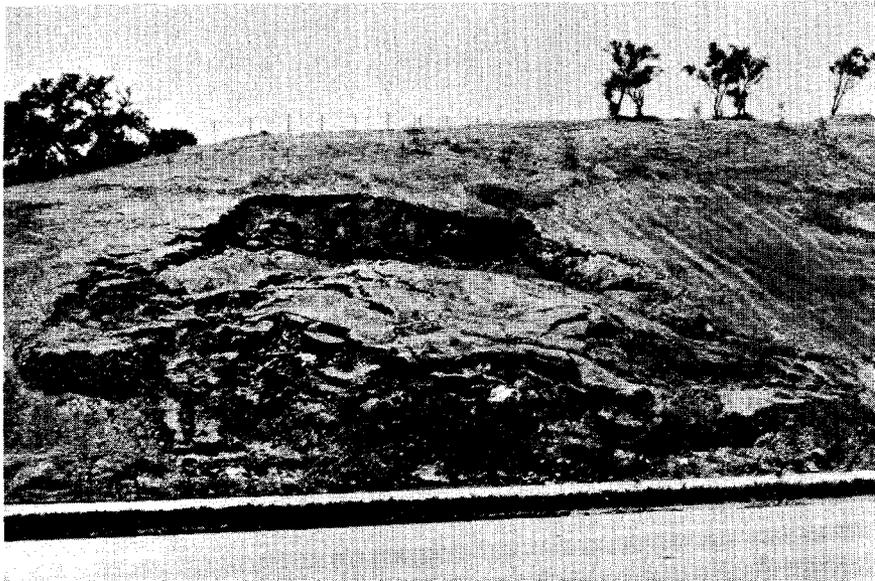
Figure 6. Photograph of Rotational Shear Failure Caused by Excavation for Highway (photo by Donald O. Doehring).

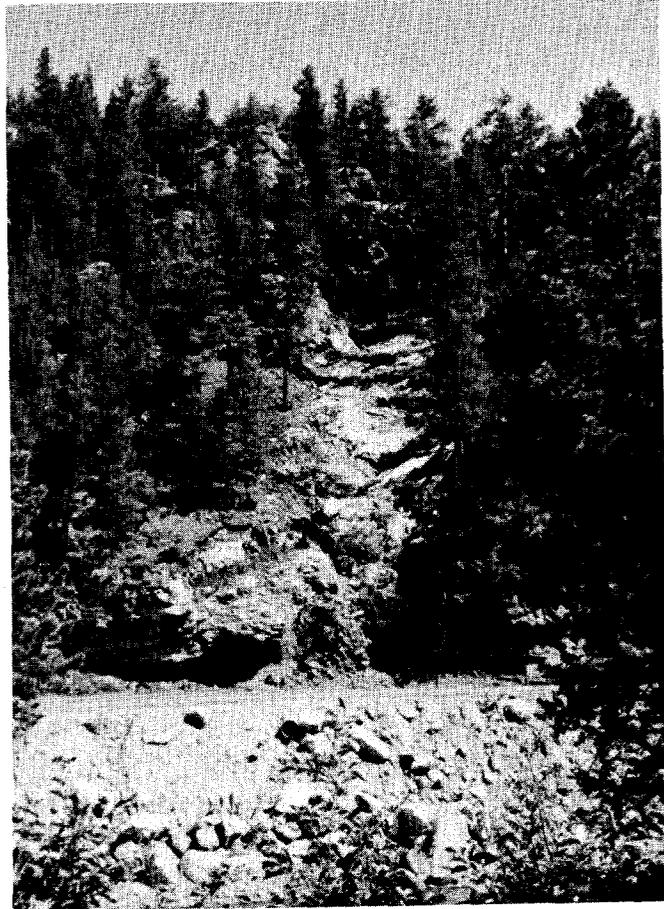
Figure 7. Shear Failure Along Shallow Plane Depicting Infinite Slope Failure (photo along Big Thompson River by Thomas V. Edgar, Colorado State University).

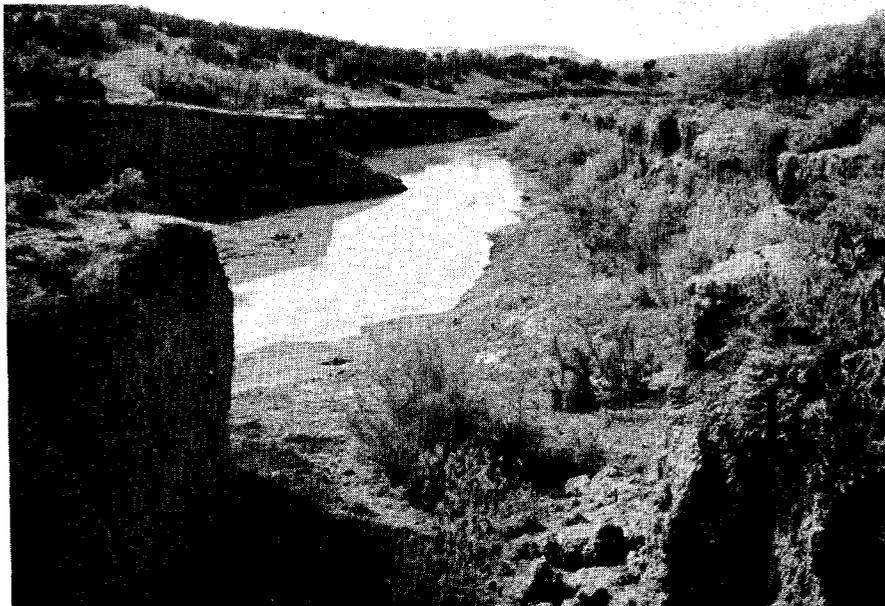
Figure 8. Evidence of Bank Toppling Along Stream in Mount Taylor Area, New Mexico. "Toppled" Material is Evident in Foreground. (Photo by T. R. Boutwell, Gulf Mineral Resources Co.)

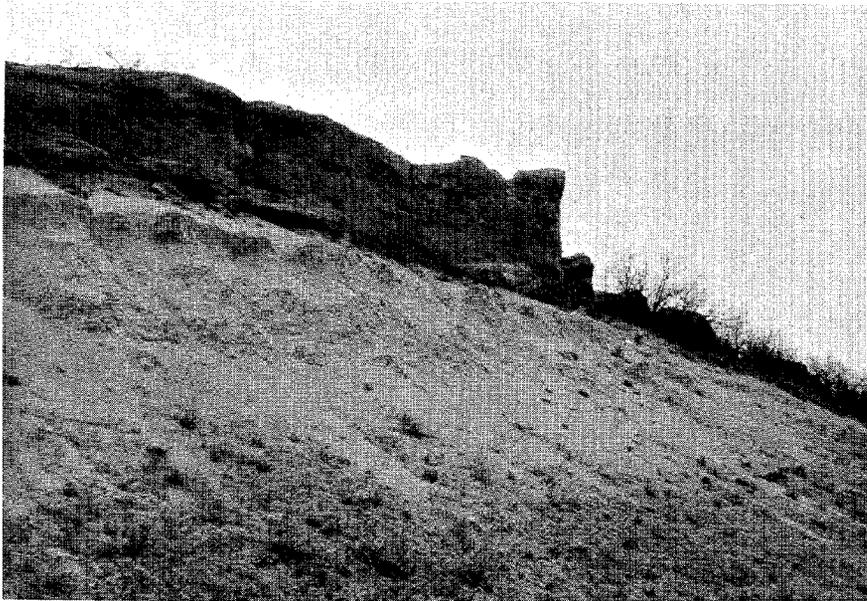
Figure 9. Erosion of Strata Underlying More Resistant Rock Leading to Toppling.

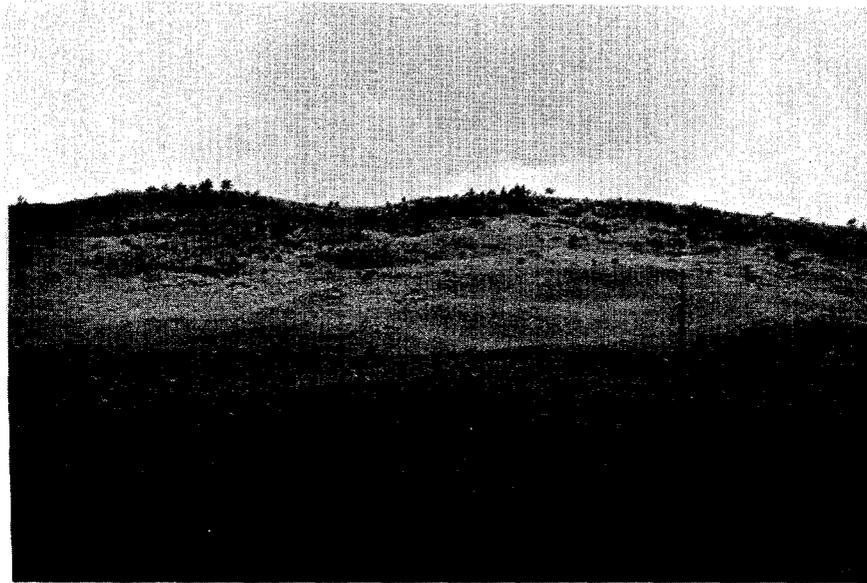
Figure 10. Hummocky Slope Surface Indicative of Creep Movement.

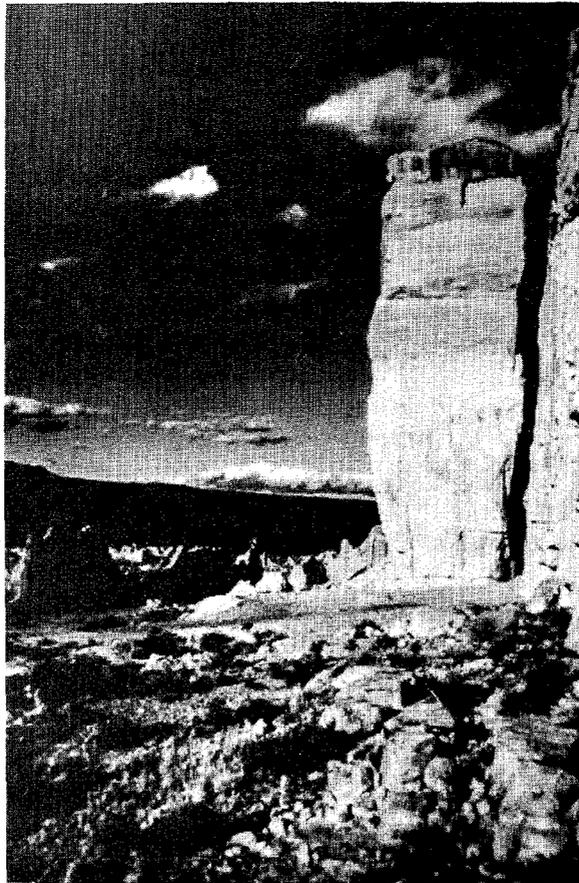
Figure 12. Threatening Rock Before Failure (photo by U.S. National Park Service).

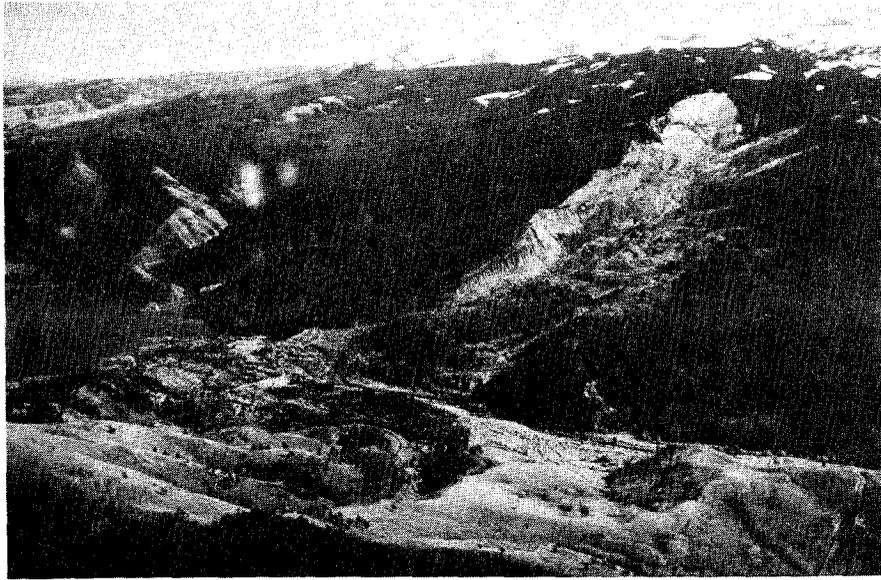
Figure 13. Gros Ventre Slide (photo by Stanley A. Schumm).

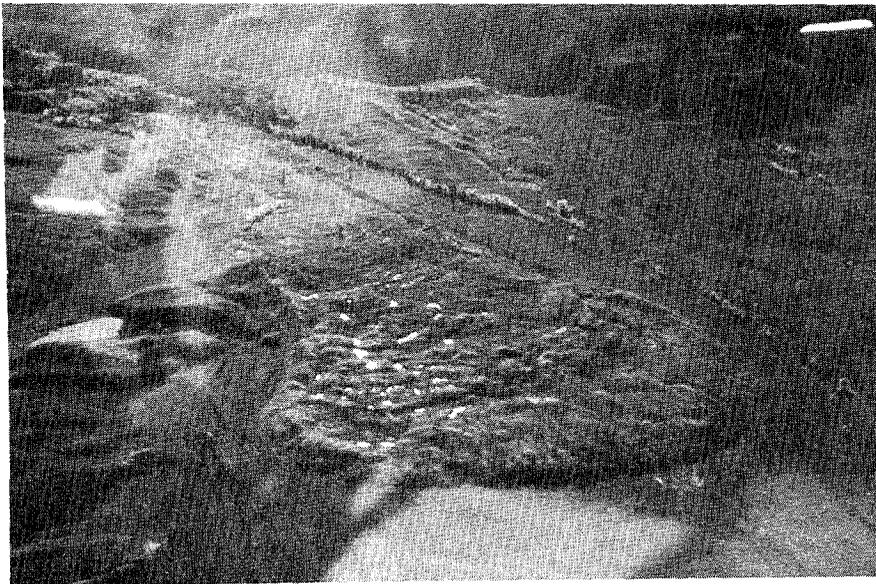
Figure 14. Evidence of Old Mudslide (photo by Stanley A. Schumm).

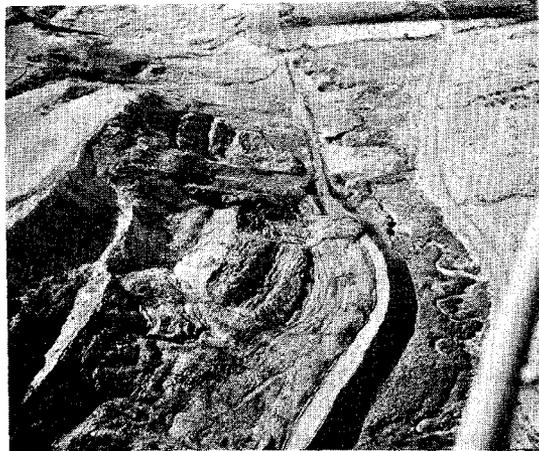
Figure 15. Disruption of Highway and Railroad Due to Mudflow (Varnes, D. J., U.S. Geological Survey).

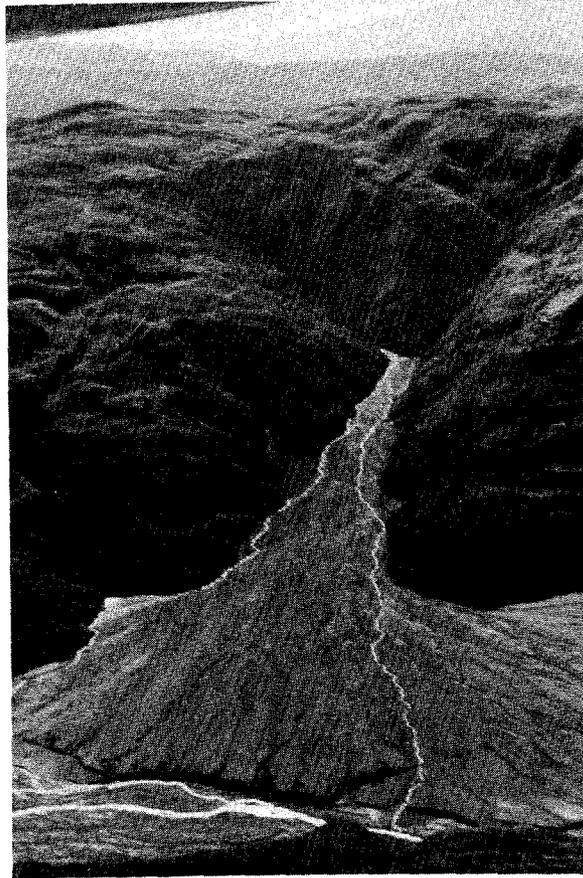
Figure 16. Alluvial Fan Contributing Sediment Load to Stream  
(photo by Stanley A. Schumm, Colorado State University).

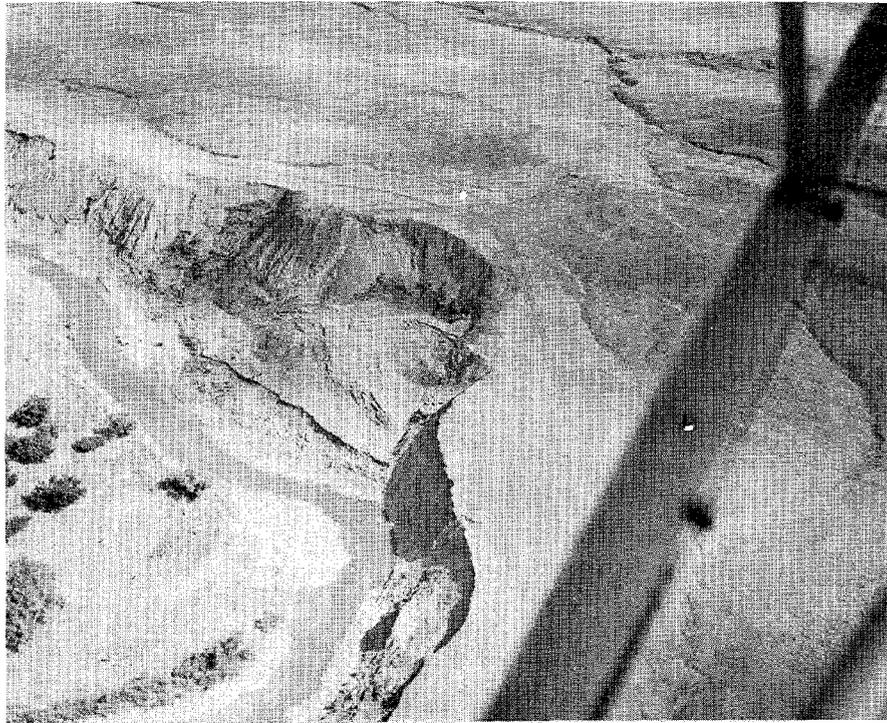
Figure 21. Shear Failure in Clay Shales  
Caused by Toe Erosion.

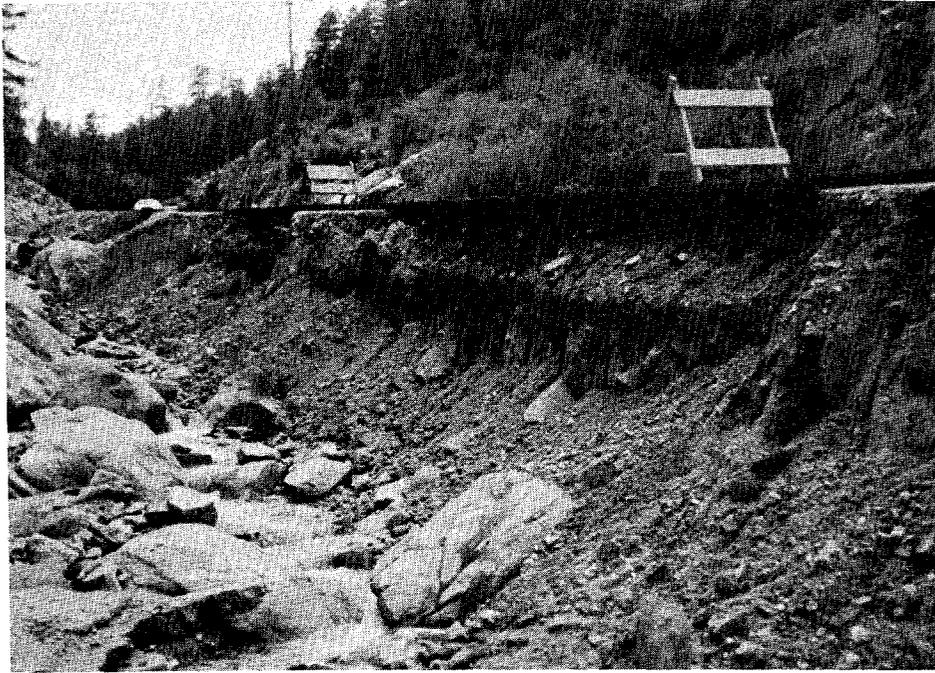
a. Undercutting of Pavement Along North Fork Big Thompson River.

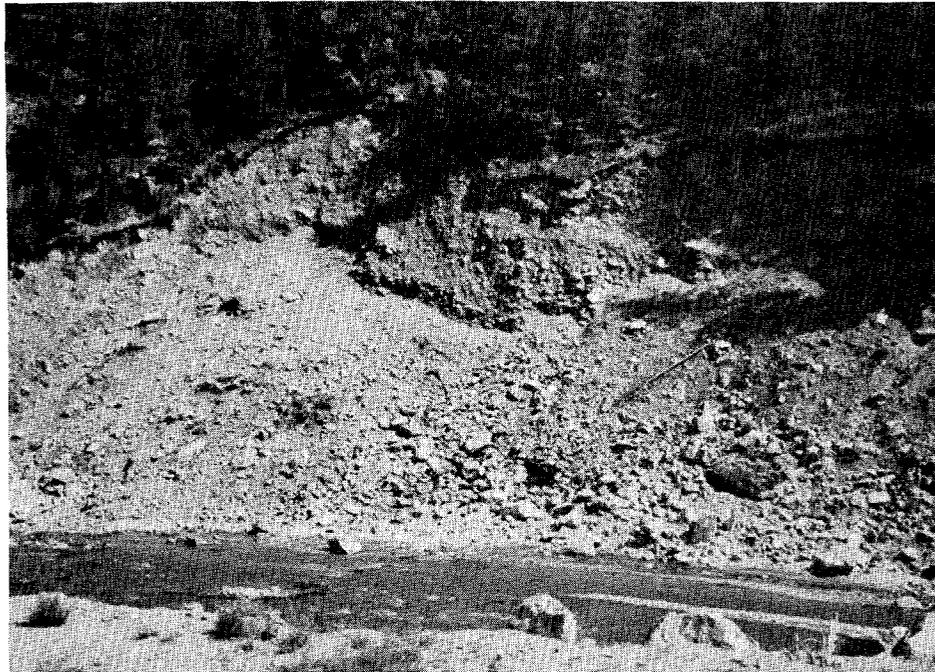
b. Slope Failure Near Glen Comfort.
