Report No. FHWA/RD-80/160

# METHODS FOR ASSESSMENT OF STREAM-RELATED HAZARDS TO HIGHWAYS AND BRIDGES

March 1981  
Final Report

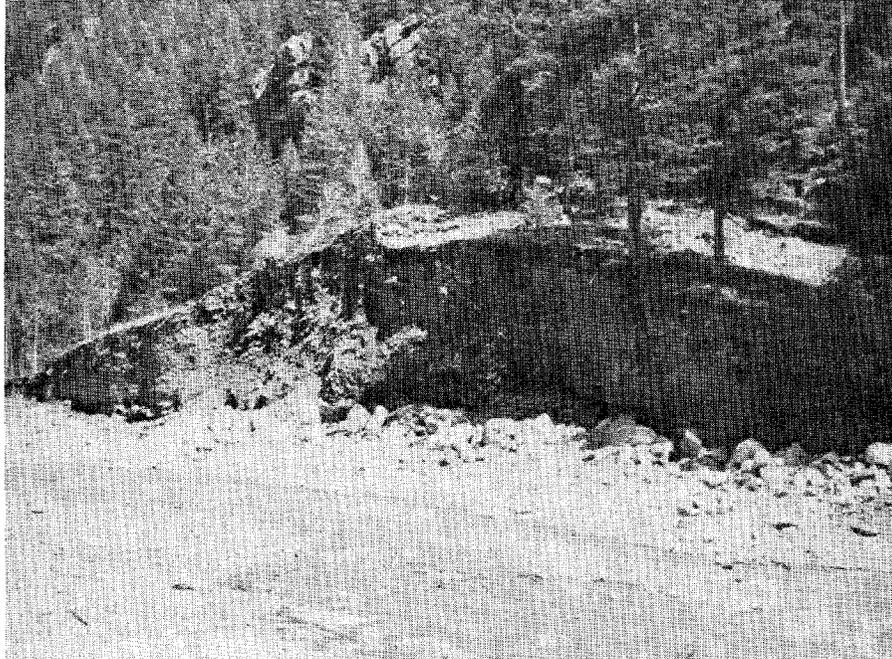
Figure 23. Severe Toe Erosion Along Debris Fan.

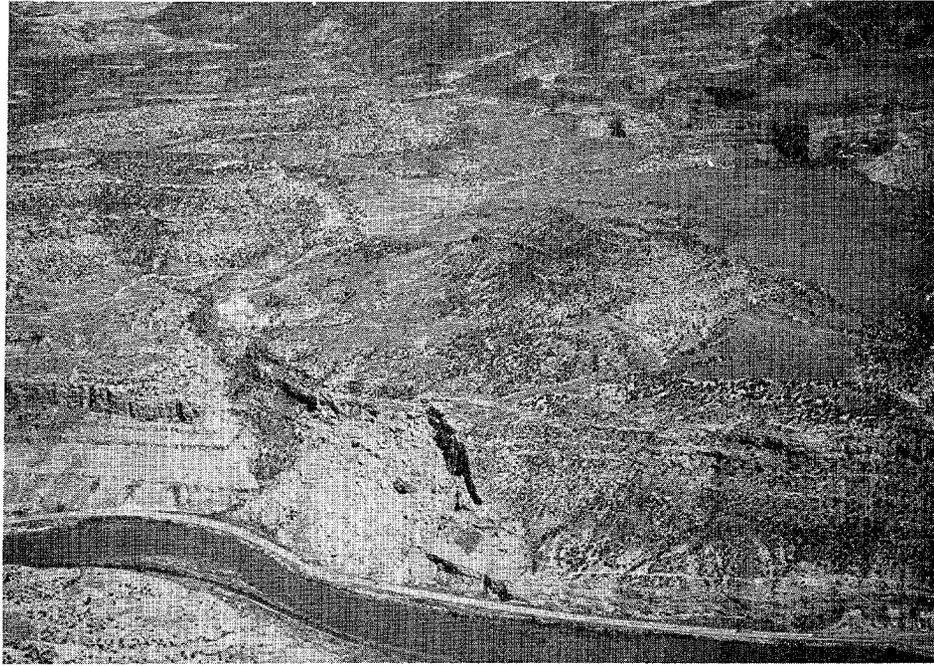
Figure 26. Slope Failure Caused by Water Introduced by Stream at Top of Slope (photo by Stanley A. Schumm, Colorado State University).

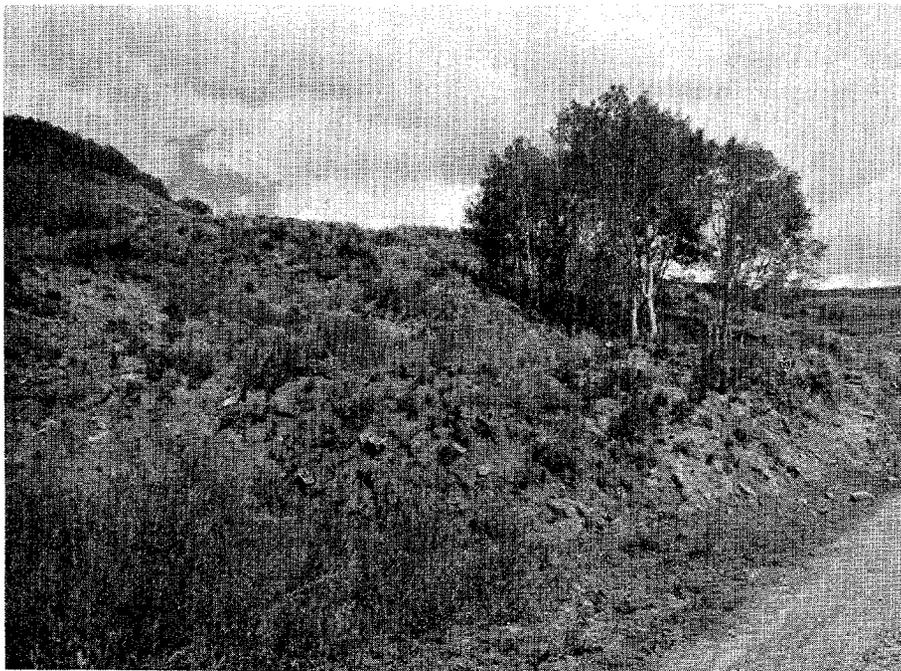
Figure 27. Trees Growing in Isolated Area Due to Drainage Patterns Contributing to Slope Failure.

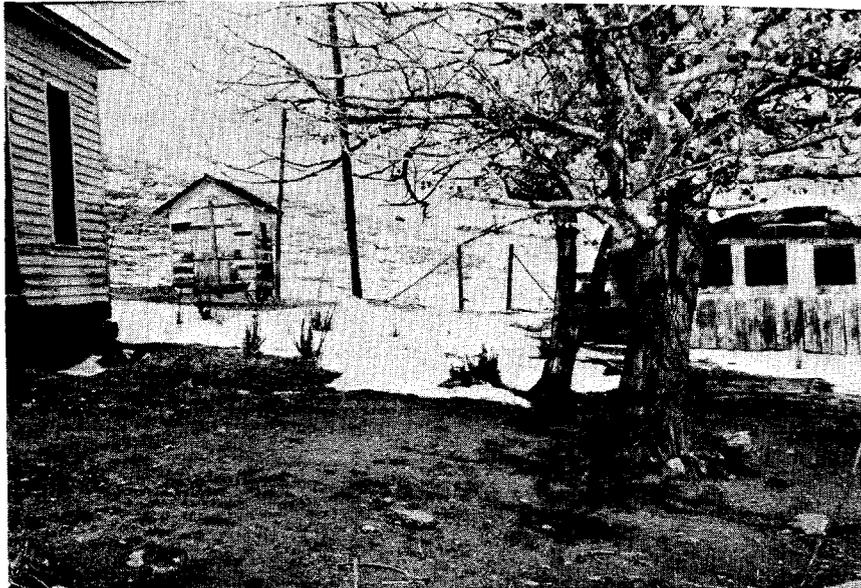
Figure 28. Misalignment of Telephone Poles and Fence Posts Due to Creep Movements (M. J. Kluth, 1976).

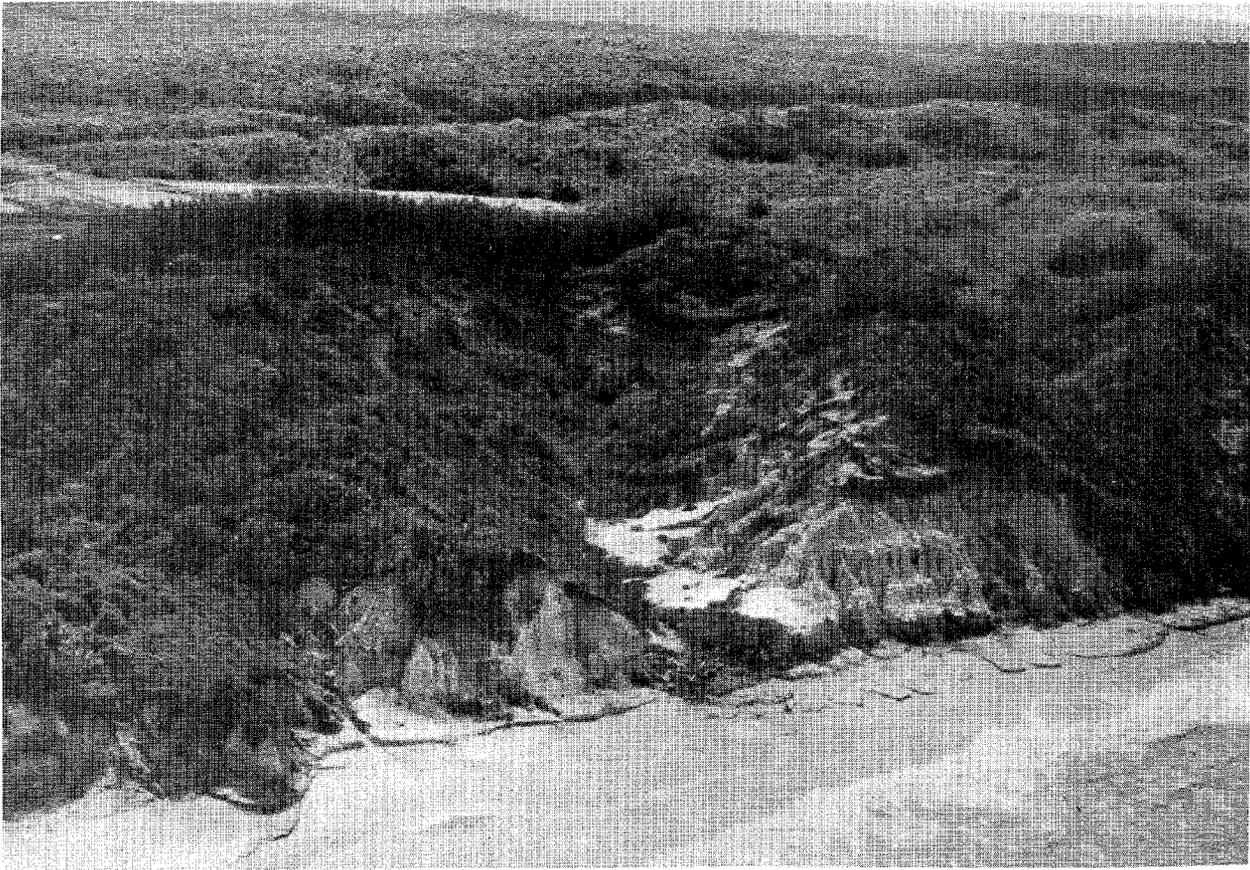
Figure 29. Slope Failure Induced by Seepage from Mill Tailings Impoundment (photo from A. Mac G. Robertson, Steffen, Robertson Kirsten and Assoc., Vancouver, B.C.).

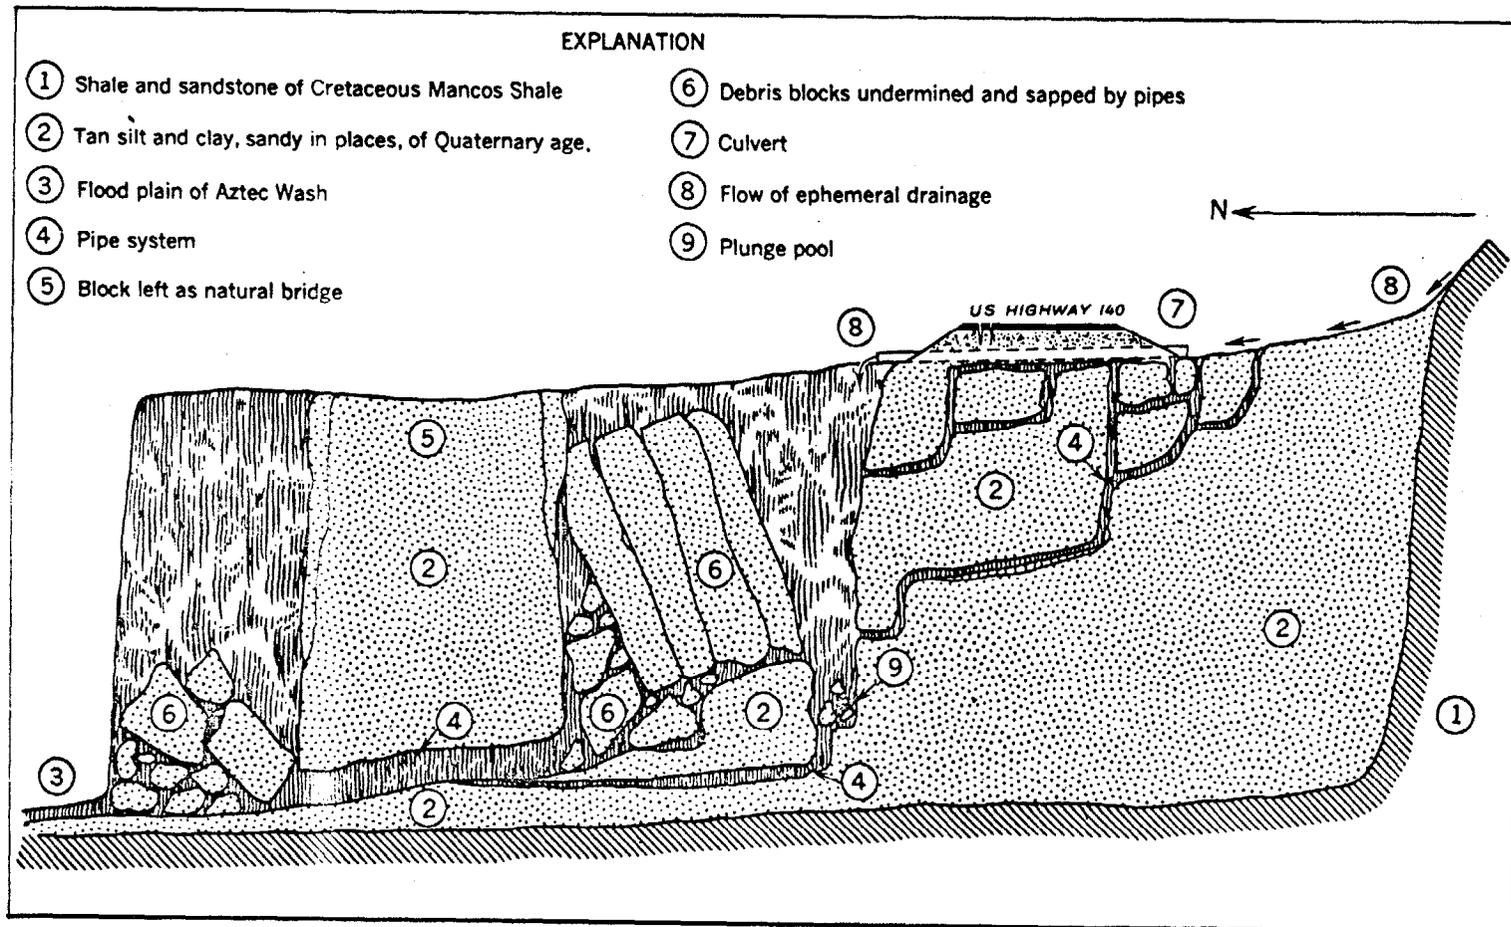
Figure 30. Idealized North-South Cross Section Under US 140 Built on Aztec Wash Valley Fill, 4-Corners Area of Southwestern Colorado. Note Incipient Piping System Beneath Roadway (from Parker and Jenne, 1967).

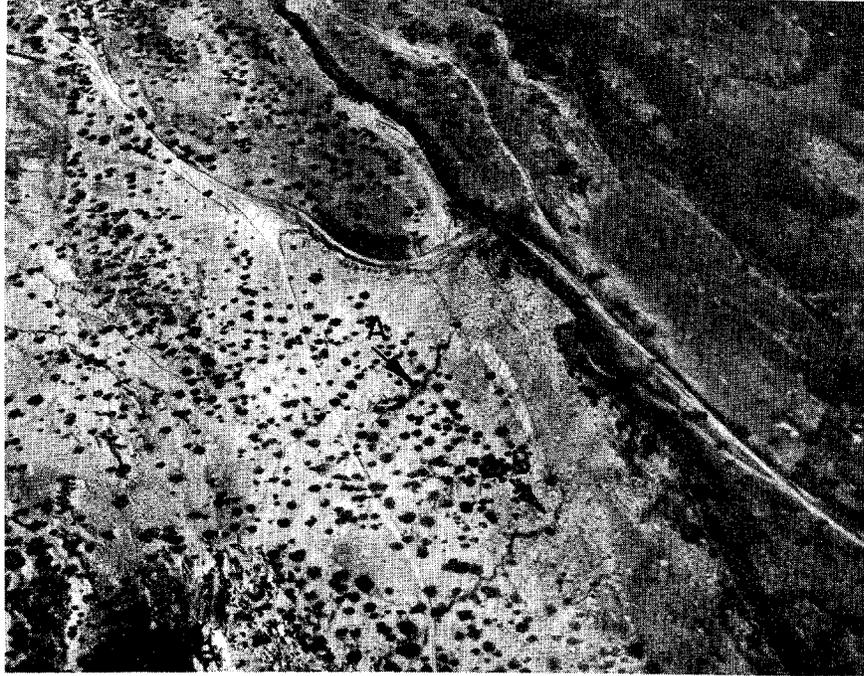
Figure 31. Evidence of Piping From Apparent Disappearance of Surface Drainage Features (Photo Compliments of Jay Lazarus, New Mexico Environmental Improvement Division).

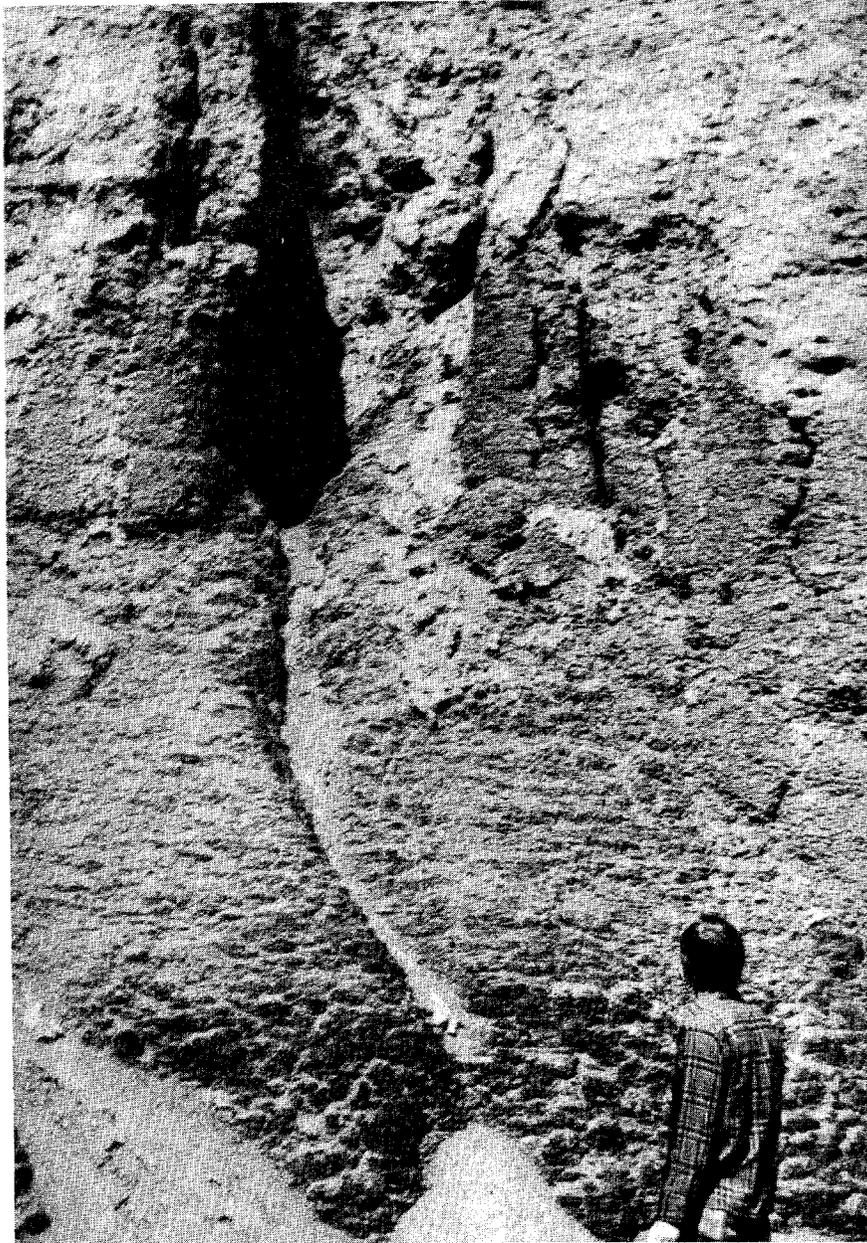
Figure 32. Pipe Formed in Loessial Deposits (Photo Compliments of Jay Lazarus, New Mexico Environmental Improvement Division).

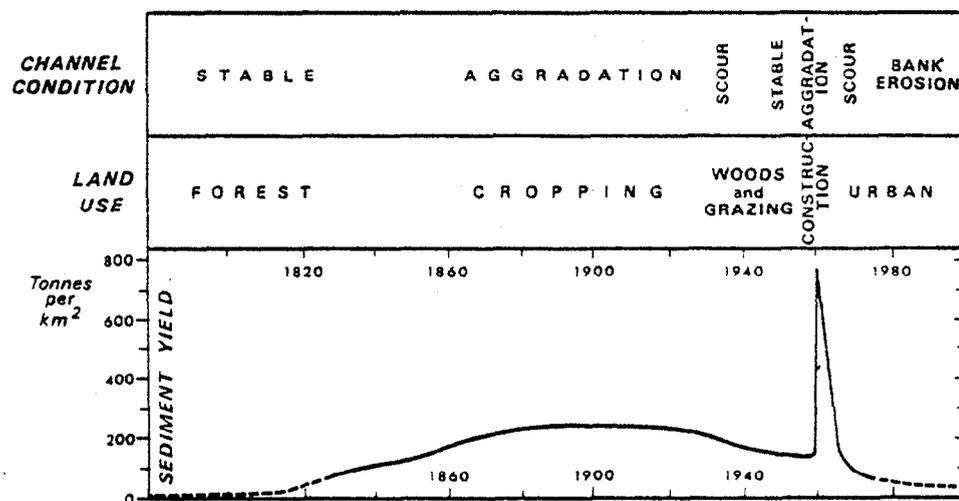
Figure 2. Relationships Between Land Use, Sediment Yield and Channel Condition for the Middle Atlantic Piedmont Region (Wolman, 1967).

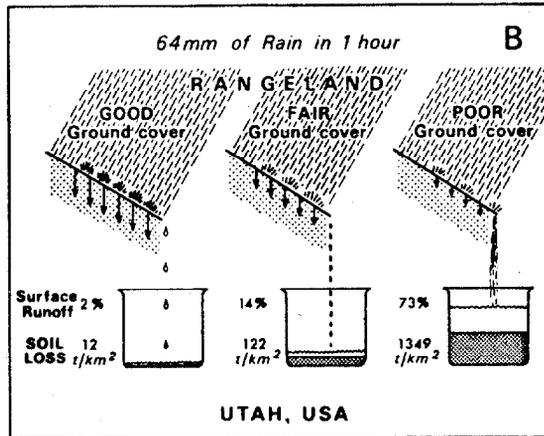
Figure 5. Influence of Range Condition on Runoff and Sediment Yield in Utah (Noble, 1965).

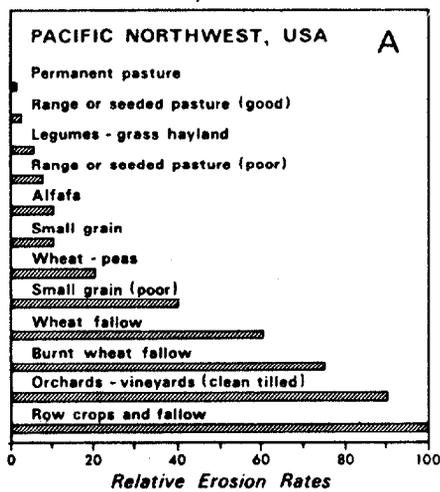
Figure 6. Relative Erosion Rates for the Pacific Northwest, U.S.A. (Gregory and Walling, 1973).

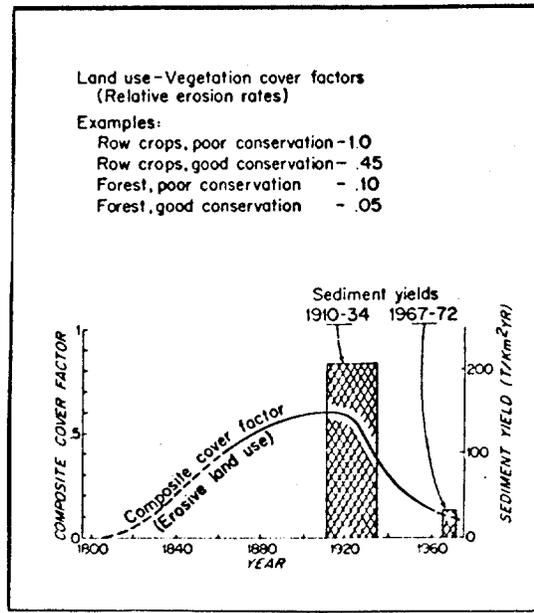
Figure 8. Changes in Land Use and Sediment Yield, Lloyd Shoals Watershed (Meade and Trimble, 1974).

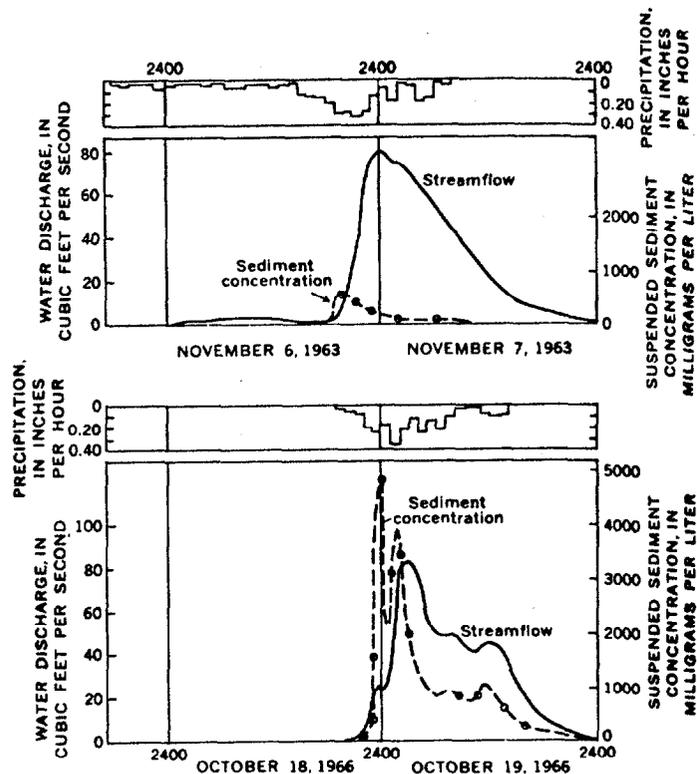
Figure 10. Variation of Precipitation, Sediment Concentration, and Water Discharge During Two Storm-runoff Periods for Bel Pre Creek, Md. (Yorke and Davis, 1971).

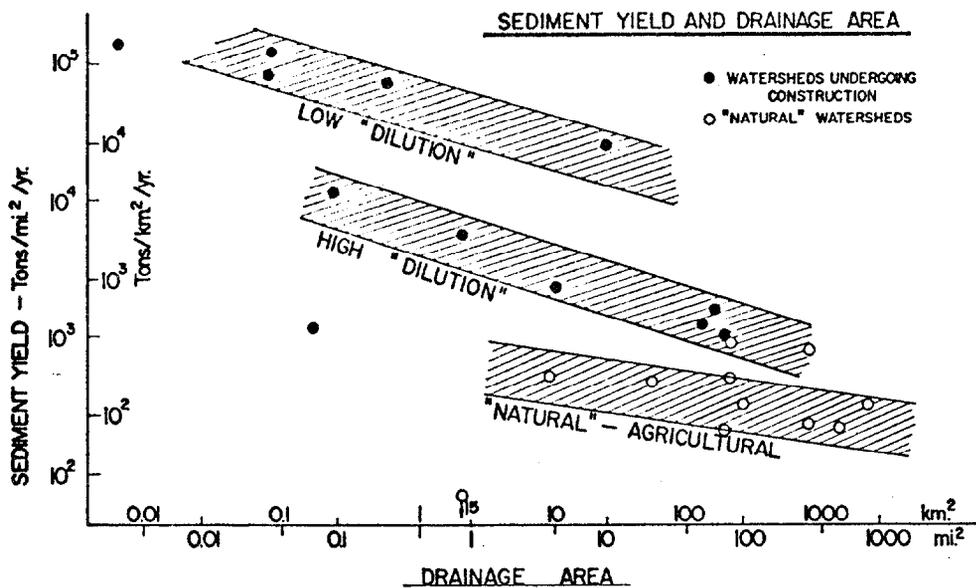
Figure 11. Sediment Yield, Drainage Area, and Construction Activity (Wolman and Schick, 1967).

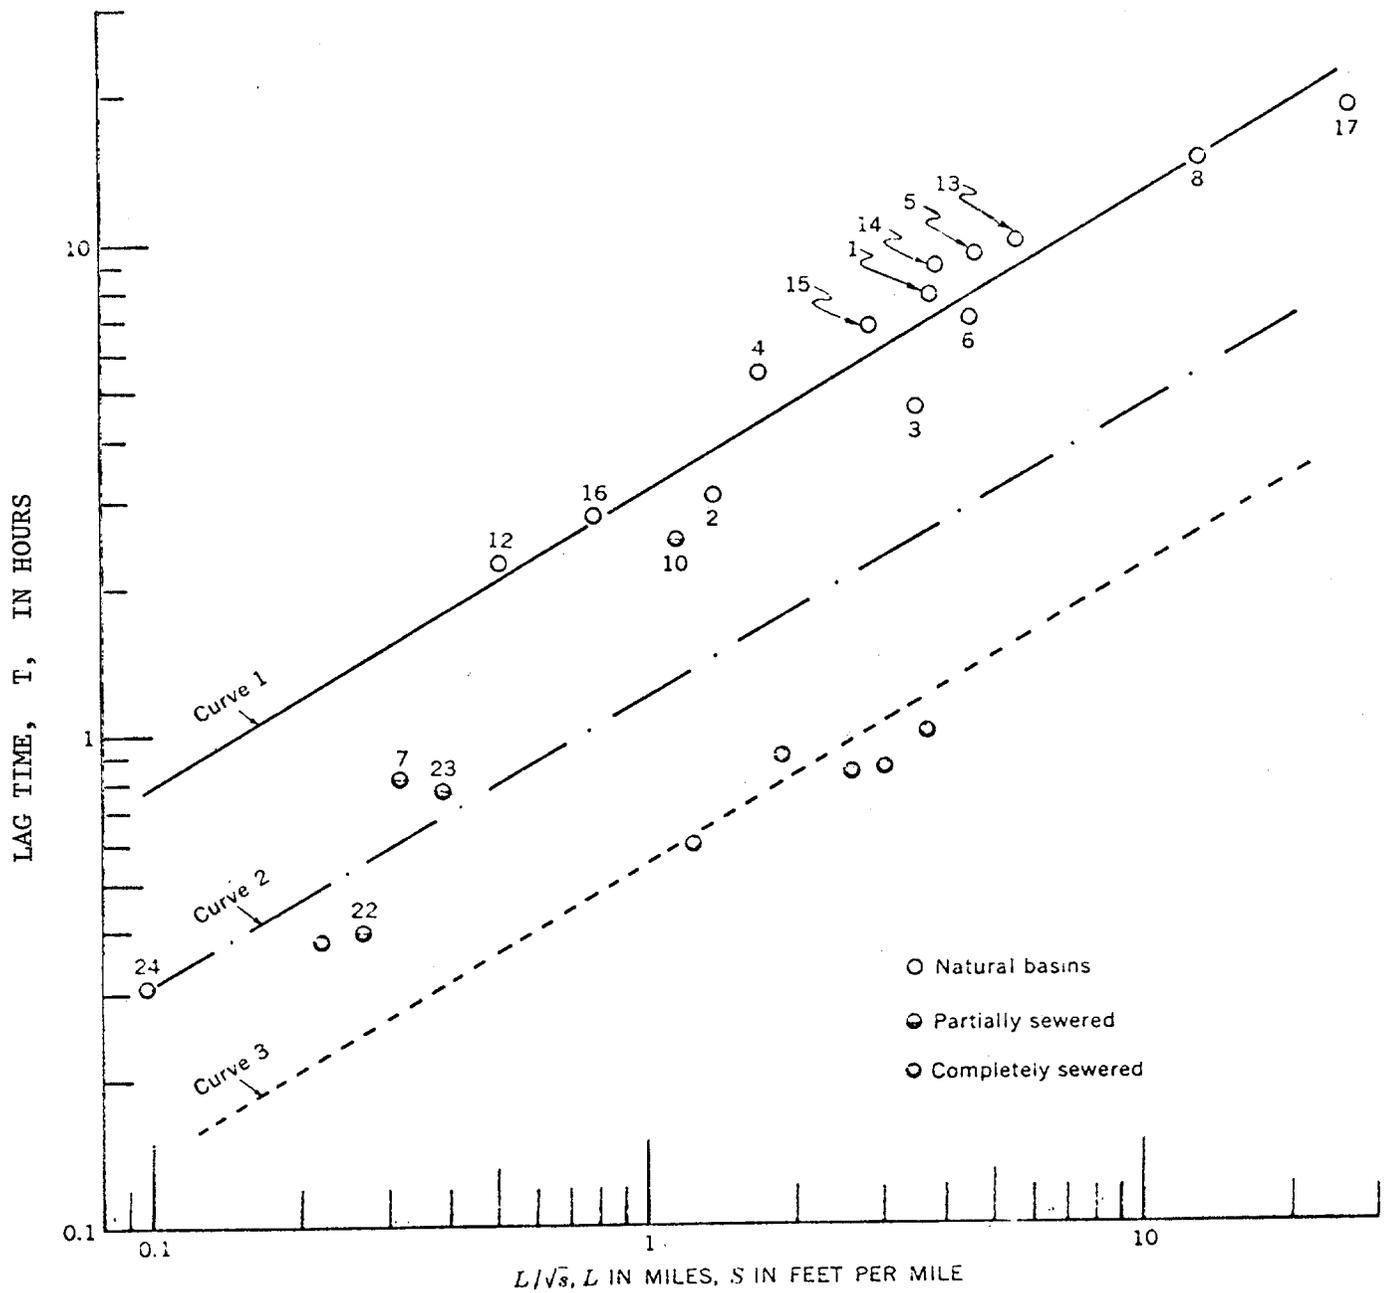
Figure 16. Effect of suburban development on lag time (Carter, 1961).

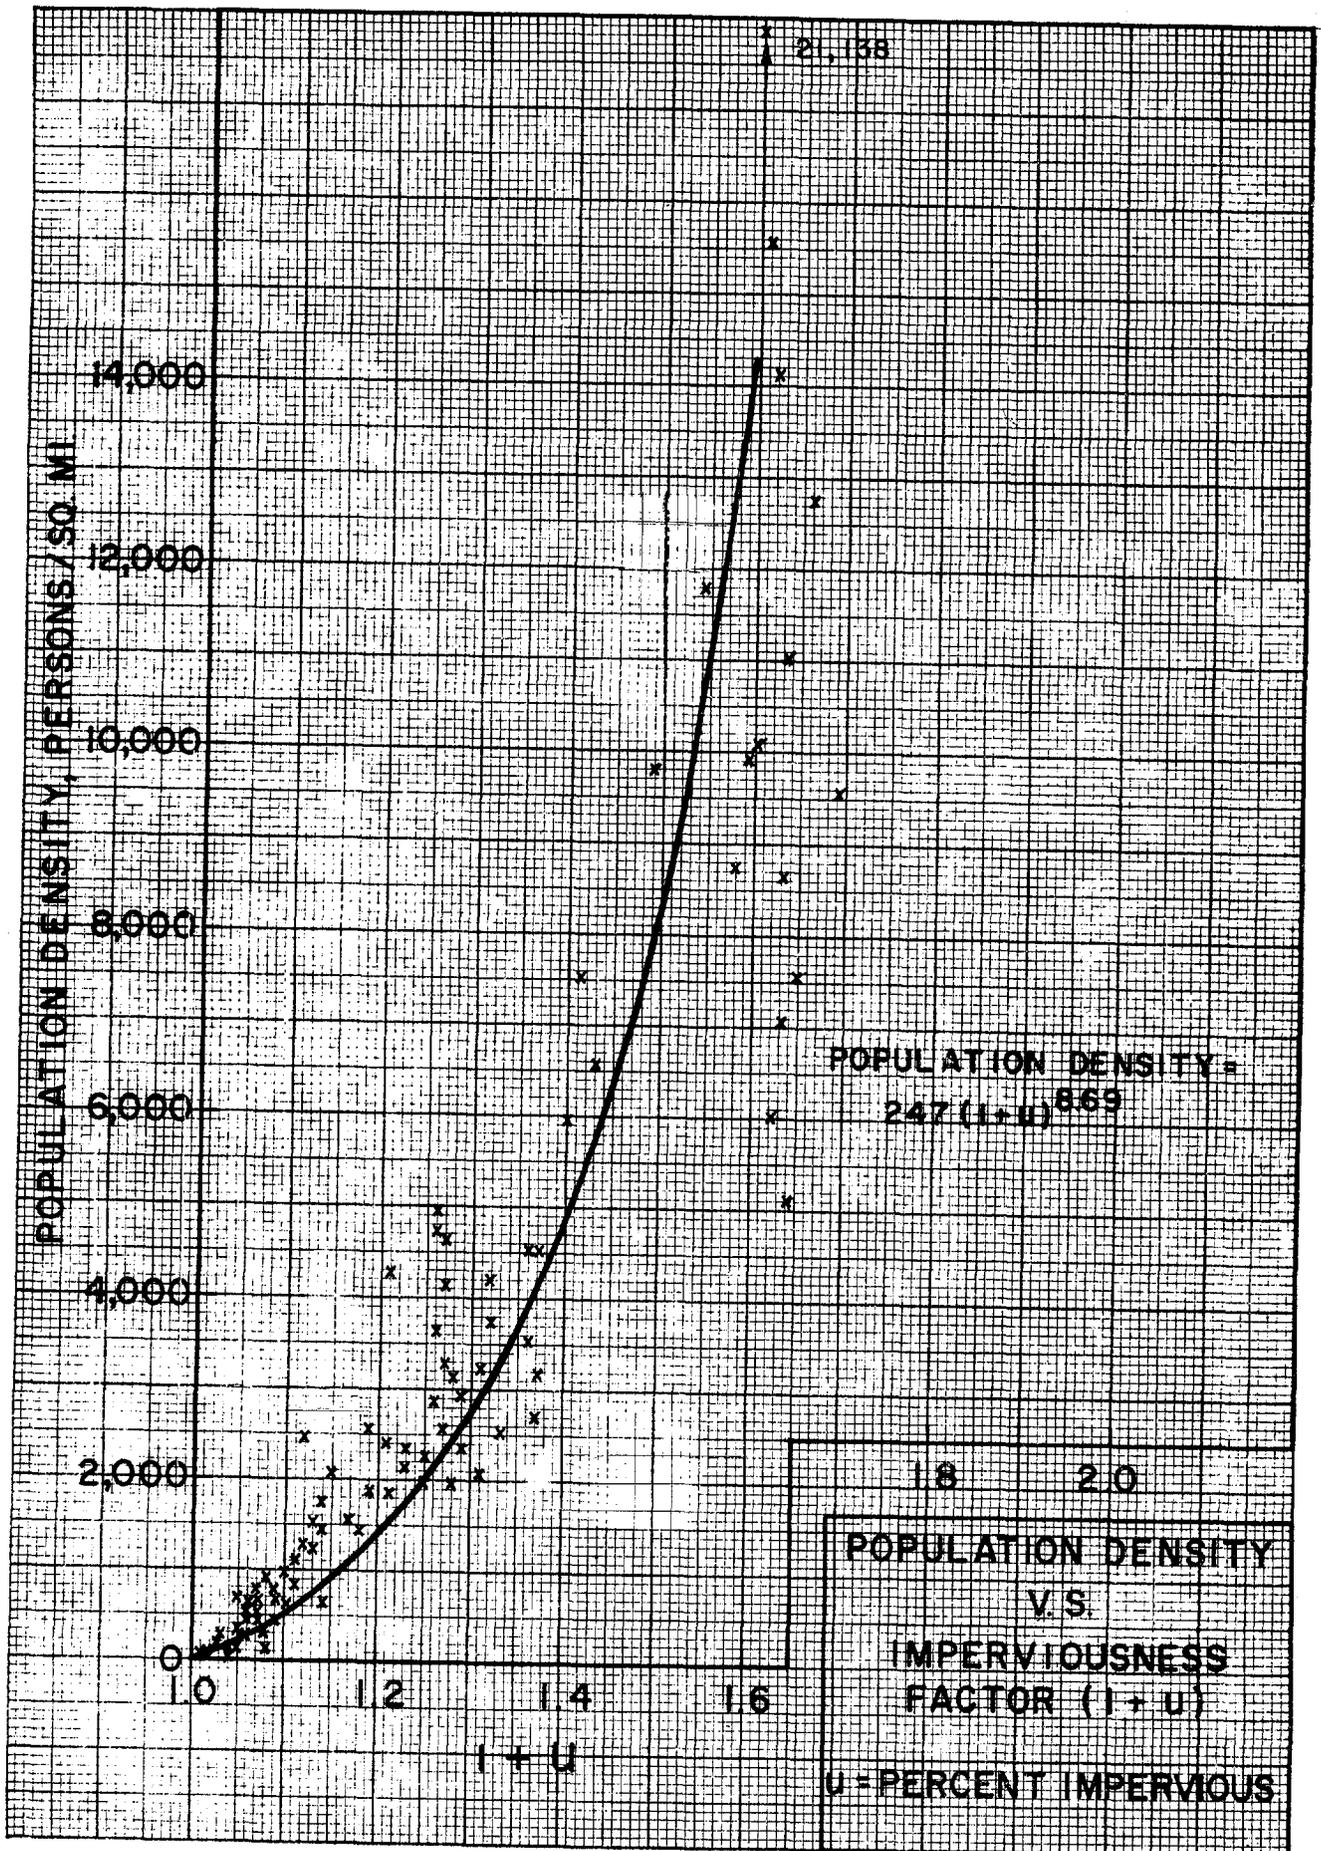
Figure 17. Population Density vs. Imperviousness Factor (U.S. Army Corps of Engineers, 1973).

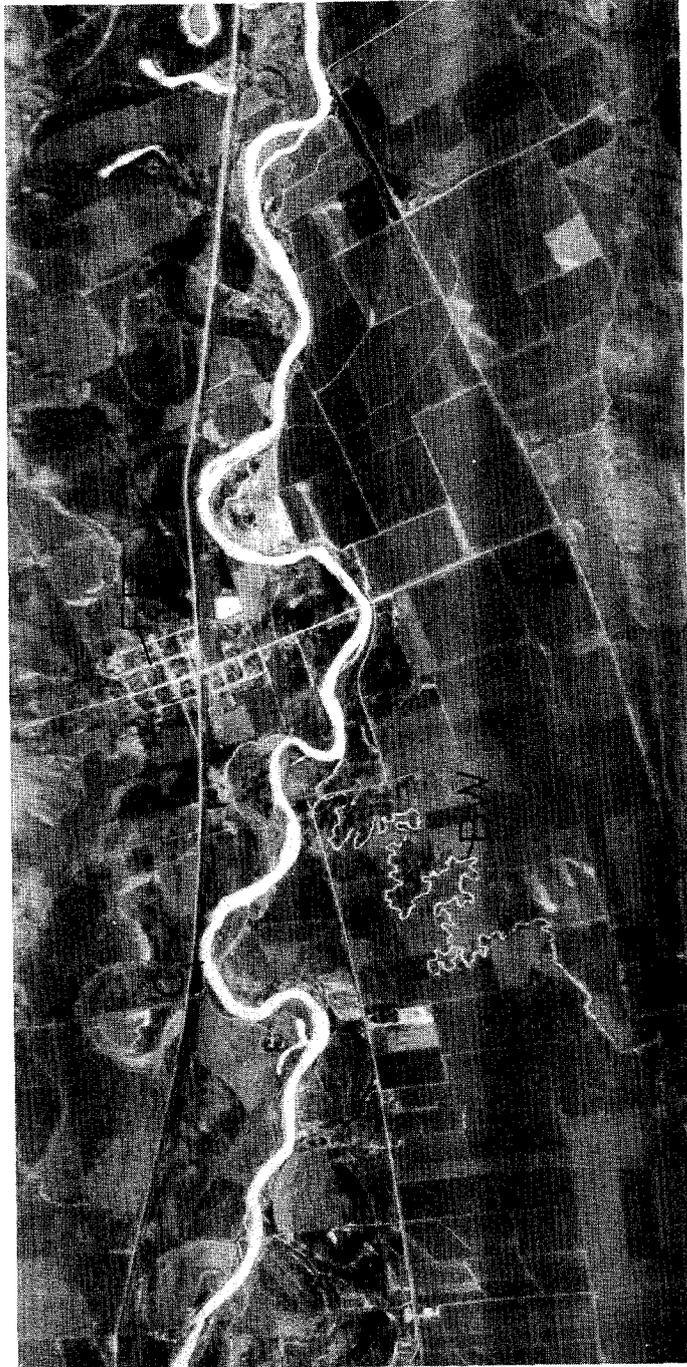
Figure 1. Meandering Reach of Clark's Fork of the Yellowstone River (after Ruff et al., (1)).  
Note two recently formed Oxbow Lakes which are the result of meander cutoff.

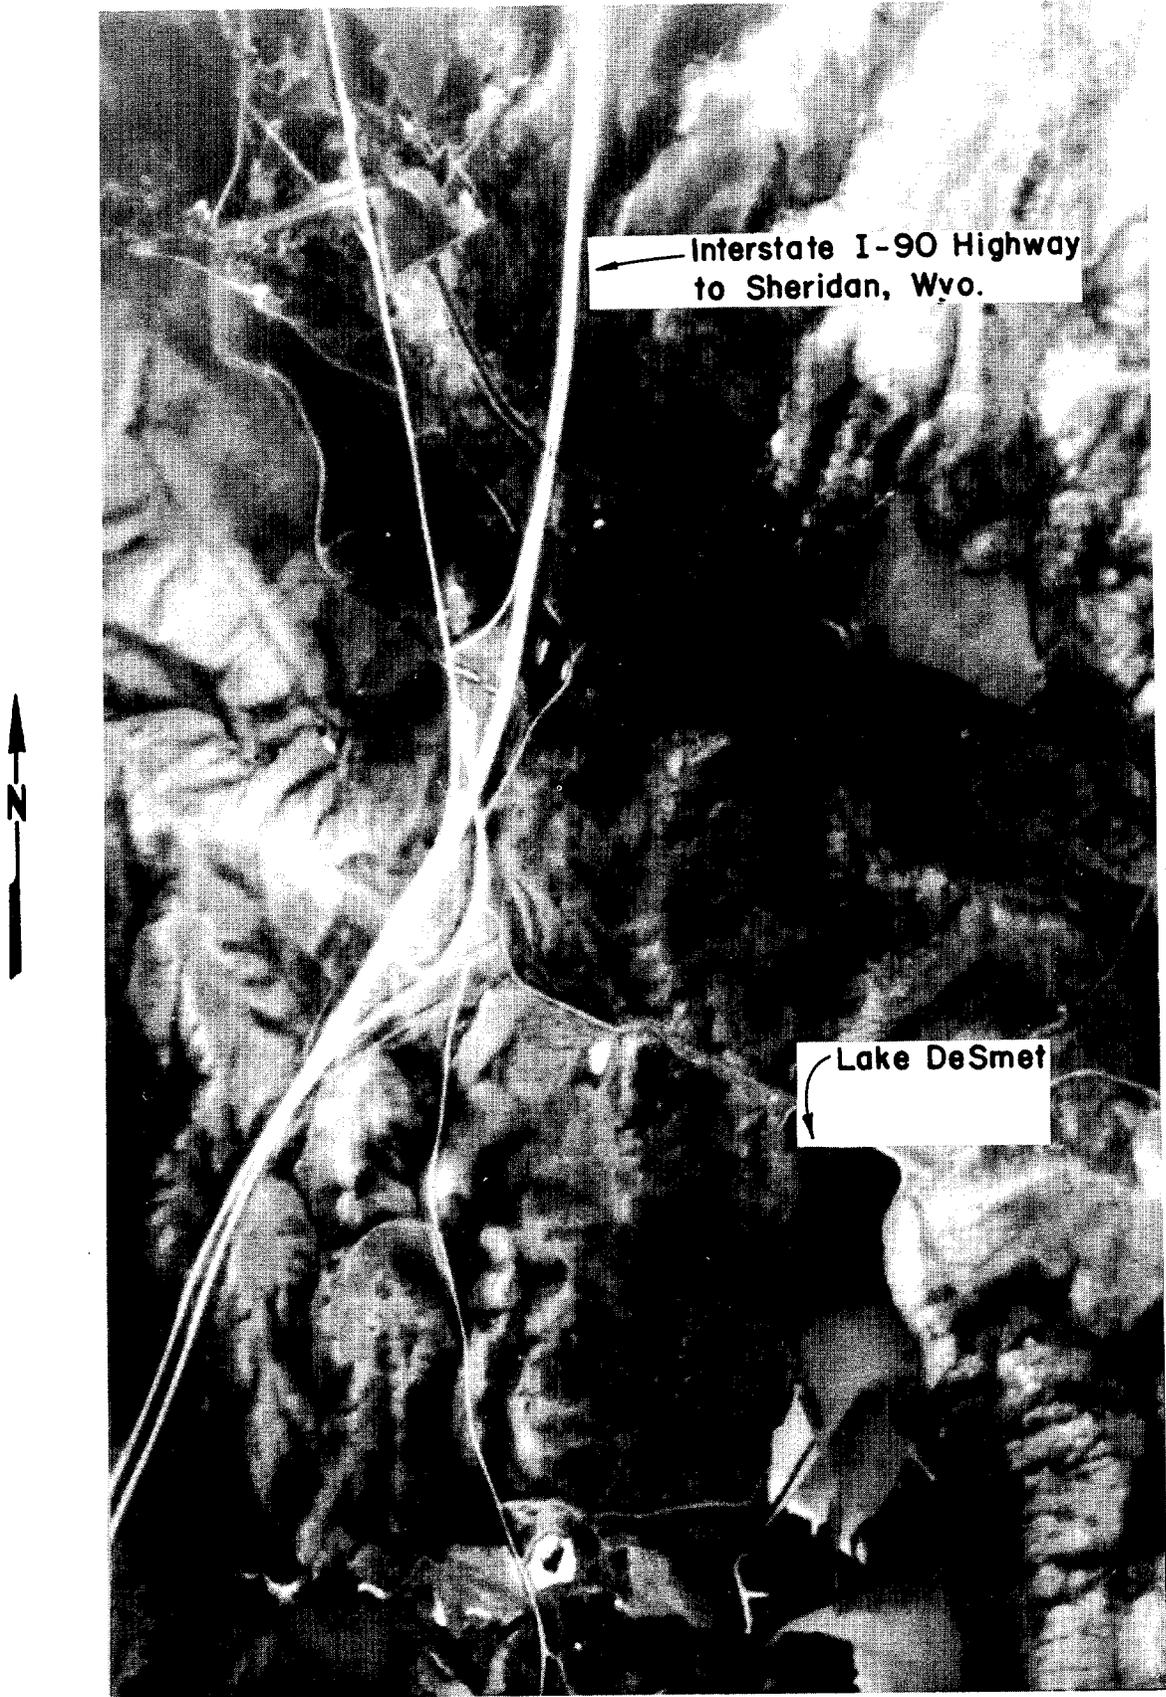
FIG. 1 Lake DeSmet Area near Sheridan, Wyoming. Thermal Infrared Image (8-14  $\mu\text{m}$ )

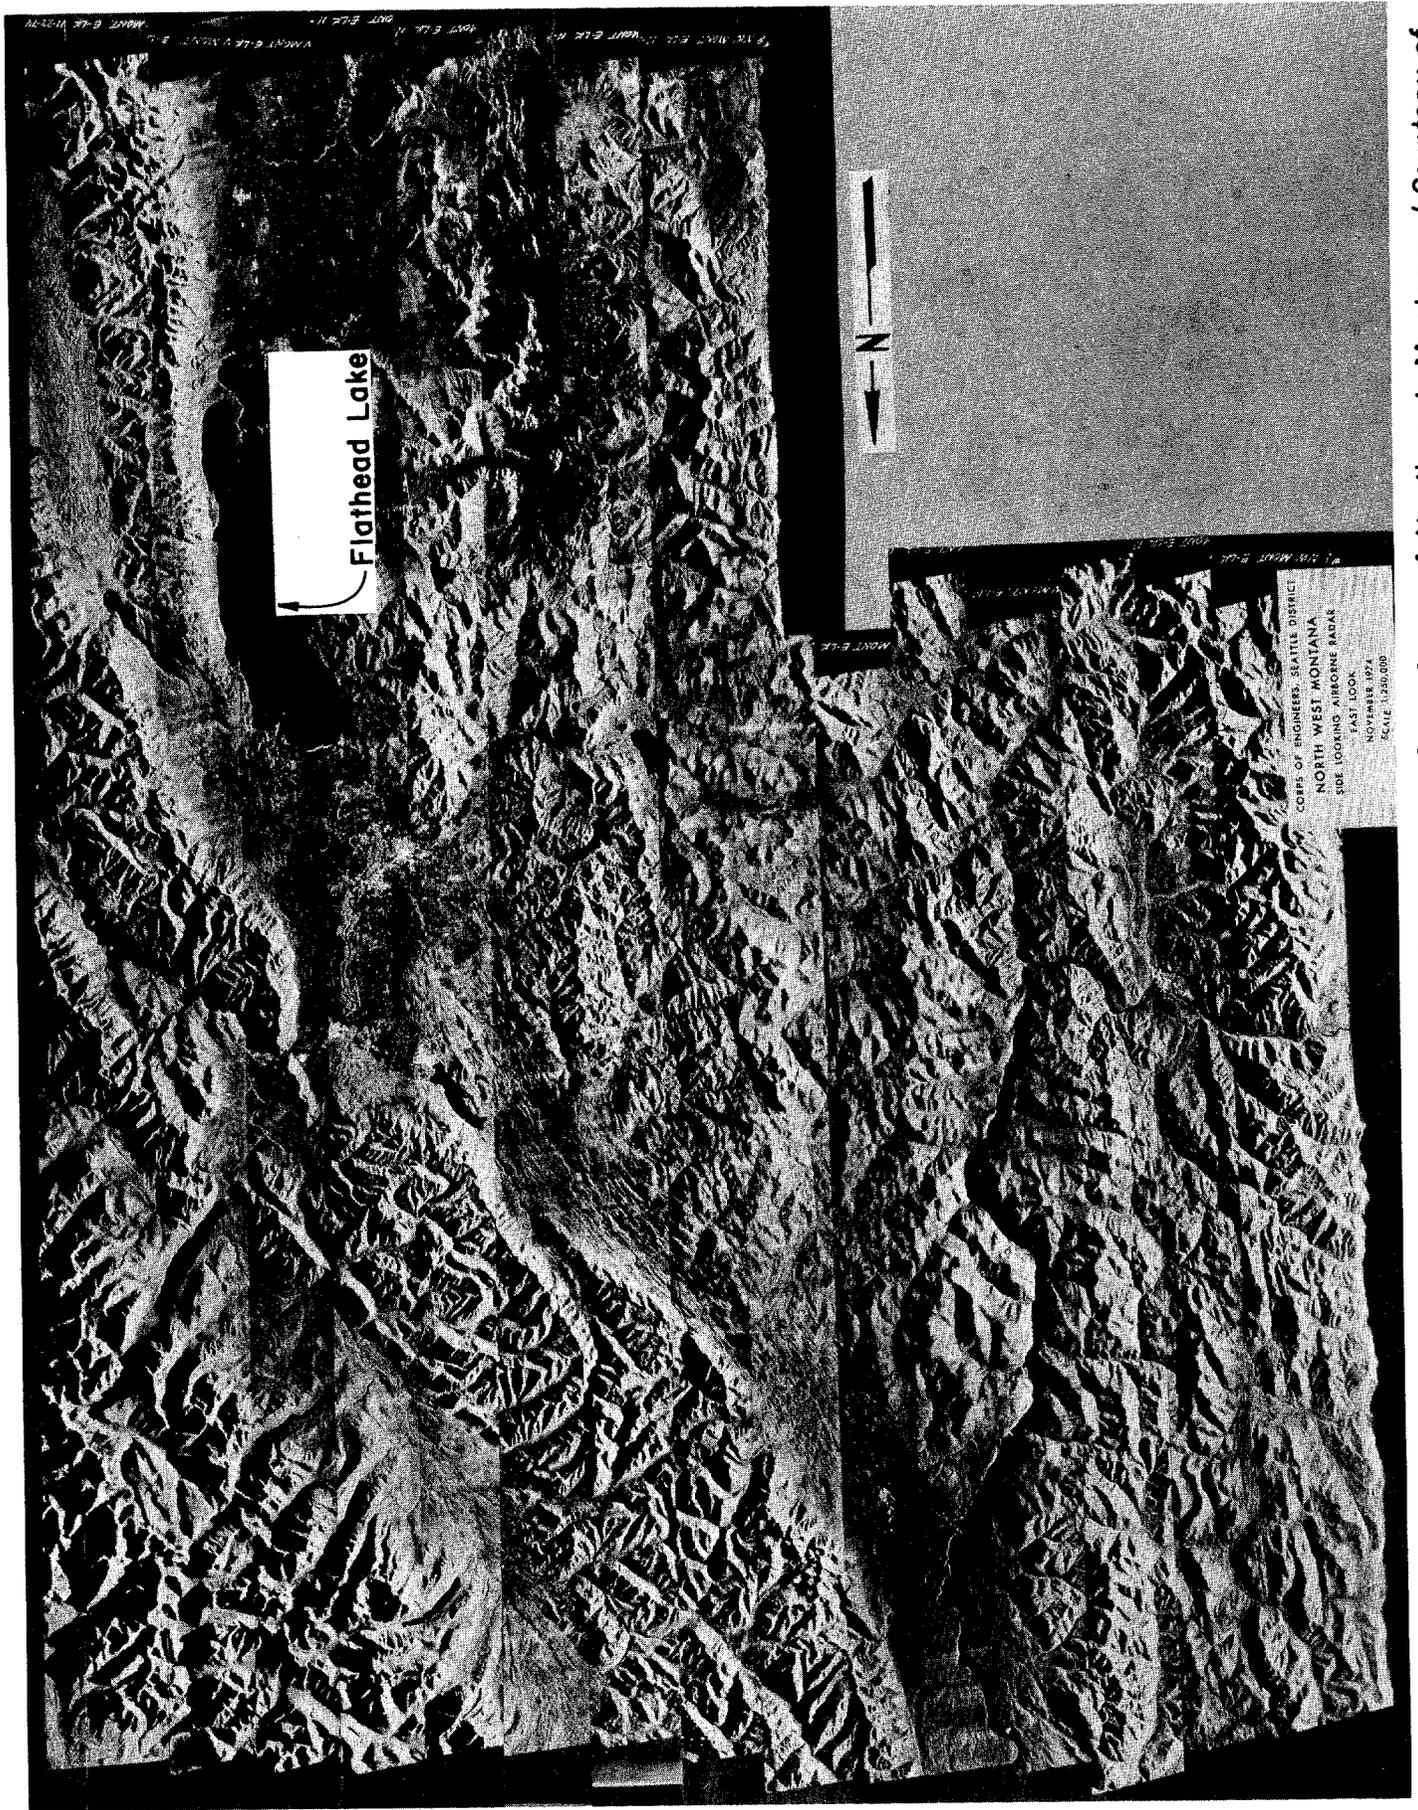
FIG. 3 Side Looking Airborne Radar (SLAR) Image East Look of an Area of Northwest Montana ( Courtesy of Corps of Engineers, Seattle District)
