Development of Cost-Competitive Timber Bridge Designs for Long- Term Performance

Natural Resources Research Institute
University of Minnesota Duluth

Research Project
Final Report 2020-16

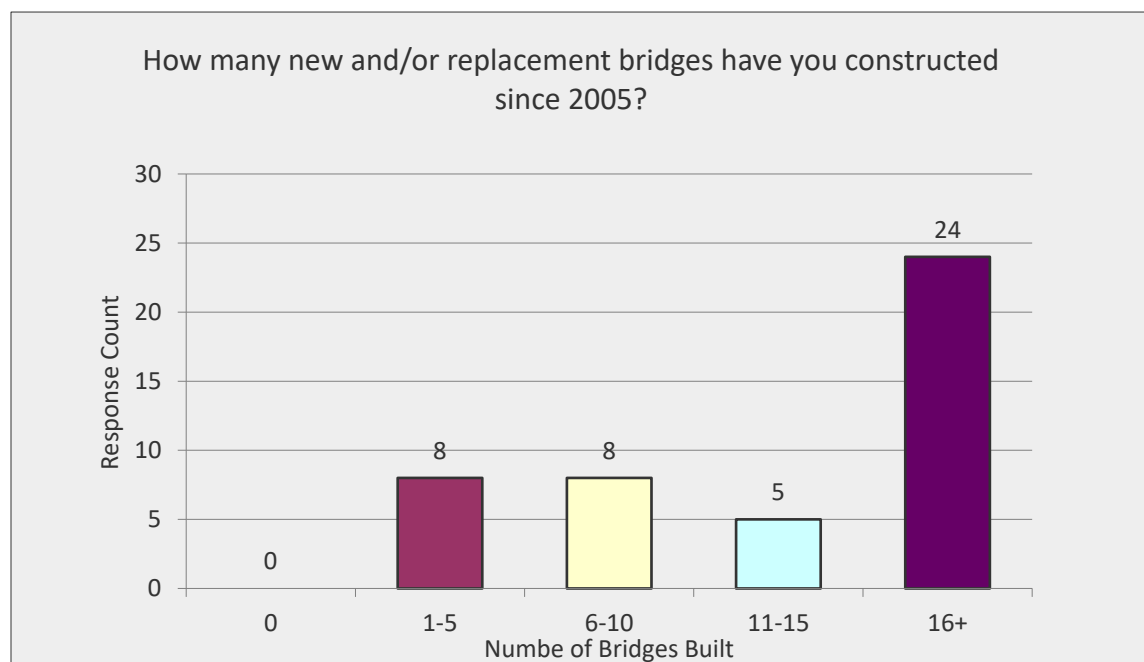
Figure 2.1 Number of bridges constructed by county from 2005 to 2016.

Figure 2.1 shows the results of this question. Almost half of the engineers surveyed constructed 16 or more bridges during this time period. The remaining engineers all had constructed at least 1 bridge but were somewhat evenly distributed between 1 and 16 bridges constructed.

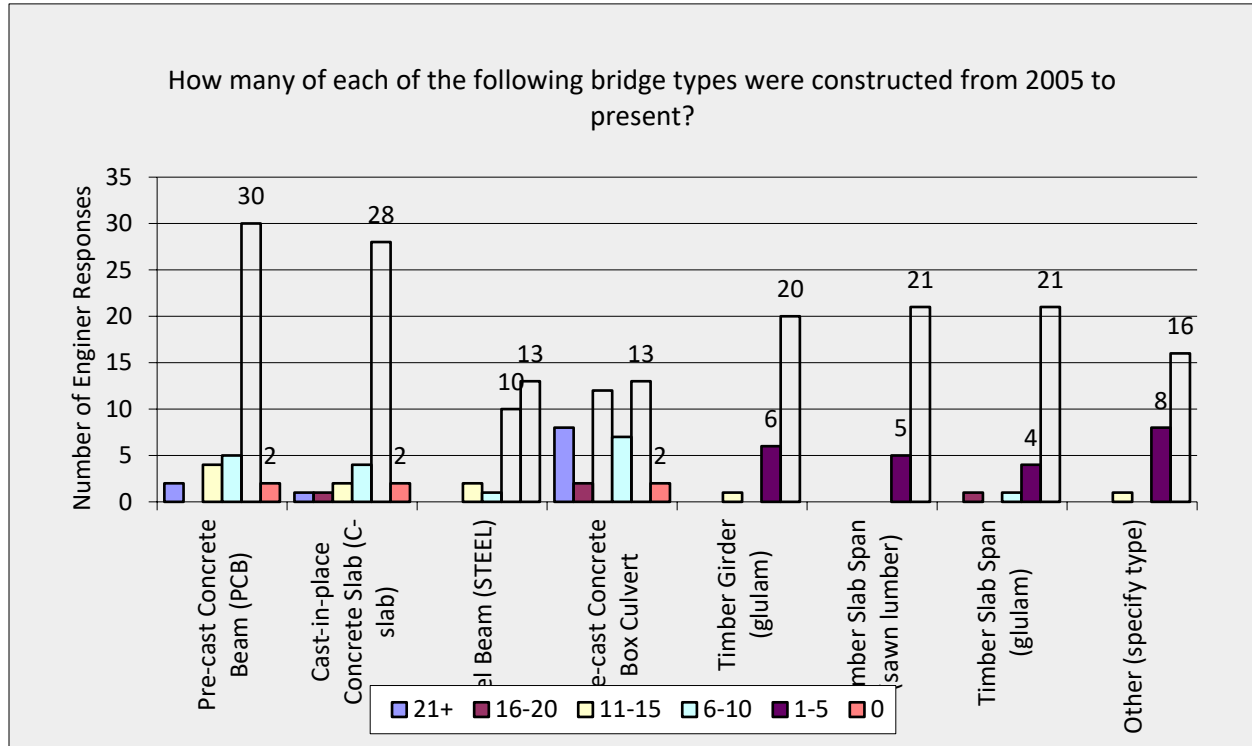
Figure 2.2 Bridges constructed by type between 2006 and 2016.

Results are shown in Figure 2.2. The majority of bridges constructed were made of concrete. Timber and steel were used in constructing significantly fewer bridges.

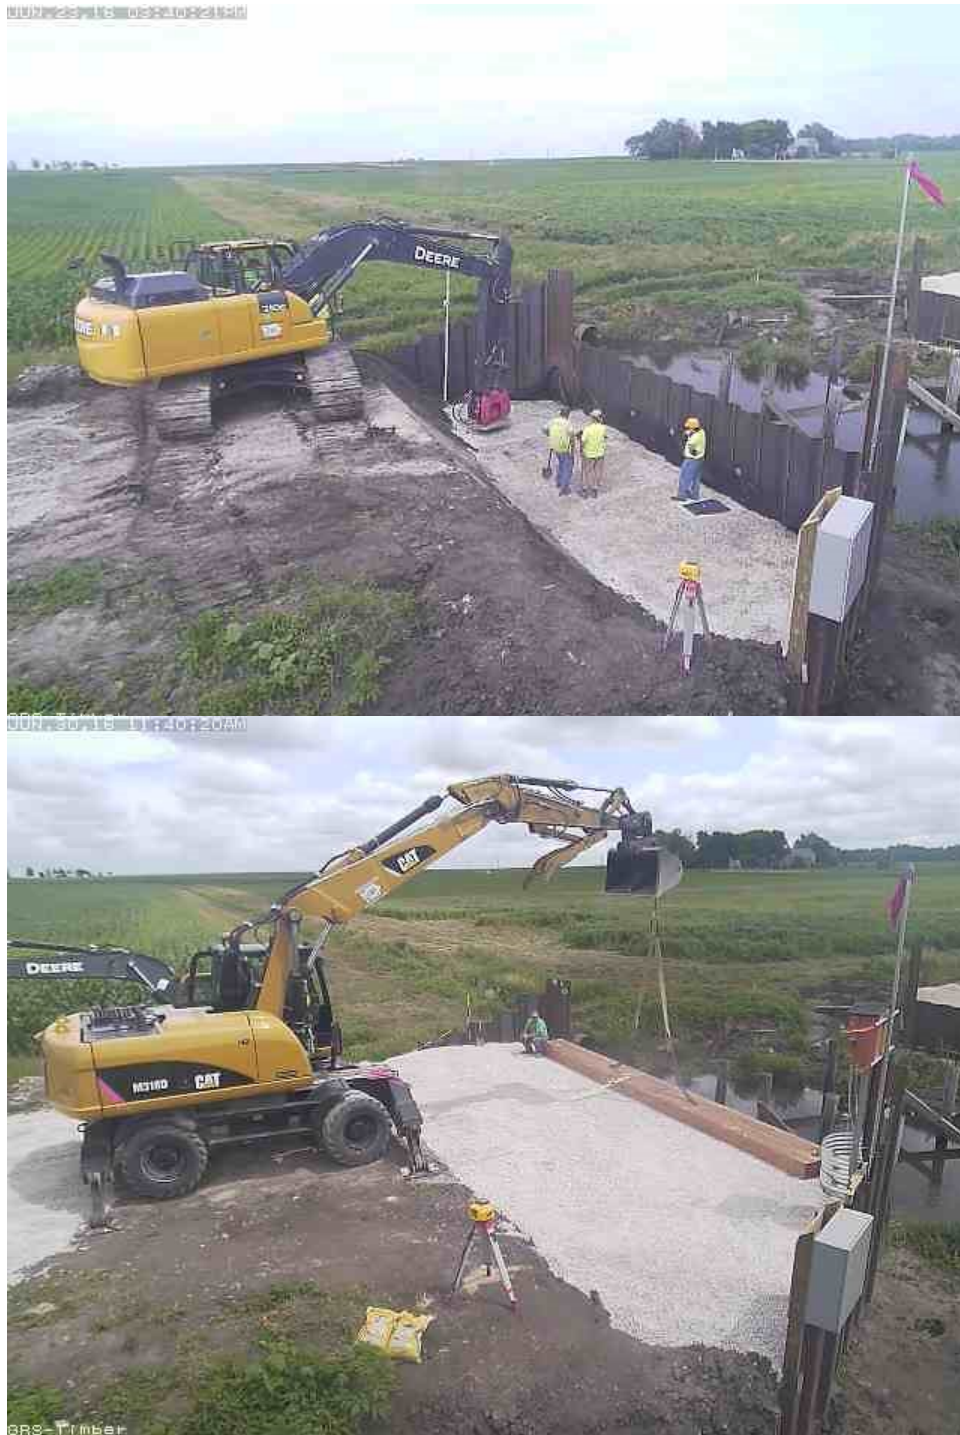
Figure 3.3 GRS abutment during construction in Buchanan County, Iowa (2016).

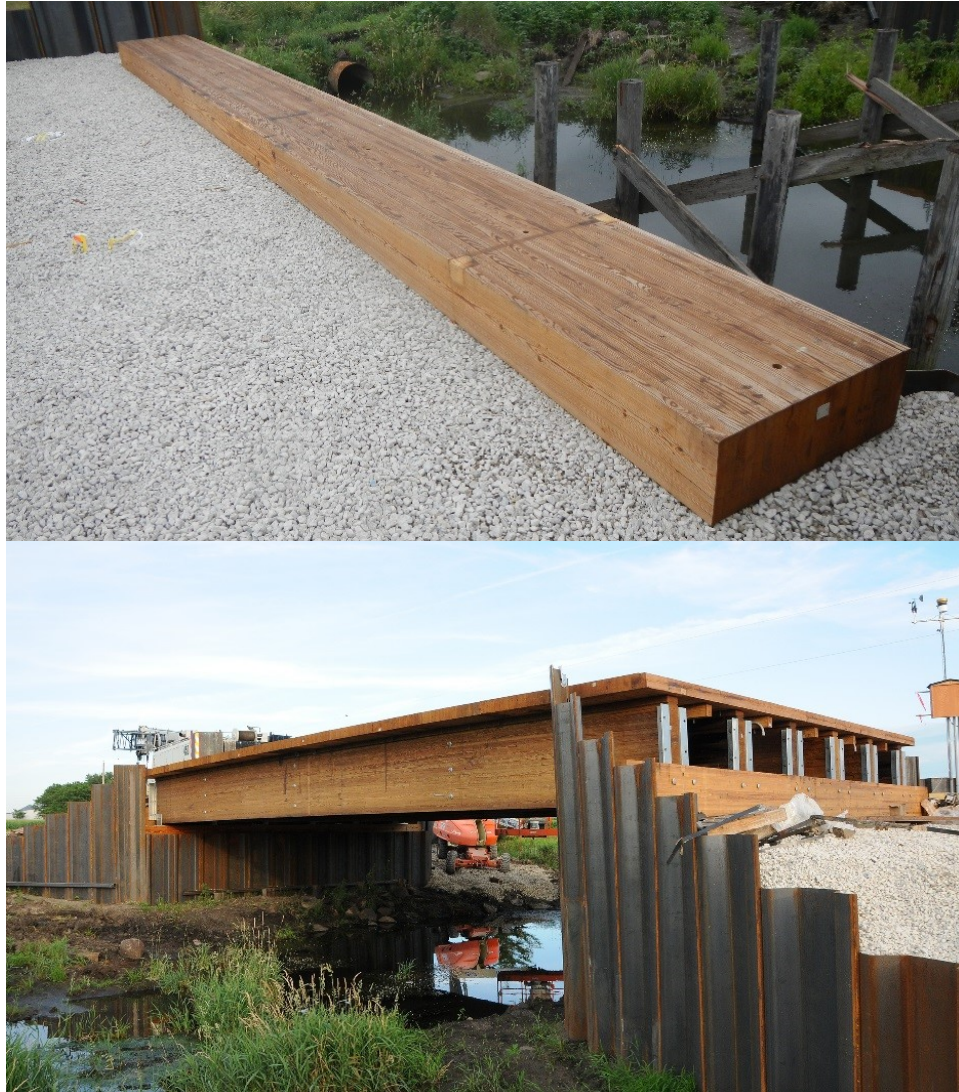
Figure 3.4 GRS abutment construction and bridge deck installation in Buchanan County, Iowa.

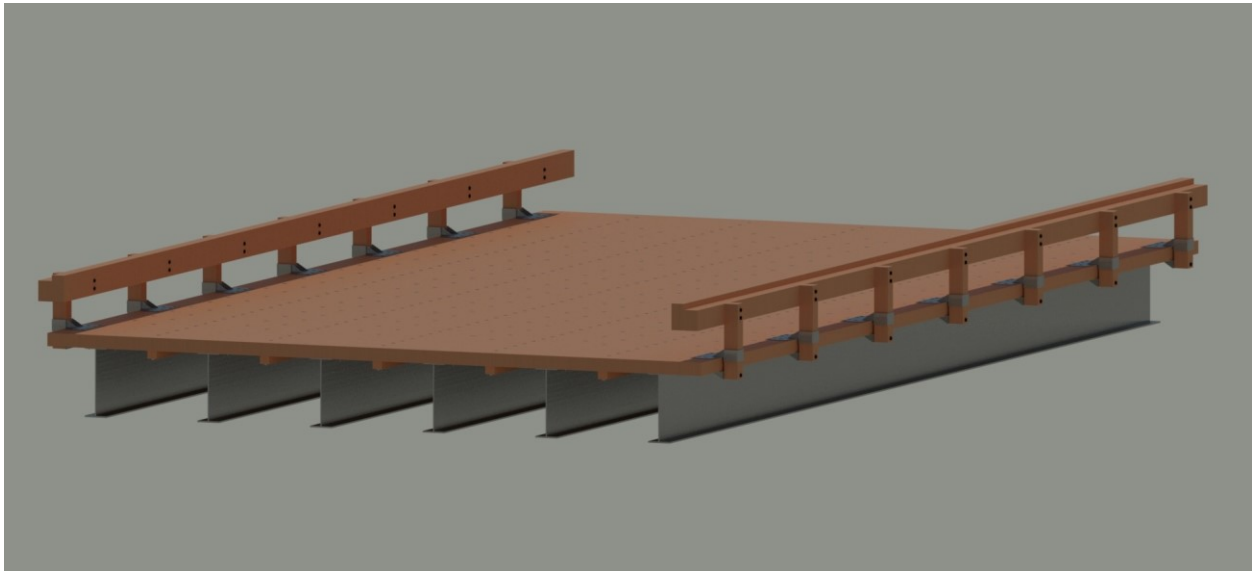
Figure 4.4 Perspective drawing of steel girder with transverse glulam timber deck, stiffeners, and railings.

Figure 4.4 shows the perspective drawing of the bridge superstructure design. The design features steel girders with diaphragms (Figures 4.4 and 4.5) with transverse glulam deck, longitudinal deck stiffeners, and the guard rail system (Figures 4.6, 4.7, 4.8, and 4.9). Drawings of galvanized flashing to protect the deck panel edges and rail posts from moisture related deterioration are shown in Figures 4.10 and 4.11.

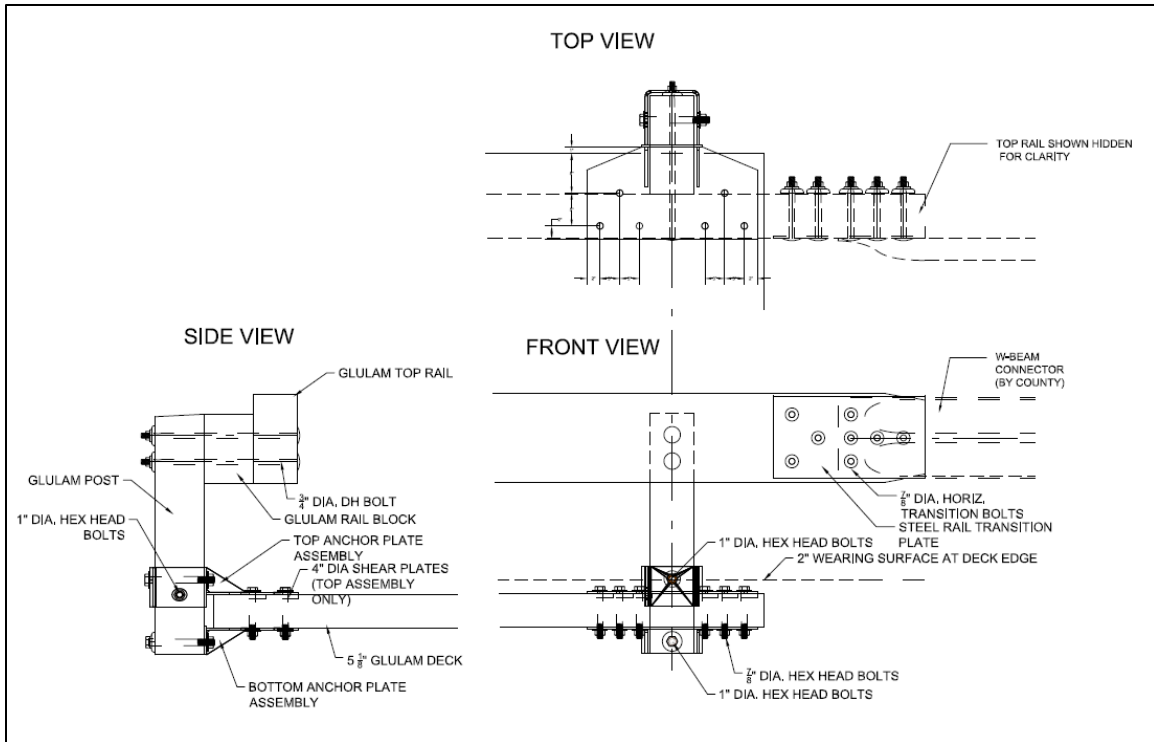
Figure 4.11 Guide rail detail.

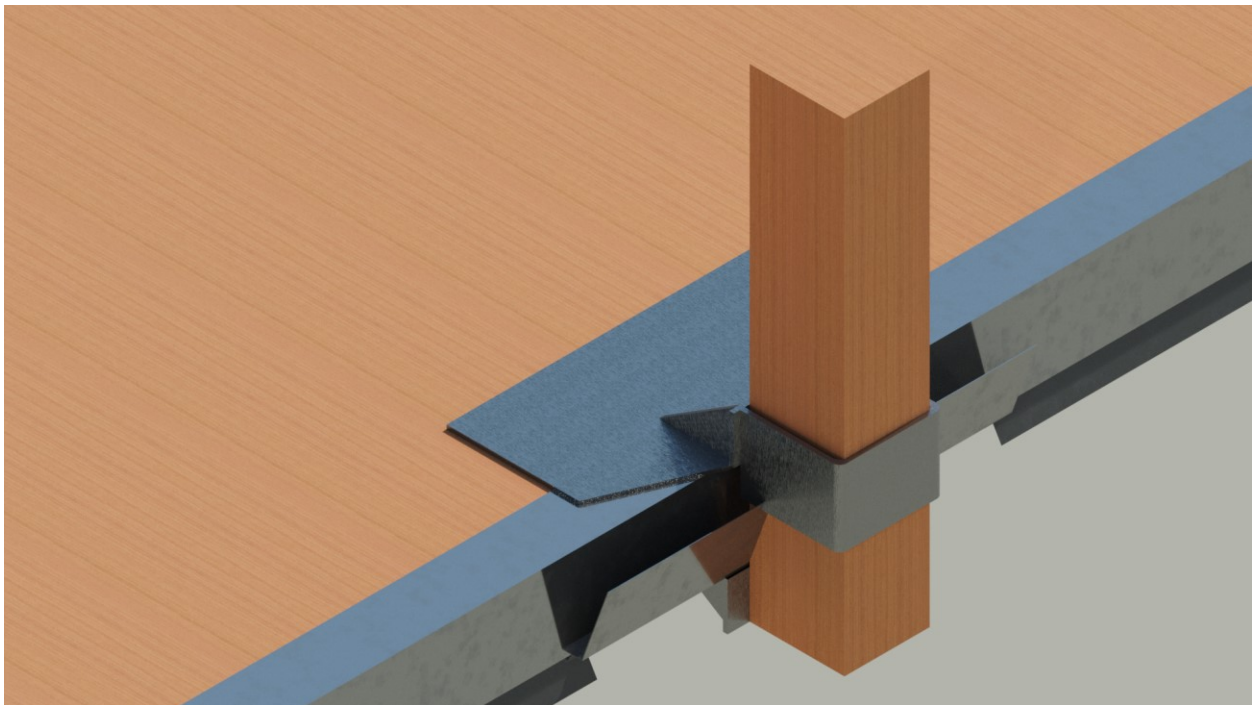
Figure 4.12 Three-dimensional rendering of proposed flashing detail between and at posts.

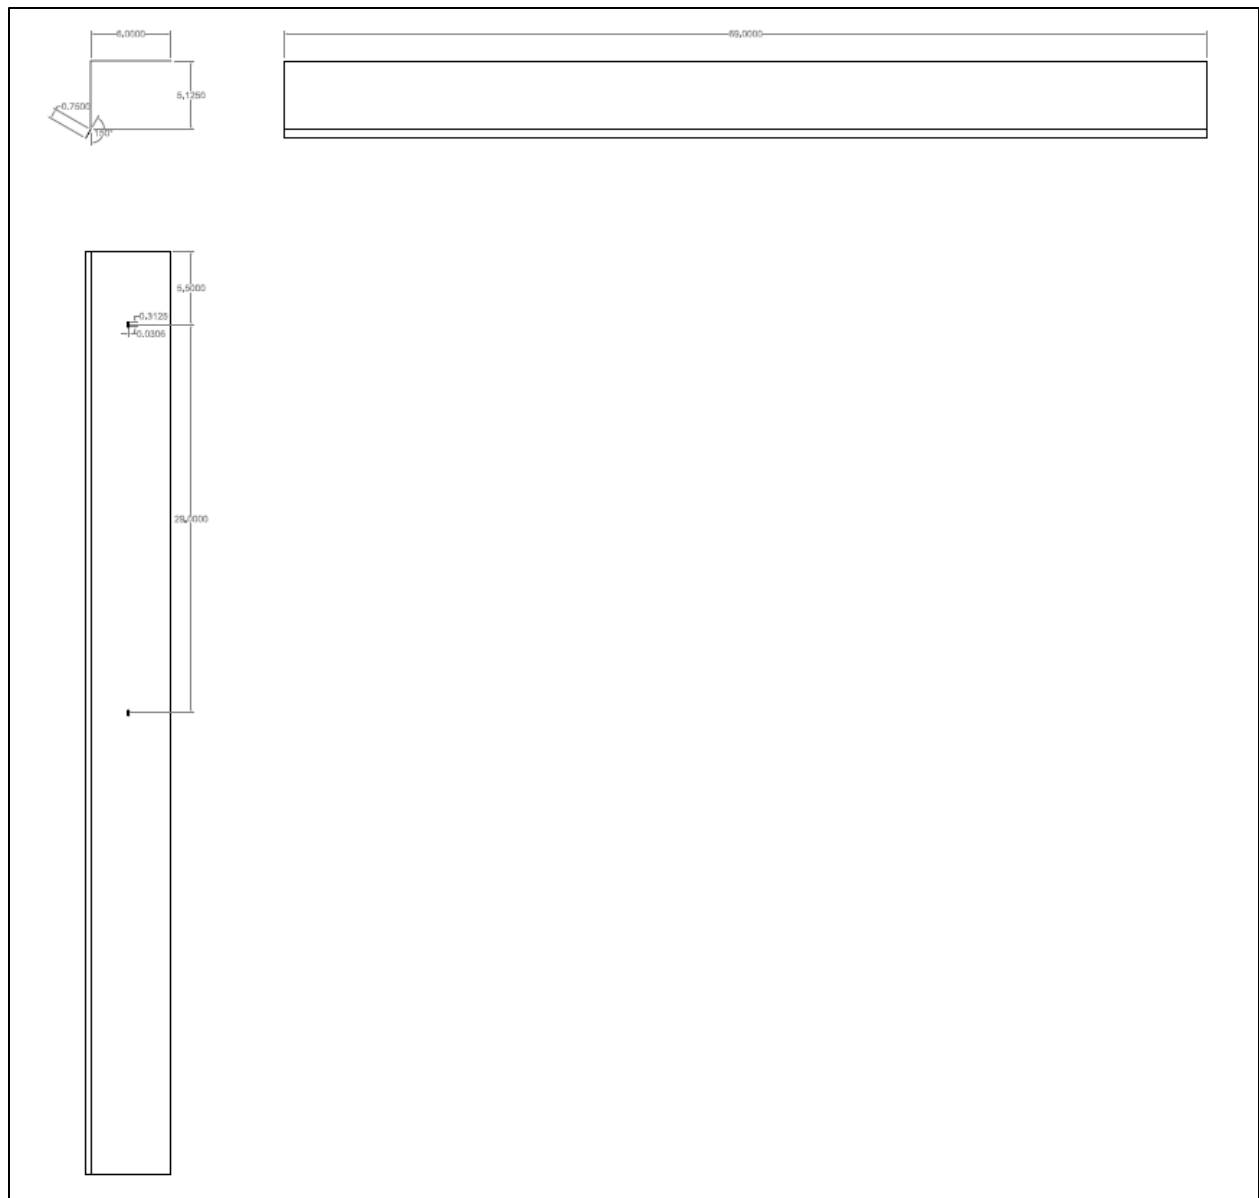
Figure 4.13 Shop drawings (3 orthogonal views) for the deck-edge flashing sections located between guardrail posts.

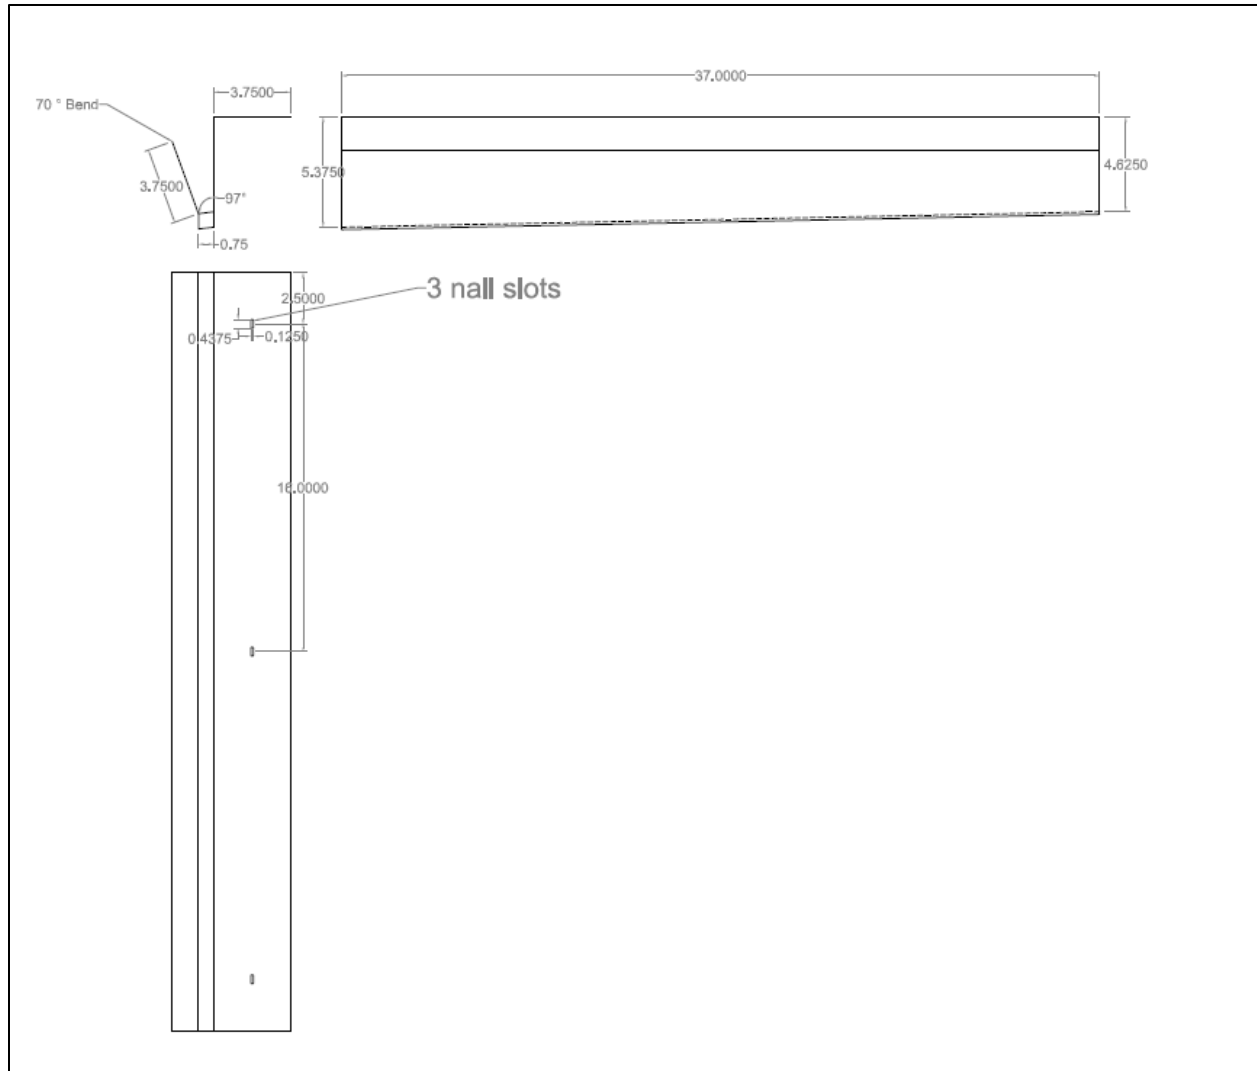
Figure 4.14 Shop drawings (3 orthogonal views) for the deck-edge flashing sections located at the guardrail posts.

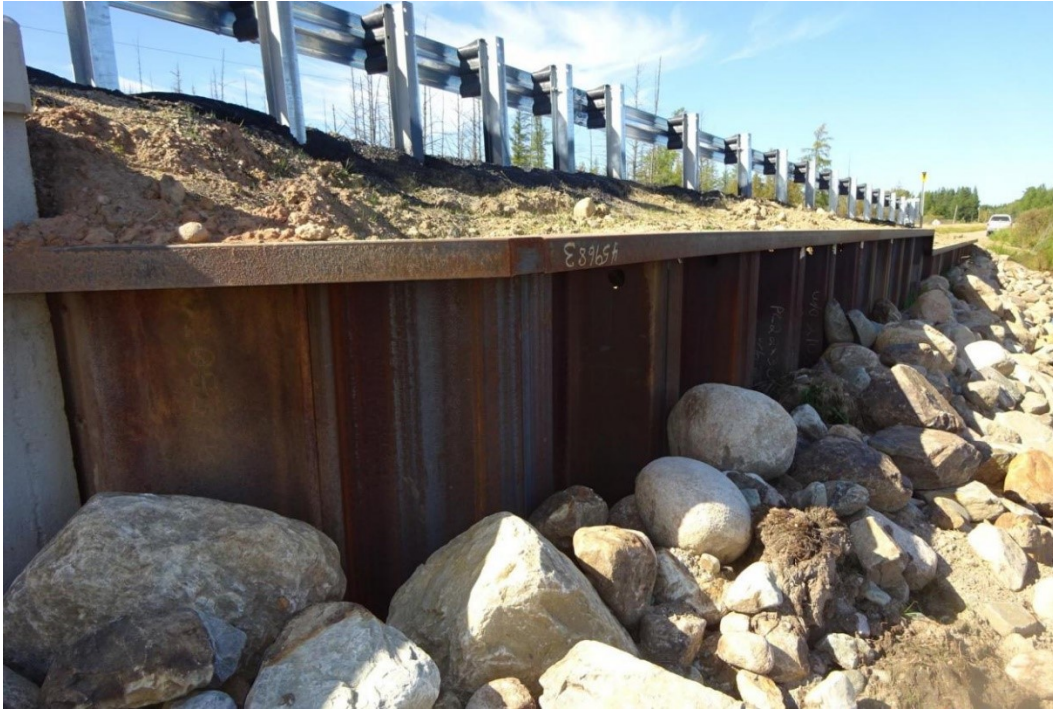
Figure 4.17 Upstream wing wall (driven sheet pile) with riprap to protect the roadway and bridge from scour erosion damages.

shows the upstream layout of the river. Figures 4.16, 4.17, 4.18, and 4.19 show the concrete abutments on the north end of the bridge and the concrete wing wall and the steel pile retaining wall.

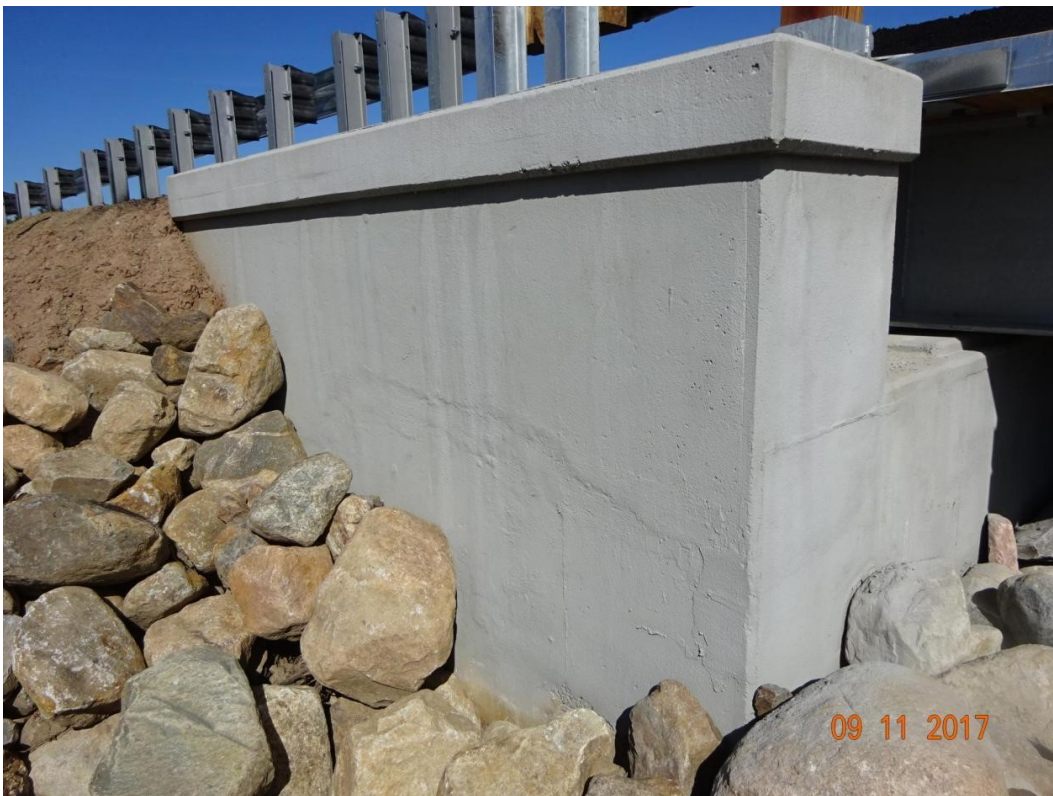
Figure 4.18 Downstream concrete abutment with riprap.

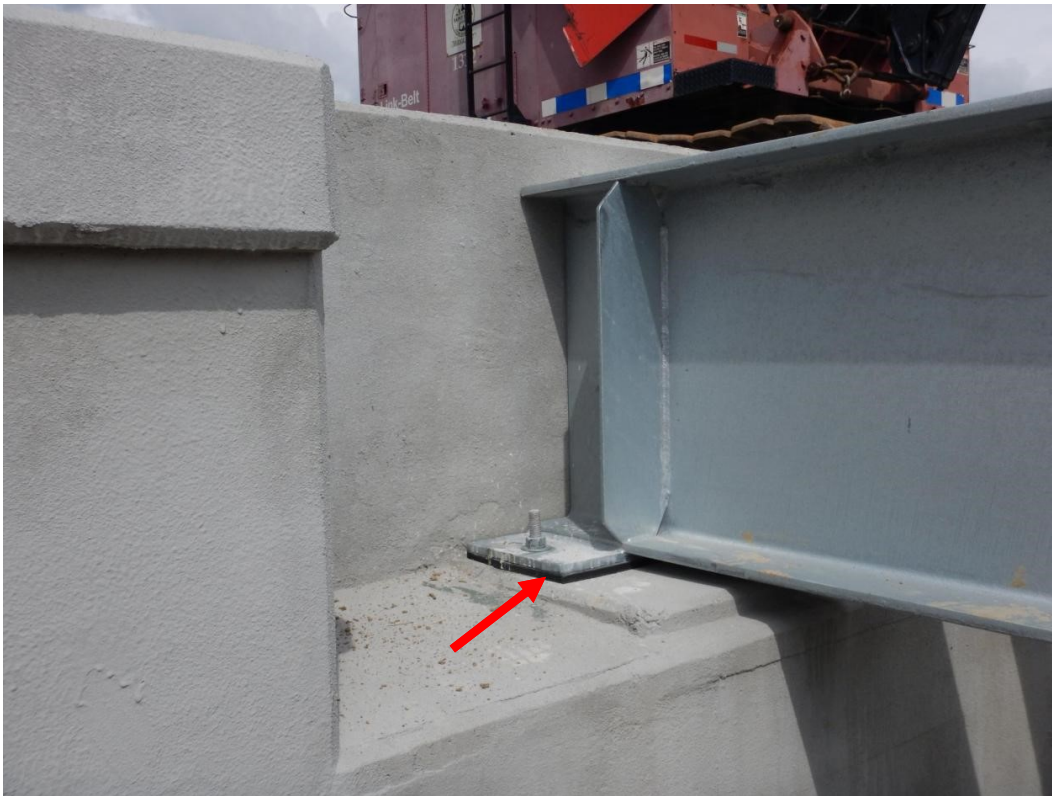
Figure 4.19 Steel beams installed onto steel bearing plates with neoprene pads.

The steel beams were installed using a crew of four individuals, which included one supervisor. The beams were installed over a three-day time period. Following installation of the beams, the bridge crew closed the construction site to await fabrication and delivery of the glulam materials.

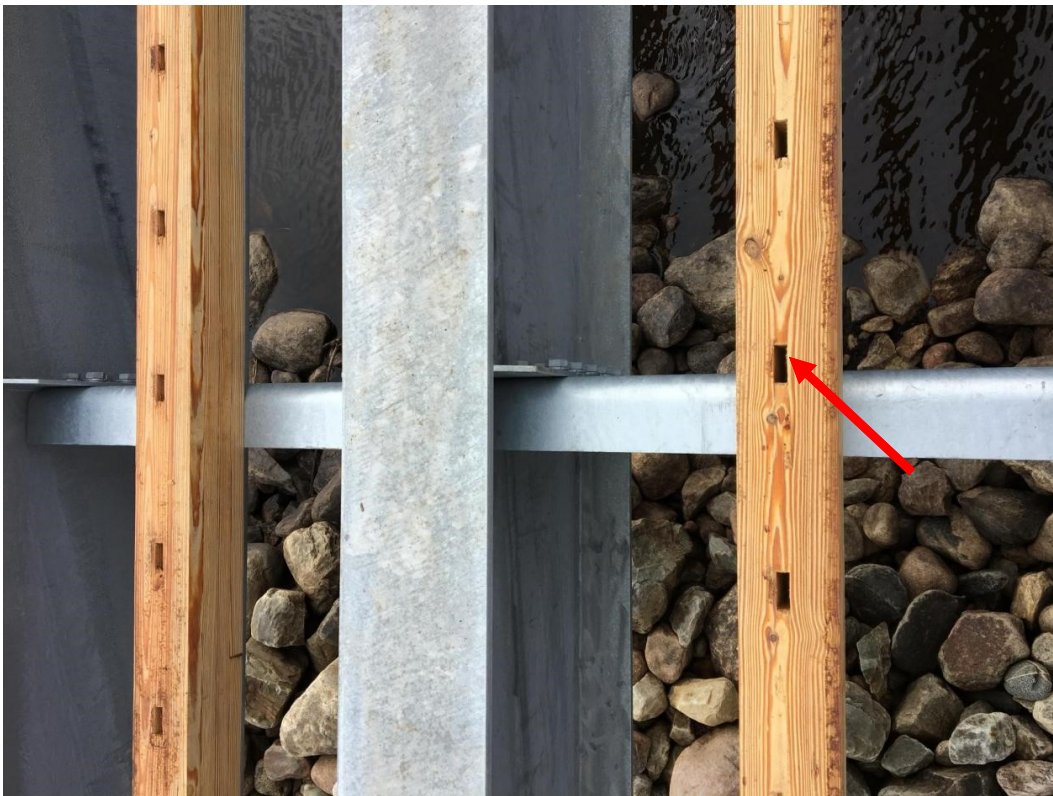
Figure 4.29 Machined slots for ease of bolt installation and dimensional movement.

A construction crane was used to move the wood materials into location. The glulam stiffeners were placed onto the bridge and then separated with one stiffener between each steel beam. The stiffeners were fabricated with a 13/16 in diameter slot that was 2 inches long to allow for easier insertion of the bolts through the glulam deck and the stiffener. It also allows for some dimensional movement of the wood materials due to changes in moisture content during its service life. One challenge noted was that approximately 20 thru-bolt locations, the insertion of the bolt conflicted with the steel diaphragms. Those bolts were field cut to a shorter length and installed, causing construction delays. The placement of the stiffener beams took approximately three man-hours. This included two installers and one crane operator. Figures 4.26, 4.27, 4.28, and 4.29 show the stiffeners being added to the superstructure.

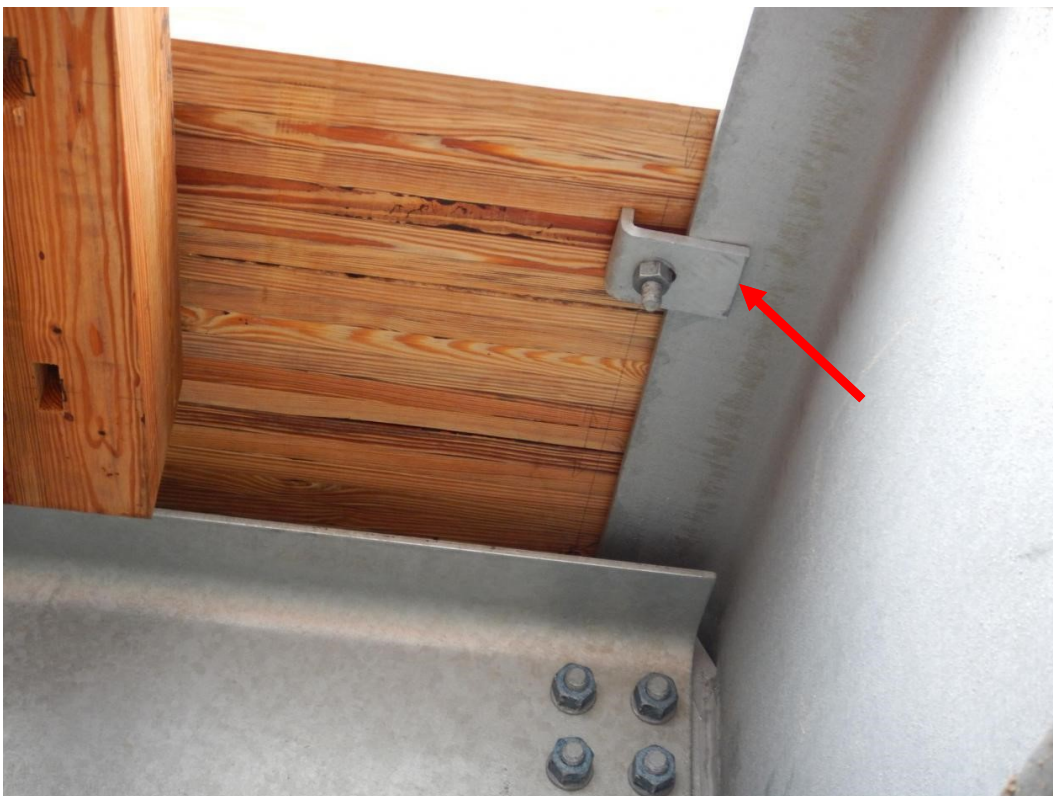
Figure 4.32 Close-up of galvanized clip connection between panel and steel beam.

Following placement of the stiffeners, the transverse glulam deck was installed onto the bridge, starting at the south end of the bridge and located on opposite end from the crane. Various techniques were used to align the panels into place and to ensure they were lined up end-to-end. This included the use of an excavator, sledge, and straps system using through bolts. The crew settled on the strap system where the crane lifted each panel into location and then pry bars were used to place the panels. A ratchet strap was also used to ensure the panels were tight edge-to-edge. The guard rail post hardware was also used to verify fit for the panels as they were installed. Deck clips were used to attach the glulam panels to the steel beams and bolts were used to connect the stiffeners to the glulam panels. Thirteen of fourteen panels were installed on day 1 and the remaining panel on day 2. The final panel had to be trimmed to width to account for as-built span dimensions between abutments. The panel cut edge was treated with several coats of copper naphthenate prior to installation. Fewer than five holes had to be drilled since they had not been drilled by the supplier. Each field drilled hole was treated with copper naphthenate preservative. Figures 4.30 to 4.42 show the deck during installation.

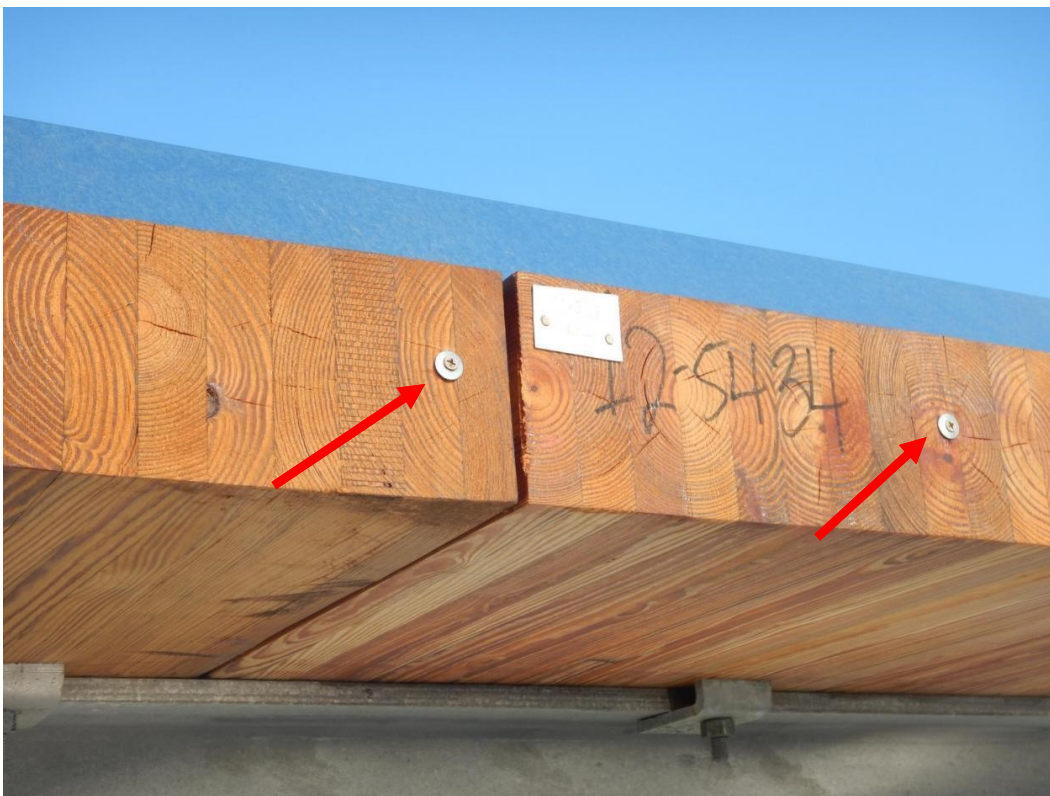
Figure 4.43 Washers attached to panel end-grain to create air space under the flashing.

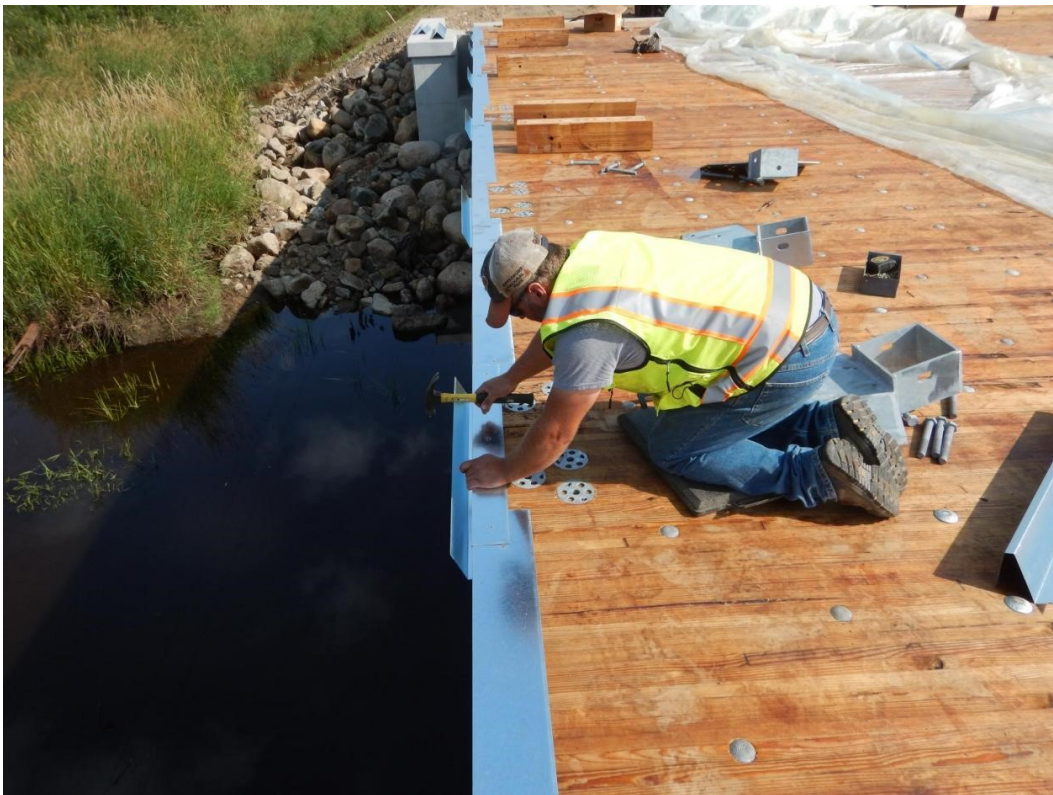
Figure 4.45 Flashing at posts was installed after the between post flashings.

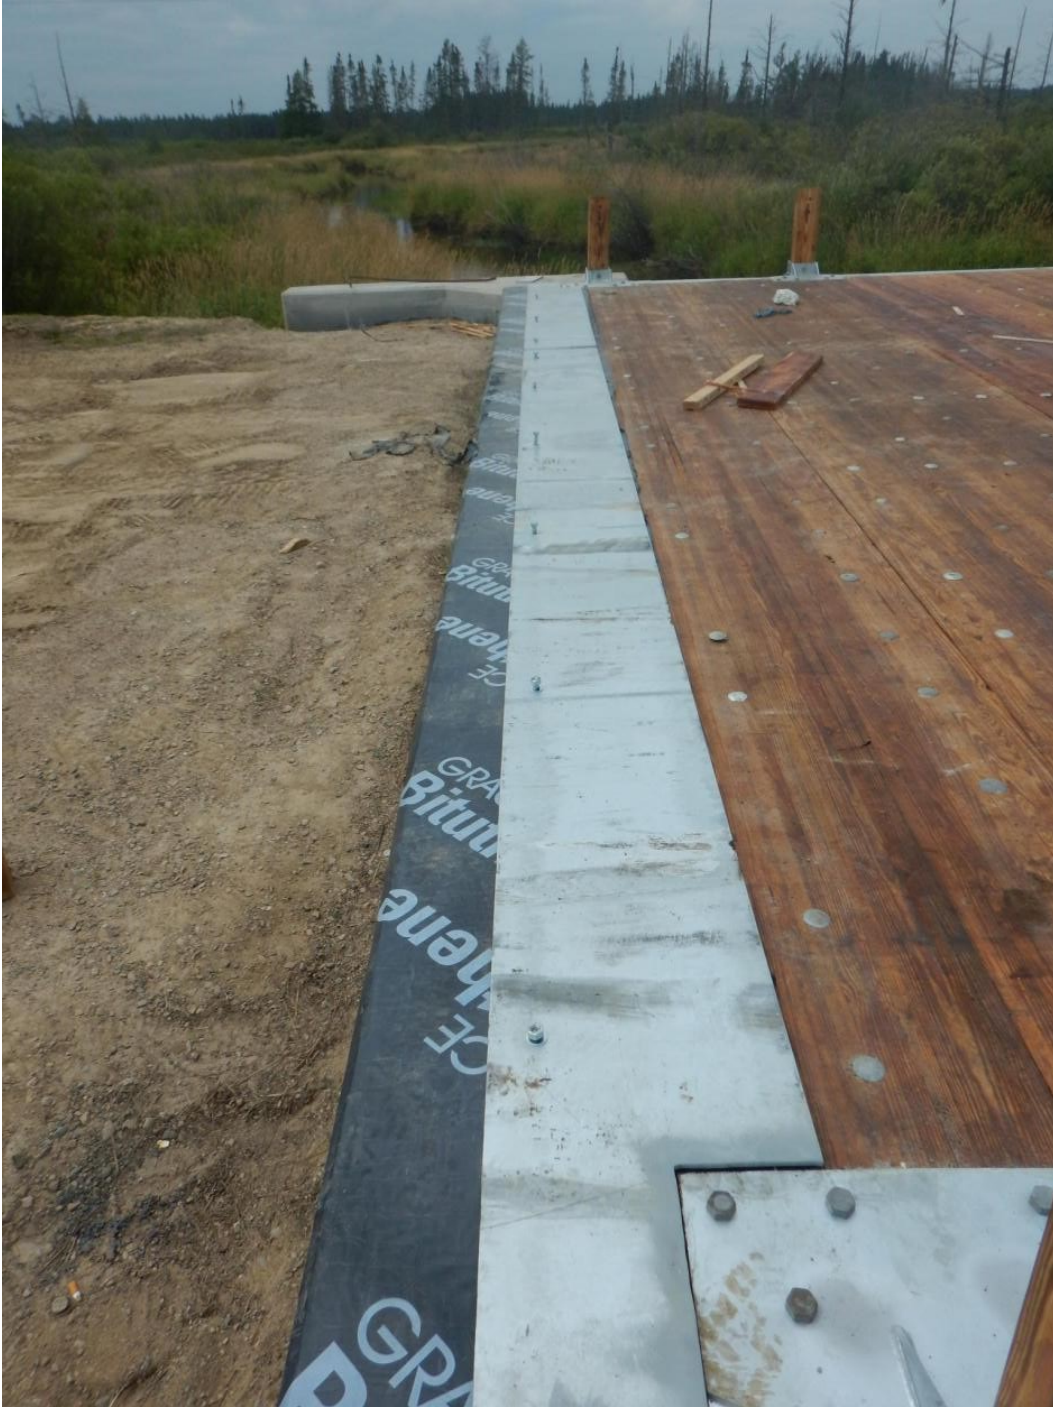
Figure 4.51 Waterproofing membrane and steel cover plate.

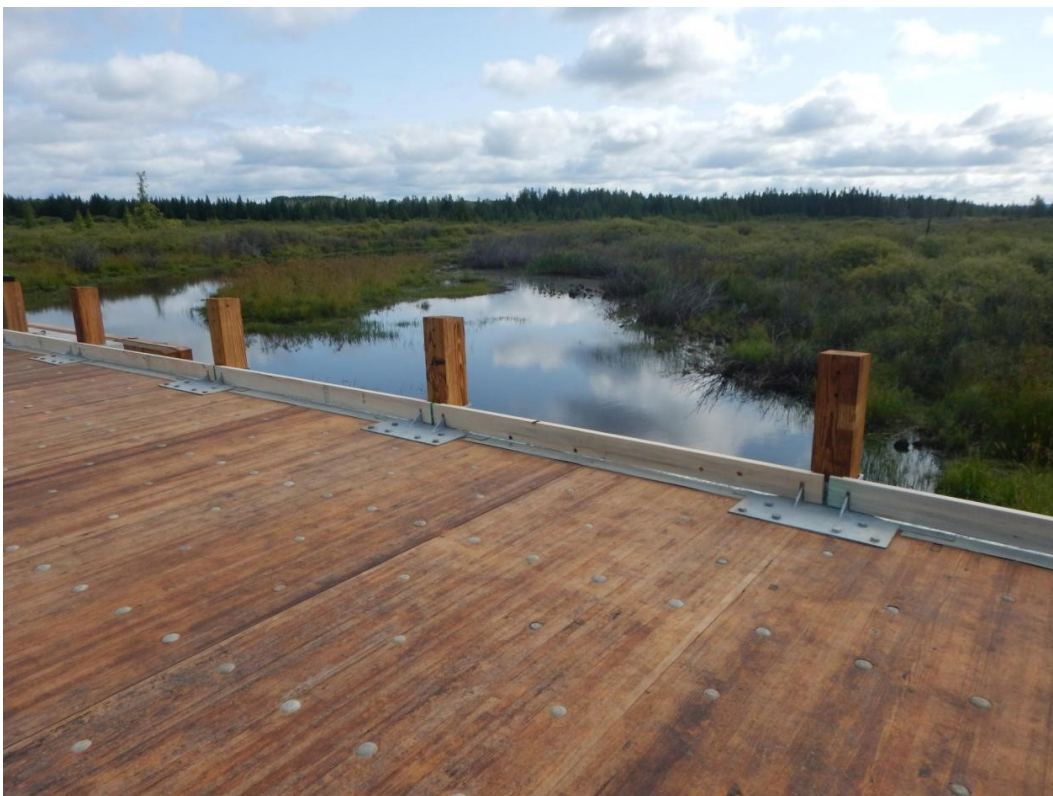
Figure 4.57 A temporary wood paving edge was developed and installed prior to overlay.

To ensure a paving edge on this curbless rail system, a temporary timber edge was installed prior to overlay. This is shown in Figures 4.57 to 4.59. It was then removed following the paving process. Figures 4.60 to 4.70 show the paving process and the installation of the waterproof reinforcing membrane.

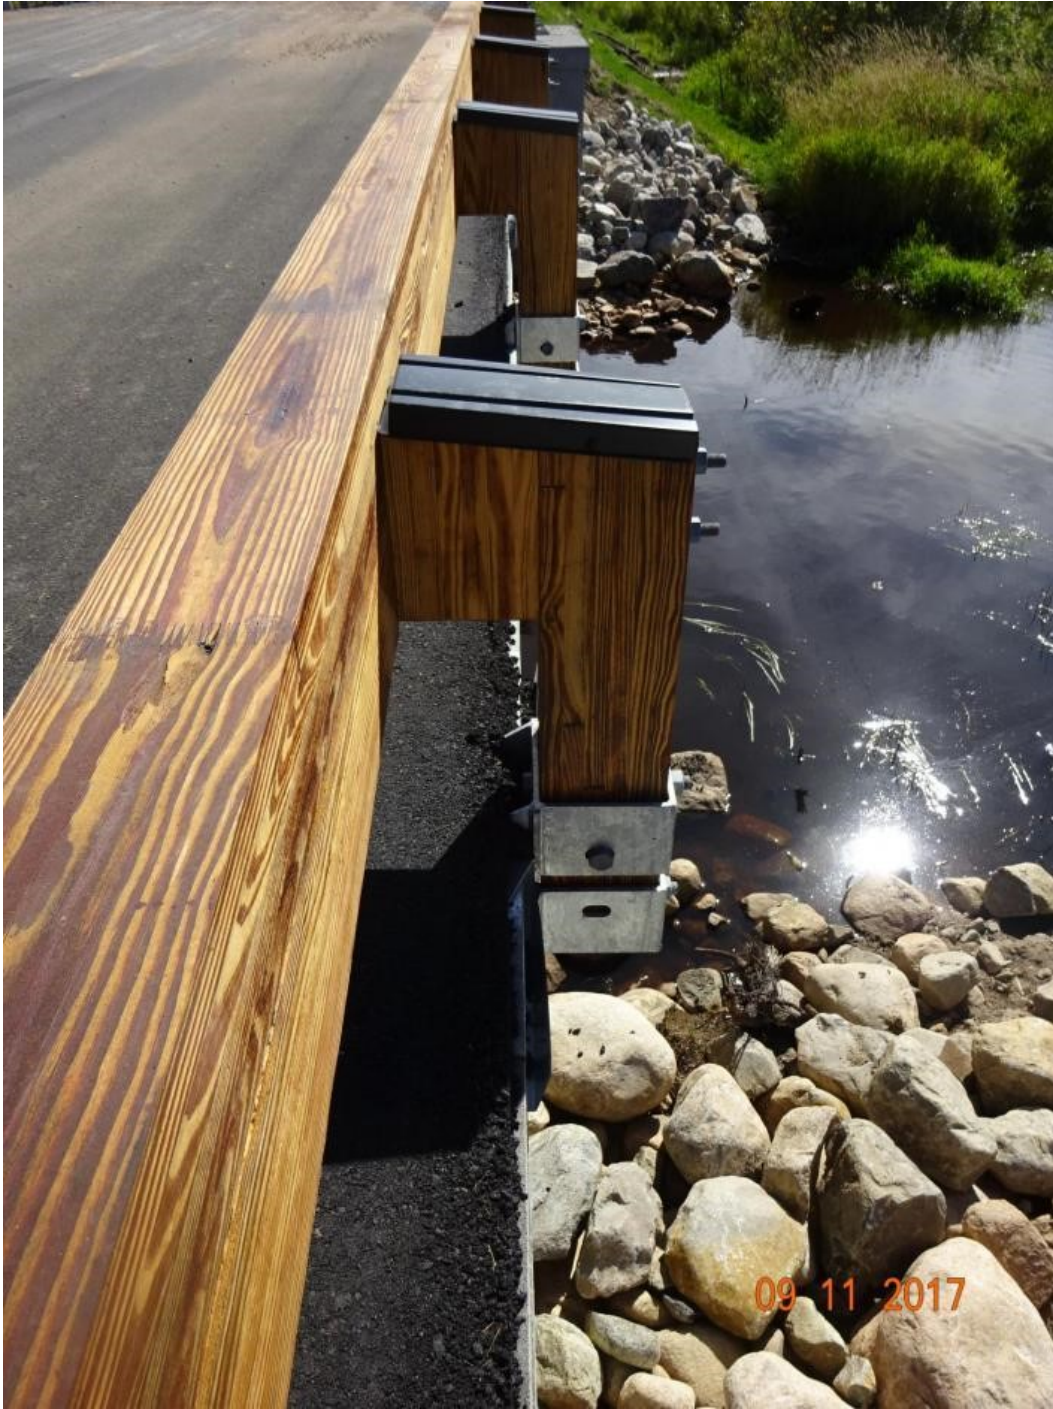
Figure 4.73 Side view showing TL2 curbless rail system used on this bridge and the installed plastic cap for moisture protection.

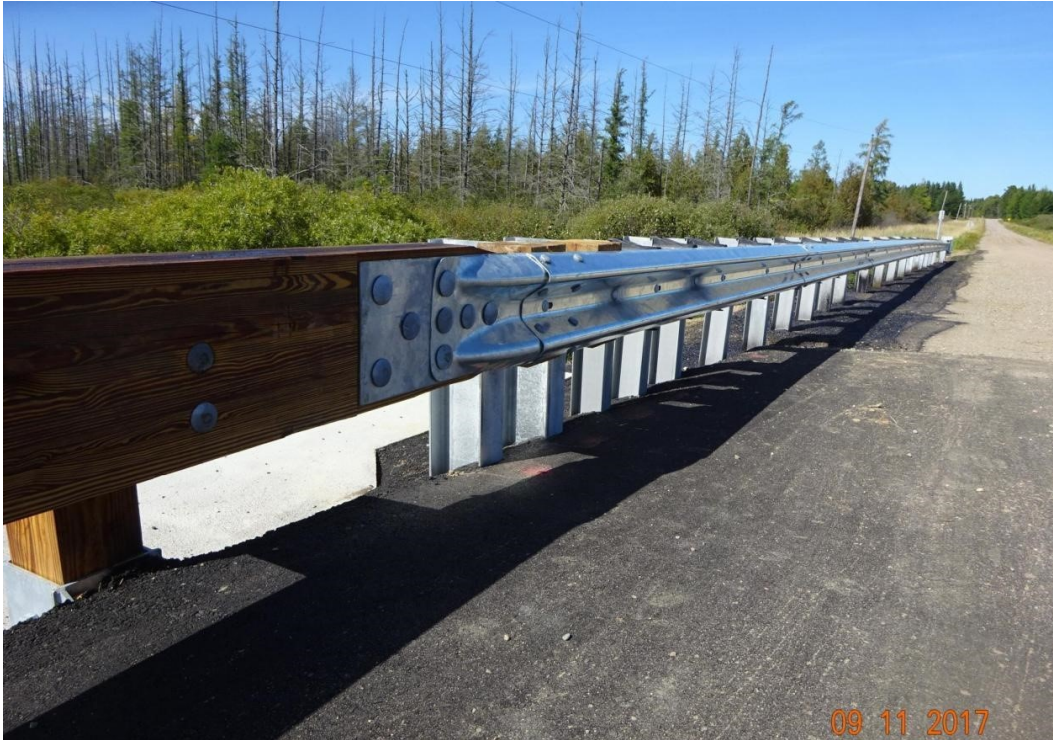
Figure 4.74 Guard rail attached to the glulam rail system.

Following paving, the temporary paving edges were removed from the bridge deck. The railing was installed according to the construction plan and design details. The guard rails were installed and attached to the bridge rails. Finally, a plastic cap was installed on top of each timber post to protect it from precipitation that can cause deterioration. Figures 4.71 to 4.75 show the bridge railing installation and connection to roadway guard rails.

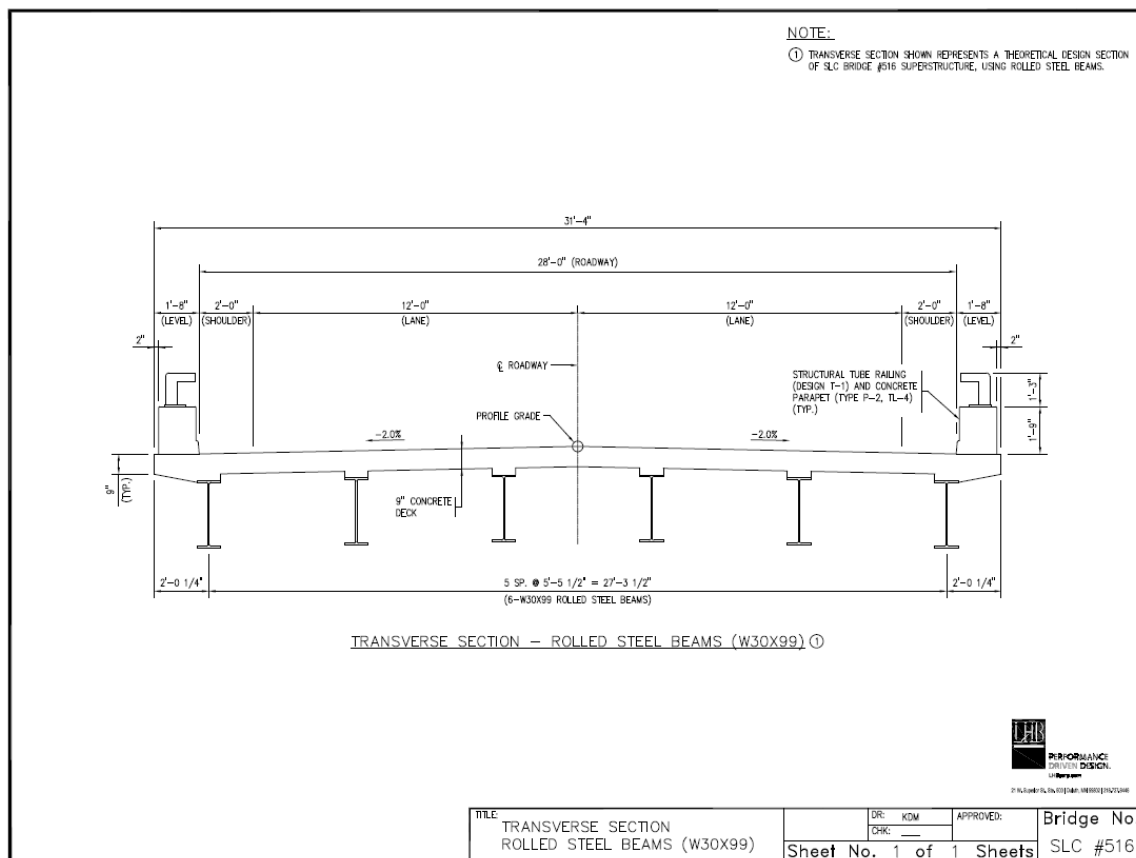
Figure 4.79 Transverse section of rolled steel beam with a concrete deck superstructure.
