Development of Cost-Competitive Timber Bridge Designs for Long- Term Performance

Natural Resources Research Institute
University of Minnesota Duluth

Research Project
Final Report 2020-16

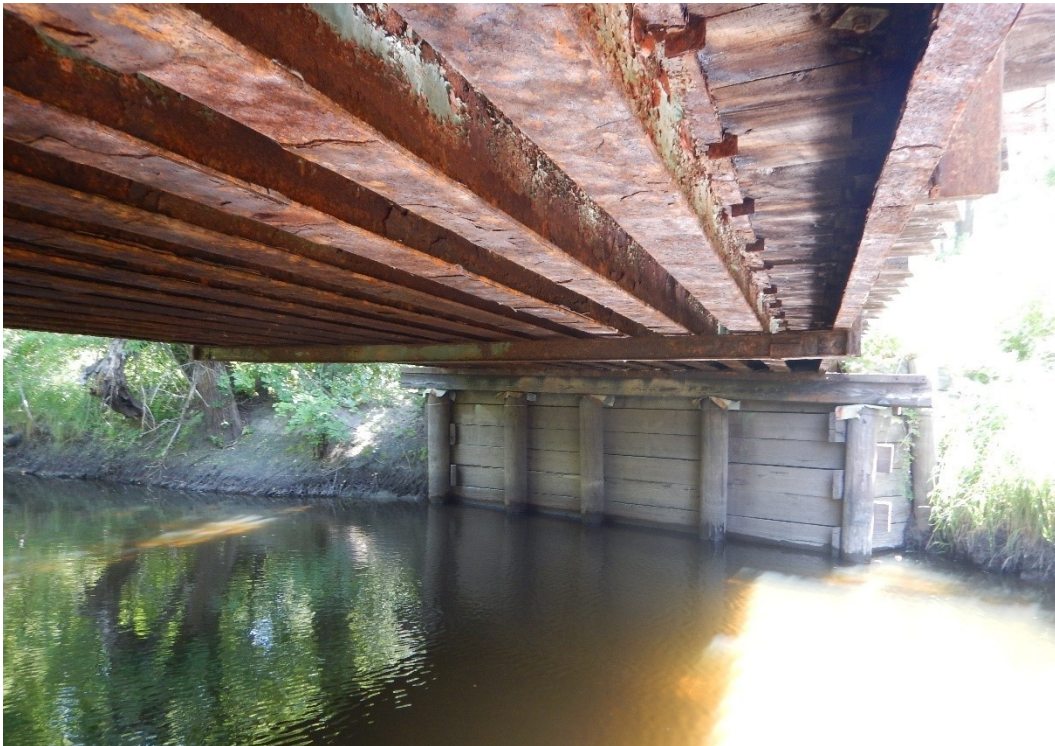
Figure 5.4 Deteriorated steel girders in underside view of the superstructure for Hennepin County Bridge L8081.

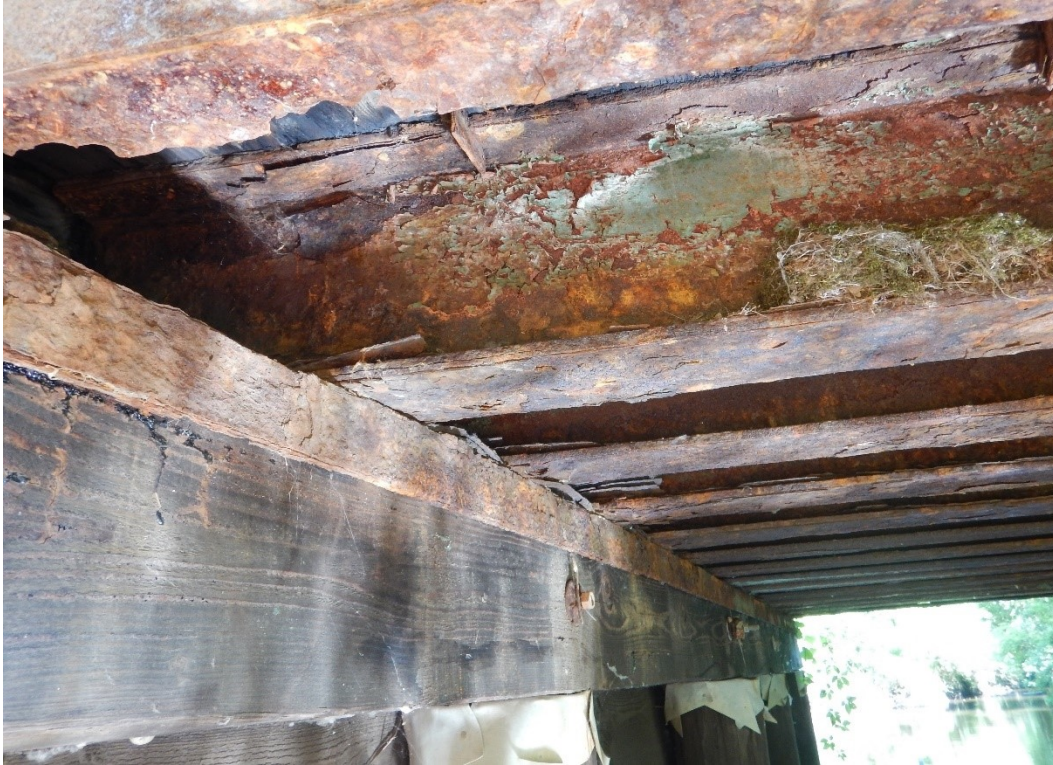
Figure 5.5 Close up of steel girder bearing on timber pile and cap abutment for bridge L8081.

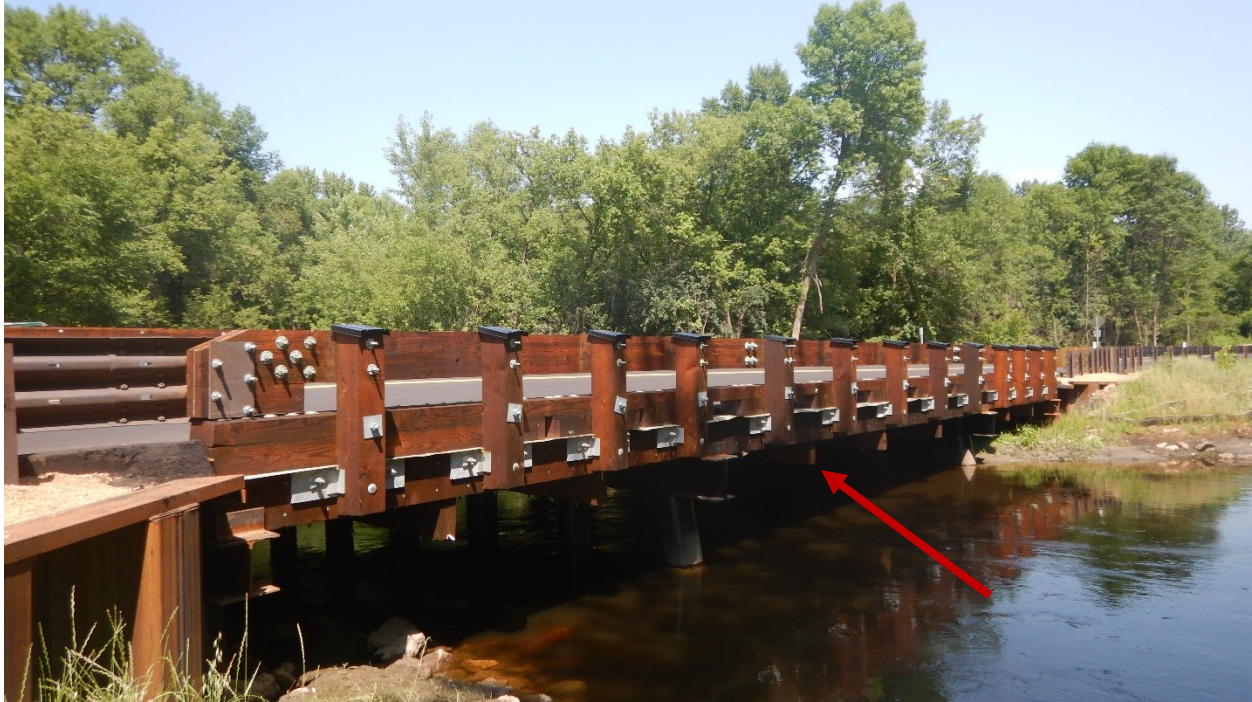
Figure 5.8 Completed picture of dowel-laminated deck with metal spikes, transverse spreader beams (highlighted with red arrow), and railings.

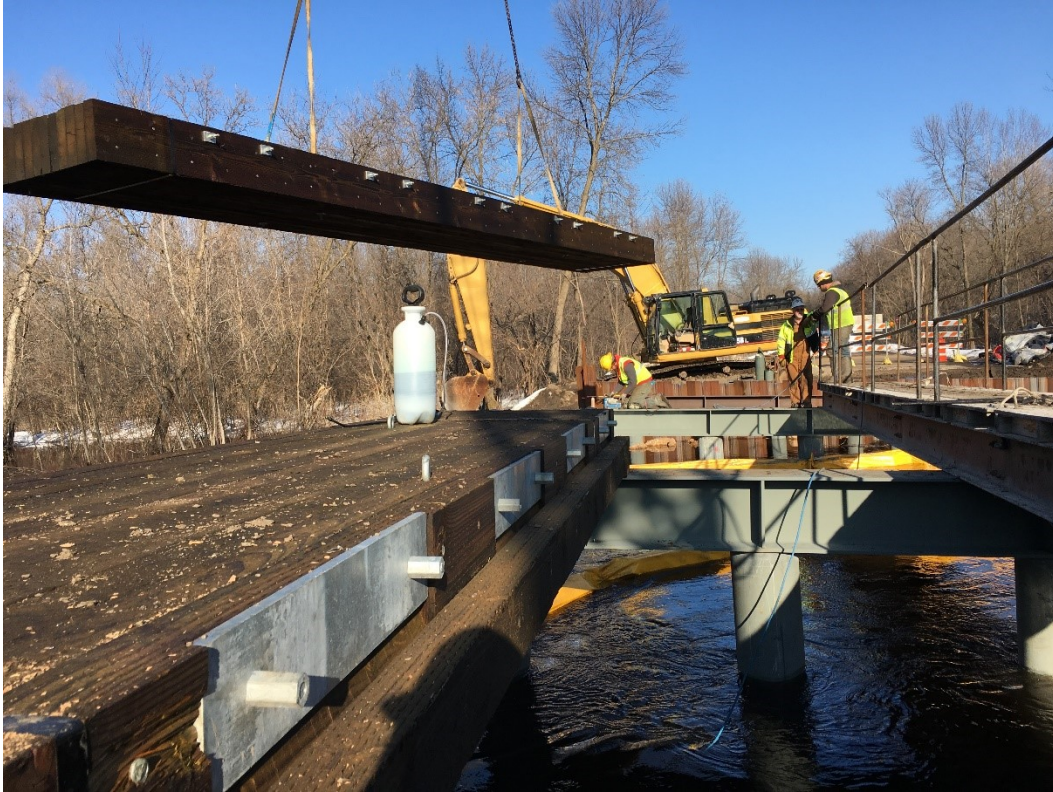
Figure 5.29 Panel C18 being installed using a crane on span 1. Steel plates are recessed into the deck panel outer lamination approximately 3-ft for the crash-tested bridge railing and curb system. Photo credit Hennepin County.

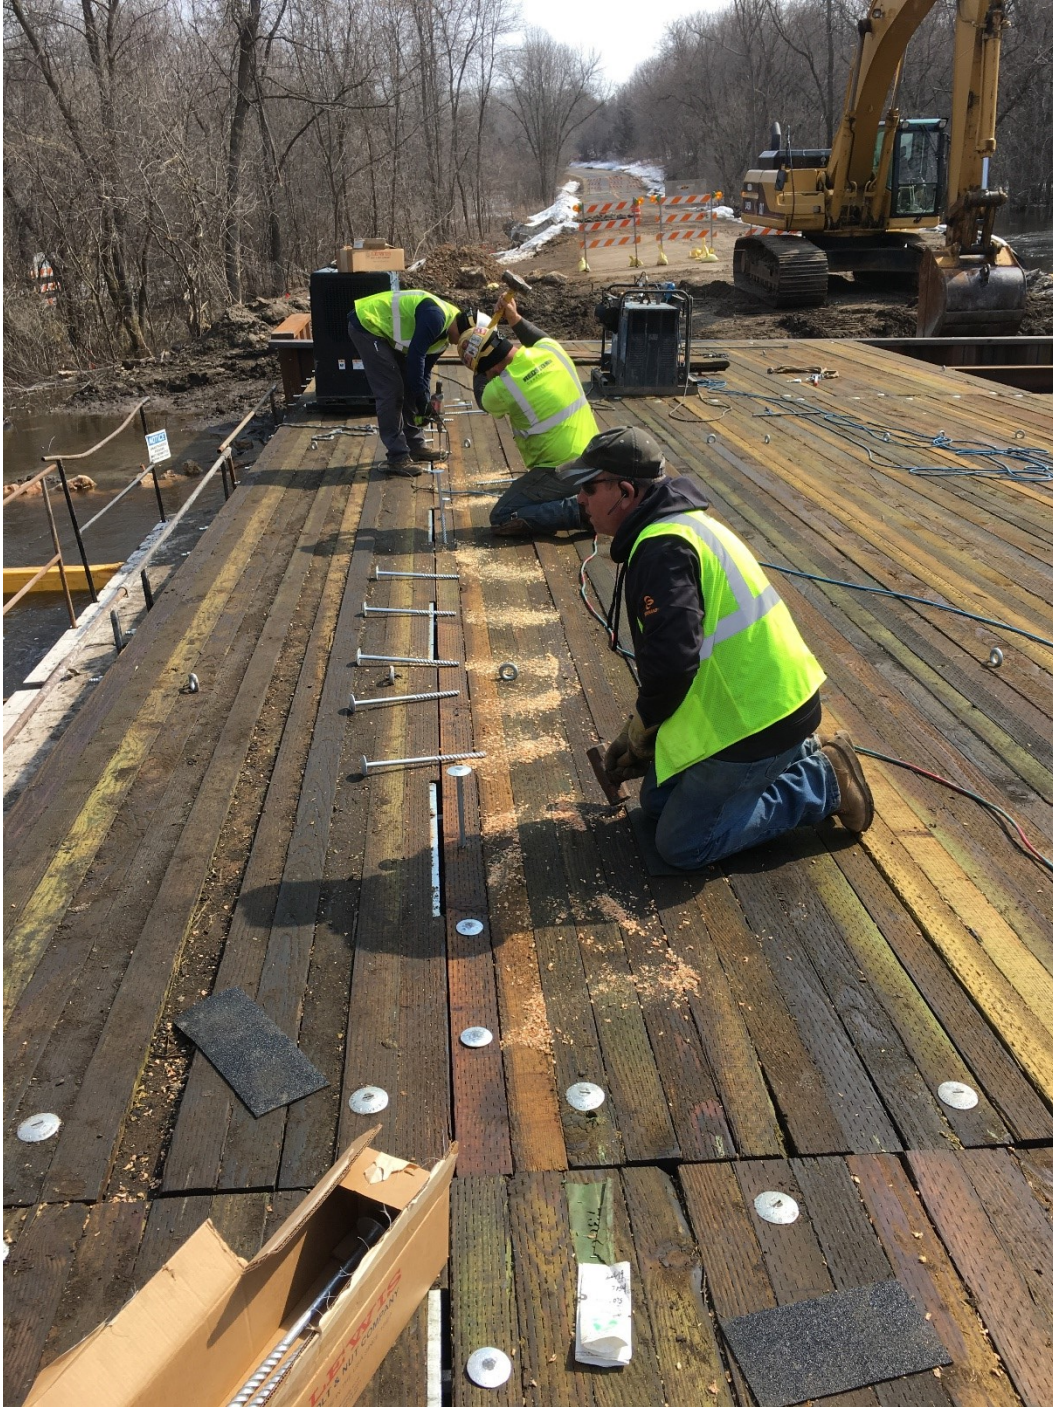
Figure 5.31 Dome head drive spikes being installed into the panel splice joint. Note the embedded steel plates at this location are installed to help anchor the crash-tested bridge railing and curb system. Photo credit Hennepin County.

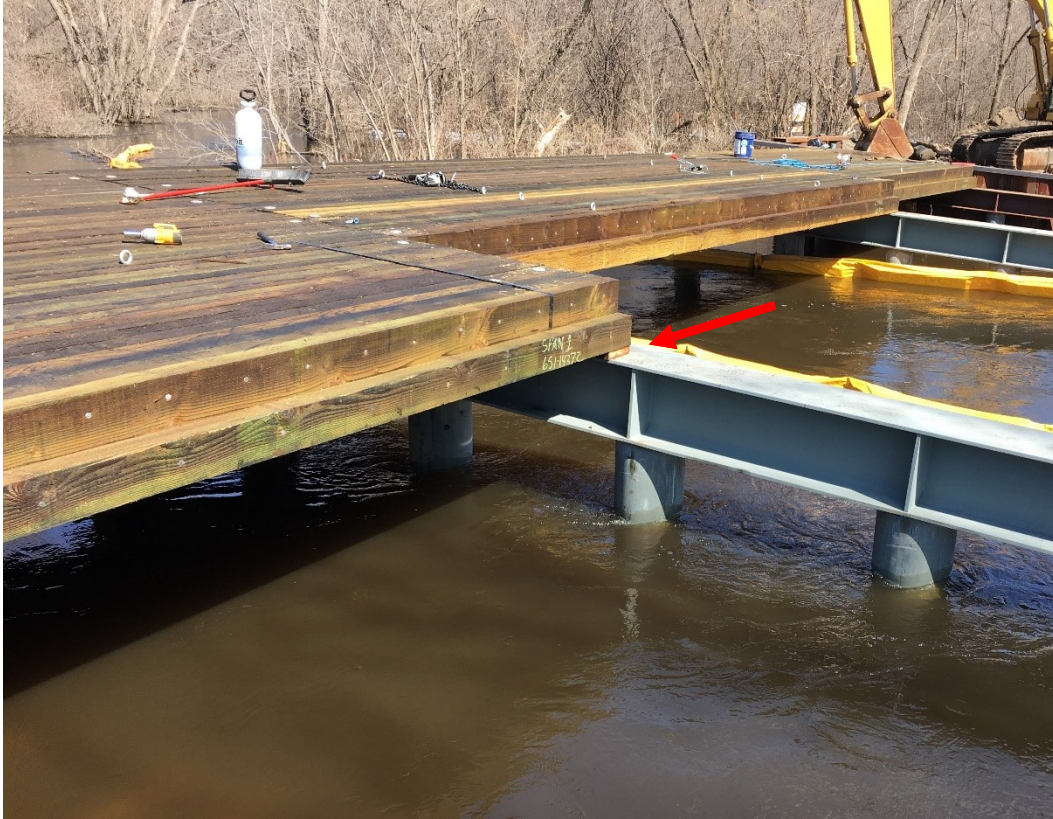
Figure 5.32 Installed panel for span 1 with sleeper blocking (identified with red arrow) at pier support to align top of timber decks. Photo credit Hennepin County.

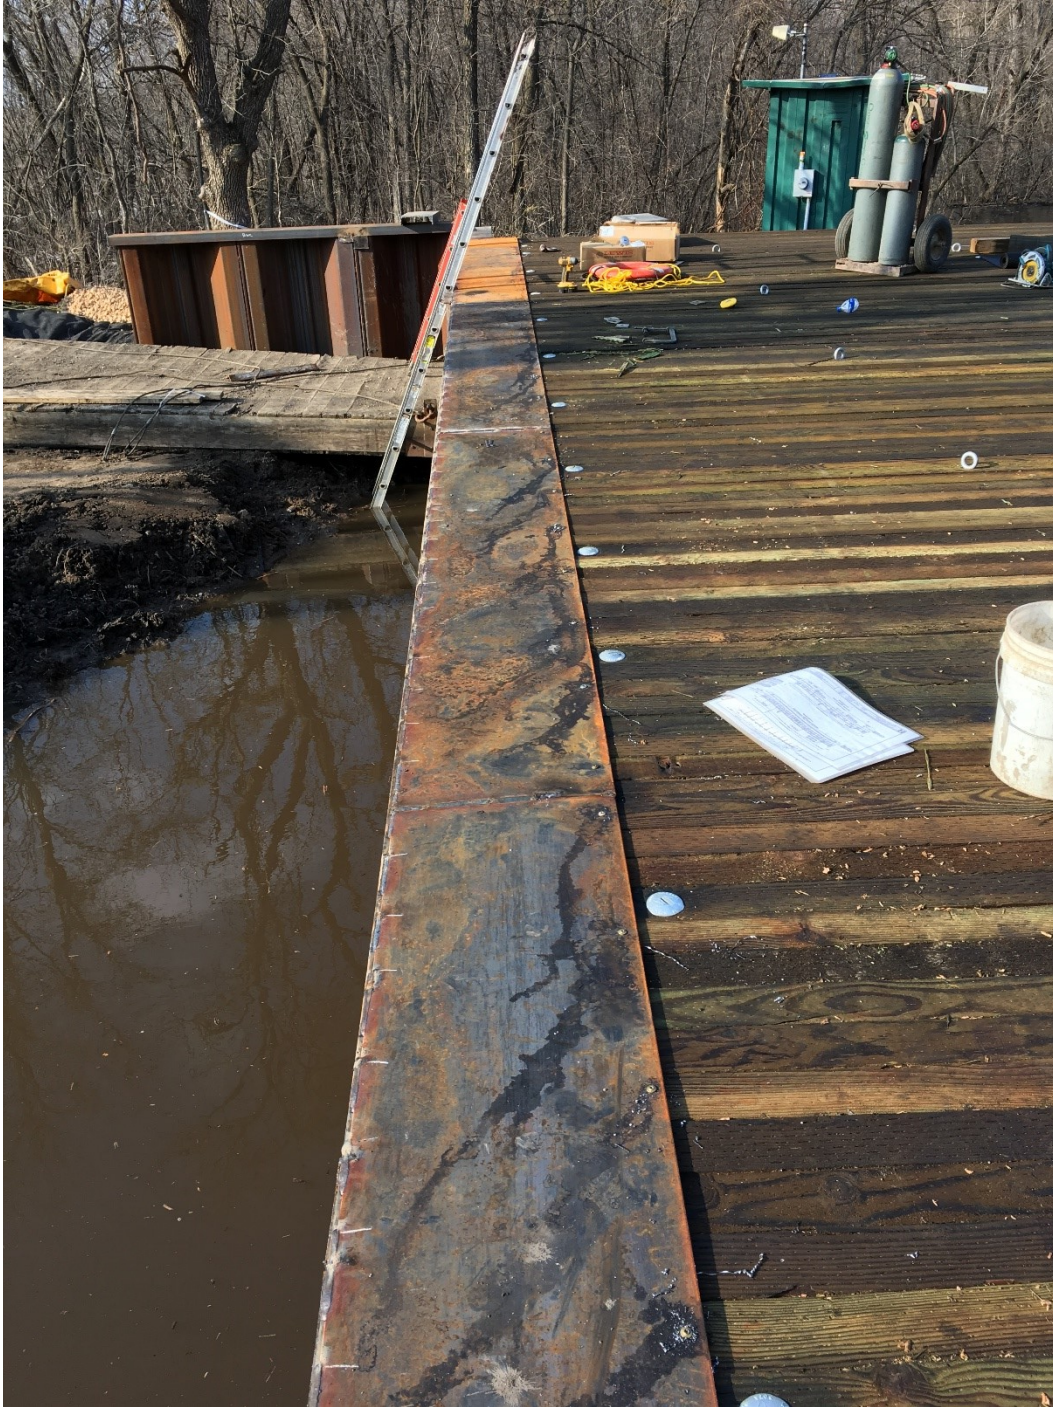
Figure 5.38 Steel plate installed over the end of the abutment cap and the end of the timber panels covering the end gap (Figure 5.32). Photo credit Hennepin County.

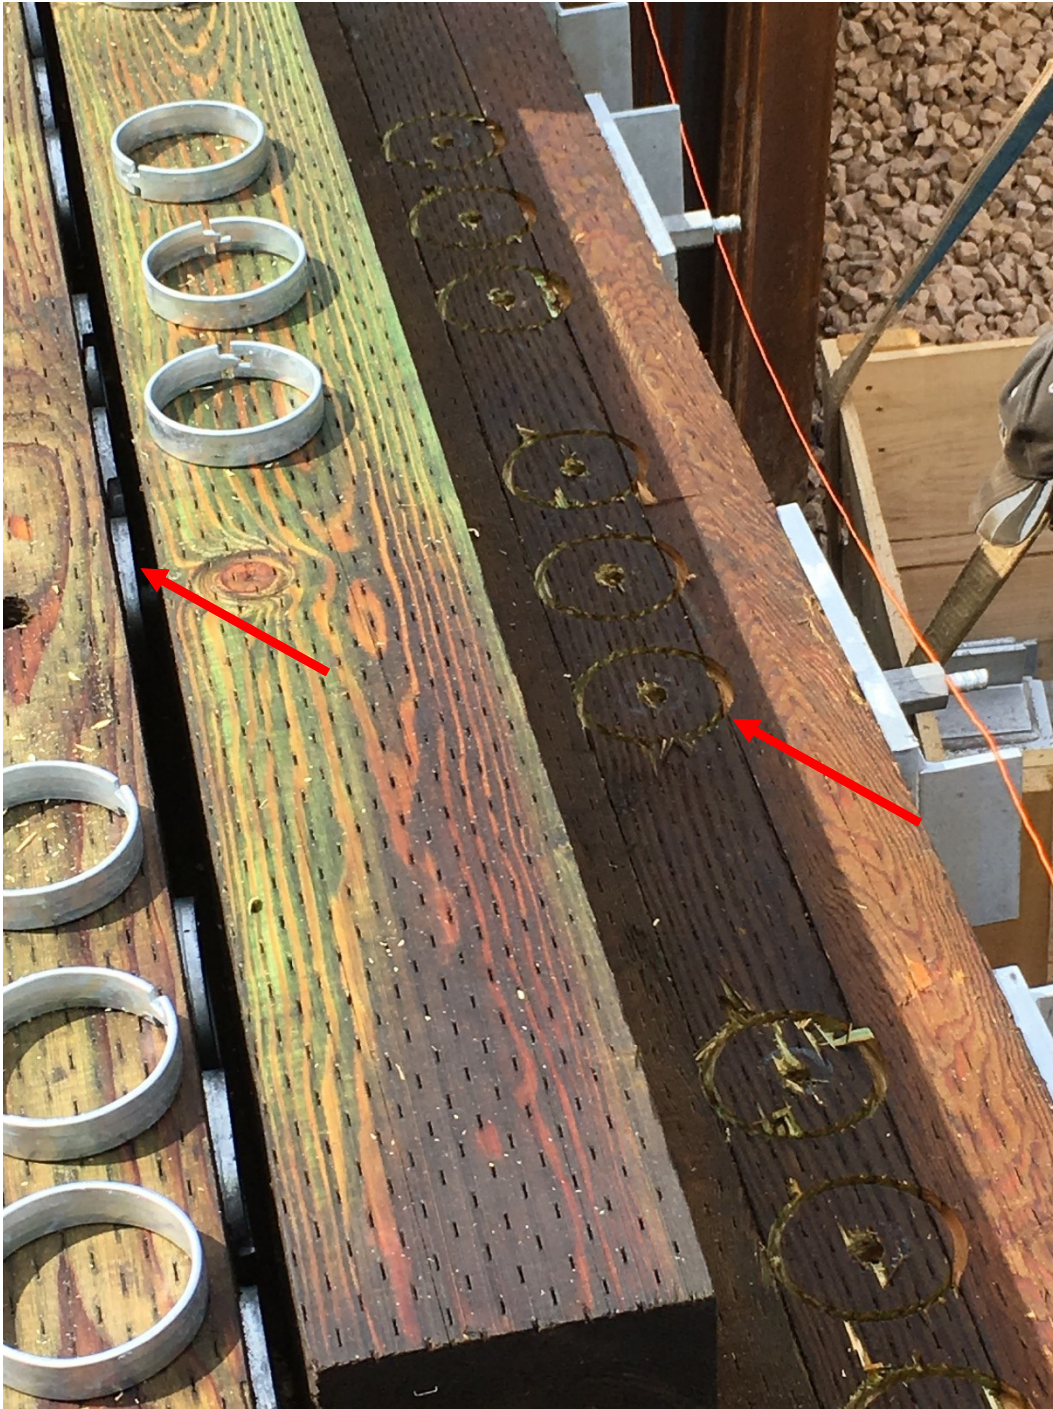
Figure 5.43 Predrilling and inserting split ring connectors at the interface of the timber deck and between the scupper blocks. Photo credit Hennepin County.

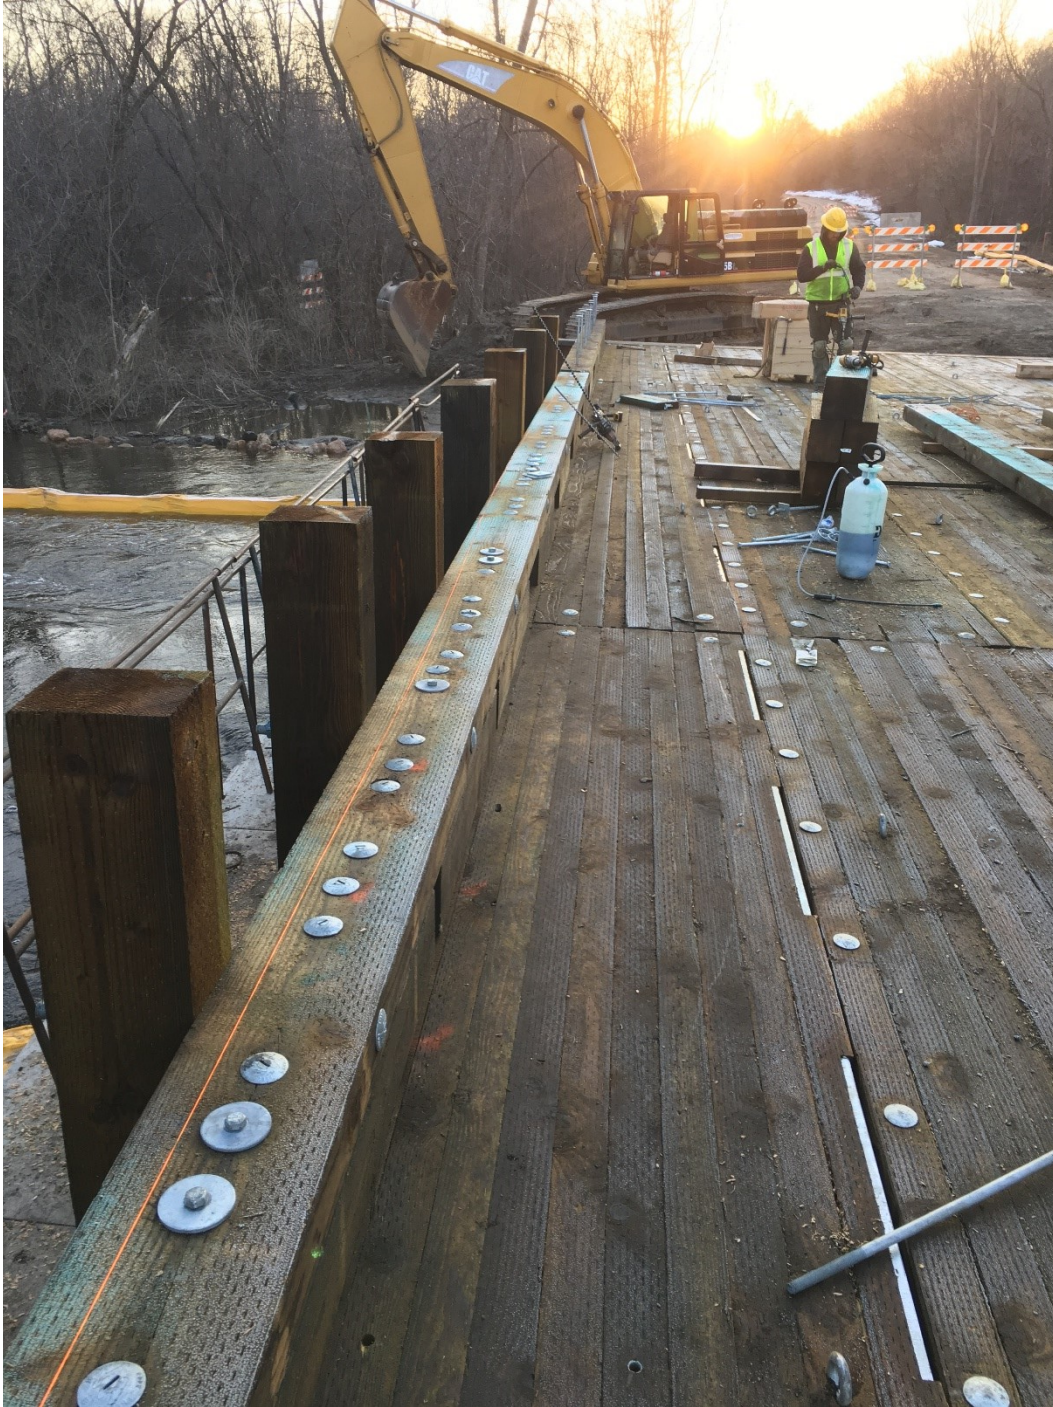
Figure 5.45 Curbs, scupper blocks, and rail posts installed along the north edge of the bridge. Embedded steel plates are to reinforce the bridge railing against vehicle impact forces. Photo credit Hennepin County.

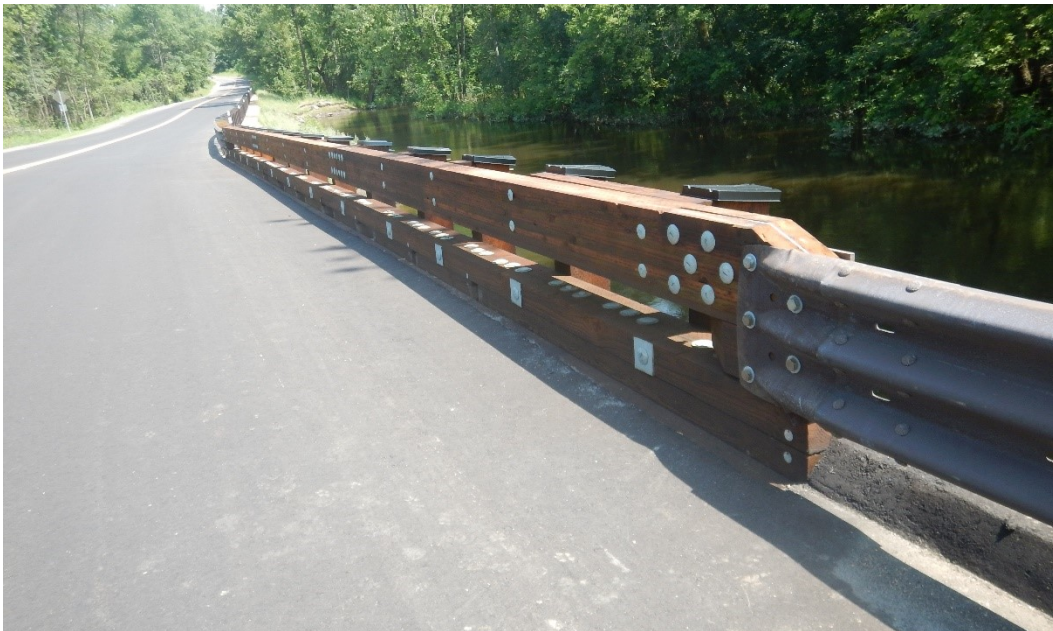
Figure 5.61 View showing TL4 rail system used on this bridge and the installed plastic cap for moisture protection.

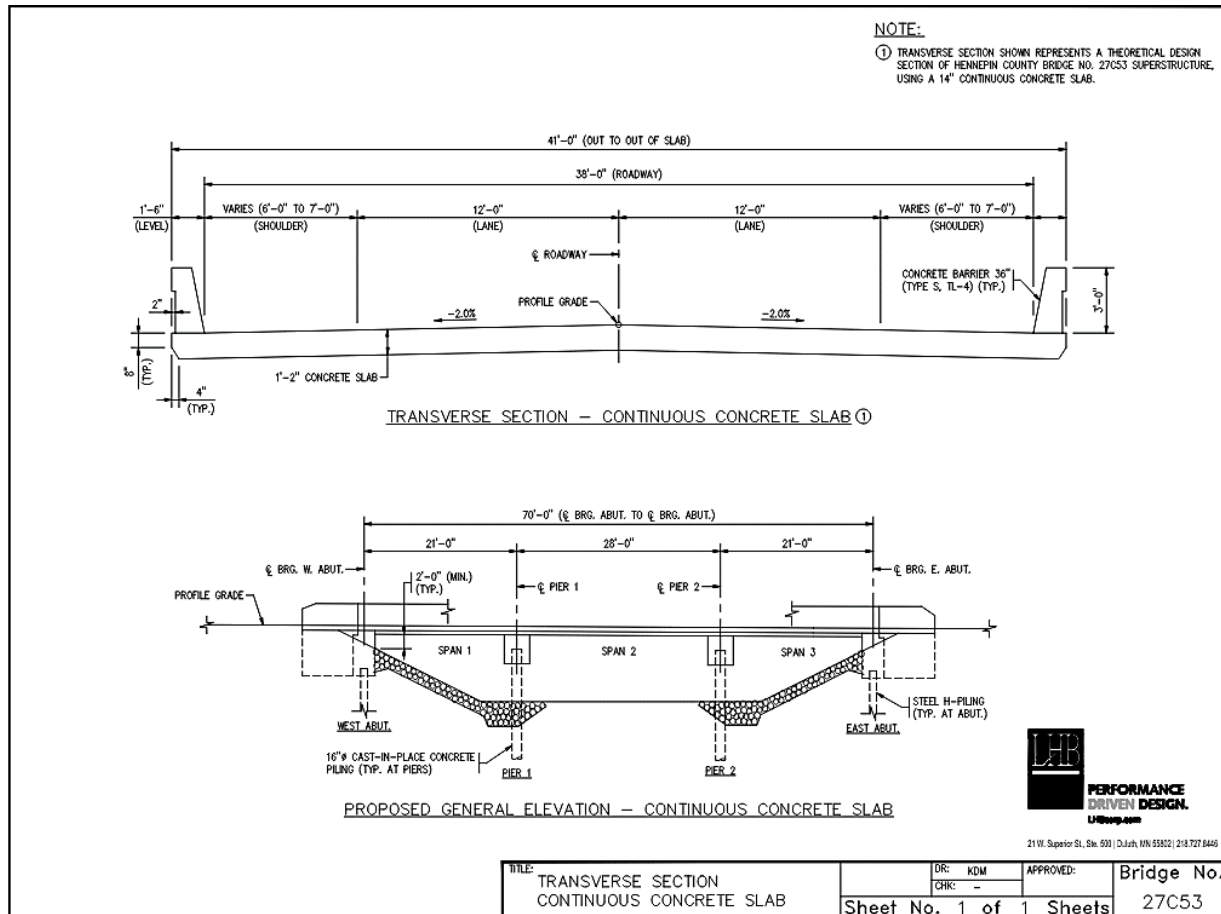
Figure 5.67 General elevation and transverse section of continuous concrete slab superstructure.

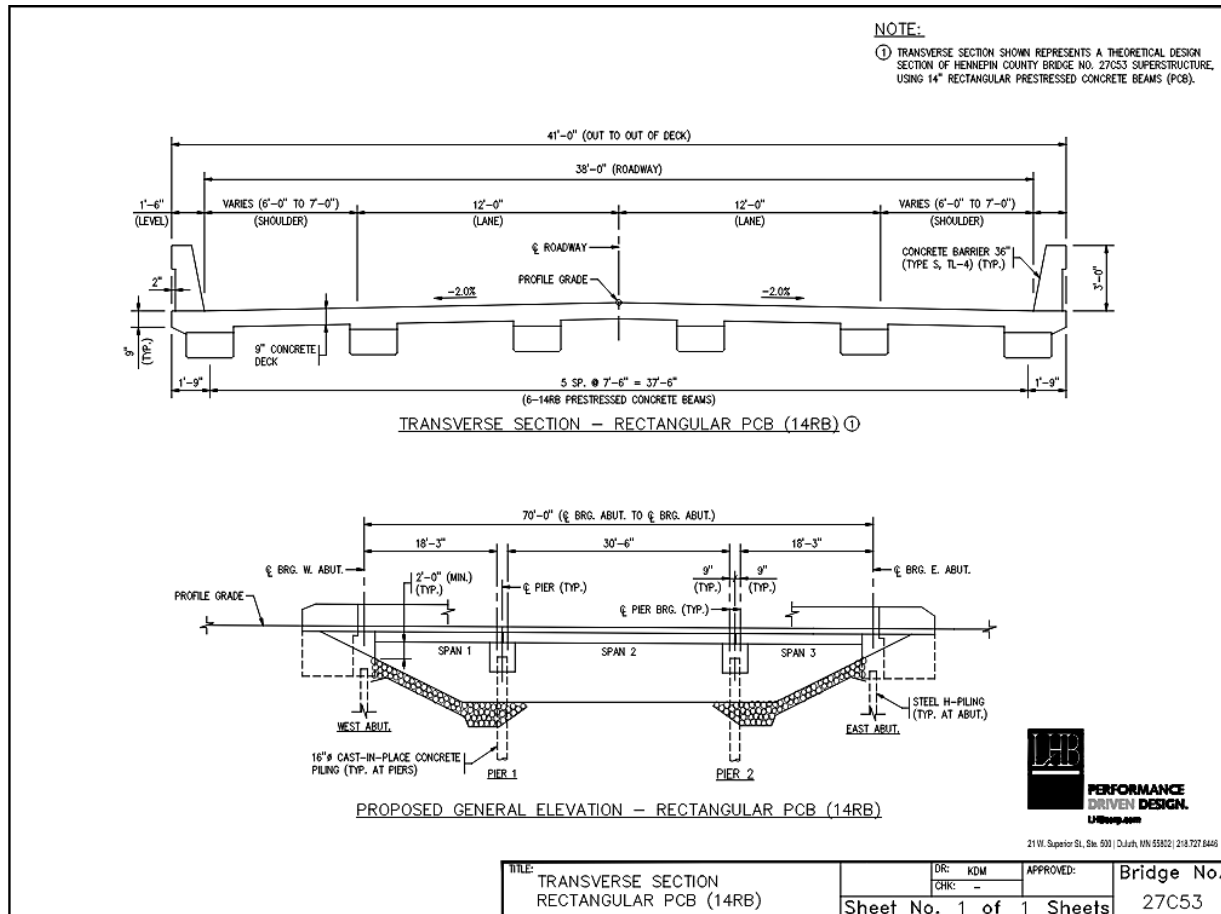
Figure 5.68 General elevation and transverse section of rectangular prestressed concrete beam with a concrete deck superstructure.
