Vermont Demonstration Project:
Warm-Mix Asphalt
Overlay and Rehabilitation
of U.S. 4A and VT 30

Final Report
June 2013

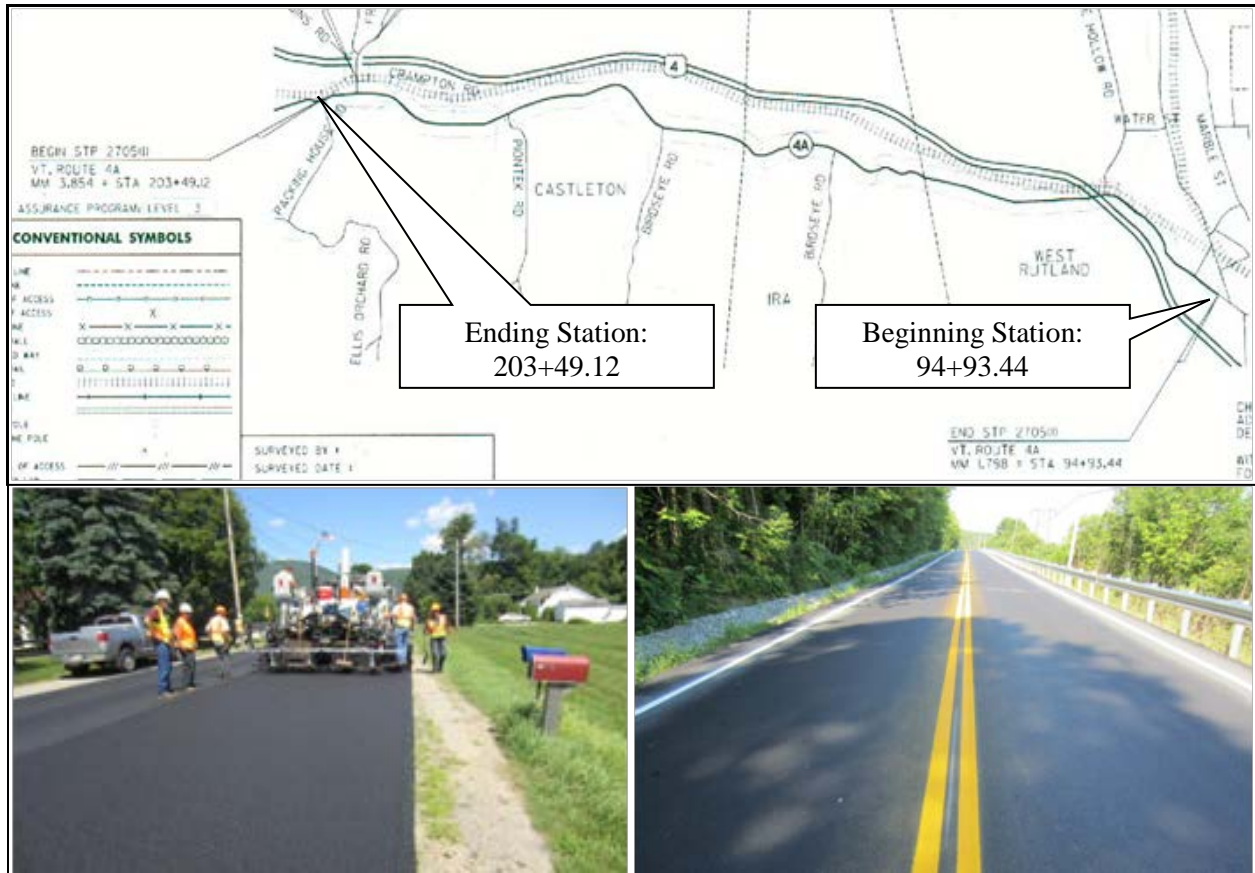
Figure 2. Project #2705—Limits and general view of U.S. 4A segment east of Castleton.

The purpose of this rehabilitation project was to improve ride quality and safety for the more than 10.5 centerline miles of U.S. 4A and VT 30 in and near Castleton (see Figures Figure 1 through Figure 3). As noted previously, the rehabilitation project was a mill and fill or replacement of the existing wearing surface. Construction began in midspring 2012, with cold-planing of the existing wearing surface beginning in May 2012. Paving was completed in September 2012. The bid construction cost was around \$5 million for all three projects or roadway segments. The Highways for LIFE grant was \$1 million, about 20 percent of the project cost. Figures Figure 5 and Figure 6 show the project construction team members. Peckham Construction Corp. of Lake George, NY, was the contractor for the project. Figure 5a shows the agency personnel directly involved in the project. Figures Figure 5b and Figure 5c show the paving crew and compaction team members, and Figure 6 shows the key inspection personnel and the contractor's quality control (QC) team members.

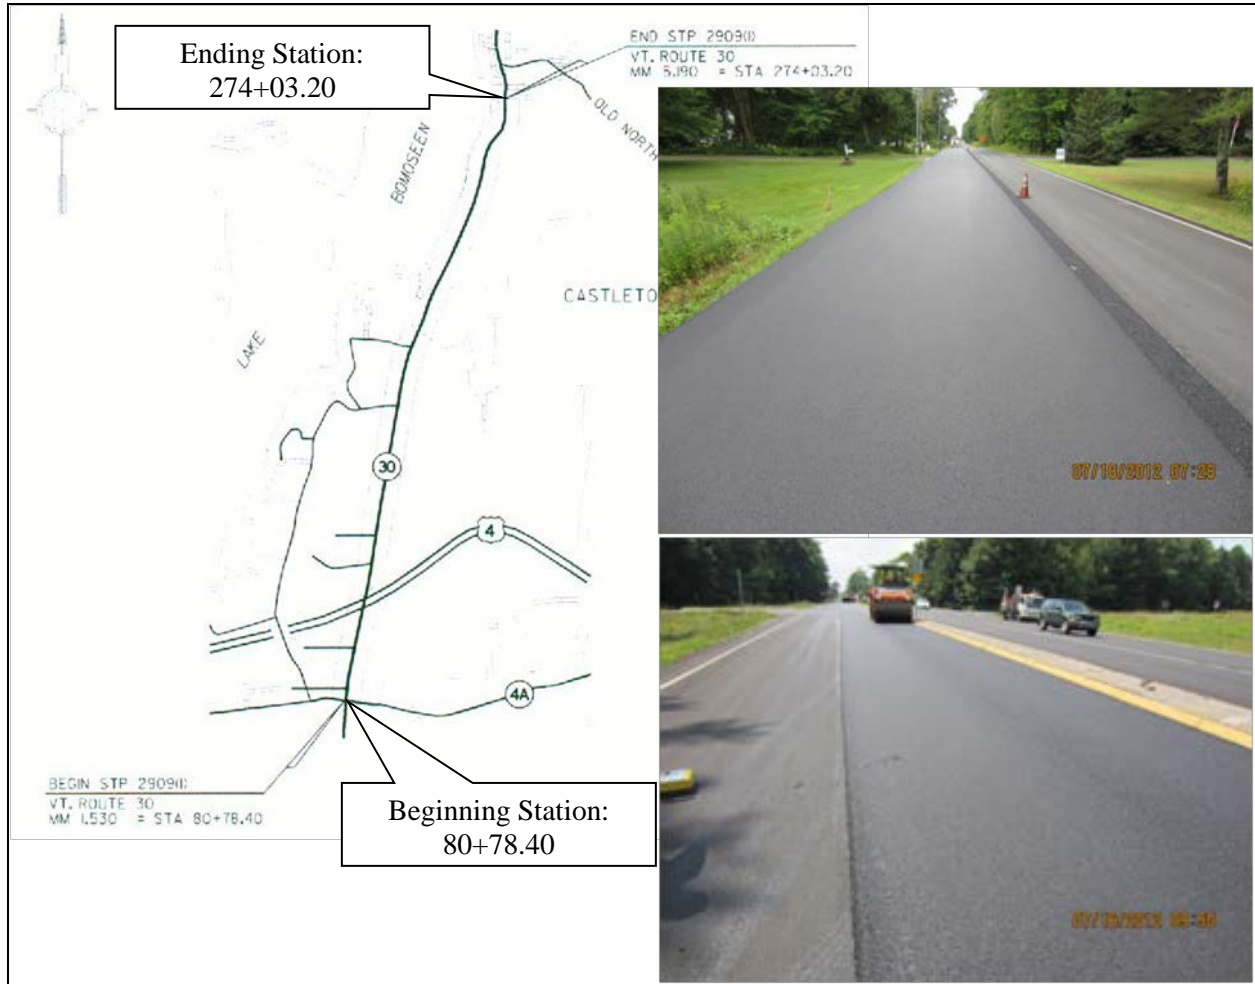
Figure 3. Project #2909—Limits and general view of VT 30 segment north of Castleton.

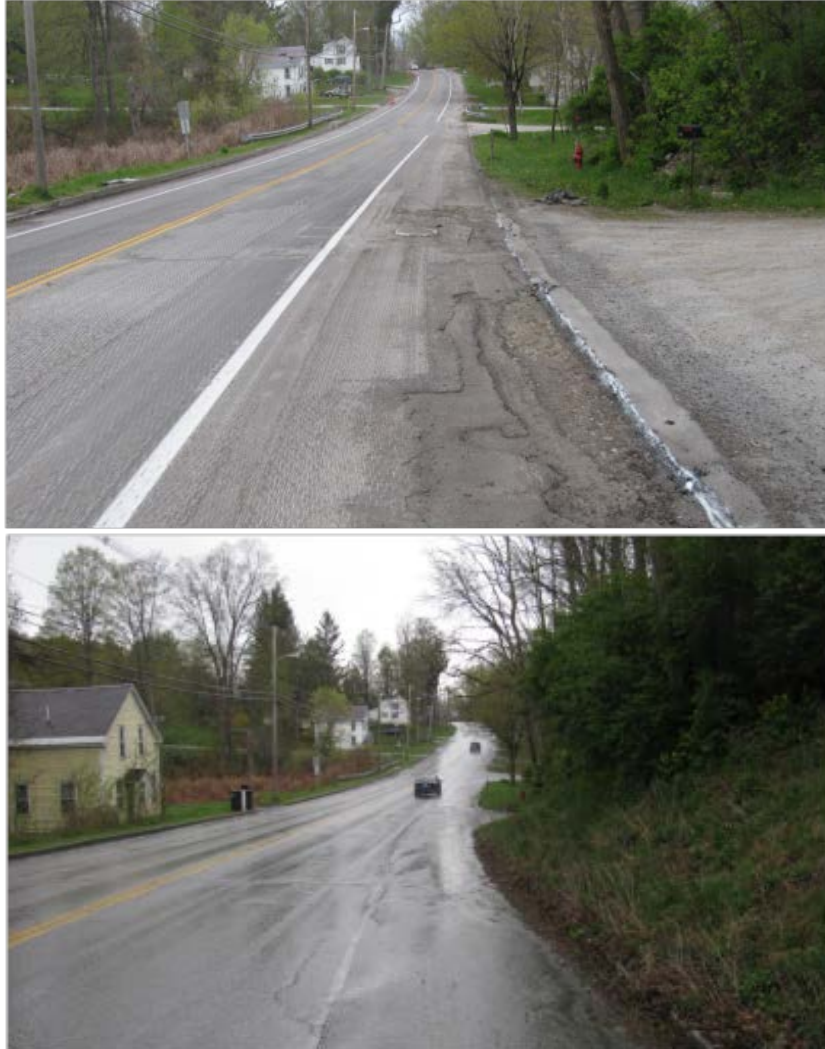
Figure 4. General view of pavement condition in two areas of the project before rehabilitation on U.S. 4A near Castleton. Condition of the other segments was similar. (Photos courtesy of Chris Thomas, Peckham Construction.)

All of these roadway segments were very rough in localized areas with transverse and longitudinal cracks and other surface disintegration distresses. Figure 4 shows a general view of the pavement before the rehabilitation project. In addition, there were localized areas with edge dropoffs that made the roadway less safe for the traveling public.

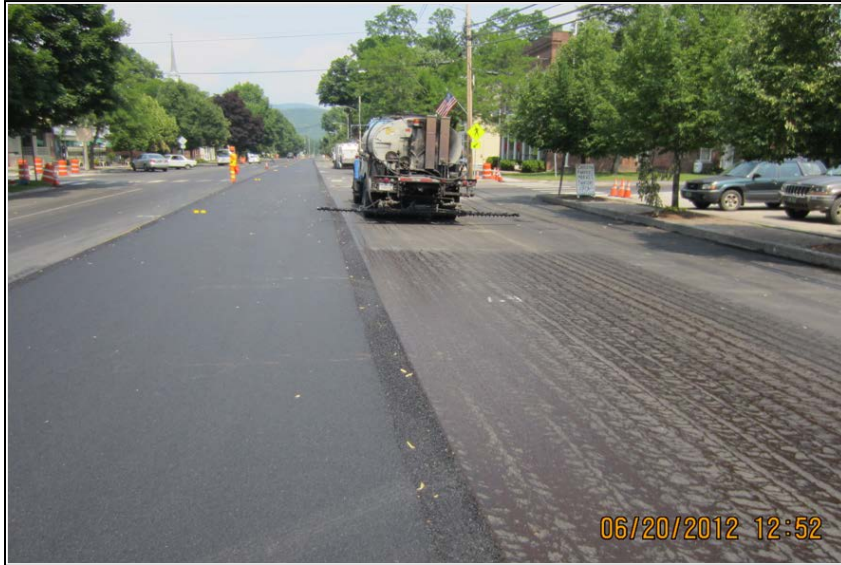
Figure 7. Tack coat (RS-1H emulsion) being applied to the surface of the leveling course before overlay placement.

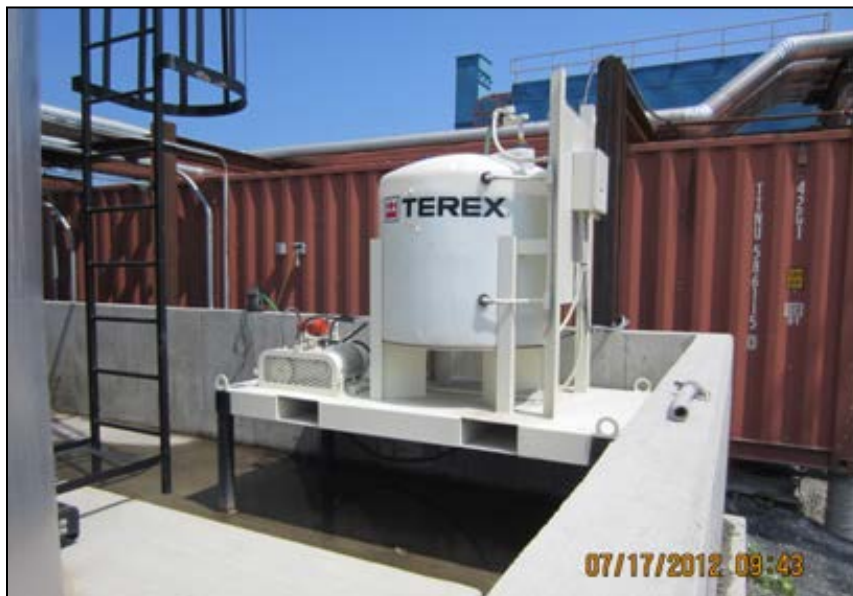
Figure 8. Terex foamer installed at the plant for producing foamed WMA.

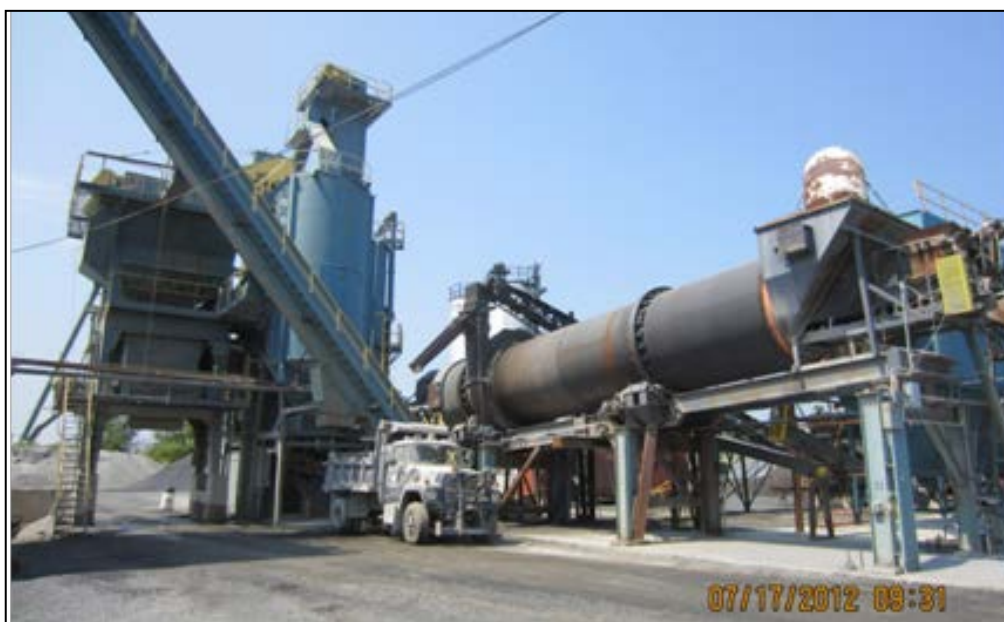
Figure 9. Peckham's drum mix plant in Hudson Falls, NY, used to produce WMA and HMA mixtures.

- The WMA foamed asphalt and organic wax technologies were used in specific locations of the project for comparison with HMA (see Table 1). All three mixtures were produced at Peckham's production facility in Hudson Falls, NY (see Figure 9). A drum mixer with a production capacity of 500 tons per hour was used to produce the mixtures. A #4 or #5 low-grade fuel was used as the burner fuel, but was preheated before combustion.
- The HMA and WMA mixtures were delivered to the project site using two types of delivery trucks (see Figure 10). End dump trucks were used more commonly and "flow boys" or horizontal discharge trucks were used infrequently.

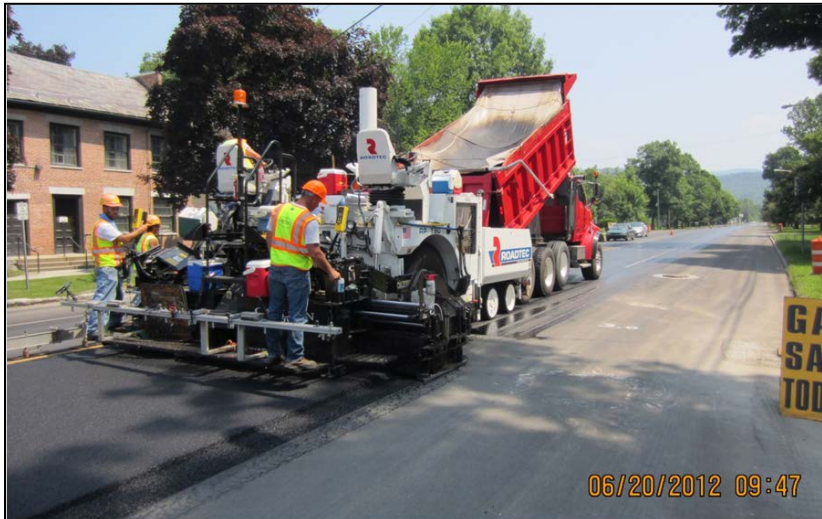
10a. Typical end dump truck used to deliver the HMA and WMA mixtures to the paver. The end dump trucks were used more frequently by the contractor.

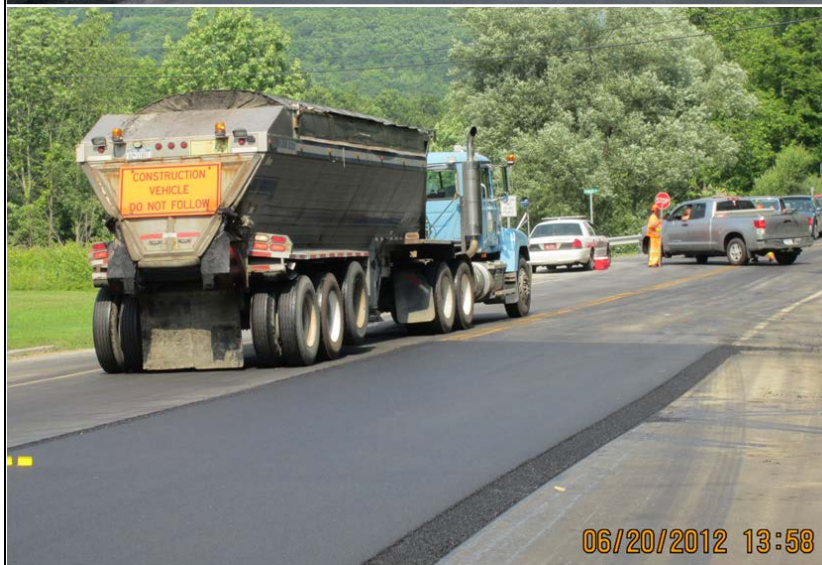
10b. Horizontal discharge trucks or flow boys were also used to deliver the HMA and WMA mixtures to the paver. This type of truck was used less frequently on this project.

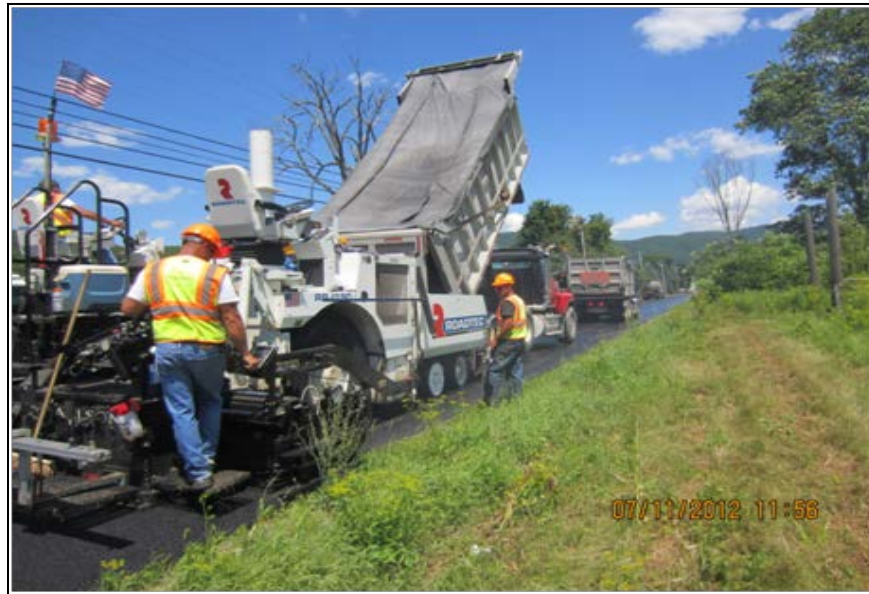
Figure 11. Paver used to place the HMA and WMA mixtures along all three roadway segments.

- A ROADTEC RR190 paver was used to place the HMA and WMA mixtures along all three roadway segments (see Figures 10a and Figure 11). The contractor's paving crew had to overcome issues with overhanging trees and power lines when paving along U.S. 4A in Castleton (see Figure 12). The paving crew was able to unload and place the WMA mixture without incident.

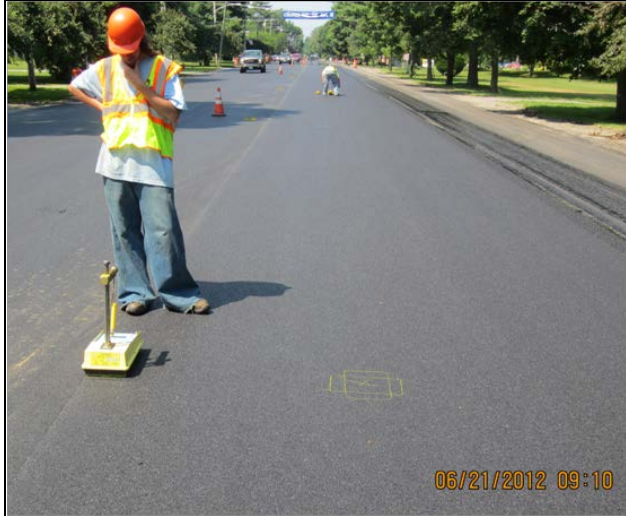
16a. Troxler nuclear density gauge used to monitor the mat density during the rolling operation.

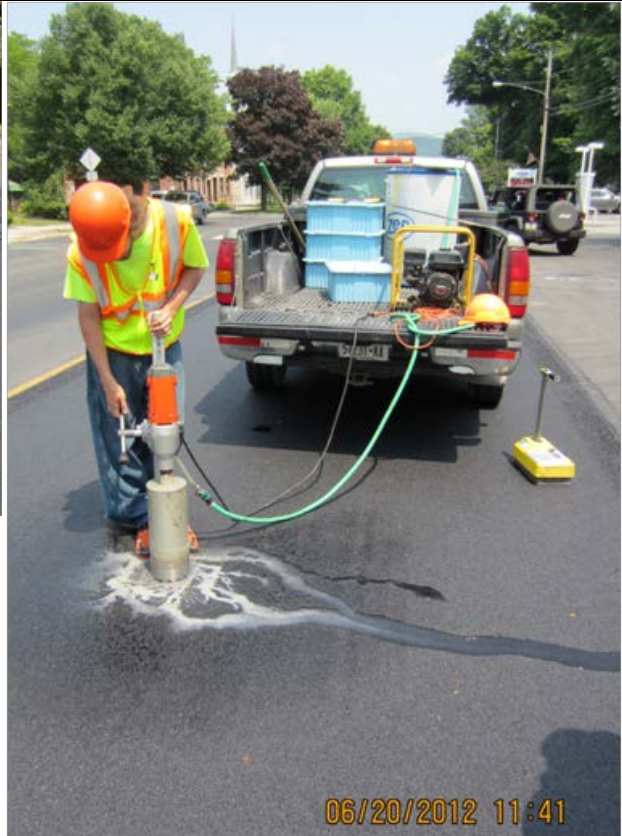
16b. Drilling cores in the WMA mat for acceptance.

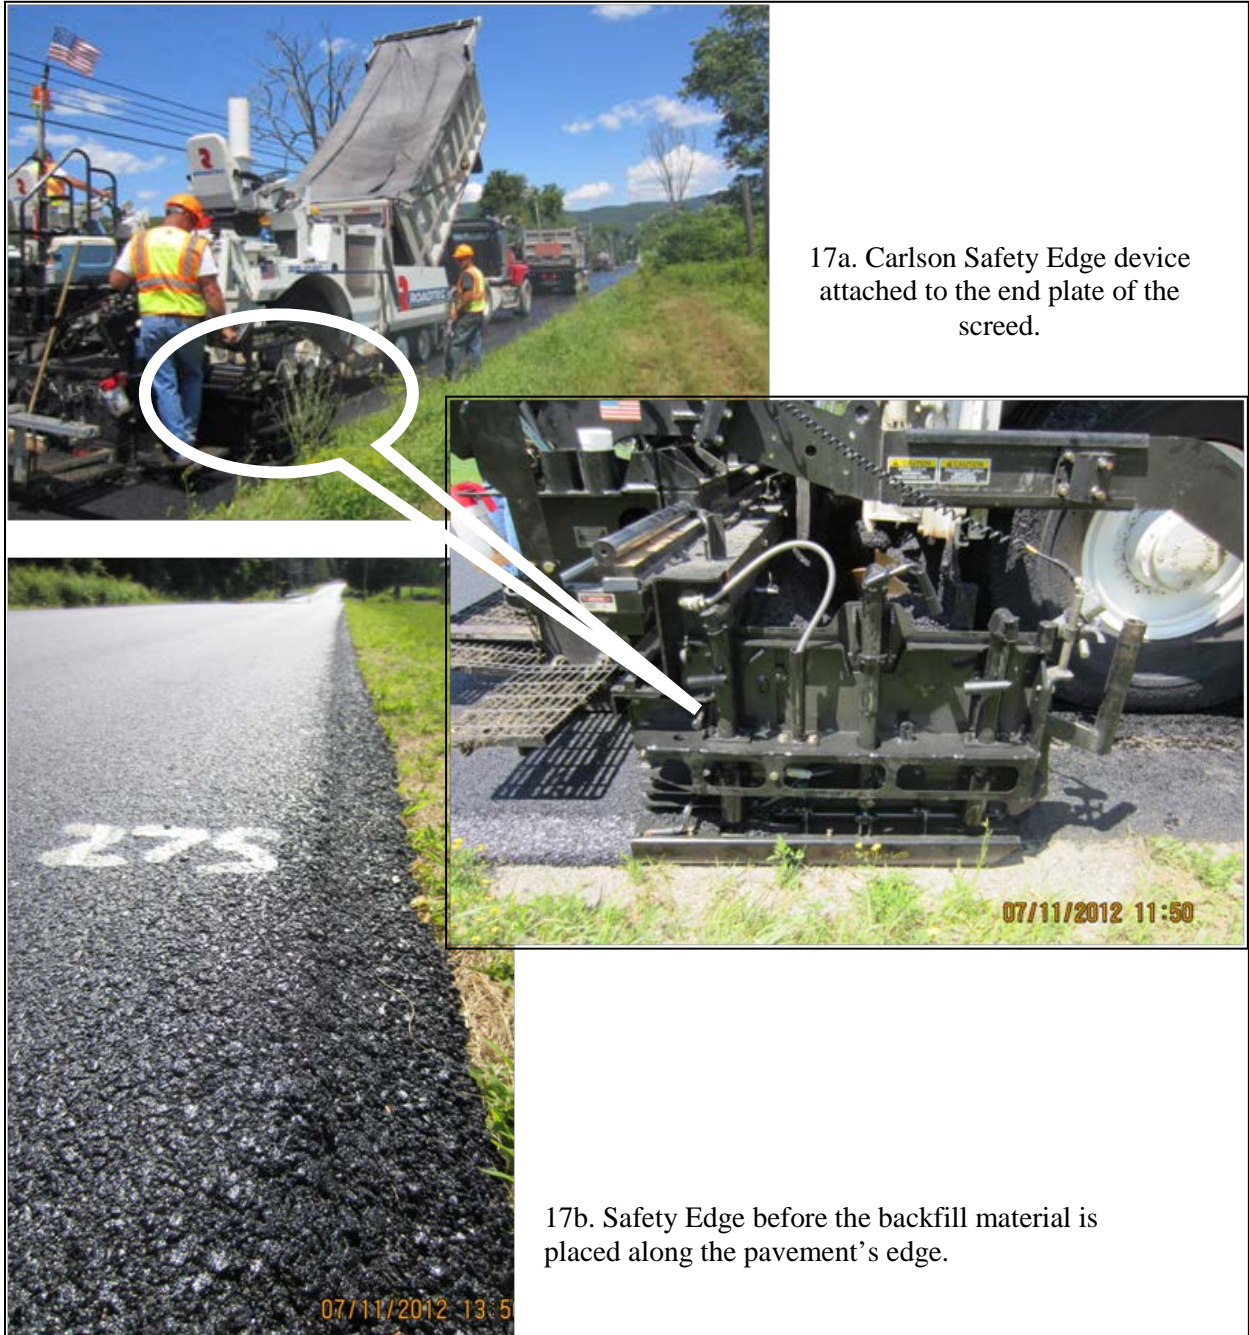
Figure 17. Safety edge placed by the Carlson device.

The Safety Edge is another strategy that is relatively new in Vermont (see Figure 17). The key benefit of the Safety Edge is that it allows vehicles driving off the pavement surface at highway speeds to safely return to the travel lane, reducing roadway departure crashes. It also reduces the amount of edge raveling and cracking that occurs along the pavement's edge, reducing future maintenance costs.

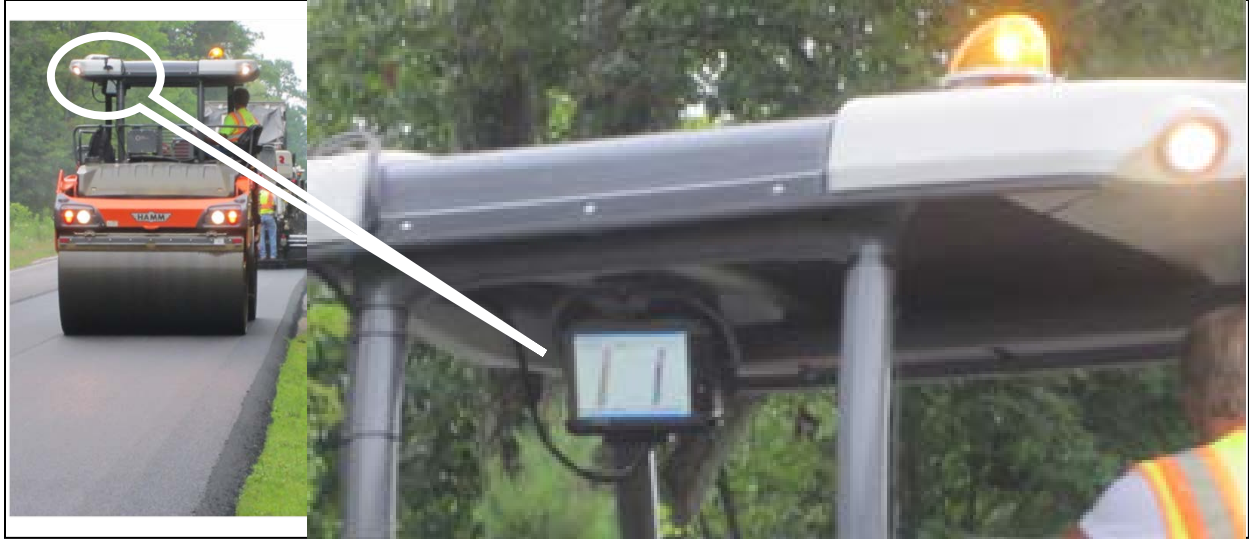
Figure 18. Display screen on the HAMM IC roller for monitoring coverage and other parameters.

because of inconsistent or no overlap between adjacent passes (see Figure 18). The other important benefit is determining the optimum number of passes over a specific point for maximizing mat density while preventing overcompaction. It is well known and reported that increasing the mat density and/or reducing its variability results in longer pavement or overlay service life and lower maintenance costs.

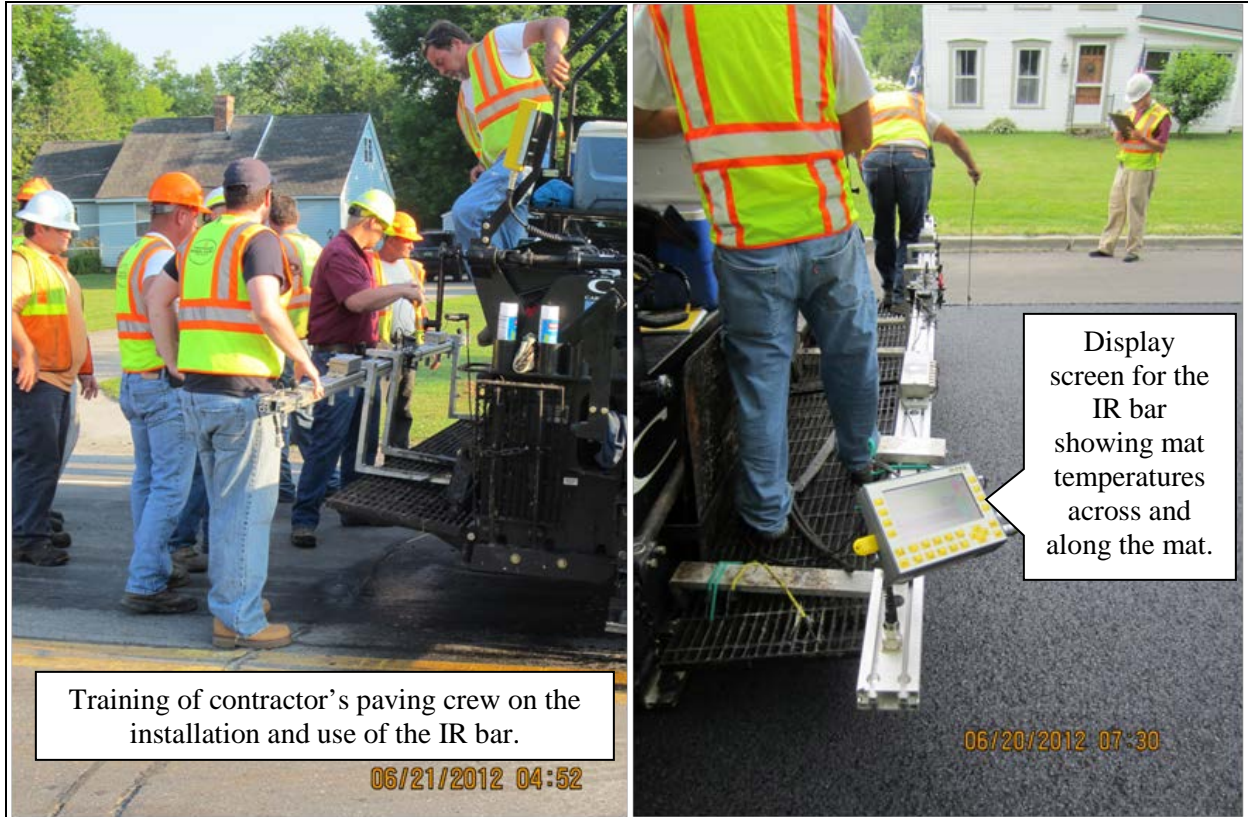
Figure 19. IR bar being installed and used to monitor mat temperatures directly behind the paver.

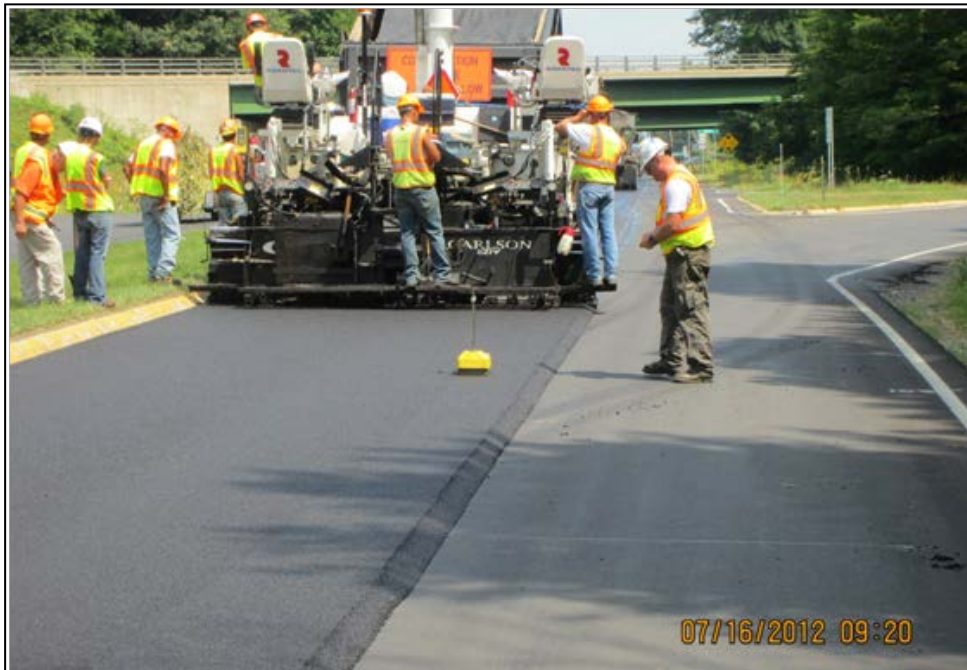
Figure 20. QC personnel taking density readings in the control strip with a nuclear density gauge.

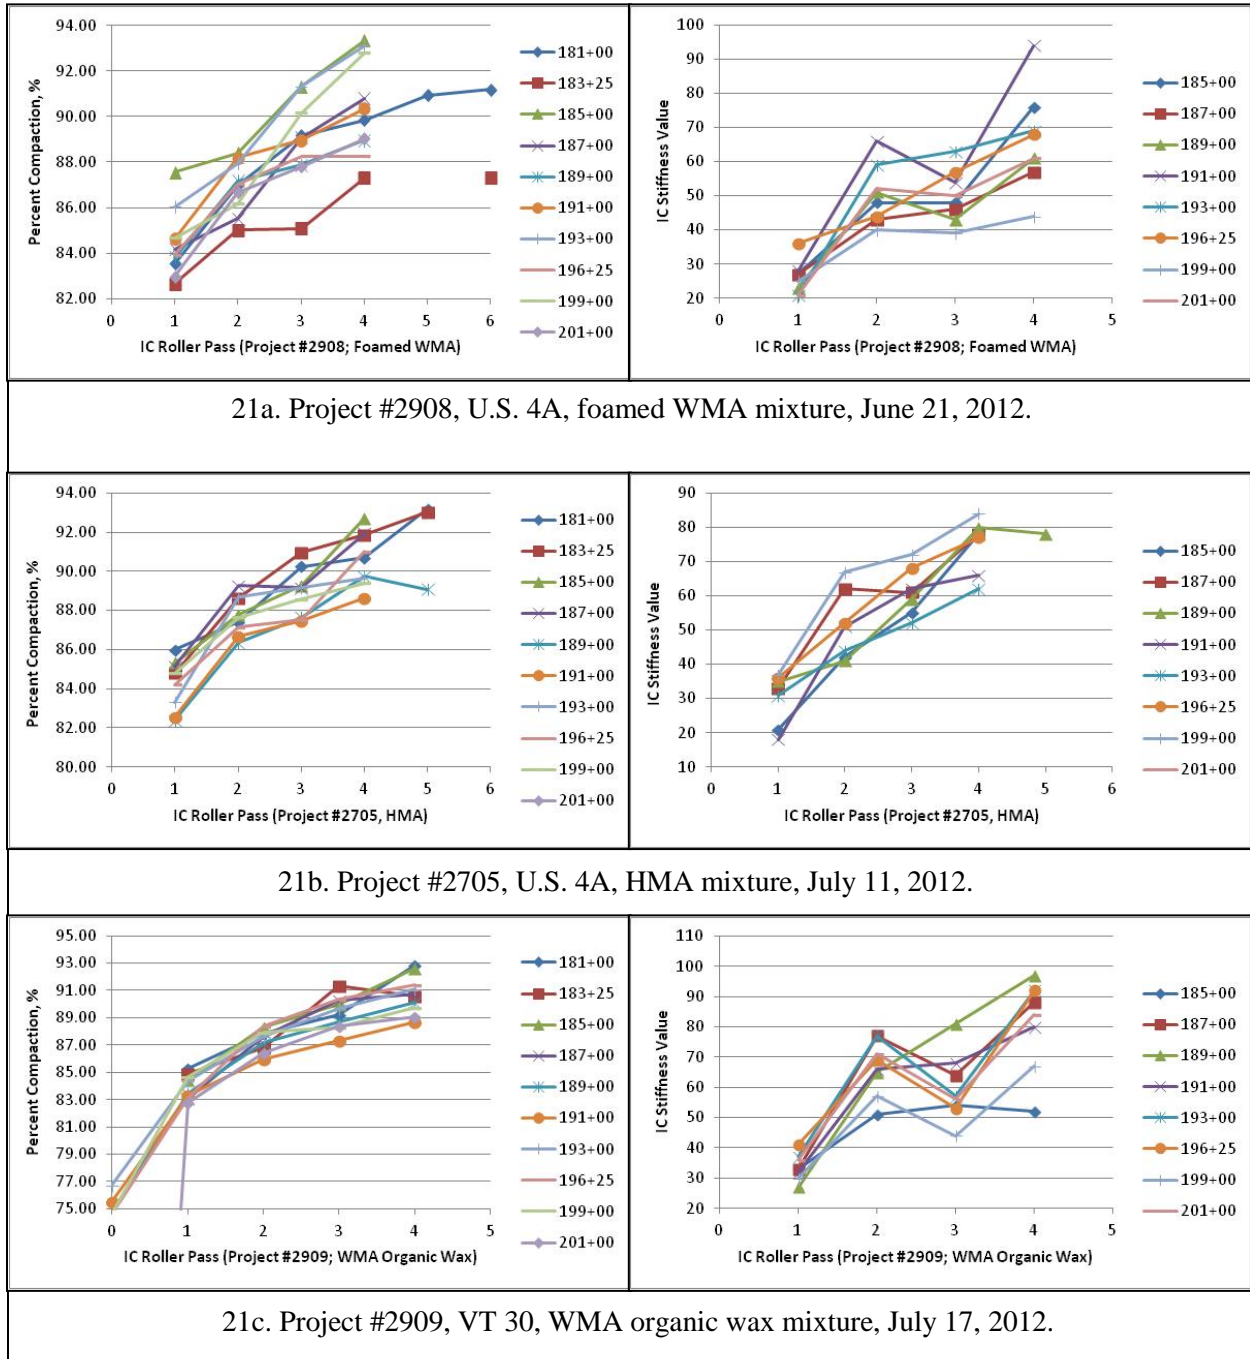
Figure 21. Density and IC stiffness growth curves for the WMA and HMA mixtures.

stiffness value increase with the number of passes. In the interest of time, more than four passes of the roller were used only at selected stations. The mat density and IC stiffness value are still increasing after four passes at most of the stations, but start to level off and decrease at five or six passes of the IC roller. After four passes, there is a much smaller increase in density. Thus, the contractor decided to use a minimum of four passes of the IC roller in setting the rolling pattern. The additional compaction effort for increasing the mat density was applied by the intermediate (Caterpillar rubber-tired) and finish (HAMM double-drum oscillatory) rollers.

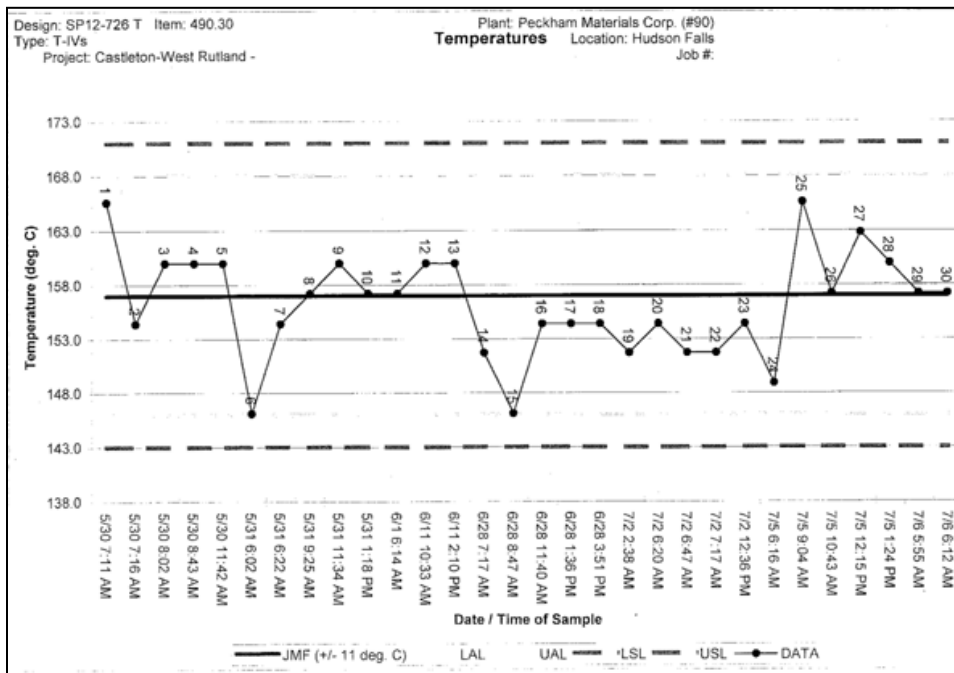
23a. HMA mixture temperature QC chart.

Mat temperature is probably the most important parameter for being able to properly compact WMA and HMA mixtures. Figure 23 includes an example of the production facility's control charts for WMA and HMA mixtures. The target production temperature at discharge was about 315 °F for HMA and 270 °F for WMA. The WMA temperature at discharge was later reduced to 260 °F because of a mixture pickup issue with the rubber-tired roller. The discharge temperature for the WMA mixtures generally varied between 255 to 265 °F when the test or control strips were completed.

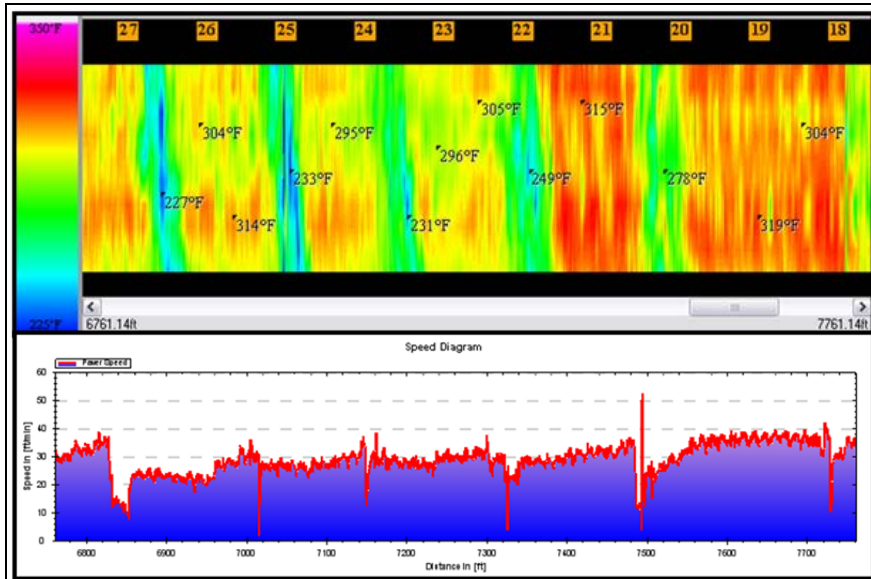
24a. Temperature profile near the beginning of construction, when many cold spots were observed in profiles and an inadequate number of trucks was available.

Figure 24. Temperature profiles and images from the IR bar.

The IR bar was used to monitor mat temperatures across and along the mat. The IR bar showed a high percentage of significant temperature differentials (cold spots) at the beginning of the project or when it was first installed and used on the project. Significant temperature differentials are defined as temperature profiles with more than 50 °F differentials. Table 3 summarizes the temperatures measured by the IR bar at the beginning of the project. Figure 24a shows an example of the IR bar temperature profile during this time. The high percentage of temperature differentials was caused by an insufficient number of trucks delivering mix to the paver, which meant the paver stopped and started many times. The contractor added trucks to resolve this issue. Figure 24b shows a more consistent mat temperature profile when an adequate number of trucks supplied mix to keep the paver moving down the roadway, not stopping and starting between truck loads.

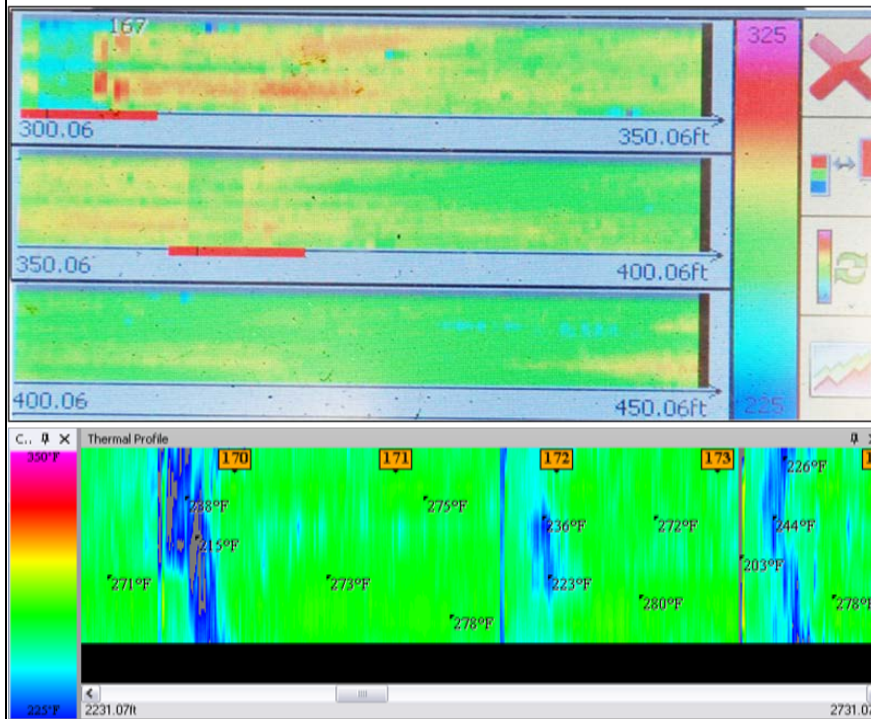
24b. Temperature profile with an adequate number of trucks and fewer cold spots observed in data.

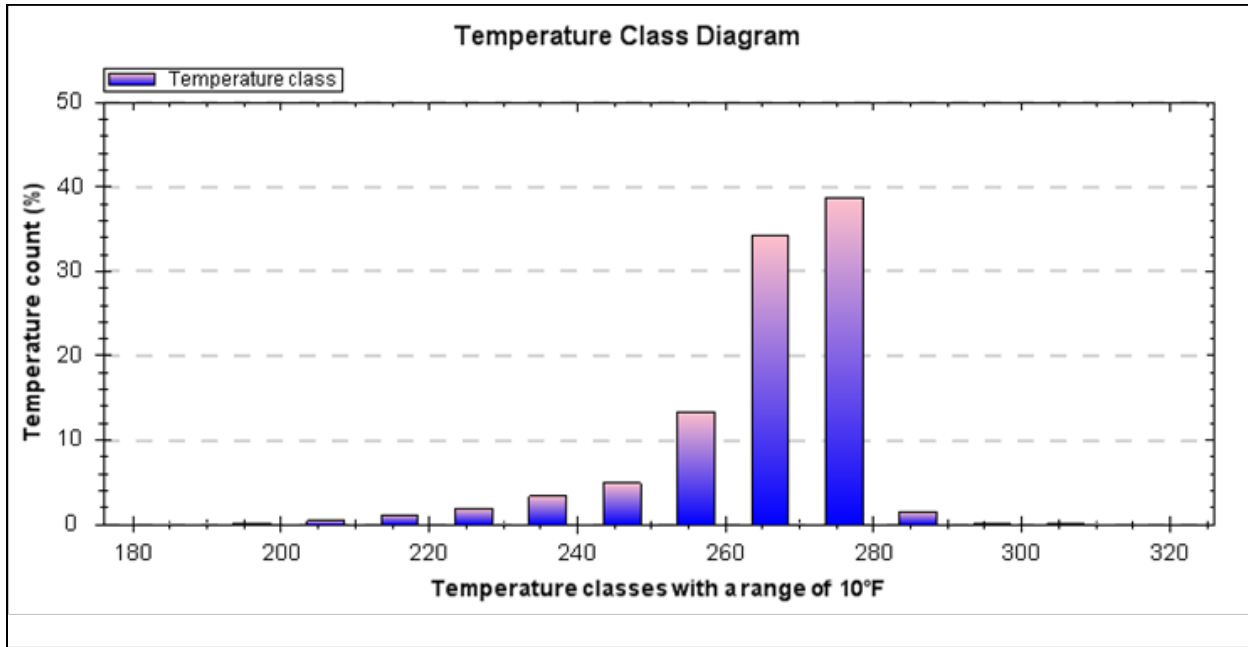
Figure 25. Histogram of mat temperatures (WMA foamed mixture) measured by the IR bar.

Figure 25 is a histogram of the mat temperatures measured by the IR bar behind the paver. As shown, it is skewed toward lower temperatures because of the cold spots from having an inadequate number of trucks at the beginning of the project. (The IR bar was not used throughout the project; it was used at the beginning, during the open house, and periodically during the test or control strips.)

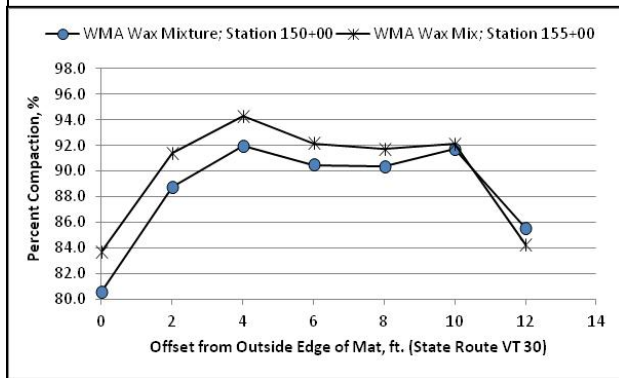
27a. Project #2908, U.S. 4A, foamed WMA mixture, June 21, 2012.

27b. Project #2705, U.S. 4A, HMA mixture, July 11, 2012.

27c. Project #2909, VT 30, WMA organic wax mixture, July 17, 2012.

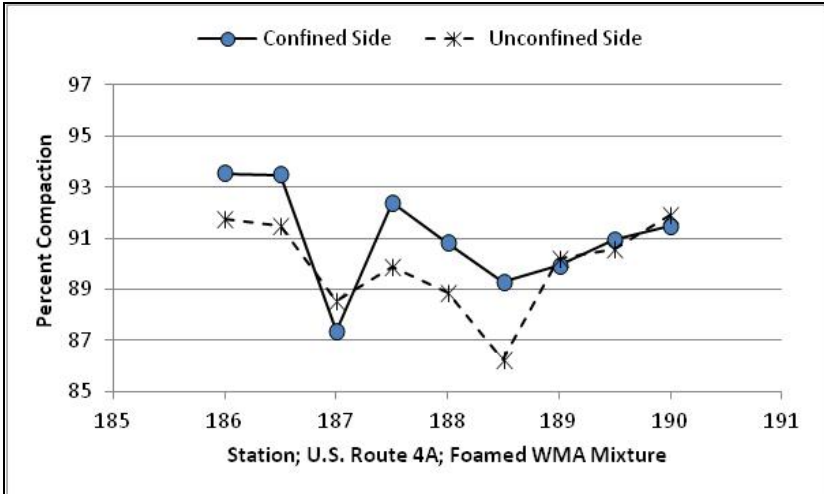
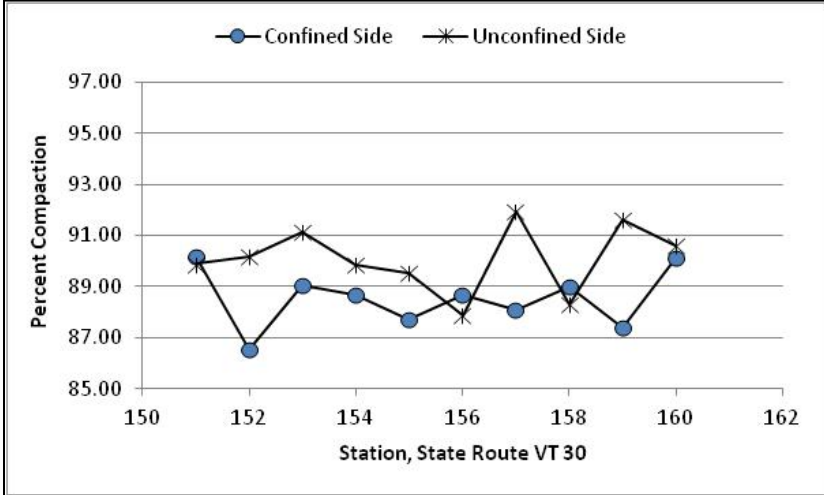
28a. Project #2908, U.S. 4A, foamed WMA mixture, June 21, 2012, density profile along longitudinal joint.

28b. Project #2705, U.S. 4A, HMA mixture, July 11, 2012.

28c. Project #2909, VT 30, WMA organic wax mixture, July 17, 2012.

Figure 28. Density profiles along the longitudinal construction joint.

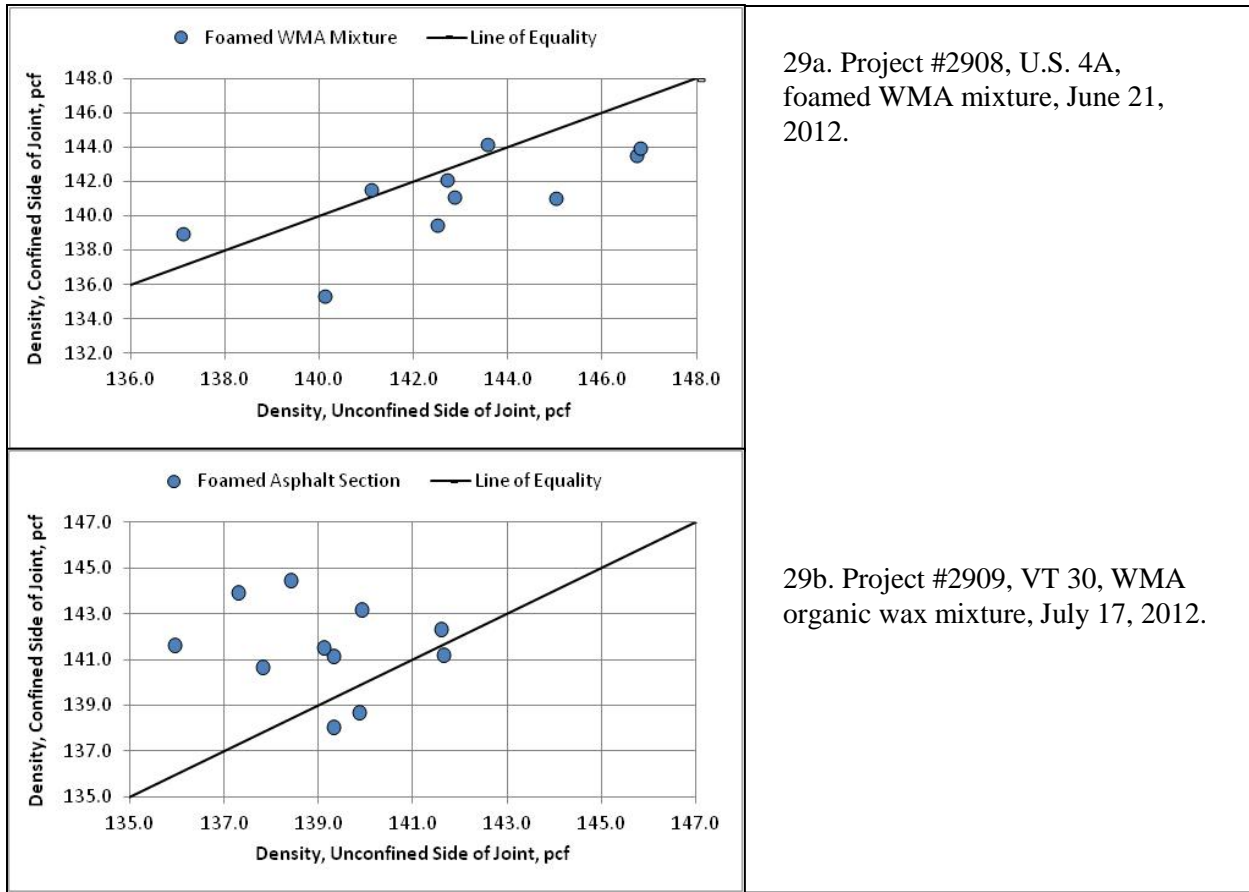
Figure 29. Comparison of the joint densities measured on the confined and unconfined sides of the longitudinal joint.

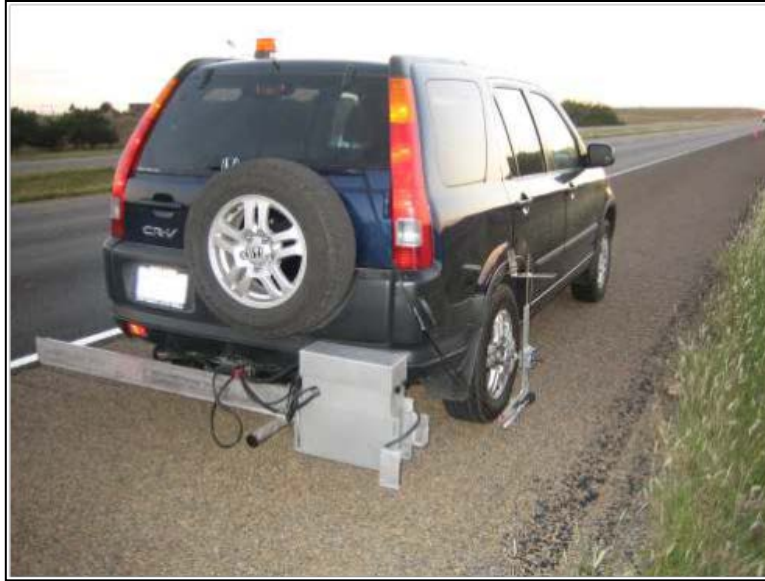
Figure 30. High-speed inertial profiler mounted behind the test vehicle.

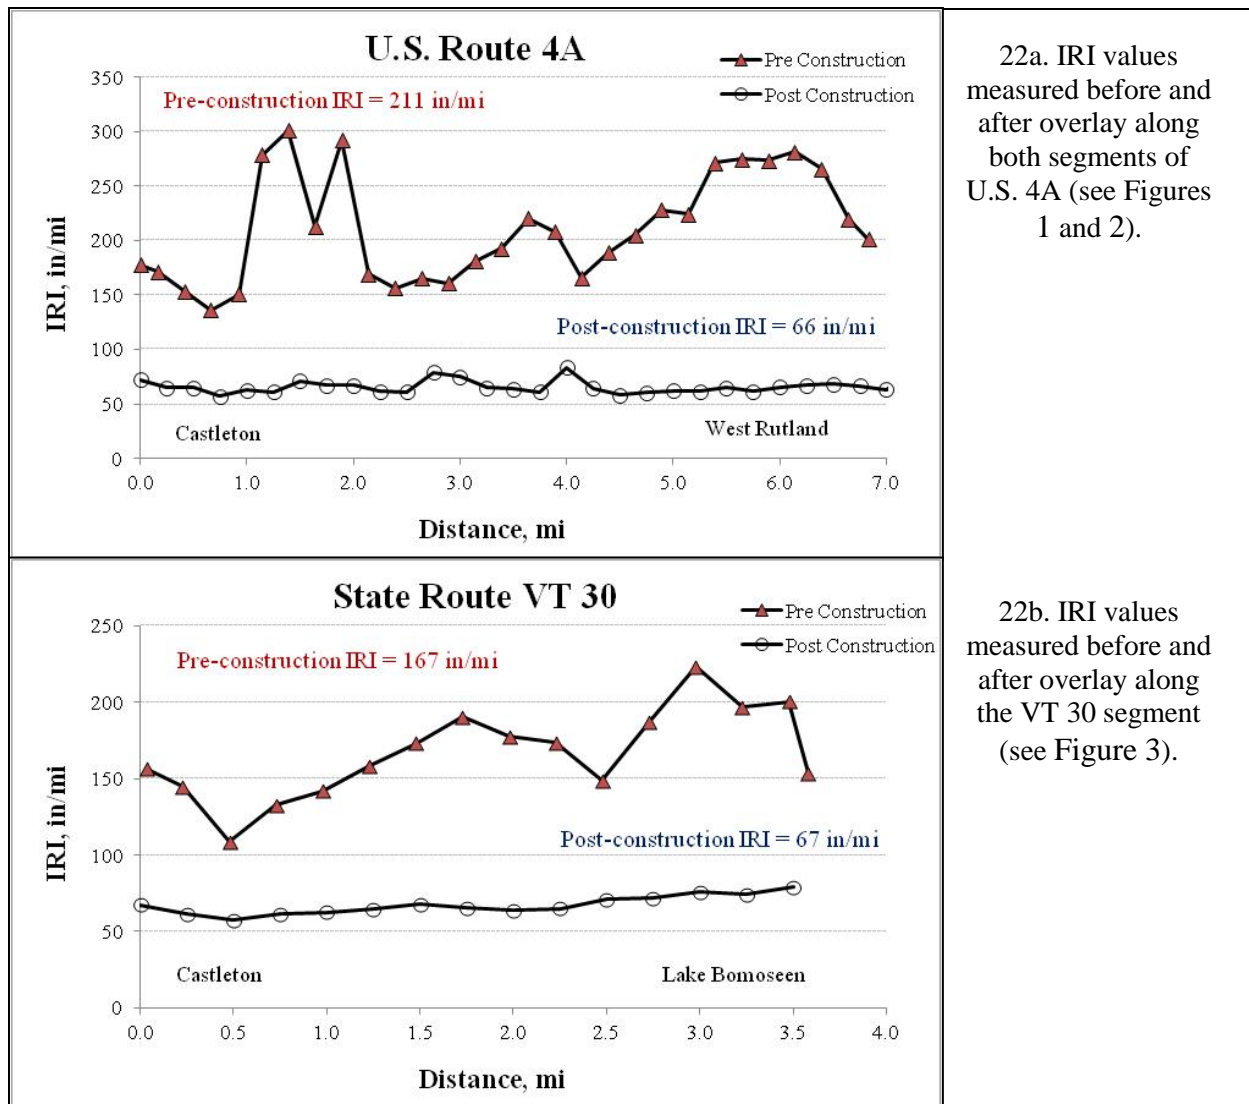
22a. IRI values measured before and after overlay along both segments of U.S. 4A (see Figures 1 and 2).

As stated previously, the rehabilitation project resulted in a significant reduction in roughness (see Figure 31) for U.S. 4A and VT 30. Reduced roughness will make the roadway safer and result in less vehicle damage.
