Vermont Demonstration Project:
Warm-Mix Asphalt
Overlay and Rehabilitation
of U.S. 4A and VT 30

Final Report
June 2013

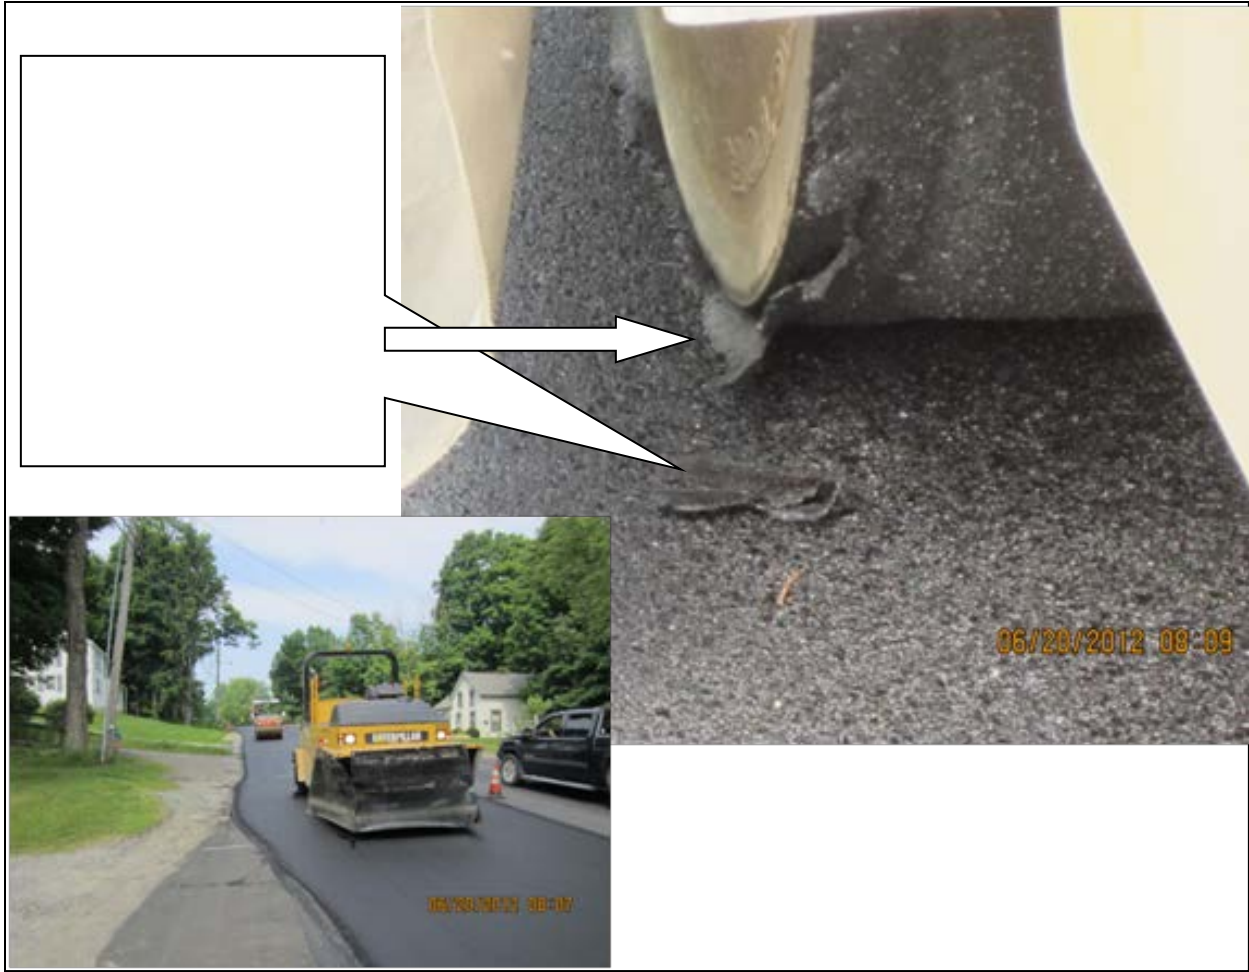
Figure 32. Rubber tires picking up the mastic from the WMA surface.

3. The WMA mixture with the foaming technology was used on U.S. 4A, and the WMA organic wax mixture was used on VT 30 (see Table 2). Shortly after paving was initiated beyond the compaction test strip for each WMA technology, it was observed that the rubber-tired roller was picking up the fines or mastic from the surface. Larger pieces of the mastic started falling off the tires in some areas (see Figure 32). The contractor's roller and QC personnel removed many of the larger pieces before the HAMM finish roller. Pickup was more predominate with the organic wax. To remedy this situation, the plant production temperatures were slightly lowered and the pneumatic roller operator delayed his rolling, which reduced the problem of mixture pickup by the rubber tires. The plant temperatures slightly increased over time and mixture pickup returned, which is believed to have caused some of the increase in IRI values toward the north end of VT 30 (see Figure 31b).

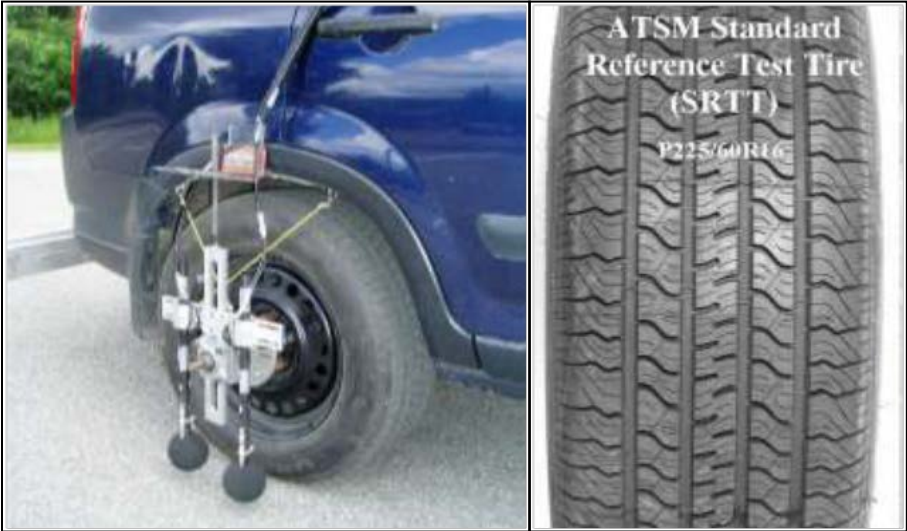
Figure 33. OBSI dual probe system and the SRTT.

VTrans has not used the OBSI test method on any past projects. This method, however, was used to collect tire-pavement SI measurements on the existing and overlaid pavement along all three roadway segments. OBSI values were measured at highway speed.

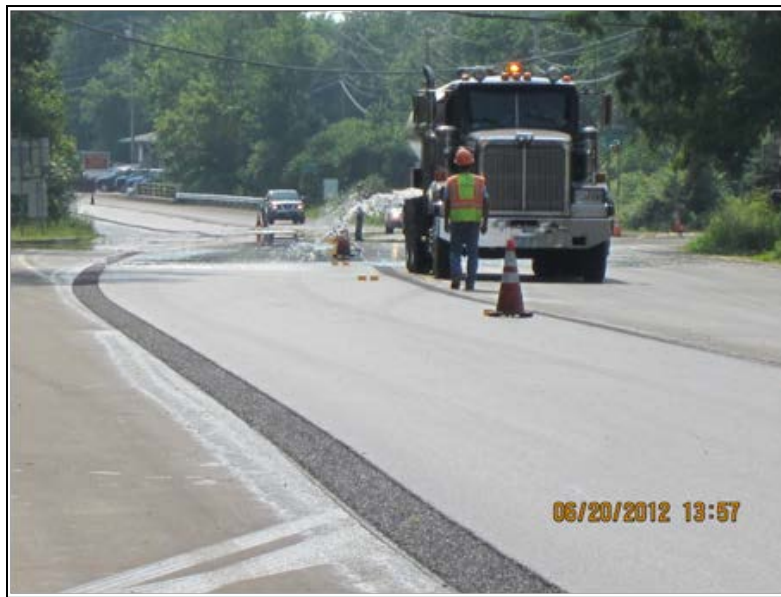
Figure 35. Recently placed WMA being artificially cooled with water to open the lane to traffic faster.

The air temperature was over 90 °F when paving through Castleton. The time needed for the mixture temperature to drop below 140 °F was more than an hour. The software program “CalCool” was used onsite to estimate this time; 69 minutes was determined for the WMA mixtures and onsite conditions. After waiting more than 50 minutes with a queue building on U.S. 4A, the contractor and agency personnel decided to artificially cool the mixture with water so the lane could be reopened to traffic and reduce the length of the construction zone (see Figure 35). The temperature of the existing surface was nearly 135 °F on a couple of afternoons.

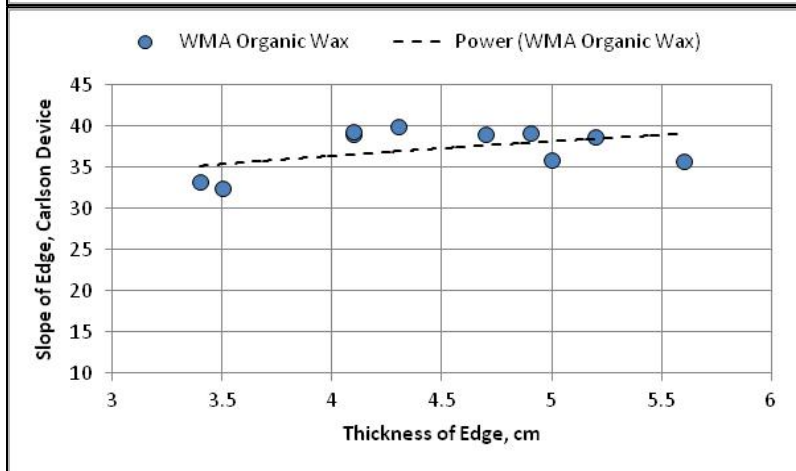
36c. Safety Edge placed with the Carlson device on VT 30, WMA organic wax, July 17, 2012.

As noted previously, a Safety Edge was added in appropriate segments of the roadway to reduce crashes in the future from vehicles departing the roadway at highway speeds when trying to recover or reenter the travel lane. The average slope of the Safety Edge is shown in Table 8 and was found to vary from about 32 to 37 degrees.

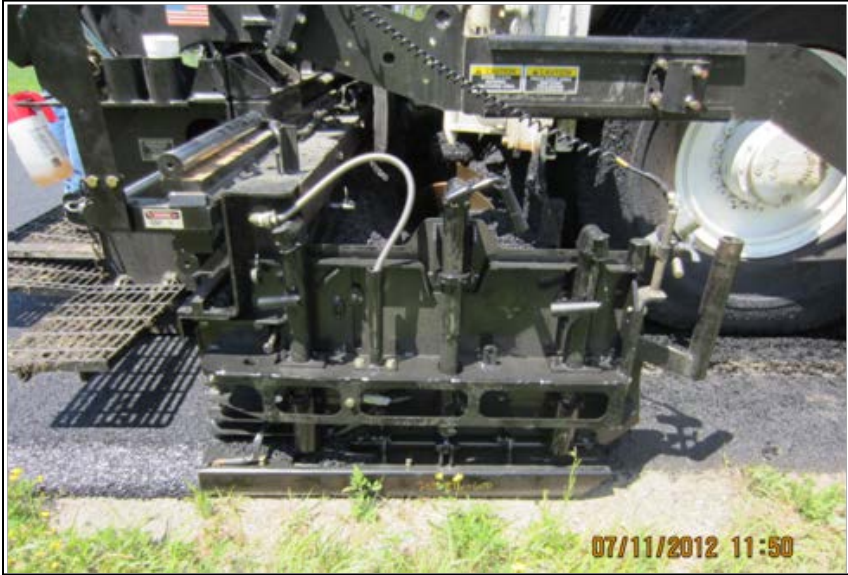
Figure 40. Closeup of Carlson Safety Edge device attached to the end plate of the screed.

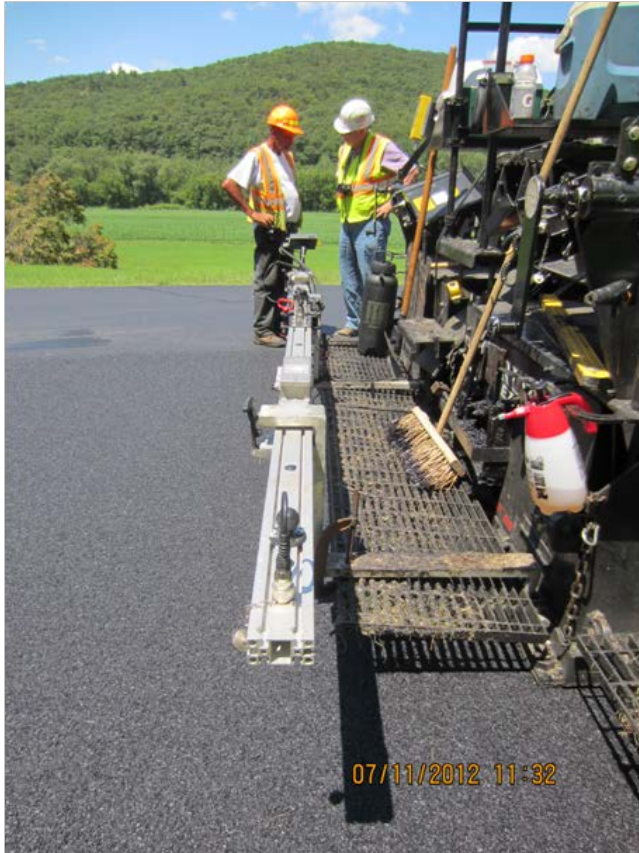
Figure 41. Participants viewing the mat surface temperatures displayed on the screen of the IR bar attached to the platform behind the screed.
