# California Demonstration Project: Safety Improvements on Mountain Ranch Road in Calaveras County

**Final Report  
June 2013**

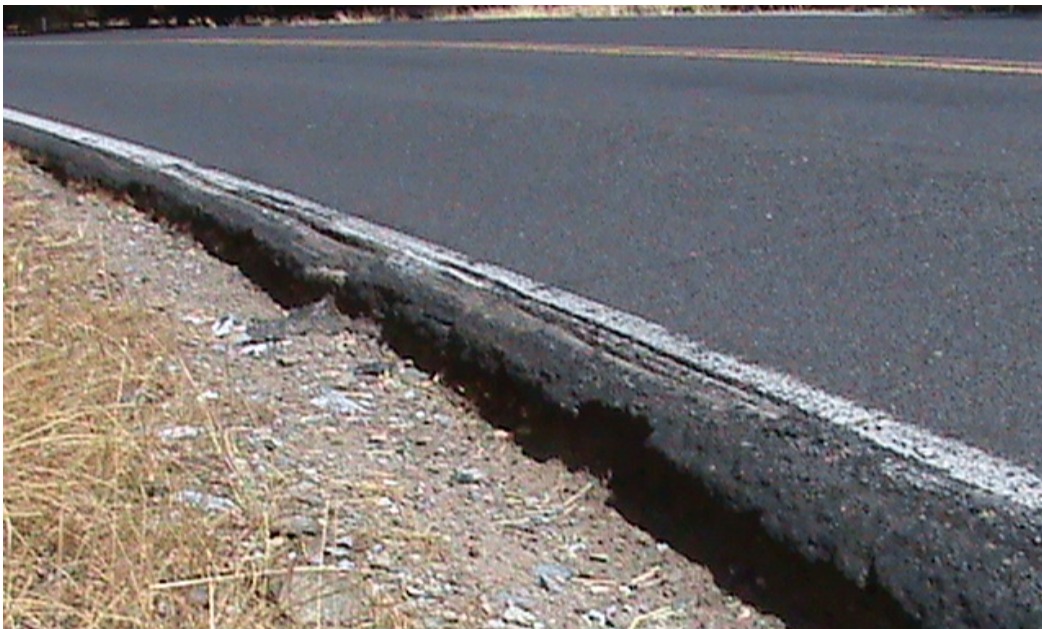
Figure 3. Typical car shackle bolt damage to Mountain Ranch Road edge on inside of turn.

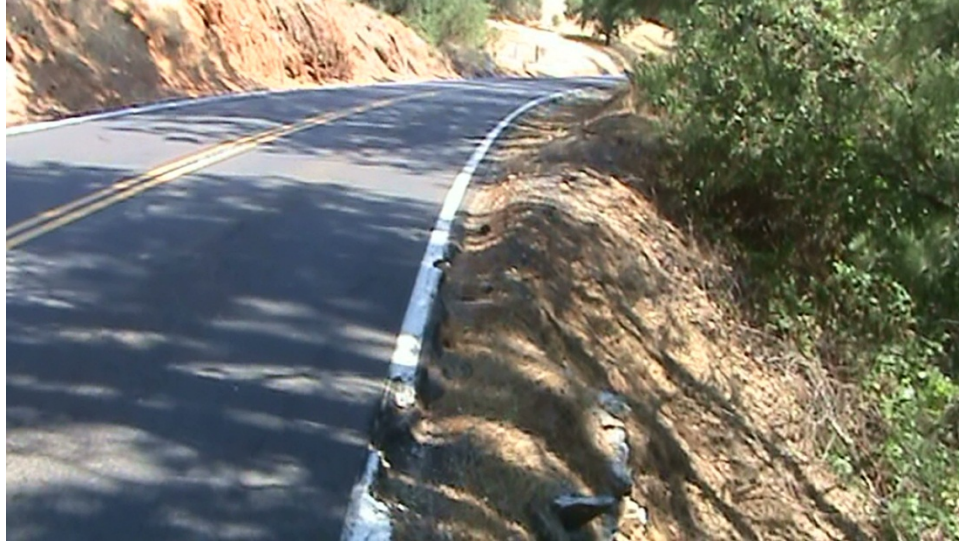
Figure 4. Typical narrow shoulders, acclivity on north (left) side of road, and declivity on south (right) side of Mountain Ranch Road.

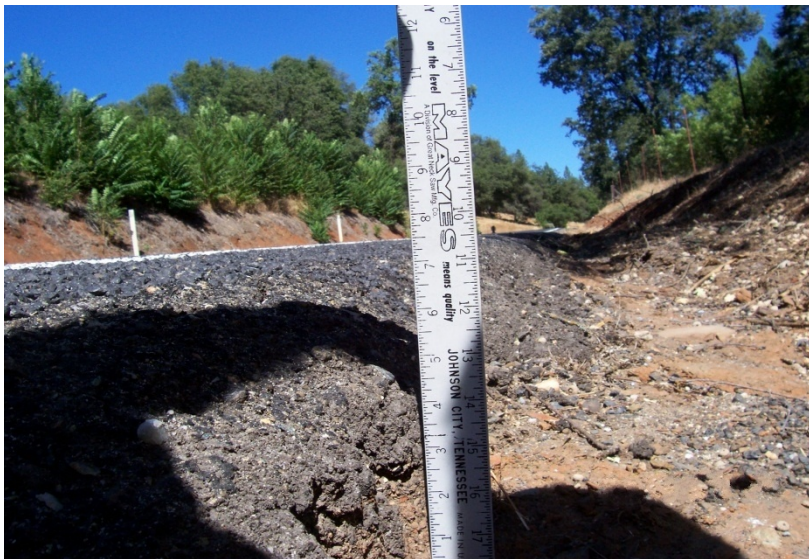
Figure 5. Typical edge-shoulder dropoff on Mountain Ranch Road.

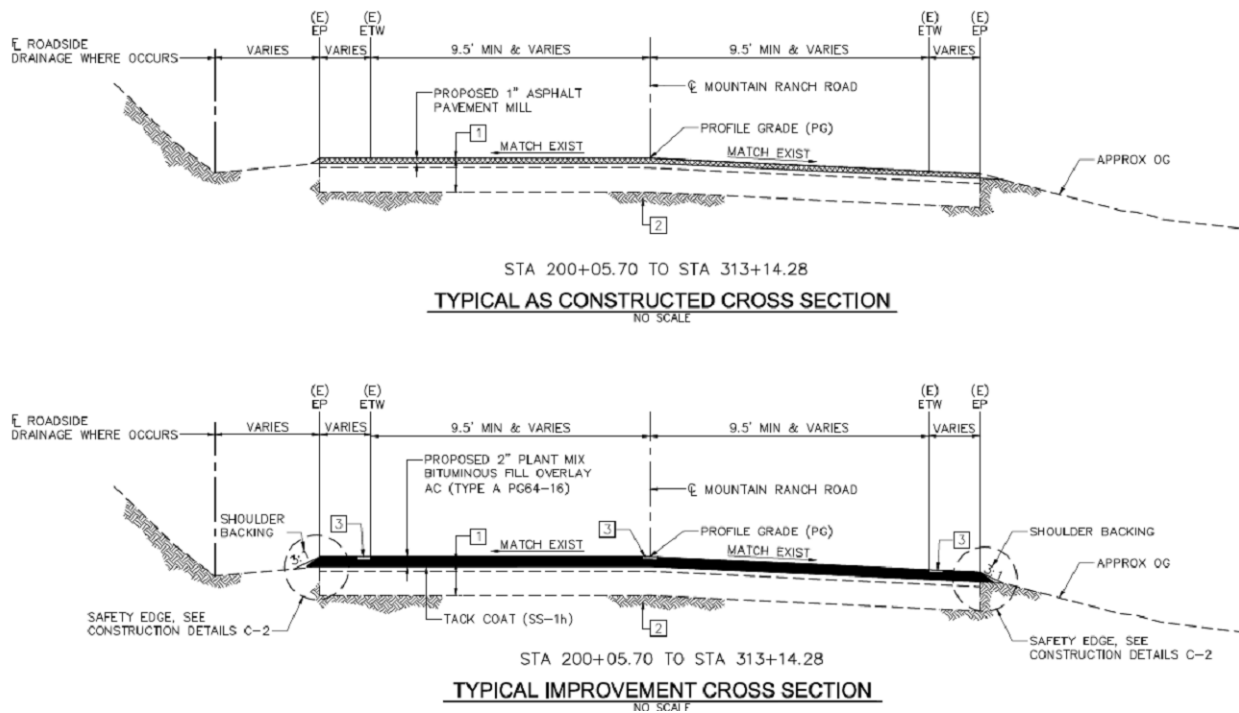
Figure 7. Plans for milling and HMA overlay with a Safety Edge on Mountain Ranch Road.

The final plans for the project were completed on December 16, 2011. The project was awarded to George Reed, Inc. on July 10, 2012. The plans for milling the existing pavement surface and placing the new HMA surface with the Safety Edge are shown in figure 6. The plans called for milling 1 in of the existing HMA pavement, placing an SS-1h tack coat, and overlaying the pavement with 2-in Type A PG 64-16 HMA overlay. The plan details for installation of the Safety Edge are shown in figure 7. The figure shows a Safety Edge slope of 30 degrees to be covered with shoulder backing material consisting of a dense-graded aggregate base material. The shoulder backing material could be filled only at locations with sufficient clearance of the Safety Edge from adjacent acclivity and declivity (see figure 3). The figure also shows details for transitioning of the Safety Edge at existing driveways and streets. Figure 8 and 9 show the plans for the installation of the guardrails and rumble strips, respectively.

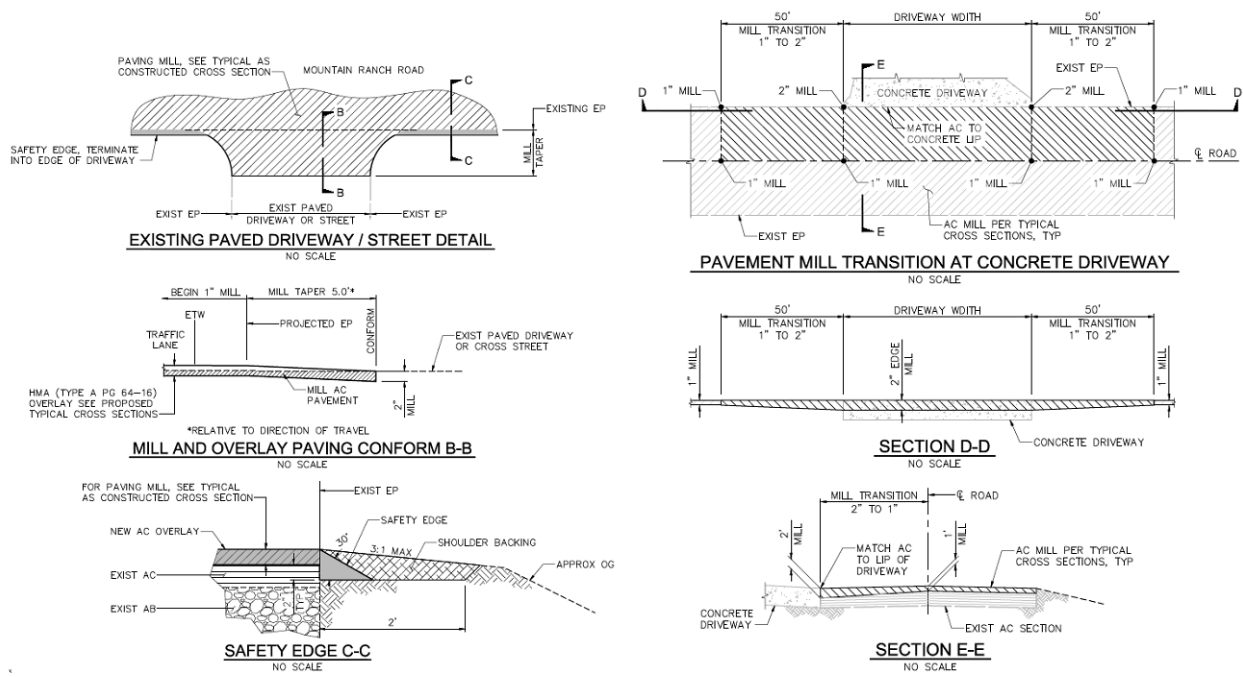
Figure 8. Safety Edge plan details for Mountain Ranch Road.

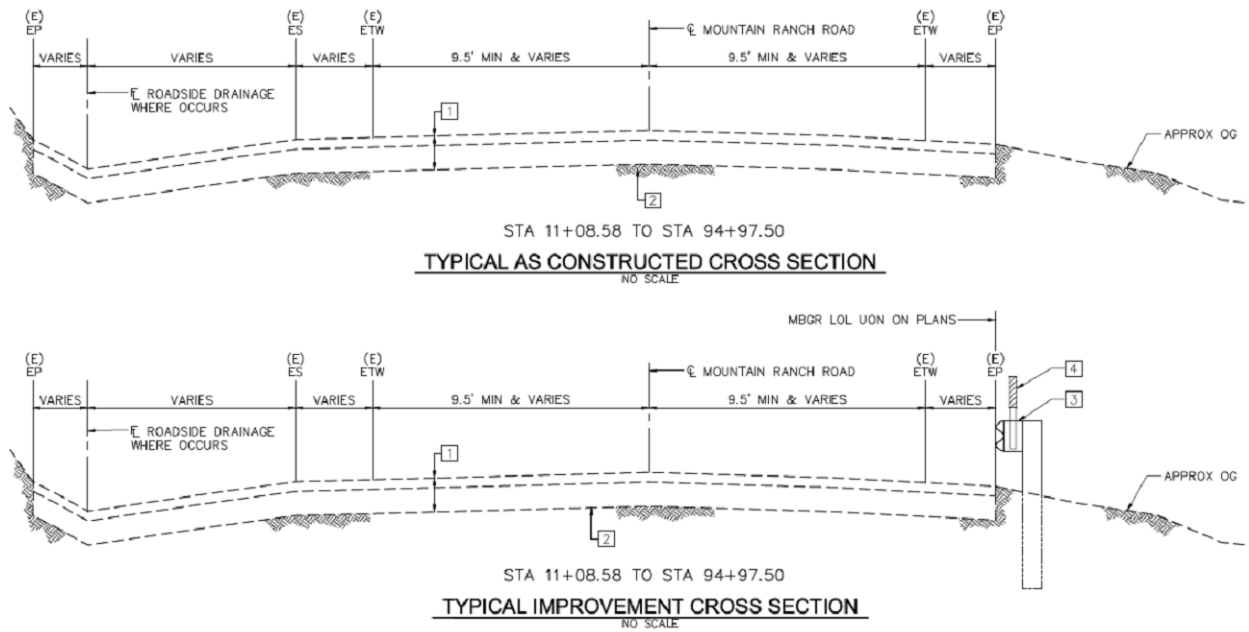
Figure 9. Plans for installation of guardrails on Mountain Ranch Road.

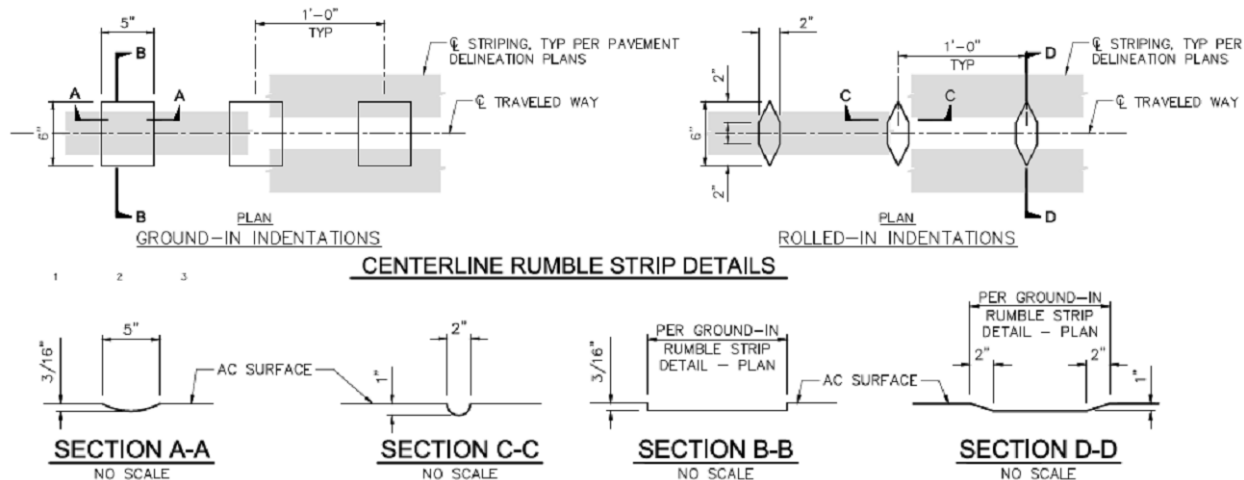
Figure 10. Plans for centerline rumble strip installation on Mountain Ranch Road.

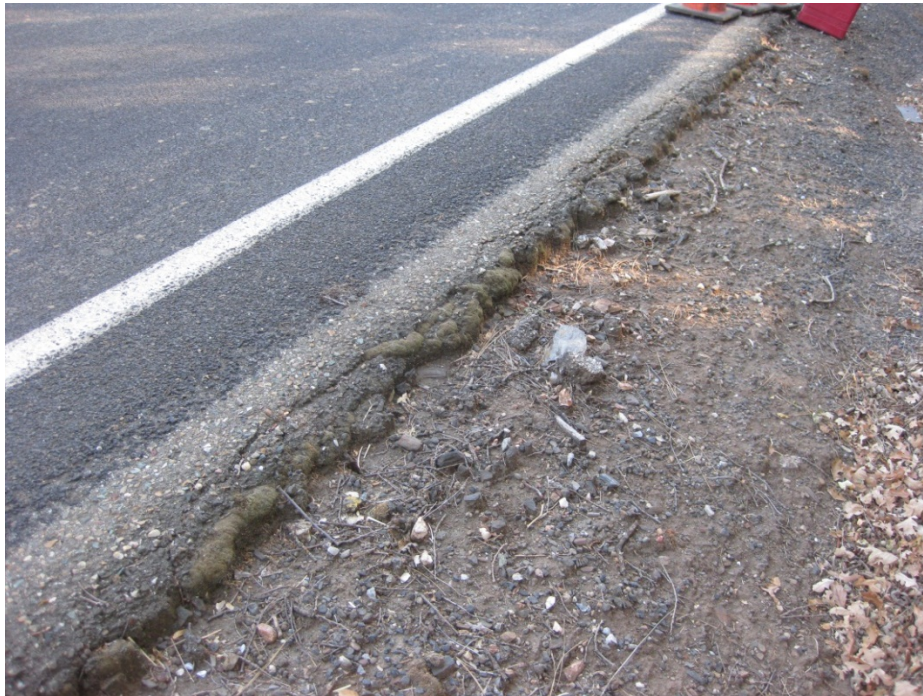
Figure 11. Condition and surface texture of existing pavement surface before milling on Mountain Ranch Road.

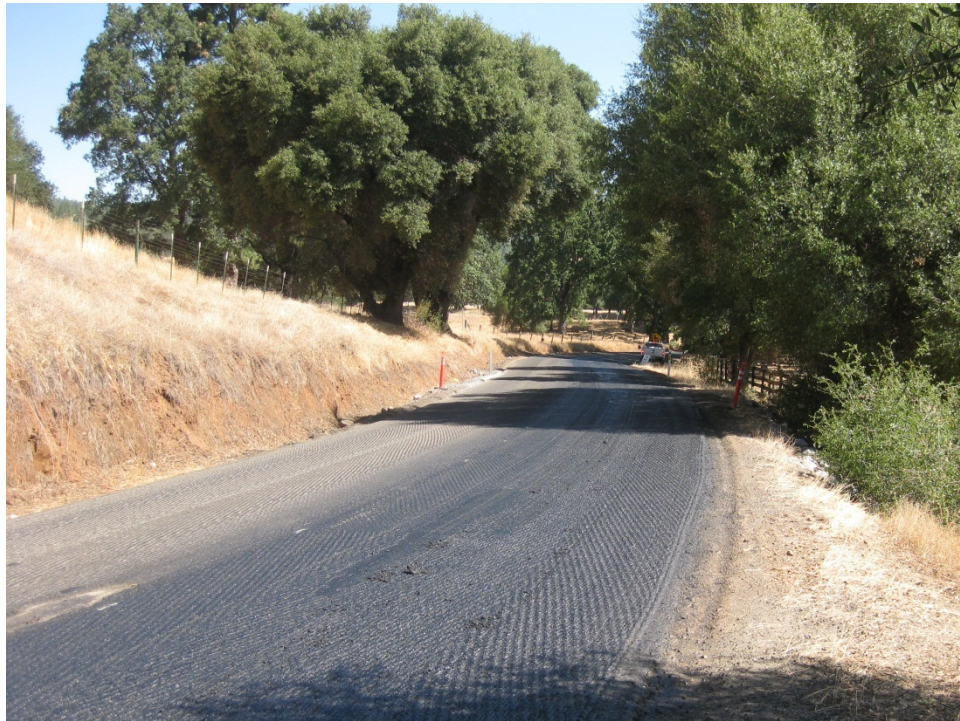
Figure 12. The existing pavement surface was milled (1 in) before HMA overlay and Safety Edge paving on Mountain Ranch Road.

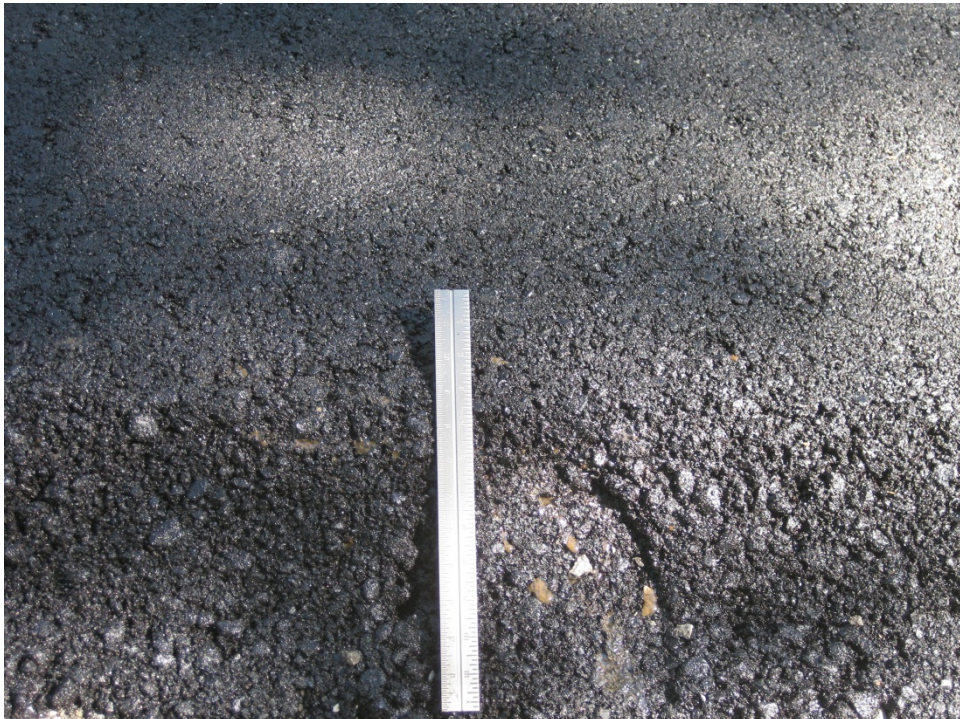
Figure 15. HMA material showing the relatively large (3/4-in nominal maximum aggregate size) aggregates for a surface mix.

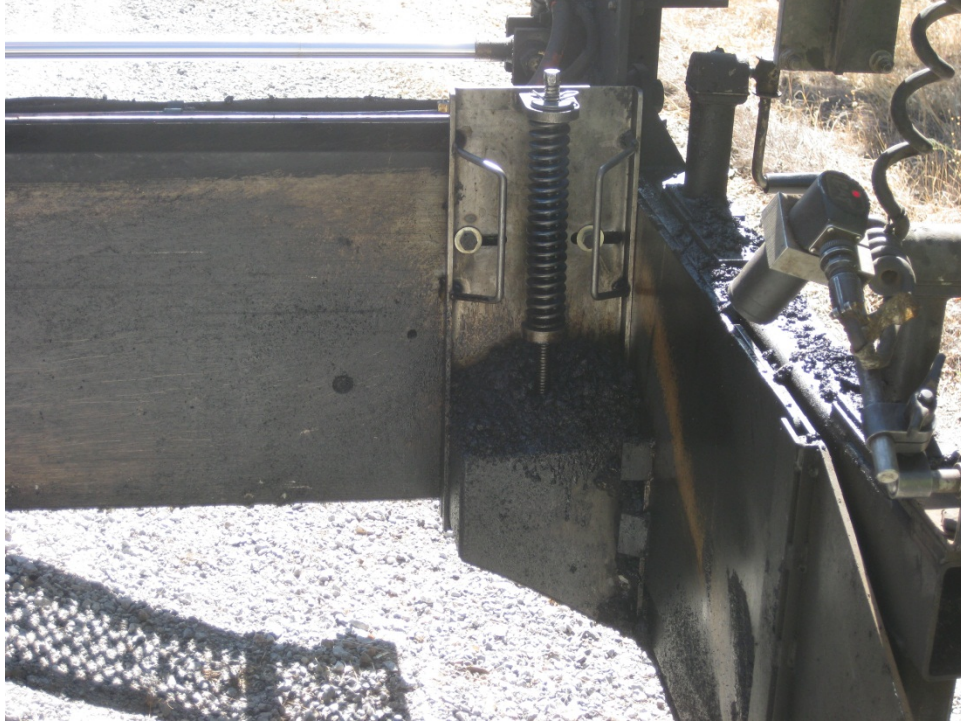
Figure 16. Advantedge® Safety Edge device installed on the paver screed.

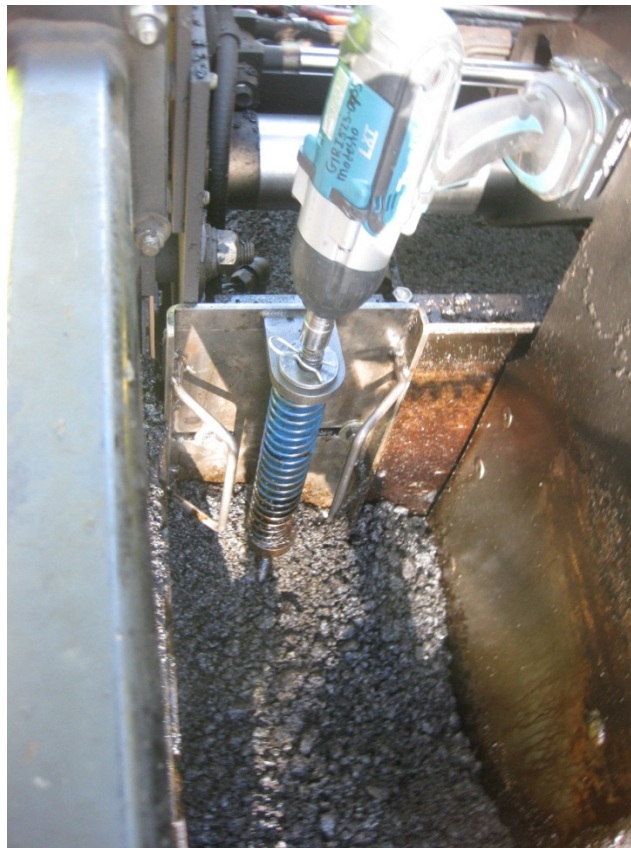
Figure 17. The Safety Edge shoe of the Advantedge® can be raised and lowered by turning the bolt at the top of the device.

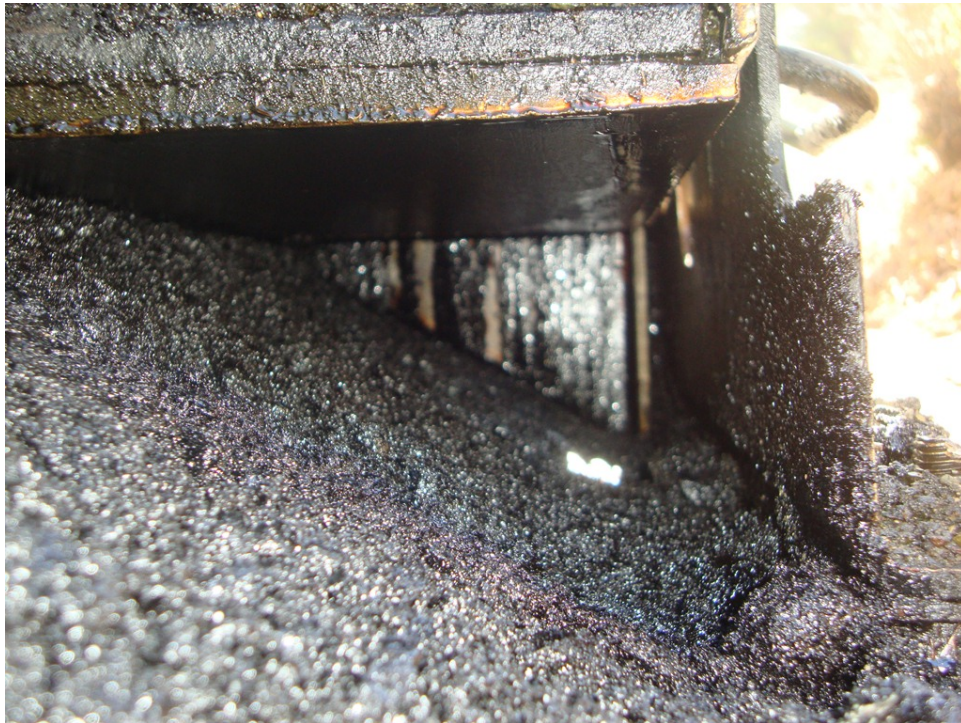
Figure 18. Safety Edge shoe of the Advantedge® device engaged onto the HMA to form the Safety Edge.

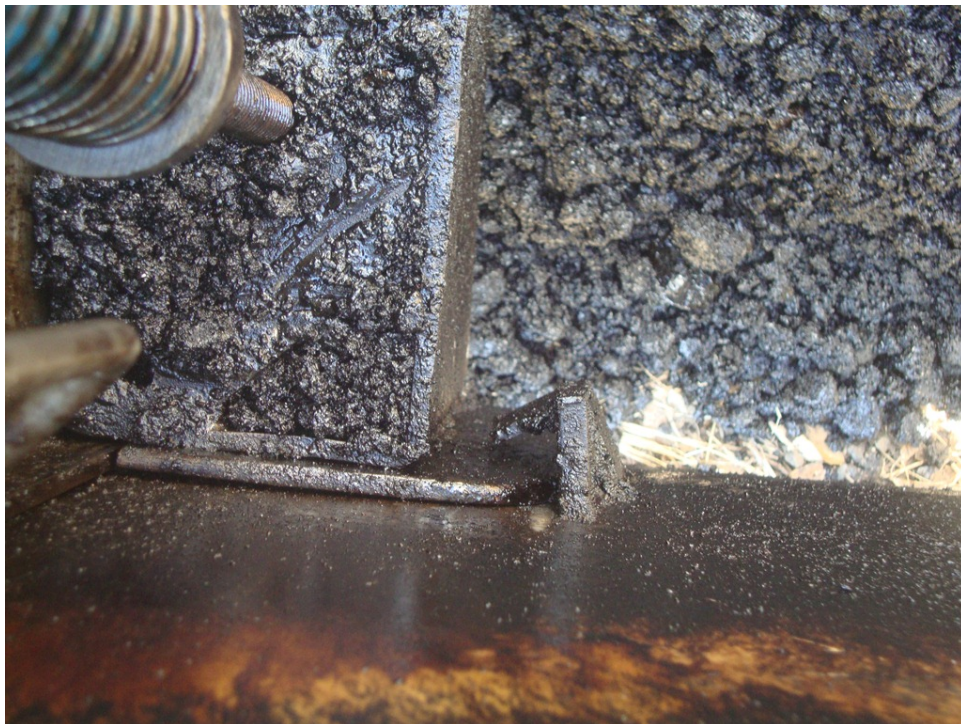
Figure 19. Contractor welded a piece of metal to the Safety Edge shoe and an angled piece to the end gate to prevent HMA from getting between the shoe and the end gate.

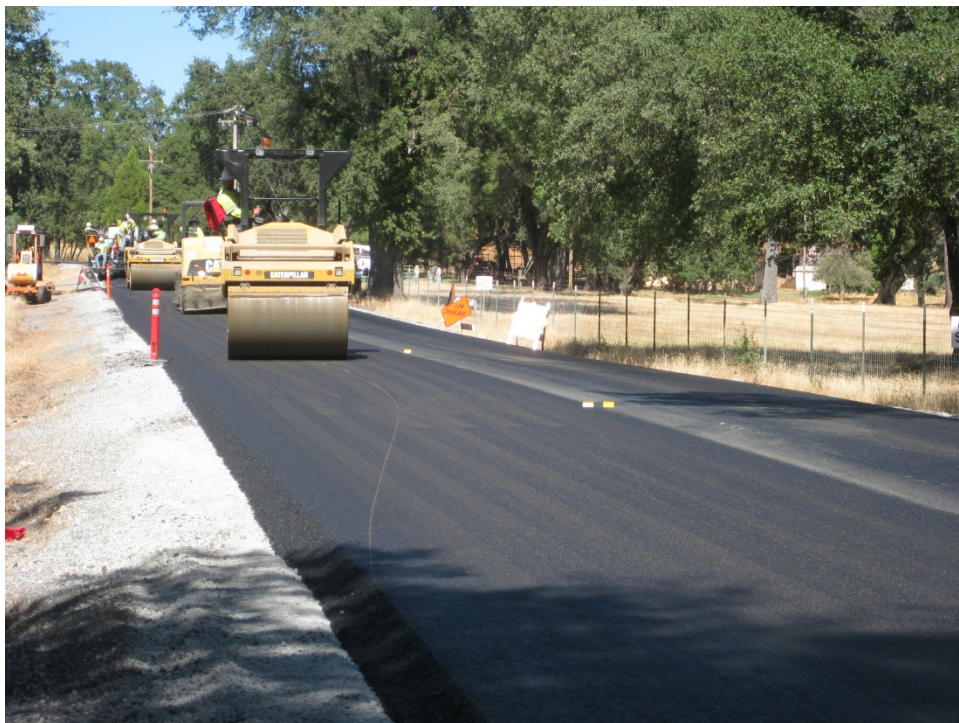
Figure 20. Three rollers used on the project to densify the 2-in HMA mat.

Compaction was performed using three rollers—a vibratory breakdown roller (Caterpillar CB54XW, 26,422 pounds (lbs)) with three passes, an intermediate roller (Caterpillar PS-150C) with five passes, and a finish roller (Caterpillar CB54, 24,000 lbs) with three passes (figures 19 through 22).

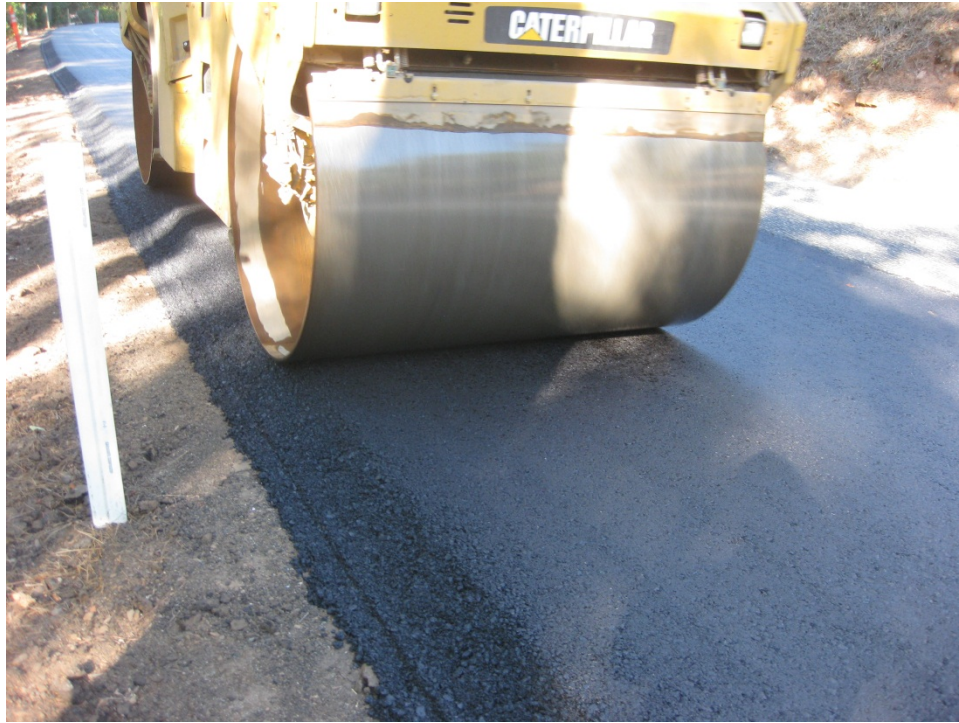
Figure 21. Breakdown steel drum vibratory roller compacting the HMA mat (edge pass with the drum typically about 2 in over the edge of the mat, although in some cases the drum was almost 12 in over the edge).

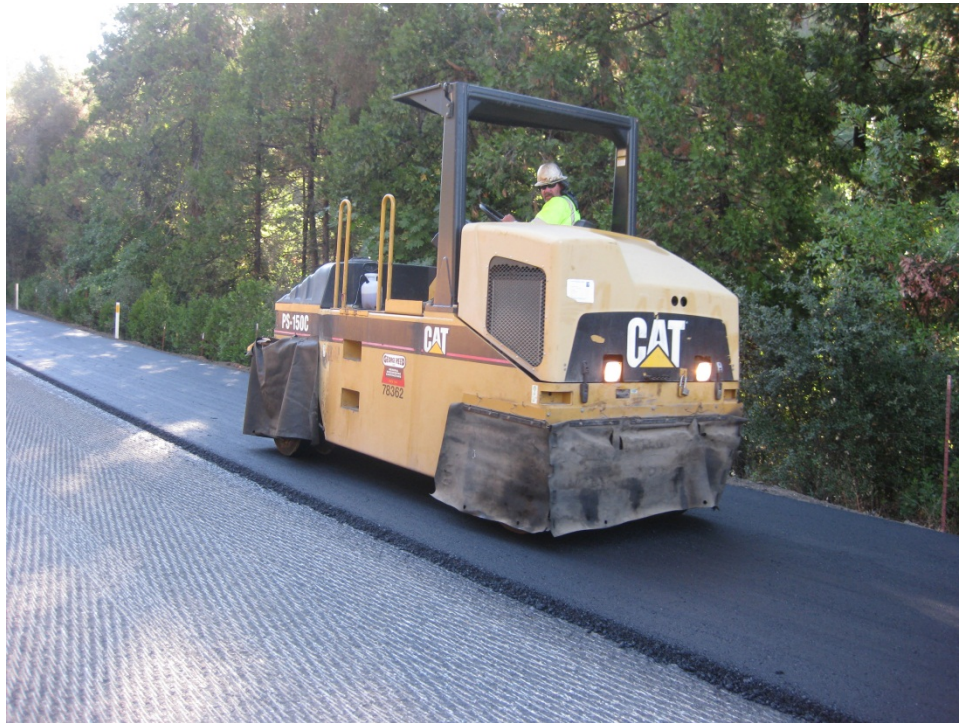
Figure 22. Intermediate pneumatic rubber tire roller was typically confined to the interior of the HMA mat (tires no closer than 6 to 9 in from the edge of the mat).

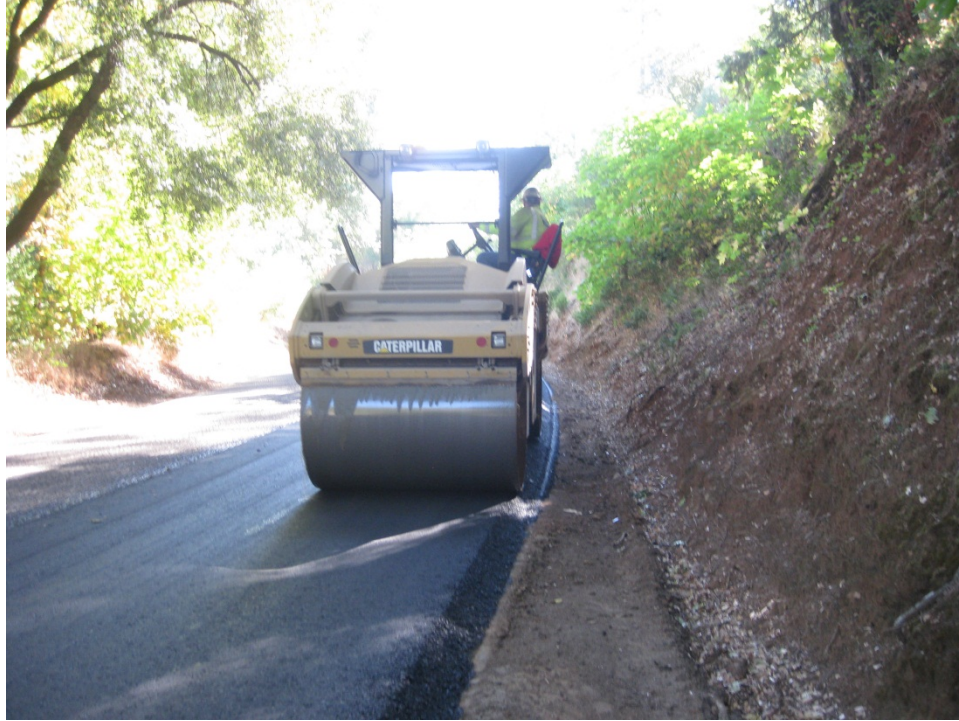
Figure 23. Finish steel-drum static roller leveling the HMA mat to the final finished surface.

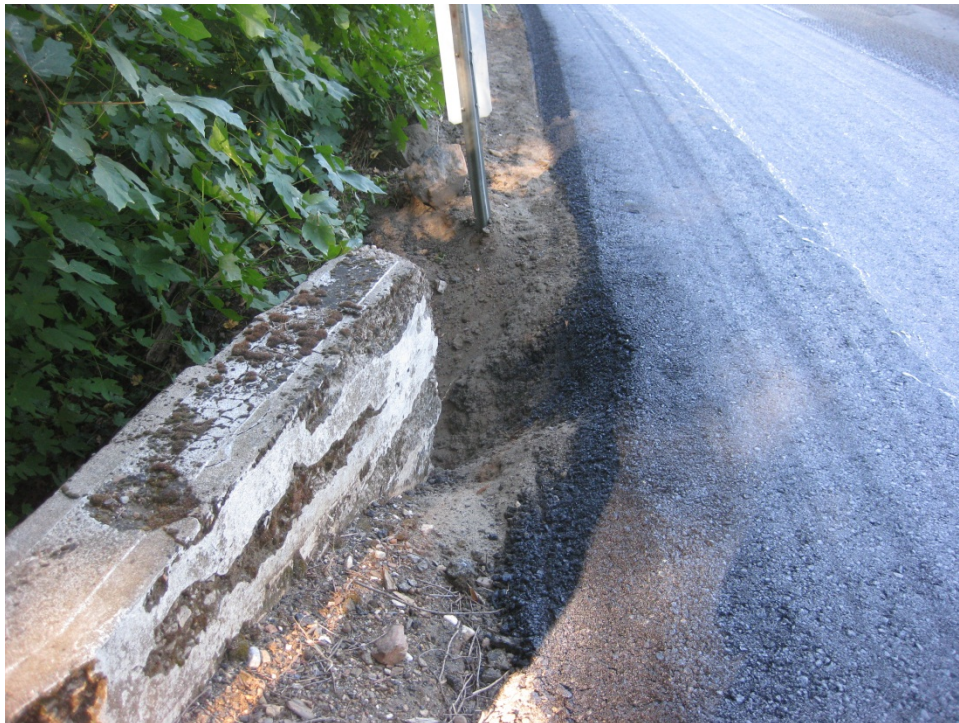
Figure 24. Small clearances between roadway edge and appurtenances such as culverts resulted in difficulty paving the Safety Edge consistently.

As shown in figures 23 through 25, the terrain and small clearances between the roadway edge and the adjacent activities and declivities made it difficult to pave the Safety Edge consistently. However, this issue was estimated to comprise less than 5 percent of the total paving project. A typically formed Safety Edge with uniform break point and Safety Edge slope is shown in figure 26. Figures 27 and 28 show a couple of minor issues encountered while paving the Safety Edge pertaining to the positioning of the Safety Edge shoe. The compaction of the edge may not have been optimum because the shoe was not fully engaged. Because of the inconsistent terrain and shoulders, it was difficult for the screed operator to consistently watch the floating of the cotter pin and ensure appropriate positioning of the Safety Edge shoe.

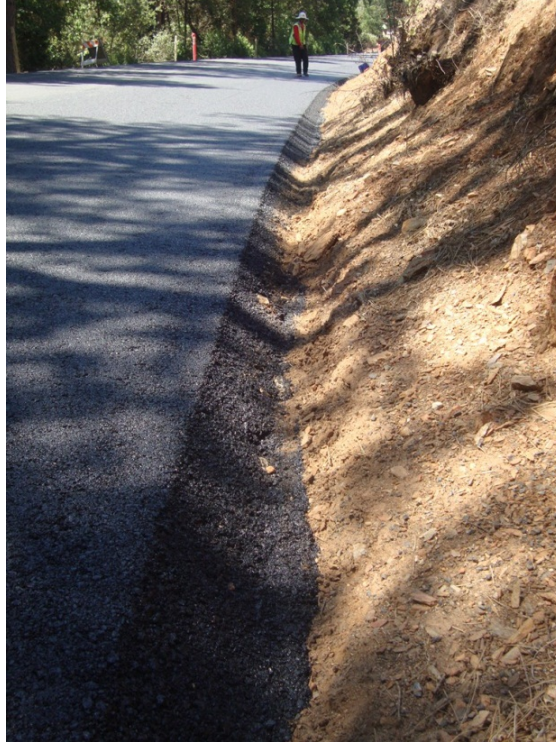
Figure 25. Small clearances between roadway edge and adjacent hillside. Even when the end gate was pulled all the way in, it was not enough to prevent loose material being pulled into the discharge area and mixing with the HMA.

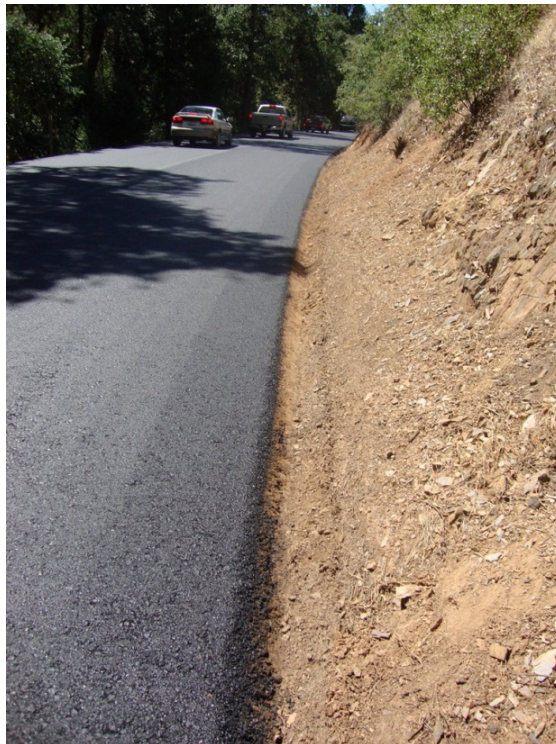
Figure 26. Worst case where hillside is very close to roadway edge and loose material is mixed with the HMA.

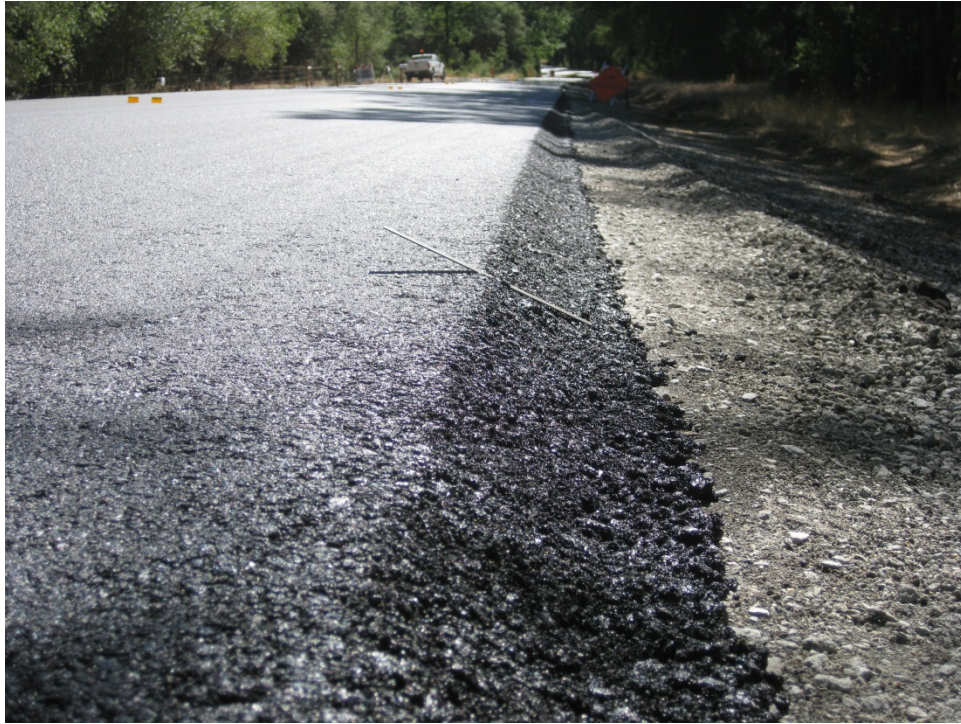
Figure 27. Typically formed Safety Edge on Mountain Ranch Road showing uniform break point and Safety Edge slope.

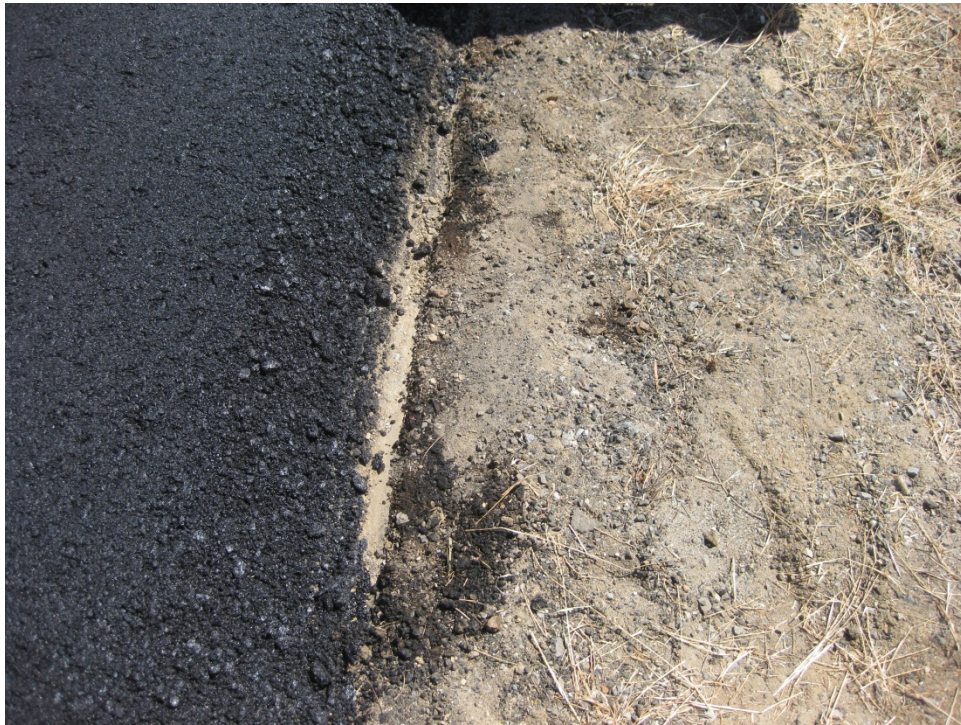
Figure 28. In a few locations, the Safety Edge shoe was too low and it pushed into the shoulder material.

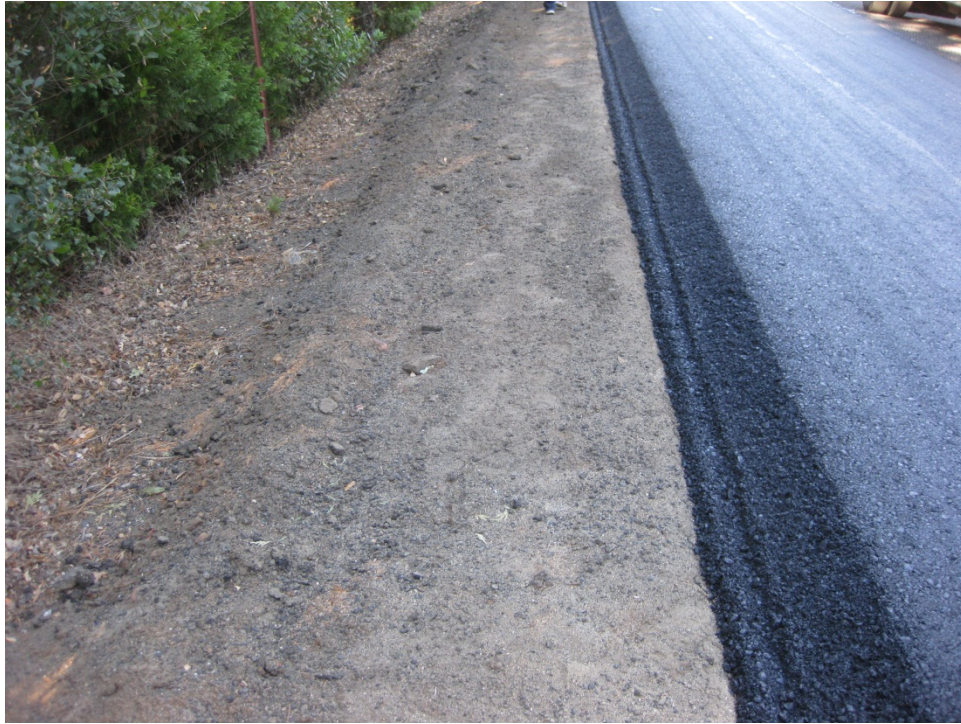
Figure 29. In some locations, the Safety Edge angle was not uniform because of the HMA thickness between the shoulder material and top of the mat compared to the vertical thickness of the Safety Edge shoe.

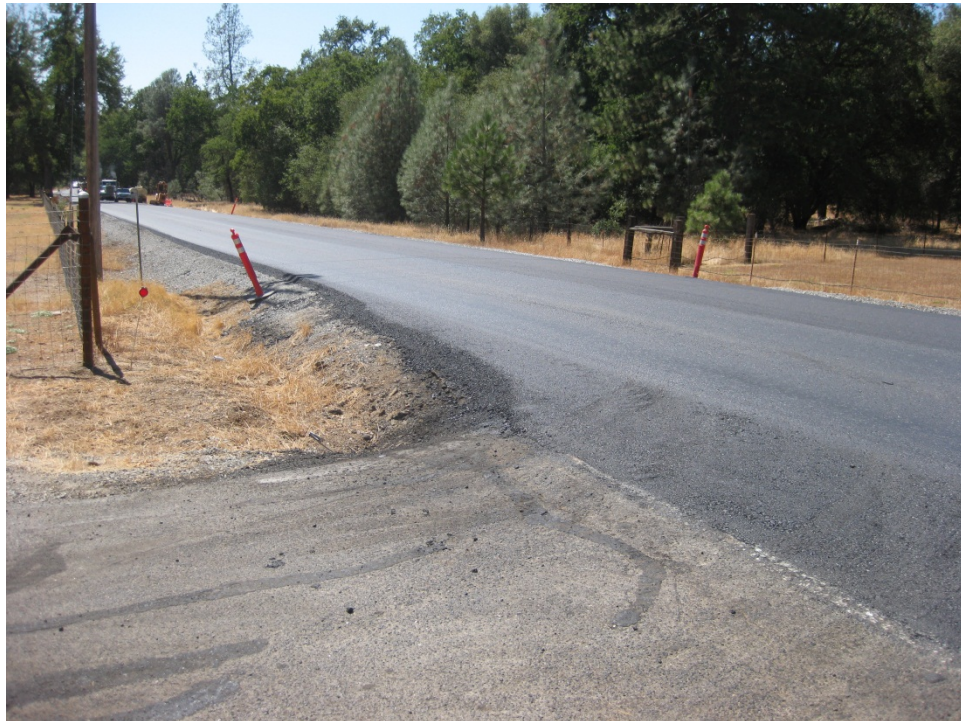
Figure 30. The Safety Edge shoe was raised when encountering driveways and cross streets.

The Safety Edge shoe was raised when encountering driveways and cross streets, as shown in figure 29, and lowered to the original position past the driveways and cross streets, as shown in figure 30. The typical final paved surface with the Safety Edge is shown in figure 31. The installation of MBGR was done between September 25 and November 21, 2012 (figures 32 through 35), and centerline rumble strips were ground on August 30, December 13, and December 14, 2012 (figure 36). One coat of temporary paint for the centerline striping was applied on December 14. Installation of the permanent retroreflective striping is scheduled for summer 2013 when temperatures are warmer for better adhesion of the striping to the pavement surface.

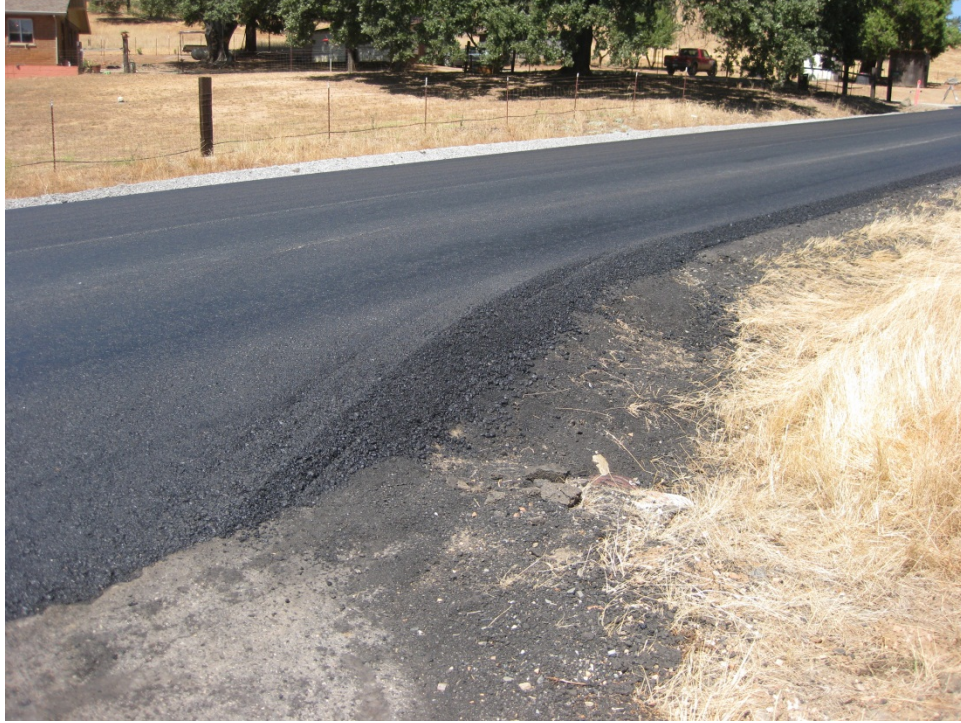
Figure 31. The Safety Edge shoe was lowered to the original position at the end of driveways and cross streets.

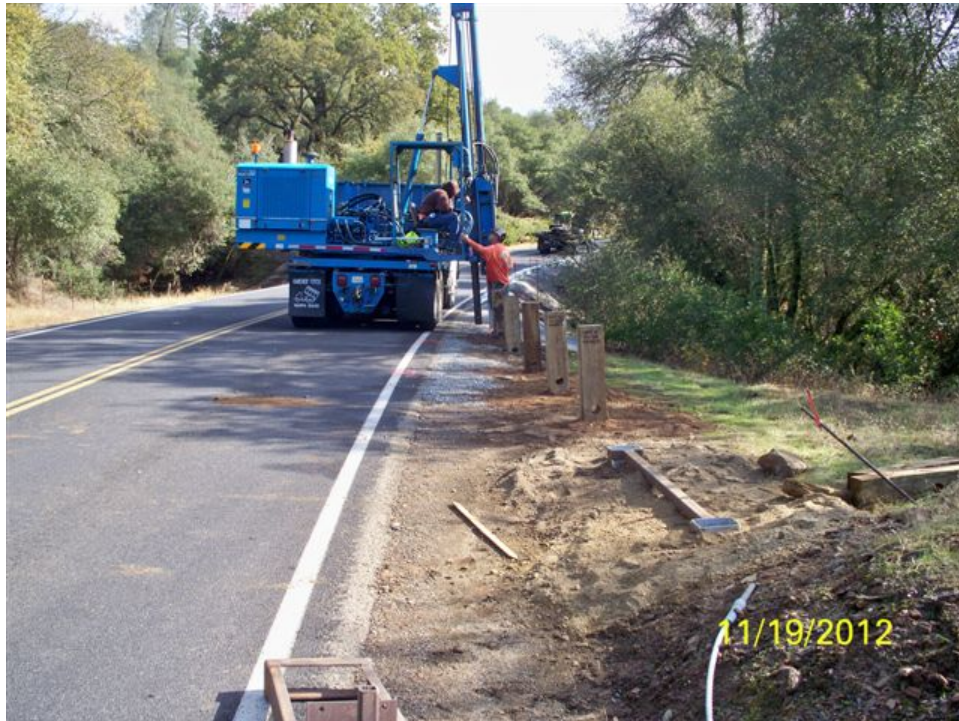
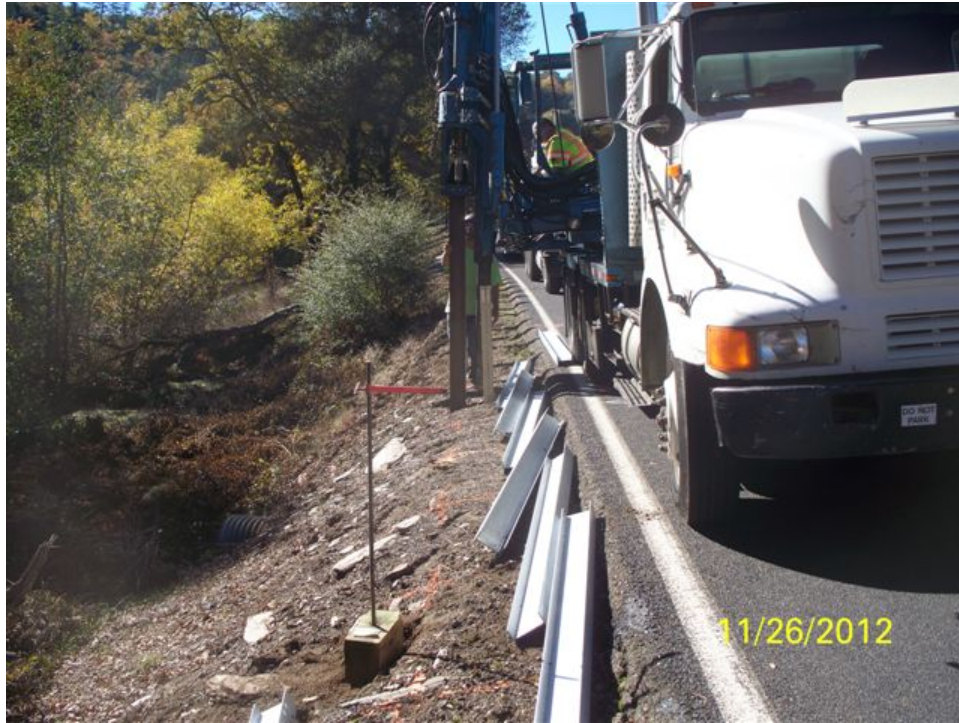
Figure 34. Driving the posts for the MBGR into the embankment material.

Figure 35. Driving the posts for the MBGR into the embankment material.

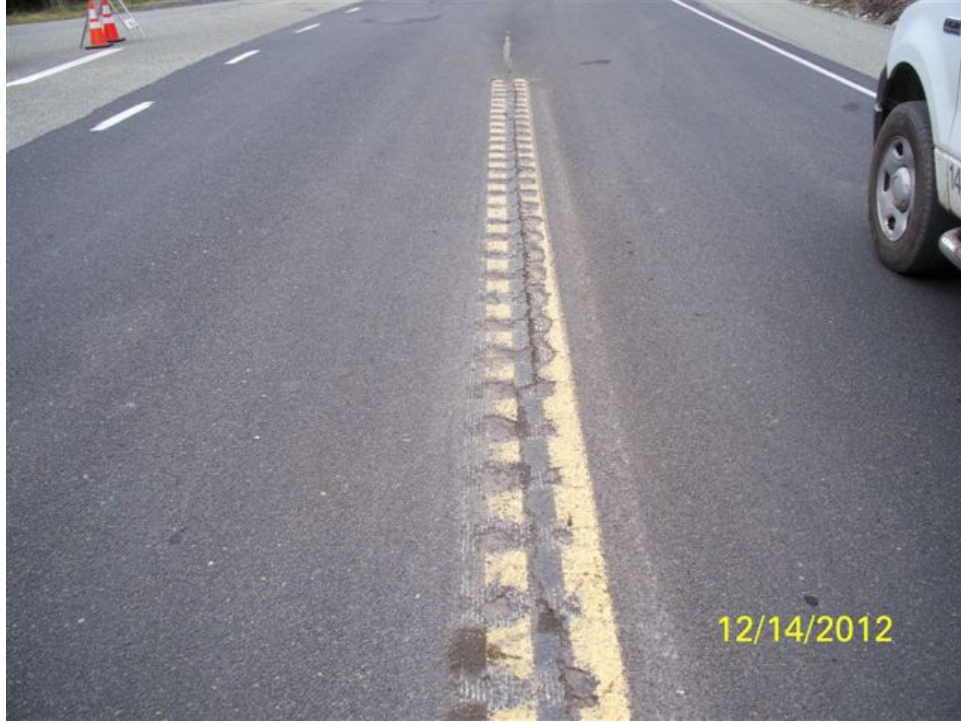
Figure 37. Ground centerline rumble strips.

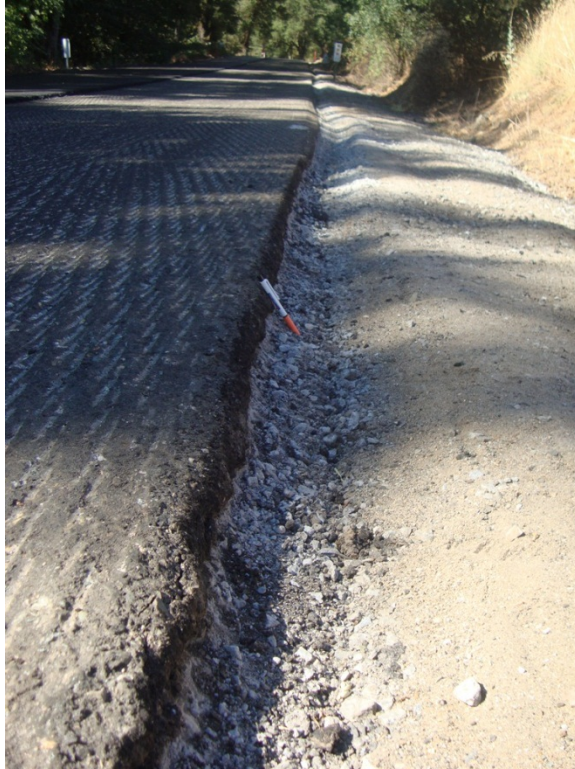
Figure 40. In many locations the shoulder material was clipped below the level of the existing pavement surface, resulting in Safety Edge heights greater than the overlay thickness.

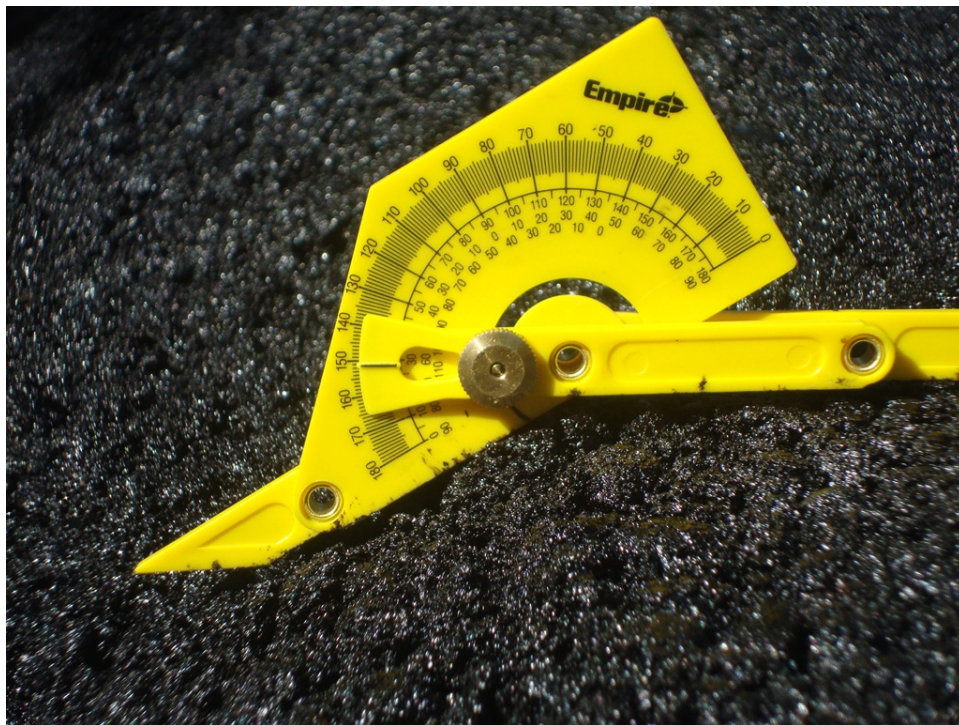
Figure 41. Typical Safety Edge slope on Mountain Ranch Road.

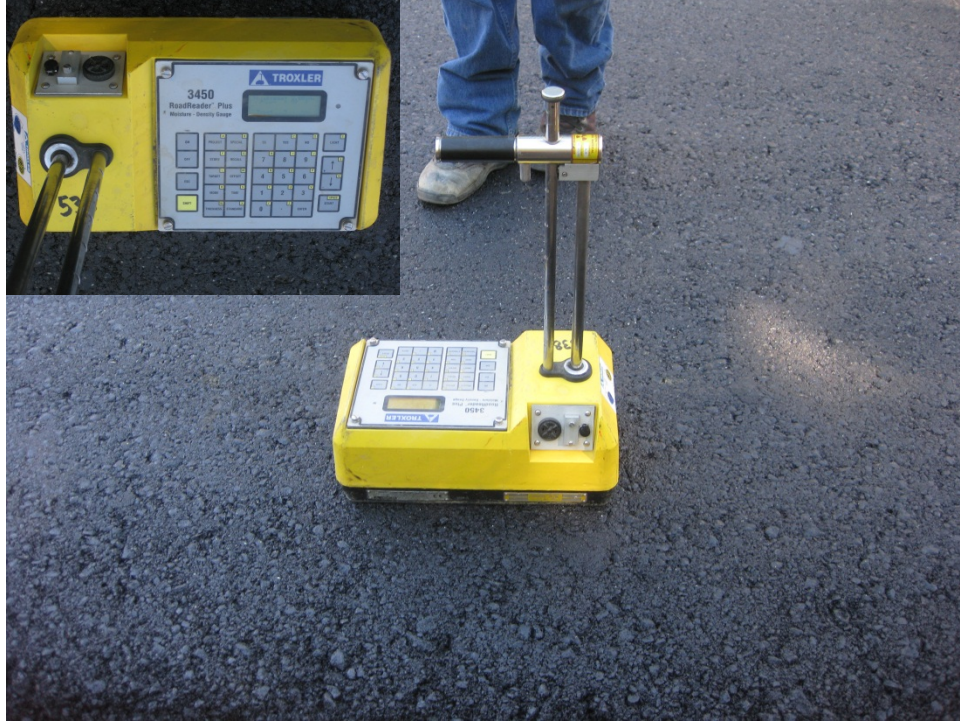
Figure 42. Measuring HMA mat density with a nuclear density gauge on Mountain Ranch Road.
