VIRGINIA I-66 CONCRETE PAVEMENT REPLACEMENT USING PRECAST CONCRETE PAVEMENT SYSTEMS

**Final Report
June 2013**

This report documents the HfL demonstration project on I-66 in Northern Virginia, which involved the use of one of HfL's vanguard technologies, the precast concrete pavement system (PCPS) for rapid slab replacement as well as alternate nighttime construction schedules to improve safety and alternate contracting methods for cost-effectiveness. Two types of PCPS were used in this project—the precast prestressed concrete pavement (PPCP) and a proprietary jointed precast concrete pavement system called Super-Slab[®].

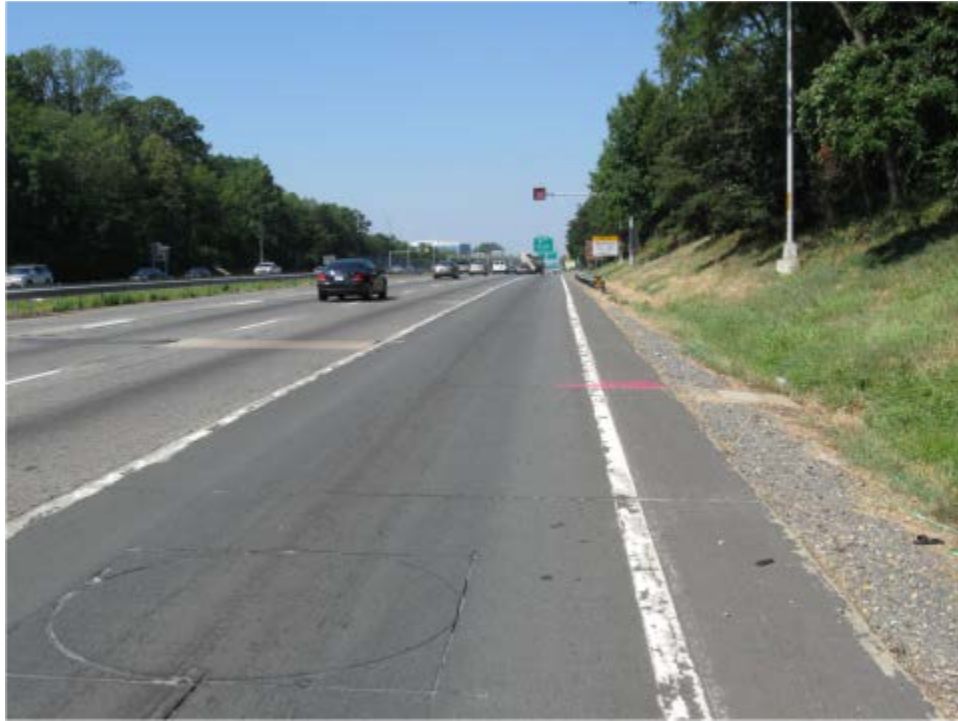
Figure 2. Westbound I-66 mainline with three lanes and an auxiliary shoulder.

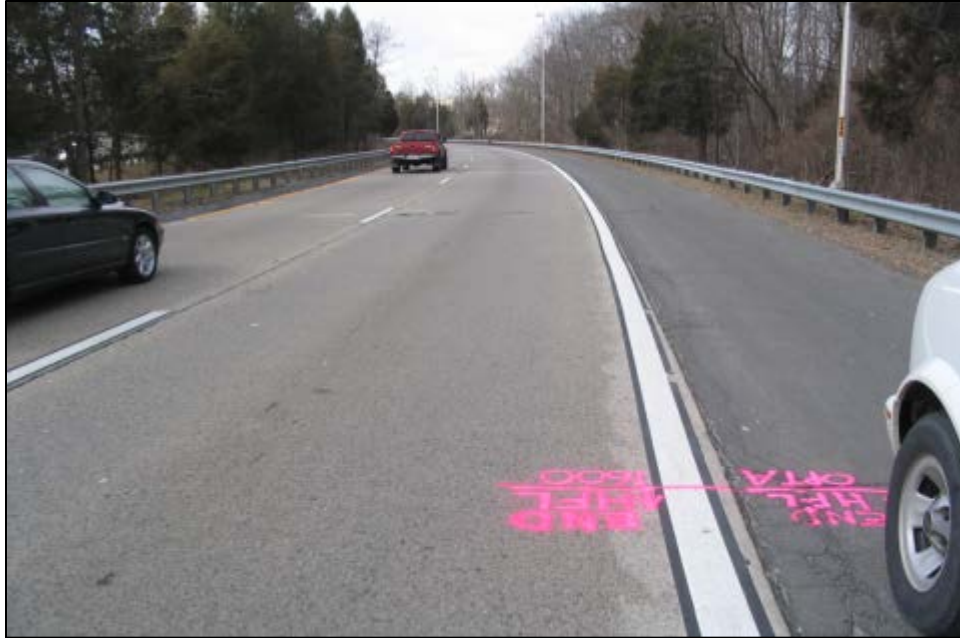
Figure 3. Ramp from I-66 to US 50 West with two lanes and a shoulder.

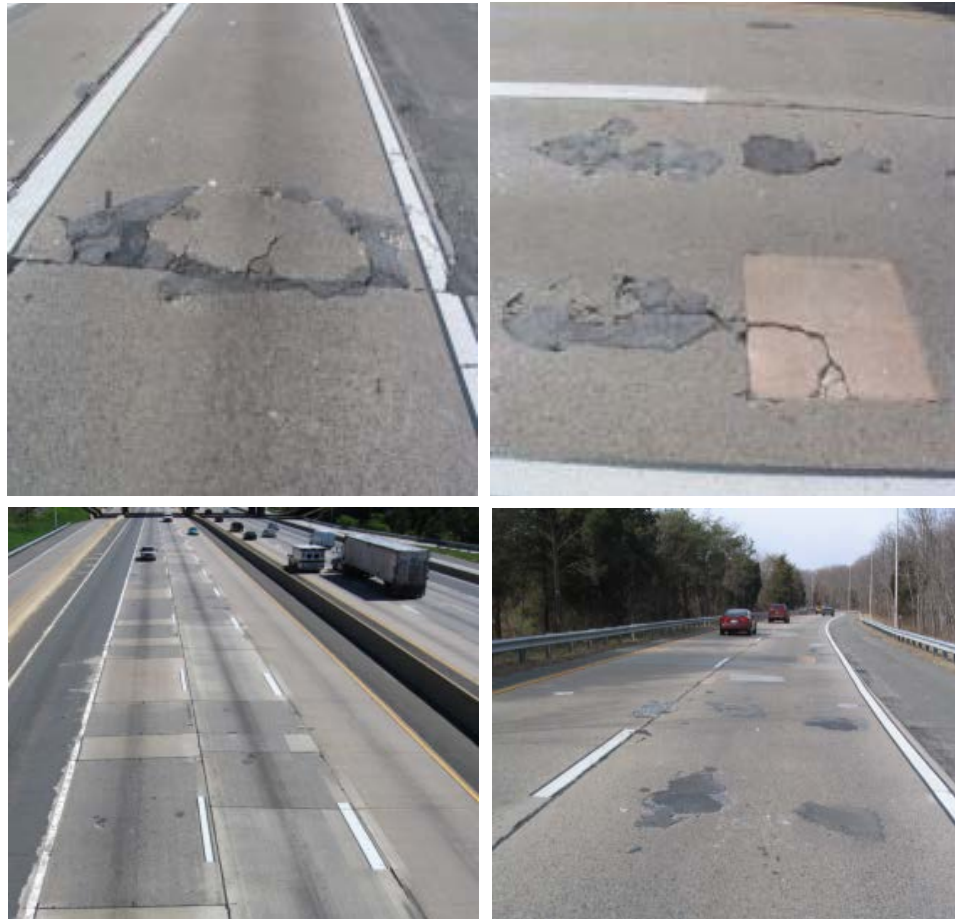
The existing pavement in this area, built in the 1960s, was in a highly deteriorated condition. The pavement structure consisted of a 9-inch jointed reinforced concrete slab over 6 inches of aggregate subbase, which was placed over a 6-inch cement stabilized subgrade. The pavement along the mainline and the US-50 West ramp suffered from extensive cracking, mid-slab spalling and deteriorated joints, as shown in Figure 6. This highway had undergone intermittent slab repairs over the last several years; however, the condition was poor enough to warrant an overall rehabilitation.

Figure 6. Surface condition of I-66 mainline and ramp leading to US 50 West in 2008.

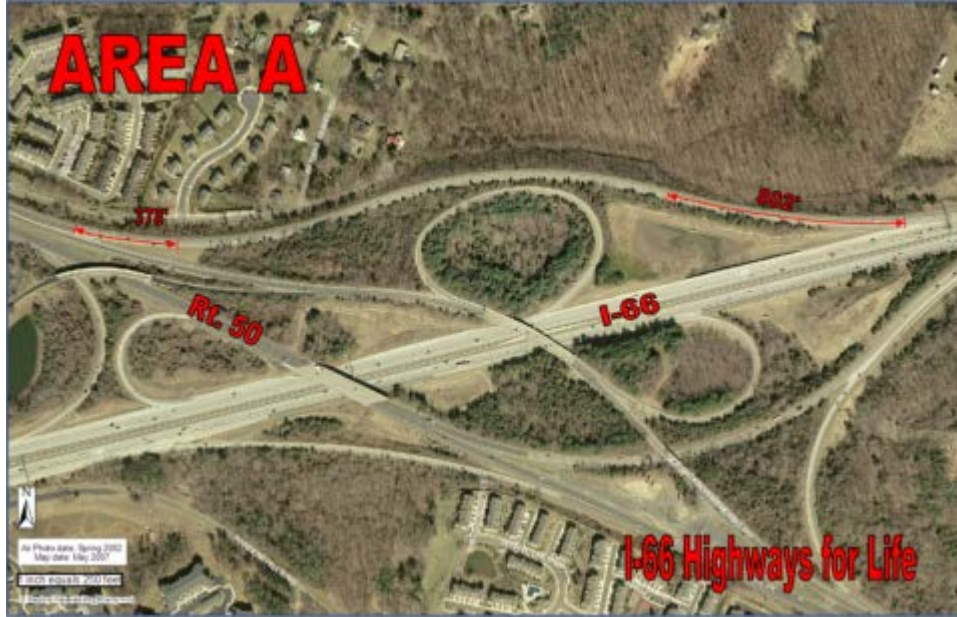
Figure 9. Area A repairs identified by VDOT for contractor bids.

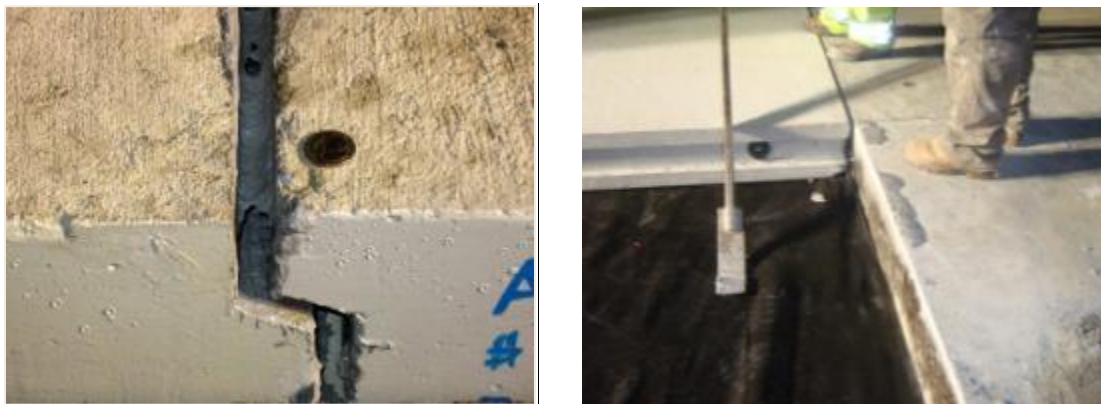
Figure 13. Shear key in PPCP panels for vertical alignment of slabs.

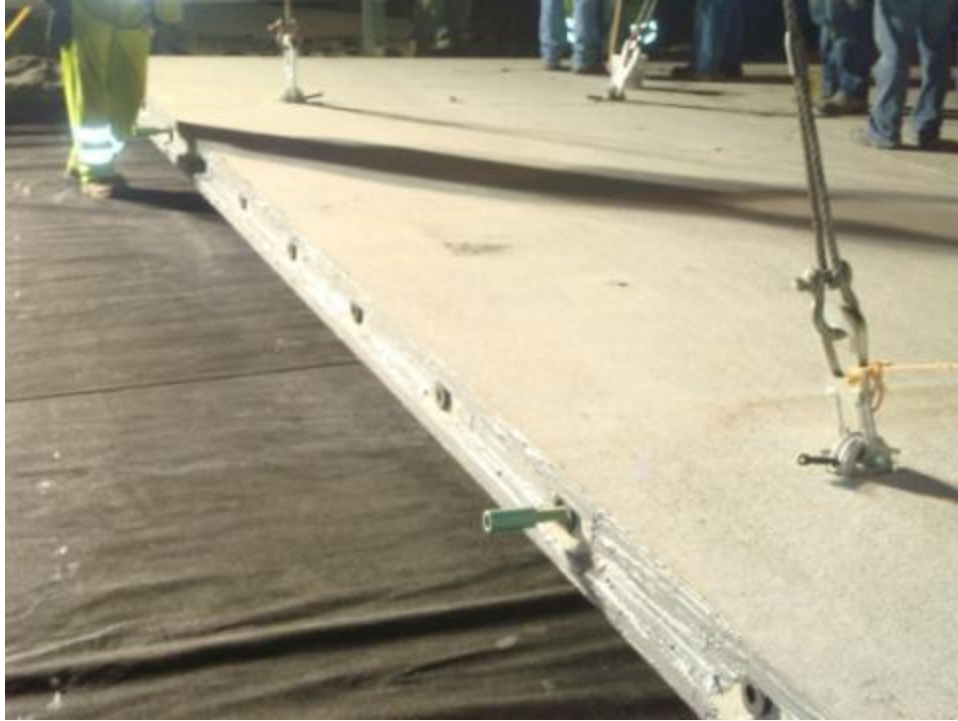
Figure 14. Ducts for post-tensioning strands.

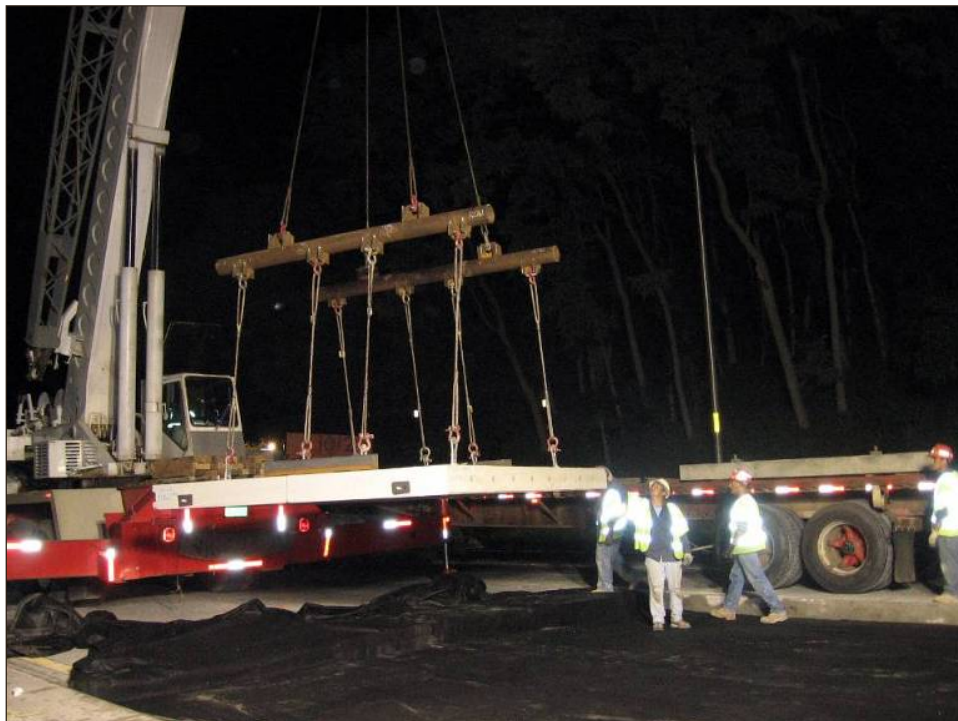
To permit slab movement (sliding) while post-tensioning, a frictionless surface beneath the slab is used. Regardless of the base type—asphalt, cement stabilized, or granular—a single layer of polyethylene sheet underneath the slab is used to permit effective post-tensioning (see Figure 15).

Figure 15. Use of polyethylene sheet underneath the slab for reducing friction.

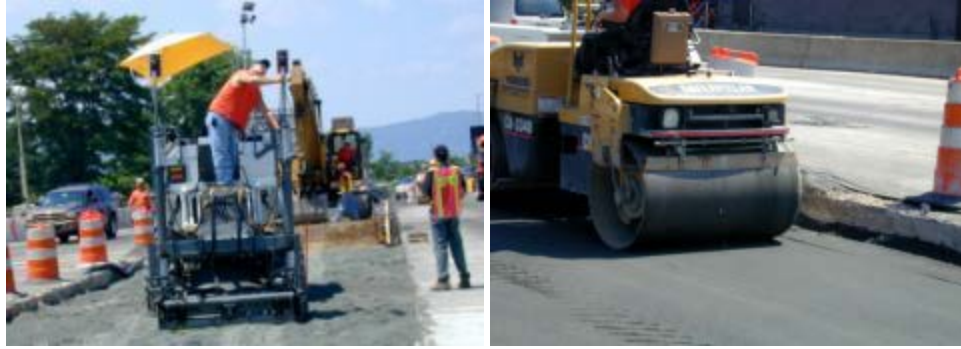
Figure 17. Use of specialized grading devices and base finish achieved (image from project in New York State, 2002).

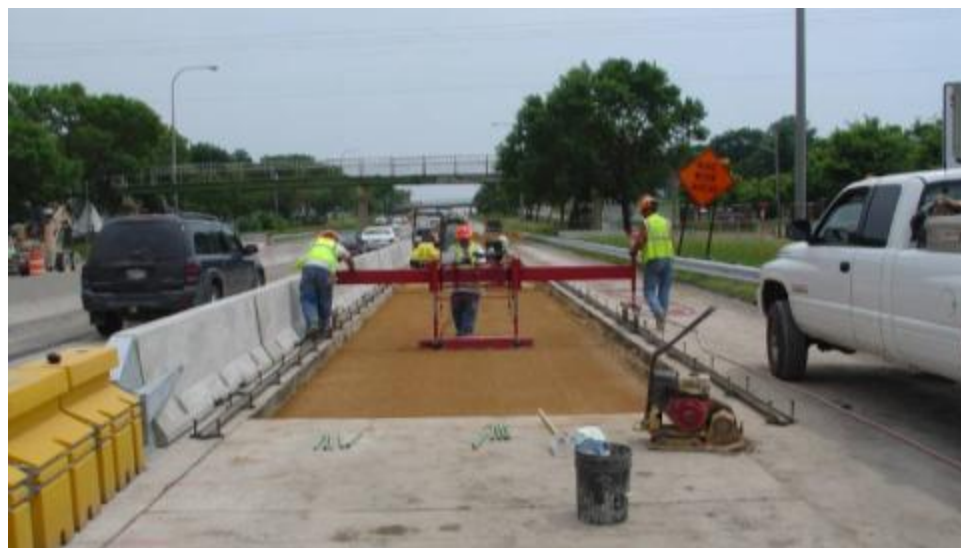
The Super-Slab[®] precast concrete slab system was developed by the Fort Miller Co., Inc., with assistance from the New York State Thruway Authority and New York DOT. This system was designed as a precast, non-prestressed concrete slab with a provision for inserting tie bars and dowel bars across the longitudinal and transverse joints, respectively. The design of this system makes it most suitable for intermittent repairs. Super-Slab[®] uses specialized construction methods; notable of them are the use of a laser-guided grader for base finishing, specialized base filler material, grouting material with specified flow properties and strength gain rates. The Super-Grader, shown in Figure 17, finishes and grades the bedding material to an accuracy of 1/16th of an inch, making the surface exactly parallel to the surface of the finished pavement. On smaller projects, or for intermittent slab repair jobs, base finishing is achieved through the use of a hand-operated grader that is supported on rails as shown in Figure 18.

Figure 18. Hand-operated grader supported on rails (image from project in New York State, 2002).

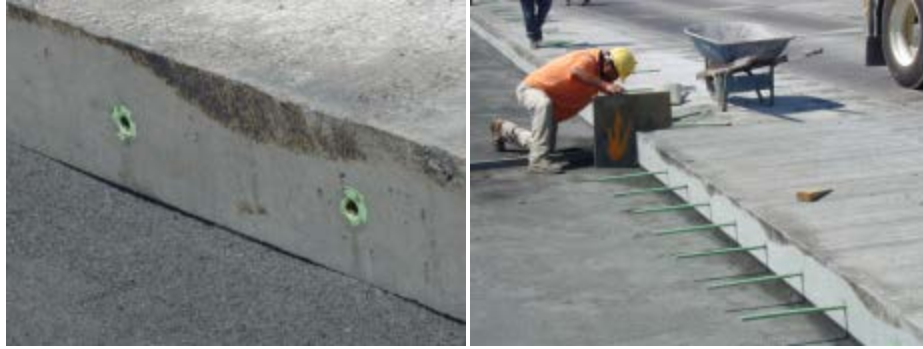
The unique feature of this precast slab technology is in its joint design. Dowel bars and tie bars are threaded into a slab through a prefabricated mechanical connector at mid-depth of the slab (Figure 19). The adjacent slab is provided with inverted dovetail slots—interconnecting slots at the bottom of the slab that perfectly align with the dowel and tie bars projecting from the first slab (slab threaded with the dowel), as shown in Figure 20.

Figure 19. Mechanical connectors for tie bars and installed tie bars (image from project in New York State, 2002).

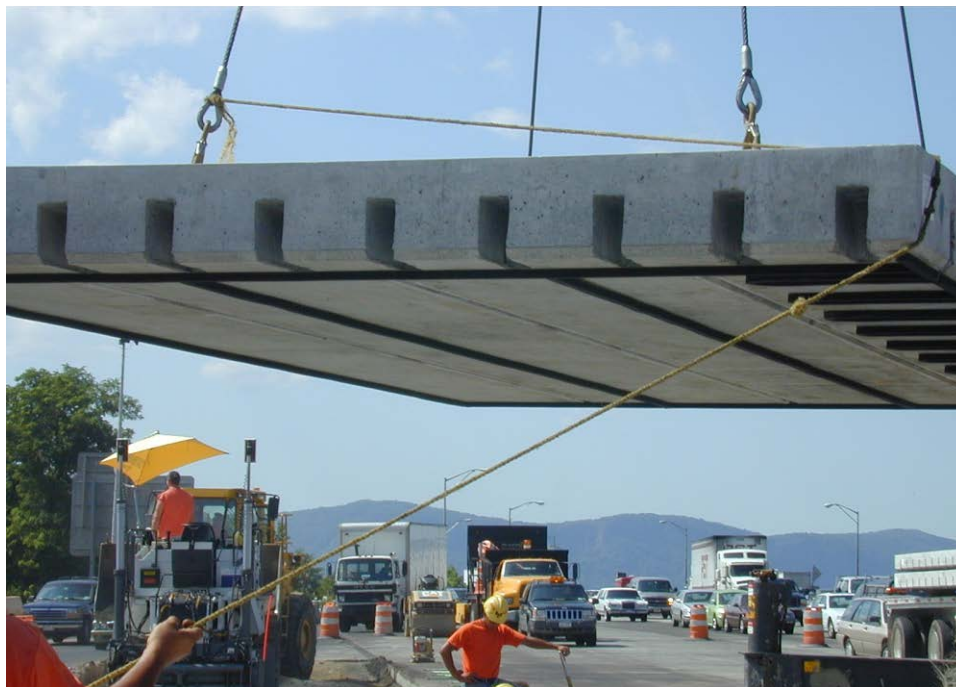
Figure 20. Inverted dovetail slots and foam gaskets underneath slab to control flow (image from project in New York State, 2002).

The Super-Slab[®] system also has a unique design for grouting the dowel bars and the bedding layer. Grout ports are provided on the top of the slab for the dowel grout and the bedding grout, as shown in Figure 21. Additionally, for even distribution of the bedding grout, grout distribution channel and foam gaskets are provided underneath the slab, shown in Figure 20 and Figure 22.

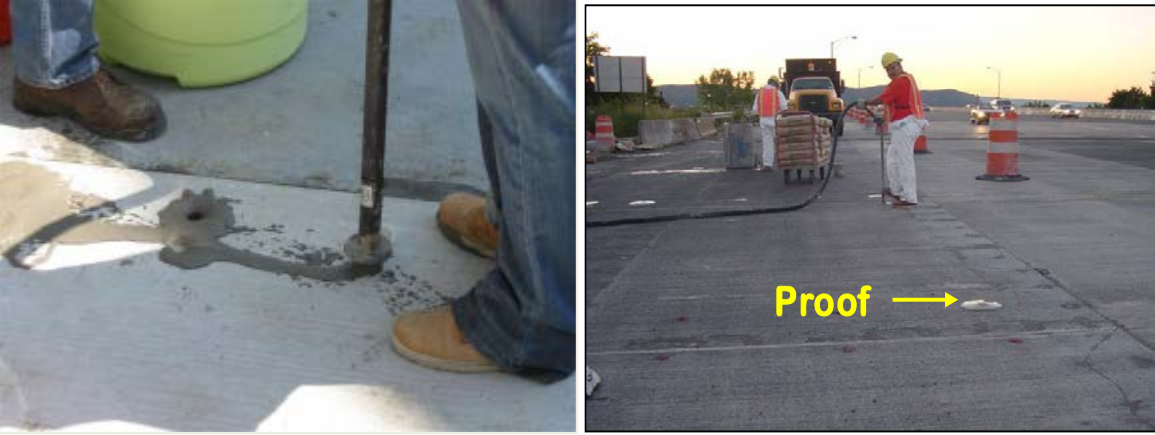
Figure 23. Verification of dowel grout and bedding grout distribution for uniform support (image from project in New York State, 2002).

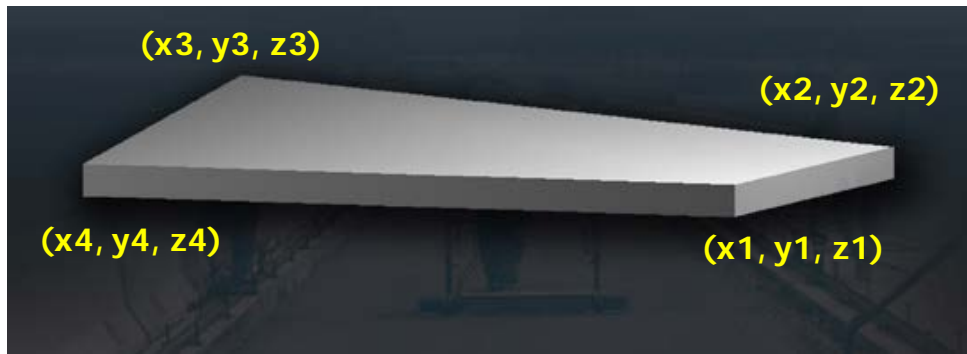
Super-Slab[®] panels can be cast to desired dimensions. They also may be cast in a single plane or as warped slabs. Single plane slabs are flat planes in which the cross slope is constant from one end to the other. Warped slabs have three corners of the slab in the same plane while the fourth corner is either higher or lower than the plane of the other three. Therefore, in warped slabs the cross slope varies uniformly from one end of the slab to the other, as shown in Figure 25.

Figure 25. Warped slab geometry in Super-Slab[®] design.

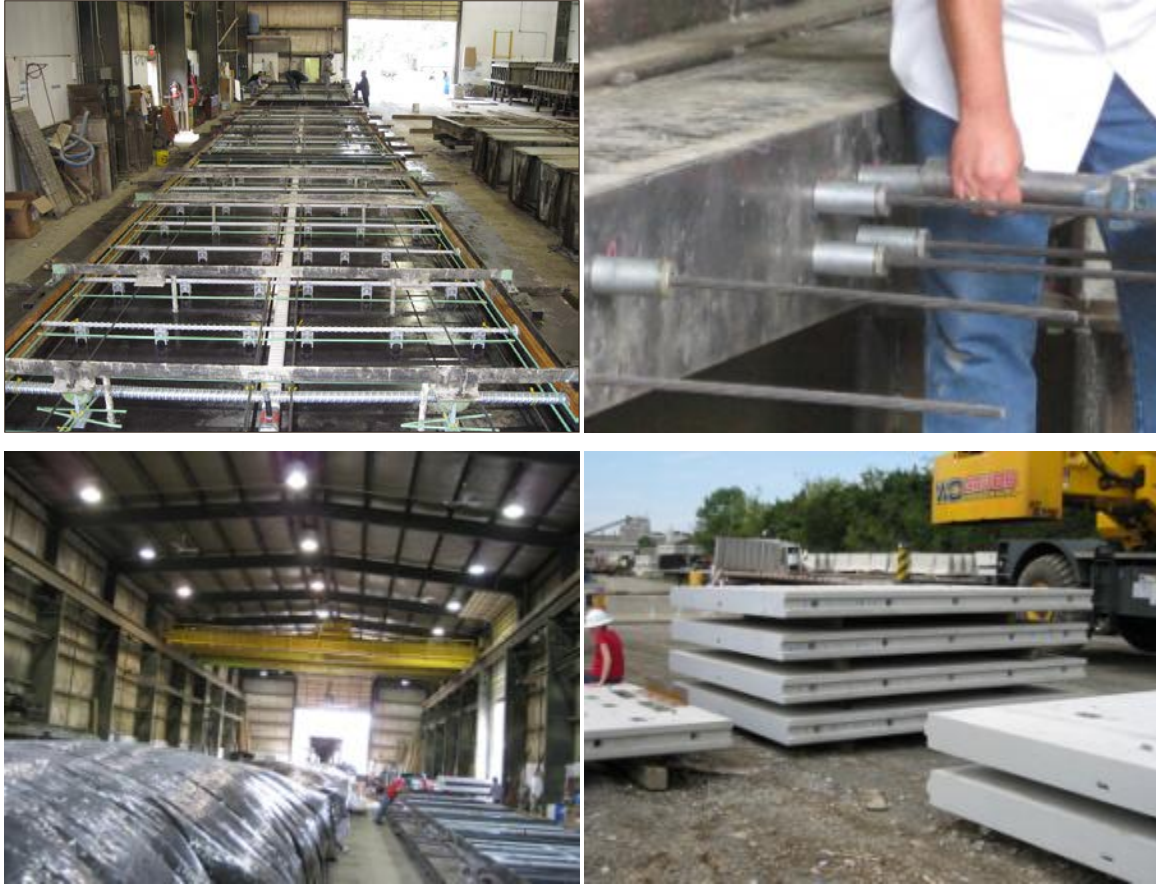
The PPCP slabs were 8.75 inches thick, and their dimensions were 12 by 10 feet and 27 by 10 feet for the single lane (lanes 1 and 2 individual) and double lane (lanes 3 and 4 simultaneous) replacements, respectively. The slabs were reinforced using Grade 60 epoxy-coated steel to withstand stresses resulting during handling and transportation. They were pretensioned in the transverse direction using 8-wire 0.5-inch strands. As shown in Figure 28, a 4-inch-high and 1.5-inch-deep tapered key way was provided along the slab edges to help with slab alignment. The slabs were broom finished on the surface. Smith Midland precast a total of 306 panels for this project. Figure 29 shows the form work used in the precasting operation.

Figure 29. PPCP formwork set up at precast plant, curing, and yard storage.

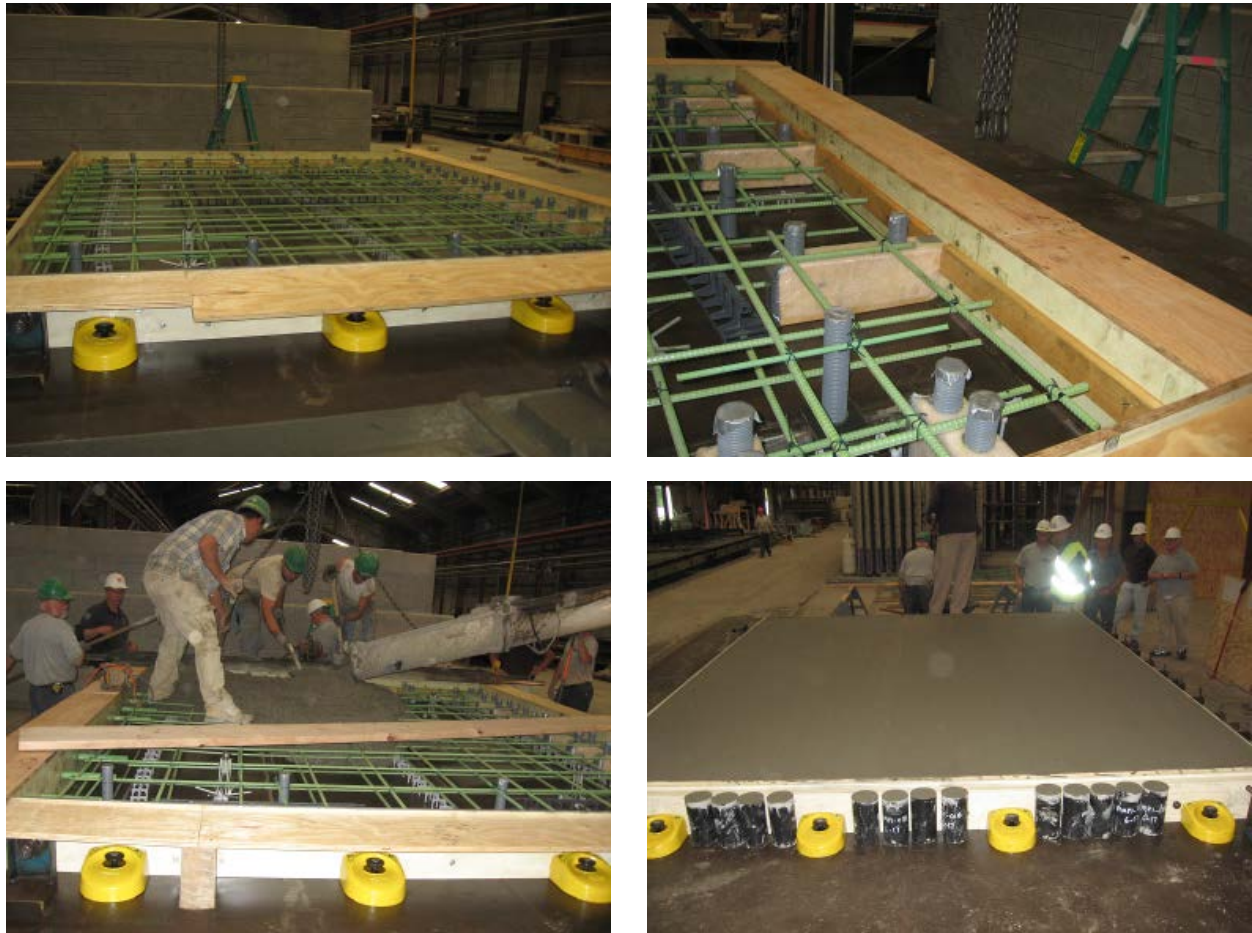
used were also Grade 60 steel. The dowels and tie bars were spaced at 12 inches and 30 inches c/c, respectively. M&M Precast cast a total of 224 panels for this project. Figure 30 shows the precast operations for the Super-Slab®.

Figure 30. Precasting operations and form work details for the Super-Slab®.

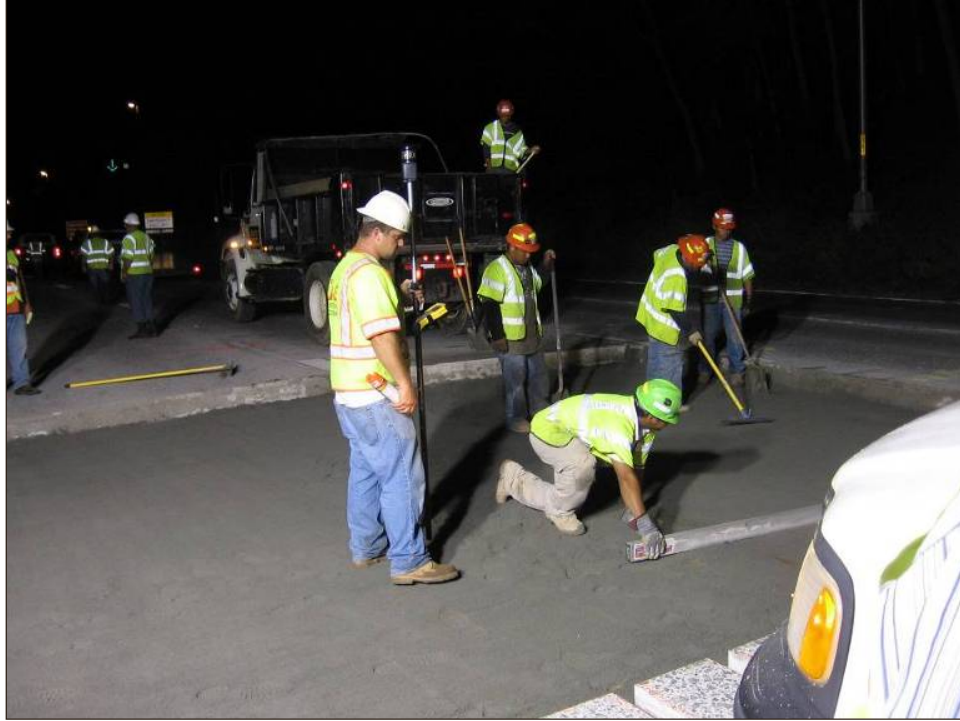
Figure 42. Base preparation and grading No. 10 aggregate for PPCP installation.

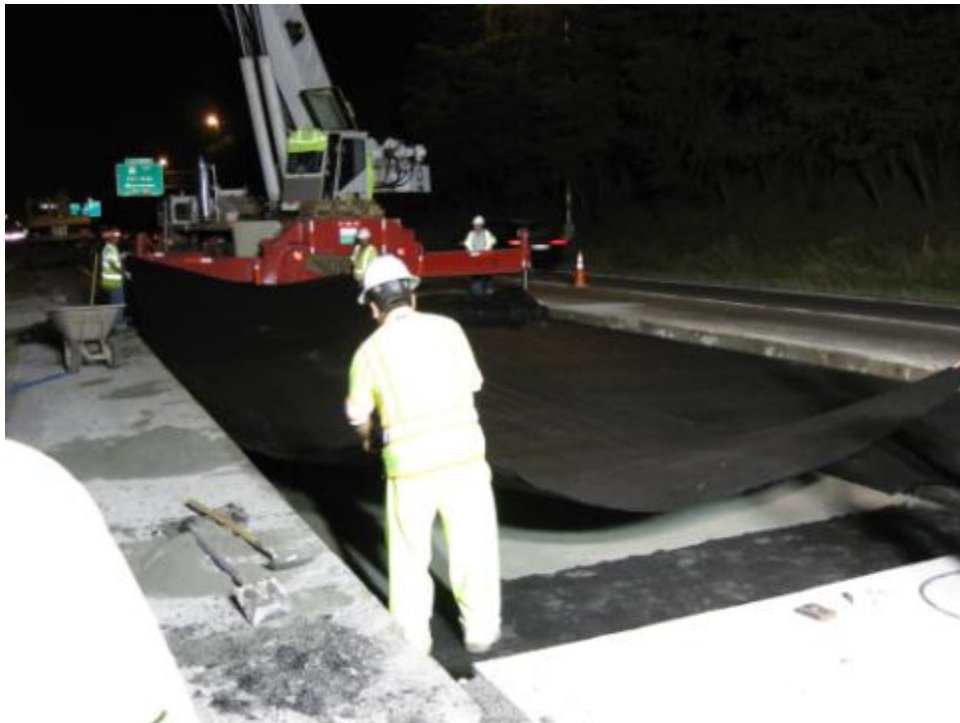
Figure 43. Geotextile fabric spread on graded base material to reduce slab-subbase friction.

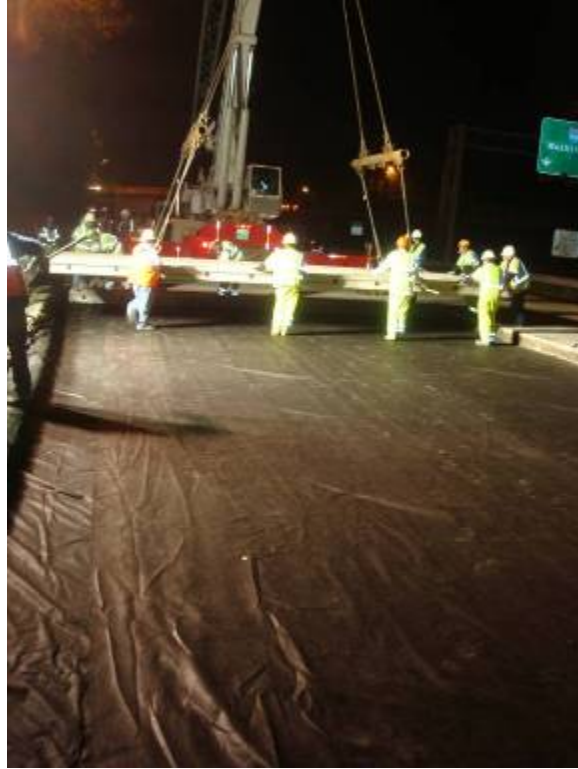
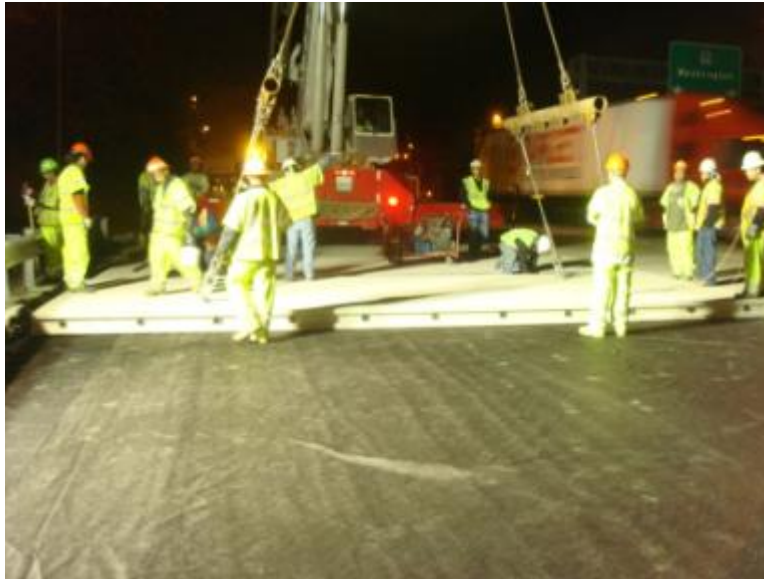
Figure 44. Slab placement and alignment (top and bottom).

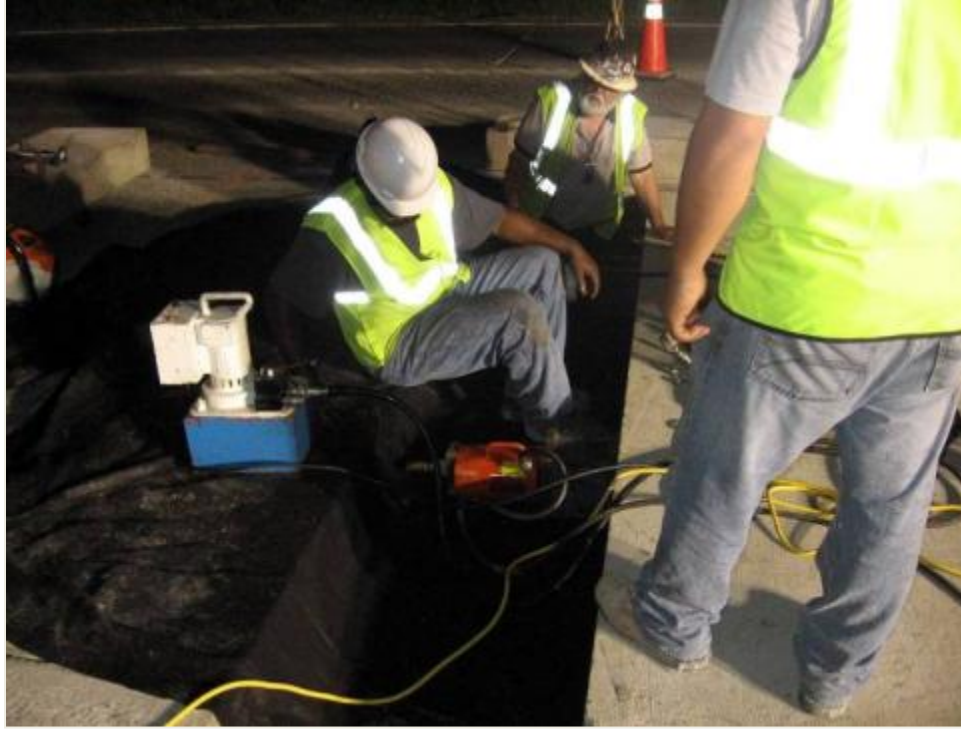
Figure 45. Initial post-tensioning.

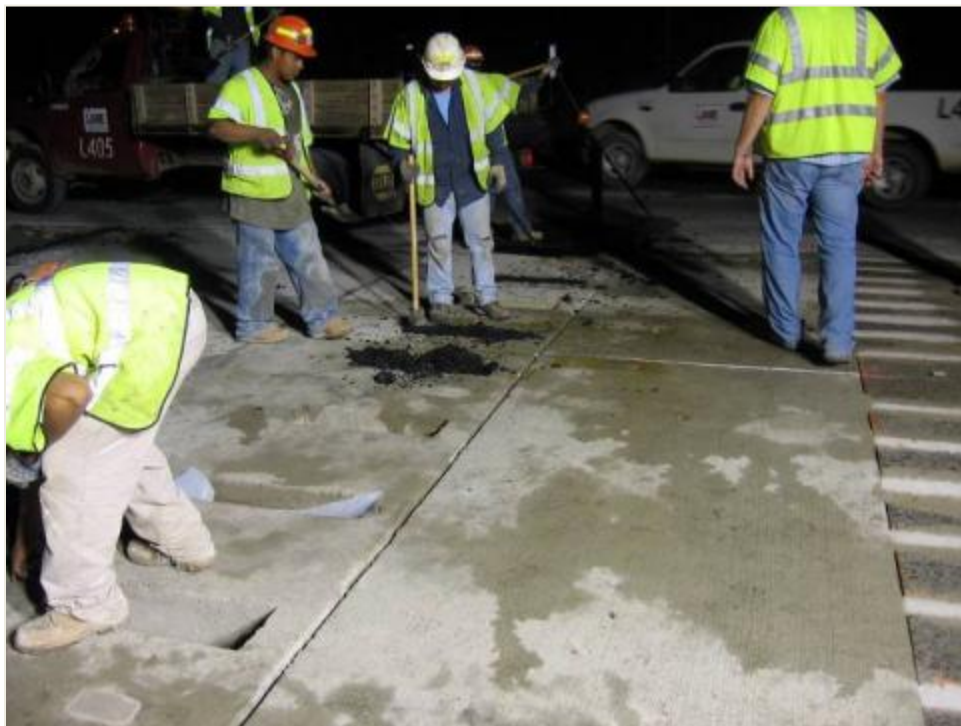
Figure 46. Cold patch in blockouts.

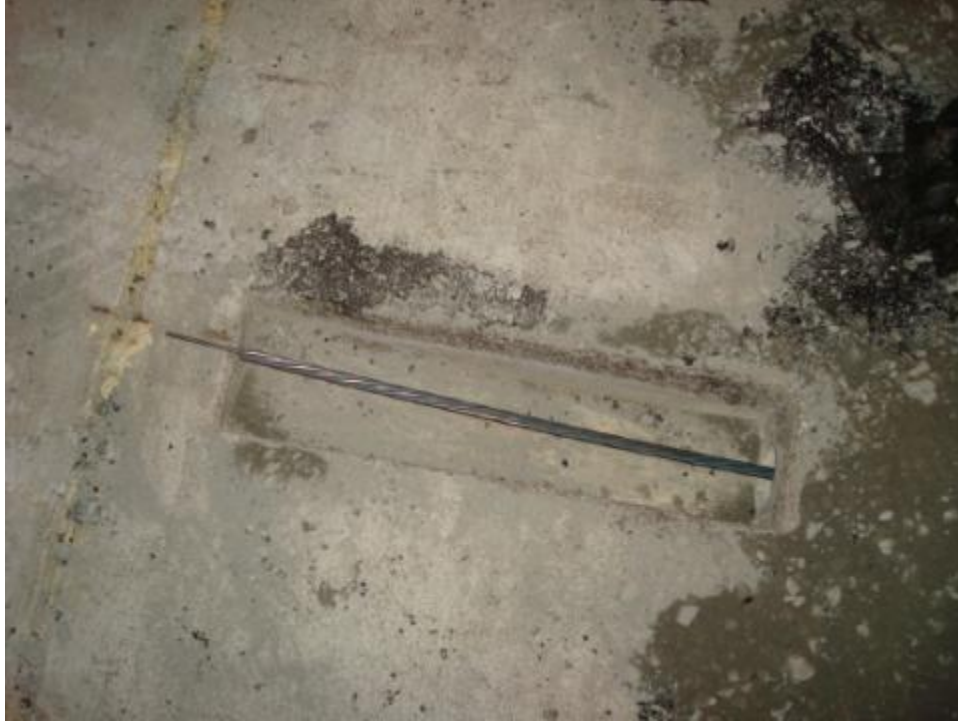
a) Tendon inserted in anchor panel blockouts

b) Post-tensioning

Figure 47. Final post-tensioning.

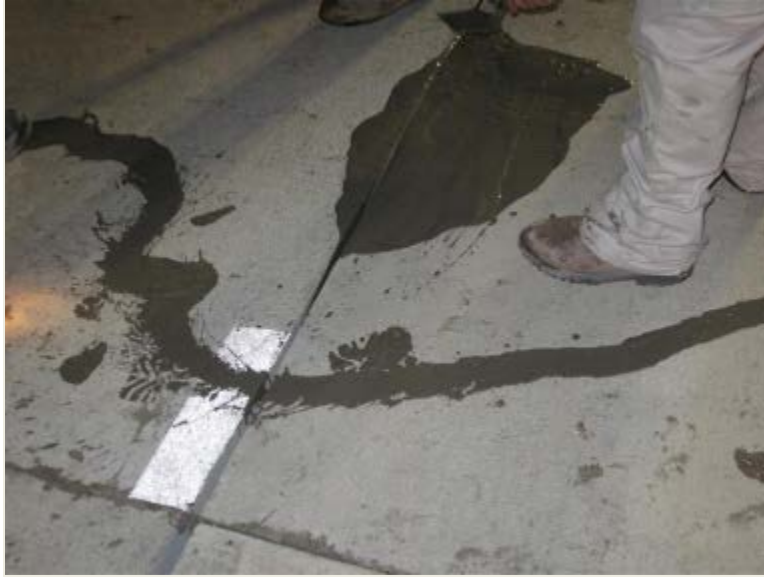
Figure 48. Grout leak from post-tensioning ducts.

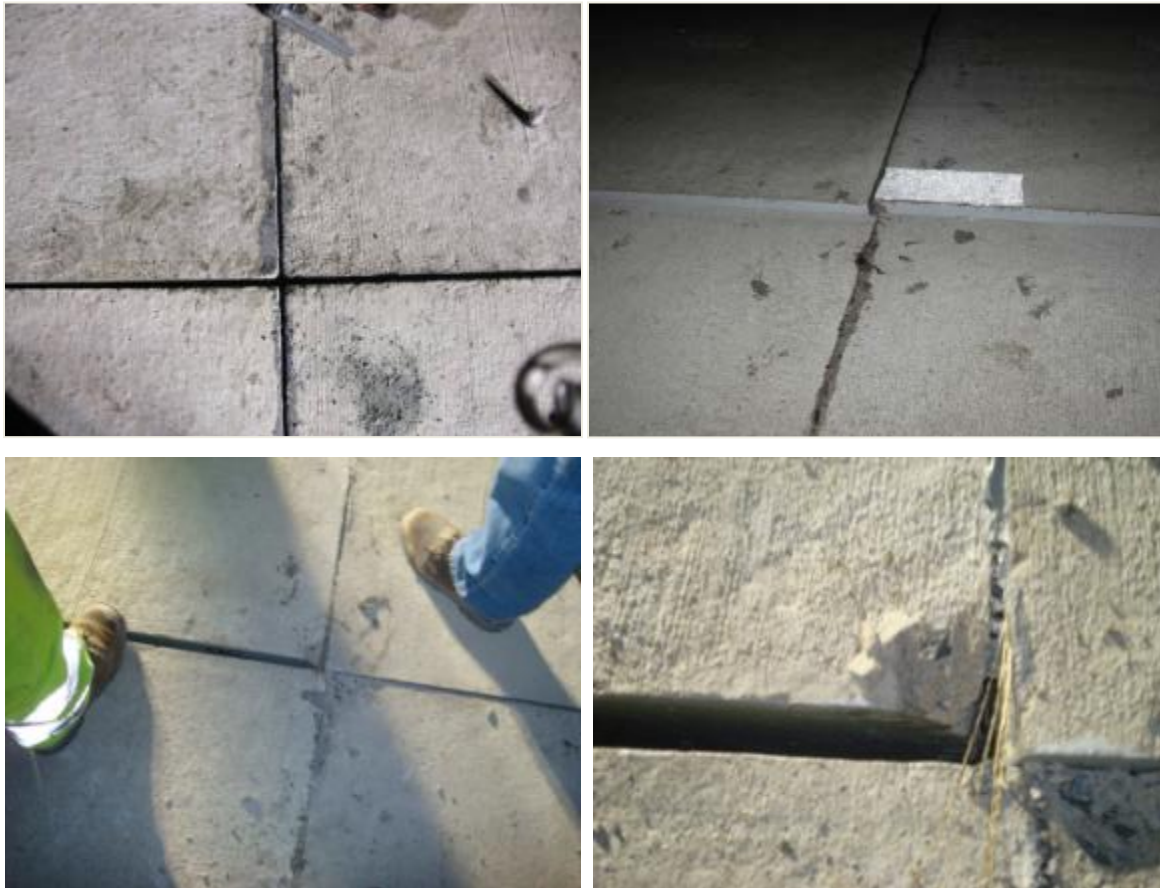
Achieving precast tolerances is also very important, and perhaps a tighter quality control process can be instituted at the precast plant. These tolerances are critical to align the panels in the longitudinal and lateral direction simultaneously. Lack of attention to this detail can result in elevation differences at joints and large joint openings (see Figure 49).

Figure 49. Issues with vertical and horizontal alignment of slabs and large joint openings.

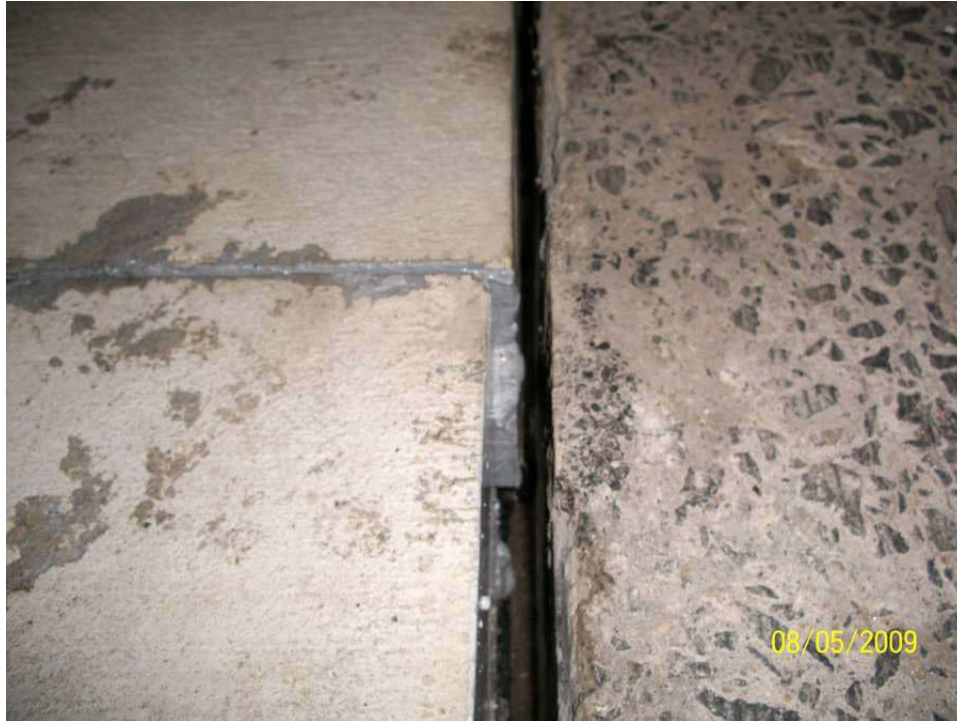
There also were some challenges faced in maintaining the joint against the existing pavement. It was found that it was important to use the survey baseline as a reference rather than attempt to perfect the alignment of each slab. A temporary cold patch or a closure pour is necessary to open the roadway to traffic after the end of a day's installation.

Figure 50. Transverse joint misalignment.

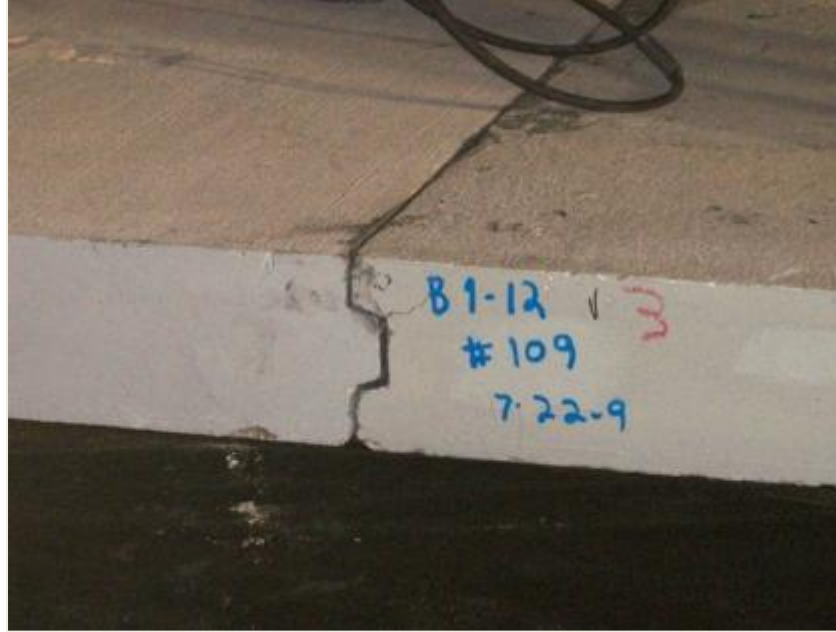
Figure 51. Crack in slab #109 at keyway. Note top of keyway rests on lower slab.

Panel Design: Cracking occurred over grout channels. Consider changing the orientation of grout channels (longitudinal instead of transverse), especially for longer panels.

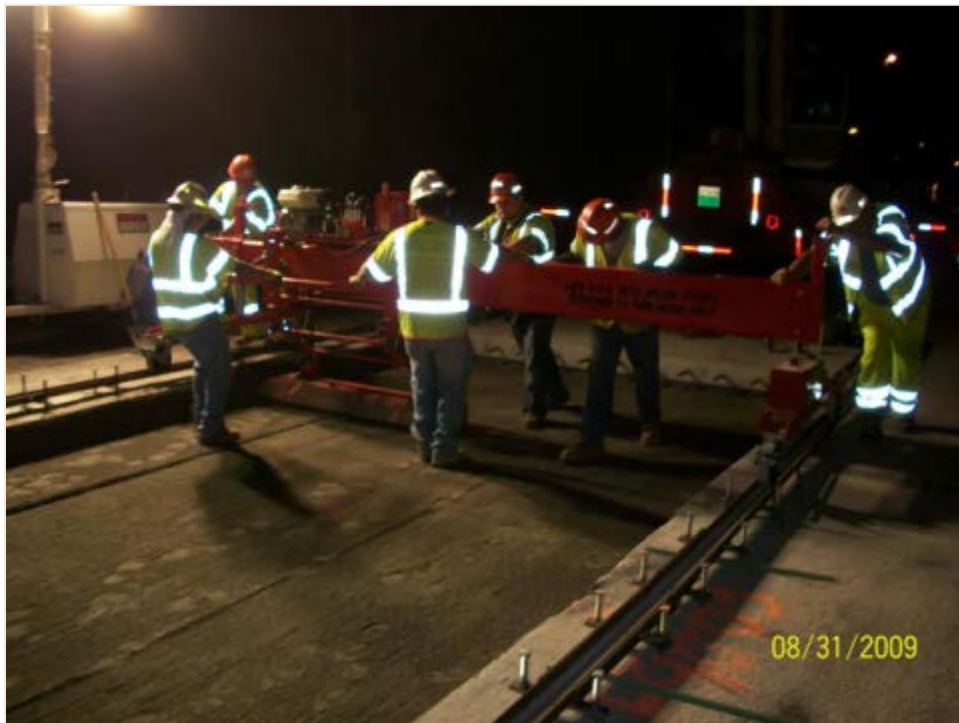
2. Removal of existing pavement as seen in Figure 54.
3. Super-grading of base layer using a rail supported and hand operated grader. A thin layer (~1/2 inch) of fine bedding material was placed, fully compacted and graded to provide a precise subgrade surface in accordance with the surveys. This was finished accurate to $\pm 1/8$ inch.
4. Anchoring tie bars in adjacent lane (see Figure 56) and threading dowels in adjacent Super-Slab[®] panel installed earlier.
5. Installation of Super-Slab[®] panels (Figure 57).
6. Grouting of dowel sockets and bedding layer (shown previously in Figure 23).
7. Grinding for smoothness requirements. The grinding operation was necessary to meet smoothness requirements in the Super-Slab[®] panels as well.

Figure 55. Fine grading of subbase material.

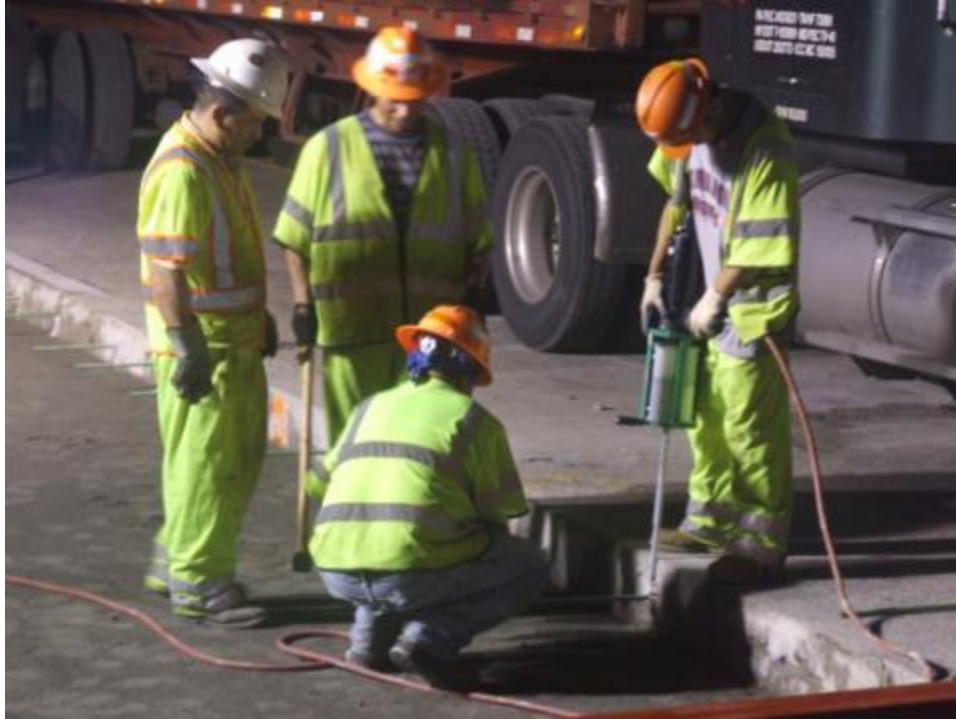
Figure 56. Anchoring tie bars in existing pavement in adjacent lane.

Longitudinal Joints: The Super-Slab[®] was placed along one lane of the entire length of the ramp. This necessitated tying the Super-Slab[®] panels to the existing pavement. Additionally, select slabs in the existing pavement were replaced using high early strength concrete in CIP construction. This process resulted in several challenges, and as a lesson learned, VDOT suggests that it might have been more productive to replace both lanes of the ramp using PCPS

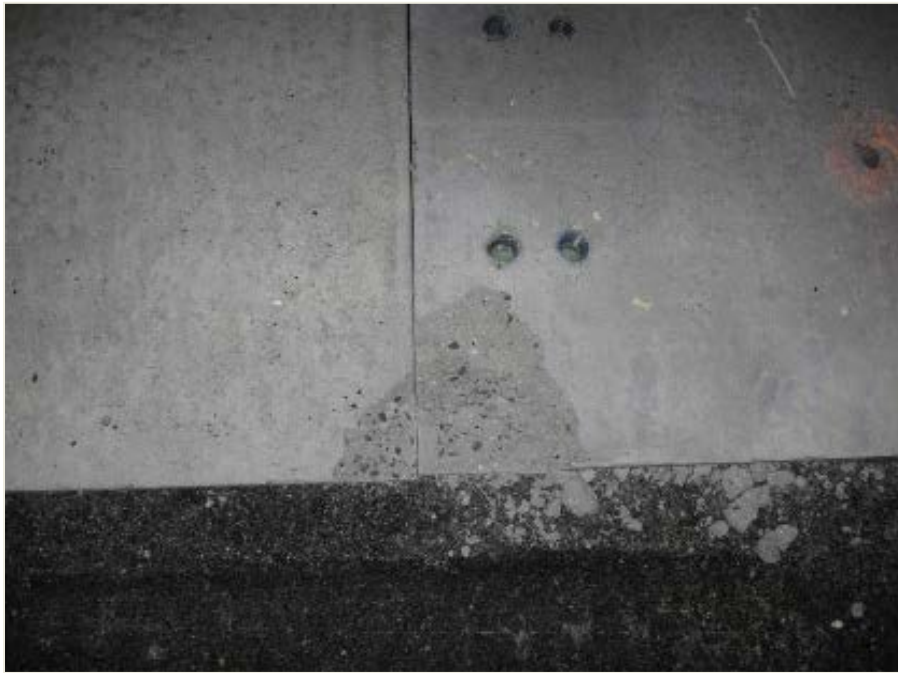
The condition of the existing lane and/or the condition of the longitudinal joint was unknown (or not determined) for each Super-slab[®] panel installation. At times, the poor condition of the joint necessitated the use of additional grout. In the event the longitudinal joint is in a bad condition, either it should be factored into the design, or it is better to replace both lanes. In this project, within the budget constraints, it could imply that both lanes of the ramp could be replaced over a shorter distance rather than one lane replaced over a longer length.

Figure 58. Spalling at joints on the ramp. Note panels were in contact.

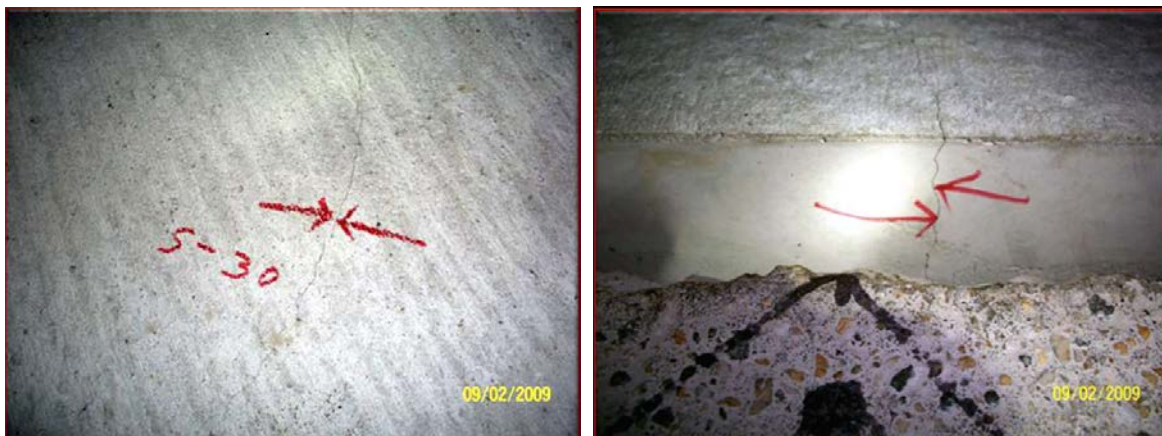
Finally, the jointed PCPS slabs also showed evidence of cracks at random locations. It was found that it is necessary to grout the panels as soon as possible and before trafficking if possible. Also, each jointed PCPS slab should not be tied along the longitudinal joint to more than one CIP slab. That way, there are no differential movements that can cause slab cracking.

Figure 59. Slab cracking observed in the jointed PCPS panels on the ramp.

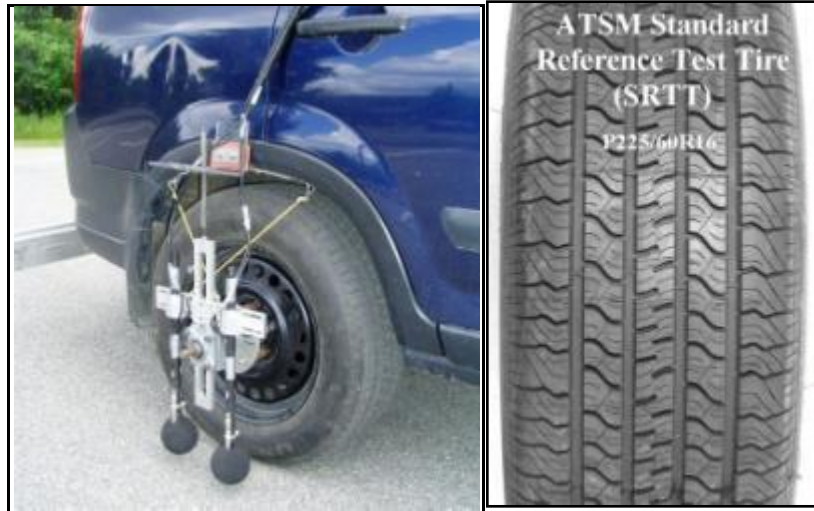
Figure 61. OBSI dual probe system and the SRTT.

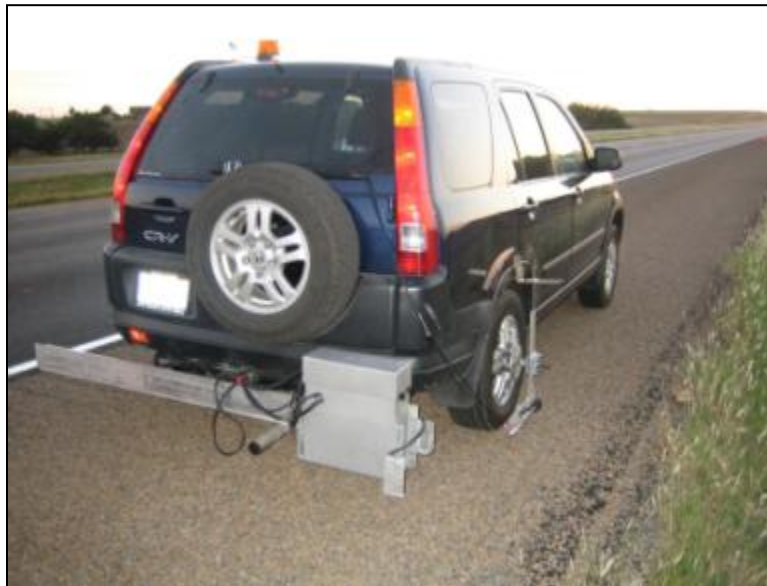
Figure 63. High-speed inertial profiler mounted behind the test vehicle.
