# Evaluation of the Performance of A1010 Bridge Steel

**Final Report**  
**January 2020**

**Sponsored by**  
Iowa Department of Transportation  
(InTrans Project 16-562)

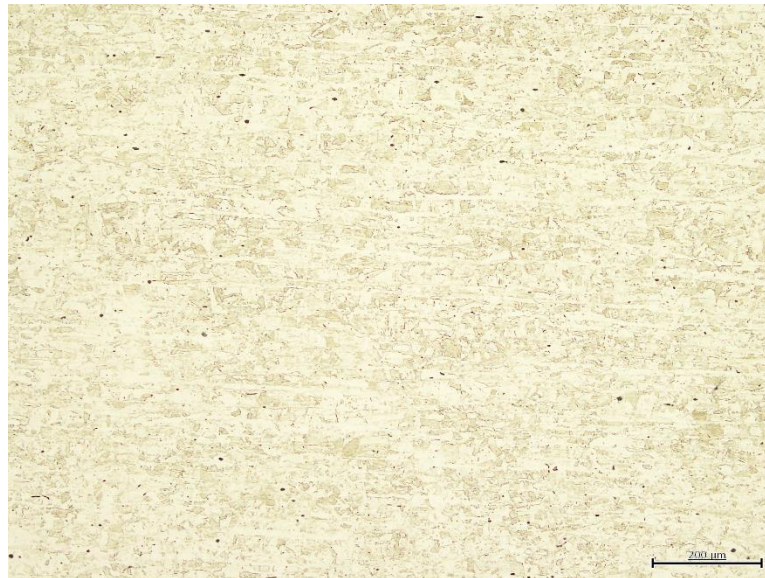
The optical microscopic image of ASTM A1010 steel was obtained using Adler's 300 Series etchant, which colorized the structure, as shown in Figure 6.

a) 50×

b) 200×

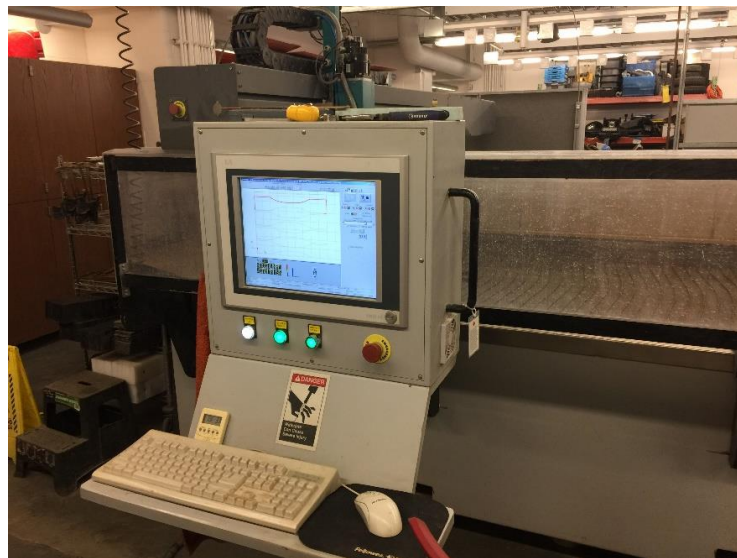
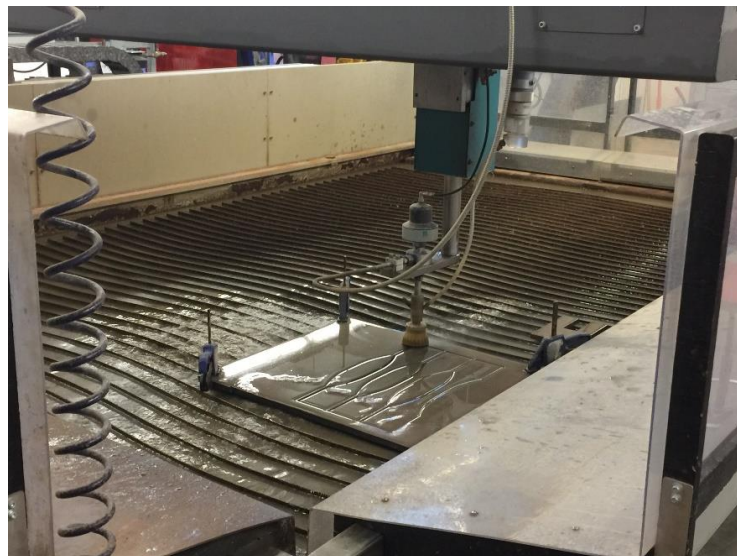
The geometry of the coupon samples was designed by following the standard test method according to ASTM E8 (ASTM 2016). The water-jet cutting technique was utilized for the A1010 tensile coupons that were cut from the plates located in the elastic region of the failure specimen after the ultimate bending test. Figure 7 shows the coupon sample preparation for the A1010 tensile tests.

a) Water-jet control system

b) Coupon sample cutting

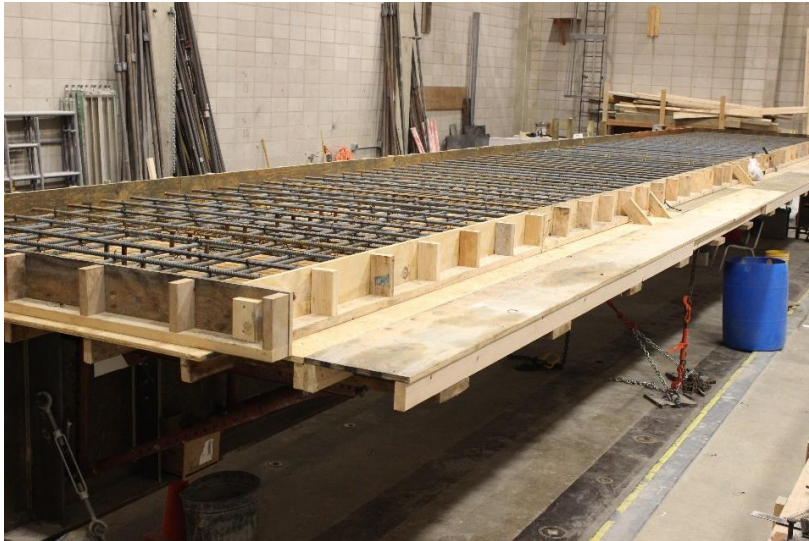
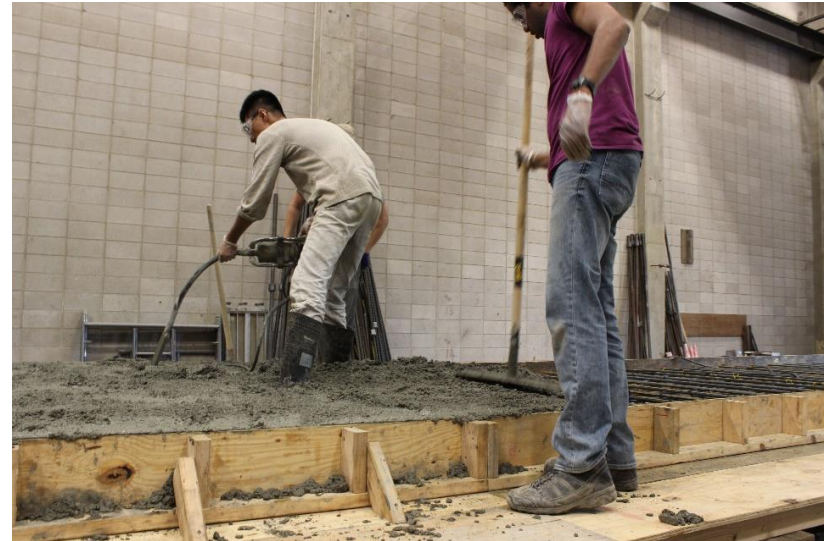
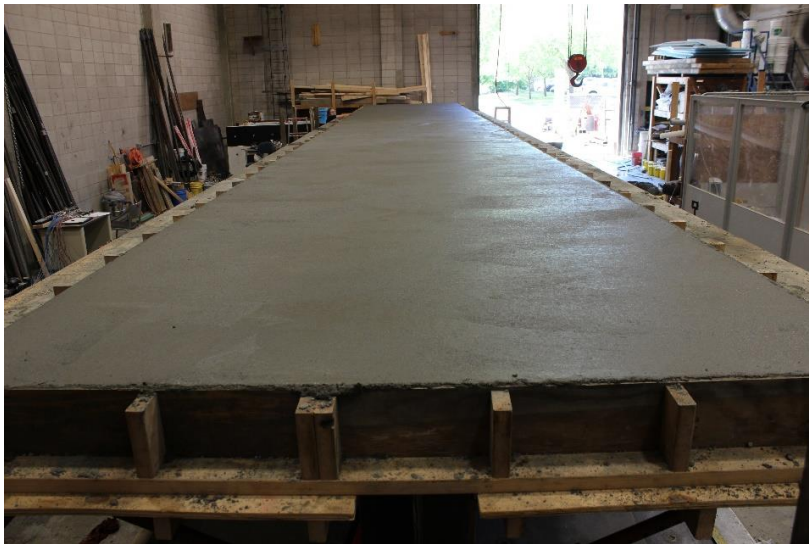
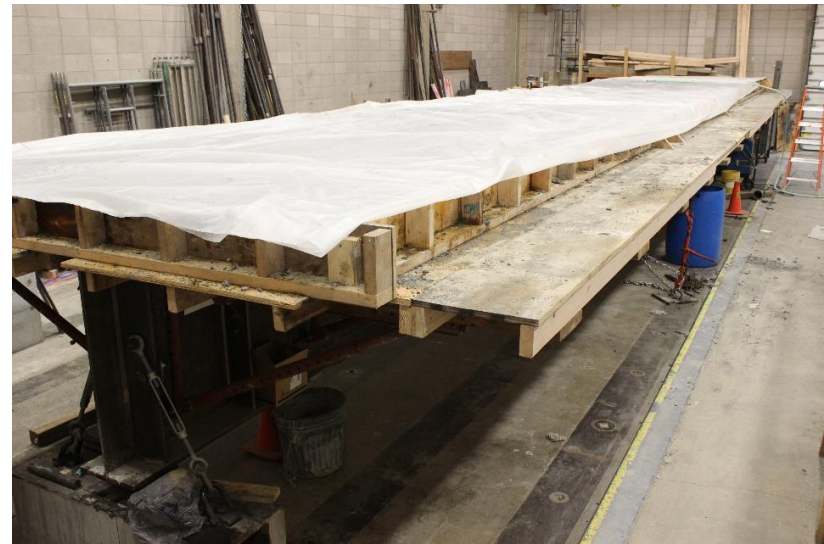
Figure 12 presents the critical steps for specimen fabrication.

a) Formwork and reinforcement

b) Concrete placement

c) Deck finishing

d) Deck concrete curing

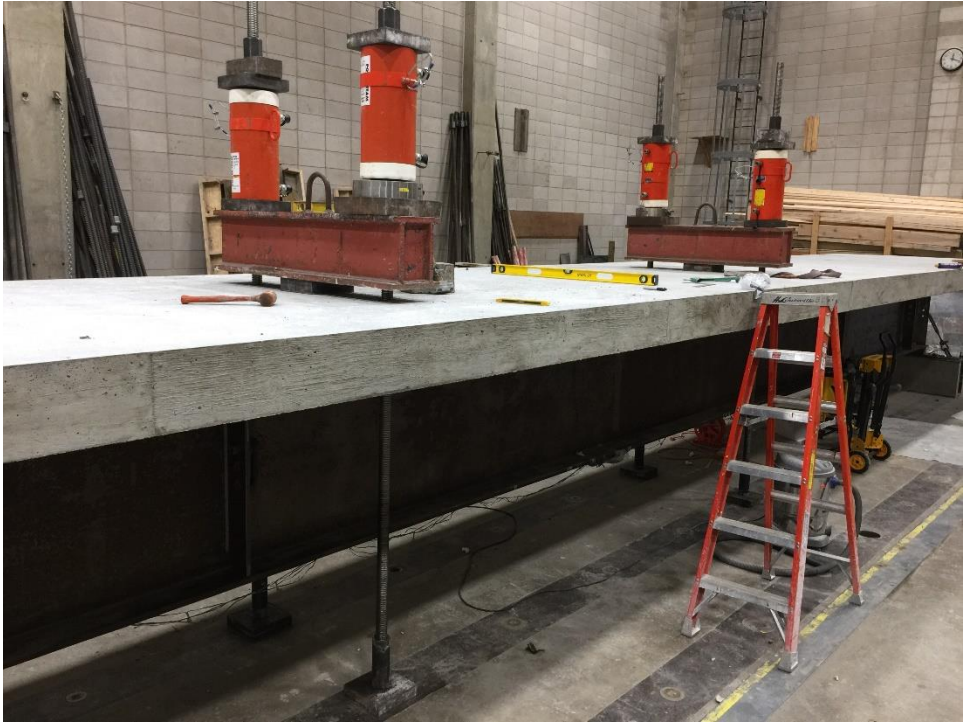
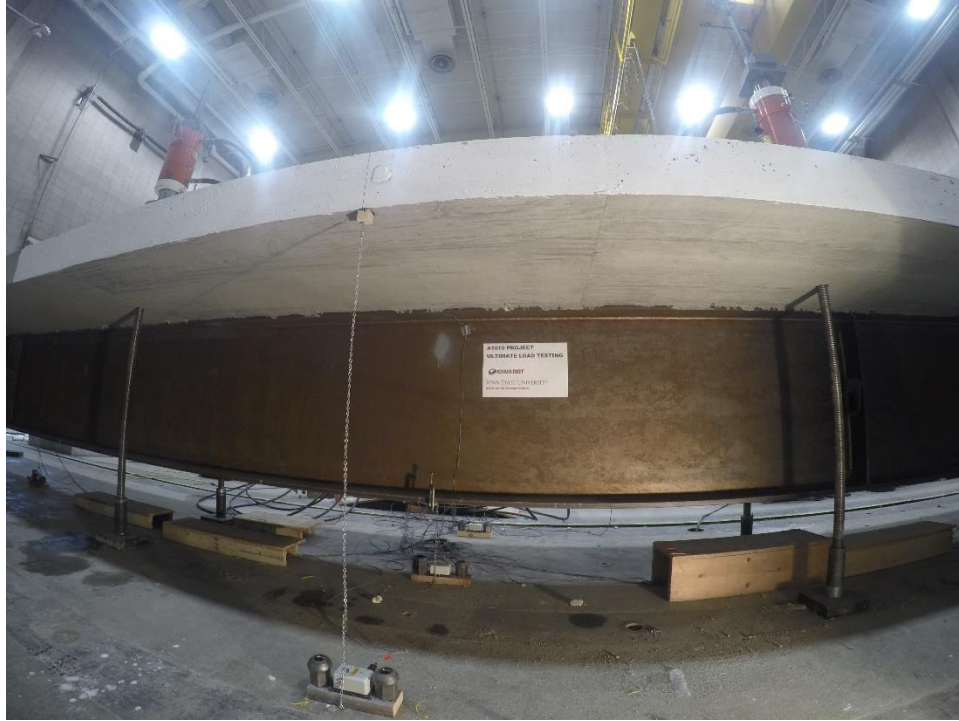
b) Side view of loading setup

c) Bottom view of loading setup

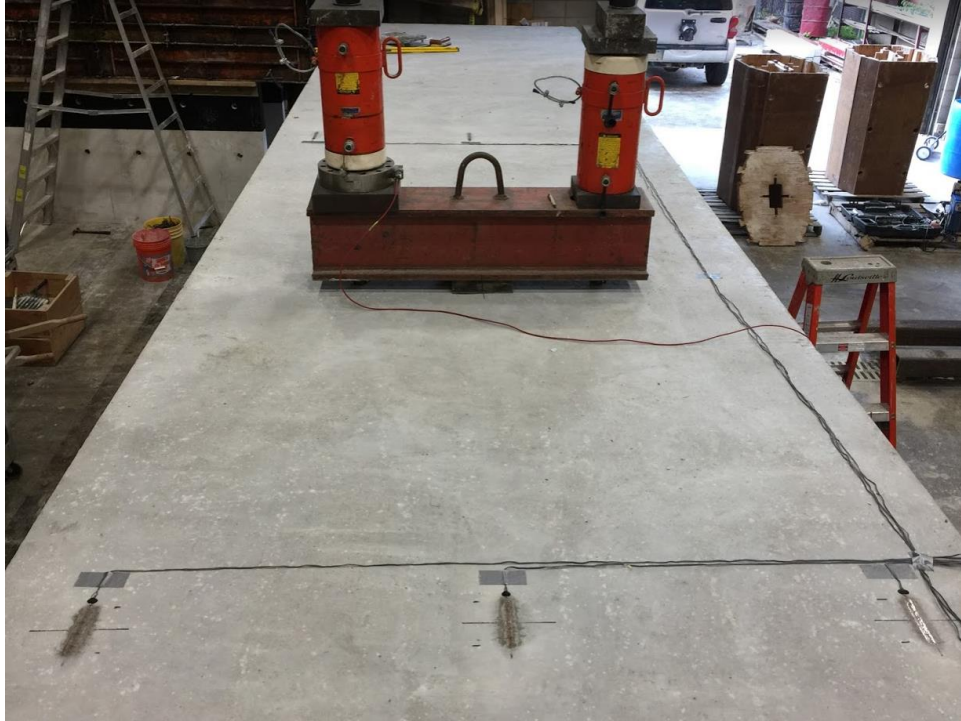
a) Strain gauge arrangement on concrete deck

b) Strain gauge on A1010 steel

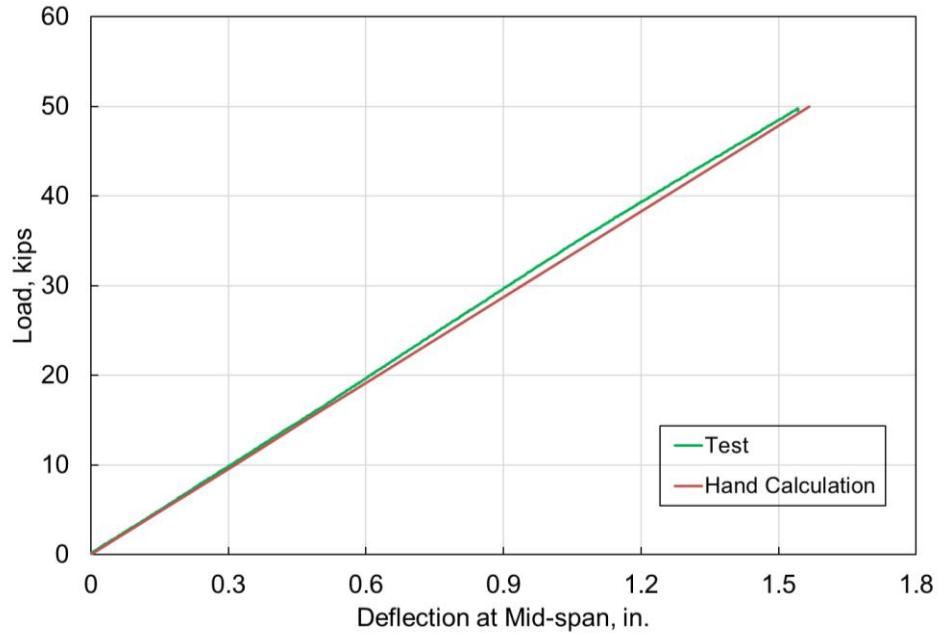
Figure 17 shows the relationship between the load-displacement curve measured from the test and that obtained from the hand calculations.

**Figure 17. Load vs. displacement, Test A**

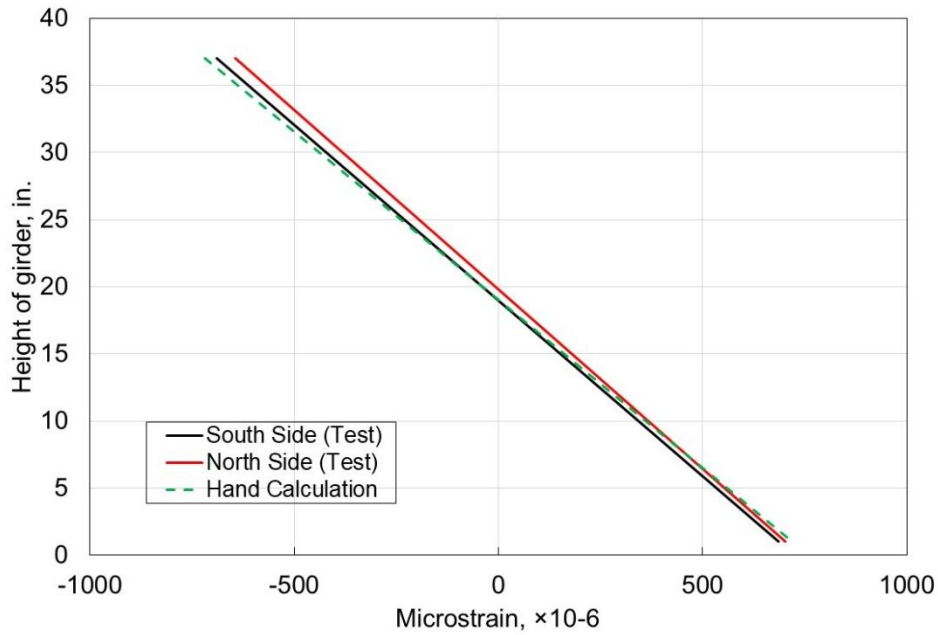
The comparison between the strain profile measured from the test and that obtained from the hand calculations subject to the load of 50 kips under Test A is shown in Figure 18.

**Figure 18. Strain profile under Test A (50 kips)**

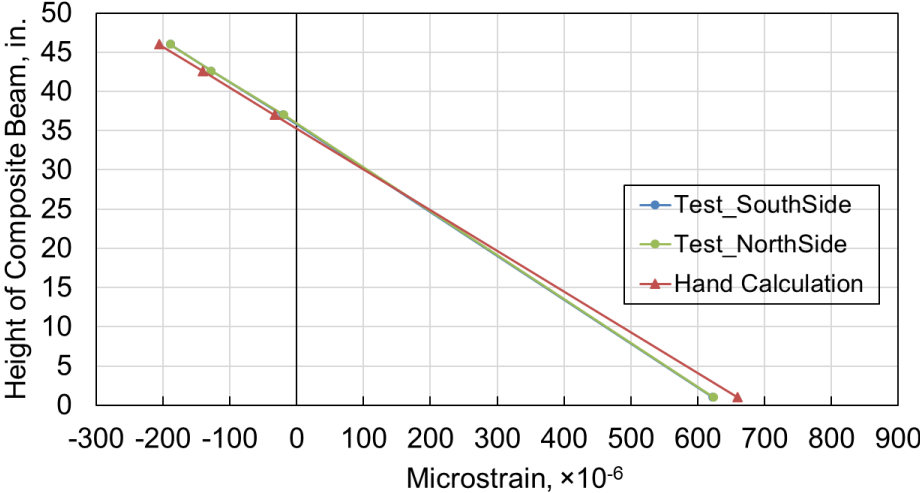
The comparison between the strain profile measured from the test and that obtained from the hand calculations subject to the load of 50 kips under Test B is shown in Figure 20 and Figure 21.

**Figure 20. Strain profile under Test B (first time, 66 kips)**

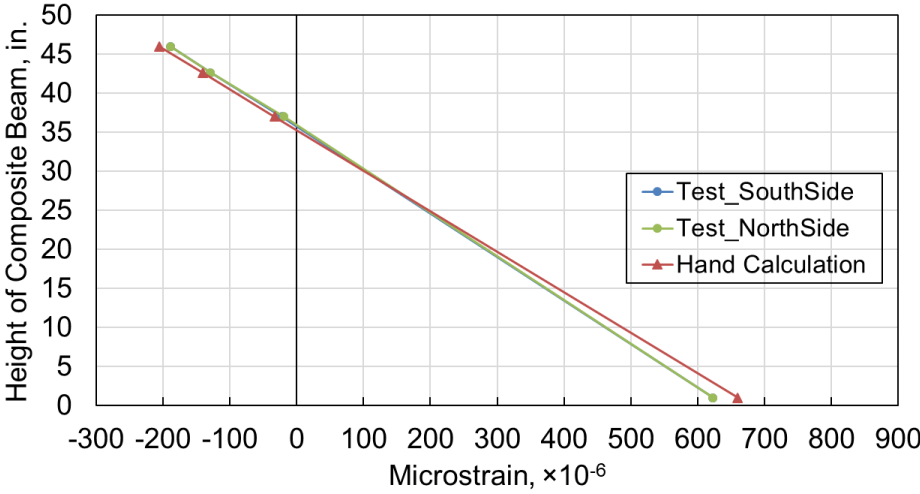
**Figure 21. Strain profile under Test B (second time, 66 kips)**

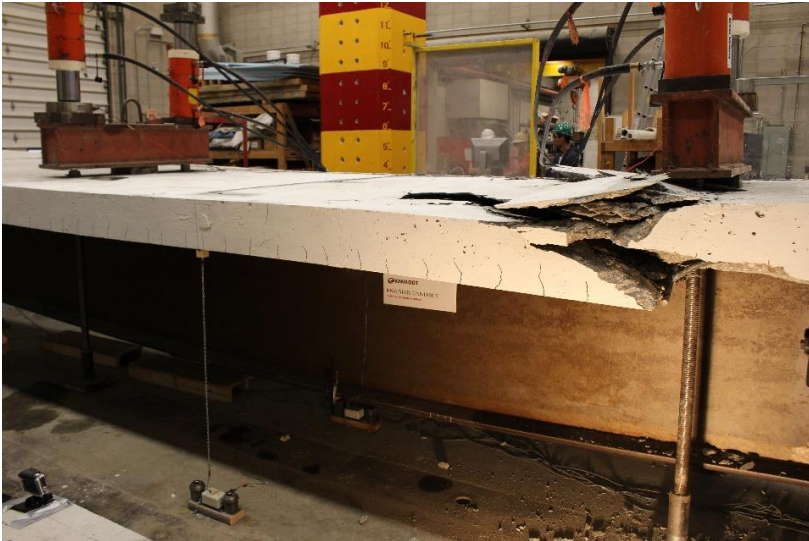
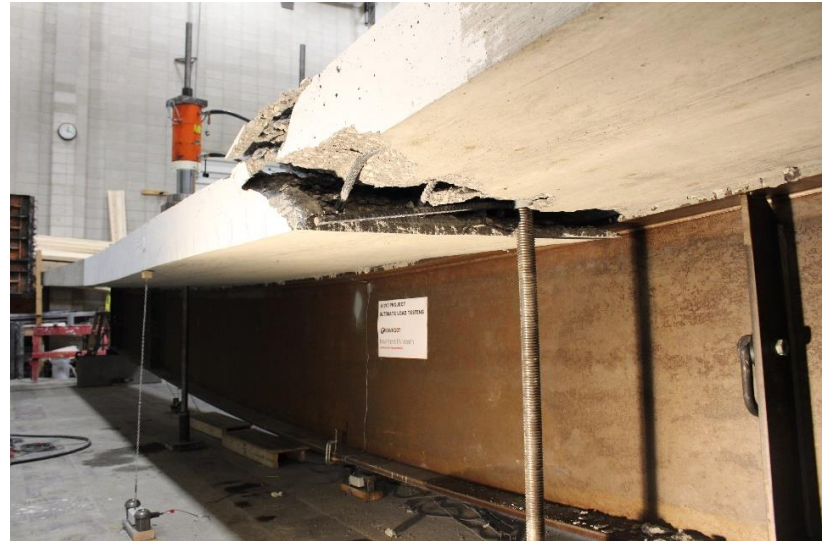
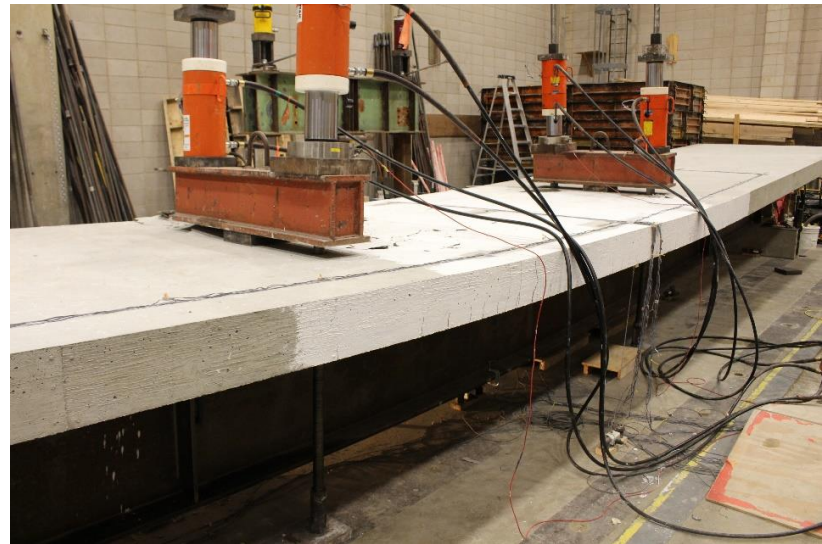
The side, bottom, and top views of the deck concrete crushing at the ultimate loading are shown in Figure 23.

a) Side view

b) Bottom view

c) Top view

d) Overall view

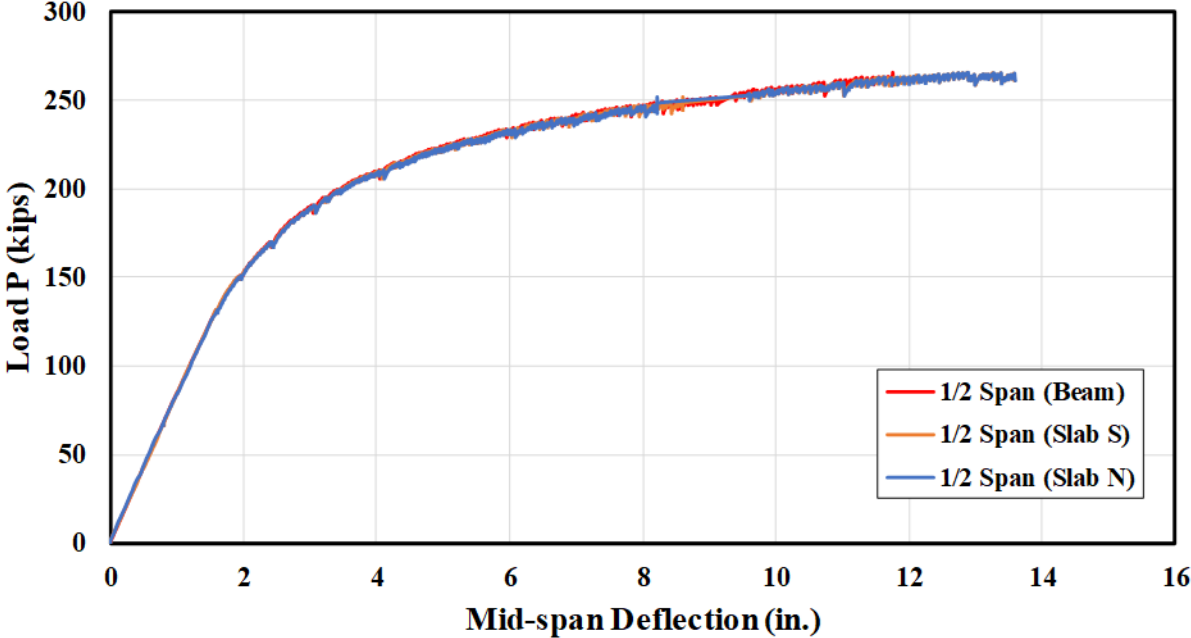
The load-deflection relationship measured at S1, S2, and S3 is shown in Figure 24 and Figure 25.

Figure 24. Maximum load-displacement curve, S2 (mid-span section)

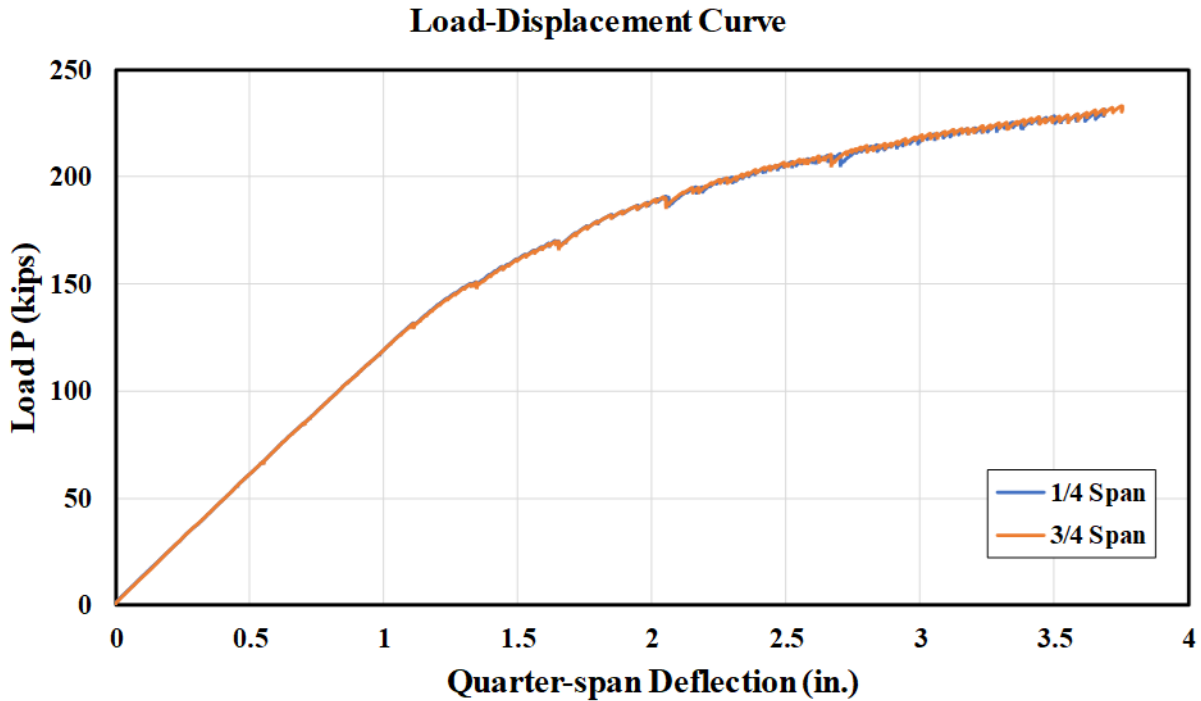
**Figure 25. Maximum load-displacement curve, S1 and S3 (quarter-span sections)**

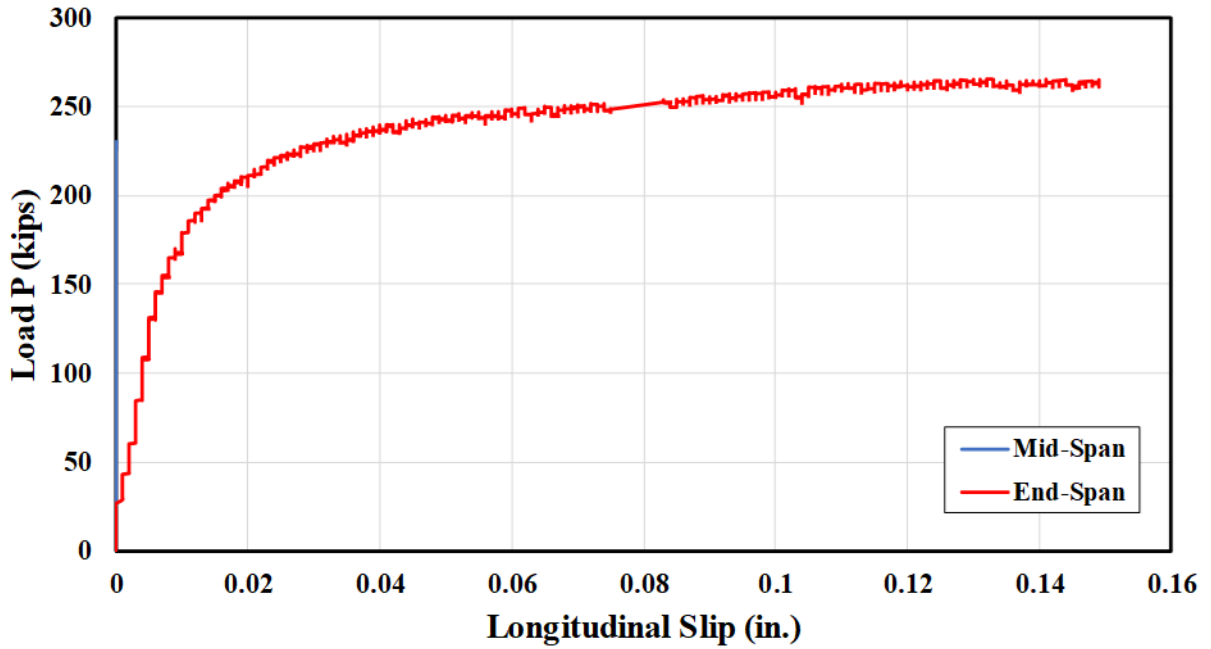
The load and longitudinal slip relationship were measured from the LVDT and are shown in Figure 26.

**Figure 26. Load-longitudinal slip relationships, S0 and S2**

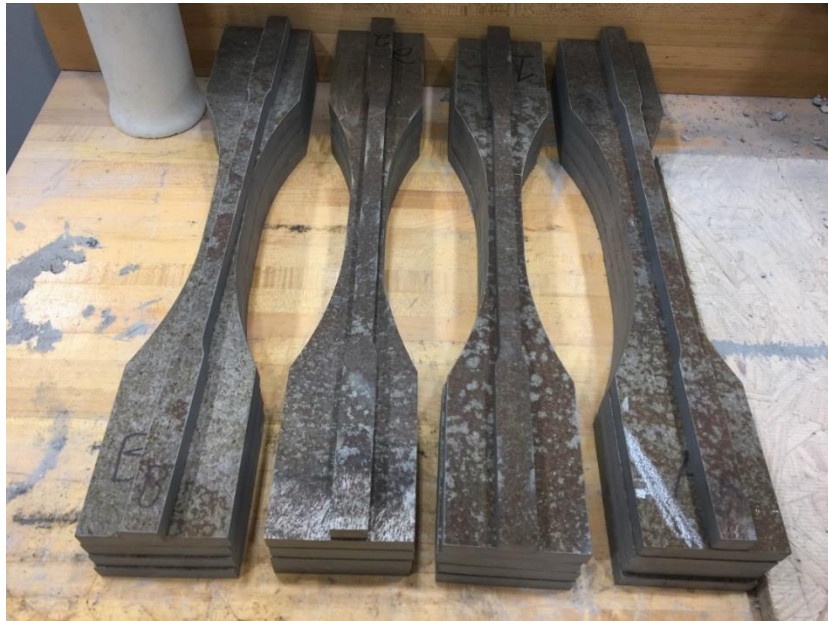
**Figure 30. Specimens for A1010 fatigue testing**

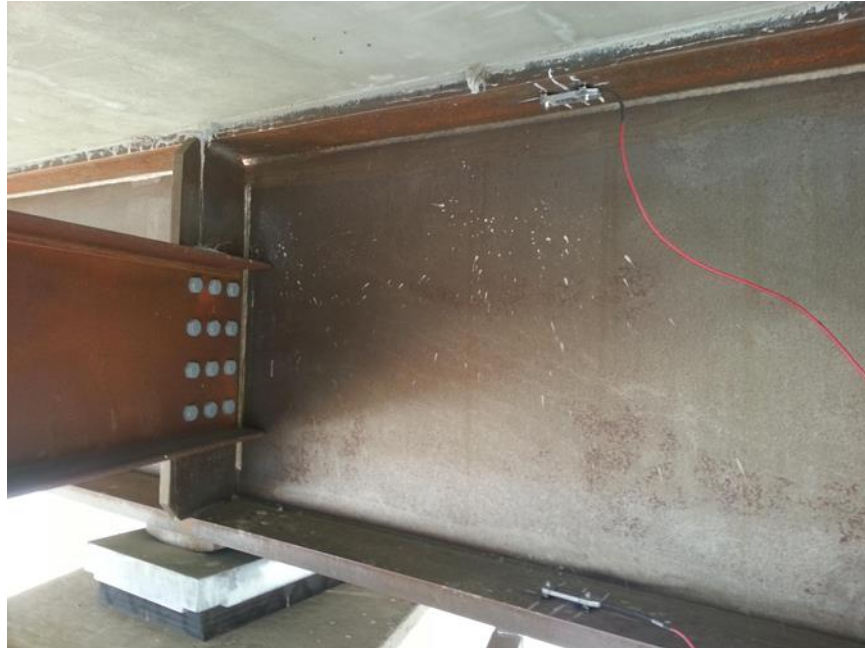
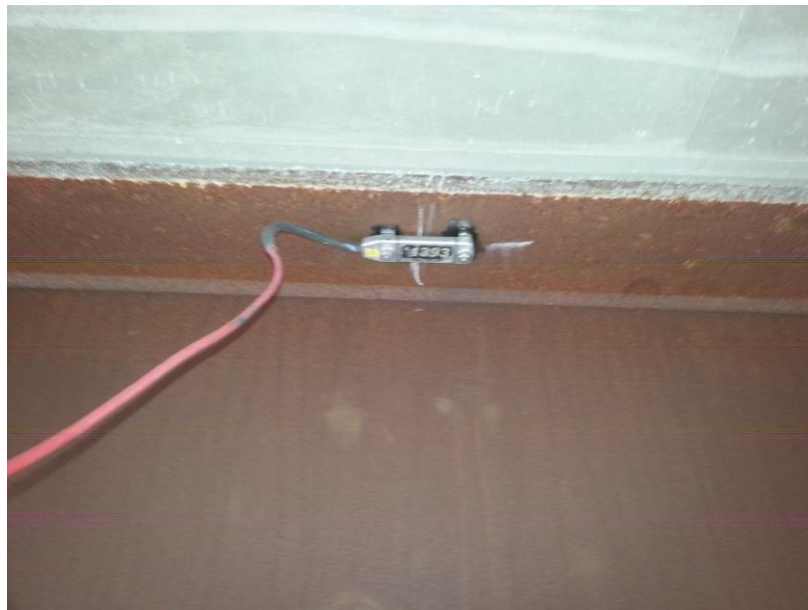
Figure 39 shows close-ups of the typical instrumentation setup.

a) Strain gauge setup on A1010 steel girder

b) Strain gauge setup on A709 steel girder

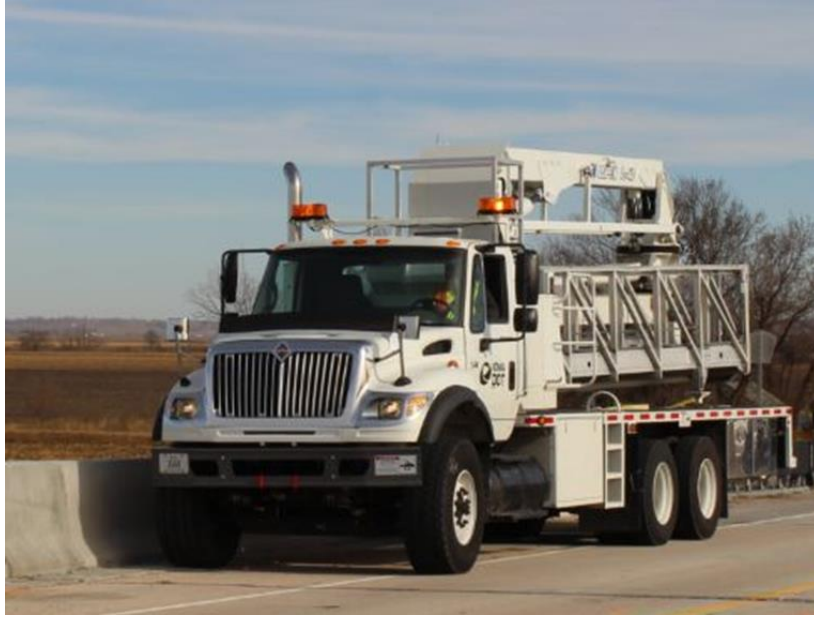
The bridge was tested using a known tandem-axle truck. In this test, a snooper truck, provided by Iowa DOT, was utilized as shown in Figure 40.

**Figure 40. Iowa DOT Salix Bridge load testing truck**

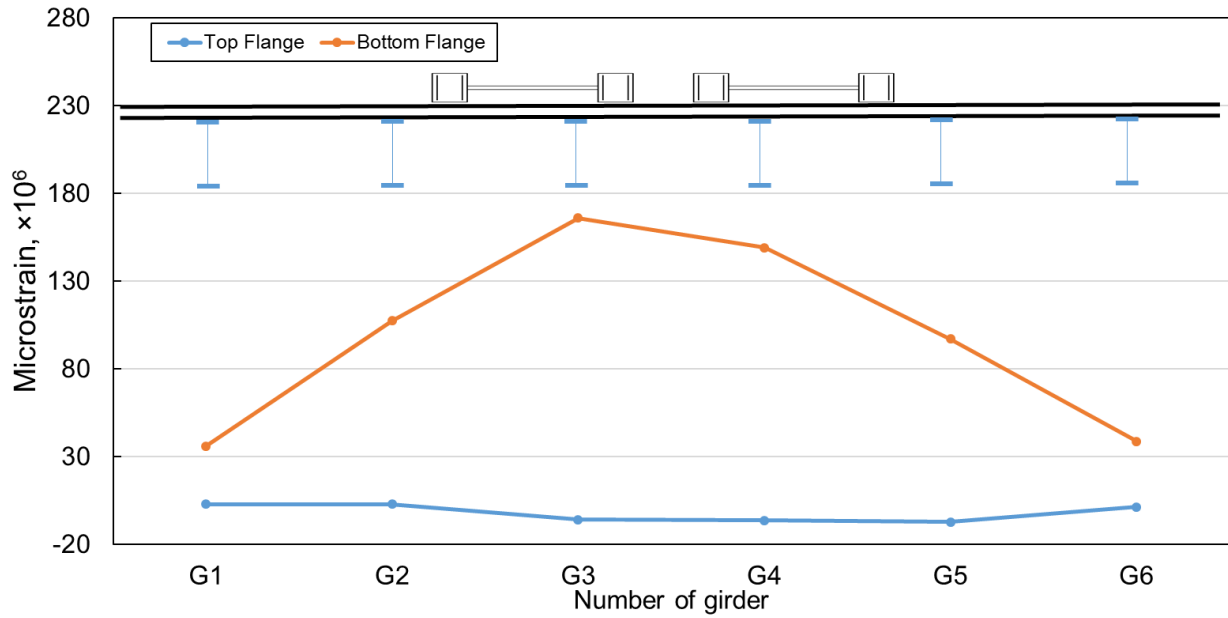
The maximum strains measured from each load case were used (with superposition of Load Case 2 and 4 for the evaluation the two-lane case) to calculate the transverse load distribution characteristics of the bridge, as shown in Figure 45.

a) Load Case 1

b) Superposition of Load Case 2 and 4

c) Load Case 3

d) Load Case 5

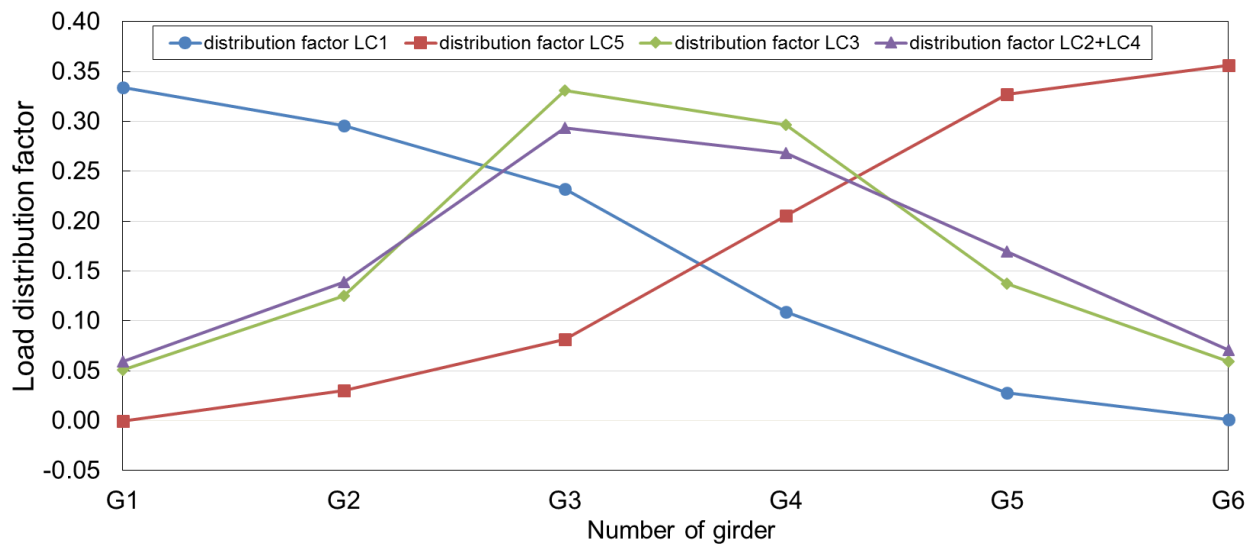
**Figure 50. Measured load distribution factors under each load case**

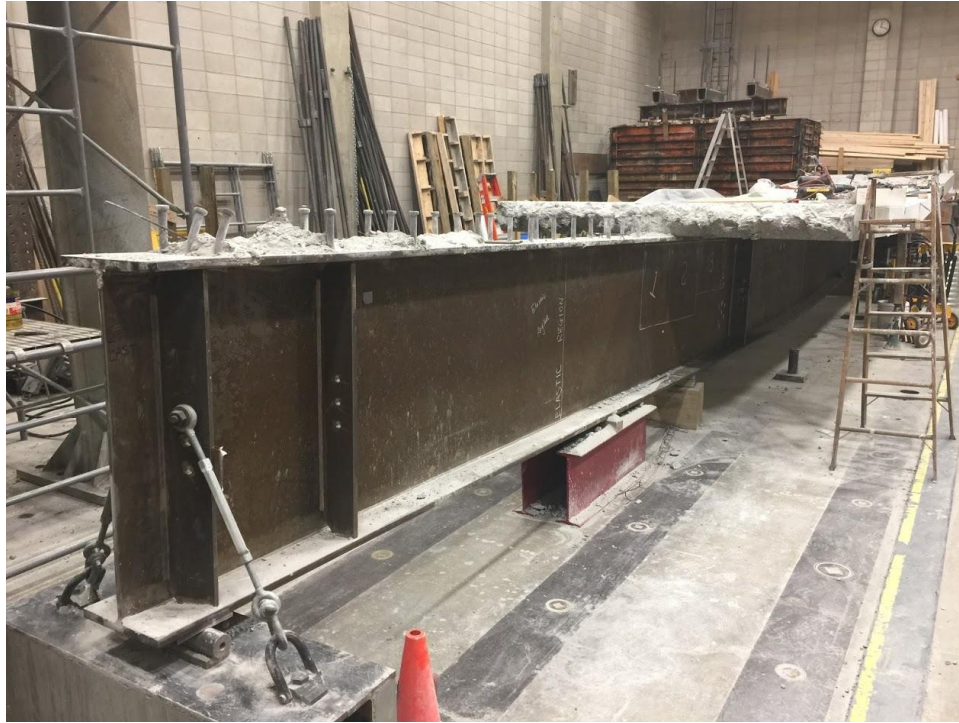
Following the completion of the laboratory testing, two approximately 12 ft long sections of the girder were removed and retained to test the galvanic corrosion potential when used with two different types of bolts. Figure 52 shows the concrete deck removal from the A1010 steel-concrete composite beam.

a) Beam after concrete deck removed

b) Concrete deck removal

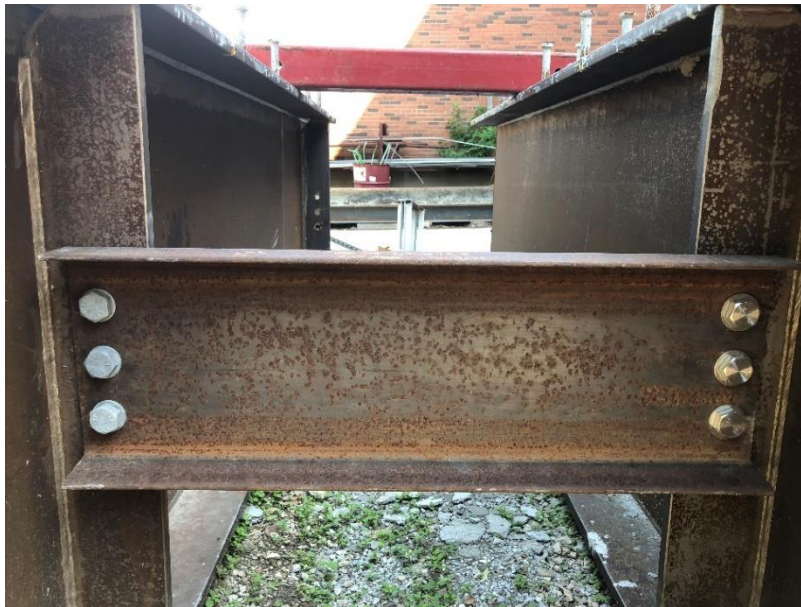
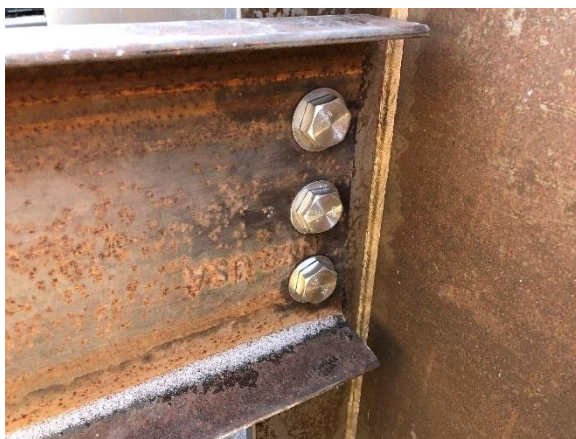
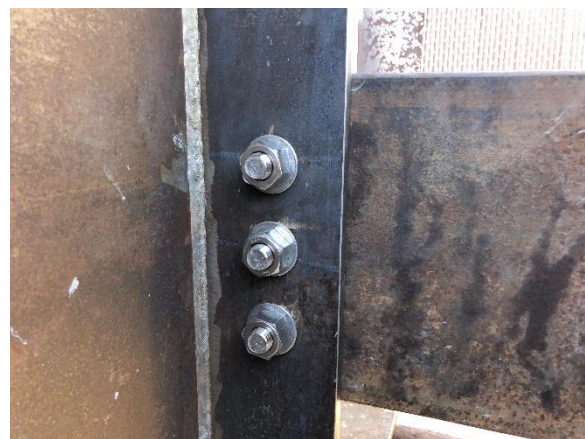
The two sections of the steel beam were connected with a galvanized cross frame, as shown in Figure 53.

a) Cross frame

b) Galvanized steel bolted connection

c) Stainless steel bolted connection

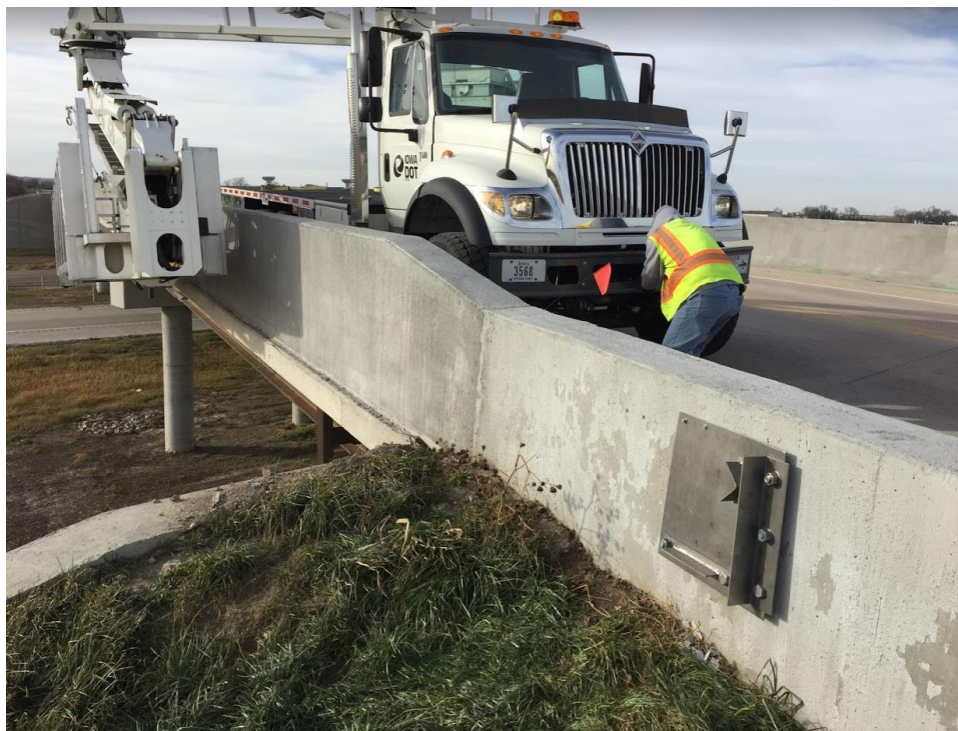
In addition to the galvanic corrosion of the A1010 steel cross frame, the research team worked with Justin Ocel of the FHWA regarding placement of an A1010 corrosion monitoring plate at the A1010 bridge site in Woodbury County. This plate was mounted at the bridge site during the first bridge load tests to monitor the development of corrosion. Figure 54 shows the A1010 plate being mounted in the field.

**Figure 54. A1010 plate mounting in the field (December 2017)**
