**National Highway
Traffic Safety
Administration**

DOT HS 812 980

Classification of Level 2 Driving Events Observed on Public Roads

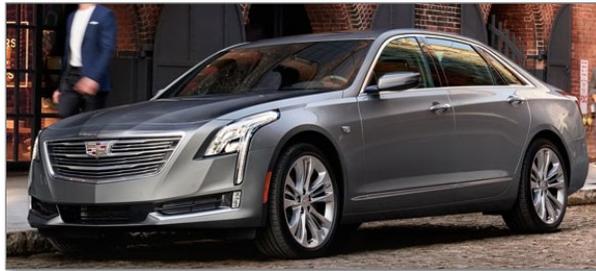
Figure 1.1. 2018 Cadillac CT6.

The level 2 driving automation system, available for the 2018 Cadillac CT6 (**Figure 1.1**), is named Super Cruise. Super Cruise can automatically steer to maintain lane position under certain

conditions on limited-access freeways that are separated from opposing traffic. The system works in conjunction with adaptive cruise control (ACC), which controls acceleration and braking while Super Cruise is enabled and in operation. At the time this report was written, Super Cruise was the only level 2 driving automation system available on the market, suggesting that drivers can use it hands-free. **Figure 1.2** illustrates the system’s availability map around Columbus, Ohio, from the Cadillac website during this study (www.cadillac.com/world-of-cadillac/innovation/super-cruise).

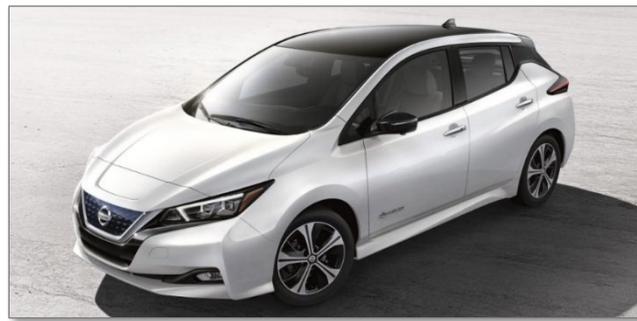
Figure 1.3. 2018 Nissan Leaf.

The 2018 Nissan Leaf (**Figure 1.3**) is available with an optional level 2 driving automation system named ProPILOT Assist (subsequently referred to simply as ProPILOT). ProPILOT includes Nissan's intelligent cruise control (ICC) and steering assist (SA) systems. When both these features are activated, ProPILOT provides level 2 driving automation functionality. The Nissan Leaf owner's manual (Nissan North America, Inc., 2018) states that ProPILOT should only be engaged during highway driving, but since the driver can enable and operate ProPILOT off highway (i.e., it is not geofenced), the Nissan Leaf was tested on the mixed and rural routes in addition to the highway route.

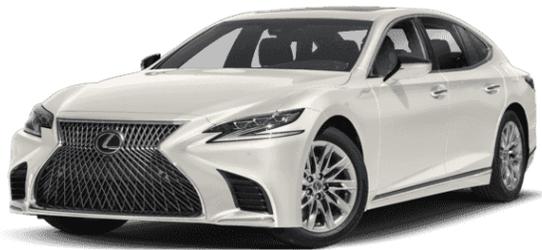
Figure 1.4. 2018 Lexus LS500.

The level 2 driving automation system available for the 2018 Lexus LS500 (**Figure 1.4**) is part of the Lexus Safety System +A option package. This package includes lane-tracing assist (LTA) and lane-keeping assist (LKA) which, when used in conjunction with ACC, to provide level 2 driving automation functionality. The Lexus LS500 owner's manual (Lexus, 2018) states that the LTA and LKA systems should only be engaged during highway driving. However, since the driver can enable and operate these systems off highway (i.e., the system operation is not geofenced), the vehicle was tested on the mixed and rural routes in addition to the highway route.

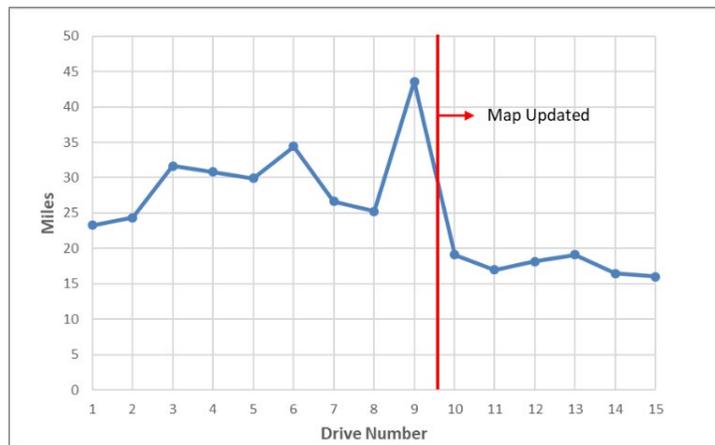
Figure 2.2. Net miles of Super Cruise unavailability

Of the 1,620 total nominal miles driven on the highway route, Super Cruise was available and active for a total of 1,180.5 miles. Of the 1,620 miles, the system was geofenced out for 63.75 miles, and the overall percentage of the net miles unavailable was 24.1 percent. It is important to highlight that, for the 6 drives after the map update, net Super Cruise unavailability averaged 18.0 percent, which was an improvement of 6.1 percent over the overall average.

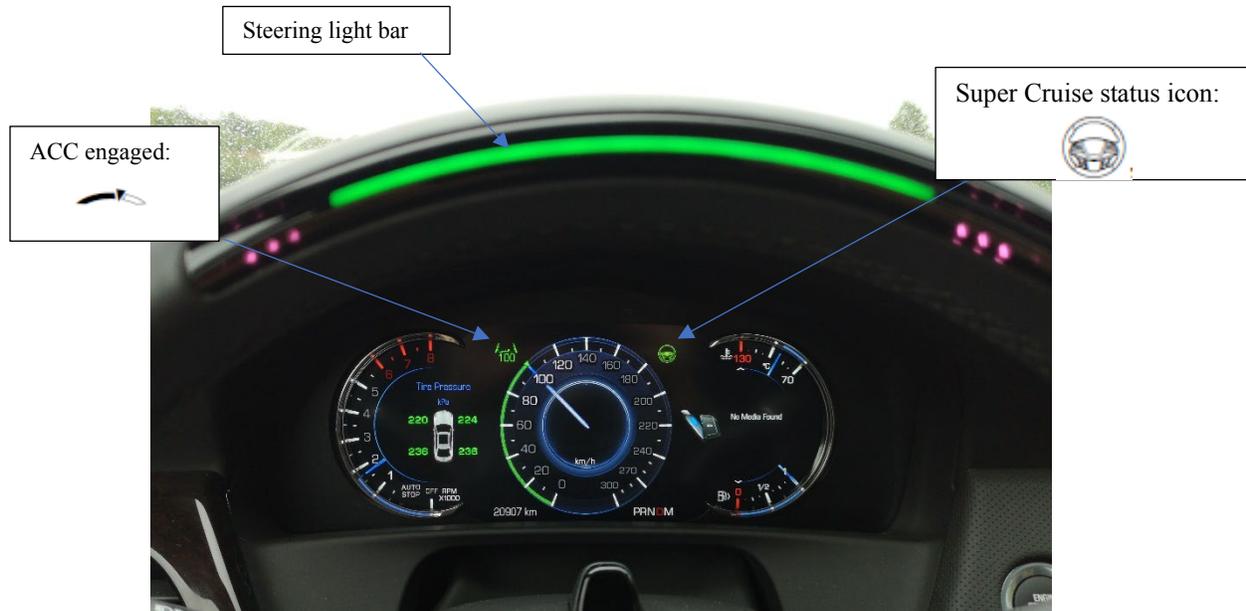
Figure 5.1. Cadillac CT6 instrument cluster.

The instrument cluster of the Cadillac CT6 and the steering light bar is shown in **Figure 5.1**. The Super Cruise system status is displayed prominently on the steering wheel in the form of a light bar. It is also displayed on the instrument cluster in the form of the Super Cruise status icon. Both the light bar and status icon change color to indicate the state/warning to the driver. The different states and warnings and their corresponding light bar and icon colors are detailed in **Table 5.1**.

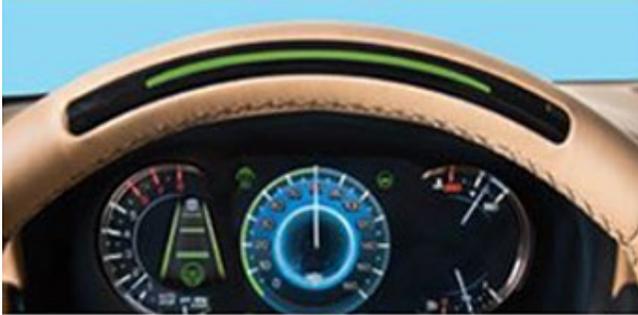
<p><u>Steering light bar:</u> flashing green <u>Super Cruise status icon:</u> green</p>	<p>Super Cruise is engaged but system detects driver is not attentive to the driving task</p>

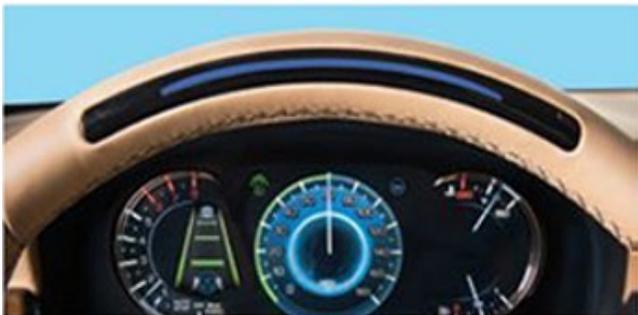
<p><u>Steering light bar:</u> flashing blue <u>Super Cruise status icon:</u> blue</p>	<p>Super Cruise is active, but system detects manual steering override. Super Cruise will resume control once vehicle is centered in the lane and steering is held steady.</p>

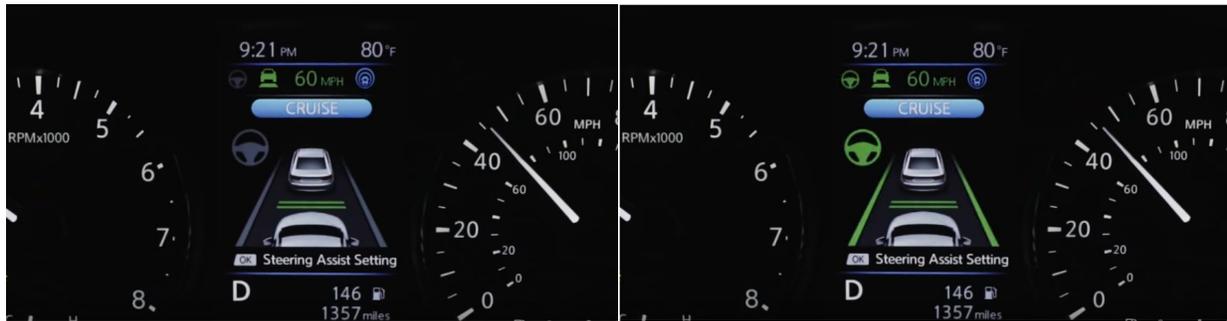
Figure 5.2. Nissan Leaf ProPILOT Assist instrument cluster display.

The Nissan Leaf ProPILOT Assist instrument cluster-based driver display is shown in **Figure 5.2**. When the system is disengaged, the lane line icon as well as the steering wheel icon appear grey (**Figure 5.2a**). When the system is engaged, the steering wheel icon and the lane line icons turn to green (**Figure 5.2b**). ProPILOT Assist engagement and disengagement is accompanied by an audible beep.

a. ProPILOT Assist disengaged

b. ProPILOT Assist engaged

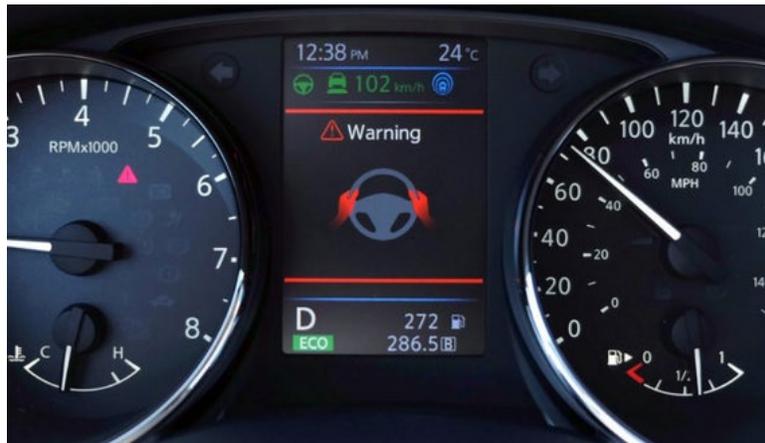
Figure 5.3. Nissan Leaf ProPILOT Assist driver engagement warning.

The Nissan Leaf monitors driver attention through touch sensors on the steering wheel. When the system senses that the driver has not touched the steering wheel for an extended period, it displays a warning to the driver to hold the steering wheel (**Figure 5.3**). Ignoring the warning leads to the system disengaging.

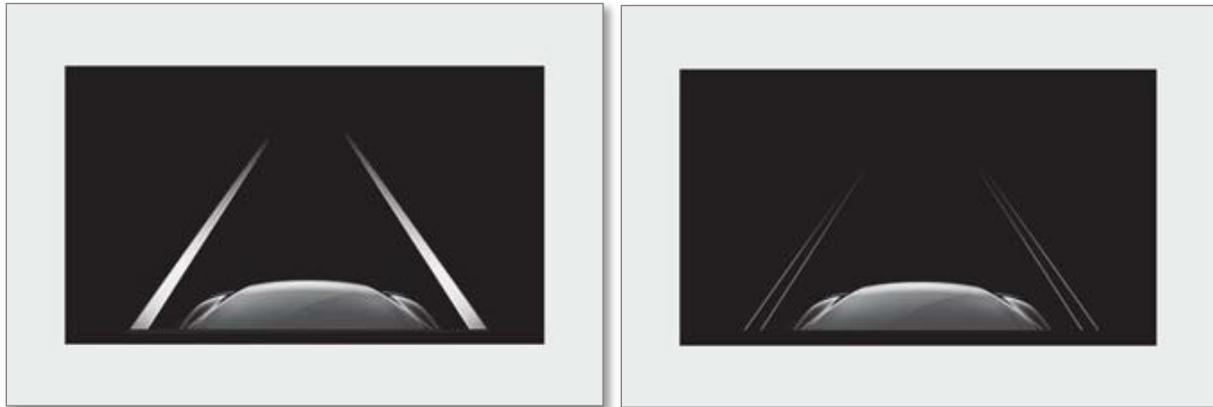
- Solid white lines displayed (**Figure 5.5a**): Indicates that the system recognizes white/yellow lane lines.
- Flashing orange on one side: Indicates lane line departure on the side the orange lines is flashing.

- Hollow white lines displayed (**Figure 5.5b**): Indicates that the system does not recognize white/yellow lane lines, or the system is temporarily canceled.

a. Lane lines recognized

b. No lane lines recognized
