Assessment of Structural Degradation for Bridges and Culverts

June 2020

1. Report No FHWA-SC-20-03		2. Government Accession No.		3. Recipient's Catalog No.	
4. Title and Subtitle <i>Assessment of Structural Degradation for Bridges and Culverts</i>				5. Report Date <i>June 2020</i>

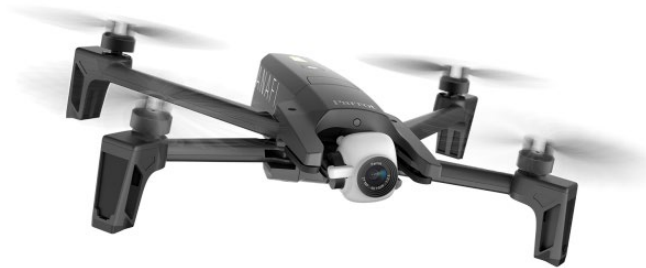
Figure 2.1. Parrot Anafi (Parrot, 2019)

Parrot Anafi: The Parrot Anafi is a 320 gram (0.71 lbs.) foldable drone with the unique ability to pan from below to directly above during flight (**Figure 2.1**). This capability lends it a distinct advantage for bridge inspection as no other drone in this segment has the capability to do so. The drone features a 4k resolution HDR (High Dynamic Range), 21 MP (Megapixels) camera that is gimbal stabilized on two axes and digitally stabilized on the third. It also offers a 2.8 X “lossless” digital zoom in 1080P (resolution in pixels) due to the oversized optical sensor. The system has an impressive operating range of 2.4 miles (3.9 kilometers) and can fly for approximately 25 minutes (Parrot, 2019). It has the lowest cost risk of any of the drone options here at approximate \$699 from the manufacturer and other vendors. Additional batteries can be purchased and charged during flight for continuous operation with battery changes. These features combined with a wind resistance of 50 km/hour (31.1 miles/hour) (make the system a capable option for bridge inspection.

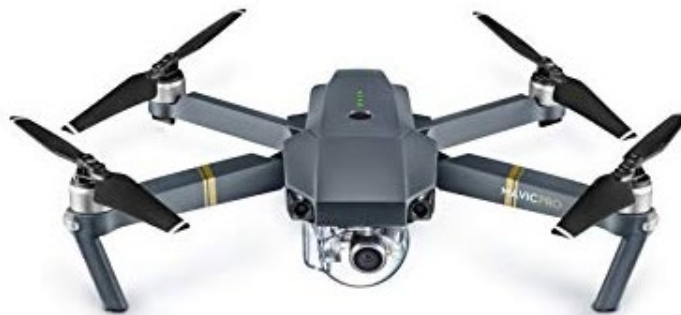
Figure 2.2. DJI Mavic Pro (DJI, 2019a)

The system weighs 734 grams (1.6 lbs.) and has a 27-minute flight time, with a single 18 MP bottom mounted camera that is 3-axis stabilized handheld system (DJI, 2019a). The camera being mounted on the bottom of the craft limits its ability to capture images overhead. The camera can be deflected upward by approximately 30 degrees which enables some overhead inspection but with increased offset. The drone has a vision-based stabilization system which aids in stable hovering and during the “return to home” function. It also has collision avoidance sensors on the front of the drone to reduce the potential for contact with structures. The system is advertised at approximate \$999 from the DJI website and other distributors. DJI is shown in **Figure 2.2**.

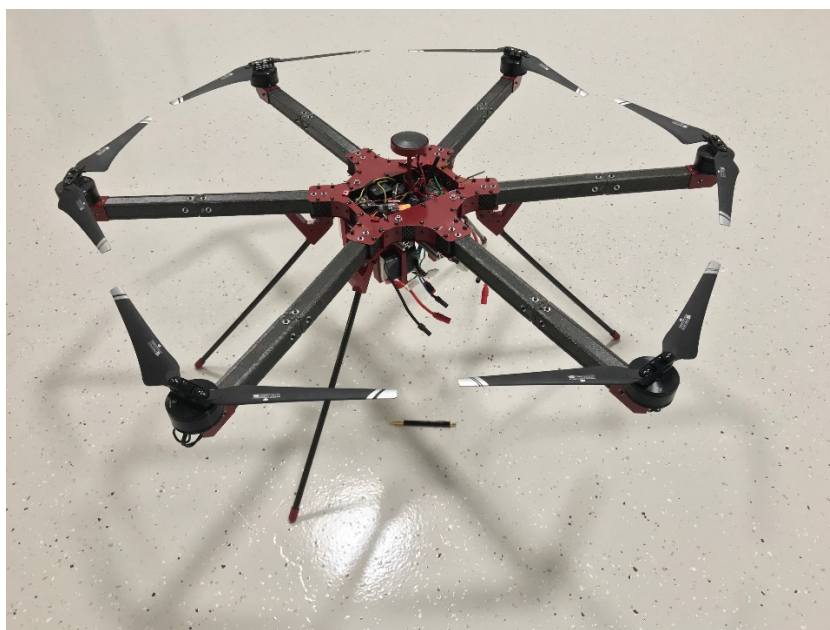
Figure 2.3. McNair/TIG Hitco drone (Photo credit: Wout De Backer)

McNAIR Center/TIG Hitco: The researchers at the McNAIR Center for Aerospace Innovation and Research, partnering with TIG Hitco, designed and produced a large hexa-copter drone which utilizes the continuous fiber 3d printing technology they developed to serve as the primary structure for the system (**Figure 2.3**). The system demonstrates the option for building a custom drone for visual inspection. Custom drones allow for more flexibility and can be tailored to the specific needs of the SCDOT and can be improved over time with emerging technologies and hardware upgrades.

This system boasts an impressive payload of 26 lbs. (11.8 kg)., a maximum flight time of 45 minutes without payload, and 18 minutes with maximum payload. The system can be modified to accept an array of different cameras and sensors to meet the needs of the inspector.

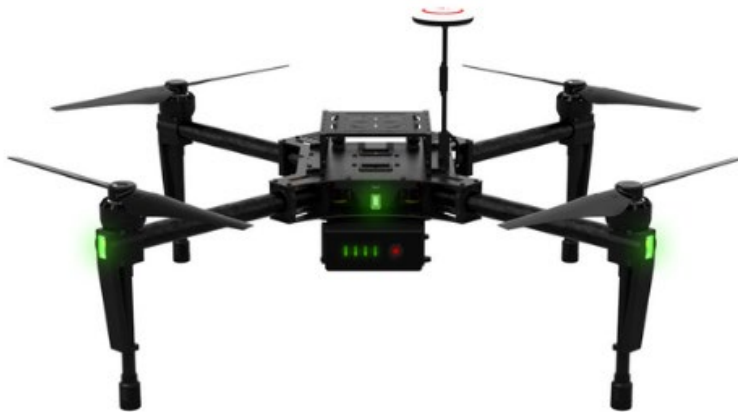
Figure 2.4. DJI Matrice 100 (DJI, 2019b)

DJI Matrice 100: The DJI Matrice 100 is a customizable and programmable flight platform, with modular frame, expansion bays, universal power and communication ports, dual battery compartments and an optional guidance package that operates as a collision avoidance suite (**Figure 2.4**). The system allows for

The system also supports dual users and an operating range of 3.5 – 5.0 km (2.2-3.1 miles). Flights can be pre-programmed which allows the operator to pay attention to camera control and recording. The system does not come with a camera, however all DJI cameras are adaptable to the system. For bridge inspection the preferred configuration would be a Zenmuse Z30 camera with two TB48D batteries and collision avoidance hardware.

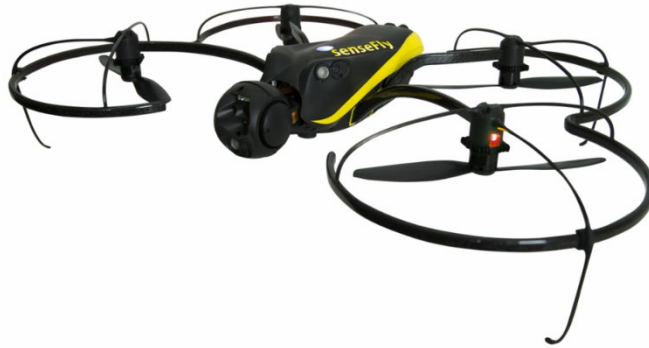
Figure 2.5. senseFly Albris (senseFly, 2018)

The flight data manager allows for geotagging of images and, using image processing software, geo-referenced maps and models of the inspected area can be generated. This capability would aid in tracking the precise location of potential defects and how they progress over time.

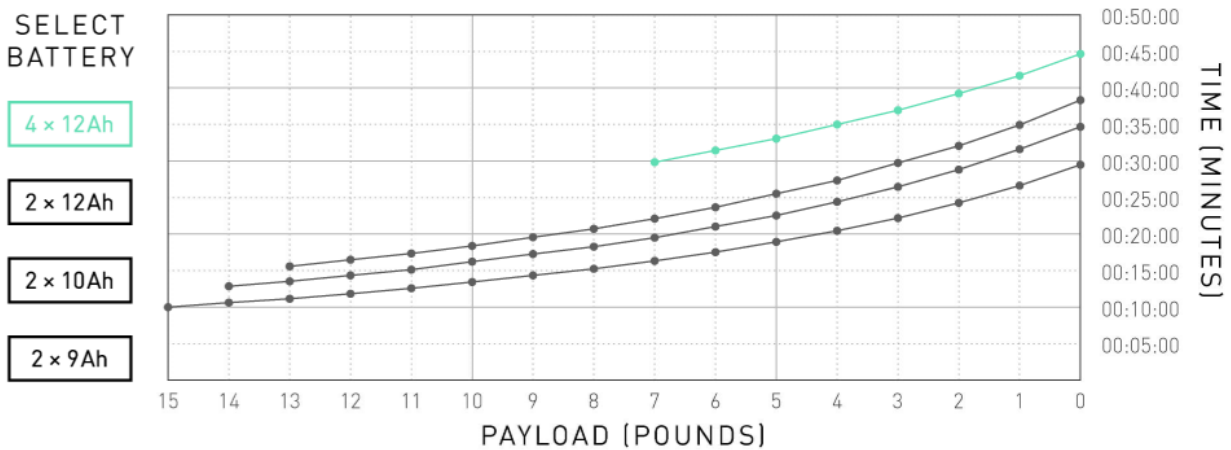
Figure 2.8. Payload vs. flight time for various battery configurations (FreeFly, 2019b)

There is an optional top and bottom-mount gimbal configuration to meet a wide range of needs, and a FPV camera mount to accommodate dual operators. This allows the pilot to focus on navigation tasks, while the second operator collects footage with the payload cameras. It also features a weather resistant enclosure for the flight control systems to prevent damage during adverse weather conditions. The system is listed for an approximate price of \$11,995 from the manufacturer before extras.

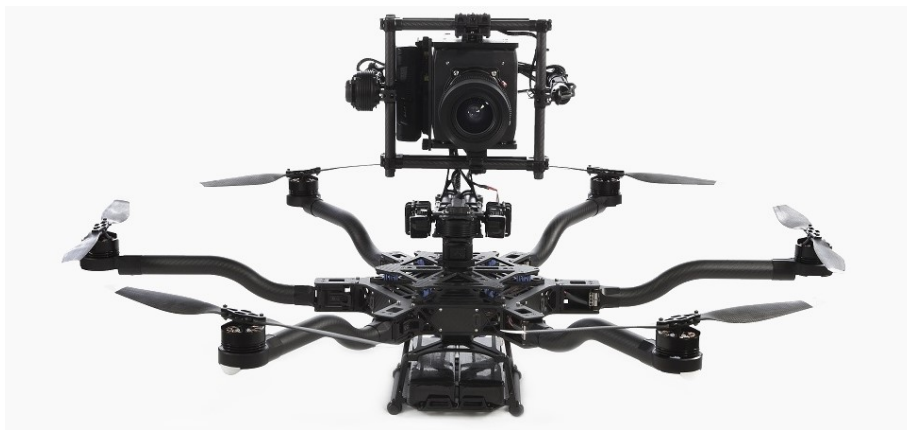
Figure 2.9. FreeFly ALTA 6 (FreeFly, 2019b)

FreeFly ALTA 6: The ALTA 6 is another FreeFly drone that may be a good candidate for bridge inspections. It is similar in design to the ALTA 8 platform, with six rotors instead of eight. It is smaller, less complex, lighter, and less costly than its larger counterpart. The system has a maximum payload of 15 lbs. (6.8 kg), which allows for a wide range of camera, sensory, and battery options. Flight time for the ALTA 6 is dependent on the batteries selected and the payload and ranges from 10-45 minutes (FreeFly, 2019b). The drone is shown in **Figure 2.9**.

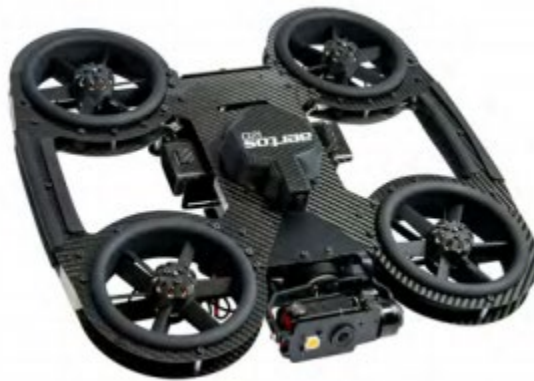
Figure 2.10. Aertos 120 (Digital Aerolus, 2019)

Digital Aerolus Aertos 120: The Aertos 120 is a drone system intended to be used for inspection in tight spaces and without the use of a GPS signal for stability and navigation (**Figure 2.10**). Instead of GPS, the drone uses onboard inertial measurement units to regulate movement. There are no collision avoidance provisions on the drone, instead the drone is designed to withstand impacts and regain stability. The propellers are ducted, and the system uses a stiff carbon fiber frame. The robustness comes at a cost, as the ducts limit the size and efficiency of the propellers, and the structure is heavy (approximately 6 lbs.) which, with the small propellers, limits the flight time to eight minutes.

Like the Parrot Anafi, the Aertos 120 can rotate the primary camera from viewing below to viewing directly above the drone. The camera is a 12 MP unit that is gimbal stabilized on two axes and the setup supports dual displays for tandem-user operations. The FPV flight camera is useful during operation as flying while facing upward can be difficult. The Aertos is advertised for use in small culverts, tunnels, electrical vaults, manholes, sewers, small tanks, and towers. The system is sold for an approximate price of \$20,000 and training is offered for a fee (Digital Aerolus, 2019).

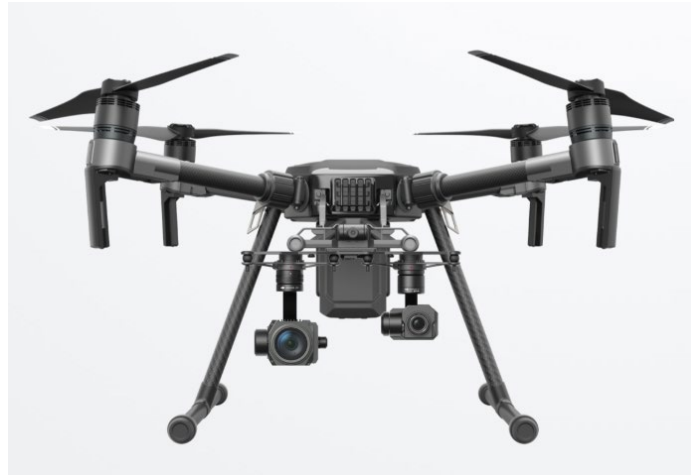
Figure 2.11. DJI Matrice 210 (DJI, 2019c)

DJI Matrice 210: DJI offers drones for industrial applications such as inspection, mapping, search and rescue, agriculture, and film (**Figure 2.11**). The Matrice 210 is a platform with a great deal of flexibility in configuration and payload. The system is designed so that a pilot can control the drone, while another operator manages the payload, collecting images, video, and data as needed. All functions can also be performed by a single operator. There are provisions to aid the pilot in collision avoidance using seven sensors which identify obstacles in front and above the drone. According to the manufacturer “A downward facing vision positioning system enables precision hovering and landing” (DJI, 2019c).

Another configuration option is the battery model, which impacts the flight time and the payload capacity. Available batteries are the TB50 and the TB55. The TB50 offers a payload of 2.34 kg (5.16 lbs.) with a maximum flight time of 13 minutes with a full payload. The TB55 allows the drone to handle a payload of 1.61 kg (3.5 lbs.) and a maximum flight time of 24 minutes with a full payload. For an empty flight, the TB50 will allow for 27 minutes of flight and the TB55 will allow for 38 minutes of flight (DJI, 2019c).

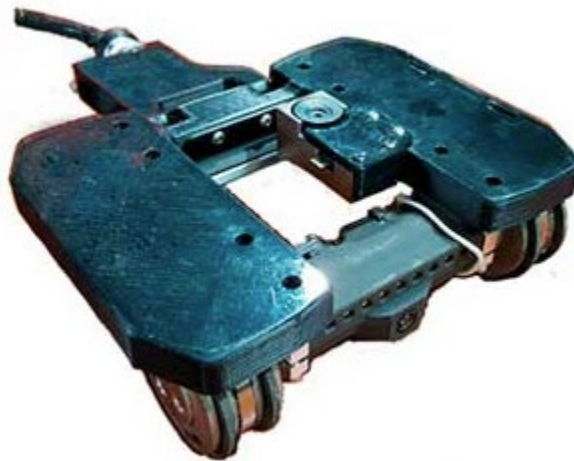
Figure 2.12. MRIS-MN1 (RTT, 2019a)

Robotic Technologies of Tennessee (RTT) - MRIS-MN1: Robotic Technologies of Tennessee (RTT) designs and produces a magnetic tethered robot capable of climbing and maneuvering on ferrous surfaces (**Figure 2.12**). The crawler uses four magnetized wheels to attach and allow the system to move on any ferromagnetic surface without falling off due to its weight, provided that the operator does not drive off a ledge. The system comes with a 25-foot tether (7.6 m) allowing the operator a considerable offset during inspections. Longer tethers are also available. The system has two onboard navigation cameras as well as a five-pound payload capacity for additional sensory equipment (RTT, 2019a).

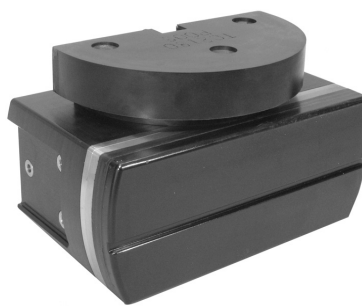
Figure 2.15. SeaBat 7130 sonar emitter (Teledyne Marine, 2019a)

Teledyne SeaBat 7130: This product is a high-resolution sonar system specifically designed for Autonomous Underwater Vehicles (AUVs) but can also operate on Remotely Operated Underwater Vehicles (ROVs) and small submarines. The SeaBat can go up to a depth of 3,000 meters and operates with a wide range of frequencies. The higher frequency allows for high resolution while the low frequency allows for long range detections. The sonar can process data into real time which allows the information collected to be delivered immediately to a computer without delay. Equipment for the SeaBat is shown in **Figure 2.15** and a data image is shown in **Figure 2.16** (TeledyneMarine, 2019a).

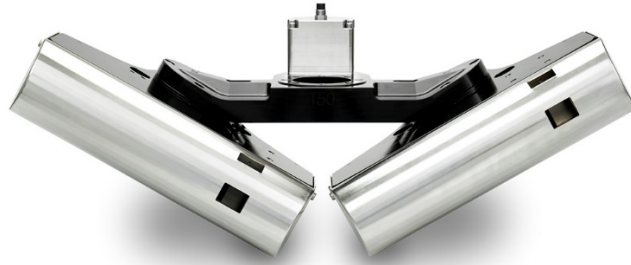
Figure 2.17. SeaBat IDH sonar head (Teledyne Marine, 2019b)

Teledyne SeaBat IDH T20/50-R: This product is like the SeaBat 7130 except it has an Integrated Dual Head (IDH) that is connected to the compact Rack mounted Sonar Processor (RSP). The RSP allows for a single point for all the cable connections and has accurate sensor time tagging and motion stabilization. The SeaBat has a range of frequency that allows for improved swath performances, less interference from other sensors, and reduced time for surveying. This product also works well in challenging acoustic conditions and develops quality data. Teledyne offers an all-in-one fully integrated survey system with a single sonar processor for two sonar heads. Since the SeaBat IDH is so compact, it allows for faster mobilization, minimal interfacing and low space requirements compared to the other SeaBat versions. The dual head sonar can be seen in **Figure 2.17** and an example of a data image from the SeaBat can be seen in **Figure 2.18** (TeledyneMarine, 2019b).

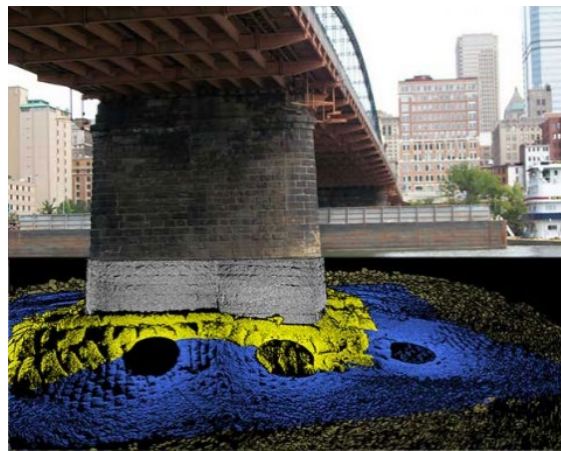
Figure 2.21. 3D multibeam scanning sonar data image, color indicates topography (TeledyneMarine, 2019d)

Teledyne 3D Multibeam Scanning Sonar: This sonar creates high resolution imagery of underwater areas and structures even when visibility is poor. The system creates 3D point clouds with an easy to operate set up and little training. The sonar can be set up on a tripod, Remote Operated Underwater Vehicle, or surface vessel. The system collects the point clouds without positioning information from a stationary stance and combines with software referred to as Quick Stitch to create the 3D profiles of the environment surveyed. The 3D scanning sonar is useful for scour monitoring and bridge inspections. The equipment can be seen in Figure 2.20 and an example of data collected and processed can be seen in Figure 2.21 (Teledyne Marine, 2019d).

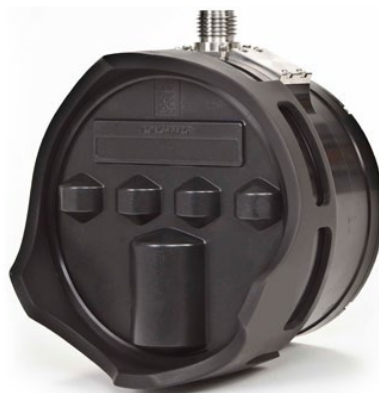
Figure 2.22. M3 sonar multibeam echo sounder (Kongsberg, 2019a)

Kongsberg M3 Sonar Multibeam Echo sounder: This device is portable and lightweight and is cost effective. It features imaging and underwater datasets from one sonar head. The sonar also has single beam image quality that collects data efficiently. Real time data is collected and the images are put together into one continuous image using a specific software. The pulses used for this sonar are more complex but allows for listening modes on the sonar along with multiple window zooms. The sonar is well-

suited for shallow water surveys. The best options for installation are on a pole mount on a surface vessel; vehicles such as small class remotely operated vehicles (ROVs); or mounted on a tripod. The M3 device is shown in **Figure 2.22** and a data image is shown in **Figure 2.23** (Kongsberg, 2019a).

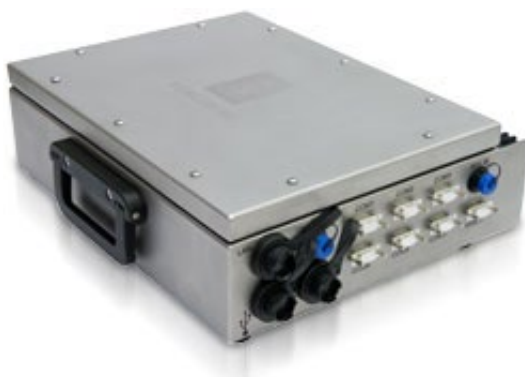
Figure 2.24. GeoSwath 4R (Kongsberg, 2019b)

Kongsberg GeoSwath 4R: The GeoSwath 4R can utilize ultra-high-resolution underwater scanning and side scan seabed mapping simultaneously. It is intended to be set up on small vessels like jet skis, and the data collected has been shown to exceed the standards for hydrographic surveys. The sonar has a wide range of frequency and the ability to cover an area of twelve times the water depth in diameter. The device is

operated from a laptop PC and the data software includes data acquisition, processing, and presentation. The device is shown in **Figure 2.24** and a data image is shown in **Figure 2.25** (Kongsberg, 2019b).

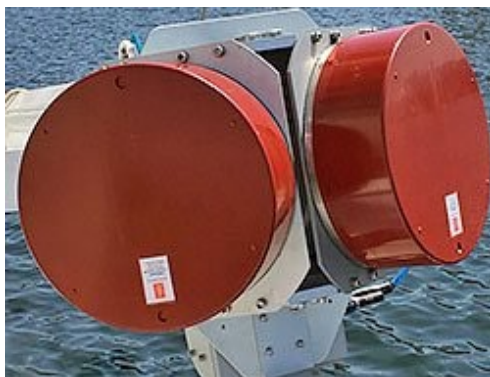
Figure 2.26. EM 2040C Dual Head Sonar (Kongsberg, 2019c)

Kongsberg EM 2040C, Compact: The EM 2040C is a compact multibeam echo sounder intended for shallow water applications. The sonar head is made up of the receiver and transmitter integrated together

and the system reaches hydrographic standards. The EM 2040C offers high resolution and a wide range of frequency. The sonar head can operate in single and dual head modes which allows data to be collected more efficiently. The maximum depth is 500 meters (1,640 ft), but Kongsberg also produces similar products that can reach to depths of 11,000 meters (36,000 ft). In **Figure 2.26**, the dual head sonar can be seen and **Figure 2.27** is an example of data imaging (Kongsberg, 2019c).

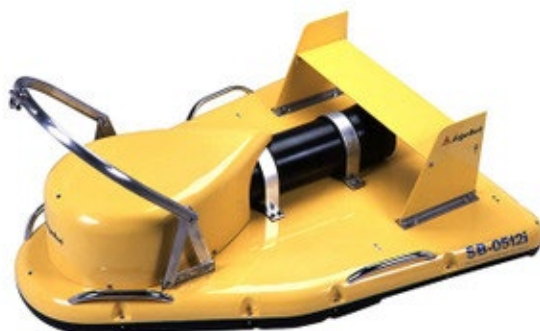
Figure 2.28. EdgeTech 2000 scanner and profiler (Edgetech, 2019a)

EdgeTech 2000: For this application, the sonar and sub-bottom profiler features are combined into a single product. There are three different types of tow fish and a wide range of frequencies. This product is designed for water depths up to 300 meters (980 ft). All types of tow fish are equipped with dual simultaneous frequency CHIRP side scan sonar. CHIRP sonar is a compressed high intensity radiated pulse that has been in use since 2009. This type of sonar transmits a sweeping range of frequencies that have pulses at least ten times the duration of a single transducer. The EdgeTech 2000 features a fully integrated

system that has all the hardware and software necessary for the data acquired. The user can choose between the side scan sonar or the sub-bottom profiler frequencies along with the built-in heading, pitch, and roll sensors. The scanner and profiler can be seen in **Figure 2.28** and a data image of concrete blocks is shown in **Figure 2.29** (Edgetech, 2017a).

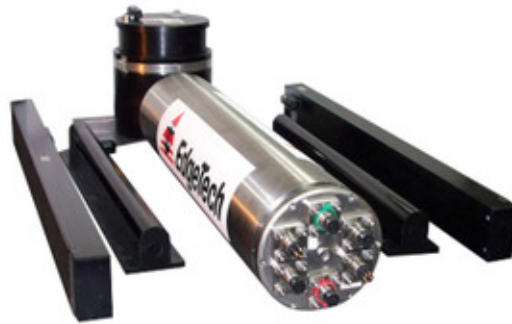
Figure 2.30. EdgeTech 2205 sonar head (Seatronics, 2019a)

EdgeTech 2205: This is a flexible and compact system that operates on underwater vehicles, including Unmanned Underwater Vehicles and Remotely Operated Vehicles. Side scan sonar data imagery and sub-bottom profiler data can be collected by the sonar system. The sonar system can independently store the data, or the information can be automatically exchanged between the system and the vehicle during the

time the vehicle is out. EdgeTech provides its own software called “Discover” to load the data but the data is also compatible with other software. It is dual frequency and includes transducer arrays, sensors, and a pressure vessel. The sonar head can be seen in **Figure 2.30** and an example of the data image is shown in **Figure 2.31** (Seatronics, 2019a).

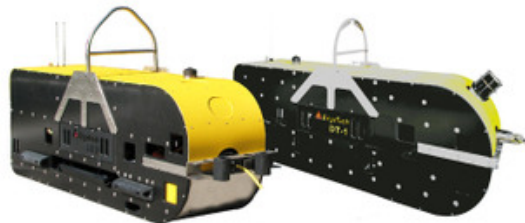
Figure 2.32. EdgeTech 2400 scanner and profiler (Edgetech, 2017b)

EdgeTech 2400 - Deep Towed: Like the EdgeTech 2205, side scan and sub-bottom profile features are combined in this product. It is designed for deep water operations and can go up to depths of 6,000 meters (19600 ft). The EdgeTech 2400 has a fully integrated turnkey system and digital telemetry over single coaxial or fiber optic tow cable. The user supplied sensors are either analog or digital channels and the system includes built-in sensors. The standard system has a choice of the combined deep tow fish, digital telemetry that runs with the coaxial cable, or a processor with EdgeTech software. The equipment can be seen in **Figure 2.32** and a data image of a pipeline from this product is shown in **Figure 2.33** (Edgetech, 2017b).

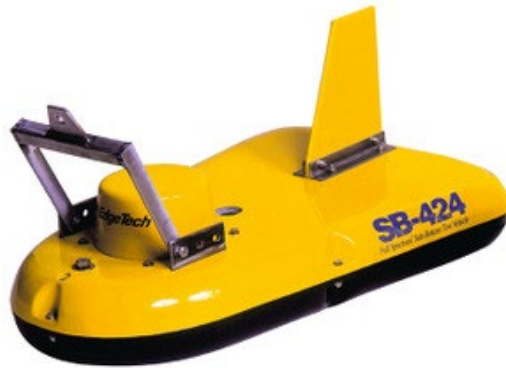
Figure 2.34. EdgeTech 3100 profiler (Seatronics, 2019b)

EdgeTech 3100: Portable Sub-Bottom Profiler: This product is like the ones described above but is a portable version. The system produces high-resolution imagery of the sub-bottom structure at depths up to 100 meters (328 ft). The EdgeTech 3100 is intended for rivers, lakes, ponds, and shallow ocean environments. The user can choose between two different tow fish having different frequency ranges. One tow fish can produce a higher resolution at lesser depths, while the other has a resolution that is slightly lower but can scan at greater depths. The system also comes with a portable splash proof topside processor, with a laptop running the EdgeTech software for the sonar data display. The tow cable length is 115 feet (35 m) but user specified lengths are available. The EdgeTech 3100 offers a portable version of the sub-bottom profiler with high resolution imagery and requires low amounts of power (AC or DC). A pole mount version is available for shallow water surveys. In **Figure 2.34**, the profiler is shown and a data image of a lake is shown in **Figure 2.35** (Seatronics, 2019b).

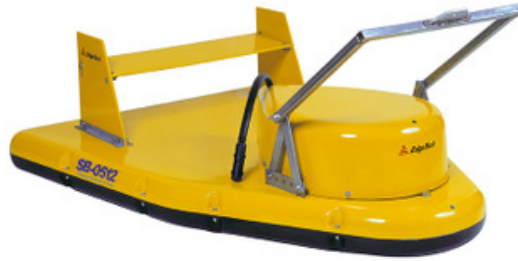
Figure 2.36. EdgeTech 3200 Profiler (Seatrronics, 2019c)

EdgeTech 3200: High Penetration Sub-Bottom Profiler: This product is a wideband frequency modulated (FM) sub-bottom profiler that produces high resolution imagery. It is useful for lakes, rivers, and oceans with depths to 200 meters (656 ft). This profiler is compatible with three different low drag tow fish that have different frequencies and operate at depths up to 300 meters. The user can select the type of tow fish based on the sub-bottom profile and the resolution and depth required. The EdgeTech “DISCOVER” Software comes with this product operating on a topside processor along with the user specified cable length and optional sensors. In **Figure 2.37**, the profiler is shown and **Figure 2.37** shows a data image of a channel infill (Seatronics, 2019c).

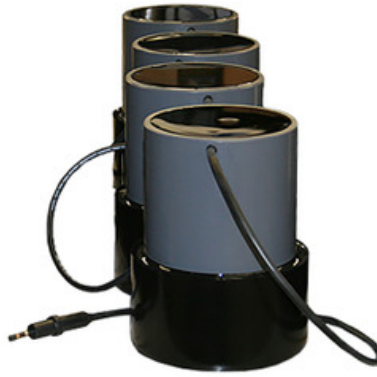
Figure 2.38. EdgeTech 3300 profiler (Edgetech, 2016)

EdgeTech 3300: Hull Mount Sub-Bottom Profiler: This product is based on EdgeTech’s Full Spectrum Technology. Advantages over other sub-bottom systems include an increase in depth along with higher resolution. EdgeTech also changed the shape of the profiler to increase accuracy of the beam patterns. This is useful for deeper water surveys and improves resolution while giving more accurate data, resulting in superior sub-bottom imagery even in full ocean depths. There is an option for dual frequency and multiple configuration options for transmitting and receiving data. The EdgeTech 3300 is versatile and creates cross sectional images of the channel bottom. The profiler can be seen in **Figure 2.38** an example of the data imagery is shown in **Figure 2.39** (Edgetech, 2016).

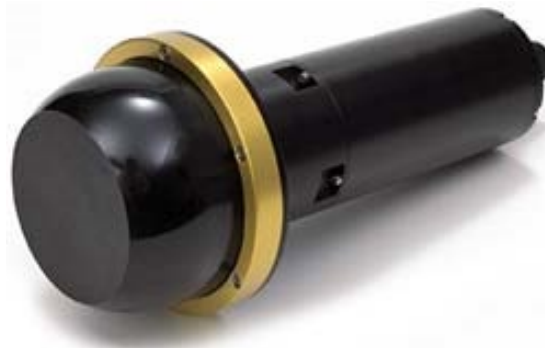
Figure 2.40. MS 1171 domed sonar head (Kongsberg, 2019d)

Kongsberg MS 1171: This product is compact and is claimed to have the highest quality and highest resolution on the market. The transducer is protected within an oil filled, pressure compensating dome. The power output is increased compared to other products and the image quality is relatively high. The scanning sonar has a 360-degree field view and a lateral range of 40 meters (131 ft). The data can be viewed in real time and shows more detail than a multi-beam sonar but software is required to process the data acquired in the field. The domed sonar head is shown in **Figure 2.40** for the Kongsberg MS117 (Kongsberg, 2019d).

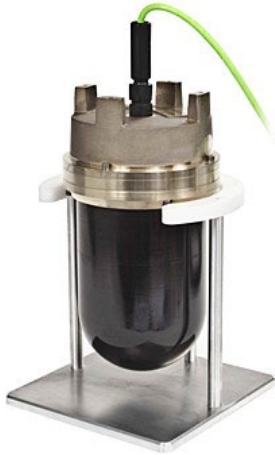
Figure 2.41. Dual-axis scanning sonar head (Kongsberg, 2019e)

Kongsberg Dual Axis Sonar (DAS): This product is based on position and can show more detail than the multi-beam sonar mentioned previously. DAS systems provide information on the dynamics of sediment scour and produce 3D point profiles. It is designed for long term monitoring in harsh conditions and can cover large areas. It works with the Kongsberg software program or in “standalone mode” which is when

the data is logged in the DAS and transmitted wirelessly. This is a continuous 3D surveying system which is useful for obtaining information about scour. The equipment can be seen in **Figure 2.41** and a data image is shown in **Figure 2.42** (Kongsberg, 2019e).

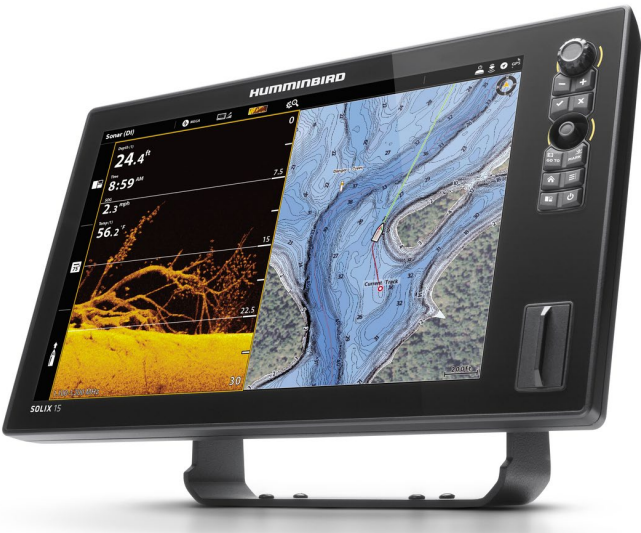
Figure 2.43. Display unit for Hummingbird Solix (Hummingbird, 2020)

Commercial sonar “fish finders”: Many companies produce sonar-based “fish finder” products for recreational fishing. In addition to helping anglers to locate fish, these products also report water depth and other underwater conditions. While this technology is not intended for scour monitoring, it could conceivably be used for basic monitoring and for identifying bridges for more detailed evaluations. Automated mapping software is available as an add-on feature for some fish finder products. An example product is the Hummingbird Solix (**Figure 2.43**) which can be combined with proprietary AutoChart mapping software. One limitation of AutoChart is that the data are not compatible with CAD software used by bridge engineers (Ross, 2019).

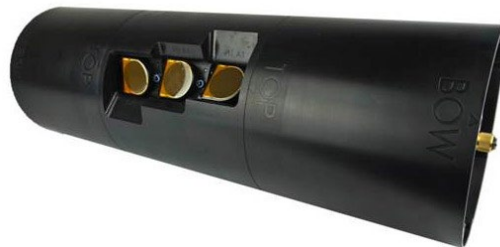
Figure 2.44. Teledyne profiler (Teledyne Marine, 2019e)

Teledyne BlueView T2250-360 Tunnel Profiler: This profiler has 360 degree profiling with data logging and real-time collection through Teledyne PDS software (an optional feature). This system is meant to be mounted on a Remotely Operated Underwater Vehicles (ROV) or Autonomous Underwater Vehicles (AUV) and is used for tunnel, pipe, or cave inspections. The tunnel profiler is a modular sensor and requires a vehicle of some sort to be attached for navigation through the pipe or culvert of interest. The product can be seen in **Figure 2.44** and a data image is shown in **Figure 2.45** (Teledyne Marine, 2019e).

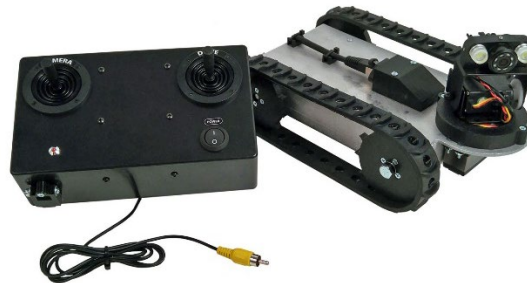
Figure 2.46. SuperDroid SST2 Robot (SuperDroid Robots, 2019a)

SuperDroid SST2 Tracked Inspection Robot (with Pan and Tilt Camera): This is an all-terrain inspection robot designed for tight spaces like culverts. It features a wide view color camera that allows the operator to see in both dark and light settings. The camera has full coverage with pan and tilt. The robot is controlled using a standard one hundred-foot Ethernet cable connected to the robot and the operator using a controller. The vehicle can maneuver along most terrain and can change direction easily. An image of this product is shown in **Figure 2.46** (SuperDroid Robots, 2019a).

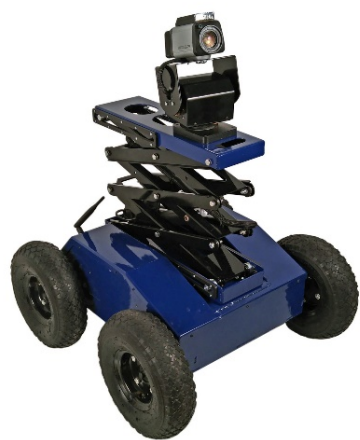
Figure 2.47. SuperDroid PTW-42-L 4WD (SuperDroid Robots, 2019b)

SuperDroid PTW-42-L 4WD: This vehicle is made for all terrain and includes a scissor lift with a pan-tilt-zoom (PTZ) camera. The robot is controlled wirelessly but can also be tethered and has a colored video display. The PTW-42-L is useful for inspecting larger objects than culverts but can still be used if the culvert is large enough (**Figure 2.47**) (SuperDroid Robots, 2019b).

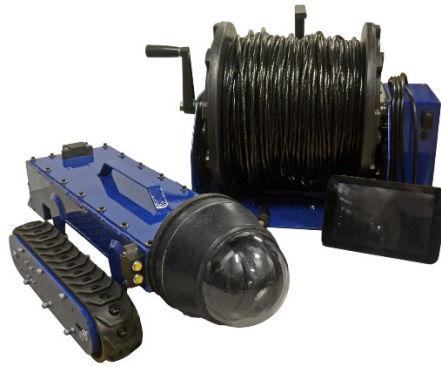
Figure 2.48. SuperDroid SCT-32-W (SuperDroid Robots, 2019c)

SuperDroid SCT-32-W Inspection Robot: This robot is specifically made for inspecting pipes and culverts. The camera has full pan and 90-degree tilt ability and has a camera installed on the back for reverse mode. The SCT-32-W is controlled with a tablet using wireless or tethered connections. The vehicle also includes LED lights that can be turned on and off to illuminate the view of the camera. The recommended tablet is a Microsoft Surface and with this the user can record the video display or take still pictures of the culvert. The SCT-32-W is designed to fit into culverts ten inches in diameter or larger. This product can be seen in **Figure 2.48** (SuperDroid Robots, 2019c).

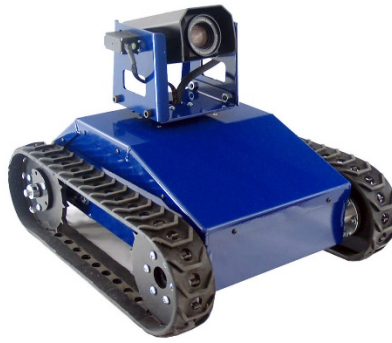
Figure 2.49. SuperDroid MLT-42 (SuperDroid Robots, 2019d)

SuperDroid MLT-42 Compact Inspection Robot: This robot is useful for tight spaces with low clearance height and has a camera with full pan and tilt. The MLT-42 can be controlled wirelessly or tethered with a maximum length of 500 feet. The tablet recommended for use is the Microsoft Surface and the operator can record the video display or take pictures of what is seen in color. This vehicle offers an encoder option which allows the user to track specific distances when something important is seen and it comes with LED lights to help improve sight in the culverts (**Figure 2.49**) (SuperDroid Robots, 2019d).

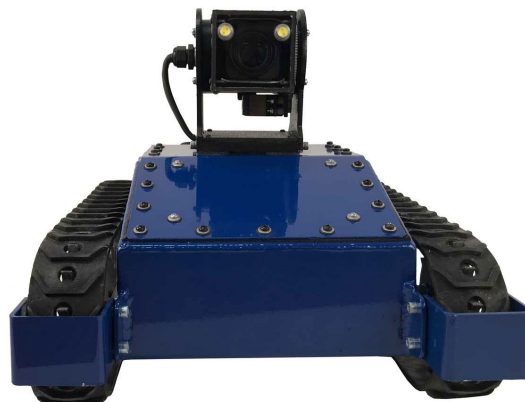
Figure 2.50. SuperDroid MLT-42-W (SuperDroid Robots, 2019e)

SuperDroid MLT-42 W Watertight Compact Inspection Robot: This vehicle is specifically designed for inspection of pipes and culverts with low clearance heights and is watertight. The camera has pan and tilt and the vehicle has LED lights for illumination. The MLT-42-W can be controlled wirelessly or with a tethered cable having a maximum length of 500 feet using a provided tablet that controls the vehicle and shows the video display (**Figure 2.50**) (SuperDroid Robots, 2019e).

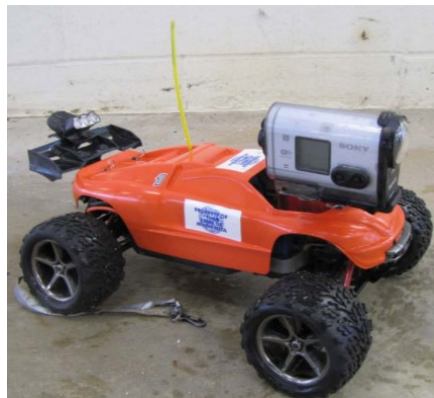
Figure 2.51. HIVE product (Minnesota DOT, 2016)

Hydraulic Inspection Vehicle Explorer (HIVE) Camera Inspection: This is a lightweight alternative to the CCTV crawler that has onboard lighting and a video camera that can pan and tilt. It is remote controlled and has video imagery transmitted by Wi-Fi to a tablet. The crawler can travel over debris and is waterproof. This crawler does not have a counter to measure distances. An image of this product is shown in **Figure 2.51** (Minnesota DOT, 2016).

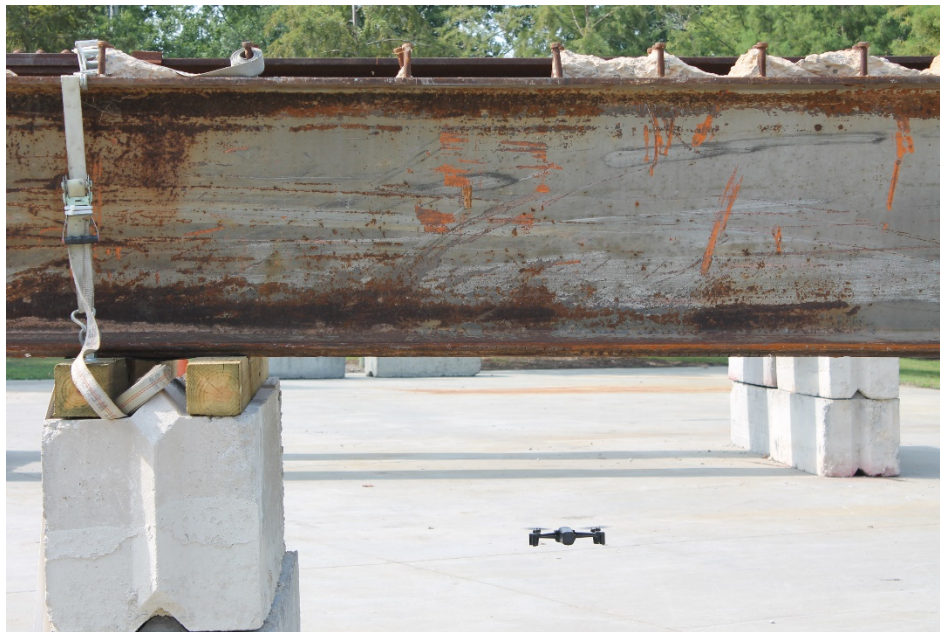
Figure 3.6. Parrot Anafi flying under steel beams

Some drawbacks noted during testing are the lack of collision avoidance sensors and no payload capacity for additional cameras and sensors. However, the system has since been outfitted with a set of propeller guards which greatly improve its ability to withstand contact during flight. Additionally, during testing an attempt was made to fly between the large steel beams with the GPS on. The beams created enough interference for the drone to begin veering to the side, strike a beam, and fall to the ground. It was not immediately clear how to disengage the GPS system to allow the system to fly between the beams and further investigation/testing is needed to verify the capabilities of tight proximity flight. Propeller guards and a tablet mount for the controller have been used successfully to further improve the Anafi's effectiveness for inspection.

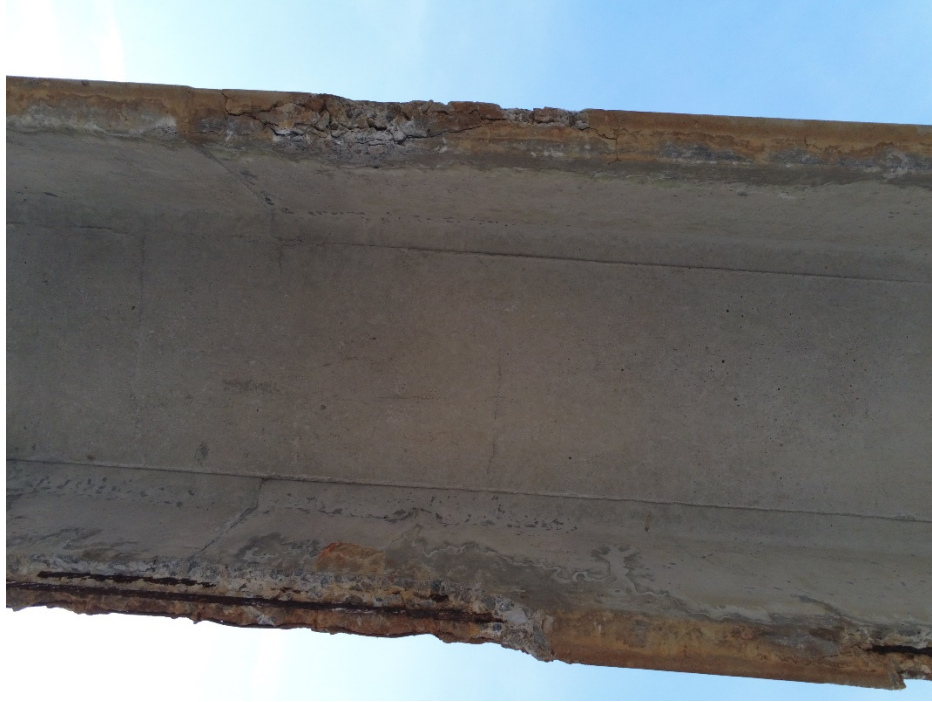
Figure 3.7. View from below double-tee girders

Parrot Anafi: During the demonstration, the drone pilot flew the Anafi under every bridge component (**Figure 3.6**), getting within inches of the structural members and allowing for high quality photographs (**Figure 3.7**) and videos. The controls are easy to use, and the pilot commented on how intuitive the system was. The drone was stable with and without GPS enabled.

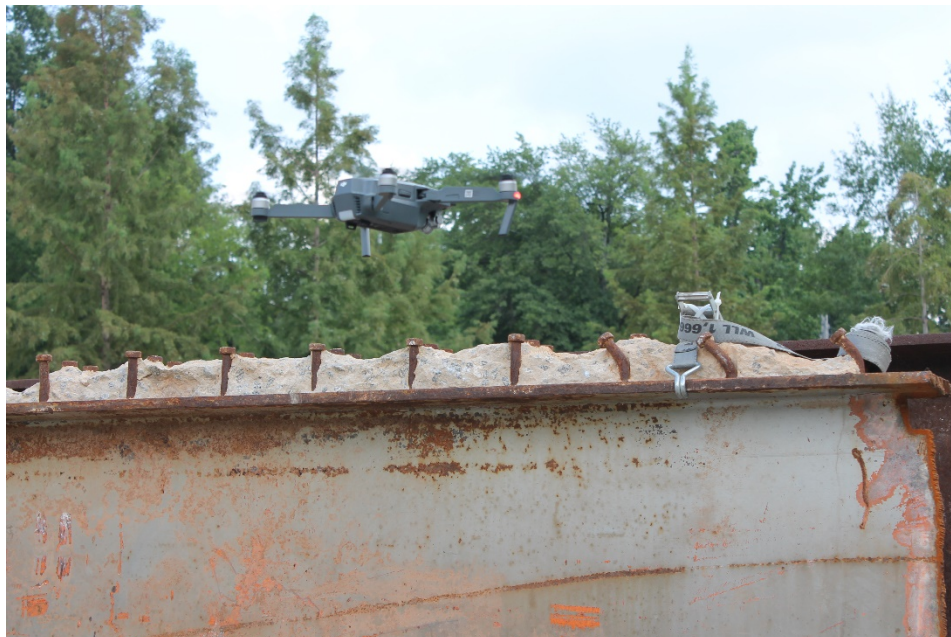
Figure 3.8. Mavic Pro observing steel beams

DJI Mavic Pro: The system appeared to have an issue with the navigation system during the early stages of the demonstration and needed to be calibrated several times to allow it to fly properly (**Figure 3.8**). The pilot was unable to take pictures of the bottom side of the bridge components due to the lack of an upward facing camera, which limited the effectiveness of an otherwise promising system.

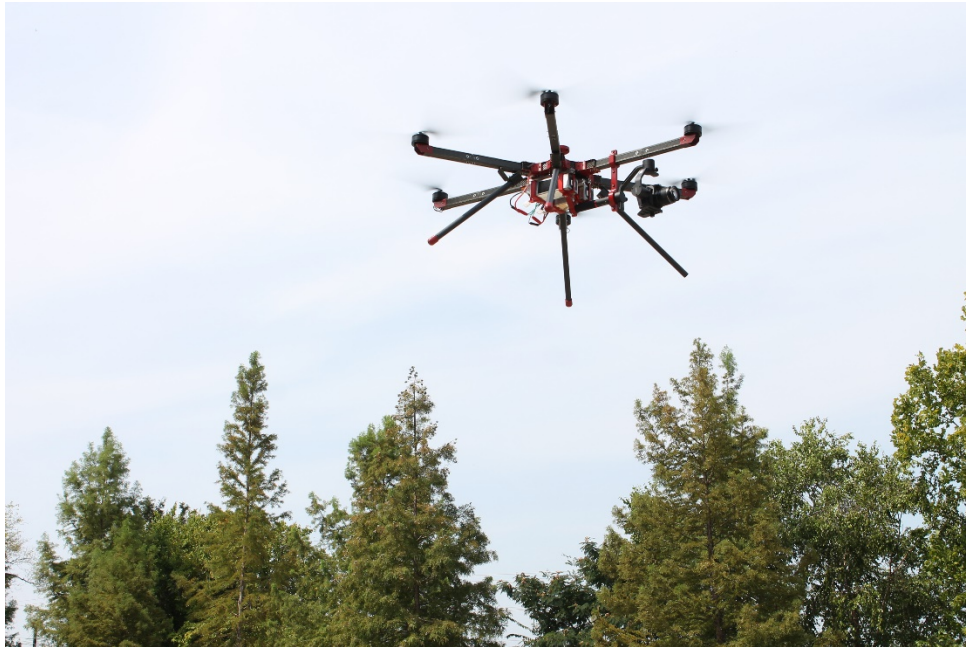
Figure 3.9. McNair/TIG Hitco Drone

McNair Center/TIG Hitco Drone: Wout DeBacker and Arturs Burgs of the McNAIR Center for Aerospace Innovation and Research and TIG Hitco respectively, brought a custom drone system to demonstrate (**Figure 3.9**). There were some technical problems with the onboard navigation system that would eventually impact most of the drones and prevented a proper demonstration of this system.

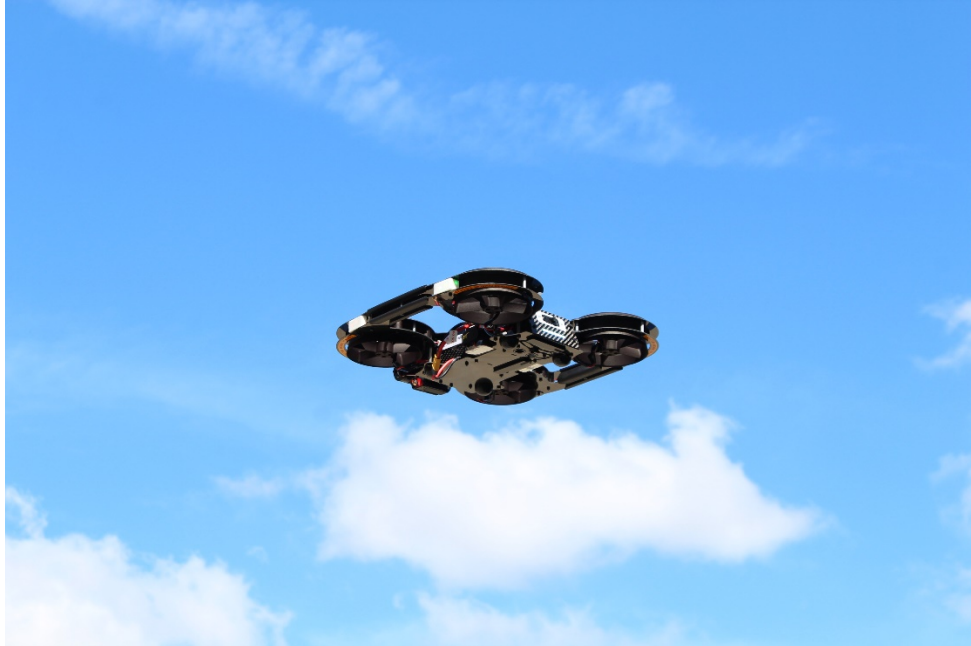
Figure 3.10. Aertor 120

Aertos 120: Representatives from Digital Aerolus demonstrated the capabilities of the Aertos 120, which represented the most robust aerial option for visual inspection at the demo (**Figure 3.10**). To showcase this, the pilot intentionally struck the bridge components repeatedly (**Figure 3.11**). The system endured many collisions and hard landings without sustaining damage.

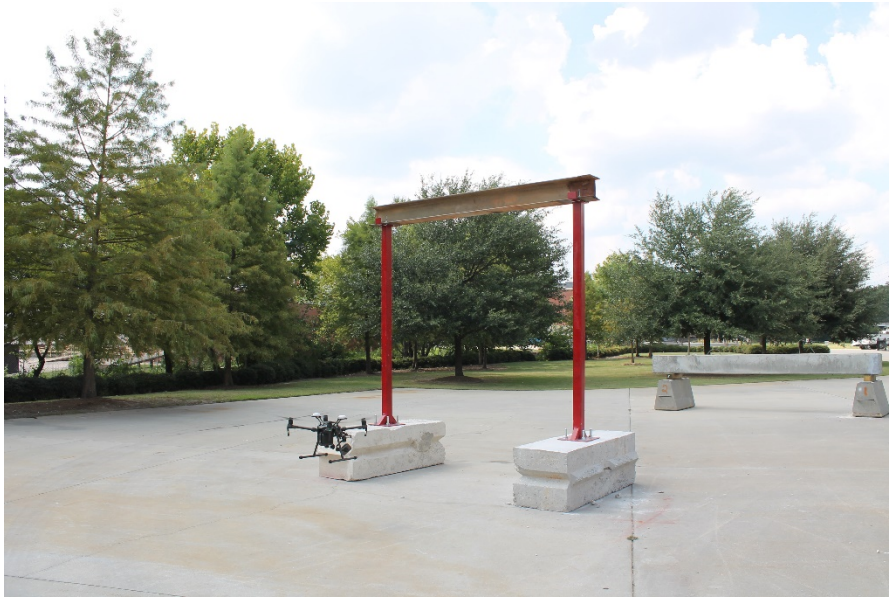
Figure 3.13. Matrice 210 line of sight view

DJI Matrice 210: Gresco and US Aerial Video demonstrated the DJI Matrice 210. The drone offers payload options of a single camera on the bottom, two cameras on the bottom, and a single camera on top. The double lower mount was demonstrated by Gresco and the single upper mount was demonstrated by US Aerial Video. In both cases the cameras demonstrated were the DJI Flir XT which is a 640 x 512 resolution thermal imaging camera, and the DJI Zenmuse Z30 which is a visible light camera with 30x optical zoom capability. The impressive capability of the camera is showcased in **Figure 3.13** and **Figure 3.14** where the former is an image of the position of the drone when the latter image was taken.

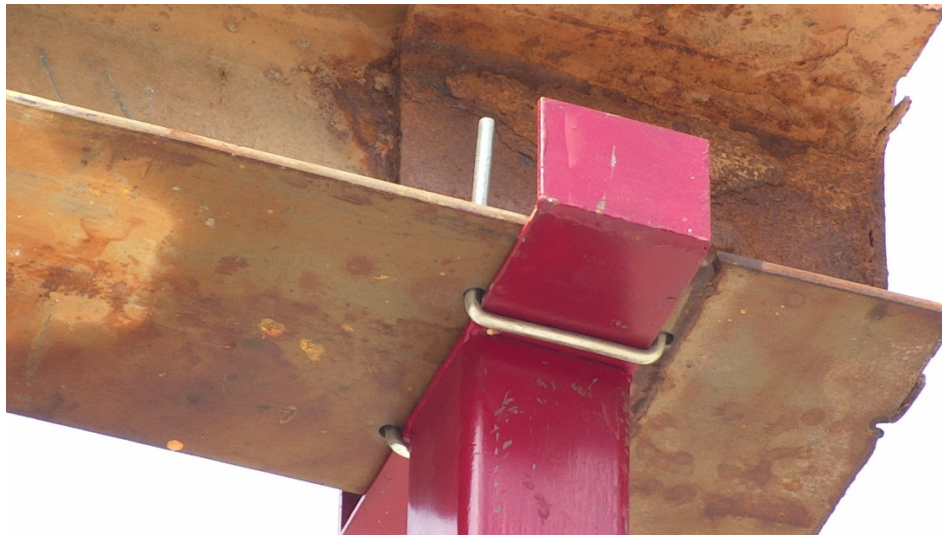
Figure 3.14. View from Matrice 210, Zenmuse Z30 (30x zoom)

Despite the lower mount for the cameras, the system showed promise in capturing excellent footage of the bridge components from below. The Z30 camera was particularly impressive due to the offset which it allowed the user to have from the area of interest (**Figure 3.14**). An XT2 Camera system was also present, which is a combination of visual and infrared cameras, allowing for simultaneous capture of footage (**Figure 3.15**).

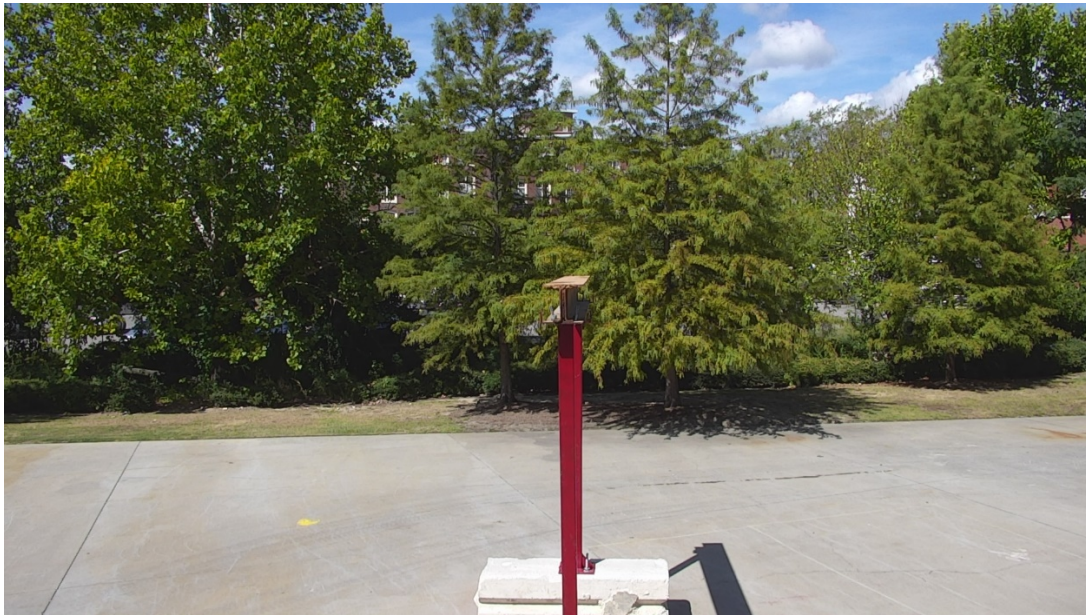
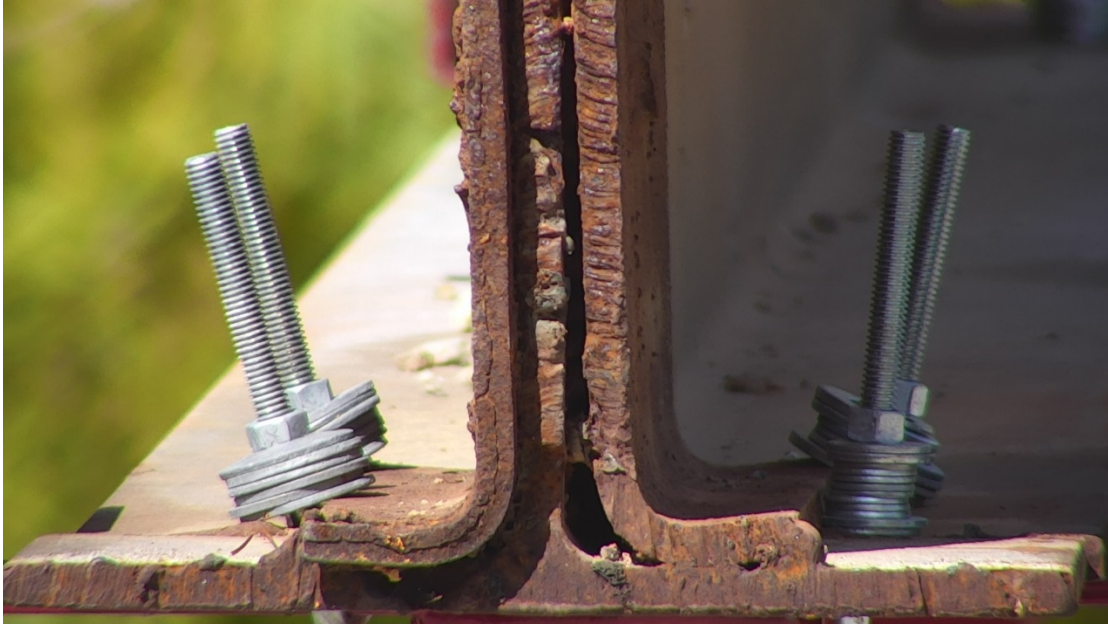
For comparison purposes, some images were taken from a 1x and then a 30x zoomed perspective (**Figure 3.16** and **Figure 3.17**).

Figure 3.16. Zenmuse Z30 1.0x magnification

Figure 3.17. Zenmuse Z30 30x magnification

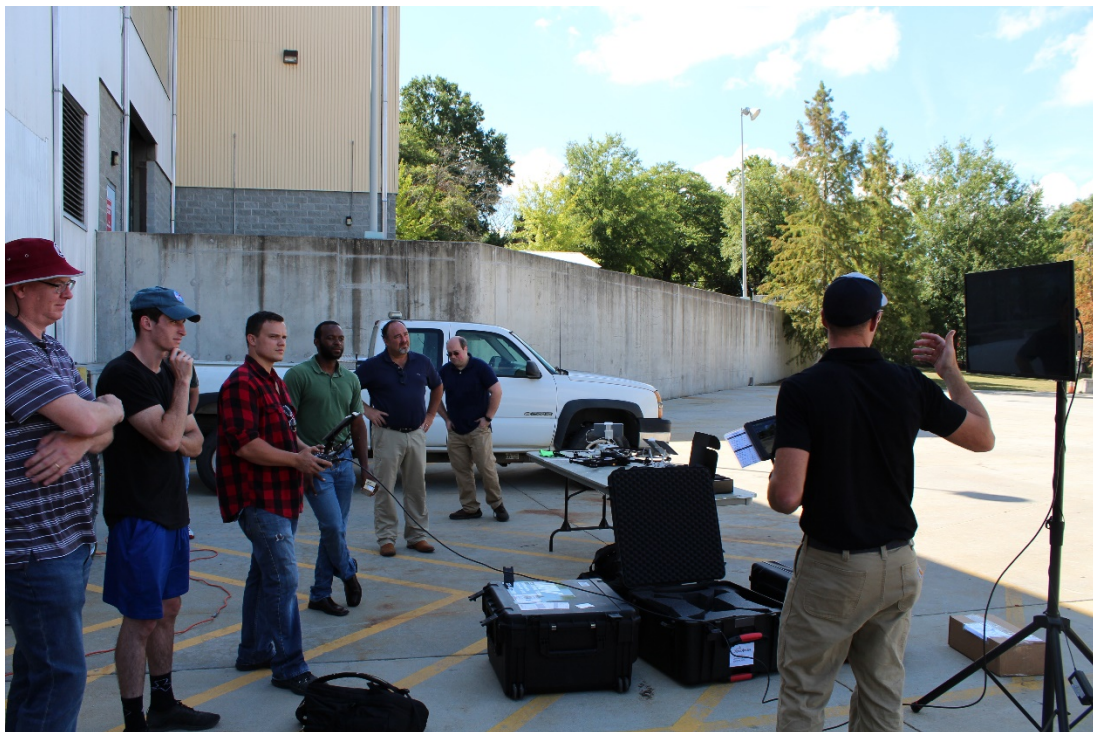
Figure 3.18. A representative from US Aerial Video pilots the drone while a researcher acts as the inspector with control of the camera payload

The M210 system also allows for a pilot and an inspector to simultaneously operate the drone. The pilot can control the drone using the FPV camera, and the inspector can control the payload cameras to take

pictures of areas of interest (**Figure 3.18**). Potential drawbacks of the system are cost, size, and a lack of a collision avoidance system, which makes the two former issues more of a concern.
