Assessment of Structural Degradation for Bridges and Culverts

June 2020

1. Report No FHWA-SC-20-03		2. Government Accession No.		3. Recipient's Catalog No.	
4. Title and Subtitle <i>Assessment of Structural Degradation for Bridges and Culverts</i>				5. Report Date <i>June 2020</i>

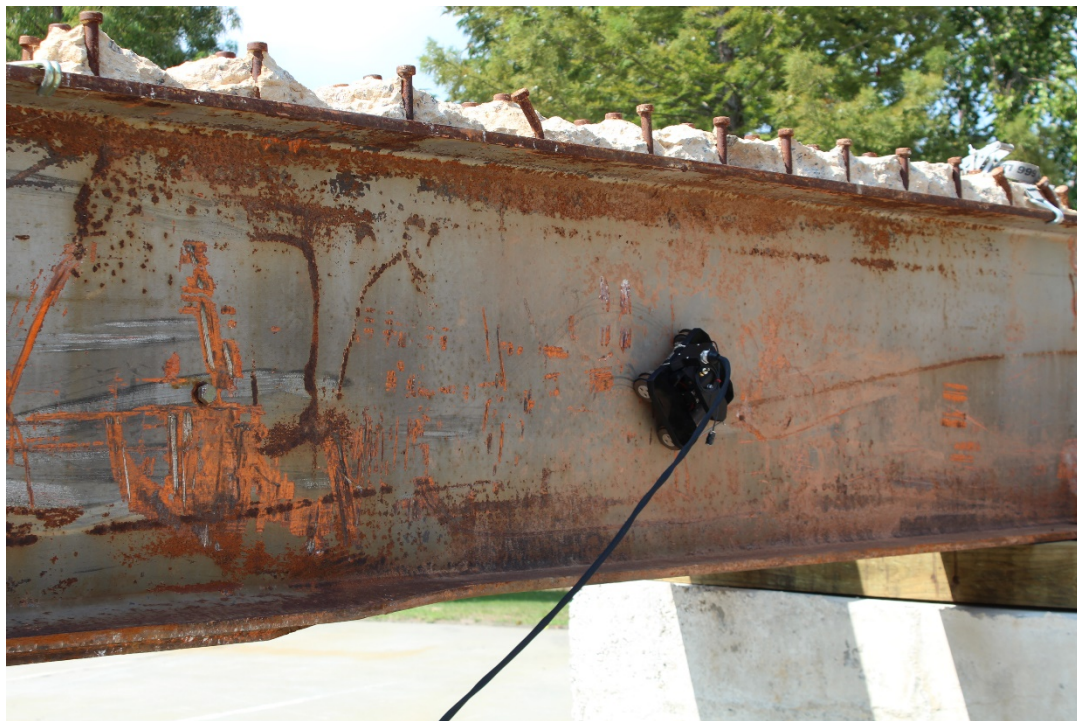
Figure 3.19. RTT MRIS-MN1 on steel beam

RTT MRIS-MN1: This crawler system is tethered, which allows it to run nearly indefinitely, as well as providing direct contact with onboard sensory equipment and cameras (**Figure 3.19**). The tether does present some inherent drawbacks for bridge inspection, and it did snag on some exposed fasteners. Additionally, the tether limits the distance that the robot can be from the operator. Wireless operating capability would significantly enhance the effectiveness of this crawler for bridge inspection.

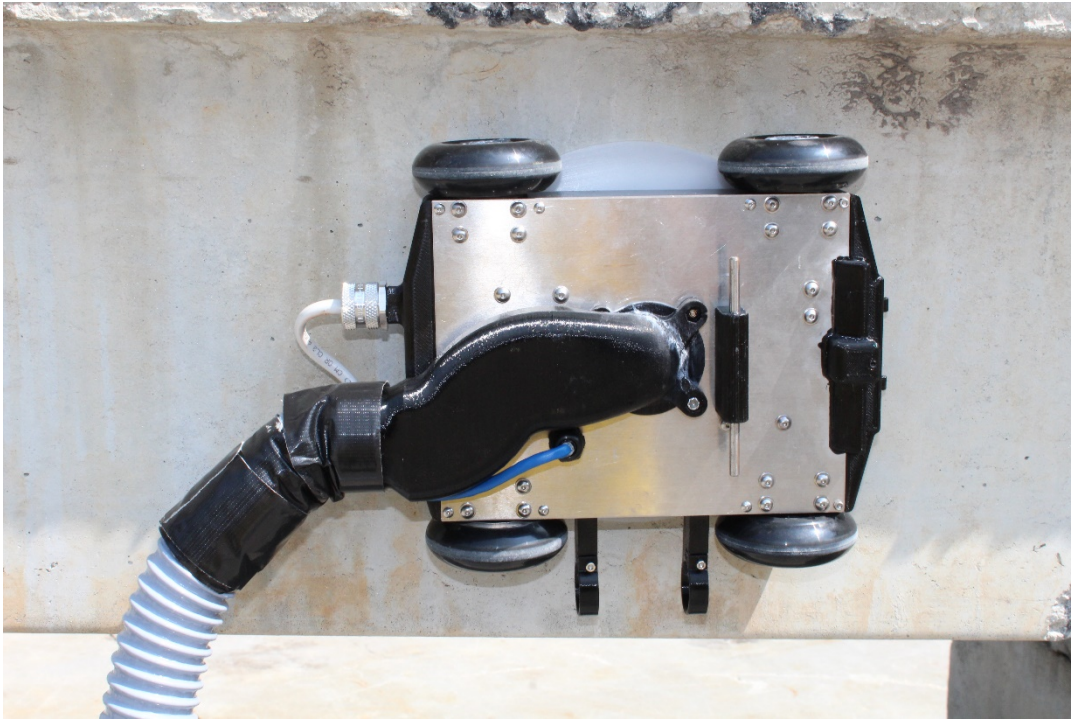
Figure 3.20. RTT vacuum prototype on double-tee concrete girder

RTT Vacuum Robotic Prototype: Unlike the MRIS-MN1 system, the vacuum prototype robotic system can bond to any surface which allows a seal to be formed, and the robot is then held up by air pressure (**Figure 3.20** and **Figure 3.21**). Concrete and steel surfaces were both effectively demonstrated. It is mentioned that a gap in the material, such as during a transition, may be enough to cause the robot to lose its bond. There are no sensory provisions yet adapted to the system as it is in the development and demonstration phase. As with the MRIS-MN1, the system is tethered both by control wires and a vacuum hose. A similar system with an onboard pump and wireless operation may be well-suited for inspection of many structures.

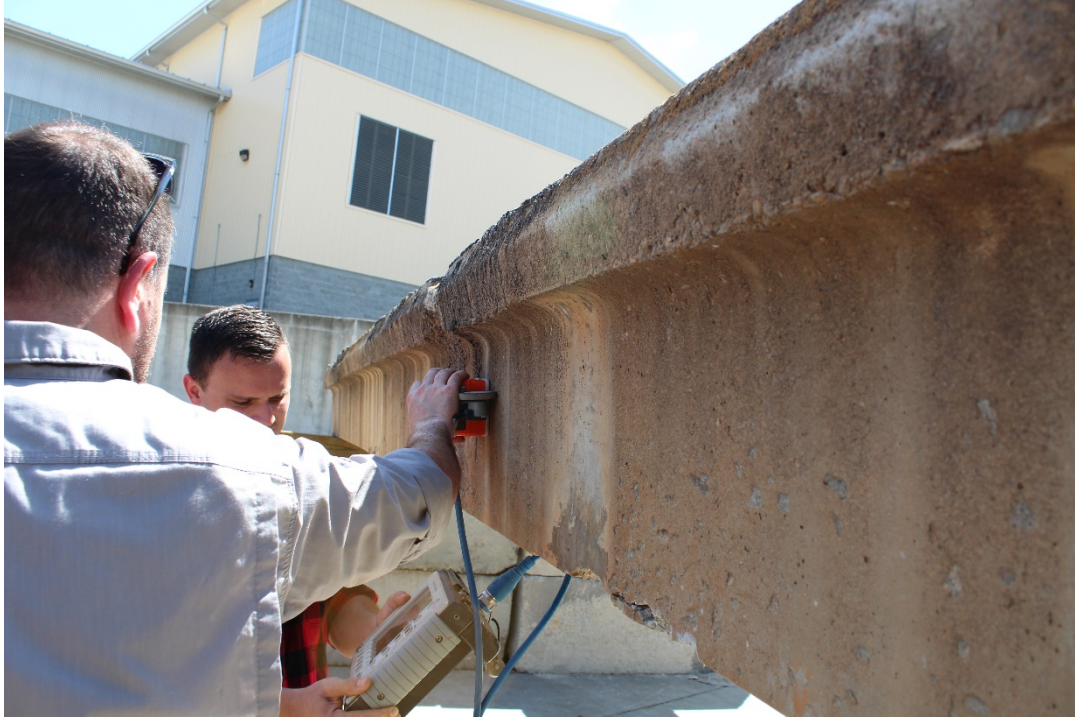
Figure 3.22. Shane Boone demonstrating GPR hardware on concrete double-tee girder

Ground Penetrating Radar: The GPR hardware (GSSR SIR 3000) (**Figure 3.22**) was able to identify reinforcement locations in the double-tee and pile specimens. The output of the scanner is a graphical representation of wave reflections in real time. From this, the relative location in distance traversed from starting point and the depth at which the reinforcement lies are shown. With a known starting point, a map of the reinforcement may be developed for existing structures where this information is not known.

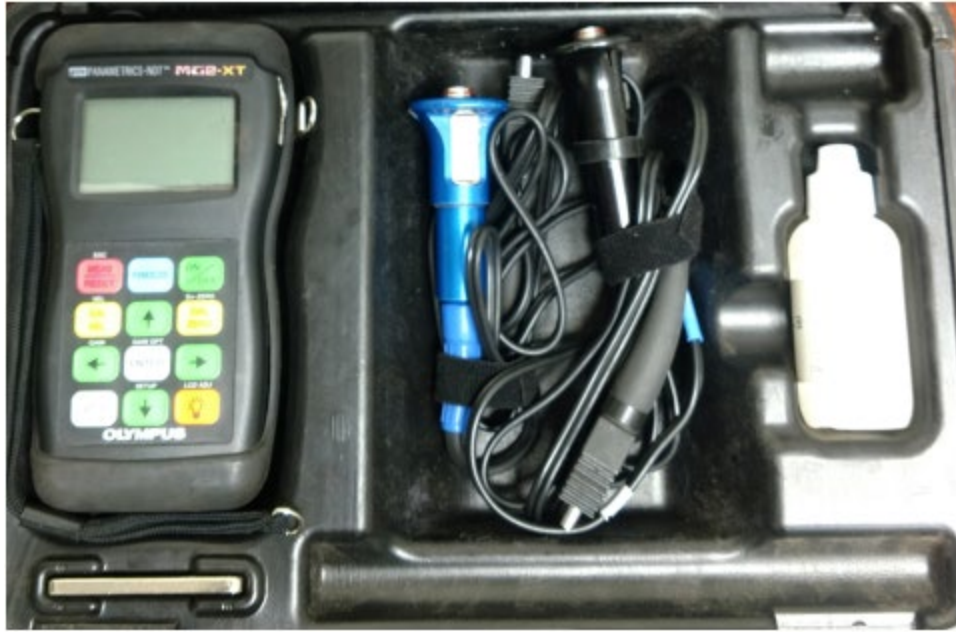
Figure 3.23. Olympus MG2-XT ultrasonic thickness gauge, photo credit: Shane Boone, BDI

Ultrasonic Thickness Testing: The ultrasonic thickness testing was conducted with an MG2-XT Gauge (**Figure 3.23**). The large steel beams were used for this test (see **Figure 3.24**) as well as a calibration block to demonstrate the accuracy of the system. During the calibration process, the system output value was within 0.001" of the expected output. (actual value: 0.200", tested value: 0.200"). Defects within the steel would have shown as an additional reflection point in the output waveform. No defects were identified in the specimens with the gauge as it requires a clean surface for accurate measurement, and the surface of the beams were quite corroded. This limitation indicates the gauge may not be effective in the field without surface preparation.

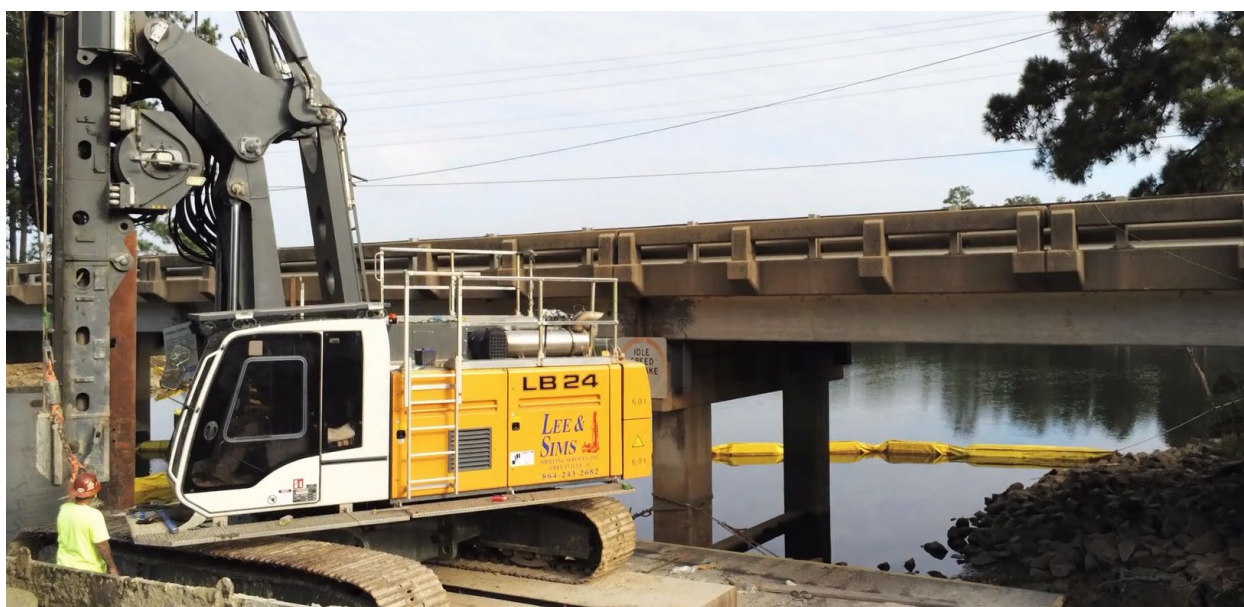
Figure 4.3. Inspection area of interest (to the right of machinery)

Because the bridge was low the operator was able to remain relatively close to the drone and maintain good line of sight. As the inspection began it was clear that the ability to move such a small drone around the equipment was necessary, as larger drones would be a distraction to work and a potential danger to the crew (**Figure 4.3**). Images of cracks were taken from several angles on plane with the bridge (**Figure 4.4**).

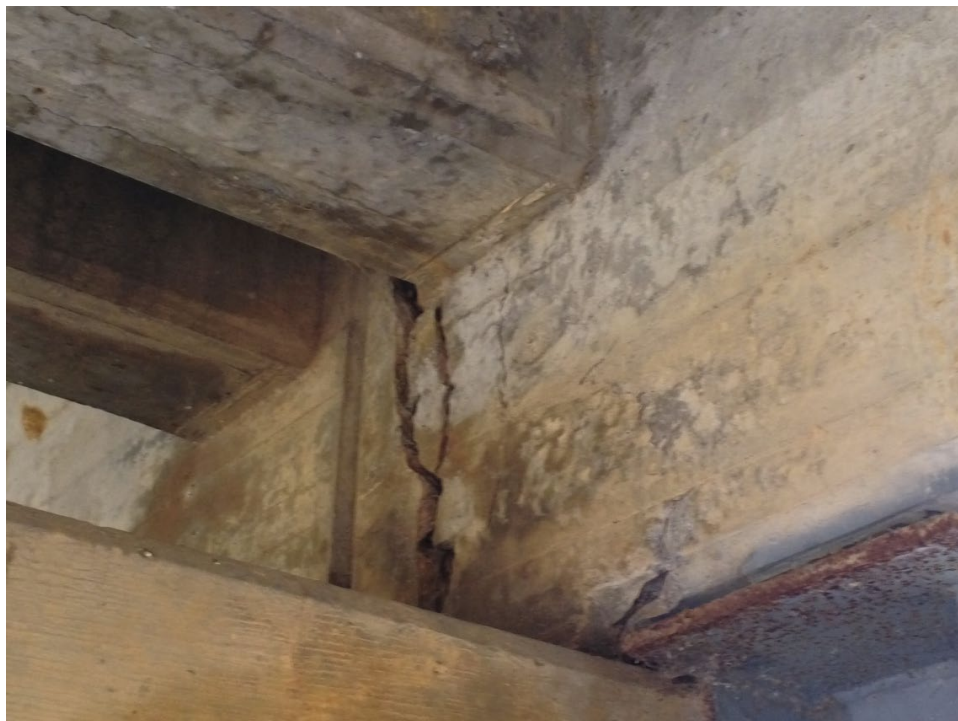
Figure 4.5. Exterior girder (inner surface)

After inspection of the exterior girder the operator moved the drone under the bridge to inspect the interior girders, beams, and deck. Cracks and delamination were observed on many of the structural members located near the eastern support. While these defects are visible from the ground on the bank, similar defects on a taller bridge (or defects above supports further away from the bank) would not be visible or easily accessible (**Figure 4.5** and **Figure 4.6**).

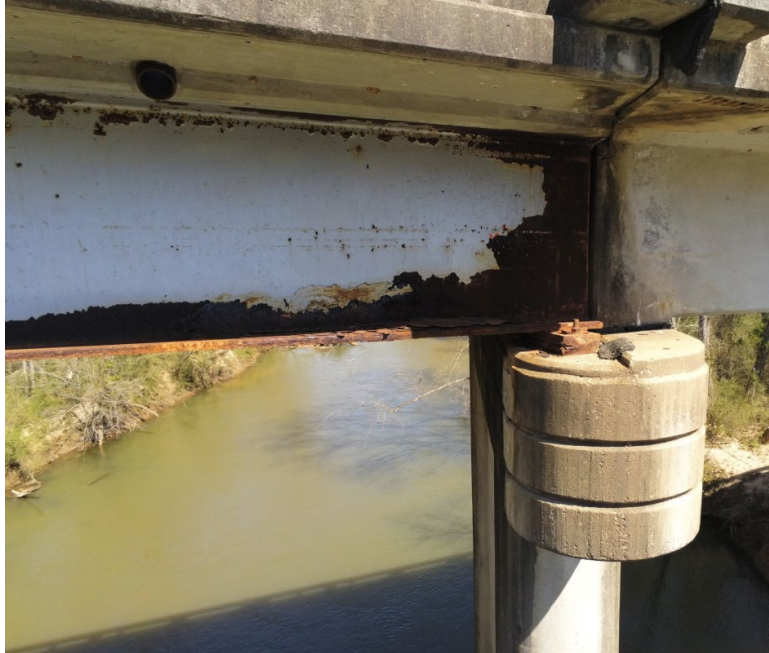
Figure 4.9. Drone image of corrosion on steel superstructure

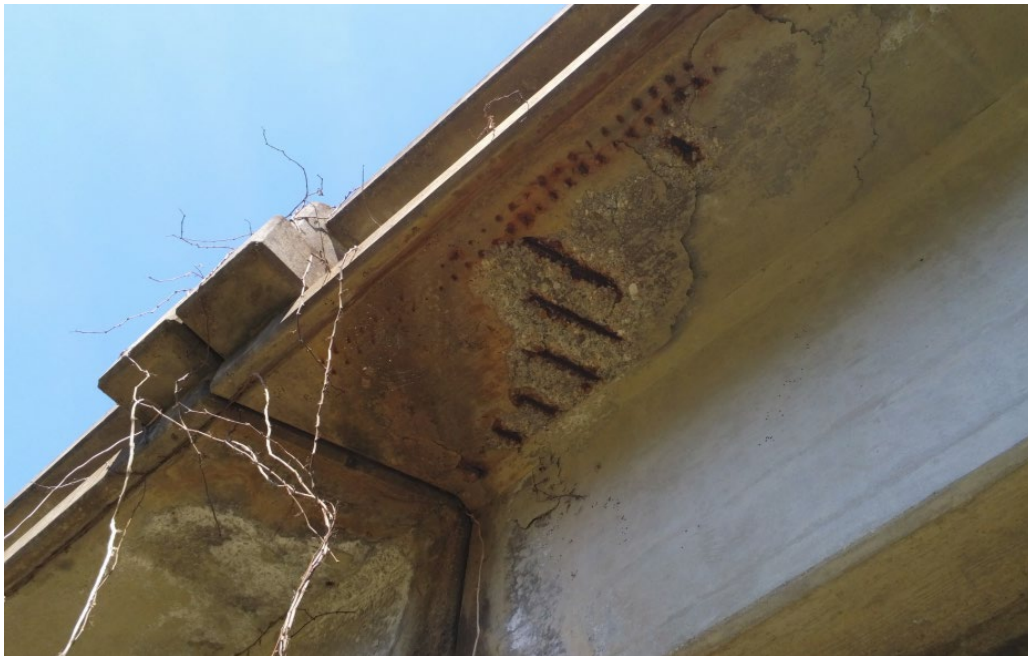
Figure 4.10. Delamination and crack development in SC HWY 105 Pacolet River Bridge

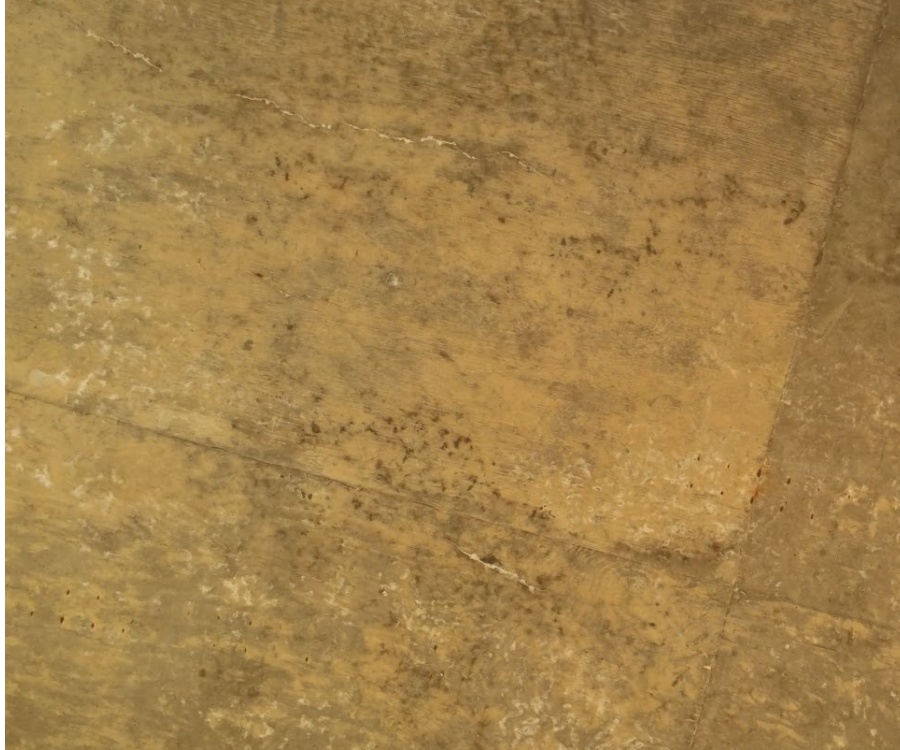
Figure 4.11. Image taken from drone recording (overhead view) of cracks in bridge deck

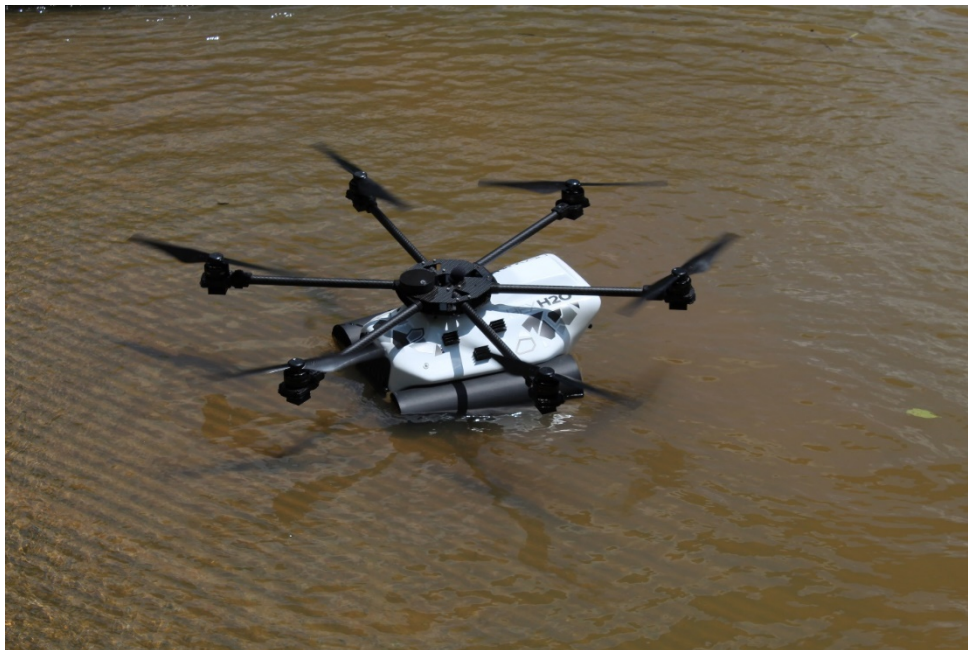
Figure 4.18. HEX H2O drone (capable of landing on and taking off from water)

HWY 601 Congaree Bridge: This site, shown in **Figure 4.17**, served as the primary demonstration location for the autonomous kayak system equipped with sonar equipment to capture information from the riverbed and linking to the GPS location. Post-processing of the data can generate a topological map of the riverbed, which is useful for monitoring the development of scour as well as accrual of debris. Supplementing the autonomous kayaks is a HEX H2O drone (Figure 4.18) which is water-proof and capable of taking off from, and landing in, water. The eventual goal of the system is to allow the kayaks to act as a carrier of the drone while conducting their own data acquisition.

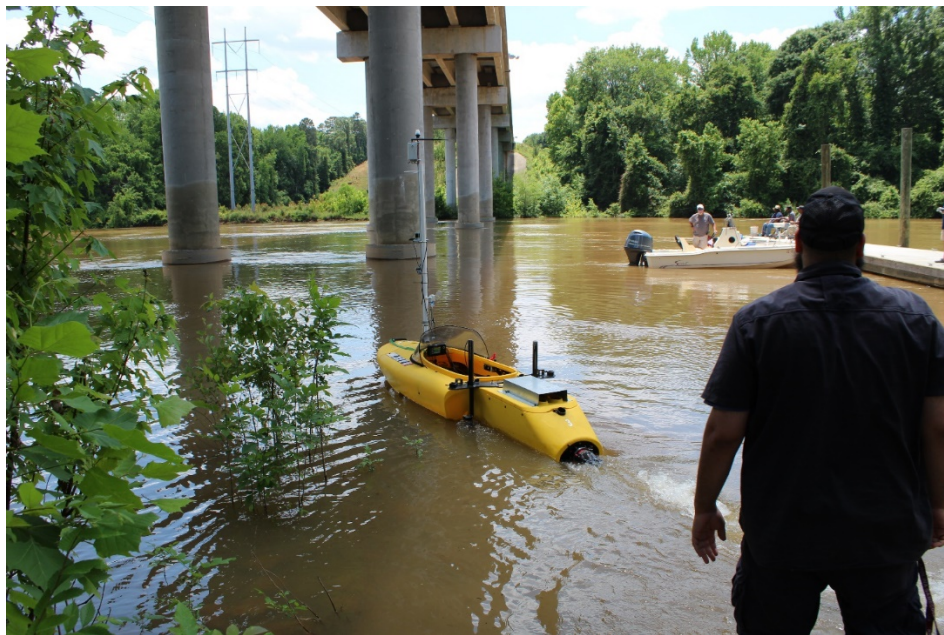
Figure 4.20. Kayak embarking in autonomous mode

The team demonstrated the autonomous and manned capabilities of the kayaks, as well as the capability of the drone to take off and land in water. No demonstration was shown of the drone landing on the kayaks, which is a process still under development by the research group. The demo started with discussions of the capabilities of the kayak and expected applications (**Figure 4.19**). **Figure 4.20** shows the kayak embarking in autonomous mode.

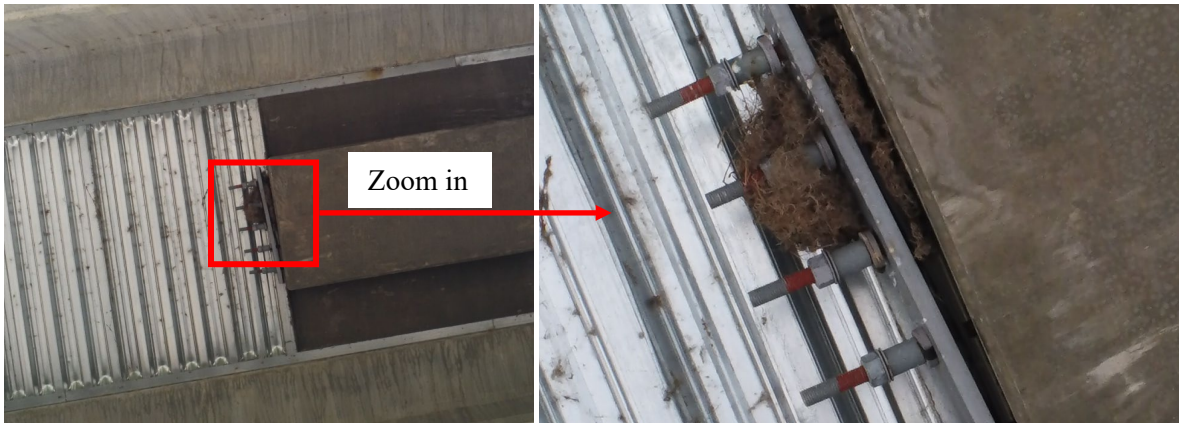
Figure 4.21. Image of superstructure with loose baseplate (taken by Parrot Anafi drone)

In regard to observations of the superstructure, a gap was noticed between a build-up and a prestressed rod baseplate as shown in **Figure 4.21**. The observation was made with the parrot Anafi drone, and this was used as an opportunity to test the proximity tolerance when deprived of GPS. The pilot was able to navigate the drone safely within two feet of the defect and take additional photographs. During the drone inspections the birds began to swarm the drones. While this did not negatively impact the drones or the field test, a mid-air collision with a bird may be inevitable in the future. Precautions should be taken to avoid loss of equipment and harm to wildlife such as the use of a small drone with floatation capabilities.

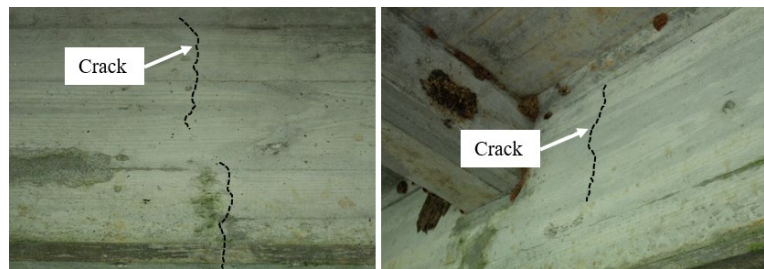
At the time of the load test (July 31, 2019), the most recent inspection had been performed on March 8, 2018 and the National Bridge Inventory (NBI) condition ratings were 6 for the deck and for the superstructure (satisfactory condition), and 4 for the substructure (poor condition) (on the NBI rating scale, the best condition possible is a 9). Flexural cracks have been seen throughout. The exterior span 4 was selected for the load test since the girders showed more extensive cracking than other spans, and the girders are more easily accessible. **Figure 5.3** shows examples of the visible flexural cracks near the midspan of interior girders. In general, the interior girders showed more cracking than the exterior girders. This data analysis is focused on AE and strain data collected from the sensors attached to interior girders 2 and 3, and crack opening displacement data collected from girders 1, 2 and 3.

Figure 5.3. Visible cracks near to the midspan of interior girders

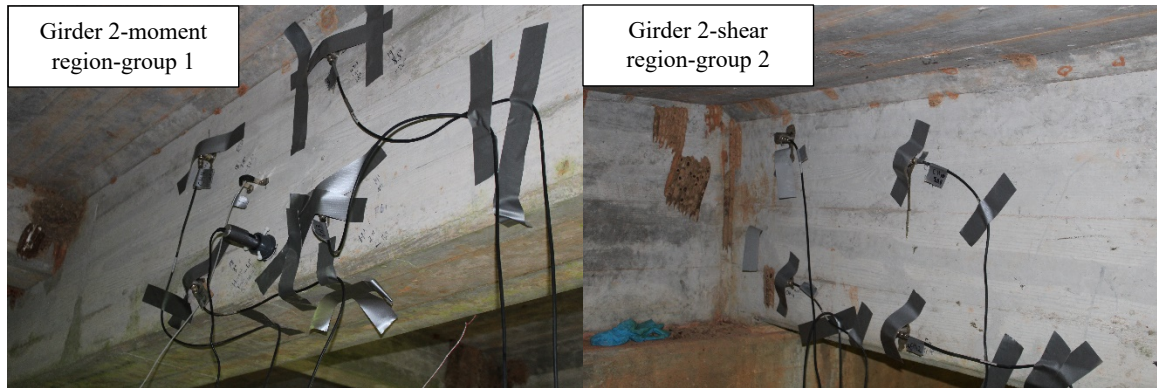
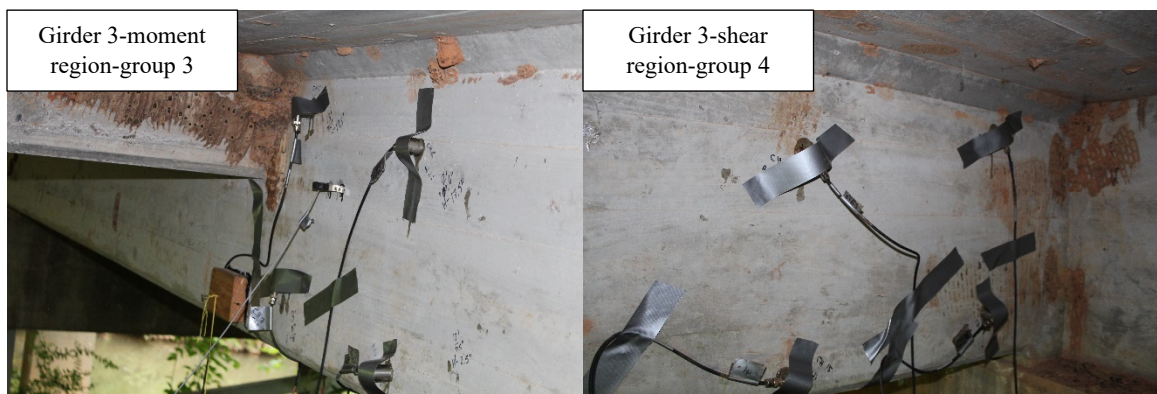
Figure 5.6. Photographs of AE sensor groups

US-221 over Hard Labor Creek bridge: Truck loading was applied to the southern exterior span 4, and both interior girders in this span were instrumented with AE sensors (manufactured by MISTRAS Group, Inc., Princeton Junction, New Jersey). Two types of AE sensors were used; eight were WDI (broadband) and eight were R6i (resonant), with an operating frequency range between 100 – 900 kHz and 40 – 100 kHz, respectively. Double bubble epoxy was used as a coupling agent to affix sensors to the girders. Eight sensors were placed near the abutment of exterior span 4 in the shear region/support areas where no cracks have been developed (four on each interior girder), while the other eight sensors were placed near the midspan in the moment regions surrounding the existing cracks in a general layout to cover the cracked areas. AE sensors were divided into groups named as shown in **Table 5.1**. **Figure 5.5** shows the AE sensor layout; the red circles refer to resonant sensors (e.g., 1R where the 'R' stands for resonant) and the black squares refer to broadband sensors (e.g., 2B where the 'B' stands for broadband). Photographs of AE sensors groups attached on interior girders are shown in **Figure 5.6**. Sensor Highway II AE system (16-channel system manufactured by MISTRAS Group, Inc., Princeton Junction, New Jersey) was used to collect the data.

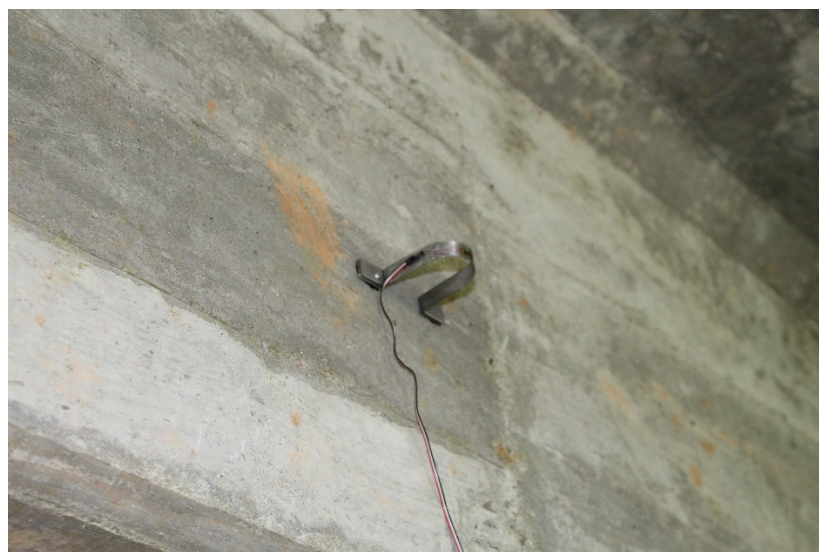
Figure 5.7. PI gauge attached on interior girder 3 to measure crack opening displacement

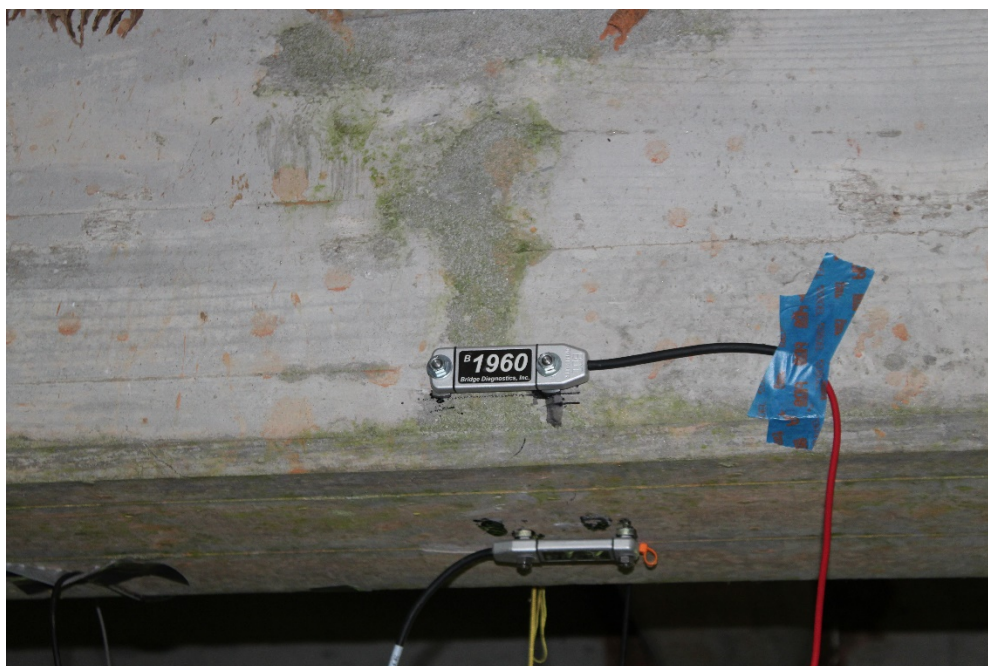
Figure 5.8. BDI strain gages attached on interior girder 3

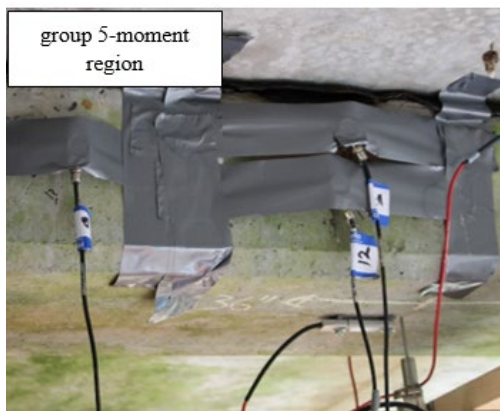
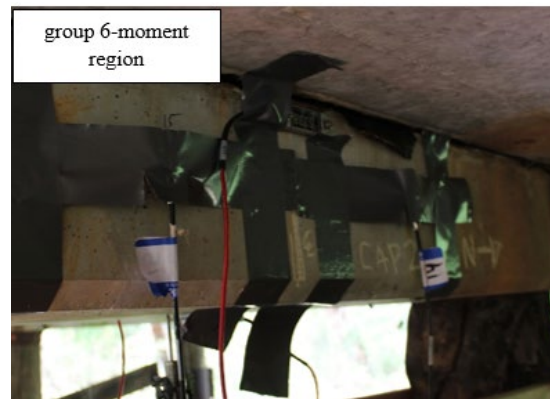
Figure 5.10. Photographs of AE sensor groups

d) Bent cap 2, east face

e) Bent cap 2, west face

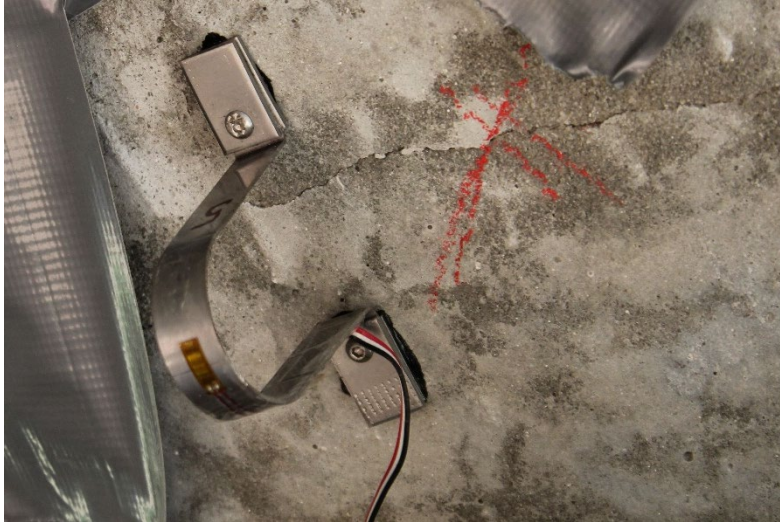
Figure 5.11. PI gauge attached on interior panel 2 to measure crack opening displacement

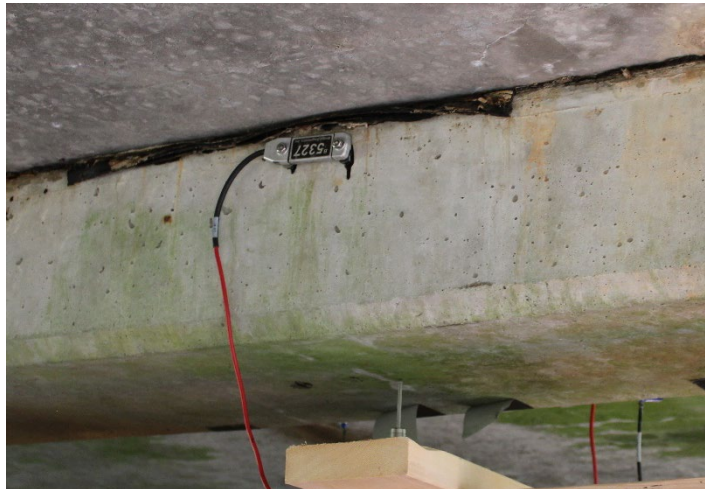
Figure 5.12. BDI strain gages attached on bent cap 2

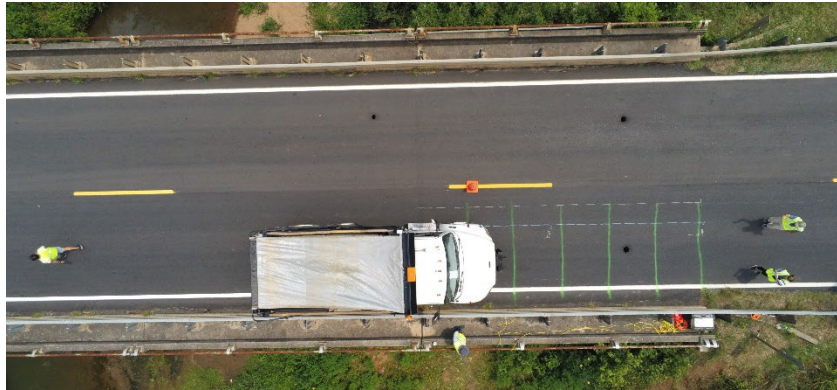
Figure 5.15. Single truck on exterior girder 1, a) sketch, b) photograph taken by Parrot Anafi drone

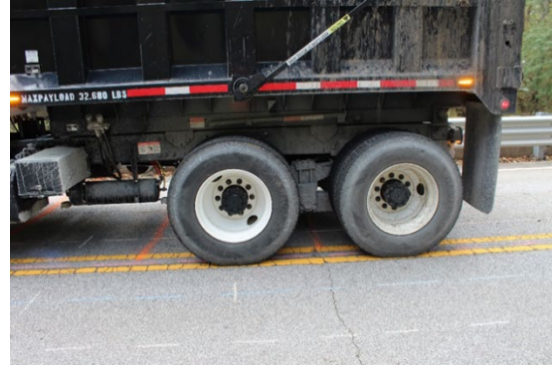
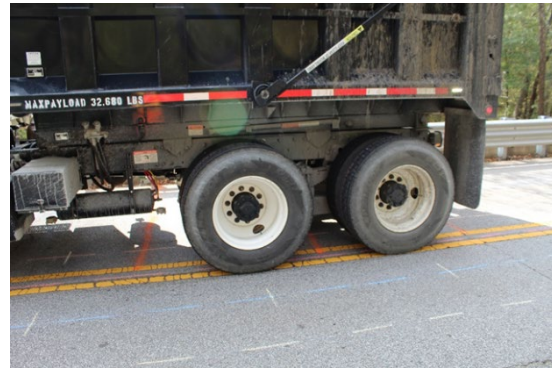
Figure 5.20. Longitudinal locations of the test truck: position 1 and 2

a) holding position 1

b) holding position 2

Truck orientations for acoustic emission: Two scenarios were used to drive the test truck longitudinally across the bridge while midspan vertical deflection, surface strain, crack opening displacement and AE signals were recorded on the interior span 2. First, the truck was driven at slow speeds along the bridge, and second, the truck was moved (loading) and stopped (holding) in 5 ft (1.52 m) increments. **Figure 5.20** and **Figure 5.21** shows example of holding stations along the bridge. These two scenarios were repeated since the crossings of the truck were oriented to cause maximum effects in specific panels as shown in **Figure 5.22**.

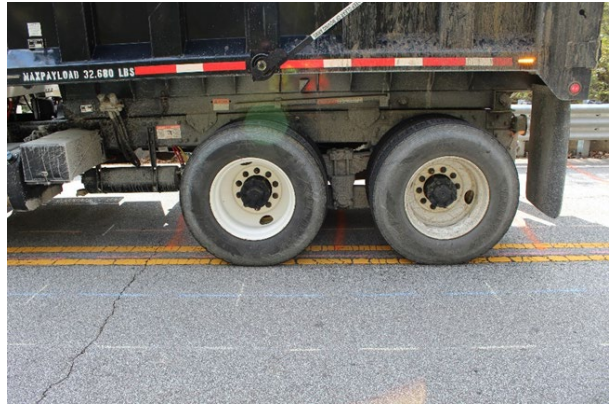
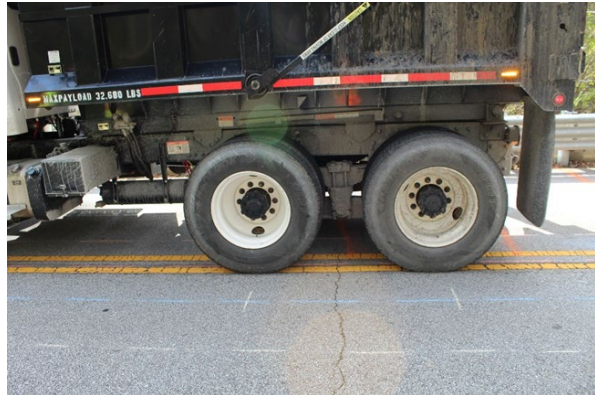
Figure 5.21. Longitudinal locations of the test truck: position 3 and 4

a) holding position 3

b) holding position 4
