*NDOR Research Project Number SPR-P1(03) P550
Transportation Research Studies*

EFFECTS OF CENTRAL ISLAND LANDSCAPE TREATMENTS AT SINGLE-LANE ROUNDABOUTS

Final Report

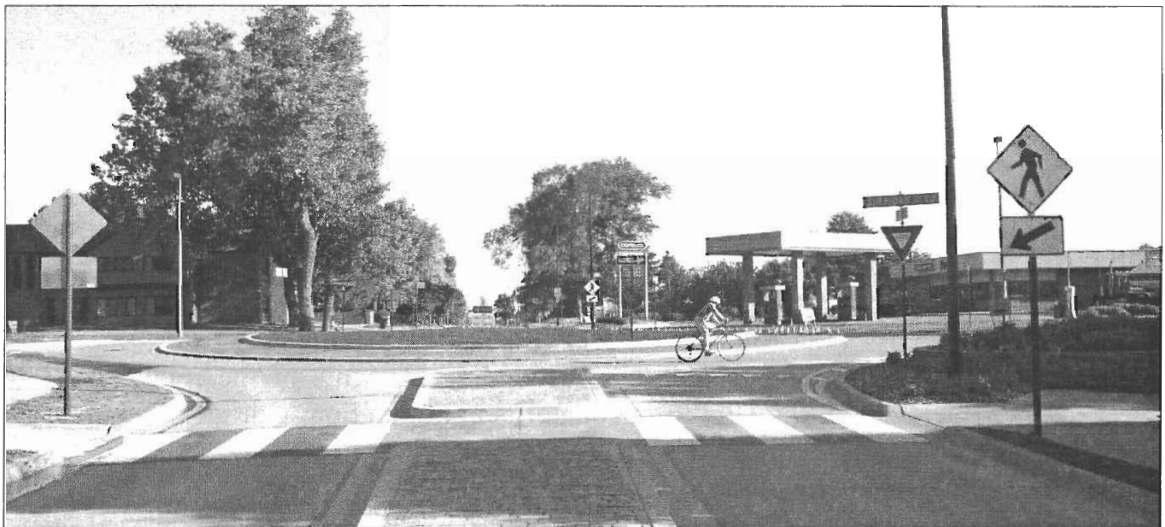
FIGURE 1B Example of Central Island with Clear Sight Line Cross View (Sheridan Boulevard and 33rd Street Intersection, Lincoln, NE)

Others suggest that the more visible all surrounding elements of the roundabout, the better able drivers should be able to negotiate its configuration, exit at the appropriate location, and view surrounding pedestrians and/or bicyclists in the process. An example of a clear central island cross view is shown in FIGURE 1B.

Bicyclists observed traversed the roundabout as a roadway user (see FIGURE 1B) or used the sidewalk and crosswalk. A few westbound bicyclists were viewed using both the roadway and part of the crosswalk to enter the hiker-biker access point (Behavior 4 in FIGURE 22).

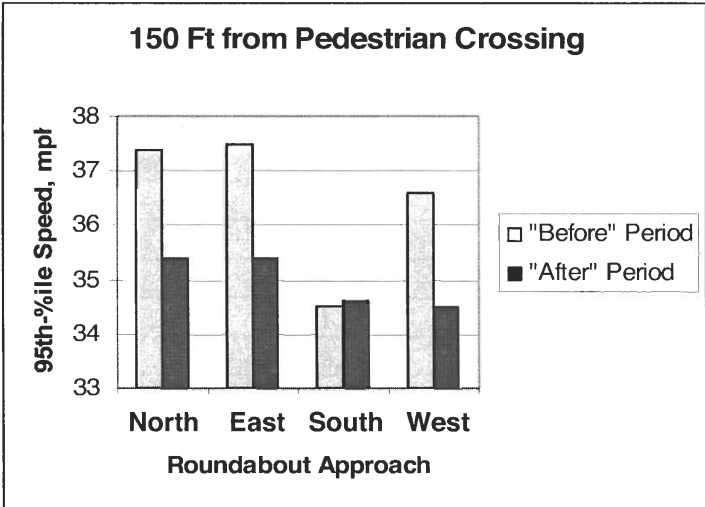
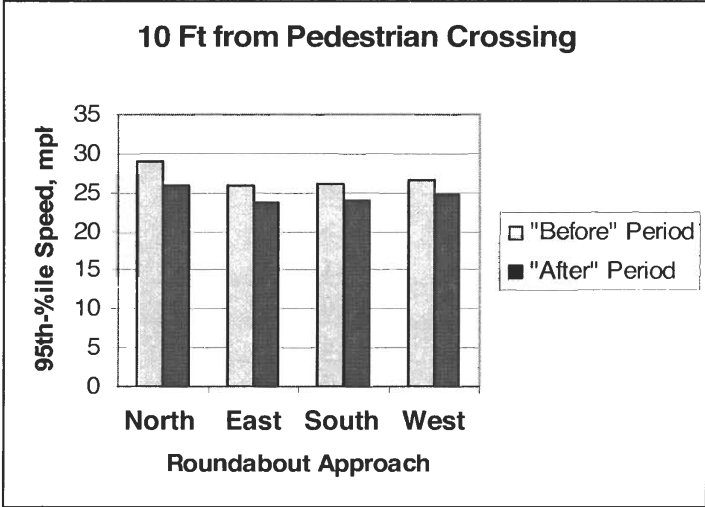
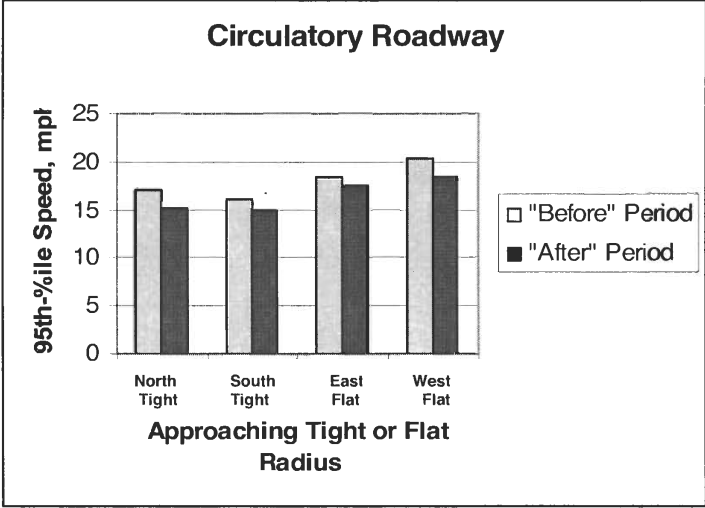
FIGURE 15 Graphical View of Difference in “Before” and “After” Period 95th-Percentile Speeds, mph

TABLES 4 and 5 summarize the speed statistic results of the “before” and “after” speed study in detail. Seven of the 12 study points resulted in a significantly lower mean speed and standard deviation at the 95 percent confidence level. Those locations with less than significant differences were very close in magnitude in both “before” and “after” conditions. The 95th- and 85th-percentile speeds at all 12 locations were lower in the “after” condition than the “before” condition as shown in TABLE 5. FIGURES 13 through 16 show the results in graphical form.

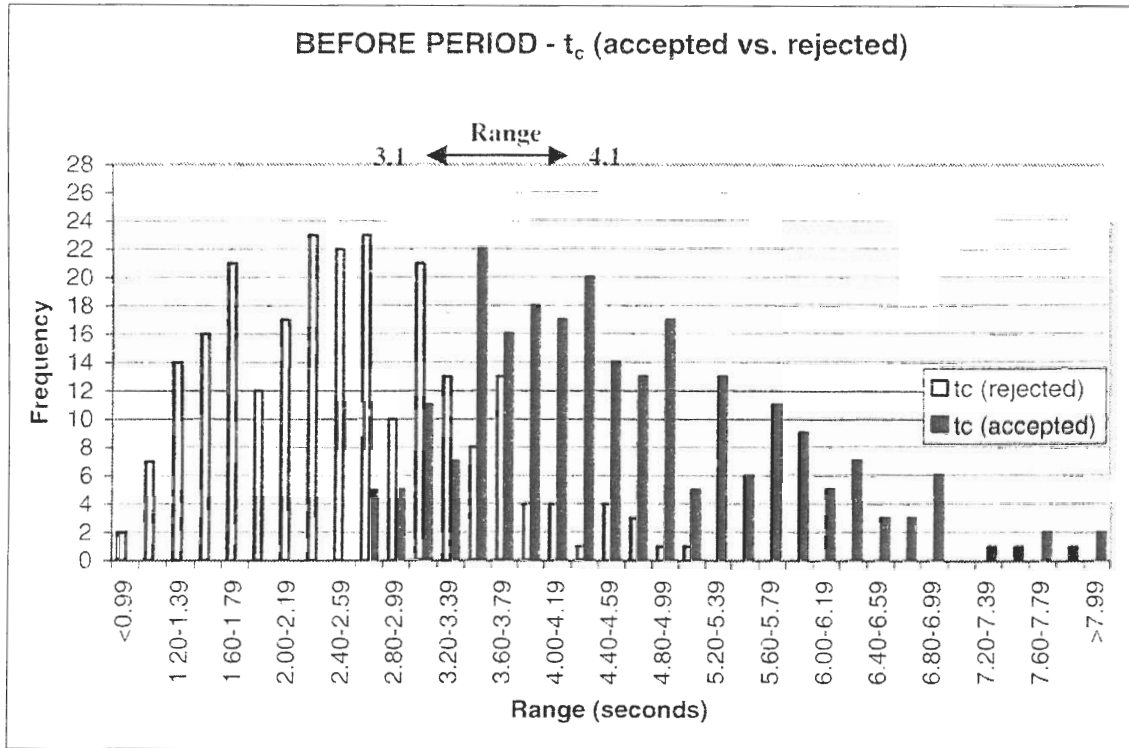
FIGURE 17 Frequency Distributions for Critical Gap, t_c , in the “Before” and “After” Periods

This change can be attributed to the overall decrease in speeds observed in the “after” period. Due to decreased speeds in the roundabout circulatory roadway, drivers accepted shorter gaps upon entrance, perhaps feeling more secure about merging their vehicles in the circulatory traffic stream since approaching drivers were traveling slower. Since the lower bound of the critical gap decreased, the potential capacity of the roundabout increased.

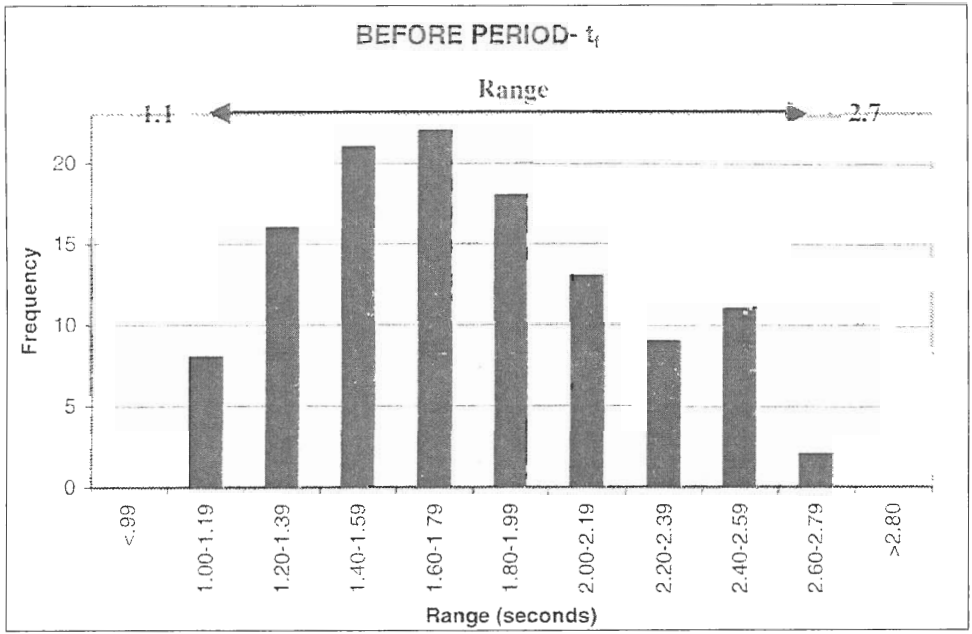
FIGURE 18 Frequency Distributions for Follow-Up Time, t_f , in the “Before” and “After” Periods

Even though the range in the “after” period was slightly larger (0.9 seconds to 3.1 seconds), it was determined to use the same range as in the “before” period because there was only one observation less than 1.1 second and two observations greater than 2.7 seconds out of more than 100 observations. FIGURE 18 shows the frequency distributions for follow-up time, t_f , in the “before” and “after” periods.

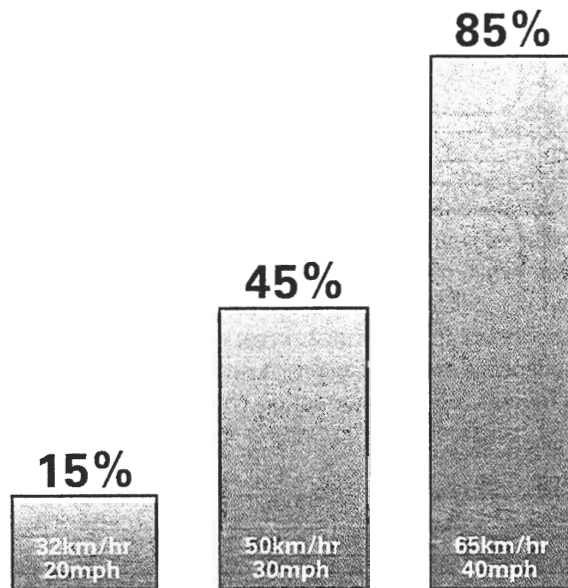
FIGURE 23 Pedestrian Chance of Fatality If Hit by Motor Vehicle

Drivers' choice of vehicle speed was also more uniform in the "after" period as evidenced by lower standard deviations. Both of these operational changes would inherently yield safer conditions for drivers, pedestrians and bicyclists. The severity of both vehicular crashes and pedestrian/bicyclists mishaps decreases drastically with changes in speed as shown in FIGURE 23 (10).
