1. REPORT NUMBER CA20-2970	2. GOVERNMENT ASSOCIATION NUMBER N/A	3. RECIPIENT'S CATALOG NUMBER N/A
4. TITLE AND SUBTITLE Vision-Based Sensor System for Site Monitoring: Wrong-Way Driving, Phase 1		5. REPORT DATE June 5, 2020

16. ABSTRACT This report presents results for research on a Vision-Based Site Monitoring (VBSM) system for monitoring Wrong-Way Driving (WWD) events. This system integrates a camera, solar power panels, and a modem into a pole-mounted package for deployment on freeway exit ramps to monitor for WWD events. The system incorporates on-camera analytics for WWD detection as well as traffic counts. Collection of WWD video is triggered by the camera analytics, and the system stores the videos for a period before and after the WWD event. The system was deployed at ten exit ramps in Northern California, and two exit ramps in Southern California. Data collected over a 39-month period (June 5, 2016-August 31, 2019) is presented, illustrating the effective performance of the VBSM system as a self-contained system for WWD monitoring application. The analysis of the data for WWD events collected shows agreement with the results of prior research studies, while providing a mo

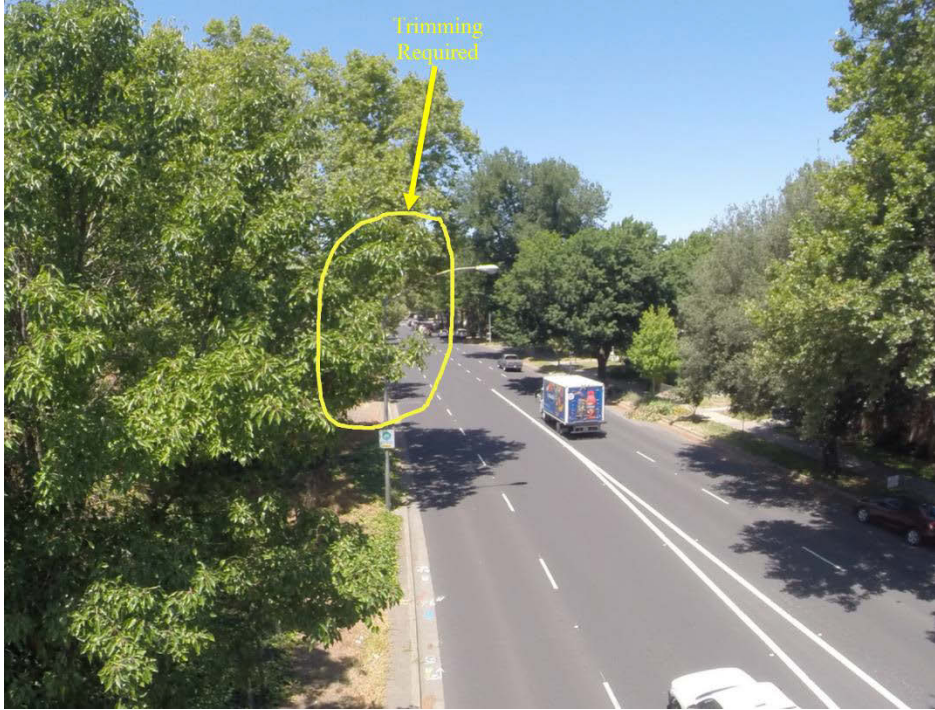
Figure 3.2: Example of tree trimming required to provide better camera FOV (US 50 WB 10th St exit)

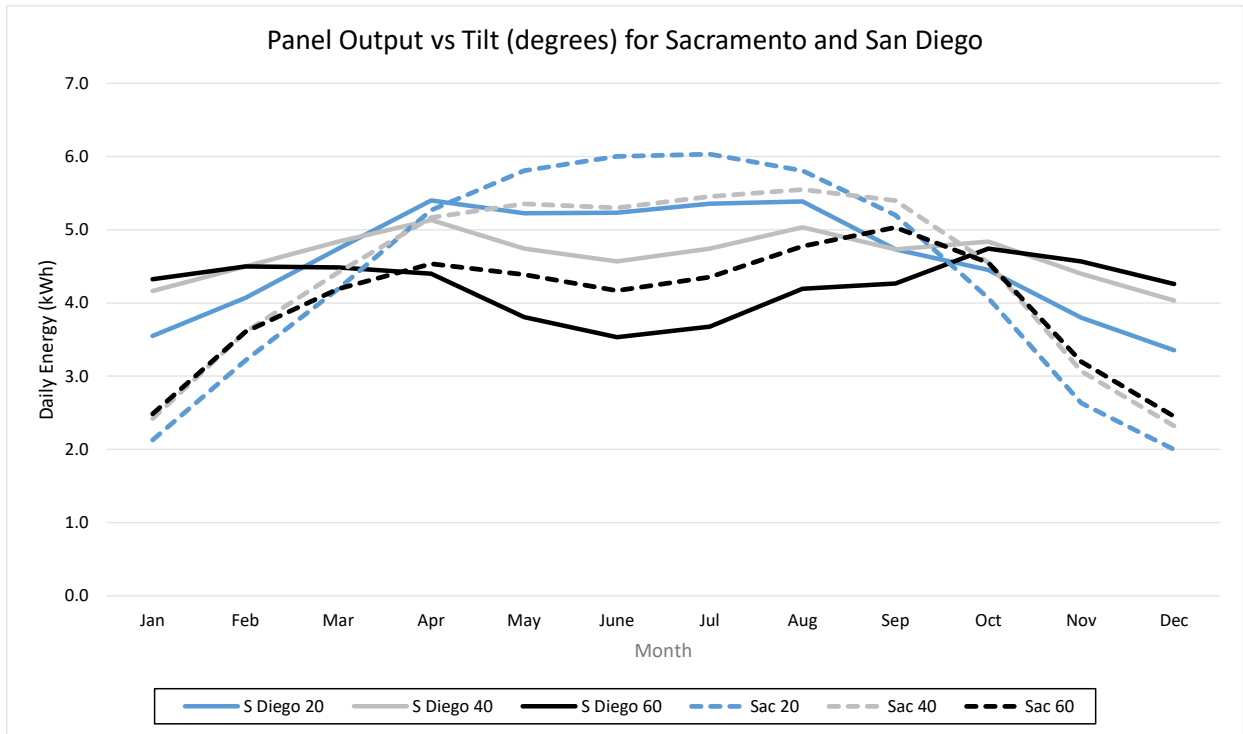
Figure 3.4: Solar panel output per day over the full year for various panel tilt angles from horizontal for Sacramento and San Diego, California¹

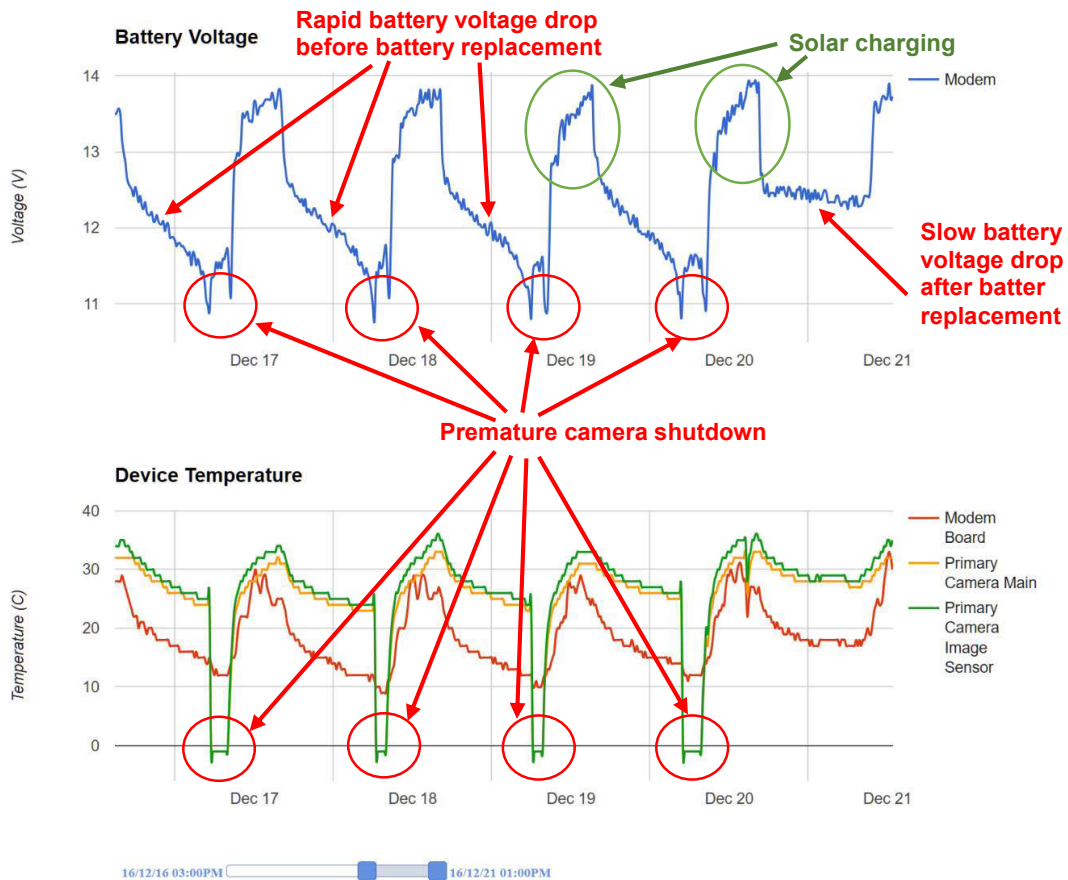
Figure 3.5: Battery voltage and device (camera motherboard, camera image sensor, and LTE modem) temperature showing camera shutdown due to degraded system battery

To allow remote diagnostics, we added automatic reporting and web-based viewing of several system operating parameters, including battery voltage and device temperature on the camera motherboard, camera image sensor, and LTE modem. This was very useful for assessing solar power sufficiency, solar charge controller health, and battery condition. It was also crucial in troubleshooting one system where the camera was automatically shutting down. In this instance, the researchers determined that one of the system batteries was failing and needed replacement. The data illustrating this is provided in Figure 3.5.

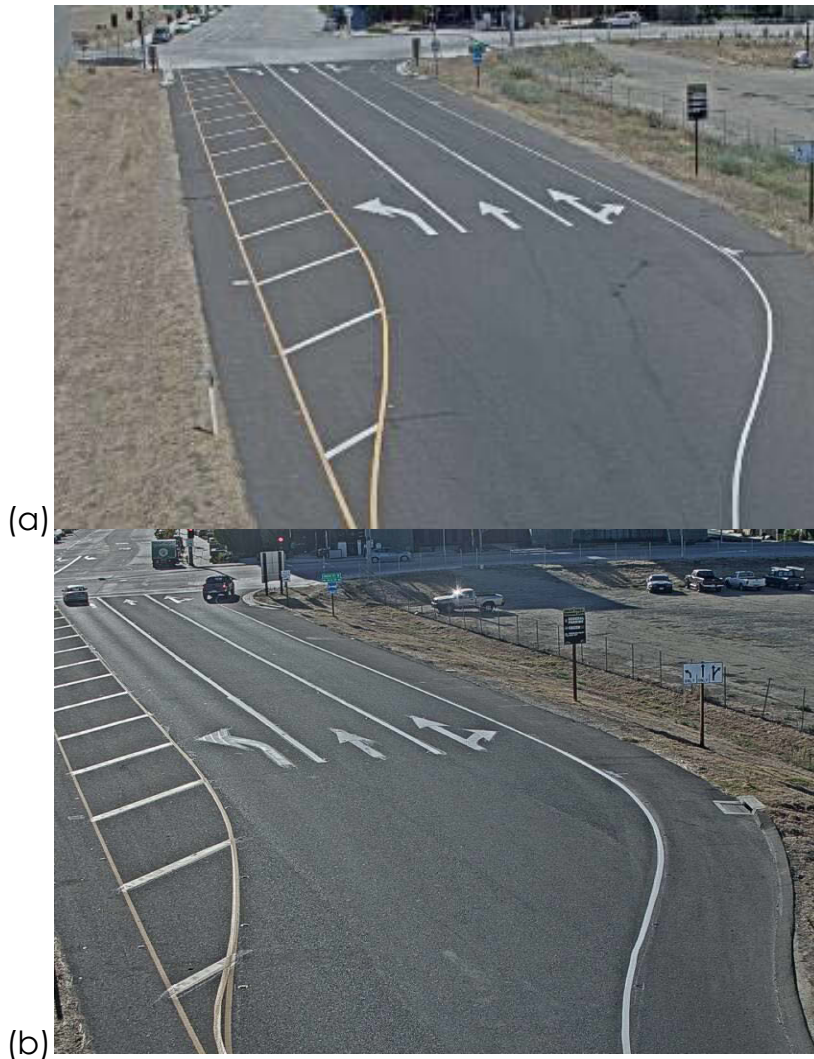
Figure 3.7: Effect of pole twist on the US 50 WB South River Road exit ramp WWD monitoring installation. (a) Camera FOV immediately after installation. (b) Camera FOV three months after installation.

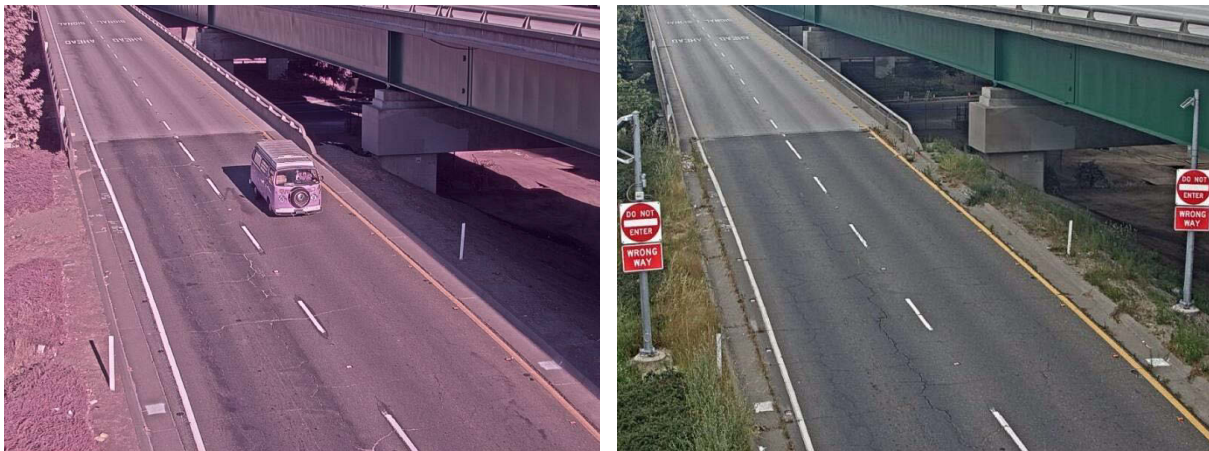
Figure 3.8: Illustration of the IR filter failure. The left image was taken before the camera replacement. The right image was taken after the camera replacement.

One Axis Q1615-E camera had internal failure which eliminated the built-in infrared (IR) filter causing a red tone in the image and video as shown in Figure 3.8. The failure occurred right after the field installation. The camera was repaired under warranty.

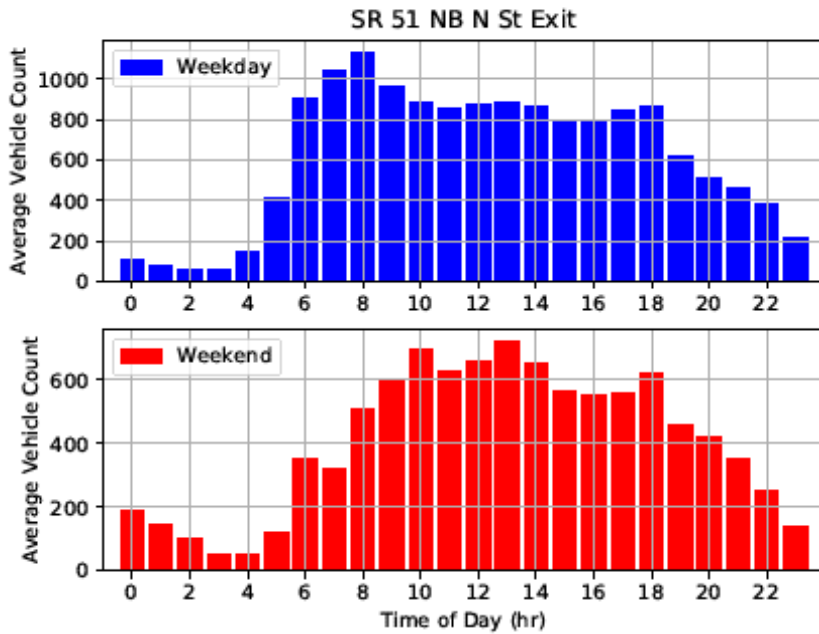
Figure 4.12: Traffic count as determined from camera analytics for NB SR 51 to N Street exit ramp in Sacramento

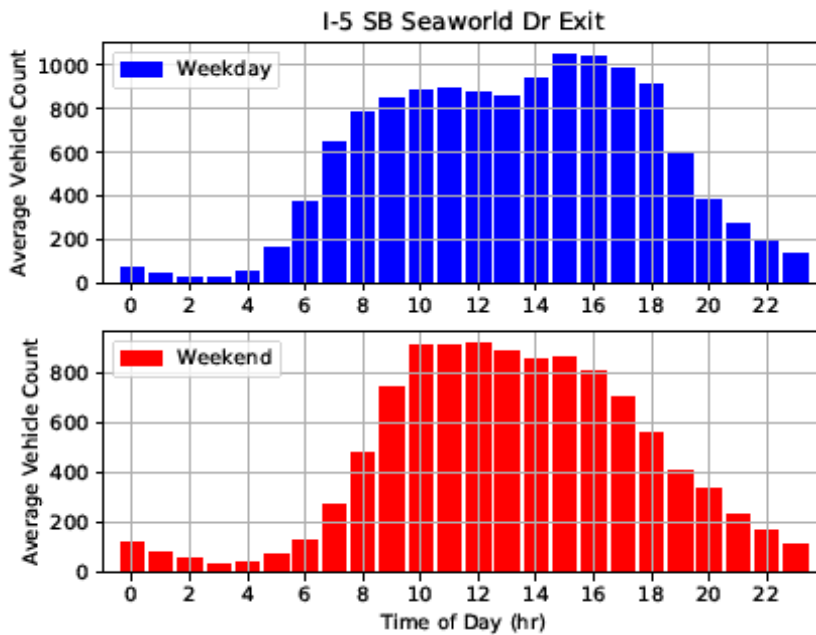
Figure 4.15: Traffic count as determined from camera analytics for SB I-5 to Sea World Drive exit ramp in San Diego

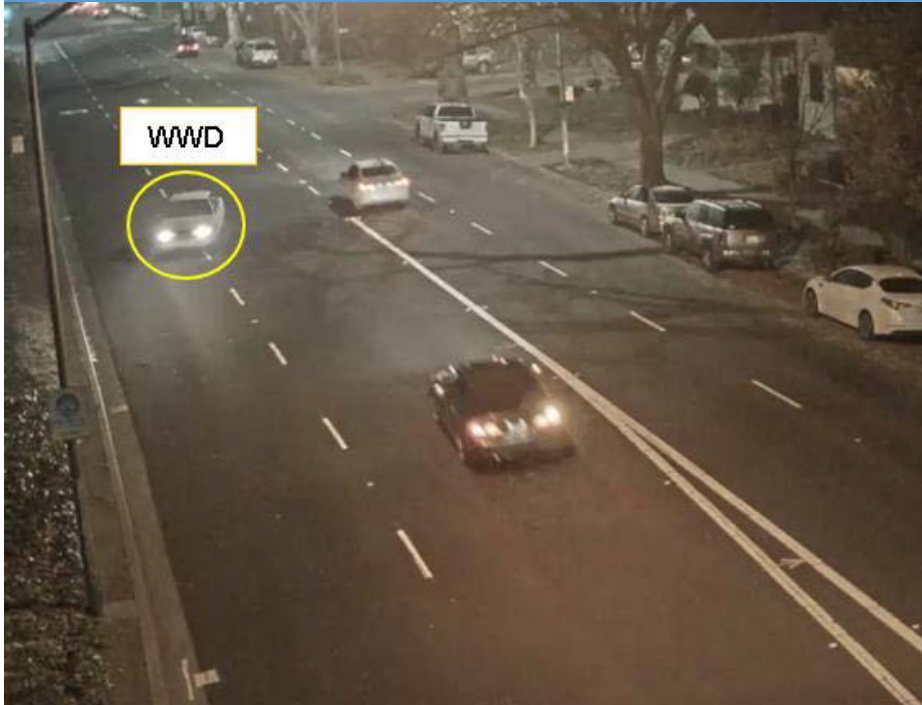
Figure 4.16: Wrong-way driver (circled in yellow) entering the exit ramp at WB US 50 at 10th Street. The driver continued onto the exit ramp despite at least five cars passing in the other (correct) direction.

- One WWD event occurred under poor visibility and rain conditions.
- In one WWD event, the driver appears to be under the influence based on the car's weaving during its approach to the exit ramp. In that case, the WWD driver passed five or more vehicles driving in the right direction and still proceeded wrong-way onto the exit ramp (see Figure 4.16).

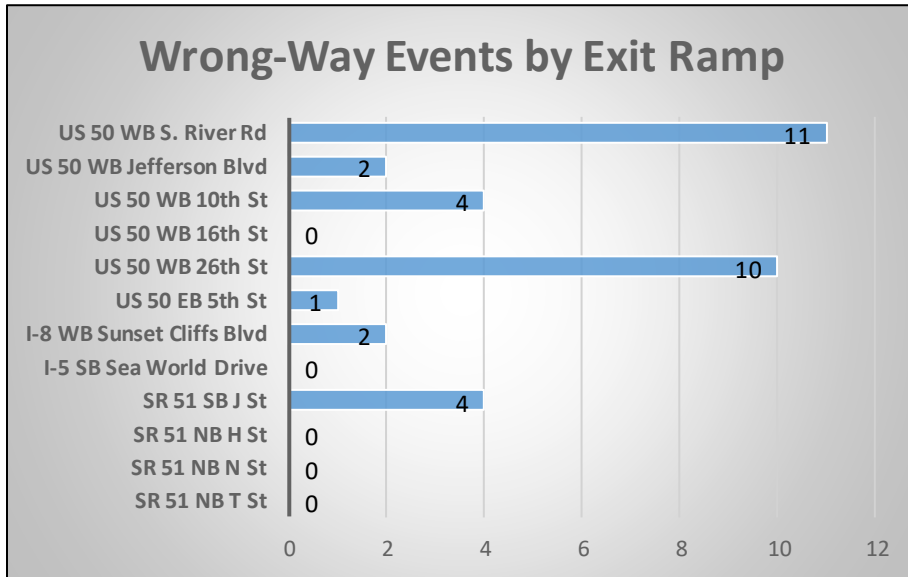
Figure 4.17: All WWD events classified by exit ramp

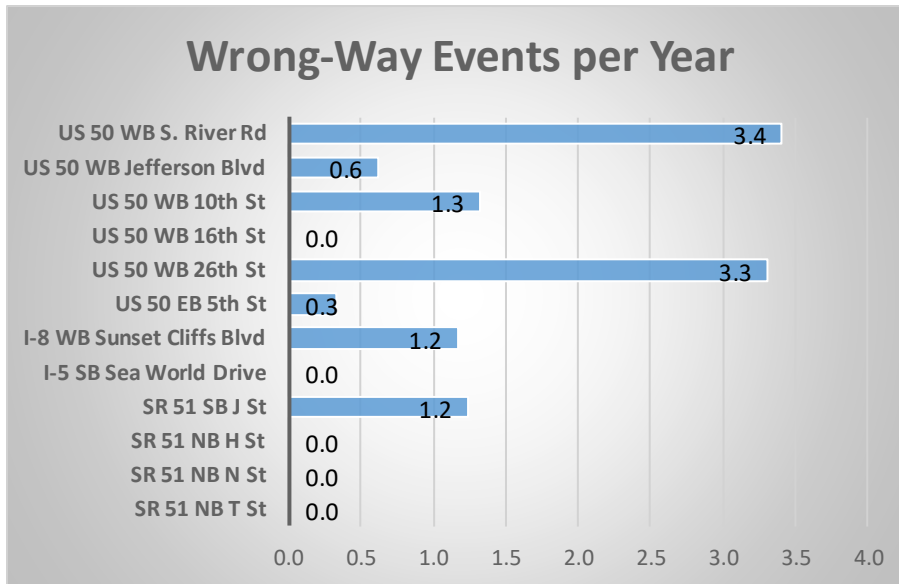
Figure 4.18: All WWD events per year per exit ramp

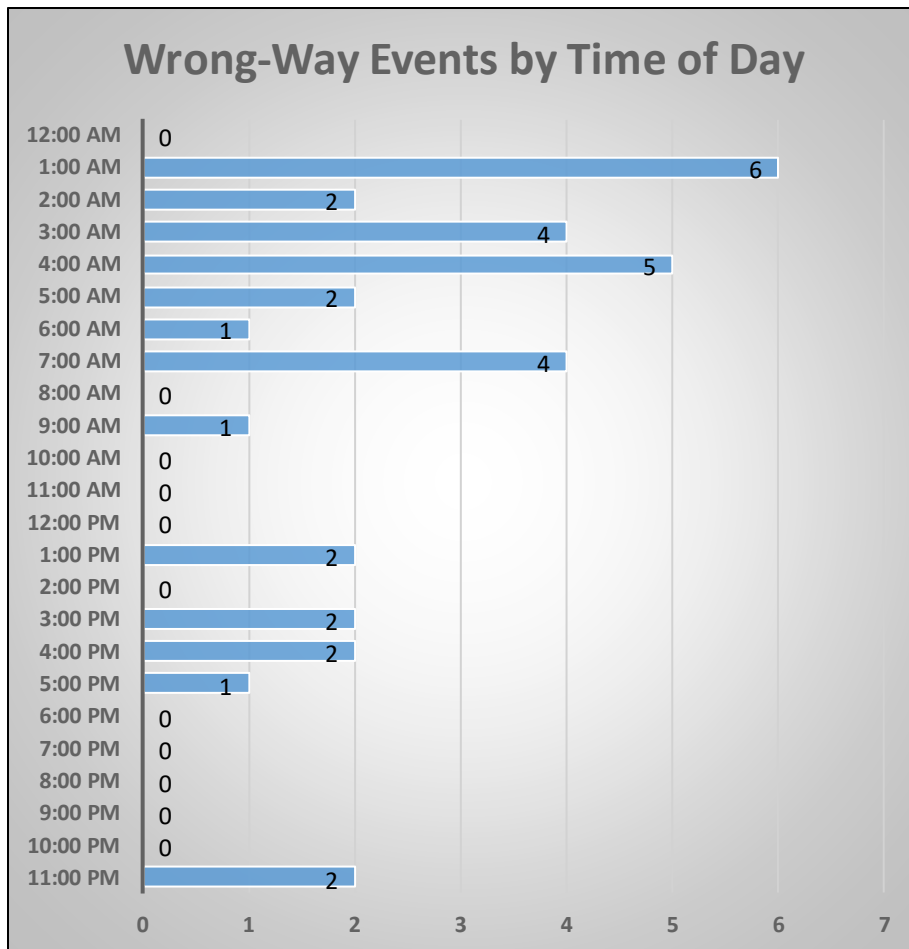
Figure 4.19: All WWD events classified by time of day

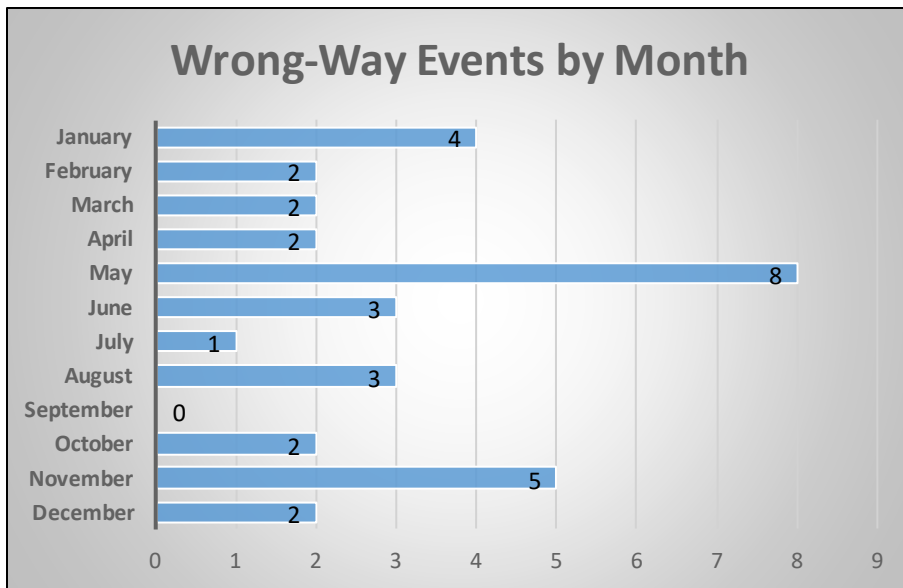
Figure 4.21: All WWD events classified by month

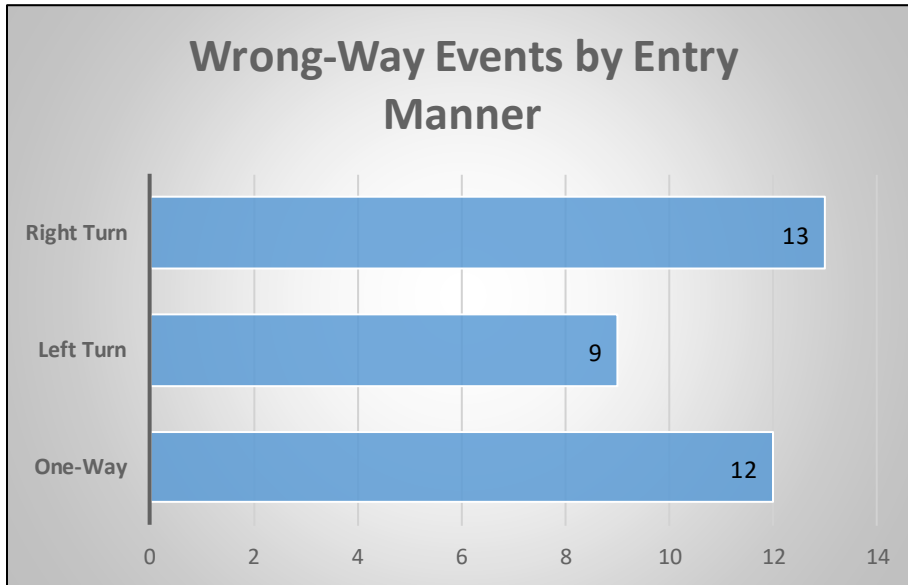
Figure 4.22: All WWD events classified by entry manner

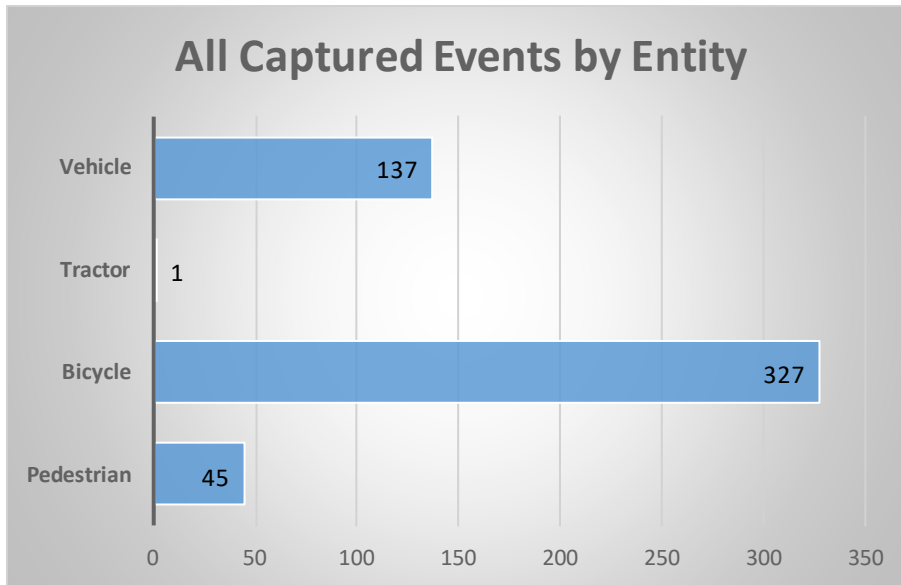
Figure 4.47: All captured events classified by entity

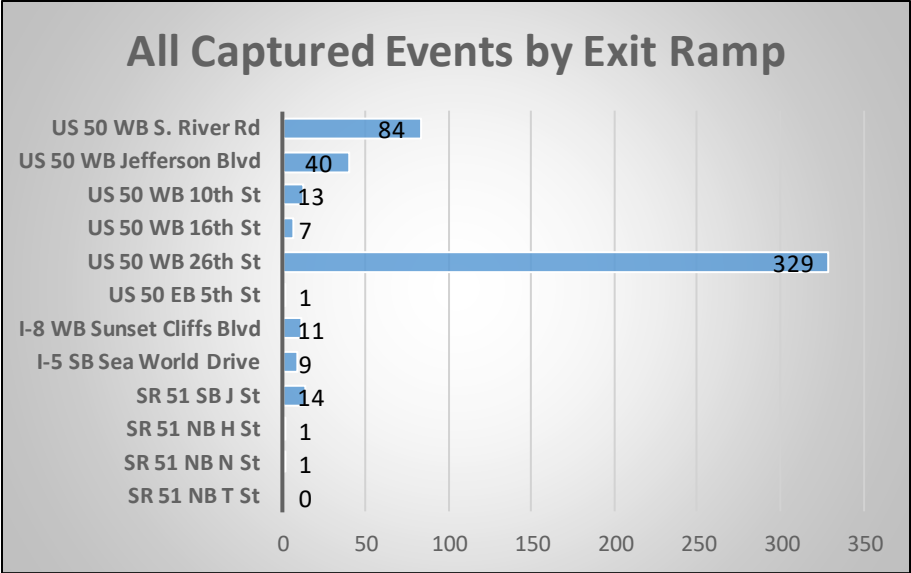
Figure 4.48: All captured events classified by exit ramp
