**Federal Railroad
Administration**

Conventional and CEM Passenger Locomotive Impact Test

1. AGENCY USE ONLY (Leave blank)		2. REPORT DATE January 2021	3. REPORT TYPE AND DATES COVERED Technical Report, January 2019	
4. TITLE AND SUBTITLE Conventional and CEM Passenger Locomotive Impact Test			5. FUNDING NUMBERS Task Order 0793 DTFR53-11-D-00008L FR17RPD00-TTCI-00-040

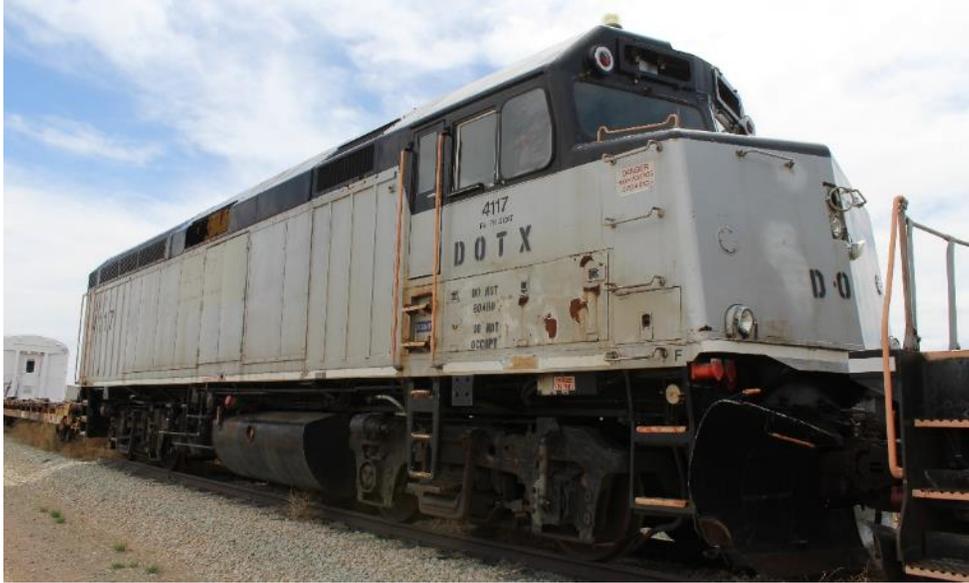
Figure 1. F40 Locomotive 4117

The F40PH-2CAT locomotive is a four-axle diesel-electric locomotive intended for use in passenger service. This test used F40PH-2CAT Locomotive 4117 as the stationary vehicle (Figure 1). The weight of this locomotive was measured to be 257,325 lbs.

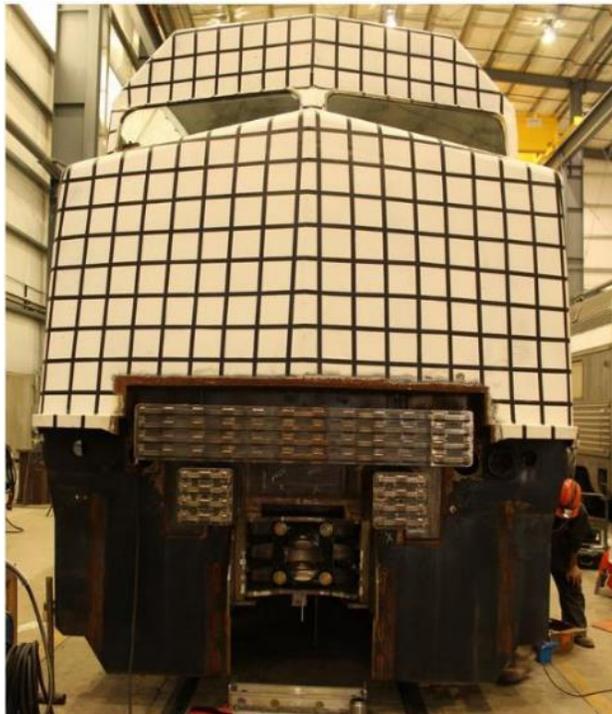
Figure 2. F40PH Locomotive 234

The F40PH locomotive is a four-axle diesel-electric locomotive intended for use in passenger service. This test used F40 Locomotive 234 as the impacting vehicle (Figure 2). The weight of this locomotive was measured to be 232,000 lbs. This locomotive was retrofitted with the CEM system.

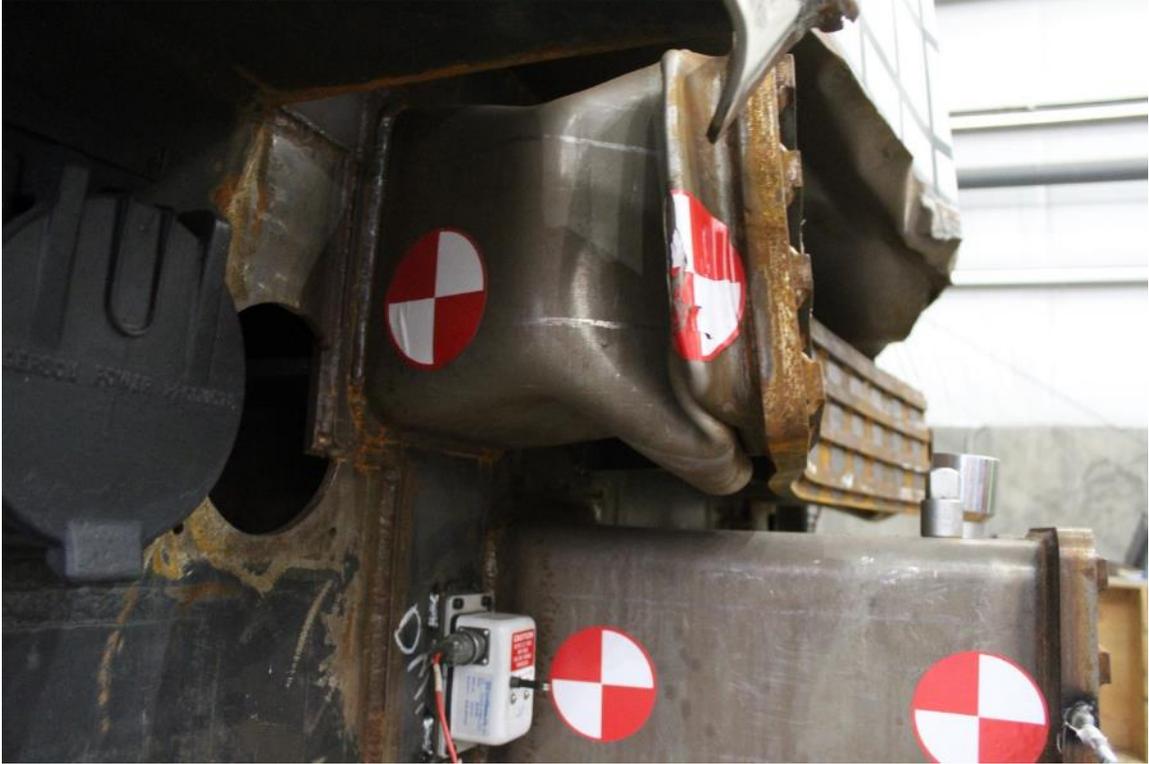
After the impact, no structural damage was observed to have occurred on either the stationary or moving locomotives. During the impact, the PBC was activated and nearly exhausted its available stroke. In addition, the upper deformable anti-climber was engaged by the nose of the stationary locomotive. This anti-climber and its crush tubes were deformed under the impact force. The lower set of anti-climbers did not come into contact with the stationary locomotive and were intact after the test. The impact was not sufficient to activate the shear bolts, which were found to be intact after they were removed from the sliding lug. The CEM components after the test are shown in Figures 40 through 43.

Figure 40. Crushed Anti-climber

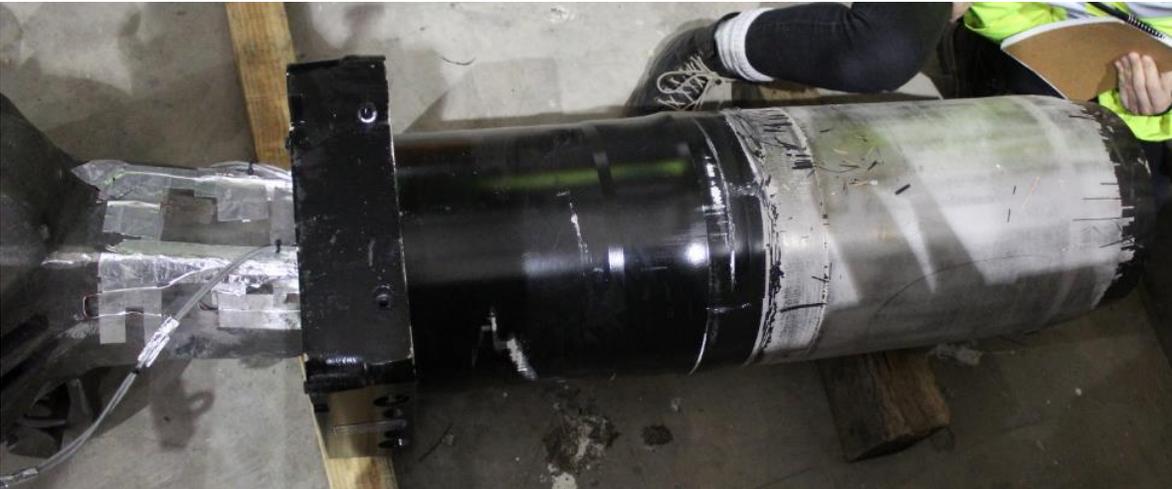
Figure 41. Activated Push-Back Coupler

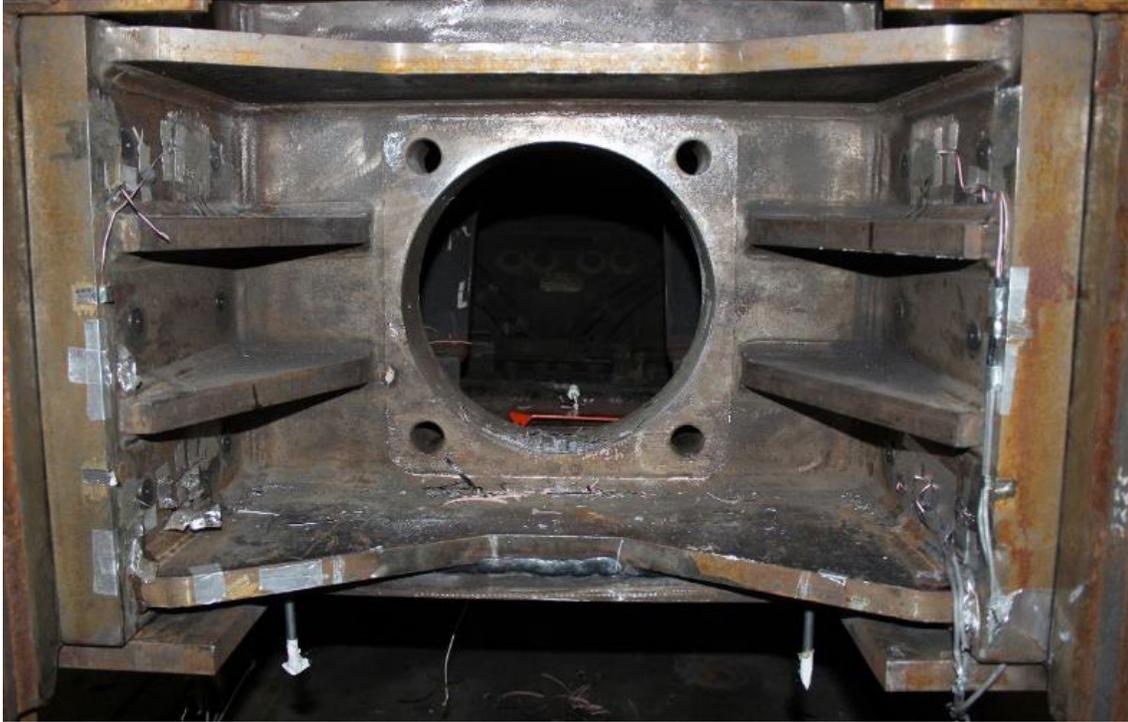
Figure 42. Sliding Lug Bolted into Draft Pocket after Test

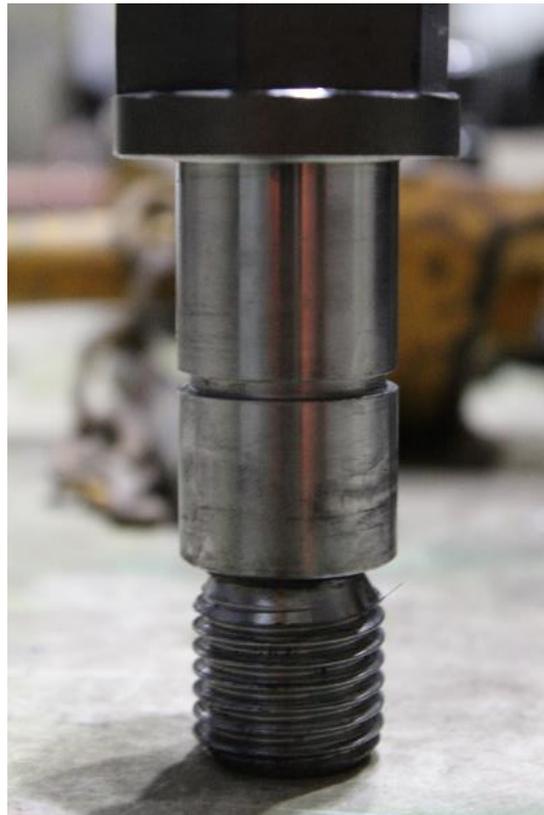
Figure 43. Intact Shear Bolt After Test
