FINAL REPORT

DEVELOPMENT OF TENDON IMAGING SENSOR

FDOT Contract Number: BDV25-977-24

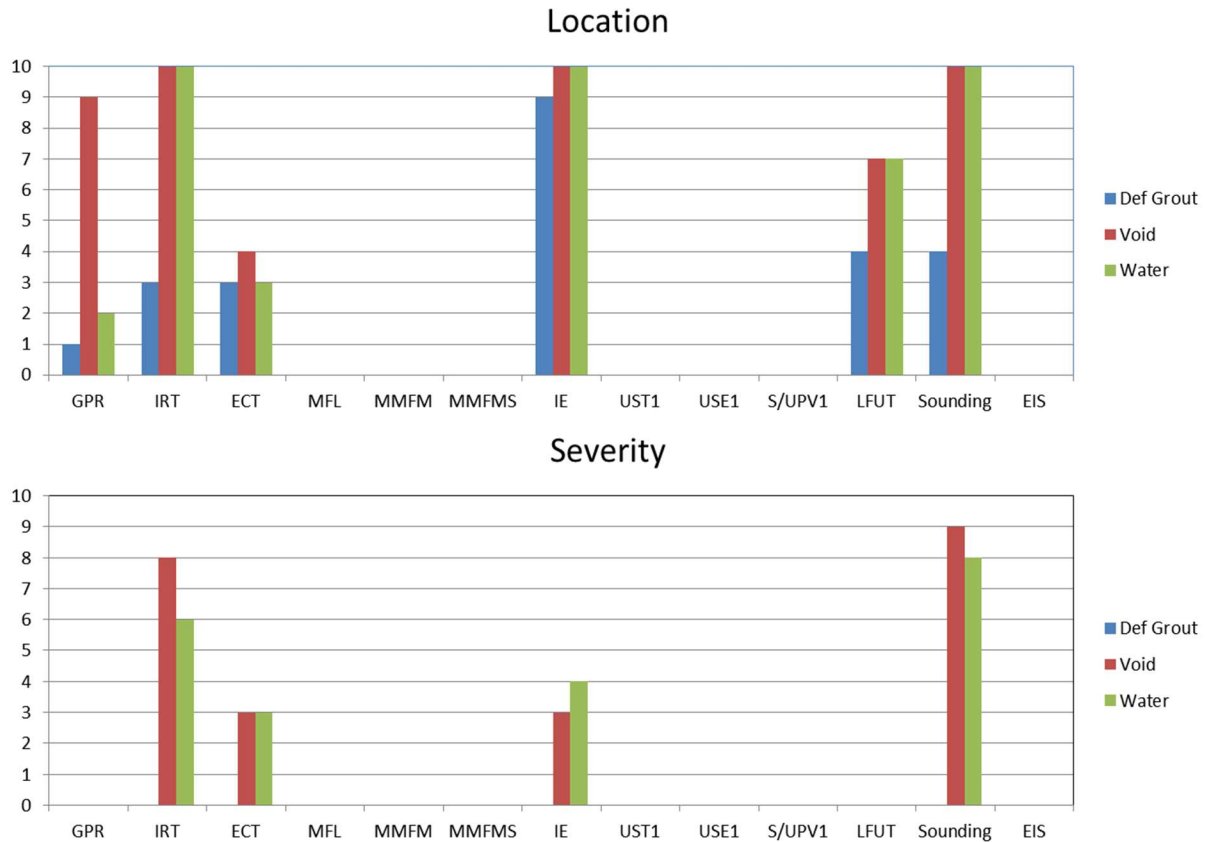
Figure 3.1 Summary of rankings (10 is best) from the NCHRP investigation [33] for ability of methods to identify location and severity of grout deficiencies, air voids, and excessive water conditions. This summary applies only to evaluation of external, polymer-duct tendons.

Some of those methods were oriented to evaluation of the strand corrosion condition and less so, or not at all, for grout condition evaluation. Figure 3.1 has been prepared based on data developed in that investigation, which evaluated the suitability of each method for detecting grout deficiencies, air voids, and excessive water conditions in polymer-ducted external tendons. The method appropriateness for each case was ranked in a 0-10 scale (10 best) based on how accurately the location and the severity of each condition was detected. It is important to note that those rankings do not include the ability of a given method to differentiate between the various deficiencies. For example, sounding provides an alert that either a void or water is present, but not an indication of which of the two it is. Those rankings indicate nevertheless that for the present analysis only a comparison set of methods GPR, IRT, ECT, IE, LFUT and Sounding merits consideration as the other methods received zero ranking.

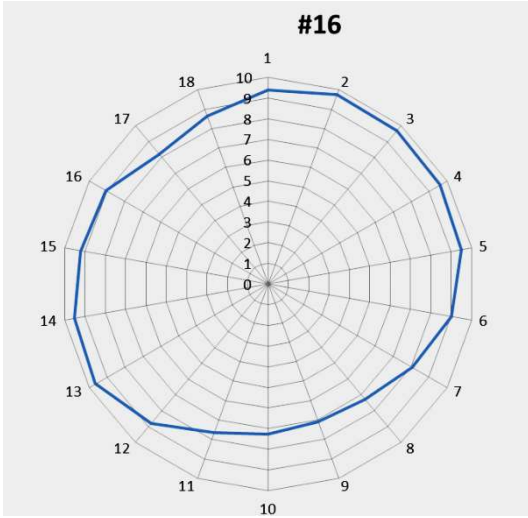
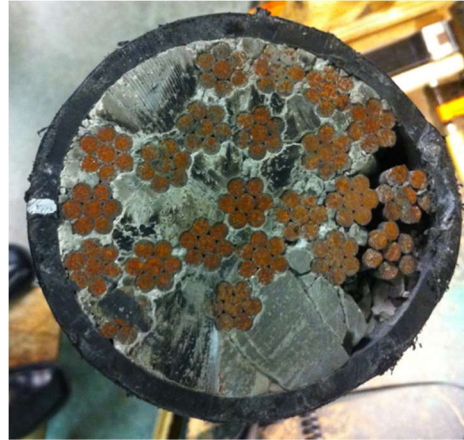
Figure 4.8 Results of semiquantitative strand configuration evaluation using an inductance device applied to two tendon samples from the John Ringling Causeway Bridge.

Given the large dimensions of the sensor, tests of the concept were not made in the small tendons used for the rotating magnet unit, but were instead made on 4 thicker tendon samples obtained from the FDOT John Ringling Causeway Bridge. The samples have 22 strands grouted within a polymeric duct of $\frac{1}{4}$ in wall thickness and an outer diameter of 4.5 in. Results are illustrated in Figure 4.8, which shows general semi-quantitative agreement with the cross-section location of the strand envelope.

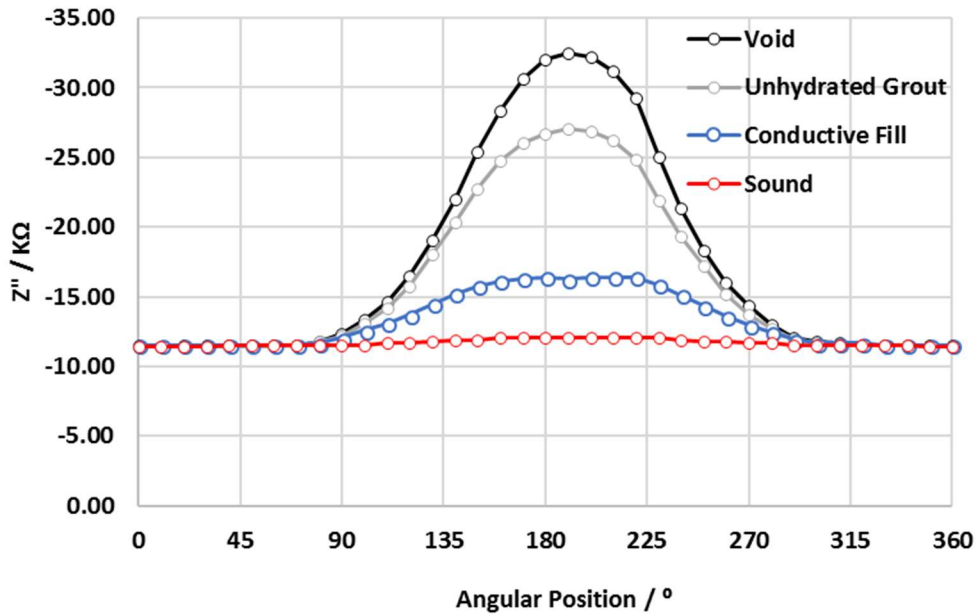
Figure 5.7 Imaginary part of the complex impedance vs. angular position for tendon segment #2 (same ages as in Figure 5.6) at center with section filled with air, unhydrated grout, and conductive fill. Impedance results for a sound cross-section also included.

Figure 5.21 Imaginary impedance value vs. angular position of the tendon (sound grout) showing the experimental values (Figure 5.7) and the model values at 1 MHz for the profile in Figure 5.18. The model results follow the experimental trends.

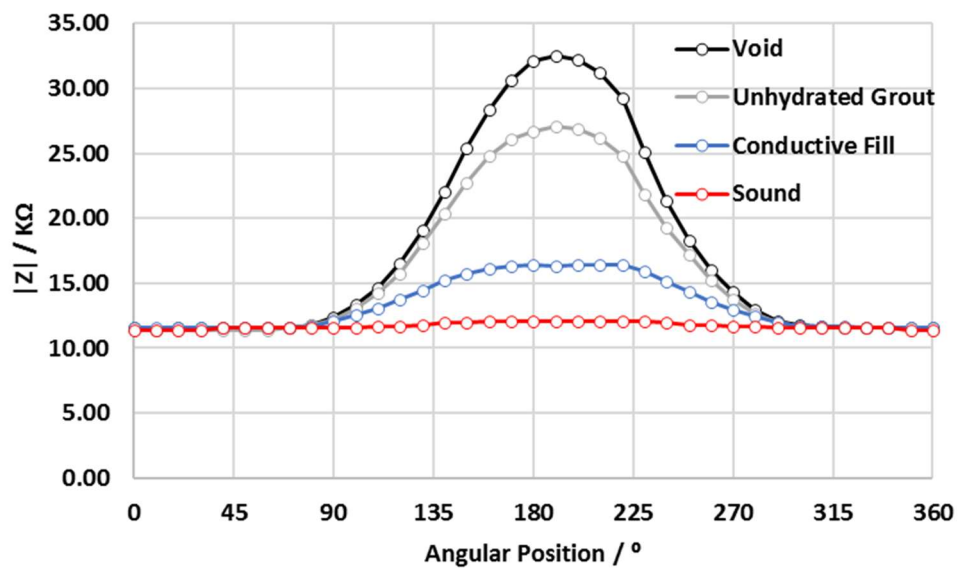
Figure 5.8 Modulus of impedance vs. angular position for tendon segment #2 (same ages as in Figure 5.6) at center with section filled with air, unhydrated grout, and conductive fill. Impedance results for a sound cross-section also included.

Figure 5.22 Modulus of impedance vs. angular position of the tendon (sound grout) showing the experimental values (from Figure 5.8) and the model values at 1 MHz for the profile in Figure 5.18. The model results follow the experimental trends.

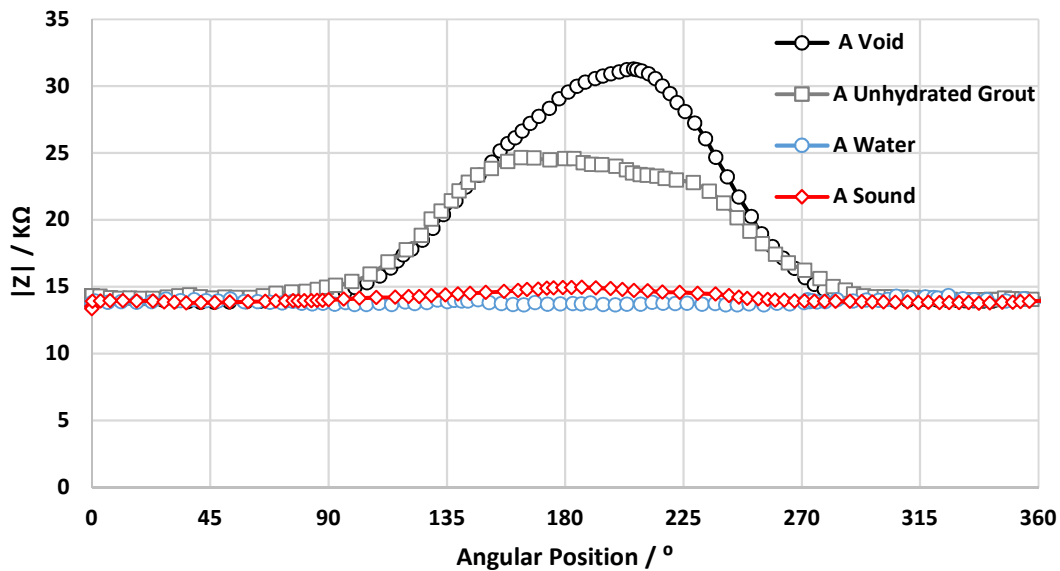
Figure 5.10 Modulus of impedance vs angular position for tendon A (age 105 days) for void (Position P3), unhydrated grout (P1), water (P5), and sound cross-section (P2).

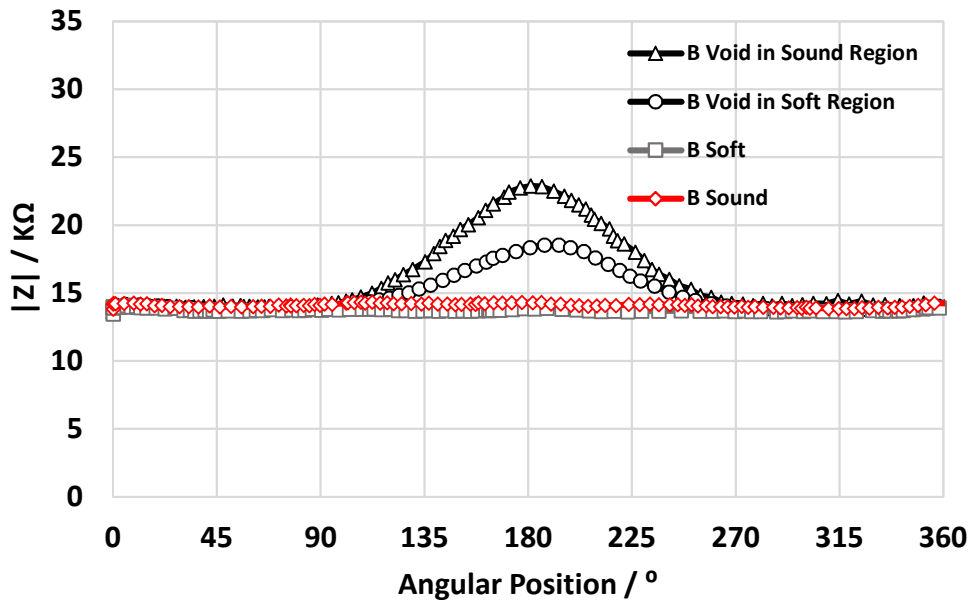
Figure 5.11 Modulus of impedance vs angular position for tendon B (age 105 days) for the different cross-sections; void in soft (P1) and void in sound grout (P4), soft (P2), and sound grout (P3).

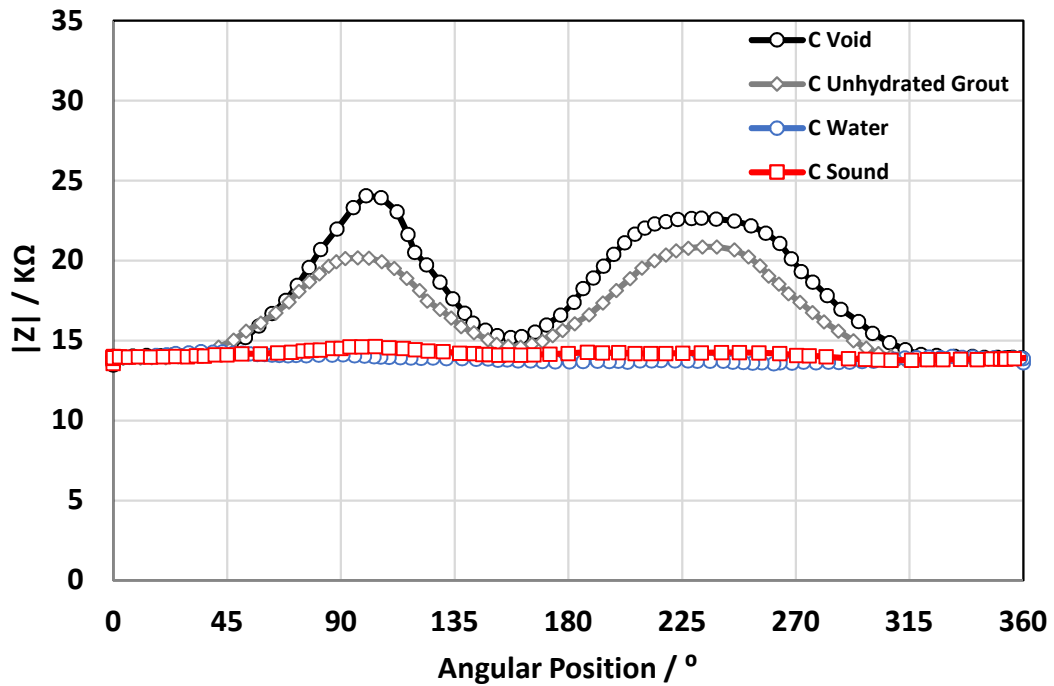
Figure 5.12 Modulus of impedance vs angular position for tendon C (age 105 days) for the different cross-section; void (P3), unhydrated grout (P1), water (P5), and sound grout (P2).

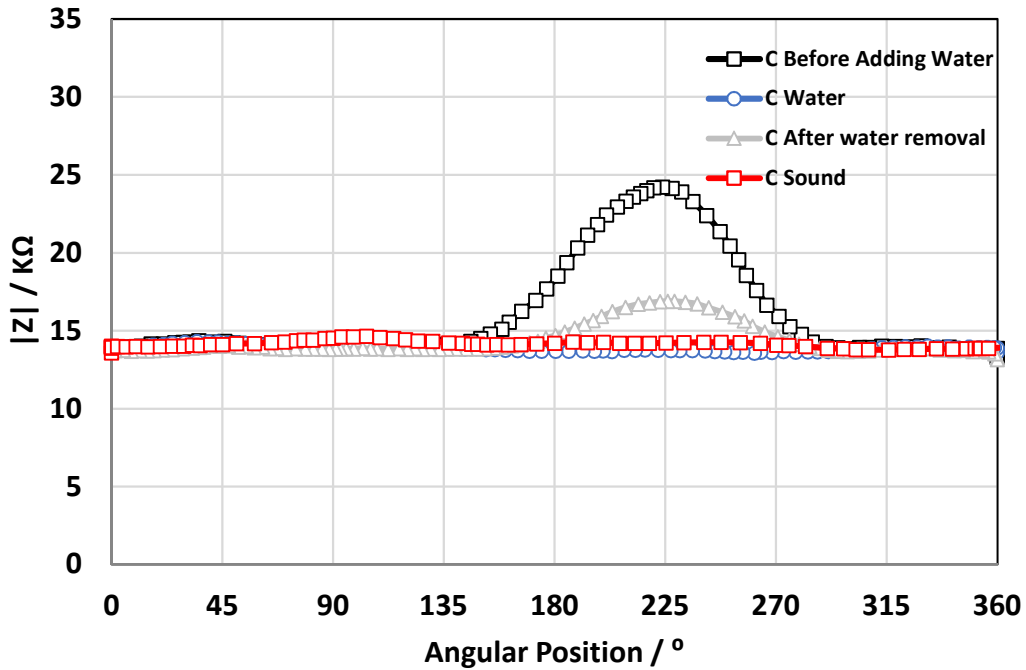
Figure 5.13 Modulus of impedance vs angular position for tendon C (age 105 days) for the same void (P5) before adding water, when water was added, and ~30 min after the water was removed. Impedance results for a sound cross-section also included.

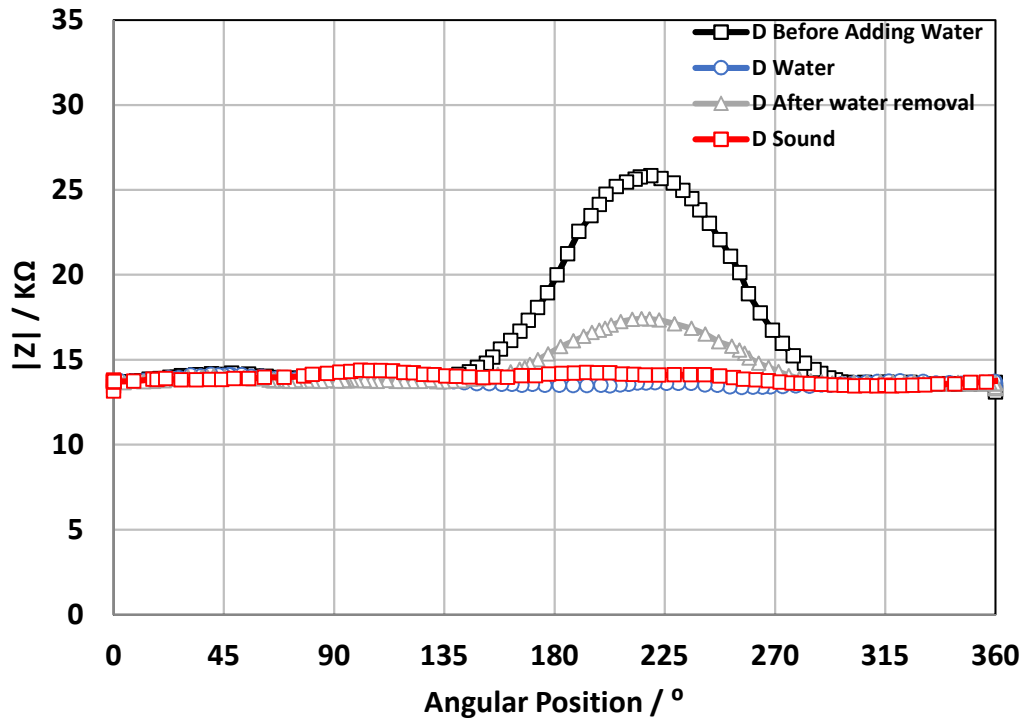
Figure 5.15 Modulus of impedance vs angular position for tendon D (age 105 days) for the same void (P5) before adding water, when water was added, and ~10 min after the water was removed. Impedance results for a sound cross-section (P2) also included.

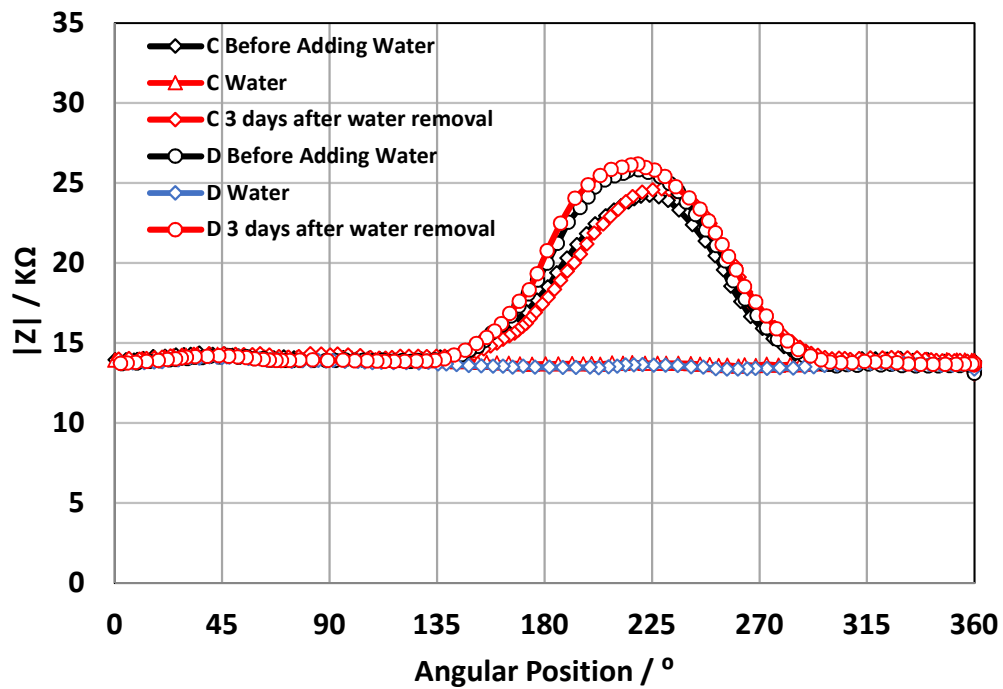
Figure 5.16 Modulus of impedance vs angular position for tendons C and D (age 105 days) for the same void (P5) before adding water, when water was added, and 3 days after the water was removed.

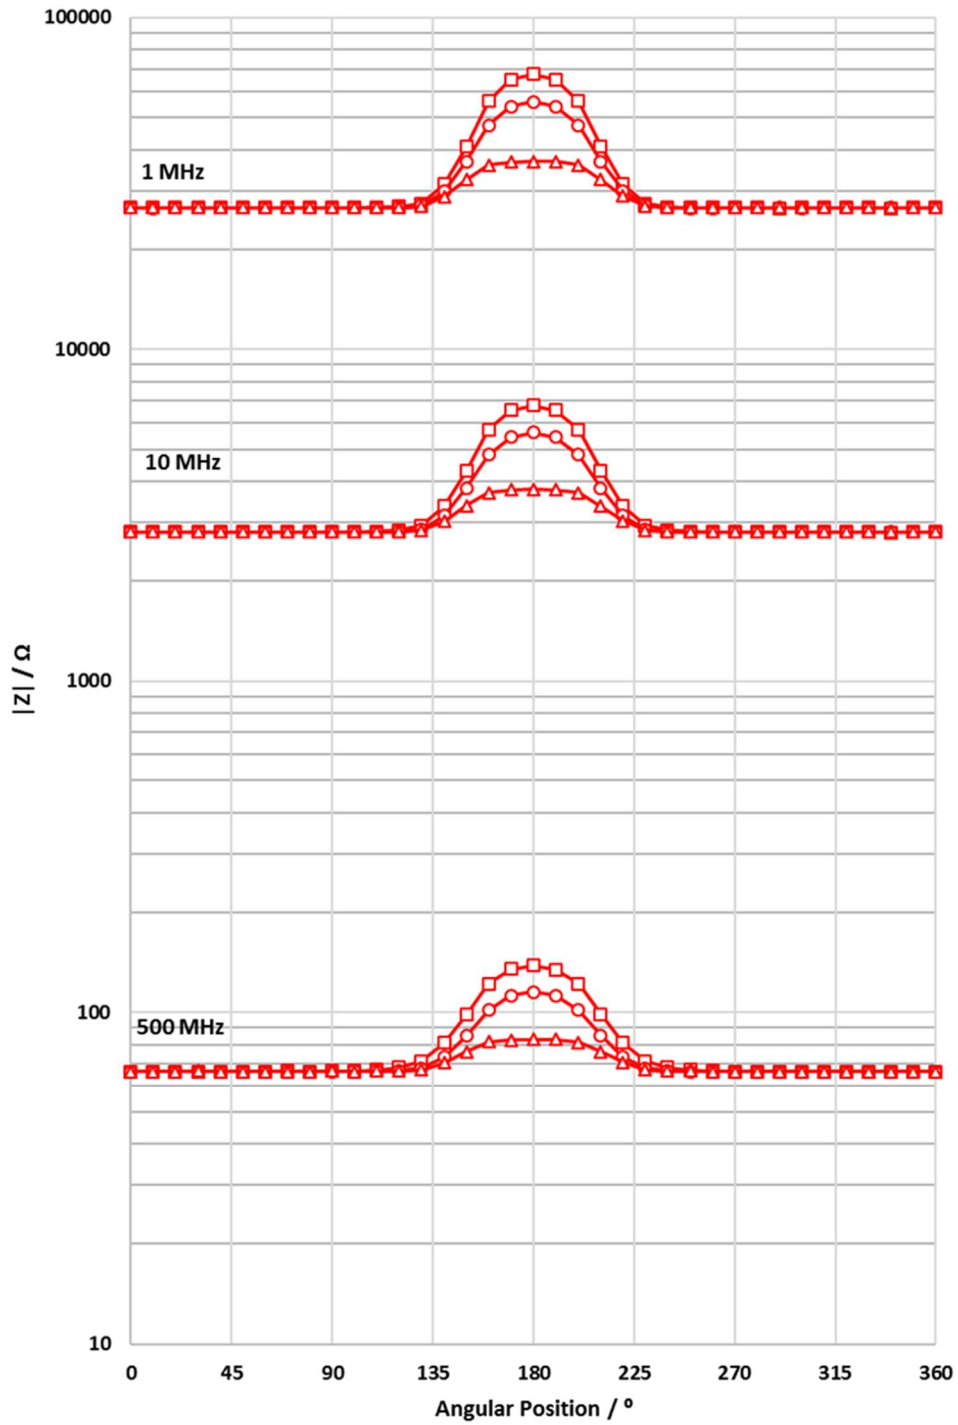
Figure 5.41 Modulus of impedance vs. angular position for Table 5.6; Tendons 1(squares), 2 (circles), and 3 (triangles) at 1 MHz, 10 MHz, and 500 MHz. Log scale is used for the y-axis to show comparison of the output of the frequencies on the same graph. The plates used for these calculations are 2.54 cm (Narrow) x 5 cm.

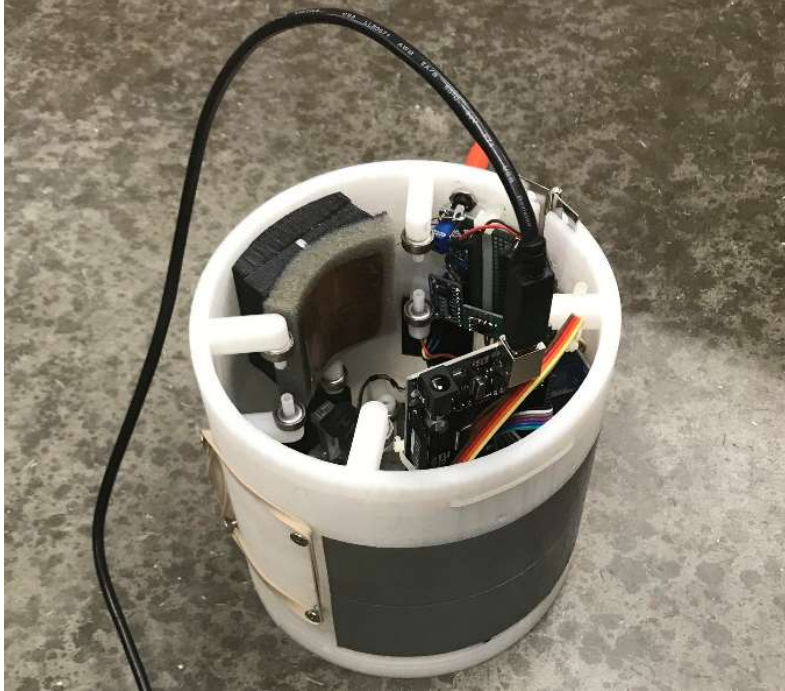
Figure 6.4 TIU-I placed in the vertical calibration position away from steel mass. Patent Pending.

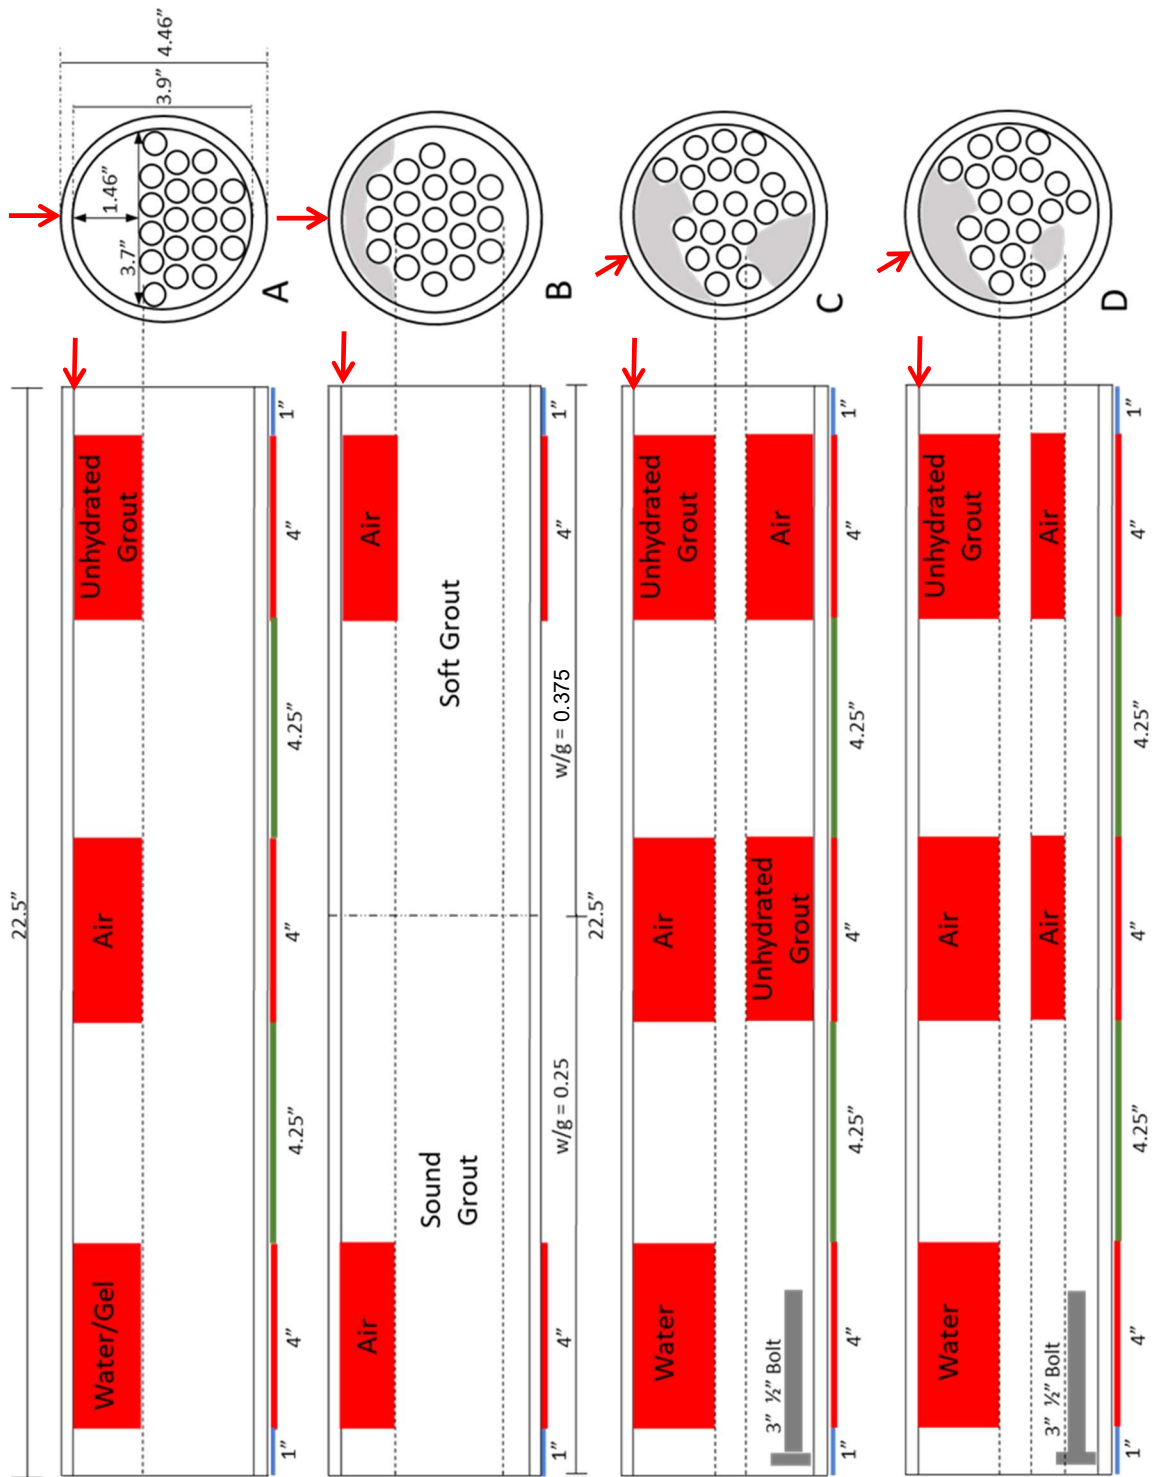
Figure 7.1 Approximate configuration for Ducts A-D.

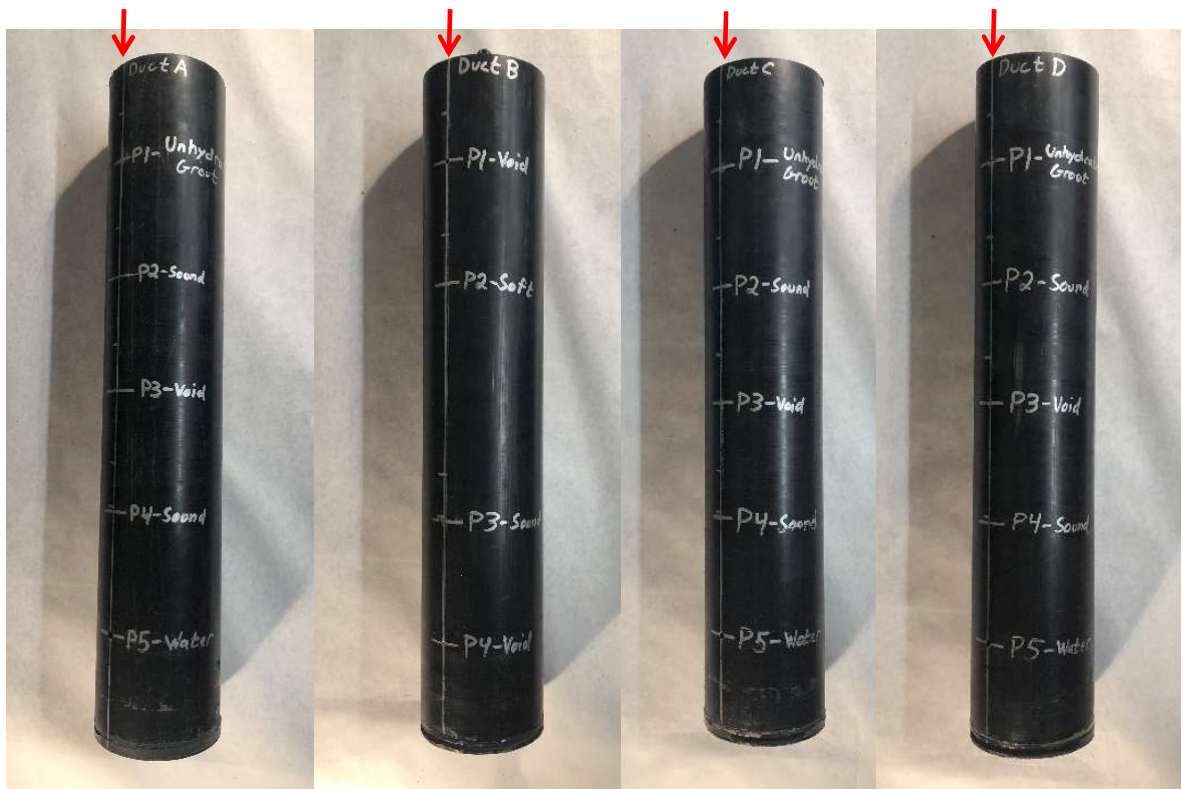
Figure 7.3 Side view of ducts A-D showing the locations of P1-P5 (different grout configurations). Arrows are keyed to positions shown in Figure 7.1

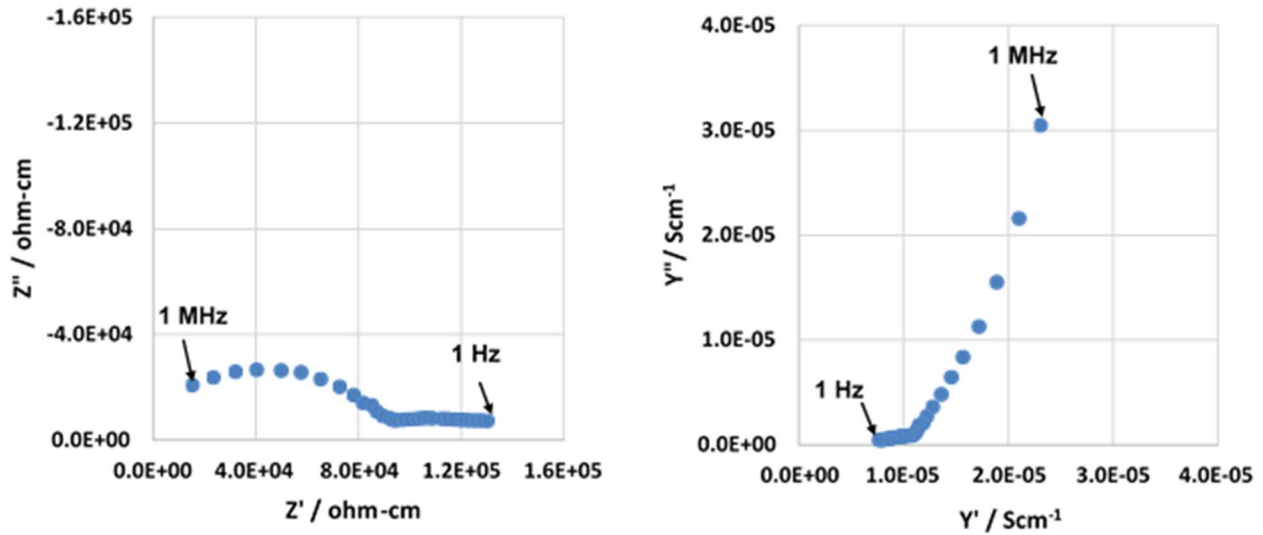
Figure A.2 Nyquist diagrams (Left: Impedivity; Right: Admittivity) for grout in test cylinder 1a using the Wenner array test to determine impedance behavior of grout. Frequency range shown, 5 points/decade. Specimen age after casting: 193 days.

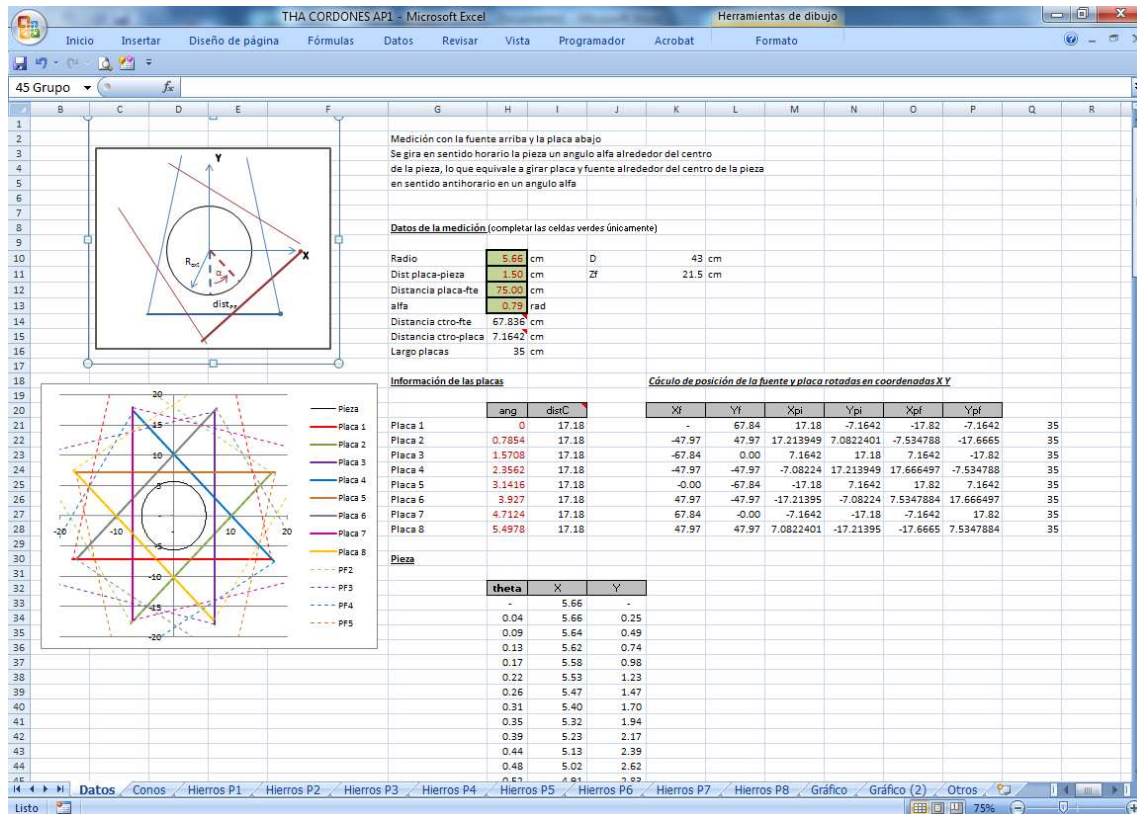
Fig. 2. Program screen with the data and drawings of sample and plate orientations. The upper graph is used to define coordinates and parameters.
