# Structural Health Monitoring of Representative Cracks in the Manhattan Bridge

FINAL REPORT  
January 2020

Rutgers, The State University of New Jersey  
And  
New York City (NYC)  
Department of Transportation

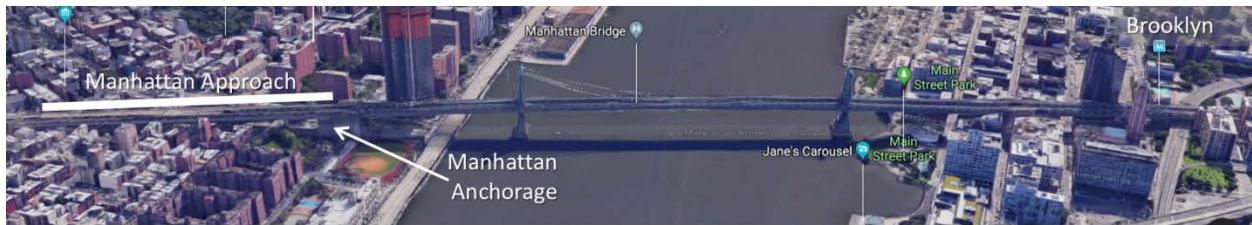
Figure 2 Layout of the Manhattan Bridge

Two spans within the Manhattan approach, which is indicated by a white strip in Figure 2, were the focus of this investigation. Figure 3 illustrates the structural layout of the south side of the Manhattan approach on which the majority of the investigation focused. The southbound side was chosen for detailed instrumentation due to the variety of rail splice conditions observed. Each side of the Manhattan approach (north and south) features four simply-supported trusses with moment release at the piers (Truss AB in south side and CD in north side) that span longitudinally between piers. A series of floor beams span transversely between these trusses, and carry four longitudinal transit stringers. As Figure 4 shows, the rails are located above each of the transit stringers and sit on timber ties that span between the transit stringers. The north side of the Manhattan approach is composed of the same framing system as the south side. A photo of the underside of the Manhattan approach showing the trusses, floor beams, and transit stringers is provided in Figure 5.

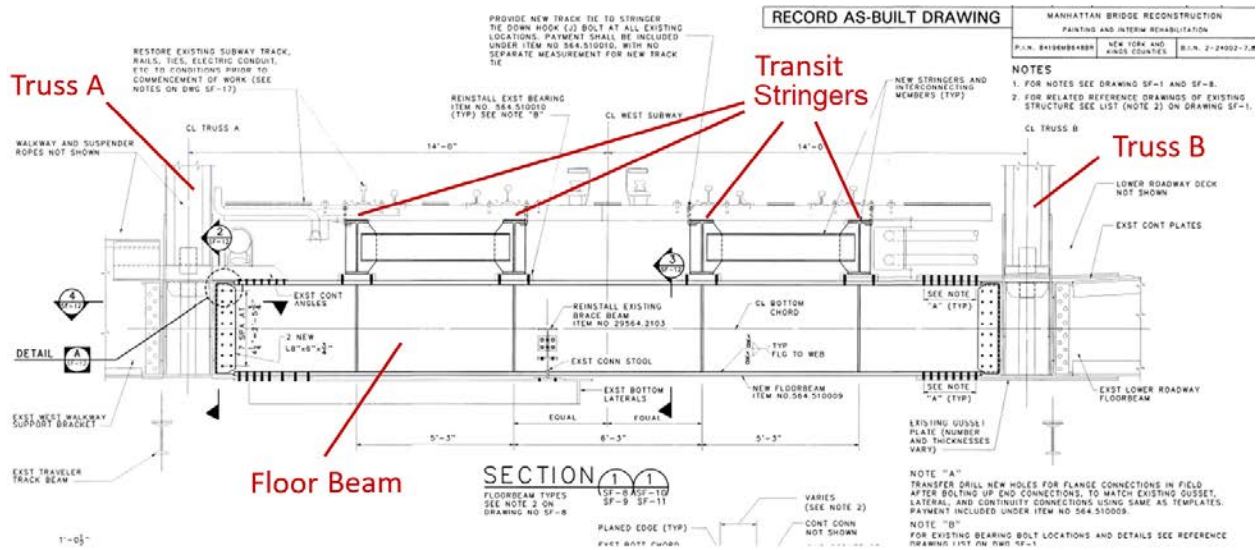
Figure 4 Cross-section of the Manhattan approach (south side)

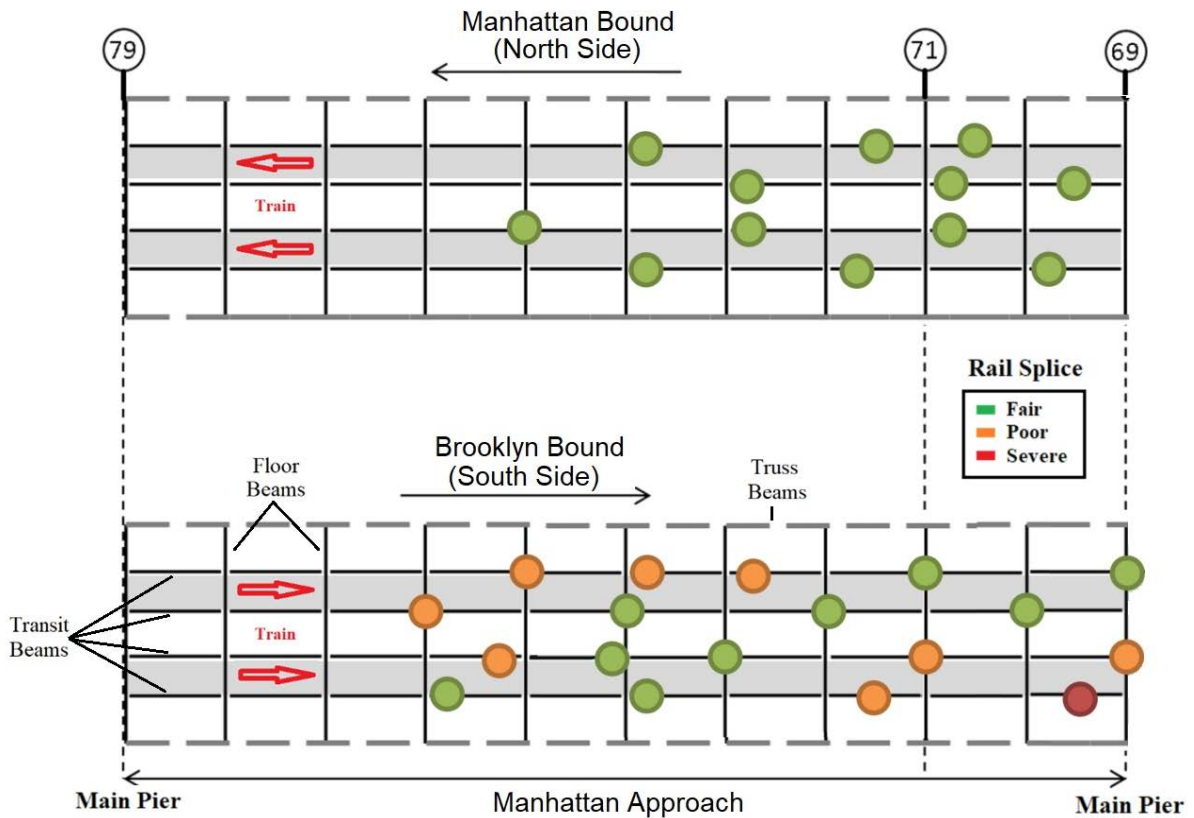
**Figure 6** Layout view of the Manhattan approach (rail splice condition map)

by visual inspection and qualitative assessment of the noise produced by a traversing train. Visual inspection of the rails was completed from the sidewalk (since this could be done without special access). Figure 7 provides photos of typical rail splices and illustrates the type of misalignment observed. The impact between the rail ends and the train wheel caused by misaligned joints amplifies the nominal stresses experienced by elements adjacent to these joints. During visual inspection, the joint misalignments were easily observed and the sound resulting from the impact of the train wheels was loud and clearly detectable. Furthermore, bolts, rail clips, and other pieces of hardware were observed on the roof beneath the problematic splices suggesting that the impact and resulting vibrations/stresses were causing these components to fail and fall from the structure.

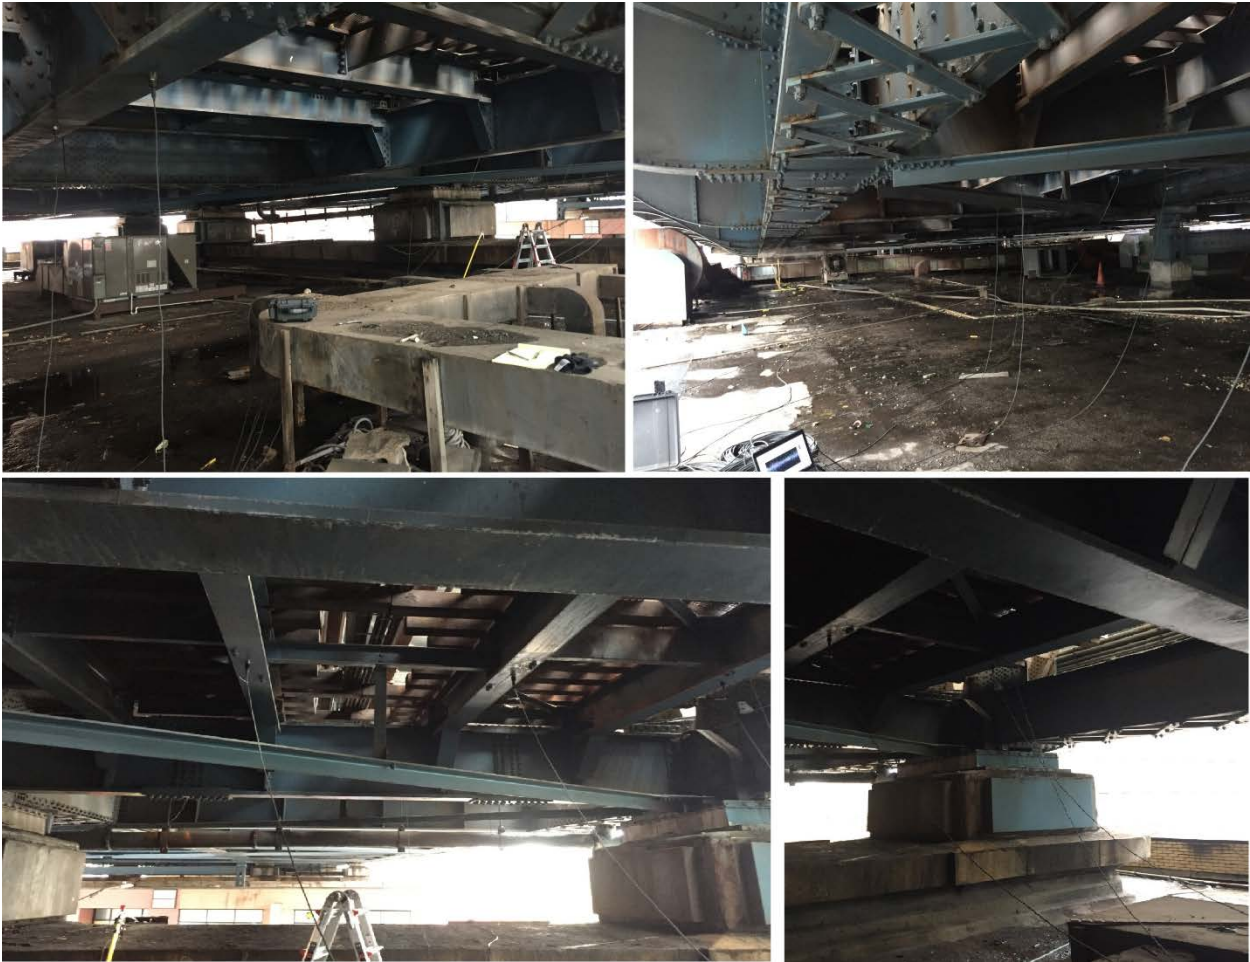
**Figure 8** Accelerometer locations (southbound)

As shown in Figure 9, the sensors used were PCB (model 393A03) ceramic shear ICP accelerometers with a frequency range of 0.5 Hz to 2000 Hz and a measurement range of  $\pm 5g$ . The accelerometers were hardwired to a National Instruments data acquisition system (DAQ) capable of sampling at more than 3200 Hz. The high sampling rate was required to adequately capture the short duration effects caused by the track irregularities.

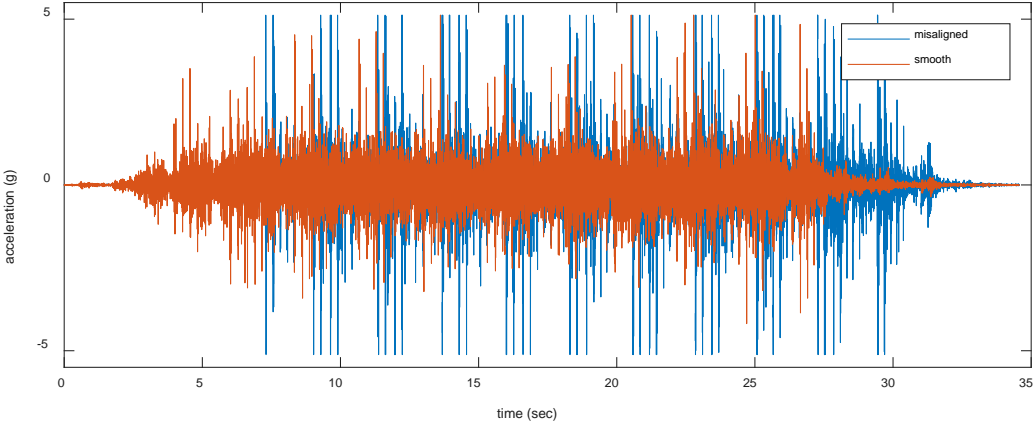
**Figure 10** Sample of acceleration data

Figure 10 provides a sample time history of acceleration during a train crossing. It is immediately obvious from the plot that the location with poor rail alignment is experiencing greater acceleration and in excess of 5g resulting in the “clipping” of data. This is due to the limitations of the sensor ( $\pm 5g$  range). While the clipping reduces the accuracy of the data, it remains useful for our purposes of comparison as the clipping has little influence over the frequency content within the range of interest ( $< 50$  Hz).

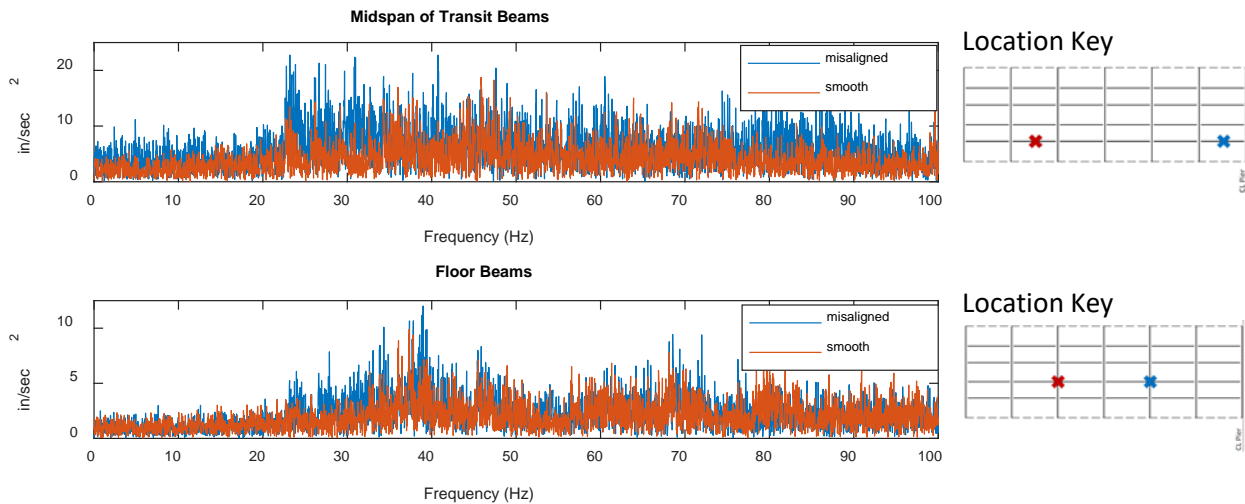
**Figure 11** Frequency content (FFT) of acceleration (red denotes good splice while the blue refers to bad splices)

Figure 11 shows a fast Fourier transform (FFT) of acceleration time histories taken in the vicinity of smooth and misaligned joints from both transit stringers and floor beams. These plots show how the amplitude of the acceleration varies with frequency. In general, the lower the frequency the more the corresponding amplitude contributes to both displacement and stress. In the case of the transit stringer response, the misaligned joint resulted in a significant (up to 100%) increase in amplitudes across all frequencies shown. In contrast, the responses of the floor beam show smaller increases in amplitude due to the misaligned joint, and these increases are focused in the 25-50 Hz range. This indicates that (as expected) the dynamic amplification that results from misaligned joint is not only attenuated as it passes from the transit stringers to the floor beams, but it is also filtered (essentially applying a band-pass filter with the 25-50 Hz range).

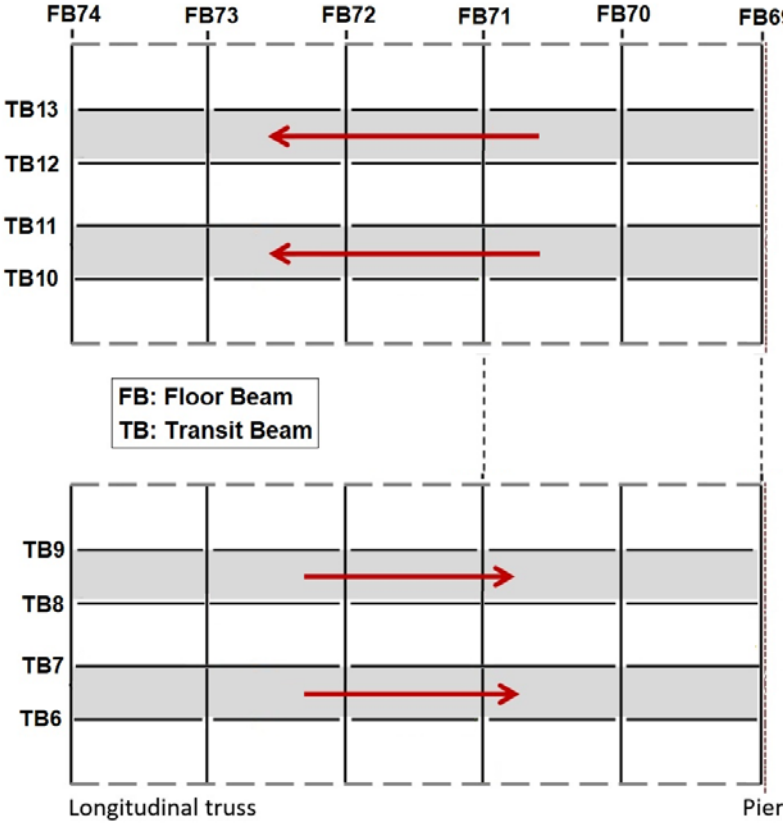
Figure 12 Designation of structural elements

Figure 12 below depicts the layout and designation of structural elements on the Manhattan approach. Figure 13 depicts the sensor layout, which is composed of 40 sensors. As shown in Figures 13 and 14, the instrumentation layout aimed to capture responses adjacent to Fair, Poor, and Severe splices (see Figure 6) as well as in high response regions or regions suspected to be particularly vulnerable to cracking. In total, the instrumentation plan was composed of 14 strain gages to capture flexural response, 16 strain gages to measure shear response (8 rosette sensors), six temperature sensors, and four crack gages.

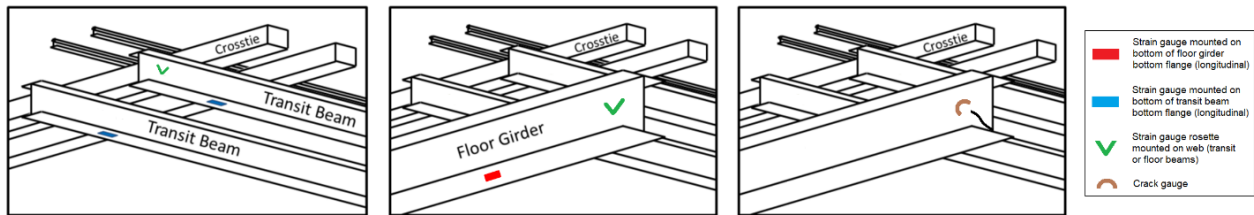
Figure 14 Typical gage mounting locations

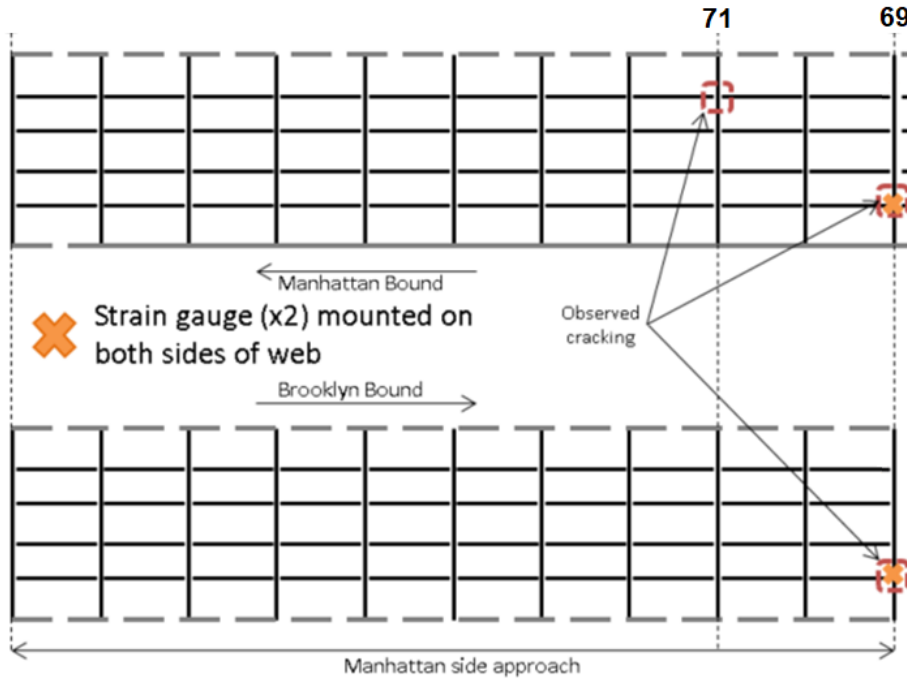
Figure 15 Instrumentation layout for fatigue crack monitoring

The crack gages were installed at locations that have demonstrated to be prone to fatigue cracking. These cracks have occurred where the transit stringers frame into the floor beam, as detailed in the Figures 15-17 below. The connection detail features a stiffener plate terminating in the web of the floor beam, thereby applying large out-of-plane forces on the web. In some locations, the stiffener plate has been retrofitted to provide a connection to the bottom flange. Gages were installed in locations where cracking was observed as well as locations where the original detail was modified to provide continuity between the stiffener plate and the bottom flange of the floor beam.

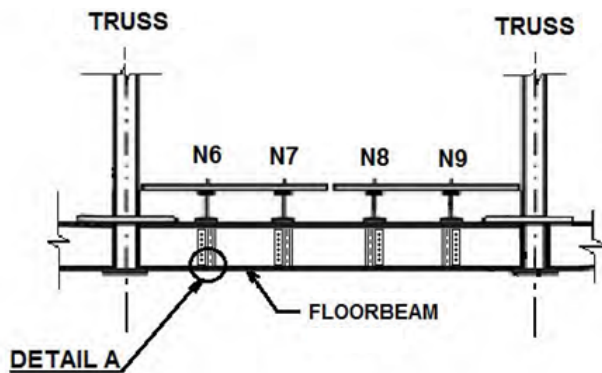
Figure 16 Typ. framing detail in locations with fatigue cracking

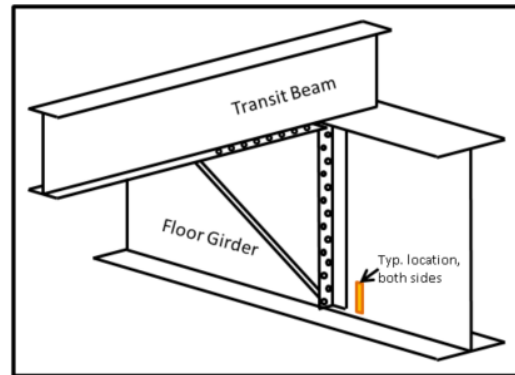
Figure 17 Typ. gage location for fatigue crack monitoring

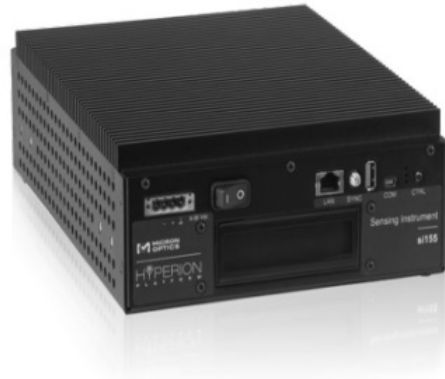
**Figure 18** Micron Optics si155 Interrogator module

The fiber-optic based SHM system was chosen for their efficiency in terms of installation and cable management, and immunity to electrical/electromagnetic interference. The fiber-optic strain sensors employed had gage lengths of 75mm, sensitivities of 1:4 pm/ $\mu\epsilon$ , and strain limits of  $\pm 2,500 \mu\epsilon$ . The optical interrogation unit (Micron Optics si155), as shown in Figure 18 is capable of monitoring 40-60 sensors, depending on sensor types. It can simultaneously accept data from strain gages, temperature gages, and other sensors. This unit has a bandwidth of 1460-1620 nm and a maximum sampling frequency of 1 kHz.

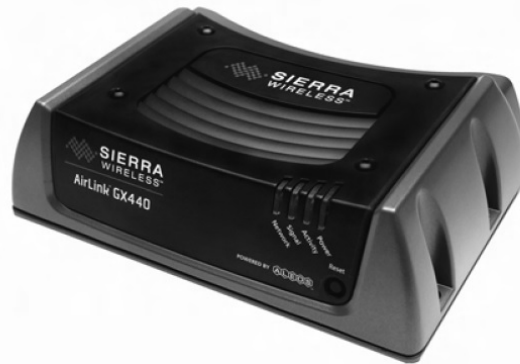
**Figure 19** Cellular modem and PC remote control interface

An active internet connection was provided by the use of an industrial cellular modem (Figure 19). This unit allowed for remote collection of data from the interrogation unit.

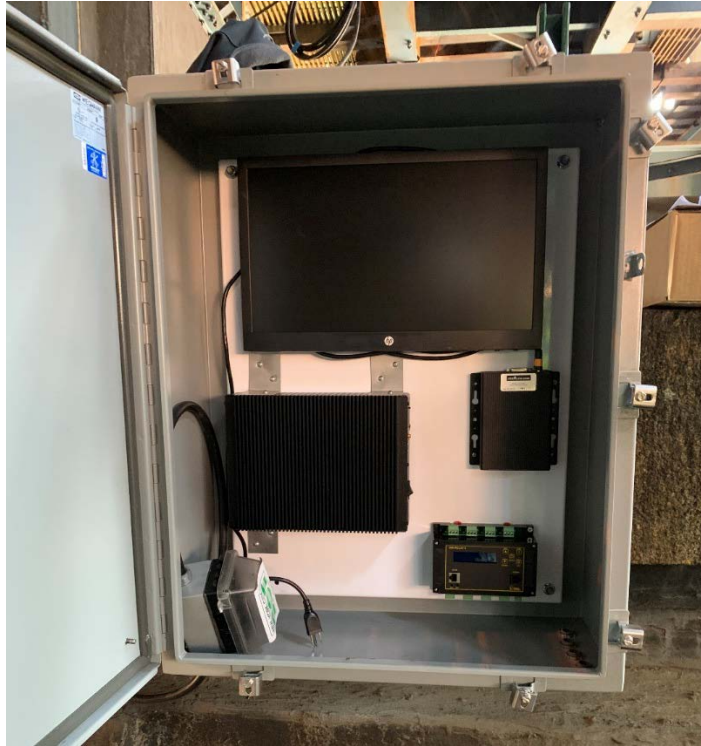
**Figure 20** NEMA enclosure housing the DAQ, processor, and communication systems

Figure 20 shows the NEMA enclosure, which housed the optical interrogator, the central processing system and the cellular modem. Figure 21 and 22 show a typical sensor installation, which included flexible conduit to carry the armored optical fiber between small NEMA enclosures that protected each sensor. Figure 23 shows an installed strain gage prior to the attachment of the NEMA enclosure, and illustrates the removal of a 3 in. by 3in. area of paint to ensure the sensor was affixed to the substrate steel. All sensors were attached to the structure via microdot welding.

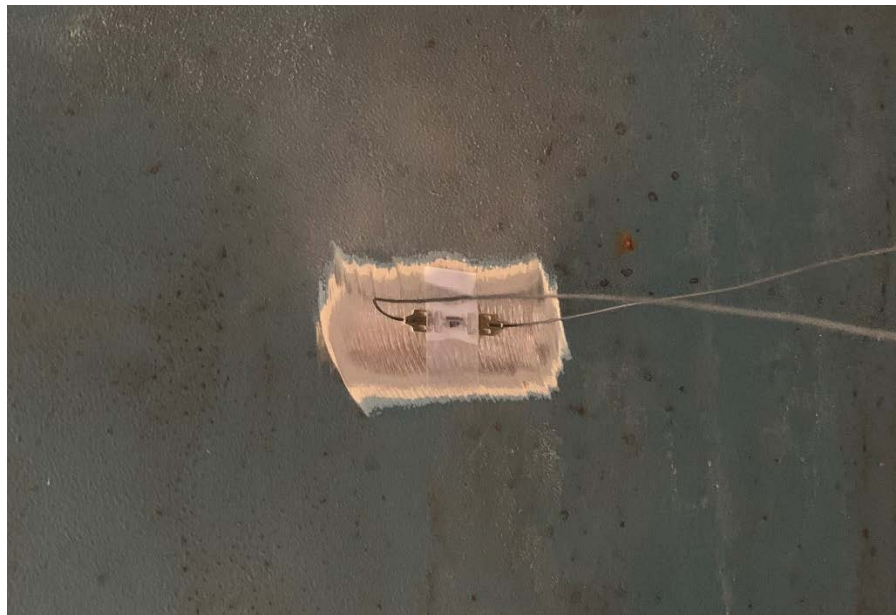
**Figure 23** Paint removal to install FBG strain gage

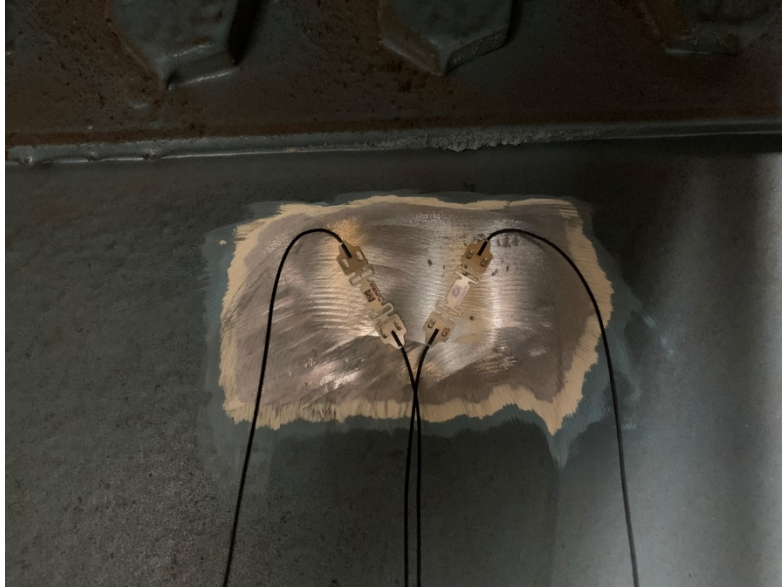
**Figure 24** Typical rosette gage installation

Figure 24 shows the schematic of a rosette shear strain sensor that was arranged in an inverted delta configuration. Generalized strain-transformation equations were used to estimate the maximum shear strain in these locations.

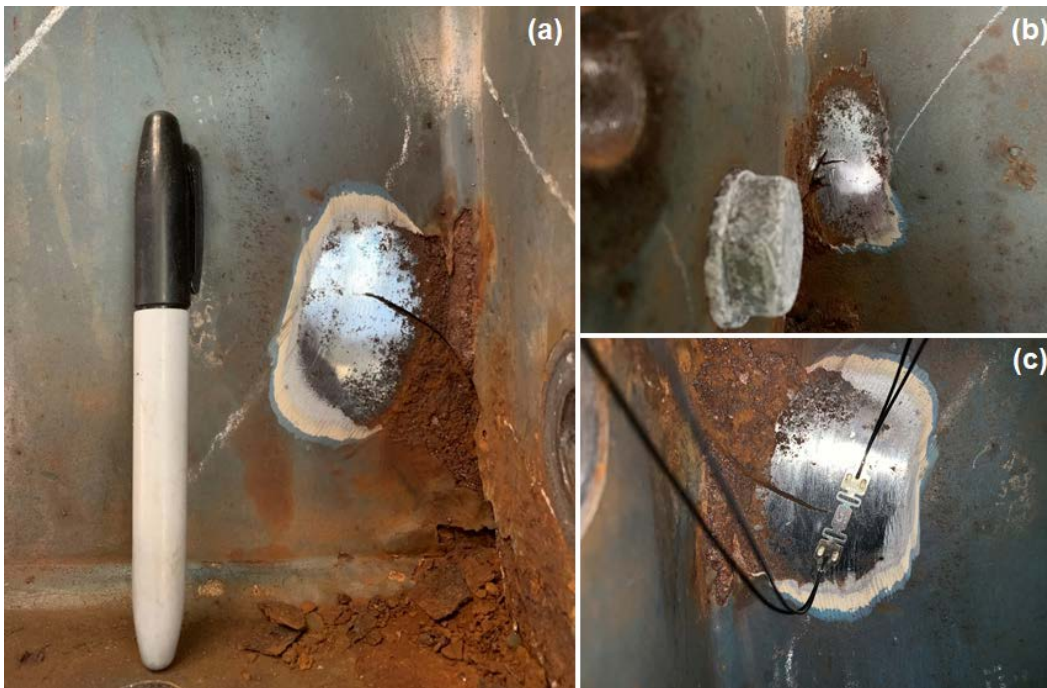
**Figure 25** a-b) Samples of crack sizes in the inspected members, c) Sample of strain gage installed at the tip of an active crack

Figures 25(a) and (b) show typical cracks that have been located in the vicinity of floor beams, and Figure 25(c) shows a crack sensor installed at the tip of an existing crack.

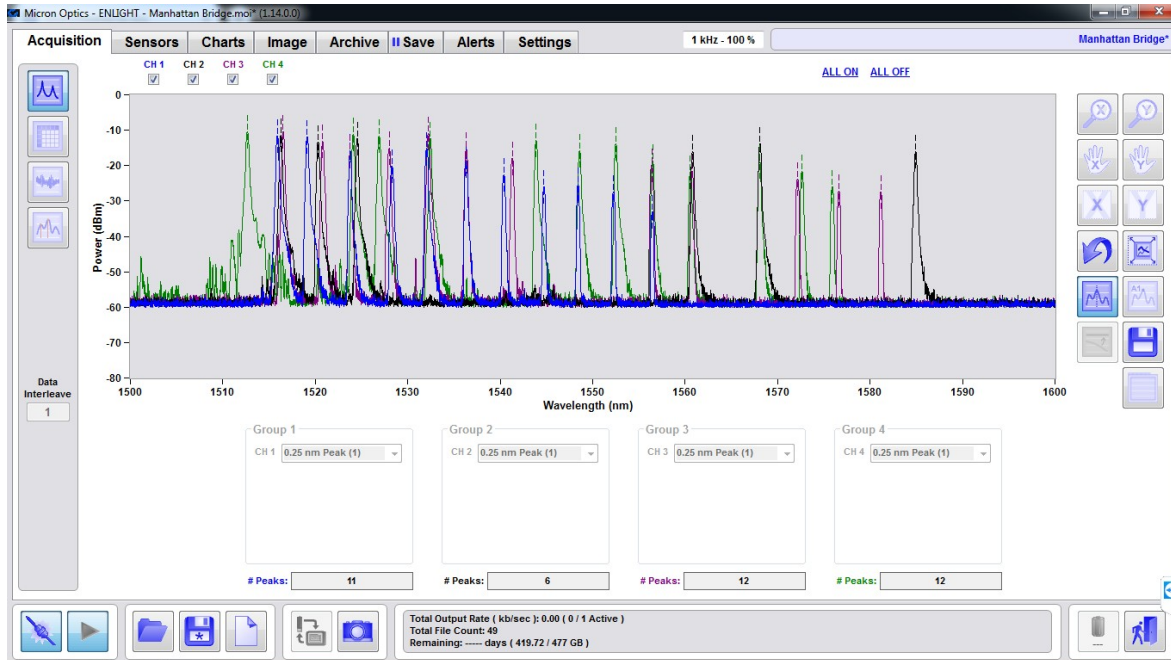
Figure 26 Typical ENLIGHT display of sensor readings

The data acquisition system used a software package known as ENLIGHT provided by Micron Optics. ENLIGHT allows the user to define and configure all sensors and transforms the light-based measurements into useable strain data. It also permits data reporting and visualization as well as data transfer to third party software. Figure 26 shows a typical sensor response in the ENLIGHT software. The software was set to record 10 minutes of sensor data every two hours at a 100 Hz sample rate.

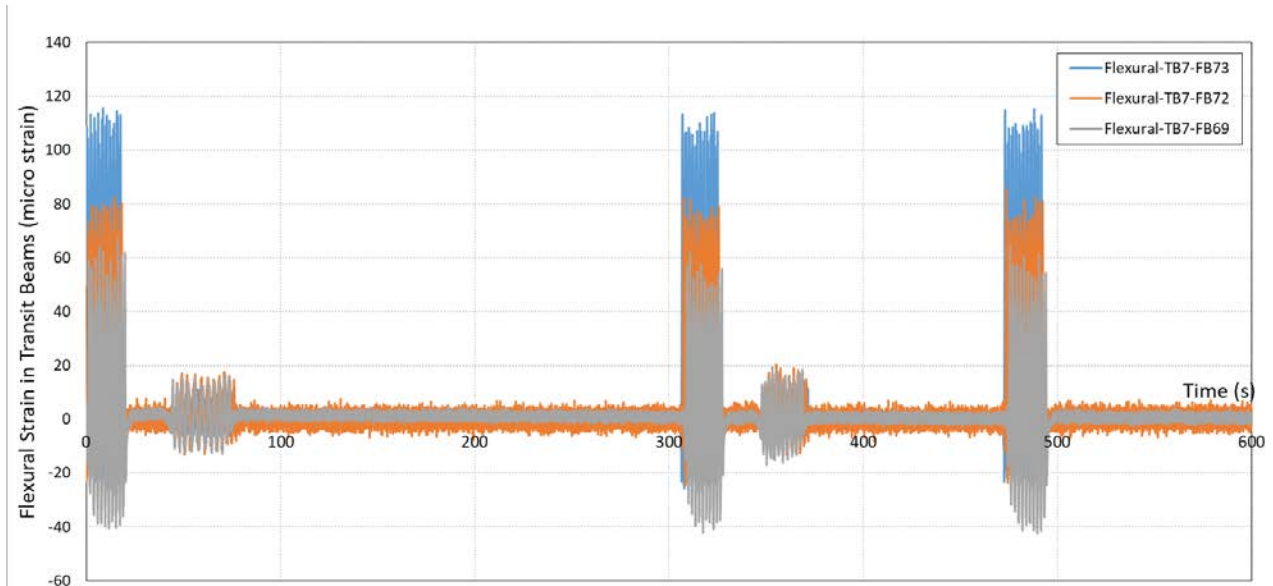
**Figure 27** Representative of strain measurements from the transit stringers

Given that monitoring took place over the course of months, the system was set to automatically collect data at regular intervals as opposed to continuously. To that end, the data was continuously collected for the first 10 mins of every 2-hour period. Figure 27 provides a sample of data collected from the installed SHM system.

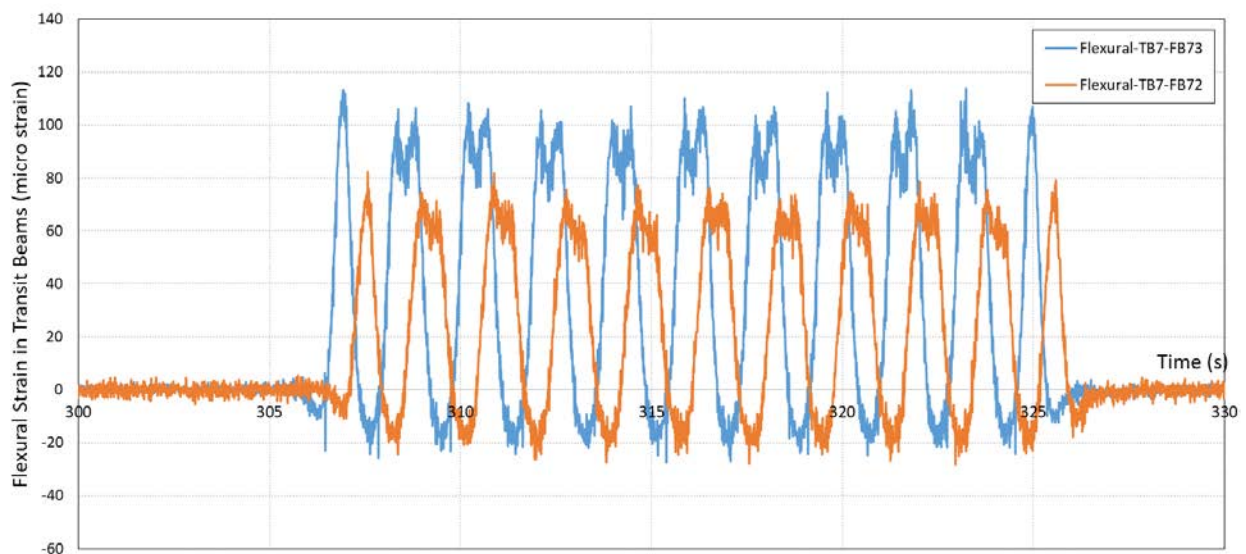
**Figure 28** Representative of strain measurements from the transit stringers for a single train cross

Simultaneous measurements from two flexural strain gages that were installed on the bottom flange of a transit stringer are shown in Figure 28. It should be noted that the measured strains have already been compensated for temperature effects and only reflect the structural response due to live load. Additionally, Figure 29 provides a closer look at one of the strain gages installed on the bottom flange of Transit Stringer 7 while the train was directly crossing over. By reviewing Figure 28 in more detail, the exact number of cars, train speed, as well as each car length could be estimated by determining the time difference between multiple cars crossing over the sensors (at a known spacing).

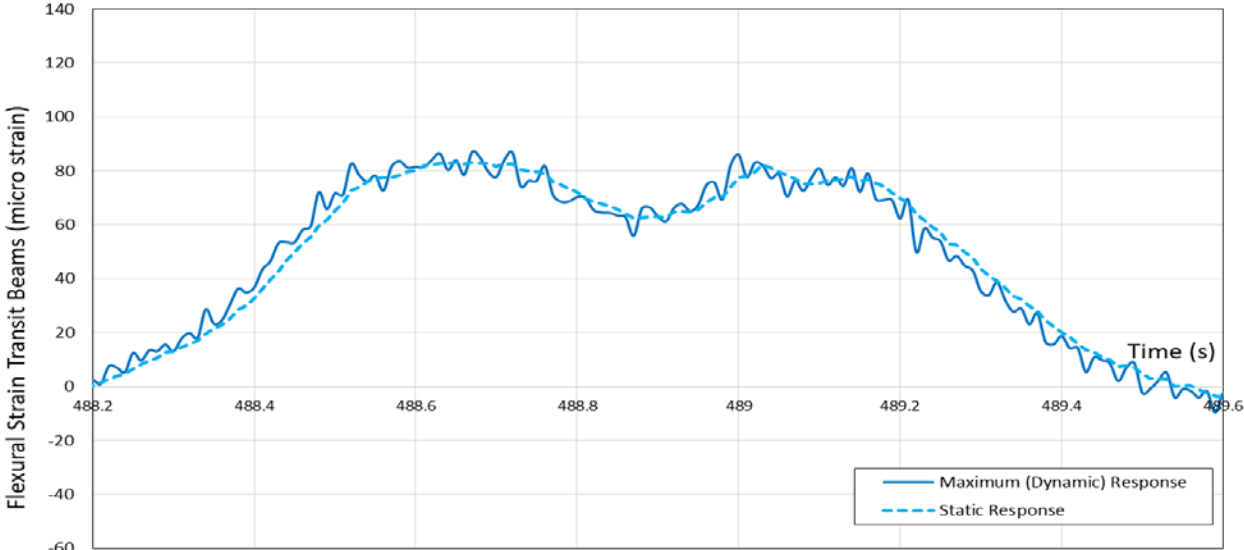
**Figure 29** Raw and filtered flexural strain response in transit stringer near good condition splice

One typical cycle from Figure 28 is displayed in Figures 29 and 30. It is composed of two superimposed cycles due to the close spacing of wheel carriages on adjacent cars. As it is the interest of this study to quantify the effect of rail splices on member responses, it is advantageous to estimate the static response to live loads so the dynamic component (and amplification) may be extracted. Perfect rail geometry should result in near unit dynamic amplification, and thus dynamic amplification of structural responses in the region of rail splices may provide reasonable measure of a splice's effect on structural performance.

One simple way of estimating static response from total response is to use signal processing techniques to filter out frequencies that correspond to the dynamic response of the structure while retaining content that is representative of the static response of the structure. In Figures 29 and 30, the dark blue color represents the raw strain gage reading while the light blue corresponds to an estimate of the static response obtained by implementing a low-pass filter. As can be seen in Figure 29, the dynamic response near a splice in good condition is not appreciably greater than the estimated static response. It may therefore be concluded that the dynamic amplification is low in this region. In contrast, the response in a region with a misaligned splice, as displayed in Figure 30, exhibits significant dynamic amplification as evidenced by the spikes in strain. These responses allow the quantification of the influence of misaligned splices that result in impacts as the train wheels cross them.

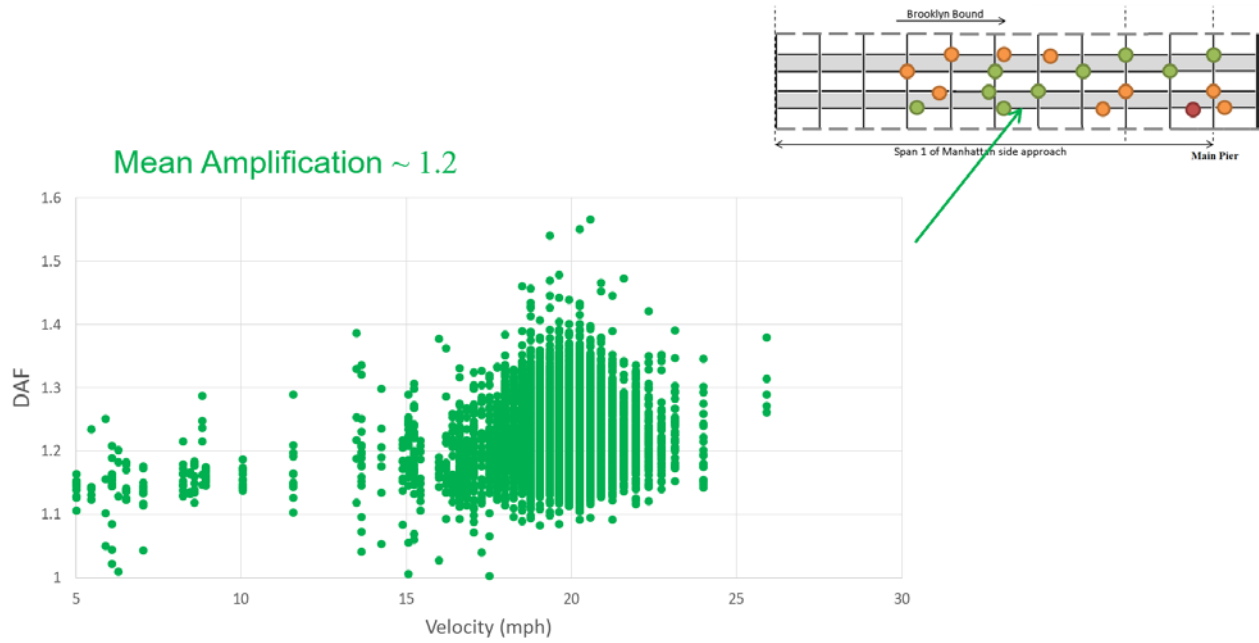
**Figure 31** Calculated DAF based on flexural strain measurement in transit stringer by sensor TB6-FB73 (adjacent to a fair splice)

Figures 31-33 are arranged in descending order of rail splice condition (“fair” to “severe”). As indicated in Figure 31, the DAF for the strain gage installed adjacent to a splice in “fair” condition falls in the range of

1.0-1.5 with an average of 1.2. The DAF ratio slightly increases for the sensors installed in the vicinity of a splice in “poor” condition, exhibiting a range of 1.1-1.6 with an average of 1.3 (see Figure 32). The DAF for the strain gage adjacent to the “severe” splice was estimated to be in the range of 1.5-3.0 with an average of 2.1 (Figure 33).

To quantify the influence of rail splices on the performance of the transit stringers, the DAFs were determined for multiple transit stringers (subjected to different splice conditions) and plotted in Figures 31-33. The plotted points in Figures 31-33 were calculated based on 120 hours of data recorded at 100 Hz during a 2-month period. A MATLAB program was developed in order to automatically analyze and separate each individual train passage over the instrumented transit stringers. Approximately 1220 single passages (events) were identified during the recorded 120 hours of data. This corresponds to an average daily estimate of 244 passages per track. As previously shown in Figure 28, each event is mostly composed of 11 train cycles. The velocity, maximum strain, as well as the DAF were calculated and plotted in Figures 31-36. The velocity of each cycle was estimated based on the time difference between the target strain gage and the adjacent strain gage, which was placed at a known distance. As noted earlier, the maximum strain was estimated after the gage response was compensated for temperature effects. Figures 31-36 include between 13,000 and 15,000 data points.

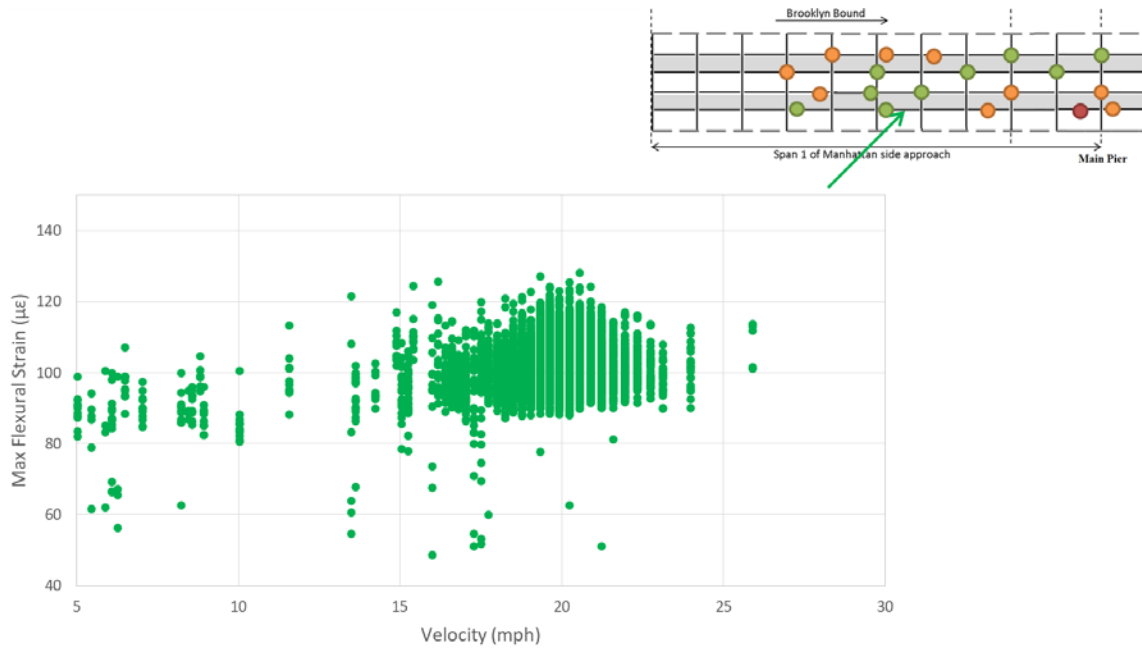
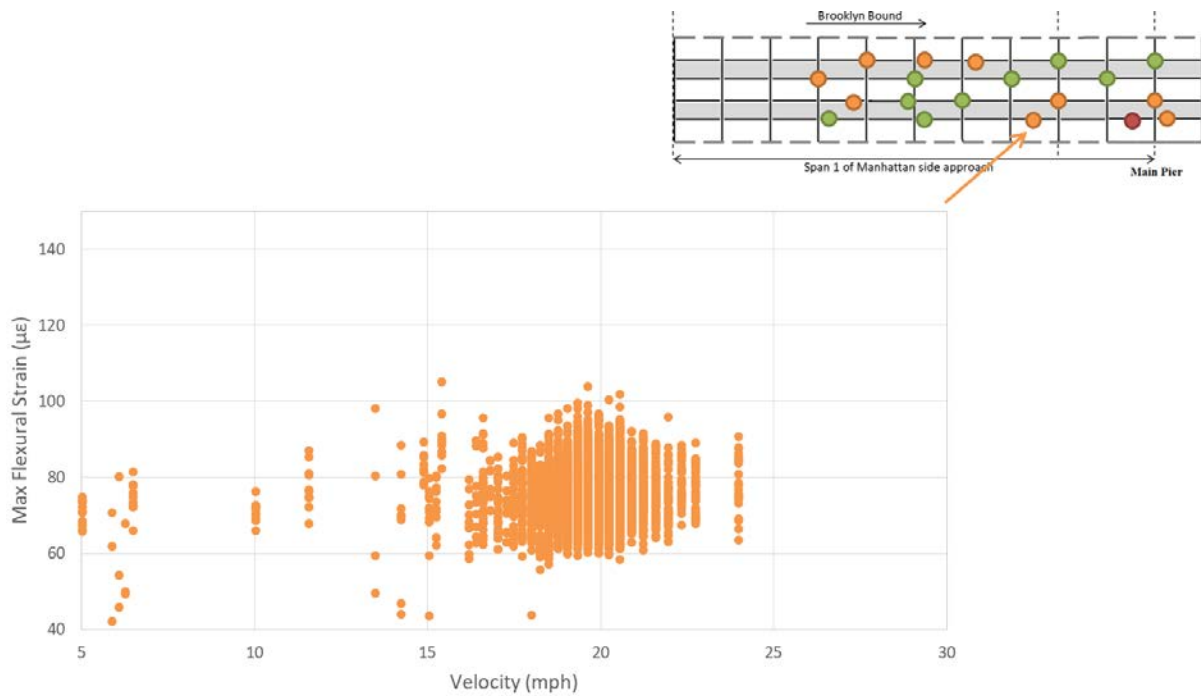
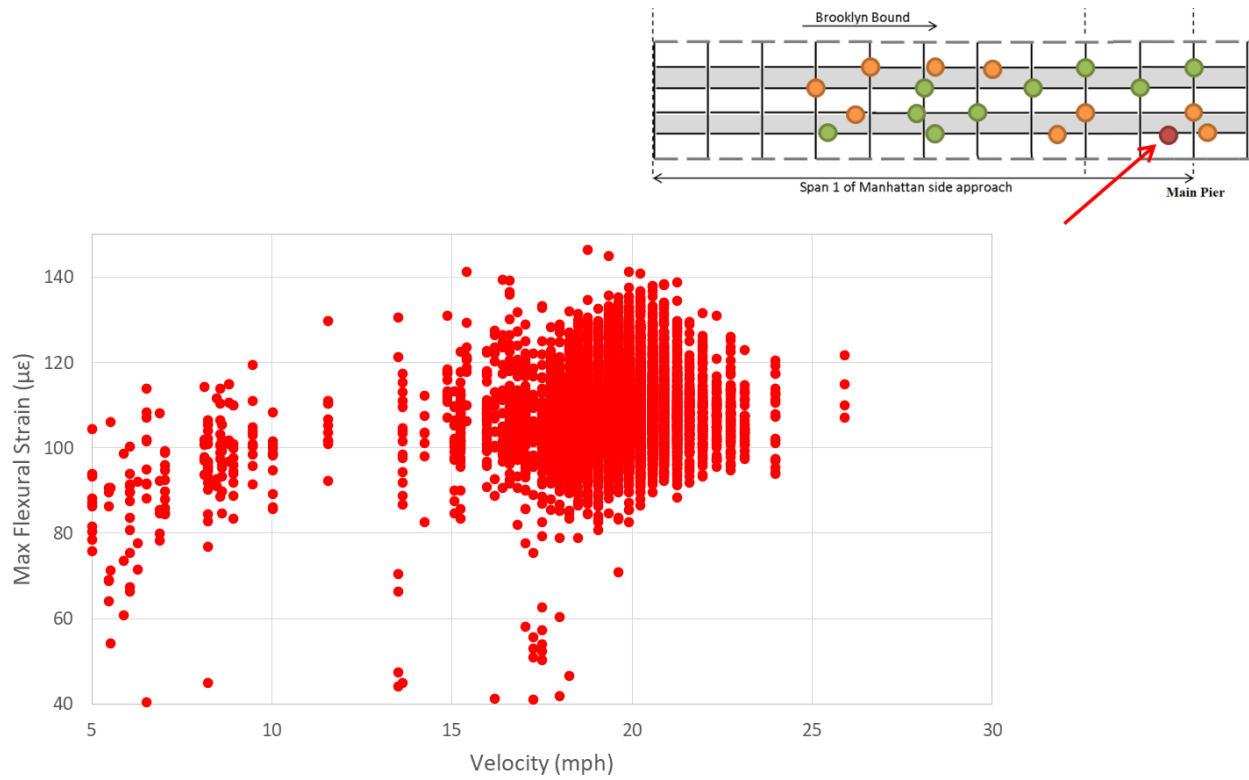
Figures 34-36 present the peak strain per load cycle as a function of train speed and are arranged in descending order of rail splice condition (“fair” to “severe”). Given the transit stringers are steel with an elastic modulus of approximately 29,000 ksi, every 35  $\mu\epsilon$  of strain corresponds to approximately 1 ksi of stress. Hence, the maximum strain illustrated in Figure 34, which is from a gage installed adjacent to a “fair” splice, corresponds to a stress range of 2.0-3.5 ksi with an average of 2.9 ksi (maximum response) and 2.5 ksi (static response). In the case of a strain gage in the vicinity of a “poor” splice (Figure 35), the stress in the transit stringer falls in the range of 2.0-3.0 ksi with an average of 2.2 ksi (maximum response) and 1.7 ksi (static response). For the gage located near the “severe” splice (Figure 36), the stress in the steel is estimated to be in the range of 2.3-4.0 ksi with an average of 3.1 ksi (maximum response) and 1.5 ksi (static response).

**Figure 34** Measured maximum flexural strain in transit stringer by sensor TB6-FB73 (adjacent to a fair splice)

**Figure 35** Measured maximum flexural strain in transit stringer by sensor TB6-FB71 (adjacent to a poor splice)

**Figure 36** Measured maximum flexural strain in transit stringer by sensor TB6-FB69 (adjacent to a severe splice)

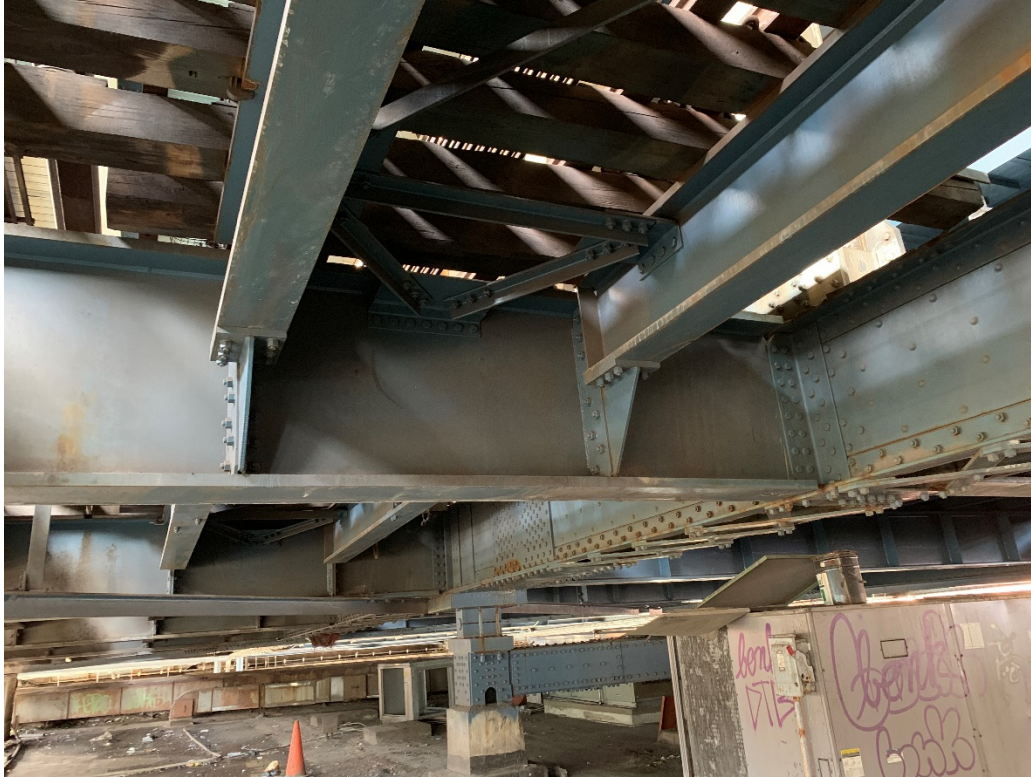
**Figure 37** Close view of the transit stringer connection details

As reported in the *AASHTO Bridge Design Manual* (Table of 6.6.1.2.3-2, reproduced in Table 1 below) [14], the constant amplitude fatigue threshold (or maximum permissible stress cycle for an indefinite fatigue life) falls in the range of 3-24 ksi depending on the detail category. As indicated in Figure 37, the majority of the connection details in transit stringers are made of high strength bolts and the fatigue-prone weld details are avoided. As a result, the transit stringer details fall under “A-D” AASHTO detail categories, which provide larger fatigue thresholds. Therefore, it is estimated that the maximum stress levels in the transit stringers (even near “severe” joints) fall under the corresponding constant amplitude fatigue threshold, and thus indicate infinite fatigue life. Importantly, this analysis is only for the transit stringers

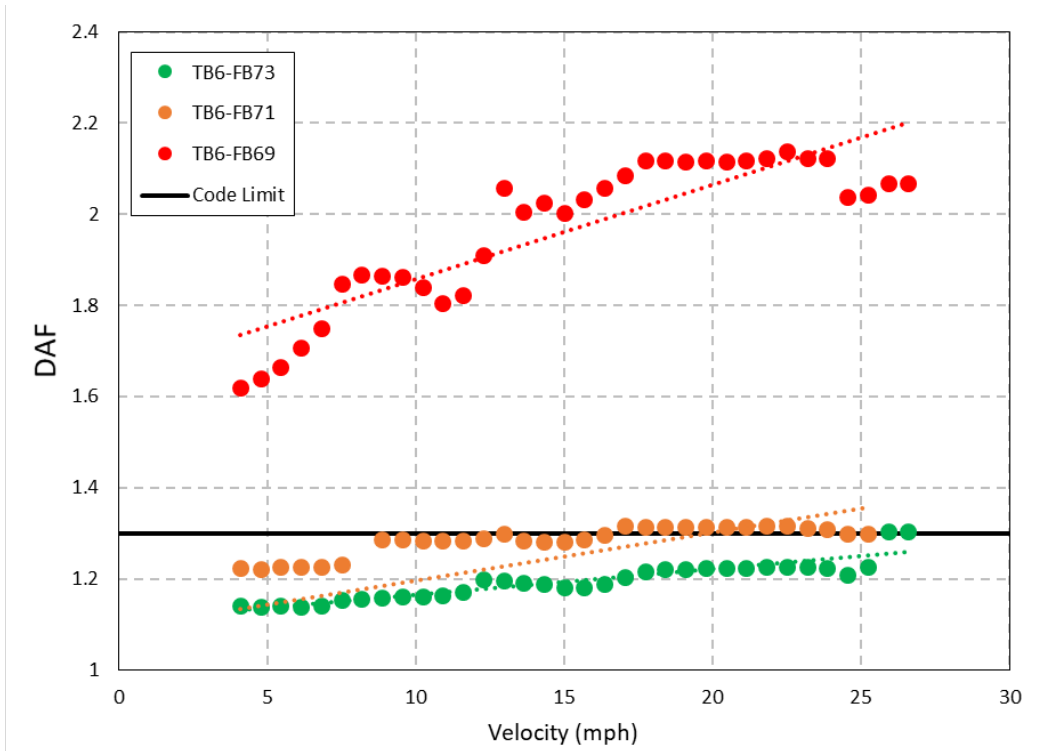
**Figure 38** Statistical calculation of transit stringers' DAFs for different splicing conditions

The statistical summary of calculated DAF values and flexural strain gages versus the train velocity is shown in Figure 38, where the associated average was separately computed for multiple ranges of train velocities. As the train velocity increases, it is obvious the transit stringers experience higher rates of dynamic amplification and flexural strain due to the higher impact force induced by the train wheel traversing the rail splice. This is because the vertical deviation at the splice must be accommodated over a shorter time period with increased train speed. Since force may be expressed as the change in momentum divided by the time over which that change occurs, it follows that as the duration over which the train wheel traverses the splice decreases, the resulting impact force increases.

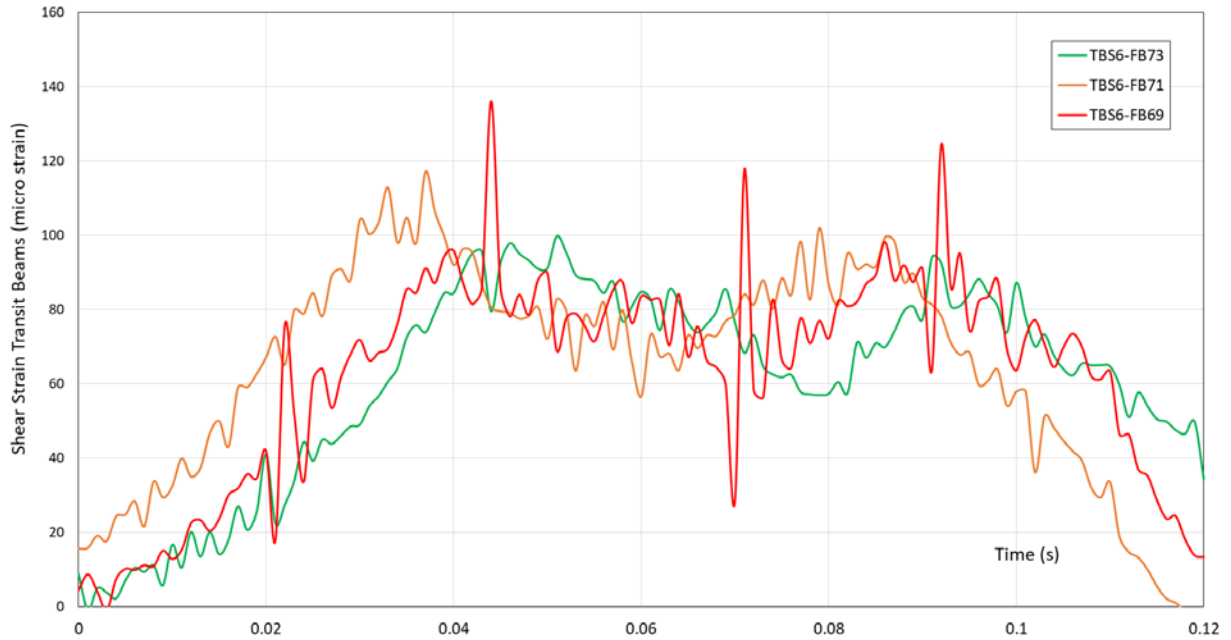
**Figure 39** Raw shear strain response in transit stringer near fair (TBS6-FB73), poor (TBS6-FB71), and severe (TBS6-FB69) splices

In addition to flexural strain measured at the bottom flange of the transit stringers, a few locations along the web of the transit stringers were instrumented using shear rosette sensors. In Figure 39, responses from three different rosette sensors installed on the web of transit stringers adjacent to “fair”, “poor”, and “severe” splices are shown. It is obvious that the dynamic response near a splice in “fair” condition is not appreciably greater than its static response. It may therefore be concluded that the dynamic amplification is low in this region. In contrast, the response in a region with a “severe” splice as displayed in Figure 39 exhibits a DAF of approximately 1.2-1.7, which is much less than observed for flexural responses. The statistical summary of calculated DAF values versus train velocity is shown in Figure 40, where the associated average DAFs were separately computed for multiple ranges of train velocities. As the train velocity increases, it is obvious that the transit stringers experience higher rates of dynamic amplification due to the higher impact force induced by the train wheel traversing the rail splice. As indicated in Figure 40, the DAF for the strain gage installed adjacent to a splice in “fair” condition falls in the range of 1.0-1.5 with an average of 1.2. The DAF ratio slightly increases for the sensors installed in the vicinity of a splice in “poor” condition, exhibiting a range of 1.1-1.6 with an average of 1.3. The DAF for the strain gage adjacent to a “severe” splice was estimated to be in the range of 1.2-2.0 with an average of 1.6.
