# Structural Health Monitoring of Representative Cracks in the Manhattan Bridge

FINAL REPORT  
January 2020

Rutgers, The State University of New Jersey  
And  
New York City (NYC)  
Department of Transportation

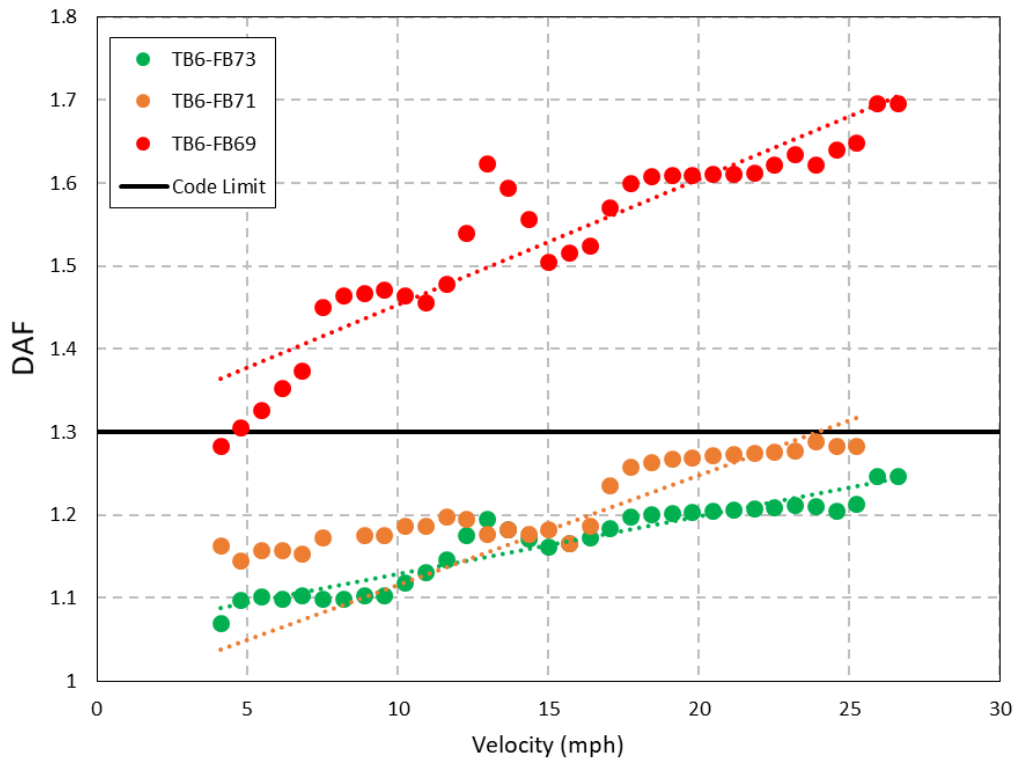
**Figure 40** Statistical calculation of transit stringers' DAFs (shear strain) for different splicing conditions

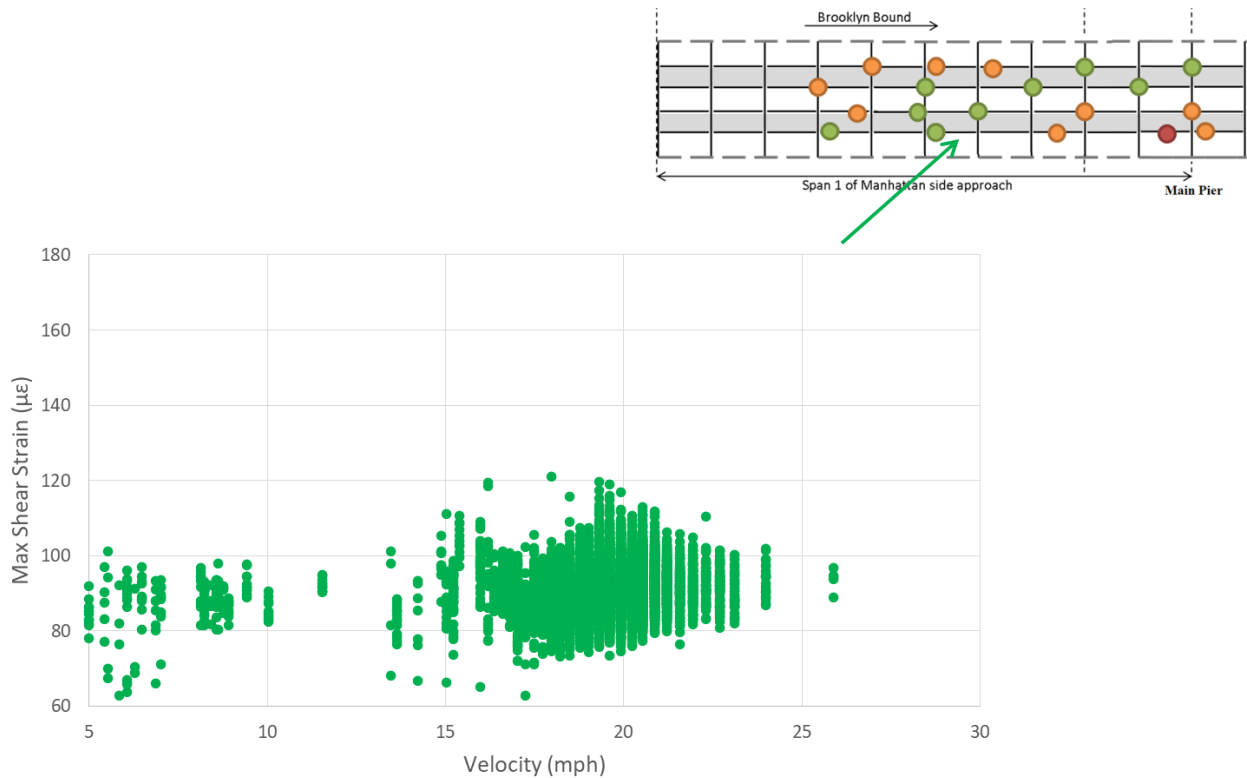
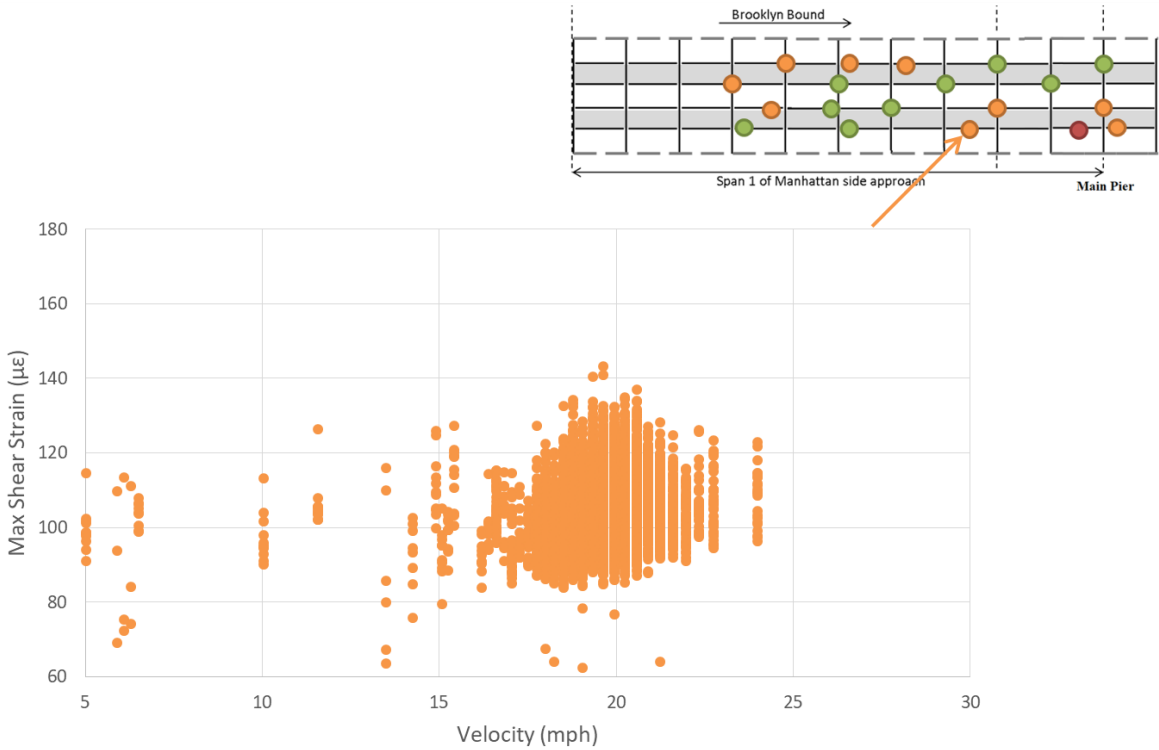
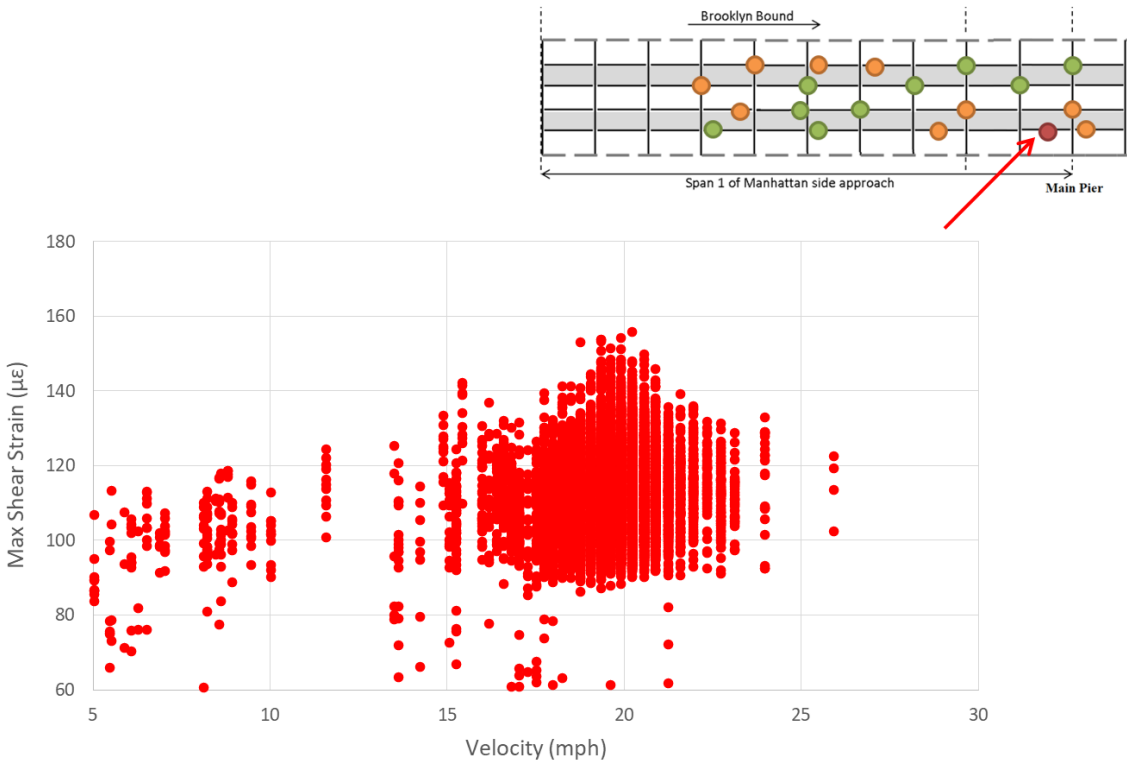
Figures 41-43 refer to the maximum shear strain response measured from the rosette sensors. The figures are arranged in descending order of rail splice condition. Given the transit stringers are steel with a shear modulus of approximately 11.5 ksi, every 87  $\mu\epsilon$  of strain corresponds to approximately 1 ksi of stress. Hence, the maximum strain illustrated in Figure 41, which is from a gage installed adjacent to a “fair” splice, corresponds to a stress range of 0.9-1.4 ksi with an average of 1.0 ksi (maximum response). In the case of a strain gage in the vicinity of a “poor” splice (Figure 42), the stress in the transit stringer falls in the range of 1.0-1.6 ksi with an average of 1.2 ksi (maximum response). For the gage located near the “severe” splice (Figure 43), the stress in the steel is estimated to be in the range of 1.0-1.8 ksi with an average of 1.3 ksi (maximum response).

**Figure 41** Measured maximum shear strain in transit stringer by sensor TB6-FB73

**Figure 42** Measured maximum shear strain in transit stringer by sensor TB6-FB71

**Figure 43** Measured maximum shear strain in transit stringer by sensor TB6-FB69

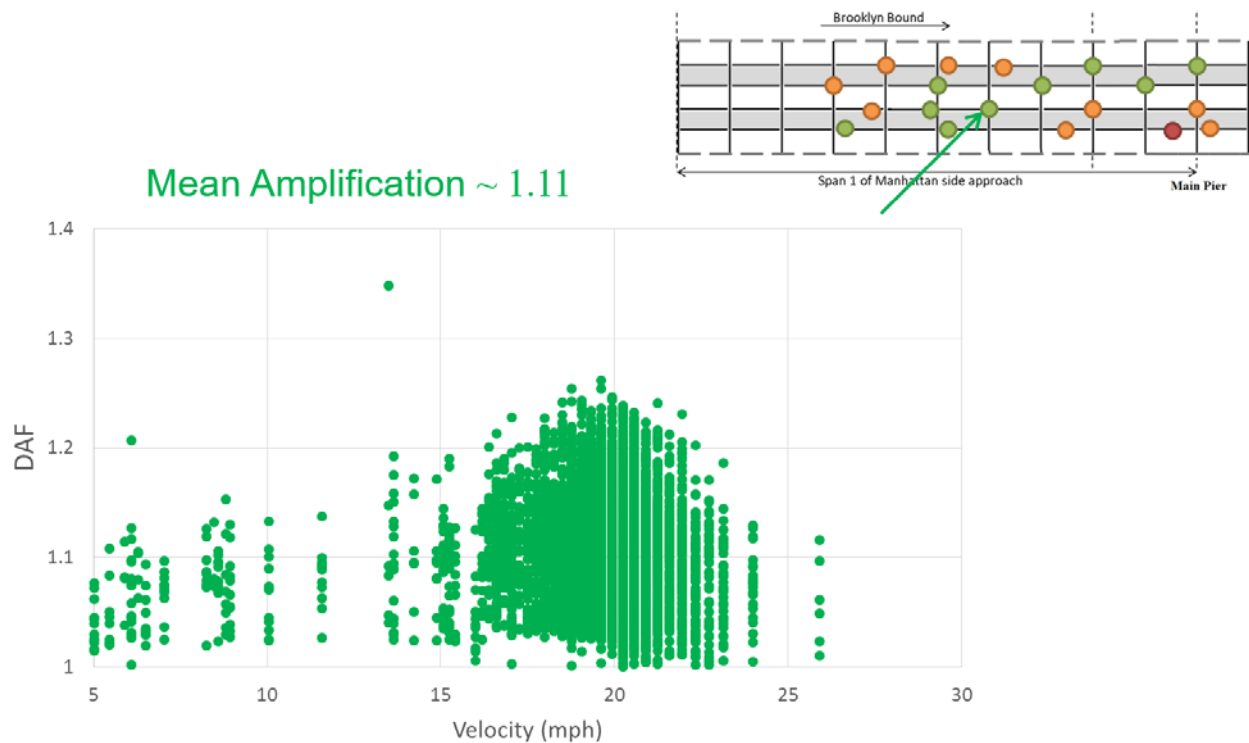
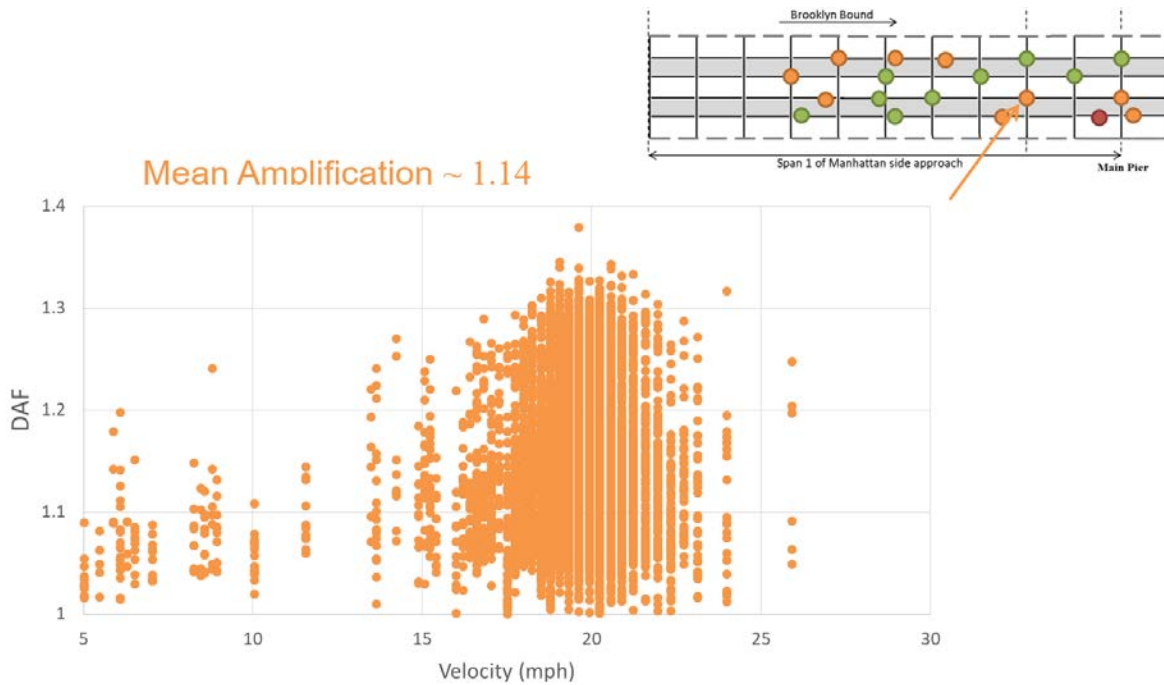
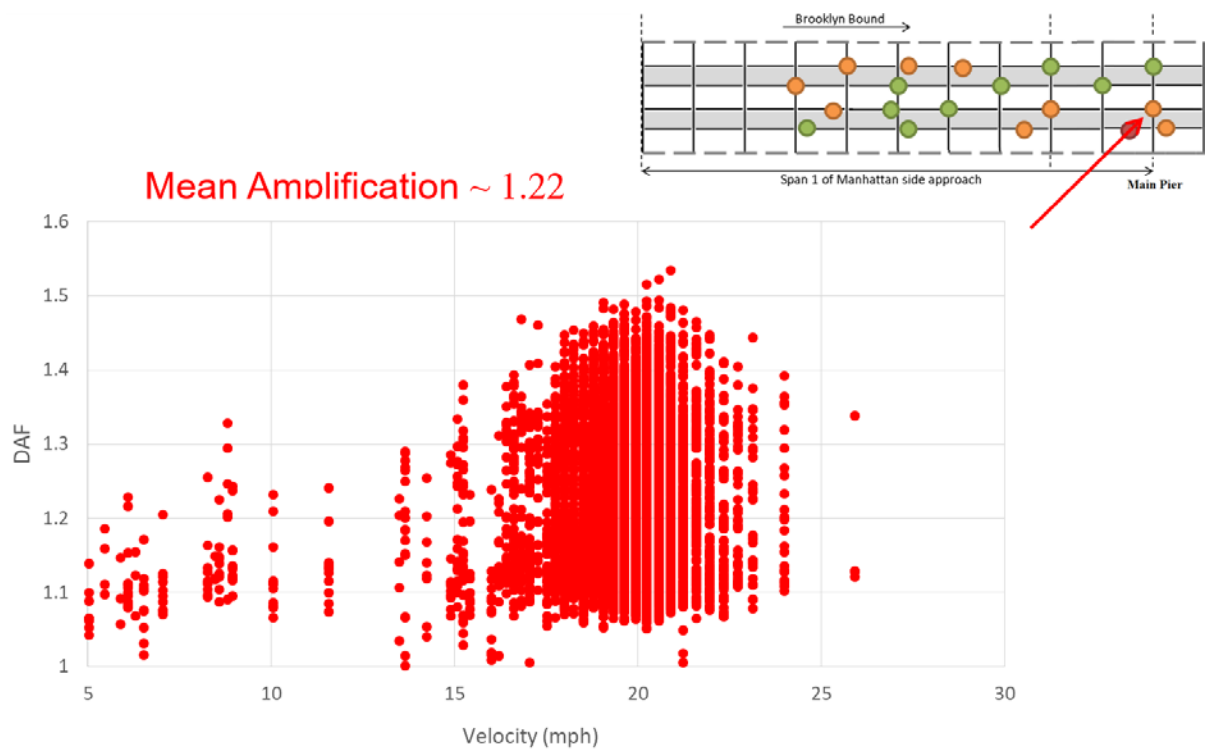
Compared to transit stringers, it was anticipated that the floor beams would exhibit lower dynamic amplification as the dynamic response is expected to attenuate as it travels from the transit stringers to the floor beams. The DAF value for the floor beams were determined for multiple floor beams (subjected to different splice conditions) and are plotted in Figures 44-46.

Figures 44-46 are arranged in descending order of rail splice condition (“fair” to “severe”). Alternatively, the statistical summary of calculated DAF values versus the train velocity is shown in Figure 47, where the associated average was separately computed for multiple ranges of train velocities. As indicated in Figure 44, the DAF for the strain gage installed adjacent to a splice in “fair” condition falls in the range of 1.0-1.25 with an average of 1.11. The DAF ratio slightly increases for the sensors installed in the vicinity of a splice in “poor” condition, exhibiting a range of 1.0-1.35 with an average of 1.14 (see Figure 45). The DAF for the strain gage adjacent to the severe splice was estimated to be in the range of 1.0-1.5 with an average of 1.22 (Figure 46). As expected, the DAF values for the floor beams were considerably less than for the transit stringers.

**Figure 44** Calculated DAF based on flexural strain measurement in floor beam by sensor FB73-TB7 (adjacent to a fair splice)

**Figure 45** Calculated DAF based on flexural strain measurement in floor beam by sensor FB71-TB7 (adjacent to a poor splice)

**Figure 46** Calculated DAF based on flexural strain measurement in floor beam by sensor FB69-TB7 (adjacent to a severe splice)

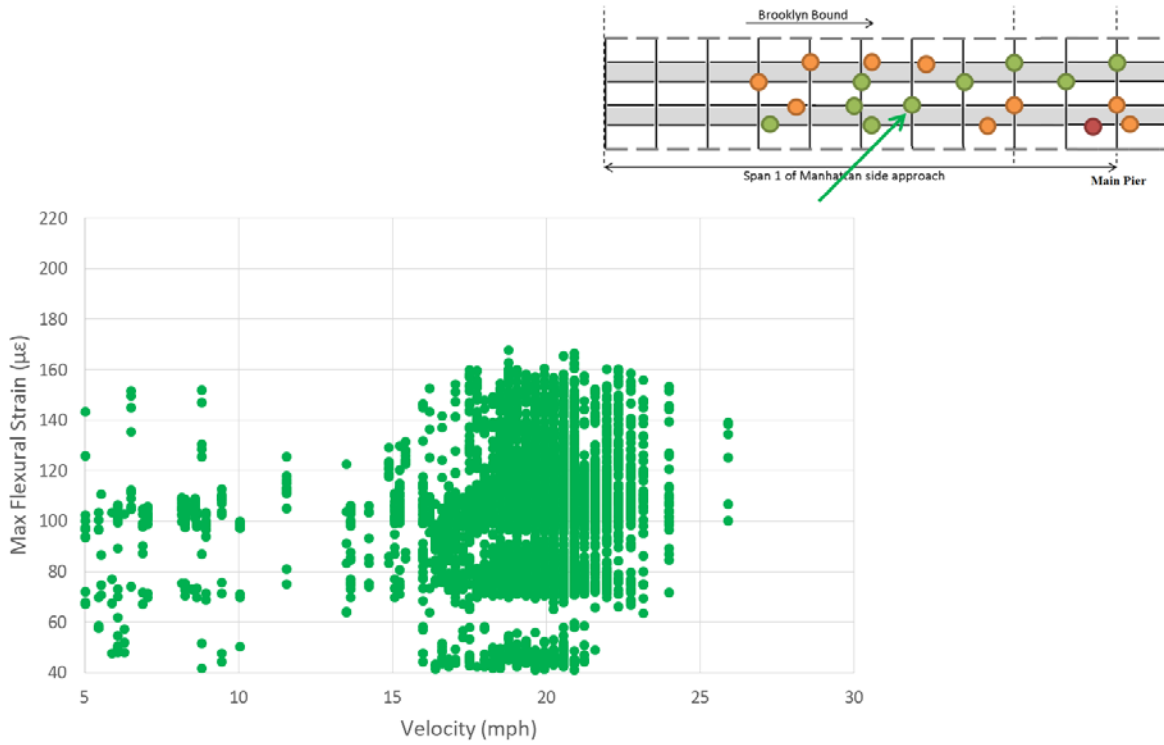
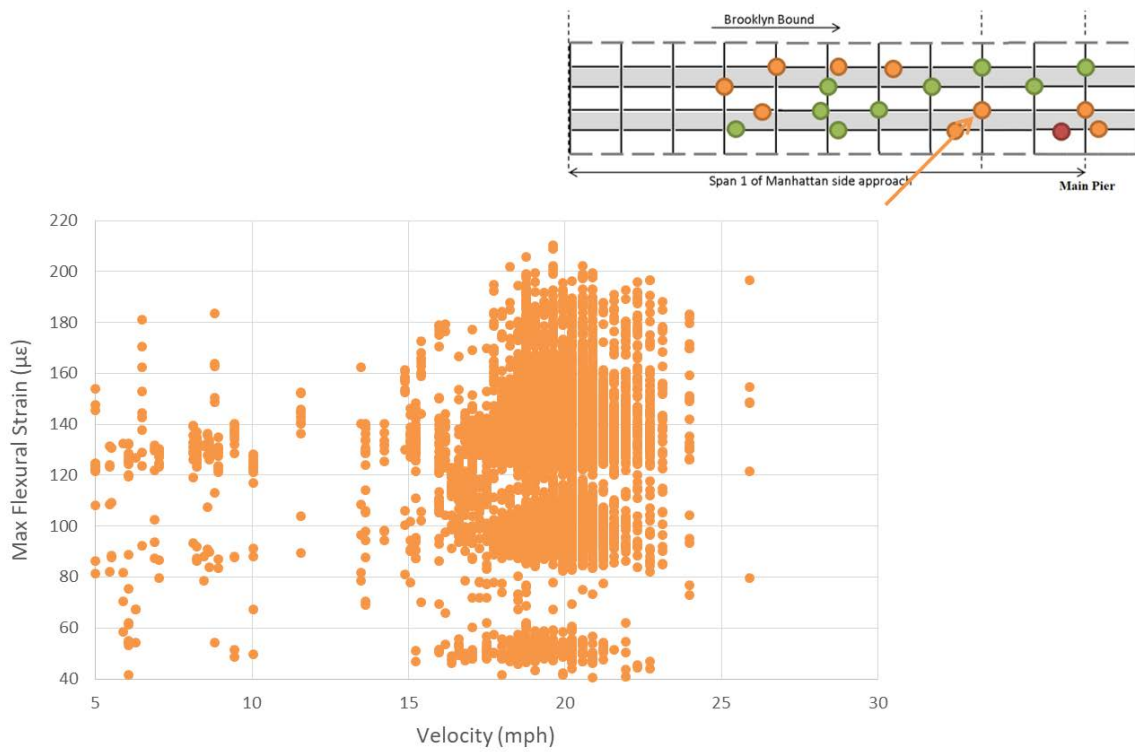
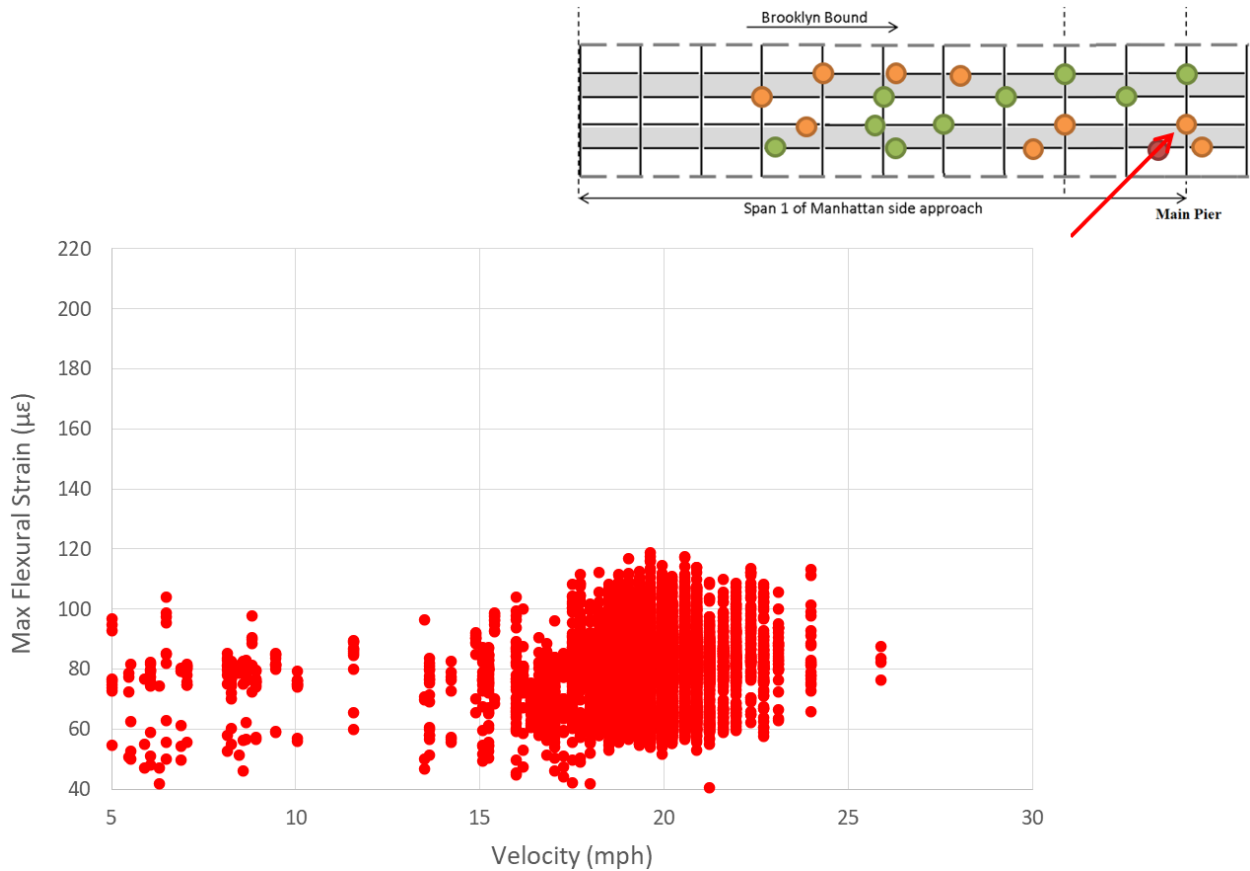
Figures 48-50 illustrate the maximum flexural strain measured from the floor beams and are arranged in descending order of rail splice condition. In a similar procedure employed for transit stringers, the maximum strain illustrated in Figure 48 is from a gage installed adjacent to a “fair” splice, which corresponds to a stress range of 1.1-4.6 ksi with an average of 3.0 ksi (maximum response). In the case of a strain gage in the vicinity of a “poor” splice (Figure 49), the stress in the transit stringer falls in the range of 1.1-5.7 ksi with an average of 3.7 ksi (maximum response). For the gage located near a “severe” splice (Figure 50), the stress in the steel is estimated to be in the range of 1.1-3.4 ksi with an average of 2.3 ksi (maximum response). Similar to transit stringers, the majority of the connection details in floor beams are made of high strength bolts and the fatigue-prone weld details are avoided. Therefore, it is estimated that the maximum stress levels in the floor beams (even near “severe” splices) fall under the corresponding constant amplitude fatigue threshold. This analysis is limited to stress-induced fatigue, and not the distortion-induced fatigue that has already been identified as the root cause of the observed cracking.

**Figure 48** Measured maximum flexural strain in floor beam by sensor FB73-TB7 (adjacent to a fair splice)

**Figure 49** Measured maximum flexural strain in floor beam by sensor FB71-TB7 (adjacent to a poor splice)

**Figure 50** Measured maximum flexural strain in floor beam by sensor FB69-TB7 (adjacent to a severe splice)

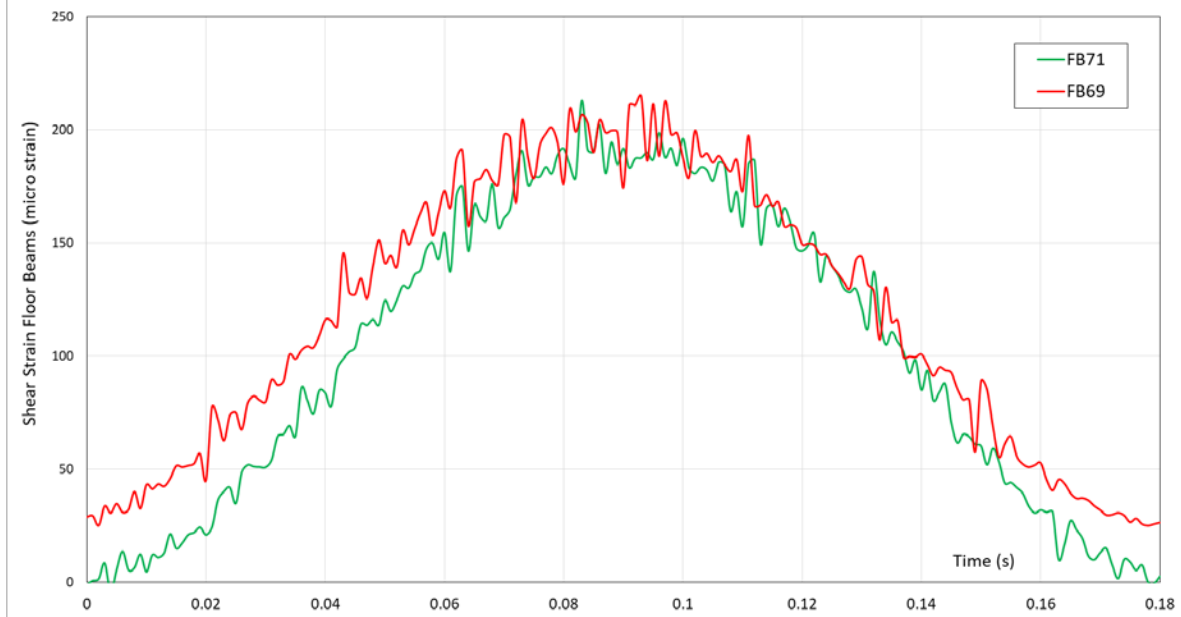
**Figure 51** Raw shear strain response in floor beam near “poor” (FB71) and “severe” (FB69) splices

In addition to flexural strain measured at the bottom flange of floor beams, a few locations along the web of the floor beams were instrumented using shear rosette sensors. In Figure 51, responses from two different rosette sensors installed on the web of floor beams adjacent to “poor” and “severe” splices are shown. As apparent in this figure, the shear response of the floor beam does not demonstrate any sensitivity to the type of splicing joints. This behavior is also apparent when examining the DAF and maximum strain values shown in Figures 52-53.

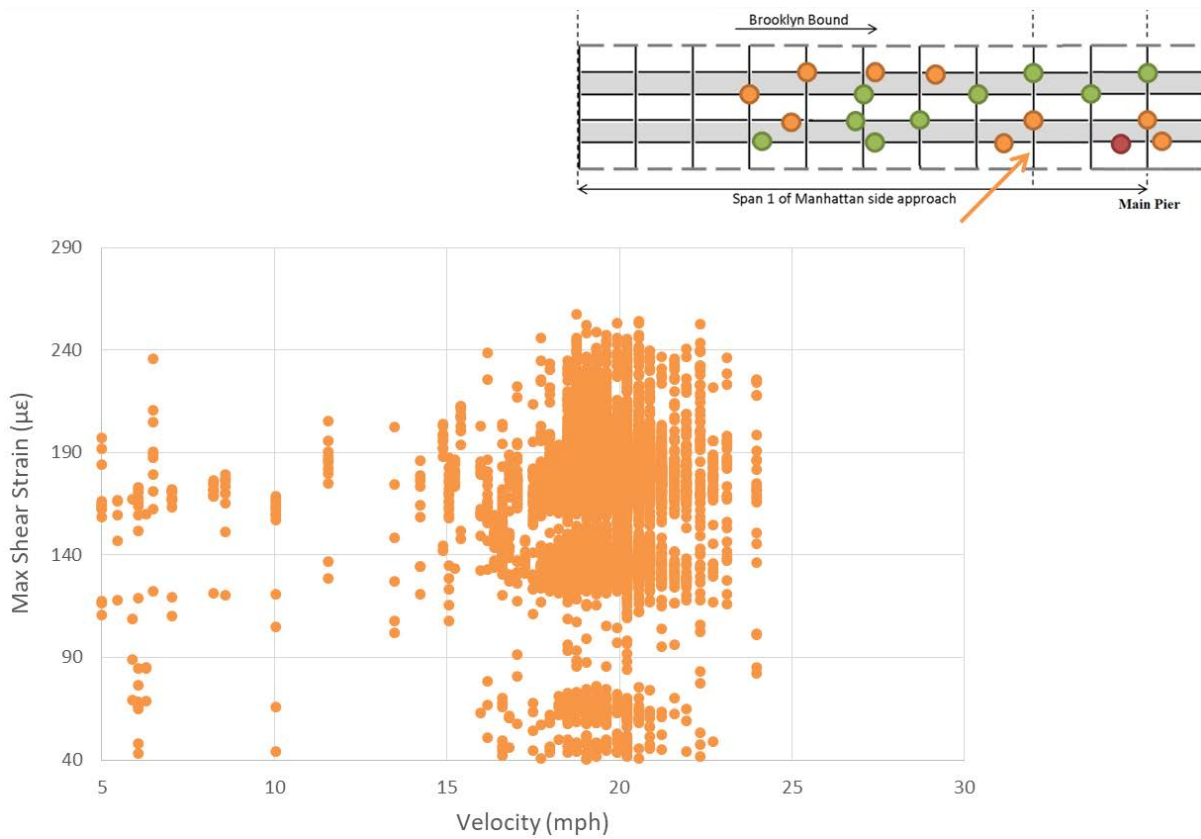
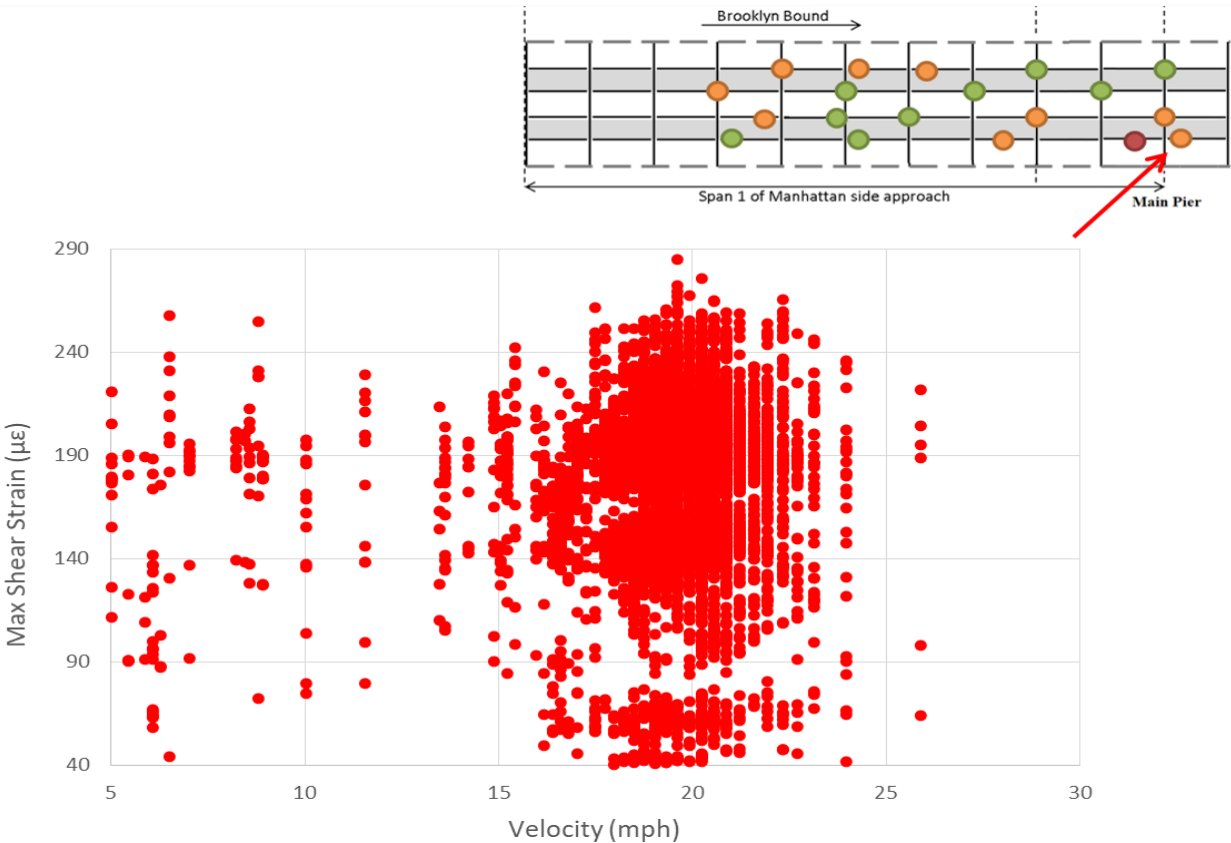
**Figure 52** Measured maximum shear strain in floor beam by sensor FB71 (adjacent to a poor splice)

**Figure 53** Measured maximum shear strain in floor beam by sensor FB69 (adjacent to a severe splice)

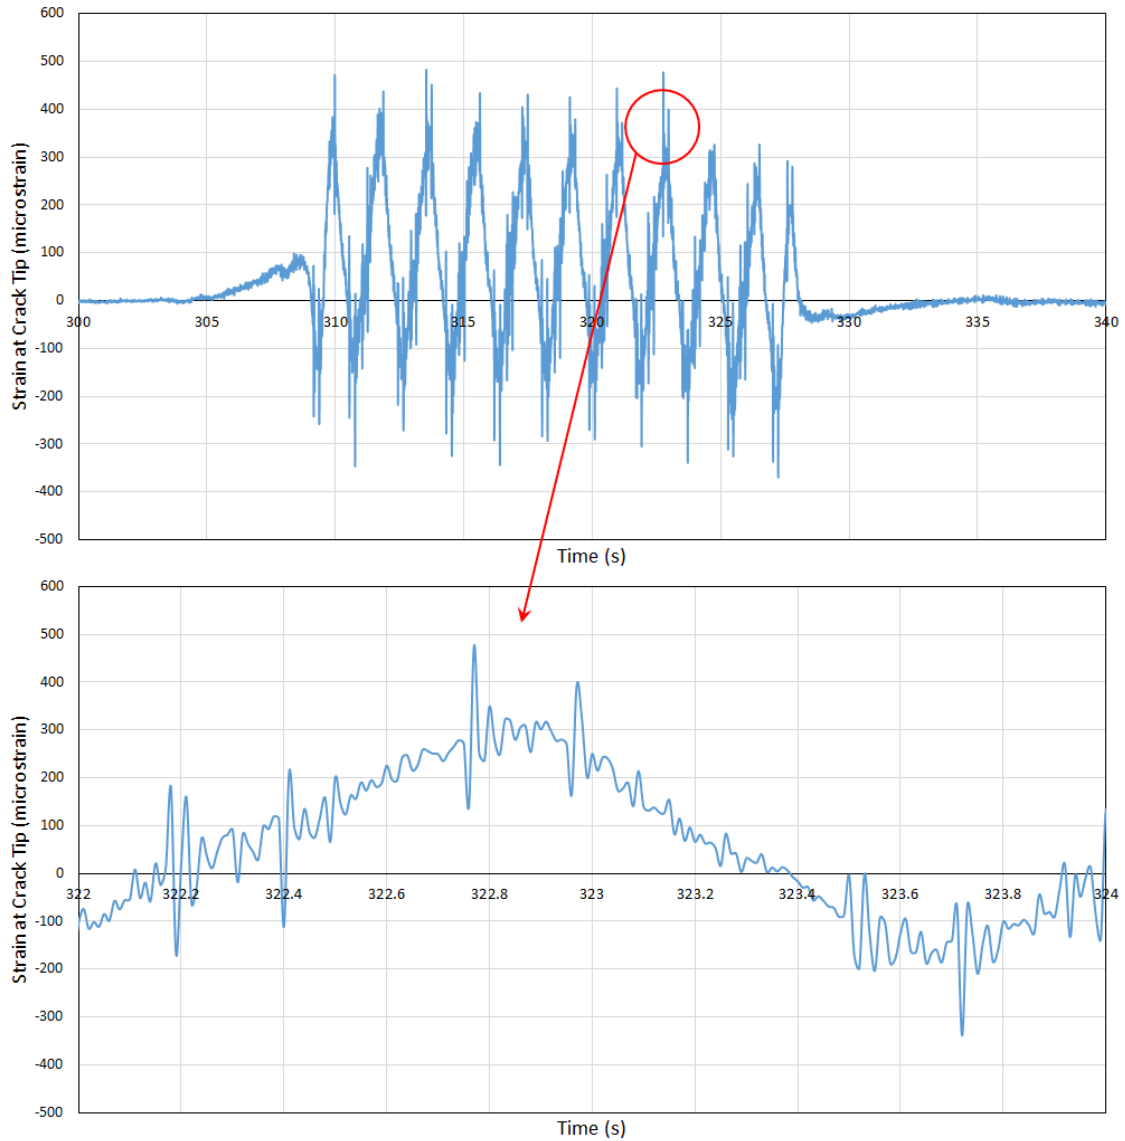
**Figure 54** Measured strain at the crack tip in floor beam by sensor FB69-TS6 (adjacent to a severe splice)

One of the secondary objectives of this study was to monitor the opening of the distortion-induced fatigue cracks to (a) identify whether or not they were active, and (b) to provide baseline data that could be used to quantify the efficacy of mitigation strategies. Figures 15-17 as well as Figure 25 show the location and snapshots of the crack sensors installed at the tip of observed cracks. The installed gages were simply strain sensors installed across the crack (parallel to the crack opening direction). Given the discontinuity associated with cracks, the measured strain is not a direct indicator of actual stress, i.e., it cannot be used via the Elastic Modulus to estimate stress. However, it is indicative of the geometric opening of the crack when it is subjected to the train passage. Figure 54 demonstrates a random strain response measured during a train passage at the south side of the bridge. The strain values are fairly large ( $> 400 \mu\epsilon$ ) and thus it can be reasonably concluded that these cracks remain active. It is interesting that even at this high-stress concentration, the effects of the severe rail splicing could be easily discerned from the rest of response. If it is of interest to the NYCDOT, a comparison between these measurements and those obtained following the retrofit of these regions would be a valuable indicator of the effectiveness of the mitigation strategy.

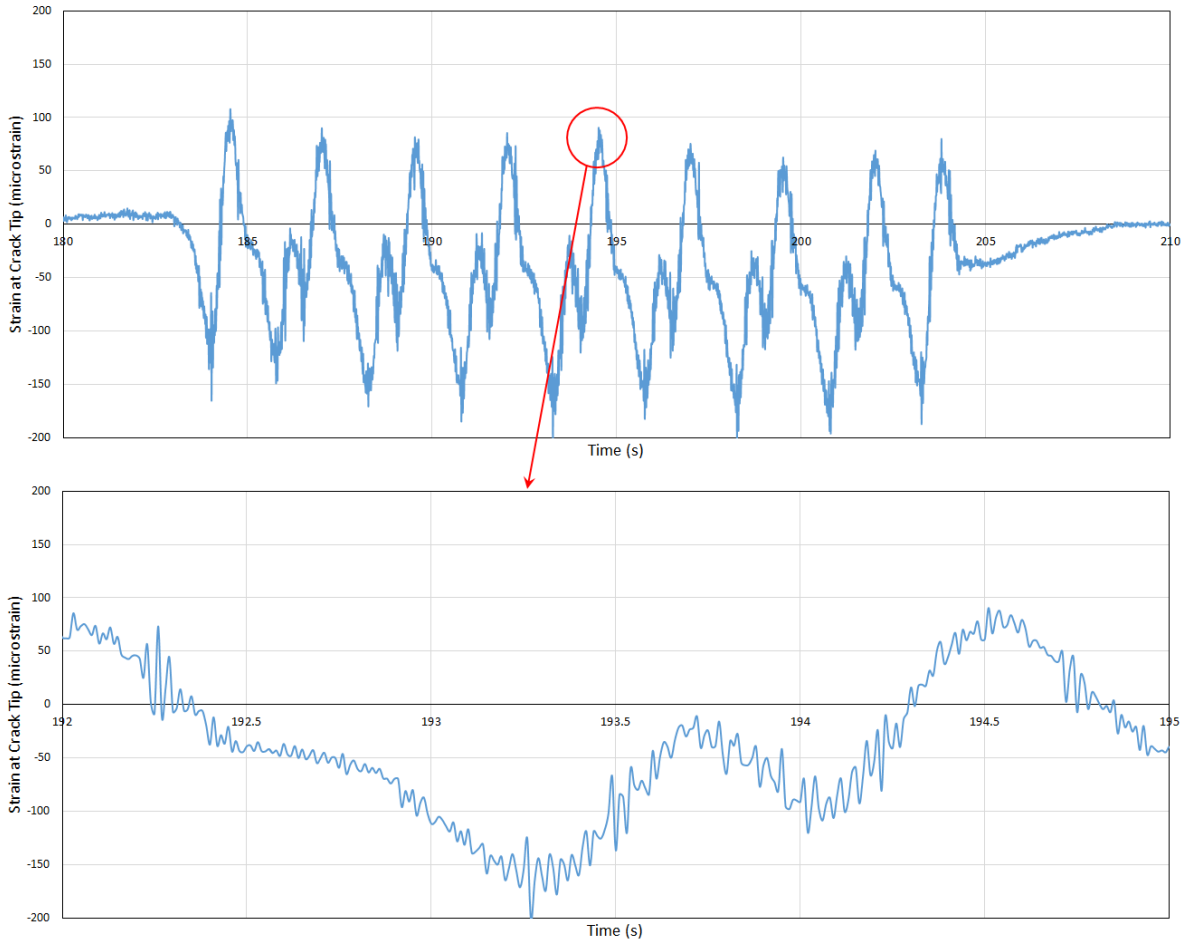
**Figure 55** Measured strain at the crack tip in floor beam by sensor FB71-TN13

In addition, Figures 55 shows a sample strain measurement from a crack sensor installed at the north side of the bridge adjacent to a distortion-induced fatigue crack. As can be observed, in this case the amplitude of the strain response is approximately 1/3 of the amplitude measured in the vicinity of the crack along the south span. This discrepancy is likely due to the localized nature of this measurement, which attenuates rapidly as a function of distance from the crack tip.

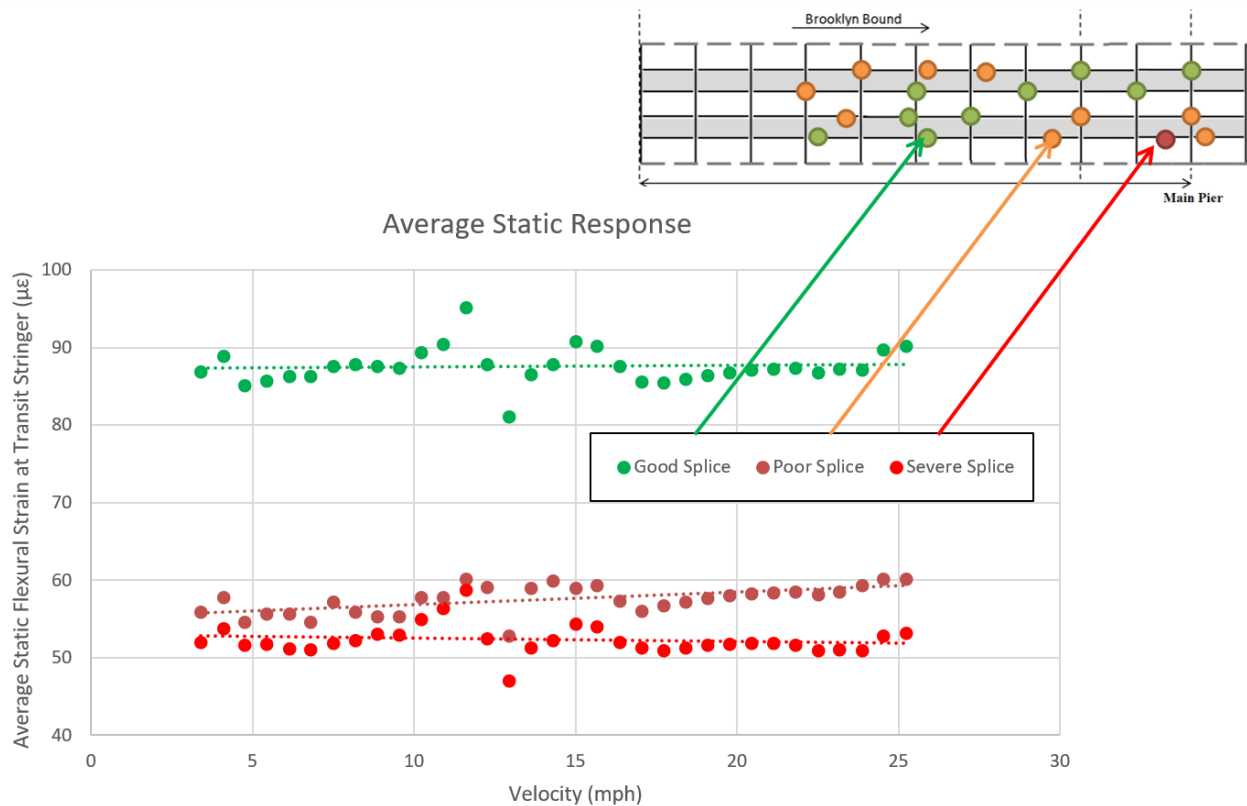
**Figure 56** Calculated static strain response on a number of transit stringers

To back calculate the weight of train with and without passengers, it is first necessary to ensure the static portion of the strain measurements truly portray the train weight. One way of validation is to investigate if the calculated static response is independent of the train velocity or not. Figure 56 shows the calculated static response on a number of transit stringers (calculated based on the filtering approach explained in Fig. 30) versus different velocity ranges as well as different rail splicing conditions. From this figure, it appears the average static strain is indeed independent of train velocity for each location/splice condition. The different strain levels apparent between the various locations shown in Figure 56 can be attributed to the particular location and the stress level induced at this location due to passing trains. As a result, it is concluded that the estimation of static responses are of sufficient accuracy to provide useful estimations of train relative weights.

To examine the relative weight of trains with and without passengers, the frequency histogram of the maximum static flexural strains (due to passage of each train wagon) is plotted in Fig. 57 from the three gages used to develop Figure 56. If the entire range shown in the histograms is assumed to be caused by different number of passengers, then it can be concluded that passengers can account for approximately 30% of the empty train weight ( $100 \times 25 / 80$ ). This 30% was estimated from the "Good Splice" histogram due to (a) it recorded the largest strain values and thus has the best signal-to-noise ratio, and (b) given the variability associated with "Poor" and "Severe" splices, the data is likely more reliable in the vicinity of "Good" splices. Compared to an approximate weight of 85 kips for an empty R160 MTA train, this analysis suggests that the passenger weight can be approximately 25.5 kip at full capacity. With an average of 200 lb per person, this extra load corresponds to approximately 128 passengers per car.
