Evaluation of Techniques to Remove Defective Grout from Post-Tensioning Tendons

Final Report

February 2020

Florida Department of Transportation (FDOT)

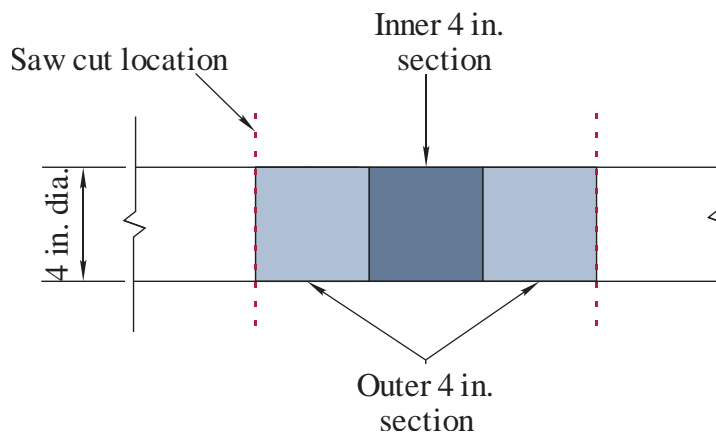
Figure 8-1. Three divisions of 1-ft-long exposed section. Samples were collected from the inner 4-in. section.

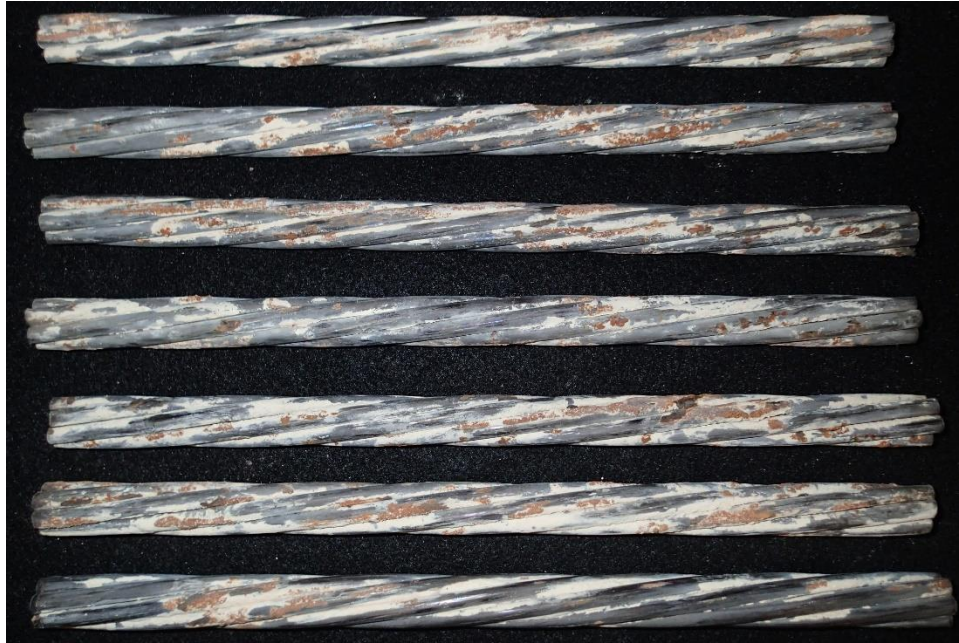
Figure 8-15. Corroded strands near port C dried TSG specimen

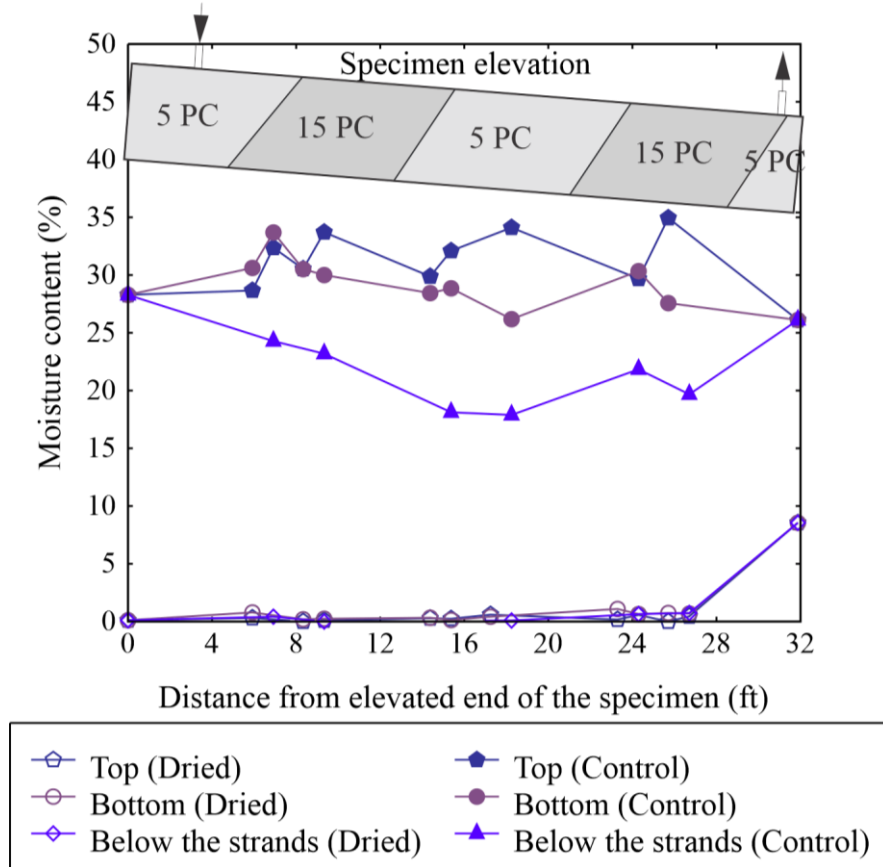
Figure 8-20. Comparison of moisture content for dried and control ISG

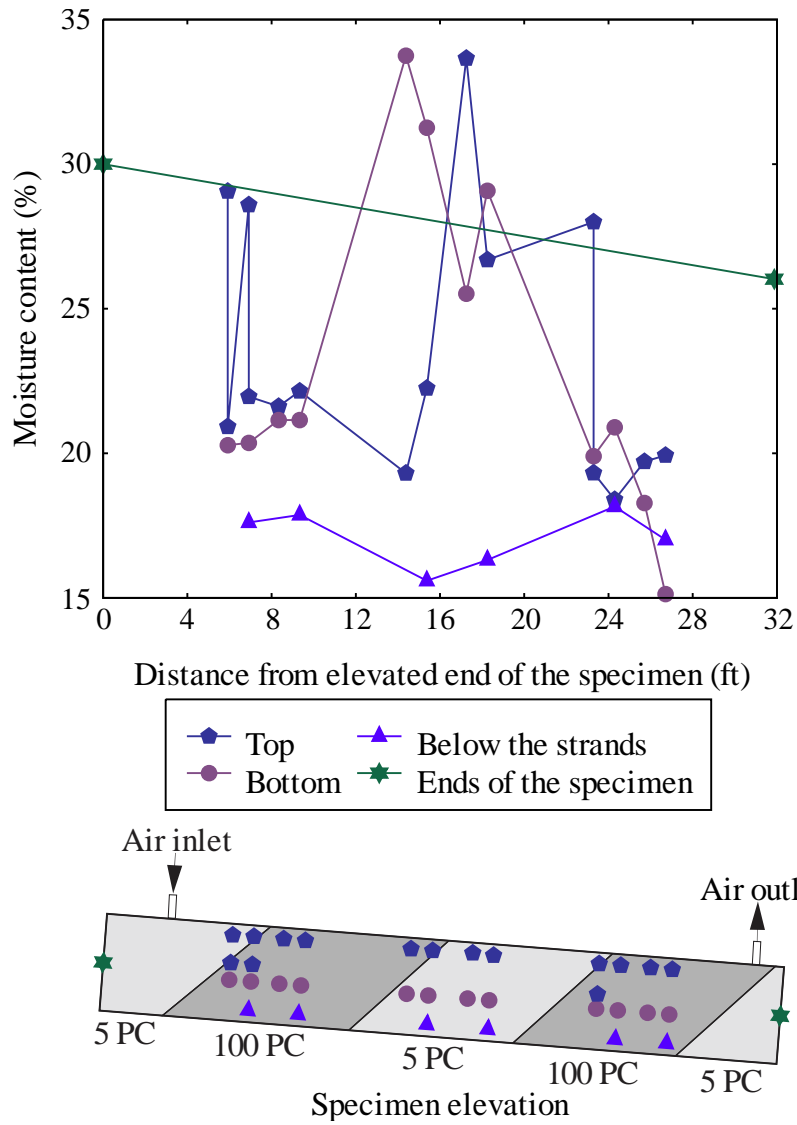
Figure. 8-25 Variation of moisture content along the length of control specimen TSG

Figure 8-25 shows the variation of grout moisture content along the length of the TSG. In general, normal grout had less moisture content than soft grout in the control specimen because of the higher cement content. Conversely, Figure 8-26 shows that normal grout had more moisture content than soft grout in dried specimen TSG due to binding ability of the portland cement in the normal grout. Along the length of the dried specimen, normal grout at the elevated end had higher moisture content than normal grout at lower end. This was attributed to normal grout absorbing moisture released by soft grout present at the elevated end. Across the cross-section in control specimen TSG, moisture content was higher for grout at the top level than for grout at the bottom level and below the strands, which was due to bleeding and segregation. Conversely, dried specimen TSG contained a bleed channel at the top of the section, which allowed dry air to pass easily through the specimen. This resulted in slightly lower moisture content in the grout at the top of the section compared to that at the bottom. But moisture content variation across the cross-section was generally the result of one type of grout filling the space above the layer of a previously placed grout of another type. For example, for the control specimen at a distance of 12 ft to 16 ft (Figure 8-25), moisture content for grout was less at the top than at the bottom because normal grout flowed into the space above the soft grout. Similarly, in Figure 8-26, between 12 ft to 16 ft, normal grout flowed into the space above the soft grout resulting in higher moisture content at the top than the bottom.

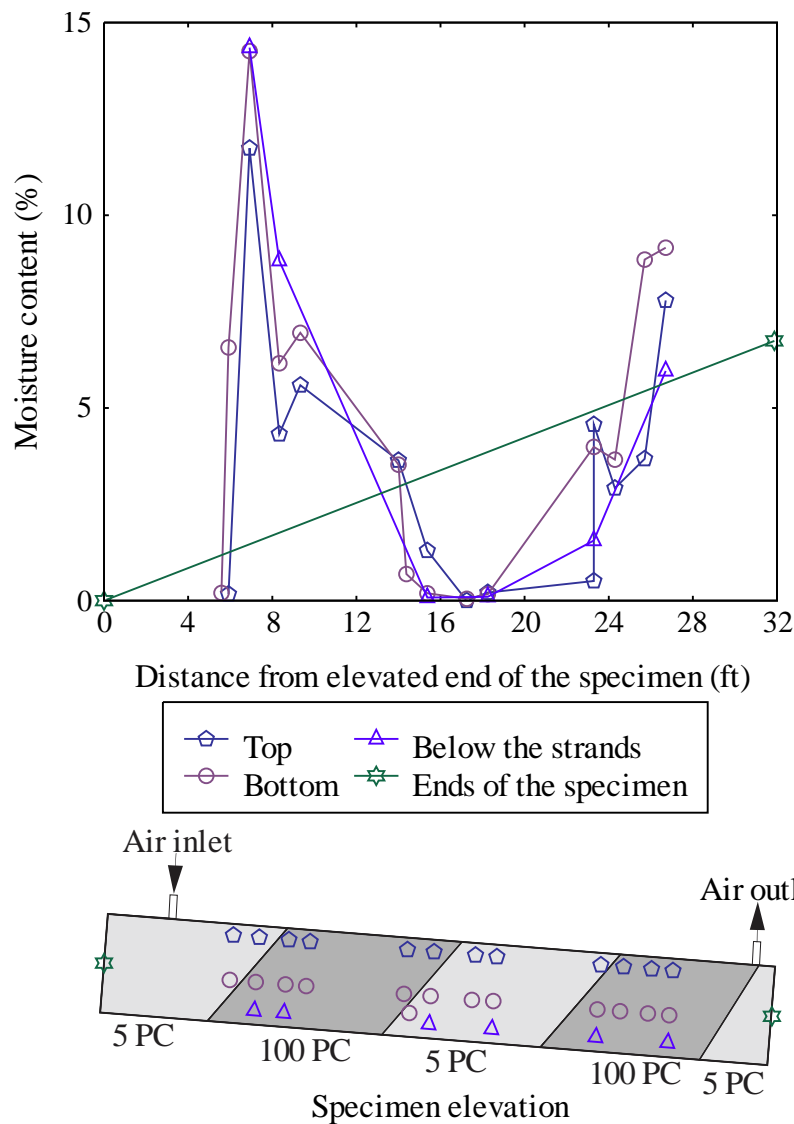
Figure 8-26. Variation of moisture content along the length of dried specimen ISG

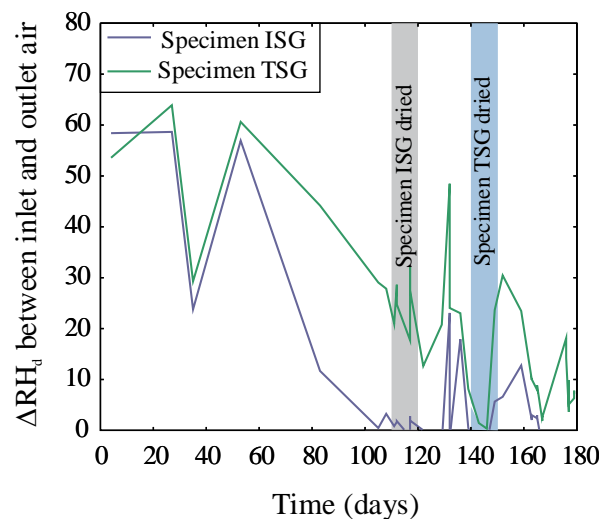
Figure 8-27. ΔRH_d vs. time

Based on criterion of $\Delta RH_d \approx 0\%$, ISG specimen was considered dried in approximately 110 to 120 days (grey shaded area in Figure 8-27). During this period, ΔRH_d was within a range of 0% to 5%. Similarly, TSG specimen was considered dried in approximately 140 to 150 days (blue shaded area in Figure 8-27), and ΔRH_d was within a range of 0% to 20%. For both specimens, ΔRH_d increased over the period between 130 to 160 days. This is thought to be due to equipment malfunctioning and drying system shut down, which allowed dried grout to absorb moisture through leaks in the specimens.

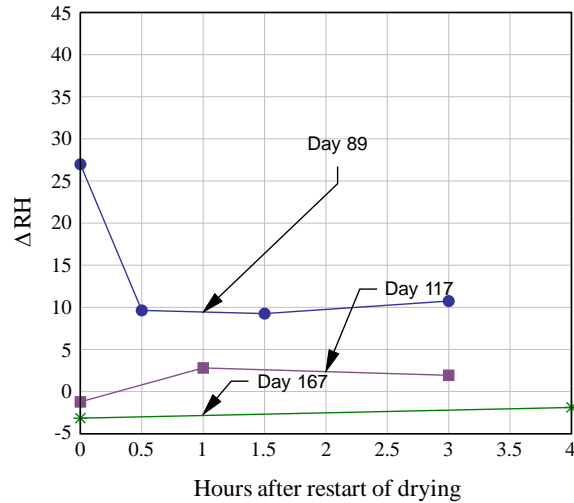
Figure 8-28. Dryness checks for dried specimen ISG

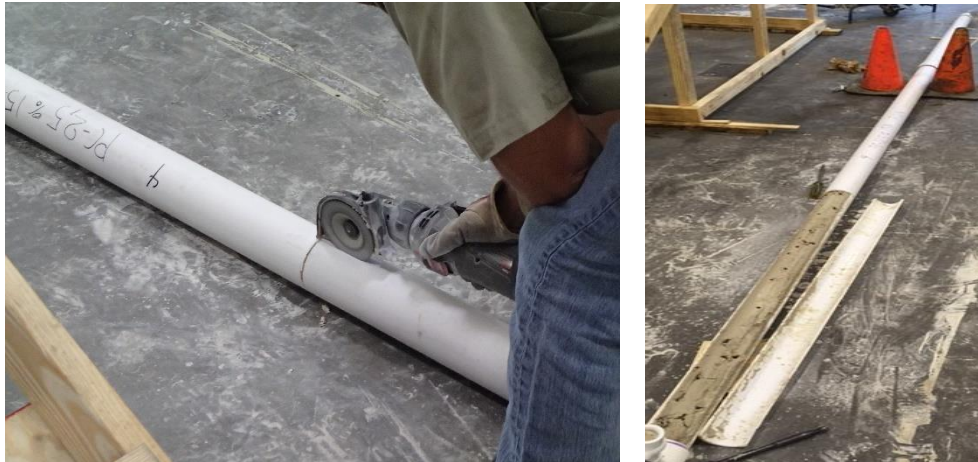
Figure A.3-8. Partial removal of PVC for inspection

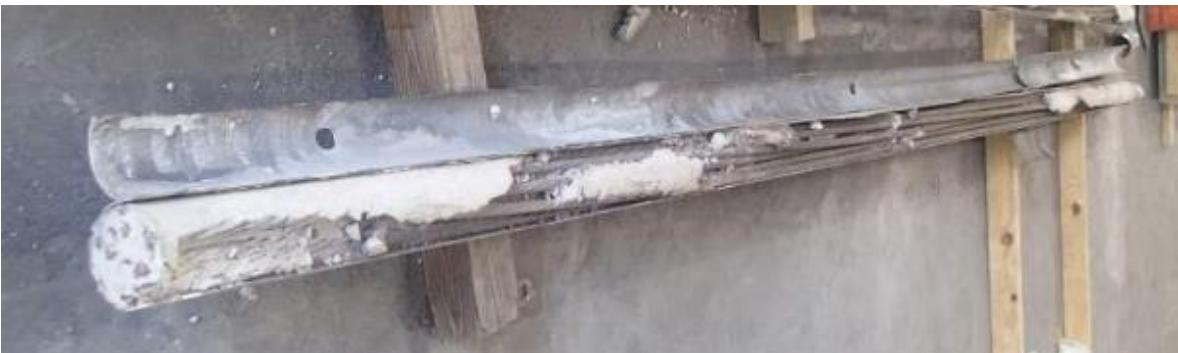
Figure A.3-17. Visual Inspection of 19S20PC-10 PC after grout removal
