FINAL PROJECT REPORT # 00042134-01-3A

Volume III: Performance of Fiber-Reinforced Self-Consolidating Concrete for Repair of Bridge Sub-Structures and Fiber Reinforced Super Workable Concrete for Infrastructure Construction

Participating Consortium Member:
Rutgers, The State University of New Jersey

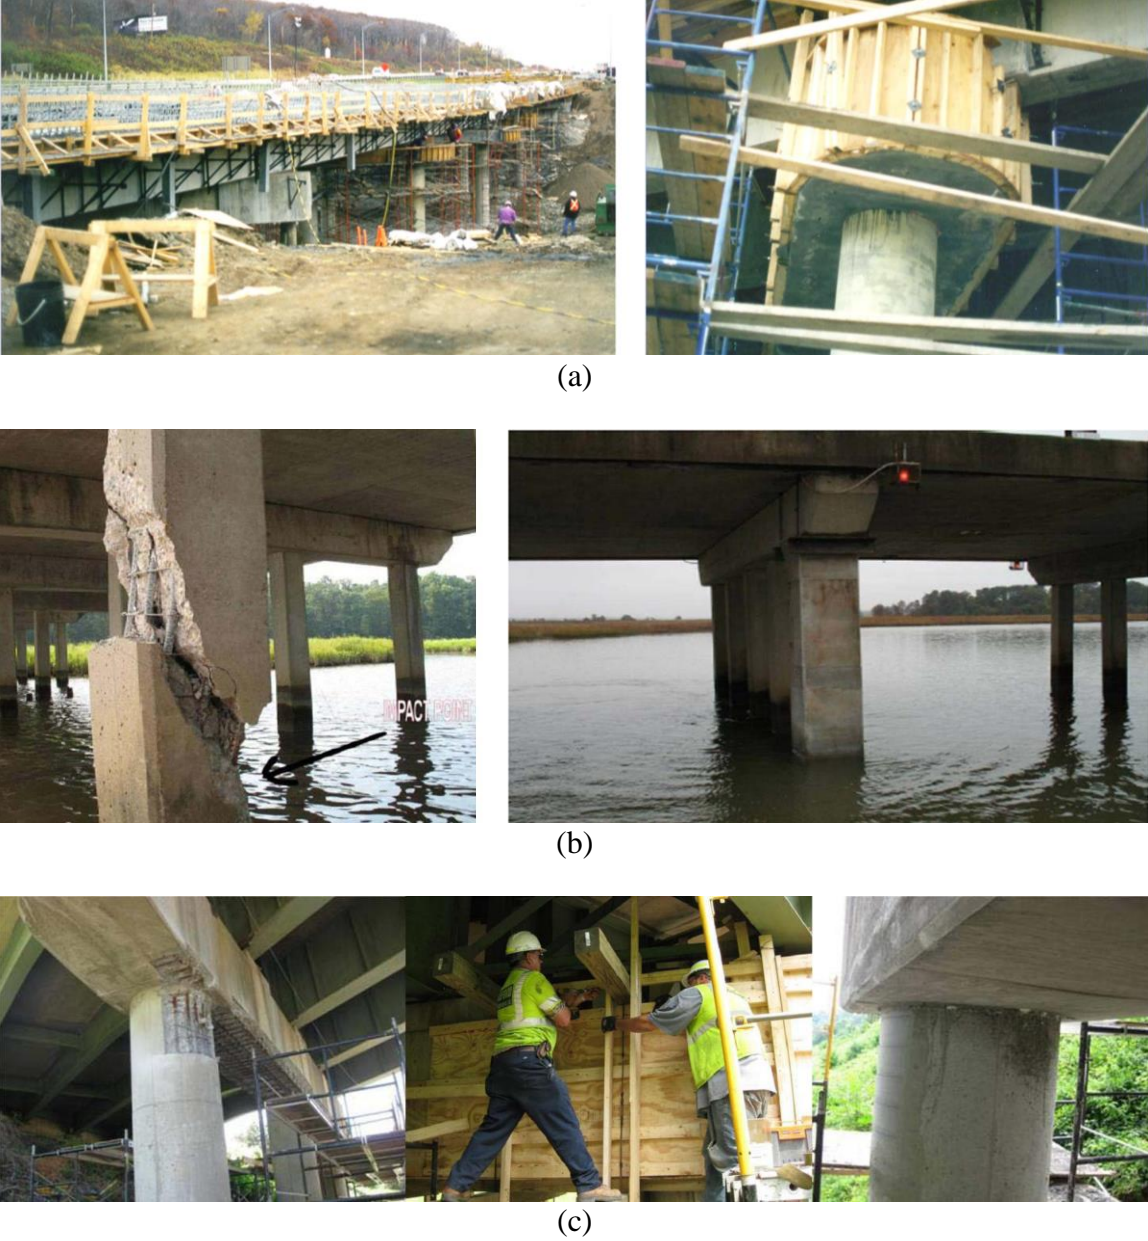
Figure 1 – Application of SCC for Repair; (a) Bridge Pier Caps and Columns in Quebec [Khayat et al, 2010], (b) Pile Damaged by a Barge in Virginia [Ozyildirim, 2013], and (c) Damaged Column and Pier Cap in Virginia [Ozyildirim, 2013].

The Quebec Department of Transportation’s primary performance specifications for SCC in 1997 have been used in many repair projects. The enhanced performances of SCC have caught the attention of several other construction companies and transportation firms in both Canada and the United States. Figure 1 show examples of such repair efforts using SCC [Khayat et al. 2010, Ozyildirim, 2013].

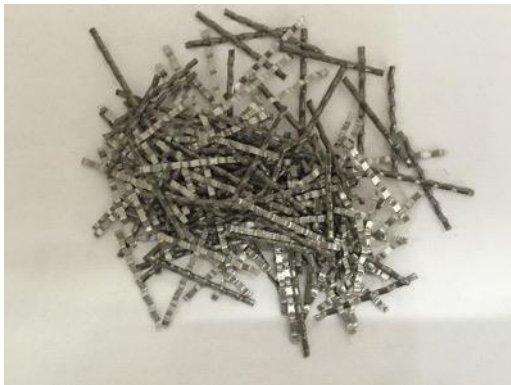
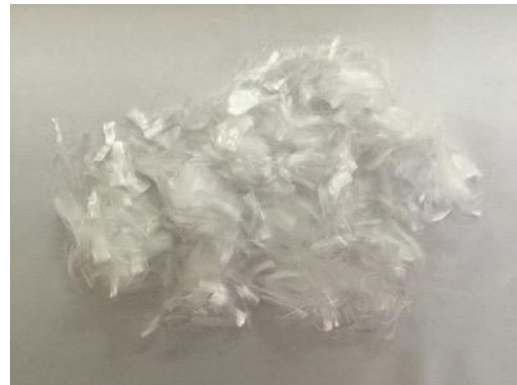
Figure 3 – Two Types of Fiber

(a) Steel Fiber (STF)

(b) Polypropylene Fiber (PPF)

The steel fiber (STF) is a crimped macro fiber with a length of 1.5 in. known commercially as PSI Crimped Steel Fiber. The aspect ratio of STF is 34 and the tensile strength is between 140-180 ksi. The polypropylene fiber (PPF) is a micro fiber with a length of 1/4 in. known commercially as PSI Fiberstrand 100. The specific gravity of PPF is 0.91 and the denier is 15. Detailed technical specifications can be found on the supplier's webpage at <http://www.euclidchemical.com>. Figure 3 shows both types of fibers used in this study.

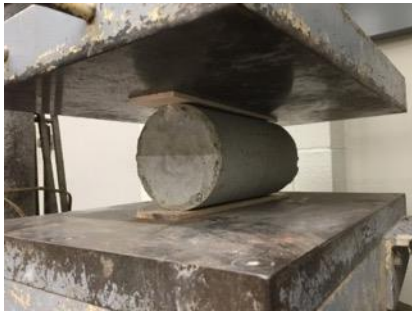
Figure 6 – (a) Tensile Strength and (b) Flexural Strength Test

The splitting tensile strength test was performed in accordance with ASTM C 496. 4 × 8-in cylinders were tested on a standard compression machine at a rate of 100 lbs. per second. Figure 6(a) shows the test setup with one plywood strip placed on the top, and one on the bottom of the curved cylinder side to distribute the load evenly. The average strength of three cylinders was taken at each testing age.

This test was carried out on 4 × 4 × 16-in. specimens in accordance with ASTM C78 using an MTS flexural strength testing machine. Figure 6(b) shows the test setup. The theoretical maximum tensile stress reached in the bottom fiber of the test beam is known as the modulus of rupture.

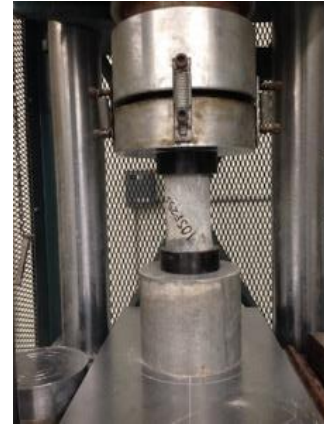
(a) Dimension

(b) Bond Strength Test

The bond strength of the different repair materials was determined in accordance with ASTM C882 as shown in Figure 8(b). The repair material was bonded to the substrate concrete specimen on a slanted elliptical plane inclined at 30° from the vertical to form a 3 in. x 6 in. composite cylinder in Figure 8(a). A full 3 in. x 6 in. cylinder was casted and cured for 28 days, then cut using a concrete saw. The slanted surface of substrate concrete was cleaned and dried, and then FR-SCC was cast in the remaining portion of cylinder. The bond strength test was performed after 28 days of wet-curing as explained previously. The compressive load required to fail the composite cylinder was determined and the bond strength was calculated as the maximum applied load divided by the area of slanted surface.

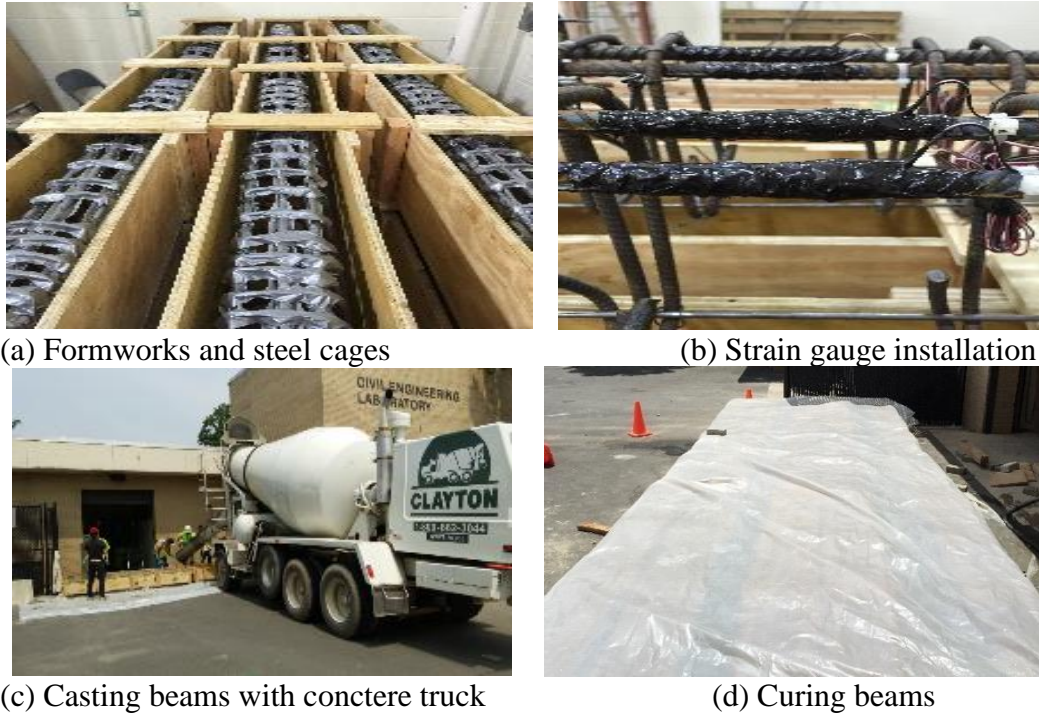
Figure 9 – Substrate Preparation

(a) Formworks and steel cages

(b) Strain gauge installation

(d) Curing beams

Ten wooden formworks and steel cages were prepared (Figure 9(a)). The formworks were 8-in wide, 12-in high and 12-ft long, and made using 3/4-in thick plywood. The formworks were coated with 3 layers of polyurethane as a repellent against the water from fresh concrete. The steel cages were constructed with #2 rebar for top reinforcement, #3 for stirrups, and either #3, #4 or #5 for bottom reinforcement. Figure 10 depicts the cross-sectional dimension of 10 beams. Different bottom reinforcements were used in order to simulate the damaged rebar by corrosion by 35% (#4) and 65% (#3) compared to #5 rebar.

A number of strain gauges were installed as per manufacturer procedure on the steel reinforcement to monitor the stain development during the flexural testing (Figure 9(b)). When the substrate was prepared with Class A, duct tape was applied on the bottom reinforcements (top reinforcement while casting, since the formworks were placed reversely) and shear stirrups to keep the reinforcements clean for the repair process.

The two control beams and 8 substrate beams were cast using Class A concrete mix provided by a local concrete supplier as shown in Figure 9(c). External vibrators were used to consolidate the concrete followed by spaying a retarding admixture on the concrete surface to delay the final setting of the substrate. The beams were covered with a plastic sheet until the next day (see Figure 9(d)) and the surface debris and duct tapes were removed and cleaned. The beams were wet-cured for 7 days and then air-cured until the day of repair.

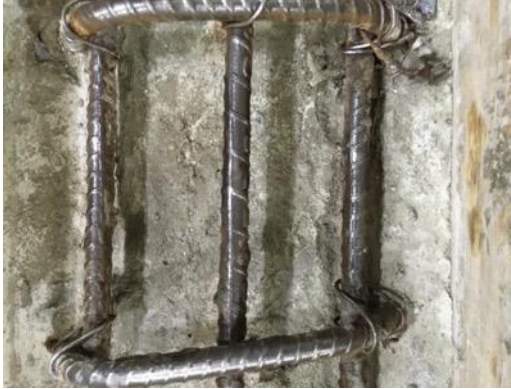
Figure 11 – Repairing Preparation

(a) Cleaned reinforcement before repair

(b) Painting beams for flexural testing

The exposed reinforcements were cleaned from any rust and debris before repairing beams as illustrated in Figure 11(a). The substrate surface was also cleaned from any debris and wet to obtain a saturated surface. Each FR-SCC batch described in Phase 1 was prepared to repair the beam, and then the beam was covered with a wet-burlap and plastic sheet for 24 hours. On the next day, the beam was placed on a loading machine, and the surface was whitewashed divided into grids as shown in Figure 11(b). The testing instrumentation was prepared and the beam was tested at an age of 3 days after the beam repair was completed.

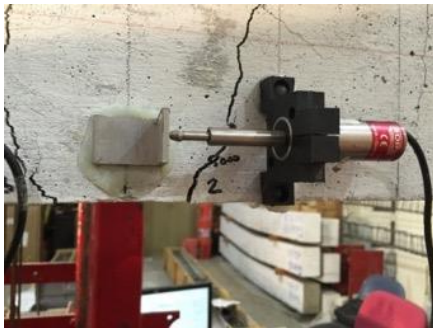
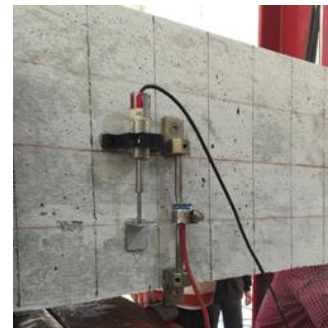
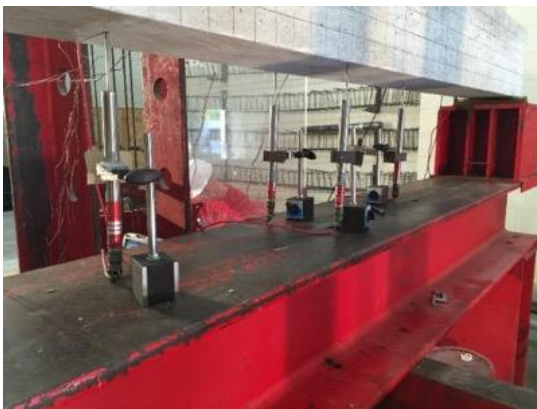
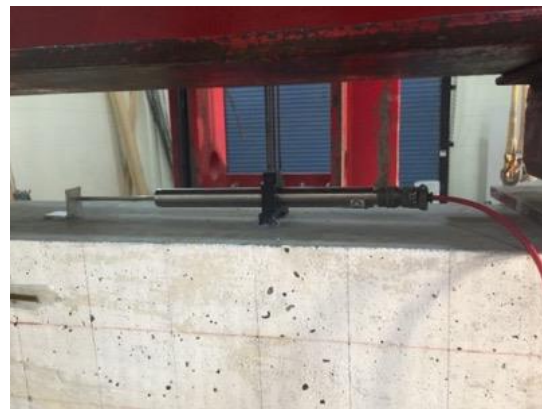
Figure 13 – Sensor Instrumentation Setup

(a) LVDT (L2)

(b) FSG (C1 and C2)

(c) LVDT and VWSG (LV)

(d) LVDT (L3 and L4)

(e) LVDT (L1)

Figure 13 shows the LVDT, FSG and VWSG installed on the beam. Figure 13(a) shows the L2 location with one LVDT, Figure 13(b) shows two FSGs at C1 and C2 locations that were attached on the concrete surface, and Figure 13(c) shows the LV locations with one LVDT and one VWSG at the interface between two materials. Figure 13(d) shows the LVDTs at L3 and L4 locations, and Figure 13(e) shows the LVDT installed on the top of the beam.

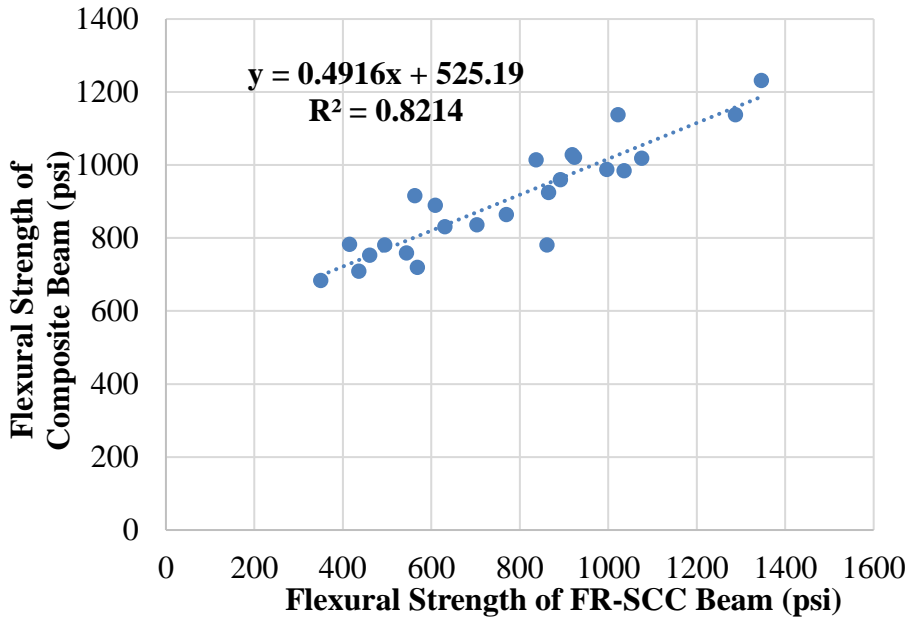
Figure 17 – Flexural Strength Correlation between FR-SCC and Composite

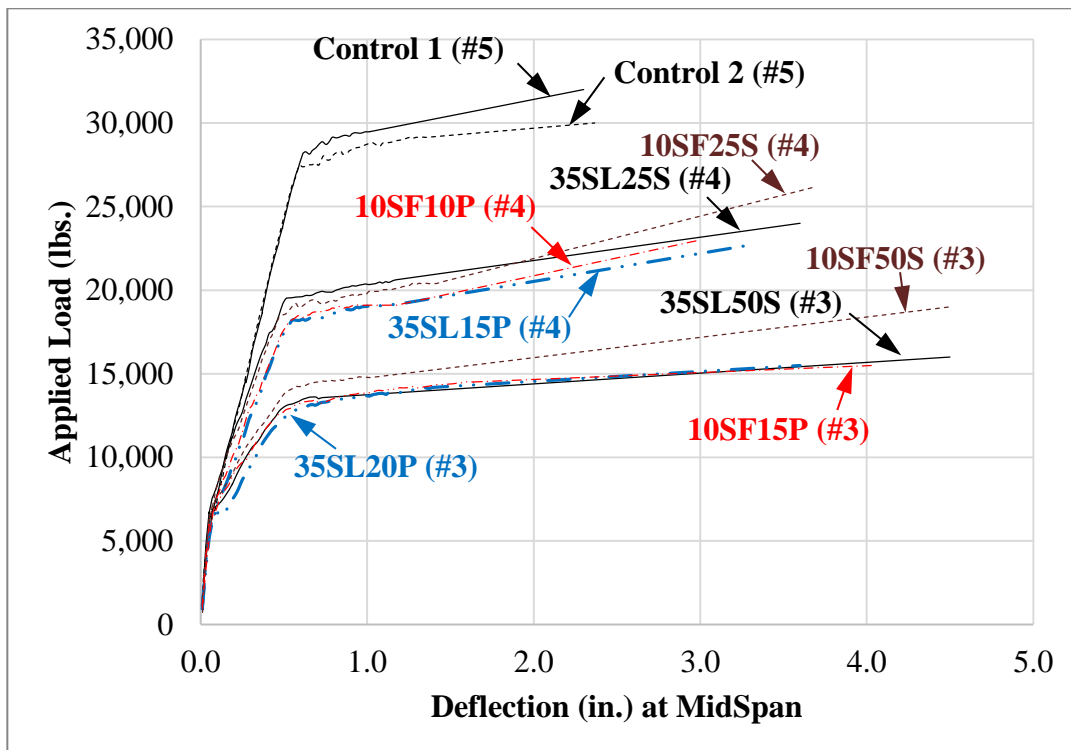
Figure 19 – Deflection at Midspan for Control Beams and FR-SCC Repaired Beams (see Sensor Location of L3 in Figure 12)

The load and deflection curves are plotted in Figure 19. A tri-linear load-deflection relationship was observed for both control beams and FR-SCC repaired beams. The first linear part of the curve represents the uncracked section which depends on the moment of inertia of each beam section. The moment of inertia is a property of the concrete cross-section, and therefore both beams (control and FR-SCC repair) show similar behavior. The second part is the post-cracking of the concrete up to steel yielding. A reduction in the beam stiffness was observed because the moment of inertia was reduced by cracking. The last part of the load-deflection curve represents the start of yielding of steel up to failure. The yielding of the steel reinforcement resulted in a dramatic degradation in the stiffness of the beam.

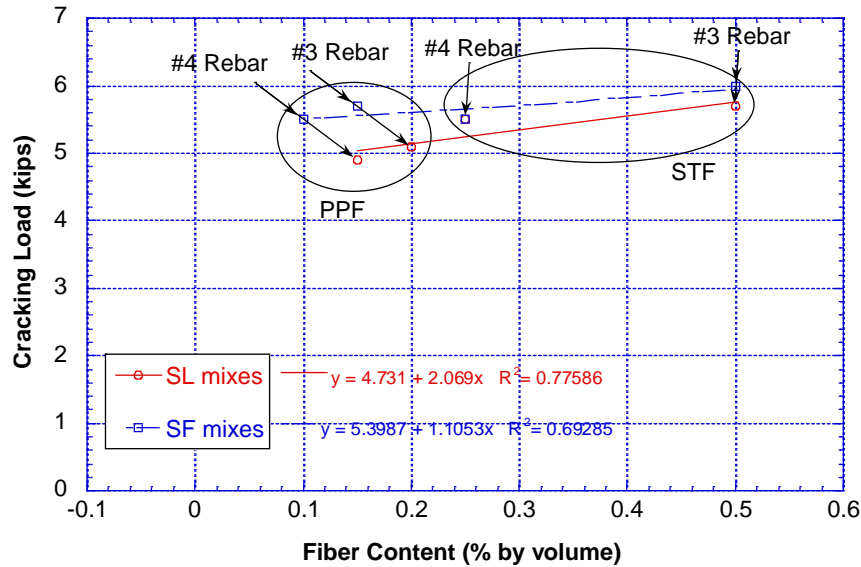
Figure 21 – Effect of Fiber Content on Cracking Load

Figure 21 depicts how the fiber content affects the cracking load. It shows that the rebar size has no effect on the cracking load. When different fiber contents are compared, higher fiber volume provides better cracking resistance to the beams. However, it is not clear whether the fiber type

has any effect on the cracking load. This is because the initial cracking is dominant by the concrete strength and capacity (which is also affected by the fiber content), but not by the rebar capacity. Figure 22 represents the effect of rebar size on ultimate load. It is clear that the fiber content does not affect the ultimate capacity of the beam, but the rebar size has a remarkable effect on the ultimate load.

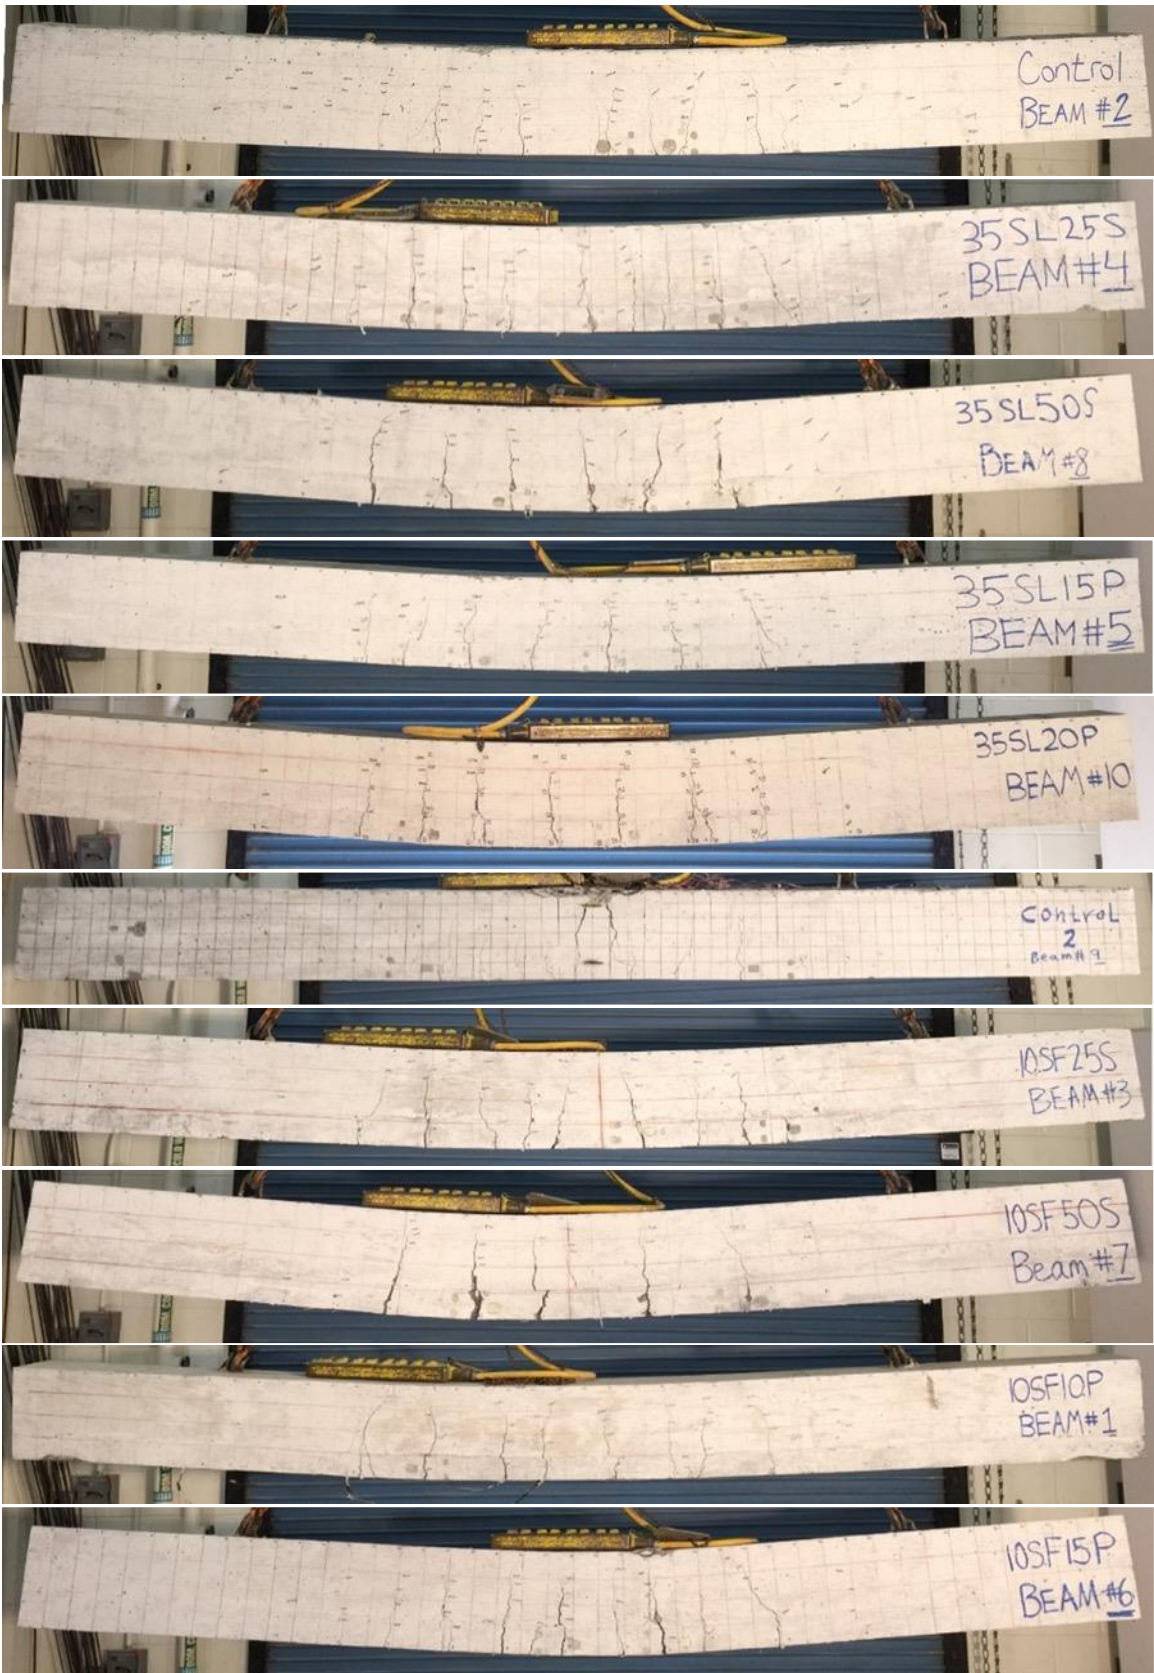
Figure 24 – Mode of Failure (Specimen name is written on the beam)

Mode of failure of all beam specimens and their crack patterns are represented in Figure 24 and Figure 25, respectively.
