FINAL PROJECT REPORT # 00042134-05-3A

Volume IV: Performance of Fiber-Reinforced Self-Consolidating Concrete for Repair of Bridge Sub-Structures and Fiber Reinforced Super Workable Concrete for Infrastructure Construction

Participating Consortium Member:
University of Oklahoma, Norman, Oklahoma

RE-CAST:
REsearch on Concrete Applications for
Sustainable Transportation
Tier 1 University Transportation Center

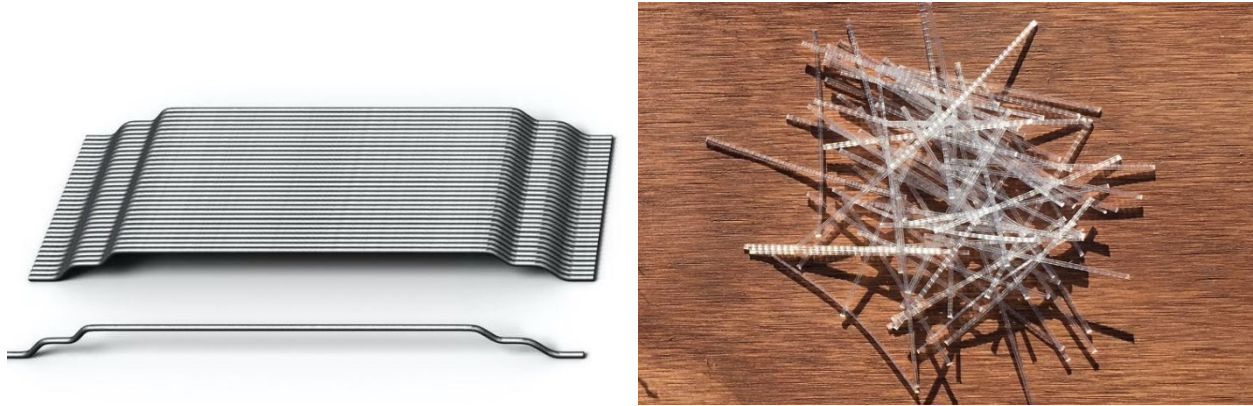
Figure 2.3: Steel (l) and Synthetic (r) Macro-Fibers

The concrete mixtures developed in this study used both steel and synthetic macro-fibers. The two fibers were chosen due to their similar physical dimensions yet recognizing that steel fibers are considerably stronger than synthetic fibers. The steel fibers were a high ductility, very high tensile strength, hooked wire fiber manufactured by Bekaert, marketed under the trade name Dramix[®] 5D. These fibers were engineered for use as supplemental flexural and shear reinforcement as well as to control shrinkage and temperature cracking. The synthetic fibers were a high-tensile strength, high modulus of elasticity, embossed fiber manufactured from a blend of polypropylene resins by BASF, marketed under the trade name MasterFiber MAC Matrix[®]. These fibers were engineered for use as secondary reinforcement to control shrinkage and temperature cracking as well as settlement cracking. Material properties and the recommended dosages of the fibers are provided in Table 2.6. A photograph of the steel and synthetic fibers is shown in Figure 2.3.

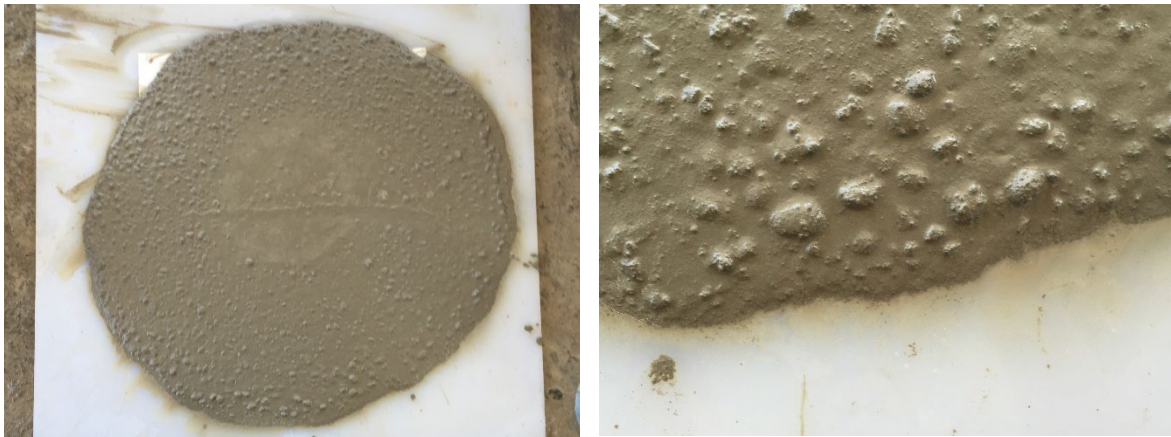
**Figure 3.1: Initial SCC Mix Design Slump Flow Behavior, Overall Spread (l) and Edge View (r)**

After several trial batches, the team arrived at the initial SCC mix design shown in Table 3.4. Table 3.5 contains the fresh and hardened material properties, and Figure 3.1 shows the slump flow behavior. In the course of developing the SCC mix design, the research team found that the Type K shrinkage-compensating cement (Komponent) reduced segregation compared to trial mixes without the expansive agent. In many ways, the Komponent acted as a viscosity modifying admixture. However, the Komponent also reduced setting time and lead to a noticeable loss in slump flow over time, which is typical of a Type K expansive agent and was also found by the Missouri S&T research team. The slump flow decreased from 30.0 inches to 21 inches after only 10 minutes.

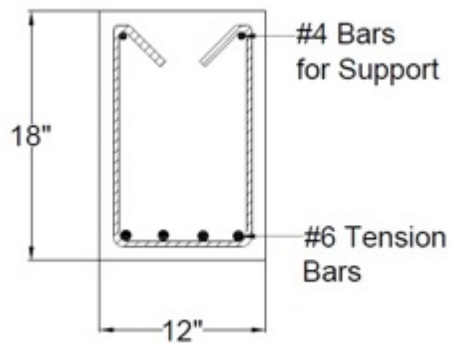
Figure 5.1: Full-Scale Control Beam Specimen Cross-Section

The design and fabrication of the control beam specimens was based on previous research on FR-SCC flexural repairs by Kassimi, et al. (2014). The beams used in this current study were 14 feet long with a cross-section of 12 inches by 18 inches. The longitudinal reinforcement consisted of four #6, ASTM A615, Grade 60, steel reinforcing bars. Transverse reinforcement against shear failure consisted of #3, ASTM A615, Grade 60, U-shaped stirrups. To ensure that a shear failure would not occur prior to a flexural failure, a stirrup spacing slightly less than the ACI 314-14 (2014) maximum stirrup spacing of one half of the effective depth was used throughout the span length. Two #4, ASTM A615, Grade 60, steel reinforcing bars were used along the top of the beams to anchor the stirrups and stabilize the reinforcing cages. Figures 5.1 and 5.2 detail the cross-sectional and elevation views of the control beam specimens, respectively.

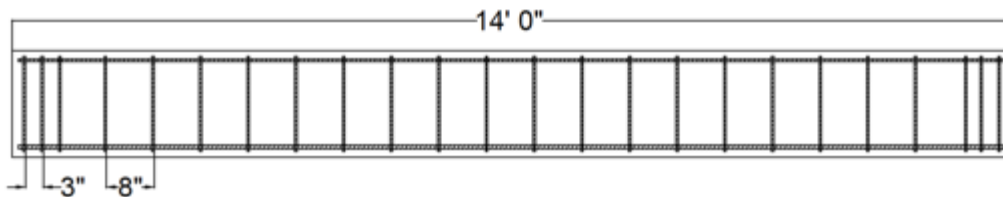
Figure 5.2: Full-Scale Control Beam Specimen Elevation

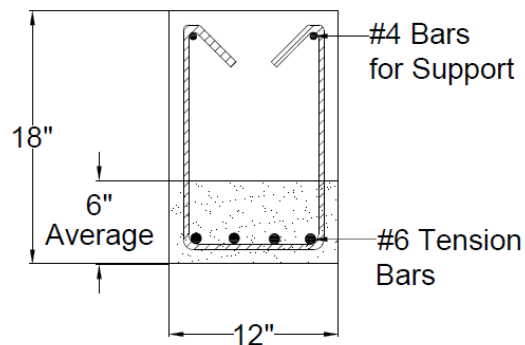
Figure 5.5: Full-Scale FR-SCC Repaired Beam Specimen Cross-Section

The design and fabrication of the FR-SCC repaired beam specimens was based on previous research on FR-SCC flexural repairs by Kassimi, et al. (2014). The beam specimens were identical to the control specimens except that the concrete was cast in two separate placements, with a repair zone along the bottom of the beams with an average depth of 6 inches. This depth was chosen to represent the effective tension zone of the beam, which must often be repaired given advanced corrosion of the bottom reinforcing steel within an actual structure. The depth was slightly sloped from 7 inches at one end of the beam to 5 inches at the other end to assist with the flow of the FR-SCC, which was placed from the end of the member with the 7-inch-thick void depth. Figures 5.5 and 5.6 detail the cross-sectional and elevation views of the FR-SCC repaired beam specimens, respectively.

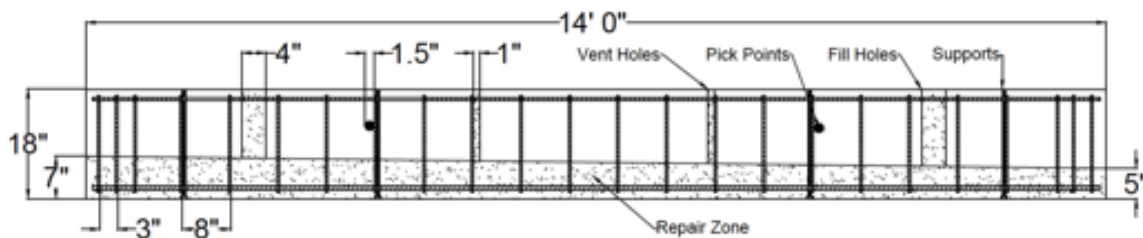
Figure 5.6: Full-Scale FR-SCC Repaired Beam Specimen Elevation

In order to simulate a true repair of the flexural zone, the control concrete was cast first and then flipped so that the repair concrete would be cast along the bottom. In order to accomplish this step, two vertical 4-inch-diameter holes were located near each end of the Class AA concrete, along with two 1-inch-diameter vent holes near the third points to help allow air to escape during the placement. In addition, two horizontal 1-1/2-inch-diameter holes were created as pick points to help maneuver the beams during fabrication. Details of the placement, vent, and access holes are shown in Figures 5.6 and 5.7.

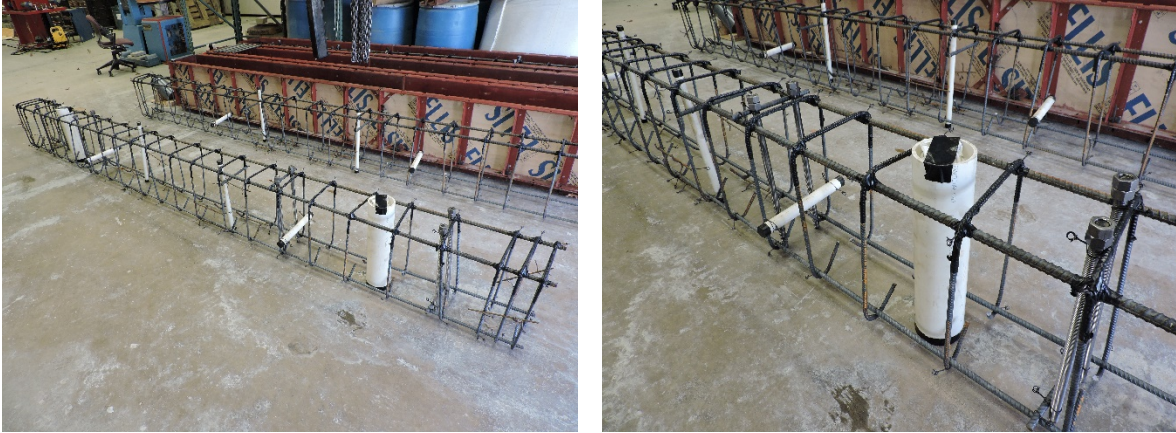
Figure 5.7: Reinforcing Cages with PVC Inserts for Access Ports, Vent Holes, and Pick Points

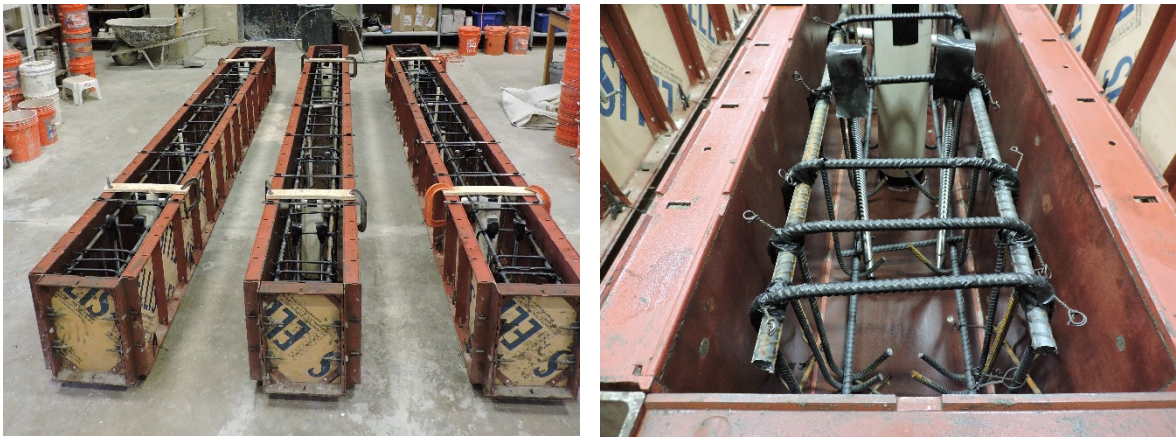
Figure 5.8: Upside Down Placement of Cages (l) and Protection of Exposed Portion of Stirrups (r)

Placement of the Class AA substrate portion for the FR-SCC repaired beam specimens involved first placing the reinforcing cages upside down within the formwork and securing the inserts, as shown in Figure 5.8(l). In addition, the portion of the stirrups within the subsequent repair zone were wrapped with black electrical tape in order to keep them clean and free from any contamination from the Class AA placement, as shown in Figure 5.6(r).

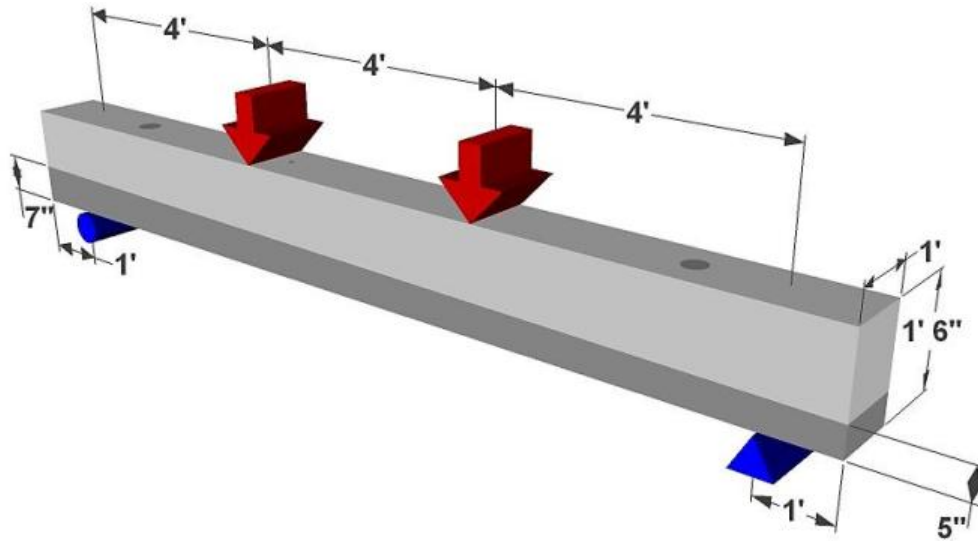
Figure 5.13: Schematic of Full-Scale Beam Specimen Test Setup

A schematic of the test setup is shown in Figure 5.13. This third point loading arrangement results in a constant moment region within the center third of the specimen. A photograph of a test specimen within the test fixture is shown in Figure 5.14. A 100-kip load cell was placed on top of the spreader beam to monitor the load being applied during the testing process. String pots were attached to metal angles adhered near midspan to monitor the beam's deflection. The load cell, two string pots, and two internal strain gages were connected to a data acquisition system to monitor the test during loading.

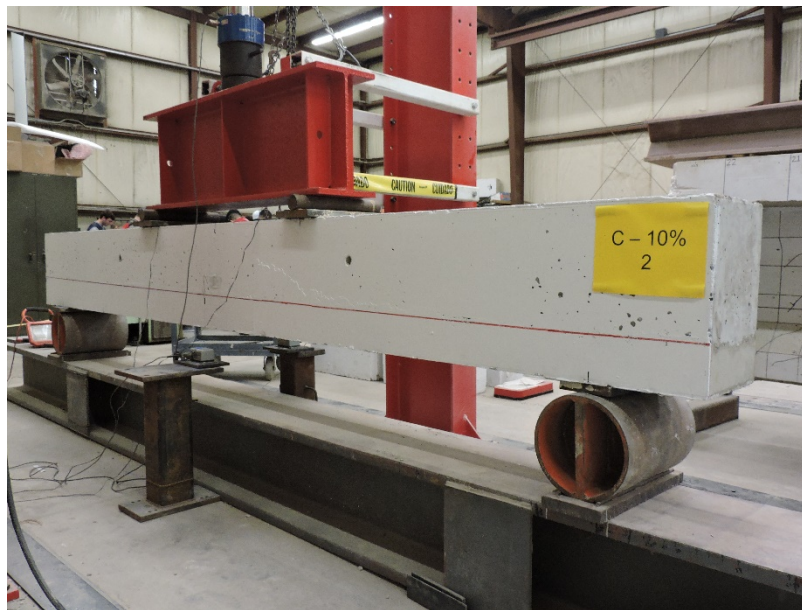
Figure 5.14: Photograph of Full-Scale Beam Specimen Test Setup

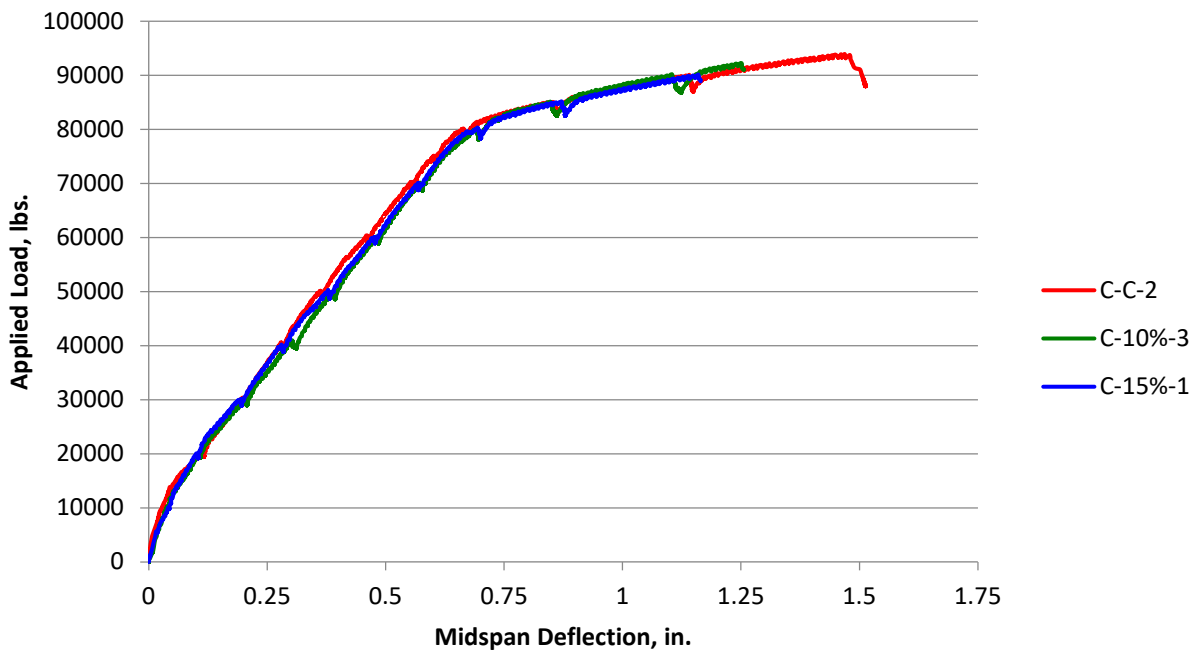
Figure 5.15: Full-Scale Beam Specimen Representative Load-Deflection Plots

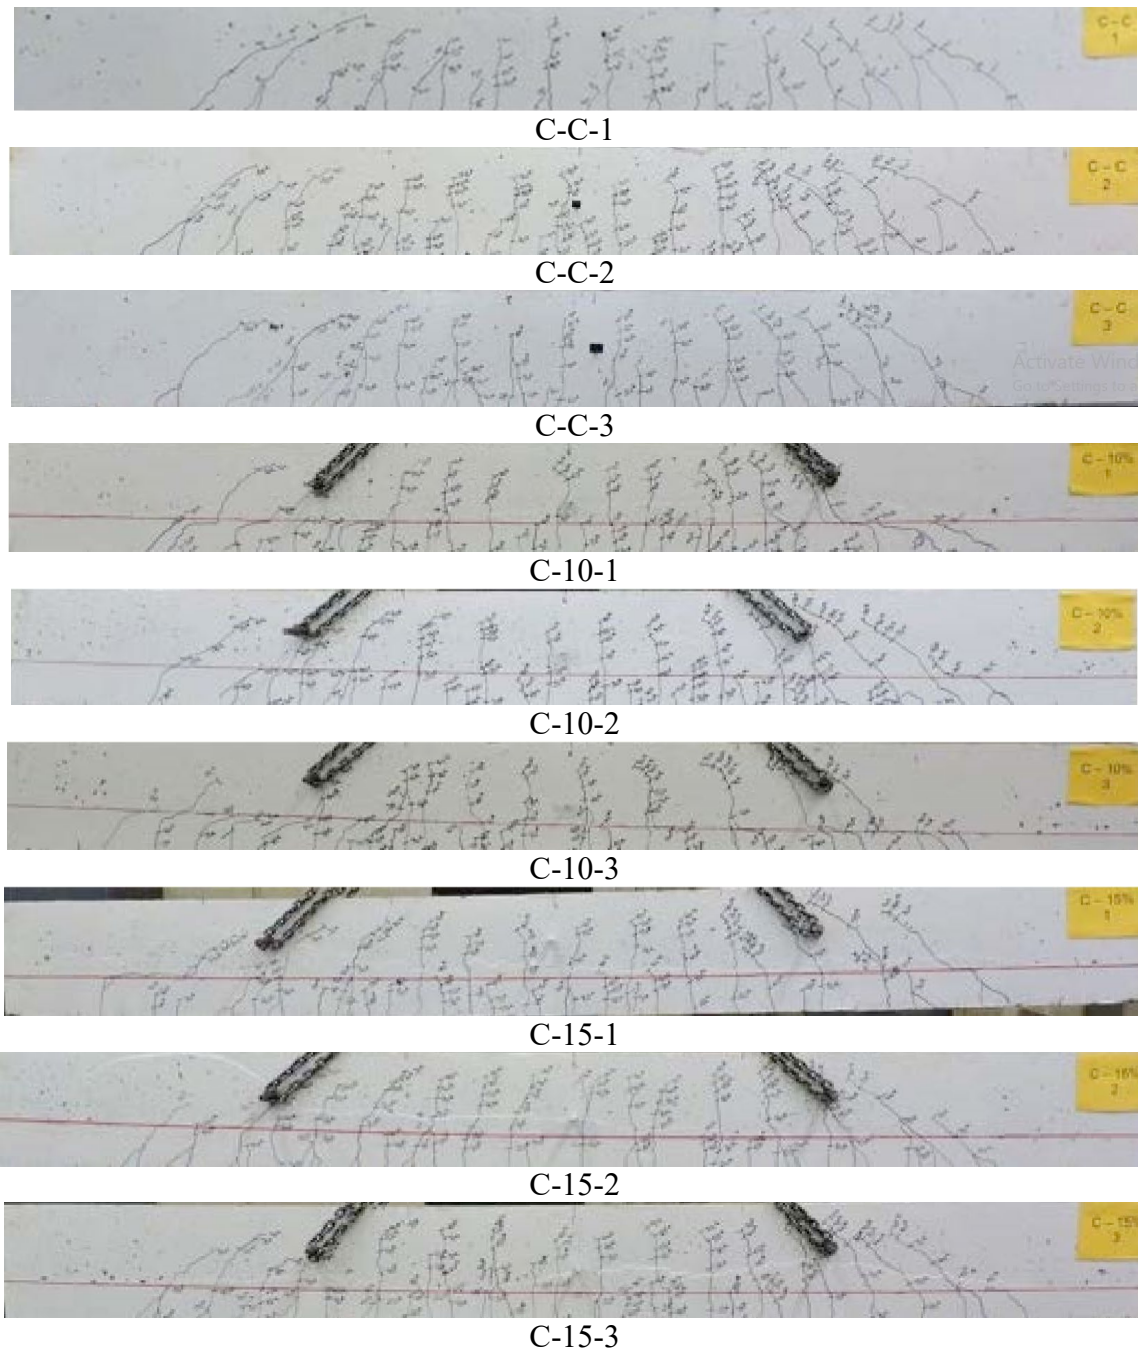
Figure 5.16: Specimen Crack Propagation During Flexural Testing

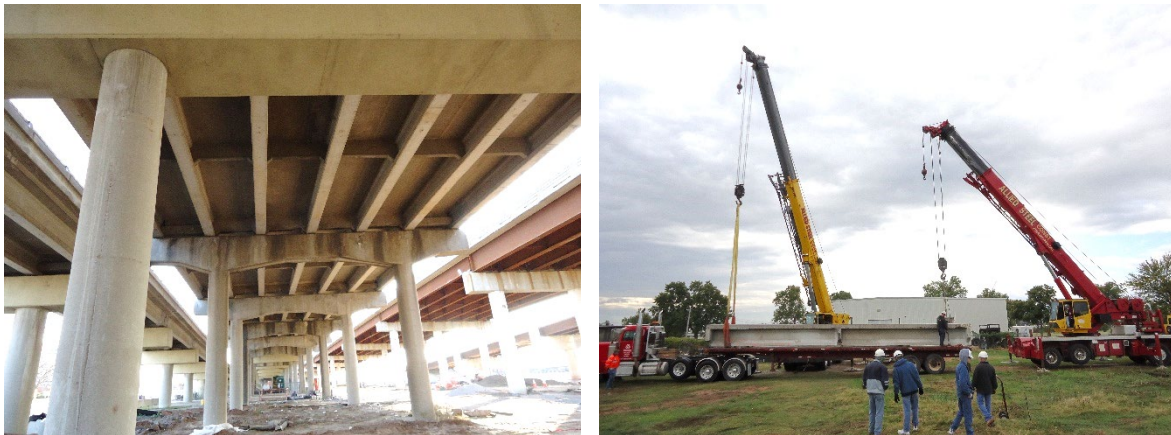
Figure 6.3: Control Girder Span Location on Bridge (l) and Delivery to Structures Lab (r)

FR-SCC repaired girder. Figure 6.3(l) is a photograph of the span from which the control girder was removed, and Figure 6.3(r) is a photograph of the girder during delivery to Fears Lab by the repair contractor.

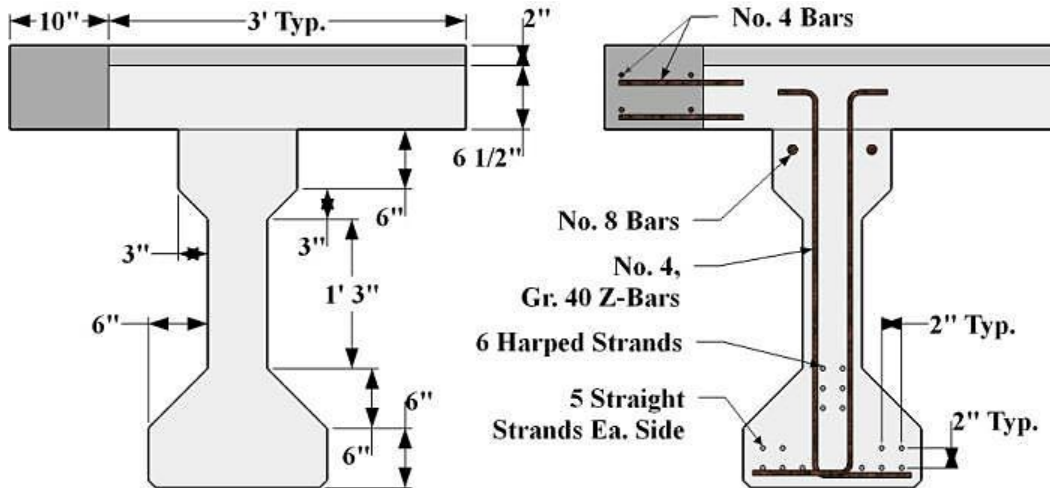
Figure 6.4: AASHTO Type II Girder Dimensions, Main Reinforcement, and Supplemental Deck

problem with prestressed concrete bridges due to leaking deck joints located at the supporting piers. The support and loading arrangements for the AASHTO girder tests are shown in Figures 6.5 and 6.6. Photographs of the test setup and instrumentation are shown in Figures 6.7 and 6.8, respectively.

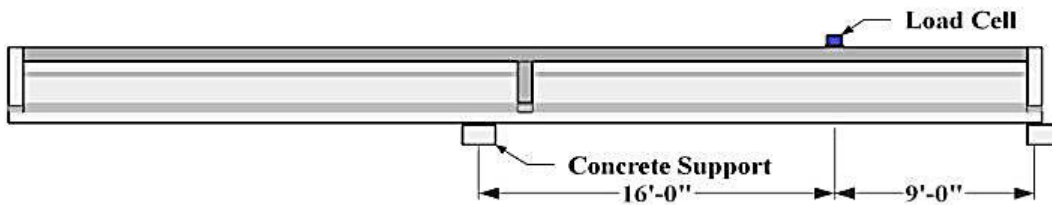
Figure 6.5: Test C1 Support Conditions (West Elevation)

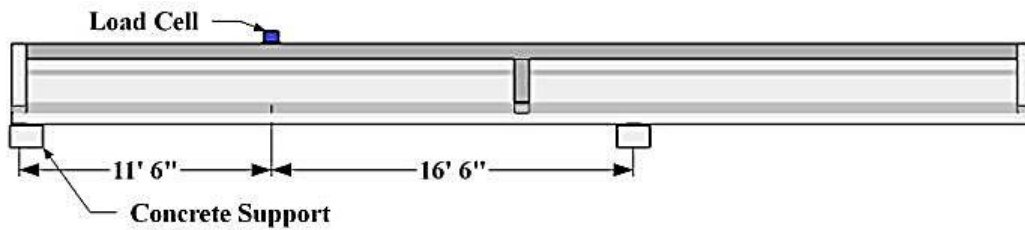
Figure 6.6: Test C2 Support Conditions (West Elevation)

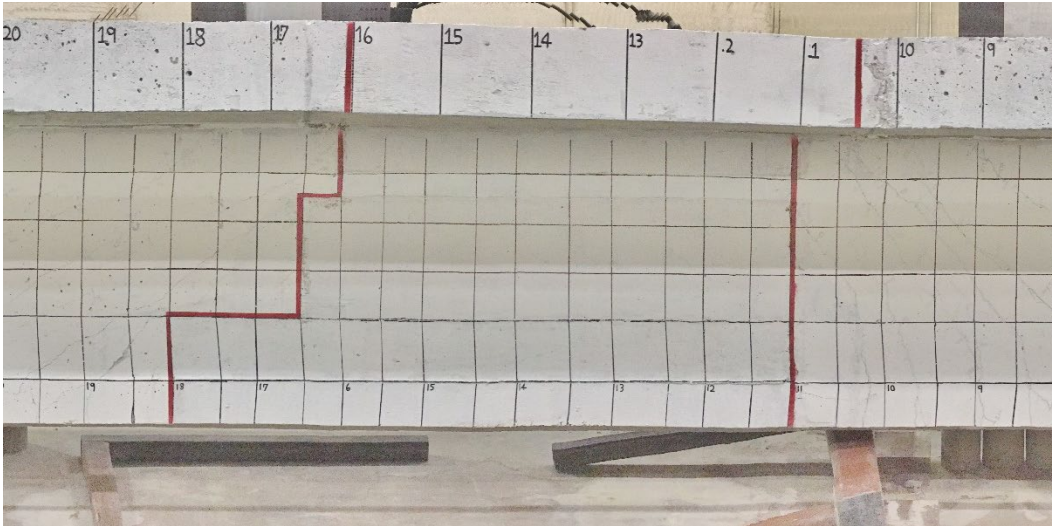
Figure 6.14: Photograph of Girder North End FR-SCC Repaired Region

As mentioned previously, the FR-SCC repaired AASHTO Type II girder had extensive deterioration near the ends of the span, primarily as a result of leaking deck joints above the pier supports. The support conditions for the AASHTO Type II repaired girder were identical to the control girder and are shown in Figures 6.11 and 6.12. The red outlined portions represent the FR-SCC repaired areas of the girder, which are shown in photographs for the two end regions in Figures 6.13 and 6.14.

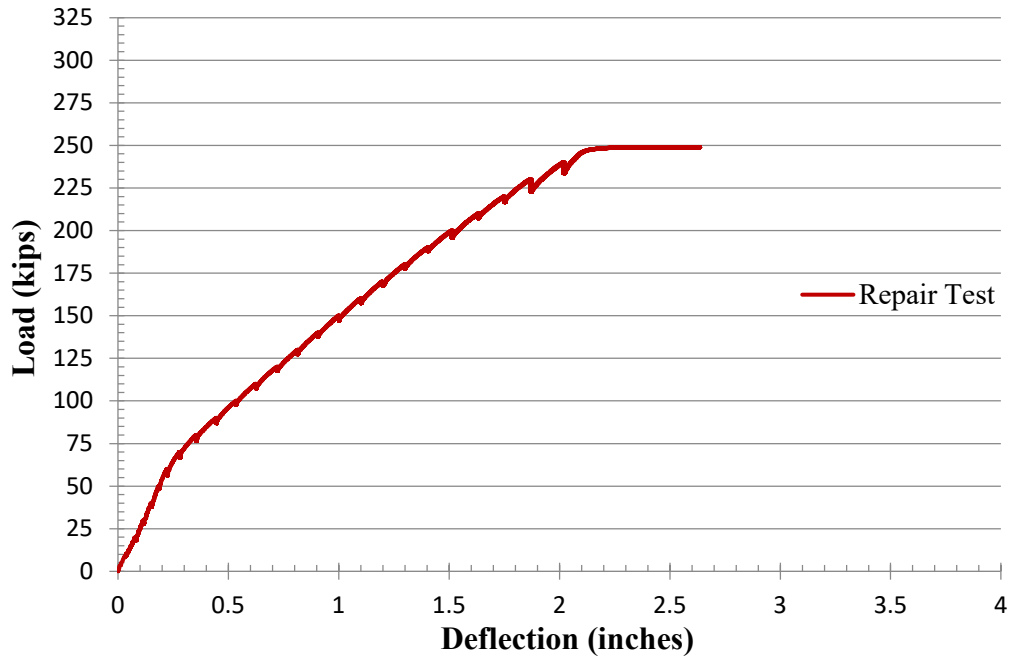
Figure 6.15: Repaired Girder C1 Support Condition Test (South End)

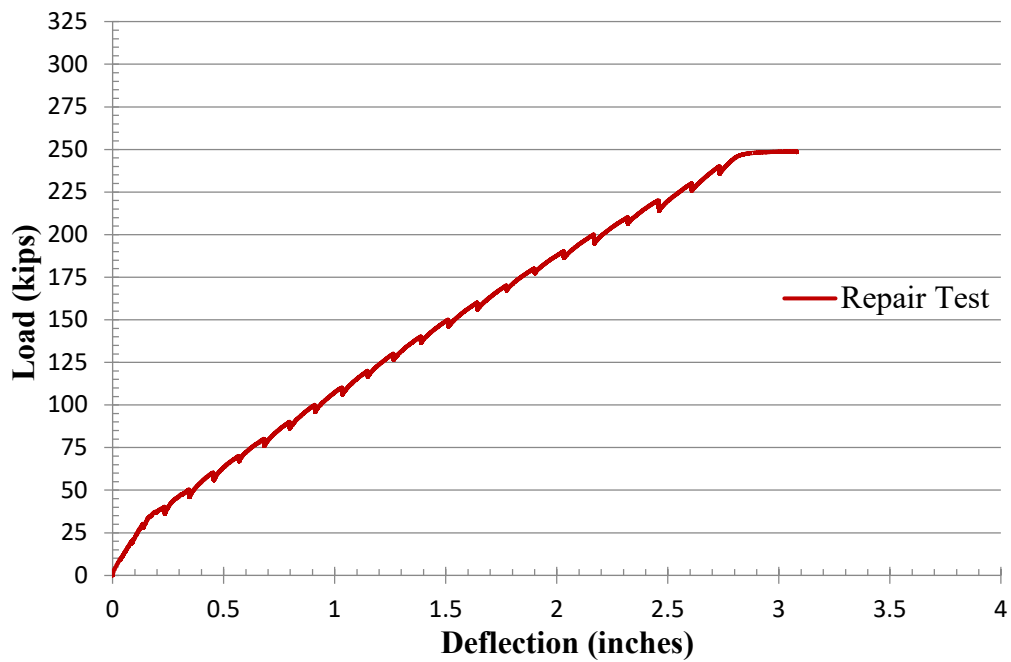
Figure 6.16: Repaired Girder C2 Support Condition Test (North End)

The failure mechanism for the C2 support condition was identified as bond-shear failure, which is characterized by shear cracks migrating downward toward the strand, followed by splitting along the strand and finally slippage of the strand. As shown in Figure 6.18, the repair underwent extensive shear cracking, and the shear cracks extended continuously from the original concrete through the FR-SCC repaired region, indicating that the repair performed very well and also bonded well and acted monolithically with the original concrete.

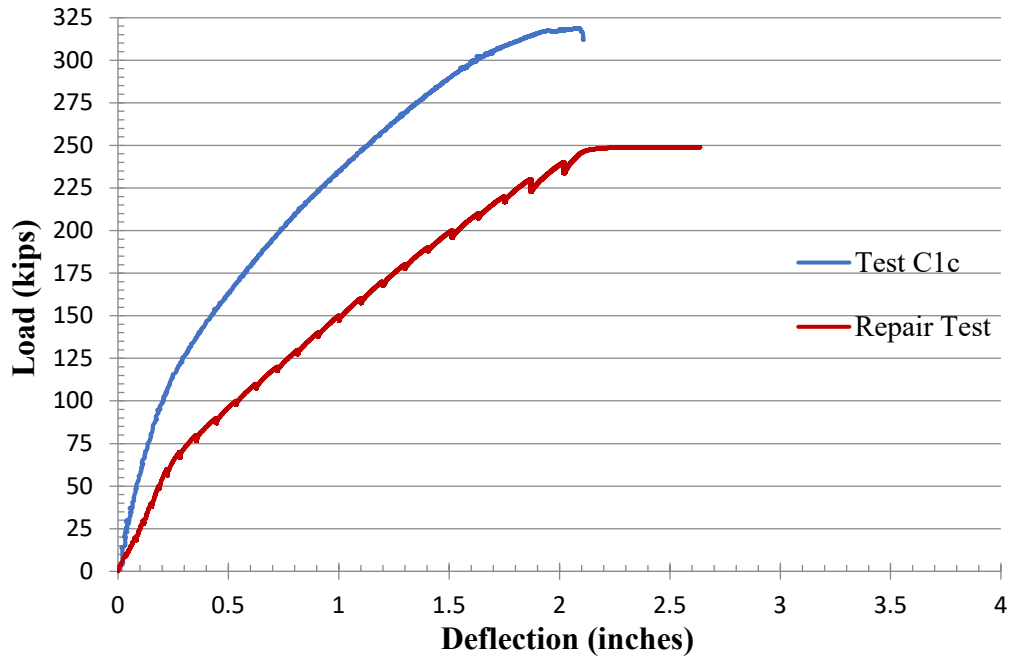
Figure 6.19: C1 Support Condition Test Comparison (South End)

Figures 6.19 and 6.20 compare the load-deflection curves for the AASHTO Type II control and repaired girders. In general, the control girders were stiffer and experienced higher failure loads, with the repaired girder reaching 78% of the control girder capacity for the C1 support condition test and 85% of the control girder capacity for the C2 support condition test. However, the repaired girder did restore the necessary design capacity for the bridge, which is noticeable given the severe deterioration and reduced operating and inventory ratings for the bridge. As a result, the FR-SCC repair material is a viable repair option for bridges suffering severe deterioration.

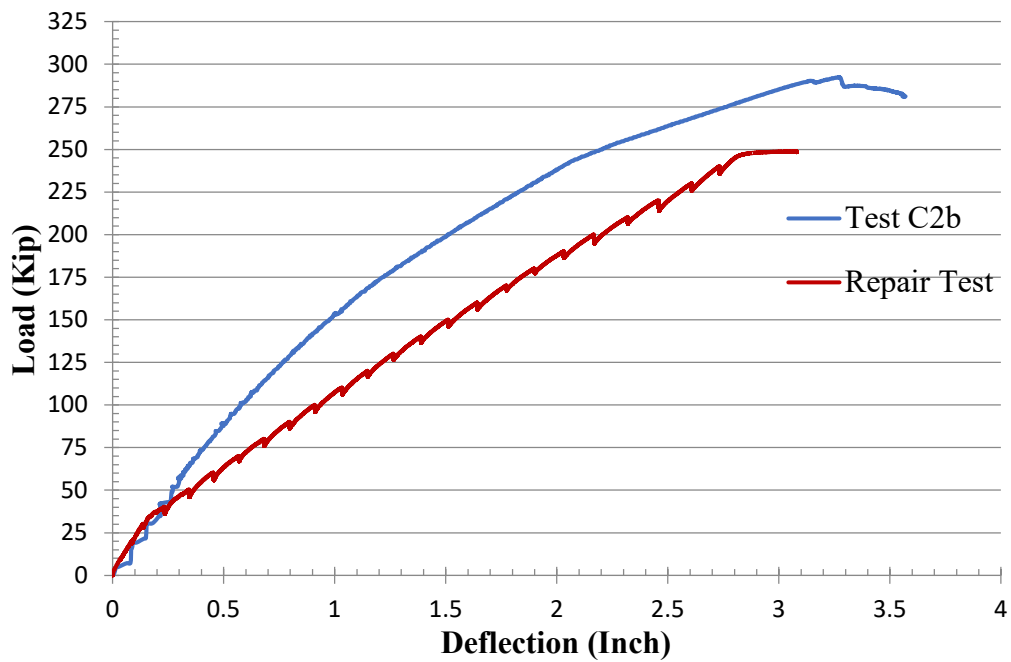
Figure 6.20: C2 Support Condition Test Comparison (North End)
