Assessment of Composite Pavement in Virginia: A Trial Section on US 60

Final Report VTRC 21-R3

**ASSESSMENT OF COMPOSITE PAVEMENT IN VIRGINIA:
A TRIAL SECTION ON US 60**

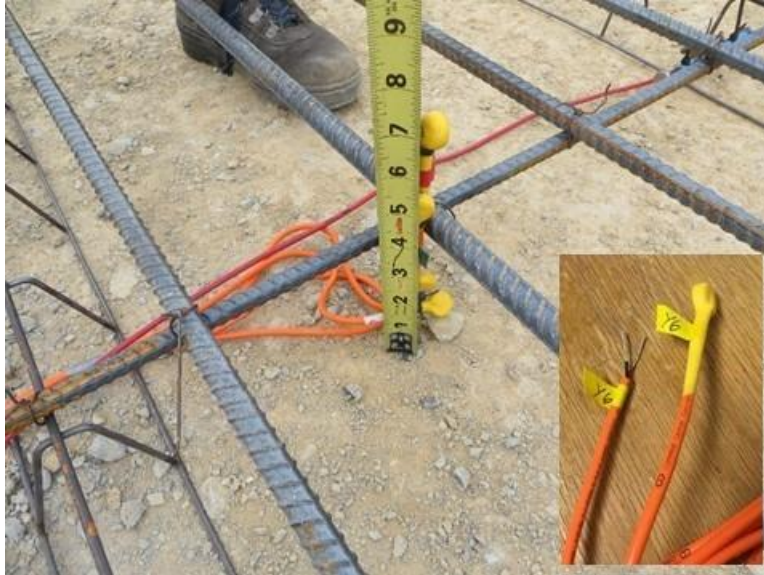
Figure 2. Temperature Measurement Sensors Installation in CRCP. CRCP = continuously reinforced concrete pavement.

Air temperature was gathered from Weather Underground (n.d.) for the Richmond, Virginia, area. These temperatures were compared to the collected temperature data to investigate the insulating effect of the asphalt layer on the CRCP temperature change.

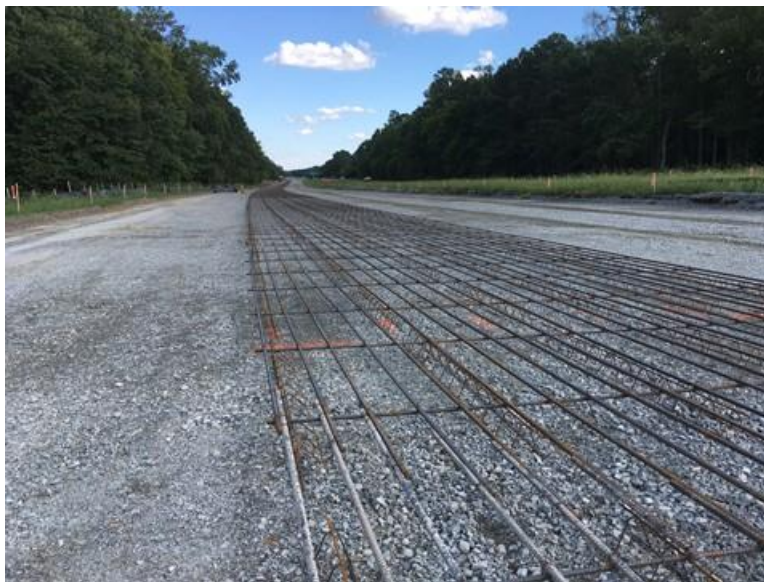
Figure 7. Reinforcement for CRCP. CRCP = continuously reinforced concrete pavement.

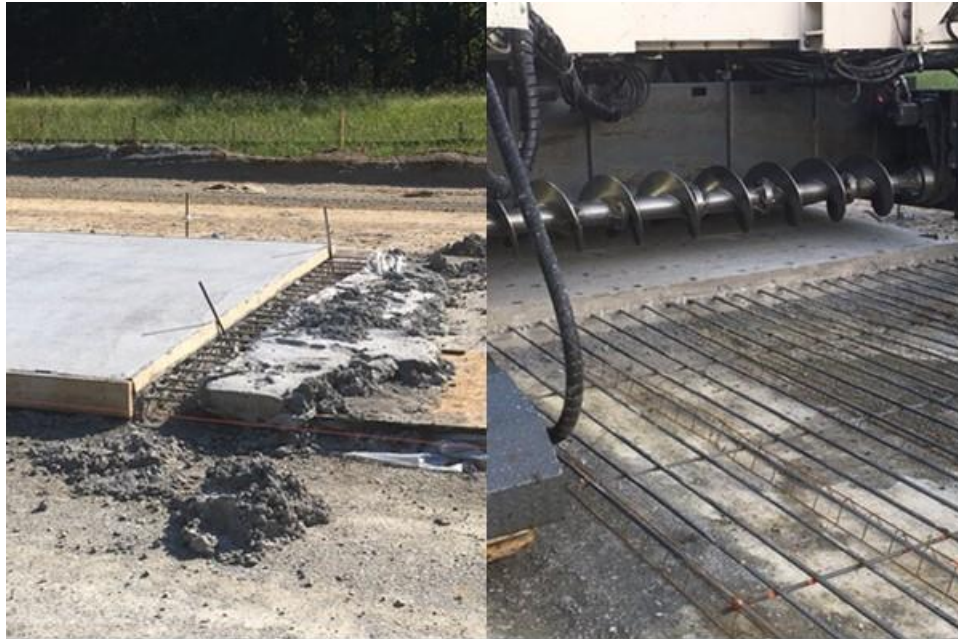
Figure 9. Construction Cold Joint With Regular Reinforcement

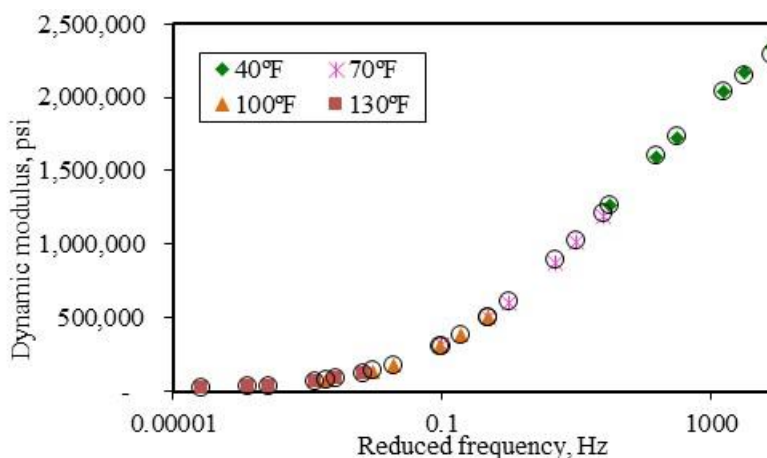
Figure 15. Dynamic Modulus of SMA Mixture (Semi-Log Scale). SMA = stone matrix asphalt.

The dynamic modulus of the SMA mixture is the major input for Pavement ME Design. Dynamic modulus test results for 4.5% air voids (selected based on field air voids, unconfined testing) are shown in Figure 15.

Pavement ME Design uses dynamic modulus (E^*) to compute critical responses for HMA materials. SMA mixture properties for pavement ME analysis are shown in Table 13. Since dynamic modulus is not tested at $-10\text{ }^\circ\text{C}$ (which is a required input in pavement ME analysis), modulus values were estimated from master curves using the time-temperature superposition principle.

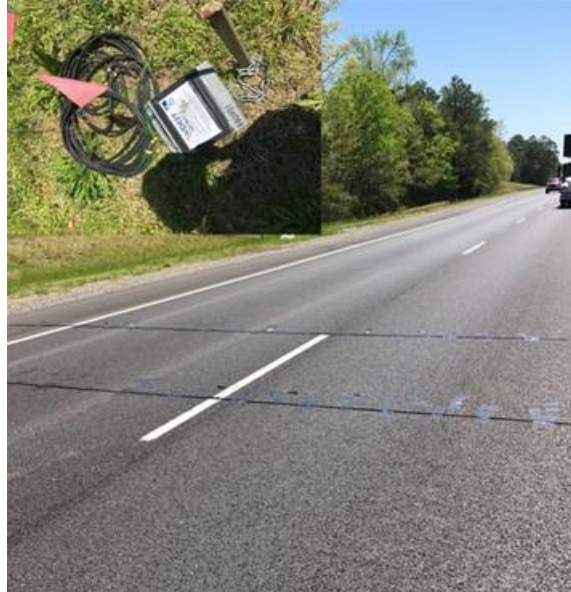
Figure 18. Traffic Data Collection Tubes on US 60W

The actual materials properties and traffic count for the project (gathered after the construction) were used for analysis using Pavement ME Design. Actual traffic count data were gathered April 27, 2018, through May 4, 2018, after 6 months of opening to traffic subsequent to the construction of the new composite section. Pneumatic tubes at 8-ft spacings, as shown in Figure 18, were installed to collect the class and volume of traffic at two locations. Location 1 was between Dry Bridge Road and the I-295 ramp. Location 2 was 300 ft west of Whiteside Road. Table 16 summarizes the traffic data.

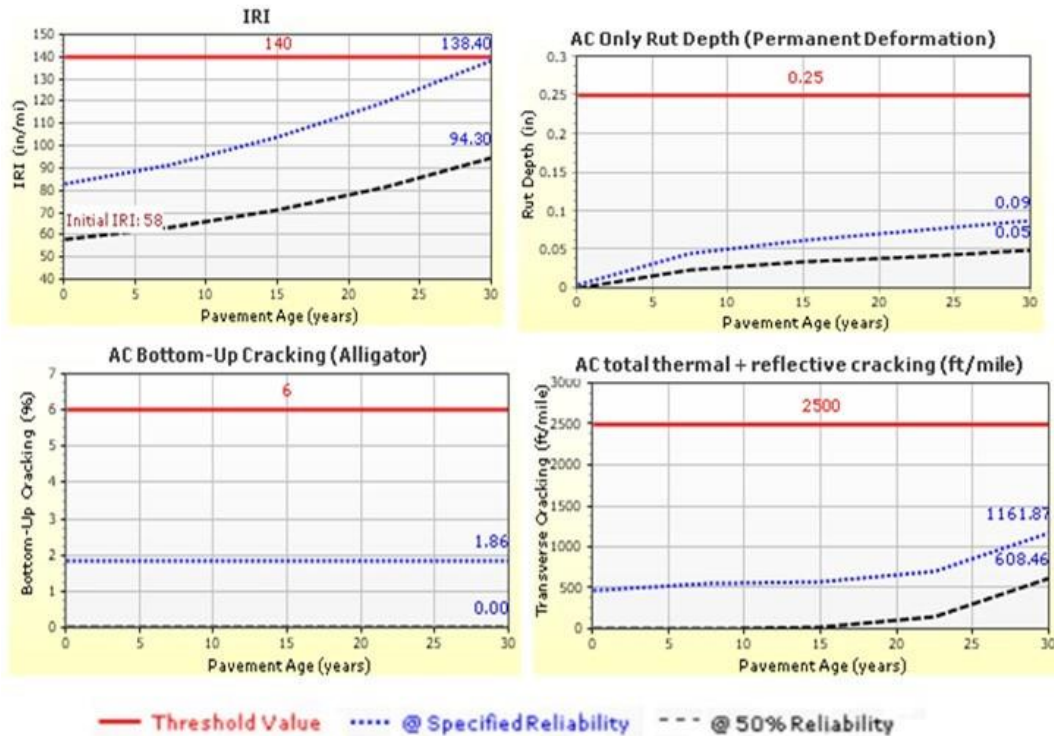
Figure 19. ME Predicted Distresses for US 60 Project With Age: (a) International Roughness Index (IRI); (b) rut depth; (c) alligator crack; (d) thermal crack. ME = mechanistic-empirical; AC = asphalt concrete.

In an SHRP2 report, Rao et al. (2013) explained the relative importance of different cracks in a composite pavement analysis. According to Rao et al., low-temperature thermal cracking is a minor issue and is not likely to occur in HMA/PCC composite pavements. The chances of surface-initiated cracks (AC top-down cracking) for composite pavements are also small because the tensile strains at the surface of the HMA layer are small. AC bottom-up cracking is also not a concern for composite pavements since it does not usually initiate at the bottom of the HMA layer for composite pavements because the HMA is almost always in compression unless there is a loss of friction between the HMA and concrete layers. Fatigue cracks in HMA/PCC composite pavements normally initiate at the bottom and top of the PCC layer and propagate to the surface with continued traffic applications. Composite pavement can develop fatigue-related distress in the form of punchouts, which should be an important design consideration (punchouts are also the main distress criteria for CRCP). Moreover, the concrete layer is the primary load-carrying component of the composite pavement system (AC over CRCP). When a heavy load is applied and repeated on a composite pavement, the HMA layer may undergo some permanent deformation, which is considered to be an important design criterion. The thickness of the HMA layer will affect rutting potential. Rutting and the number of punchouts are expected to increase when truck traffic increases.

The transverse and reflective crack prediction models in the version of Pavement ME Design used for this project analysis have been revised. The latest version of Pavement ME Design has incorporated the revised models, but it is not yet available for VDOT’s use because it needs local calibration. Therefore, these distresses will not be considered in the subsequent analysis in this report. However, with adequate thickness and steel reinforcement (cracks in the CRCP are held tight by the reinforcing steel) in the CRCP, transverse cracks can be reduced as can the reflection of transverse cracks. Moreover, SMA mixtures rich in binder content and the use of polymer modified binder should make SMA perform well against reflective cracking. Hence, reflective cracking is not a big concern for AC over CRCP.

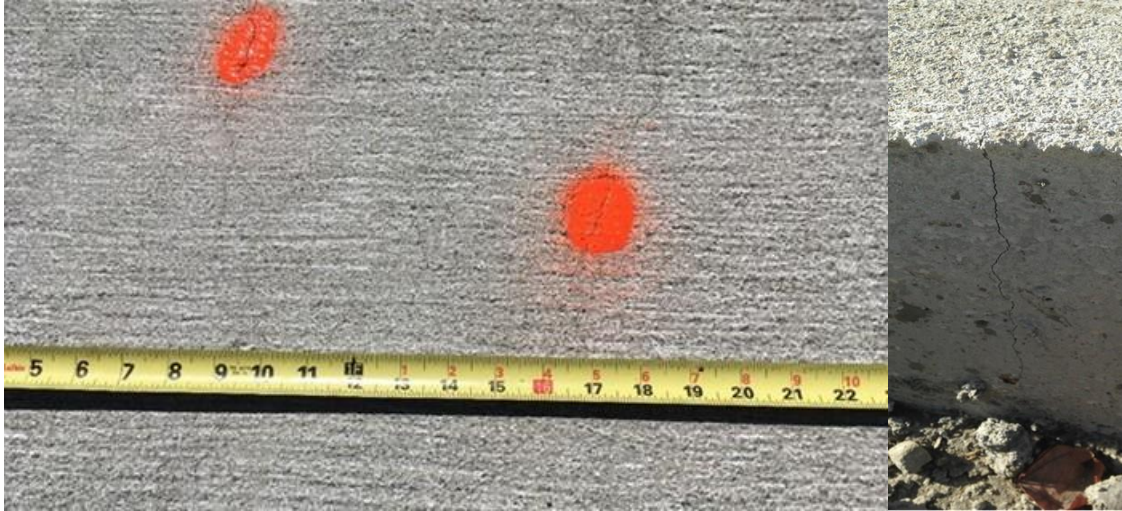
Figure 21. Crack Survey on US 60 CRCP Exposed Surface After 3 Weeks of Curing. CRCP = continuously reinforced concrete pavement.

A CRCP is supposed to crack at 3- to 8-ft spacings, but the cracks usually stay tight because of the presence of reinforcing steel. The section of CRCP on US 60W was surveyed for cracks after 3 weeks of curing, as shown in Figure 21, before it was overlaid with asphalt. Two 500-ft sections of the right lane were randomly selected to collect crack width and spacing information. These sections were surveyed between 10 a.m. and 12 p.m. Most cracks were smaller than 0.3 mm at 10 a.m. and 0.4 mm at 11 a.m., with a range between 0.1 and 0.6 mm. The crack spacing was 3 to 8 ft, as expected. Histograms of crack spacing and width at 11 a.m. are presented in Figure 22.
