GEORGIA DOT RESEARCH PROJECT 17-05

FINAL REPORT

**QUANTIFYING THE IMPACT OF COVER
DEFICIENCIES ON BRIDGE DECK SERVICE LIFE:
RECOMMENDATIONS FOR CONTRACTING**

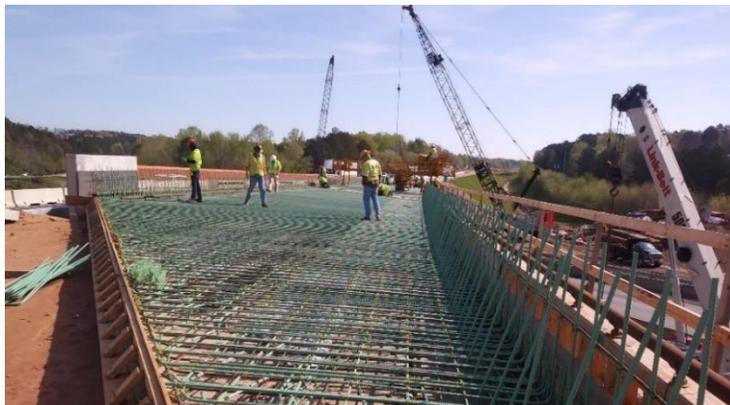
Figure 1. Photo. I-85 Exit 115 construction prior to concrete pour.

In order to establish a practical understanding of the techniques and methods used to ensure appropriate deck concrete cover in Georgia, the research team attended the concrete pour of an I-85 interstate bridge in April 2018, shown in Figure 1. The site was located one mile south of Exit 115 (SR 20) on I-85 south, about 38 miles to the northeast of Atlanta. The design of this section included epoxy-coated top rebar mat and a specified cover of 2.75 inches. During the construction, researchers interviewed GDOT, Federal Highway Administration (FHWA), ATKINS, and C.W. Matthews personnel present.

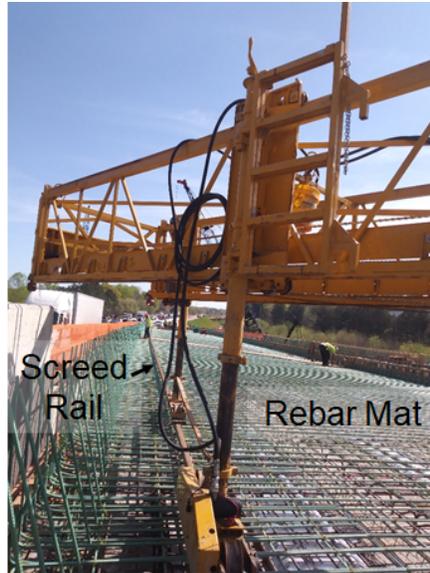
First, the elevation of the rails that the finishing machine rides on is set (one on each side along the length of the deck), which will ensure that the bottom of the screed is at the correct height along the deck. The rails must be level and straight, as they serve as the reference for all reinforcement placement. Key elements of the cover verification process are shown in Figure 3. If the rails are incorrectly set, the resulting cover could be placed systematically too shallow or deep.

Figure 3. Photo. Key elements of the cover verification process.

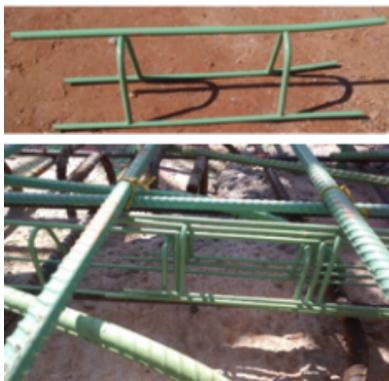
The next step is to place the lower standoffs, called chairs (see Figure 4), which separates the lower rebar mat from the bottom of the slab (top of the stay-in-place formwork). The lower mat bars are placed and then tied together with rebar ties. Next, larger chairs are placed in order to support the upper rebar mat. The upper mat rebar is then put into place and tied together.

Figure 4. Photo. Chairs used to set appropriate standoff distance between rebar mats.

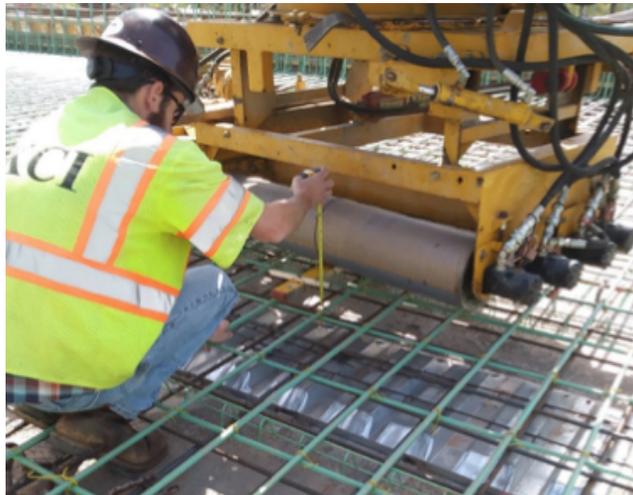
Next, the contractor, under the supervision of GDOT and the consultant for the project, performs a “dry run” of the pour. Typically the dry run occurs the day before the actual pour. During the dry run, the screed is moved systematically over the deck (side-to-side and then front-to-back), with cover measured laterally every ten feet, and longitudinally at least once per deck bay. To measure cover, the screed head is fitted with a leveled piece of lumber as shown in Figure 5. The height of the lumber represents the future top of the deck. A GDOT inspector measures the perpendicular distance from the top of the rebar mat to the bottom of the lumber with a measuring tape. Discussions with the GDOT personnel indicated that the cover measurements need to be “exactly” correct at this point. Any deviations from the expected values are fixed by the contractor on the spot.

Figure 5. Photo. GDOT inspector measuring the concrete cover using a tape measure and lumber affixed to the bottom of the screed head.

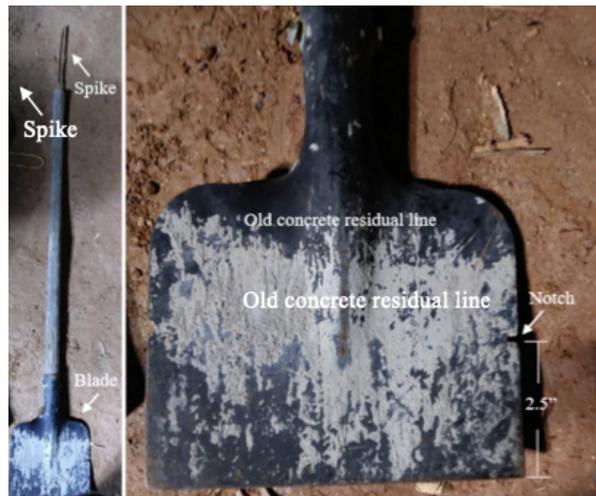
pour, GDOT inspectors and hired contractors verify the cover, along with the slump of the concrete, air entrainment, and pour rate. At this stage, inspectors use a modified shovel to measure the concrete cover. The modified shovel, shown in Figure 6, has notches in the blade portion at both 2.5 inches and 2.75 inches from the edge of the blade, as well as an 8.25 inch-long spike on the opposite side for measuring total slab thickness. To perform a measurement, the inspector plunges the blade into the fresh concrete (typically within a minute after the screed has passed) until it makes contact with the top mat. Then the inspectors pulls the blade out. If the residual concrete does not reach exactly the level of the premade notch, the inspector measures the residual level on the blade using a tape measure.

Figure 6. Photo. Modified shovel used to measure concrete cover consisting of a blade end and a spiked end. An expanded view of the blade shows the right-side notch, which is located 2.5 inch from the blade's edge.
