**TECHNICAL REPORT 0-6922-1**  
TXDOT PROJECT NUMBER 0-6922

# **Evaluation of Long-term Strength and Durability Properties of Pre-stressed Concrete Girders with Microcracking**

February 2020; Published September 2020

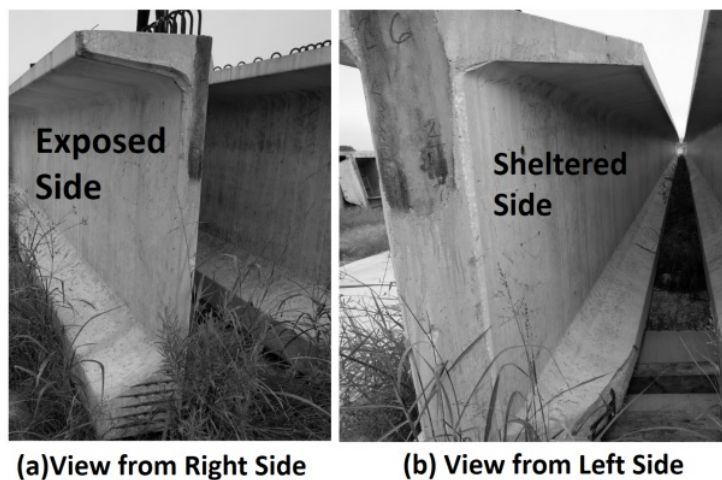
Figure 3.1: Typical overcast girder showing (a) exposed face and (b) sheltered face

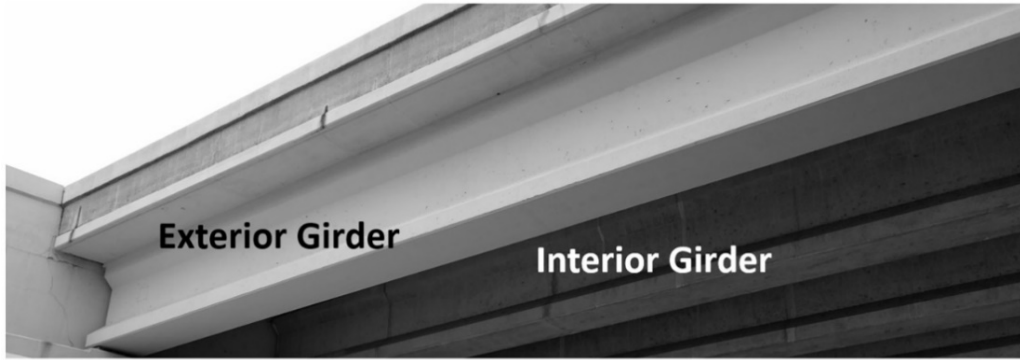
**(a) Typical In-Service Girder**

*Figure 3.3: (a) Typical in-service girder showing exterior and interior girders and (b) pictorial representation of end and middle sections of girder*

Some of the in-service girders examined in this project were exterior girders (see Figure 3.3a) and were exposed to the elements more readily than the interior girders (see Figure 3.3b). It was found that the face of the girder exposed to the environment was painted, which can be readily seen in Figure 3.3a (notice the lighter color of the exterior girder as compared to the interior girder in Figure 3.3a). This paint is an opaque sealer, i.e., a solvent-borne stain-type coating capable of waterproofing as well as coloring finished concrete. The paint consists of a blend of acrylic and silicone resins and toning pigments suspended in solution at all times by a chemical suspension agent and solvent. The paint conformed to the Texas Department of Transportation Specification DSM8110 [48]. The paint coating on the exterior girders was provided with the intention of protecting the girders from the effects of weathering and for aesthetic reasons.

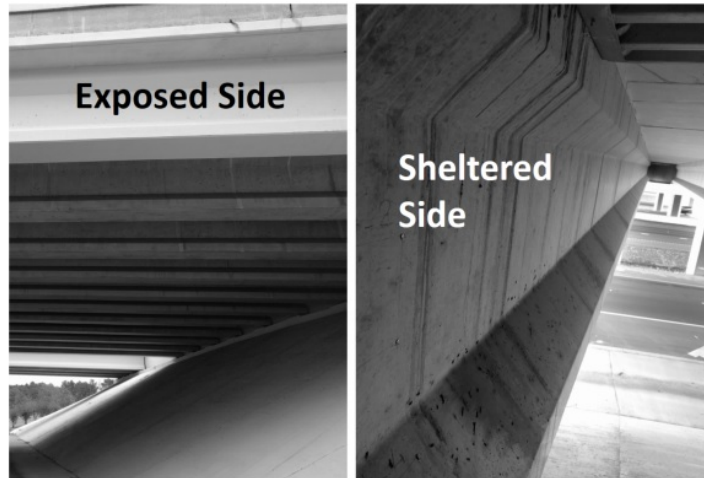
*Figure 3.4 In-service girder showing (a) exposed face and (b) sheltered face*

Measurements taken on the exposed face of the exterior girders (i.e., the face on the exterior side of the girder) are referred to as “Exposed” whereas the measurements that were taken on interior girders and the unexposed face of the exterior girders are referred to as “Sheltered” (see Figure 3.4b). Additionally, each girder can be considered to be comprised of “End” and “Middle” sections (see Figure 3.4b). Like the overcast girders, the ends of the in-service girders also have pre-stressing release cracks.

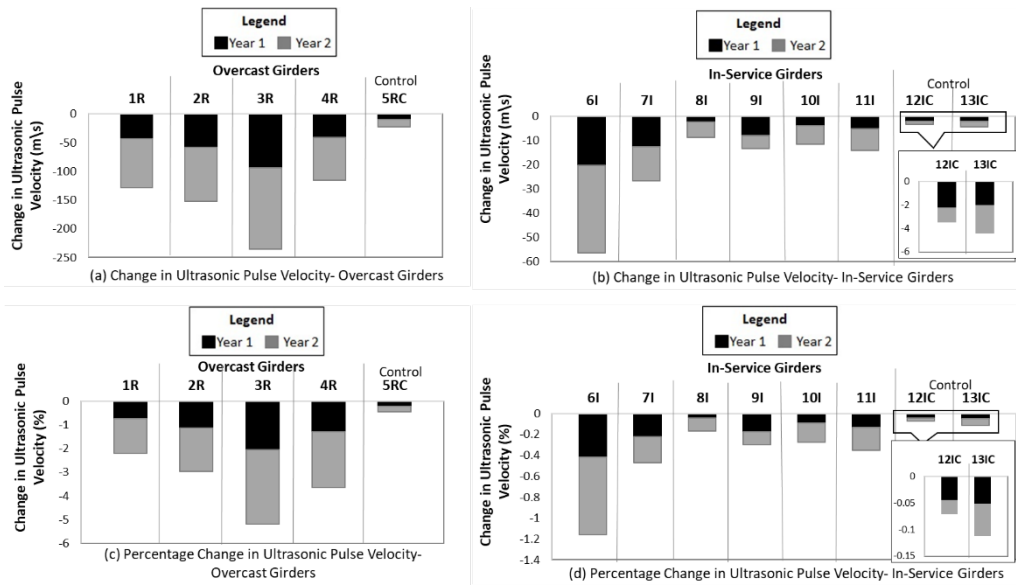
Figure 3.10: Magnitude and percentage change in pulse velocity over the one- and two-year monitoring period

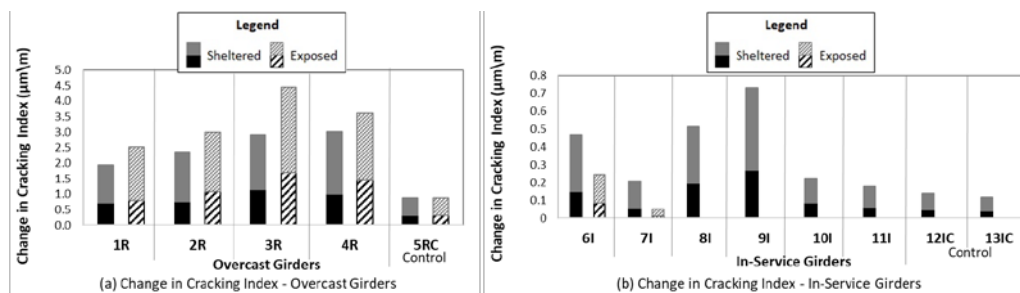
Figure 3.12 shows the change in cracking index for all girders based on the exposure conditions. The exposed faces of the overcast girders have a greater increase in cracking index than the sheltered faces (see Figure 3.1a). However, this behavior is not observed in the exposed faces of the in-service girders (see Figure 3.4b). In-service Girders 6I and 7I are exterior girders, each with one face exposed and one face sheltered, as seen in Figure 3.3. The sheltered faces of these girders display a greater change in cracking index than the exposed face of the in-service girders. This can be attributed to the paint on the exterior face of the girder (Figure 3.4a). The remaining in-service girders (8I-11I, 12IC, and 13IC) do not have exposed surfaces as they are interior girders. Figure 3.13 shows the impact of exposure conditions on the change in average crack widths for all girders. Overall, like the change in cracking index, the change in average crack width is greater for the exposed faces than the sheltered faces in the cracked overcast girders (see Figure 3.13a). The paint has the same effect on the average crack width as it does on cracking index (i.e., greater change in crack width on exposed face than the sheltered face), as seen in Figure 3.13b.

Figure 3.12: Effect of exposure conditions on change in cracking index over the one- and two-year monitoring period

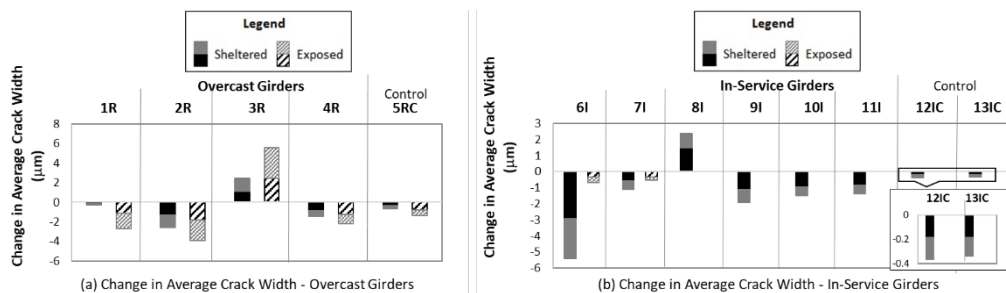
Figure 3.13: Effect of exposure conditions on change in average crack width over the one- and two-year monitoring period

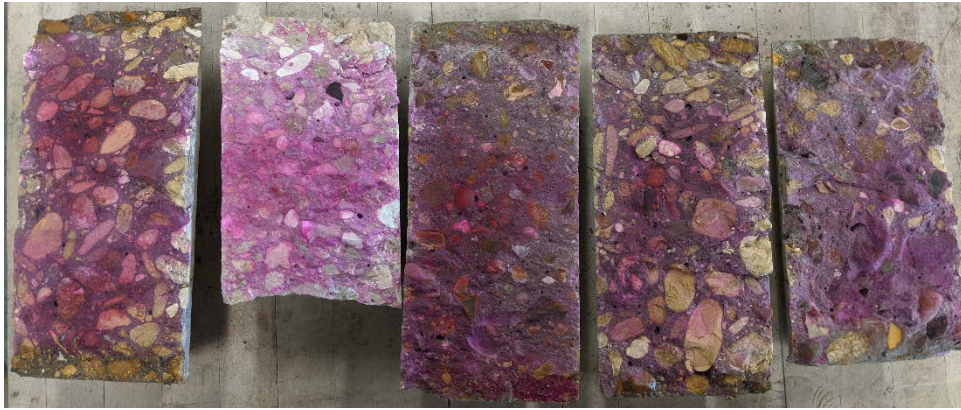
(a) Split Specimens with Phenolphthalein Indicator Sprayed

Carbonation coefficient was determined in accordance with *CPC18–RILEM Concrete Permanent Committee–Measurement of hardened concrete carbonation depth* [108]. Two cores from each field visit were used. Each core had two exposed faces. Thus, four values of carbonation depth were measured from each girder from each field visit. Cores extracted from the first, second, and third round of field visits were exposed for 3 years, 2 years, and 1 year, respectively. In addition, the carbonation depth at time of extraction was also calculated by using the samples previously used for splitting tensile strength. The split surfaces of the samples were sprayed with a phenolphthalein indicator. The areas that were basic turned pink due to the basic nature of concrete while the areas that had carbon dioxide diffusion remained colorless due to the formation of carbonic acid. Thus, the depth of the colorless zone was measured to estimate the depth of carbon dioxide diffusion (see Figure 4.4).

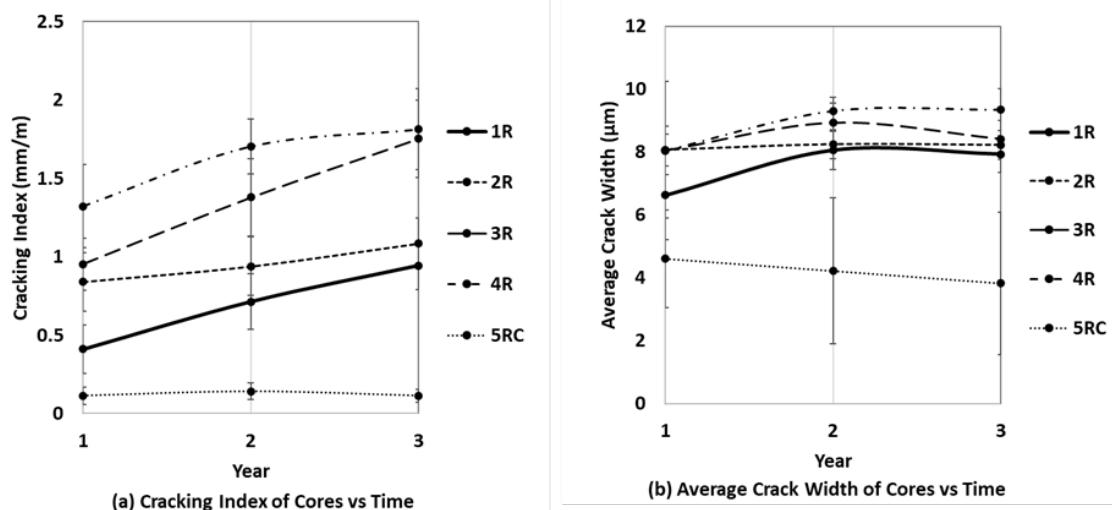
5RC. However, it can also be seen that increasing crack index is not always associated with an increase in crack width, rather the average crack width may increase or decrease with time (see Figure 4.11b). As shown in Figure 4.11b, whether the average crack width increases or decreases depends on whether new cracks have formed. In Figure 4.12, the leftmost figure represents the initial state of cracks on the surface of a concrete specimen. However, the three figures to the right show difference scenarios that can occur with time. Crack widening is observed in girders that show an increase in average crack width and cracking index. Girders 1R, 2R, 3R and 4R in the first year, and Girders 3R and 4R in the second year show an increase in both average crack width (see Figure 4.11b) and cracking index (see Figure 4.11a). This indicates the formation of cracks (#) and widening of existing cracks ( $\Sigma W$ ) as shown in Scenarios B and C. However, Girder 5RC in the first year and Girders 1R, 2R and 5RC in the second year show an increase in the cracking index (see Figure 4.11a), but a decrease in the average crack width (see Figure 4.11b). As shown in Scenario A in Figure 4.12, this indicates the formation of new cracks is occurring at a greater extent than the widening of existing cracks. The average crack width (ACW) is function of the number of cracks (denoted as #) in Figure 4.12)) and the sum of measured crack widths ( $\Sigma W$ ). Thus, when # increases without a proportional increase in  $\Sigma W$ , ACW decreases over time.

Figure 4.11: Change in cracking of cores over the monitoring period

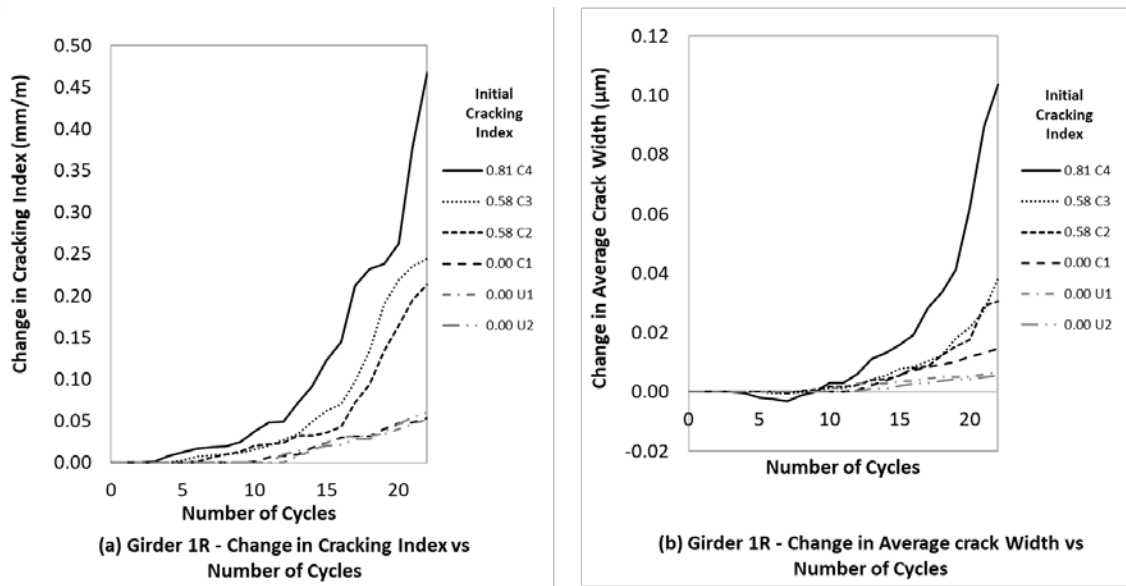
Figure 4.17: Change in cracking with exposure

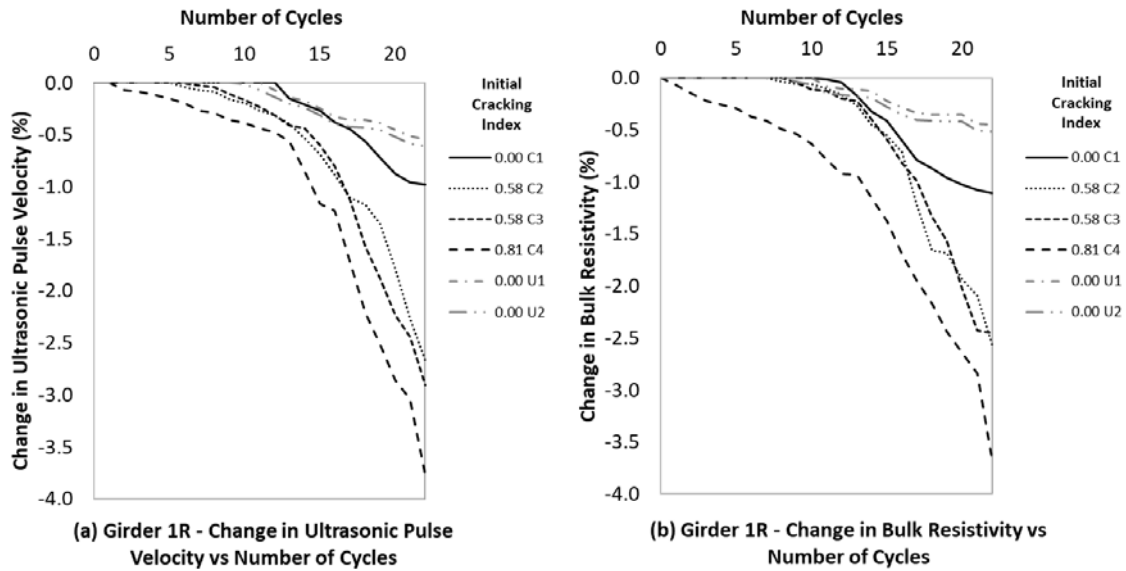
Figure 4.19: Change in ultrasonic pulse velocity and bulk resistivity with exposure

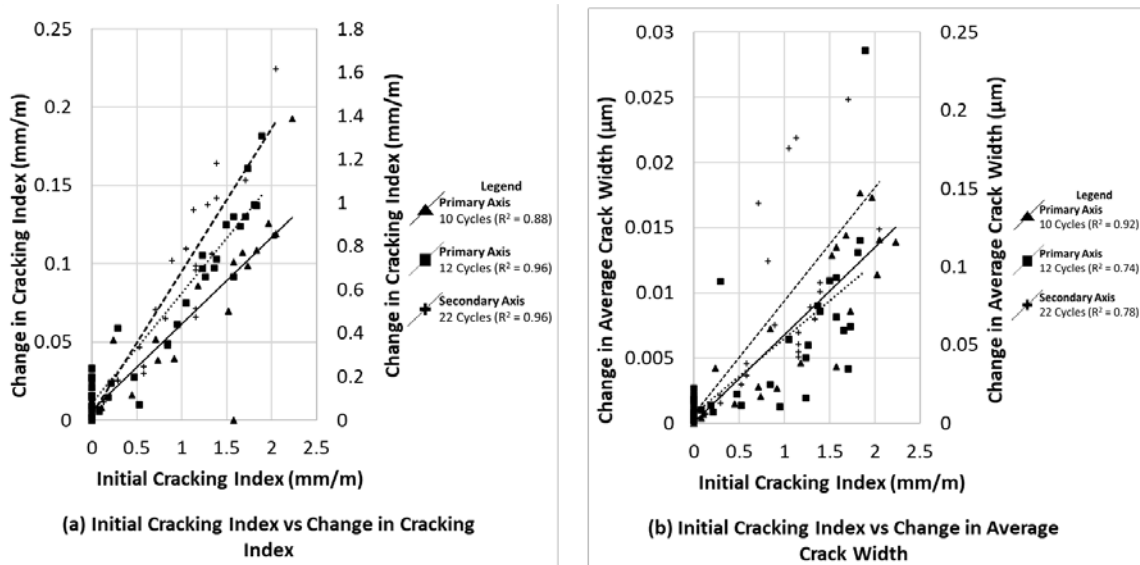
*Figure 4.20: Effect of initial cracking on final cracking values*

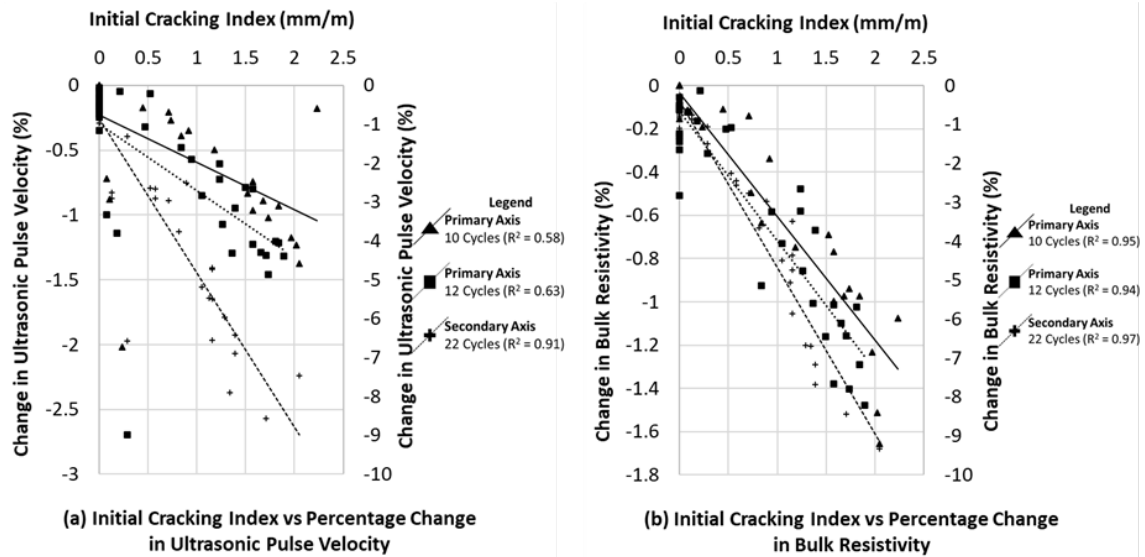
Figure 4.22: Effect of Initial cracking on the percentage change in ultrasonic pulse velocity and bulk resistivity

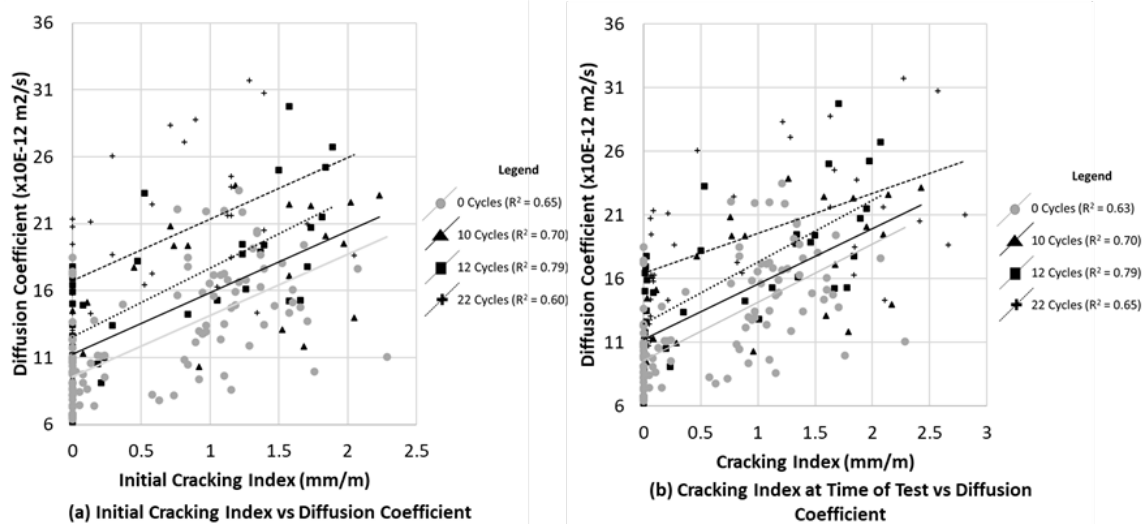
Figure 4.23: Effect of cracking index and exposure on diffusion coefficient and correlation coefficients

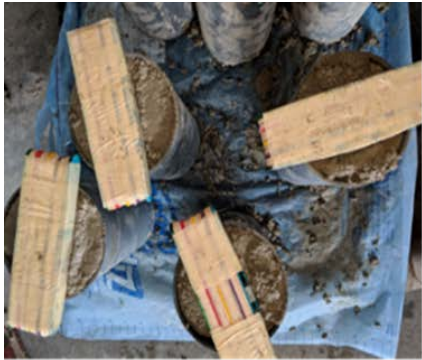
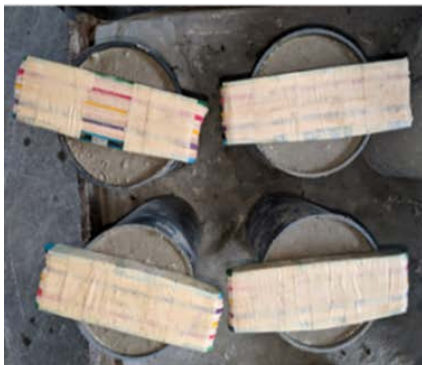
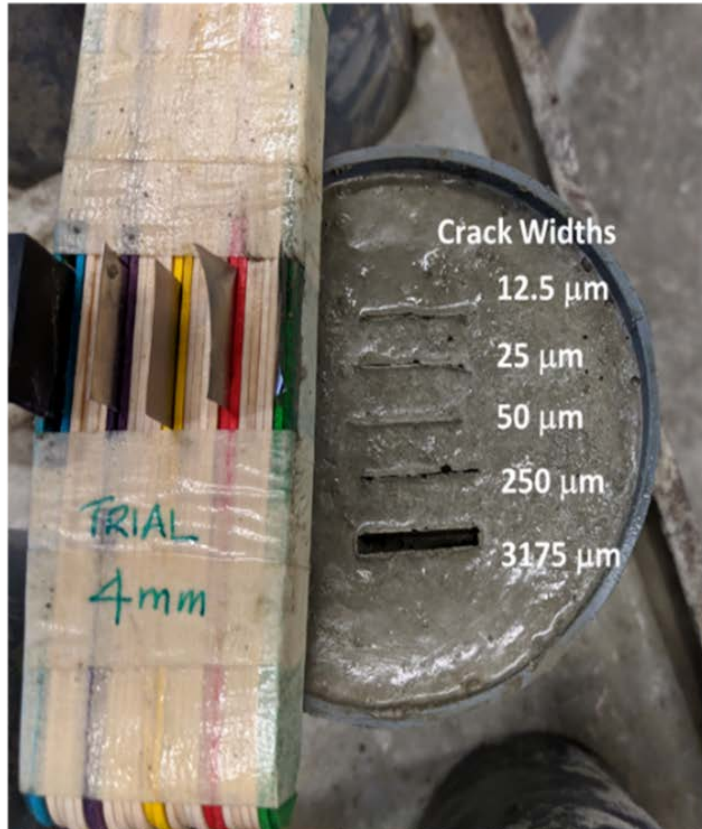
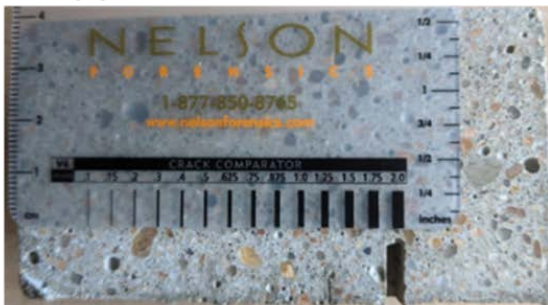
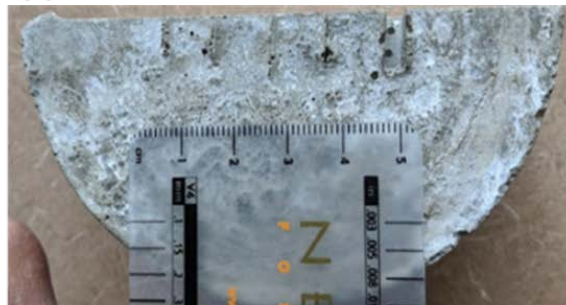
**(a) Before Vibration**

**(b) After Vibration**

**(c) After Removal of Shims**

**(d) Sectional View of cracks**

**(e) Plan View of cracks**

Standard 100x200 mm (4x8 in.) cylinders were cast using the CEM proportions. Micro and macro cracks were embedded in the wet mixture using lubricated stainless steel (12.5 µm [0.0005 in.], 25 µm [0.001 in.], 50 µm [0.002 in.], 250 µm [0.01 in.]) and plastic (3175 µm [0.125 in.]) shims (see Figure 5.1). The cylindrical molds were half filled with mortar and shims were placed. Mortar was carefully filled through the gaps between the shims (see Figure 5.2a). The molds were placed on a vibrating table to allow the mortar to fill the gaps between shims (see Figure 5.2b). Trials were conducted to determine the best time to remove the shims. It was found that removing the shims just before the final set occurred (8 hours) allowed for easy extraction of the shims without disturbing the cracks (see Figure 5.2c). Figure 5.2d and Figure 5.2e show the cross-sectional and plan views of the embedded cracks in the hardened samples respectively.

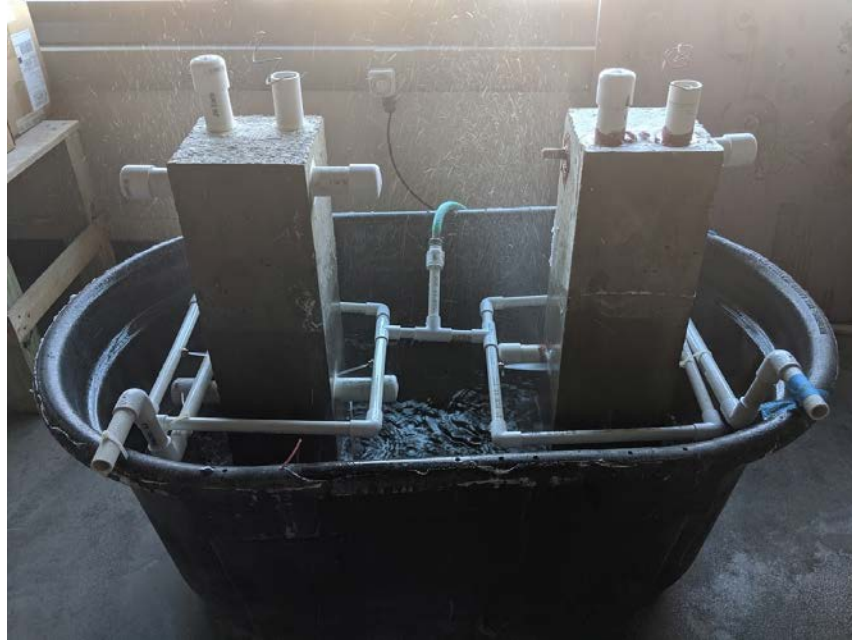
(a) Marine Exposure Tank

Figure 6.2: (a) Marine exposure tank and (b) schematics of setup

Figure 6.2 shows the marine simulation tank set-up. A 100-gallon plastic tub was filled with 50 gallons of saltwater at 35.2 ppm concentration (simulating salt-water concentration at UT marine exposure site at Port Aransas [178]). A PVC piping system was designed and set-up to spray the salt-water over the surface of the concrete block. The spray system was placed on a timer to spray saltwater on the surface of the block intermittently. Experimental tests were conducted to determine the time for surface drying, as this would allow for increased salt saturation. Surface drying was found to occur at 11 hours. Thus, the timer was set to spray the surface of the block for thirty minutes every twelve hours. Three identical blocks were cast and subjected to the following exposure conditions (see Figure 6.2):

- Block A - Placed in the marine simulation tank after 28 days of curing.
- Block B - Exposed to the atmosphere after 28 days of curing until the block exhibited surface microcracking. The block did not show signs of adequate surface microcracking with just exposure to the environment. Thus, to accelerate the cracking, the block was exposed to accelerated weathering by subjecting the block to four cycles of surface wetting and drying each day. The surface of the block was saturated with water for five minutes and allowed to dry for six hours.
- Block C – Placed indoors at 73°F to perform as a control specimen.

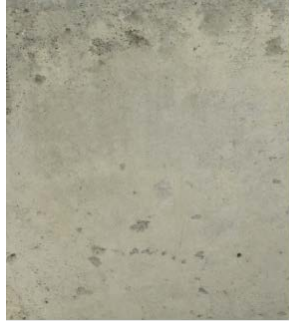
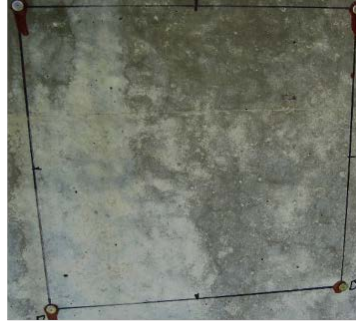
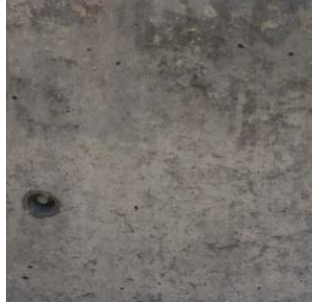
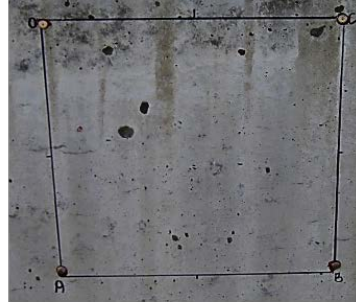
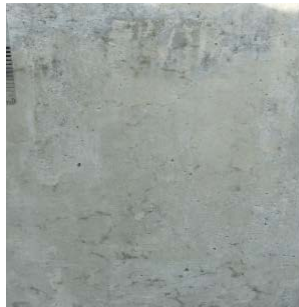
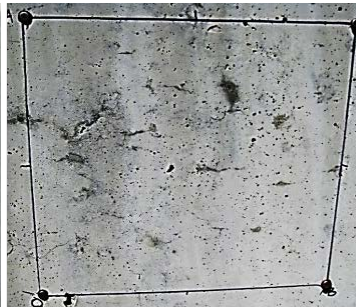
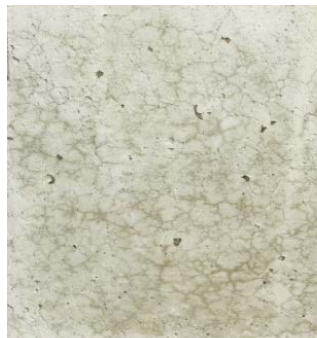
Visual Rating - 0

Cracking Index - 0

Visual Rating - 1

Cracking Index - 0.003 in/yd

Visual Rating - 2

Cracking Index - 0.025 in/yd

Visual Rating - 2.5

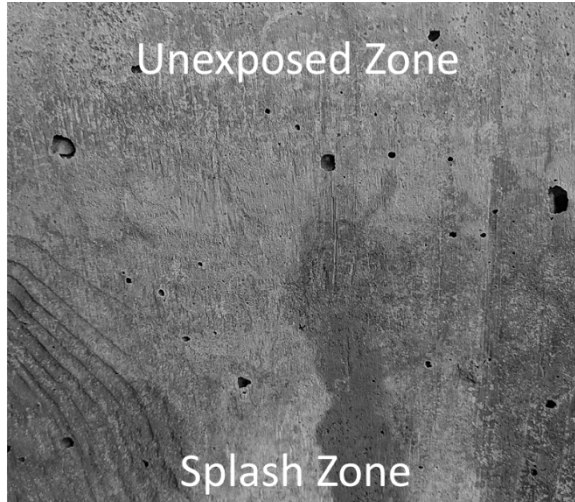
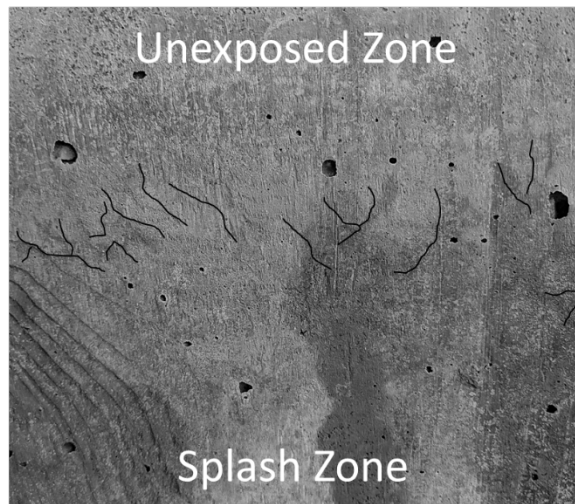
CI-0.015 in/yd, VRI- 1.5)

(b) Cracking in area between Unexposed and Splash Zones

(c) Highlighted Microcracks

Figure 6.5: Corrosion-induced microcracking in Block A in the (a) splash and (b) unexposed zones with (c) highlighted cracks, where CI is the cracking index and VRI is the Visual Rating Index

Block A exhibited corrosion-induced microcracking in the splash zone after 7 months of exposure. At the end of 14 months, the block began to exhibit corrosion-induced microcracking in the region between the splash zone (cracking index of 0.047 in./yd) and unexposed zone (cracking index of 0.015 in./yd) as well (see Figure 6.5a and Figure 6.5b). Figure 6.5c shows the same figures with the microcracks highlighted to aid viewability. An additional set of readings were taken in this intermediate zone as well for the remainder of the testing period.

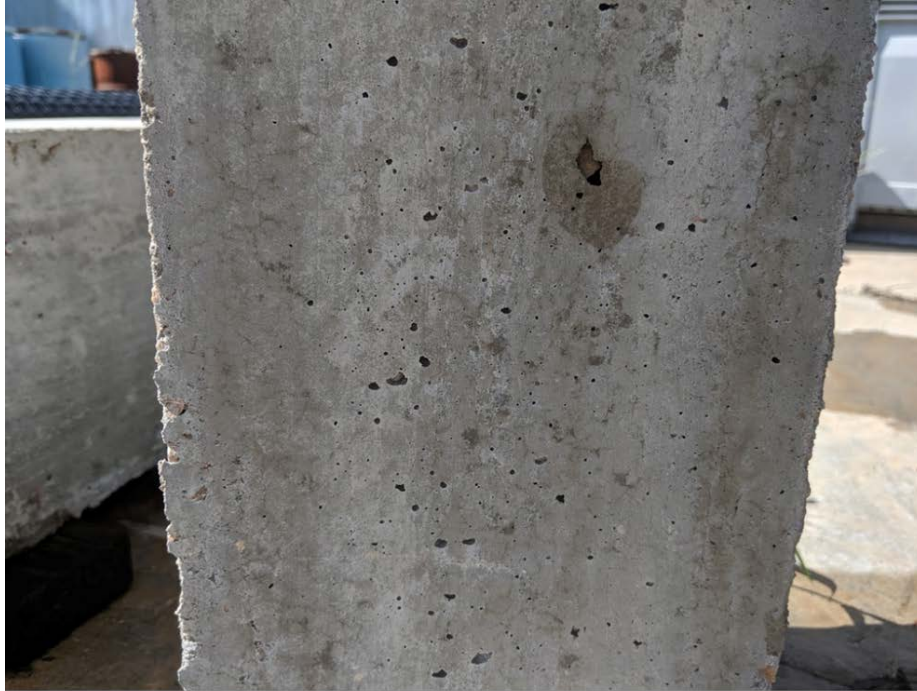
**(a) Cracking Index - 0.01 in/yd (Visual Rating – 1.5)**

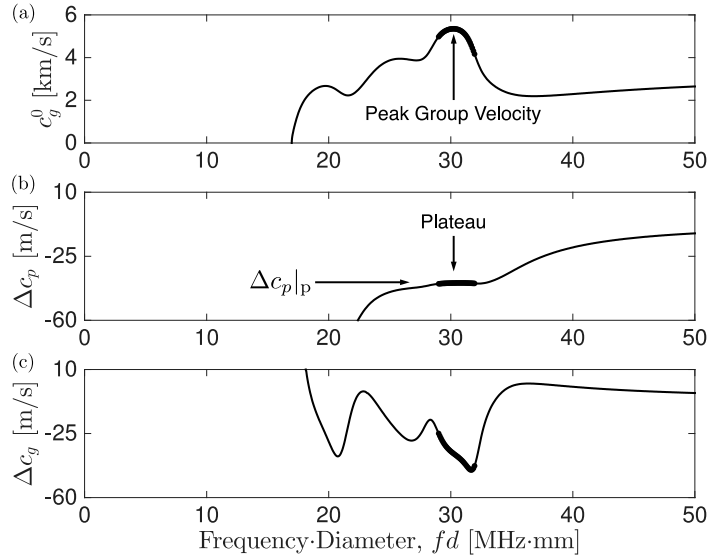
*Figure 7.5: (a) Unstressed group velocity dispersion curve of L(0,9) mode, with (b) phase velocity change under 400 MPa axial stress, and (c) group velocity change under same stress. Curves bolded in peak group velocity region. Phase velocity change stabilizes to  $\Delta c_p|_p$  at peak group velocity, with group velocity change less stable.*

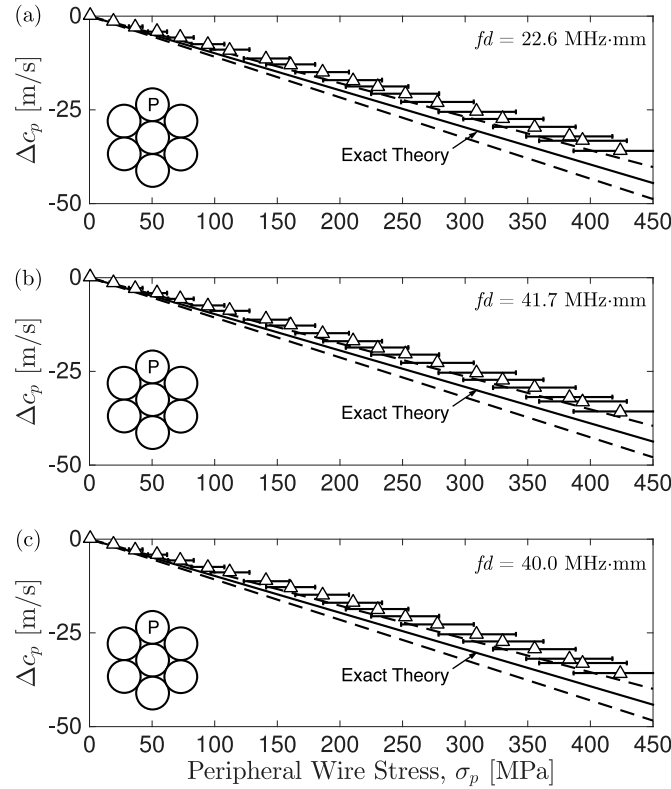
Figure 7.11: Experimental phase velocity change in peripheral (P) wire for (a) L(0,7) mode at  $fd = 22.6$  MHz-mm, (b) L(0,12) at 41.7 MHz-mm, and (c) L(0,12) at 40.0 MHz-mm, with error bars for the variability in strain gauge readings. Theoretical change for a steel rod overlain with material uncertainty bounds.

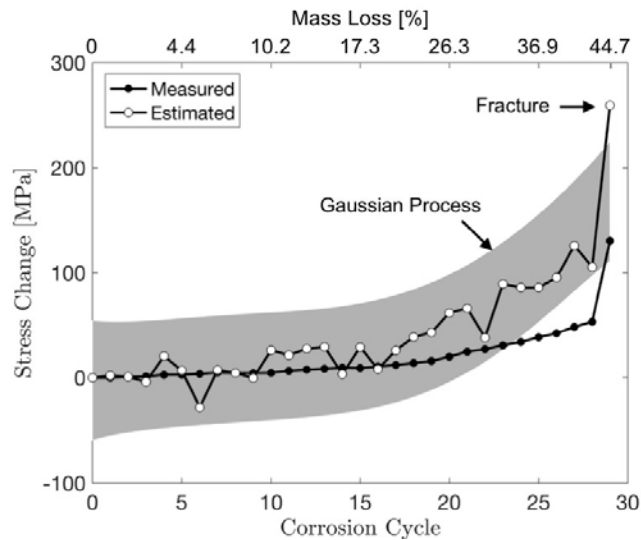
Figure 7.23: Stress change estimated using data fusion of six higher-order mode pairs, ranging from  $L(0,8)$ - $L(0,14)$ . Shaded area overlain as 95% confidence interval from Gaussian process regression. Stress change measured based on strain gages is overlain.

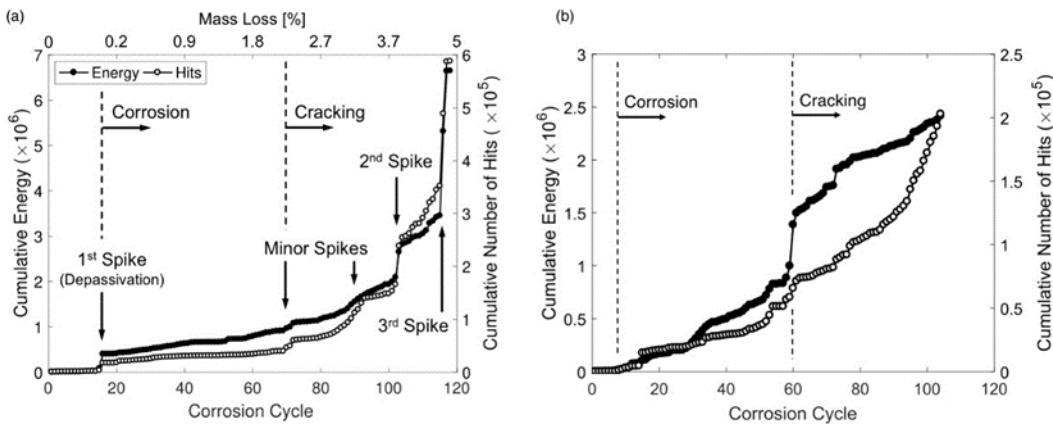
Figure 7.32: Acoustic emission activity recorded over the corrosion process for (a) Specimen A and (b) Specimen B, in terms of cumulative energy and number of hits. Corrosion onset (depassivation) may be seen at cycle 15 where the first activity spike occurred.

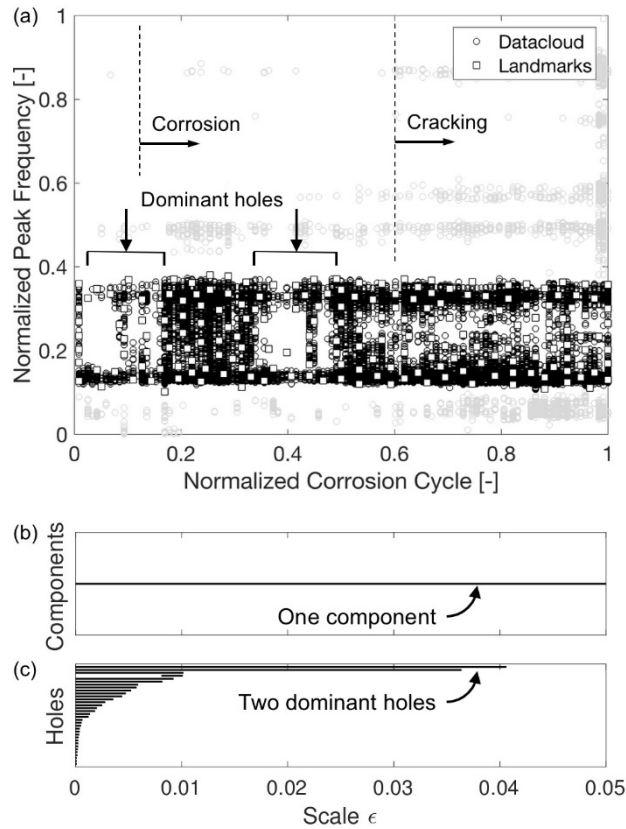
Figure 7.34: Topological data analysis for datacloud of 30–110 kHz frequency band in Specimen A. (a) Datacloud with dominant holes highlighted, with data points from remaining bands overlain in light gray. (b),(c) Barcodes, indicating one component and two dominant holes.

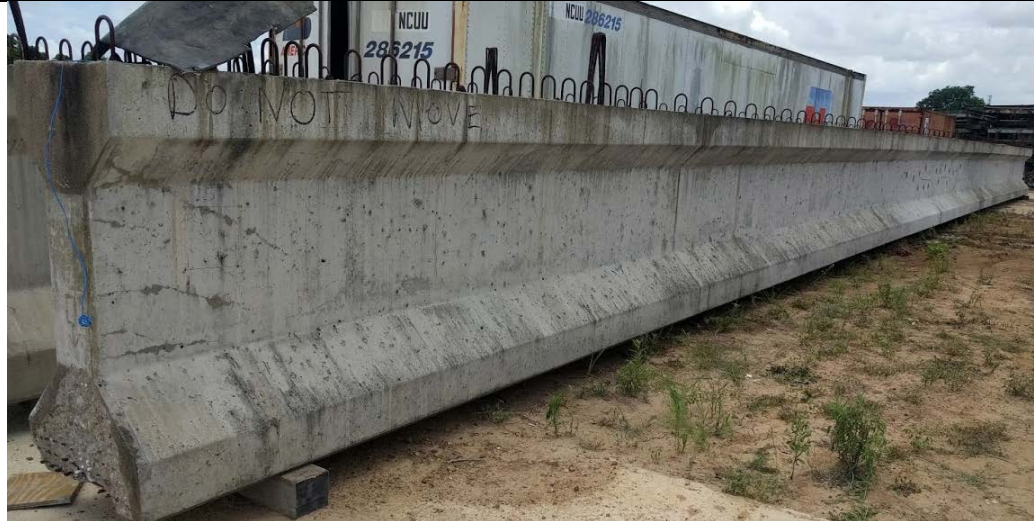
Source: Images by Authors  
Figure A.1: Girder 1R

Girder Notation	1R	Overcast Girder 1
Girder Name: Bexar NH2002(683), 0521-04-223, K-4-02-792		Location: Valley Pre-stress Products, Eagle Lake, Texas
Cast Date: 03/06/2007		In-Service Date: -
Orientation: East-West		Exposure: South Face Exposed

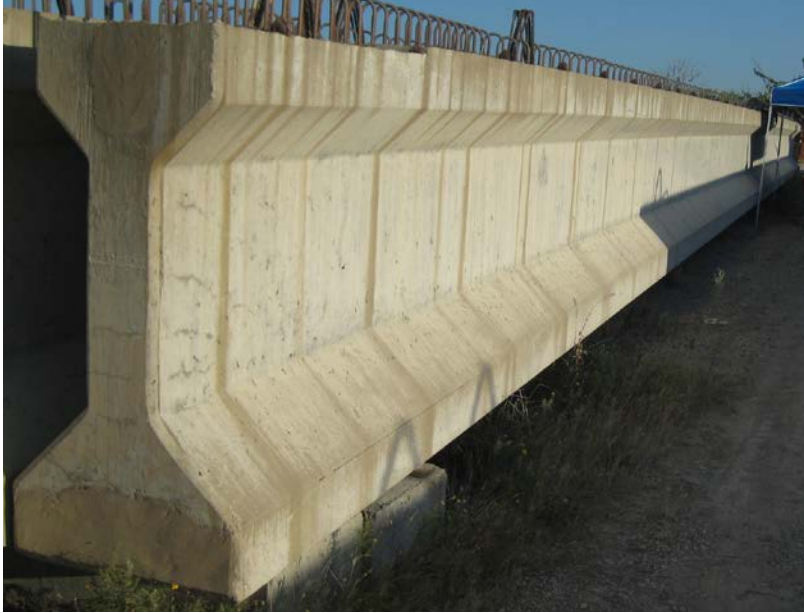
Source: Images by Authors  
Figure A.2: Girder 2R

Girder Notation	2R	Overcast Girder 2
Girder Name: 0047-14-063, STP 2008(363) MM, D-A (AA-35), (AA3-10)		Location: Texas Concrete Company, Waco, Texas
Cast Date: 07/24/2009		In-Service Date: -
Orientation: East-West		Exposure: South Face Exposed

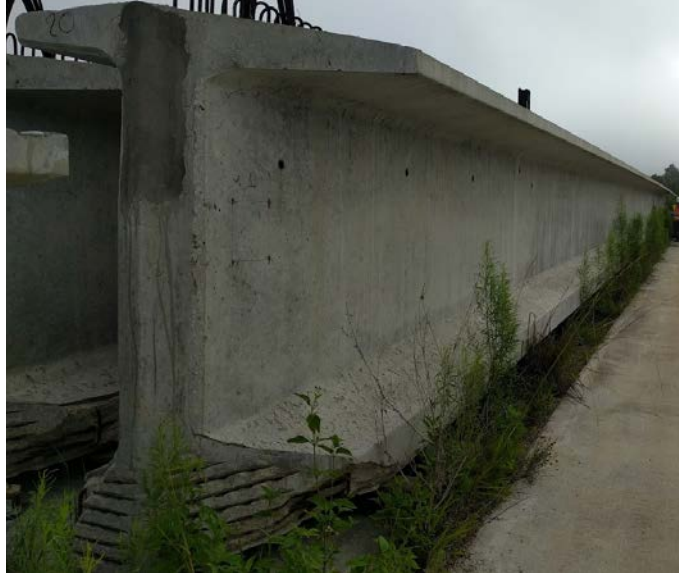
Figure A.3: Girder 3R

Girder Notation	<b>3R</b>	Overcast Girder 3
Girder Name: Q1 TX70-26, Tarrant/Dallas, #3718		Location: Bexar Concrete Works, San Antonio, Texas
Cast Date: 02/14/2011		In-Service Date: -
Orientation: North-South		Exposure: West Face Exposed

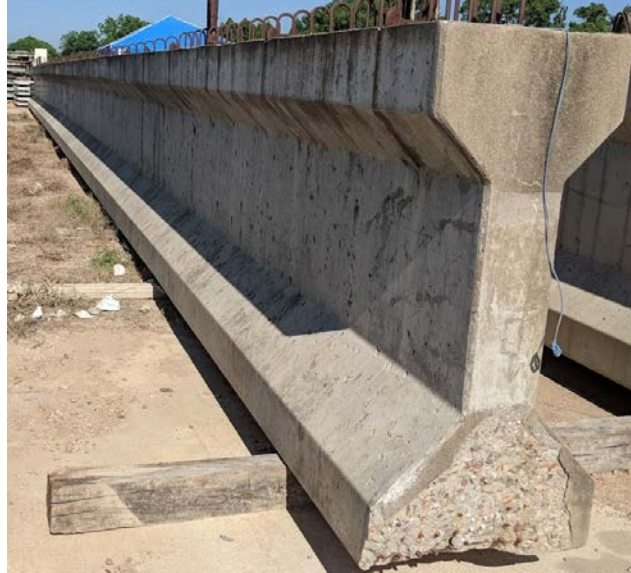
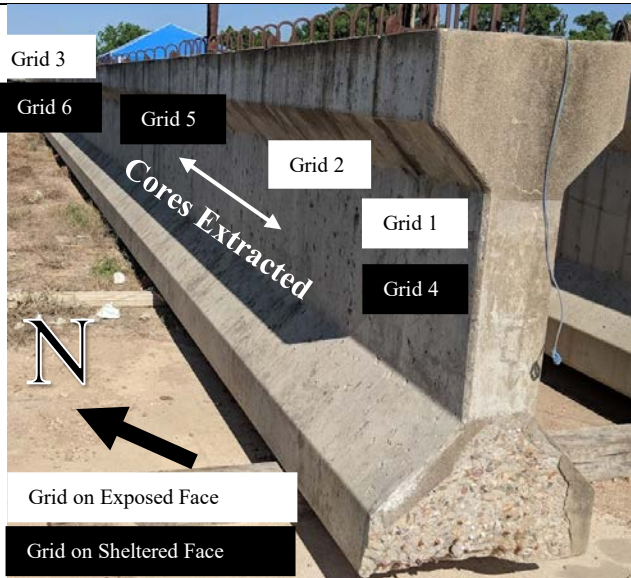
Figure A.4: Girder 4R

Girder Notation	4R	Overcast Girder 4
Girder Name: Collin Co, 08559 SH21, 05 CNPM, J-4-11-33, DL 1164B		Location: Valley Pre-stress Products, Eagle Lake, Texas
Cast Date: 12/14/2009		In-Service Date: -
Orientation: East-West		Exposure: North Face Exposed

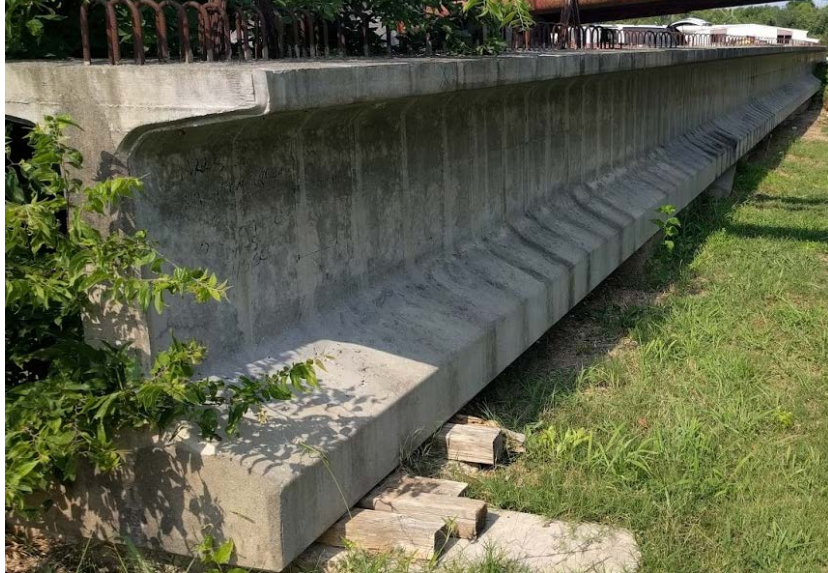
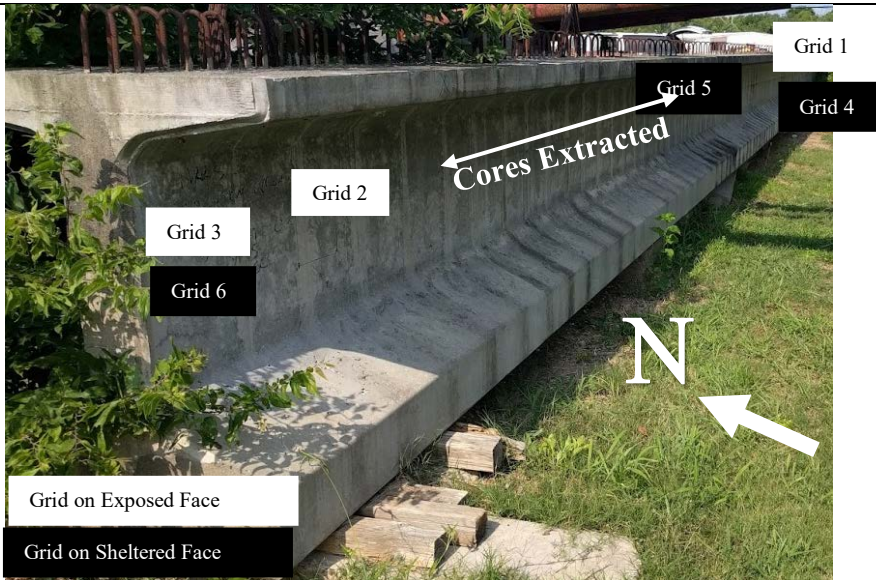
Figure A.5: Girder 5RC

Girder Notation	<b>5RC</b>	Overcast Control Girder 5
Girder Name: Harris Co, C 1.5		Location: Texas Concrete Company, Victoria, Texas
Cast Date: 05/04/2009		In-Service Date: -
Orientation: East-West		Exposure: South Face Exposed

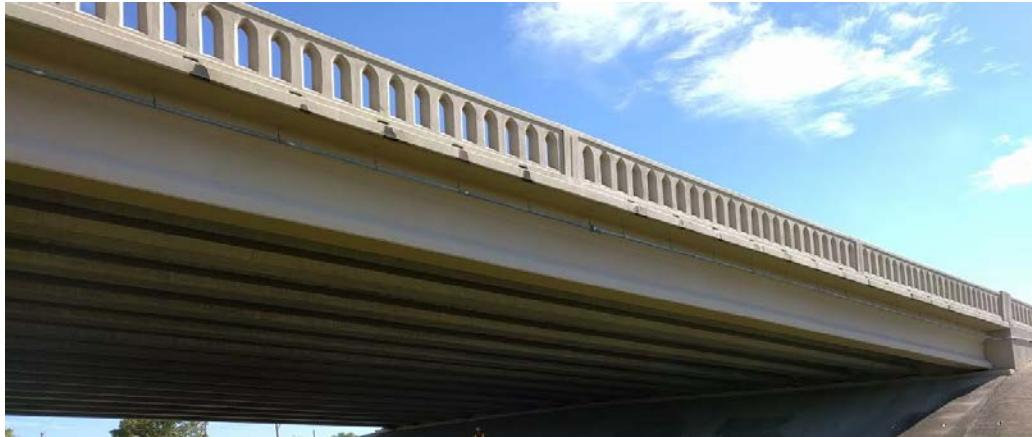
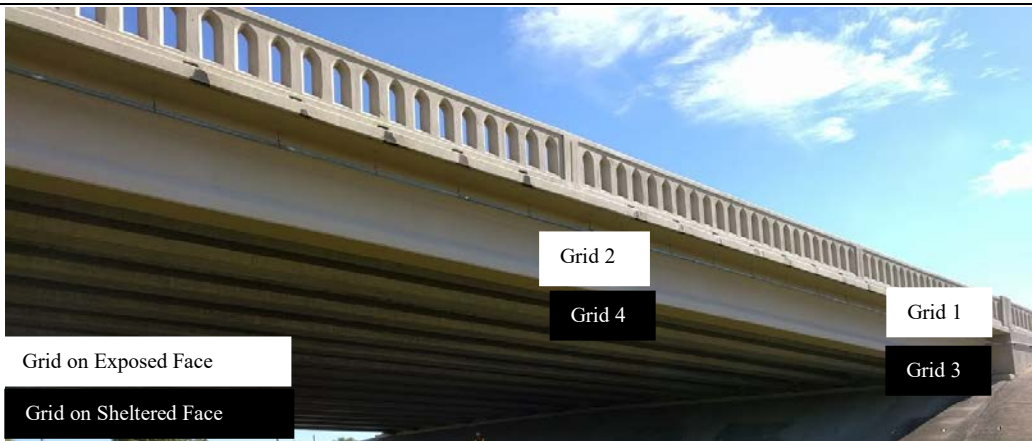
Source: Images by Authors  
Figure A.6: Girders 6I, 8I, 9I, and 12IC

Girder Notation	<b>6I 8I and 9I 12IC</b>	In-Service Exterior Girder 6 In-Service Interior Girders 8 and 9 In-Service Control Girder 12
Girder Name:		Location: Inwood and Hampton, Dallas, Texas
Cast Date: March-April 2007		In-Service Date: 2010

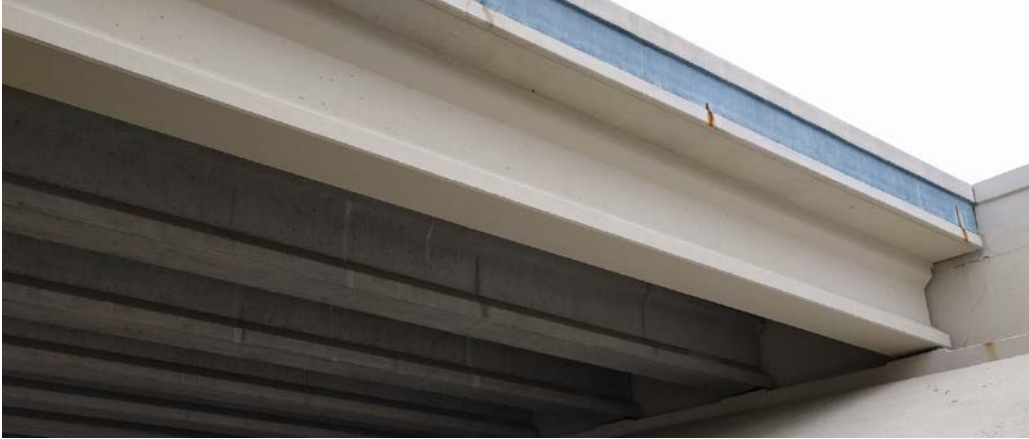
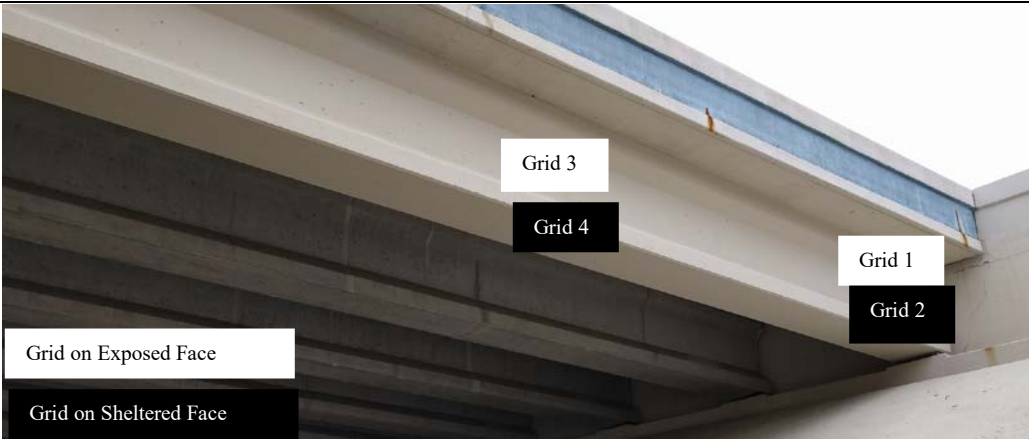
Girder Notation	<b>7I 10I and 11I 13IC</b>	In-Service Exterior Girder 7 In-Service Interior Girders 10 and 11 In-Service Control Girder 13
Girder Name: -		Location: I30 and US93, Texarkana, Texas
Cast Date: January – February 2005		In-Service Date: 2008

<p style="text-align: center;">Grid 3 Grid 4 Grid 1 Grid 2</p> <p>Grid on Exposed Face Grid on Sheltered Face</p>		
<p>Source: Images by Authors Figure A.7: Girders 7I, 10I, 11I and 13IC</p>

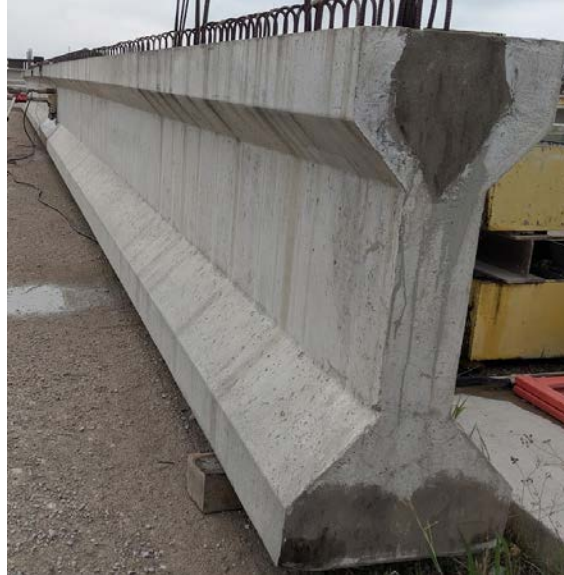
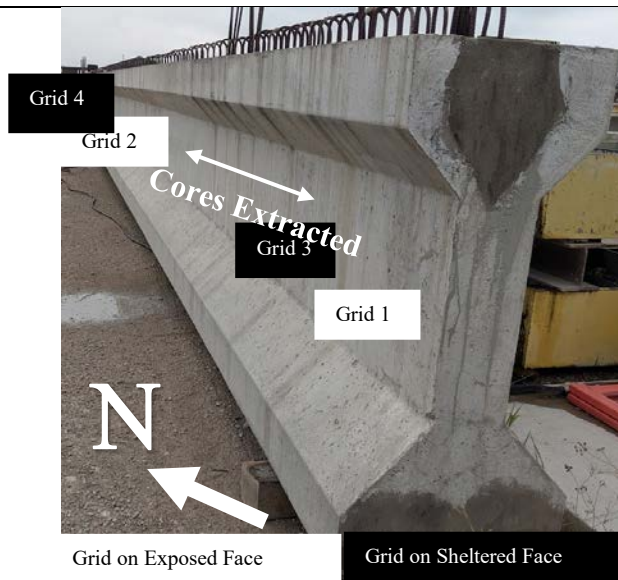
Figure A.8: Girder 14V

Girder Notation	<b>14V</b>	Validation Girder 14
Girder Name: HEI #123374, Collin, B-4-C-27		Location: Heldenfels Enterprise Inc, San Marcos, Texas
Cast Date: 12/16/2013		In-Service Date: -
Orientation: East-West		Exposure: South Face Exposed
