Installation and Initial Evaluation of Paving Fabric Interlayers for Mitigating Reflective Cracking in Pavements

HARIKRISHNAN NAIR, Ph.D., P.E.
Senior Research Scientist

Final Report VTRC 20-R33

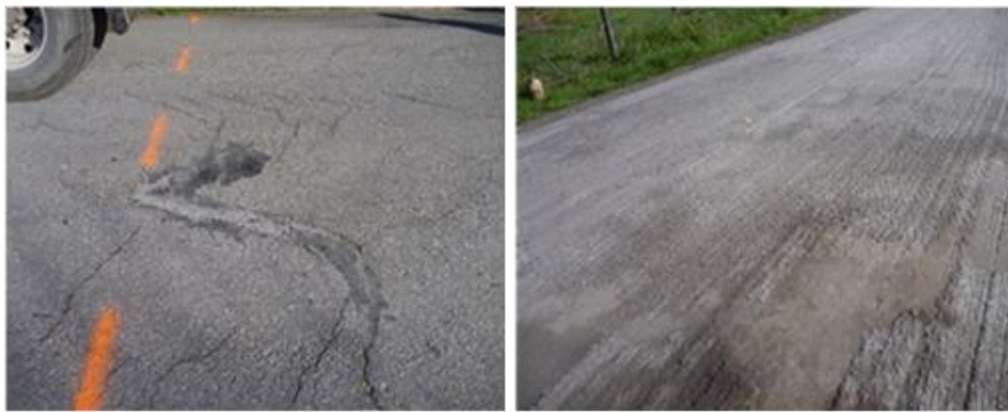
Figure 1. Slippage Cracks and Milled Surface on Route 611

at a thickness of 1.5 in. For this particular application, a leveling course was not needed. However, slippage cracks found at the beginning of the project triggered pre-placement surface milling for approximately 130 ft (Figure 1). Surface debris was removed and the pavement was thoroughly swept before installation. Figure 2 shows the interlayer placement procedure. First, an asphalt binder (PG 64S-22) was used as a tack coat. An application rate of 0.13 gal/yd² (applied at a temperature of 310°F) was used for the milled surface, and an application rate of 0.11 gal/yd² was used for the unmilled surface. Second, the interlayer was placed immediately following the tack coat application using a laydown machine, as shown in Figure 2. The interlayer overlapped 4 in along the transverse joint (overlap between rolls), as shown in Figure 3. Third, the asphalt overlay was placed (Figure 4). Also, as shown in Figure 4, 6 in of additional interlayer width (each lane was approximately 10 ft wide and interlayer that was 10 ft, 6 in wide was installed) was provided for longitudinal joint overlap.

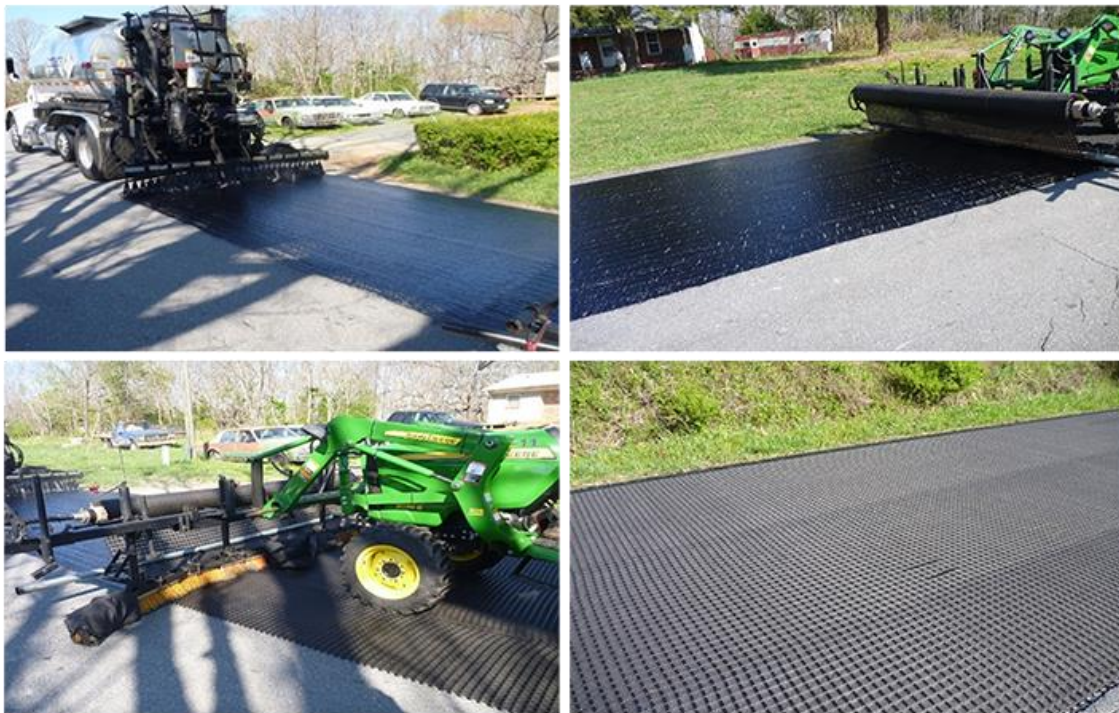
Figure 2. Interlayer Placement on Route 611

The interlayer arrived in 328-ft (100-m) rolls and was placed for a total length of 1,000 linear feet on both lanes for full-width coverage. Both lanes were paved on the same day, and traffic was allowed on one lane while paving was done on another lane. The interlayer fabric, which was pre-coated with bitumen, was roughly 1 mm thick. An asphalt surface mixture having a nominal maximum aggregate size (NMAS) of 9.5 mm was placed above the interlayer

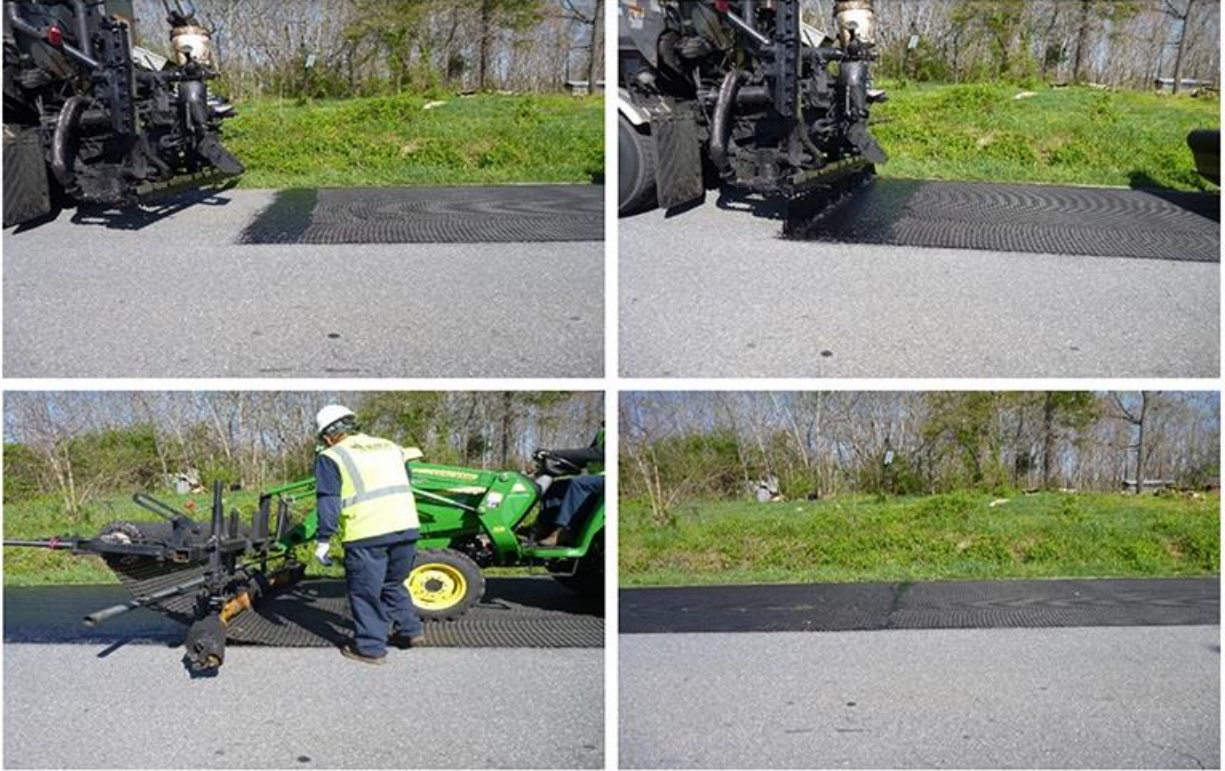
Figure 3. Longitudinal Interlayer Overlap (Route 611)

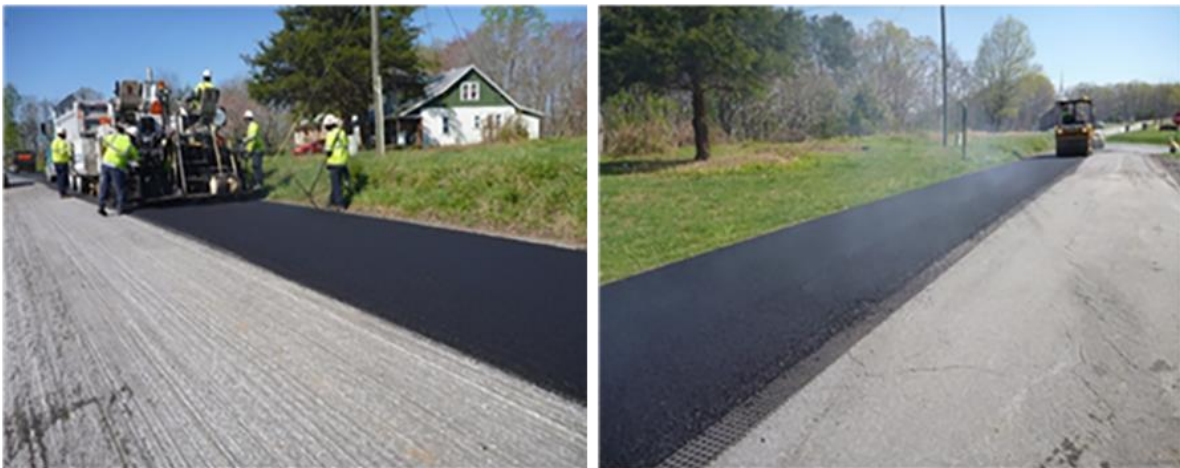
Figure 4. Asphalt Overlay Placement

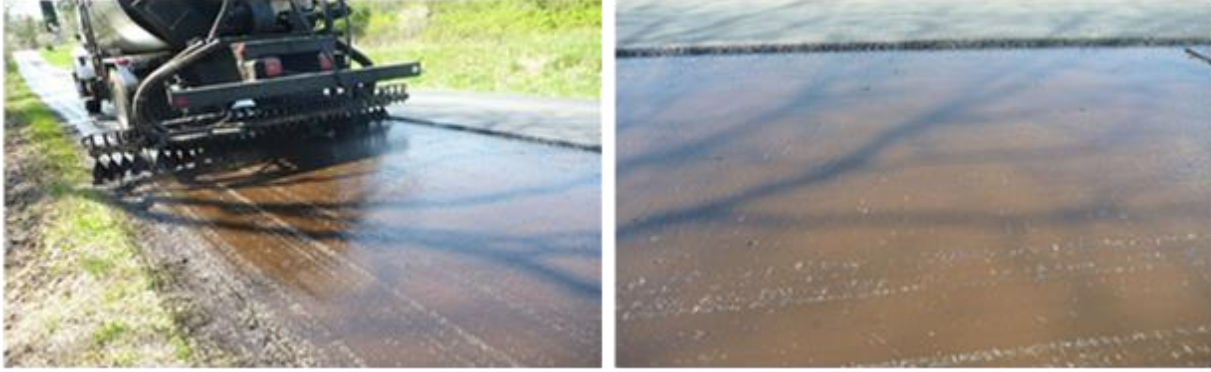
Figure 5. Tack Application at the Control Section

The remaining 3 miles of the overlay project, contiguous to the 1,000-ft test section, did not contain the interlayer and served as an experimental control section. In the control section, a conventional tack coat application rate of 0.09 gal/yd^2 (using a CRS-1H emulsion) was used, as shown in Figure 5.

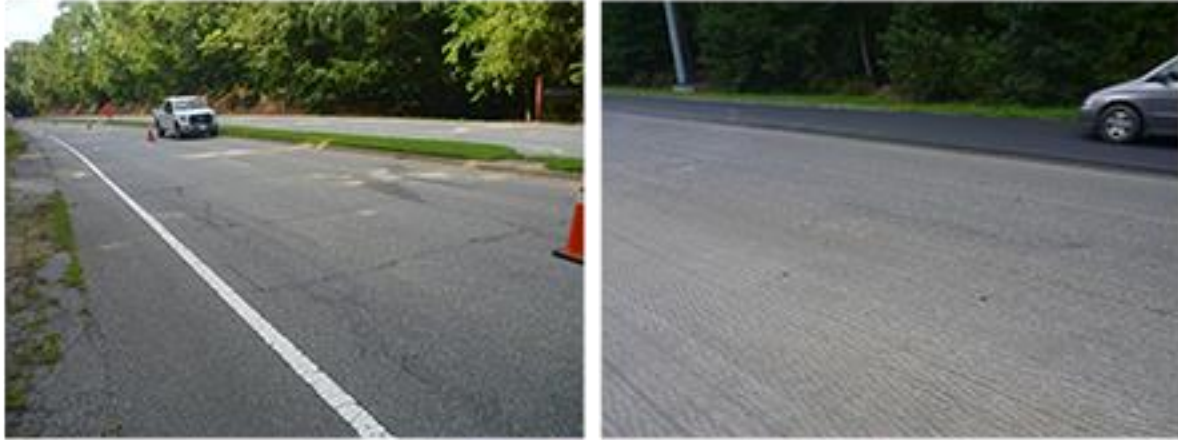
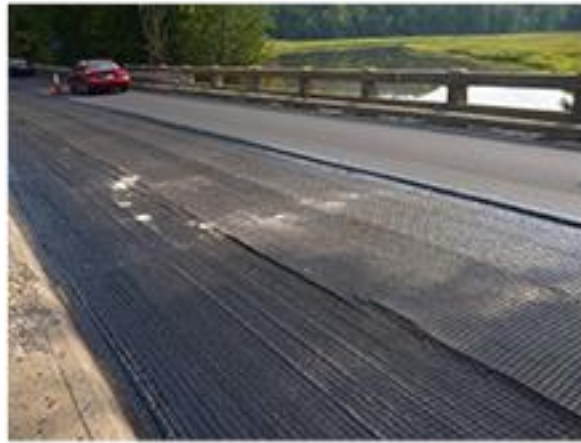
Figure 6. Fabric Placement on Route 143

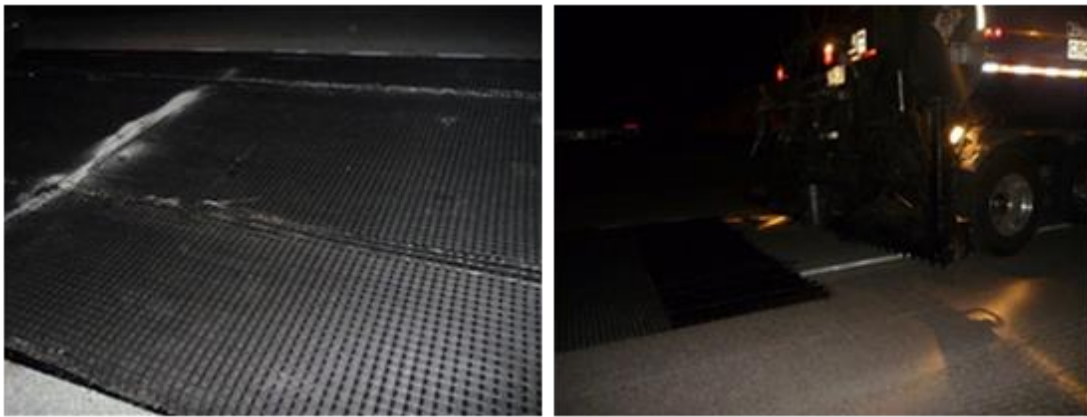
Figure 7. Fabric Placement on US 17

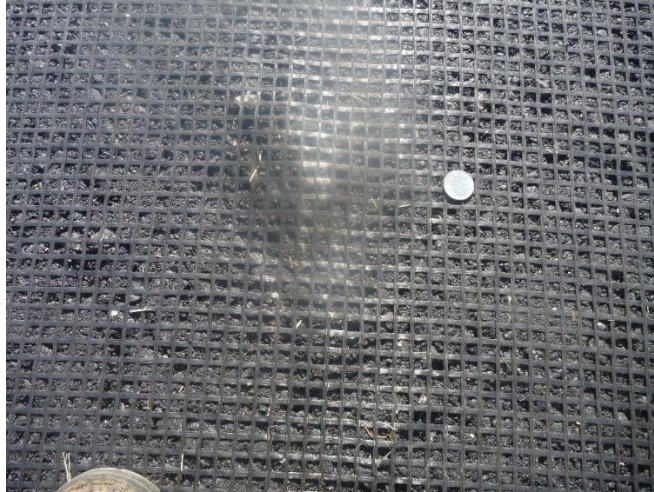
Figure 8. Interlayer Used on US 460

A different type of fabric (designated “Type B” in this report) was placed on US 460 in October 2018. Type B fabric is composed of high-strength glass filament yarns woven into a grid and coated with resin (Figure 8). According to the manufacturer, the coating enhances the bond between layers of asphalt. Type B fabric properties include tensile strength = 100kN/m (560 lb/in); grid size = 12 mm x 12 mm; etc.

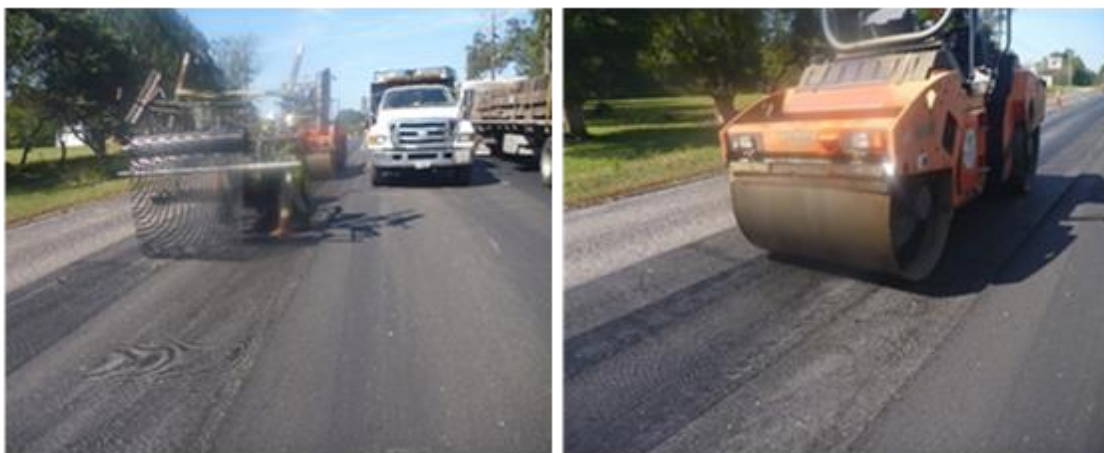
Figure 9. Interlayer Placement on US 460

The fabric roll length was 328 ft, but the width was 5 ft. The project was 1.12 miles long with a 2-in asphalt overlay on top. The placement procedure was also different than with the Type A projects. The surface was milled first, and a leveling course with asphalt mixture (3/4-in-thick SM 12.5D mixture) was installed. Fabric was placed on the leveling course once the asphalt mixture cooled down to 100°F. The fabric was rolled into place using steel rollers (Figure 9). An initial trial with pneumatic tire rollers did not work because the roller picked up the fabric. Next, an asphalt emulsion was applied on top of the fabric, and then the asphalt overlay was placed on top of that (Figure 10). A 6-in longitudinal overlap (alongside and next longitudinal roll) was provided for the next roll of fabric. A dust-free surface is very important for this fabric placement. Care should be taken when driving the emulsion truck over the fabric to avoid tearing/bunching/pickup. Because of the 5-ft width of each roll, multiple overlaps resulted in a slower installation rate. The additional use of a leveling course also reduced the construction speed.

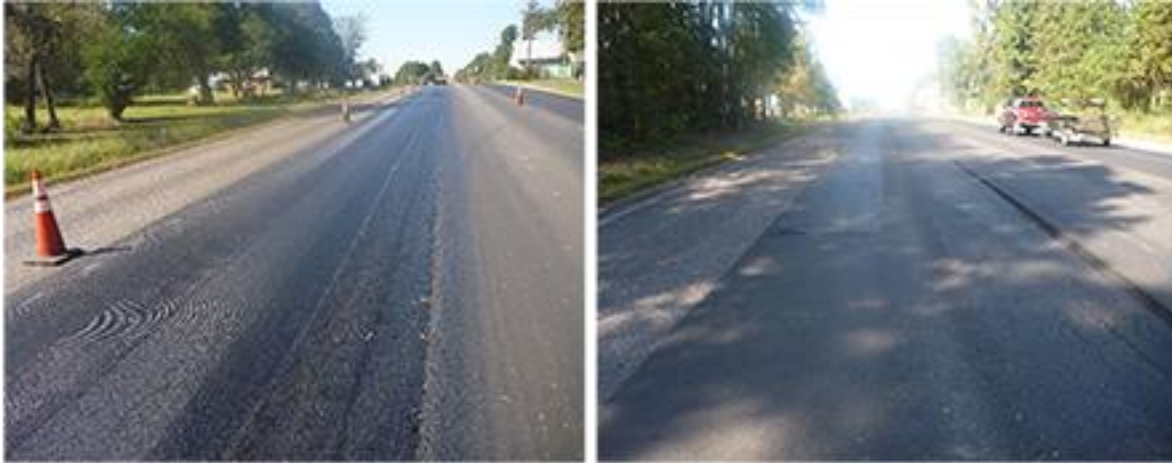
Figure 10. Emulsion Application and Overlay on US 460

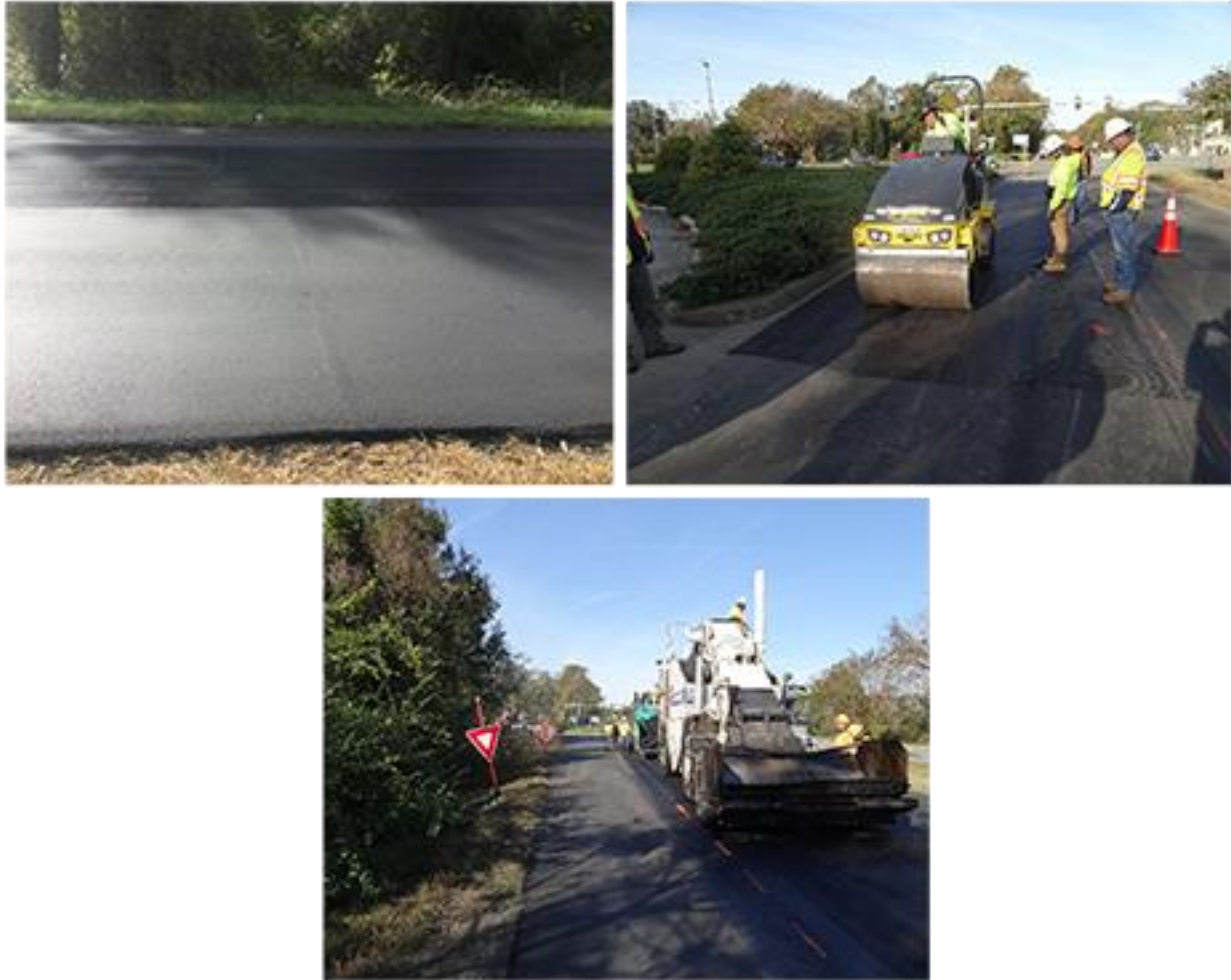
Figure 11. Interlayer and Overlay Placement on SR 30

A second Type B interlayer was placed on SR 30 in York County in October 2018 on exposed JCP. Concrete patching was first conducted on deteriorated surfaces (approximate total quantity of 1,000 yd²), and joint sealant was installed in existing joints. As with the US 460 project, application of the fabric was preceded by a leveling course, which consisted of a nominally 1-in-thick asphalt surface mixture having an NMA of 4.75 mm (VDOT designation SM-4.75). This mixture incorporated 30% reclaimed asphalt pavement (RAP), 24% natural sand, and an asphalt content of 6.3% PG 64S-22. The percentage passing the No. 4, No. 16, and No. 200 sieves was 92%, 54%, and 9.1%, respectively. SM 4.75 mixtures were produced in accordance with VDOT's special provision for SM 4.75 mix design (VDOT, 2016).

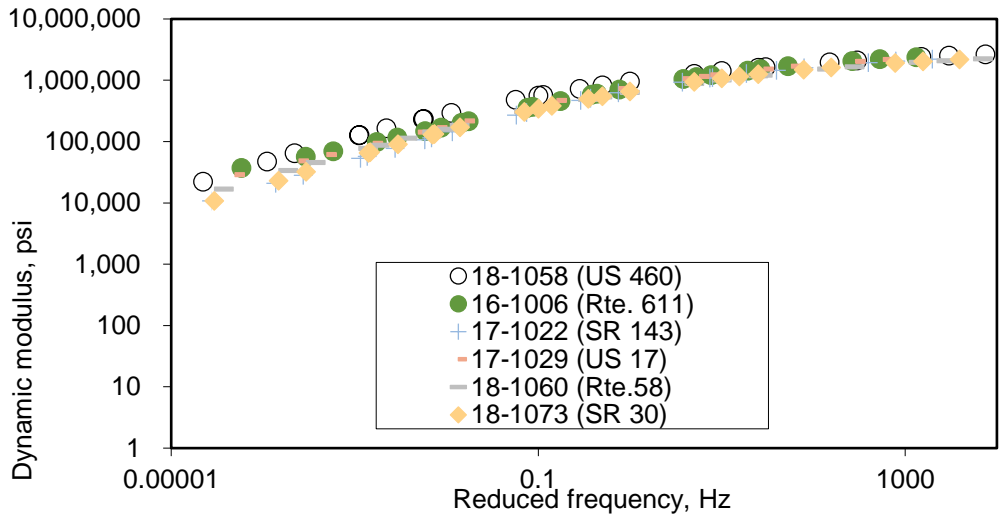
Figure 13. Dynamic Modulus Results (log-log Scale)

Dynamic modulus is one of the inputs required in AASHTOWare Pavement ME Design and is a measure of mixture stiffness. These data will be useful for future calibrations of pavement sections with interlayers. Figures 12 and 13 show dynamic modulus test results in semi-log and log-log scale. The figures show that modulus values are different for high and intermediate temperatures. Mixture 18-1058 showed the highest stiffness among all mixtures. Modulus differences among mixtures are due to changes in binder content and binder stiffness. With all mixtures using nearly 30% RAP, the stiffness of the RAP binder is also affecting the dynamic modulus.

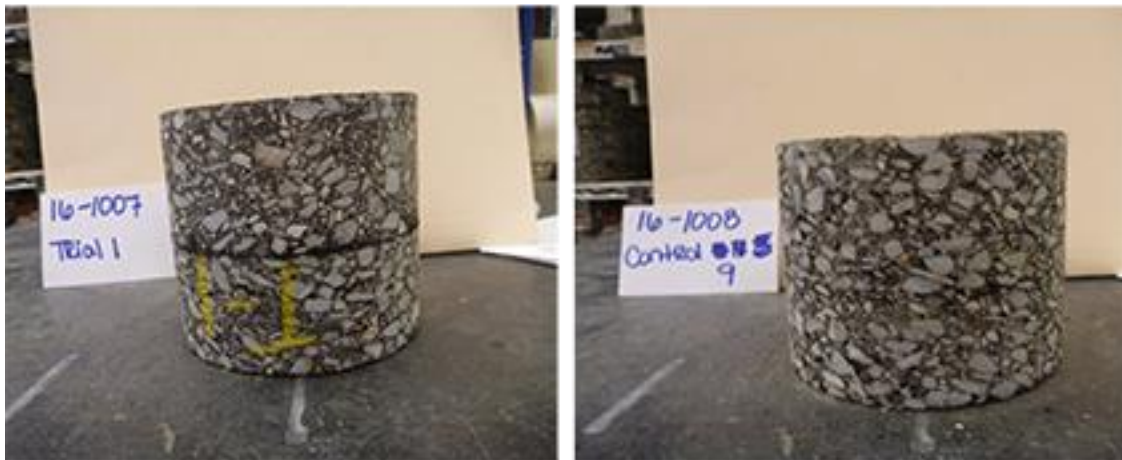
Figure 13. Cores from Route 611 Project: (left) from interlayer section; (right) from control section

One of the keys to good interlayer installation (and ultimately performance) is establishing a good bond between the various layer components. To examine bond strength, cores were taken (eight cores from each project) 3 weeks after each project was completed for three of the Type A installations (Route 611, SR 143, and US 17). Figure 13 shows cores from the interlayer and the control section from the Route 611 project. Cores were also taken from the Route 611 project after 1 year in service. Table 7 shows the bond strength results for Route 611. The interlayer section showed lower bond strength compared to the control section (without an interlayer) at 3 weeks in service, a trend that is also evident after 1 year. In both the control and interlayer sections, shear strength had decreased and tensile strength had increased when core test results of initial and 1-year tests were compared.
