# Standard Design for Nebraska County Bridges

**Final Report  
M-064**

December 2019

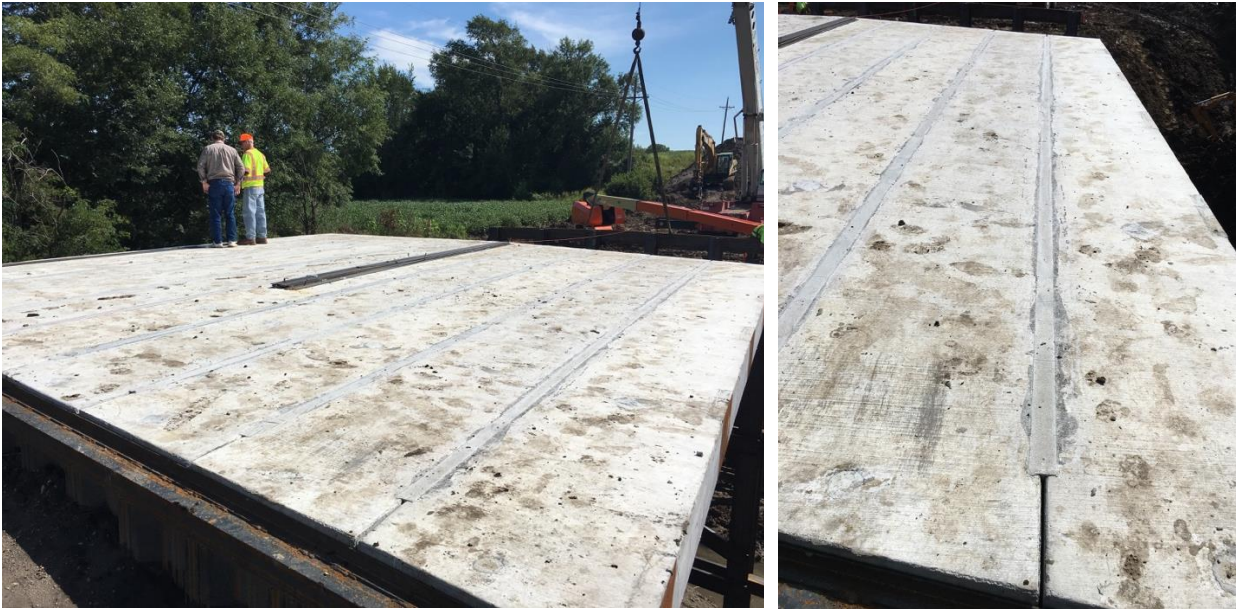
The grout between these longitudinal shear keys easily cracks and creates a path for water and chlorides to penetrate through. Even though deicing salt may not be used in the counties, vehicles that cross the bridges can bring chlorides into these joints. The structural performance

**Figure 1.3: Grouts Between Longitudinal Shear Keys**

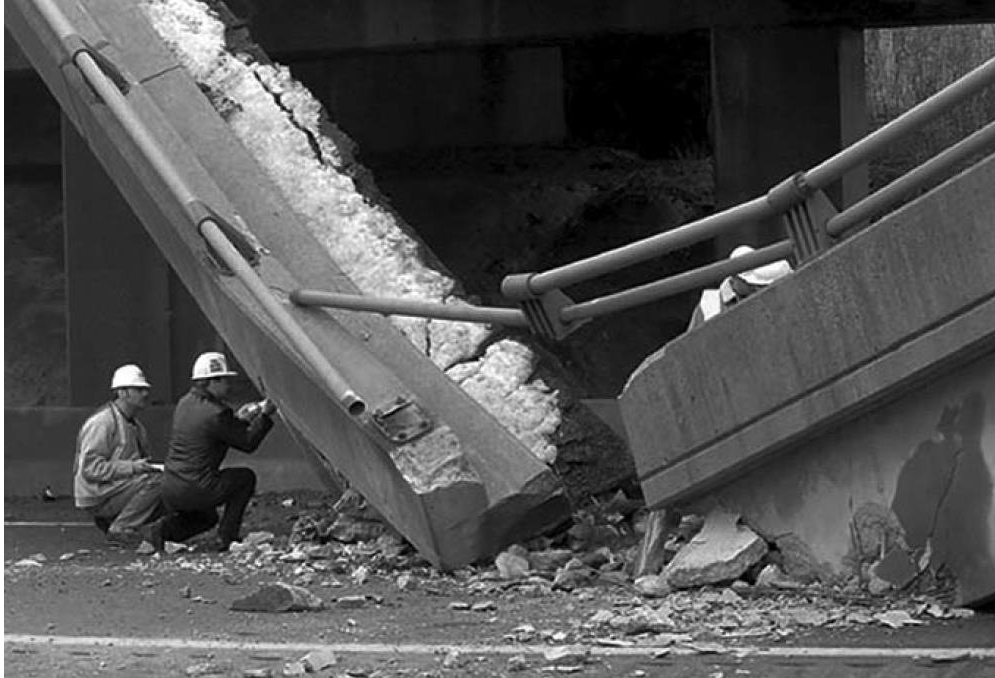
**Figure 2.9: Forensic Examination of Non-composite Adjacent Precast Prestressed Concrete Box Beam Bridge Failure in Pennsylvania (retrieved from Naito et al., 2010)**

From this inspection it was noted that an impact may have happened to a specific beam, and that 20 of the 60 strands were broken in that member. The other members were only moderately damaged and the bridge was rated as poor (four on a scale of zero to nine). Beam replacement was labeled as a priority. It was later discovered after the collapse through inspection that 39 of the 60 strands were severely damaged through corrosion and it was believed that there was no indication of an impact before the collapse. This bridge had four spans each of which had eight pretensioned box beams with an approximate two-inch bituminous overlay with no water-proofing membrane. The bridge beams were poured and erected in 1960. The clear cover from the strands to the exterior surface for the beam that collapsed ranged from 1 foot and 5/16 inches to 1 foot and 9/16 inches which met the 1953 AASHTO Standard Specifications for

The next item the research team investigated was the shear reinforcement. The shear stirrups were not placed below the bottom layer of prestressing strands and for the ease of construction an L-shape was used and placed between the first and second layer of strands which was common practice at the time the bridge was constructed. It should be noted this is no longer a standard practice. It was also found that many of the top and bottom L-shaped stirrups were not physically lap-spliced in the middle and were separate from each other. Due to this lack of splice contact and also the short development length provided (12 in.), the authors were concerned about the shear capacity for these box girders. An interesting note for this bridge was the way in which the void was formed and the drains that were used. The voids were constructed with the use of cardboard void forms. It was found that these forms moved during concrete placement and created a final product that did not match the design drawings with regards to wall thickness. In the late 1950's,  $\frac{3}{4}$  inch diameter drains were placed in both the top and bottom flange. These drains allowed moisture to enter the void and wet the cardboard. This cardboard eventually degraded and possibly blocked the exit drains leading to excess water being held inside the void. The excess water not only added to the potential corrosion of strands but also increased the total live load on the member. Both air content and concrete strength were found to be within the design requirements. Upon investigation it was found that over 40% of the strands were found to be in serious or critical condition, which means that the strands were deteriorated to a point that seriously affected the primary structural components of the bridge and corrective action was needed based on the PennDOT Superstructure Condition Rating Guidelines. With all the forensics of this bridge, there were two major takeaways with respect to

bridge inspection and evaluation that the research team suggested to prevent a similar failure. The first was to deduct 125% of the total cross-sectional area from all exposed strands when calculating the structural capacity. The other suggestion based on the observations of this collapse case was that strands adjacent to or intersecting a crack should not be considered as an effective strand due to possible corrosion.

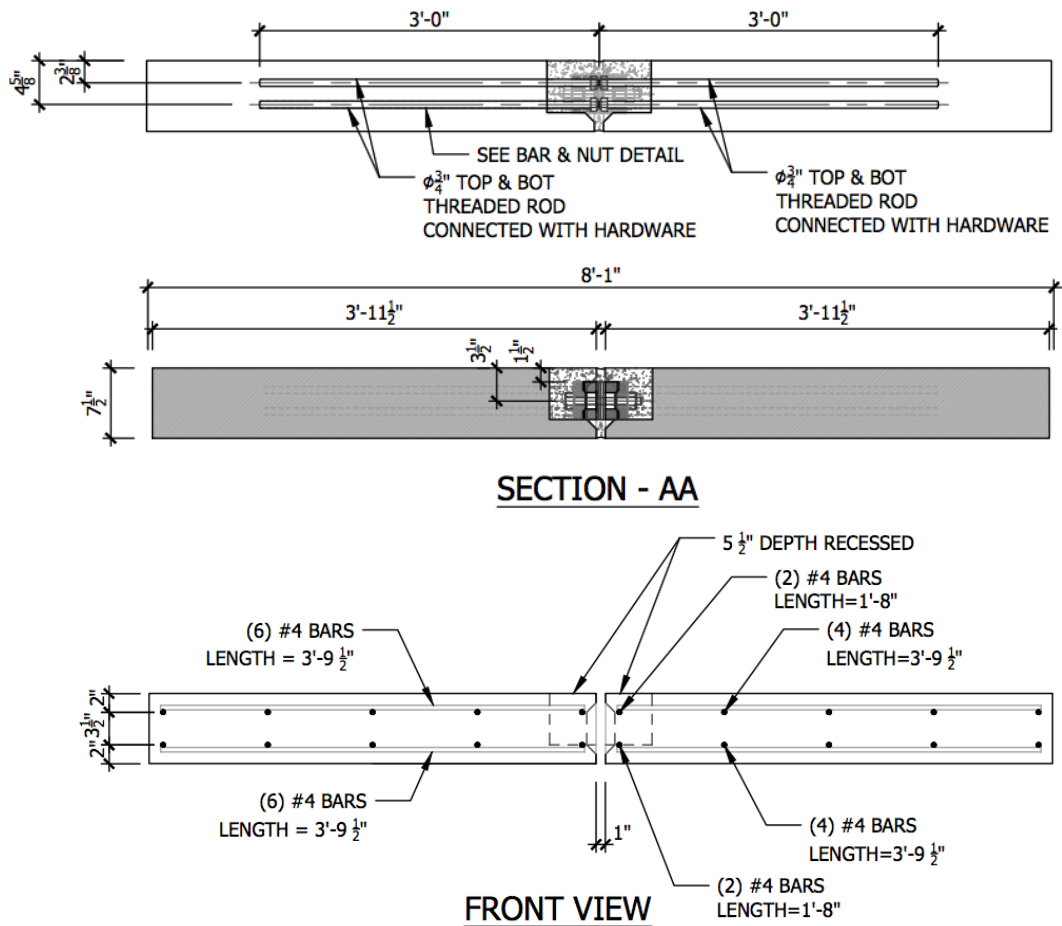
(a) rebar layout      (b) bolt connection      (c) threaded bar connection

**Figure 3.2: Plan and Section View of Slab Specimens Connected**

It should be noted that the block out around the mechanical joint follows the details provided in Figure 3.2. It should also be noted that these block out designs should be redesigned to allow more space for the removal and replacement of the connection bolt. This was learned after the building experience.

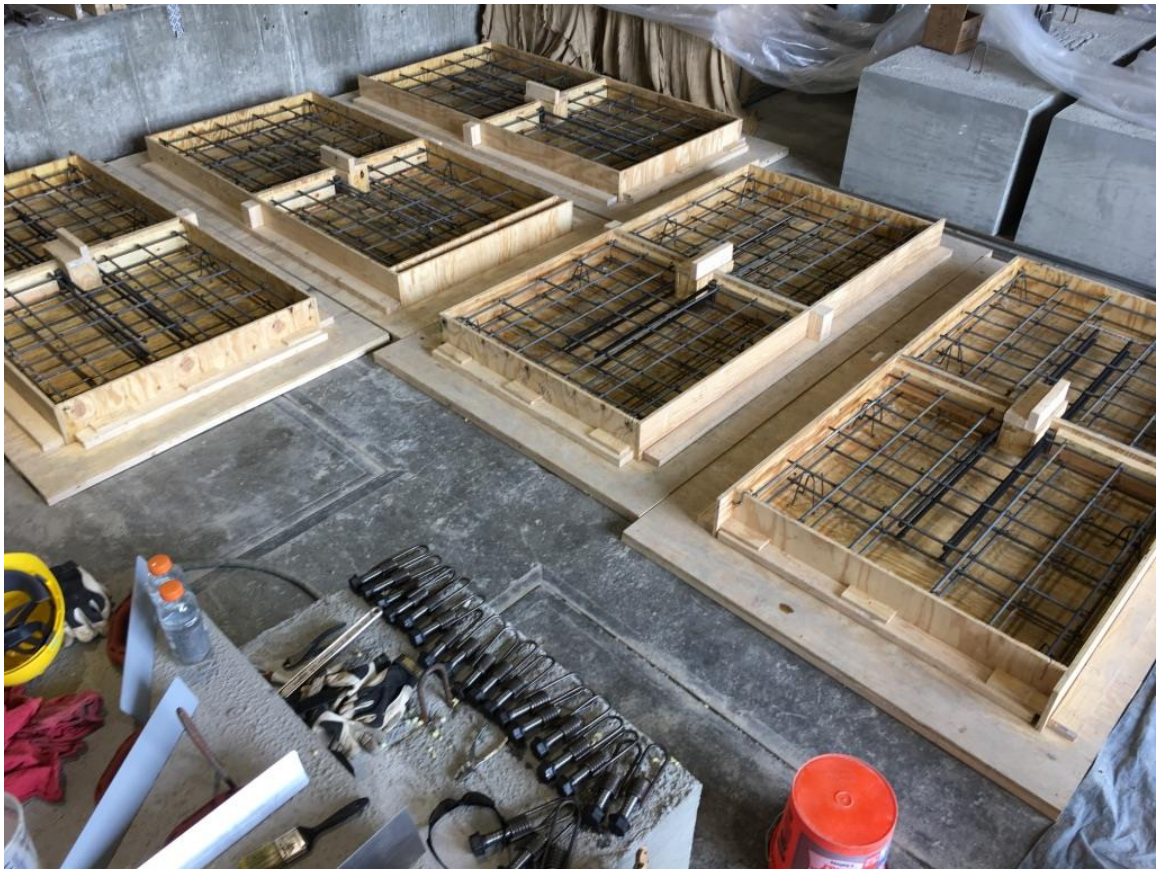
**Figure 3.5: Formwork for Mechanical Connection Slab Panels**

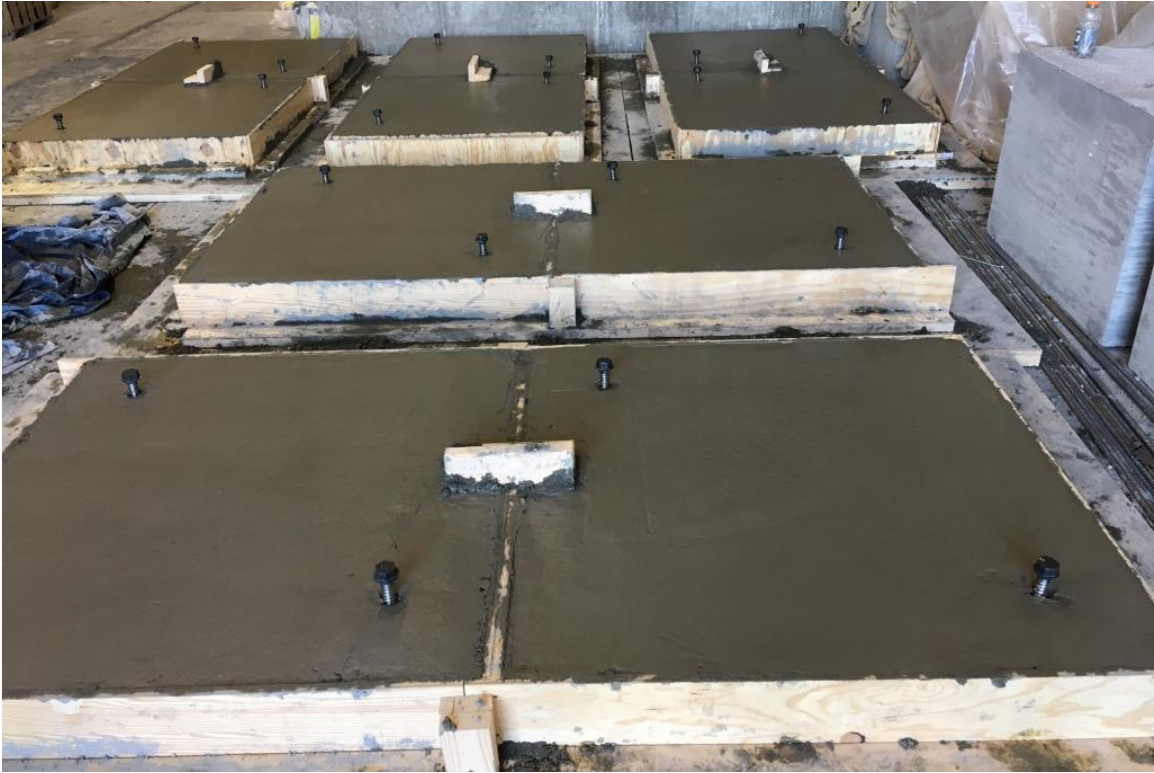
**Figure 3.6: Finished Slabs After Anchor Placement**

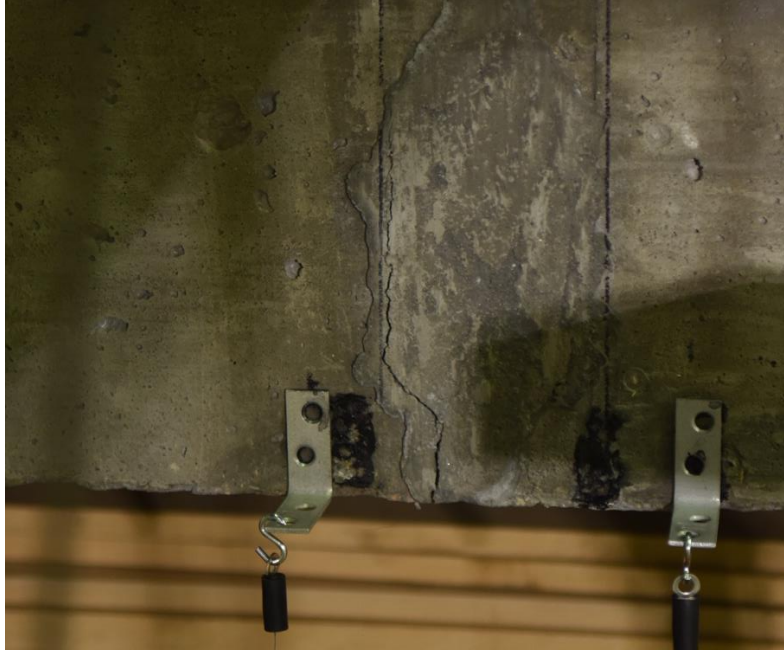
**Figure 3.12: Initial Cracking at the Grout Interface (Specimen F-F-1)**

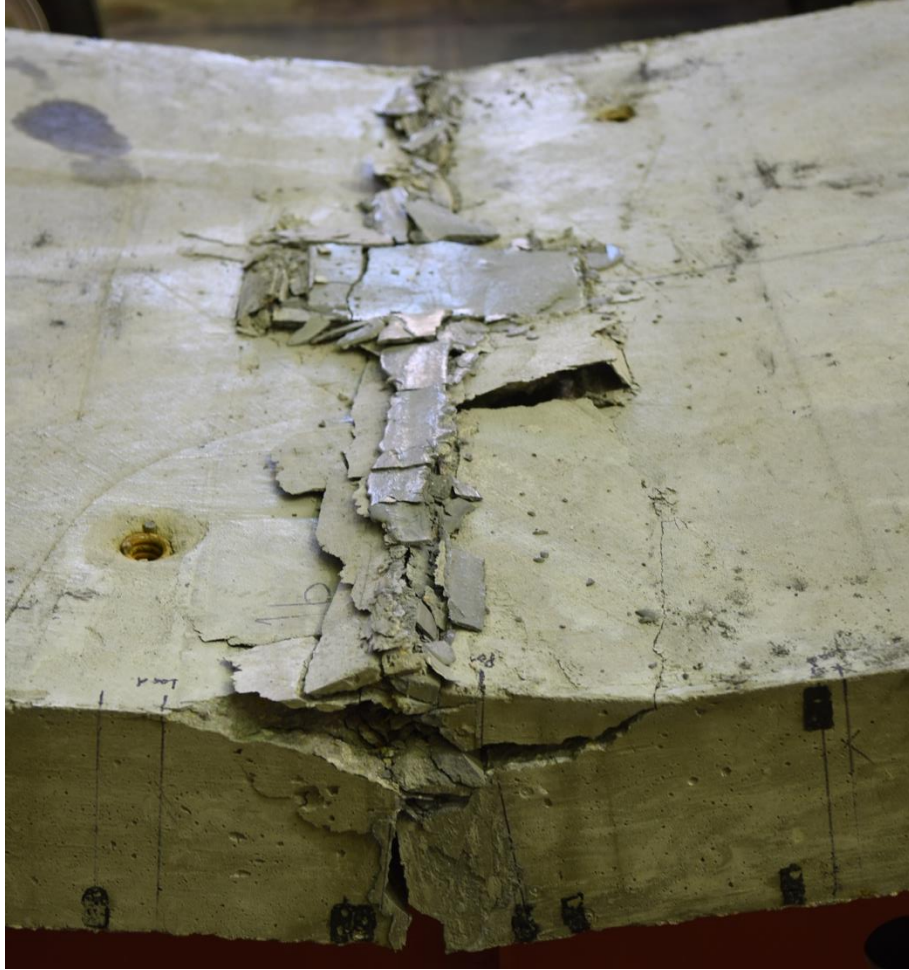
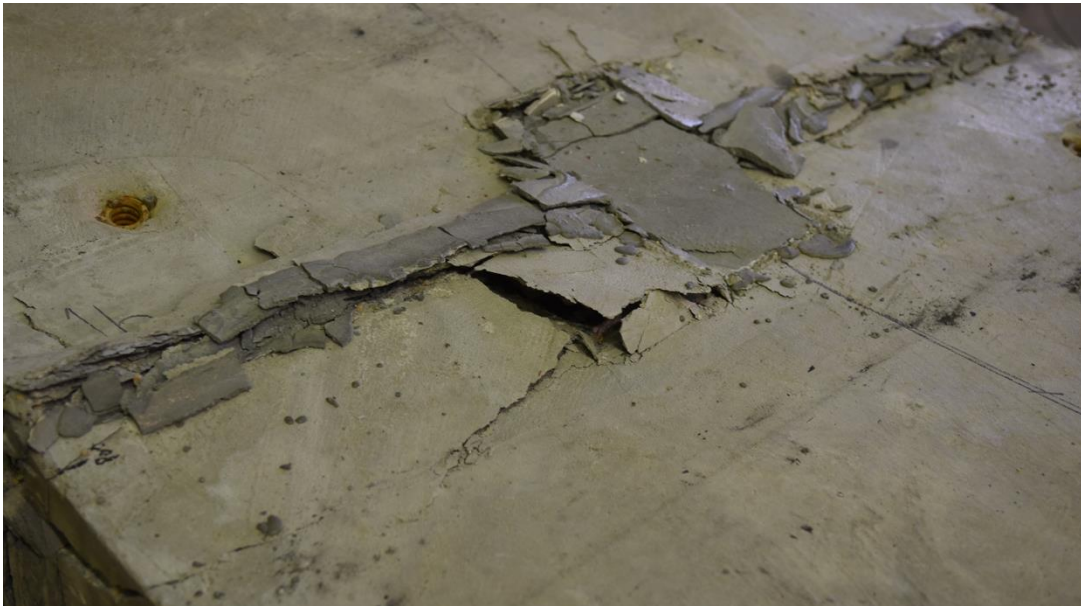
Figure 3.16 shows a close-up photo of the joint taken after the test was complete. Other than the shear crack that initiated at the corner of the joint where the shape changes that propagated through the slab to the loading points and some cracks initiating from the corners of the block out area, no other cracks were observed in the two slabs connected. The grout was taken out after the testing was complete to observe the performance of the mechanical joint after failure. As shown in Figure 3.17, the two slabs were still connected by the ASTM A490 bolt through the mechanical joint. All fine threaded bars were embedded in concrete well.

**Figure 3.16: Specimen F-F-1 Joint Close-up Photo after Failure**

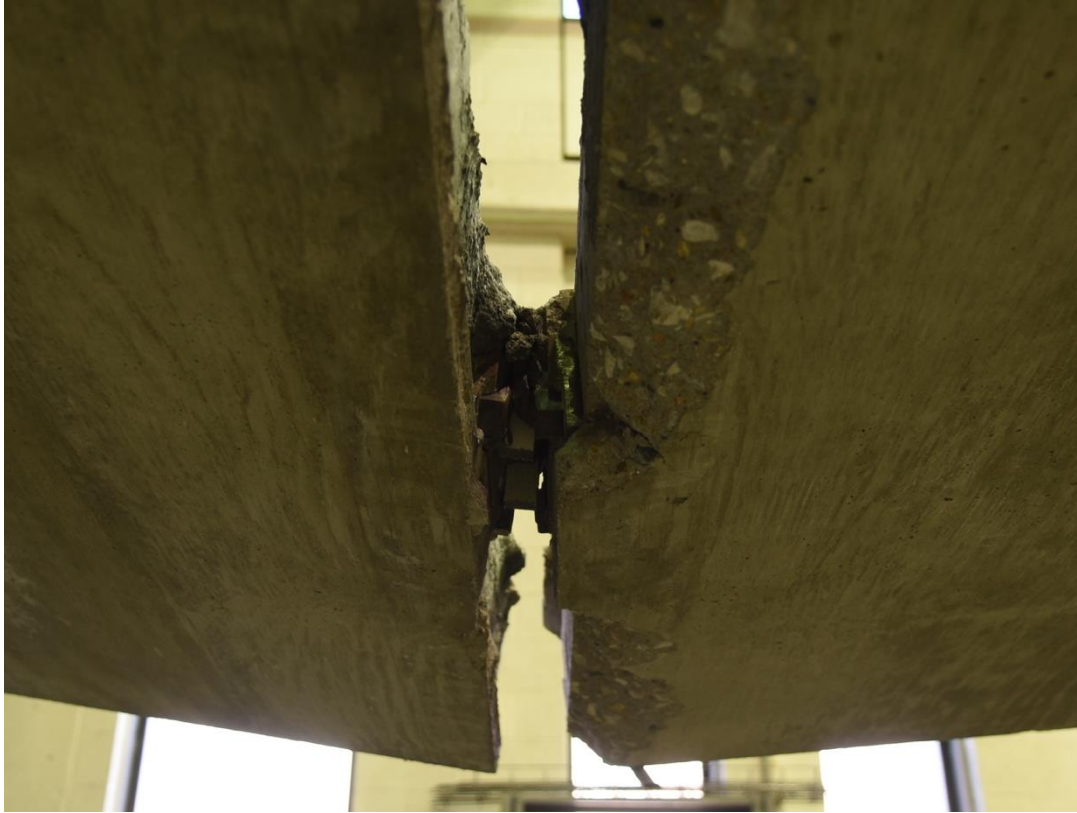
**Figure 3.17: Mechanical Joint Connecting the adjoining Slabs after Failure**

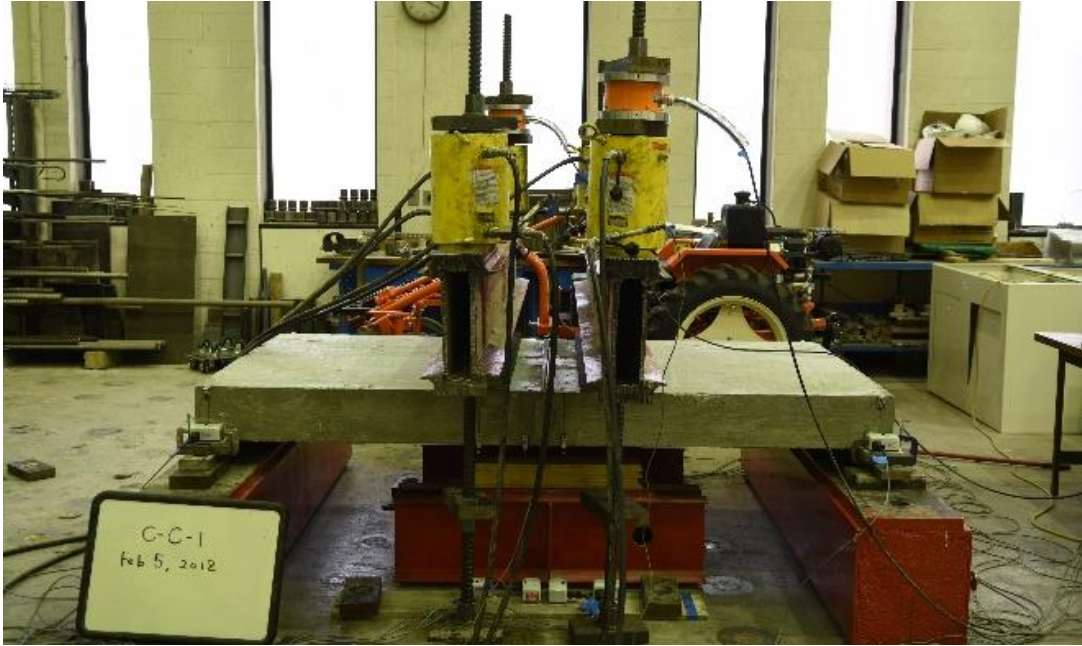
This section provides the test results of the four-point bending test on the specimen containing coarse all-threads on each side (Specimen C-C-1, Figure 3.18). The first crack was observed at a similar location as shown in Specimen F-F-1 at the interface between the grout and the specimen in the south side (front). However, on the north side (back), as shown in Figure 3.19, the crack that initiated from bottom started to shear through the grouting. As more load was applied, the crack propagated in an inclined direction towards the loading point as shown in Figure 3.20. The crack at the joint opened up wide allowing the two slabs to rotate until the top of the grout crushed (Figure 3.21). However, the top of the concrete slab did not crush as much as Specimen F-F-1.

**Figure 3.18: Four-point Bending Test Setup (Specimen C-C-1)**

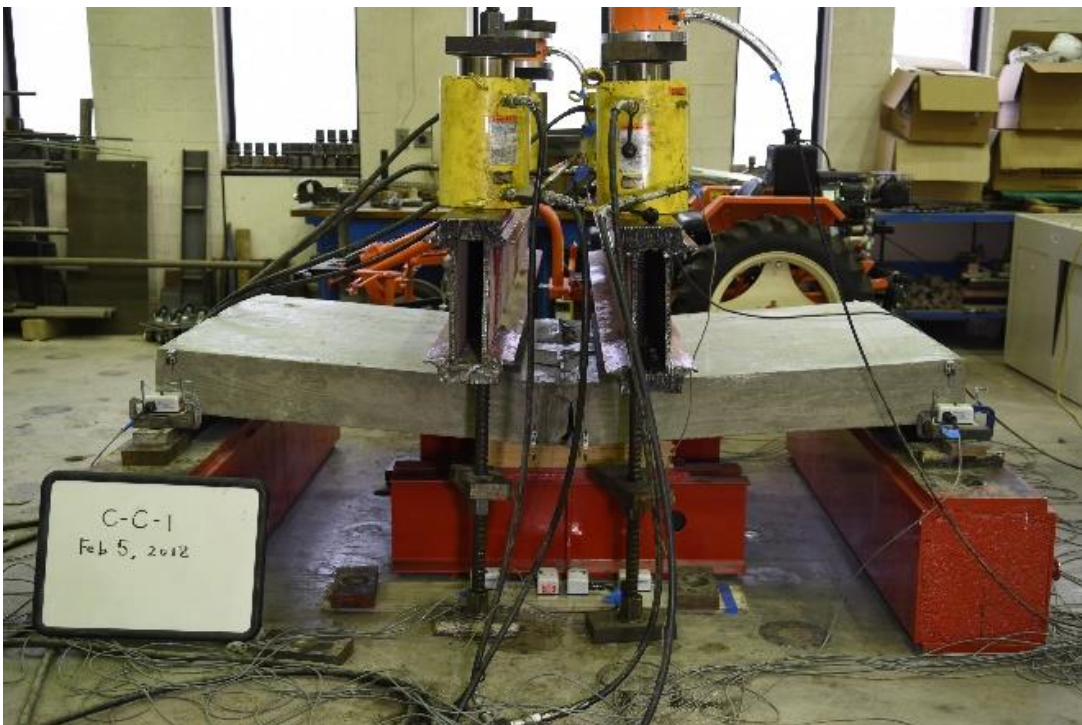
**Figure 3.21: Specimen C-C-1 at Failure (view from South side)**

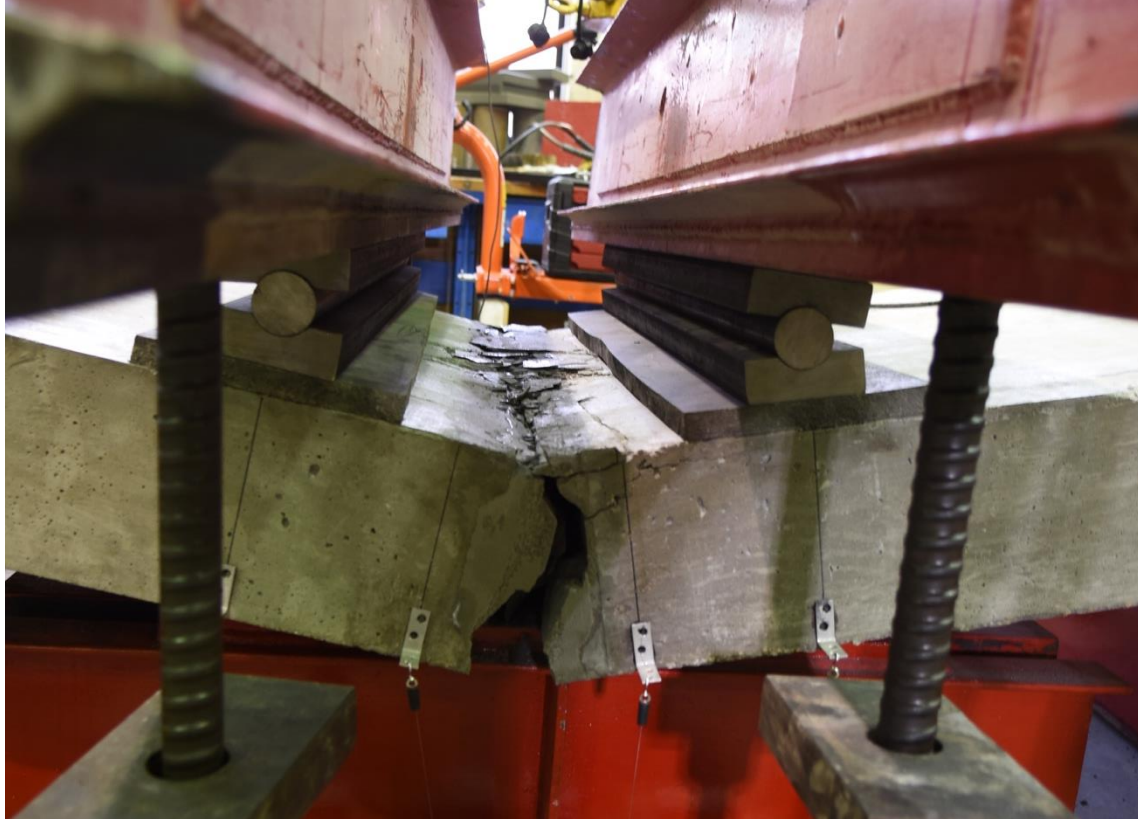
**Figure 3.22: Specimen C-C-1 at Failure (view from North side)**

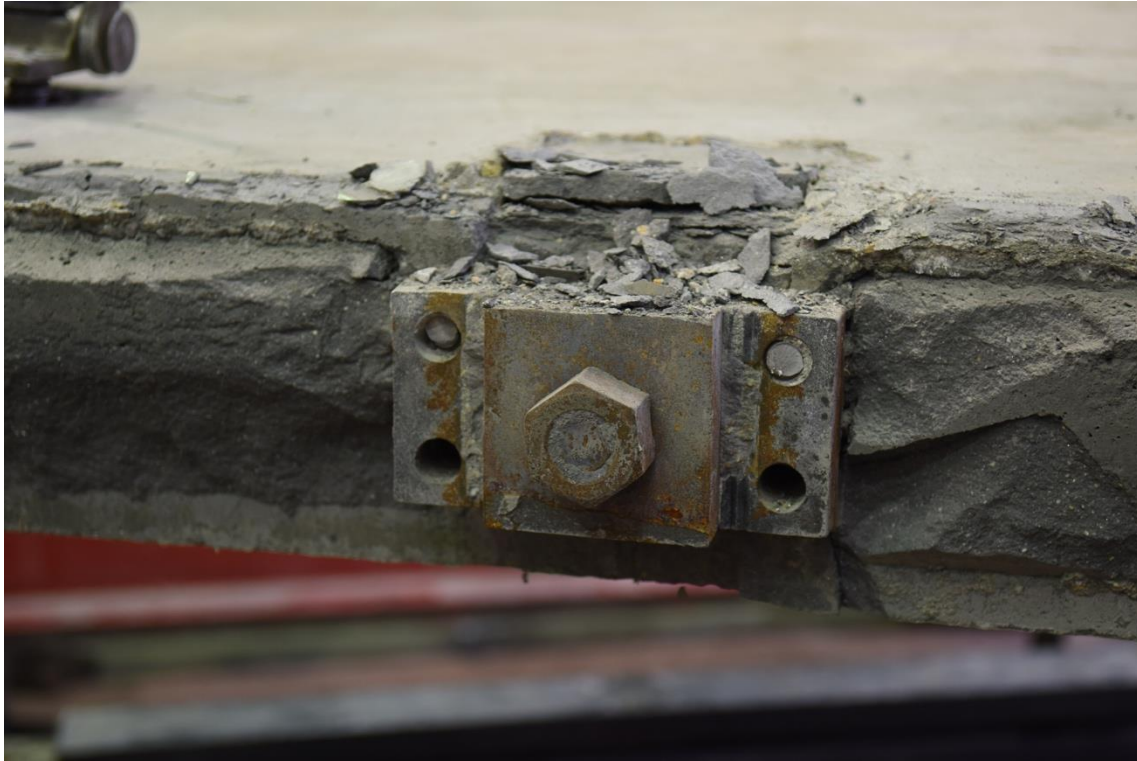
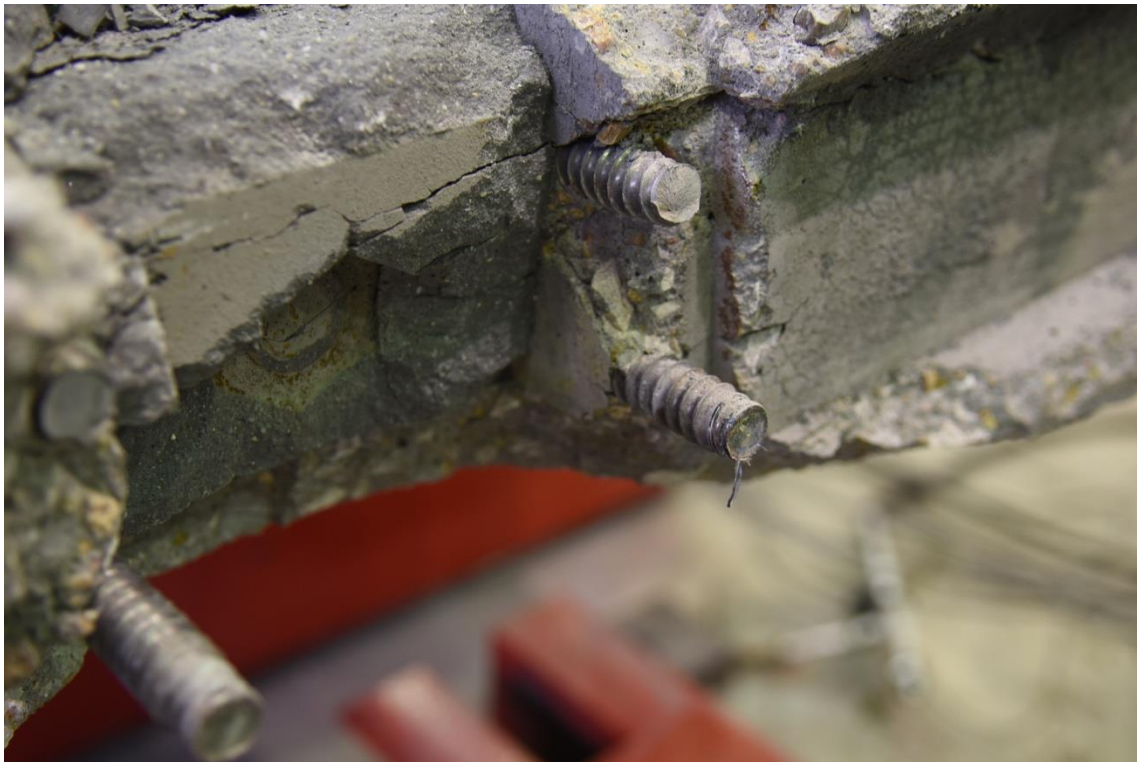
After the test was complete, all the grout was taken out to check the mechanical connection. The coarse threaded bars were noted to have sheared off as shown in Figure 3.24. This was possibly caused by less bond of the coarse threads compared to the fine threaded bars. If the threaded bars were slipping near failure, there is a possibility that all the moments were taken by these threaded bars before failure, which is the reason Specimen C-C-1 was not able to take more rotation and the load capacity dropped suddenly at a smaller deflection value than Specimen F-F-1.

**Figure 3.24: Mechanical Joint Shear Failure (Specimen C-C-1)**

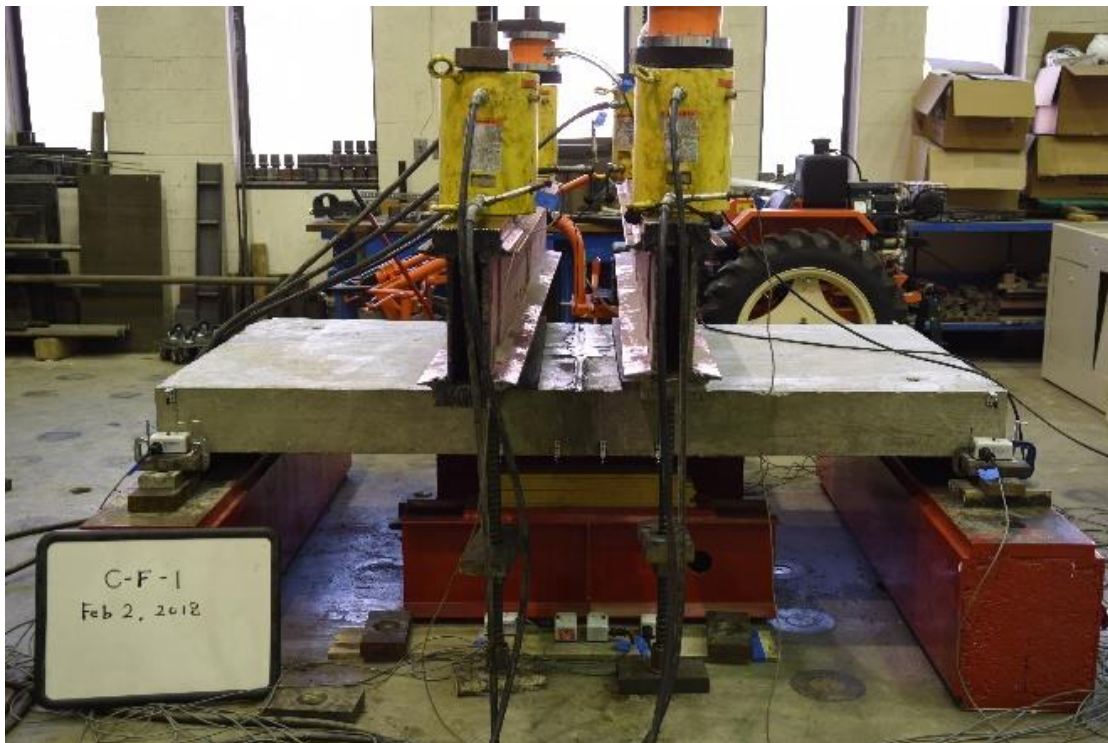
This section provides the test results of the four-point bending test that was conducted on the specimen containing fine all-threads on one side and coarse all-threads on the other side (Specimen C-F-1, Figure 3.25). Initial cracking was shown at the interface between the slab and the grouting similar to other specimens as shown in Figure 3.26. This crack shown in the interface opened larger as more load was applied. And, as load increased, the crack at the interface started to propagate in an inclined direction starting from where the shape of the grout shear key changes towards the loading point as shown in Figure 3.27. There was no crack through the grout as shown in the case with Specimen C-C-1. The top of the grouting crushed before failure as shown in Figure 3.28.

**Figure 3.25: Four-point Bending Test Setup (Specimen C-F-1)**

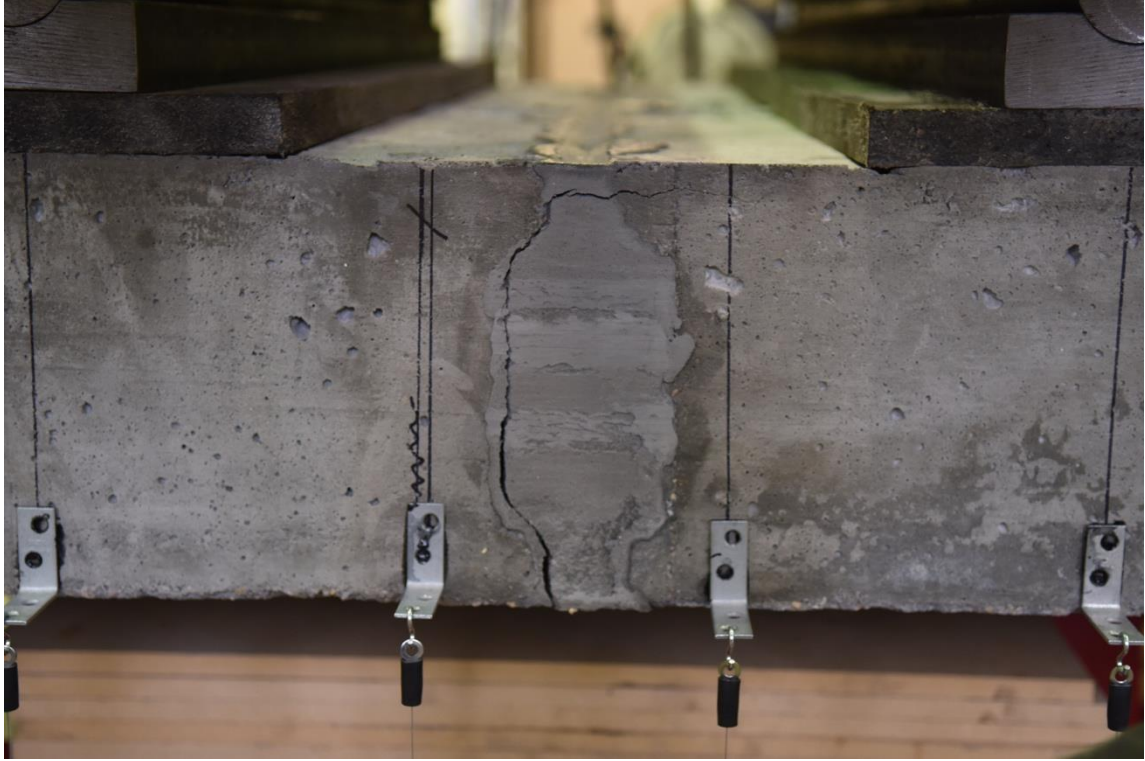
**Figure 3.26: Initial Cracking at the Grout Interface (Specimen C-F-1)**

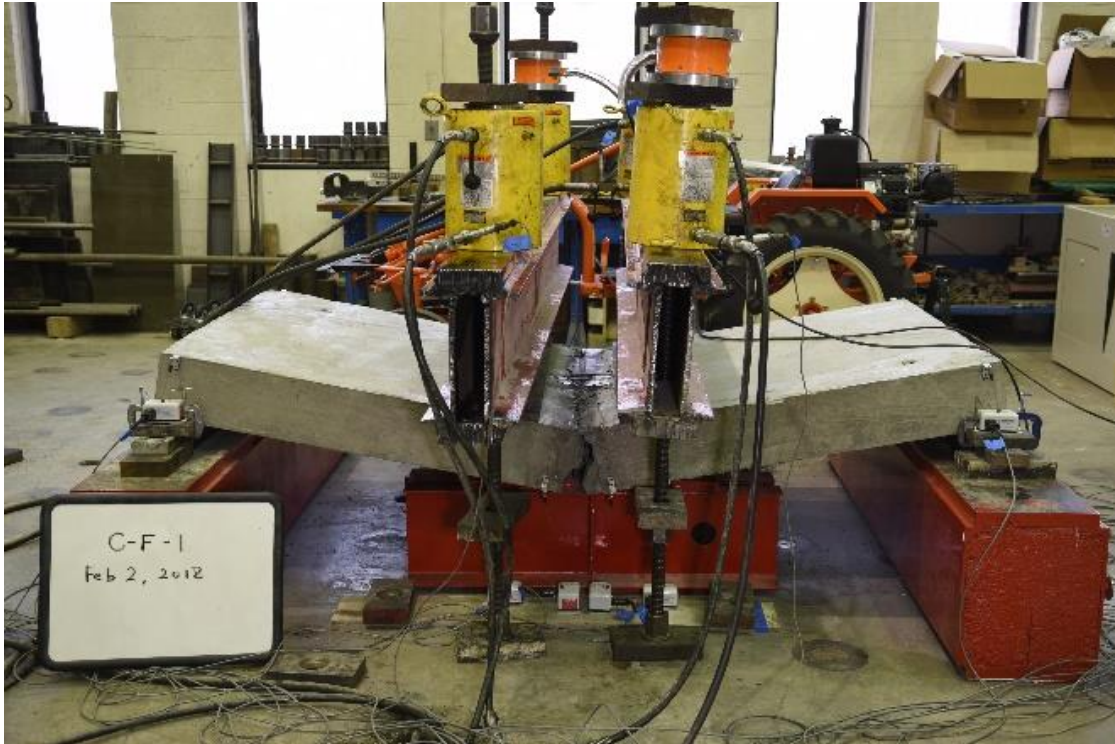
**Figure 3.28: Specimen C-F-1 at Failure**

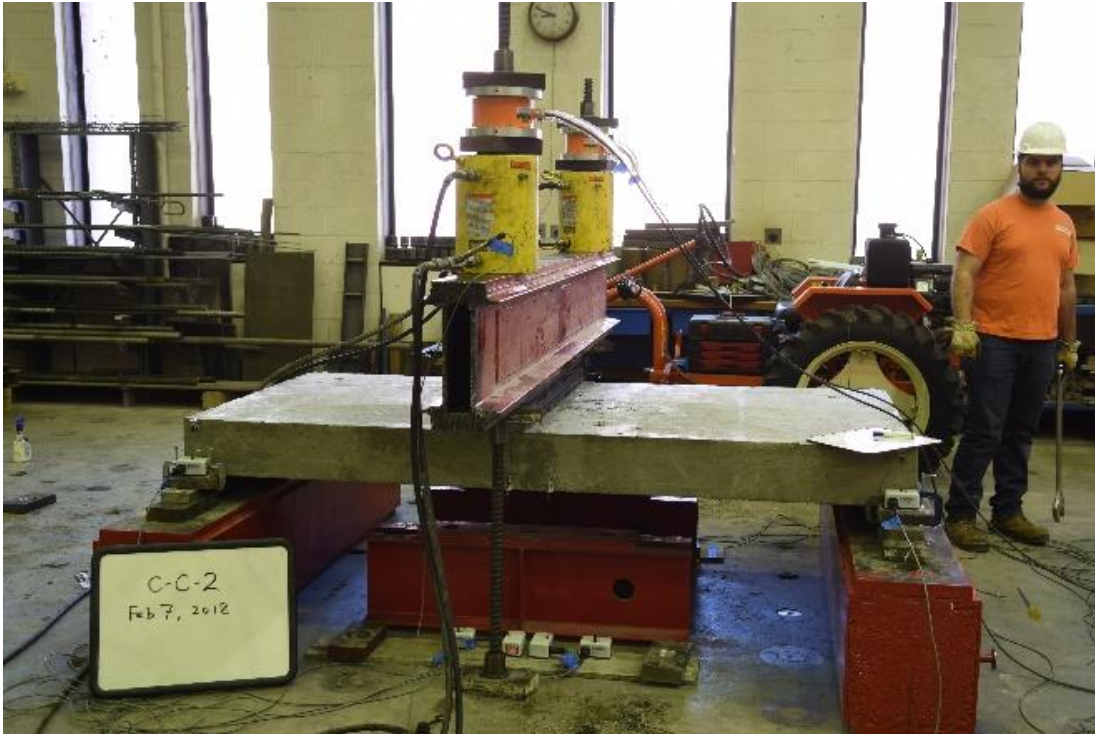
This section provides the test results of the three-point bending test that was conducted on the specimen containing coarse all-threads (Specimen C-C-2, Figure 3.30). Initial cracking was seen at the interface between the slab and the grout similar to other specimens as shown in Figure 3.31. This crack shown at the interface opened larger as more load was applied. As load increased, the crack at the interface started to propagate in an inclined direction starting from where the shape of the grout shear key changes towards the loading point as shown in Figure 3.32.

**Figure 3.30: Three-point Bending Test Setup (Specimen C-C-2)**

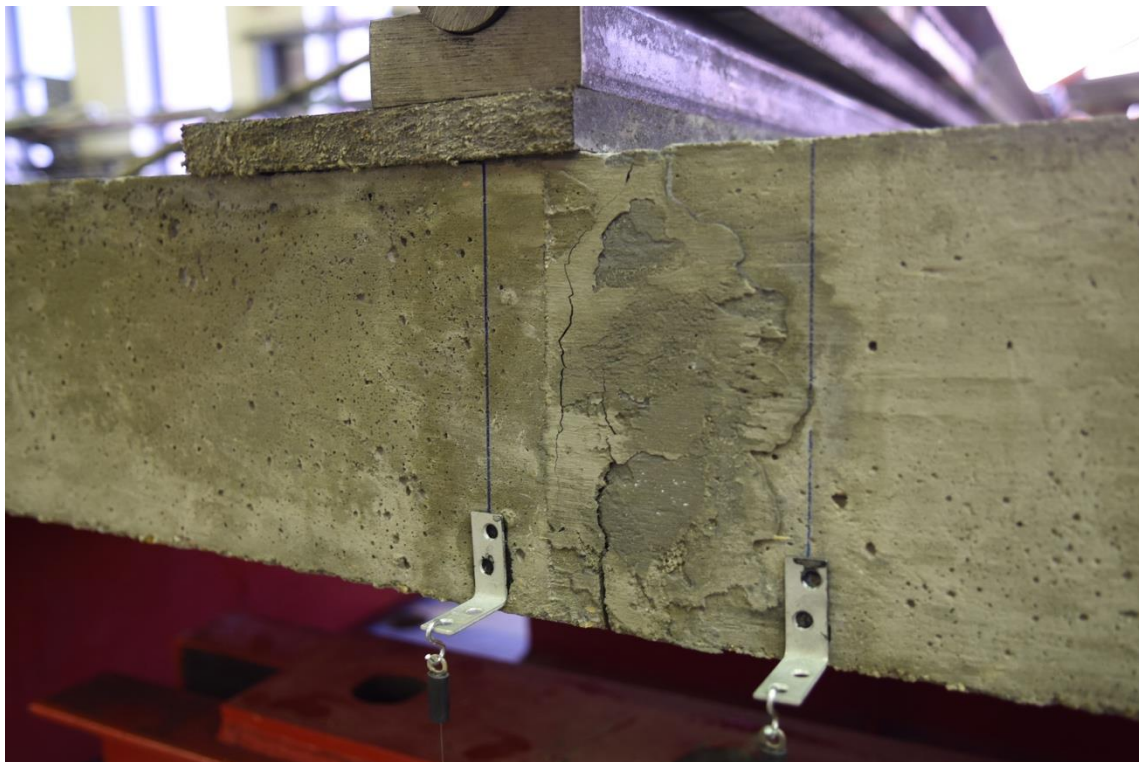
**Figure 3.31: Initial Cracking at the Grout Interface (Specimen C-C-2)**

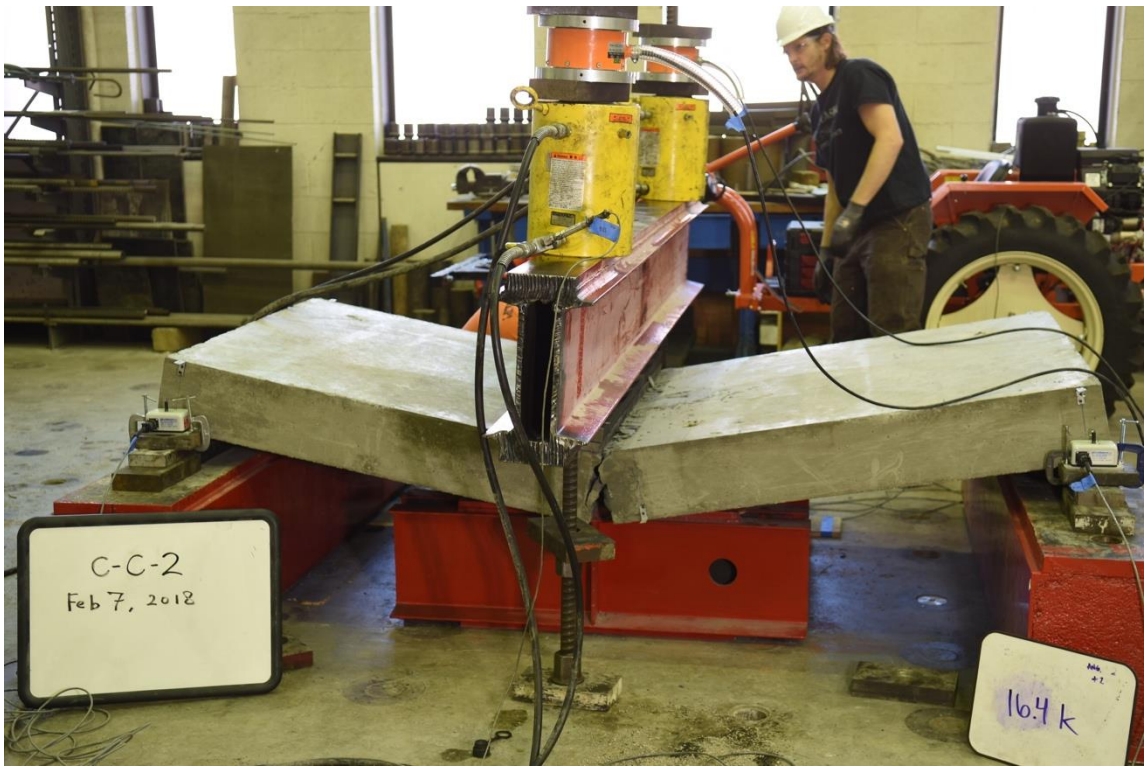
**Figure 3.33: Specimen C-C-2 at Failure**

The failure mode was relatively more brittle in this test compared to the identical specimen tested in four-point bending. There was not much crushing seen in the grout or the concrete slab at failure but rather a huge gap at the interface between the shear key and the slab that was loaded as shown in Figure 3.33. The load-displacement curve for Specimen C-C-2 is shown in Figure 3.34. The maximum load reached was 15.4 kips and the deflection at peak load was 1.4 in. Unlike the four-point bending tests, the load dropped suddenly and it was not possible to see further deflection due to rotation (without further load increase). The shear span for this test was rather slender ( $a/d = 5.8$ ) where it is known that the member fails at a disrupt inclined cracking load. The reading at failure load from the two load cells was 15.4 kips and the reaction force at each support would be 7.7 kips. Considering that the spreader beam weight under the hydraulic ram was 2 kips and including the moment caused by self-weight (5.4 kip-ft) of the slab, the total experimental joint moment was 36.9 kip-ft.

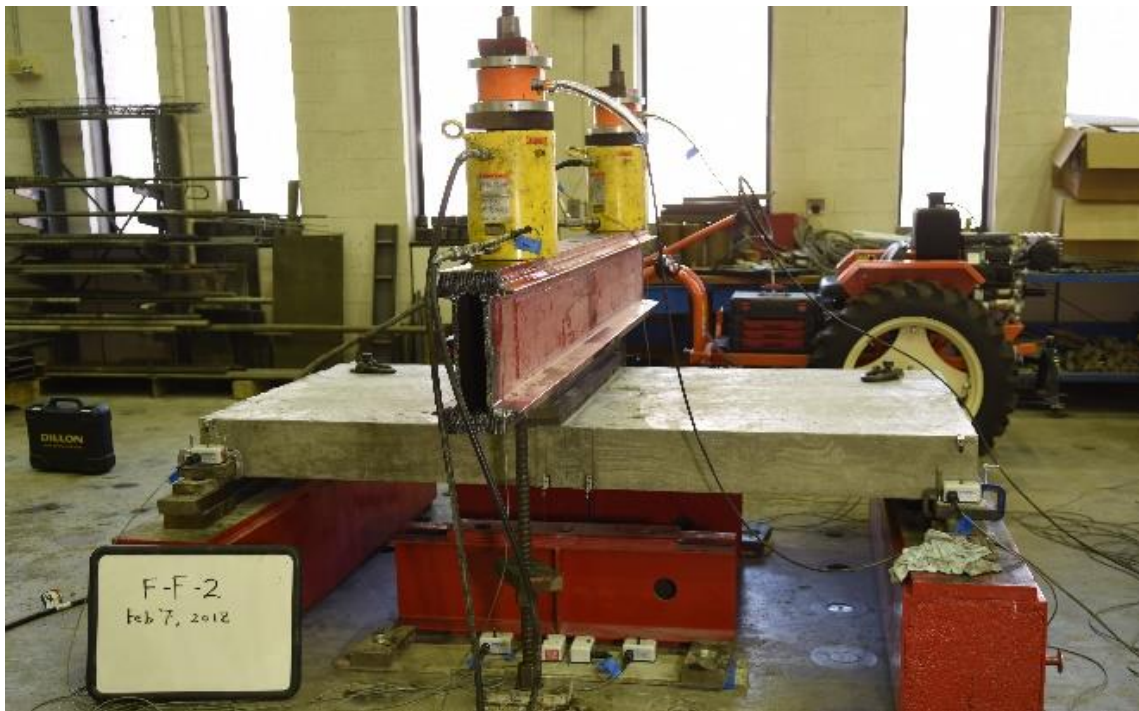
This section provides the test results of the three-point bending test that was conducted on the specimen containing fine all-threads (Specimen F-F-2, Figure 3.35). Initial cracking was shown at the interface between the slab and the grout and inside the grout key as shown in Figure 3.36. As load was increased, it is interesting to note that there was an inclined shear crack through the grout as shown in Figure 3.37. This crack was inclining towards the loading point. As additional load was applied, these cracks opened wider and an additional inclined shear crack was observed as shown in Figure 3.38. The close-up photo of the joint taken from the North side of the specimen indicates that the grout key as a whole is about to fall out from the joint before failure (Figure 3.39).

**Figure 3.35: Three-point Bending Test Setup (Specimen F-F-2)**

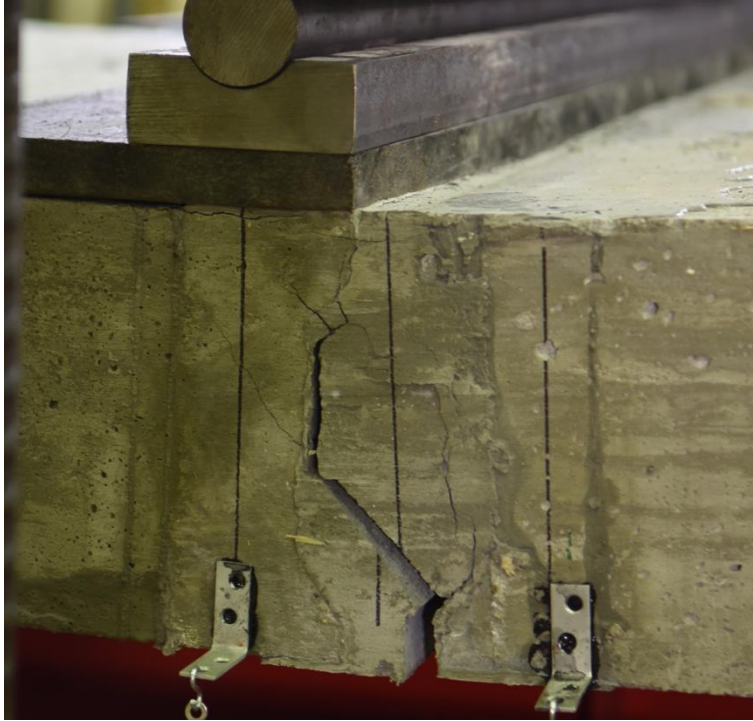
**Figure 3.38: Grout Joint Close-up Photo (Specimen F-F-2, South view)**

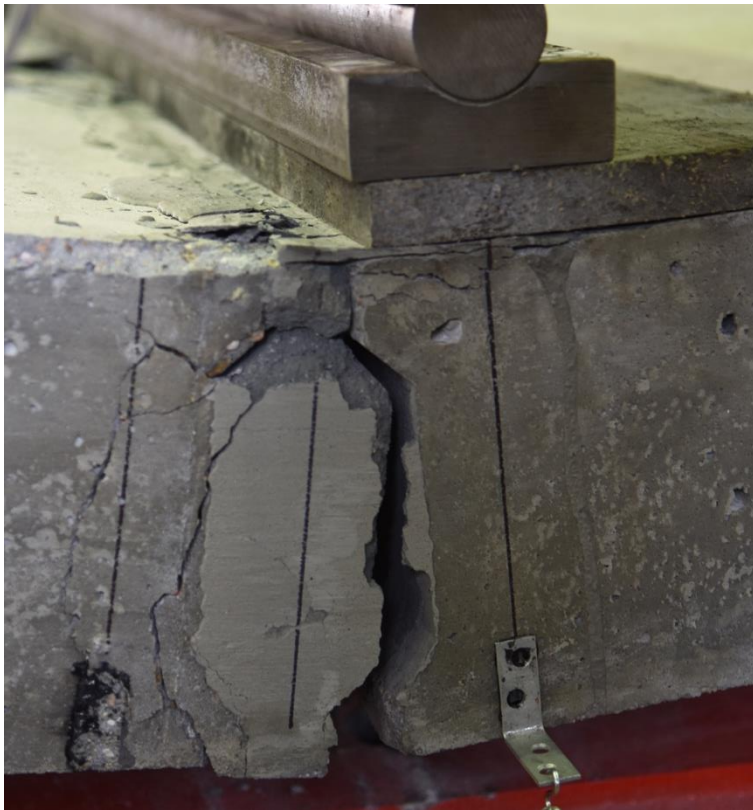
**Figure 3.39: Shear Key before Failure (Specimen F-F-2, North view)**

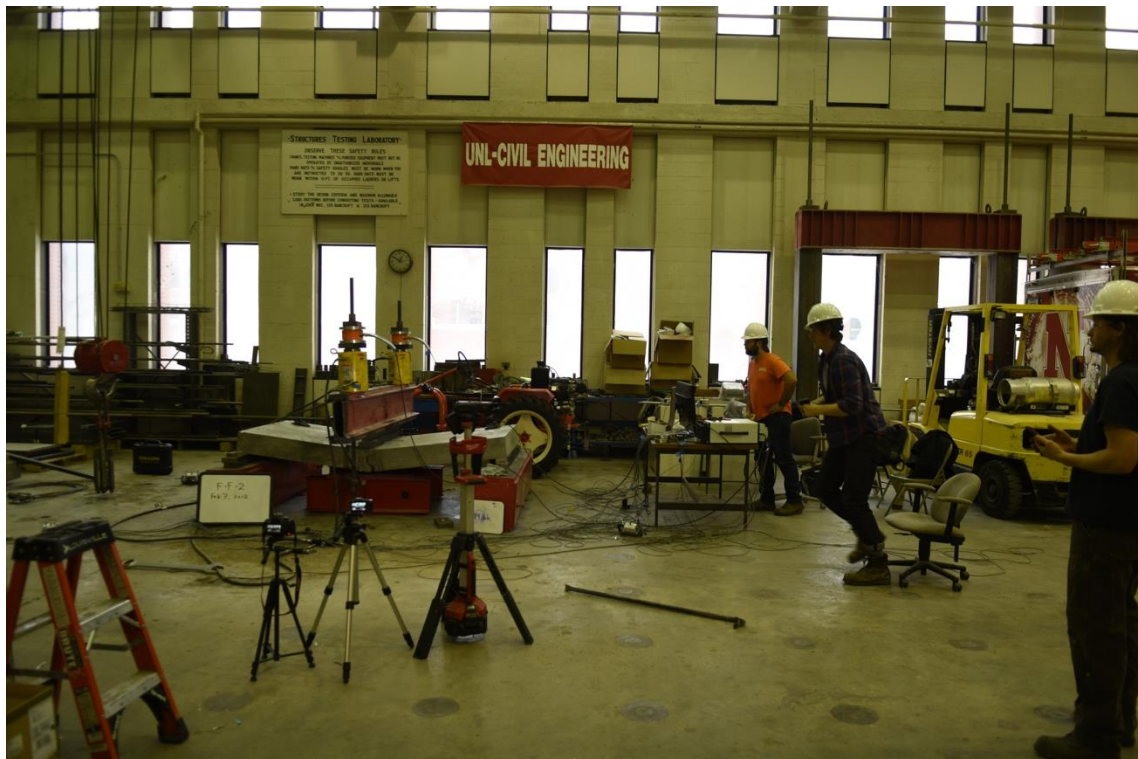
The failure mode was similar to Specimen C-C-2 and relatively more brittle compared to the identical specimen tested in four-point bending (Figure 3.40), showing a sudden drop in load. However, the load-displacement curve shown in Figure 3.41 demonstrates that Specimen F-F-2 reached to a higher load and deflected more than what was seen in Specimen C-C-2. The maximum load reached was 18.3 kips and the deflection at peak load was 3.8 in. The reading at failure load from the two load cells were 18.3 kips providing a reaction force at each support of 9.15 kips. Considering that the spreader beam weight under the hydraulic ram was 2 kips and including the moment caused by self-weight (5.4 kip-ft) of the slab, the total experimental joint moment was 42.2 kip-ft.

**Figure 3.40: Specimen F-F-2 at Failure**
