# Standard Design for Nebraska County Bridges

**Final Report  
M-064**

December 2019

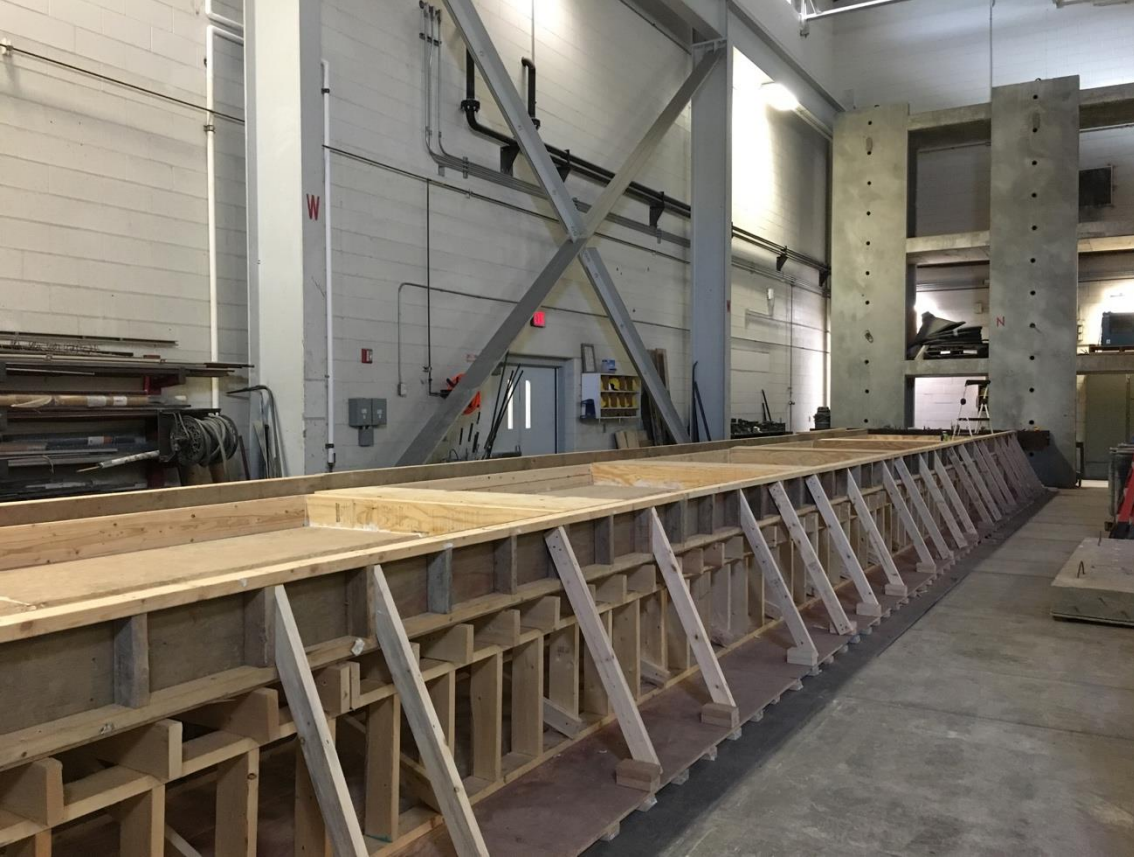
**Figure 4.4: Complete Full-Scale Formwork for County Bridge Specimen**

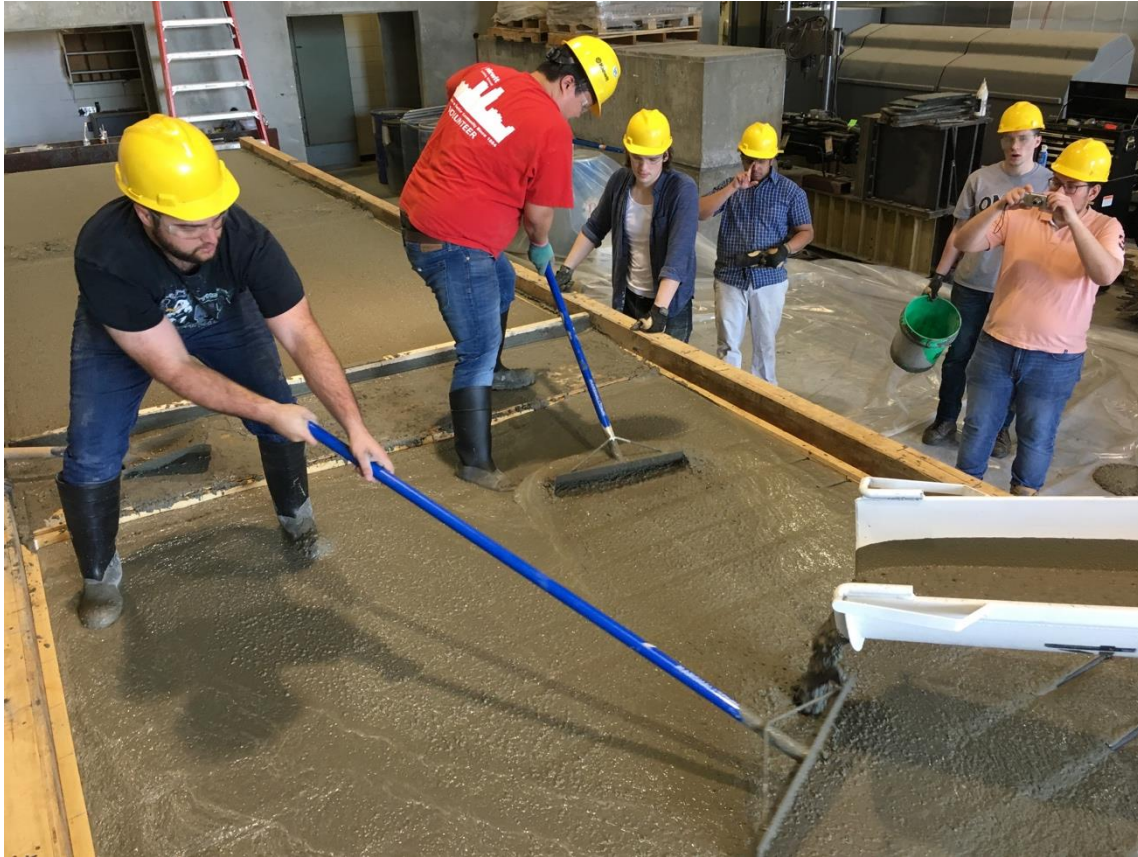
The following procedure described in this section was identical for both pours with three trucks used in each case. Two people ran the chute and raked concrete while two other people ran the screed board. While this process was going on six people filled the test cylinders for all three trucks. The process was relatively simple with the use of self-consolidating concrete.

**Figure 4.7: Casting Self-Consolidating Concrete for Full-Scale Bridge Specimens**

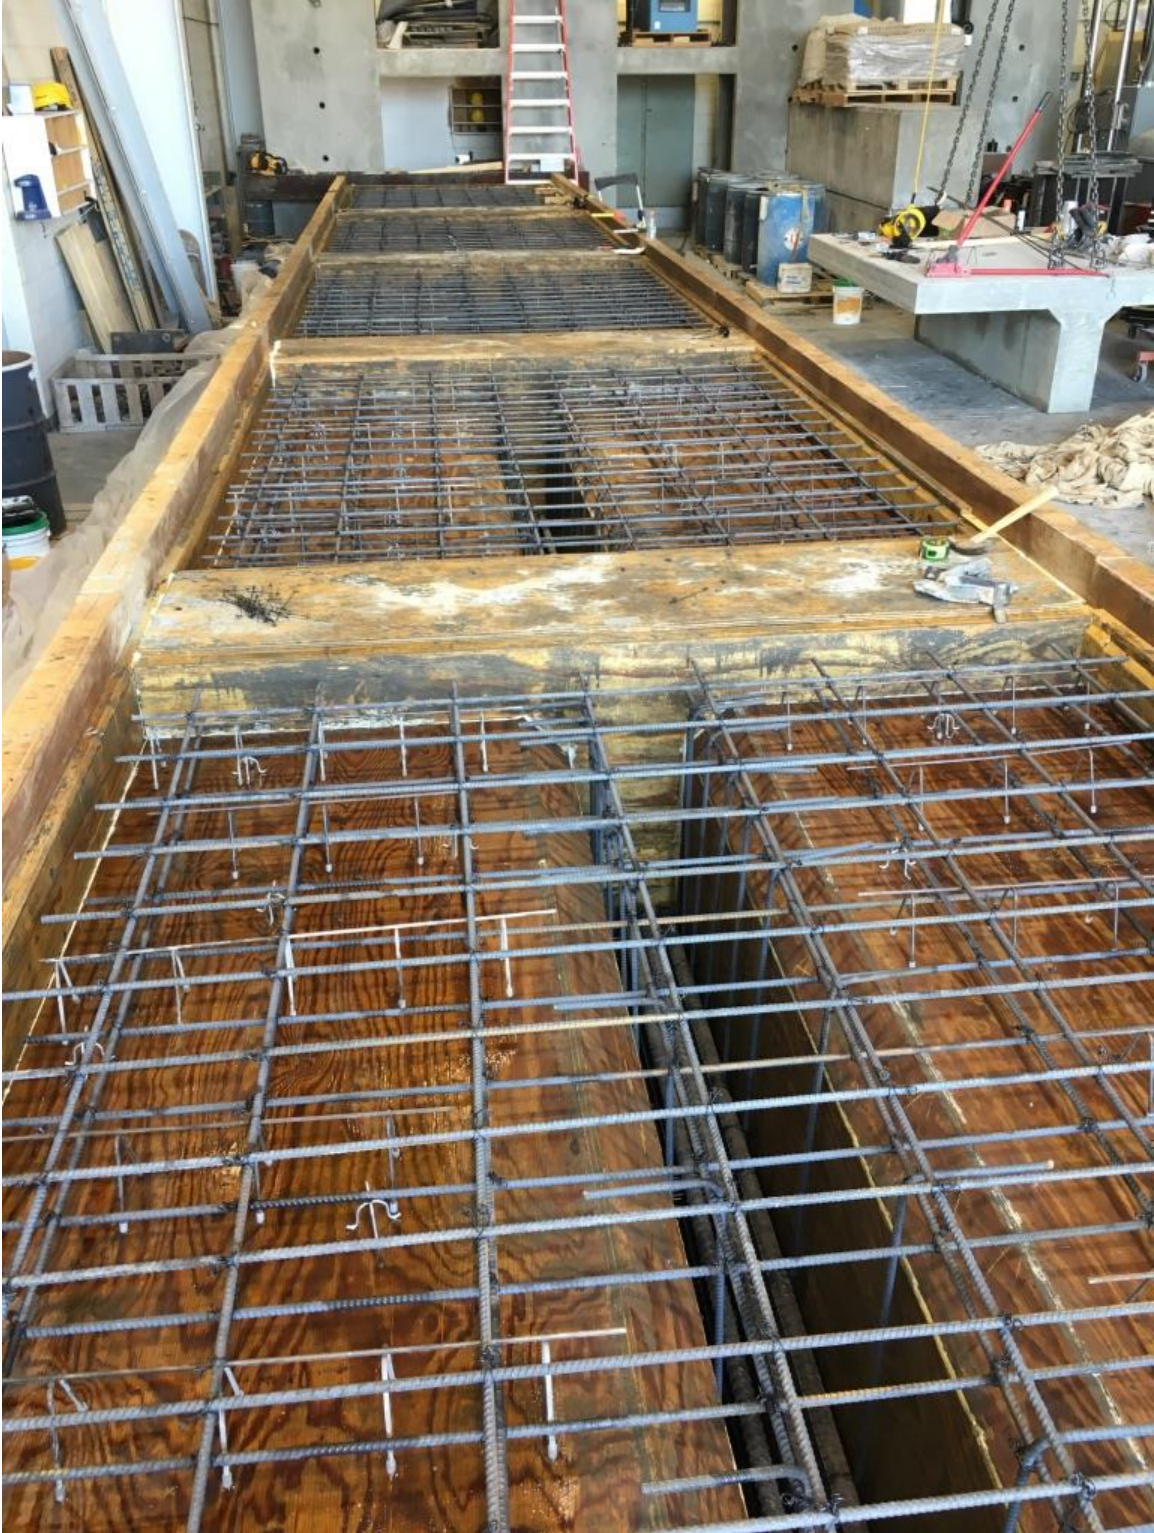
**Figure 4.9: Steel Assembly for the Second Pour**

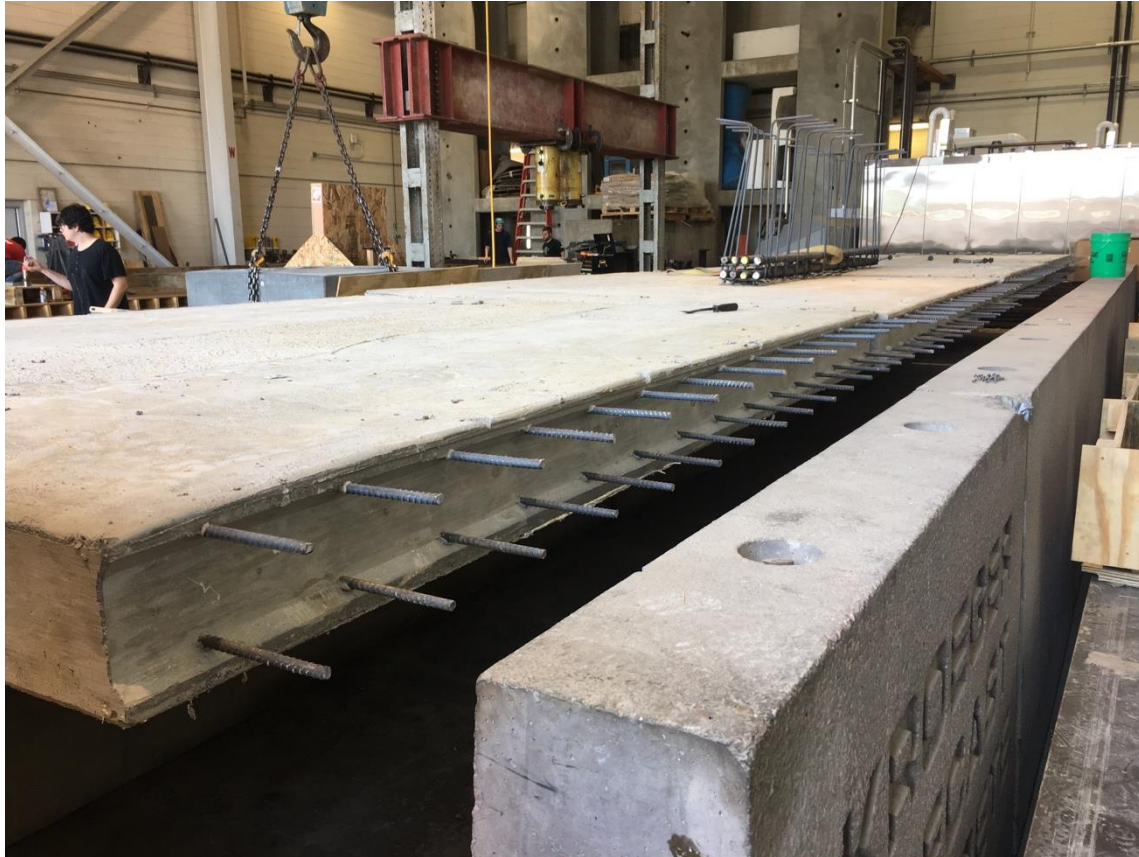
**Figure 4.11: Test Specimens with Short Splice Length**

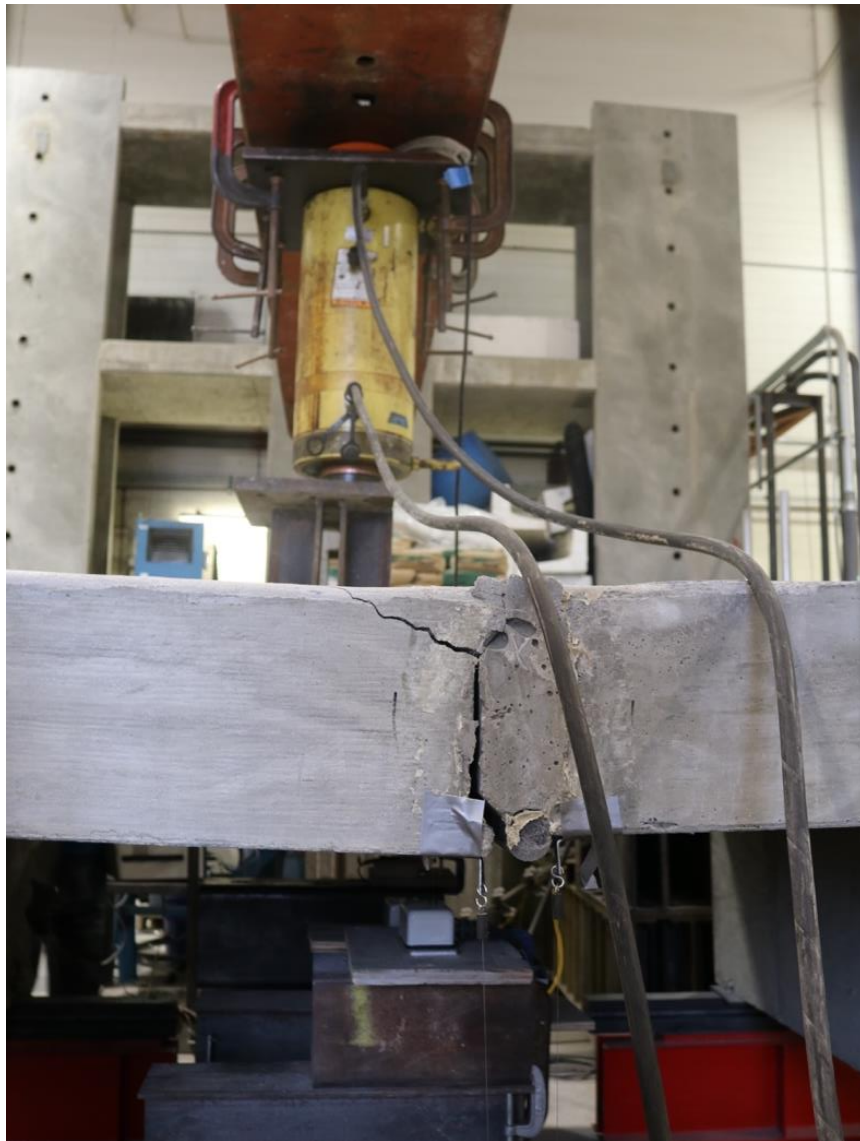
Full-scale specimen with the mechanical joint (F-M) was tested first. Figure 4.14 is a close-up view of the grouted joint during testing. Similar to the behavior observed with small-scale specimens, the first crack initiated at the interface between the grout and the slab specimen.

**Figure 4.14: Close-up view of the Grouted Joint (Specimen F-M)**

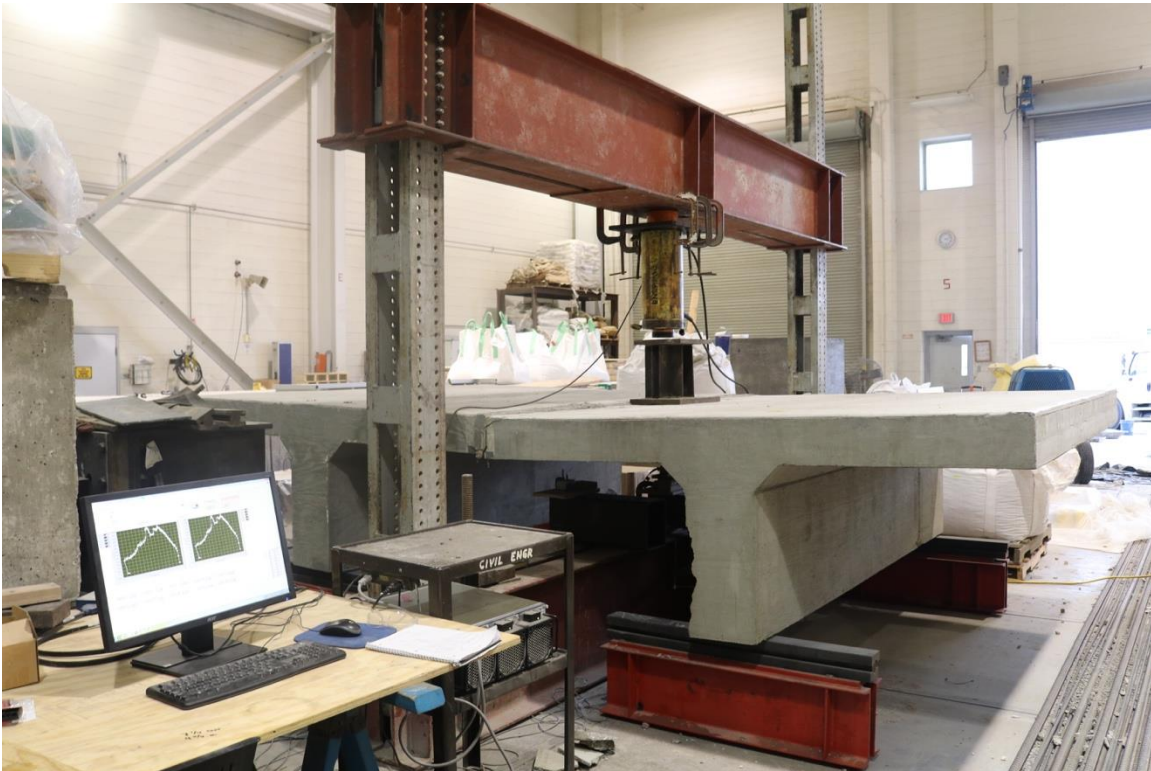
The test was terminated when the specimens were not able to take more load but started to rotate creating large deflections at the joint. Because no neoprene pads were supplied at the interface of the steel support and the slab specimens, inclined shear cracks were observed in the stem portion of the specimen near the supports and concrete cover started to spall off at that location as shown in Figure 4.15.

**Figure 4.15: Specimen F-M at Failure**

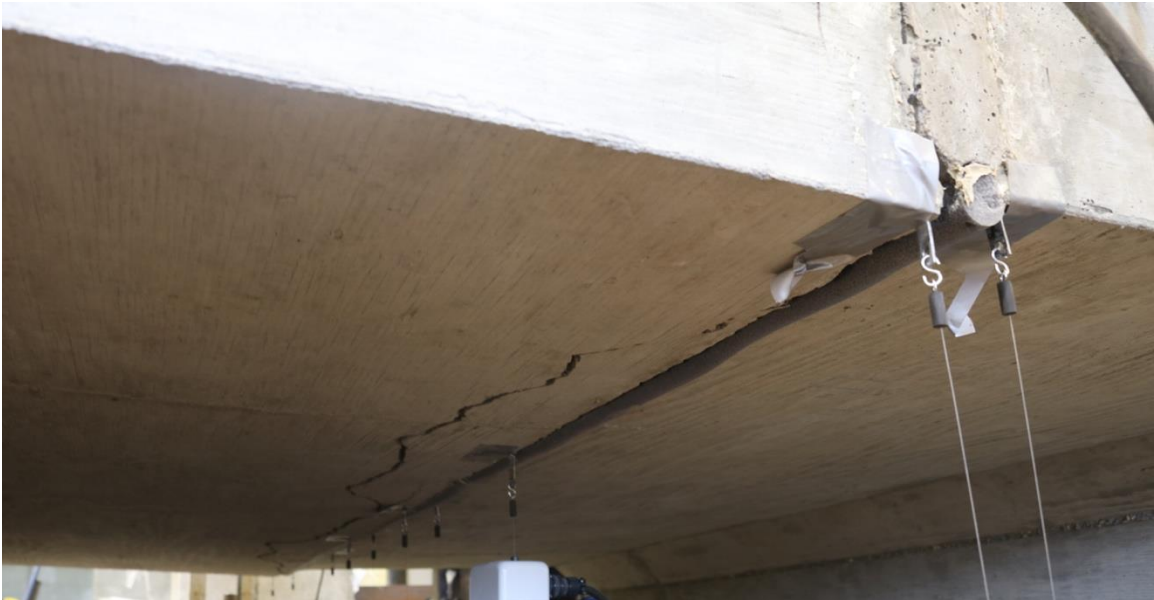
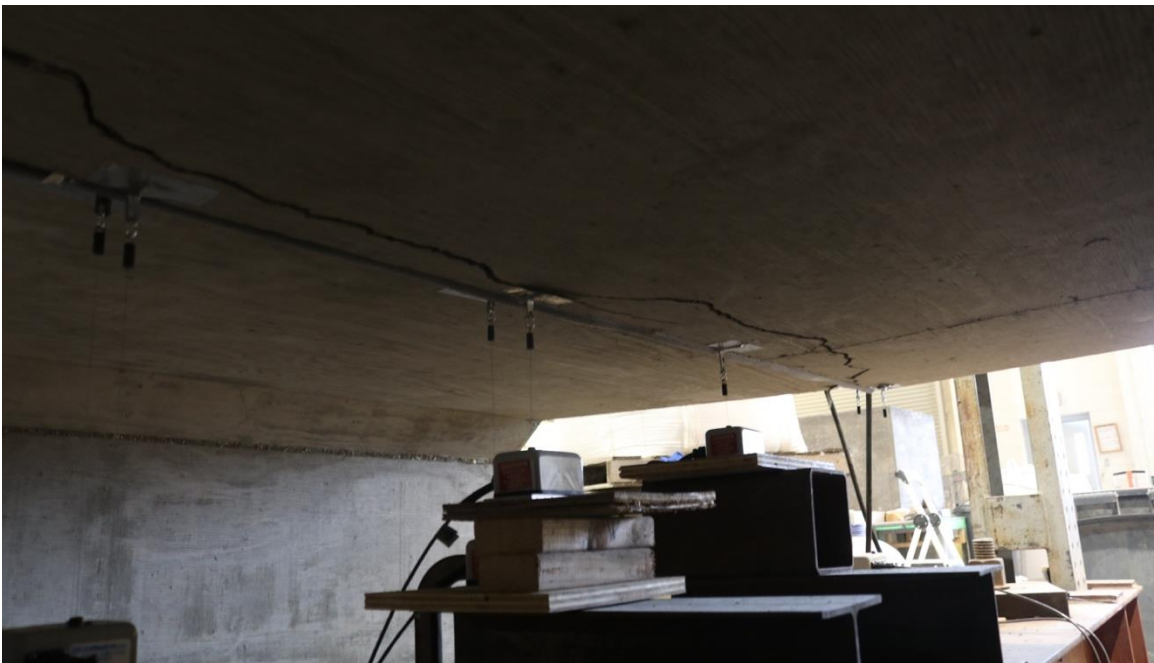
Figure 4.16 shows two photos taken from the bottom of the specimen. It is interesting to note that the shape of the crack close to the interface followed the angle of the Nelson-stud shear connectors on the mechanical joint which were placed in 45 degrees. After the completion of the testing, the two slab specimens were removed from the test setup, and as shown in Figure 4.17, the shape of the grout attached to the mechanical joint is the shape of the crack that was observed

underneath the slab specimen that is orientated based on the shape of the mechanical joint. It can be concluded that the failure mode was governed by insufficient length in development with the 8 in. Nelson studs in the joint system introduced in Figure 4.6.

**Figure 4.16: Close-up view of the Grouted Joint (Specimen F-M)**

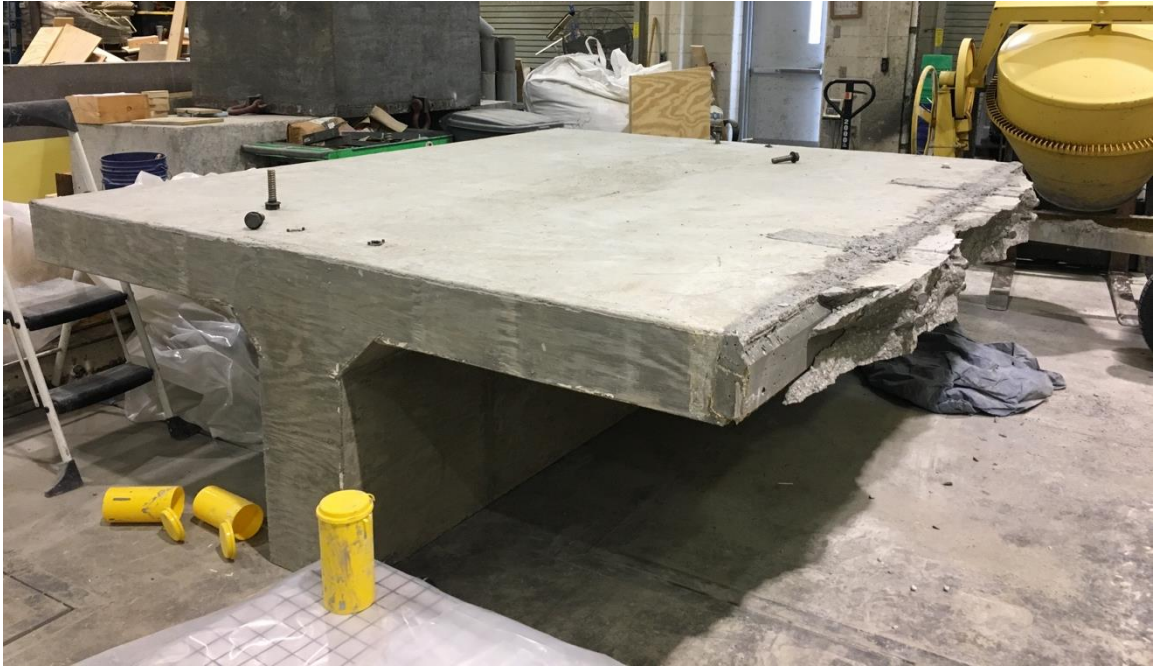
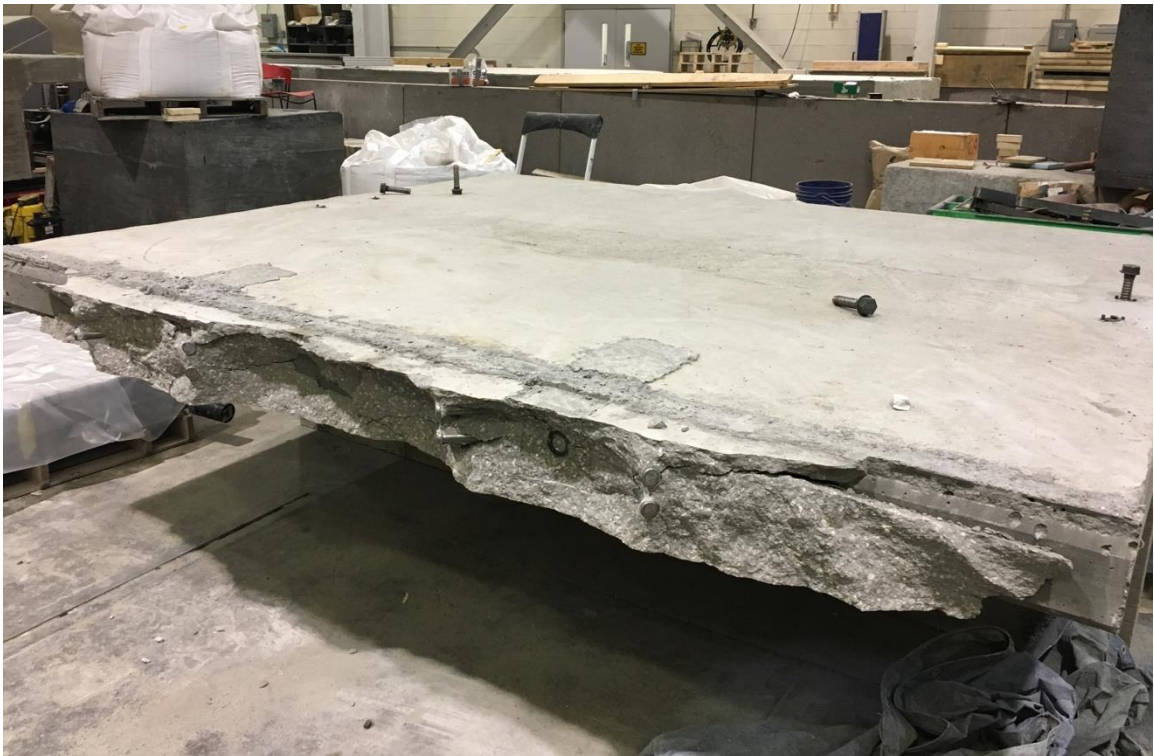
**Figure 4.17: Grout Shear Key Bond Failure (Specimen F-M)**

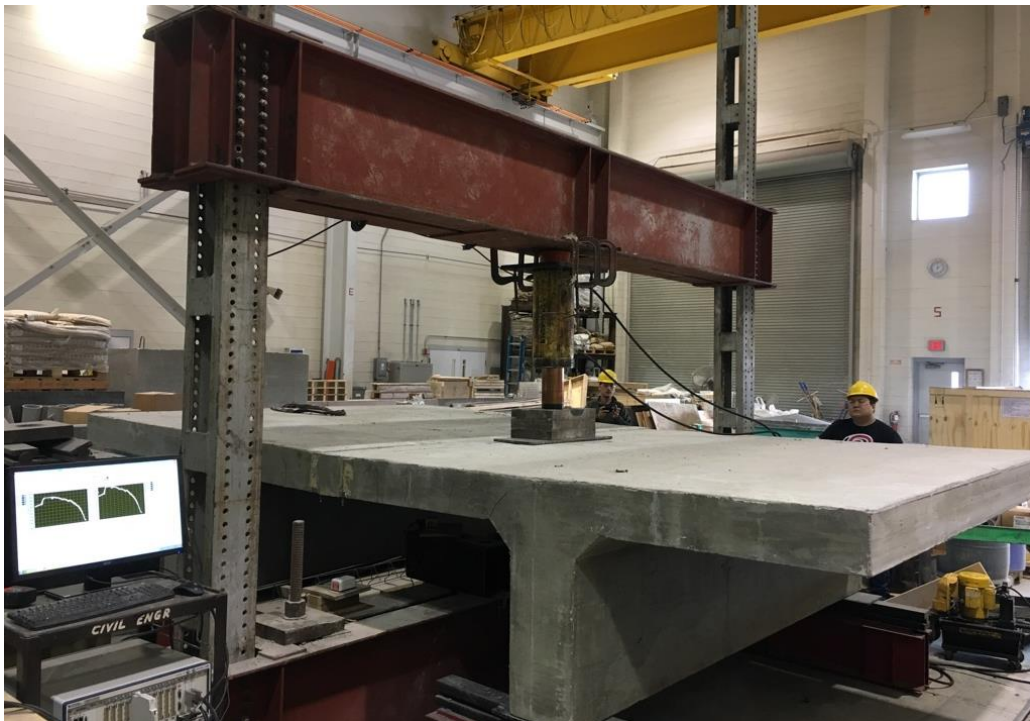
**Figure 4.21. Test Setup and Loading of Specimen F-R-SHPC**

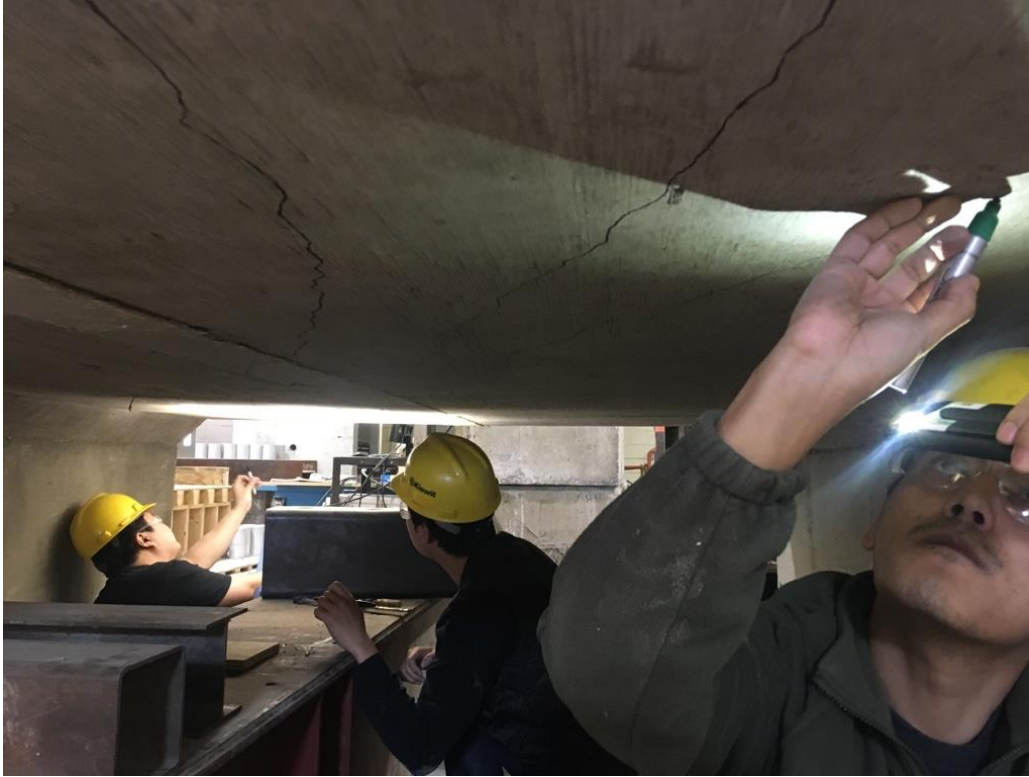
Figure 4.22. Crack Mapping and Failure of Specimen F-R-SHPC

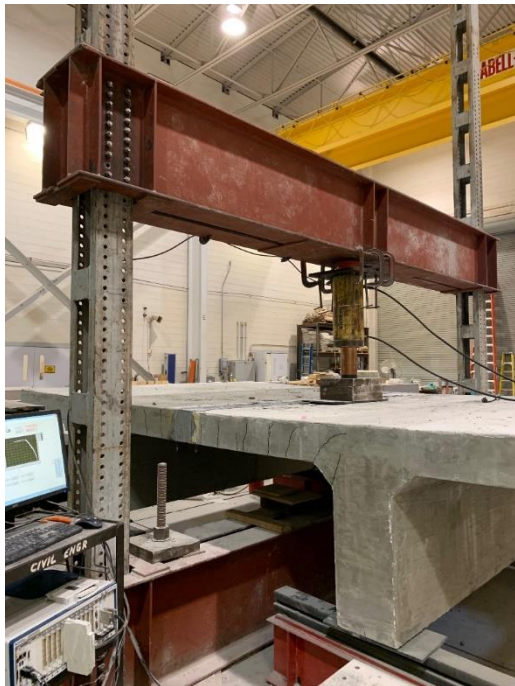
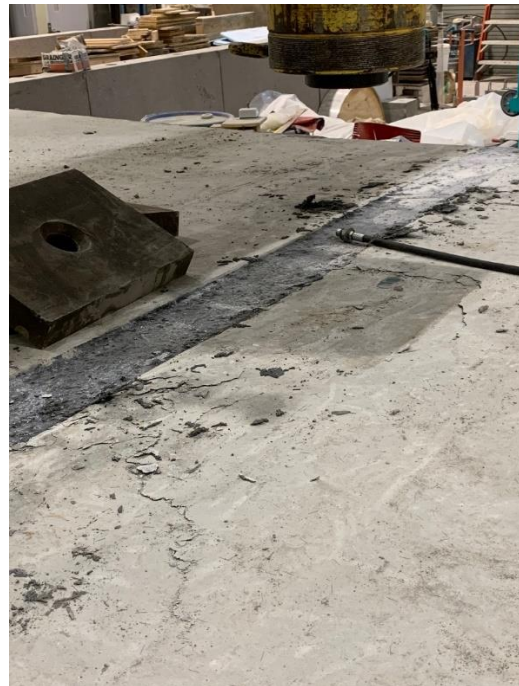
(a) Test setup

(b) After failure

**Figure 4.26. Test Setup and Loading of Specimen F-N-UHPC**

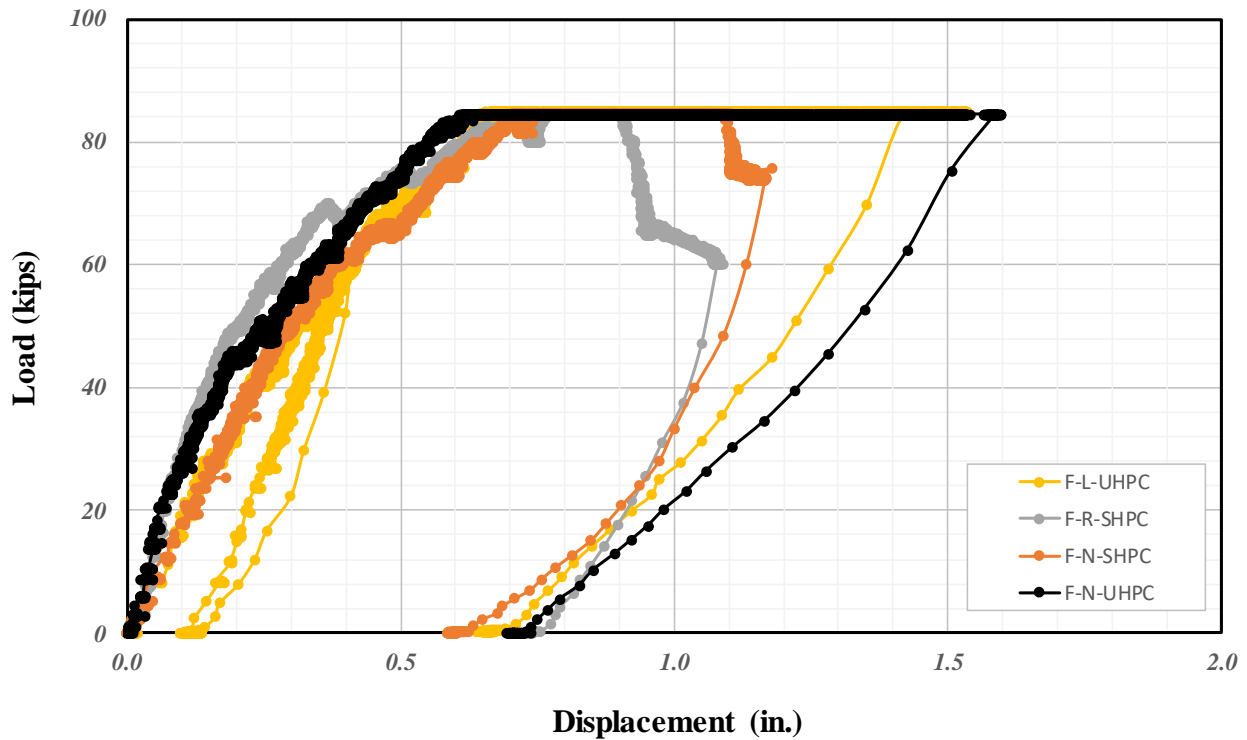
**Figure 4.28. Load-Displacement of Specimens with Ultra-High-Performance or Super-High-Performance Concrete Joints**

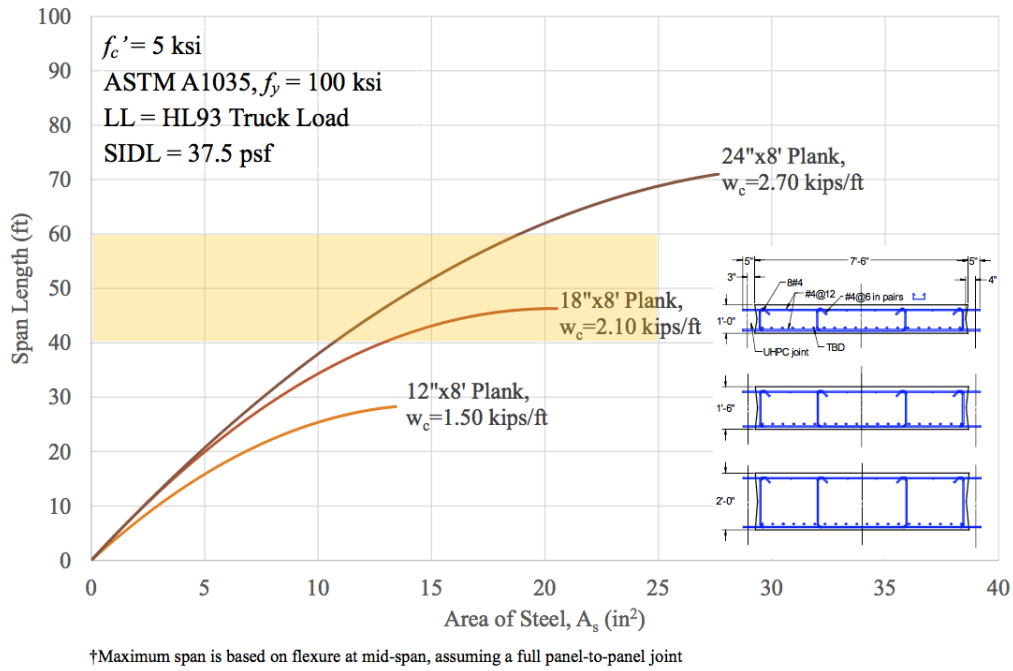
**Figure 5.2. Design chart for wide concrete plank ( $f'_c = 5,000$  psi)**

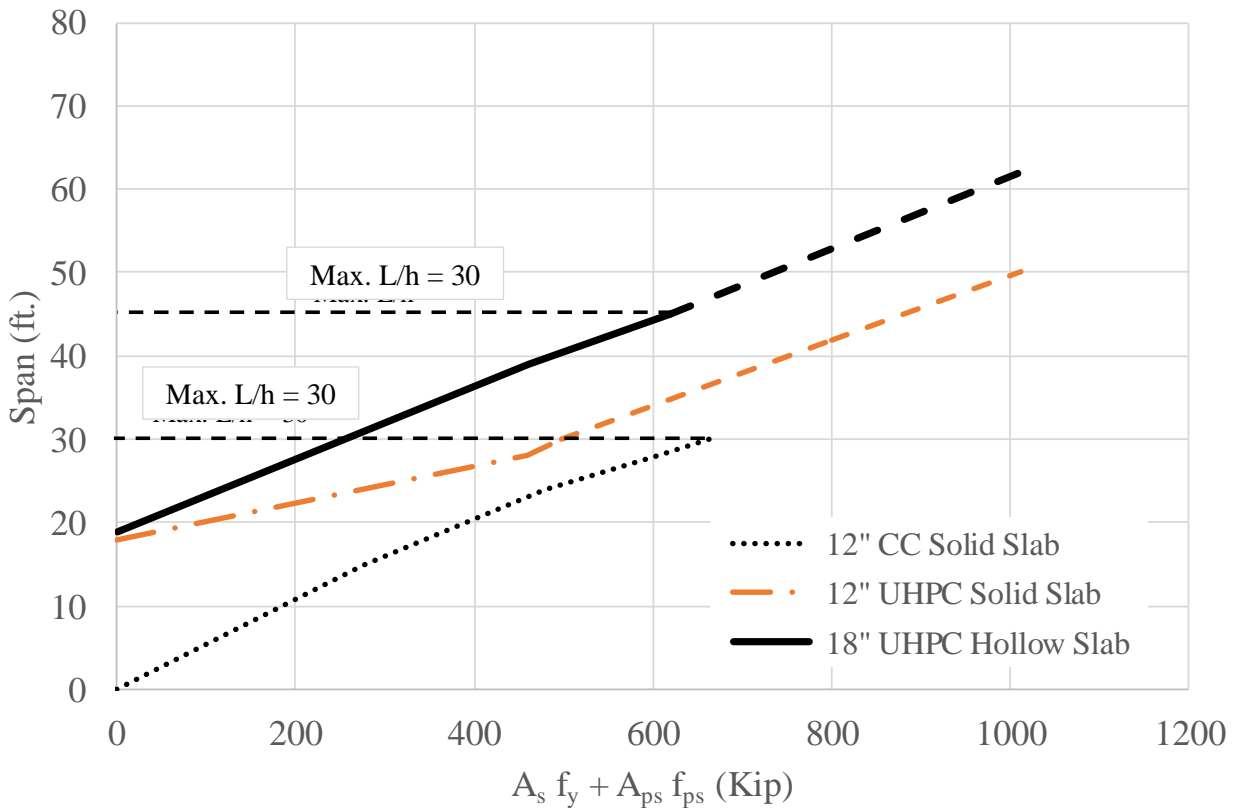
**Figure 5.8. Design chart for alternative planks**
