# Corrosion-Resistant Stainless Steel Strands for Prestressed Bridge Piles in Marine Atmospheric Environments

**Final Report VTRC 20-R2**

### **CORROSION-RESISTANT STAINLESS STEEL STRANDS FOR PRESTRESSED BRIDGE PILES IN MARINE ATMOSPHERIC ENVIRONMENTS**

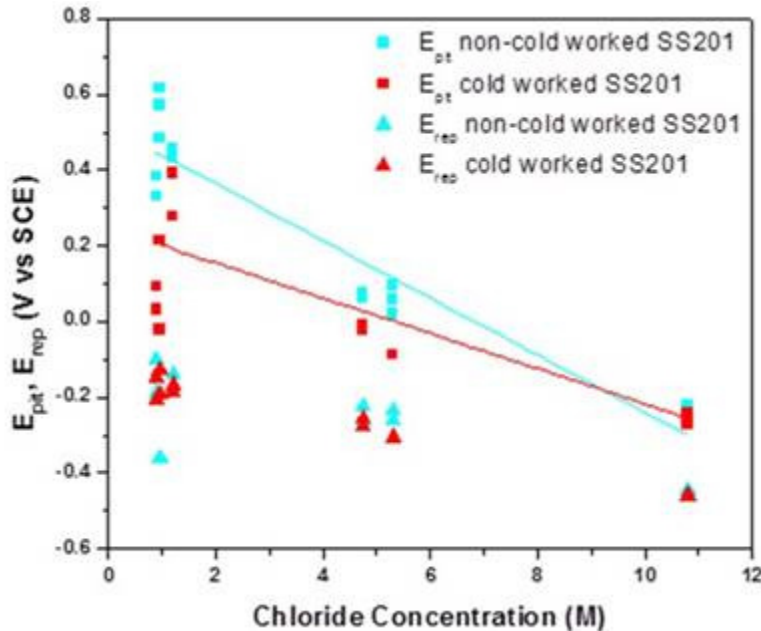
**Figure 7. Effect of Chloride Concentration on Pitting ( $E_{pit}$ ) and Repassivation Potential ( $E_{rep}$ ) for Stranded Cold Worked AISI 1080, Non-Cold Worked 201 Austenitic Stainless, Cold Worked 201 Austenitic Stainless, and Stranded Cold Worked 2205 Duplex Stainless Steels**

The pitting potential of both non-CW201 and CW201 steels tends to decrease as the chloride concentration increases, as can be seen by the red and blue solid lines in Figure 7. The electronic pitting potential tended to be higher for the non-CW201 material (blue squares) when compared to the cold worked material (red squares). The higher electronic potential demonstrates that cold working has a negative effect on corrosion resistance. However, the difference in corrosion resistance gets smaller as the chloride concentration increases. The effect of cold working becomes negligible when the environment becomes more corrosive (high chloride concentration).

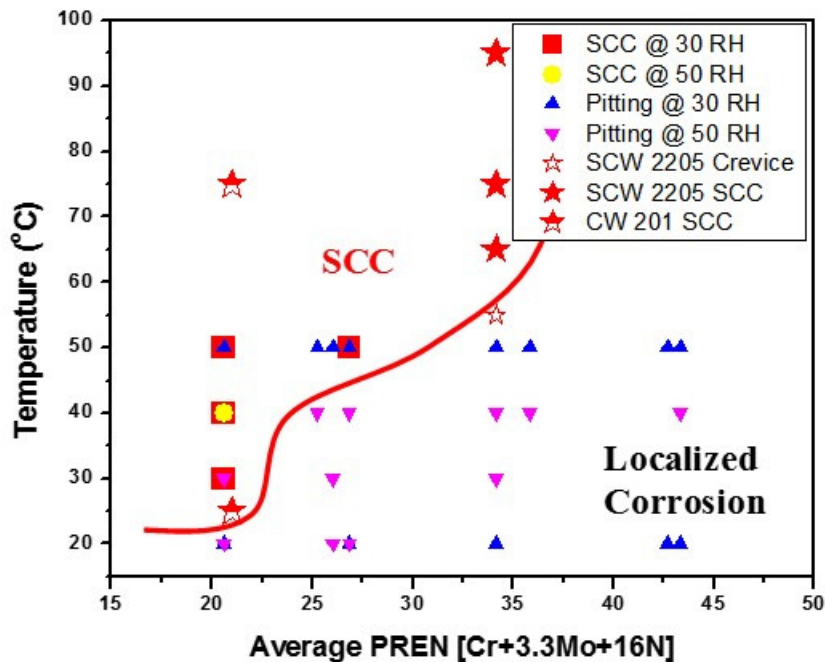
Figure 12. Stress Corrosion Cracking Susceptibility Map in Terms of Temperature and Pitting Resistance Equivalent Number. Includes data for cold worked 201 austenitic stainless steel, data for stranded cold-worked 2205 duplex stainless steel, and data from Prosek et al. (2009).

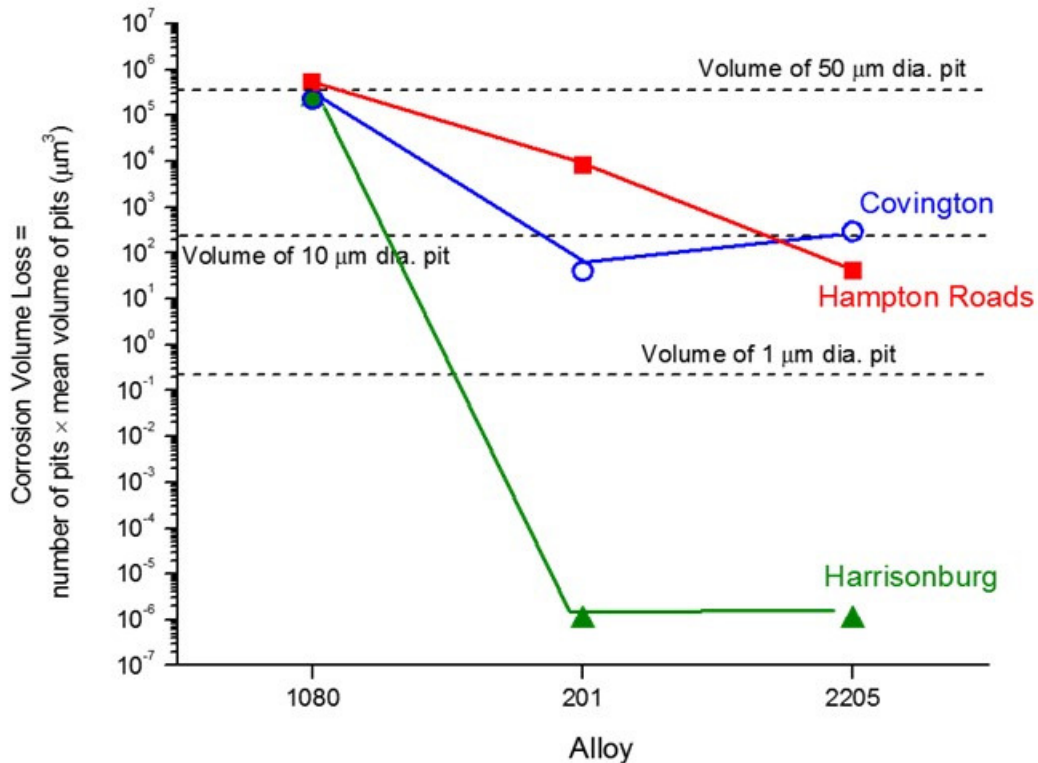
Figure 14. Corrosion Volume Loss Analysis of the Different Materials Exposed to Different Field Locations

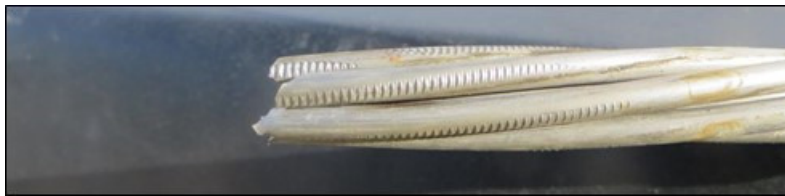
**Figure 17. Fracture at Wedge Tip Location With Strand Breaking Before Completing Fabrication of First Set of Stainless Reinforced Concrete Piles**

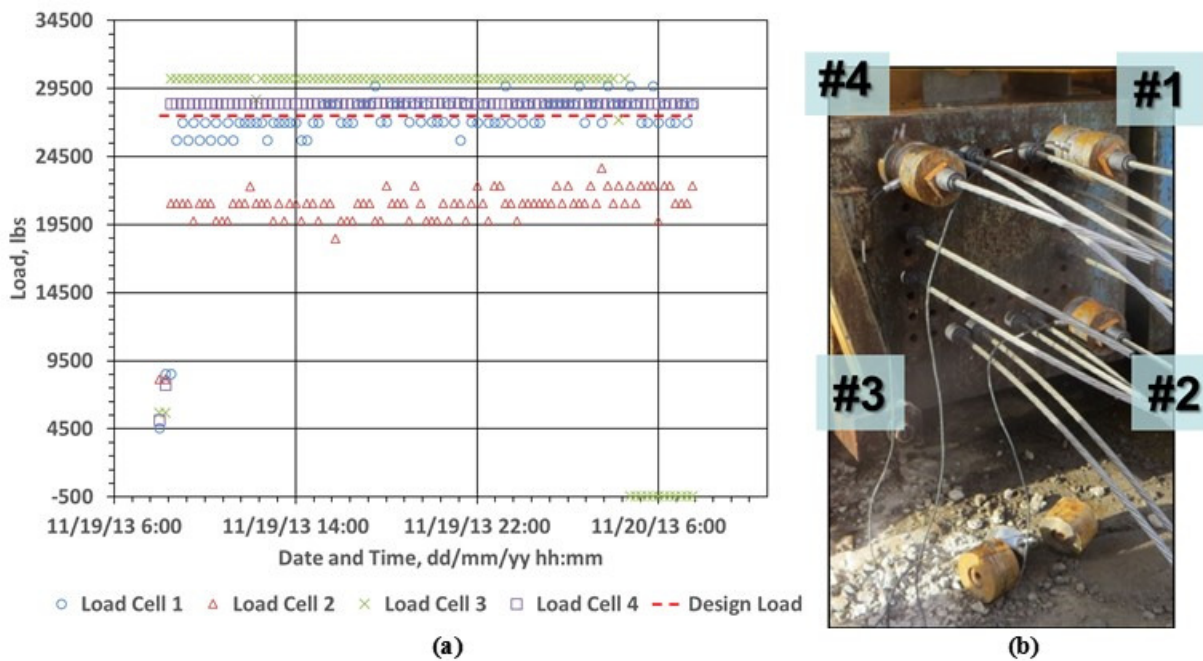
**Figure 18. Load Data Captured During Failure of Several Stainless Steel Strands: (a) load cell data; (b) photograph showing the corresponding load cell with each channel number indicated**

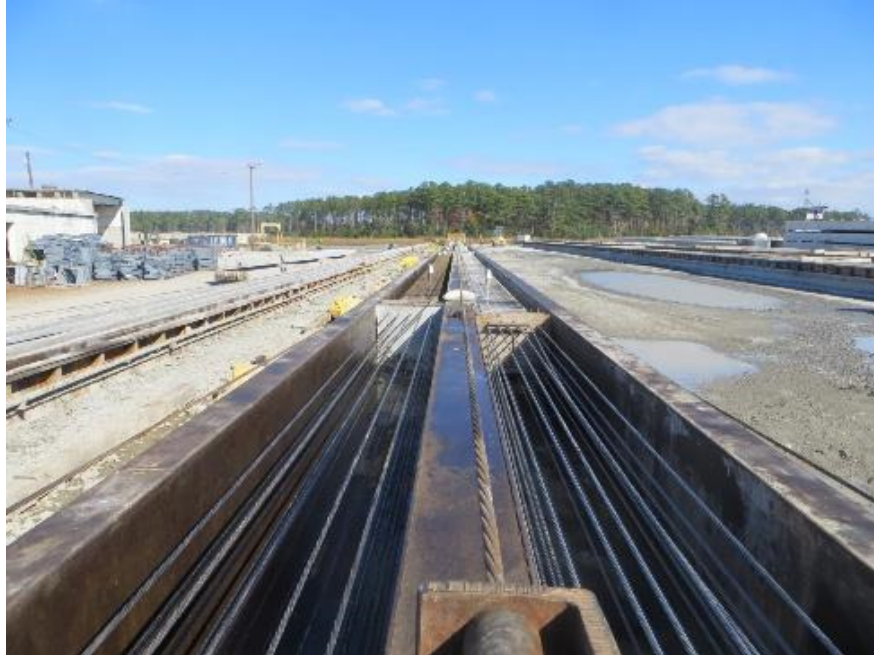
**Figure 19. Preparing to Make 24-in-Square Prestressed Concrete Piles. Conventional steel strand shown on the left and 2205 stainless strand shown on the right in a 400-ft-long bed. Not shown are the steam curing pipes that lay adjacent to the bed near the ground.**

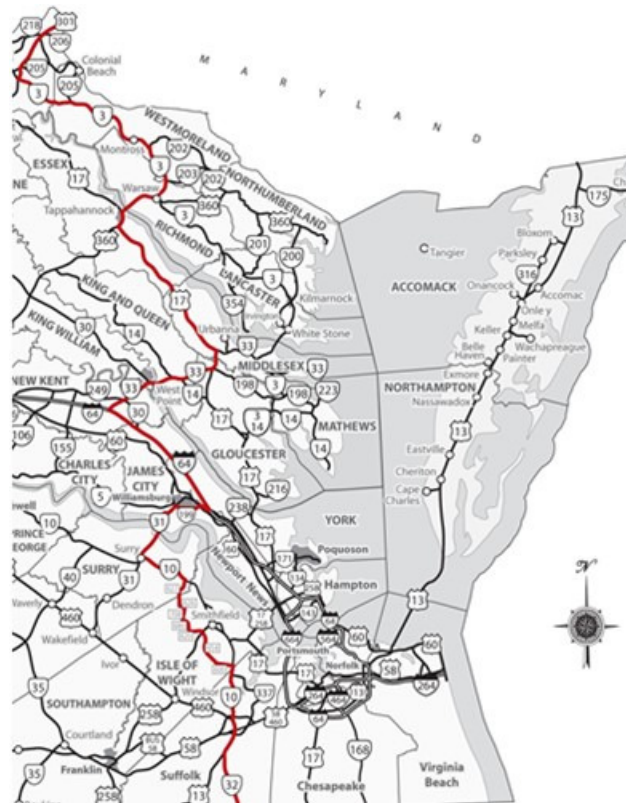
Figure 21. Region Requiring Use of CFRP or SCW2205 Steel Strands in Piles. Region to the east (right) of the red line requires CFRP or SCW2205 steel reinforcement (VDOT, 2018). CFRP = carbon fiber reinforced polymer

After the successful completion of several projects and the demonstration that SCW2205 reinforced concrete piles could be successfully fabricated and driven, procedures were established by VDOT for routine use of the material as reinforcement in piles (VDOT, 2018). The geographical area to the right of the red line on the map in Figure 21 shows the region where VDOT now requires the use of either CFRP or SCW2205 steel strands in piles exposed to tidal waters. The corrosion-resistant piles can also be used at other locations with corrosive characteristics throughout the state. This region includes the High Rise Bridge, which is currently under construction and is one component of a more sizable construction project. This portion of the project includes construction of a new High Rise Bridge that will be higher and wider than the old bridge when finished. The piles used in the High Rise Bridge will include prestressed CFRP strand reinforcement in some piles and SCW2205 steel strand reinforcement in other piles.

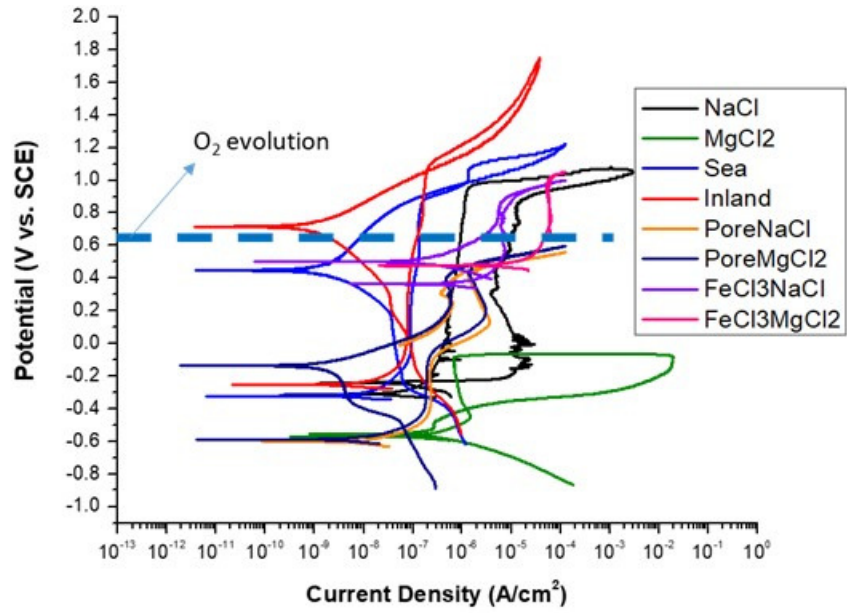
Figure B2. Cyclic Polarization at 25 °C Showing Effect of Various Electrolytes on Electrochemical Behavior of SCW2205 Steel

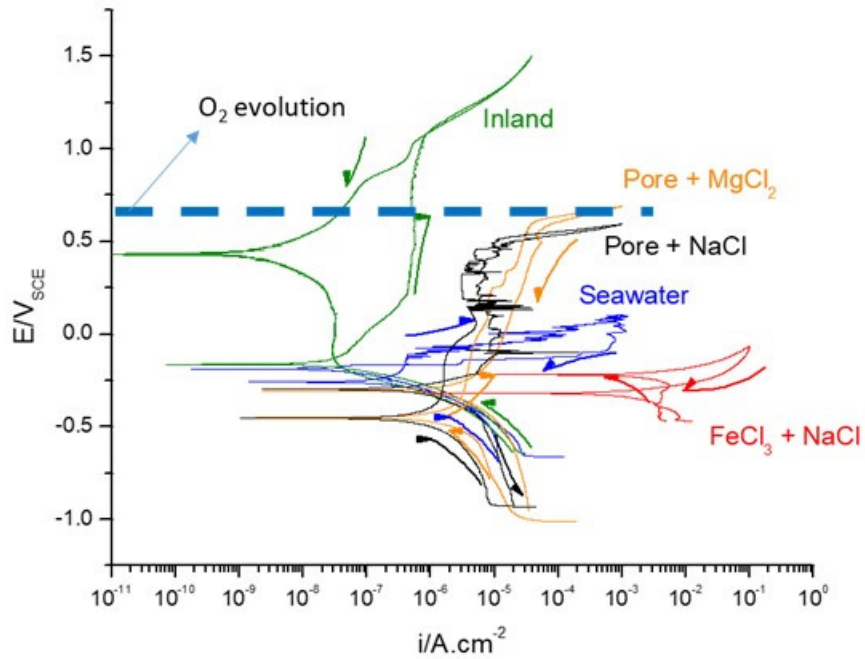
Figure B3. Cyclic Polarization at 25 °C for CW201 Steel Material

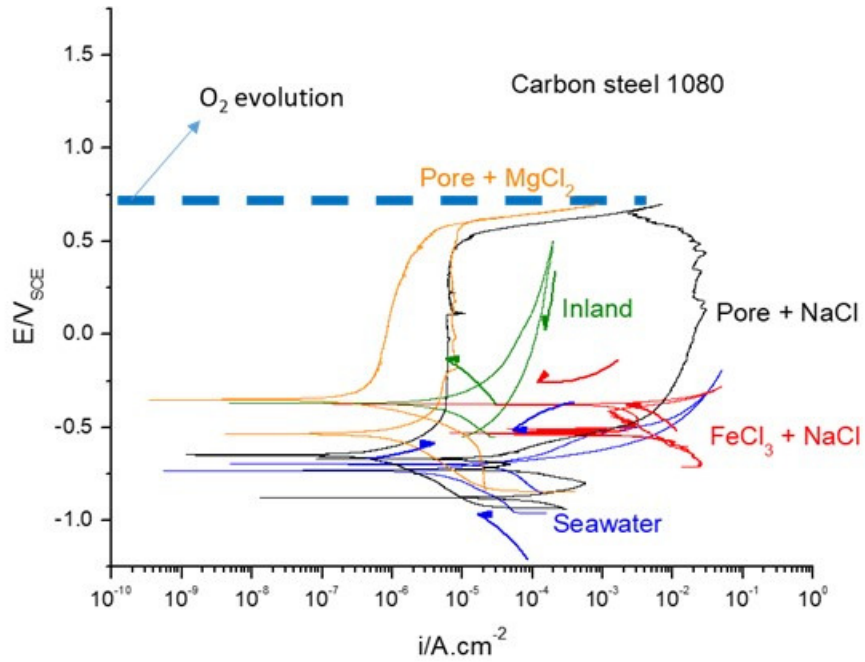
Figure B4. Cyclic Polarization at 25 °C for SCW1080 Steel

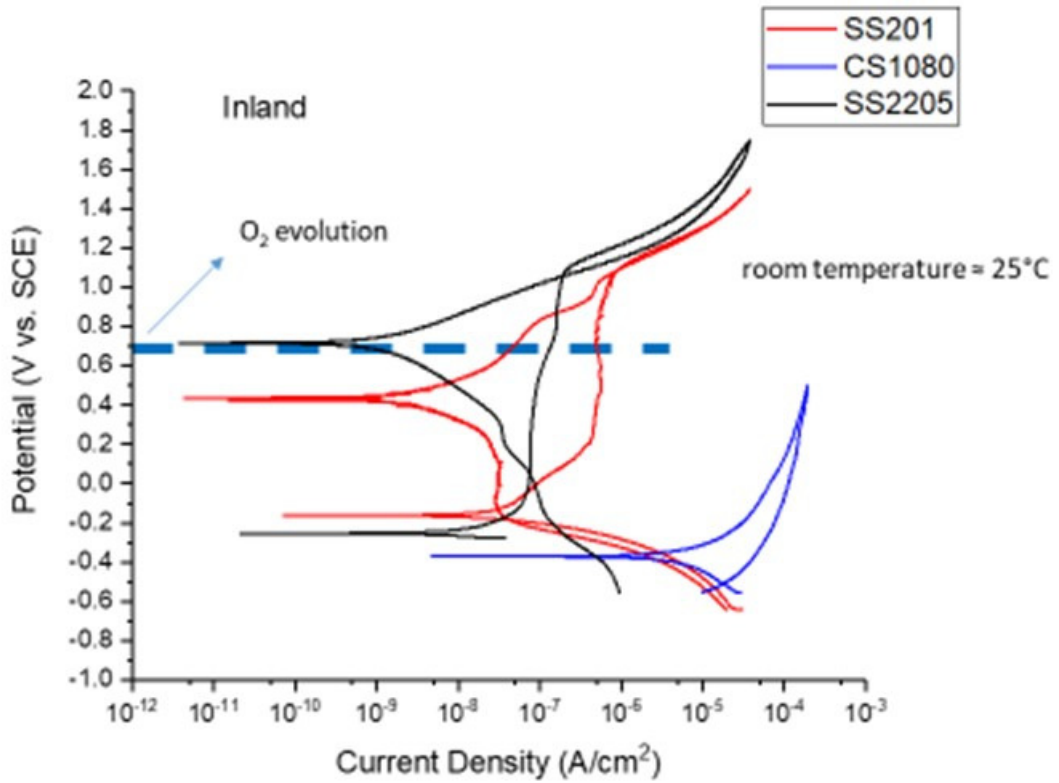
Figure B9. Cyclic Polarization at 25 °C for All Materials in Solution Simulating Inland Exposure

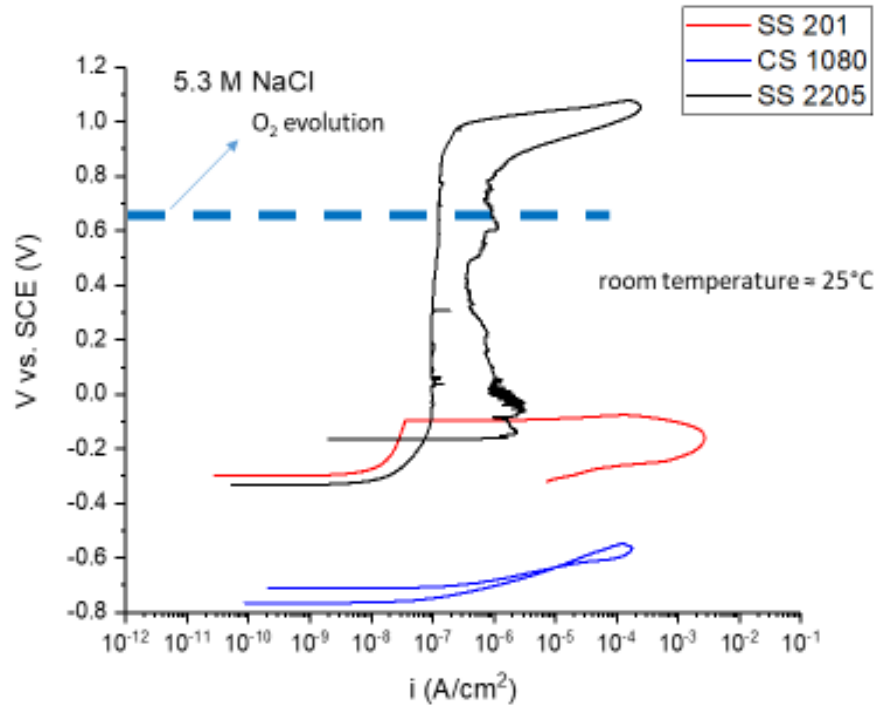
Figure B12. Cyclic Polarization at 25 °C for All Materials in 5.3 M NaCl Solution

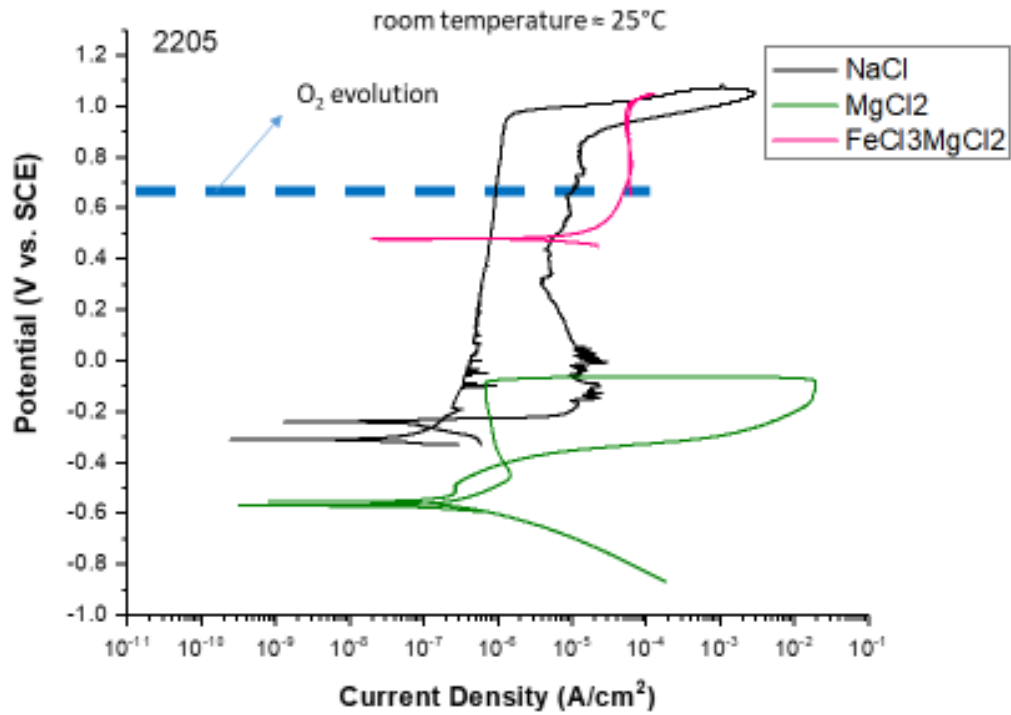
Figure B14. Cyclic Polarization at 25 °C for SCW2205 in 5.3 M NaCl, 5.4 M MgCl<sub>2</sub>, and FeCl<sub>3</sub> + MgCl<sub>2</sub> Solutions

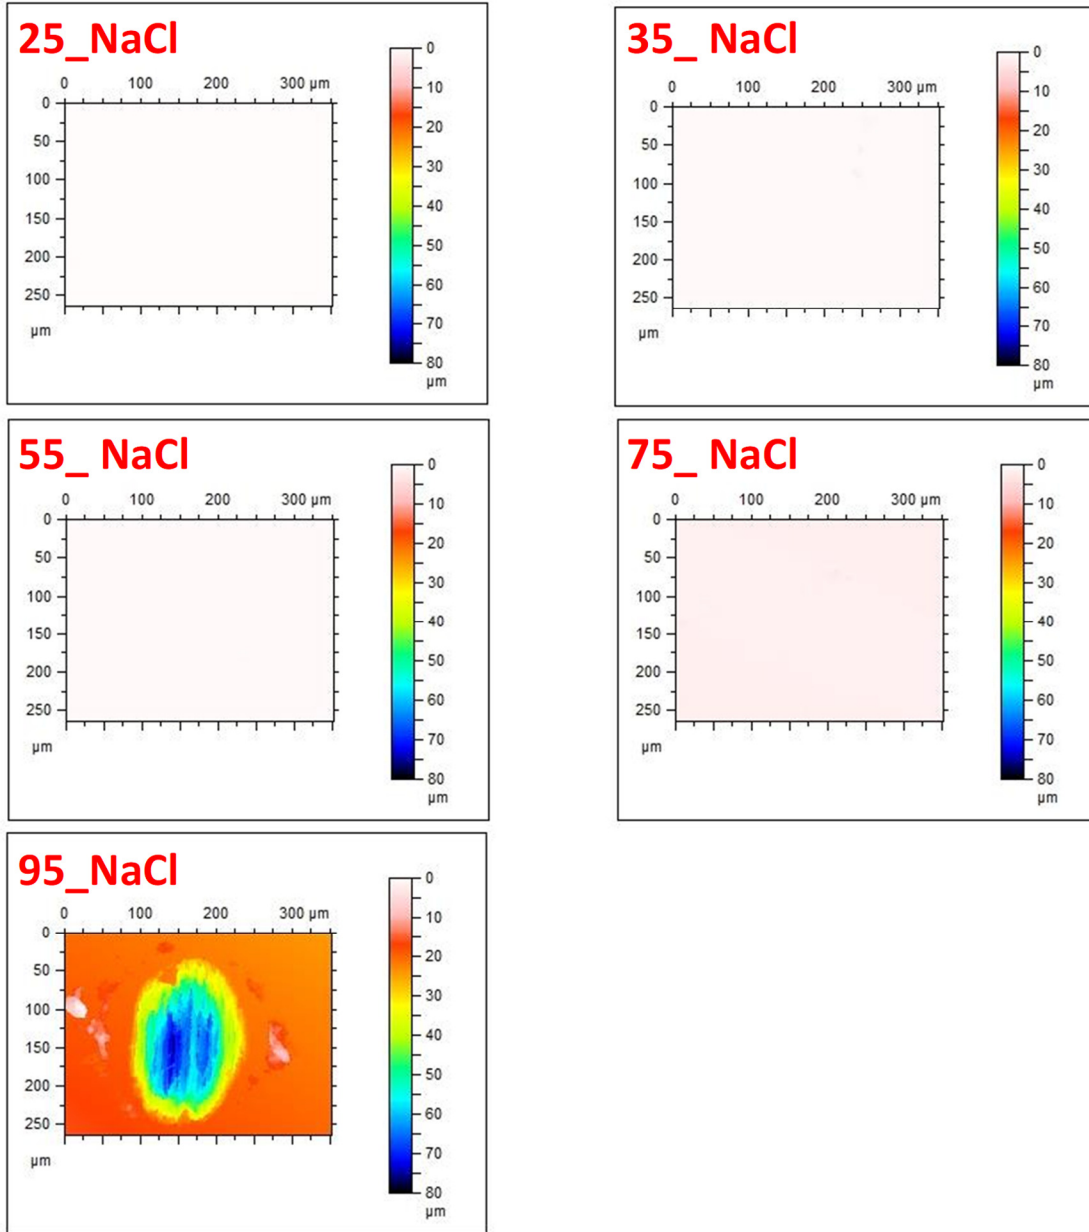
**Figure C11. Corrosion Morphology of Pits Grown on SCW2205 Steel Under Droplets of Saturated NaCl at Different Temperatures. Each image first identifies in red in the upper left corner the temperature in Celsius, followed by an underscore, and then the exposure environment that was used for corrosion testing.**

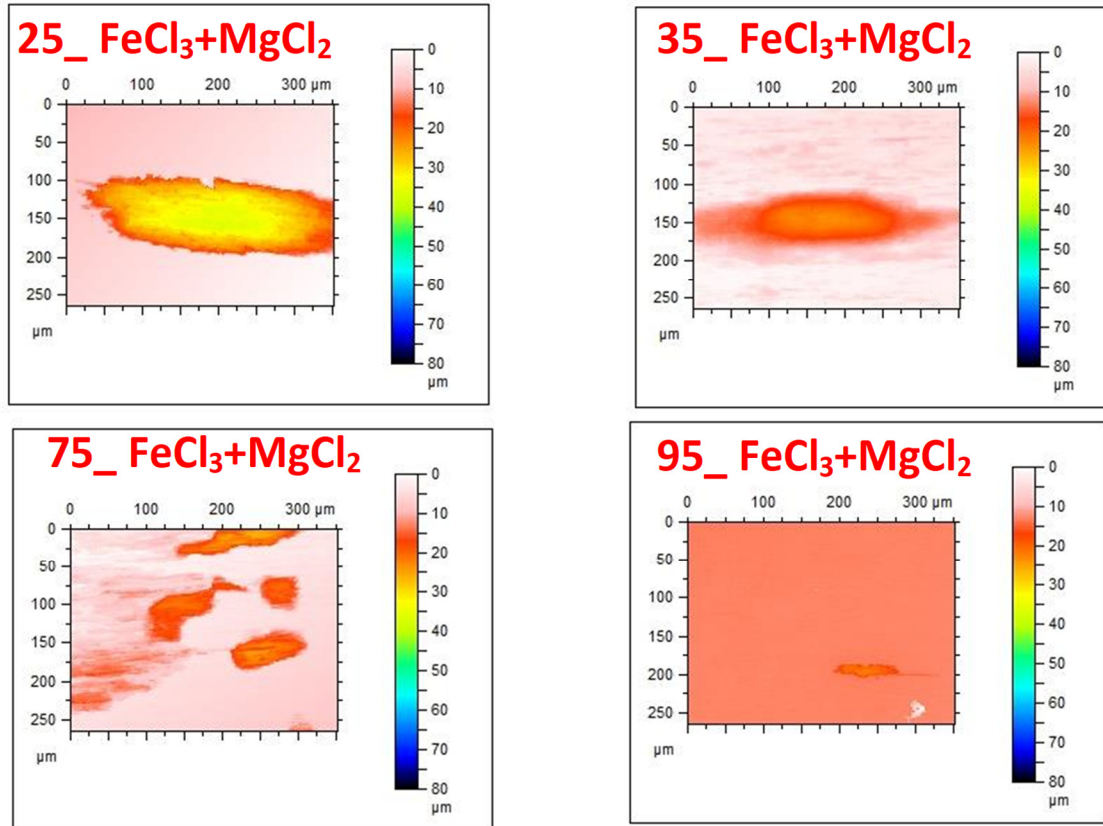
**Figure C13. Corrosion Morphology of Pits Grown on SCW2205 Steel Under Droplets of FeCl<sub>3</sub> + MgCl<sub>2</sub> at Different Temperatures. Each image first identifies in red in the upper left corner the temperature in Celsius, followed by an underscore, and then the exposure environment that was used for corrosion testing.**
