Pedestrian Crossings and Safety on Four Anishinaabe Reservations in Minnesota

NOVEMBER 2020

Research Project
Final Report 2020-29

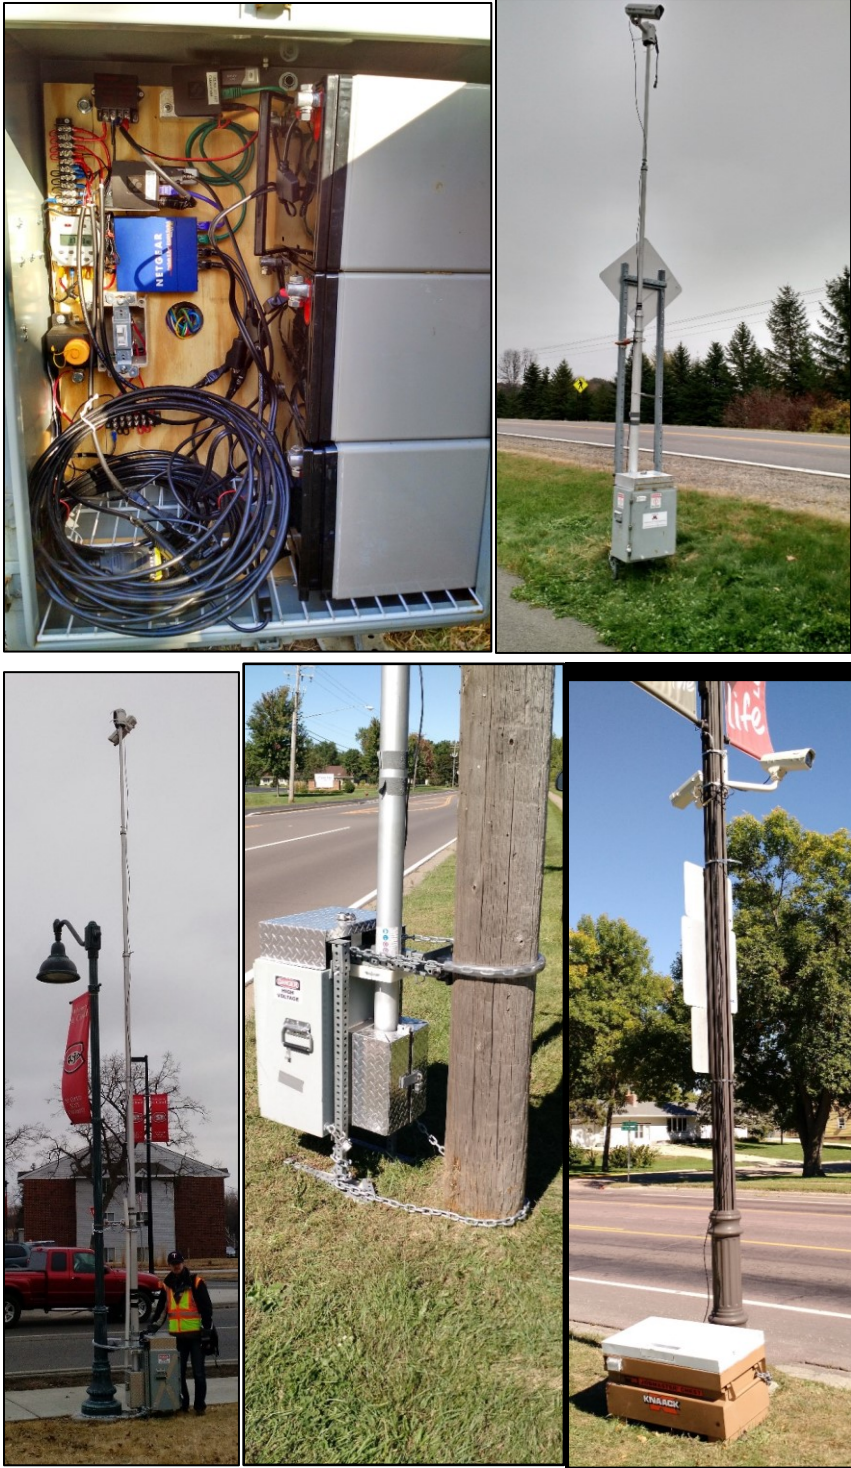
Figure 3.3 Images of Standard MTO Monitoring System Used in Project.

The MTO set a goal of monitoring long enough at each location to observe at least 200 pedestrian crossings. The video cameras were operable only during daylight hours; electronic timers were used to stop video during night-time hours when traffic could not be observed and to re-start at daybreak. Each video camera continued operating until its batteries were dead. Given this procedure, the number of days each video camera operated varied across sites. The number of observations that were obtained also varied across sites.

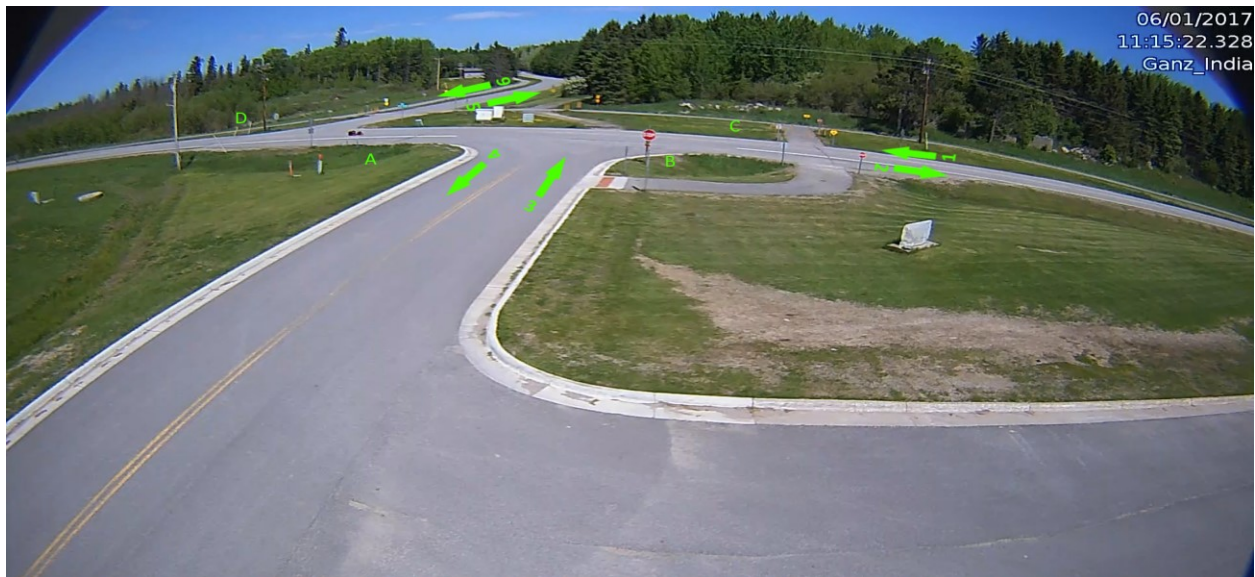
Figure 4.1 County Road 104 and Farm Road

The major concern with this location is that pedestrians, including unaccompanied children, who use the Vermillion Trail or walk along Farm Road need to cross CSAH 104 to reach the Government Center. Tribal representatives said drivers on CSAH 104 sometimes speed along this section.

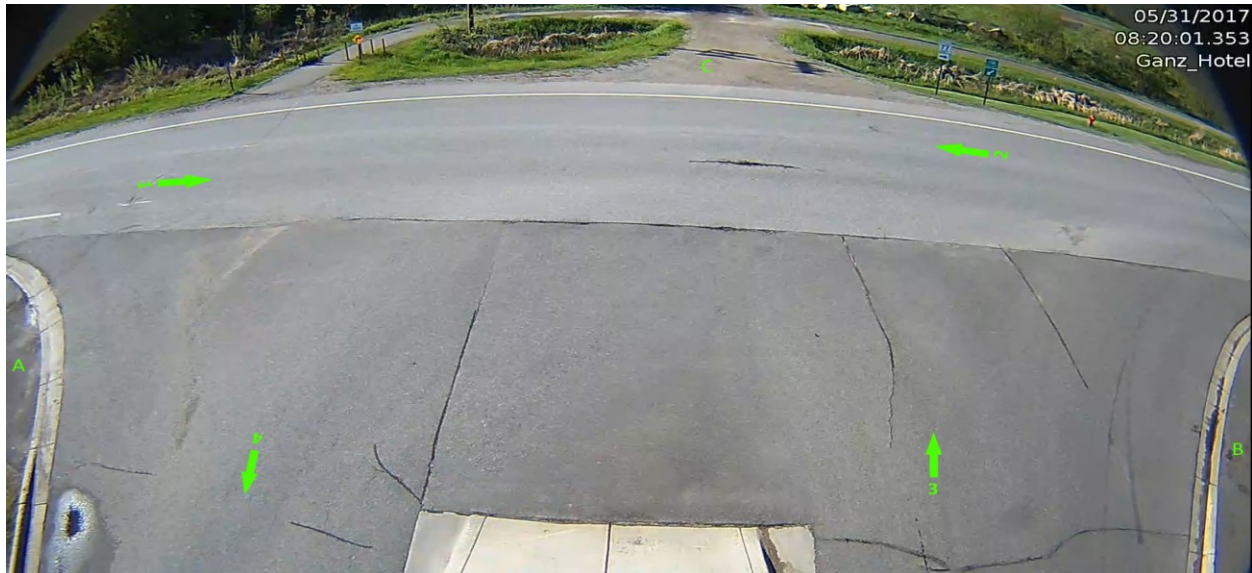
Figure 4.2 County Road 104 and Gold Spur Road

The major concern with this location is that pedestrians walk through or near the parking lot on the south side of the CSAH 104 to access Gold Spur Road. The crossing is not marked. Many vehicles heading east on CSAH 104 turn left (north) on Gold Spur Road to go the Casino.

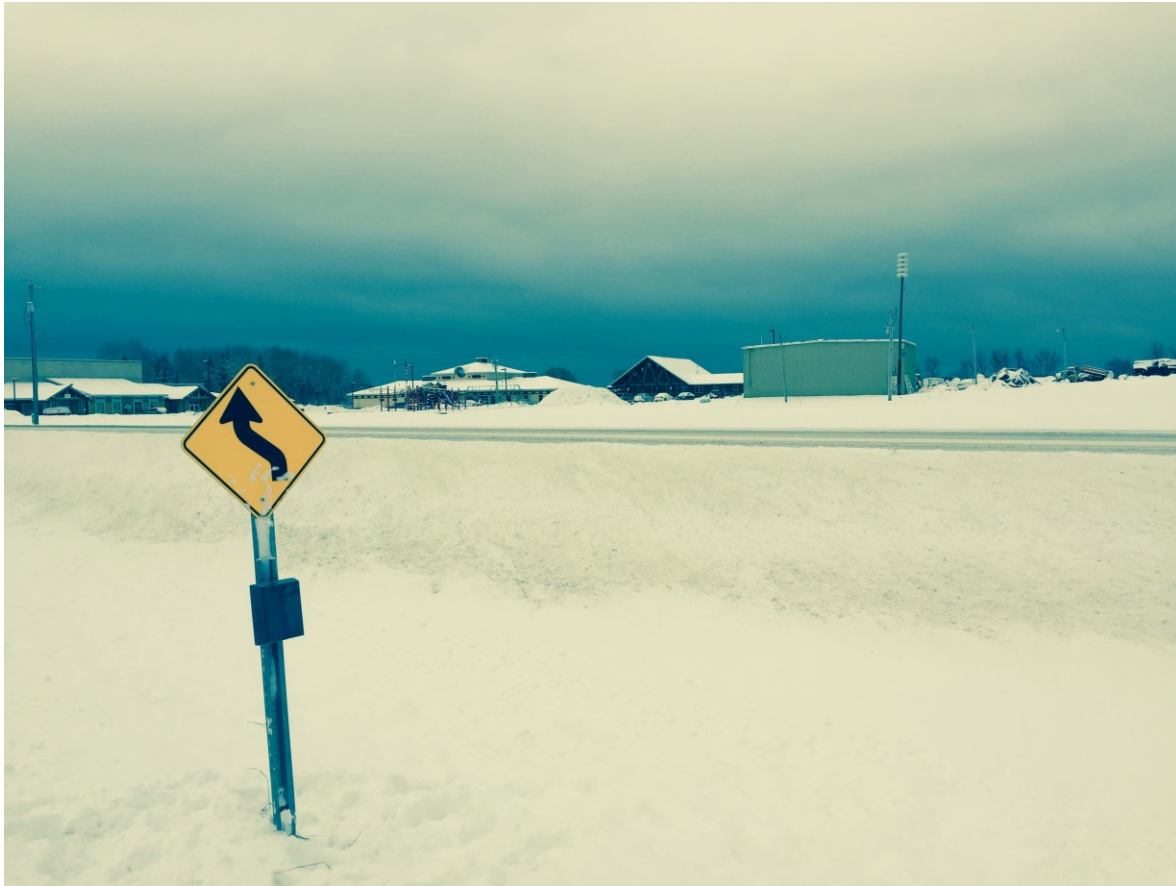
Figure 4.3 Infrared Pedestrian and Bicycle Monitor on Vermillion Trail West of Farm Road

Figure 4.3 is a picture of the infrared pedestrian and bicycle monitor installed on the Vermillion Trail on the north side of CSAH 104, east of Farm Road. The Bois Forte Tribal Government Center complex is in the background. The Vermillion Trail provides a safe place to walk and has reduced concerns among Tribal members about the safety of pedestrians who previously walked along CSAH 104. The Bois Forte Band is seeking funds to expand its trail network. The infrared monitor was installed to provide information to support these planning efforts.

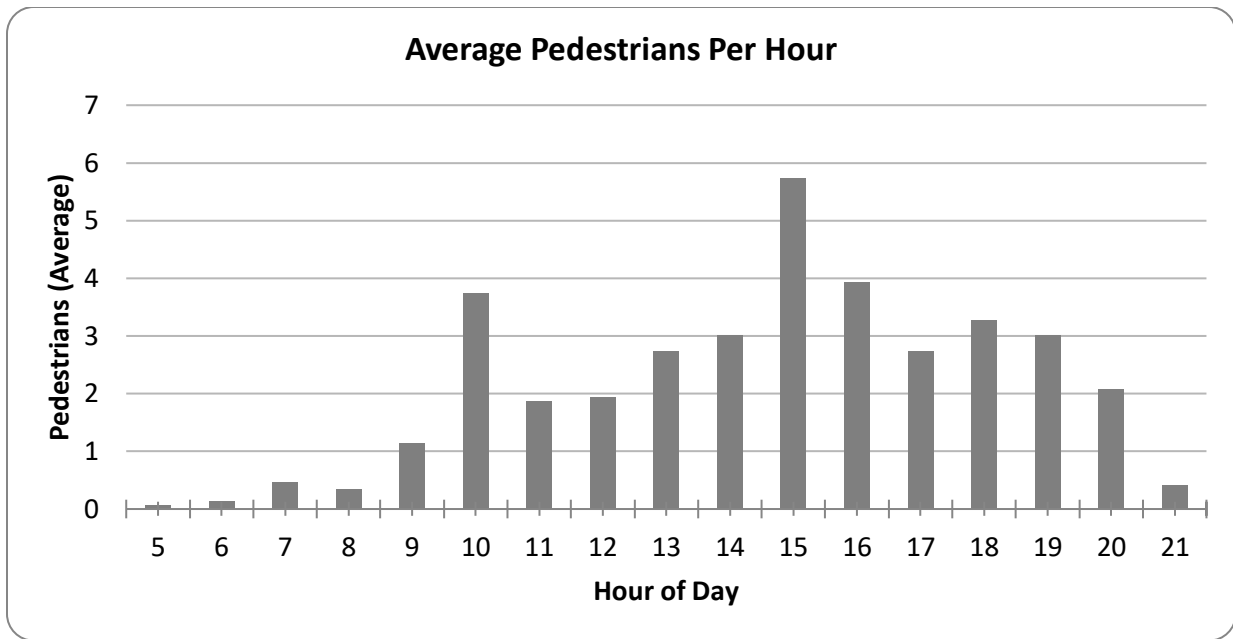
Figure 4.4 CSAH 104: Average Hourly Pedestrian Crossings near Farm Road

The average number of pedestrians crossing County Road 104 at Farm Road during daylight hours was 39 per day (Table 4.2). The maximum number of pedestrians observed crossing at Farm Road during a single day was 70. Approximately 9% of the crossings at Farm Road involved interactions with vehicles. The actual number of pedestrians crossing at this location each day is likely higher because it is probable that some pedestrians cross during the night.

Analyses of video revealed instances where unaccompanied children crossed CSAH 104. The analyses also revealed that pedestrians often did not use the unmarked crossing to the Vermillion Trail east of Farm Road, especially if they were heading north or south along Farm Road or were to or from the west on the Vermillion Trail. Instead, these pedestrians typically walked southeast at angles from the Vermillion Trail or Farm Road to access the Tribal Government Complex. Figure 4.5 is a picture of pedestrians, including children, approaching this crossing.

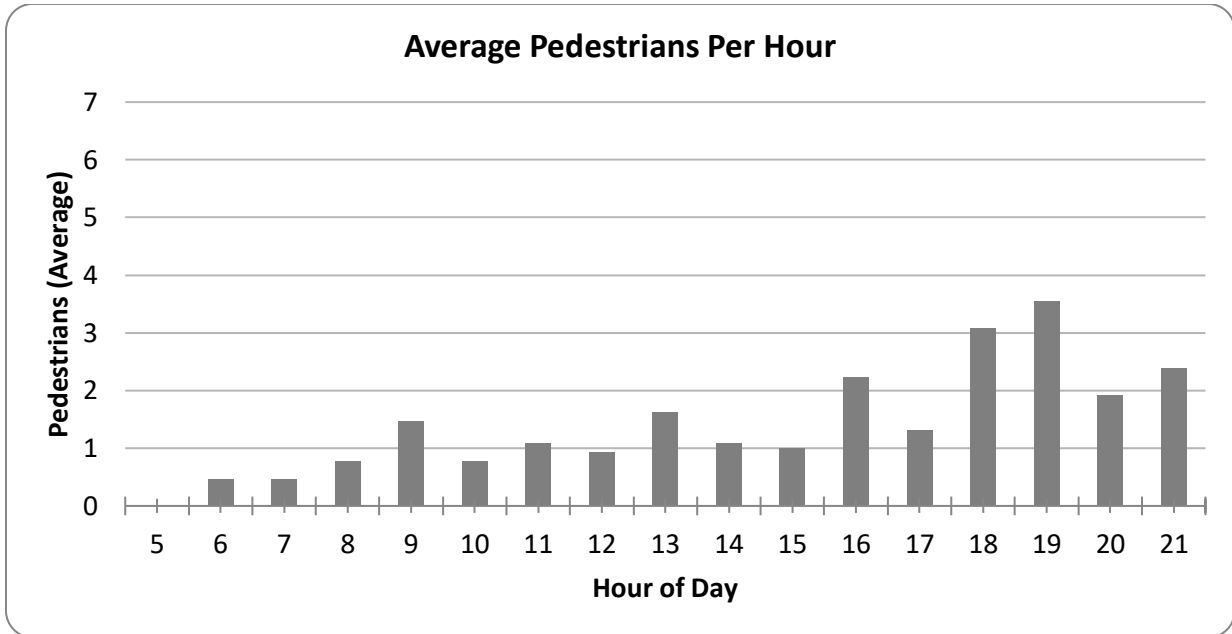
Figure 4.6 County Rd 104: Average Hourly Pedestrian Crossings at Gold Mine Spur Road

At the Gold Mine Spur Road intersection, the average number of pedestrians crossing each day over the 12 day period was 26. The maximum number of pedestrians observed crossing during any day was 46.

Approximately 16% of these crossings involved interactions (e.g., vehicles waited for pedestrians or vice-versa). The highest volume of crossings per hour occurred between 6:00 p.m. and 7:00 p.m. and between 7:00 p.m. and 8:00 p.m. (between three to four pedestrians per hour during each of these hours). Figure 4.7 is a picture of pedestrians, including children, crossing at this location.

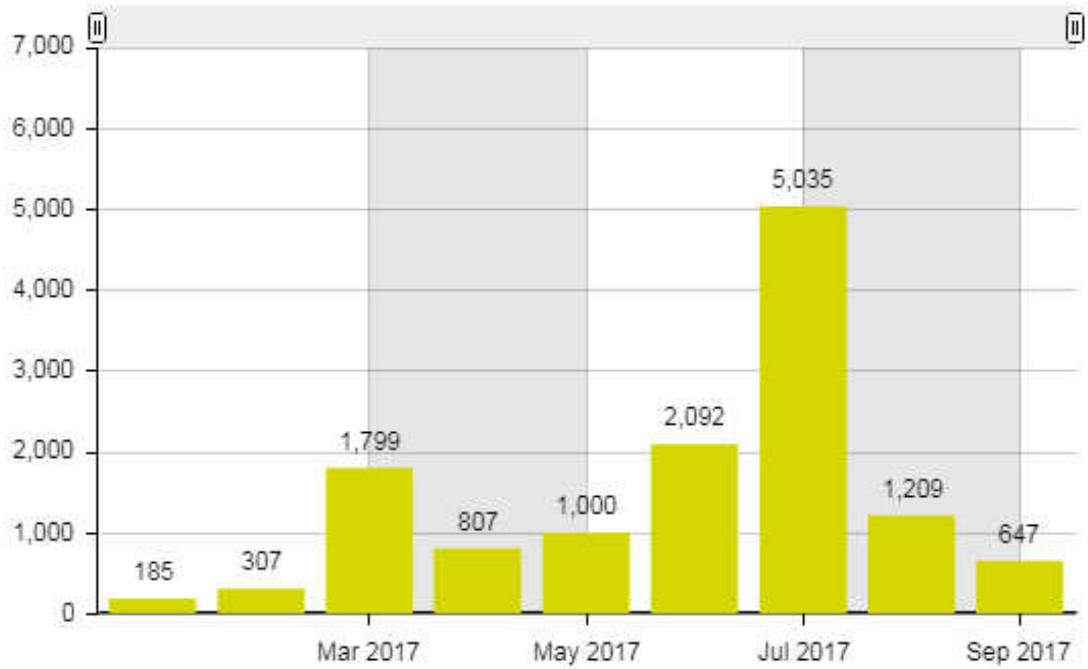
Figure 4.8 Vermillion Trail Monthly Trail Traffic: January 2017 – September 2017

As noted above, the traffic on July 8 accounted for approximately 7.7% of all traffic in the nine-month monitoring period and for 20% of the July monthly traffic. This volume, which is more than 21 times average daily traffic for the nine-month period, seems unusually high and could be an anomaly, although very high daily counts associated with organized events are common on trails. To help determine whether the July 8 traffic count volume is valid, hourly totals for the day were analyzed (Figure 4.13). The hourly patterns are suggestive of some type of day-long event, with traffic in and out. A traffic volume of 250 was recorded between 7:00 a.m. and 8:00 a.m., and a comparable volume (220) was recorded between 3:00 p.m. and 4:00 p.m.

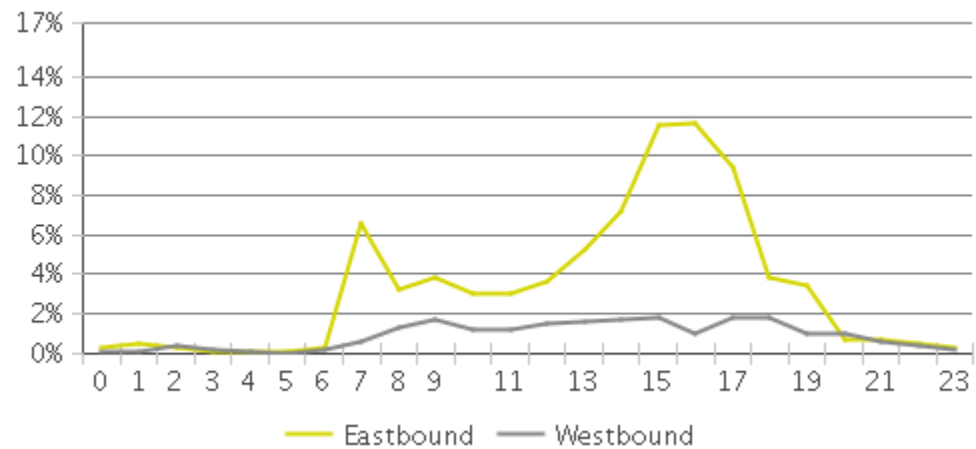
Figure 4.12 Vermillion Trail Weekend Hourly Traffic Profile

Hourly traffic profiles for weekdays and weekend days, respectively, are presented in Figures 4.11 and 4.12. Trail traffic peaks between 3:00 p.m. and 5:00 p.m. on both weekdays and weekends, with the busiest hours accounting for 12% to 15% of traffic. A small morning peak exists on weekends that does not exist on weekdays.

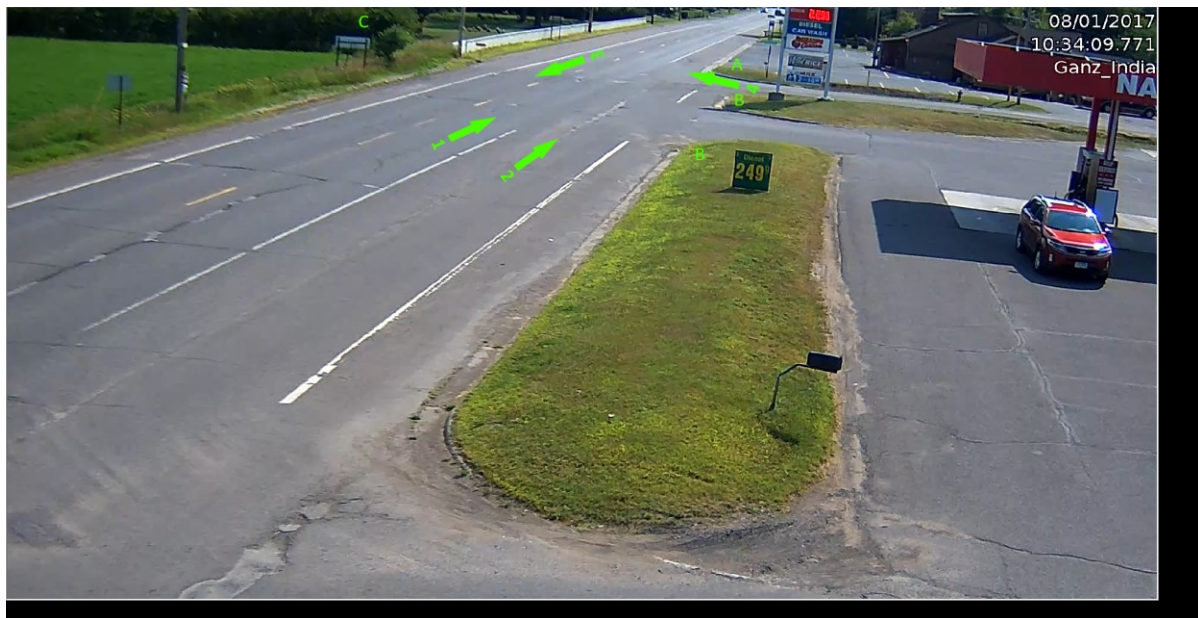
Figure 4.14 Cloquet: Big Lake Road and Pinewood Drive (Location 1)

Figure 4.14 is an east-facing picture of the Big Lake Road and Pinewood Drive intersection in Cloquet taken from the video camera used to monitor pedestrian crossings. Big Lake Road runs east-west at this location. Pinewood Drive ends at a T-intersection on the south side of Big Lake Road. The major safety concern with this location is that pedestrians walk along the northern side of Big Lake and cross to the gas station and convenience store. No formal pedestrian facilities are located at this intersection. The letters and numbers in the image are general locations where pedestrians and vehicles, respectively, were coded.

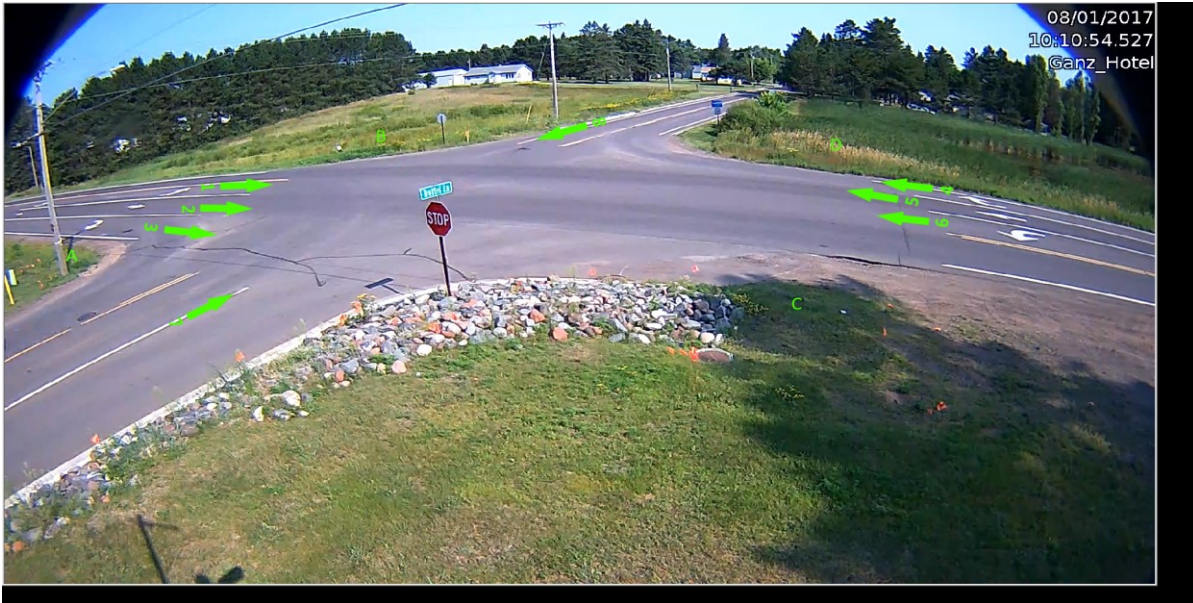
Figure 4.15 Cloquet: Big Lake Road and Trettel Lane (Location 2)

The major safety concerns with this location are that pedestrians walking along Trettel Lane cross Big Lake Road at an unmarked crossing and that pedestrian's walk along the northern side of Big Lake Road. No pedestrian facilities are located at this intersection.

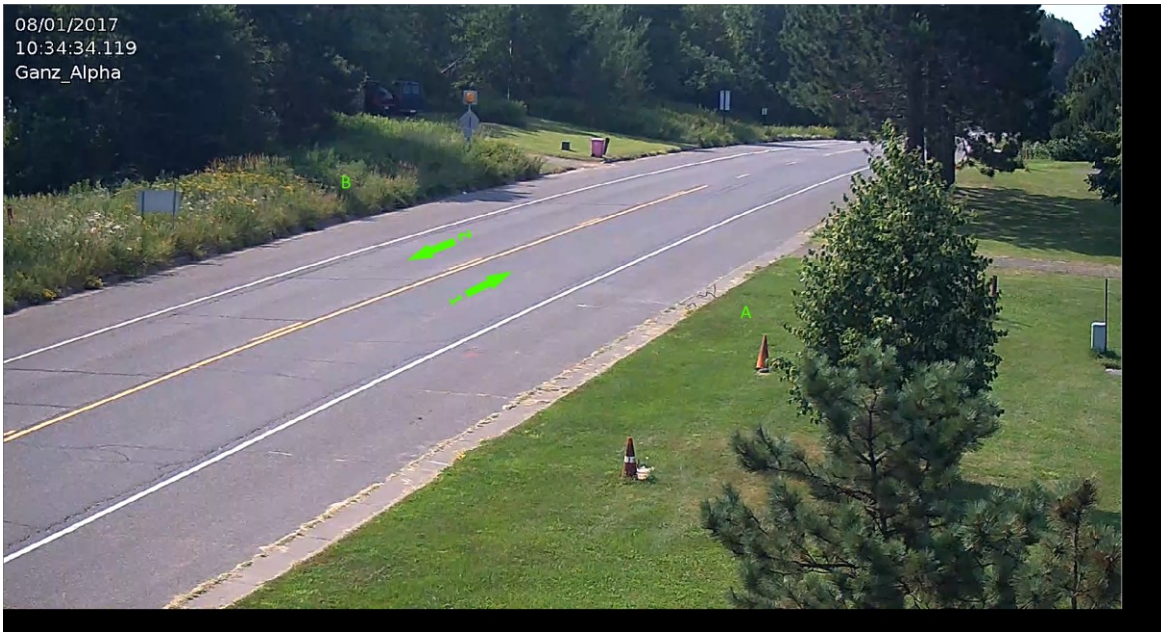
Figure 4.16 Cloquet: Brevator Road (Location 3)

Figure 4.16 is a west-facing picture of the Big Lake Road and Brevator Road intersection in Cloquet taken from the video camera used to monitor pedestrian activity. Big Lake Road runs east-west at this location; Brevator Road runs north-south at this intersection. The green arrows show the direction of vehicular traffic flow. This section of road has wide shoulders used by pedestrians. The letters and numbers in the image are general locations where pedestrians and vehicles, respectively, were coded.

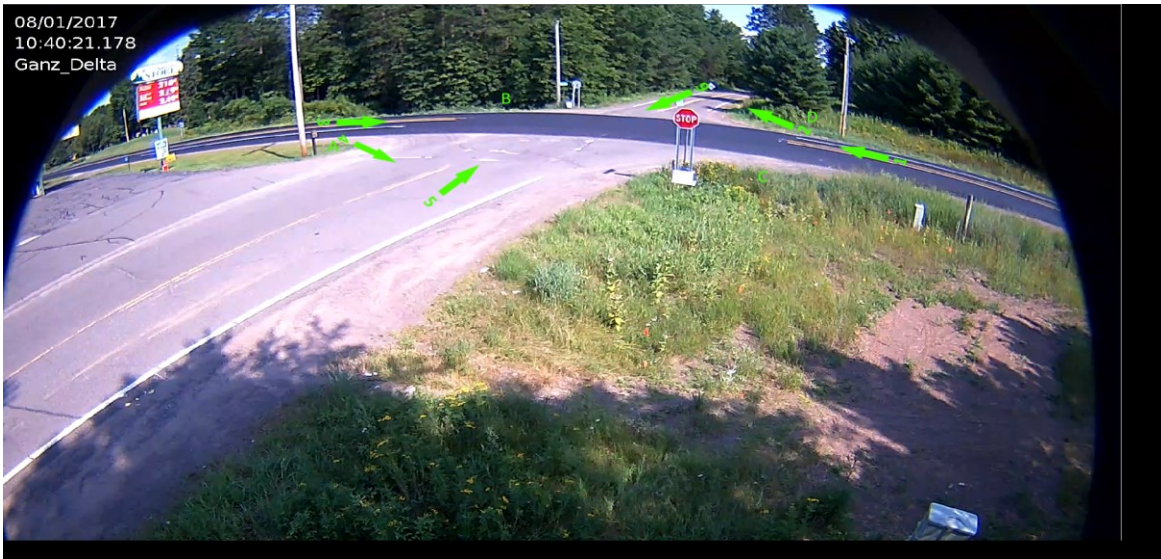
Figure 4.17 Sawyer: Minnesota 210 and Mission Road (Location 4)

The major safety concerns with this location are that pedestrians walking south along Mission Road from an elderly housing unit and other points of origin cross TH 210 to access the grocery store/gas station and post office. The crossing is unmarked. No pedestrian facilities are located at this intersection.

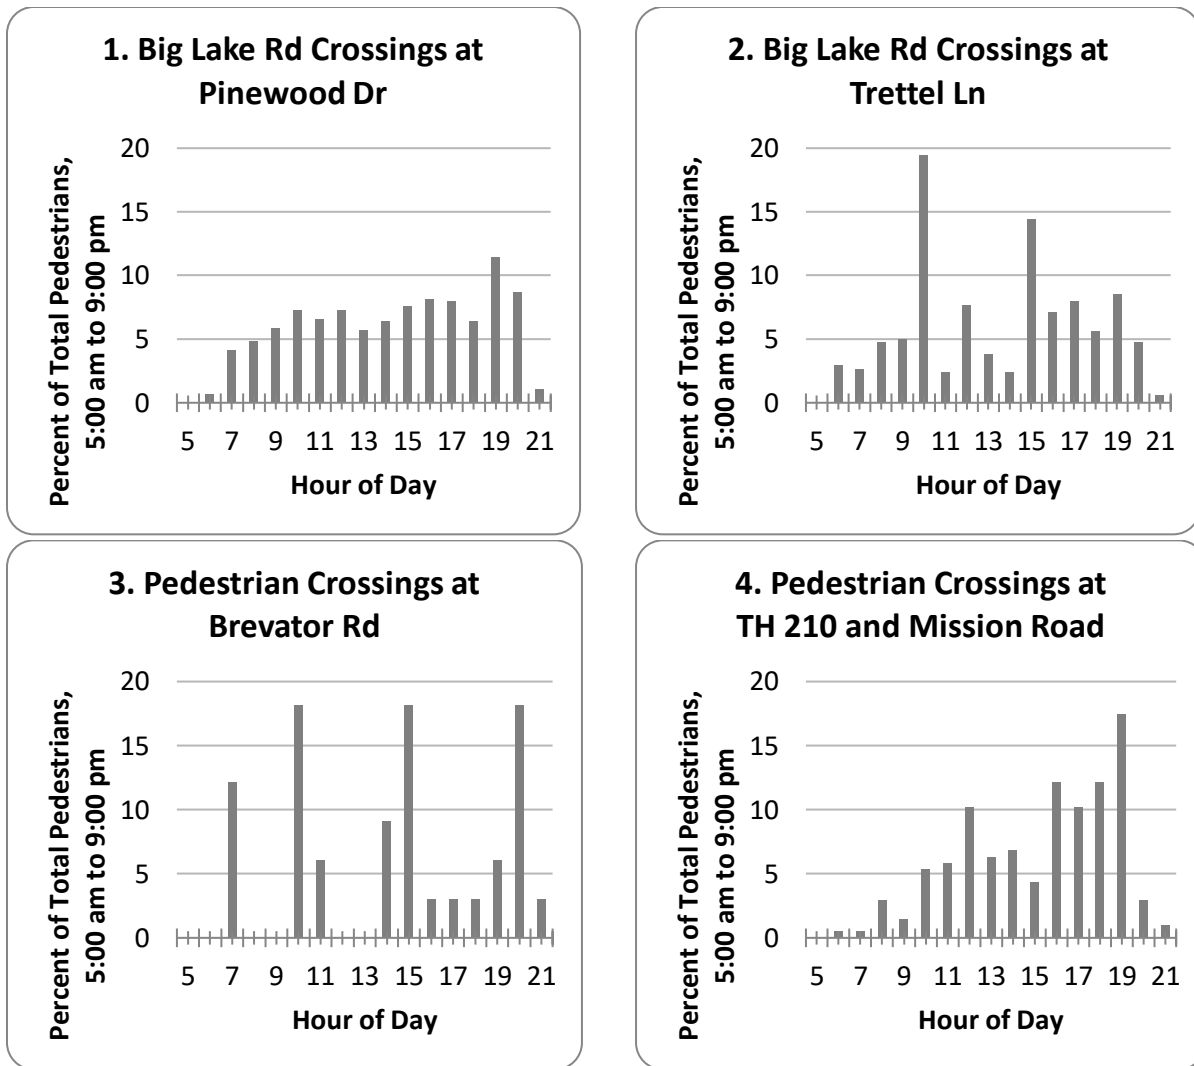
Figure 4.18 Percent of Crossings by Hour of Day, Fond du Lac Monitoring Sites

Site	Days of Data	Total Pedestrians Observed	Average Pedestrians Per Day	Maximum Pedestrians Per Day	Average Vehicles Per Day Observed	Total Pedestrians With Interactions	% Pedestrians With Interaction
Cloquet - Big Lake Rd & Pinewood Dr	20	578	29	61	4034	166	28.7%
Cloquet - Big Lake Rd & Trettel Ln	11	339	31	56	6497	99	29.2%
Cloquet - Brevator Rd	11	33	3	8	1242	3	9.1%
Sawyer - MN 210 & Mission Rd	17	206	12	23	4086	68	33.0%

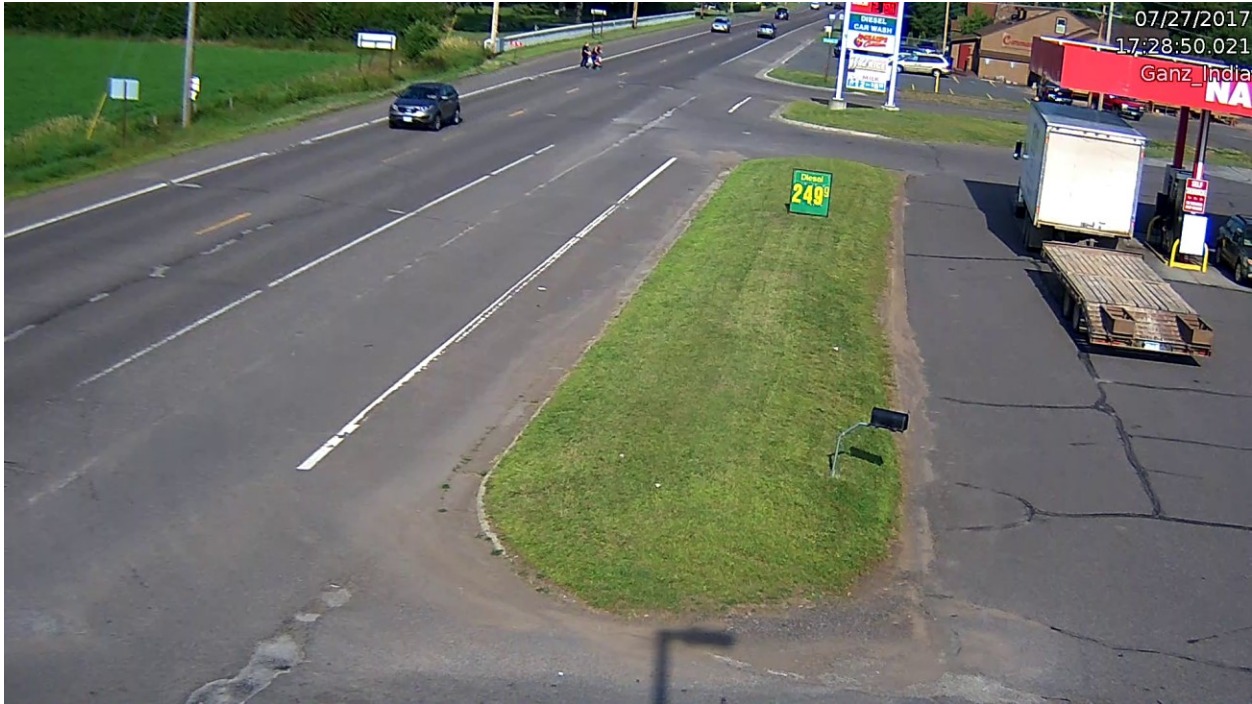
Figure 4.19 Pedestrians Crossing Big Lake Road at Pinewood Drive

The average number of pedestrians crossing Big Lake Road at Pinewood Drive during daylight hours was 29 per day (Table 4.3). The maximum number of pedestrians observed crossing during a single day was 61. Approximately 29% of these crossings involved interactions with vehicles. The crossings were highest from 7:00 p.m. to 8:00 p.m. (11% of daily traffic; Figure 4.18). The actual number of pedestrians crossing at this location each day is likely higher because it is probable that some pedestrians cross at night-time. Figures 4.19 is a picture of pedestrians observed crossing at this location.

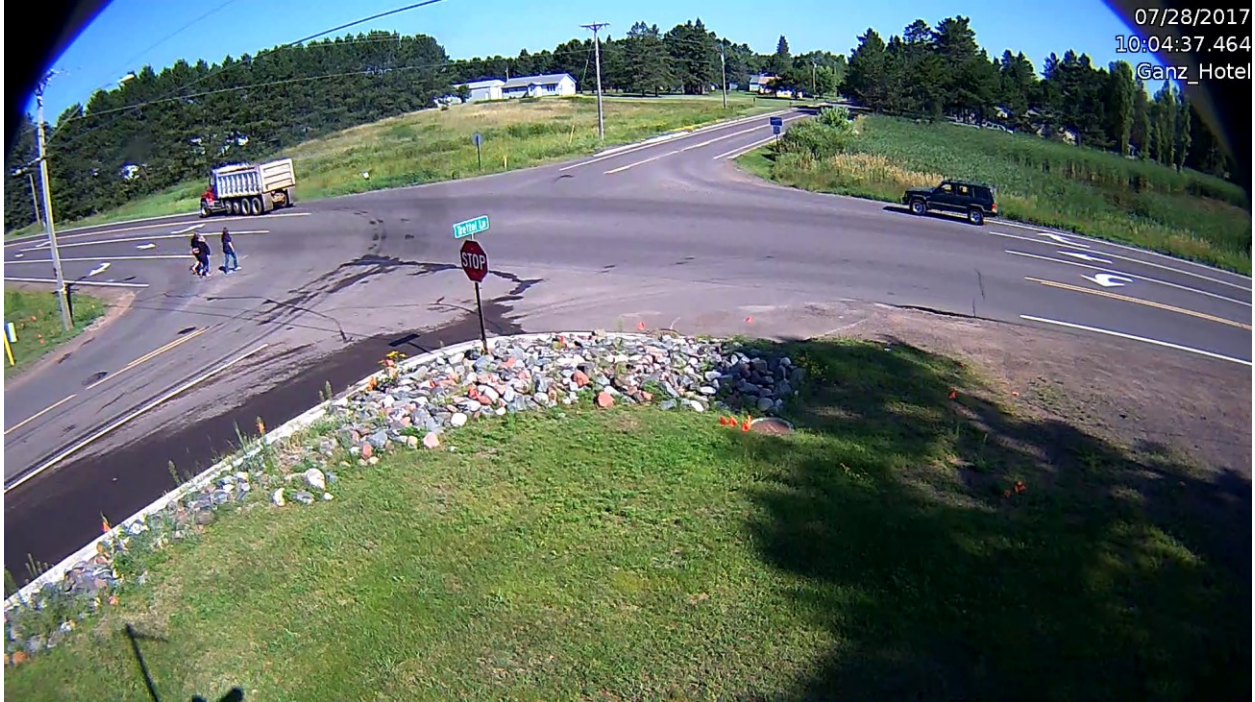
Figure 4.20 Pedestrians Crossing Big Lake Road at Trettel Lane

The average number of pedestrians crossing Big Lake Road at Trettel Lane during daylight hours was 31 per day (Table 4.3). The maximum number of pedestrians observed crossing during a single day was 56. Approximately 29% of these crossings involved interactions with vehicles. The crossings were highest from 10:00 a.m. to 11:00 a.m. (19% of daily traffic) and from 3:00 p.m. to 4:00 p.m. (14% of daily traffic; Figure 4.18). The actual number of pedestrians crossing at this location each day is likely higher because it is probable that some pedestrians cross at night-time. Figures 4.20 is a picture of pedestrians observed crossing at this location.

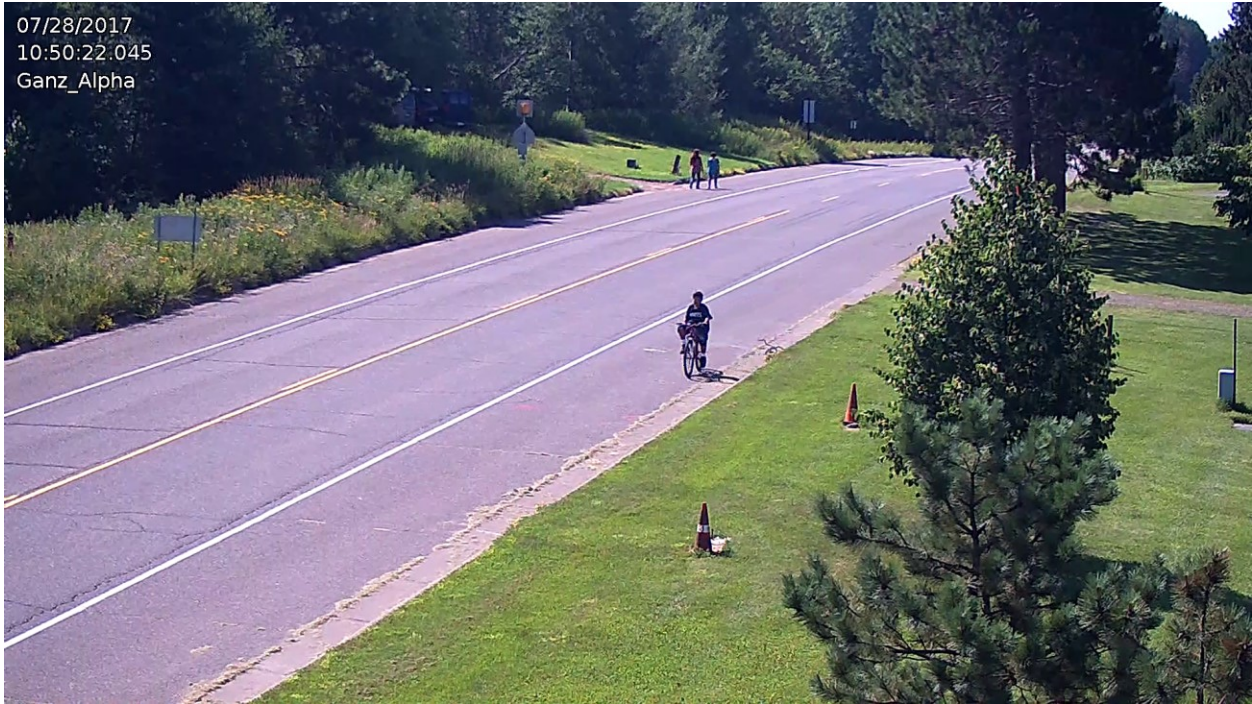
Figure 4.21 Pedestrians and Cyclists in the Right-of-Way

The average number of pedestrians crossing Big Lake Road at Brevator Road during daylight hours was 3 per day (Table 4.3). The maximum number of pedestrians observed crossing during a single day was 8. Approximately 9% of these crossings involved interactions with vehicles. Because the total volumes were so low, identification of peak crossing times involves great uncertainty. The greatest numbers of pedestrians were observed at 10:00 a.m., 3:00 p.m., and 8:00 p.m. (Figure 4.18). The actual number of pedestrians crossing at this location each day is likely higher because it is probable that some pedestrians cross at night-time. Figure 4.21 is a picture of a pedestrian walking in the right-of-way at this location.

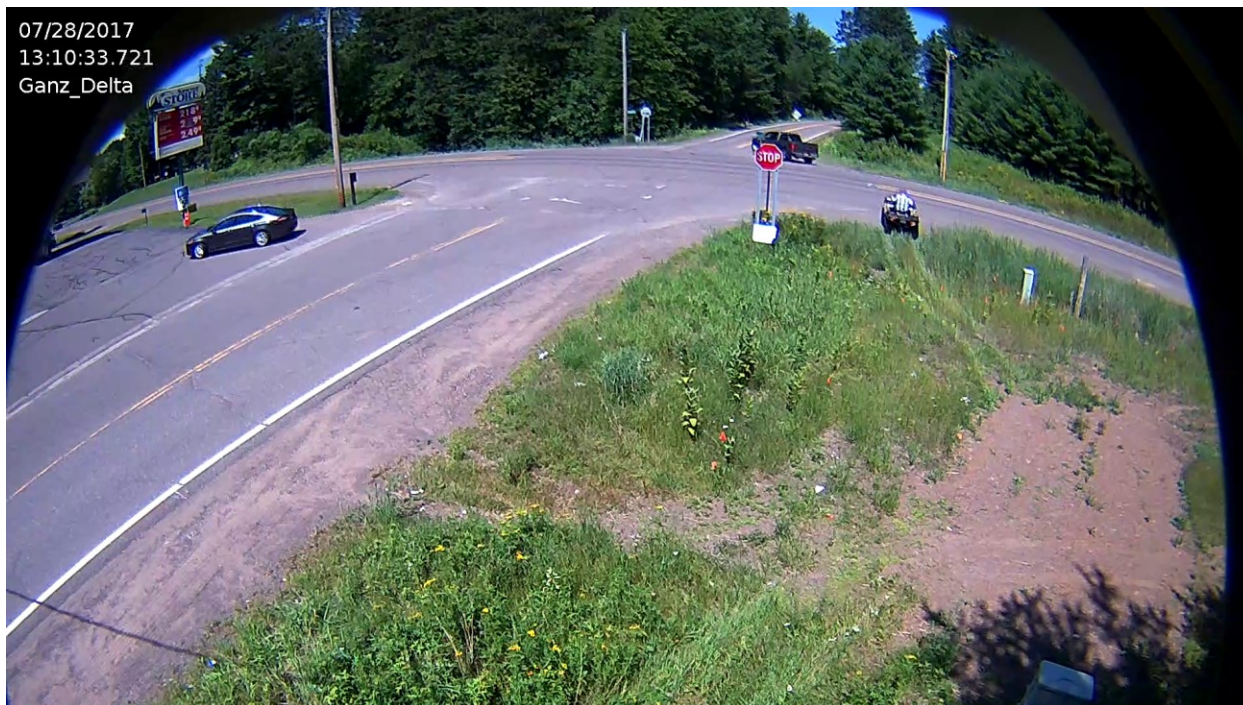
Figure 4.22 Off-road, Four-wheel Vehicle Crossing TH 210 at Mission Road

The average number of pedestrians crossing TH 210 at Mission road in Sawyer during daylight hours was 12 per day (Table 4.3). The maximum number of pedestrians observed crossing during a single day was 23. Approximately 33% of these crossings involved interactions with vehicles. The majority of crossings occurred during mid- to late-afternoon and early evening, peaking from 7:00 p.m. to 8:00 p.m. (17% of daily traffic; Figure 4.18). The actual number of pedestrians crossing at this location each day is likely higher because it is probable that some pedestrians cross at night-time. In addition, pedestrians and cyclists do not present the only risks associated with this crossing. Figure 4.22 is a picture of an off-road vehicle observed crossing at this location.

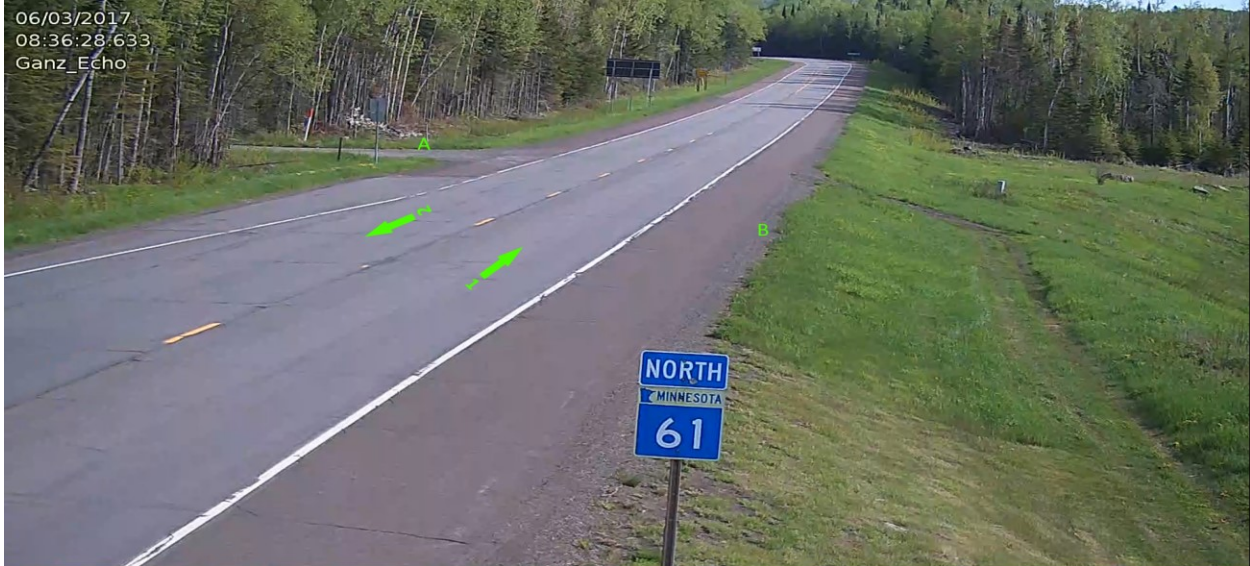
Figure 4.23 TH 61 and Blazes Pit Road (unmarked crossing north of Marina Road)

The major safety concerns at this location are that pedestrians cross TH 61 at an unmarked crossing from the gravel exit (on the west side of the road in Figure 4.23) down an informal footpath on the east side of TH 61 that leads to the Trading Post and other destination. Given the remote area and density of forest along TH 61, it is unlikely that drivers expect pedestrians to cross at this location. No pedestrian facilities exist at this location.

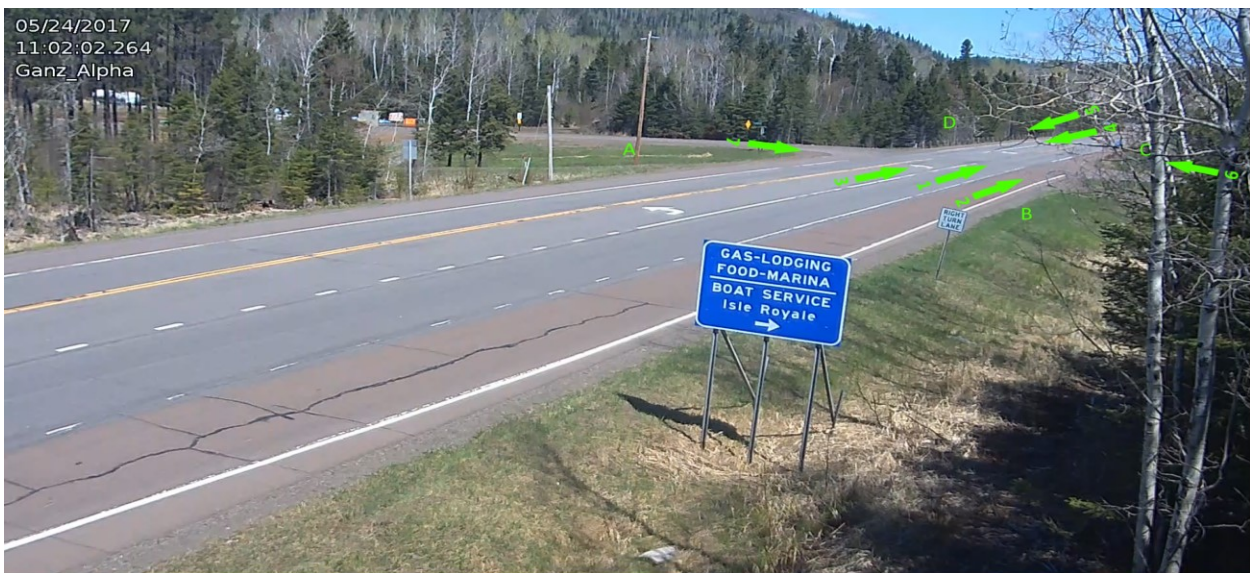
Figure 4.24 TH 61 and Stevens Road

The major safety concerns at this intersection are pedestrian crossings from a residential subdivision to the west to various destinations on the east, or the Lake Superior side of TH 61. No pedestrian facilities exist at this location.

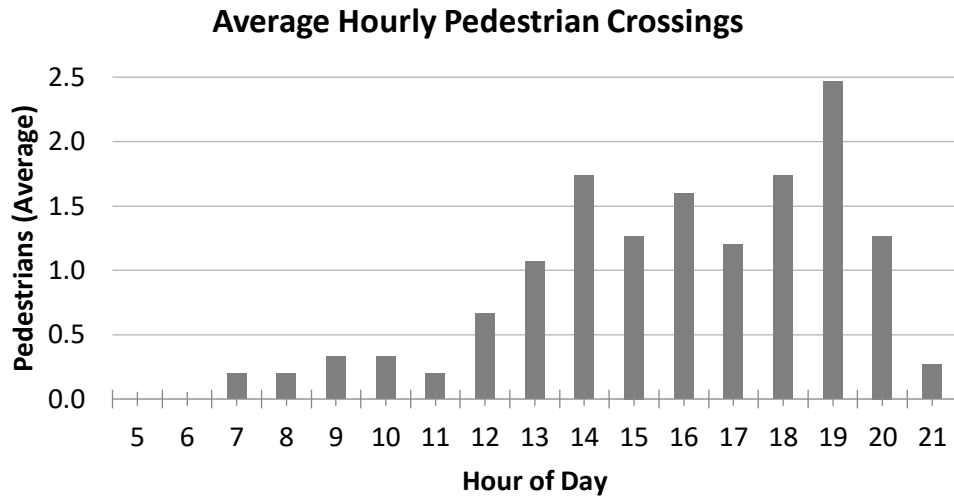
Figure 4.25 TH 61 and Unmarked Crossing by Blazes Pit Road: Average Hourly Pedestrian Crossings

The average number of crossings per day was about 14. Approximately 21% percent of these crossings involved interactions with vehicles (e.g., either vehicles or pedestrians altering their behavior). The maximum number of pedestrians observed crossing in any one day was 38. The peak hour for pedestrian crossings was between 7:00 and 8:00 p.m. (approximately 18% of total traffic; Figure 4.25). Figure 4.26 is a picture of pedestrians observed crossing at this location.

Table 4.4 summarizes counts of pedestrian crossings at these two locations. Figures 4.26 and 4.28 present images of pedestrians observed crossing at these locations during the monitoring period. Figures 4.25 and 4.27 present pedestrian crossing by hour at the two sites, respectively. The average numbers of crossings per day at the two locations were comparable, with volumes slightly higher at the informal crossing north of Marina Road.

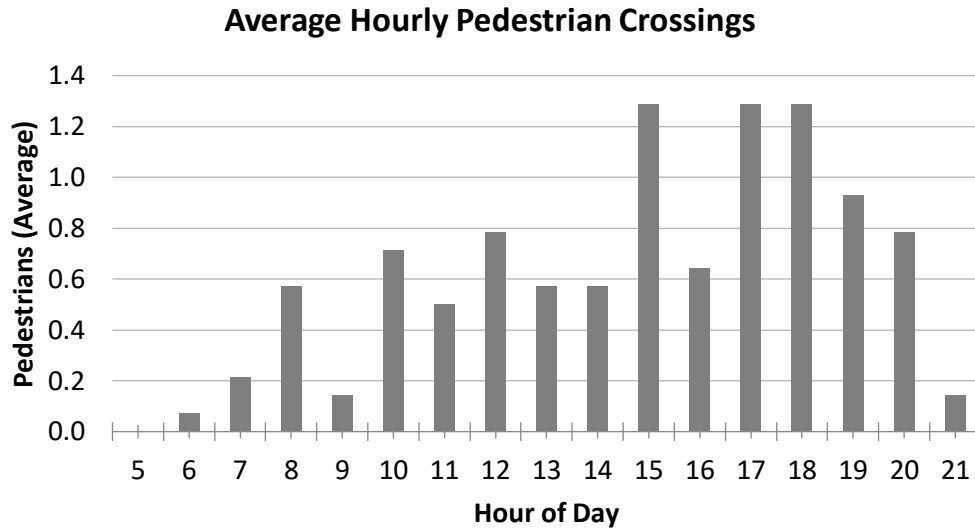
Figure 4.27 TH 61 and Stevens Road: Average Hourly Pedestrian Crossings

(Figure 4.27). Pedestrian crossing TH 61 are not the only activity associated with risk at this location. Figure 4.28 is a picture of is picture of a cyclist riding in the wrong direction on TH 61.

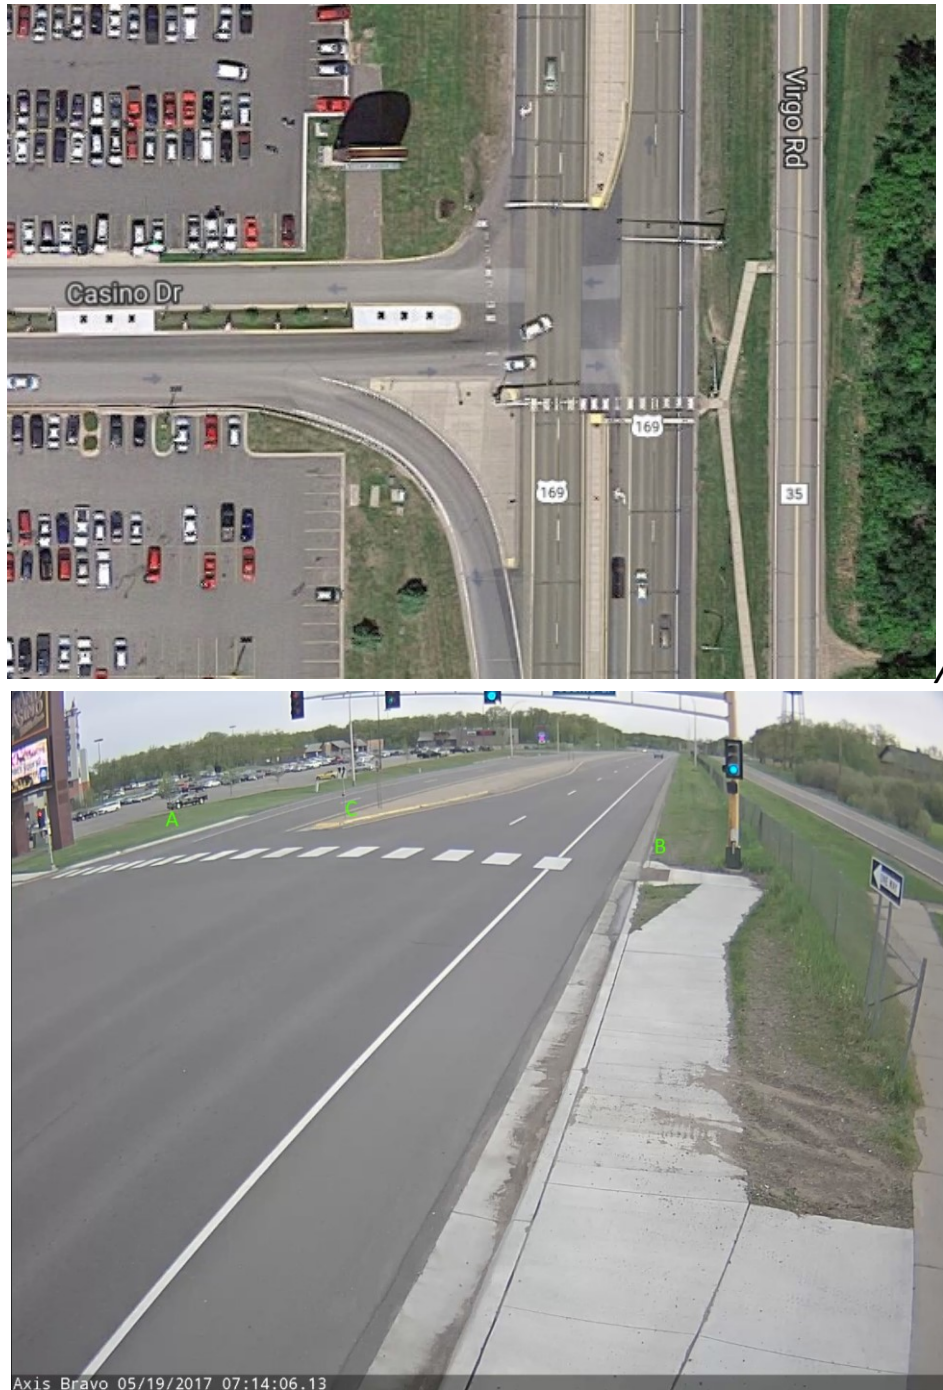
Figure 4.29 TH 169-Casino Drive Intersection: Plan View and Marked Crosswalk, Facing North.

Figure 4.29 includes two photographs: an overhead plan view of the TH 169-Casino Drive intersection and a north-facing picture of TH 169 taken from the video camera used to monitor pedestrian crossings at this intersection. TH 169, which runs mostly north-south at this location, including turning lanes for drivers to enter Casino Drive. The sidewalks extending from the crosswalk on the eastern side of TH 169 were built in anticipation of the planned sidewalk on the western side of Virgo Road. The letters and numbers in the image are general locations where pedestrians and vehicles, respectively, were coded. Because of the existence of the traffic signal and crosswalk, Band representatives did not consider this intersection to pose major risks. However, the volume of pedestrians using the site was unknown, and monitoring was undertaken to provide this information and for purposes of comparing to the pedestrian crossing volumes at the unmarked crossing to the north.

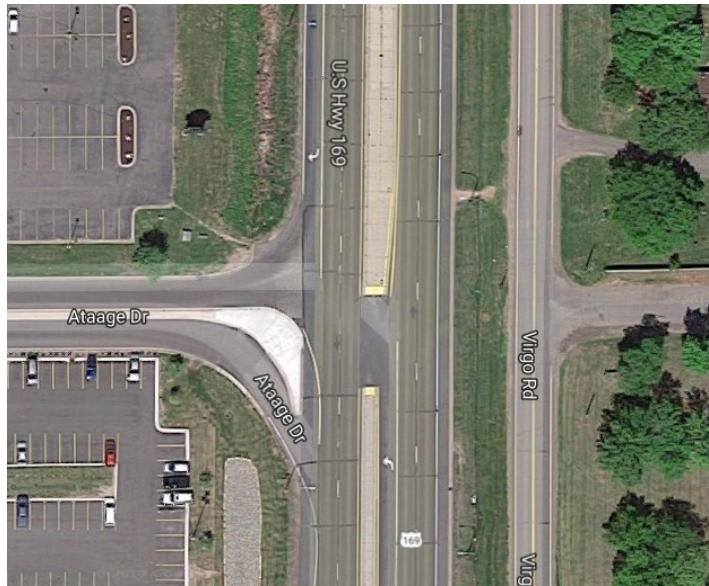
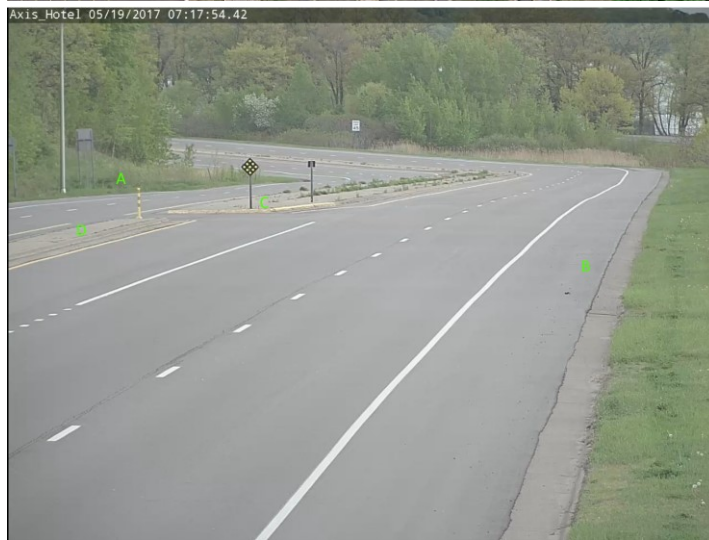
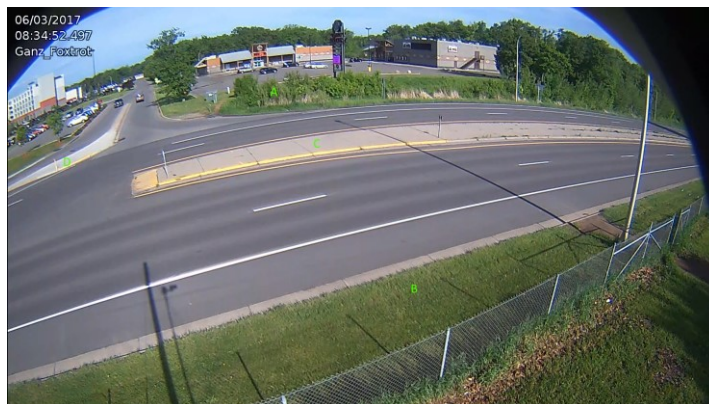
Figure 4.30 Unmarked Crossing on TH 169: Plan View, North-Facing View, Video Camera View.

The major safety concerns at this location were conflicts between people walking and driving. Transportation managers had observed pedestrians walking, running, and sometimes pushing baby carriages across TH 169, often pausing to wait on the raised median. Drivers had been observed slowing or stopping to allow pedestrians to cross. As noted, the Band already had identified potential countermeasures to address these risks. The principal objective of monitoring was to identify actual crossing volumes and provide more information about the magnitude of risk.
