Pedestrian Crossings and Safety on Four Anishinaabe Reservations in Minnesota

NOVEMBER 2020

Research Project
Final Report 2020-29

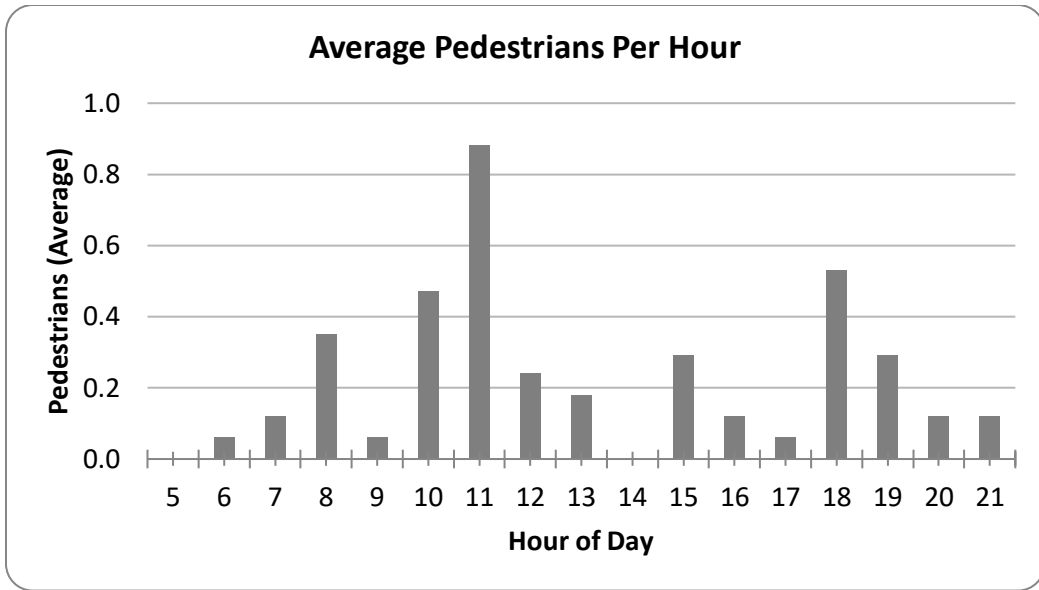
Figure 4.31 TH 169-Casino Drive Intersection: Average Hourly Pedestrian Crossings

The average number of pedestrians crossing TH 169 during daylight hours was four persons per day (Table 4.5). The maximum number of pedestrians observed crossing during a single day was 11. These crossings were highest from 11:00 a.m. to noon (Figure 4.31). Figure 4.32 is a picture of pedestrians, including an individual in a wheel chair, crossing TH 169.

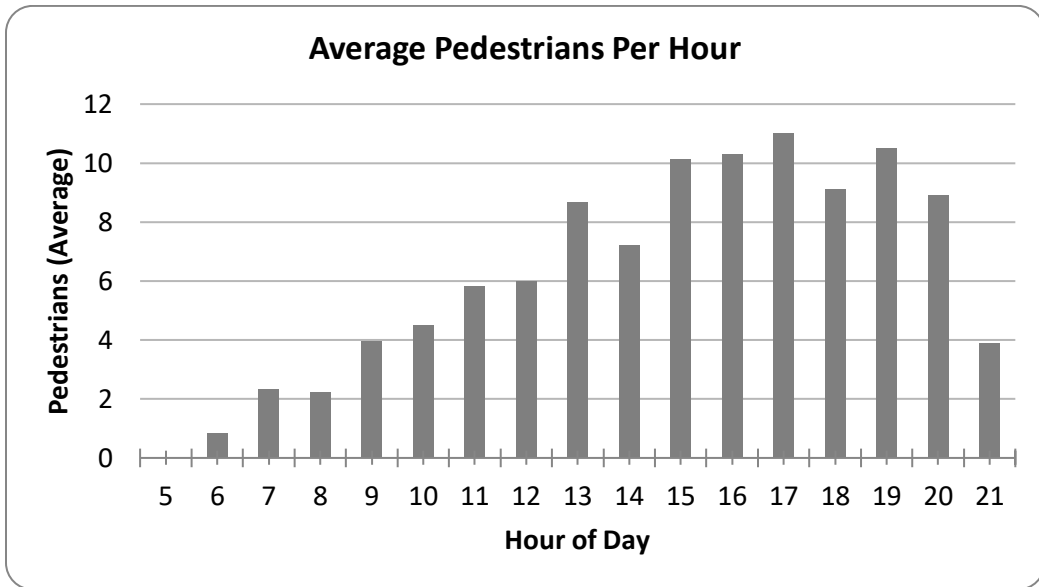
Figure 4.33 TH 169 Unmarked Crossing from Virgo Road to Ataage Average Hourly Pedestrian Crossings

The average number of pedestrians using the informal crossing to Ataage Drive was 136 per day for the 20-day sample and 125 per day for the 3-day sample (Table 4.5). The maximum number of pedestrians observed crossing were 210 and 155 for the two samples. Approximately 54% of the crossings involved interactions with vehicles. Crossings were highest, about 9 to 11 persons per hour, from 3:00 p.m. through 9:00 p.m. (Figure 4.33). Figure 4.34 is a picture of pedestrians crossing TH 169 at this location.

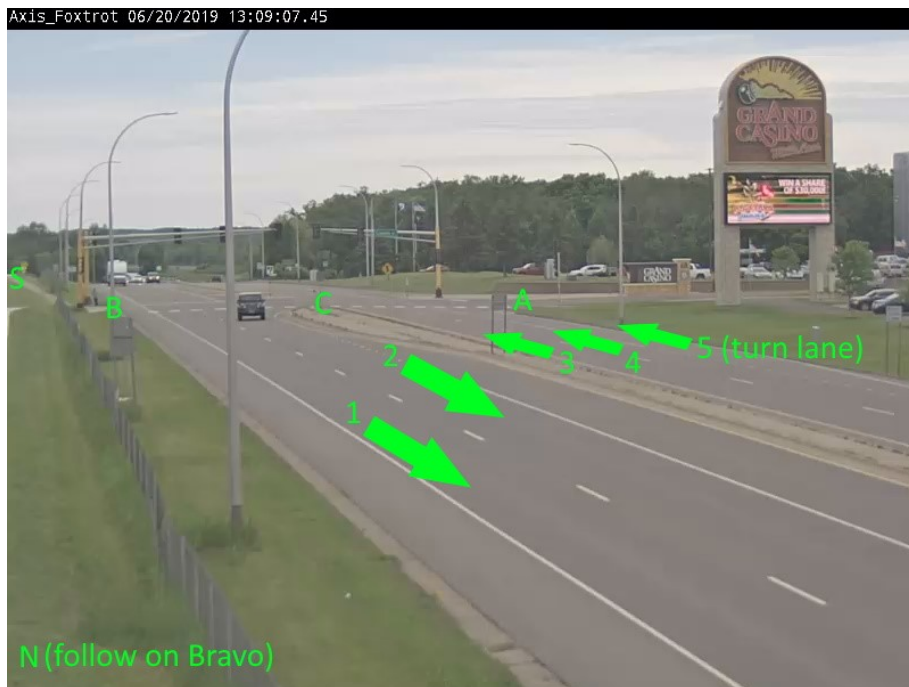
Figure 4.35 Traffic Flows at Marked Crosswalk across TH 169 at Casino Drive.

crosswalk across Virgo Road. The research team completed supplemental monitoring of pedestrian activity in the summer of 2019 to provide information about use of the new sidewalk and to provide additional information about pedestrian crossings through the break in the fence prior to installation of the PHB. The research team followed the same procedures and used the same protocols for video camera installation and data reduction. Video camera perspectives were adjusted to provide views of the new sidewalk. Figure 4.35 is a picture of the marked crosswalk across TH 169 at Casino Drive. Figure 4.36 is a picture of the informal, unmarked crossing across TH 169 accessed through the break in the fence that separates Virgo Road and TH 169. Figure 4.375 is a picture from the video camera used to monitor pedestrian use of the new crosswalk across Virgo Road and the new sidewalk. The letters and numbers in the image are general locations where pedestrians and vehicles, respectively, were coded.
