Final Report

**PERFORMANCE EVALUATION OF GROUT MATERIALS FOR
CONNECTING PRECAST CONCRETE BRIDGE DECK PANELS**

Prepared for the Tennessee Department of Transportation

January, 2017

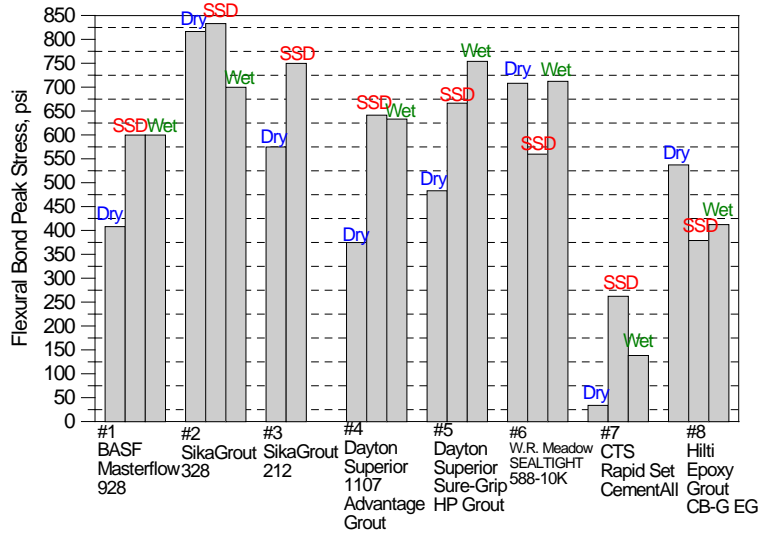
Figure 5.1 Illustration of flexural bond strength of composite specimens with different substrate surface moisture conditions

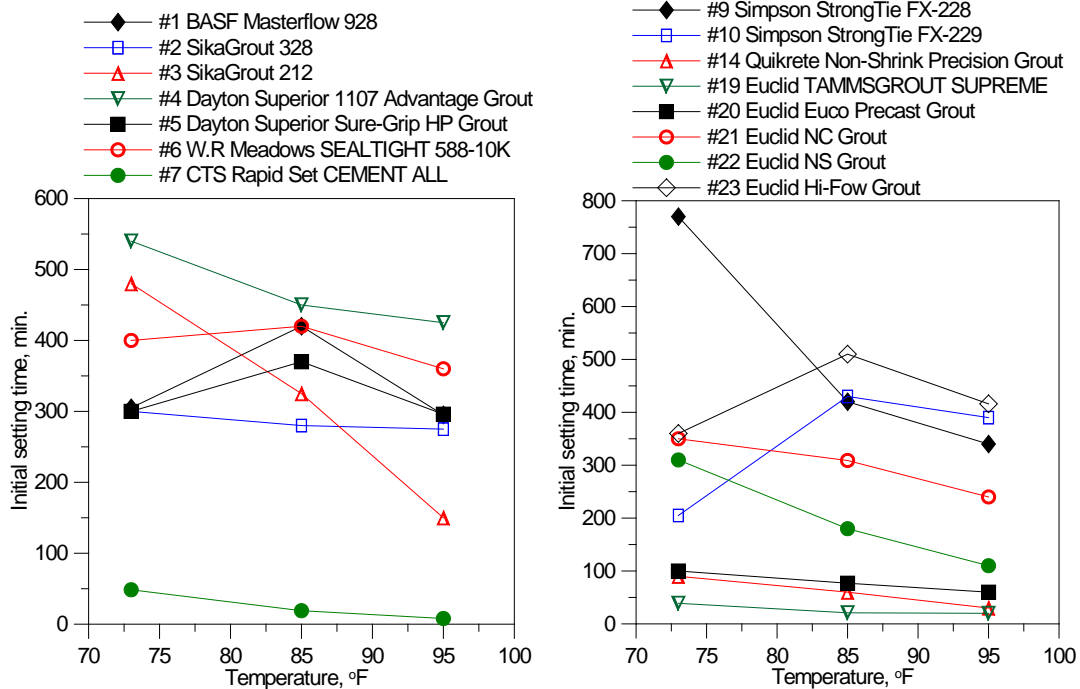
Figure 5.4 Effects of temperature on initial setting time of 15 grout products

Shrink Precision Grout, and #19 Euclid TAMMSGROUT SUPREME, the temperature rise would lead to serious problems because these products would become flash-set and could no longer be adequately mixed, placed, and finished.

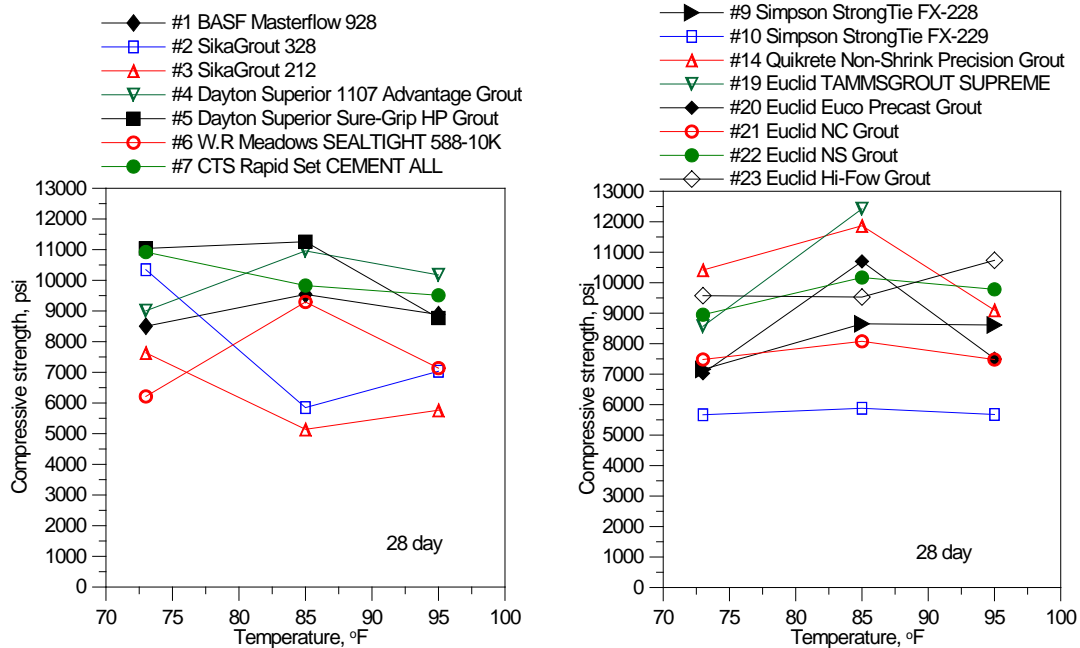
Figure 5.8 Effects of temperature on 28-day compressive strength of 15 grout products

It became evident that the effects of temperature on the compressive strength development of grout products were complicated. It was certain that an increase in temperature would undoubtedly improve the early-age compressive strength of grout products. However, no single relation could truly describe how the compressive strength varied with the temperature. This was because many factors would affect the compressive strength development. One main reason was that different products used different materials and proportions as well as different quality control procedures.

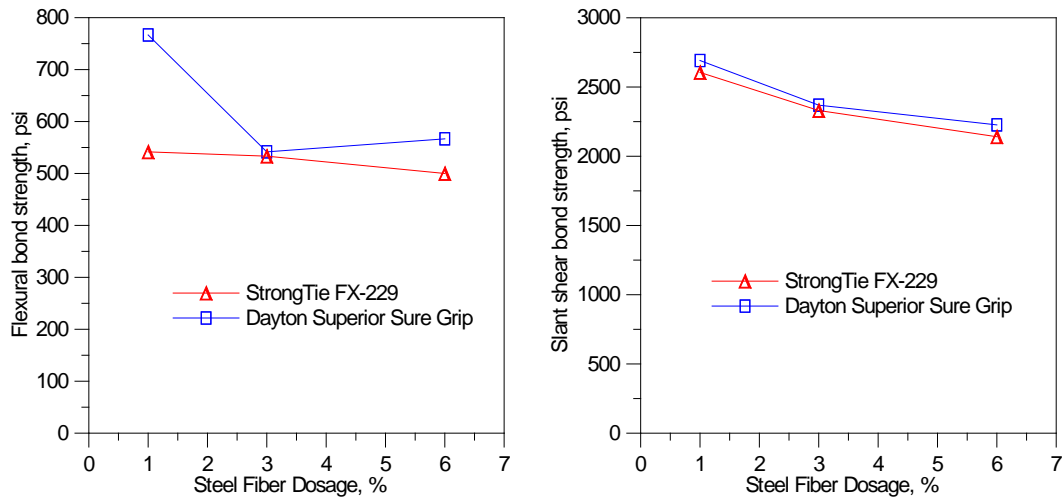
Figure 6.2 Flexural and slant shear bond strength of two grout products with different steel fiber dosage and SSD substrate moisture condition at normal temperature (73°C)

The steel fiber dosage also affected the bond strength of grout products. In this study, two products were investigated with the fiber dosage varying from 1% to 6% by weight. The results were illustrated in [Figure 6.2](#). Clearly, increasing the fiber dosage from 1% to 6% would reduce both the flexural and the slant shear bond strength of grout products. This reflected that a low percentage of steel fibers was more advantageous for improving the bonding capacity. This may be associated with the change in flow behaviors as a result of increasing steel fiber dosage. As can be seen from [Table 6.4](#), introducing 1% steel fiber into the grout increased the mini slump spread, implying that a small dosage of steel fibers helped to facilitate the flow, which in turn aided in achieving intimate contact. However, adding a high percentage of steel fibers especially 6% drastically reduced the mini slump spread, which would negatively affect the bonding due to the reduced flowability that may cause poor contact at the interface.

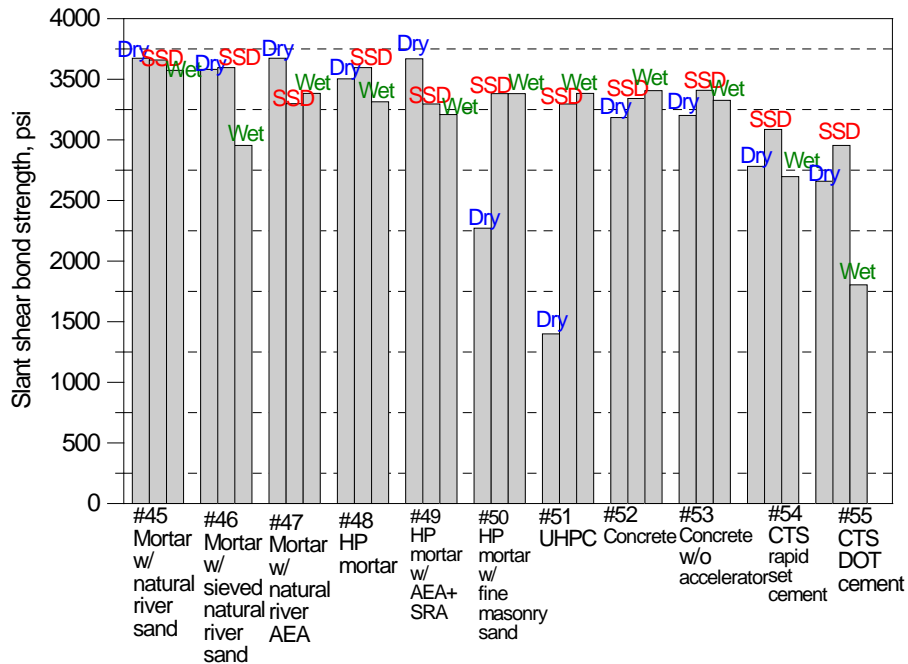
Figure 6.4 Slant shear bond strength of cementitious mortar and concrete developed in this study

Similarly, the variation of slant shear bond strength with the substrate surface moisture conditions is illustrated in Figure 6.4. As compared with the flexural bond strength (Figure 6.3), the slant shear bond strength evidently showed less variation when the substrate moisture changed. Also, it became more obvious that the UHPC and the high performance mortar with the fine masonry sand exhibited the lowest bond strength (both flexural and slant shear) in the presence of dry substrate.

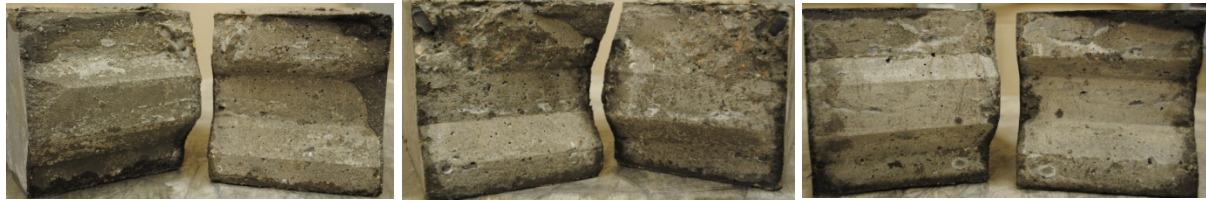
Figure A1 - Failure patterns of flexural bond test for BASF Master Flow 928 at different substrate surface moisture conditions at normal temperature (73°F) at 28 days (Mix #1)

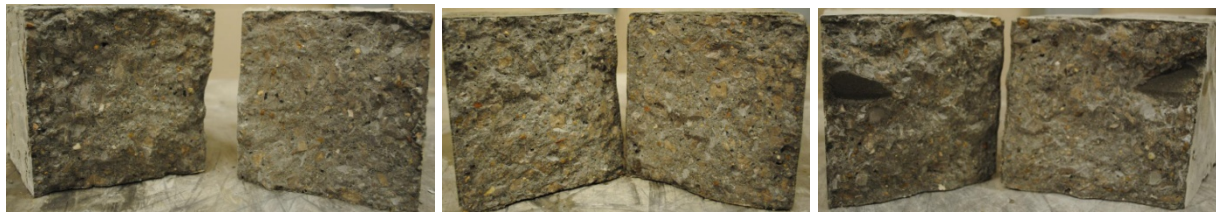
Figure A2 - Failure patterns of flexural bond test for Sika Grout 328 at different substrate surface moisture conditions at normal temperature (73°F) at 28 days (Mix #2)

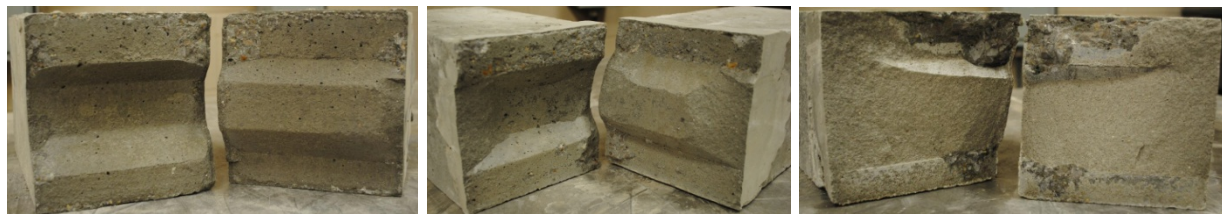
Figure A4 - Failure patterns of flexural bond test for Dayton Superior 1107 at different substrate surface moisture conditions at normal temperature (73°F) at 28 days (Mix #4)

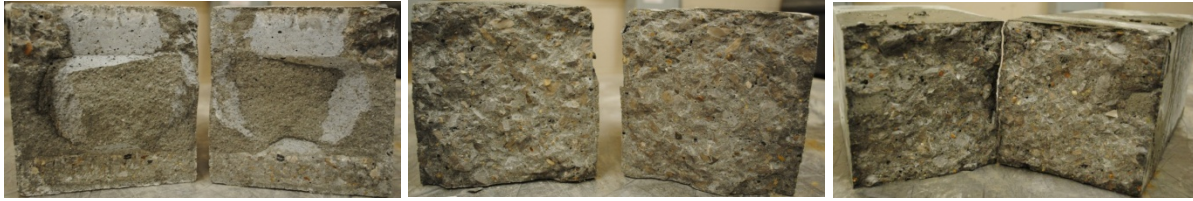
Figure A5 - Failure patterns of flexural bond test for Dayton Superior Sure Grip at different substrate surface moisture conditions at normal temperature (73°F) at 28 days (Mix #5)

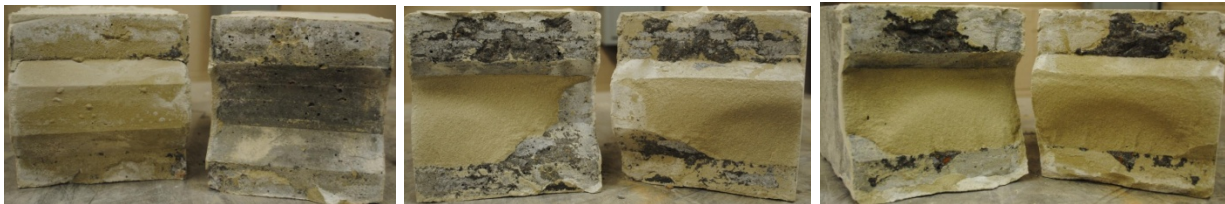
Figure A7 - Failure patterns of flexural bond test for CTS CEMENT ALL at different substrate surface moisture conditions at normal temperature (73°F) at 28 days (Mix #7)

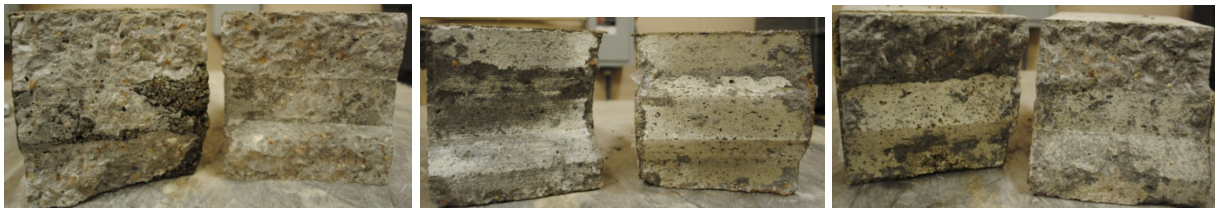
Figure A8 - Failure patterns of flexural bond test for Hilti Epoxy Grout CB-G EG at different substrate surface moisture conditions at normal temperature (73°F) at 28 days (Mix #8)

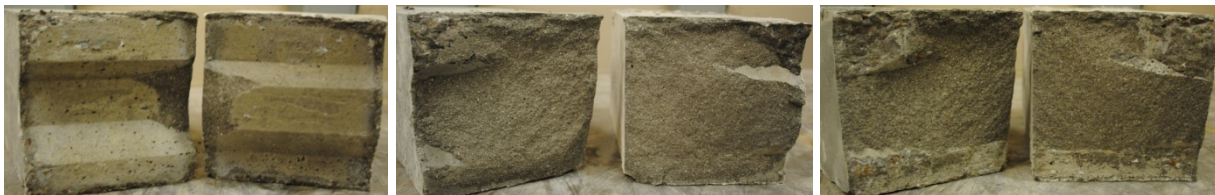
Figure A9 - Failure patterns of flexural bond test for SIMPSON Strong-Tie FX-228 at different substrate surface moisture conditions at normal temperature (73°F) at 28 days (Mix #9)

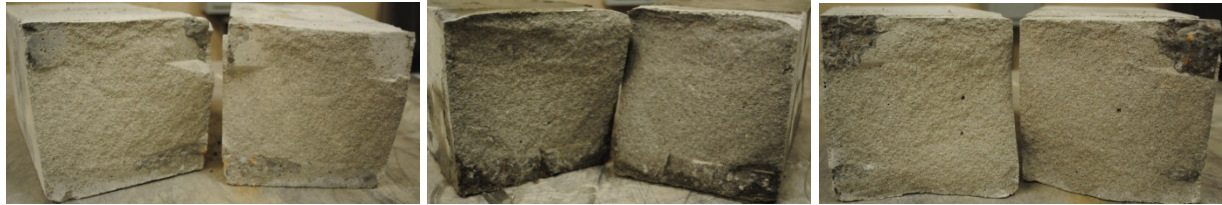
Figure A10 - Failure patterns of flexural bond test for SIMPSON Strong-Tie FX-229 at different substrate surface moisture conditions at normal temperature (73°F) at 28 days (#10)

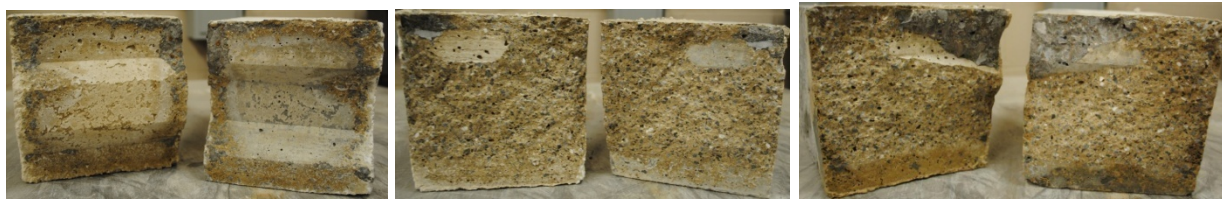
Figure A12 - Failure patterns of flexural bond test for Ceratech Pavemend SL at different substrate surface moisture conditions at normal temperature (73°F) at 28 days (Mix #12)

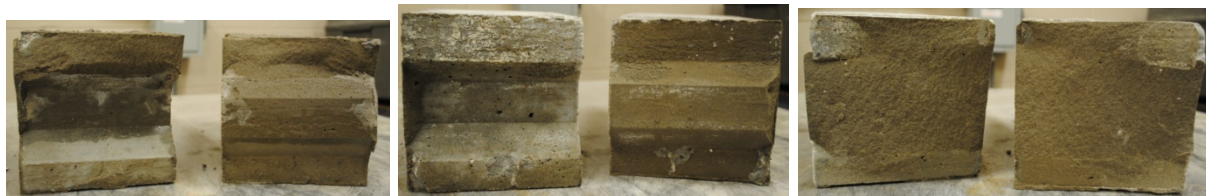
Figure A13 - Failure patterns of flexural bond test for Vexcon Certi-Vex Grout #1000 at different substrate surface moisture conditions at normal temperature (73°F) at 28 days (Mix #13)

The VEXCON CERTI-VEX Grout #1000 performed poorly in this study and was inadequate for the closure pour application.

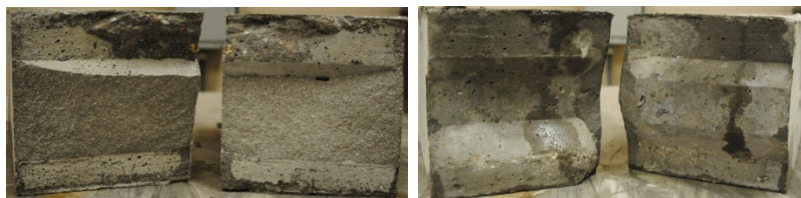
Figure A14 - Failure patterns of flexural bond test for Quikrete Non-Shrink Precision Grout at different substrate surface moisture conditions at normal temperature (73°F) at 28 days (Mix #14)

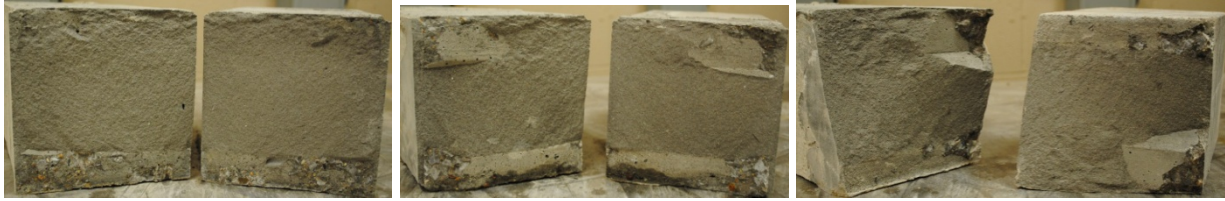
Figure A15 - Failure patterns of flexural bond test for ChemMasters Conset™ Grout at different substrate surface moisture conditions at normal temperature (73°F) at 28 days (Mix #15)

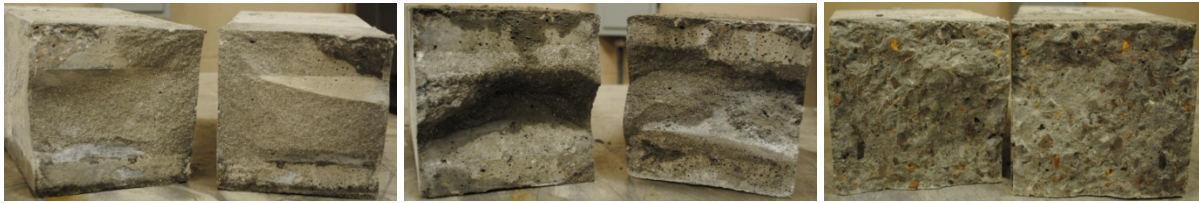
Figure A17 - Failure patterns of flexural bond test for Kaufman Non-Shrinking Precision Grout at different substrate surface moisture conditions at normal temperature (73°F) at 28 days (Mix #17)

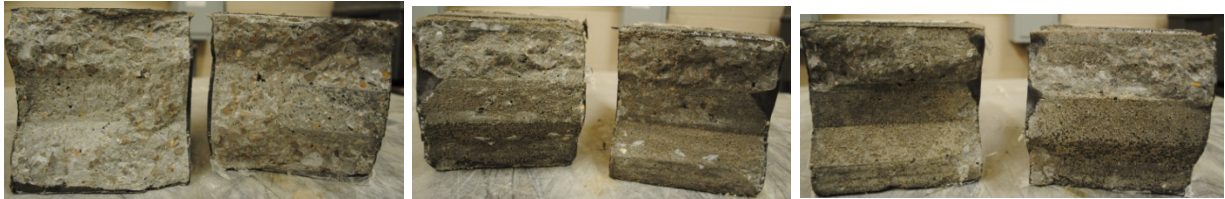
Figure A18 - Failure patterns of flexural bond test for Euclid E3-DP at different substrate surface moisture conditions at normal temperature (73°F) at 28 days (Mix #18)

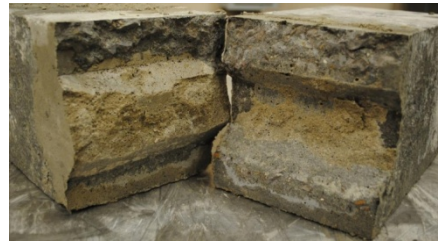
Figure A20 - Failure patterns of flexural bond test for Euco Precast Grout at different substrate surface moisture conditions at normal temperature (73°F) at 28 days (note: dry and wet specimens were debonded during demolding and the failure mode was not recorded) (Mix #20)

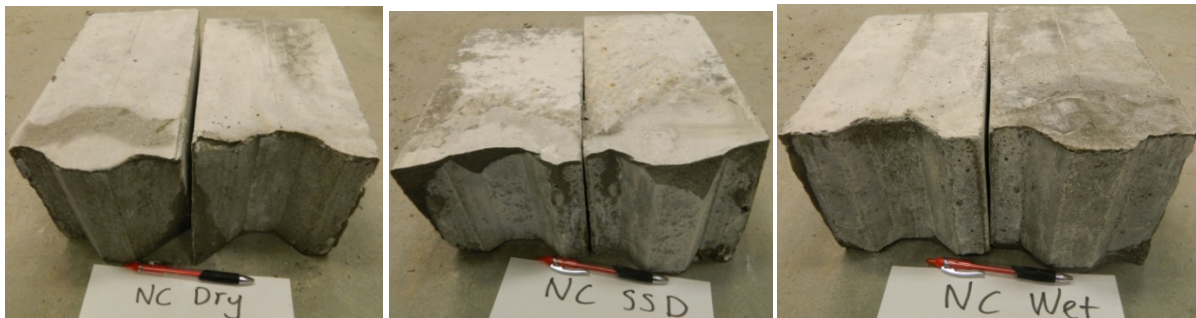
Figure A21 - Failure patterns of flexural bond test for Euclid NC Grout at different substrate surface moisture conditions at normal temperature (73°F) at 28 days (Mix #21)

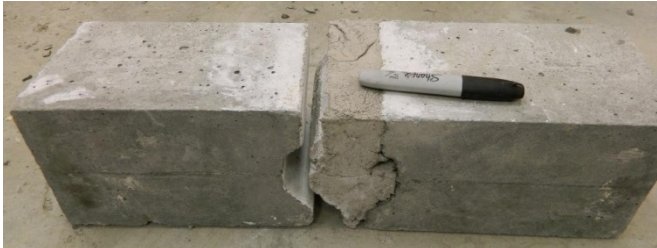
Figure A25 – Specimen broke at demolding for Phoscrete VO-Plus for all substrate surface moisture conditions (Mix #25)

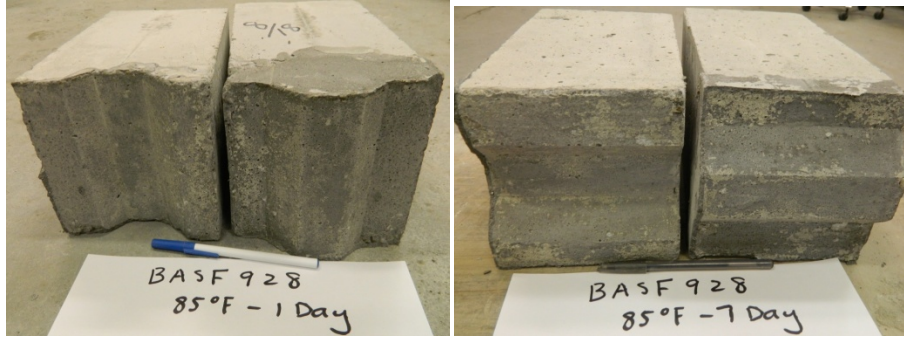
Figure A26 - Failure patterns of flexural bond test for BASF 928 Grout at different ages at medium temperature (85°F) (Mix #1)

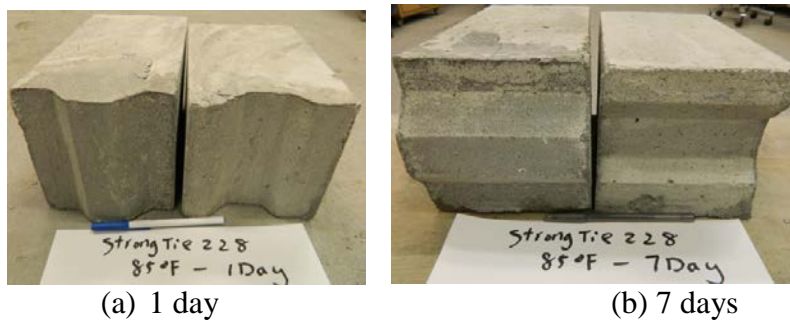
Figure A33 - Failure patterns of flexural bond test for Simpson StrongTie FX-228 Grout at different ages at medium temperature (85°F) (Mix #9)

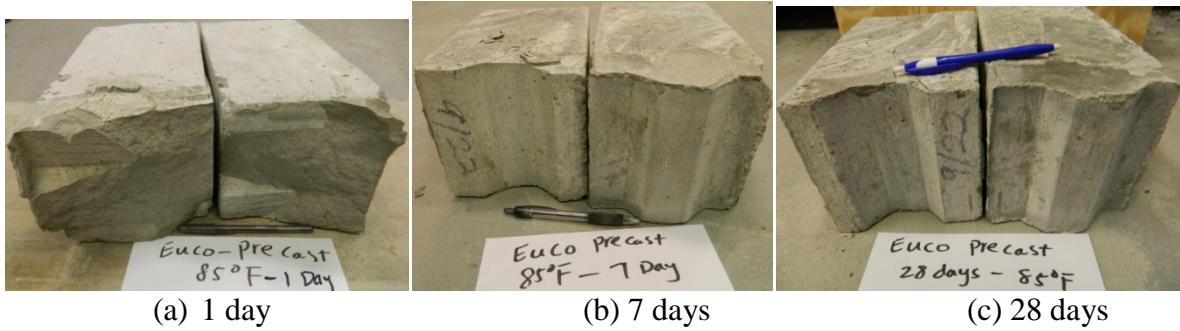
Figure A37 - Failure patterns of flexural bond test for Euclid Euco-PreCast Grout at different ages at medium temperature (85°F) (Mix #20)

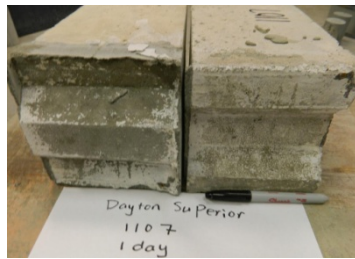
Figure A44 - Failure patterns of flexural bond test for Dayton Superior 1107 Grout at different ages at high temperature (95°F) (Mix #4)

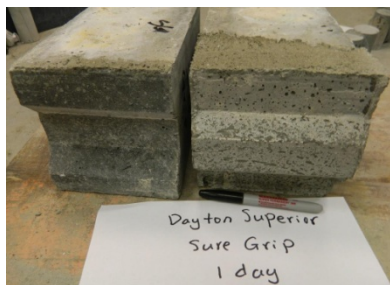
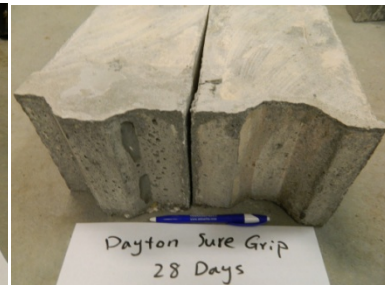
Figure A45 - Failure patterns of flexural bond test for Dayton Superior SureGrip Grout at different ages at high temperature (95°F) (Mix #5)

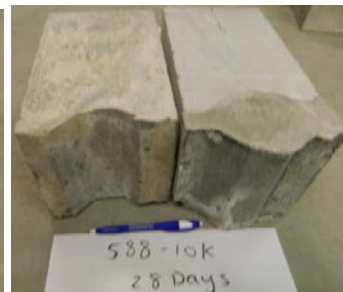
Figure A46 - Failure patterns of flexural bond test for W.R. Meadows 588-10K Grout at different ages at high temperature (95°F) (Mix #6)

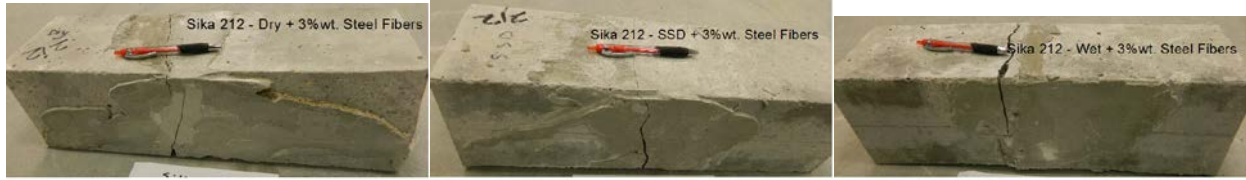
Figure A58 - Failure patterns of flexural bond test for Sika 212 with 3% steel fiber addition at different substrate surface moisture conditions and normal temperature (73°F) (Mix #3)

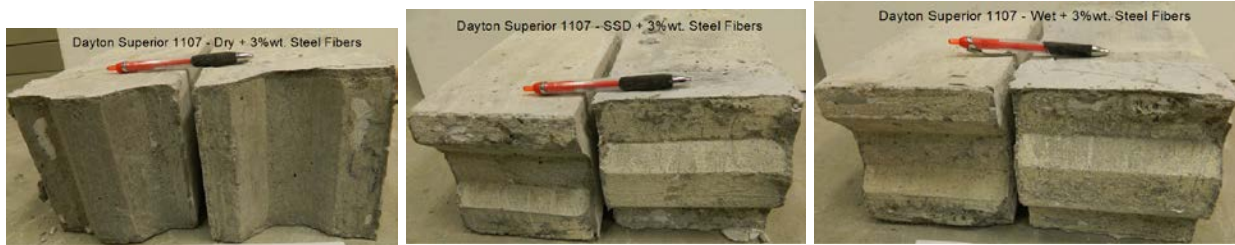
Figure A59 - Failure patterns of flexural bond test for Dayton Superior 1107 with 3% steel fiber addition at different substrate surface moisture conditions and normal temperature (73°F) (Mix #4)

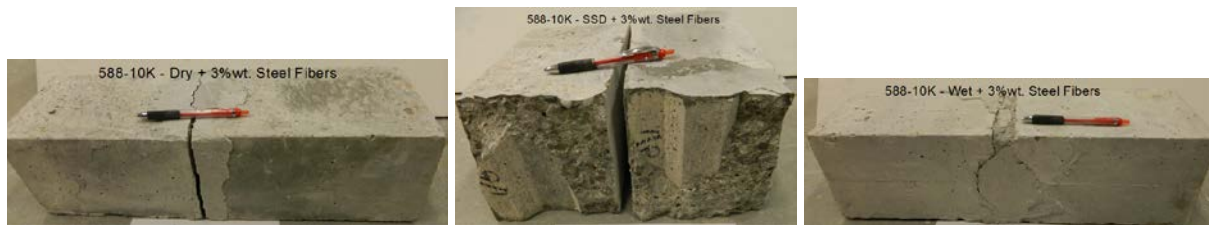
Figure A60 - Failure patterns of flexural bond test for W.R. Meadows 588-10K with 3% steel fiber addition at different substrate surface moisture conditions and normal temperature (73°F) (Mix #6)

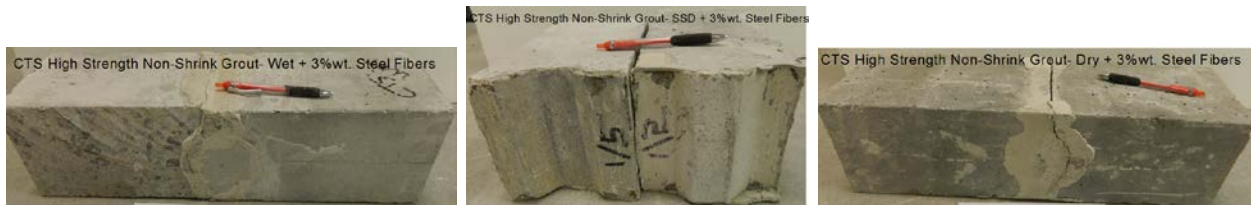
Figure A61 - Failure patterns of flexural bond test for CTS CEMENT ALL grout with 3% steel fiber addition at different substrate surface moisture conditions and normal temperature (73°F) (Mix #7)

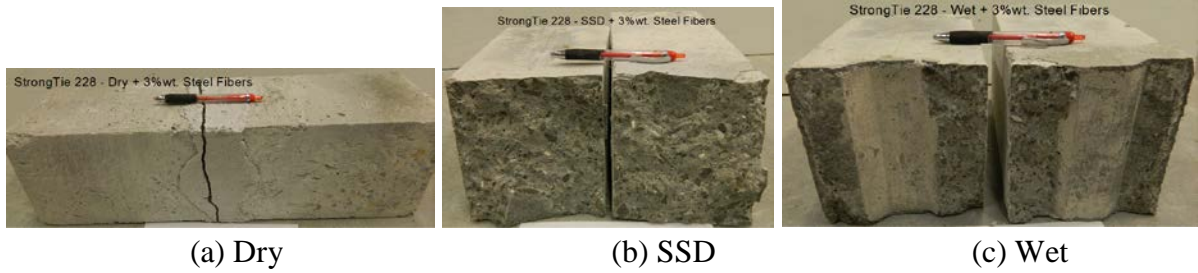
(a) Dry (b) SSD (c) Wet
 Figure A62 - Failure patterns of flexural bond test for Simpson StrongTie FX-228 with 3% steel fiber addition at different substrate surface moisture conditions and normal temperature (73°F) (Mix #9)

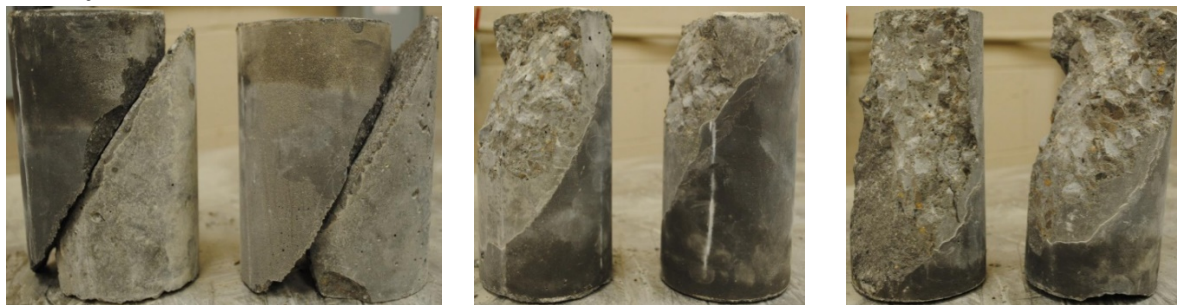
Figure B1 - Failure patterns of slant shear bond test for BASF Master Flow 928 at different substrate surface moisture conditions at normal temperature (73°F) (Mix #1)

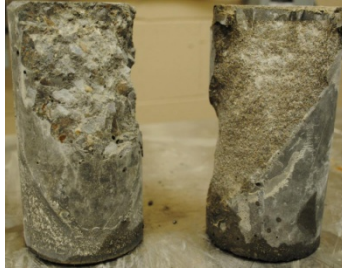
Figure B6 - Failure patterns of slant shear bond test for W.R Meadows 588-10K at different substrate surface moisture conditions at normal temperature (73°F) (Mix #6)

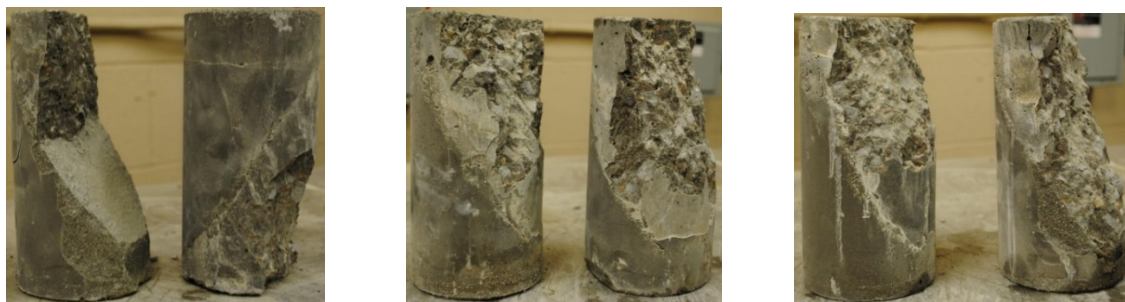
Figure B9 - Failure patterns of slant shear bond test for SIMPSON Strong-Tie FX-228 at different substrate surface moisture conditions at normal temperature (73°F) (Mix #9)

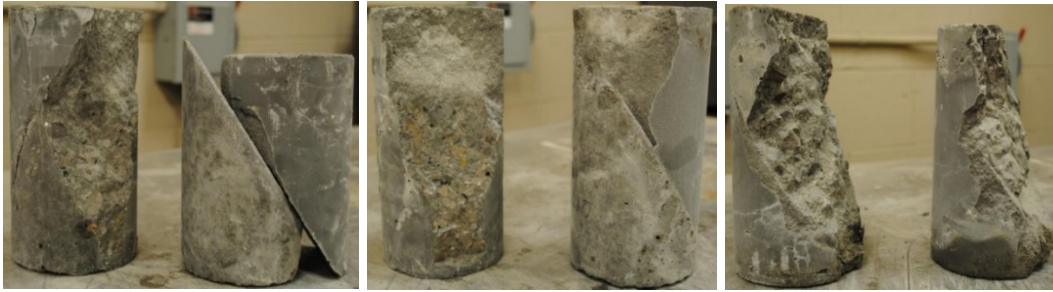
Figure B15 - Failure patterns of slant shear bond test for ChemMasters Conset Grout at different substrate surface moisture conditions at normal temperature (73°F) (Mix #15)

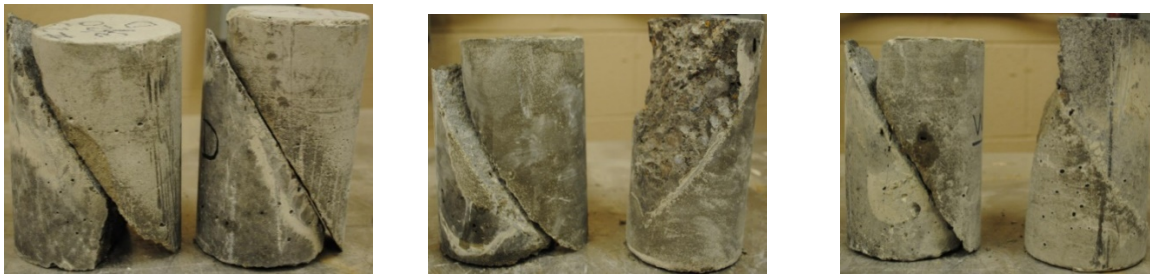
Figure B16 - Failure patterns of slant shear bond test for Ash Grove Non-Shrink Grout at different substrate surface moisture conditions at normal temperature (73°F) (Mix #16)

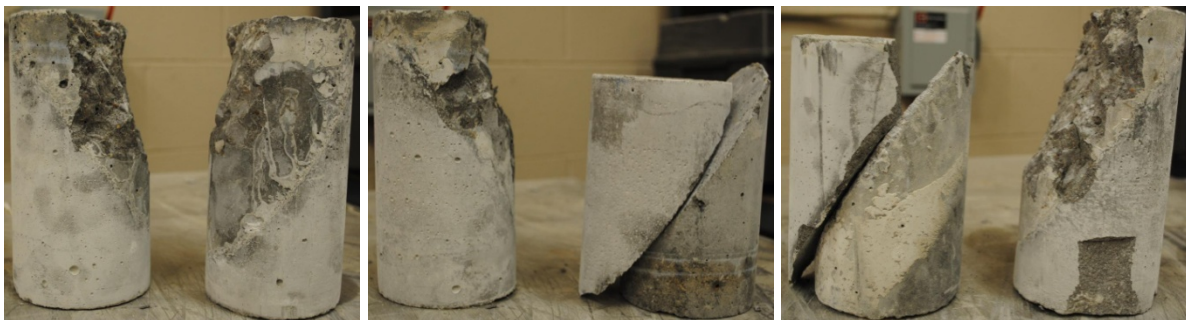
Figure B17 - Failure patterns of slant shear bond test for Kaufman Non-Shrinking Precision Grout at different substrate surface moisture conditions at normal temperature (73°F) (Mix #17)

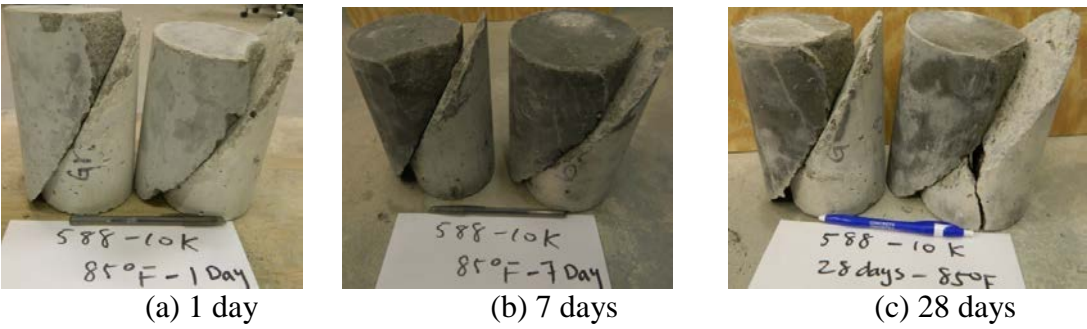
Figure B31 - Failure patterns of slant shear bond test for W.R Meadows 588-10K Grout at different ages at medium temperature (85°F) (Mix #6)

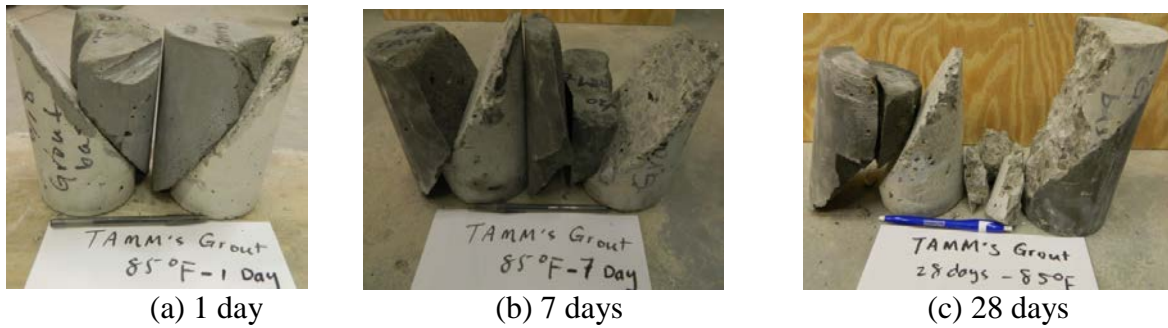
Figure B36 - Failure patterns of slant shear bond test for TAMM's Grout Supreme at different ages at medium temperature (85°F) (Mix #19)

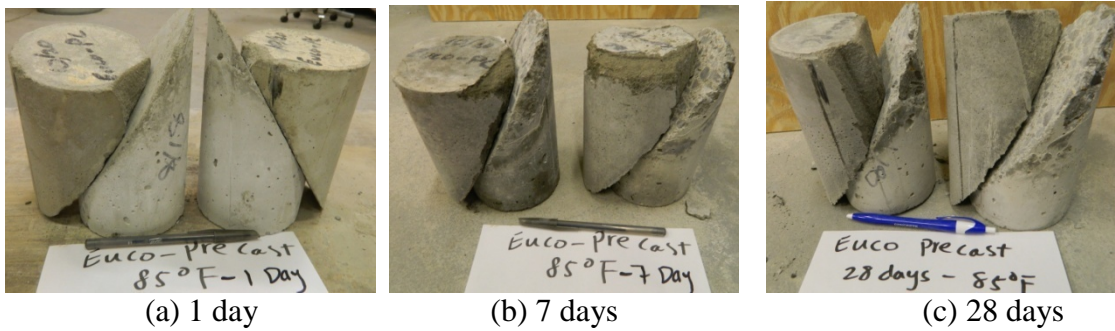
Figure B37 - Failure patterns of slant shear bond test for Euclid Euco Pre-cast Grout at different ages at medium temperature (85°F) (Mix #20)

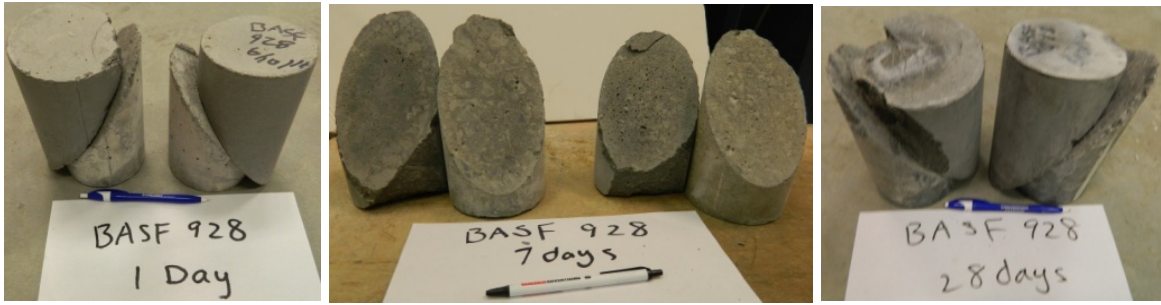
Figure B41 - Failure patterns of slant shear bond test for BASF Master flow 928 Grout at different ages at high temperature (95°F) (Mix #1)

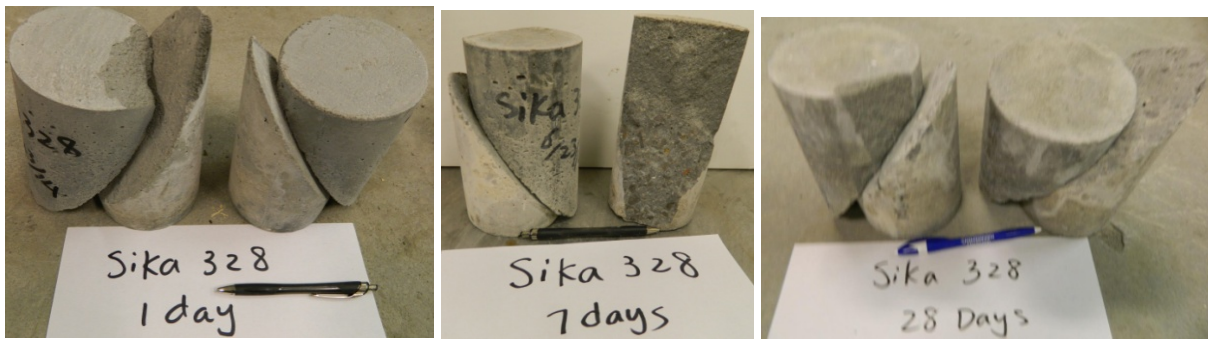
Figure B42 - Failure patterns of slant shear bond test for Sika 328 Grout at different ages at high temperature (95°F) (Mix #2)

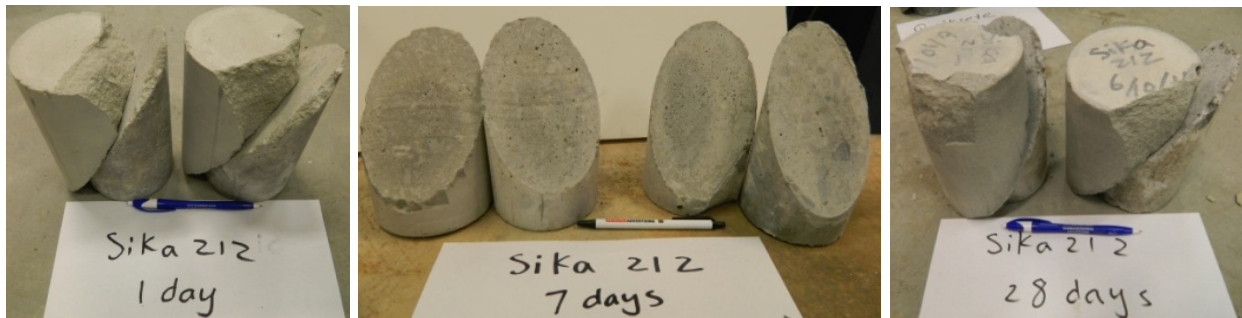
Figure B43 - Failure patterns of slant shear bond test for Sika 212 Grout at different ages at high temperature (95°F) (Mix #3)

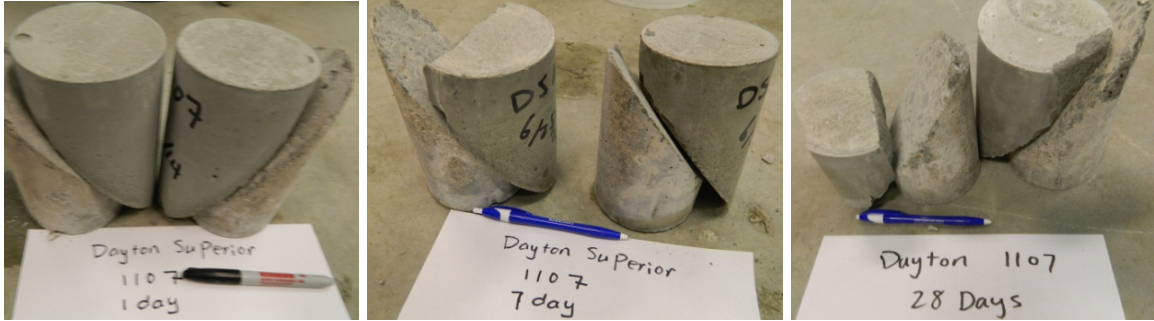
Figure B44 - Failure patterns of slant shear bond test for Dayton Superior 1107 Grout at different ages at high temperature (95°F) (Mix #4)

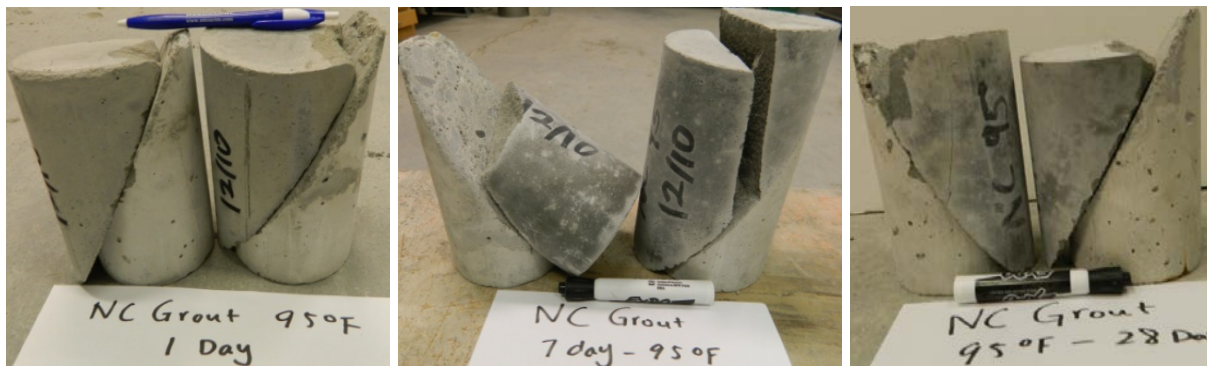
Figure B51 - Failure patterns of slant shear bond test for Euclid Euco NC Grout at different ages at high temperature (95°F) (Mix #21)

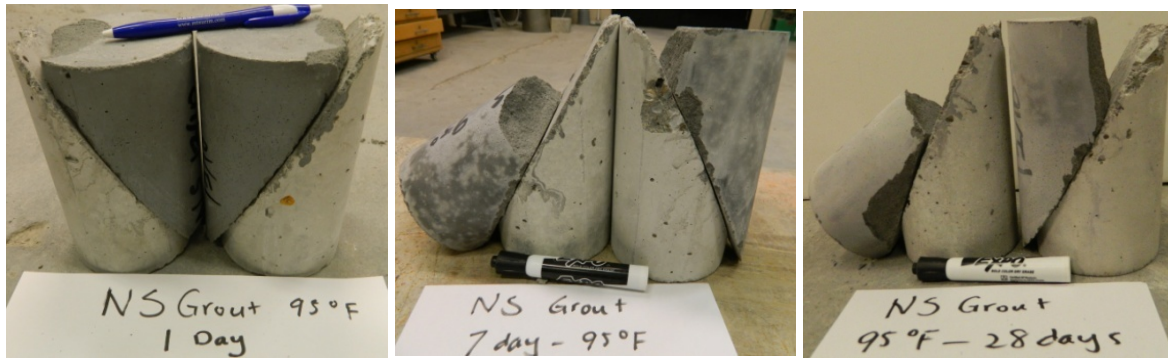
Figure B52 - Failure patterns of slant shear bond test for Euclid Euco NS Grout at different ages at high temperature (95°F) (Mix #22)

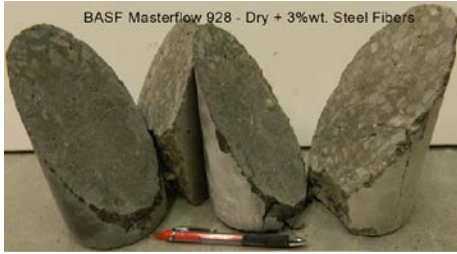
Figure B56 - Failure patterns of slant shear bond test for BASF Masterflow 928 with 3% steel fiber addition at different substrate surface moisture conditions and normal temperature (73°F) (Mix #1)

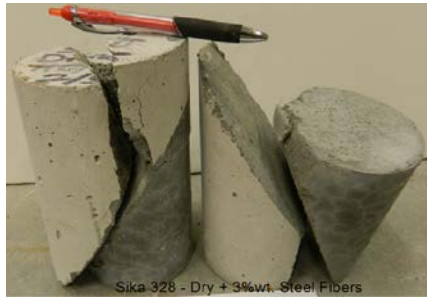
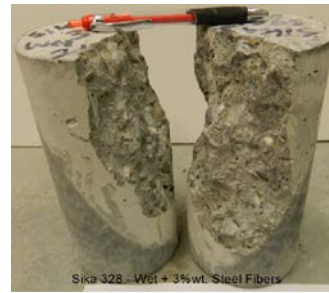
Figure B57 - Failure patterns of slant shear bond test for Sika 328 Grout with 3% steel fiber addition at different substrate surface moisture conditions and normal temperature (73°F) (Mix #2)

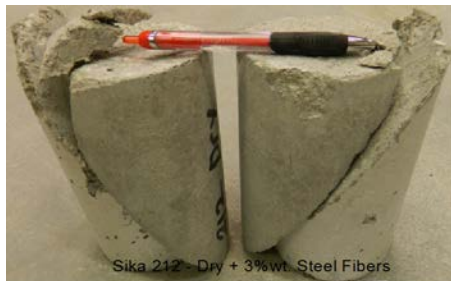
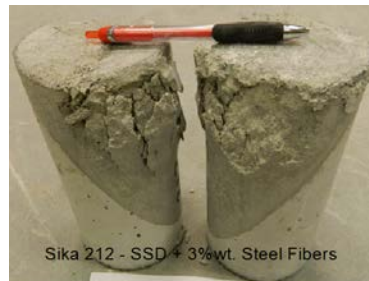
Figure B58 - Failure patterns of slant shear bond test for Sika 212 Grout with 3% steel fiber addition at different substrate surface moisture conditions and normal temperature (73°F) (Mix #3)

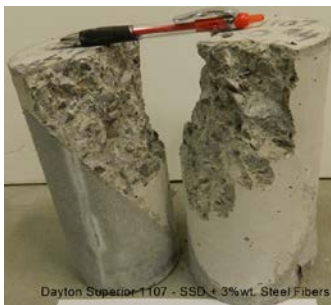
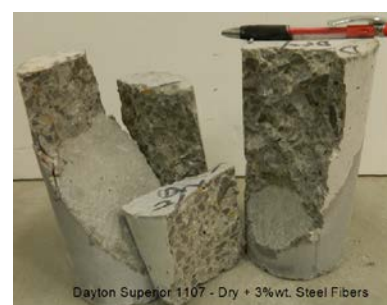
Figure B59 - Failure patterns of slant shear bond test for Dayton Superior 1107 with 3% steel fiber addition at different substrate surface moisture conditions and normal temperature (73°F)
(Mix #4)

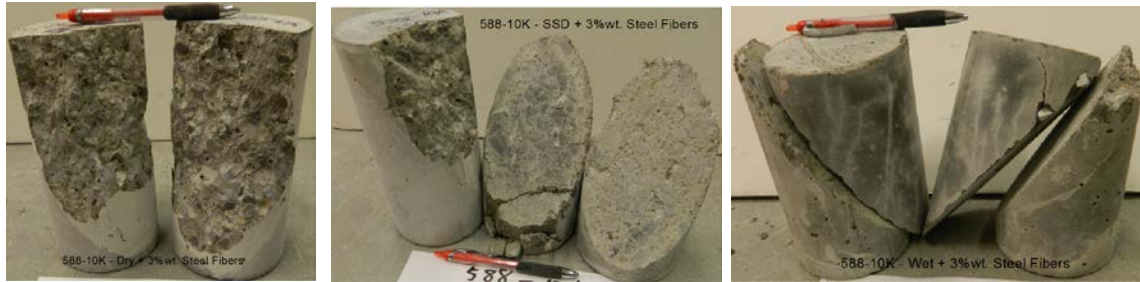
Figure B60 - Failure patterns of slant shear bond test for W.R. Meadows 588-10K with 3% steel fiber addition at different substrate surface moisture conditions and normal temperature (73°F)
(Mix #6)

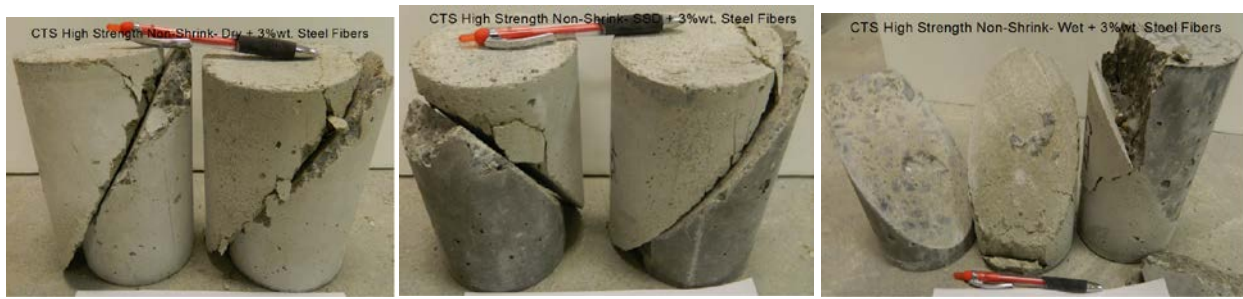
Figure B61 - Failure patterns of slant shear bond test for CTS CEMENT ALL with 3% steel fiber addition at different substrate surface moisture conditions and normal temperature (73°F) (Mix #7)

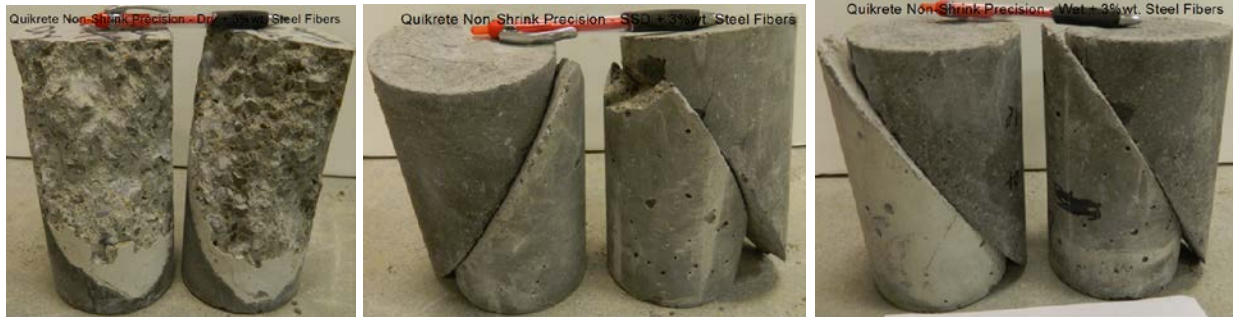
Figure B63 - Failure patterns of slant shear bond test for Quikrete non-shrink precision with 3% steel fiber addition at different substrate surface moisture conditions and normal temperature (73°F) (Mix #14)

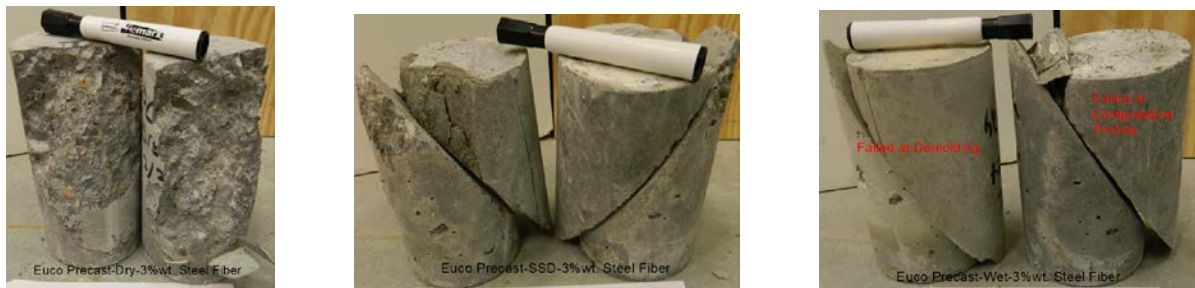
Figure B64 - Failure patterns of slant shear bond test for Euco Precast grout with 3% steel fiber addition at different substrate surface moisture conditions and normal temperature (73°F) (Mix #20)

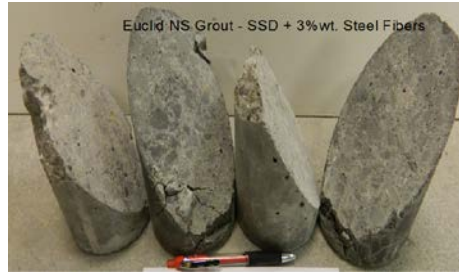
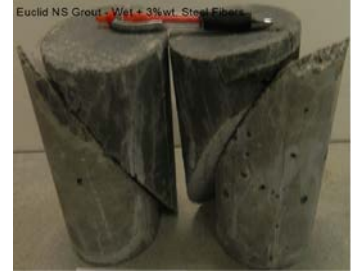
Figure B66 - Failure patterns of slant shear bond test for Euclid NS grout with 3% steel fiber addition at different substrate surface moisture conditions and normal temperature (73°F) (Mix #22)

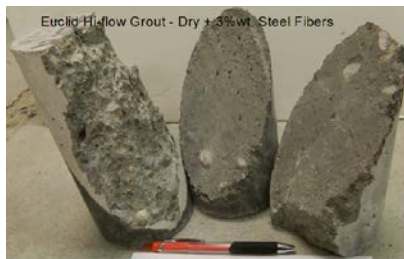
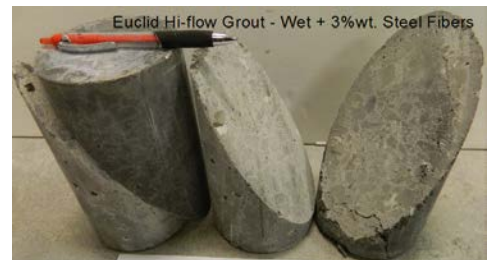
Figure B67 - Failure patterns of slant shear bond test for Euclid Hi-flow grout with 3% steel fiber addition at different substrate surface moisture conditions and normal temperature (73°F) (Mix #23)

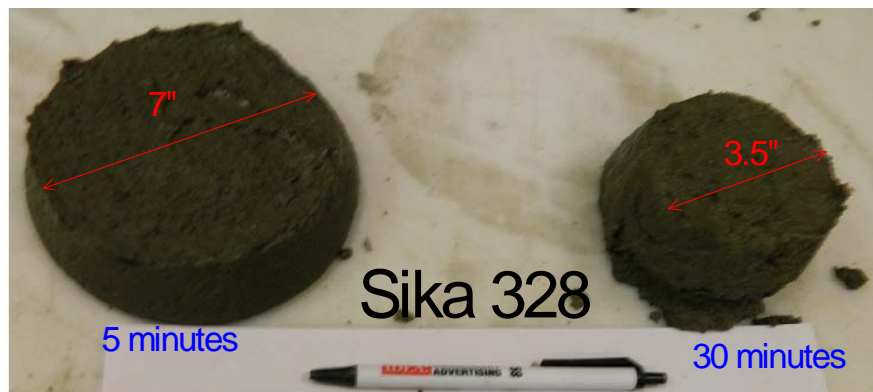
Figure C36 - Spread of mini slump test for Sika 328 Grout at different time at high temperature (95°F) (Mix #2)

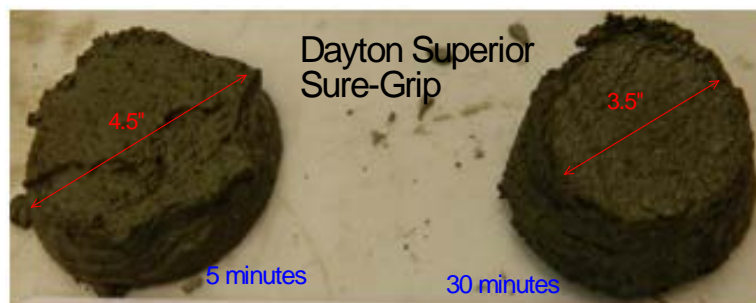
Figure C39 - Spread of mini slump test for Dayton Superior SureGrip Grout at different time at high temperature (95°F) (Mix #5)

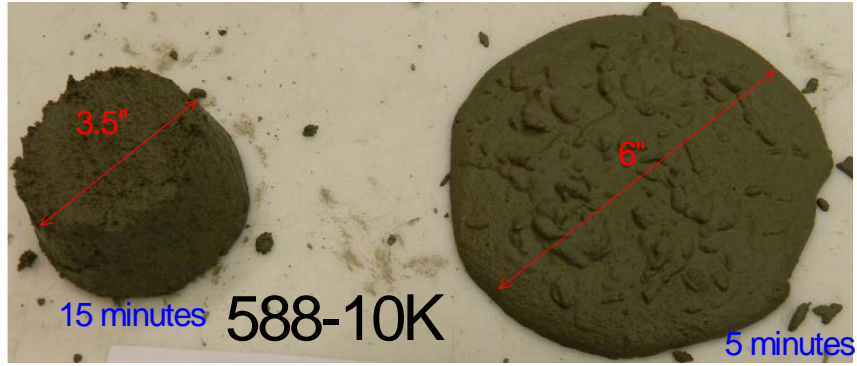
Figure C40 - Spread of mini slump test for W.R Meadows 588-10K Grout at different time at high temperature (95°F) (Mix #6)

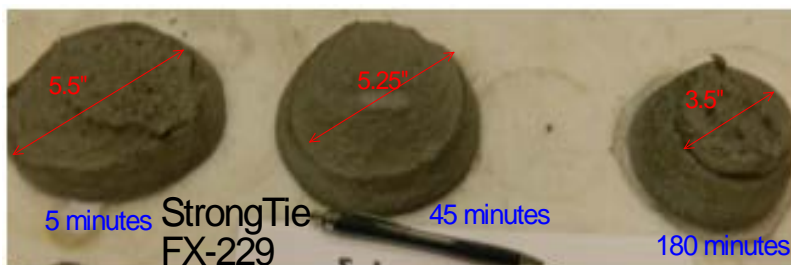
Figure C43 - Spread of mini slump test for Simpson StrongTie FX-229 Grout at different time at high temperature (95°F) (Mix #10)

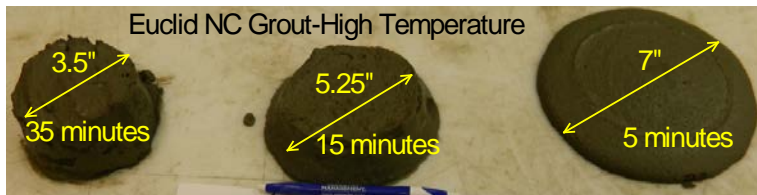
Figure C46 - Spread of mini slump test for Euclid NC Grout at different time at high temperature (95°F) (Mix #21)
