Final Report

**PERFORMANCE EVALUATION OF GROUT MATERIALS FOR
CONNECTING PRECAST CONCRETE BRIDGE DECK PANELS**

Prepared for the Tennessee Department of Transportation

January, 2017

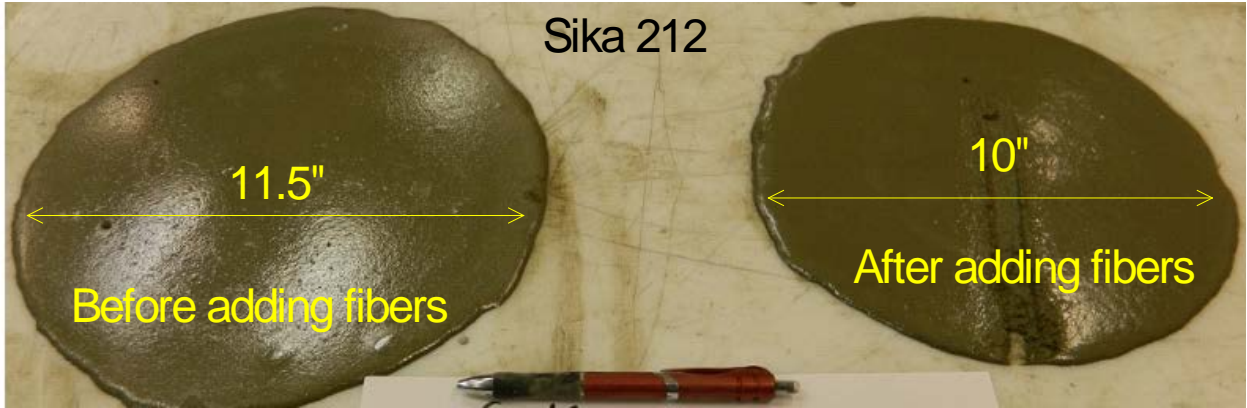
Figure C57 - Spread of mini slump test for Sika 212 Grout at normal temperature (73°F) with 3% steel fiber addition (Mix #3)

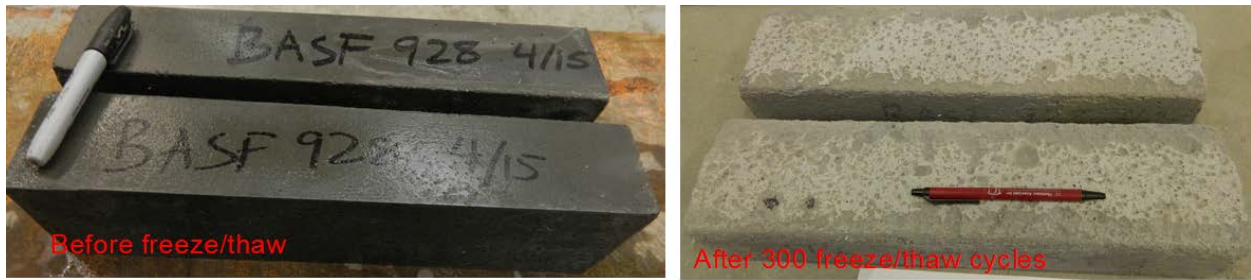
Figure D1- Visual appearance of specimens before and after freeze and thaw test for BASF Masterflow 928 (Mix #1)

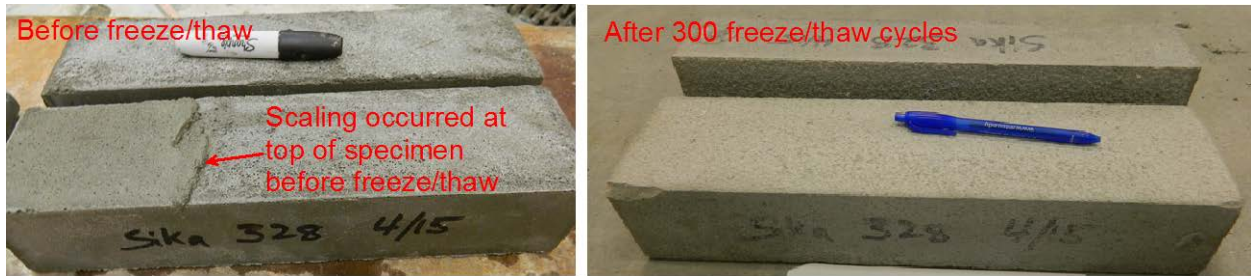
Figure D2- Visual appearance of specimens before and after freeze and thaw test for SikaGrout 328 (Mix #2)

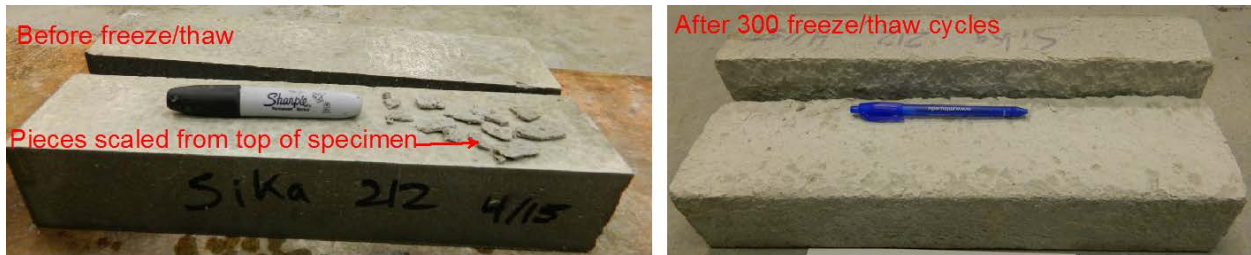
Figure D3- Visual appearance of specimens before and after freeze and thaw test for SikaGrout 212 (Mix #3)

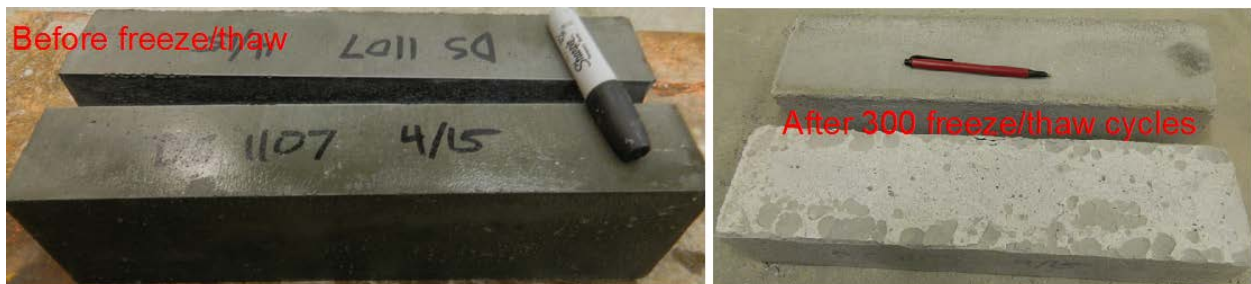
Figure D4- Visual appearance of specimens before and after freeze and thaw test for Dayton Superior 1107 Advantage Grout (Mix #4)

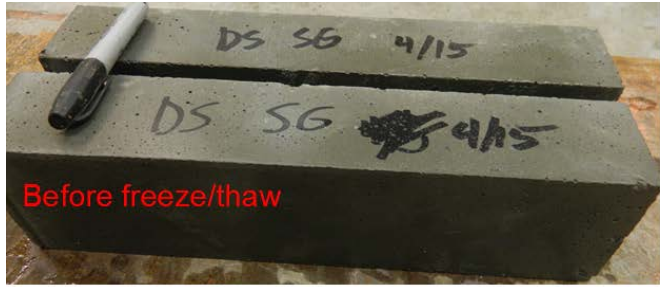
Figure D5 - Visual appearance of specimens before and after freeze and thaw test for Dayton Superior Sure-Grip High Performance Grout (Mix #5)

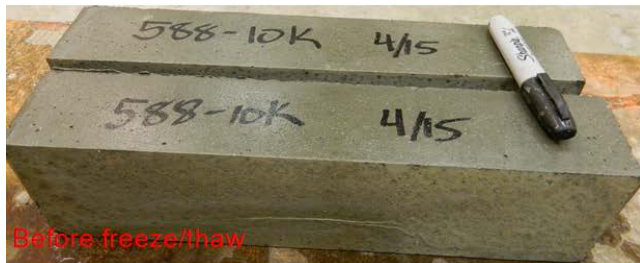
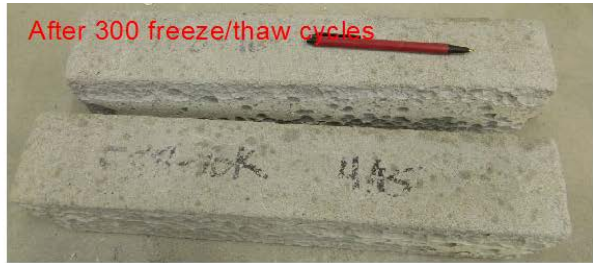
Figure D6- Visual appearance of specimens before and after freeze and thaw test for W.R Meadow SEALTIGHT 588-10K (Mix #6)

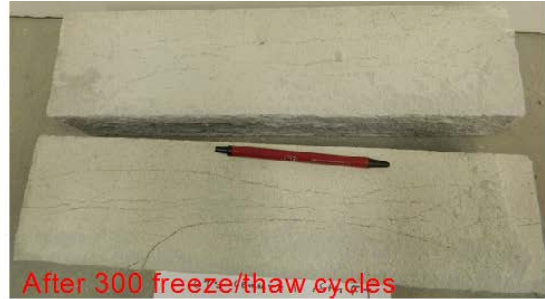
Figure D7- Visual appearance of specimens before and after freeze and thaw test for CTS Rapid Set CEMENT ALL Grout (Mix #7)

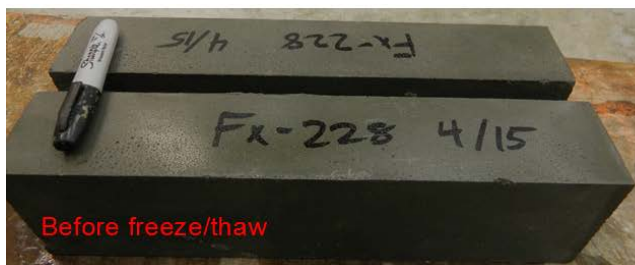
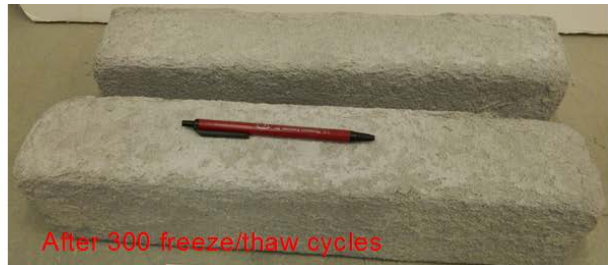
Figure D8- Visual appearance of specimens before and after freeze and thaw test for Simpson StrongTie FX-228 (Mix #9)

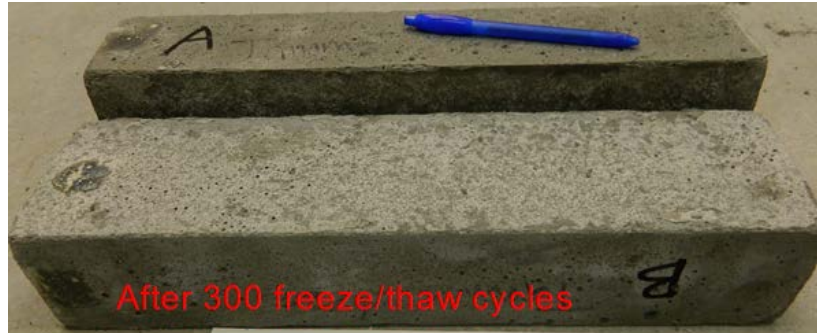
Figure D9- Visual appearance of specimens after freeze and thaw test for Euclid TAMMs GROUT SUPREME (Mix #19)

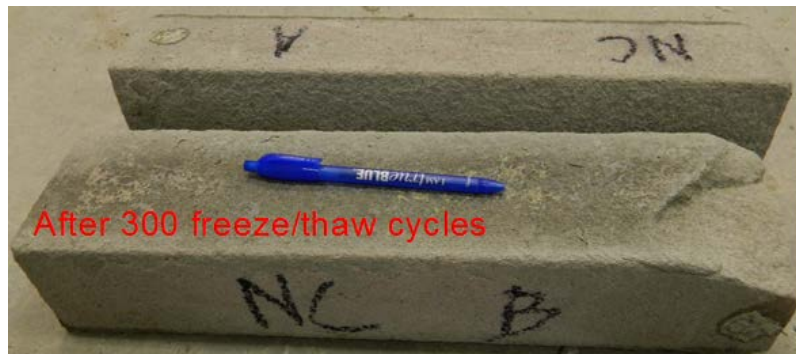
Figure D11- Visual appearance of specimens after freeze and thaw test for Euclid NC Grout (Mix #21)

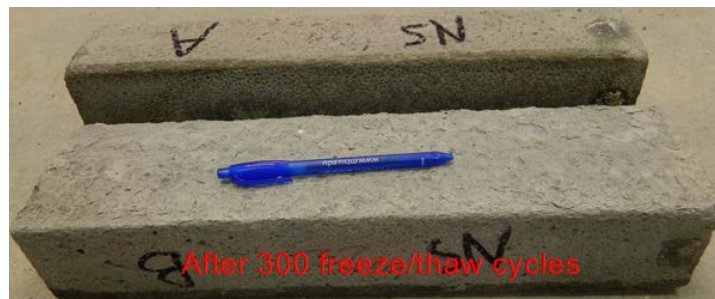
Figure D12- Visual appearance of specimens after freeze and thaw test for Euclid NS Grout (Mix #22)

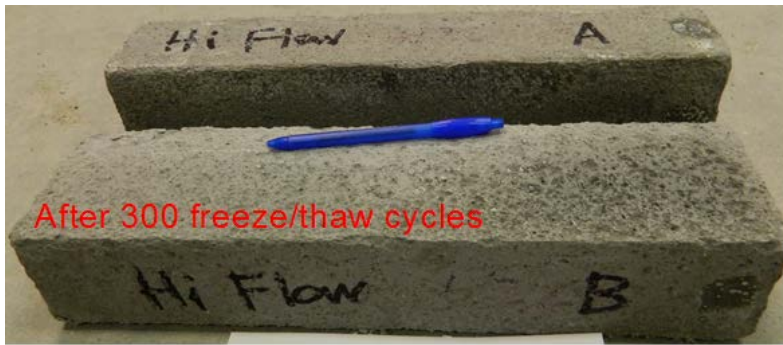
Figure D13- Visual appearance of specimens after freeze and thaw test for Euclid Hi-flow Grout (Mix #23)

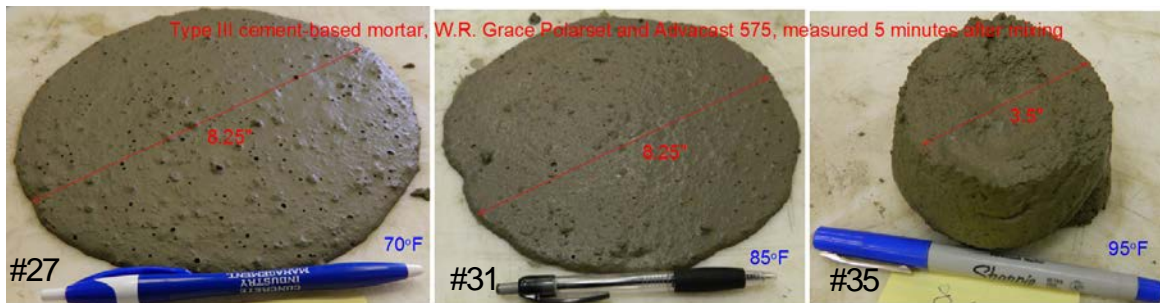
Figure E2-Spread of mini slump test for type III cement-based mortars (#27, #31, and #35) using W.R. Grace Polarset (accelerator) and Adva-Cast 575 (superplasticizer) at different temperatures

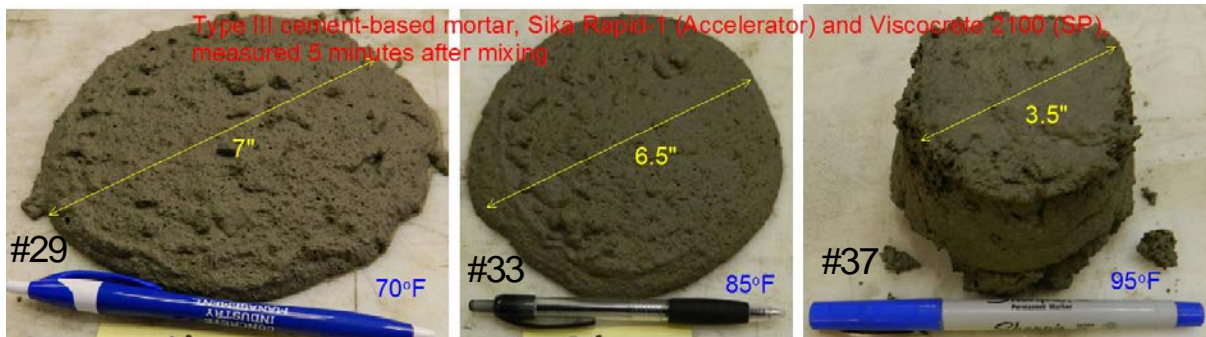
Figure E4-Spread of mini slump test for type III cement-based mortars (#29, #33, and #37) using Sika Rapid-1 (accelerator) and Viscocrete 2100 (superplsticizer) at different temperatures

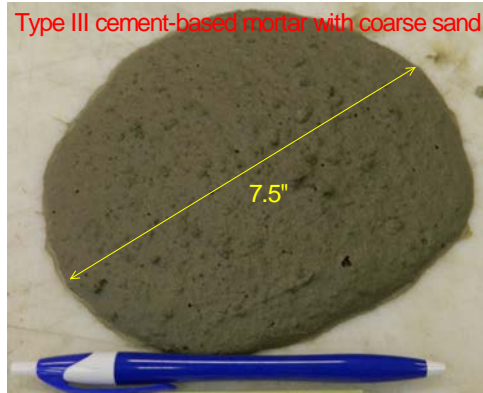
Figure E6-Spread of mini slump test for type III cement-based normal mortar with natural river sand (#45)

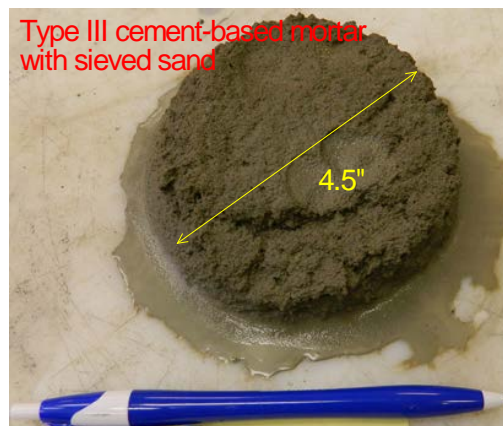
Figure E7-Spread of mini slump test for type III cement-based mortar with sieved river sand (#46) (note: water separation possibly due to insufficient paste)

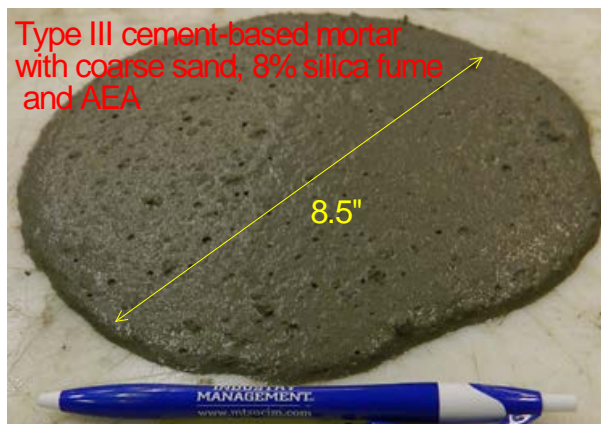
Figure E8-Spread of mini slump test for type III cement-based normal mortar with natural river sand, silica fume, and AEA (#47)

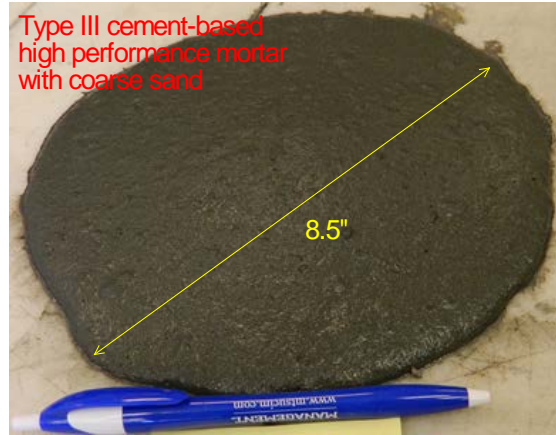
Figure E9-Spread of mini slump test for type III cement-based high performance mortar with natural river sand (#48)

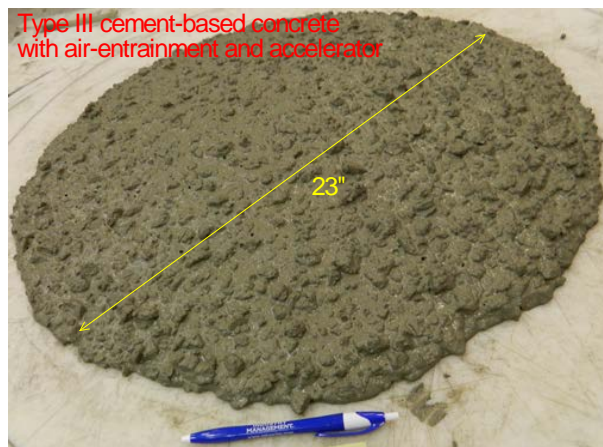
Figure E13-Spread of slump test for type III cement-based concrete with accelerator (#52)

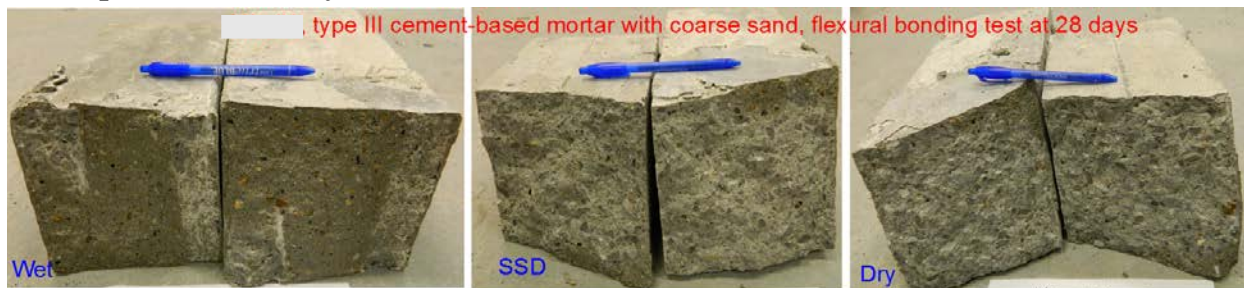
Figure F1-Failure mode of flexural bond test at 28 days for type III cement-based mortar using natural river sand and different substrate surface moisture conditions (#45)

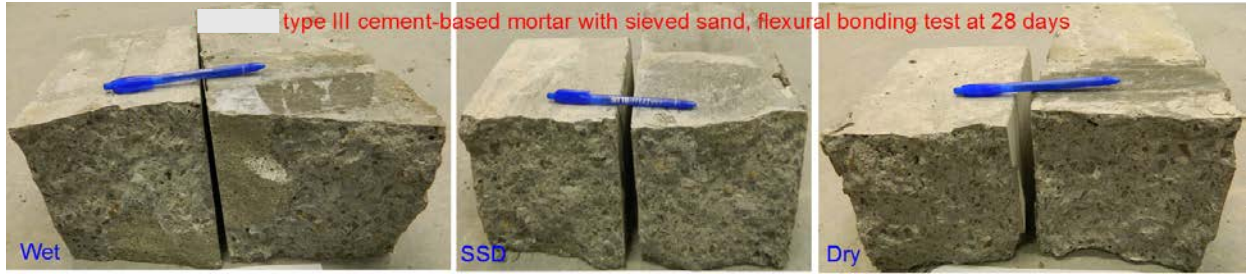
Figure F2-Failure mode of flexural bond test at 28 days for type III cement-based mortar using sieved river sand and different substrate surface moisture conditions (#46)

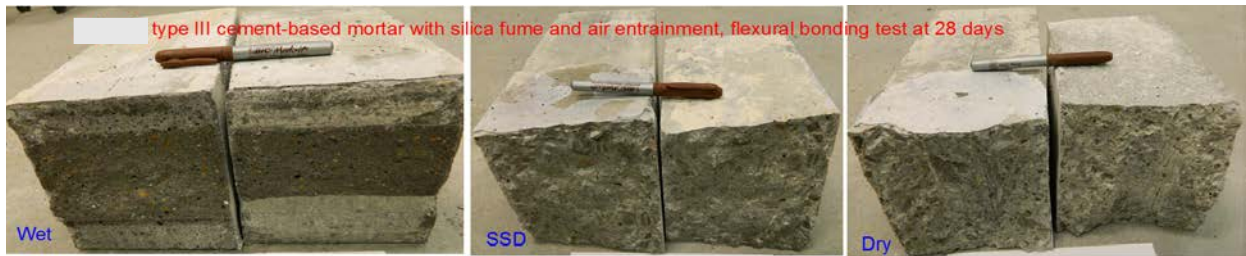
Figure F3-Failure mode of flexural bond test at 28 days for type III cement-based mortar using natural river sand, AEA, and different substrate surface moisture conditions (#47)

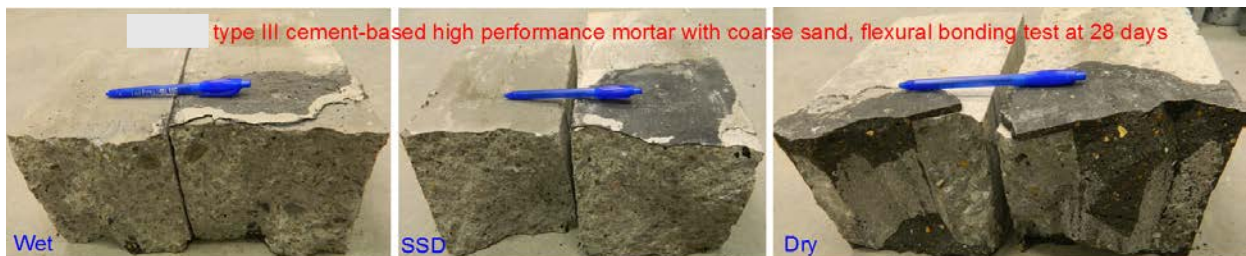
Figure F4-Failure mode of flexural bond test at 28 days for type III cement-based high performance mortar using natural river sand and different substrate surface moisture conditions (#48)

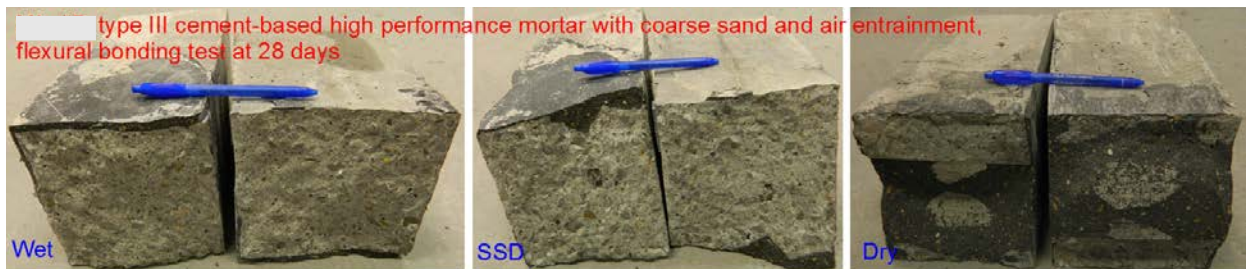
Figure F5-Failure mode of flexural bond test at 28 days for type III cement-based high performance mortar using natural river sand, AEA, and different substrate surface moisture conditions (#49)

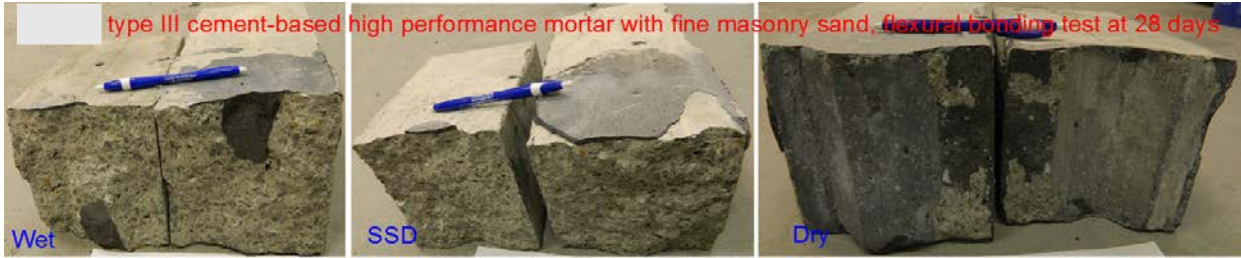
Figure F6-Failure mode of flexural bond test at 28 days for type III cement-based high performance mortar using fine masonry sand and different substrate surface moisture conditions (#50)

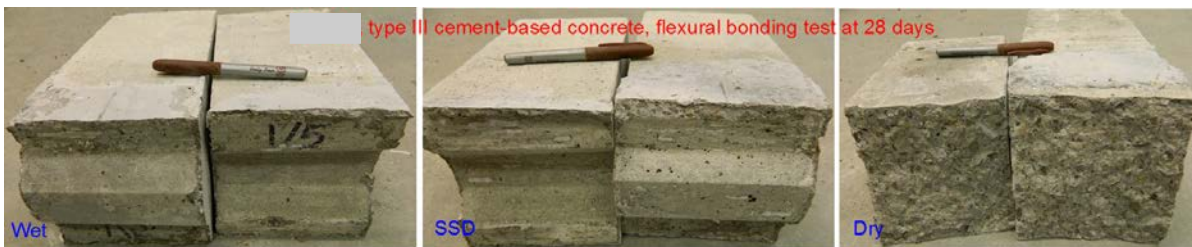
Figure F8-Failure mode of flexural bond test at 28 days for type III cement-based concrete with different substrate surface moisture conditions (#52)

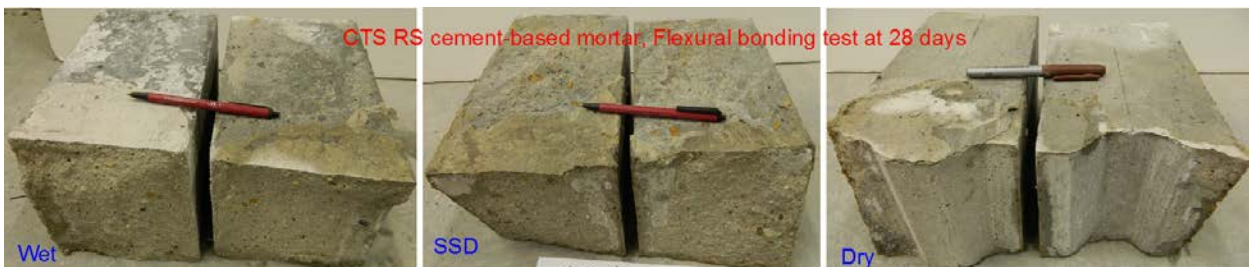
Figure F9-Failure mode of flexural bond test at 28 days for CTS rapid set cement-based mortar with different substrate surface moisture conditions (#54)

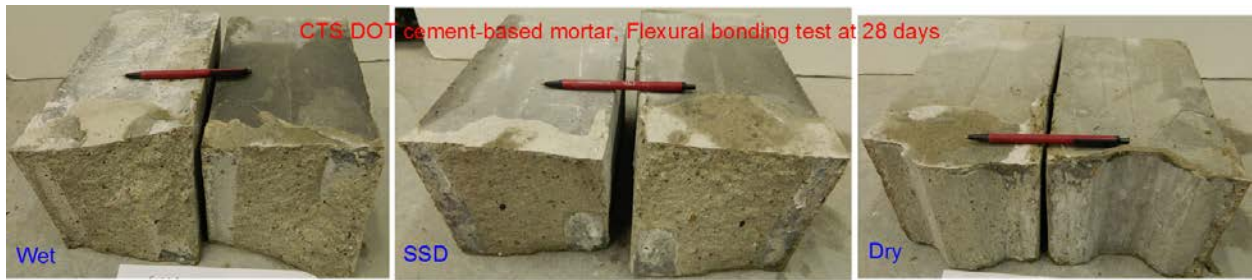
Figure F10-Failure mode of flexural bond test at 28 days for CTS DOT cement-based mortar with different substrate surface moisture conditions (#55)

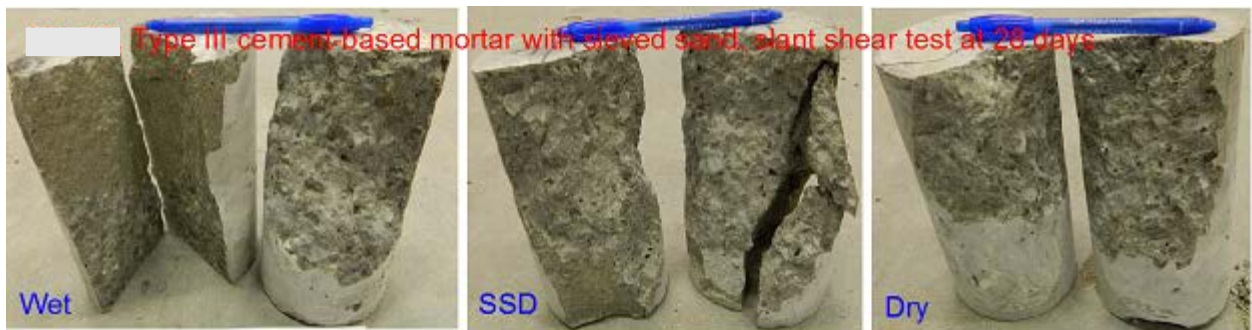
Figure G2-Failure mode of slant shear bond test at 28 days for type III cement-based mortar using sieved river sand and different substrate surface moisture conditions (#46)

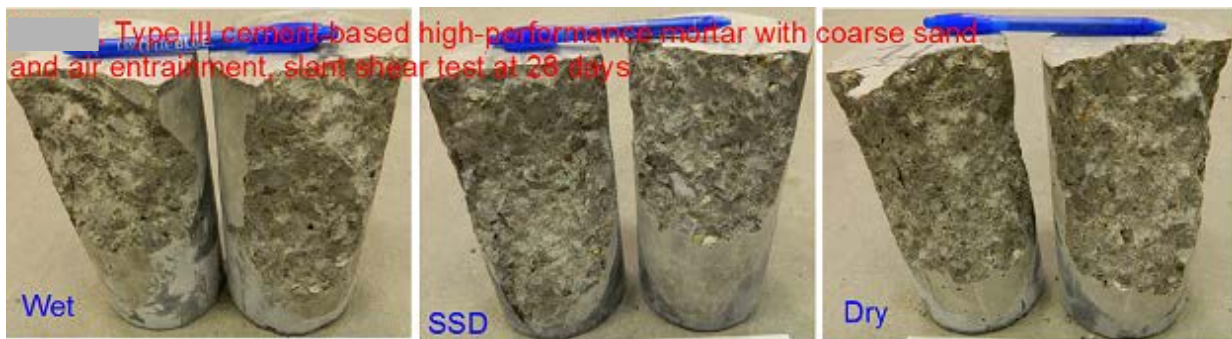
Figure G5-Failure mode of slant shear bond test at 28 days for type III cement-based high performance mortar using natural river sand, AEA, and different substrate surface moisture conditions (#49)

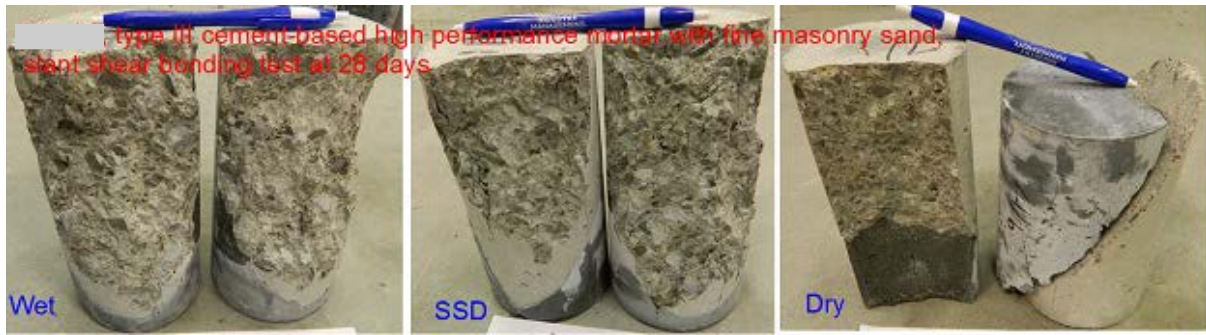
Figure G6-Failure mode of slant shear bond test at 28 days for type III cement-based high performance mortar using fine masonry sand and different substrate surface moisture conditions (#50)

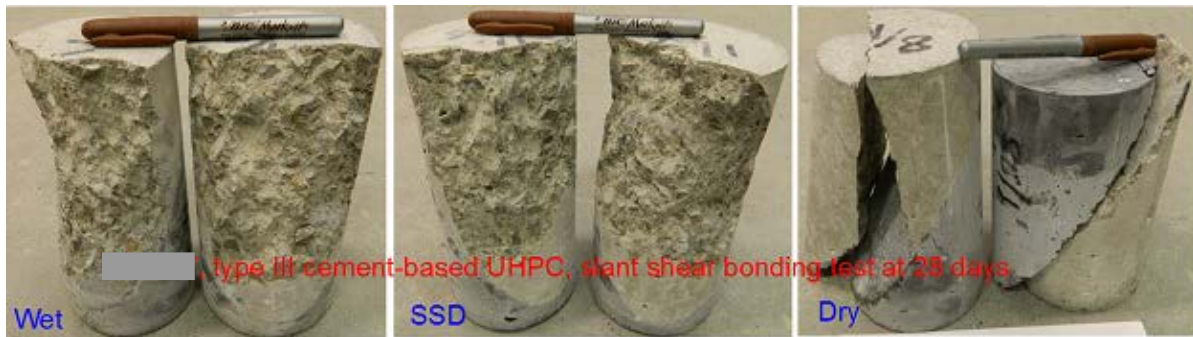
Figure G7-Failure mode of slant shear bond test at 28 days for type III cement-based UHPC with different substrate surface moisture conditions (#51)

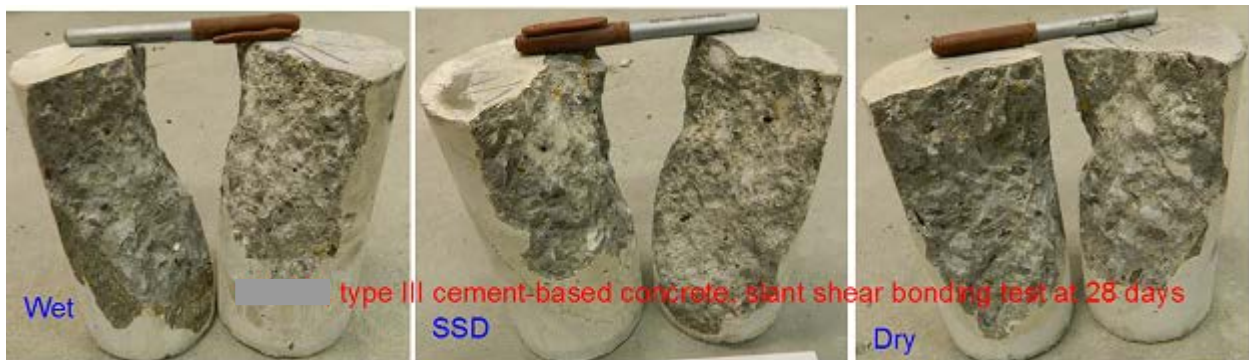
Figure G8-Failure mode of slant shear bond test at 28 days for type III cement-based concrete with different substrate surface moisture conditions (#52)

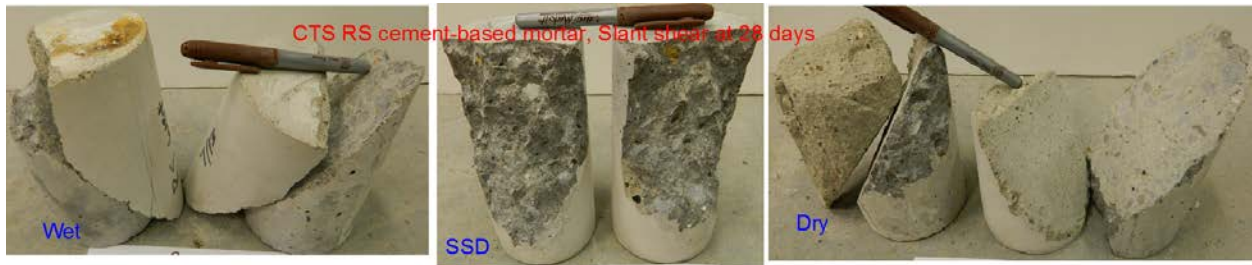
Figure G9-Failure mode of slant shear bond test at 28 days for CTS rapid-set cement-based mortar with different substrate surface moisture conditions (#54)

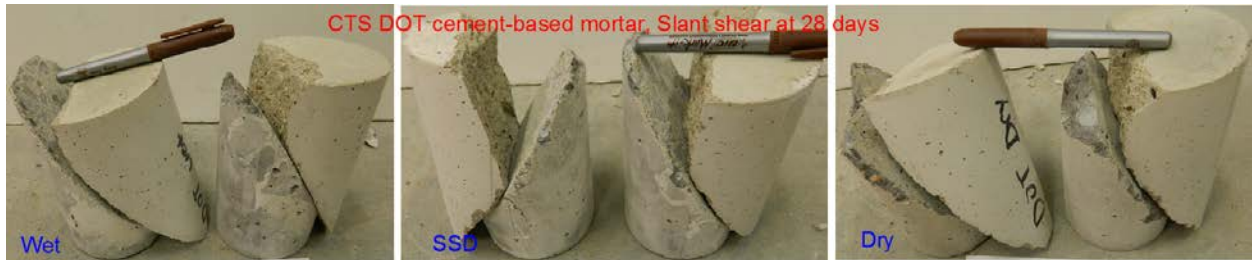
Figure G10-Failure mode of slant shear bond test at 28 days for CTS DOT cement-based mortar with different substrate surface moisture conditions (#55)

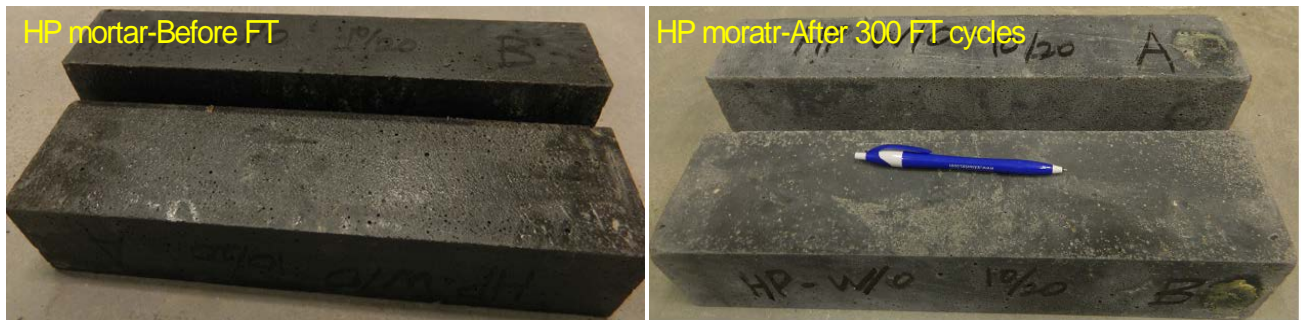
Figure H3-Visual appearance of freeze and thaw test specimens for type III cement-based high performance mortar (#48)

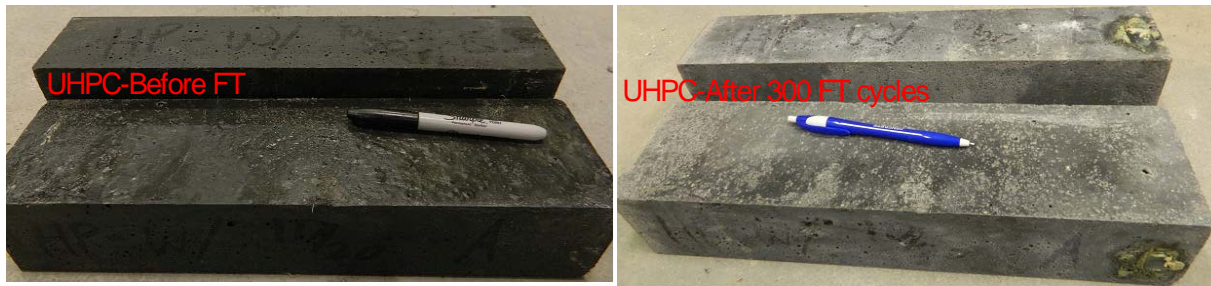
Figure H5-Visual appearance of freeze and thaw test specimens for type III cement-based UHPC (#51)

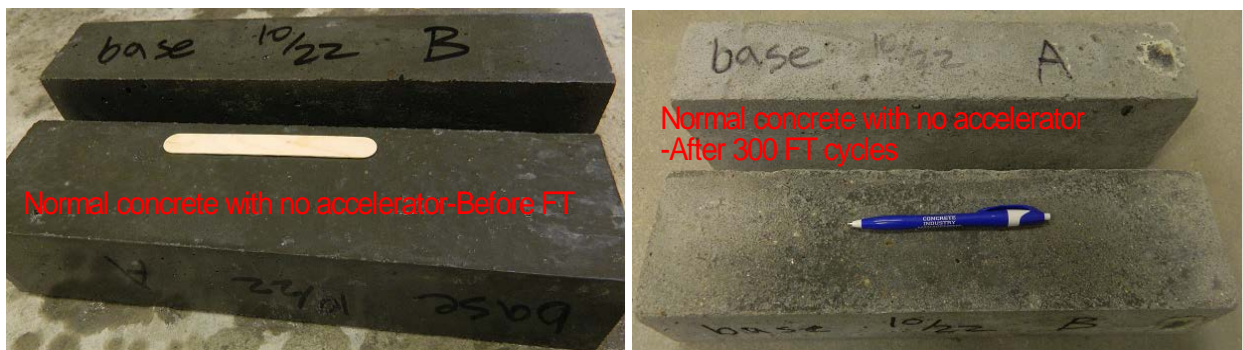
Figure H7-Visual appearance of freeze and thaw test specimens for type III cement-based concrete without accelerator (#53)

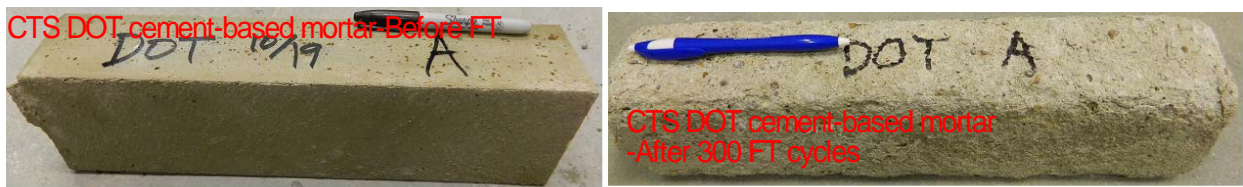
Figure H9-Visual appearance of freeze and thaw test specimens for CTS DOT cement-based mortar (#55)
