# **Maintenance Strategies for Open-graded Friction Course (OGFC)**

Submitted to the Tennessee Department of Transportation  
Research Development and Technology Program

Department of Civil and Environmental Engineering  
The University of Tennessee, Knoxville

August 2019

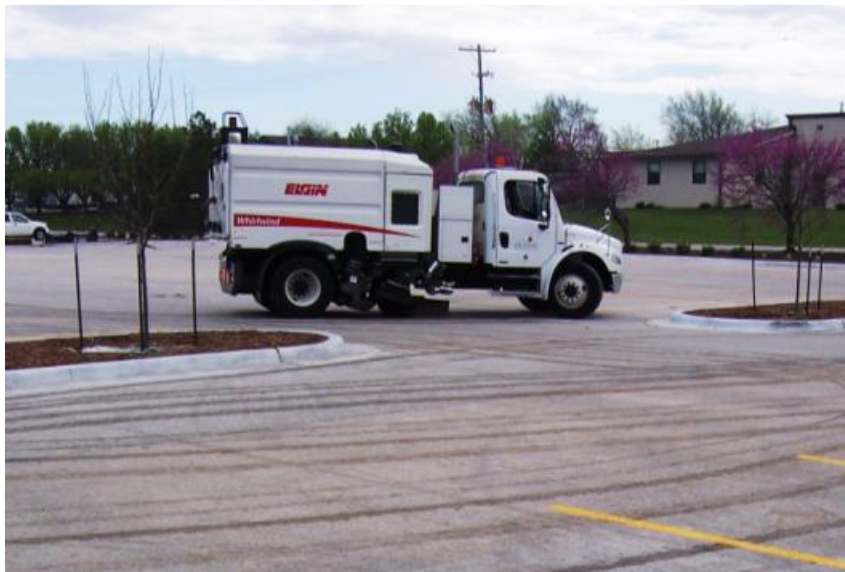
Figure 2-1 Typical pavement cleaning operations

According to the experience from Portland cement pervious concrete pavement, clog cleaning maintenance can be achieved by standard street cleaning equipment containing a vacuum to remove particles from the surface (Ferguson, 2005). Figure 2-1 shows routine maintenance on pervious concrete in Olathe, Kansas. The stripping seen in the picture is from water used for dust control. It should be noted that the typical cleaning speed used for traditional pavement or curb and gutter applications does not allow enough time to completely clean debris from the OGFC surface pores.

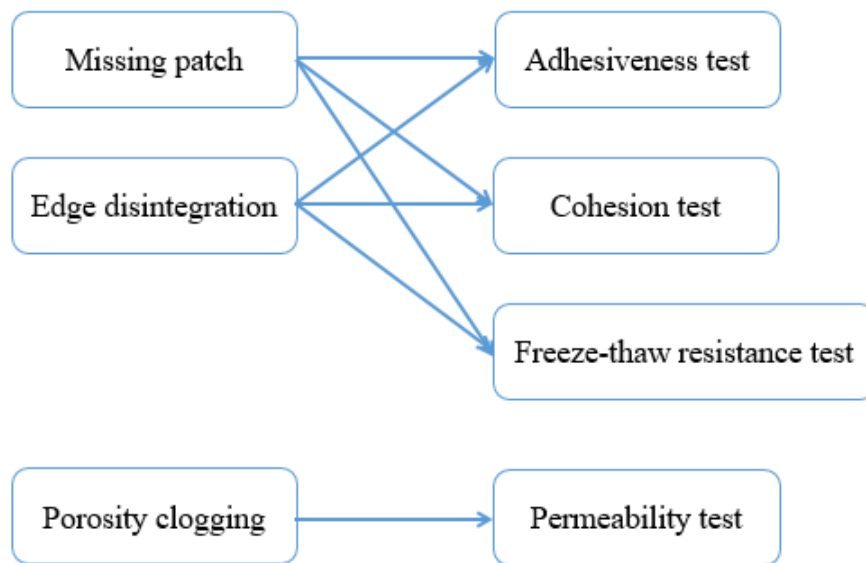
Figure 3-2 Distresses and lab tests

The main distresses after patching in OGFC pavements generally include missing patch, edge disintegration, and void clogging. To investigate the resistance of patching materials to those distresses, four laboratory tests were performed. Adhesiveness and

Figure 3-2 shows the distresses and corresponding proposed laboratory tests.

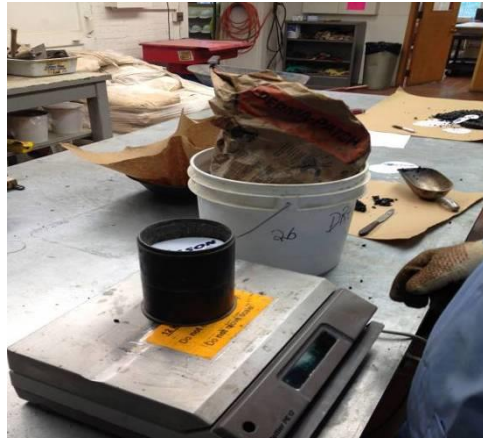
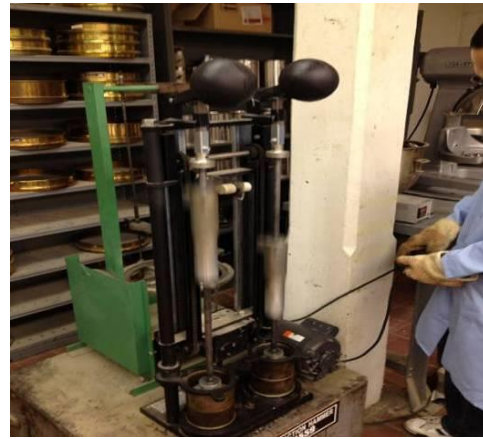
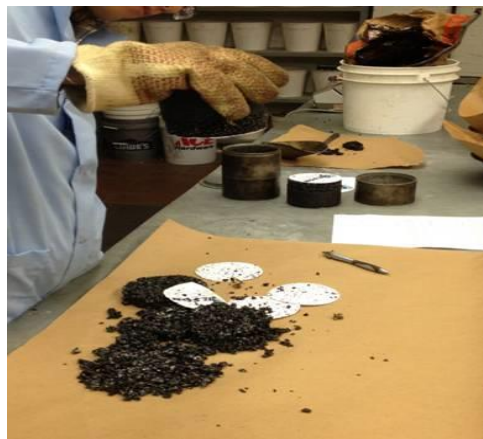
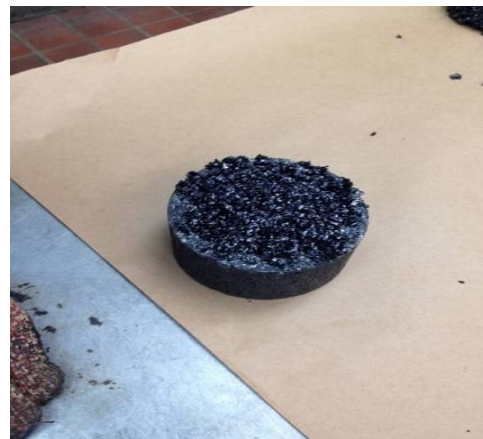
Figure 3-3 Procedure of adhesiveness test

(a) Weighing materials

(b) Sample compaction

(c) Measuring the Time

(d) Weighing the Remnants

Several laboratory tests have been tried in an effort to produce a suitable procedure to evaluate the adhesiveness of patching materials. Anderson et al. (1988) proposed a shear test to evaluate the bonding strength of patching materials with old pavement, but the results were inconclusive. In another study, Virginia DOT evaluated different cold mix patching materials through coating, stripping, cohesion, adhesion and workability tests, and they recommended an adhesion test procedure for quality control of cold patching materials (Prowell & Franklin, 1996). This study adopted this method as follows: Loose mixture of 500 g was placed in a 100-mm diameter Marshall mold on top of compacted HMA with a thickness of 75-mm and compacted with 10 blows of a standard Marshall hammer. The compacted sample was extruded, and then inverted. The adhesion of the mixture was measured by the amount of time it took for the specimen to debond from the substrate HMA. The test was conducted at room temperature (25°C). Figure 3-3 shows the testing procedure.

Aquaphalt is a pre-mixed repair material, which reacts and hardens with solely water. Therefore, water curing is necessary for Aquaphalt. Before compaction, water was added in the loose mixture. An adhesiveness test was performed 15 mins after the compaction. Water accounted for 10% of the mass of the mixture. To make the comparative

analysis, adhesiveness tests of all three patching materials were performed 15 mins after compaction.

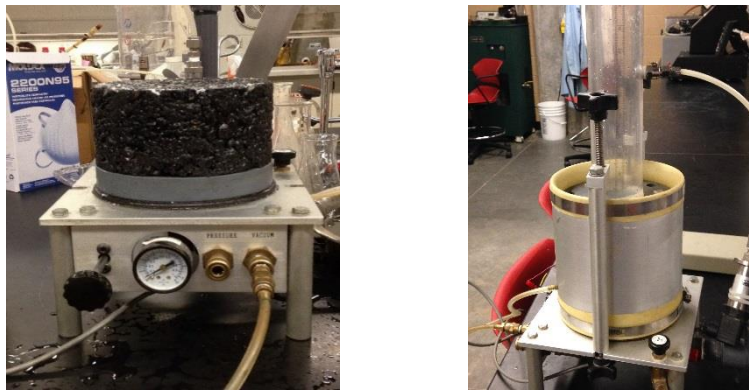
Figure 3-5 Permeability test setup and sample

Permeability is an important parameter of a pervious mixture since the material is designed to perform as a drainage layer in pavement structures. Due to the high porosity and the interconnected air voids path, Darcy's law for laminar flow is no longer applicable for pervious mixtures. In this study, a permeability measurement device and method developed by Huang et al. (Huang, Mohammad, & Chris Abadie, 1999) for drainable asphalt mixtures (similar to pervious concrete in function) were used. Figure 3-5 shows the specimen and device for the permeability tests.

$$v = \frac{dQ}{A_2dt} = \frac{A_1}{A_2} \frac{dh}{dt} = \frac{r_1^2}{r_2^2} \frac{dh}{dt} \quad (5)$$

where,  $Q$  is the rate of flow,  $A_1$  and  $A_2$  are the cross section areas of upper cylindrical reservoir and the specimen,  $r_1$  and  $r_2$  are the corresponding radius of upper cylindrical reservoir and the specimen.

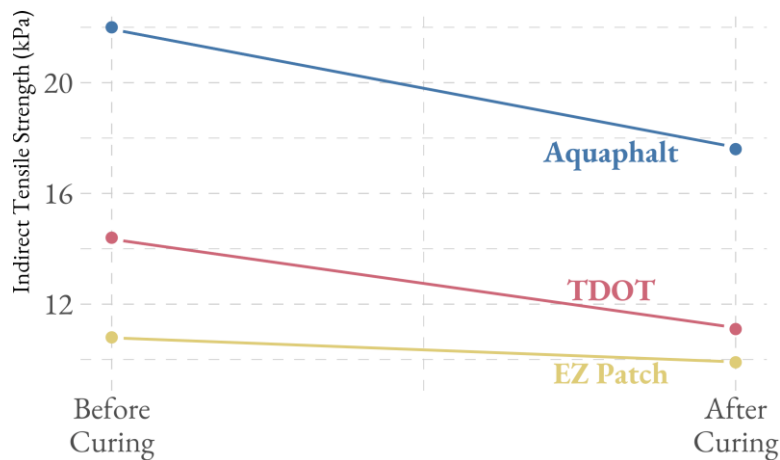
Figure 3-10 Indirect tensile strengths before and after freeze-thaw cycle

Figure 3-10 shows the indirect tensile strength of mixtures before and after the freeze-thaw cycle. As indicated, Aquaphalt had highest indirect tensile strength among the three-cold mixes, followed by TDOT cold patching then EZ Patch, mainly because the air voids of TDOT cold patching and EZ patching are higher than that of Aquaphalt. Figure 3-11 shows the TSR test results of different mixes. EZ patching shows the highest TSR value. However, its indirect tensile strengths before and after curing were the smallest of the three materials.

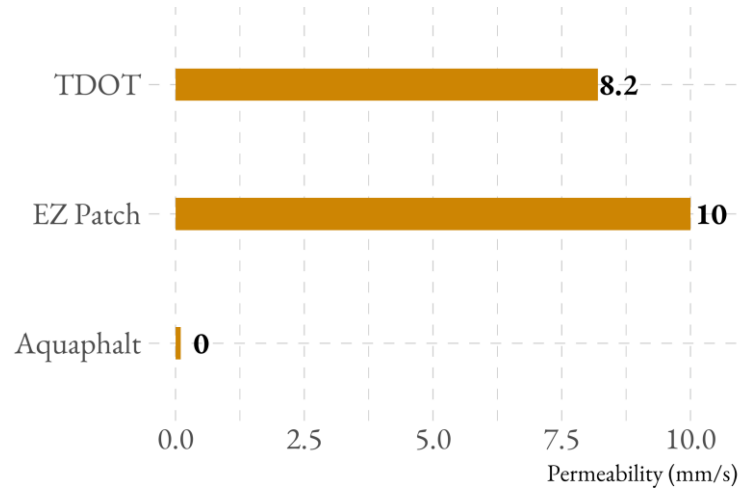
Figure 3-12 Permeability test result

For TDOT cold patching and EZ patching, the permeability showed just a slight difference.

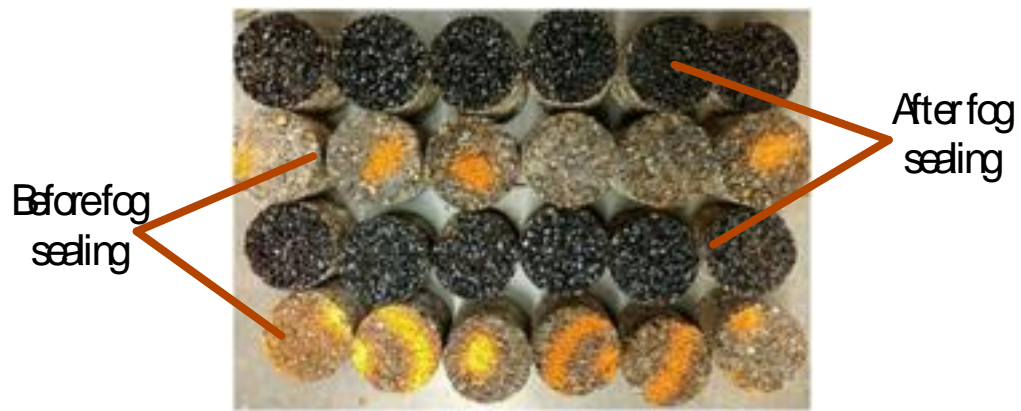
Figure 4-2 OGFC cores with and without fog seal treatment

seals, with 12 from the pavement shoulder and 12 from the traffic lane, as shown in Figure 4-2. The length of the section treated with fog sealing was about 300 m. On the pavement shoulder, two different application rates (0.59 l/m<sup>2</sup> and 0.36 l/m<sup>2</sup>) were used, while only one was used on the traffic lane (0.45 l/m<sup>2</sup>). Figure 4-3 schematically shows the application of fog seal and the locations of the cores. Figure 4-4 shows the OGFC pavements before and after the fog sealing treatment. It was around 1.5 hours between the fog sealing treatment and coring to let the asphalt emulsion break adequately.

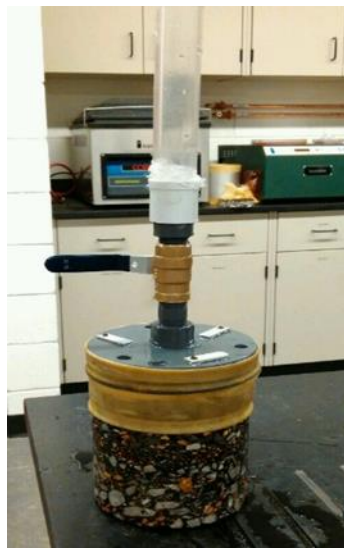
Figure 4-6 Permeability test setup

High permeability is an important function of OGFC, which allows water to drain off the pavement surface quickly, and thus significantly improves drivers' visibility in rainy days. Because the OGFC layer of the field project was only 3.2 cm thick and highly porous, it is hard to maintain the integrity of the OGFC layer when cutting cores. To avoid this issue, a new permeability test was developed (Figure 4-5 and Figure 4-6). During the test, the upper part of an OGFC specimen with a thickness of 2.2 cm was sealed by a membrane and the rest was left open for water flow. A plastic tube with a length of 87 cm was used to provide water head. The time required for the water in the standpipe to drop from the top to the bottom was recorded and then used to calculate the permeability.

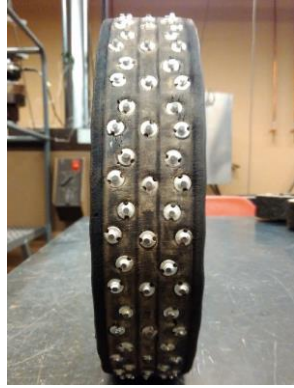
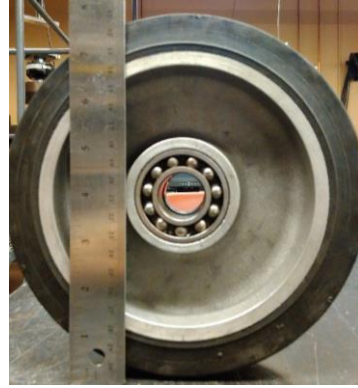
(a) Side view

(b) Front View

Figure 4-8 Studded rubber wheels for abrasion test

In this study, APA was utilized to measure the abrasion resistance of OGFC cores before and after applying fog sealing. To make the abrasion loss more significant, steel studs (2 mm in diameter and 3 mm in height) were embedded into the originally smooth rubber surface, as shown in Figure 4-8. The introduction of studs can better simulate the tires' abrasion action on the surface of OGFC pavements, and thus more realistically simulate the raveling failure of OGFC pavements.

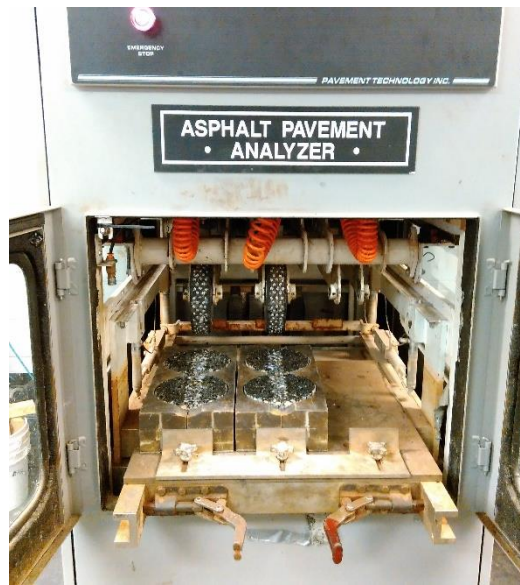
Figure 4-9 LWT abrasion test

Through the APA, the repeated wheel loads were applied to the cores by two moveable loaded wheels (Figure 4-9). Prior to testing, the original cores taken from the field were cut to fit into the specimen holder, which has a dimension of 75 mm in height and 152.4 mm in diameter. Before weighing the samples, the surfaces of the OGFC cores were cleaned by a steel brush to remove loose aggregate particles. Subsequently, the samples were placed into the APA and subjected to 12000 cycles of repeated loads at a frequency of 2 cycles/second. A wheel load of 800 N was applied to provide a sufficient impacting and abrasive force to the specimens, which was chosen through multiple trial tests. The weight loss after the LWT abrasion testing was used to evaluate the effect of the fog seal treatment, which was calculated as a percentage using Eq. (1):

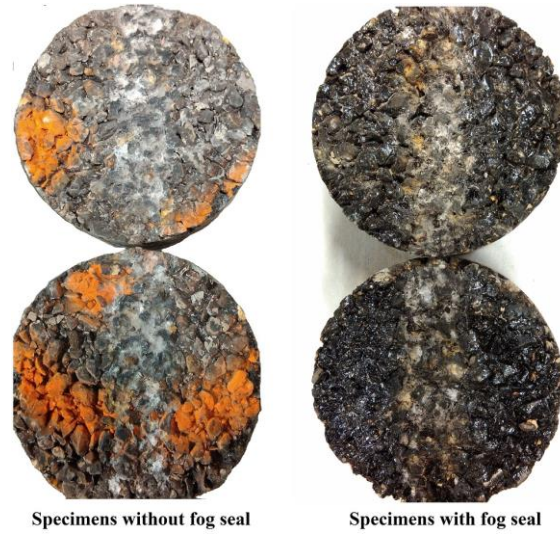
Figure 4-12 Cores after loaded wheel abrasion test

Figure 4-12 shows the specimens after the LWT abrasion test, and Figure 4-13 presents the results of the loaded wheel abrasion test. Clearly, when applying no fog seal, the abrasion loss was about 0.8% for the shoulder, and the fog seals used significantly reduced the abrasion loss. In the traffic lane, when applying fog seals at a rate of 0.45 l/m<sup>2</sup>, the abrasion loss was only about 0.5%, while the average abrasion loss reached 1% for samples without fog seal. The weight loss due to abrasion was reduced by about 50% after applying the fog seal.

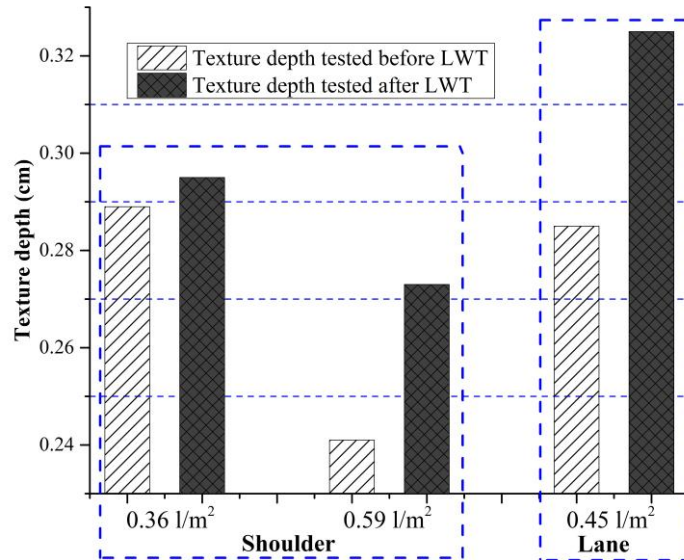
Figure 4-14 Comparison of texture depth before and after abrasion test

texture depth increased after the LWT abrasion test, indicating that the reduced texture depth of OGFC due to applying fog seals could be restored by abrasion. This situation also implies that although fog sealing reduced skid resistance of OGFC pavement, it could be restored by moving vehicles after opening to traffic.

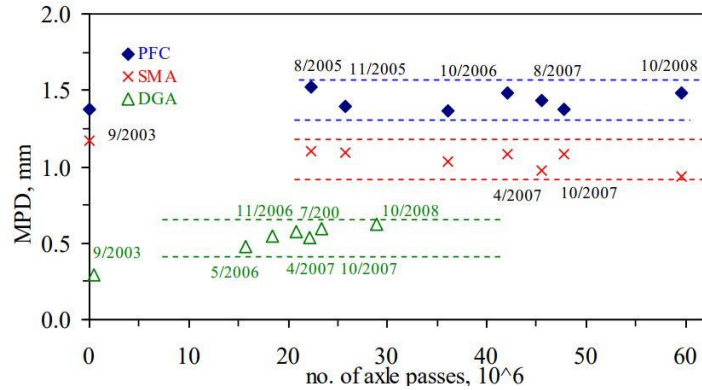
Figure 5-2 Change in texture depth, MPD: mean profile depth, in mm.

texture depth of OGFC was larger than those of SMA and DGHMA. In addition, the texture depth of OGFC did not change significantly after more than three years of service.

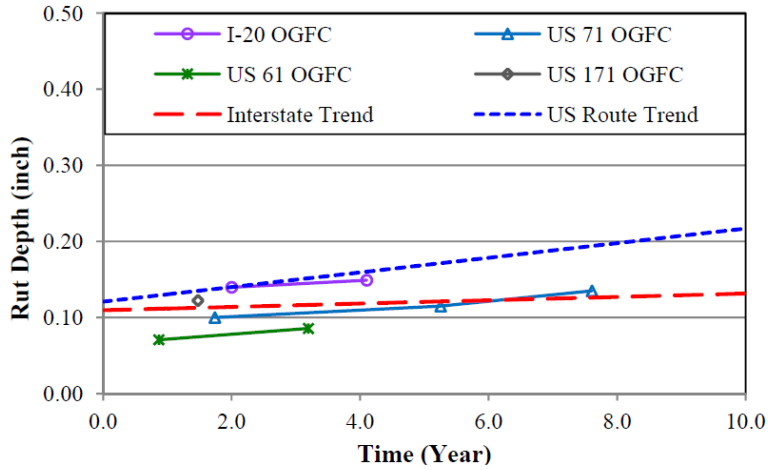
Figure 5-3 Rut depth

In Louisiana, the rutting, IRI, and random cracking data of OGFC were collected from PMS (Abadie, 2013). To compare the performance of sections with/without an OGFC layer, the data associated with early Louisiana Superpave roadways were collected from five Interstates (15,000–60,000 ADT) and four US routes (8,000–25,000 ADT, constructed in the late 1990s) (Kabir, Icenogle, King Jr, & Abadie, 2011). Since the construction and survey data for the OGFC and Superpave pavements were different, to show the developing trend of performance clearer, the performance indices (rut depth, IRI, and cracking) were plotted according to the same service time. Figure 5-3 shows the rutting development of OGFC, and the Interstate and US route trends were drawn using the Superpave data only. It was observed that the overall rutting performance of OGFCs was considerably better than those of the Superpave US routes.

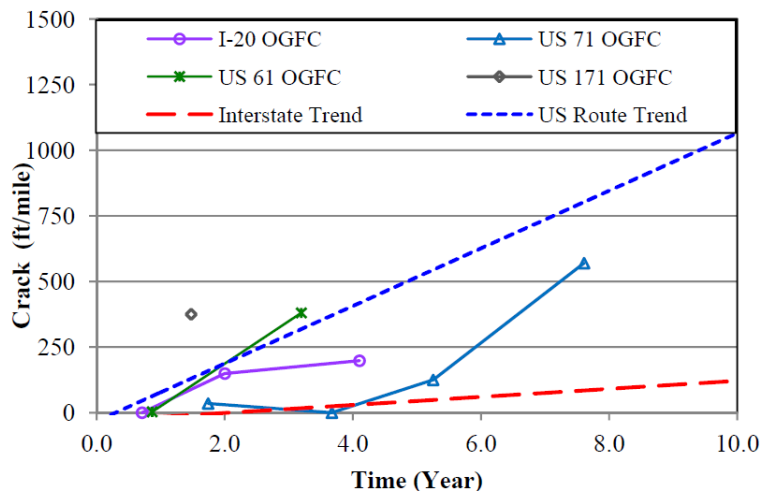
Figure 5-5 Random cracking

and transverse cracks (Kabir et al., 2011). The number of cracks in I-20 was larger than that of the Interstate trend, whereas the number of cracks in US 71 OGFC was significantly lower than that of the US route trend. The number of cracks in US 171 OGFC at the first service year were significantly larger than other test sections, which could most probably be due to construction quality variation. When considering rutting, IRI, and cracking, OGFC was found to have comparable performances with conventional Superpave mixtures.

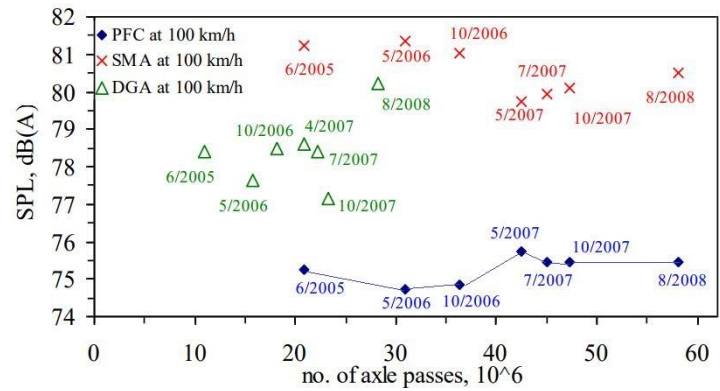
Figure 5-6 Change in noise

The changes of noise were recorded in a segment of I-74 locating in the east of Indianapolis (McDaniel 2010). It can be observed from Figure 5-6 that the OGFC (PFC) pavement had a lower level of noise in contrast to the SMA and DGHMA pavements. For the OGFC pavement, the sound pressure level (SPL) value slightly increased from June 2005 to Aug. 2008.

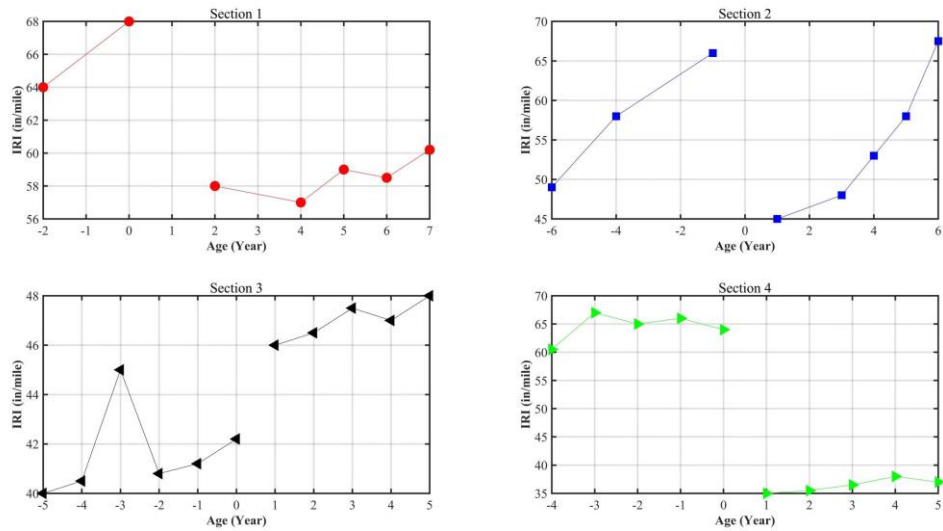
Figure 5-7 IRI of four sections

The IRI data was shown in Figure 5-7. The horizontal axis in the figure is the service time of pavement. Negative values on the axis mean the years before the OGFC treatment and positive values indicate the years after treatment. It should be noted that the performance data corresponding to year 0 could be measured either before or after the treatment. It can be seen that the IRI clearly decreases after the OGFC treatment except for Section 3. Taking Section 4 as an example, the IRI before the treatment was above 60 inch/mile, whereas it was below 40 inch/mile after the treatment. For Section 3, the IRI was maintained between 40 and 50 inch/mile and the performance improvement was indiscernible. It can be concluded that for most OGFC pavements, the roughness performance was improved after the treatment. All OGFC pavements maintained an excellent level of roughness for five years of service.
